Canadian Coast Guard Foreshore Biophysical Survey

**Public Works and Government
Services Canada**

Final Report

February 2013

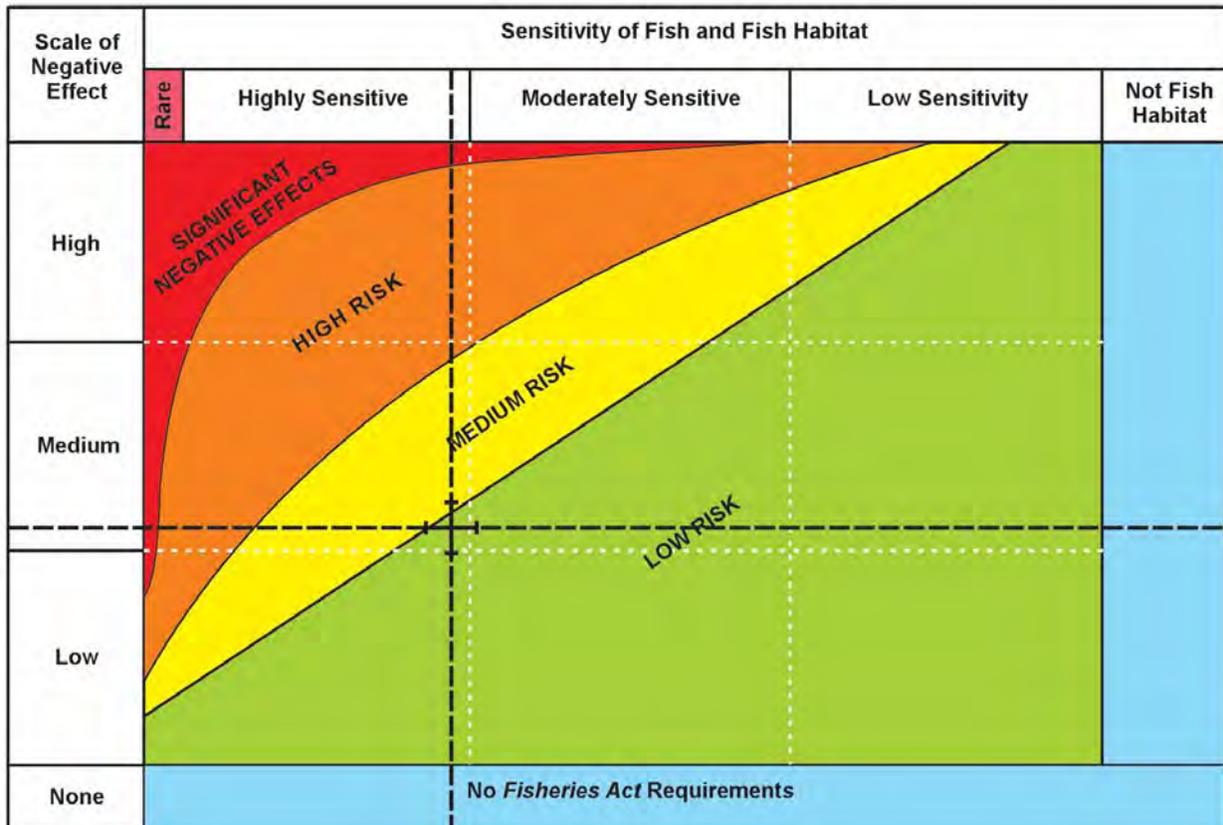
Figure 1: Risk Assessment Matrix with Overall Risk to Fish and Fish Habitat

Table 6: Sensitivity of Fish and Fish Habitat				
Species Sensitivity	Species' Dependence on Habitat	Rarity	Habitat Resiliency	Overall Rank (L, M, H)
Eelgrass is considered sensitive marine habitat and ran along all transects running in an intermittent band between 110 m and 80 m from the HHWM, to 120 m along Transect 1 and 2, 135 m along transect 5, and to 140 m from the HHWM along transect 4	Eelgrass plays an important role in the ecological function and biophysical structuring of nearshore marine environments by filtering the water column, stabilizing sediment, buffering shorelines and providing valuable habitat (refuge, rearing and feeding habitat) Eelgrass meadows have high levels of primary production. Several organisms were observed using the eelgrass habitat including hooded nudibranchs (in abundance at several locations)	No rare or protected species were observed in the area	Structures may have initial physical impacts on eelgrass habitat where pilings are installed. Eelgrass may be affected by reduced solar inputs beneath the installed dock Habitat would be very sensitive to any spills or grounding effects	H

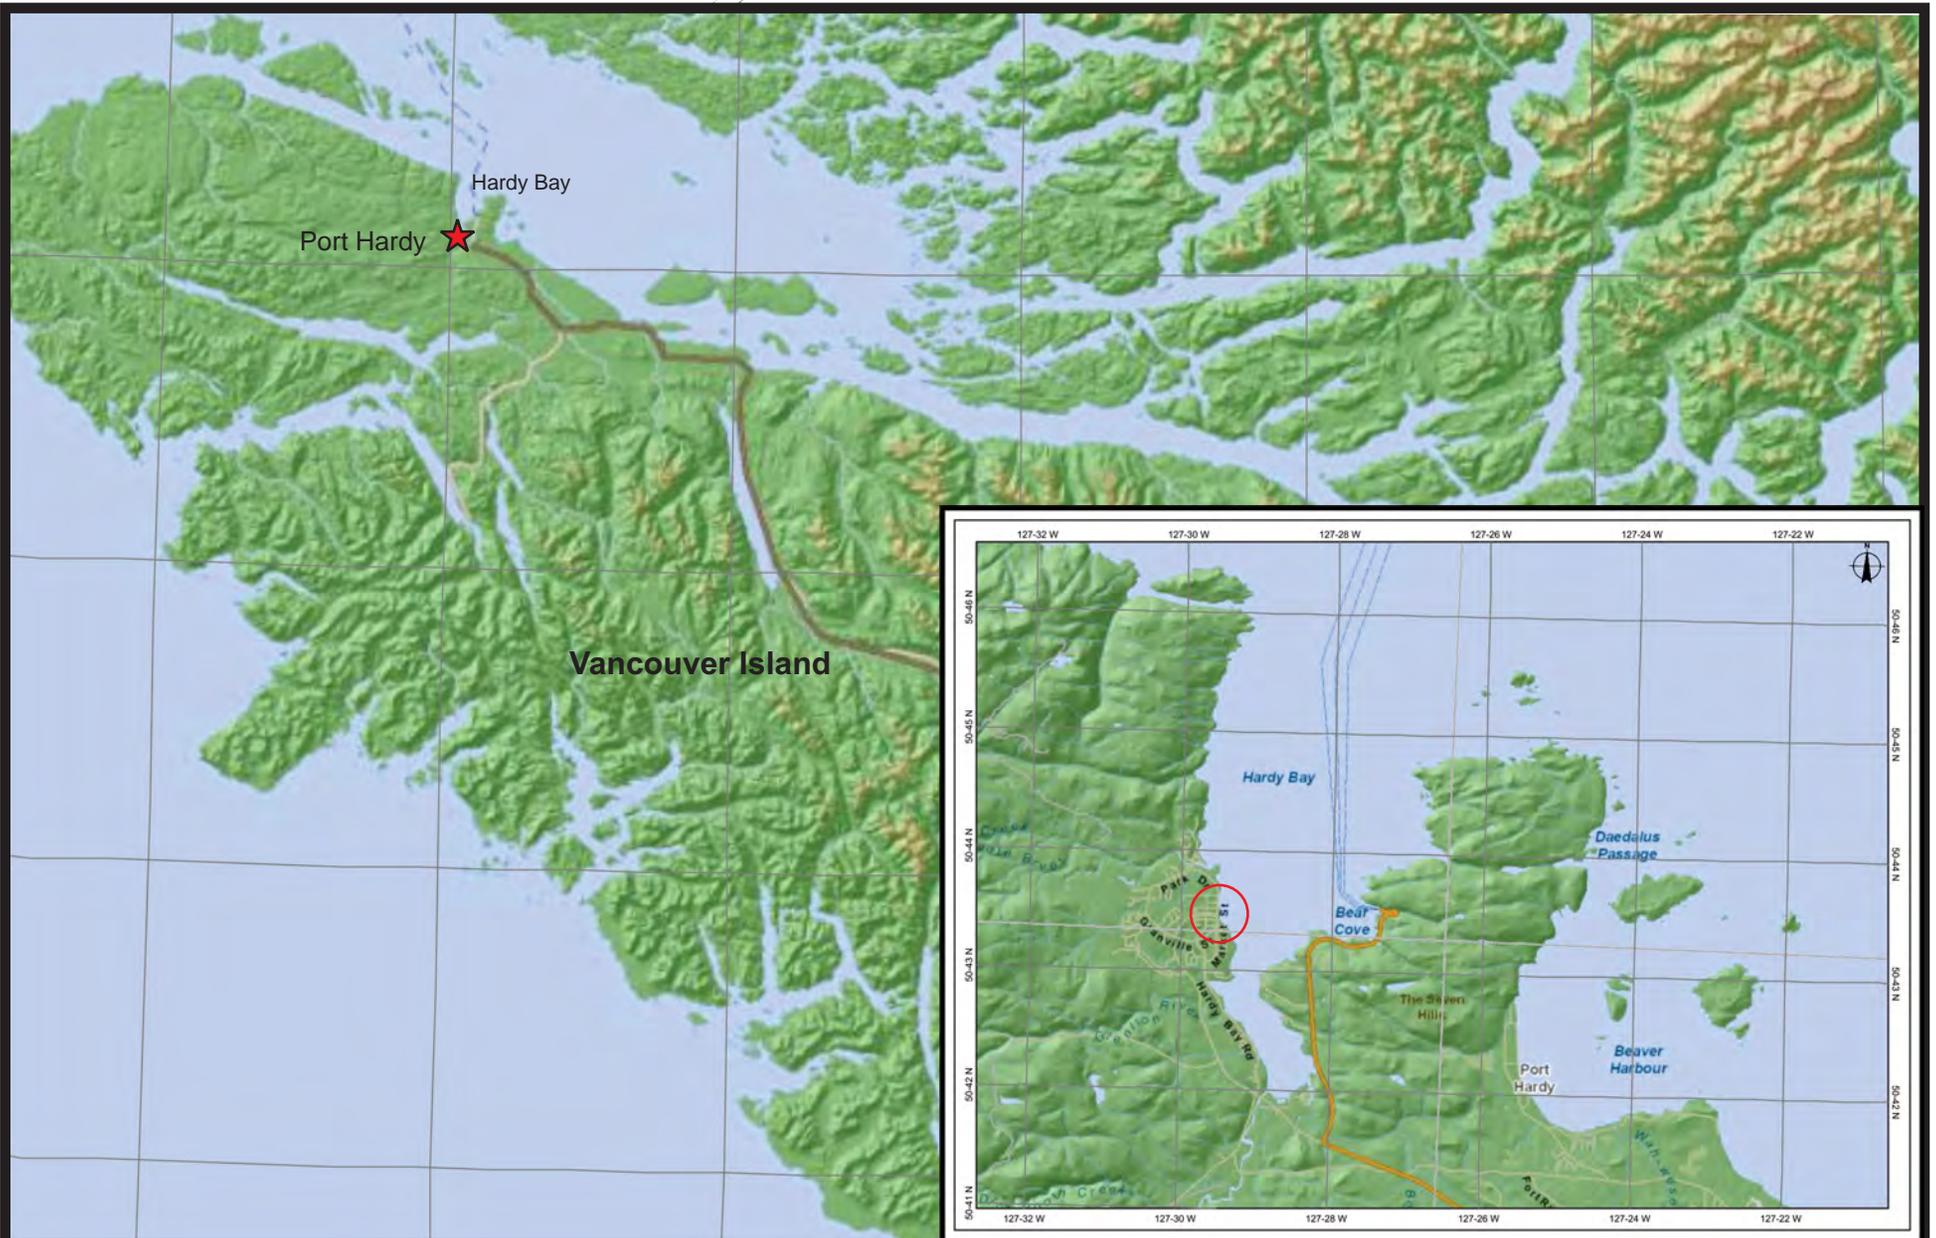
Figure 1: Proposed Development Site Overview
 Imagery Source: iMapBC; Basemap 1:1,000,000; Insert 1:60,000
 Created: January, 2013
 Created by AC
 Datum: NAD83

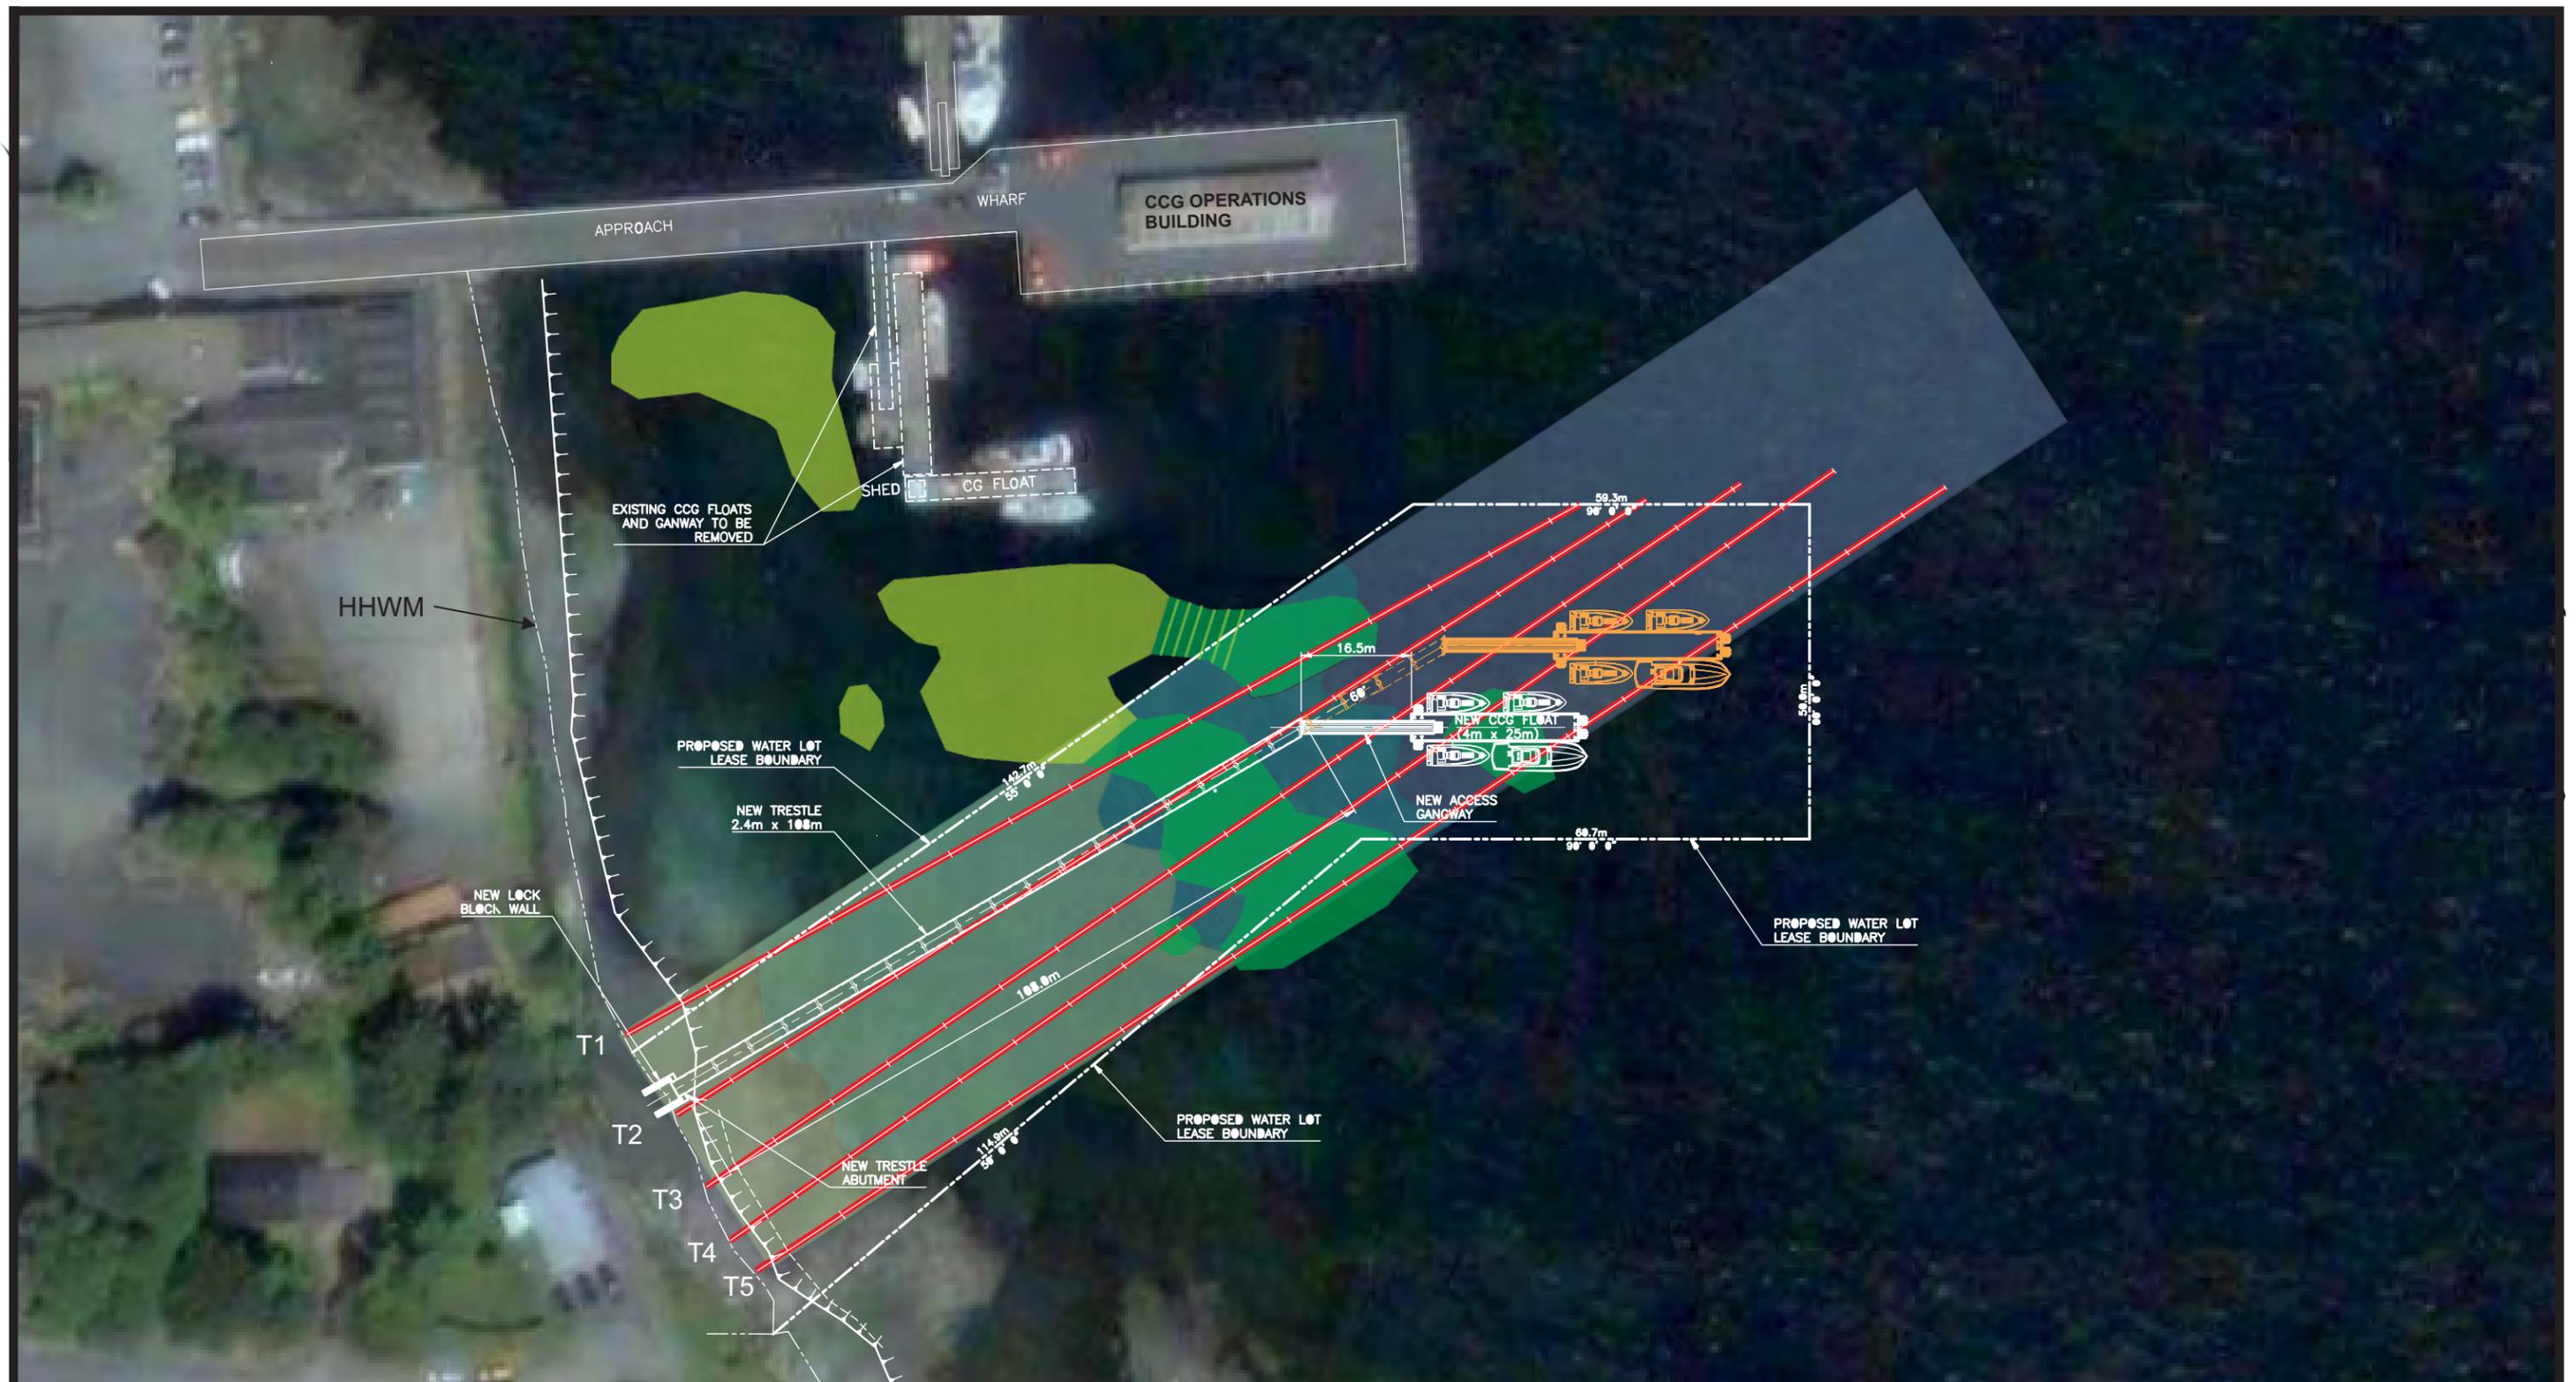
Figure 4: Alternate Siting Alignment

Created: February, 2013
 Created By: AC
 Datum: NAD83

For definitions of technical terms used in this section to describe species abundances and substrate classes refer to the methods section of this report. Tables 1 through 5 (Appendix 3) summarize field observations of the biophysical surveys conducted on Transects 1 through 5 over the four above-mentioned zones. Figures 4 (Appendix 1) show depth contour profiles of each transect.

As part of the biophysical survey, eelgrass was identified and the approximate location of eelgrass beds were mapped (Figure 3 and Figure 4; Appendix 1). As proposed, the CCG float may be situated over a small portion of eelgrass. Figure 4 (Appendix 1) provides a possible alternate siting alignment for the float, moving its location further to the northeast to avoid the eelgrass beds.

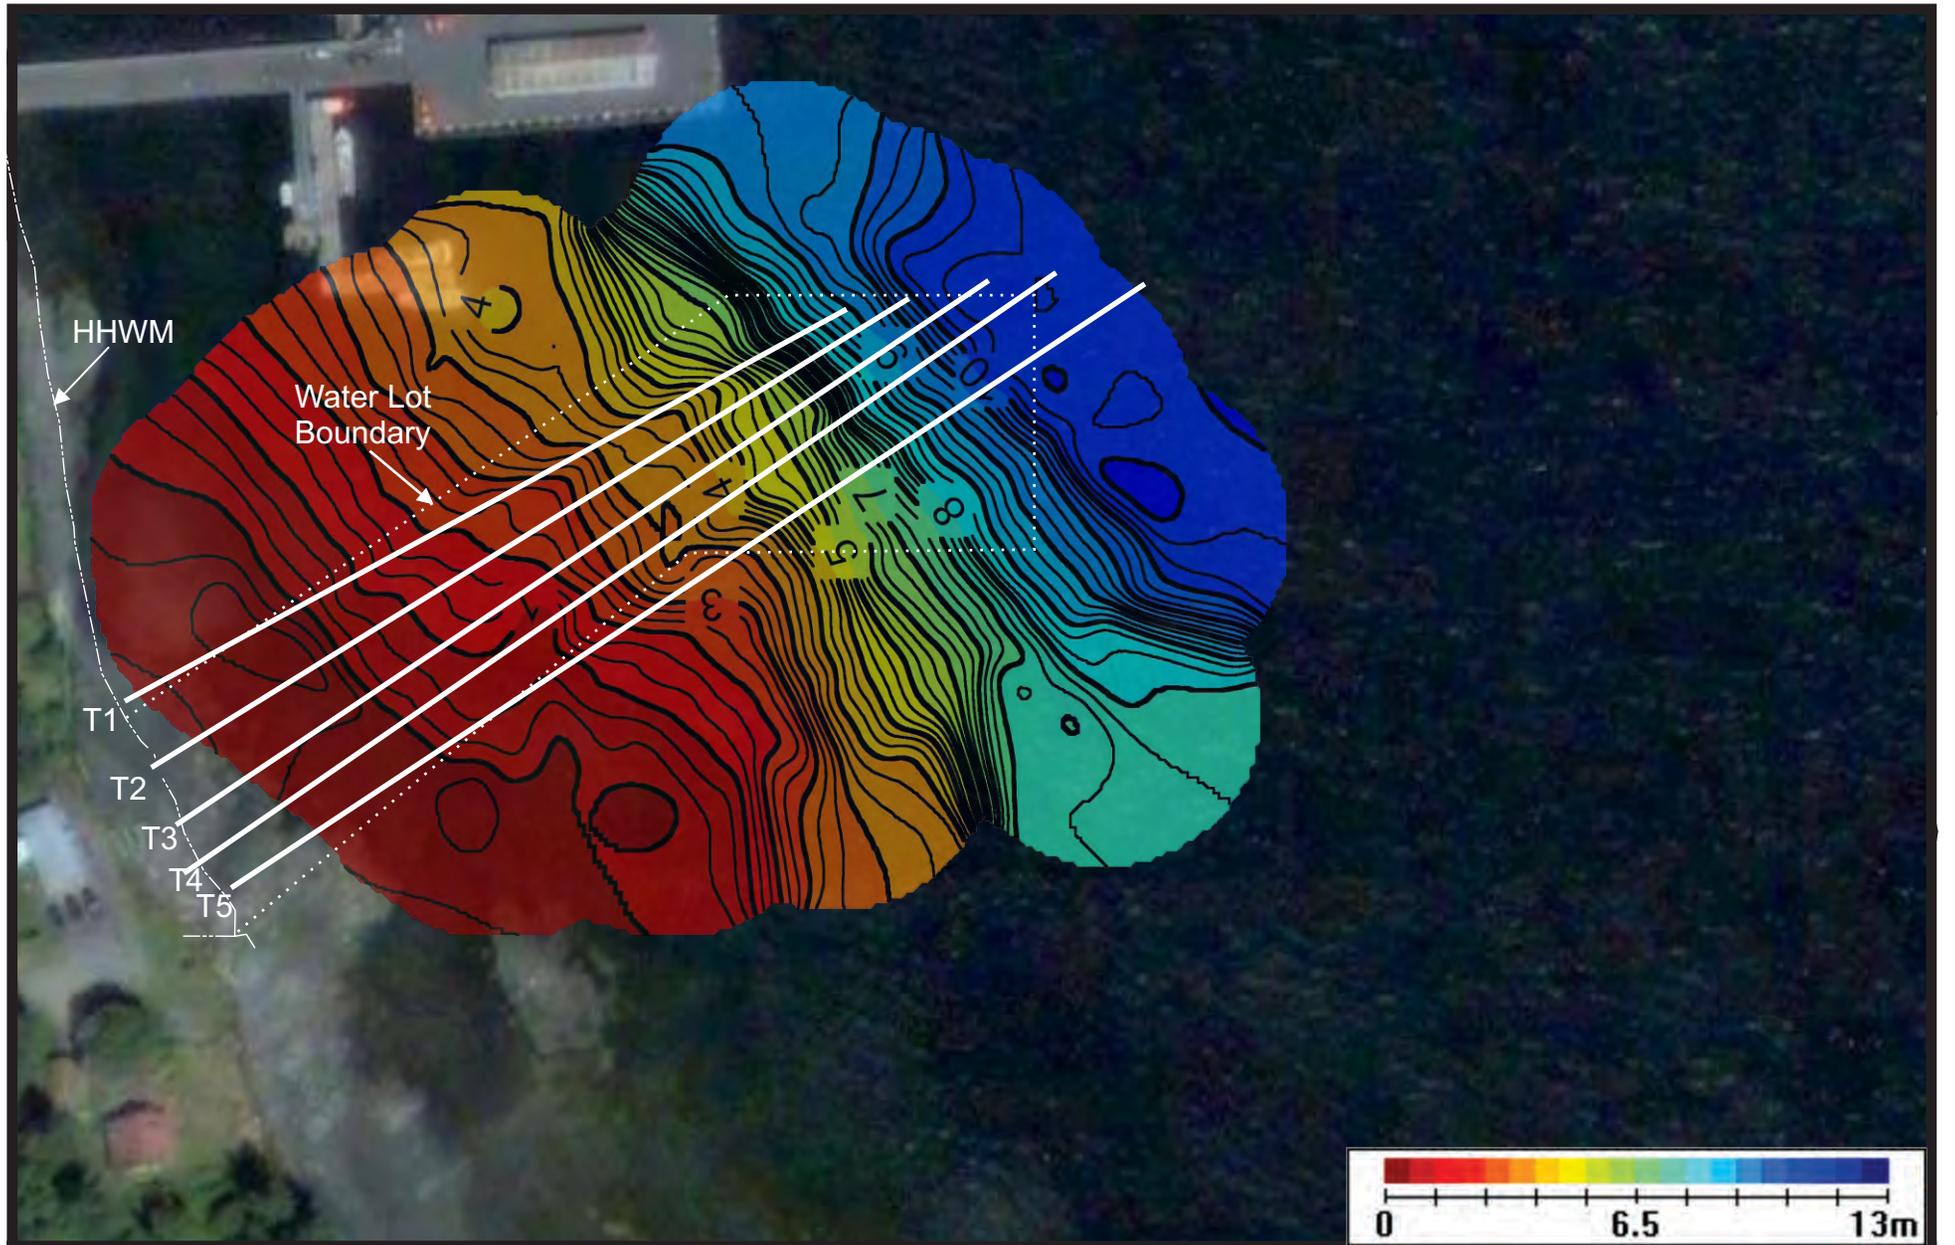
Figure 5: Bathymetry
 Created: January, 2013
 Created by AC
 Datum: NAD83

Data from bathymetric surveys was then overlaid on previously created maps of the water lot to display shore contour data. Figure 5 (Appendix 1) provides a schematic of subtidal bathymetry for the project site.

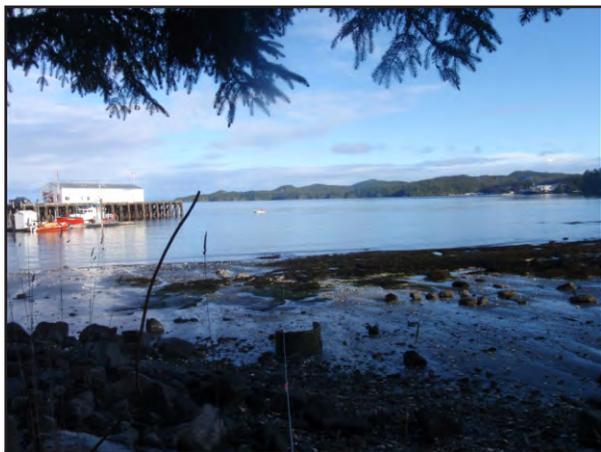
Photo 7: Transect 1 (0 m); looking northeast at transect foreshore and SCUBA survey vessel (December 18, 2012)

The first 0 m to 5 m from the HHWM included a steep boulder and riprap slope with terrestrial grasses protruding from between the boulders. Cobble and gravel substrates were also dominant directly adjacent to the boulder slope. Extending towards the water from the boulder wall substrates were dominated by sand and shell hash with occasional boulder or cobble patches. Between 15 m and 19 m from the HHWM, intermittent sections of flat bedrock were noted as the dominant substrate (Photos 7, 8, 20, 32, 44 and 56, Appendix 2).

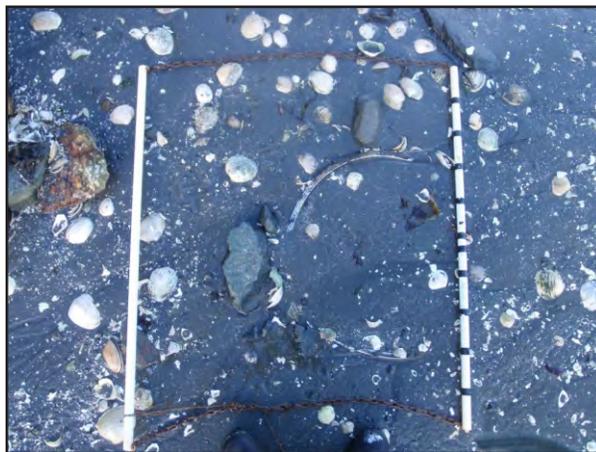
Photo 8: Transect 1 (10 m); Upper Intertidal Zone; looking at sand and shell hash substrate (December 18, 2012)

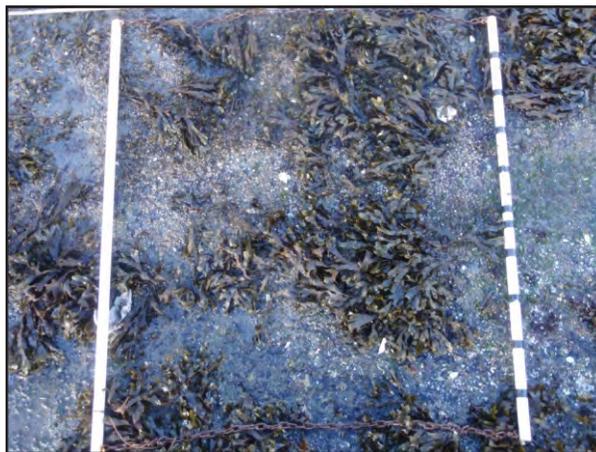
Photo 10: Transect 1 (30 m); Mid Intertidal Zone; looking at quadrat with rockweed (December 18, 2012)

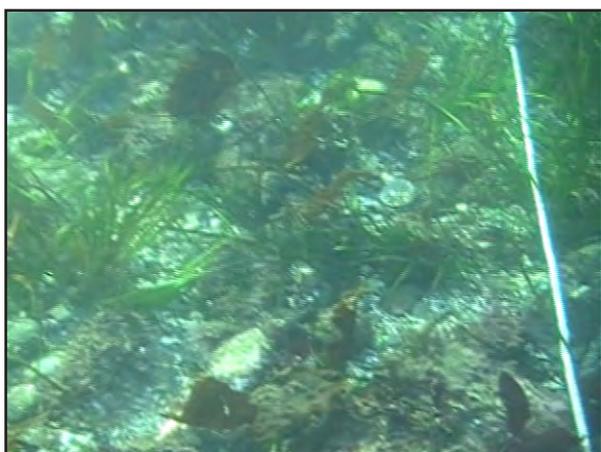
Photo 11: Transect 1 (90 m); Lower Intertidal Zone; looking at substrate with eelgrass present (December 18, 2012)

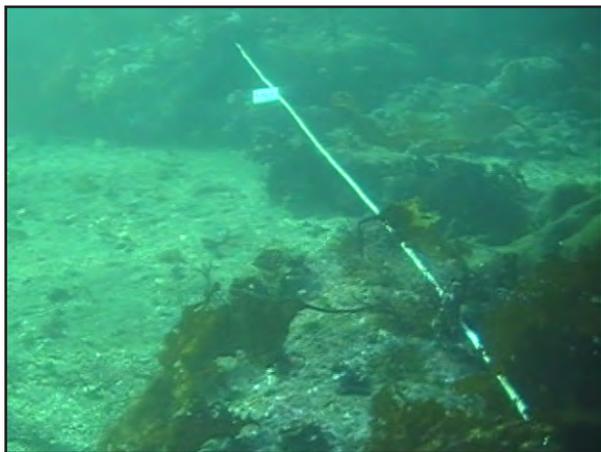
Photo 13: Transect 1 (135 m); Subtidal Zone; looking at silt/sand and boulder substrate (December 18, 2012)

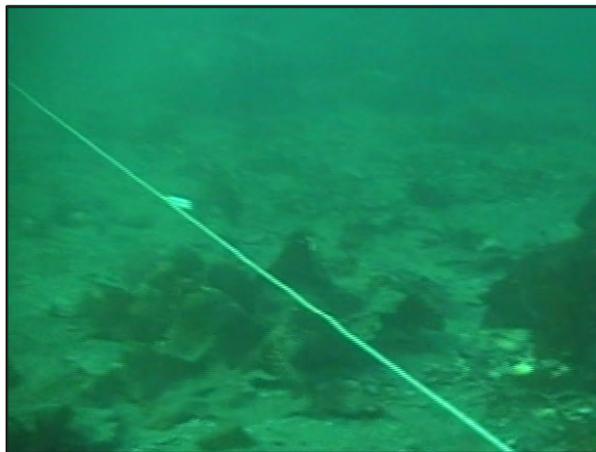
Photo 14: Transect 1 (150 m); Subtidal Zone; looking at silt substrate (December 18, 2012)

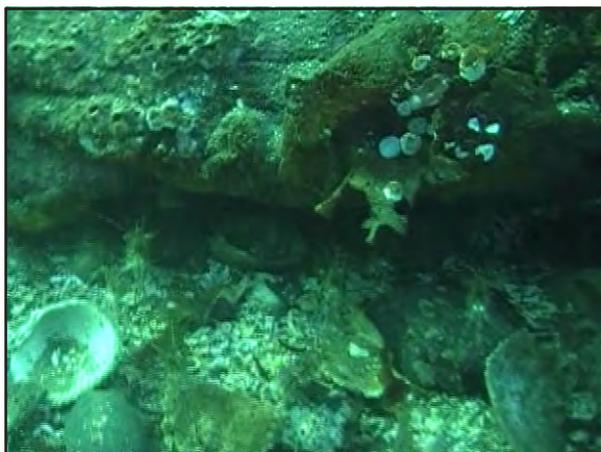
Photo 15: Transect 1 (140 m); Subtidal Zone; looking at small (~1 m tall) rock wall (December 18, 2012)

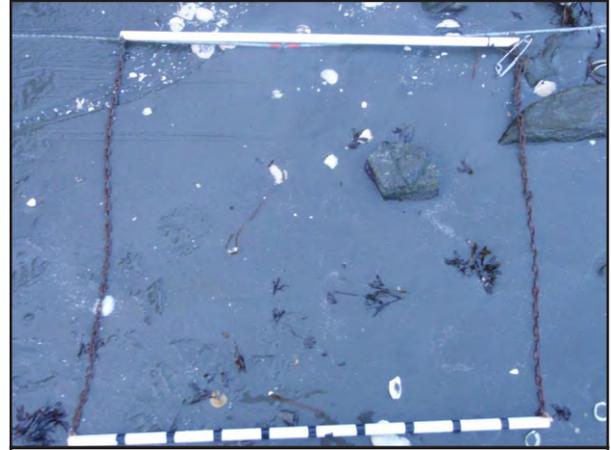
Photo 20: Transect 2 (10 m); Upper Intertidal Zone; looking at sand substrate (December 18, 2012)

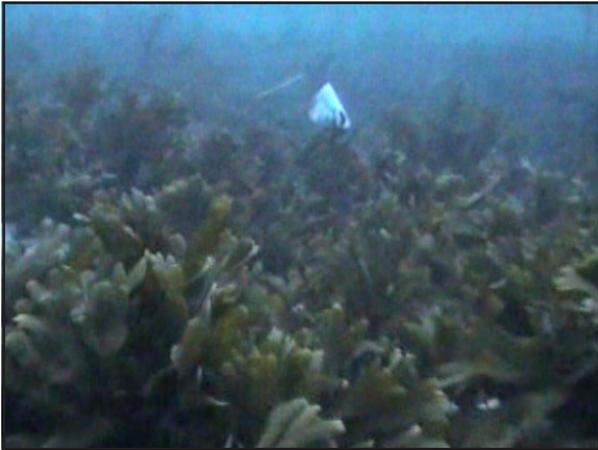
Photo 21: Transect 2 (30 m); Mid Intertidal Zone; looking at rockweed covering substrate (December 18, 2012)

- Photo 21: Transect 2 (30 m); Mid Intertidal Zone; looking at rockweed covering substrate (December 18, 2012)
- Photo 22: Transect 2 (70 m); Mid Intertidal Zone; looking at silt substrate (December 18, 2012)

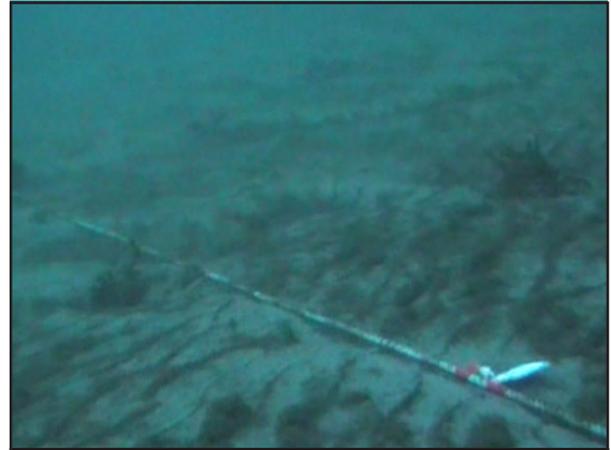
Photo 22: Transect 2 (70 m); Mid Intertidal Zone; looking at silt substrate (December 18, 2012)

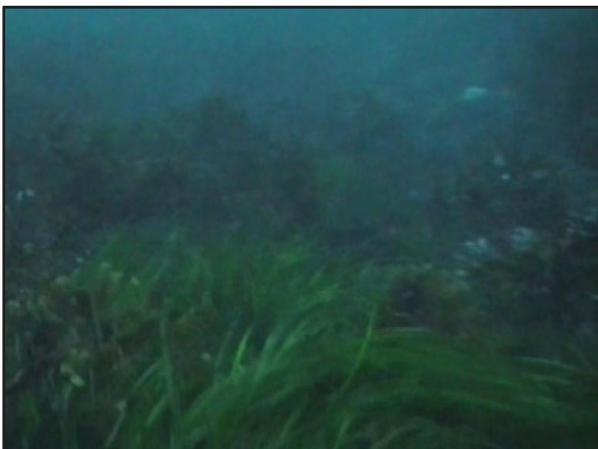
Photo 23: Transect 2 (85 m); Lower Intertidal Zone; looking at eelgrass covering substrate (December 18, 2012)

- Photo 23: Transect 2 (85 m); Lower Intertidal Zone; looking at eelgrass covering substrate (December 18, 2012)
- Photo 24: Transect 2 (105 m); Lower Intertidal Zone; looking at eelgrass covering substrate (December 18, 2012)

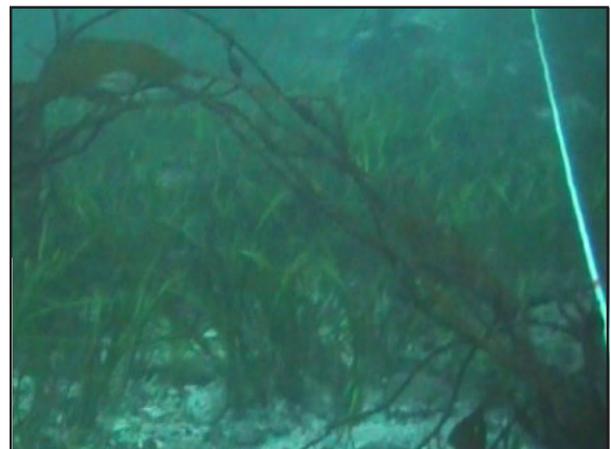
Photo 24: Transect 2 (105 m); Lower Intertidal Zone; looking at eelgrass covering substrate (December 18, 2012)

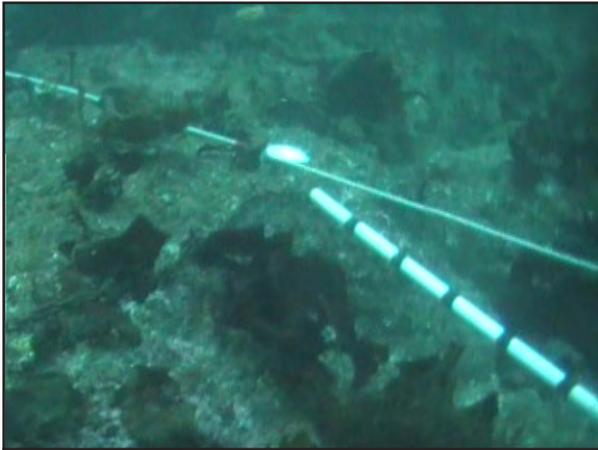
Photo 25: Transect 2 (120 m); Subtidal Zone; looking at boulder substrate (December 18, 2012)

- Photo 25: Transect 2 (120 m); Subtidal Zone; looking at boulder substrate (December 18, 2012)
- Photo 26: Transect 2 (150 m); Subtidal Zone; looking at small (~1 m) rock wall (December 18, 2012)

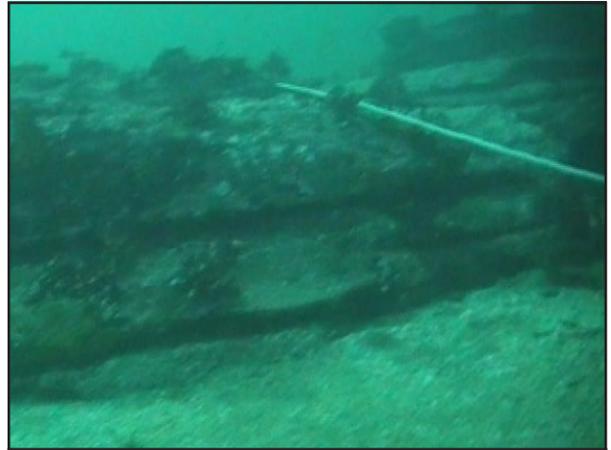
Photo 26: Transect 2 (150 m); Subtidal Zone; looking at small (~1 m) rock wall (December 18, 2012)

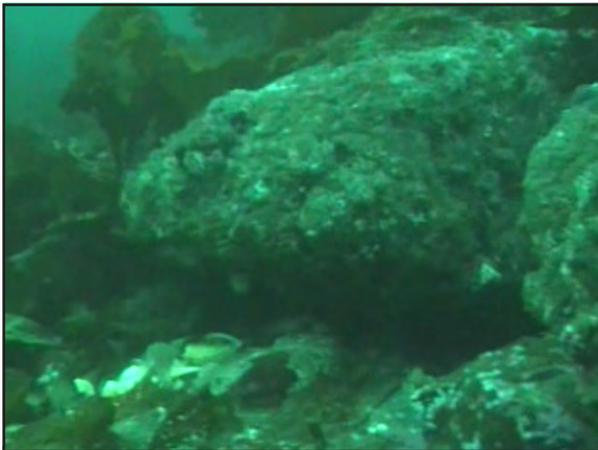
Photo 27: Transect 2 (~180 m); Subtidal Zone; looking at boulder substrate (December 18, 2012)

- Photo 27: Transect 2 (~180 m); Subtidal Zone; looking at boulder substrate (December 18, 2012)
- Photo 28: Transect 2 (120 m); Subtidal Zone; looking at kelp growing near transect line (December 18, 2012)

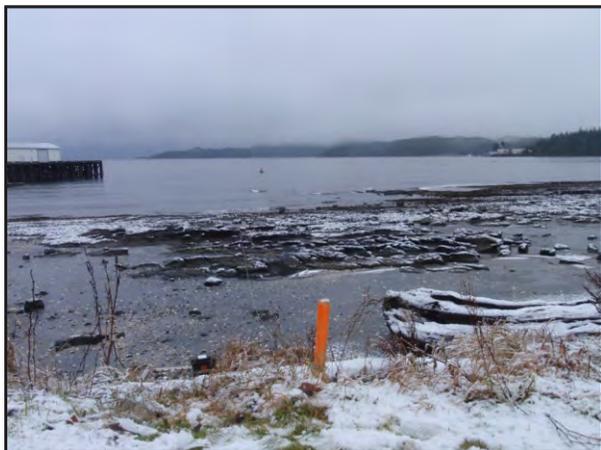
Photo 31: Transect 3 (0 m); Upper Intertidal Zone; looking at foreshore and transect marker from HHWM (December 19, 2012)

- Photo 31: Transect 3 (0 m); Upper Intertidal Zone; looking at foreshore and transect marker from HHWM (December 19, 2012)
- Photo 32: Transect 3 (5 m); Upper Intertidal Zone; looking at riprap wall and CCG building behind HHWM (December 19, 2012)

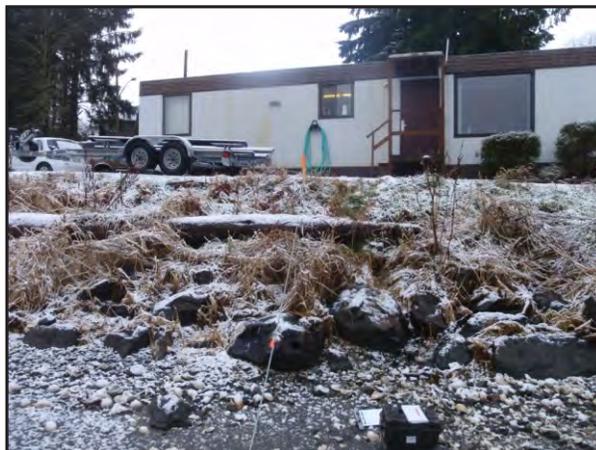
Photo 32: Transect 3 (5 m); Upper Intertidal Zone; looking at riprap wall and CCG building behind HHWM (December 19, 2012)

The HHWM was located at the top of a sloped riprap wall (~1.5 m high) with terrestrial grasses interspersed between the rip rap boulders (Photo 32, Appendix 2). Large woody debris (logs) was noted as part of the wall at the south end of the site, near Transect 5 (Photo 55, Appendix 2). At the top of the riprap wall the ground leveled out with the Canadian Coast Guard accommodation building located behind the POC at Transect 3 (Photo 32, Appendix 2). Between the accommodation building and the top of the riprap wall there was small patch of lawn and a gravel path extending along the entire site.

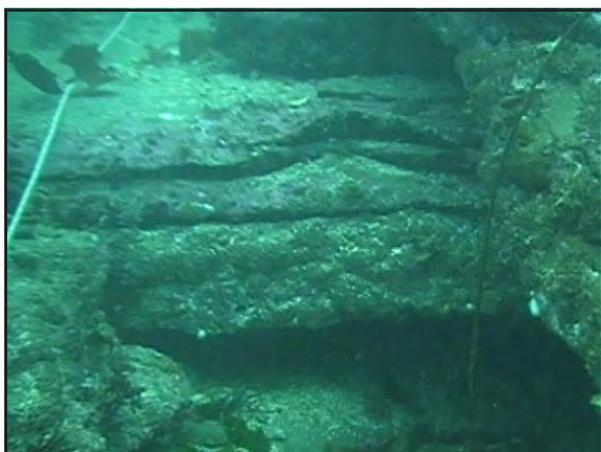
Photo 41: Transect 3 (150 m); Subtidal Zone; looking at bedrock wall (December 19, 2012)

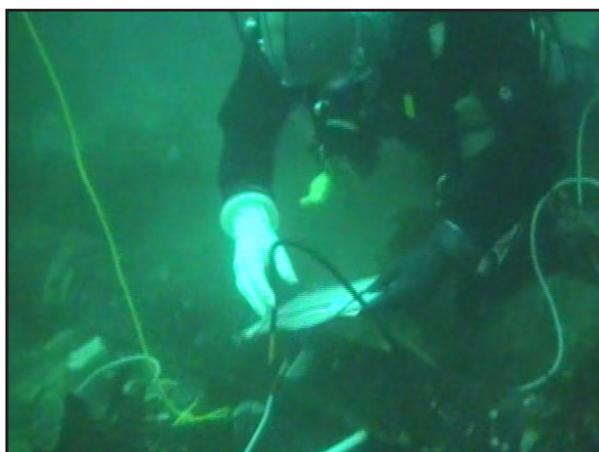
Photo 42: Transect 3 (183 m); Subtidal Zone; looking at end of transect and pipeline (December 19, 2012)

A pipeline was noted running across the site at 183 m on Transect 3 and 190 m on Transect 4 and 5 (Photos 42 and 65, Appendix 2).

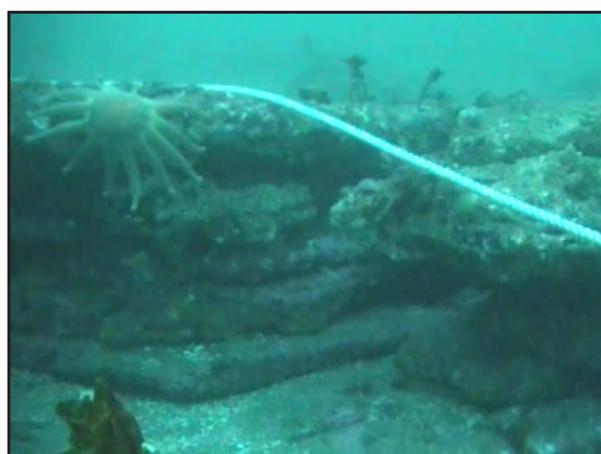
Photo 54: Transect 4 (145 m); Subtidal Zone; looking at small (~1 m tall) rockwall (December 19, 2012)

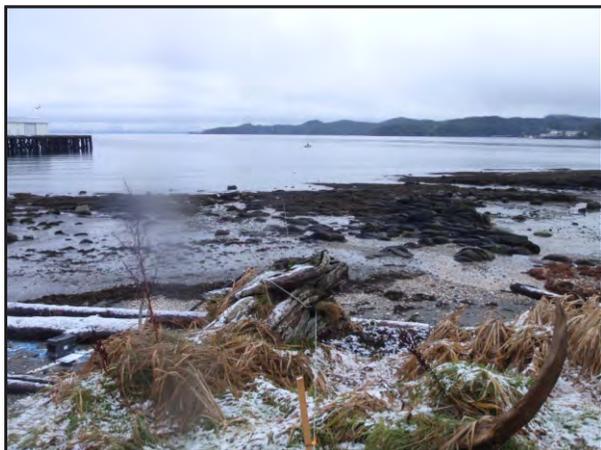
Photo 55: Transect 5 (0 m); Upper Intertidal Zone; looking at transect foreshore from HHWM (December 20, 2012)

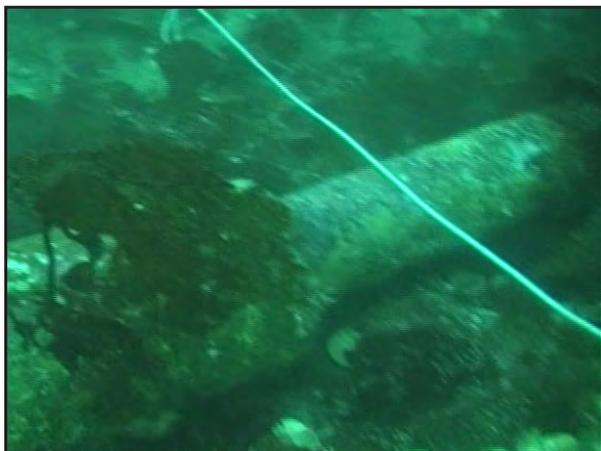
Photo 65: Transect 5 (190 m); Subtidal Zone; looking at pipeline running across transect (December 20, 2012)

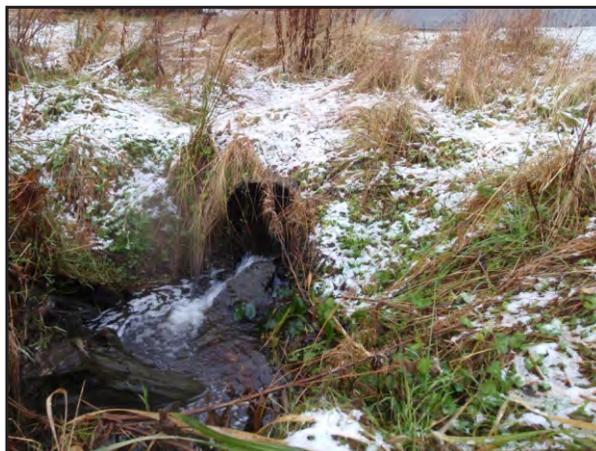
Photo 66: Transect 5 (0 m); looking at culvert and mouth of small (1 m wetted width) stream south of transect 5, adjacent to HHWM (December 20, 2012)

A small stream was noted approximately 5 m south of Transect 5. The stream flowed from a culvert (1 m wetted width at mouth of culvert) near Transect 5 POC, into a dense patch of grass, then onto the beach (Photo 66, Appendix 2).
