# Basic Impact Analysis

For: Riverbank Stabilization  
Rocky Mountain House National Historic Site

Prepared for:  
Parks Canada Agency  
Banff Field Unit

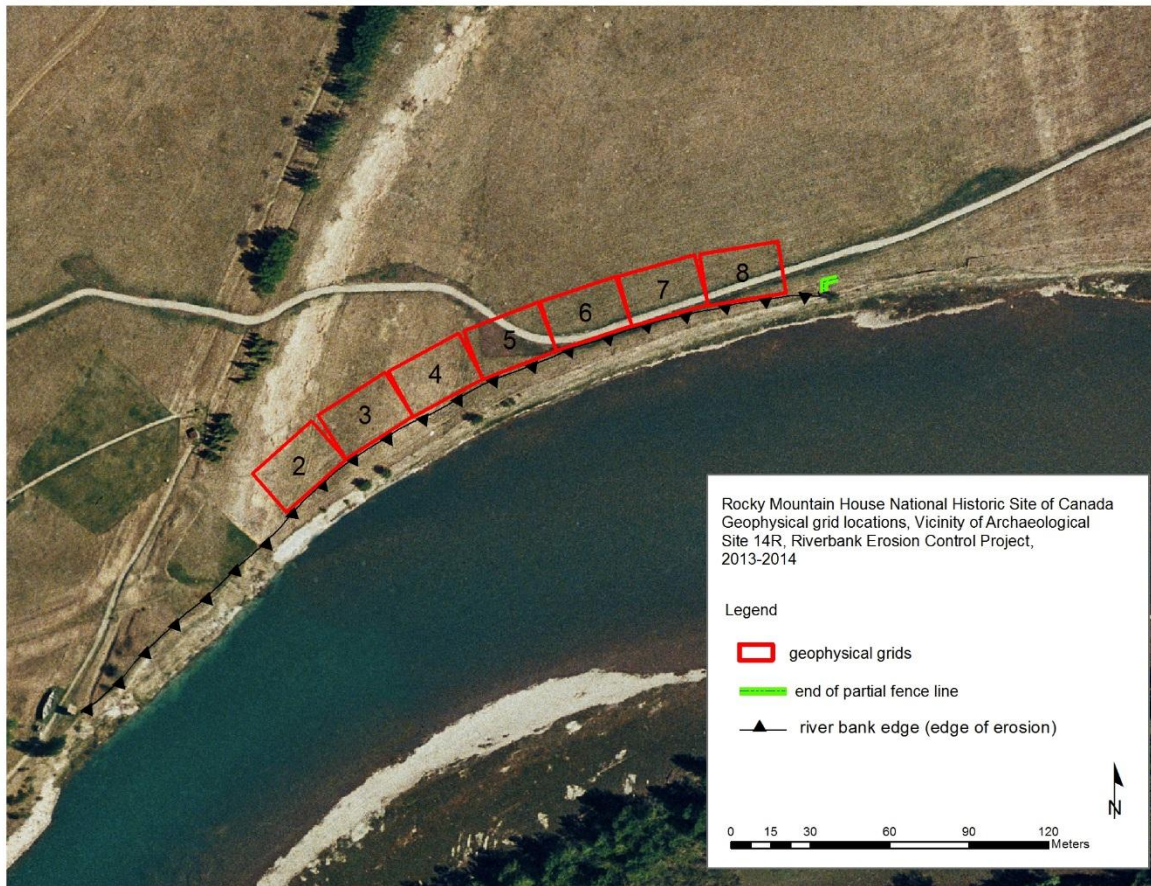
Figure 1 Geophysical grid locations, riverbank erosion project, Rocky Mountain House National Historic Site of Canada. From Perry (2014: 2).

Figure 1 Geophysical grid locations, riverbank erosion project, Rocky Mountain House National Historic Site of Canada.	19
Figure 2 Geophysical grid locations overlain on the 1976 archaeological test locations, Rocky Mountain House National Historic Site of Canada.	20
Figure 3 View ENE across the study area. Grid 2 is in the foreground.	21
Figure 4 View WSW of the study area from the north end of Grid 8.	21
Figure 5 View SE of the south wall profile of Test #1, Anomaly #1, in Grid 2. This shows the typical soil profile noted in many of the test units.	22
Figure 6 View NNW of the west wall profile of Tests #1 and #3, Anomaly 54, Grid 5 showing the ash and charcoal lens (natural feature).	22
Figure 7 View WSW of the south wall profile of Test #1, Anomaly 81, Grid 5 showing the buried palaeosol.	23
Figure 8 View WNW of the north wall profile of Test #1, Anomaly 76, Grid 8 showing the gravel lens associated with the nearby bicentennial trail.	23

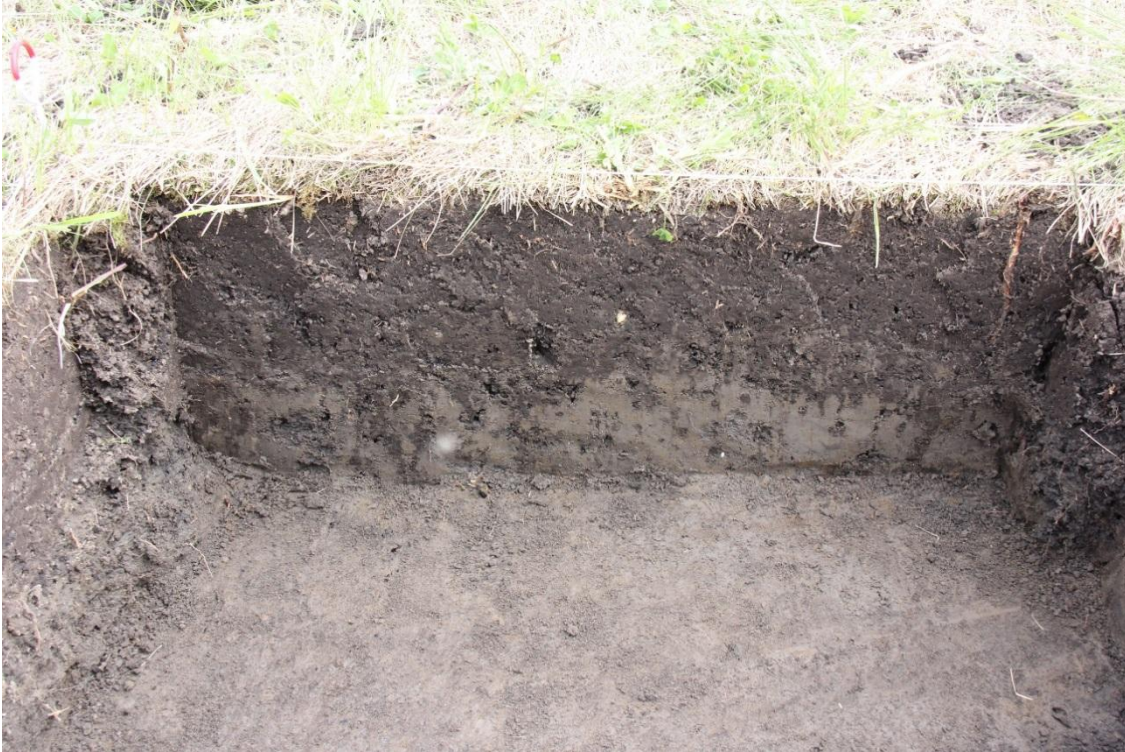
Figure 5 View SE of the south wall profile of Test #1, Anomaly #1, in Grid 2. This shows the typical soil profile noted in many of the test units.

coloured cultivation (plough) zone of approximately 10+ cm thickness that in turn is underlain by a thick stratum of medium brown sandy clay that is variously mottled with lighter or darker brown silts (Figure 5). This typical soil profile has been found within previous archaeological excavations elsewhere across the national historic site where the post-fur trade era agricultural use of the land involved the cultivation of hay fields. Artefacts and faunal remains have almost always been recovered within the cultivation layer and within the top few centimetres of the underlying clay. Historic features have likewise been found within the same relative stratigraphic context of the soil profile.

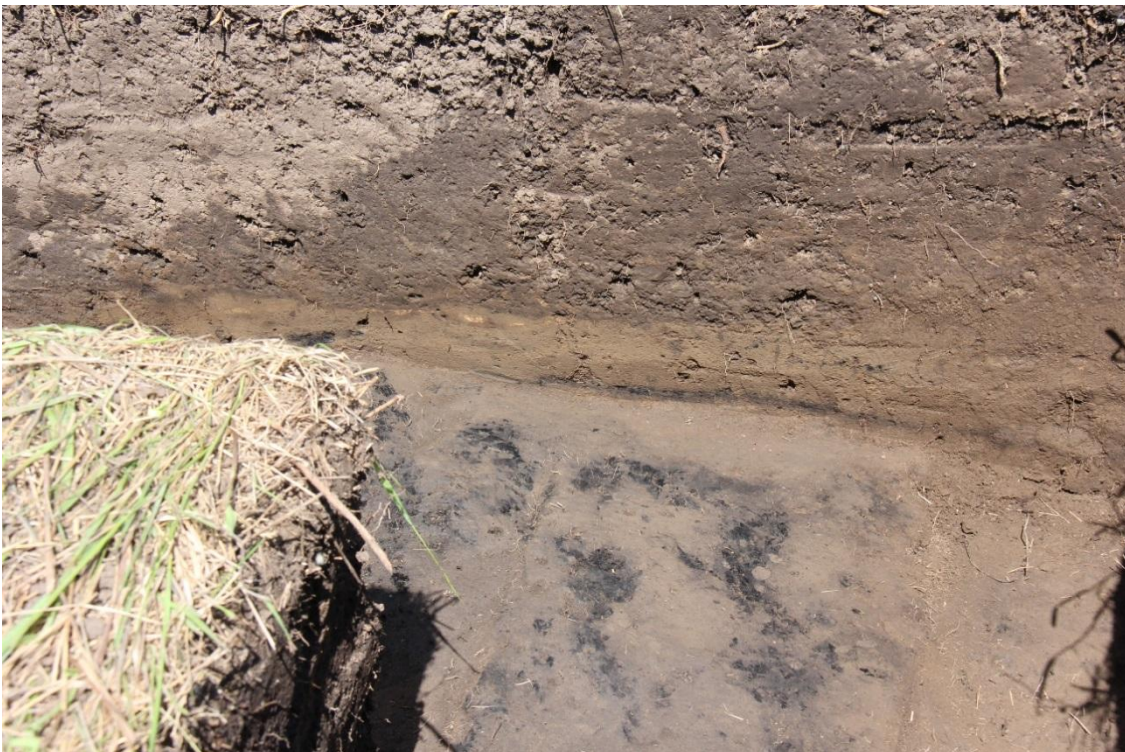
Figure 6 View NNW of the west wall profile of Tests #1 and #3, Anomaly 54, Grid 5 showing the ash and charcoal lens (natural feature).

The excavator found a single small faunal bone fragment. The charcoal and ash feature was clearly within a sealed stratigraphic context, showing no evidence of being intrusive from higher in the soil profile (Figure 6). It is therefore a natural feature: the remnants of burned wood of unknown date. Three charcoal samples were taken from the main concentration for possible future analysis. There is no evidence for any cultural feature within the profile walls of this expanded test unit.

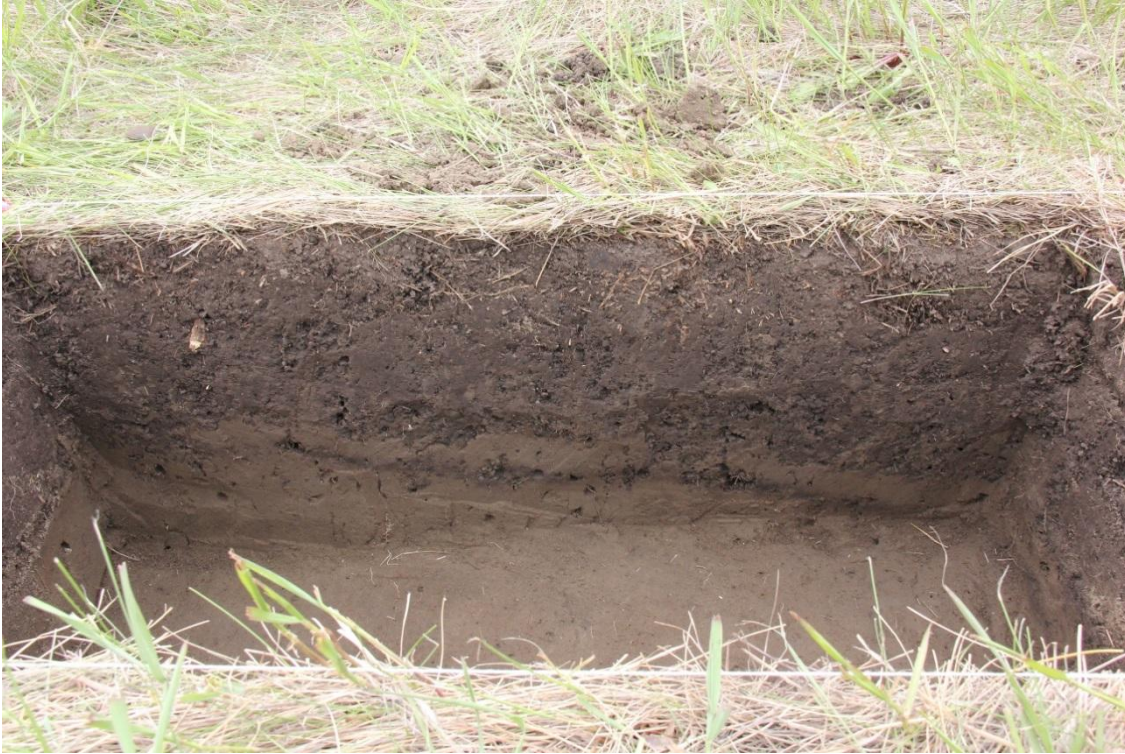
Figure 7 View WSW of the south wall profile of Test #1, Anomaly 81, Grid 5 showing the buried palaeosol.

feature within the profile walls of the test unit. A buried palaeosol was visible in the south wall profile, measuring 1cm to 2cm thick and situated 4cm below the base of the cultivation zone (Figure 7).

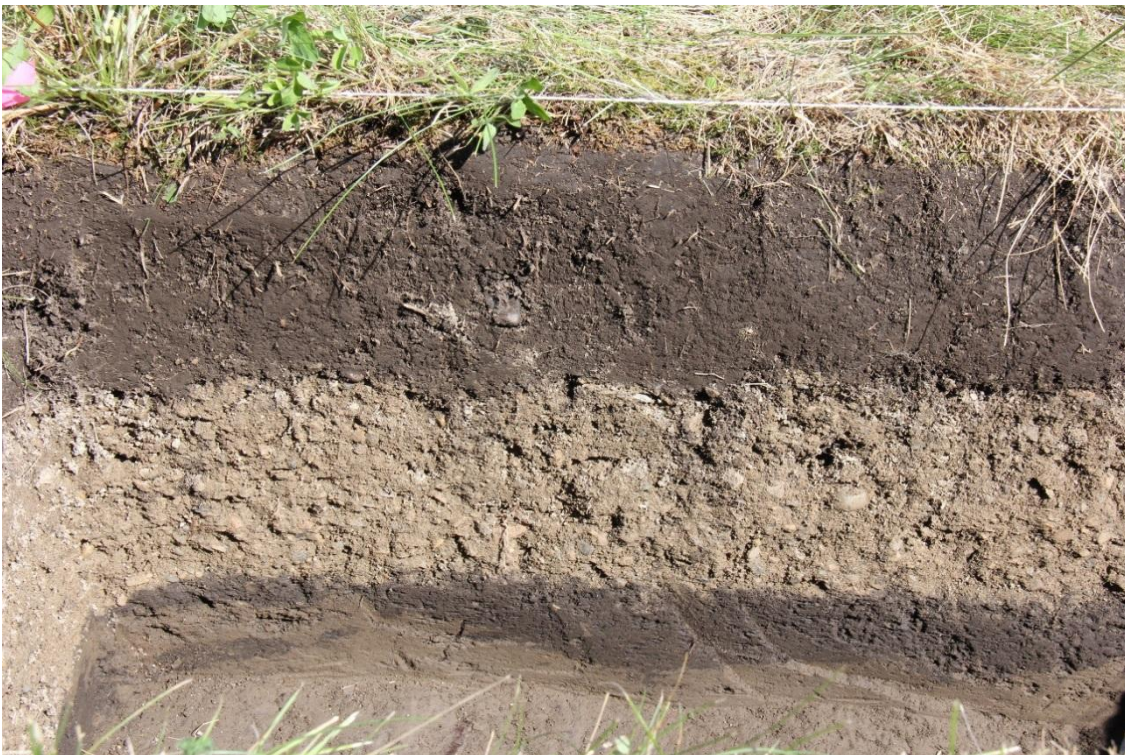
Figure 8 View WNW of the north wall profile of Test #1, Anomaly 76, Grid 8 showing the gravel lens associated with the nearby bicentennial trail.

Test #1: Located at 27.0m to 28.0m N and 6.0m to 6.5m W within Grid 8, this 0.5m by 1.0m test was excavated to a depth of 40cm DBS, well into the clay layer below the cultivation zone. Due to the proximity of this test to the bicentennial trail a thick gravel layer was present in the soil profile (Figure 8). However, no other cultural evidence was found.
