PROJECT TITLE : HASTING SWING BRIDGE PIVOT PIER FOAM INJECTION

PROJECT NUMBER R.0557746.001

- .1 Work of this Contract comprises foam injection under the pivot pier and north abutment of the Hasting Swing Bridge , located in the Town of Hastings Ontario.

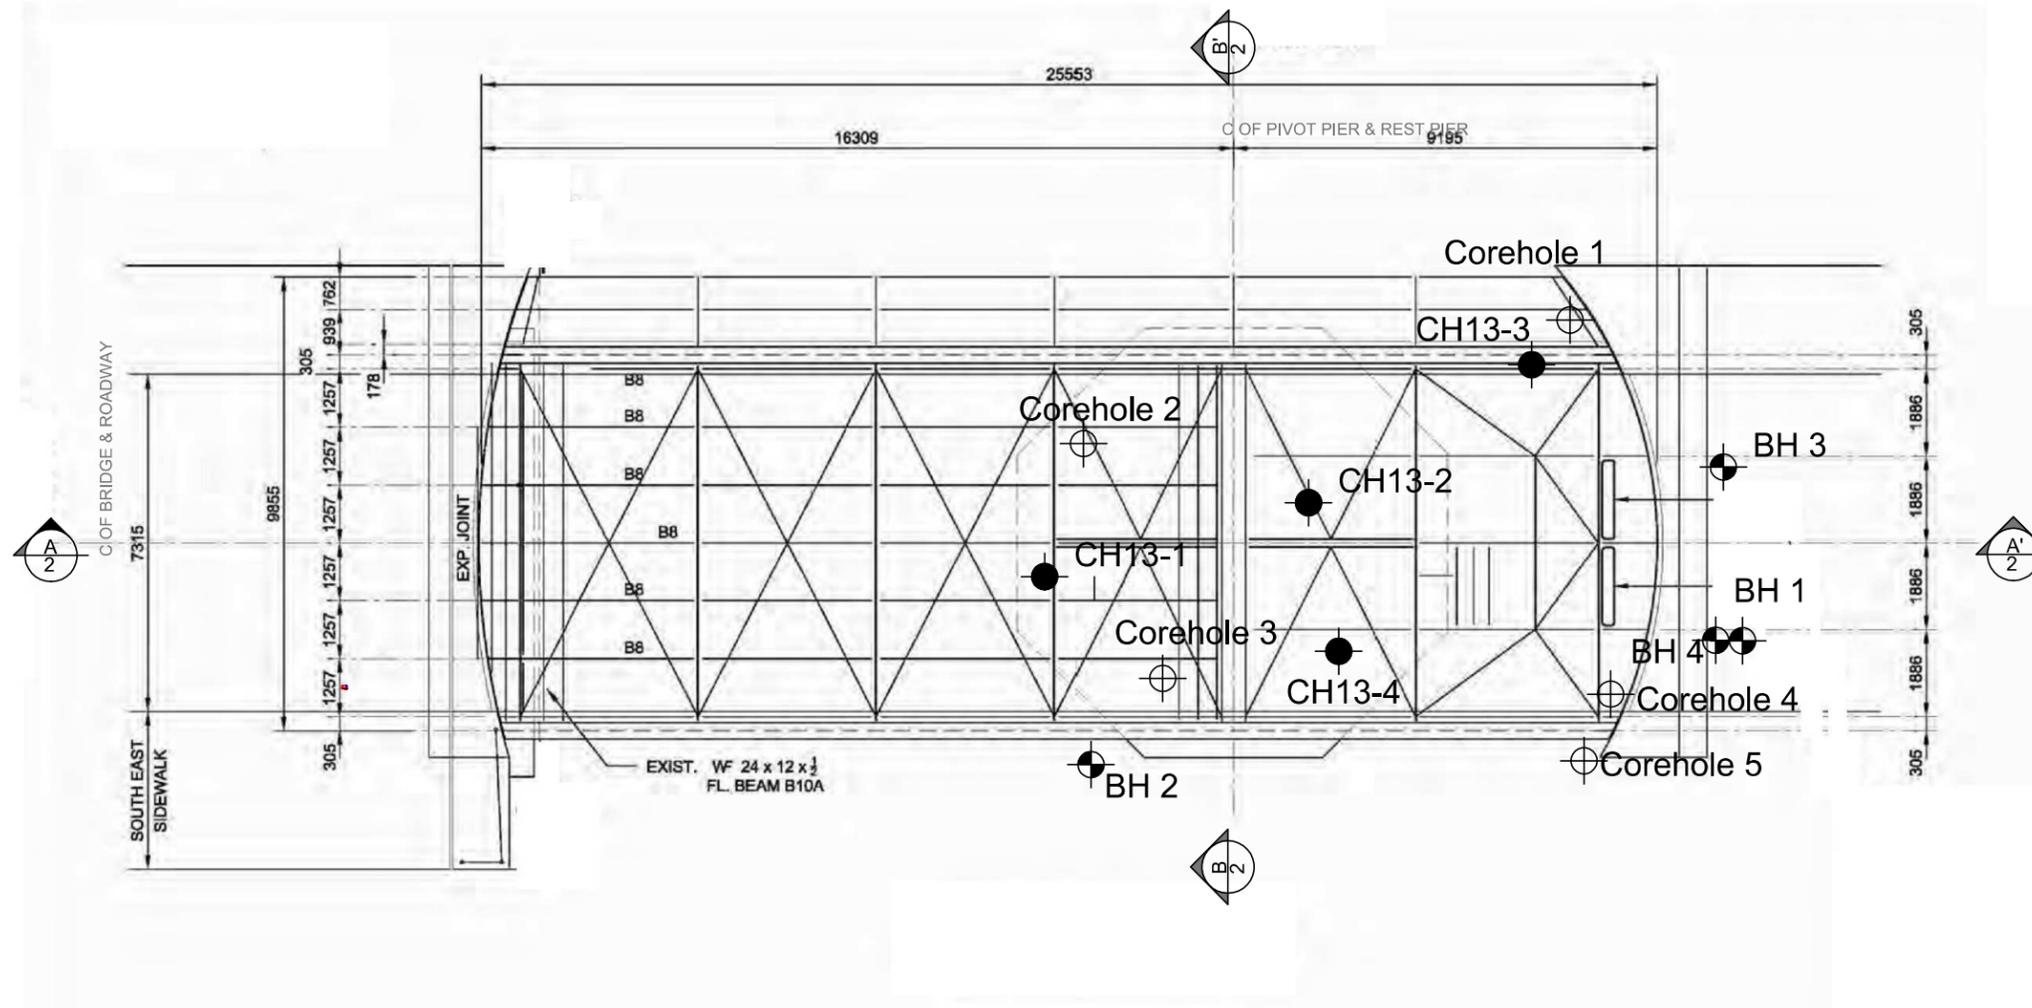
- CH13-1      **Current Corehole locations carried out by SPL**
- Corehole 1      **Previous Corehole locations carried out by Golder**
- BH1      **Previous Borehole locations carried out by Golder**

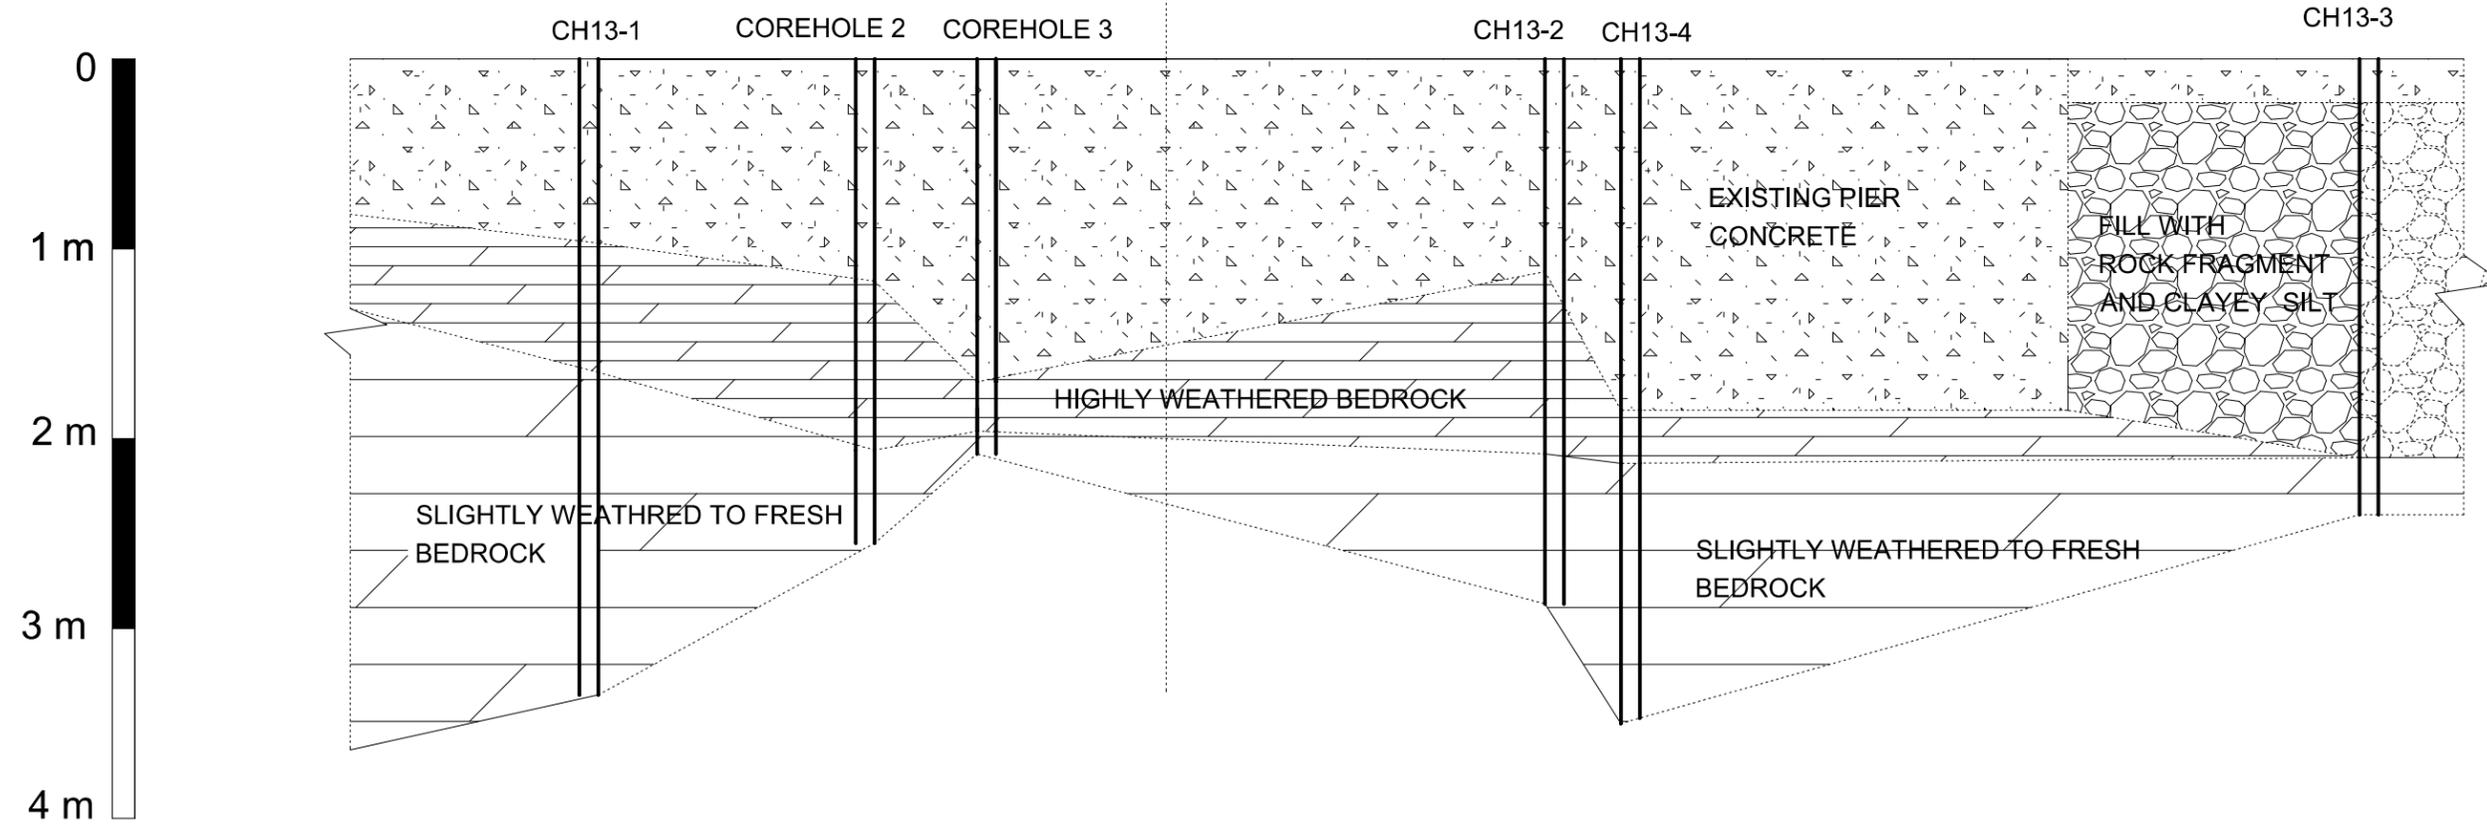
# CROSS SECTION A-A

1. Not to scale, all locations are approximate
2. The assumed boundary of the concrete footings & soil strada are based on limited corehole data and should be considered approximate

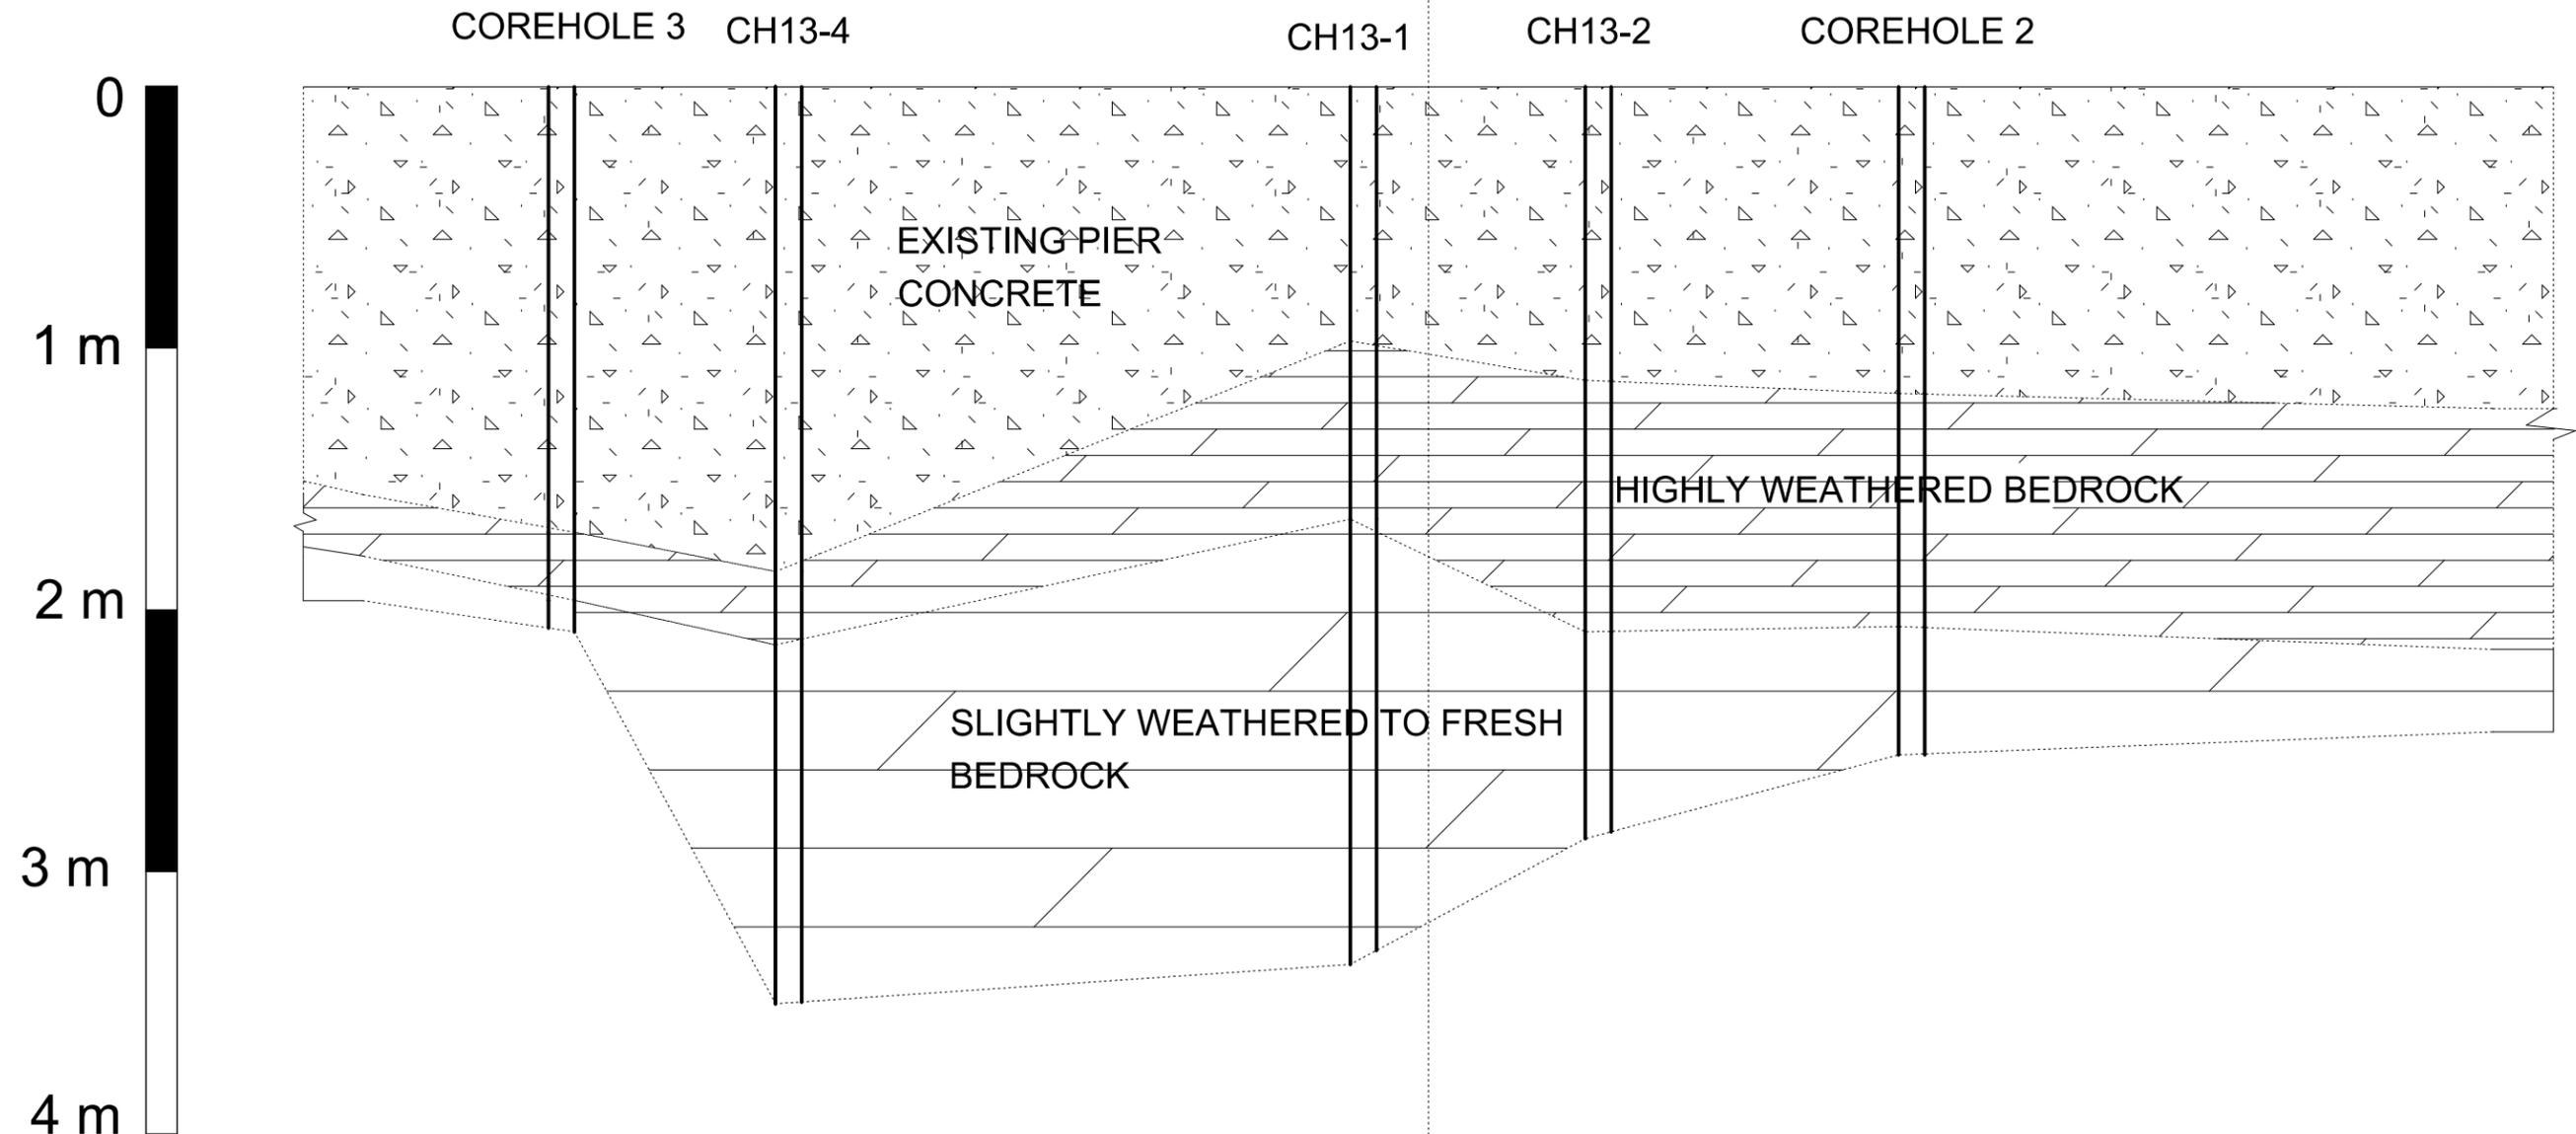
# CROSS SECTION B-B

1. Not to scale, all locations are approximate
2. The assumed boundary of the concrete footings & soil strada are based on limited corehole data and should be considered pproximate

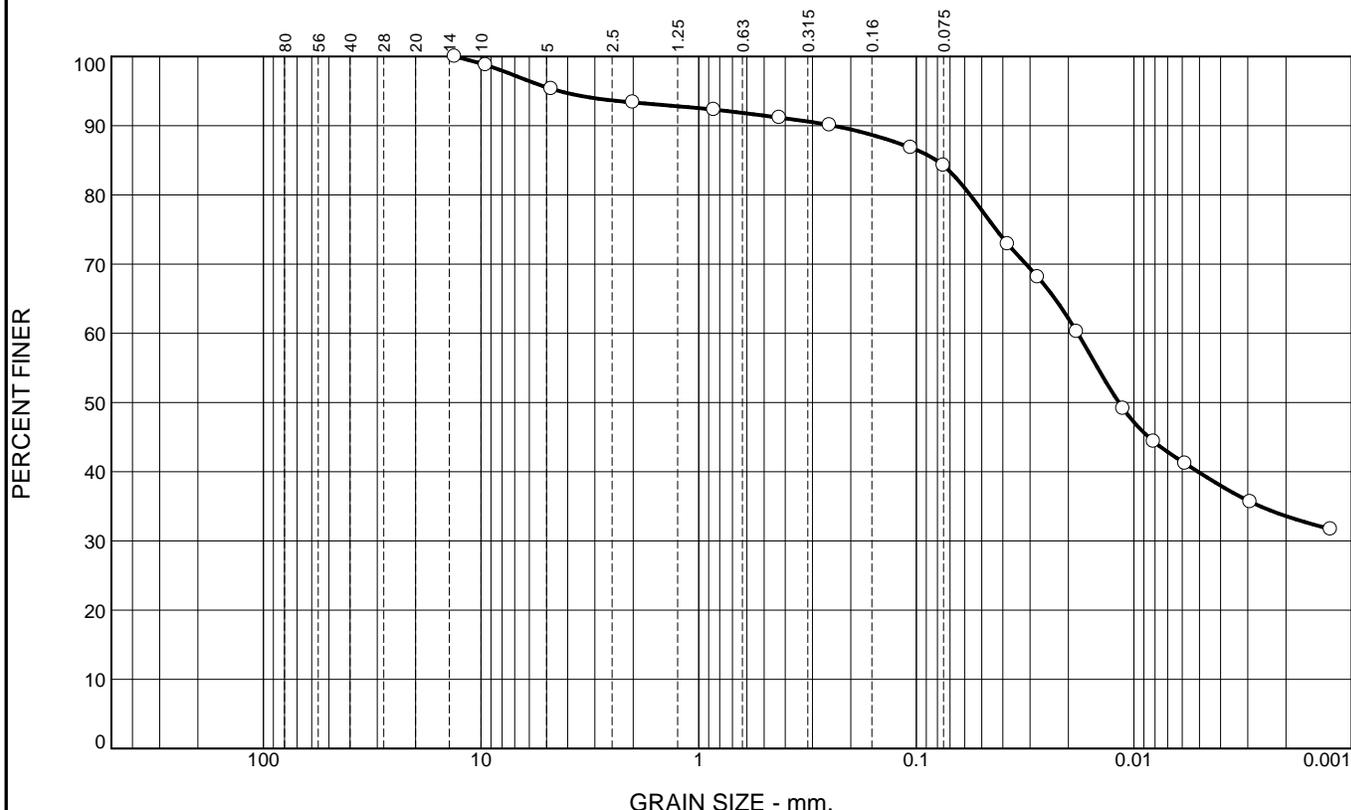
# Particle Size Distribution Report

% +75mm	% Gravel		% Sand			% Fines	
	Coarse	Fine	Coarse	Medium	Fine	Silt	Clay
0.0	0.0	4.7	1.9	2.2	7.0	50.6	33.6

SIEVE SIZE	PERCENT FINER	SPEC.* PERCENT	PASS? (X=NO)
13.2mm	100.0		
9.5mm	98.8		
4.75mm	95.3		
2.00mm	93.4		
0.850mm	92.3		
0.425mm	91.2		
0.250mm	90.1		
0.106mm	86.8		
0.075mm	84.2		
0.0380 mm.	72.9		
0.0277 mm.	68.1		
0.0183 mm.	60.2		
0.0112 mm.	49.1		
0.0081 mm.	44.4		
0.0058 mm.	41.2		
0.0029 mm.	35.7		
0.0012 mm.	31.7

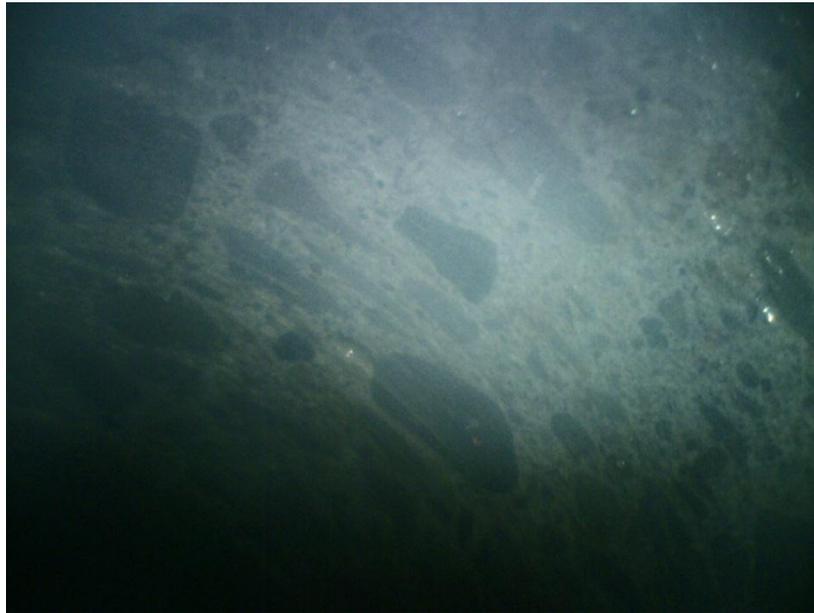
**Photograph 1: no cracking or fracture of the pier concrete noted inside the corehole**

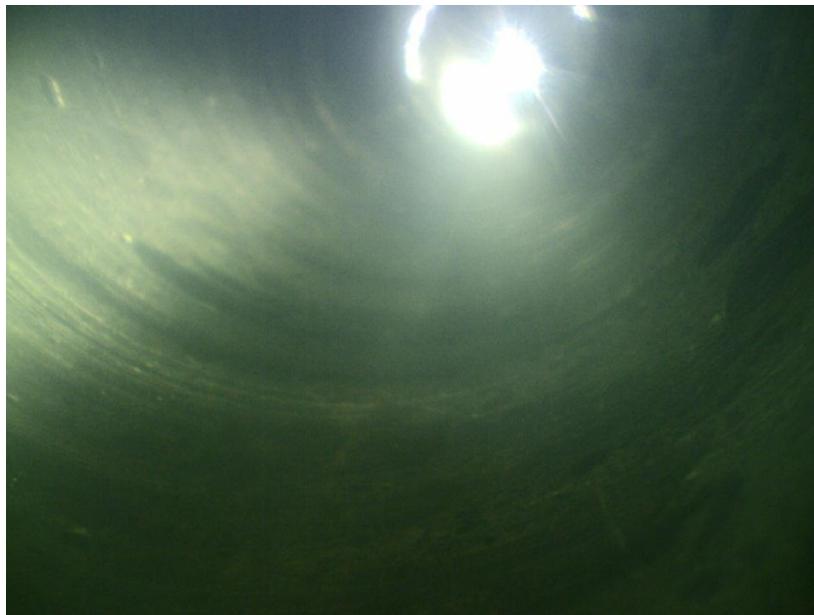
**Photograph 2: no cracking or fracture of the pier concrete noted inside the corehole**

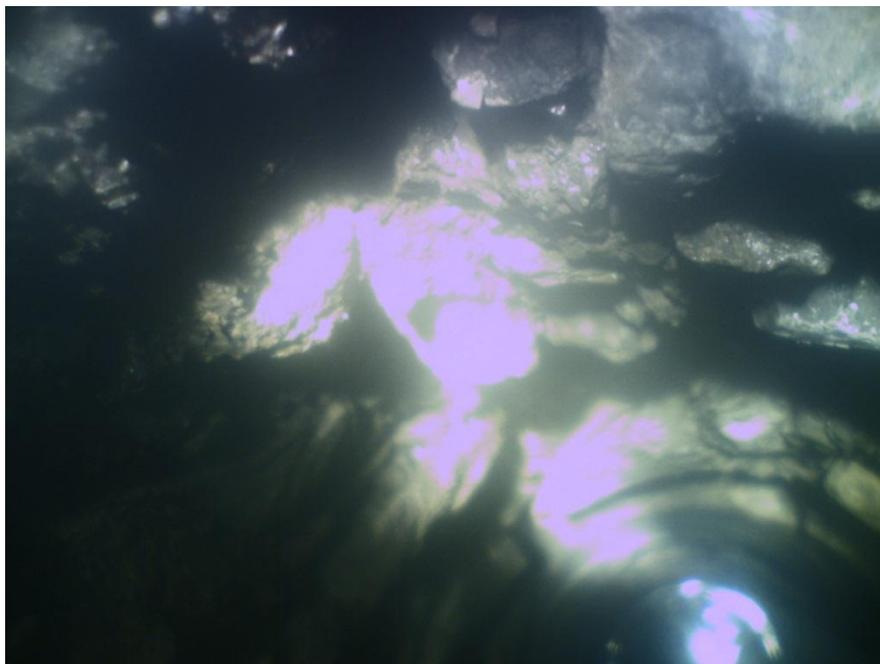
**Photograph 4: highly weathered rock below pier concrete; note the clayey silt soil within the voids between rock pieces**

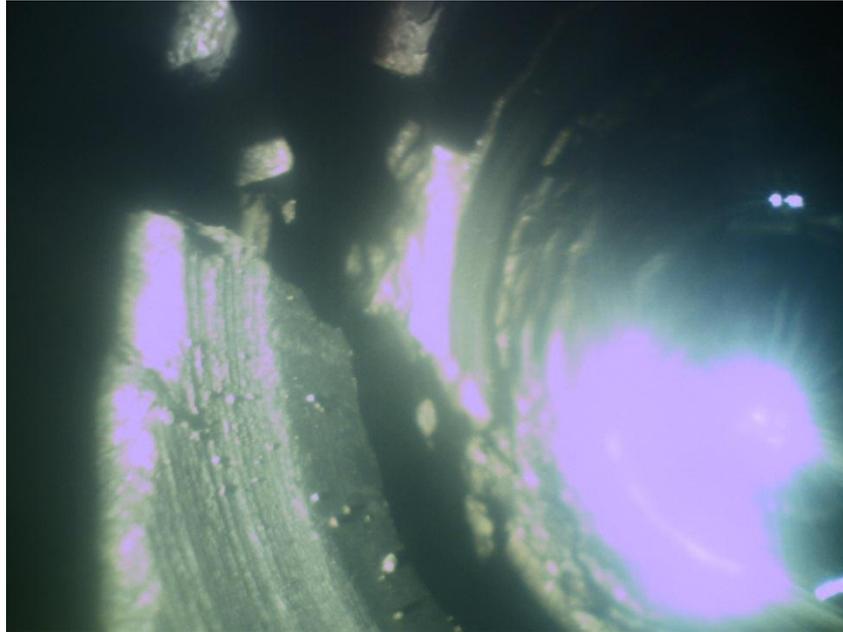
**Photograph 5: void between pier concrete and bedrock and highly weathered rock pieces**

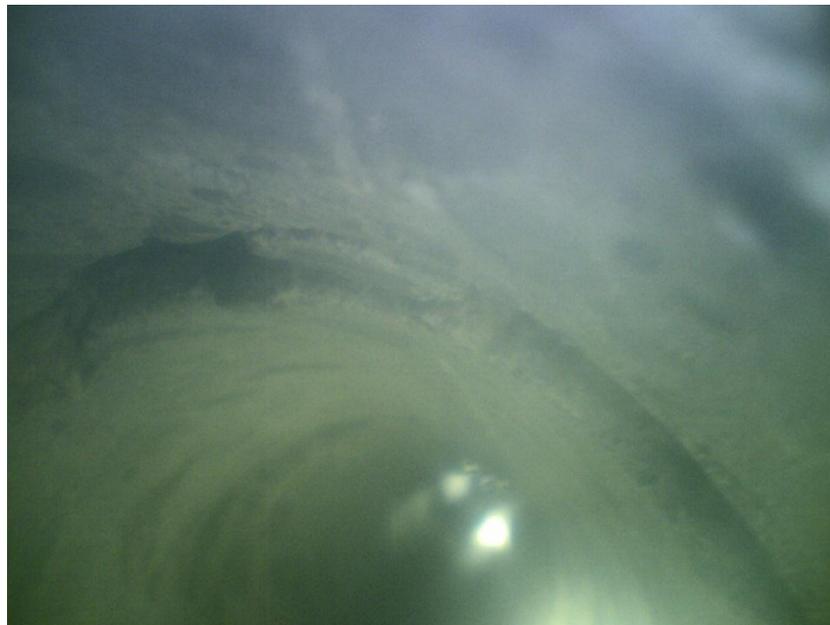
**Photograph 6: approximately 1 inch void between the pier concrete and bedrock**

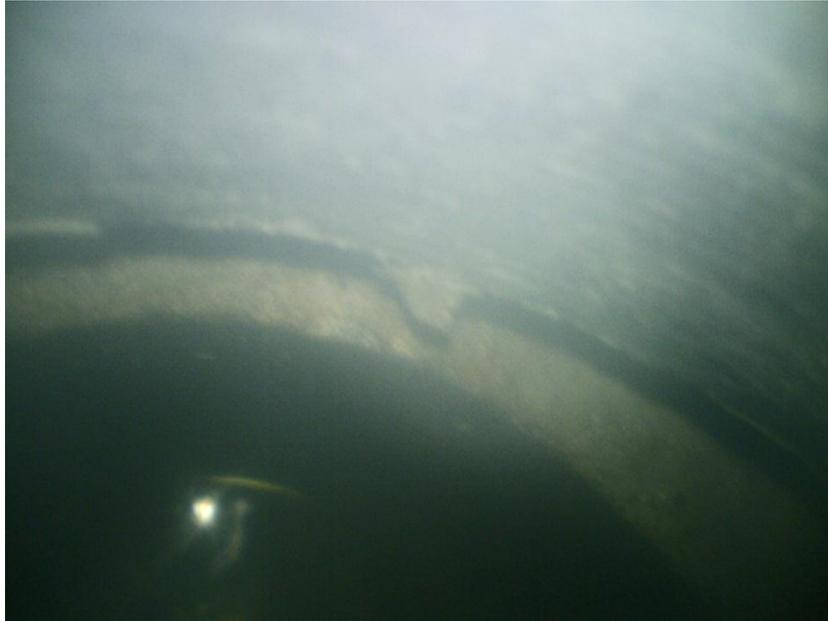
**Photograph 7: approximately 2 inches void between the pier concrete and bedrock**

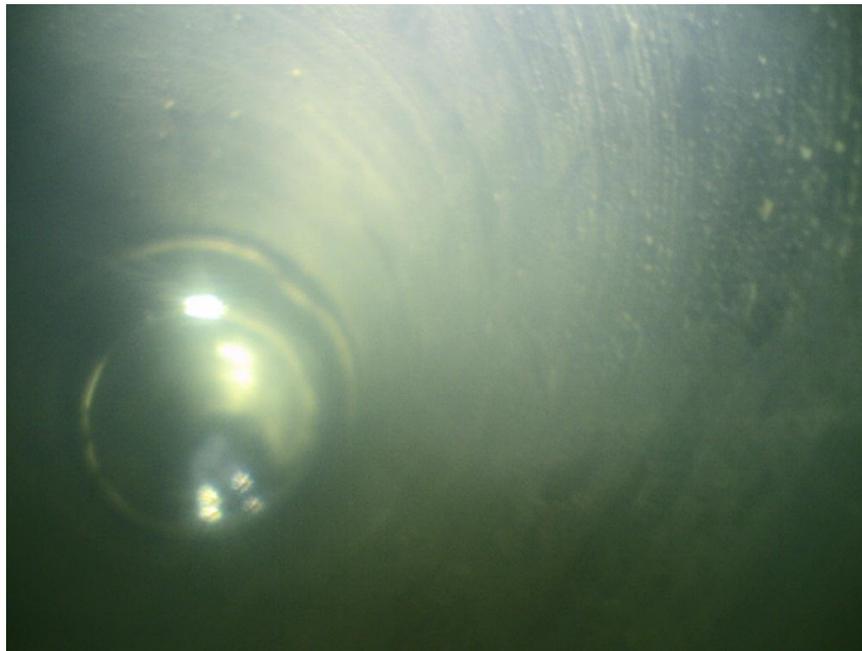
**Photograph 8: the void between the pier concrete and bedrock**

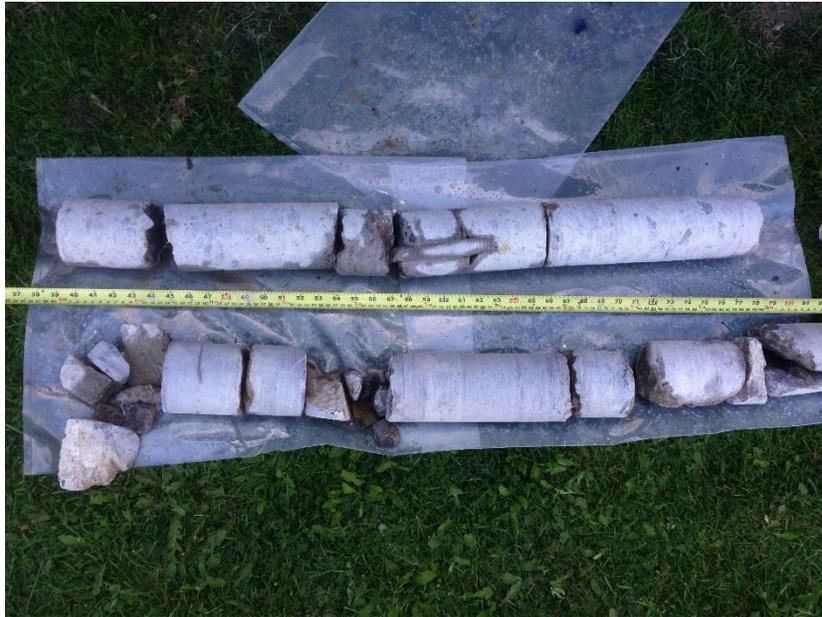
**Photograph 1: Corehole CH 13-1 Concrete Cores and partial Rock Cores**

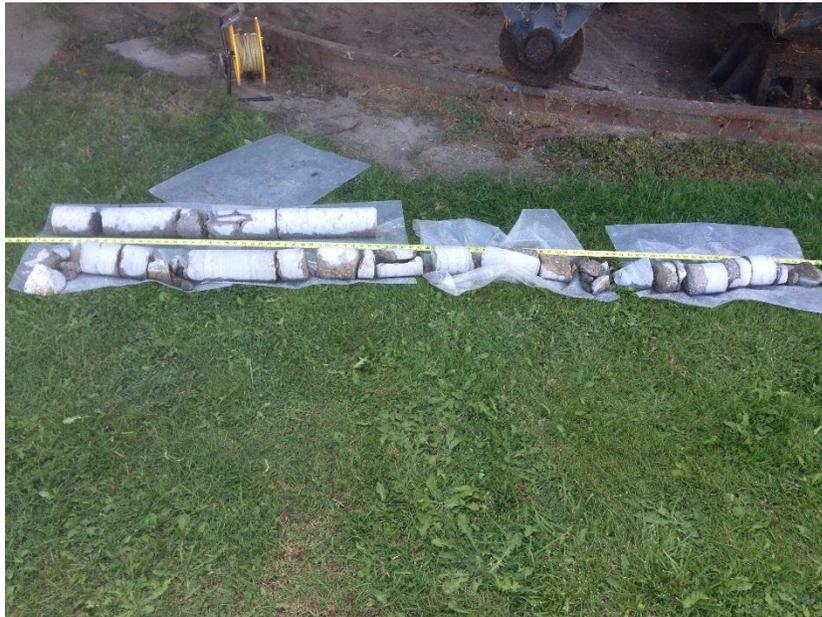
**Photograph 2: Corehole CH 13-1 Concrete Cores and full depth Rock Cores**

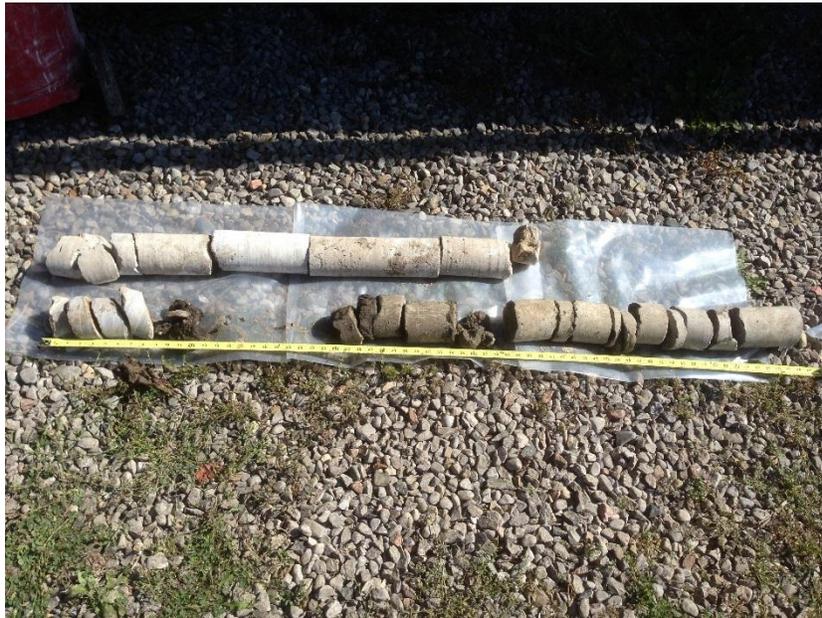
**Photograph 3: Corehole CH 13-2 Concrete Cores and full depth Rock Cores**

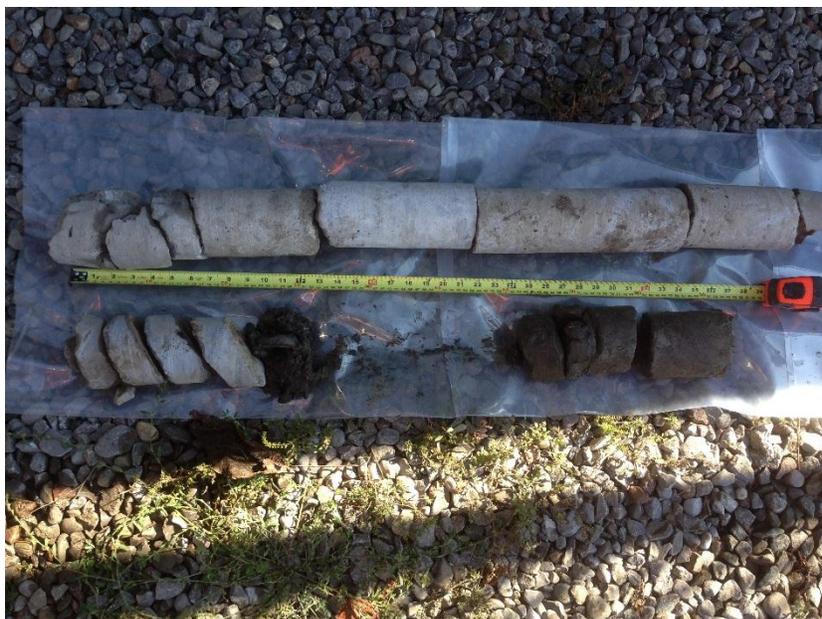
**Photograph 4: Corehole CH 13-2 Concrete Cores and zone of clayey silt within the limestone rock**

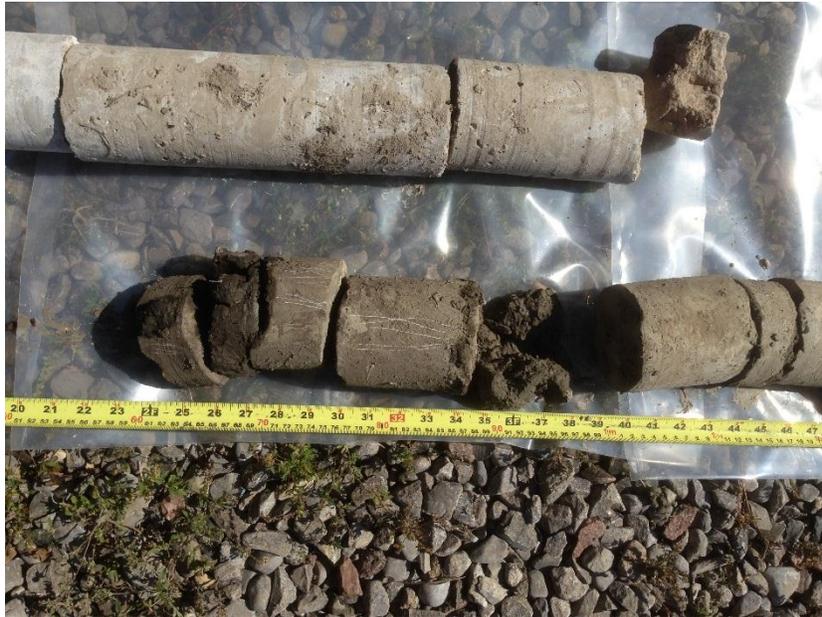
**Photograph 5: Corehole CH 13-2 Layers of clayey silt within the limestone rock**

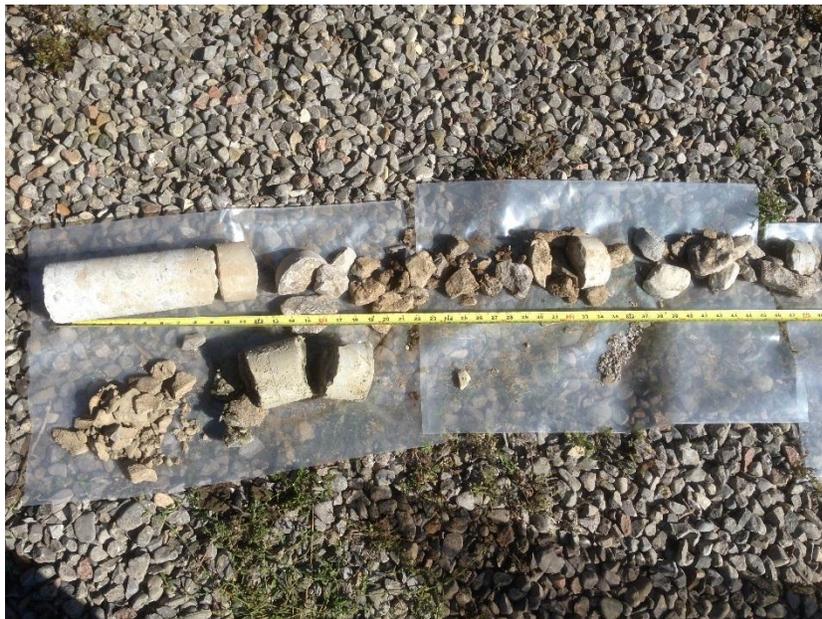
**Photograph 6: Corehole CH 13-3 Concrete Cores and Rock Fills or Highly Weathered Rock pieces**

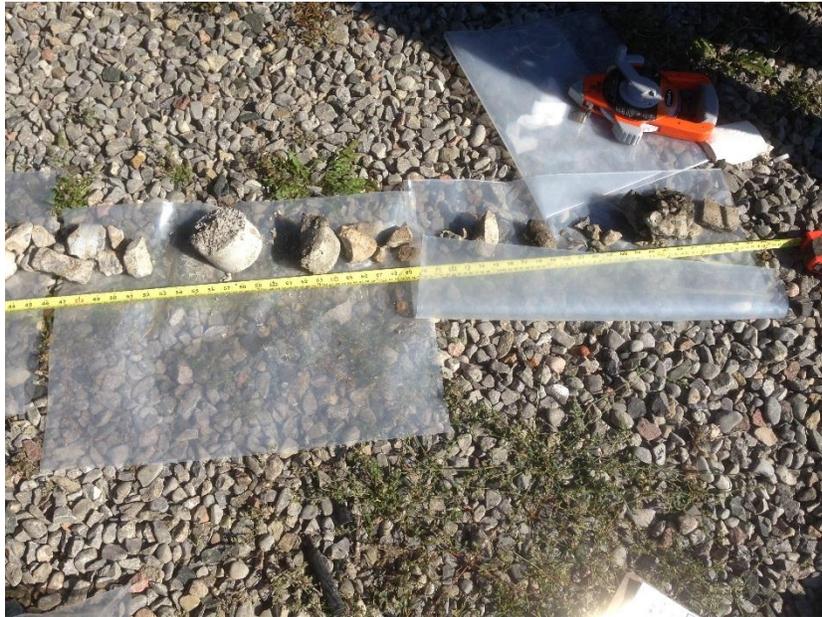
**Photograph 7: Corehole CH 13-3 Rock Fills or Highly Weathered Rock Pieces**

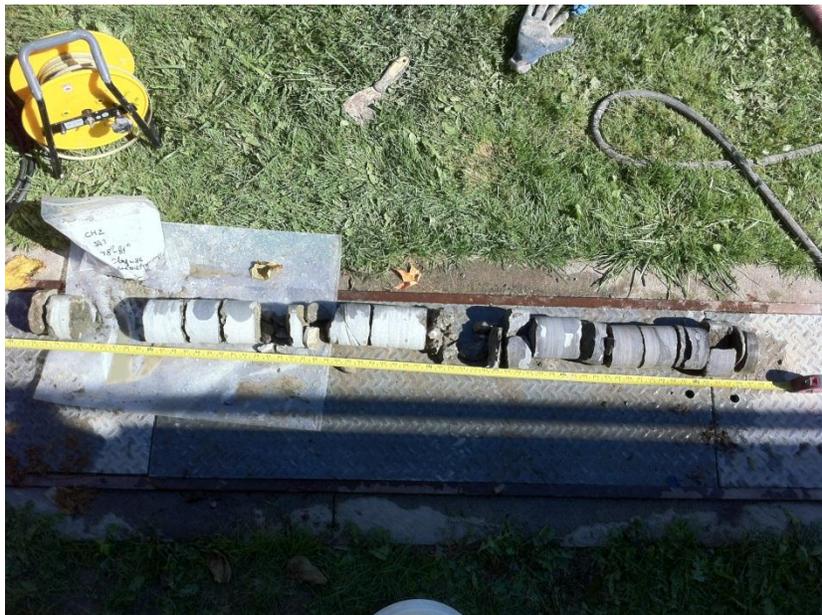
**Photograph 8: Corehole CH 13-4 Rock Cores**

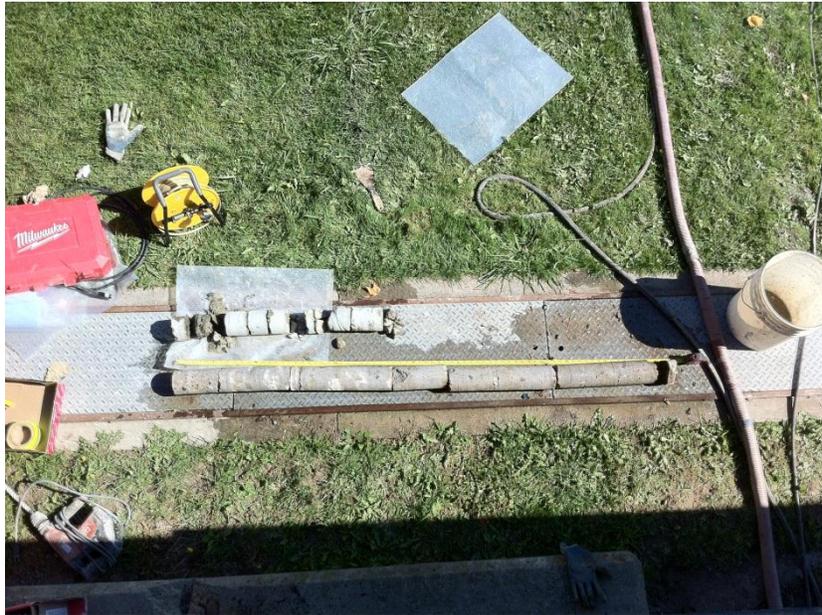
**Photograph 9: Corehole CH 13-4 Concrete Cores and Rock Cores**

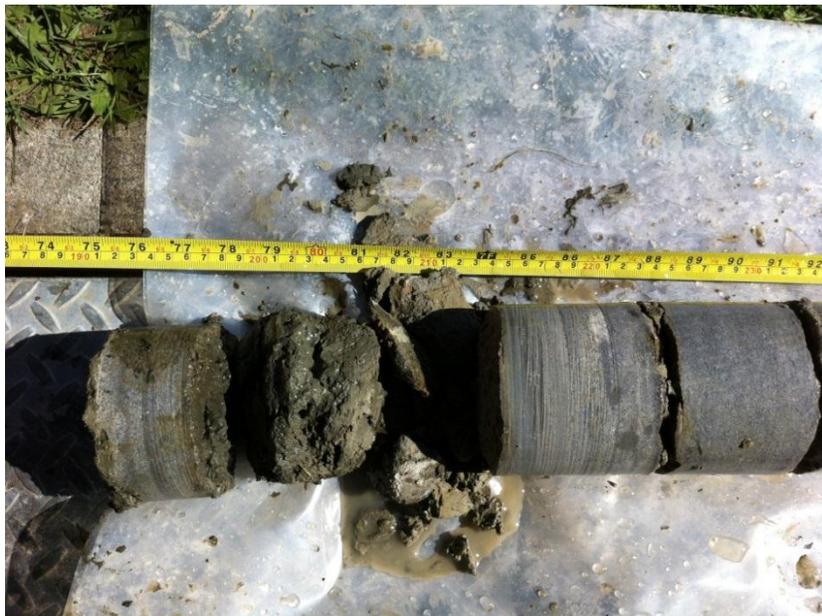
**Photograph 10: Layers of clayey silt within the limestone rock**

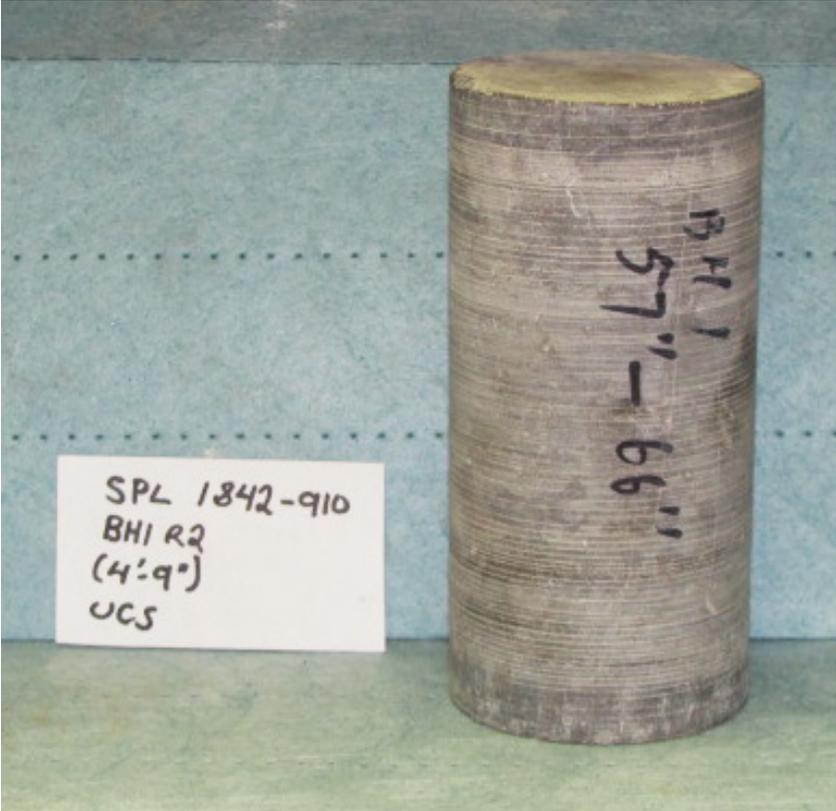
**Pre-Test Samples**

<b>Sample (depths indicated)</b>	<b>Bulk Density (g/cm<sup>3</sup>)</b>	<b>UCS (MPa)</b>	<b>Young's Modulus (GPa)</b>	<b>Poisson's ratio</b>
BH1, Run-2 (4'9"-5'6")	2.72	41.9	41.860	---

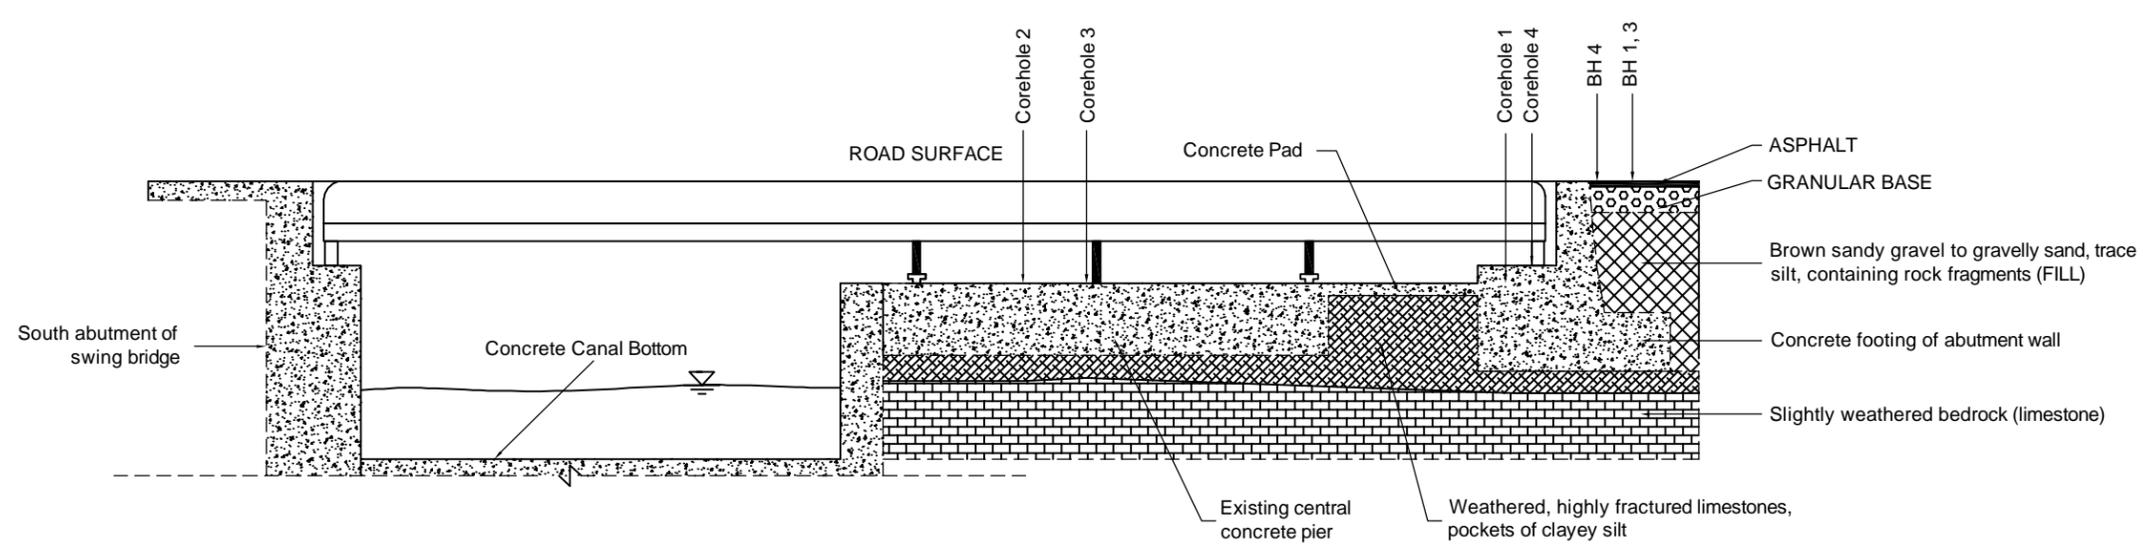
FIGURE 3A

CROSS SECTION A-A

NOT TO SCALE  
ALL LOCATIONS ARE APPROXIMATE

Based on the results of rock coring, the bedrock at the site generally consists of slightly weathered to weathered, grey to dark grey, fine grained fossiliferous limestone of the Lindsay and Verulam Formations. This bedrock was confirmed by coring in Coreholes 1 to 4 and in Test Pit 1 to depths of 1.8 m to 3.0 m below the existing ground surface. The surface elevation of the bedrock is variable at the test hole locations, as shown on the cross section drawings, Figures 3A to 3C.

The Borehole, Corehole and Test Pit Location Plan, Figure 2, was developed based on the previous drawing provided by Delcan and on measurements made during our field investigation. The cross-sections of the existing structures below the water and ground, as shown on Figures 3A to 3D, are based on the interpretation of our borehole/corehole/test pit data, and therefore should be considered as approximate only and are only suitable for illustrative purposes. Site Photographs are provided on Figures 6A to 9R.

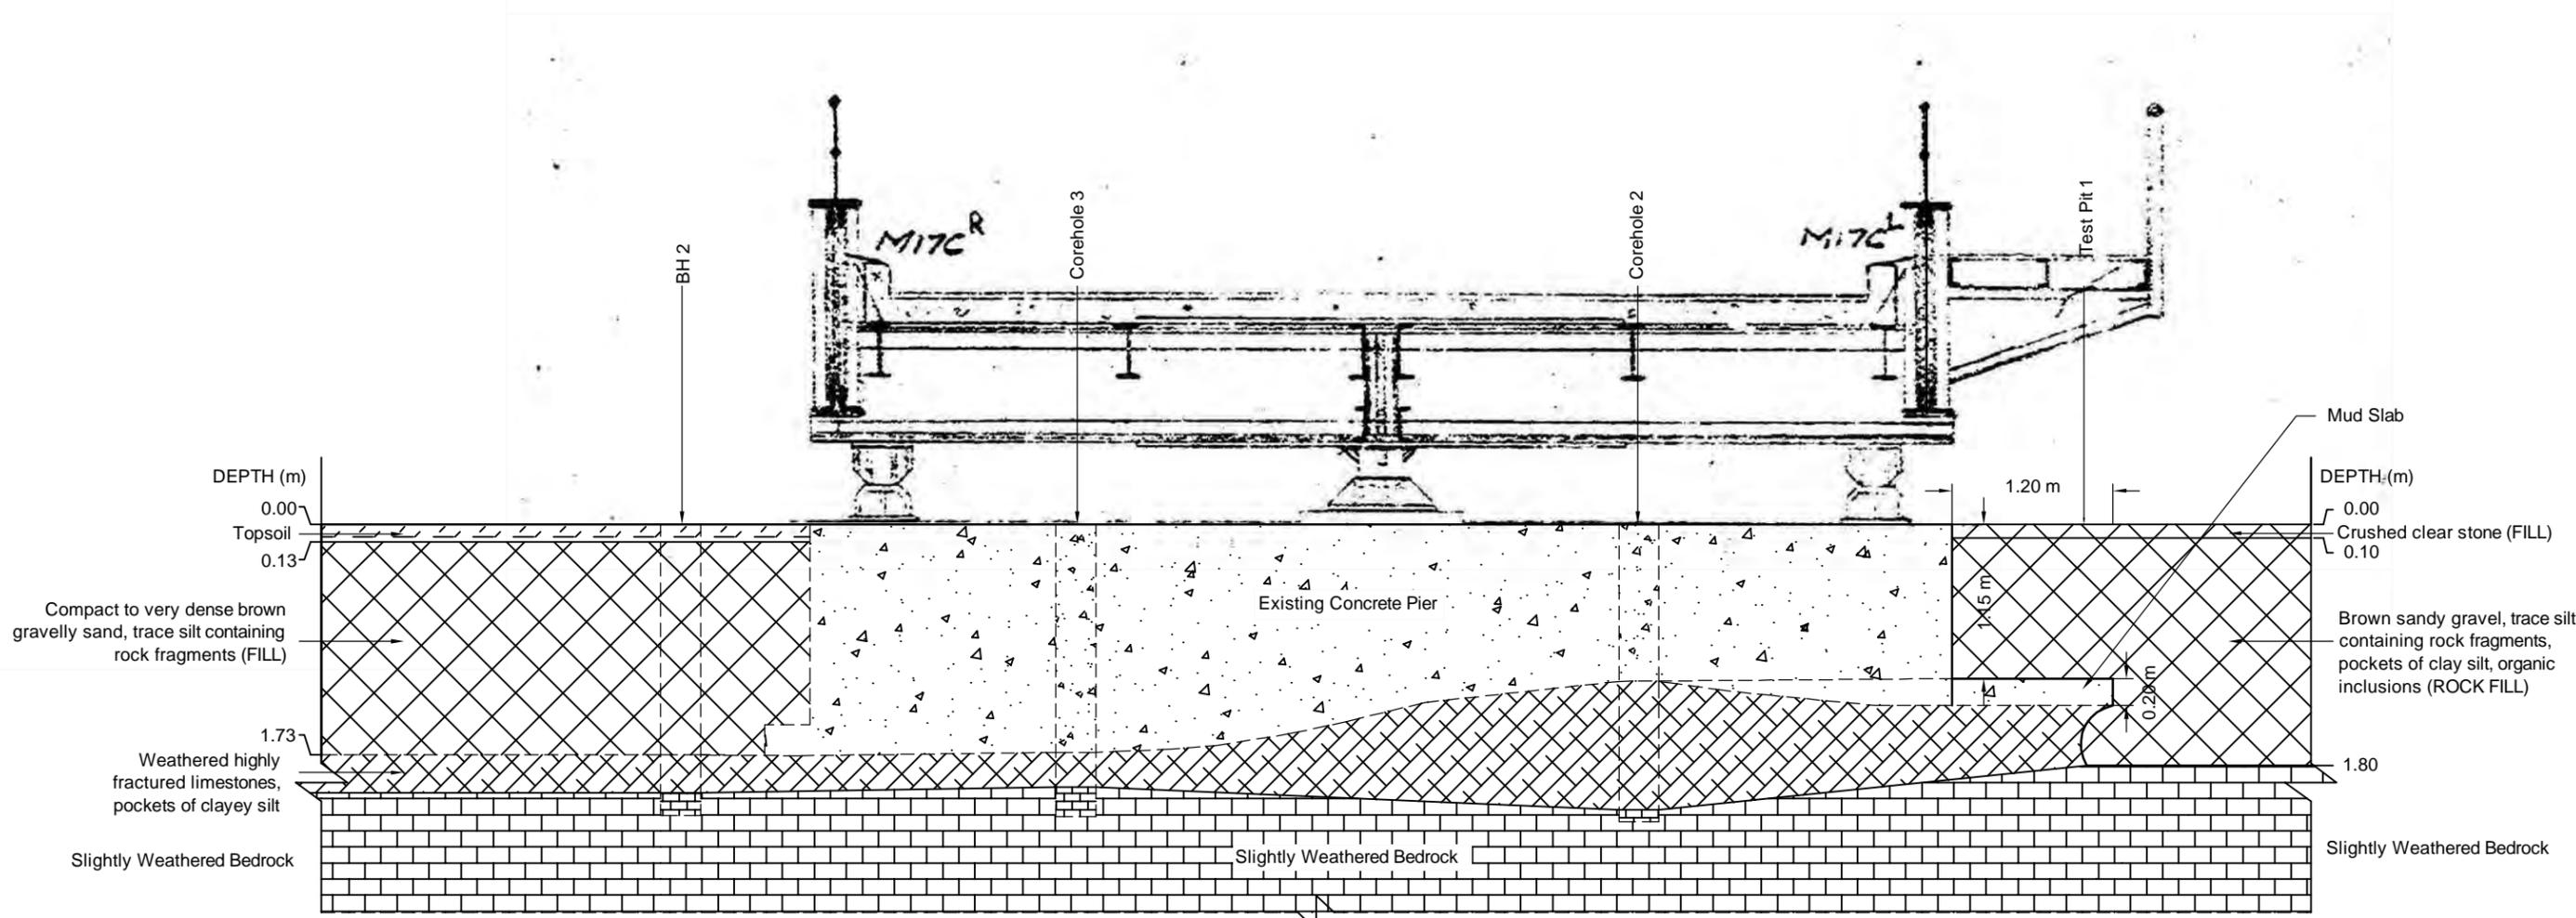
PROJECT				Delcan Hastings Swing Bridge Trent-Severn Canal, Hastings, Ontario			
TITLE				<b>CROSS SECTION B - B</b>			
PROJECT No. 11-1184-0022		FILE No.		AA01			
DESIGN		SCALE	AS SHOWN	REV.	0		
CADD	MK	MAY 2011					
CHECK							
REVIEW							
				<b>FIGURE 3B</b>

Cross Section B - B
