PROJECT TITLE : HASTING SWING BRIDGE PIVOT PIER FOAM INJECTION

PROJECT NUMBER R.0557746.001

- .1 Work of this Contract comprises foam injection under the pivot pier and north abutment of the Hasting Swing Bridge , located in the Town of Hastings Ontario.

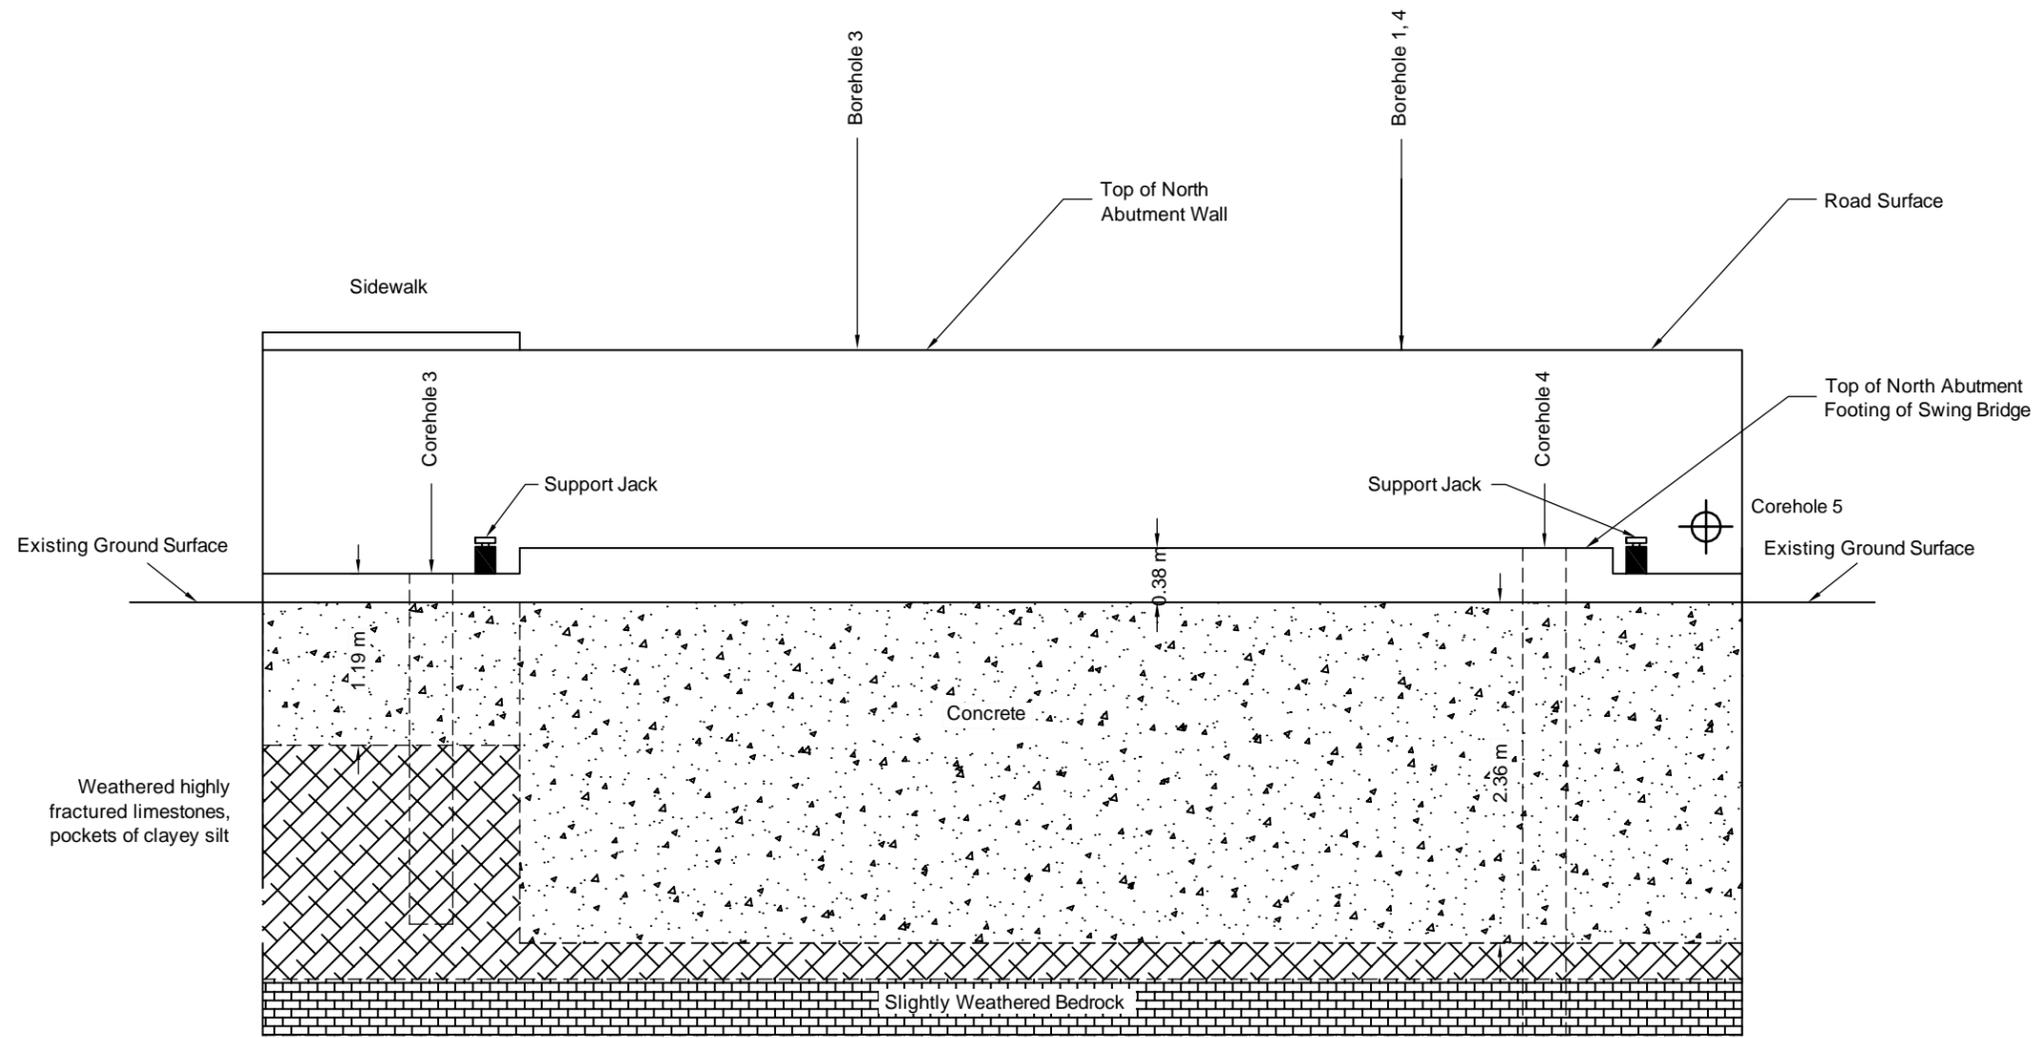
**FIGURE 3C**

**Cross Section C - C**

Based on the results of rock coring, the bedrock at the site generally consists of slightly weathered to weathered, grey to dark grey, fine grained fossiliferous limestone of the Lindsay and Verulam Formations. This bedrock was confirmed by coring in Coreholes 1 to 4 and in Test Pit 1 to depths of 1.8 m to 3.0 m below the existing ground surface. The surface elevation of the bedrock is variable at the test hole locations, as shown on the cross section drawings, Figures 3A to 3C.

The Borehole, Corehole and Test Pit Location Plan, Figure 2, was developed based on the previous drawing provided by Delcan and on measurements made during our field investigation. The cross-sections of the existing structures below the water and ground, as shown on Figures 3A to 3D, are based on the interpretation of our borehole/corehole/test pit data, and therefore should be considered as approximate only and are only suitable for illustrative purposes. Site Photographs are provided on Figures 6A to 9R.

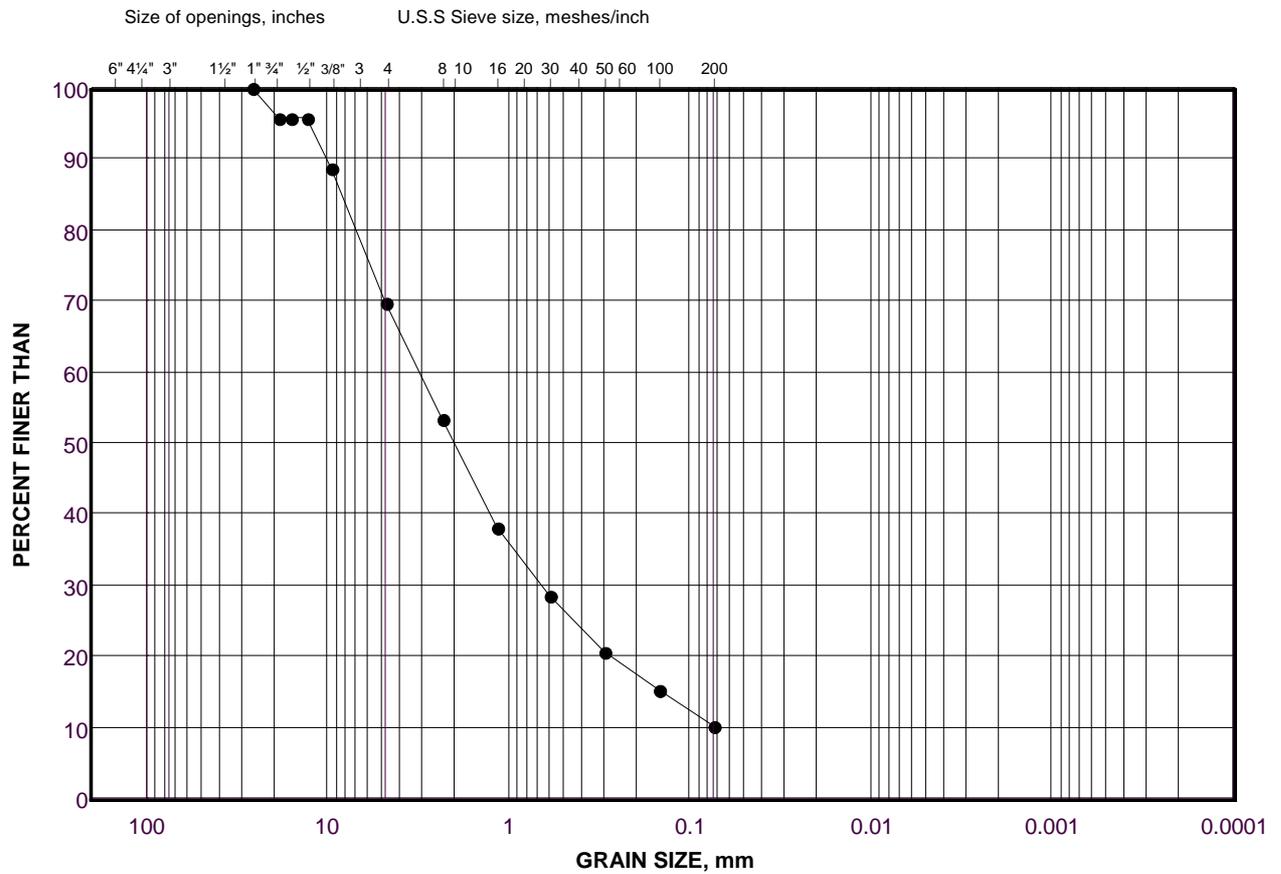
FIGURE 4

## GRAVELLY SAND

<b>COBBLE</b>	COARSE	FINE	COARSE	MEDIUM	FINE	SILT AND CLAY SIZES
<b>SIZE</b>	GRAVEL SIZE		SAND SIZE			FINE GRAINED

The existing subgrade soils and shallow groundwater conditions encountered in the coreholes/boreholes and test pits, as well as the results of the field and laboratory testing, are shown in detail on the Record of Borehole/Corehole and Record of Test Pit sheets, following the text of this report. Lists of abbreviations and symbols are provided to assist in the interpretation of the borehole logs. Profiles of the structure and the subsurface stratigraphy below the structure are presented on cross section drawings, Figures 3A to 3C. The results of soil laboratory gradation analyses are provided on Figures 4 and 5.

Fill materials were encountered in all of the boreholes and in the test pit. The fill extended to depths ranging from 1.2 m to 2.7 m below ground surface. The fill materials are associated with previous backfilling behind the abutment walls and surrounding the central pier. The fills are variable in composition but generally consist of silty sand, gravelly sand and sandy gravel with variable sized rock fragments encountered at all depths. Standard penetration tests carried out within the various fill materials gave variable N values ranging widely from 3 blows to 53 blows per 0.3 m penetration, indicating a very loose to very dense relative density, although the higher N values could be influenced by the presence of the large sized rock fragments. The in-situ water content of the fill samples tested ranged widely from 2 percent to 9 percent. Grain size distribution curves for samples of the sandy gravel and gravelly sand fills are shown on Figures 4 and 5.

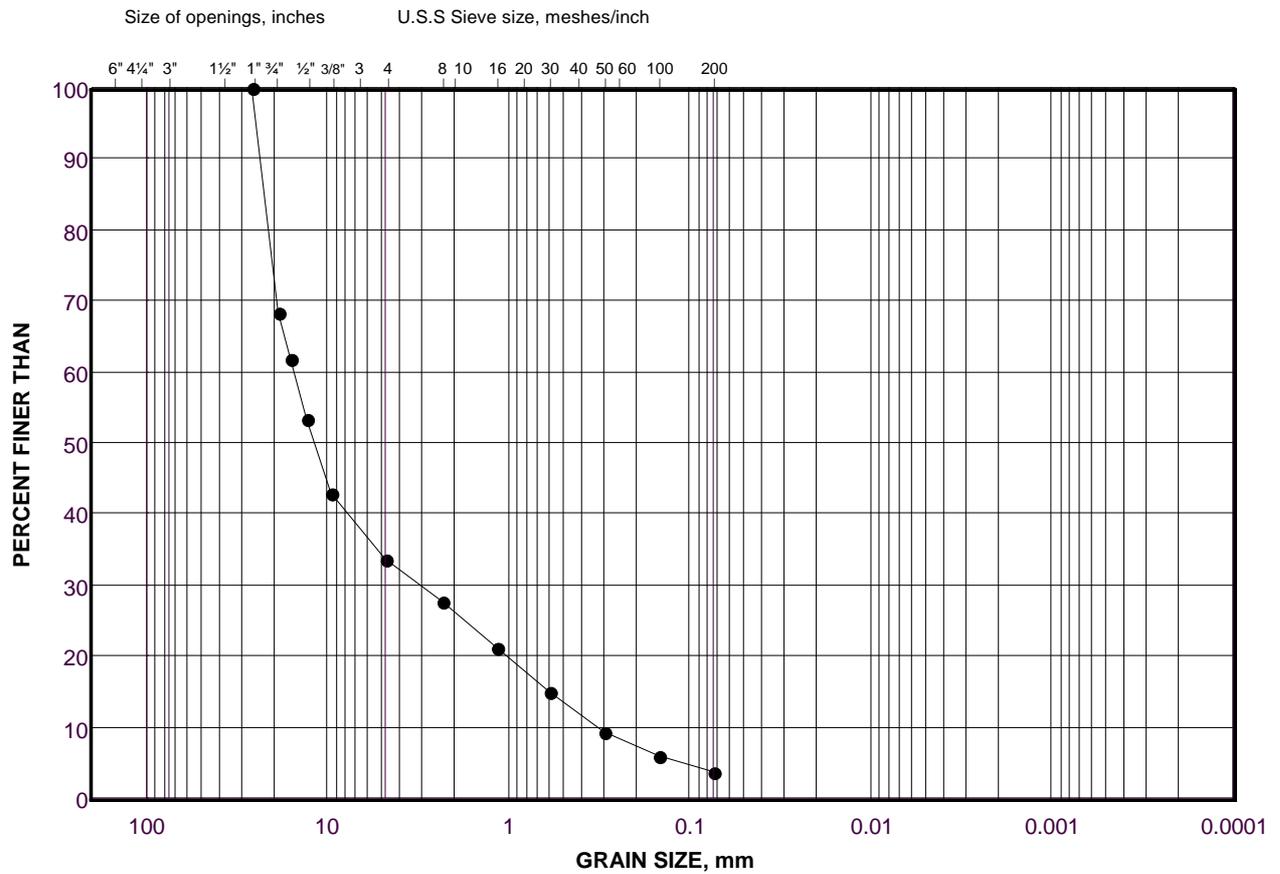
FIGURE 5

## SANDY GRAVEL

<b>COBBLE</b>	COARSE	FINE	COARSE	MEDIUM	FINE	SILT AND CLAY SIZES
<b>SIZE</b>	<b>GRAVEL SIZE</b>		<b>SAND SIZE</b>			<b>FINE GRAINED</b>

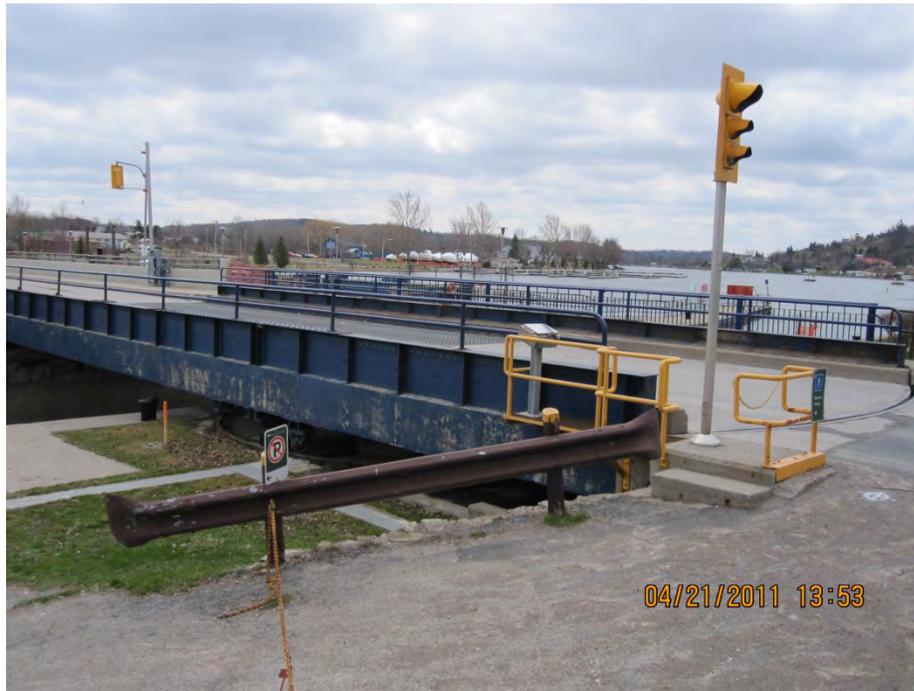
Figure 6A

No.1: Overview of the Hastings Swing Bridge from north side of bridge, looking southwest.

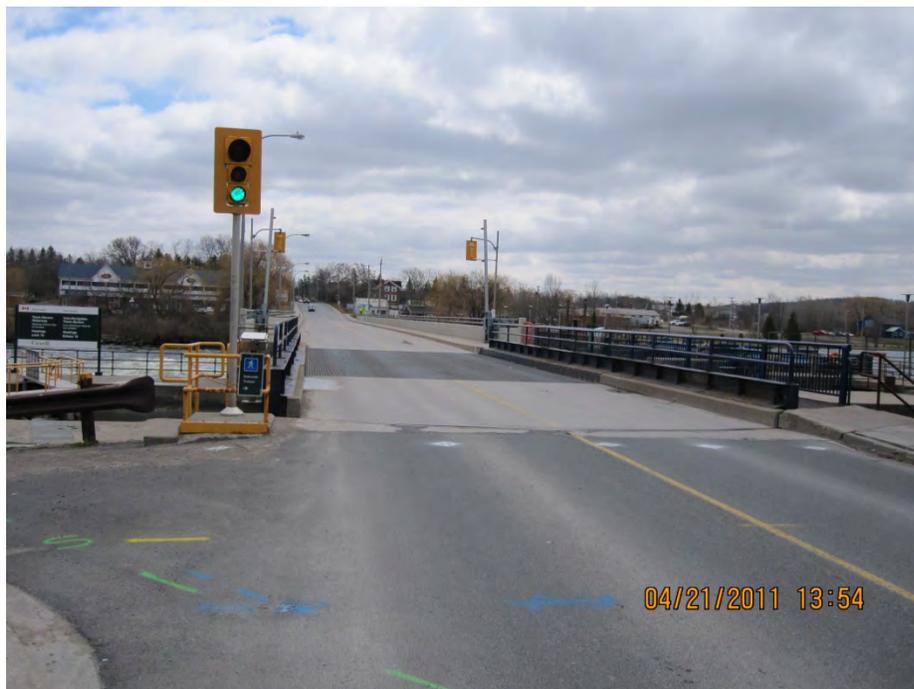
No.2: Overview of the Hastings Swing Bridge, looking south. The fixed bridge with concrete guard rail is located immediately south of the swing bridge.

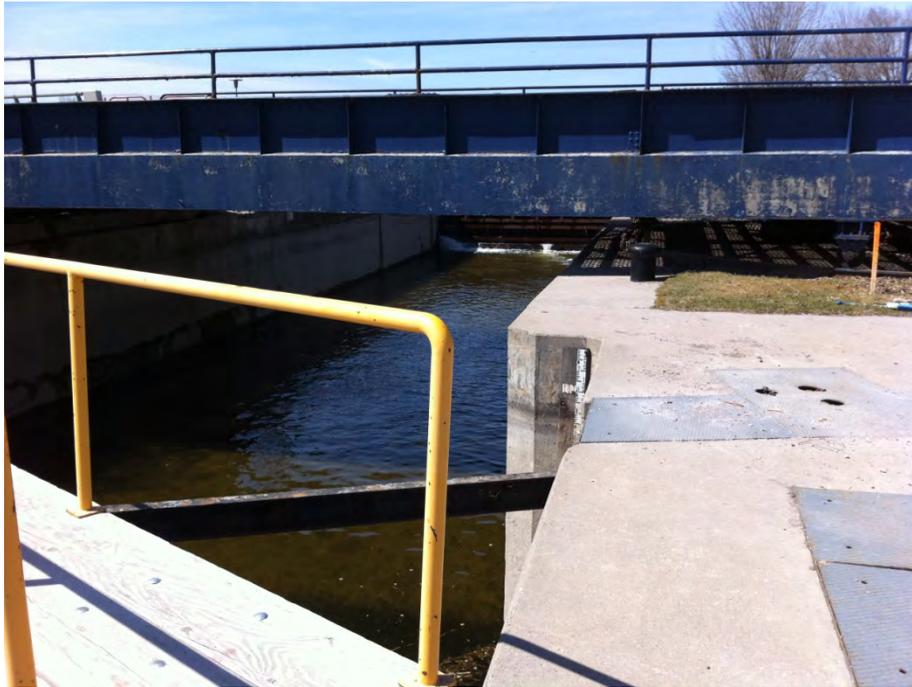
Figure 6B

No.3: Overview of the Hastings Swing Bridge at the position open to vehicle traffic, looking west, standing on top of the gate of Lock 18.

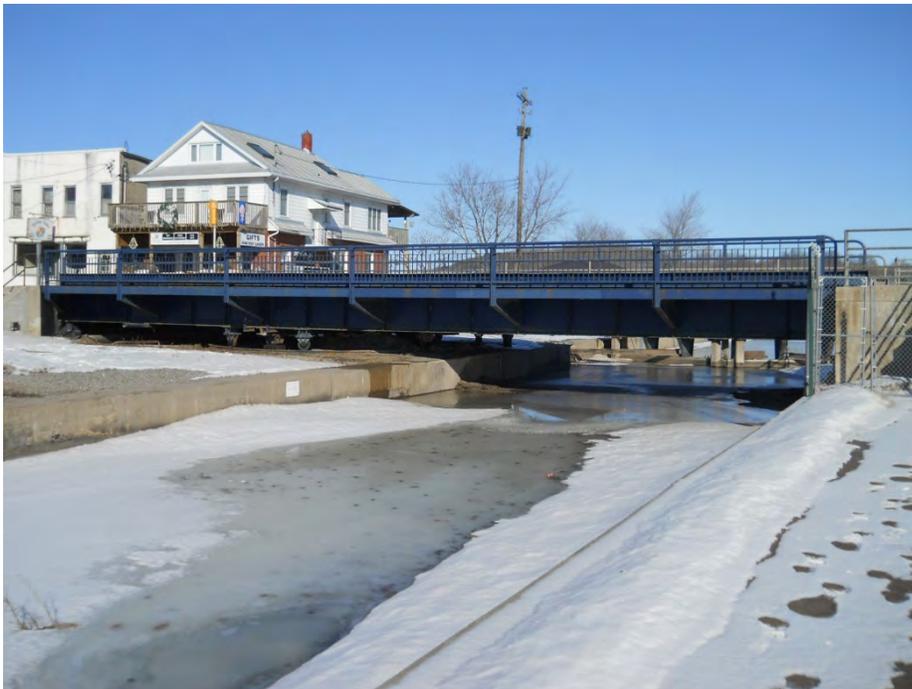
No.4: Overview of the Hastings Swing Bridge at position open to vehicle traffic, looking east.

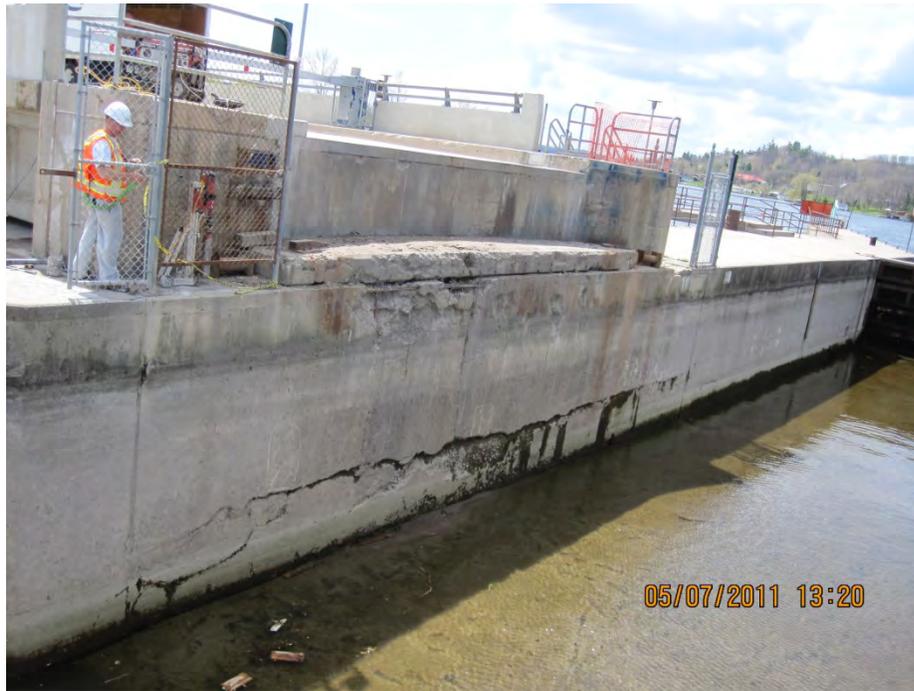
No.5: South abutment of swing bridge and south canal concrete wall, looking southeast, taken when the swing bridge was swung away and water in canal was lowered.

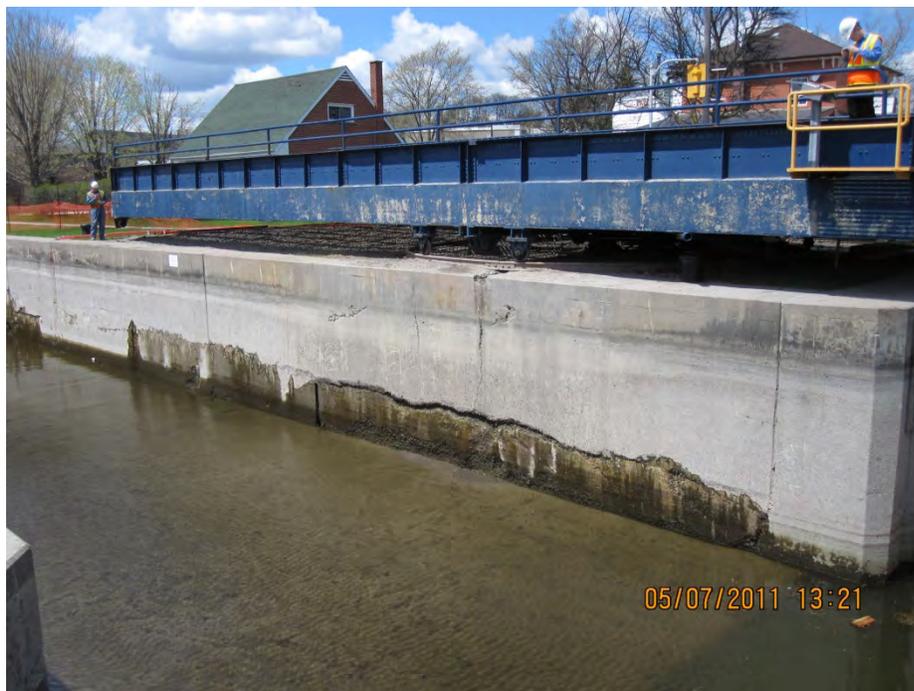
No.6: The north canal concrete wall, looking northwest, taken when the swing bridge was swung away and water in canal was lowered.

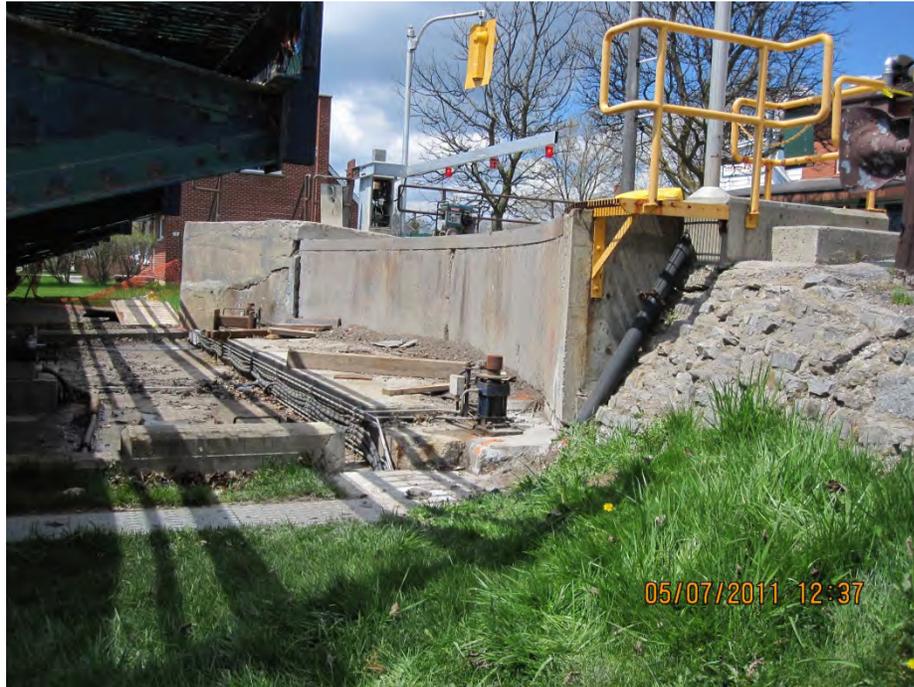
No.7: Overview of the North Abutment Wall; looking west after the swing bridge was swung away.

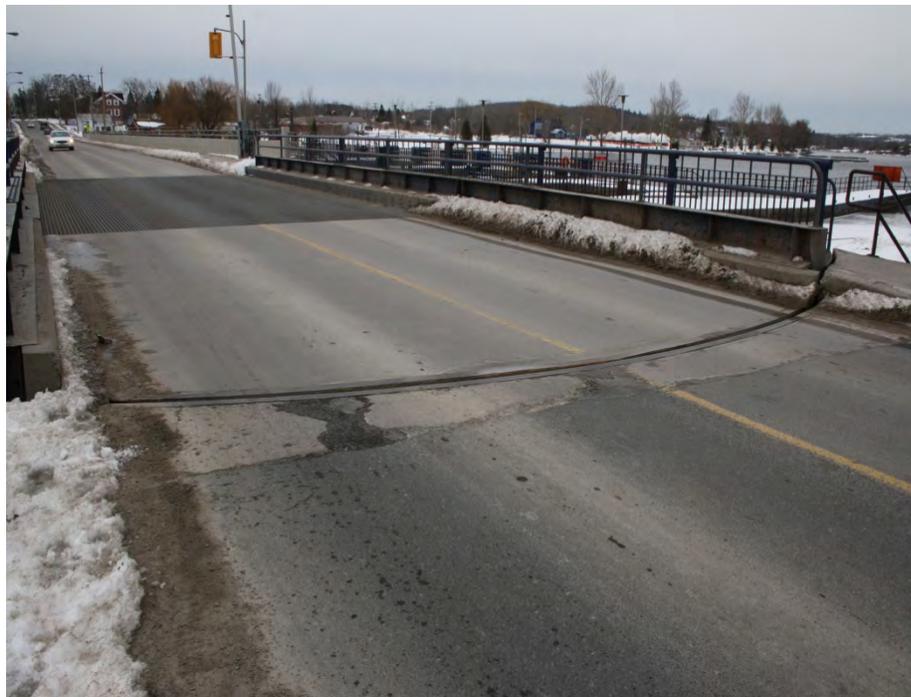
No.8: The swing bridge deck, looking south; a combination steel grate and concrete deck.

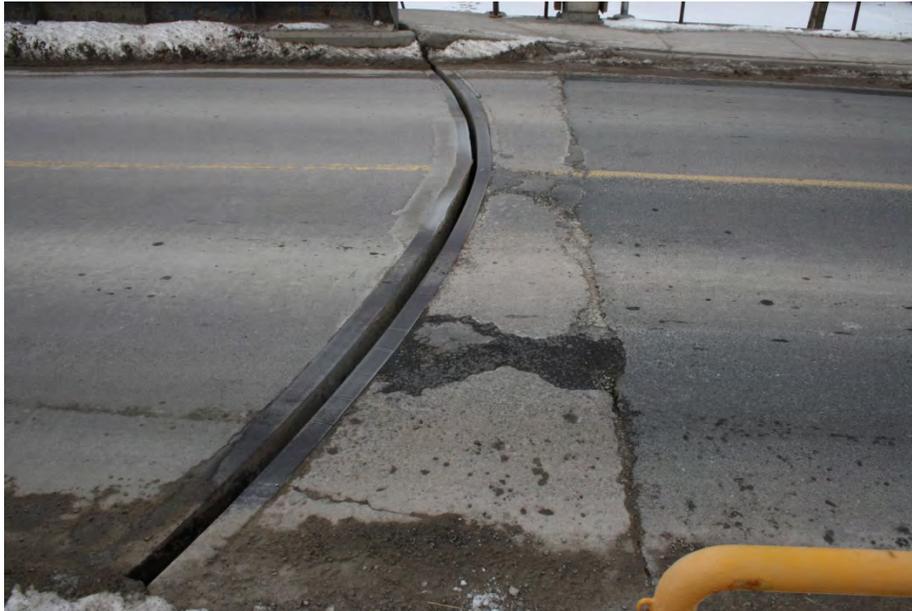
No.9: The north abutment wall and north nosing, looking west. Note the recent repair south of the steel nosing plate on the bridge deck; note the deterioration on top of the abutment wall and asphalt patch repair.

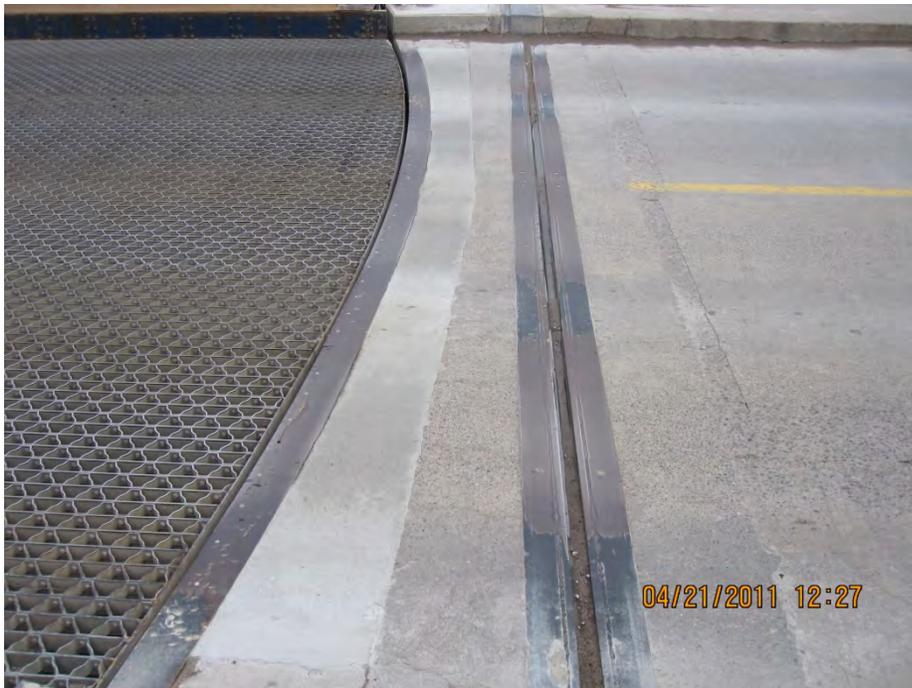
No.10: The south abutment wall and south nosing, looking west. Note the recent repair (lighter colour concrete) south of the steel plate on the abutment wall.

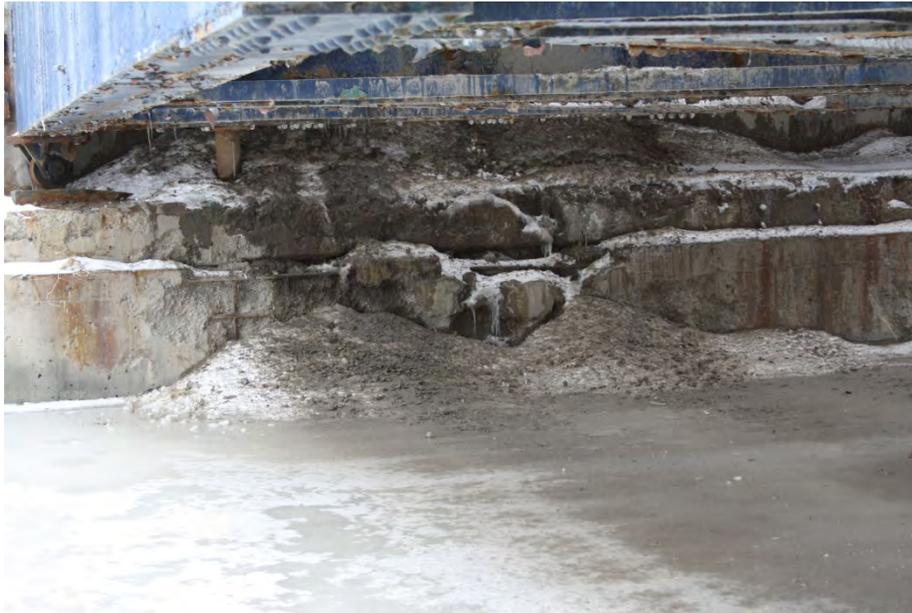
No.11: The south abutment underneath the bridge deck, looking south; note the deterioration of the concrete, exposed steel rebar; note the snow, salt and sands or soils falling from the steel grate deck.

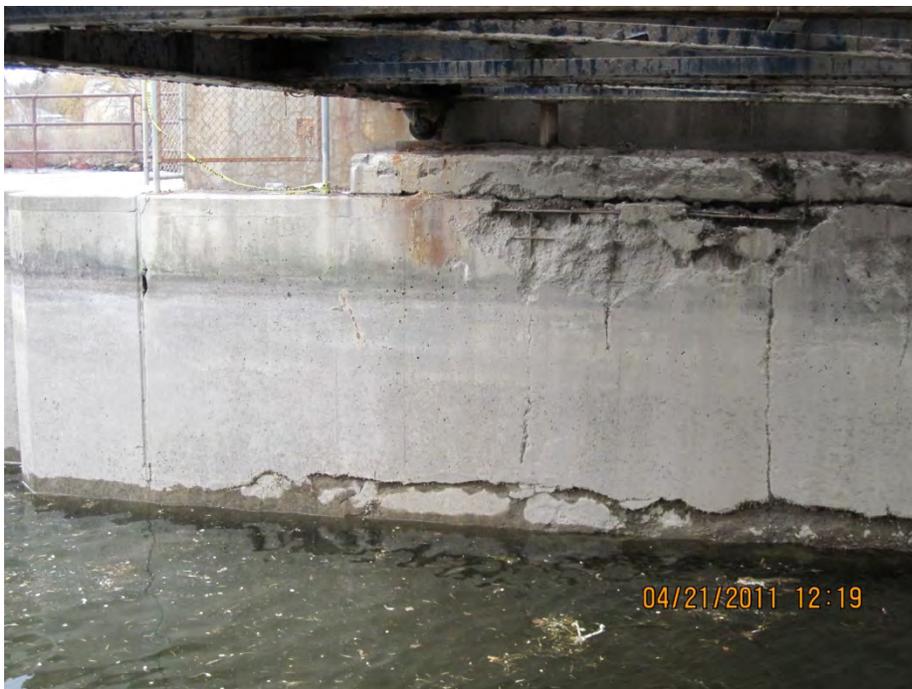
No.12: The south abutment underneath the bridge deck, looking south; note the deterioration of the concrete, exposed steel rebar at or immediate below the abutment slab; also note the nearly horizontal deterioration of the concrete at lower portion of the south canal wall.

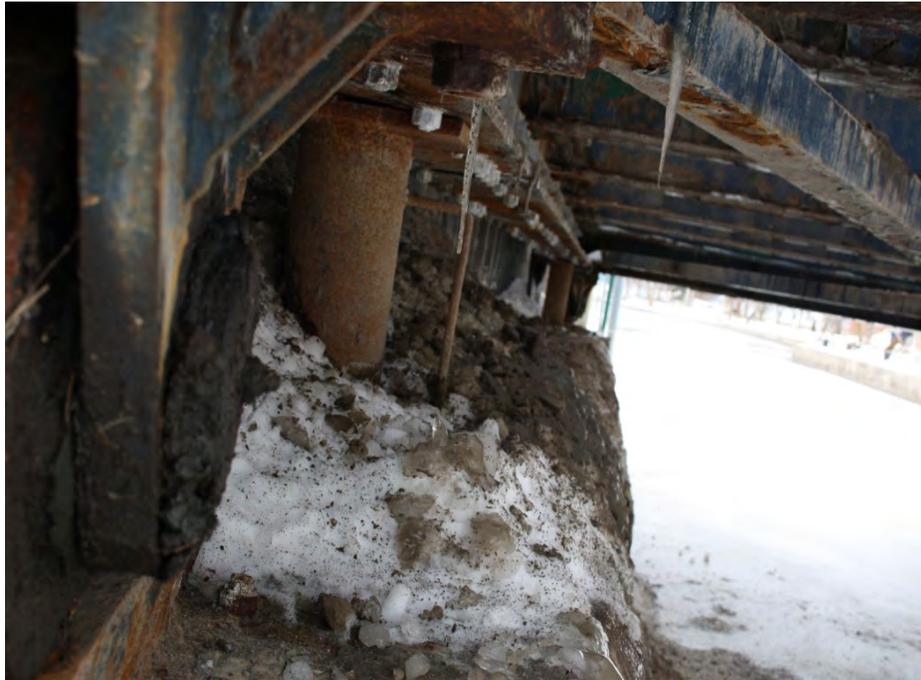
No.13: The south abutment underneath the bridge deck, looking west; note the snow, salt and sands or soils falling from the steel grate deck; note two steel posts used to support the bridge during the non-operational seasons.

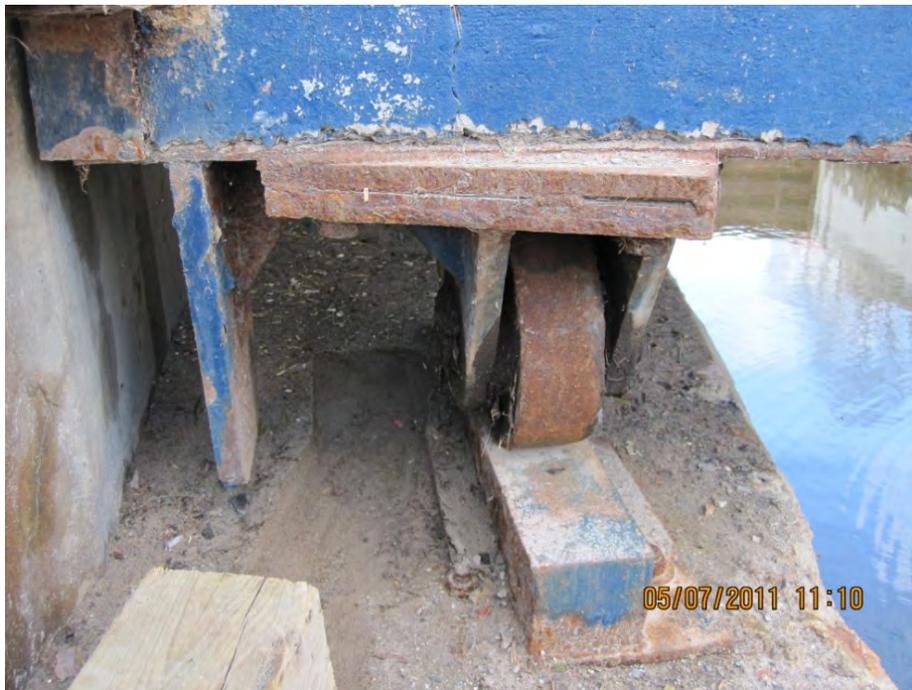
No.14: The south abutment, looking west; note the steel wheel sitting on top of the steel plate to support the bridge during the operational seasons.

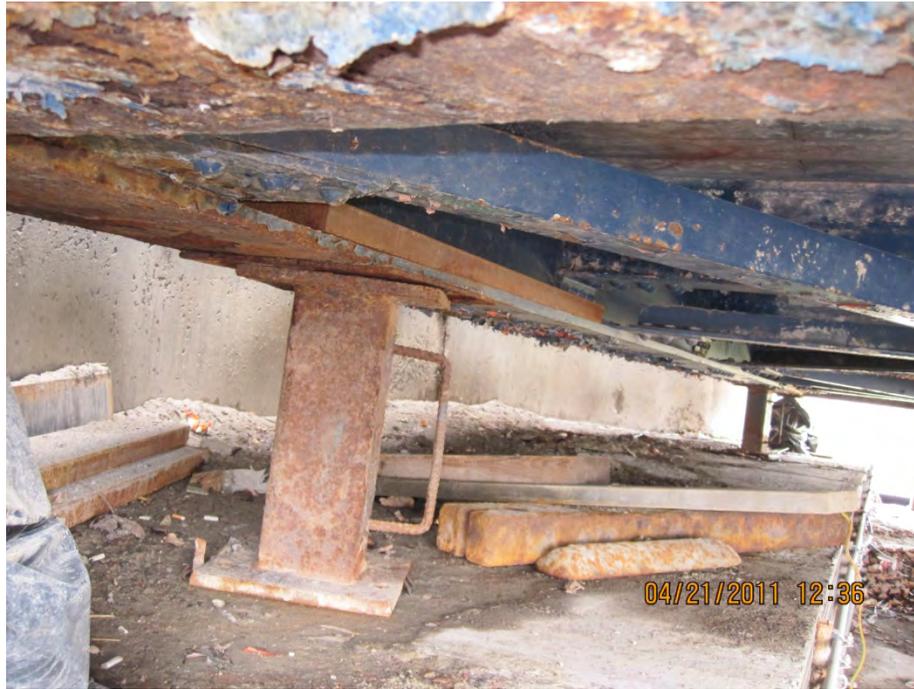
No.15: The north abutment underneath the bridge deck, looking east; note two steel posts used to support the bridge during the non-operational seasons.

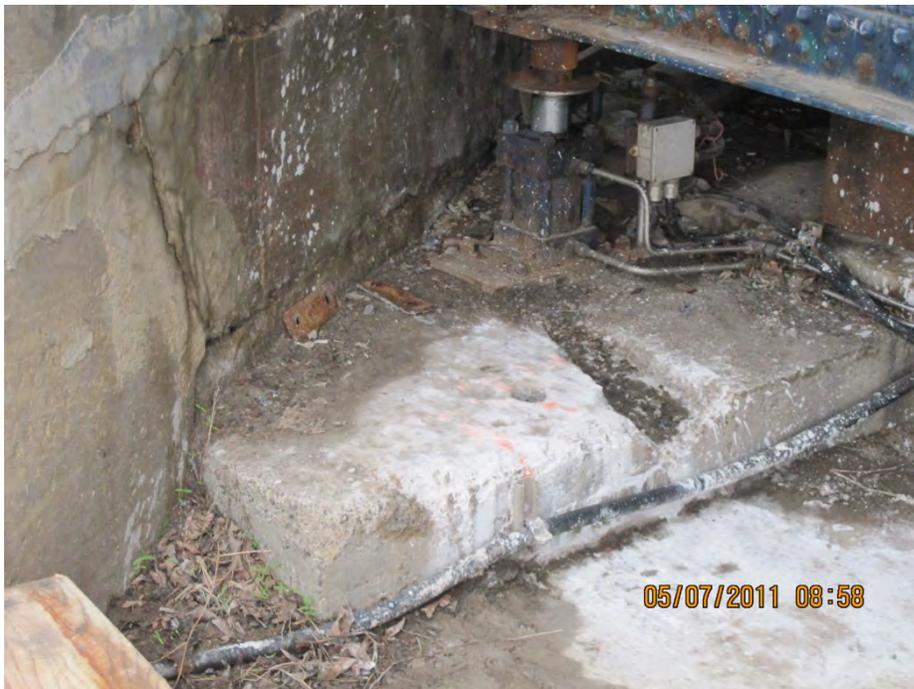
No. 16: The north abutment west side of the bridge, looking northeast; note the support hydraulic jack used to support the bridge during the operational seasons.

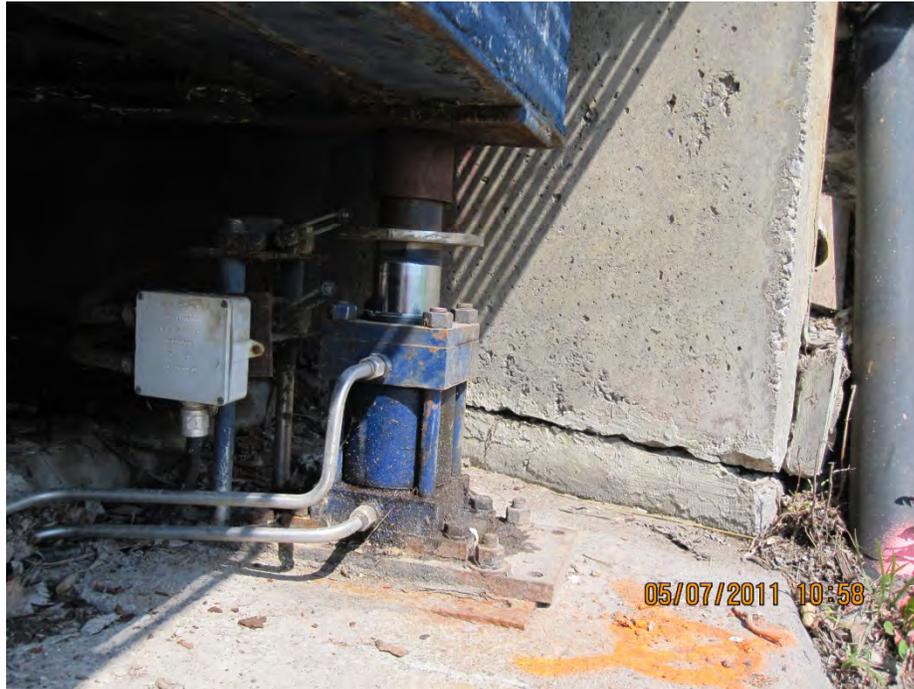
No.17: The north abutment east side of the bridge, looking northwest; note the support hydraulic jack used to support the bridge during the operational

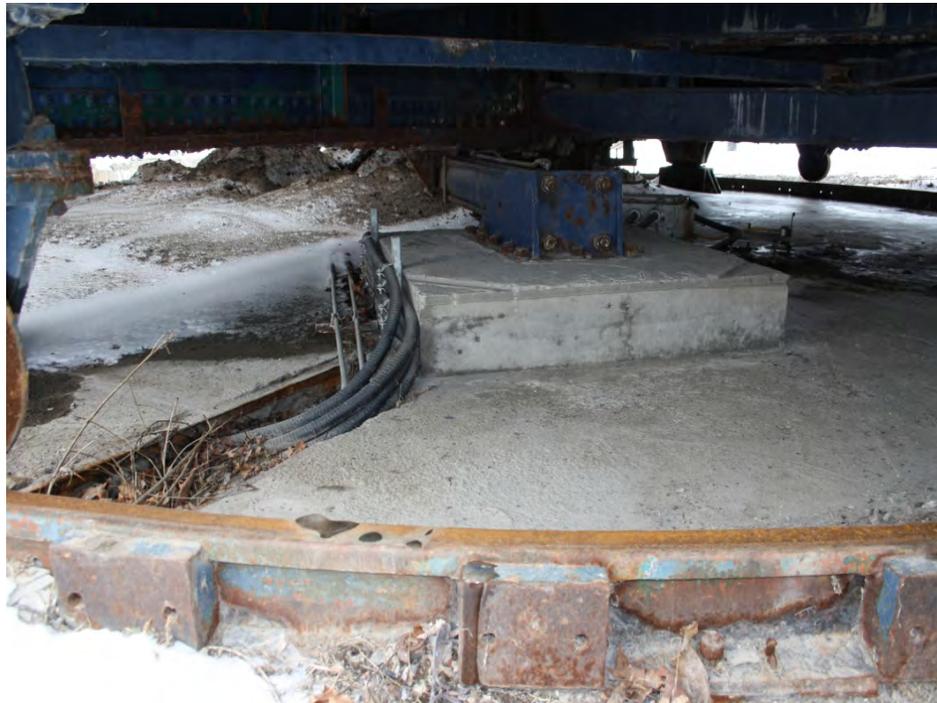
No.18: The central concrete pivot pier; note that the concrete at the surface of the pier appeared to be recently resurfaced; note the hydraulic system and the hydraulic jack used to swing the bridge.

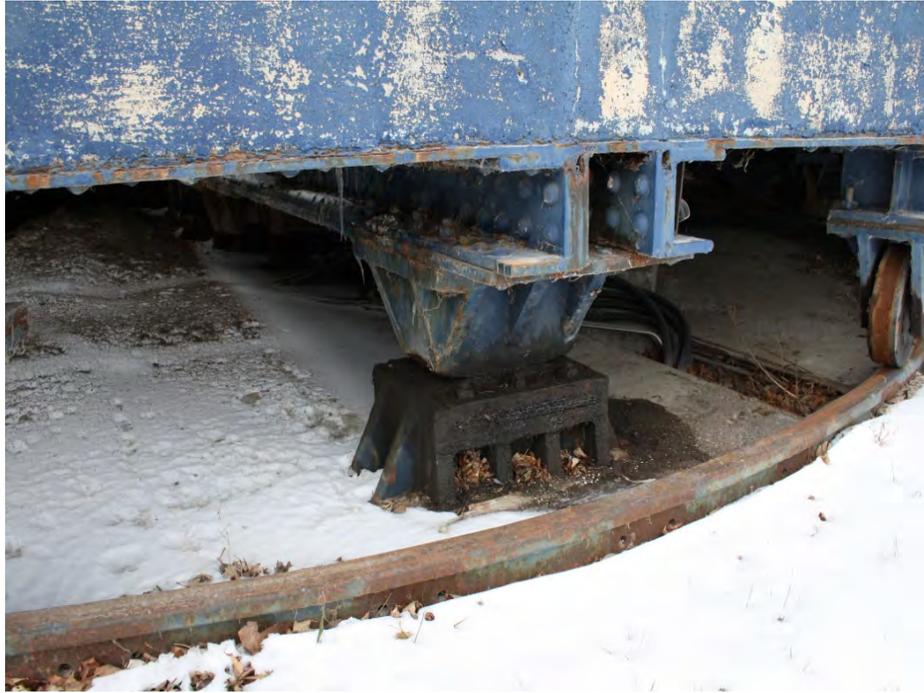
No.19: The central concrete pier; note the circular steel track on top of the concrete pier, the balance wheel on the track and steel pillow block rest to support the transverse beam of the swing bridge.

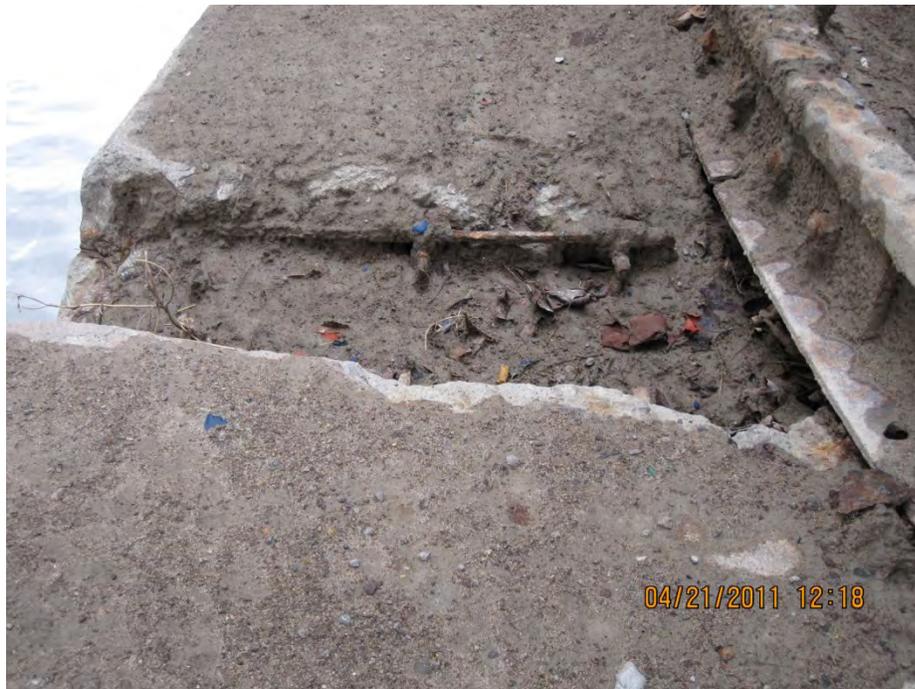
No.20: The north canal concrete wall; note the deterioration of concrete on the wall surface and exposed and eroded steel rebar and the void underneath the steel track on top of the central pier.

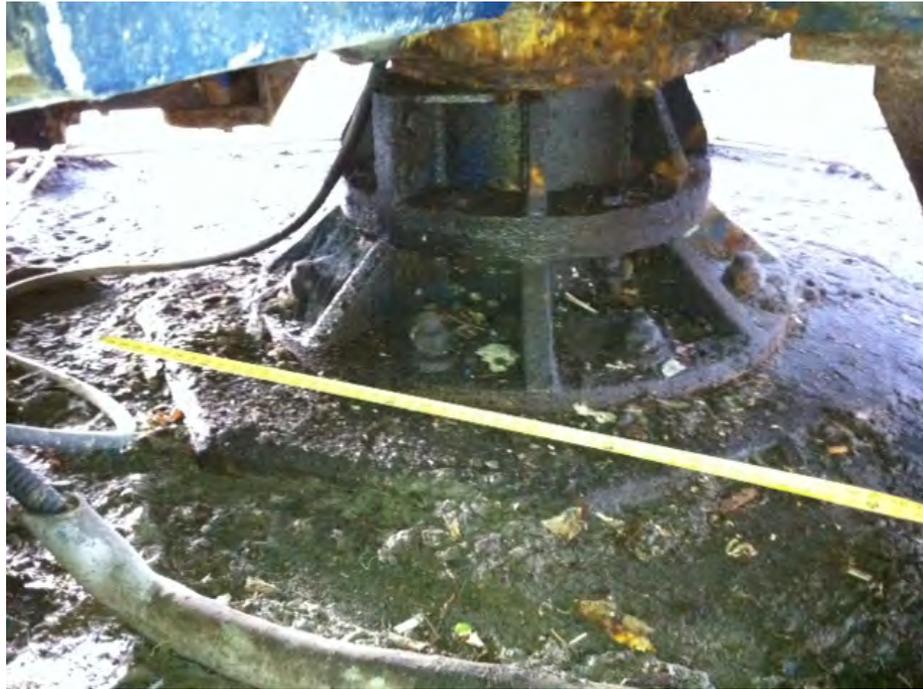
No.21: Central pintle with a round steel plate (Approx. Dia. 0.8m) bolted on concrete platform slightly elevated above the pier concrete.

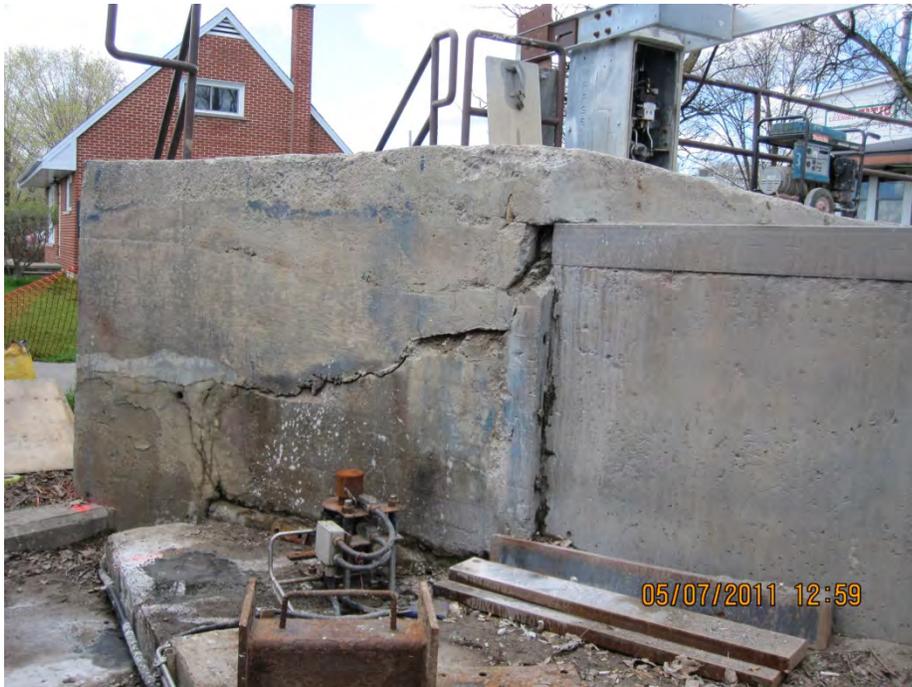
No.22: The west portion of the swing bridge abutment wall (the portion for the sidewalk and stairs). Note the concrete wall was poured in different years and the cracks between different pours.

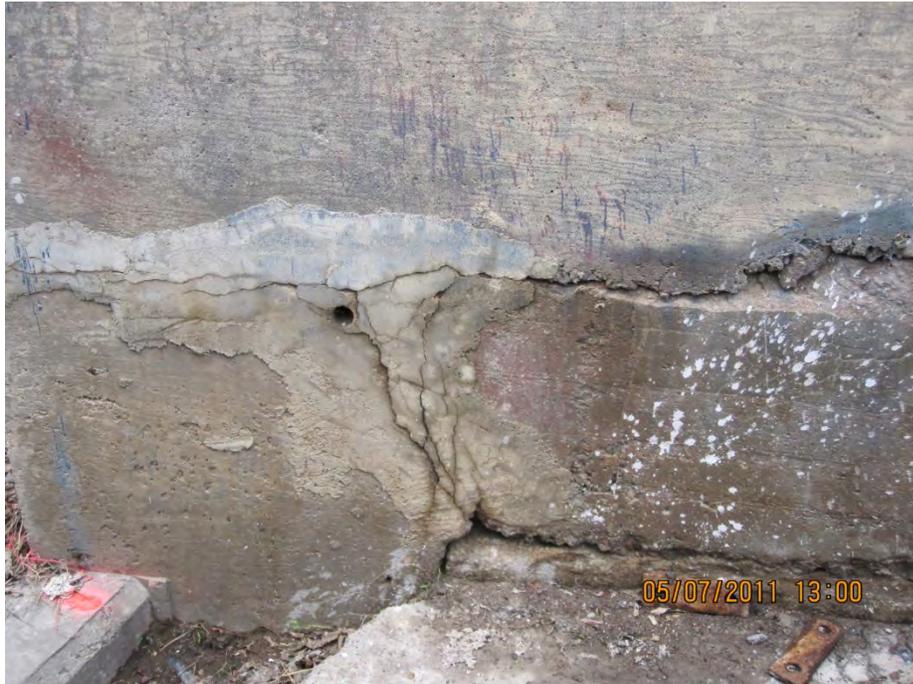
No.23: A close look of the west portion of the swing bridge abutment wall (the portion for the sidewalk and stairs). Note the concrete wall was poured in different years and the cracks between different pours; note the drainage hole on the wall.

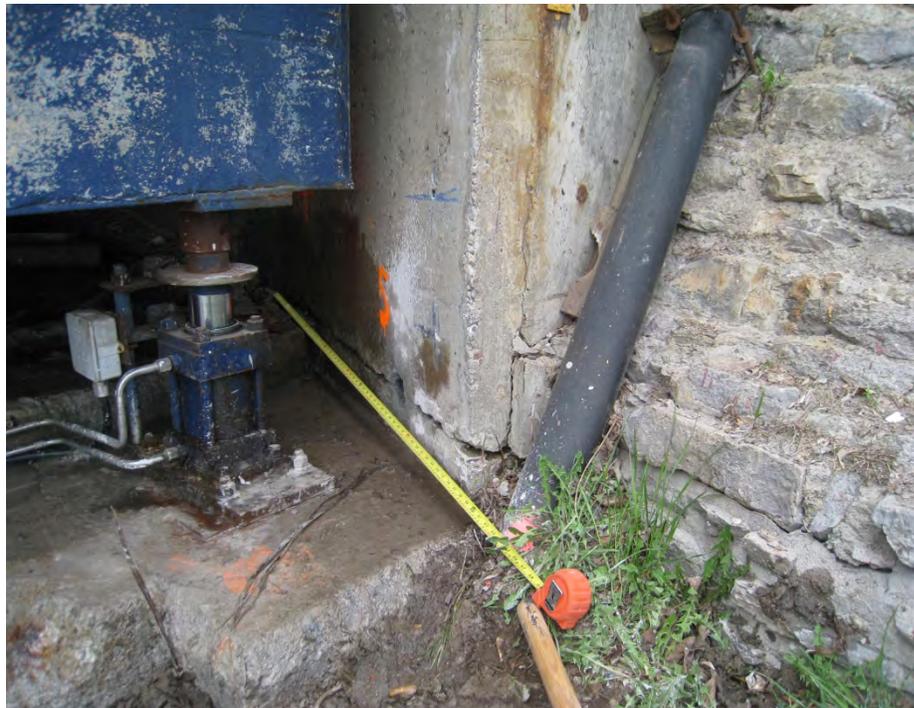
No.24: The northeast of the swing bridge; note the nearly-straight-line crack from the edge of the wing wall extending west to a distance of about 1.5 m.

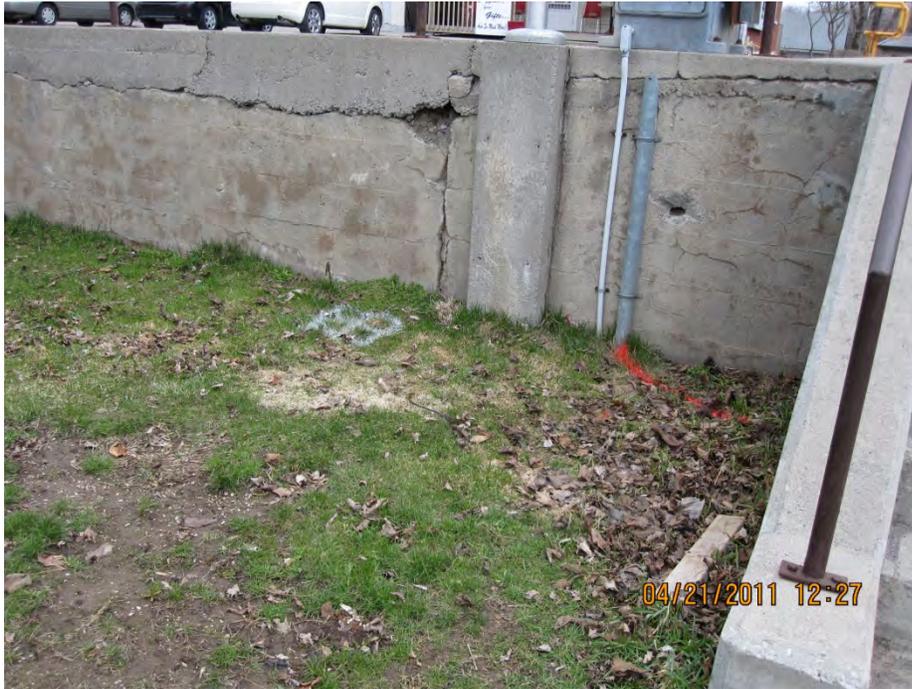
No.25: The retaining wall on the northwest side of the swing bridge; note the upper portion of the concrete was poured in different years and cracks between the different pours; note the deterioration of lower portion concrete.

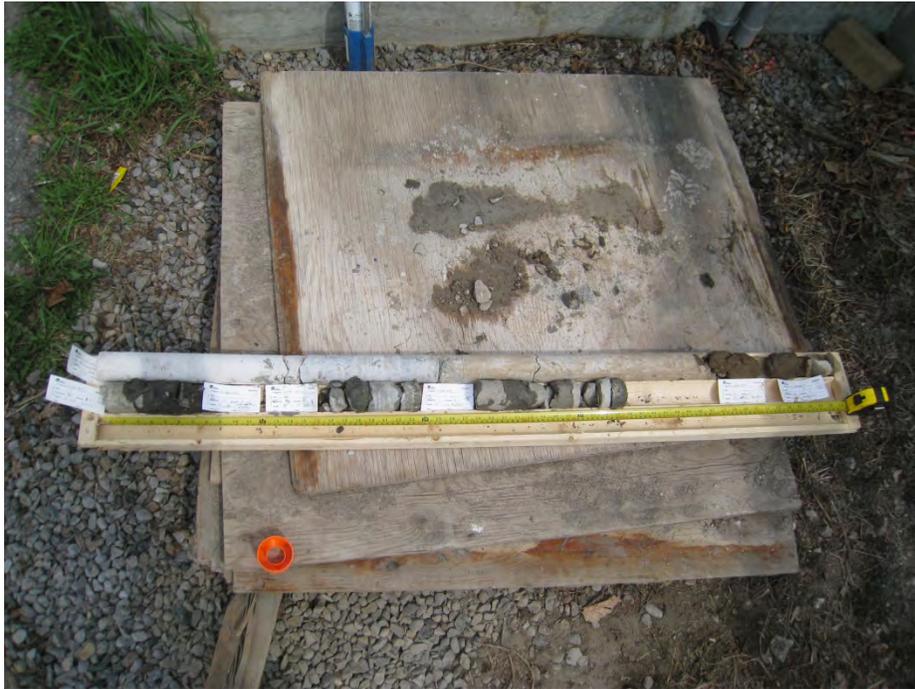
No.29: Photograph of the Corehole 1 cores.
