PROJECT TITLE : HASTING SWING BRIDGE PIVOT PIER FOAM INJECTION

PROJECT NUMBER R.0557746.001

- .1 Work of this Contract comprises foam injection under the pivot pier and north abutment of the Hasting Swing Bridge , located in the Town of Hastings Ontario.

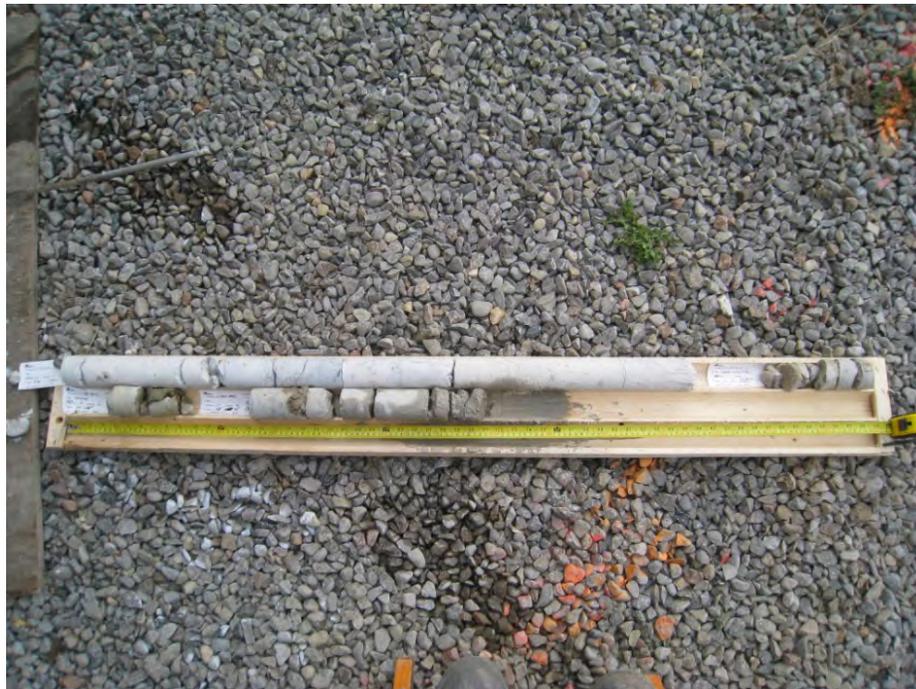
No.30: Photograph of the Corehole 2 cores.

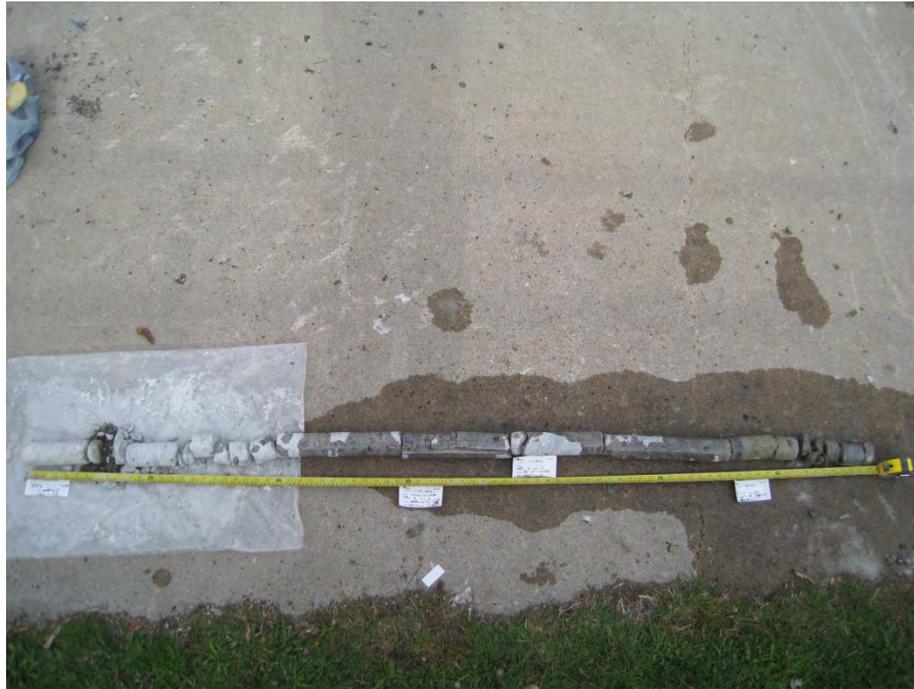
No.31: Photograph of the Corehole 3 cores.

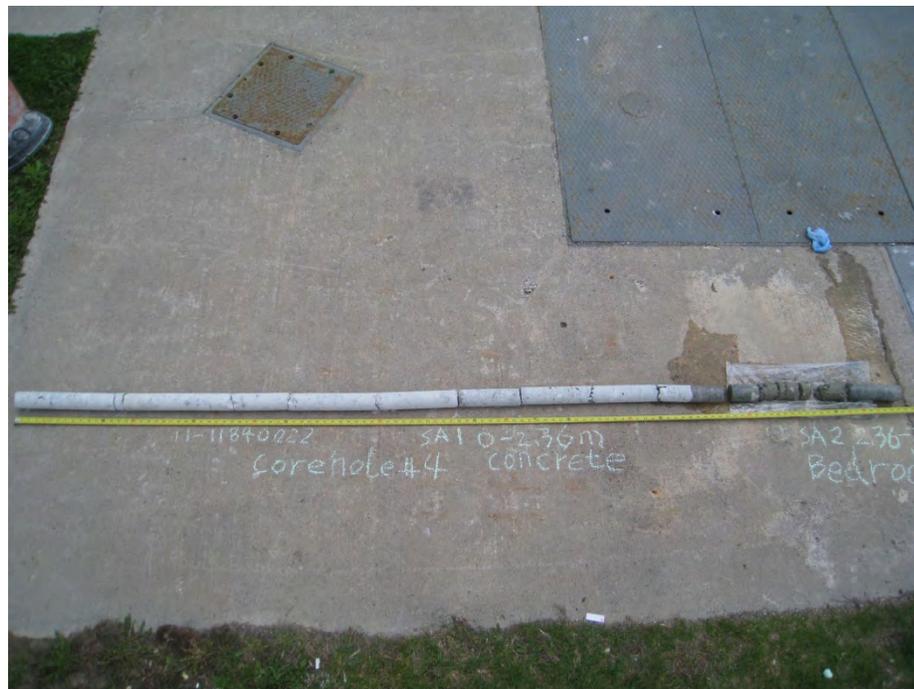
No.32: Photograph of the Corehole 4 cores.

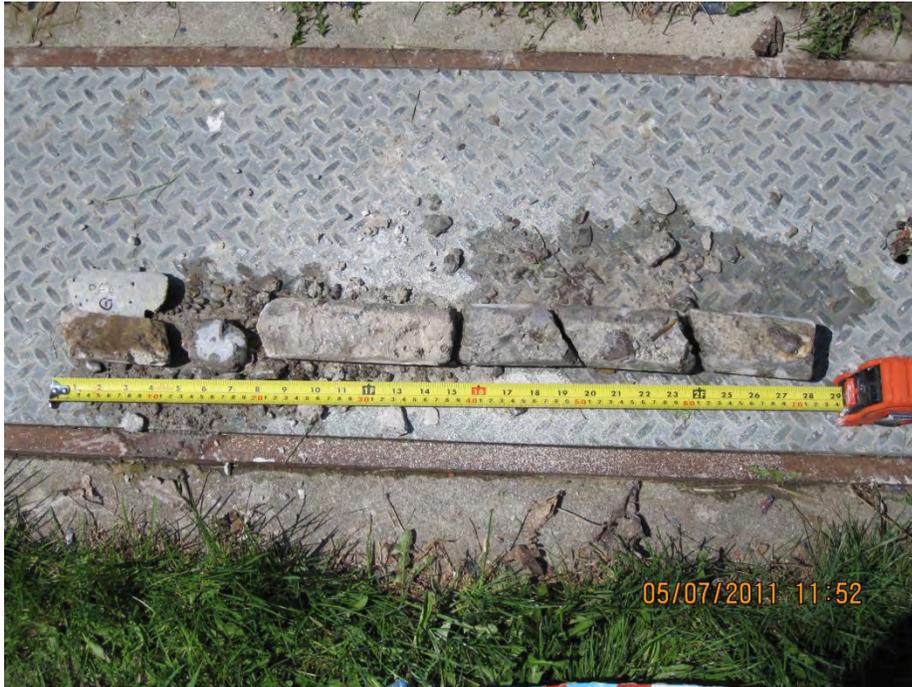
No.33: Photograph of the Corehole 5 cores.

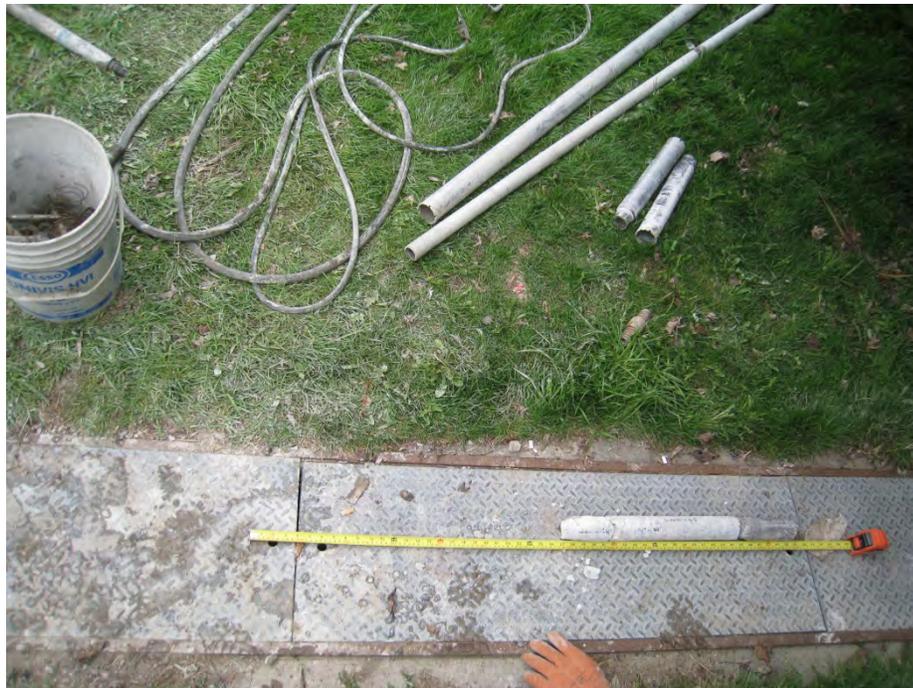
No.34: Photograph of the Corehole 5 cores.

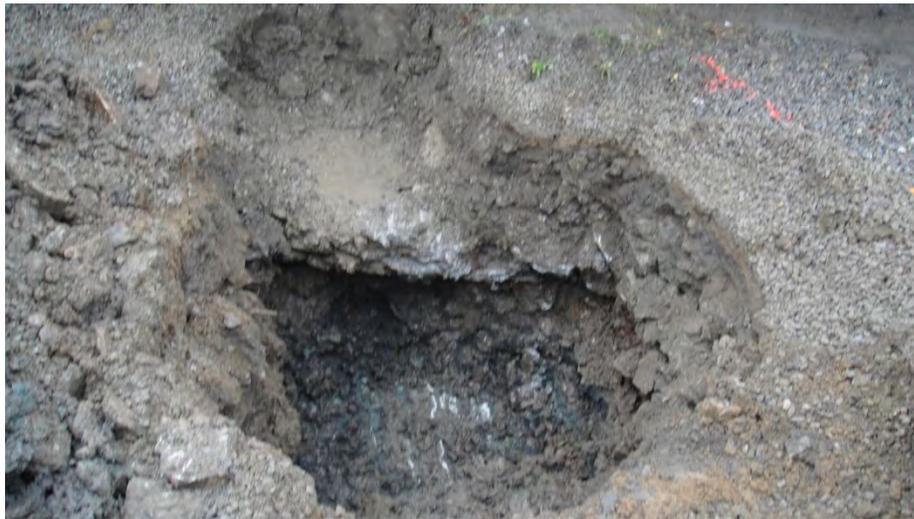
No.36: Photograph of the Test Pit 1. The limestone bedrock exposed at the bottom of the test pit.

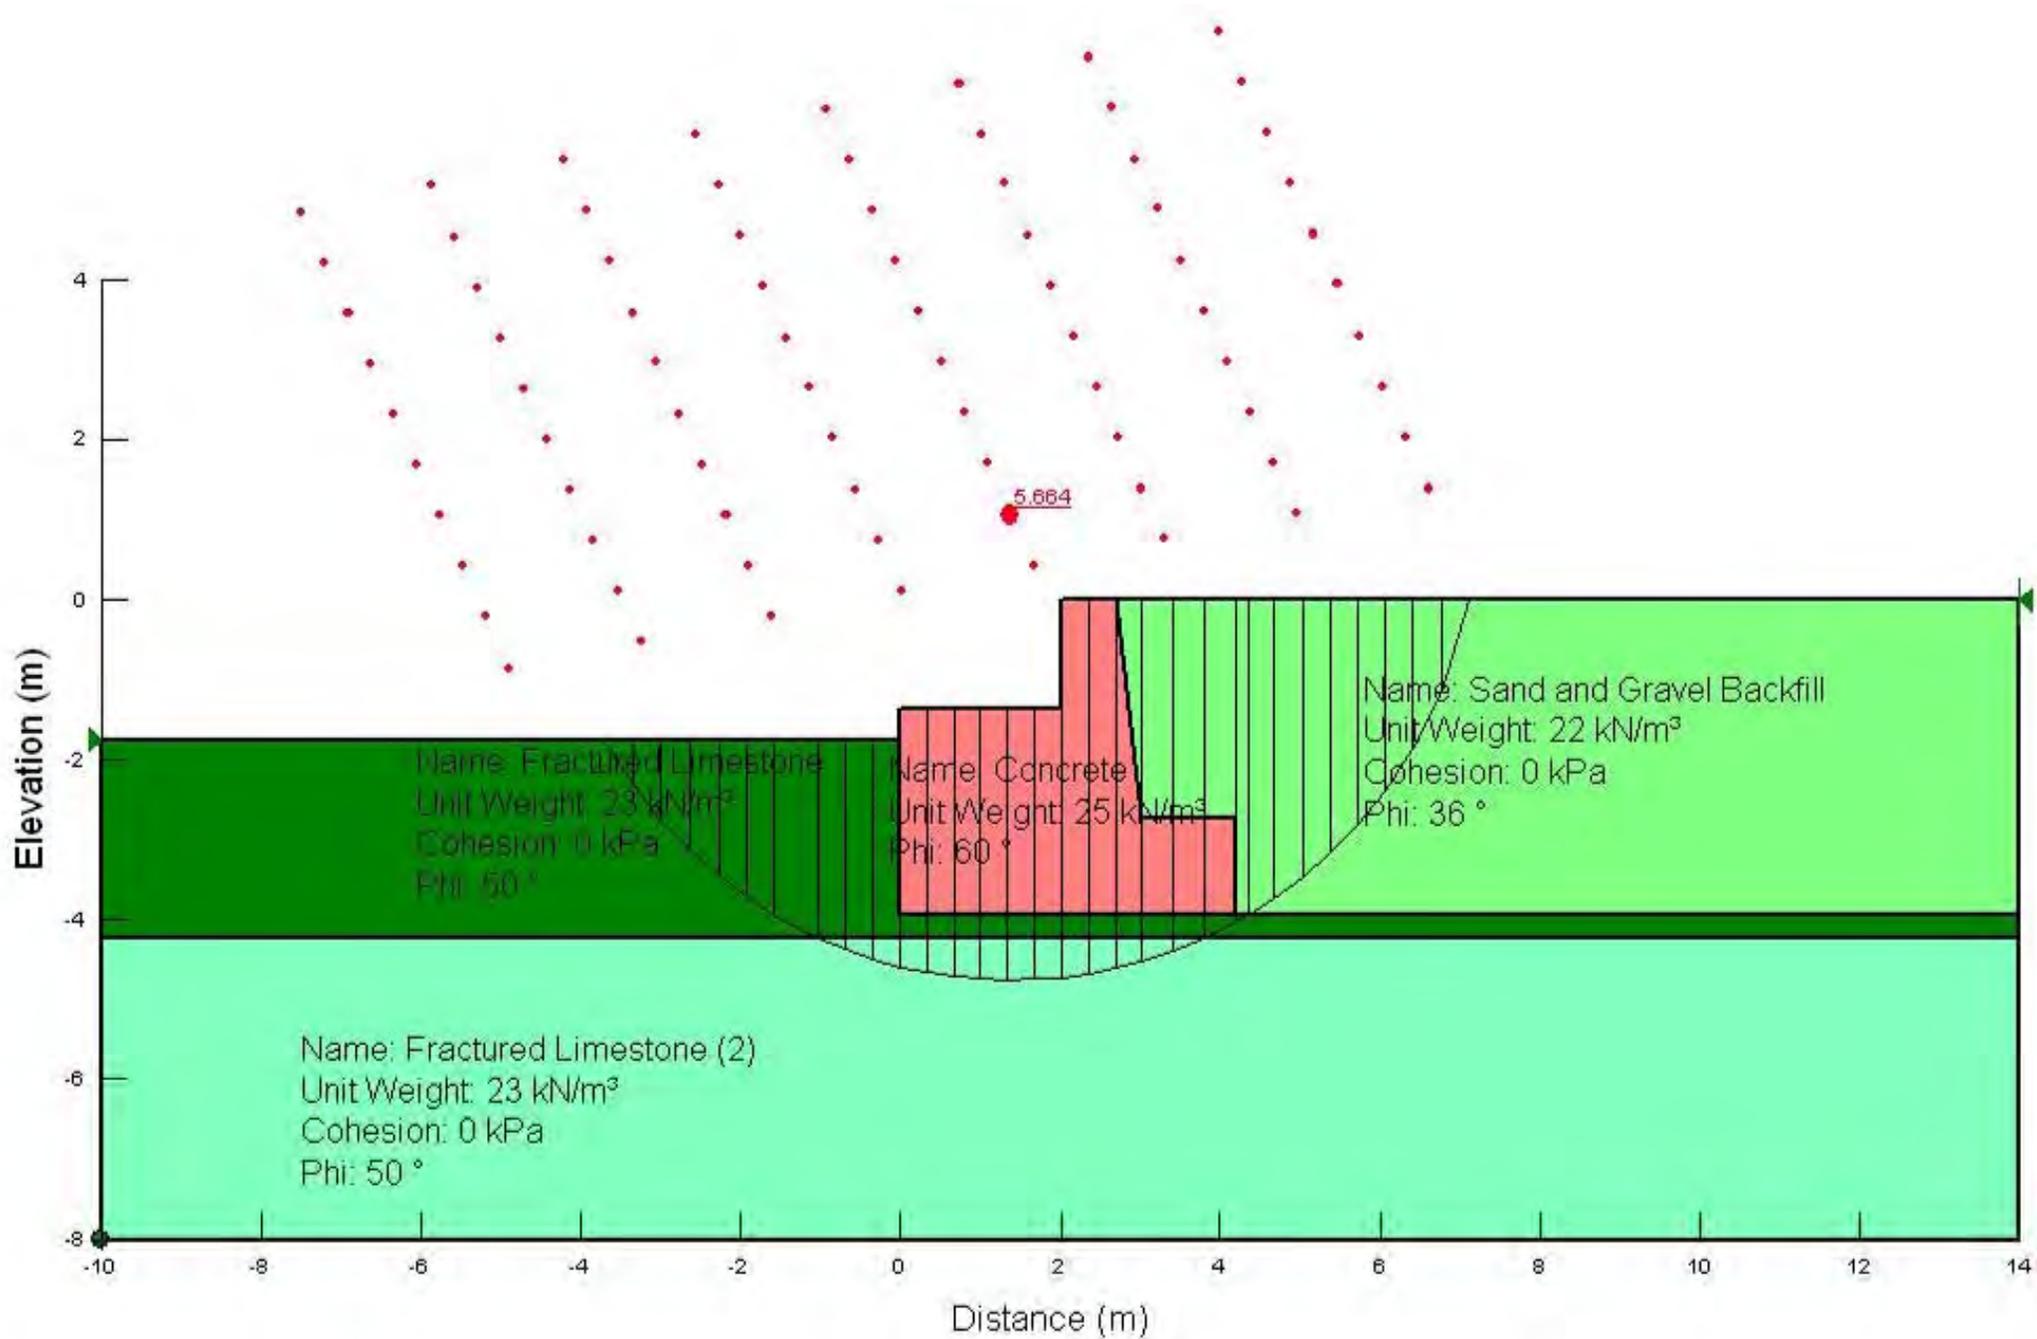
Figure 7- Global Stability Analysis of the North Abutment Wall

A global stability analysis has been carried out as shown on Figure 7. Based on the analysis, global stability factor of safety for the north abutment is greater than the typical minimum requirement of 1.5. However, a more detailed structural stability analysis may be necessary, especially at the location of the existing crack at the east portion of the abutment wall. The following parameters are provided for structural stability analysis purposes:

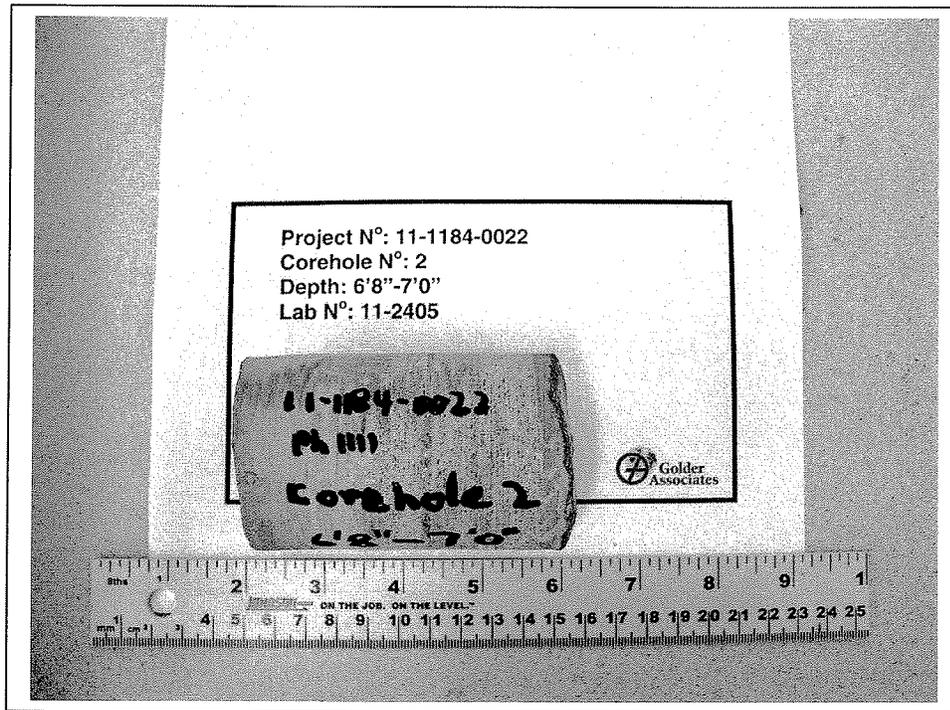
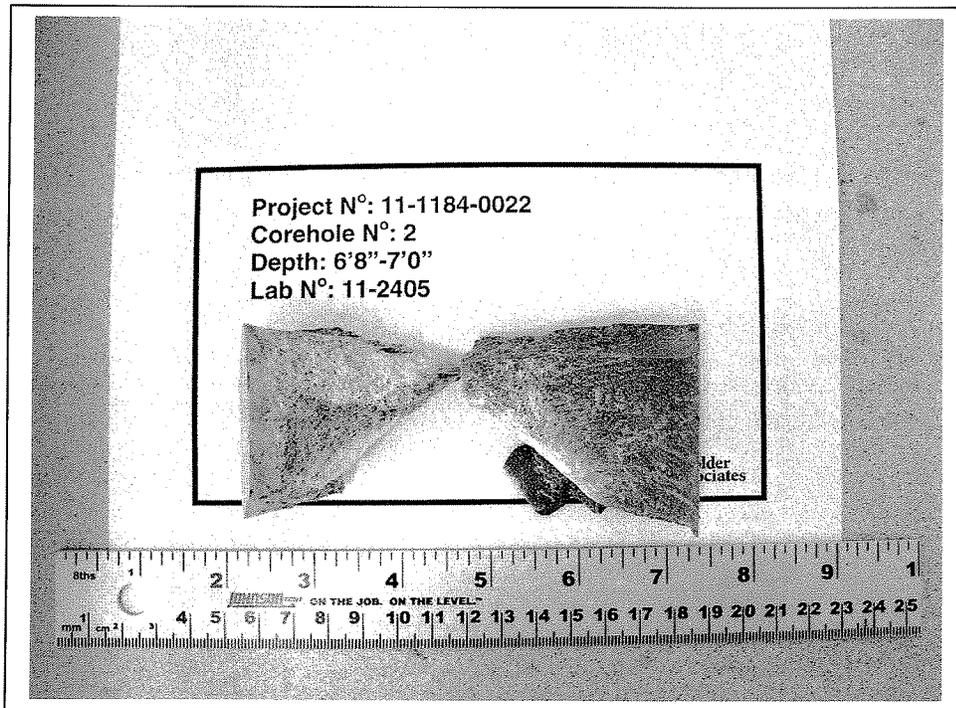
ASTM D7012-07

BEFORE COMPRESSION

AFTER COMPRESSION

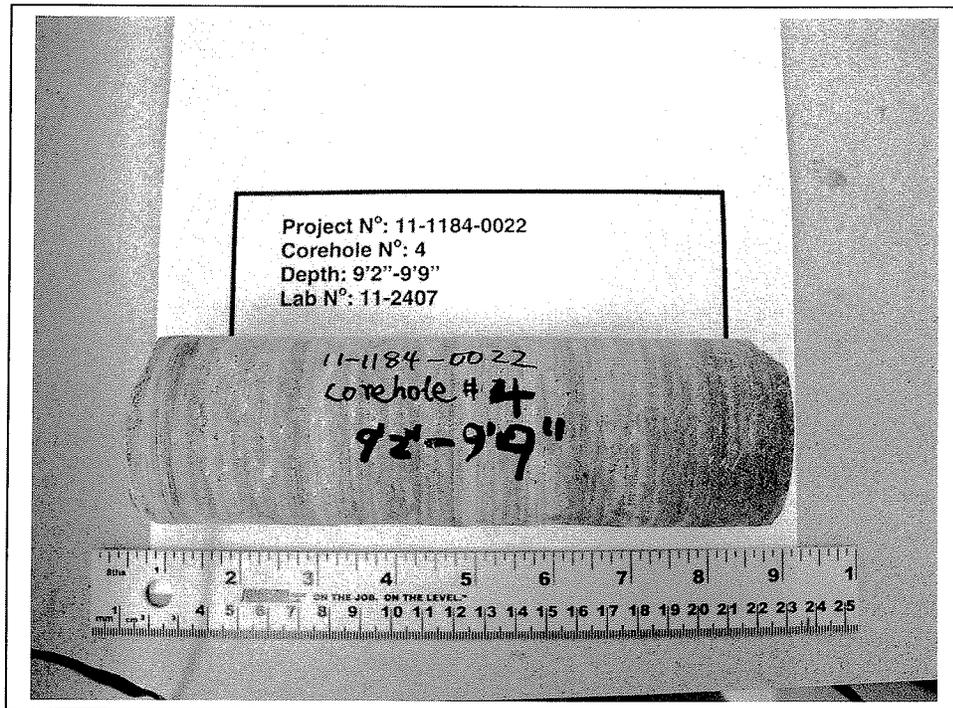
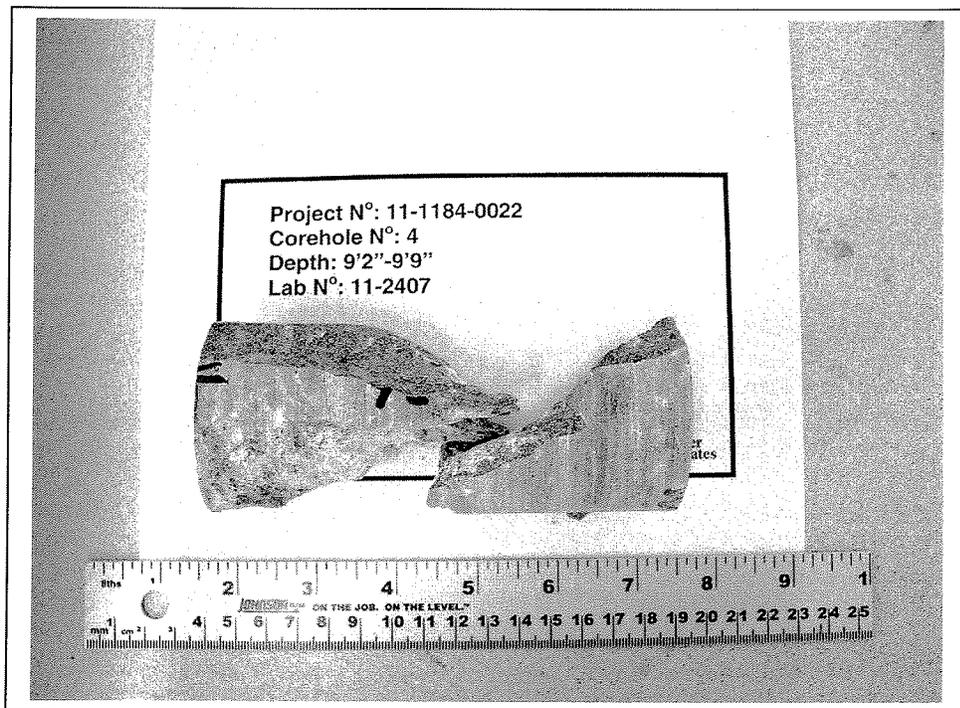
UNCONFINED COMPRESSION TEST  
ASTM D7012-07

BEFORE COMPRESSION

AFTER COMPRESSION
