GRANVILLE ISLAND MARINE STRUCTURE REPAIRS

Contract Package #1

DRAWING INDEX

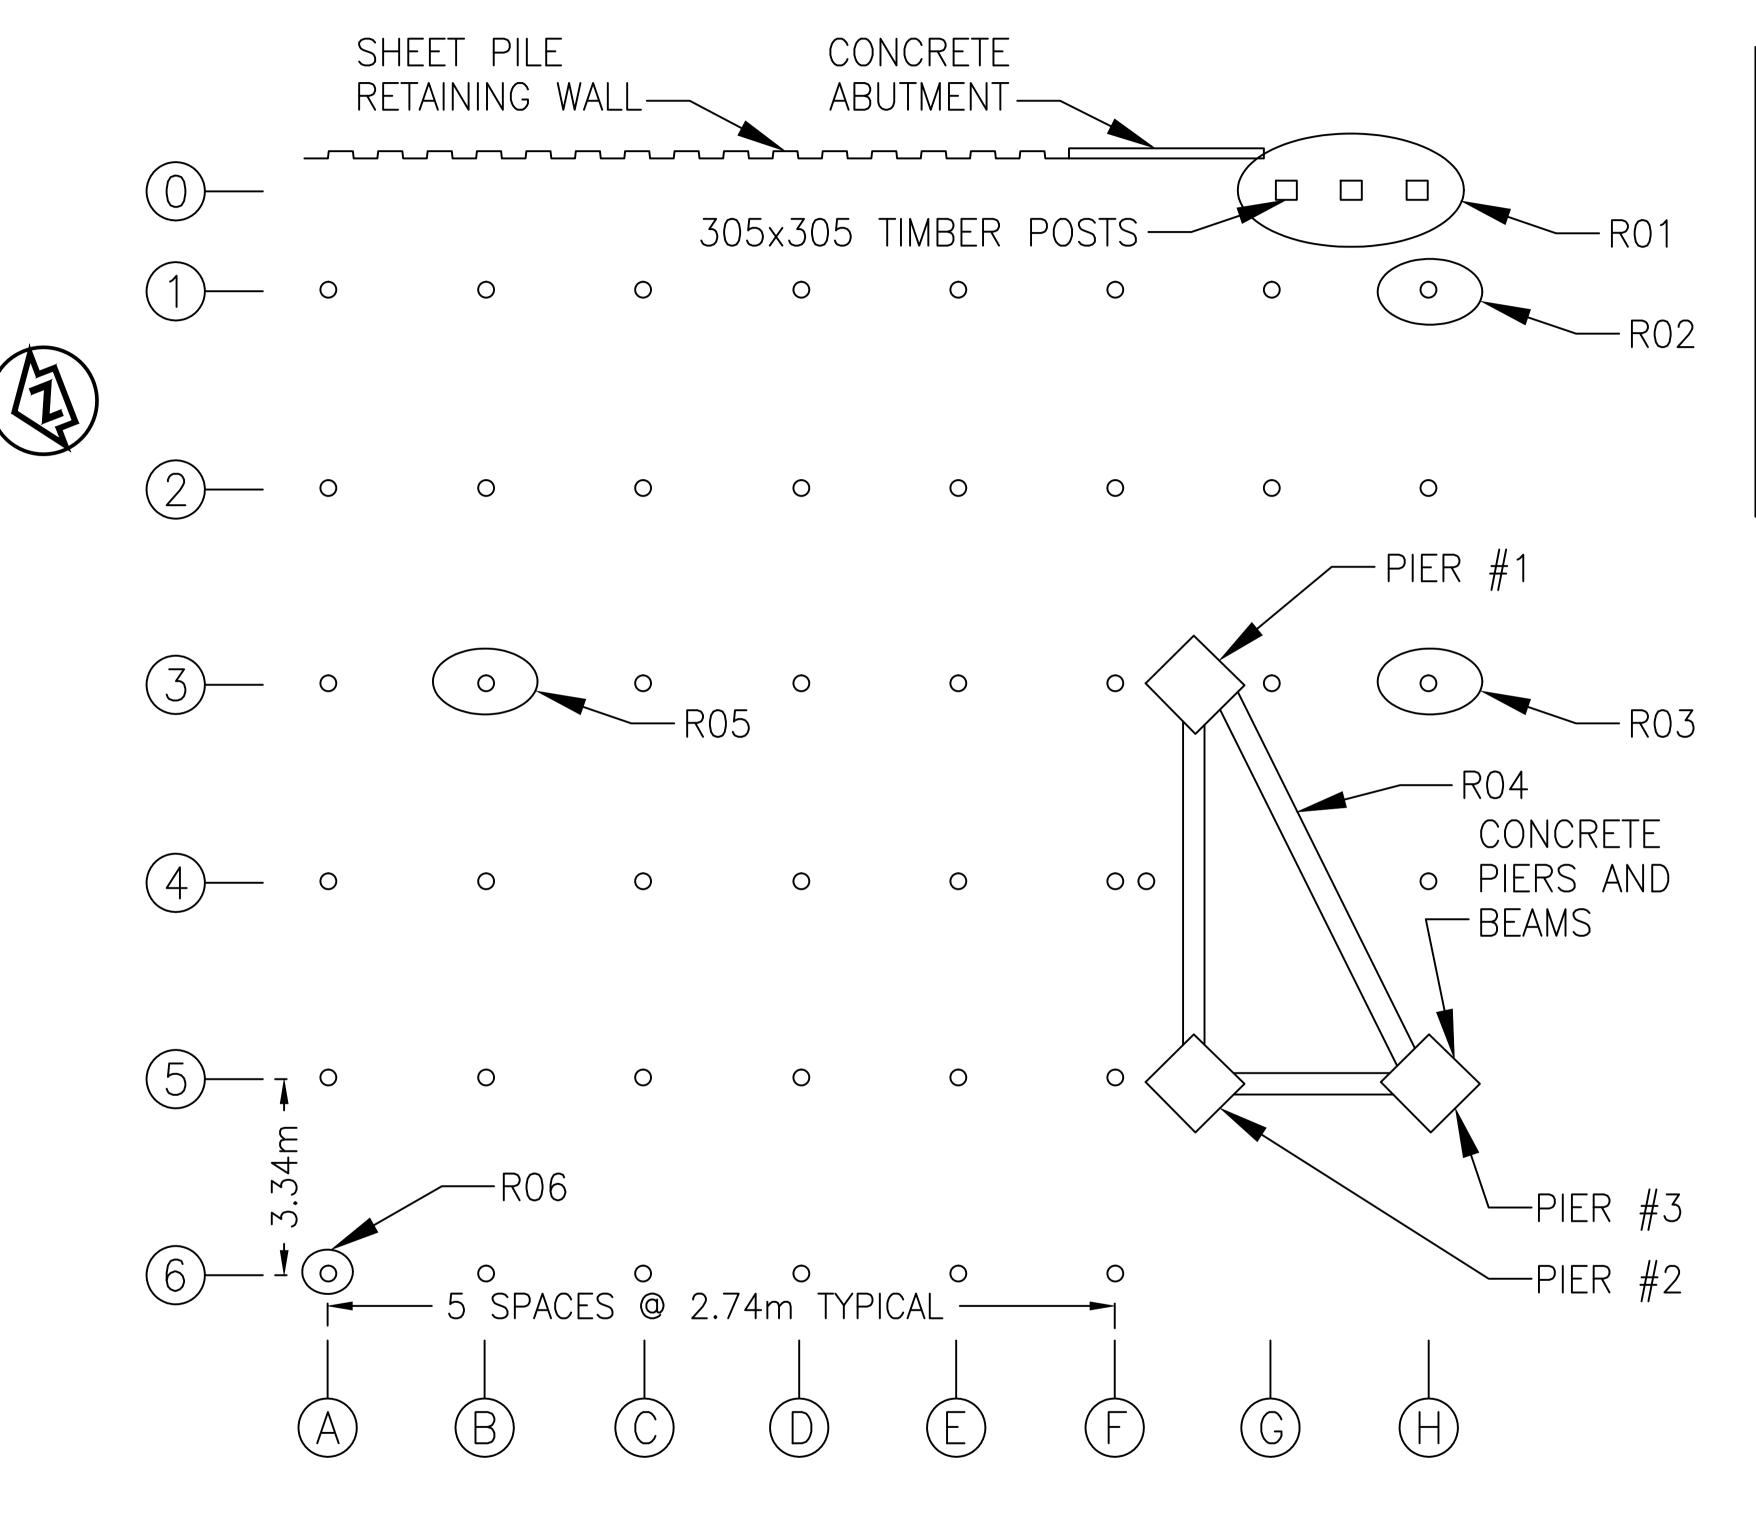
REPAIR No.	DESCRIPTION	REPAIR DETAIL/DWG No.
R01	BENT O, REPLACE CAP AND INSTALL NEW POSTS SUPPORTED ON CIP SONATUBE FOOTINGS	8-F2
R02	FRESH HEAD AND INSTALL CORBEL	8-F5
R03	FRESH HEAD AND INSTALL DOUBLE CORBEL BLOCK	8-F4
R04	CONCRETE AND SUB-BEAM RETROFIT	11\12
R05	INSTALL STEEL BANDS	9-F1
R06	INSTALL STEEL BANDS	9-F1

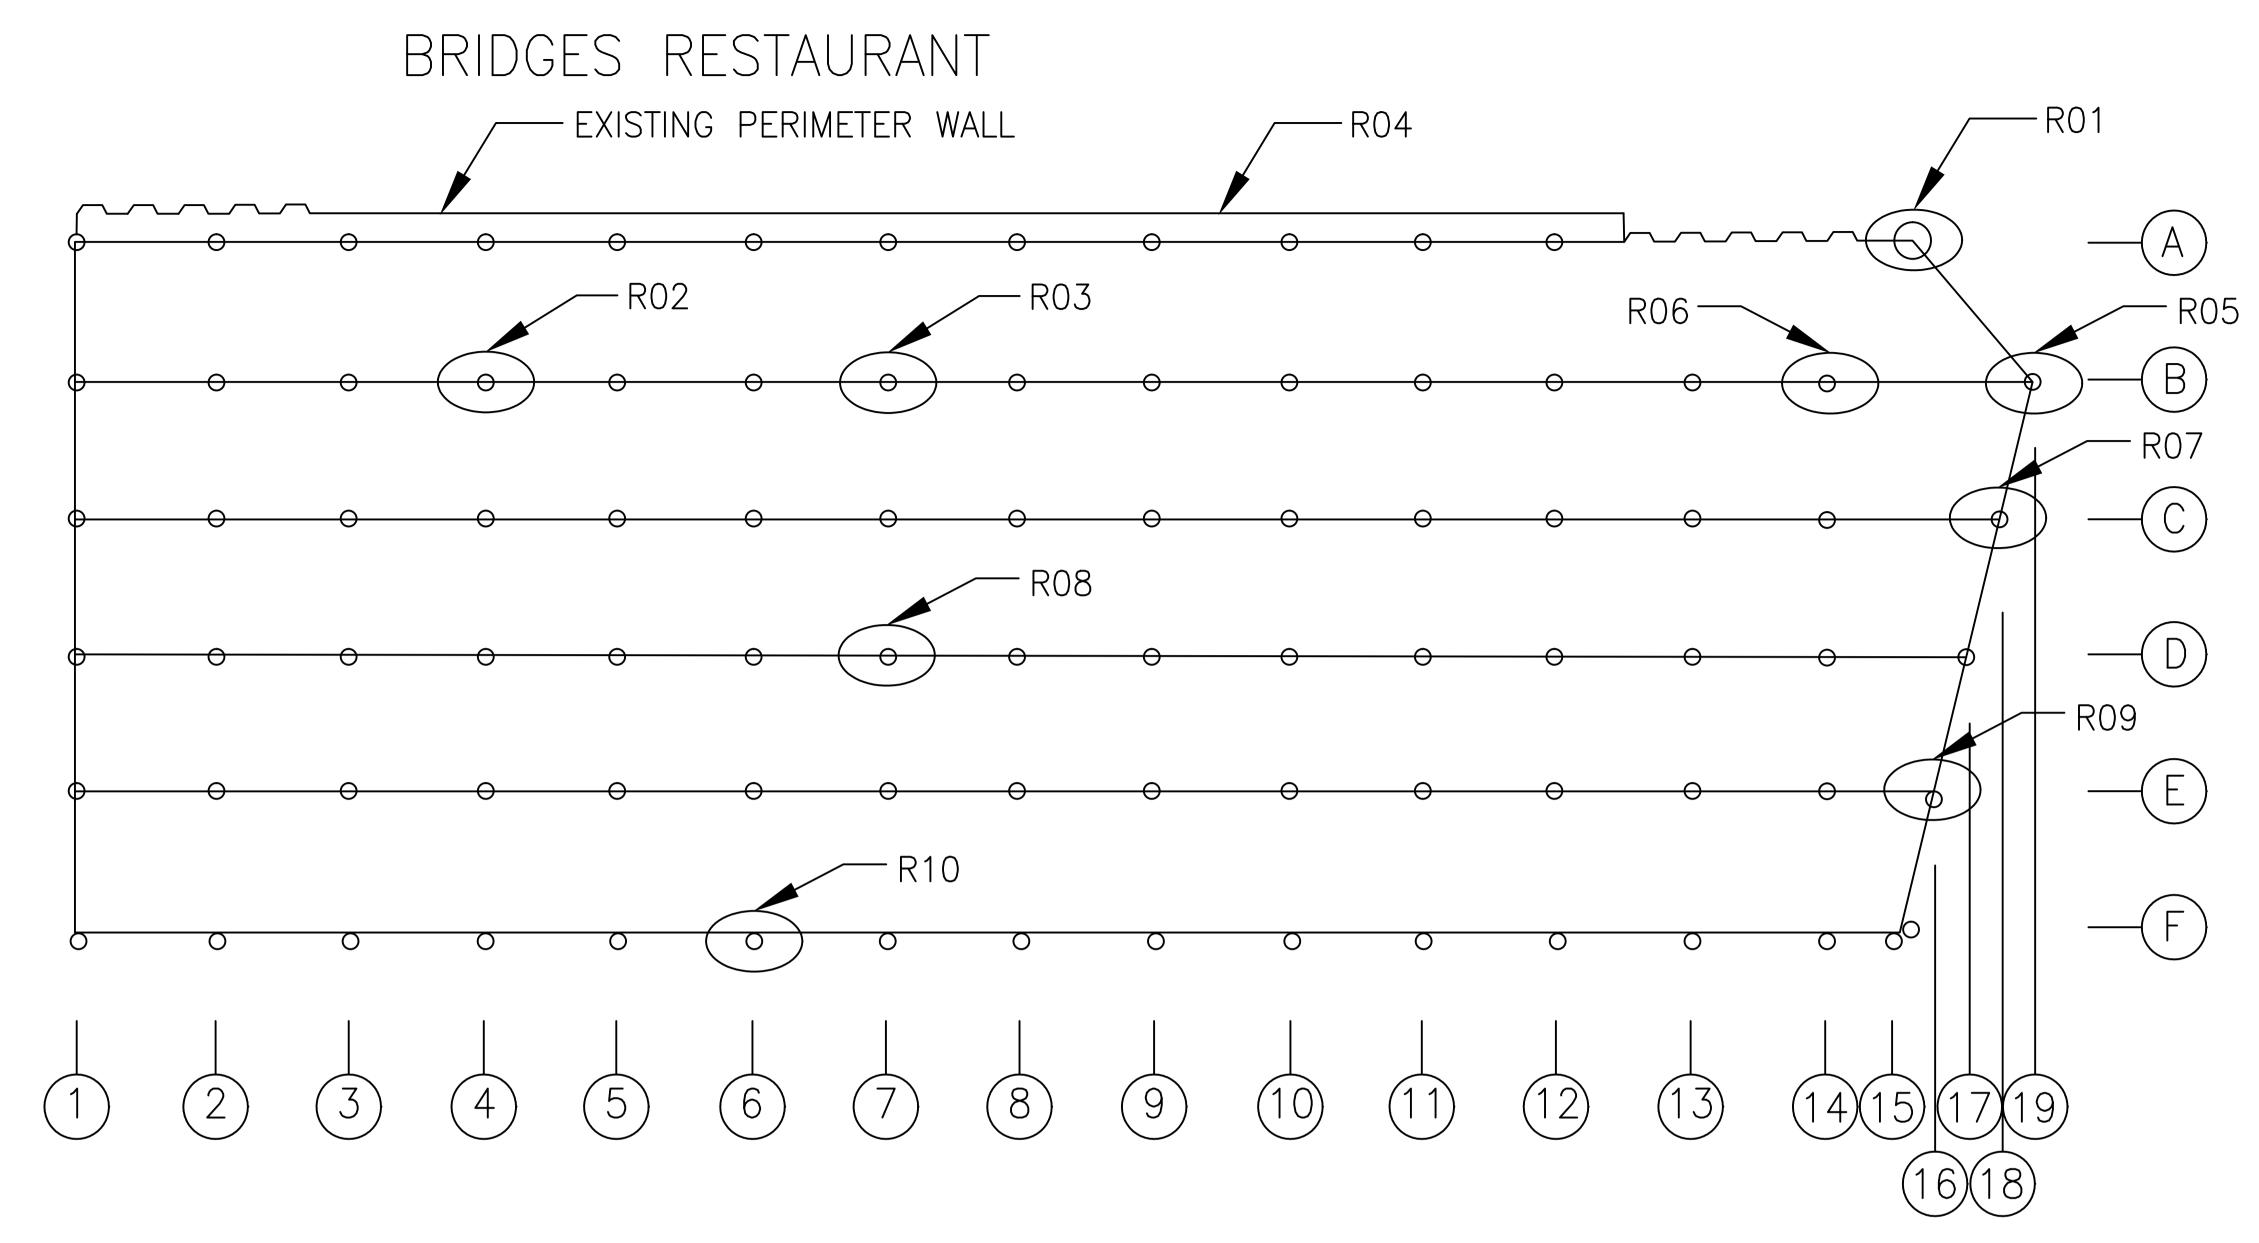
REPAIR No.	DESCRIPTION	REPAIR DETAIL/DWG No.
R01	INSTALL CHANNEL PATCH	9-F5
R02	REMOVE LARGE BOULDER. INSTALL STEEL ANGLE BRACKETS INTO TOP OF PILE COMPLETE WITH LAG BOLTS TO PREVENT FURTHER SHIFTING. REFERENCE DRAWING 8, FIGURE F-2, DETAIL A FOR ANGLE DETAIL.	8-F2
R03	INSTALL STEEL BANDS	9-F1
R04	FILL UNDERMINED CONCRETE ABUTMENT W/ CONCRETE	8-F1
R05	INSTALL STEEL BANDS	9-F1
R06	INSTALL STEEL BANDS	9-F1

REPAIR No.	DESCRIPTION	REPAIR DETAIL/DWG No.
R07	INSTALL STEEL BANDS	9-F1
R08	INSTALL STEEL BANDS	9-F1
R09	INSTALL STEEL BANDS	9-F1
R10	INSTALL STEEL BANDS	9-F1

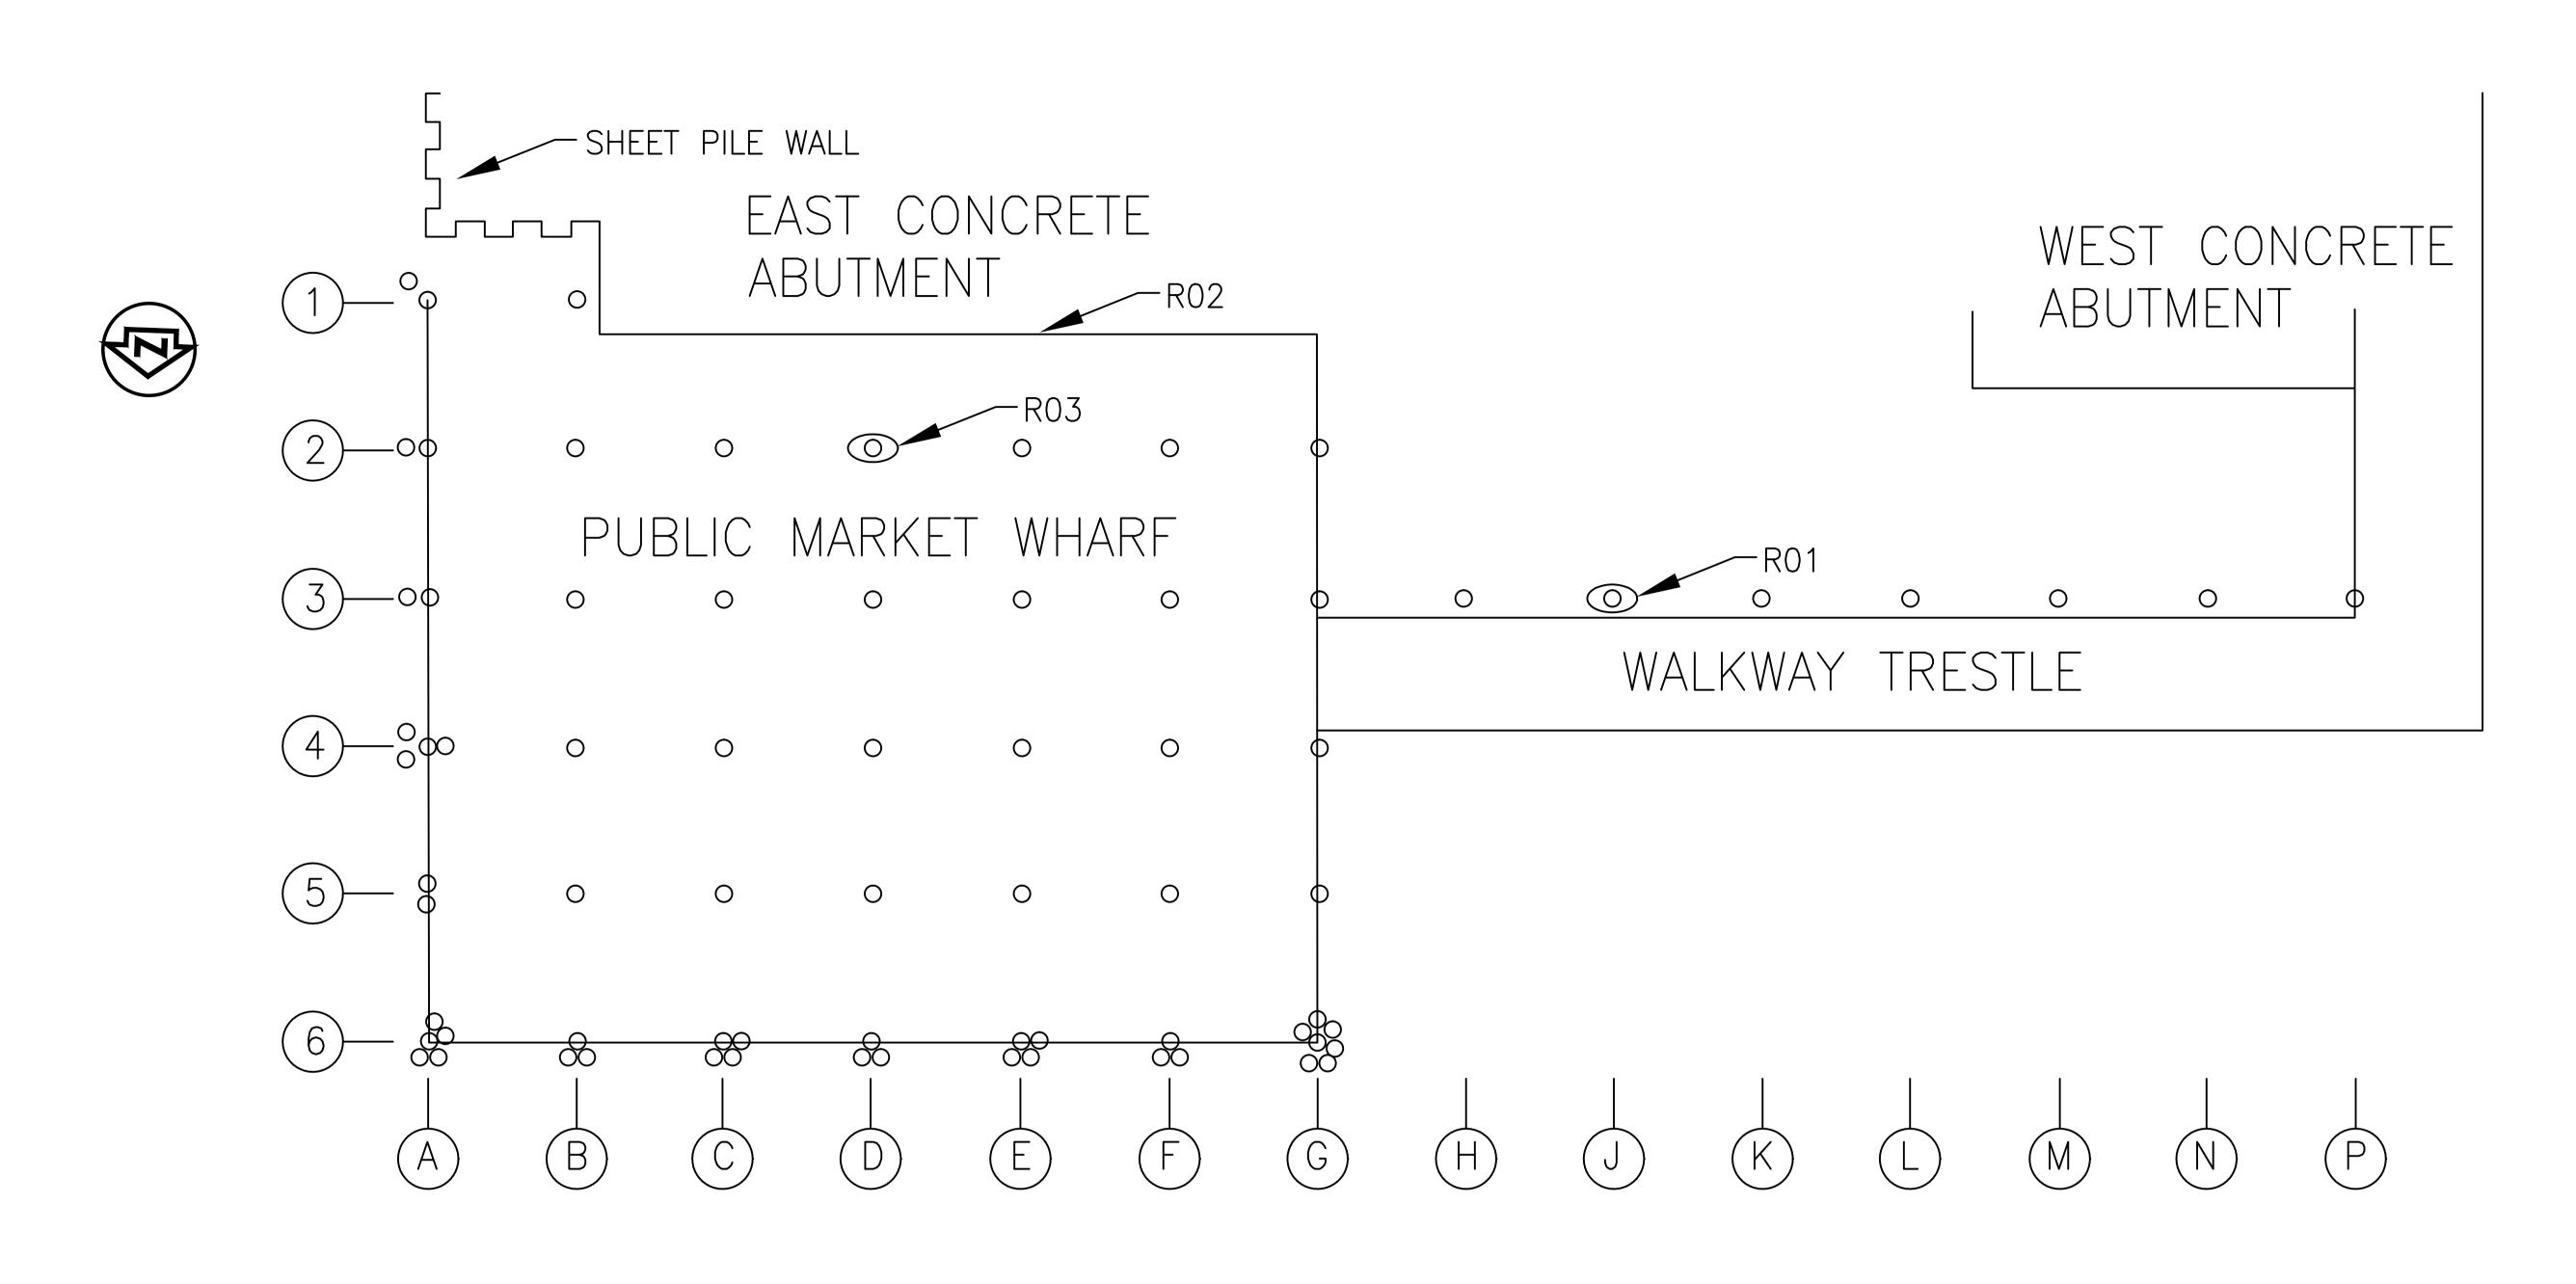
REPAIR No.	DESCRIPTION	REPAIR DETAIL/DWG No.
R01	INSTALL STEEL BANDS	9-F1
R02	FILL UNDERMINING OF FOOTING WITH CONCRETE	8-F1
R03	FRESH HEAD AND INSTALL SUB-CAP	8-F5

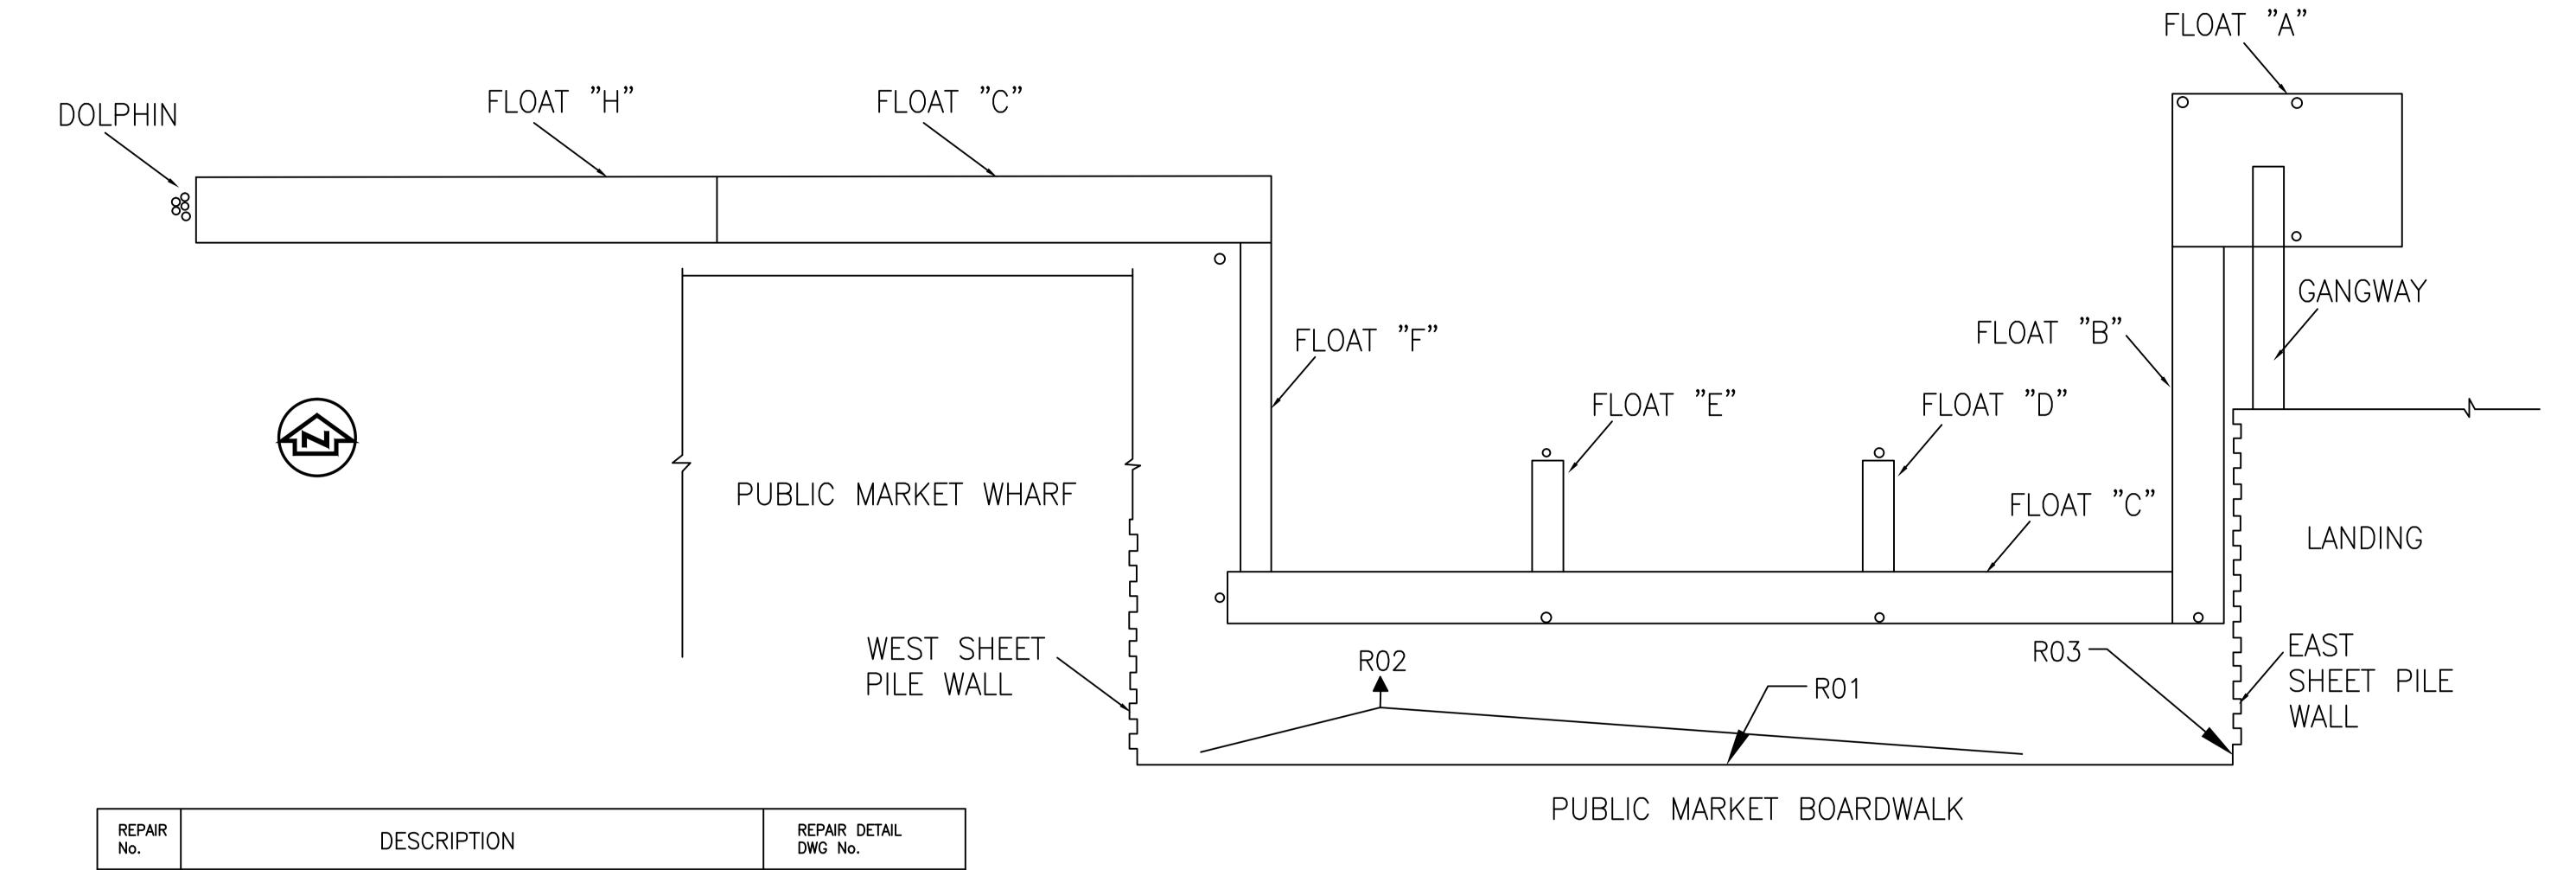
REPAIR No.	DESCRIPTION	REPAIR DETAIL DWG No.
R01	REPLACE PEDESTALS	8-F3
R02	RESTORE ROCK SLOPE PROTECTION IN FRONT OF BOARDWALK	10-F2
R03	RESTORE ROCK SLOPE PROTECTION IN FRONT OF STAIRS	10-F1A

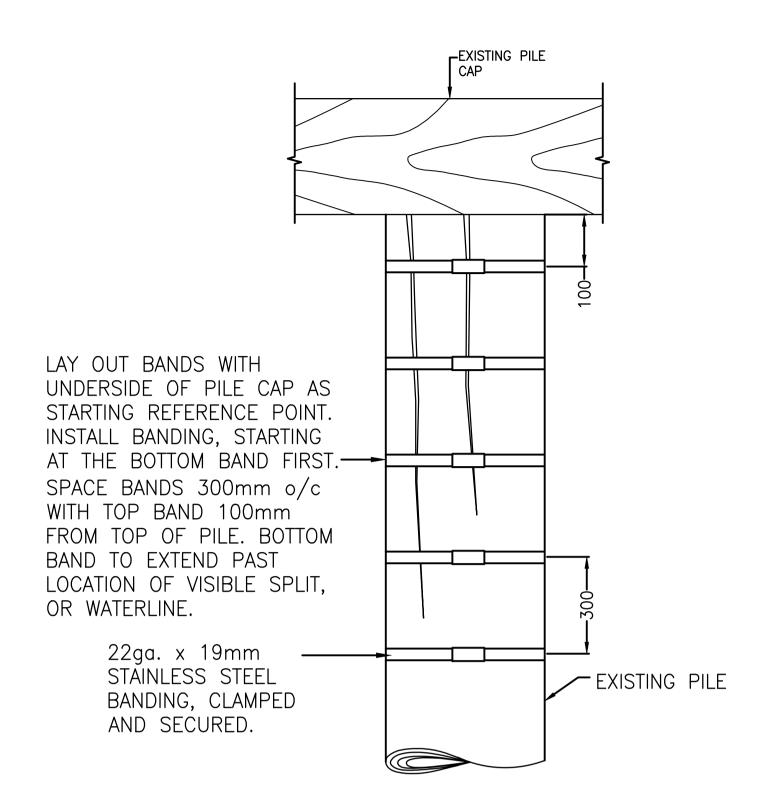
FIGURE 1

TYPICAL PILE BANDING DETAILS

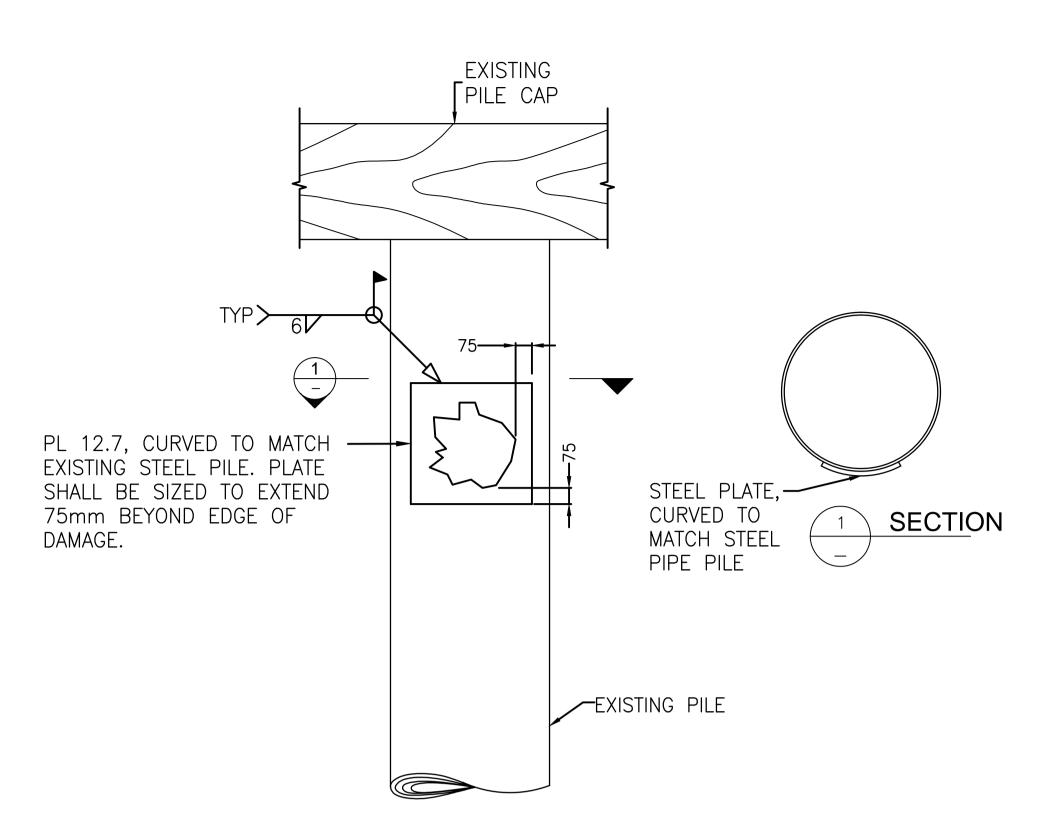
FIGURE 3

TYPICAL STEEL PILE PLATE PATCHING DETAILS

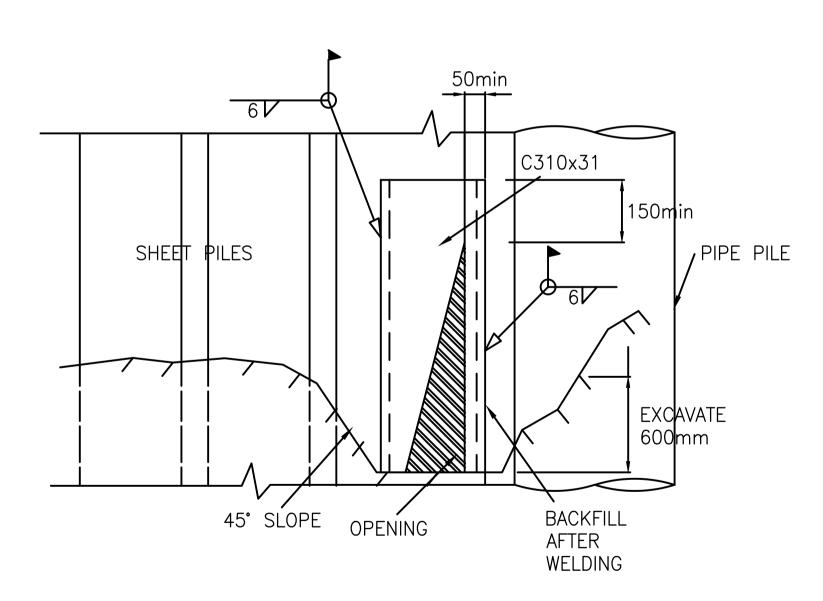
FIGURE 5

BRIDGES DOCK CONNECTION DETAIL

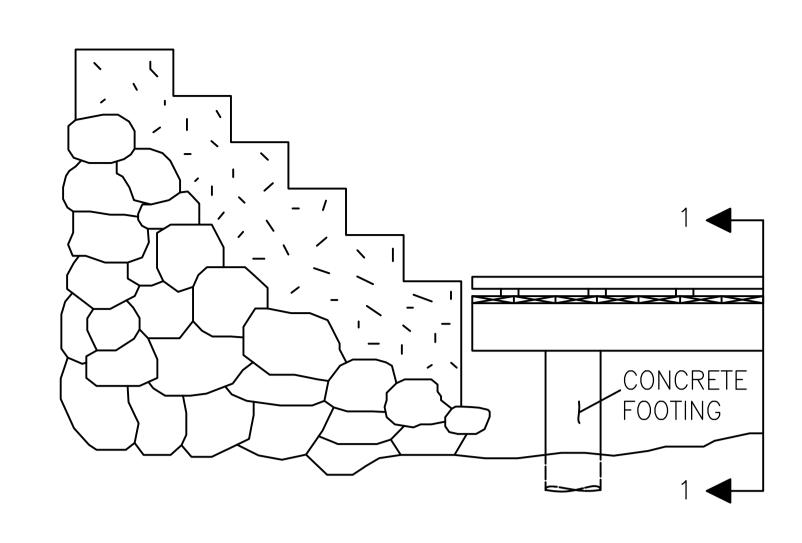
FIGURE 1A

PUBLIC MARKET BOARDWALK ROCK ARMOURING ELEVATION

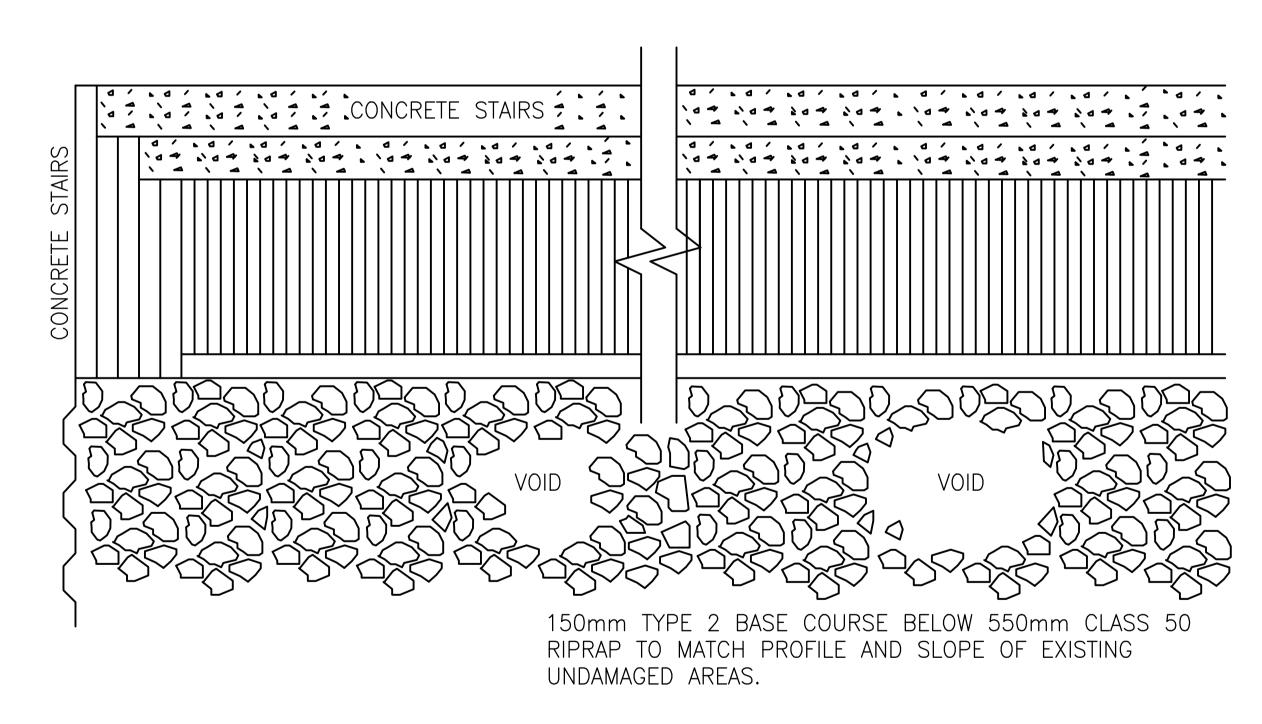
FIGURE 2

PUBLIC MARKET BOARDWALK ROCK ARMOURING PLAN

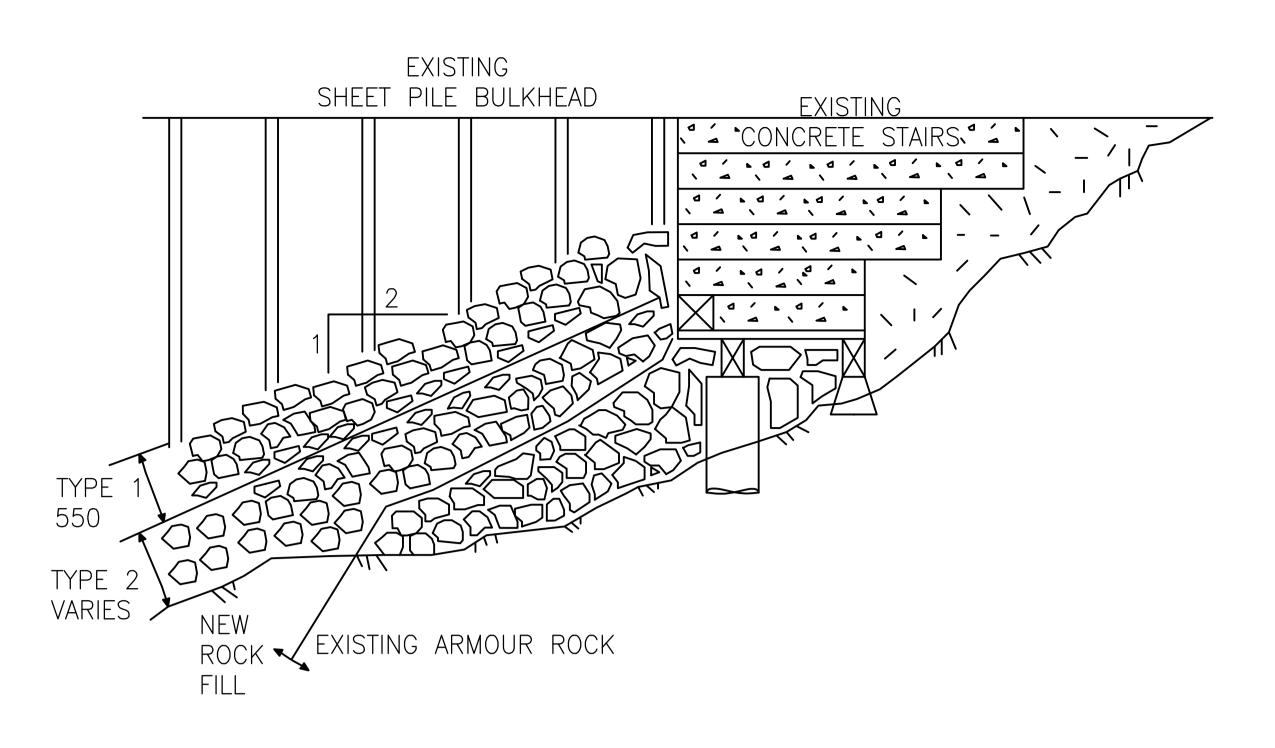
FIGURE 1B

PUBLIC MARKET BOARDWALK ROCK ARMOURING

- 1. TYPE 2 FOR BASE, TYPE 1 FOR TOPPING.
- 2. TYPE 1: CLASS 50 RIPRAP* TYPE 2: BRIDGE END FILL*

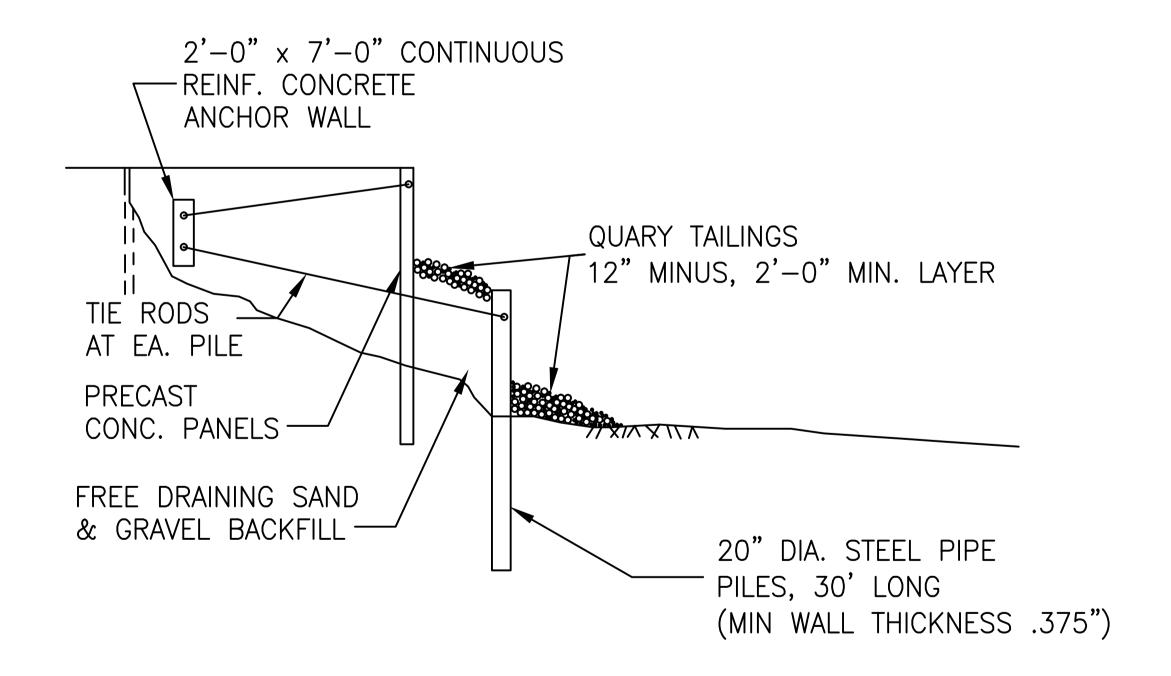
FIGURE 3

TYPICAL SEAWALL SECTION (FOR REFERENCE)

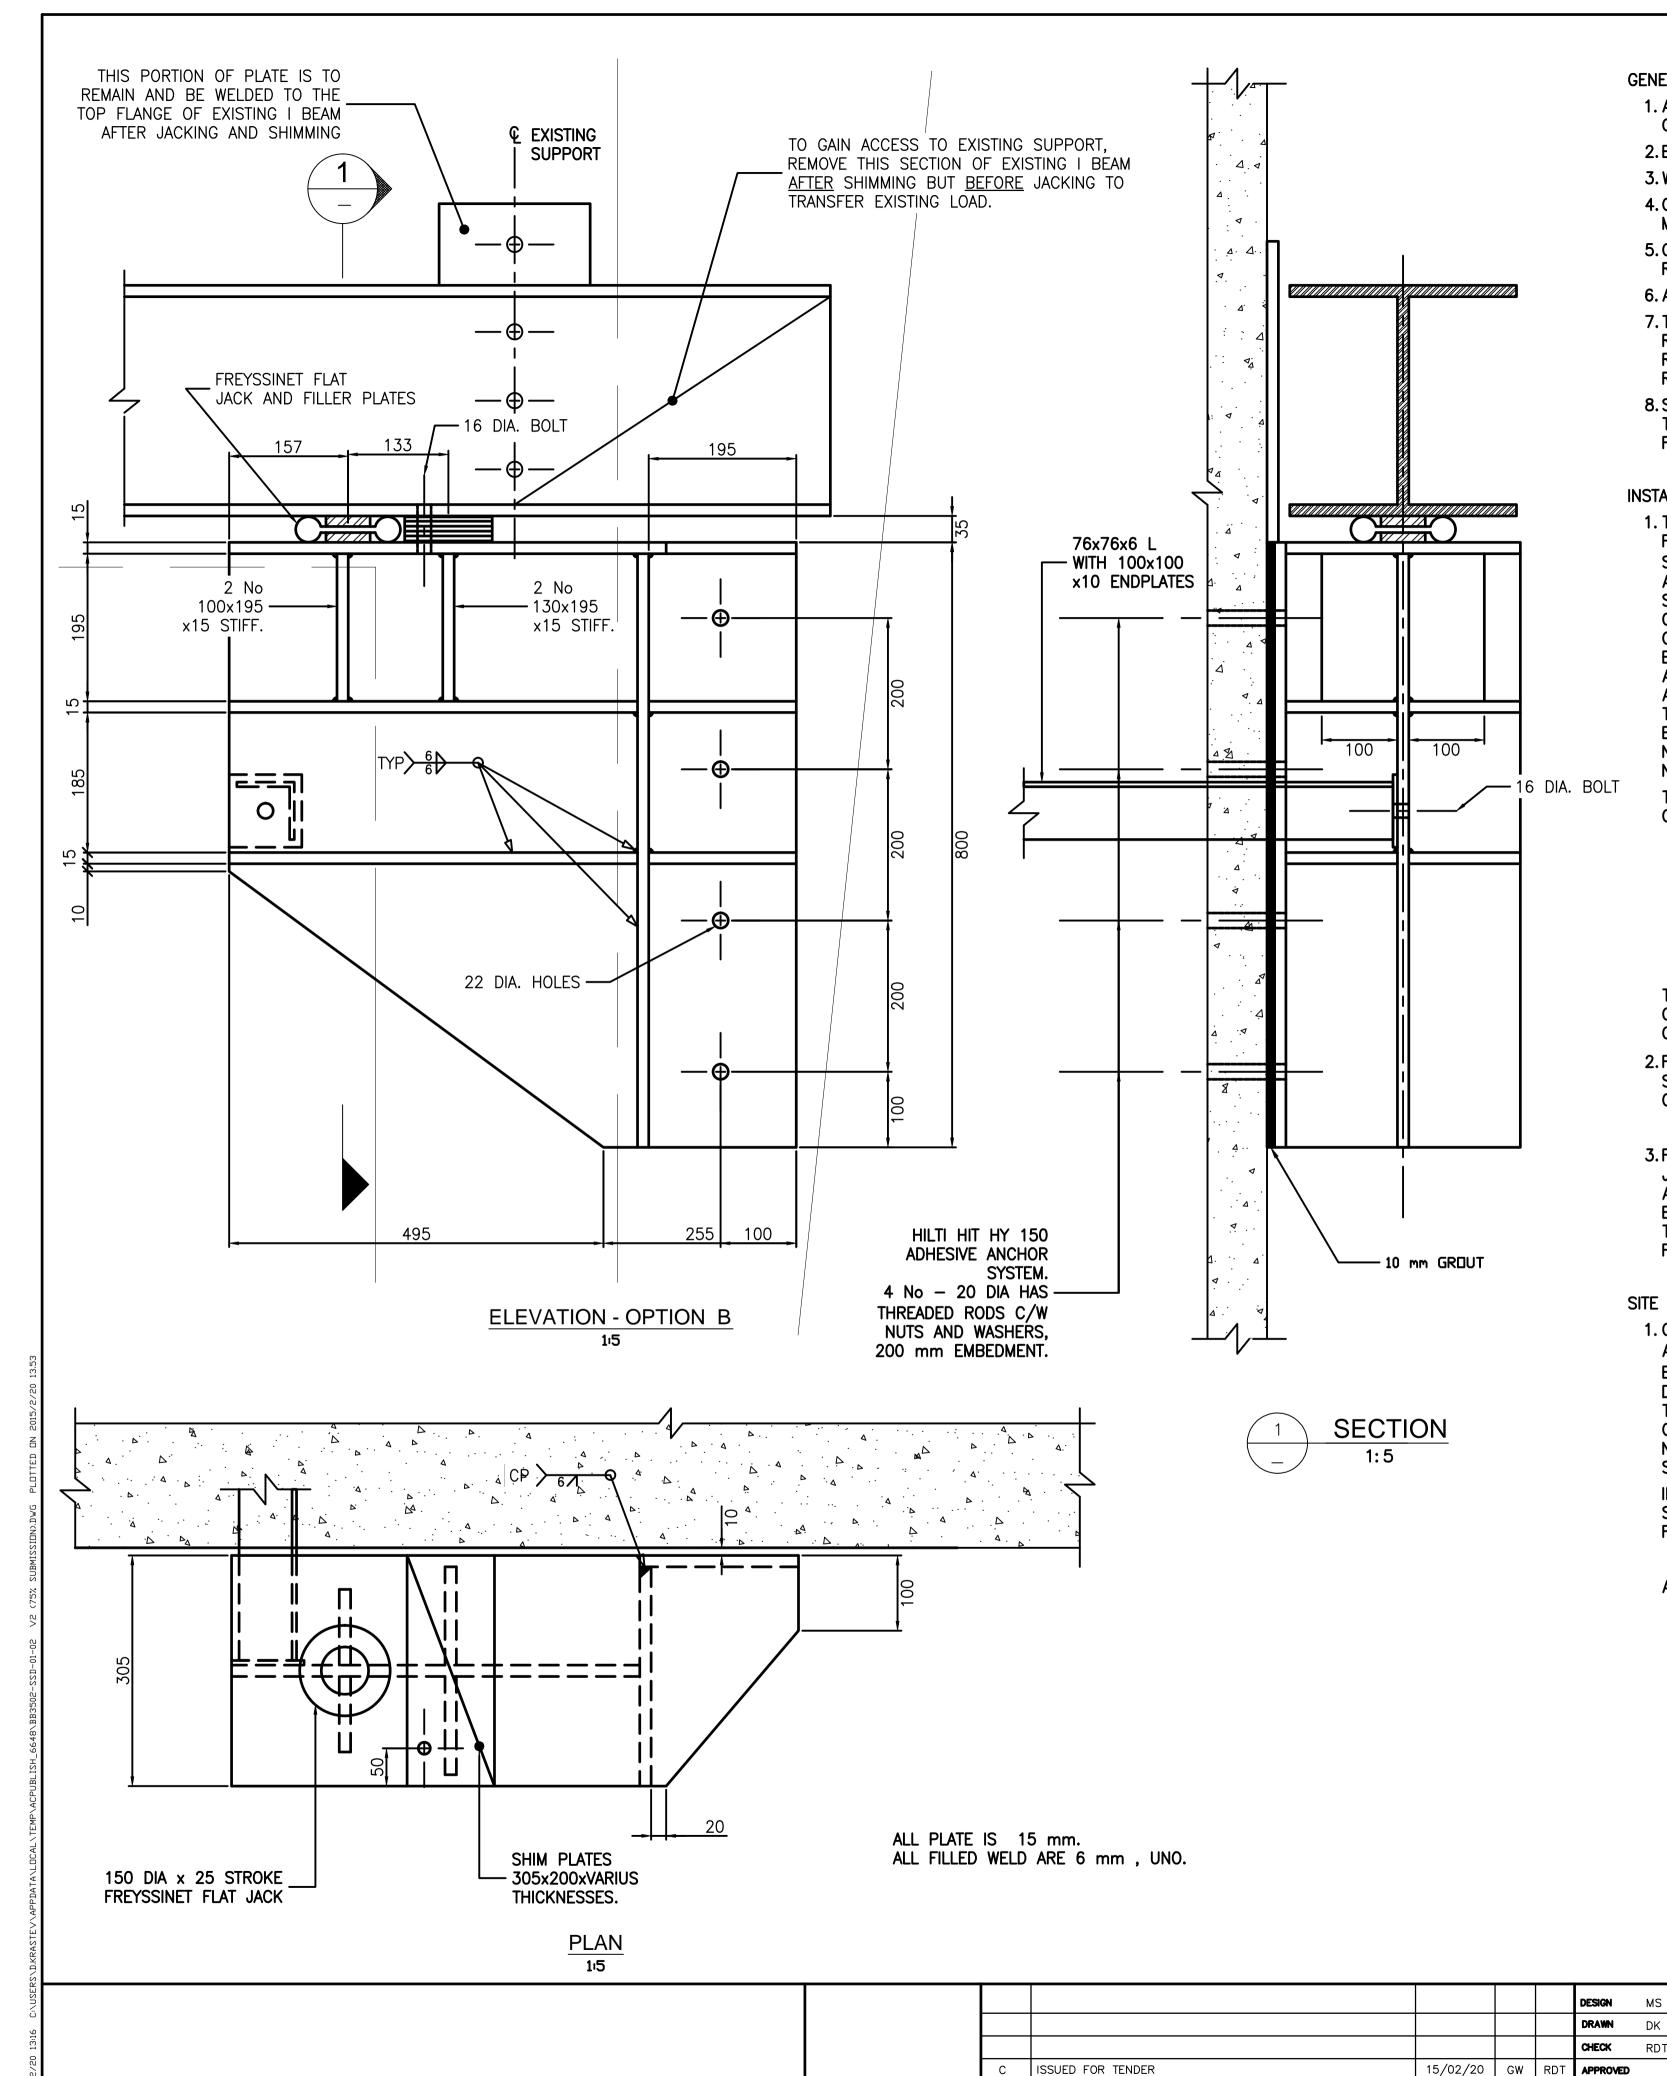
INSTALLATION OF ADDITIONAL SUPPORT CORBELS

1. THE REINFORCED CONCRETE STRUCTURE, SUPPORTED ON ITS OWN FOUNDATIONS WITHIN THE TIMBER WHARF, WAS ORIGINALLY DESIGNED TO SUPPORT A DERRICK CRANE (NOW PARTIALLY DISMANTLED AND UNUSABLE). A LOW LEVEL BEAM CONNECTING TWO OF THE CRANE COLUMNS ACTS AS A SUPPORT FOR A PORTION OF THE WHARF DECK BUT HAS SUFFERED FROM CORROSION OF THE BEAM SOFFIT REINFORCEMENT, RESULTING IN SEVERE CRACKING AND DAMAGE. IT IS UNDERSTOOD THAT THE EXISTING STEEL BEAMS, INSTALLED ON EACH SIDE OF THE DAMAGED BEAM, WERE PROVIDED AS EITHER ALTERNATIVE OR ADDITIONAL SUPPORT FOR THE WHARF DECK ABOVE. IT IS NOT KNOWN IF THE WHOLE OF THE DECK LOAD WAS TRANSFERRED TO THE STEEL BEAMS AT THE TIME OF INSTALLATION BUT BEFORE REPAIR WORK FOR THE CONCRETE BEAM CAN PROCEED, THIS FACT NEEDS TO BE DETERMINED AND CONSEQUENTLY WHETHER LOAD TRANSFER NEEDS TO BE ACCOMPLISHED BY BEAM JACKING.

TWO APPROACHES HAVE BEEN ADOPTED FOR THE ADDITIONAL BEAM SUPPORT CORBELS AS FOLLOWS:

- (a)IF ON CLOSE INSPECTION IT CAN BE DETERMINED THAT THE STEEL BEAMS ARE CARRYING THE MAJORITY OF THE DECK LOAD. THE SIMPLIFIED SUPPORT CORBEL WILL BE ADOPTED.

- (b)IF IT CAN BE SHOWN THAT THE MAJORITY OF THE DECK LOAD IS STILL SUPPORTED BY THE REINFORCED CONCRETE BEAM. SOME ADDITIONAL JACKING WILL BE REQUIRED AND THE LARGER JACKING CORBEL WILL BE ADOPTED.

- INSTALL HILTI HIT HY150 SYSTEM ANCHORS AND RECHECK ANCHOR
- MOUNT CORBELS WITH A 10MM GAP BETWEEN CORBEL AND CONCRETE
- FORM/SEAL EDGES OF CORBEL REAR PLATE AND GROUT INTERFACE
- TIGHTEN ANCHOR BOLT NUTS.

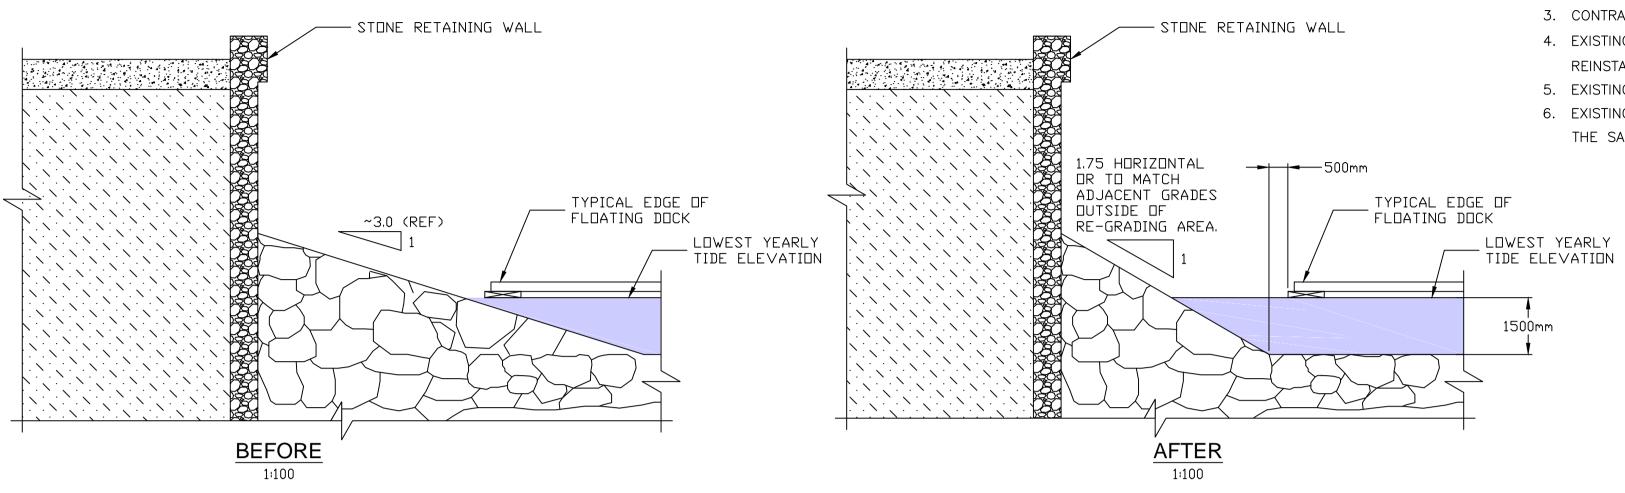
- 1. REGRADED BANK TO TERMINATE AT LEAST 500 mm BEFORE EDGE OF FLOATING DOCK AT A DEPTH OF 1500 mm. MEASUREMENTS TO BE RELATIVE TO LOWEST YEARLY TIDE ELEVATION.
- REGRADED BANK TO BE LEFT IN A STABLE CONDITION, NOT SUSCEPTIBLE TO EROSION OR SLOUGHING.
 CONTRACTOR TO COORDINATE WITH CMHC FOR ACCESS TO SITE.
- 4. EXISTING GRASS AND LANDSCAPING SHALL BE PROTECTED FROM THE CONSTRUCTION WORKS AND/OR REINSTATED AFTER CONSTRUCTION TO A PRE-CONSTRUCTION CONDITION OR BETTER.
- 5. EXISTING SLOPE GRADE TO BE CONFIRMED ON SITE.
- 6. EXISTING RIPRAP SHALL BE REMOVED, PROTECTED, AND PLACED BACK ON THE REGRADED SLOPE AT THE SAME DISTRIBUTION AND COVER AS THE EXISTING CONDITION.
