DRAWINGS & SPECIFICATIONS
for
Fire Suppression System Upgrade
For The Herbarium & Insectary Rooms
NRCAN Pacific Forestry Centre
Victoria, BC

Project No.: R.062840.001

HAZARDOUS BUILDING MATERIALS ASSESSMENT

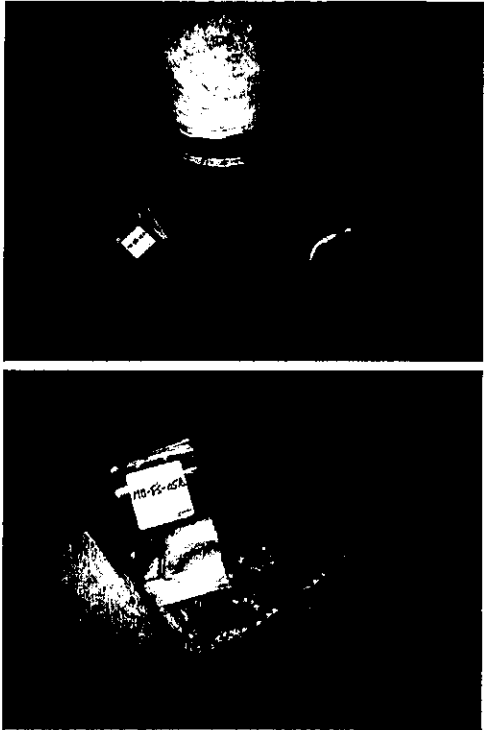
Table 5.1-1: Summary of Identified ACMs – A WING		
Identified ACM Description		Photo
Grey colour fire stop caulking applied to floor penetrations for mechanical ductwork throughout the penthouse.

Condition	GOOD	
% Type	5% Chrysotile	
Friability	Non-friable	
Silver colour fire stop caulking (rigid consistency) applied to floor penetrations for mechanical ductwork throughout the penthouse.

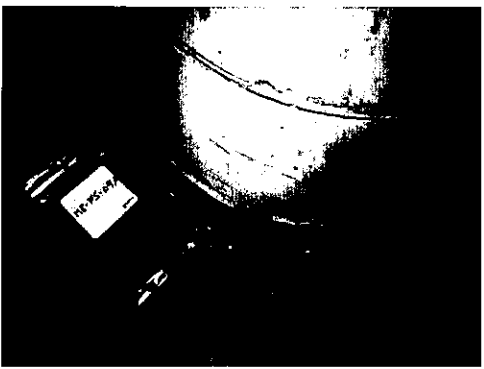
Condition	GOOD	
% Type	5% Chrysotile	
Friability	Non-friable

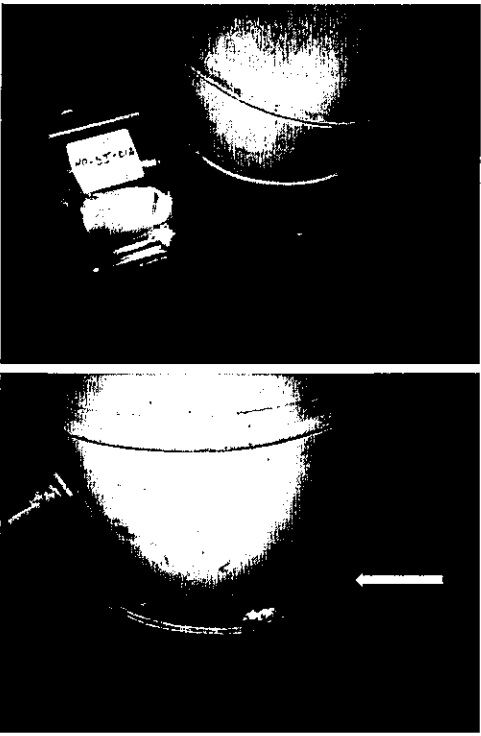
Condition	GOOD	
% Type	75 - 80% Chrysotile	
Friability	Friable	
White colour fibrous insulation between mechanical ductwork and floor penetrations in the penthouse. This material may be present, concealed in other areas of the building.

Condition	GOOD	
% Type	50% Chrysotile	
Friability	Friable

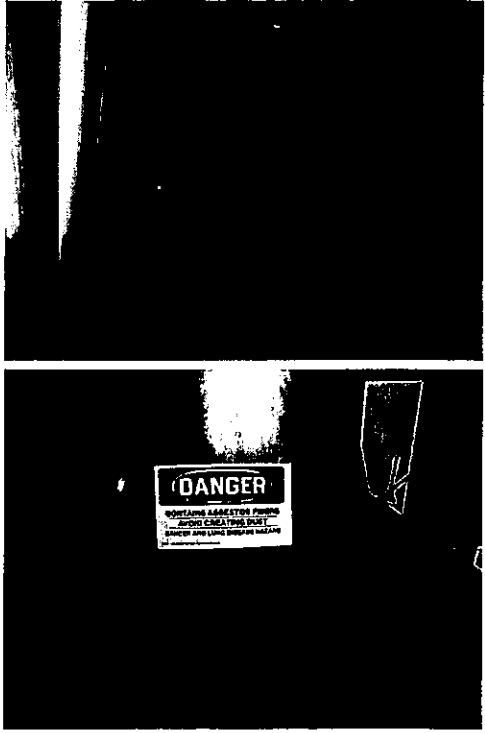
Identified ACM Description		Photo
Red colour duct mastic on mechanical ductwork joints throughout (exhaust ducting and return ducting).

Condition	GOOD	
% Type	4% Chrysotile	
Friability	Non-friable

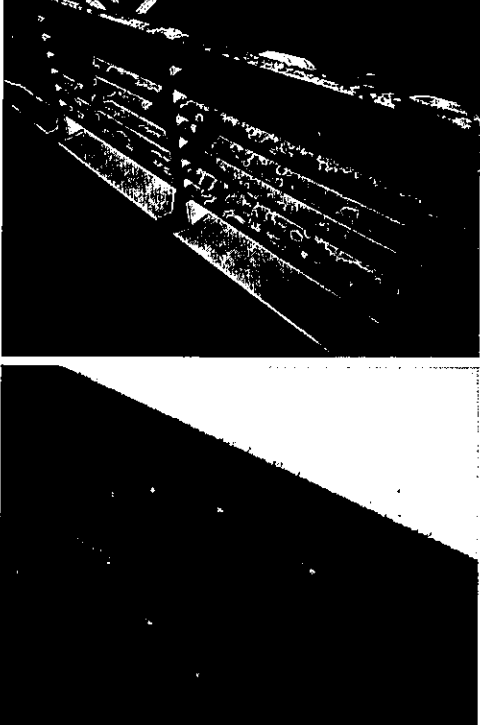
Lead-Containing Material Description	Photo
<p>White colour paint – Present on metal rooftop railing (18,000 ppm).</p> <p>This material was observed in POOR condition (rusting and flaking paint throughout railing structure) and paint chip debris was observed on the roof.</p>

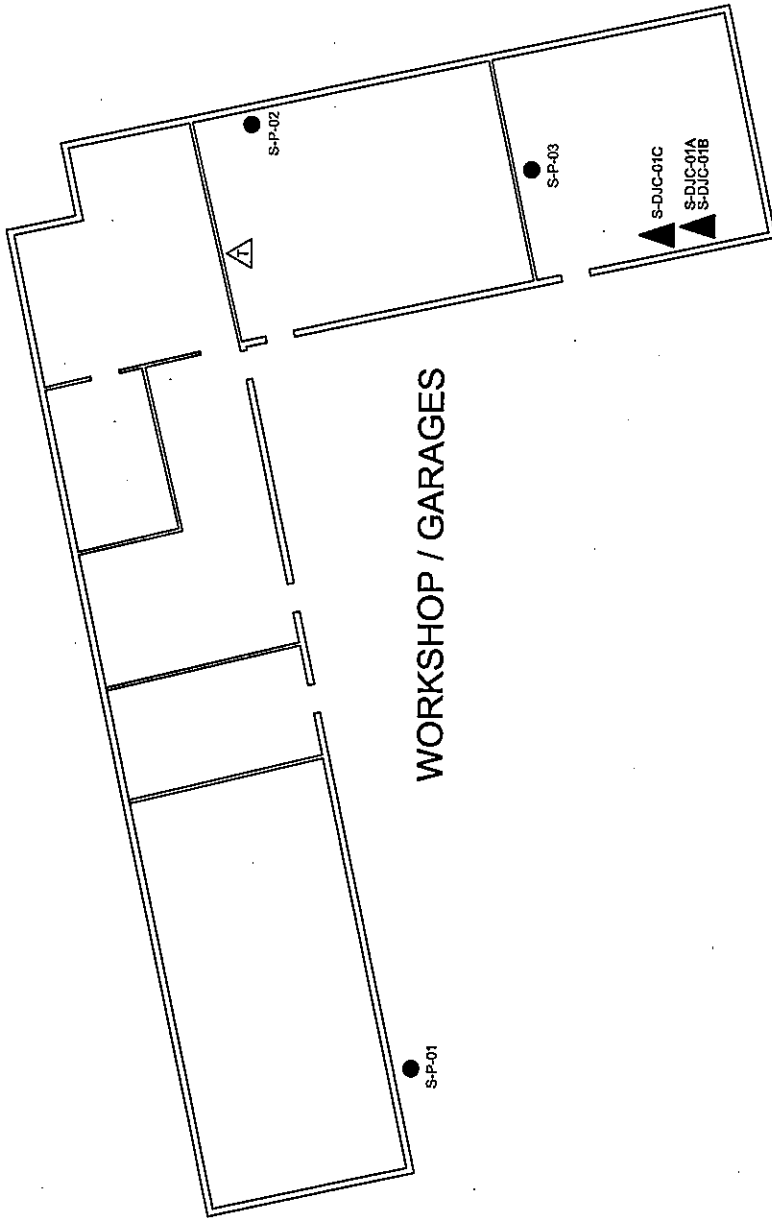
- ▲ BULK SAMPLE LOCATION (FOR ASBESTOS)
- PAINT SAMPLE LOCATION (FOR LEAD)
- △ MERCURY-CONTAINING THERMOSTAT

FLOOR PLAN SHOWING HAZARDOUS BUILDING MATERIALS AND BULK SAMPLE LOCATIONS PACIFIC FOREST SERVICE CENTRE, 506 WEST BURNSIDE ROAD, VICTORIA, BC	Project No.: 115614042	Dwg. No.: 10	
	Scale: N.T.S.		
	Date: 14/03/11		
	Dwn. By: CD VM, SL2014030084	App'd By: TW	
Client: PWGSC
