SOLICITATION AMENDMENT
MODIFICATION DE L'INVITATION

Title - Sujet Timber Training Wall Repairs	
Solicitation No. - N° de l'invitation F1700-150464/A	Amendment No. - N° modif. 001
Client Reference No. - N° de référence du client	Date 2015-09-10
GETS Reference No. - N° de référence de SEAG PW-\$PWY-026-7603	
File No. - N° de dossier PWY-5-38145 (026)	CCC No./N° CCC - FMS No./N° VME
Solicitation Closes - L'invitation prend fin at - à 02:00 PM on - le 2015-09-17	Time Zone Fuseau horaire Pacific Daylight Saving Time PDT
F.O.B. - F.A.B. Plant-Usine: <input type="checkbox"/> Destination: <input checked="" type="checkbox"/> Other-Autre: <input type="checkbox"/>	
Address Enquiries to: - Adresser toutes questions à: Liu (PWY), Patty	Buyer Id - Id de l'acheteur pwy026
Telephone No. - N° de téléphone (604) 775-6227 ()	FAX No. - N° de FAX (604) 775-6633
Destination - of Goods, Services, and Construction: Destination - des biens, services et construction: DFO - Steveston Wingdam No. 2 - Richmond, BC

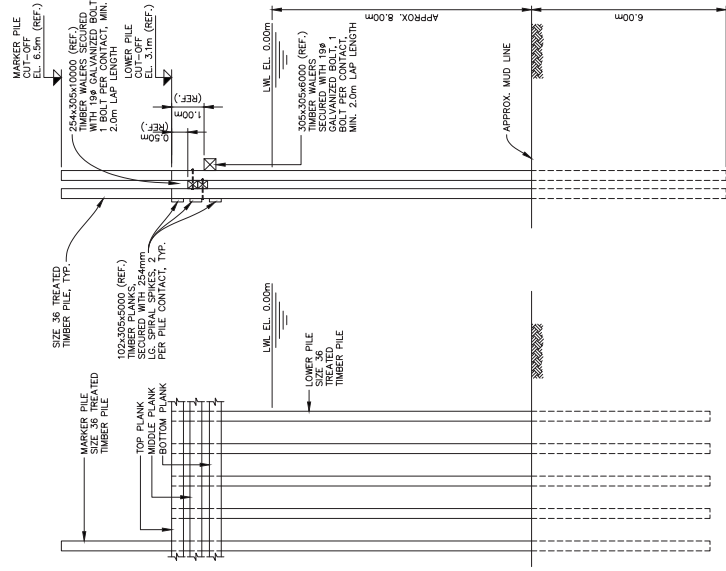
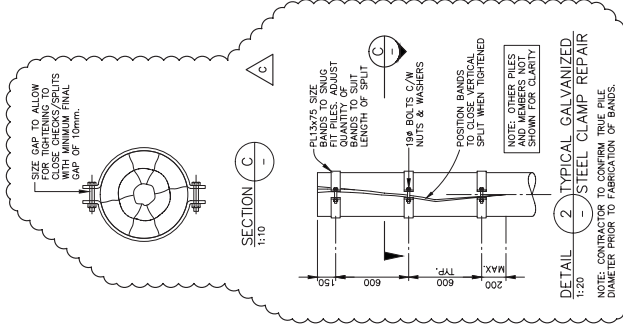
PILE REPAIRS		RECOMMENDATION	QTY.	LOCATION
M4-M15	37	INSTALL MISSING OR DAMAGED OFFSHORE MARKER PILES IN MISSING SECTION OF WALL		WALL
M4-M15	37	INSTALL MISSING OR DAMAGED INSIDE LOWER PILES IN MISSING SECTION OF WALL		WALL
M4-M15	36	INSTALL MISSING OR DAMAGED OFFSHORE LOWER PILES IN MISSING SECTION OF WALL		WALL
M4-M17	4	REPAIR 34 1/4 INCH OFFSHORE LOWER PILES EAST OF M3 MARKER PILE WITH GALVANIZED STEEL CLAMPS		WALL
M4-M17	4	REPAIR 34 1/4 INCH OFFSHORE LOWER PILES WEST OF M3 MARKER PILE WITH GALVANIZED STEEL CLAMPS		WALL
M19-M20	2	RE-SECURE 34 1/4 INCH INSIDE LOWER PILES EAST OF M3 MARKER PILE TO HODGE AND INSIDE WALKERS		WALL
M20-M21	2	RE-SECURE 34 1/4 INCH INSIDE LOWER PILES WEST OF M3 MARKER PILE TO HODGE AND INSIDE WALKERS		WALL
M21-M22	2	RE-SECURE 34 1/4 INCH INSIDE LOWER PILES EAST OF M3 MARKER PILE TO HODGE AND INSIDE WALKERS		WALL
M22-M23	1	RE-SECURE 34 1/4 INCH INSIDE LOWER PILE EAST OF M3 MARKER PILE TO HODGE AND INSIDE WALKERS		WALL

M23-M25	1	REPAIR 34 1/4 INCH EAST LOWER PILE WEST OF M3 MARKER PILE TO HODGE AND INSIDE WALKERS		WALL

INSHORE WATER REPAIRS		
LOCATION	QTY.	RECOMMENDATION
M1-M14	46	INSTALL MISSING INSHORE WALLERS APPROX FROM M1 - M14
M15 E, M23 E	21	INSTALL MISSING INSHORE WALLERS APPROX FROM M15 E - M23 E

MIDDLE WALER REPAIRS		
LOCATION	QTY.	RECOMMENDATION
M1	1	RE-SECURE MIDDLE WALER TO THE INSHORE AND OFFSHORE H1 MARKER PILE
M6-M14	10	INSTALL MISSING OR DAMAGED MIDDLE WALER IN MISSING SECTION OF WALL APPROX. FROM M6 - M14

PLANK REPAIRS		RECOMMENDATION
LOCATION	QTY	
M6-M14	34	INSTALL MISSING OR DAMAGED UPPER, MIDDLE AND LOWER FACING PLANKS IN MISSING SECTION OF WALL APPROX. FROM M6 - M14
M14-M15	1	REPLACE DAMAGED UPPER FACING PLANK
M15-M16	3	INSTALL MISSING TOP, MIDDLE AND BOTTOM FACING PLANKS APPROX. FROM M15 - M16

Steel clamps for split pile repairs shall be galvanized PL 13 mm x 75 mm size band to snug fit piles typically spaced at 600 mm throughout the length of the split. The clamps shall be positioned to close the split pile when tightened and shall use 19 mm diameter galvanized bolts complete with nuts and washers to close the clamps for a snug fit around the pile. Note that clamps shall be sized for a snug fit

and the contractor shall confirm the true clamp size and pile diameter prior to fabrication. Shimming of steel clamps shall not be permitted. View attached drawing.
