Department of Fisheries and Oceans

FULTON DAM SAFETY REVIEW  
2008 HYDROTECHNICAL ASSESSMENT

V13201140

March 2009

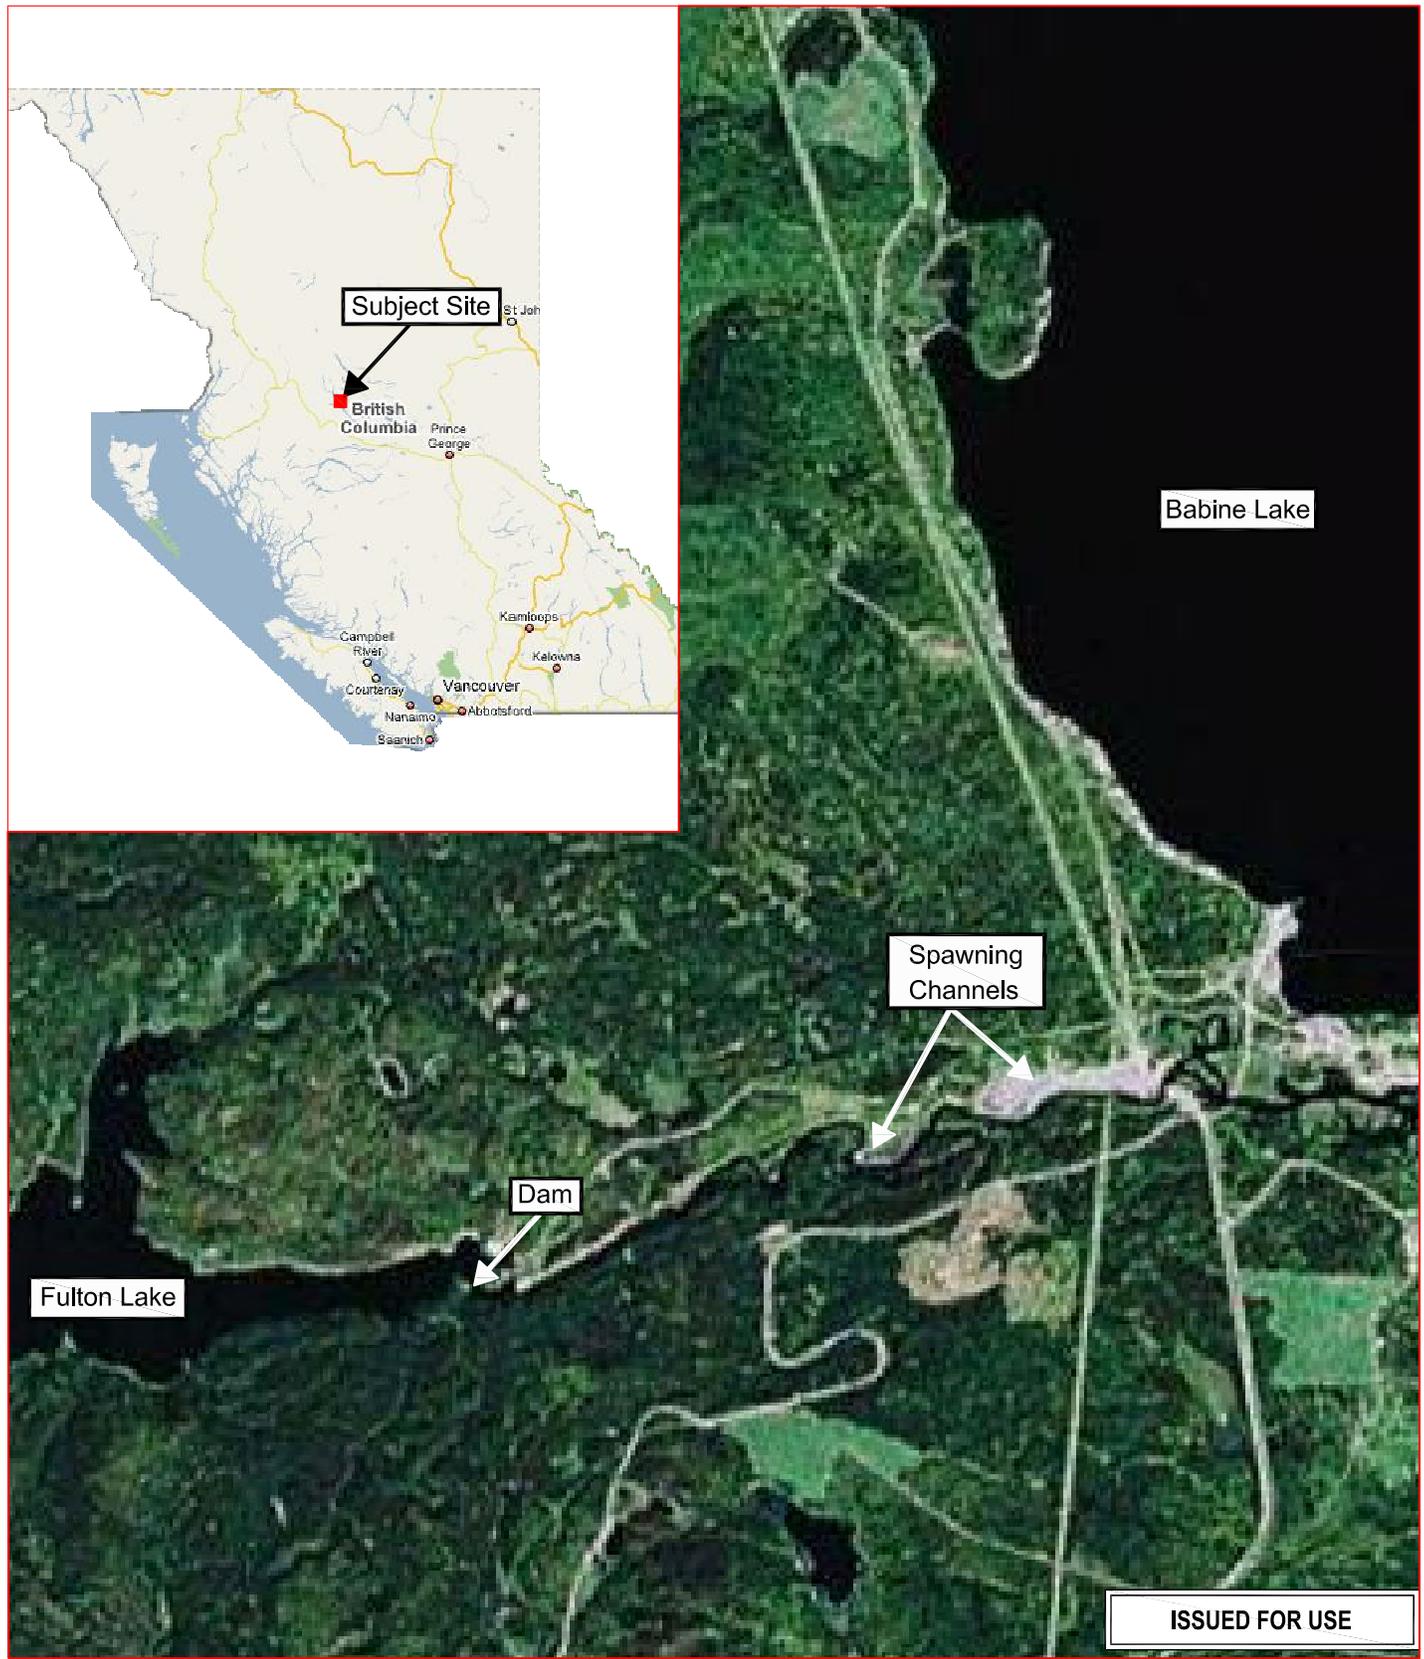
CLIENT  Department of Fisheries and Oceans	<b>FULTON DAM SAFETY REVIEW 2008 HYDROTECHNICAL ASSESSMENT</b>				<b>Figure 1</b>
	<b>LOCATION MAP</b>

Fulton Dam is located about nine kilometres south of Granisle, B.C. and about six kilometres upstream of Babine Lake on the Fulton River (Figure 1). The dam is a concrete gravity structure, approximately 17 m high and 55 m long, which is used to supply water to the Fulton River Spawning Channel facility operated by the Department of Fisheries and Oceans (DFO). The dam was constructed in 1968.

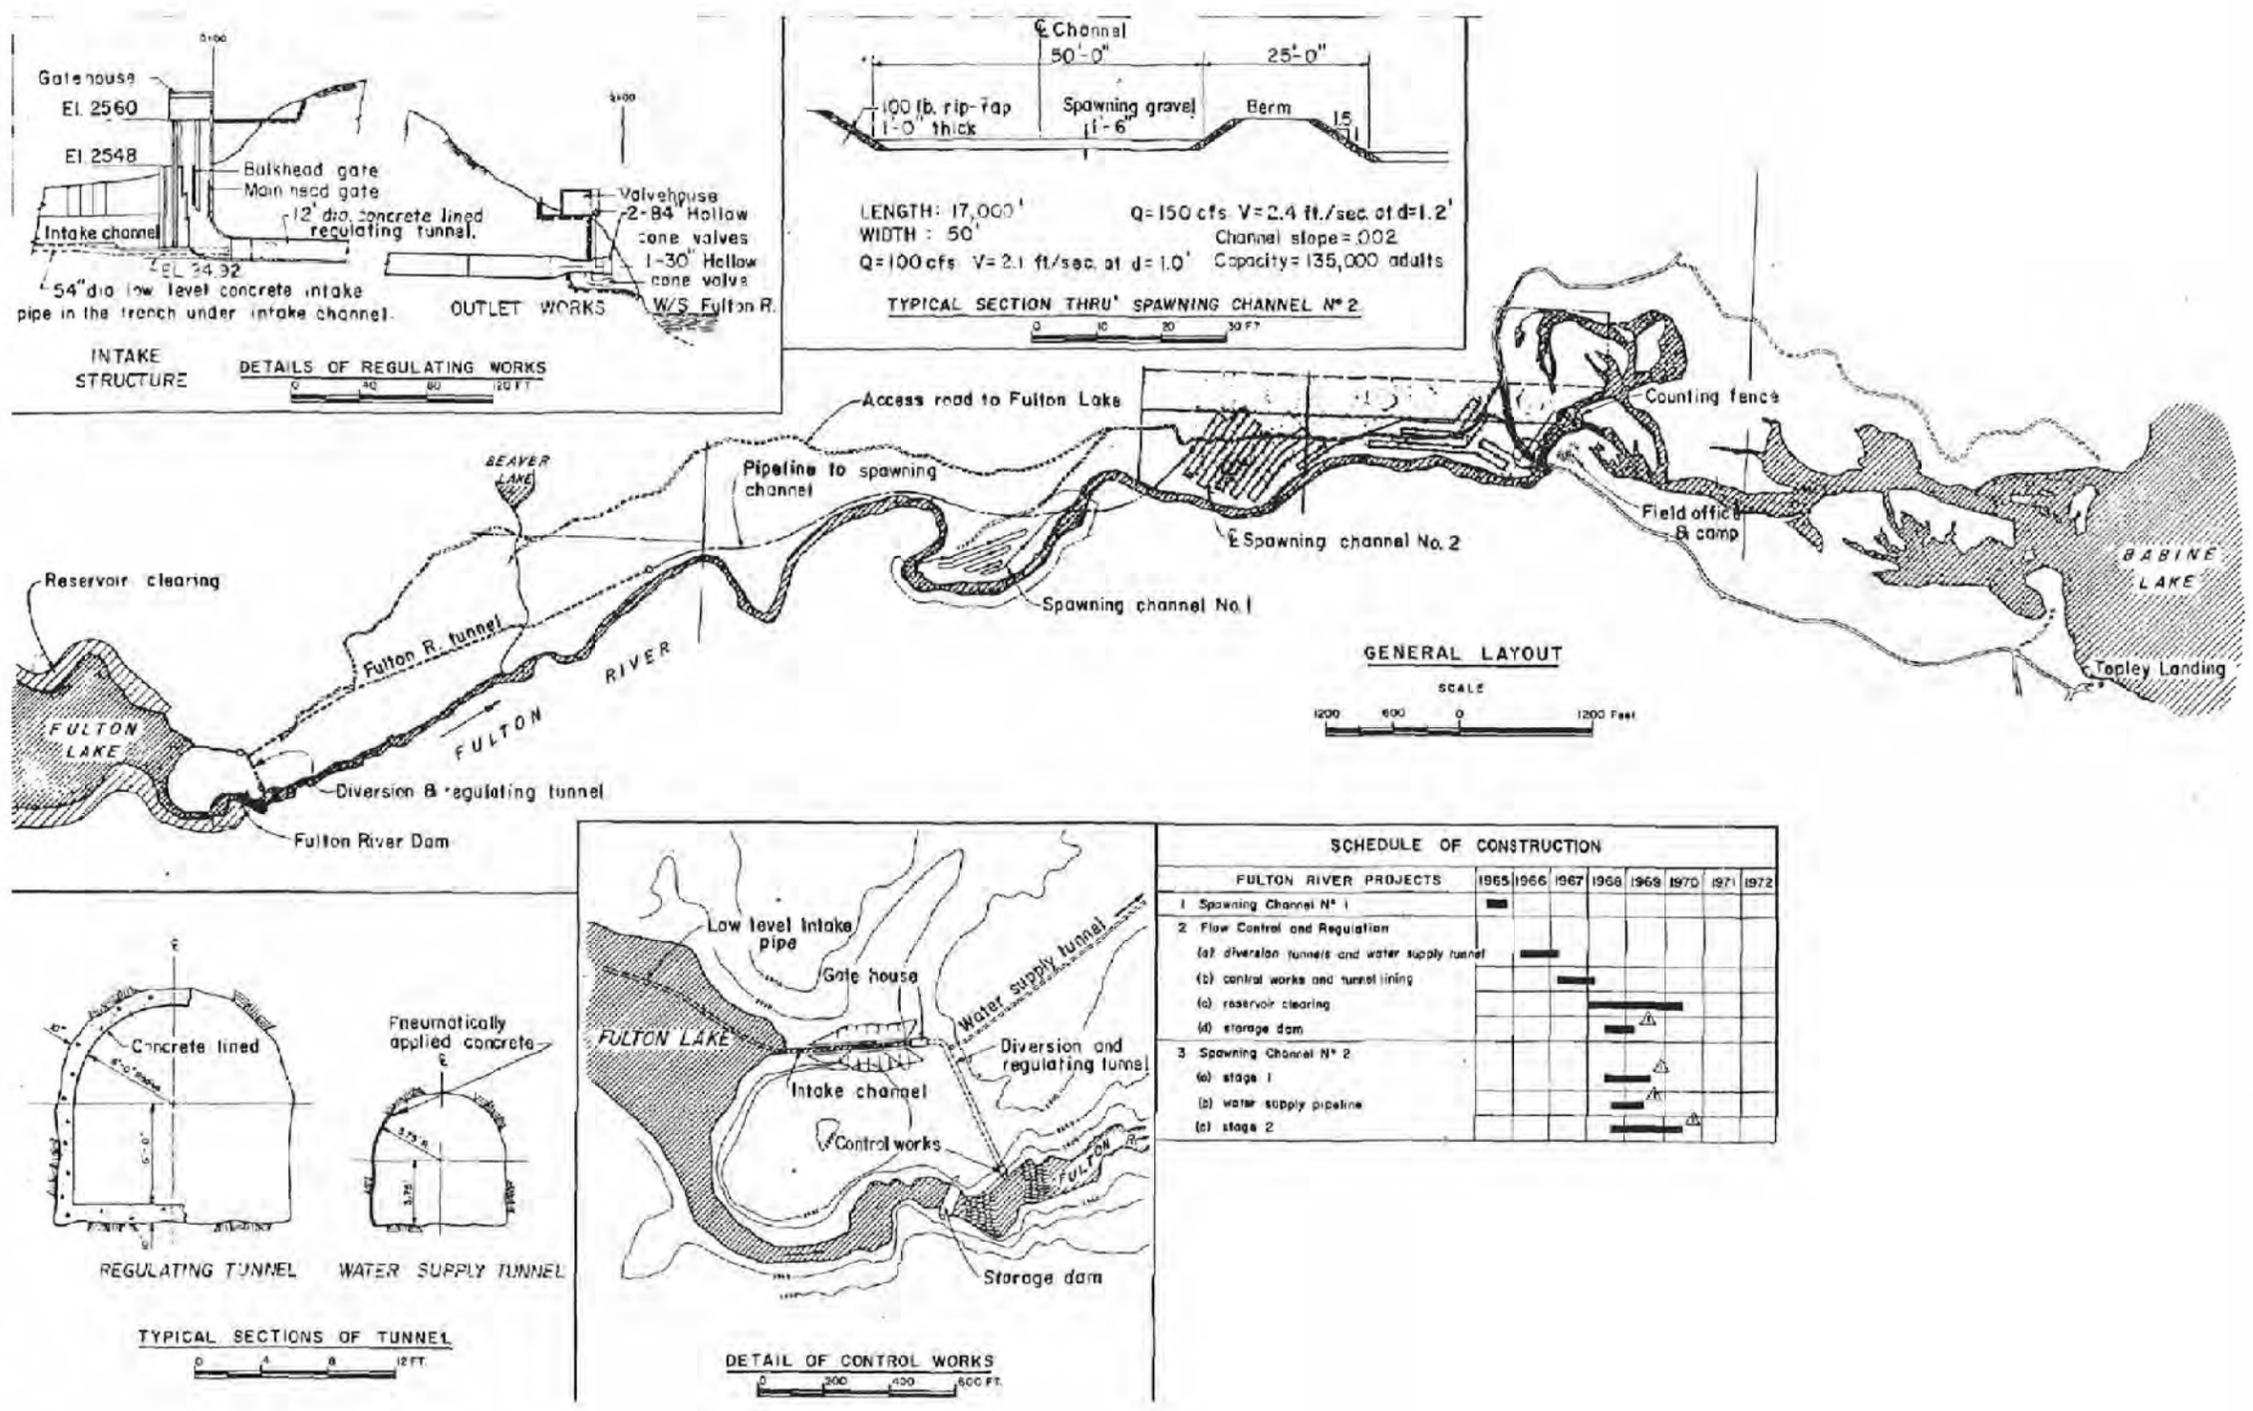
Figure 2

**NOTES**  
 Base drawing obtained from Fulton Dam Safety Review Report by UMA Engineering Ltd. dated August 1997 (2507-0175-001-00-01)2007 based on DFO Drawing No. 21-19-G75R1 Babine Lake Development Fulton River General Layout

An overall plan of the Fulton River Facility is shown on Figure 2. Additional plans and drawings related to the dam structure can be found in Appendix A.

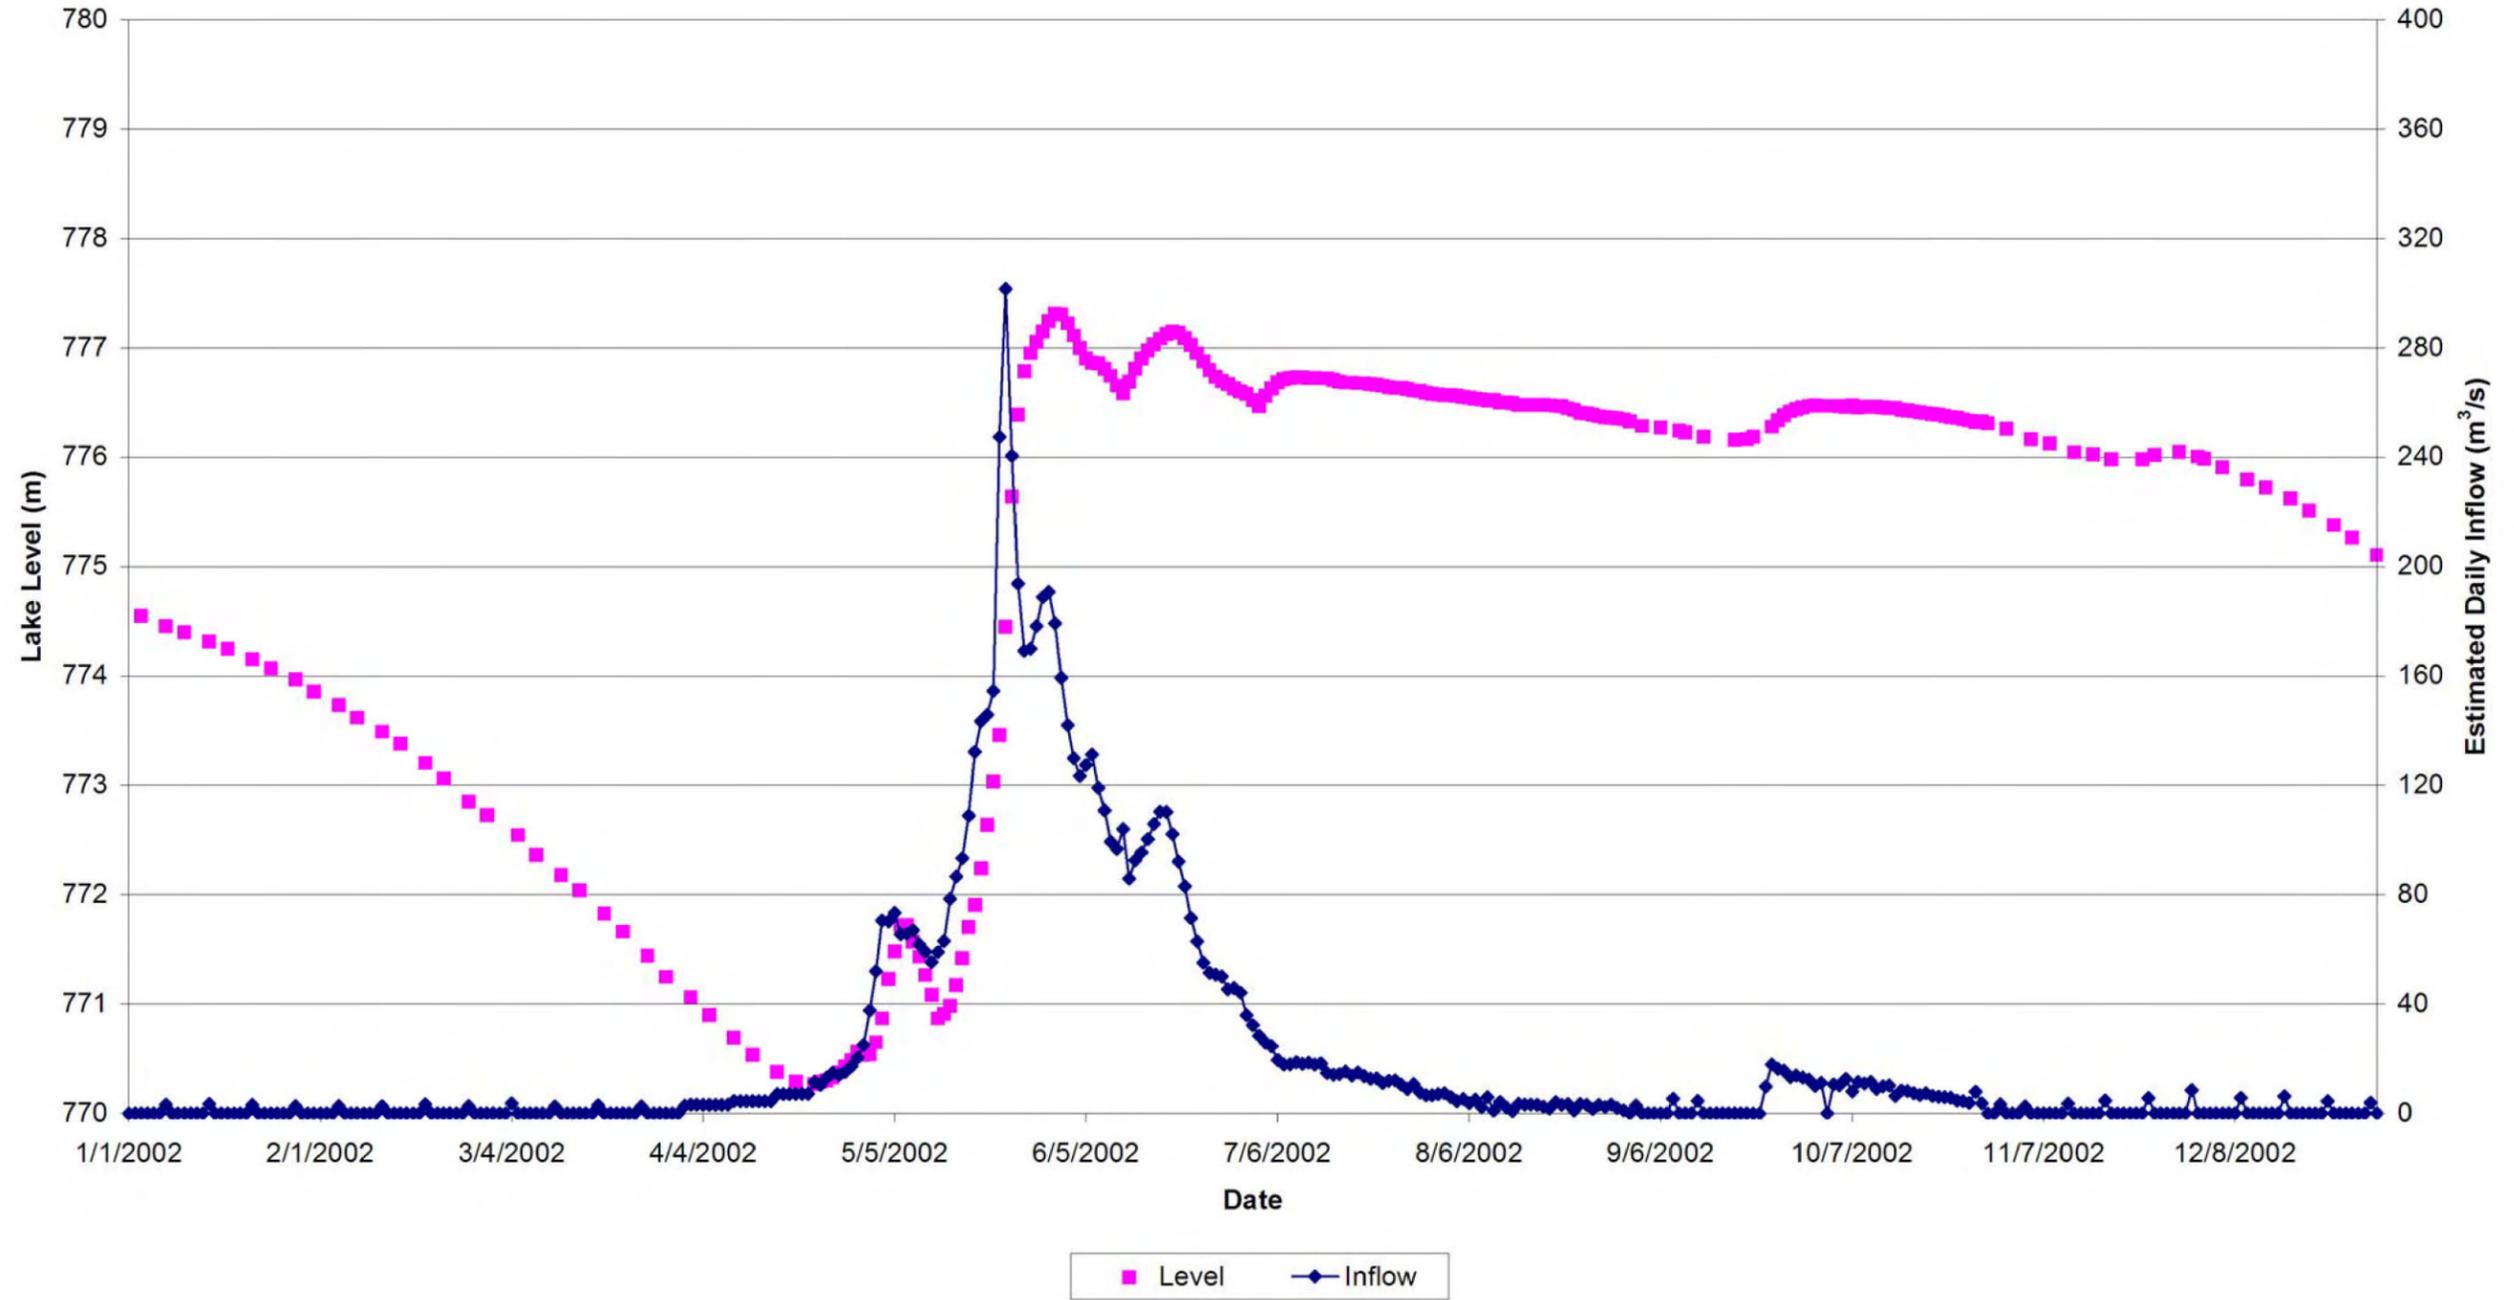
### 2002 Fulton Lake Levels and Inflows (Jan-Dec)

CLIENT Department of Fisheries and Oceans	<b>FULTON DAM SAFETY REVIEW 2008 HYDROTECHNICAL ASSESSMENT</b>				<b>Figure 6</b>
	<b>2002 FULTON LAKE INFLOW HYDROGRAPH AND LAKE ELEVATIONS</b>				
	PROJECT NO. V13201140	DWN ML	CKD RJW	REV 0	
	OFFICE VANC	DATE February 16, 2009

Figure 6 shows the annual hydrograph and lake elevations of Fulton Lake in 2002 with the largest peak flow and snowmelt runoff volume. Graphs of the estimated daily inflow data and daily lake elevation data from 1973 to 2008 can be found in Appendix B.

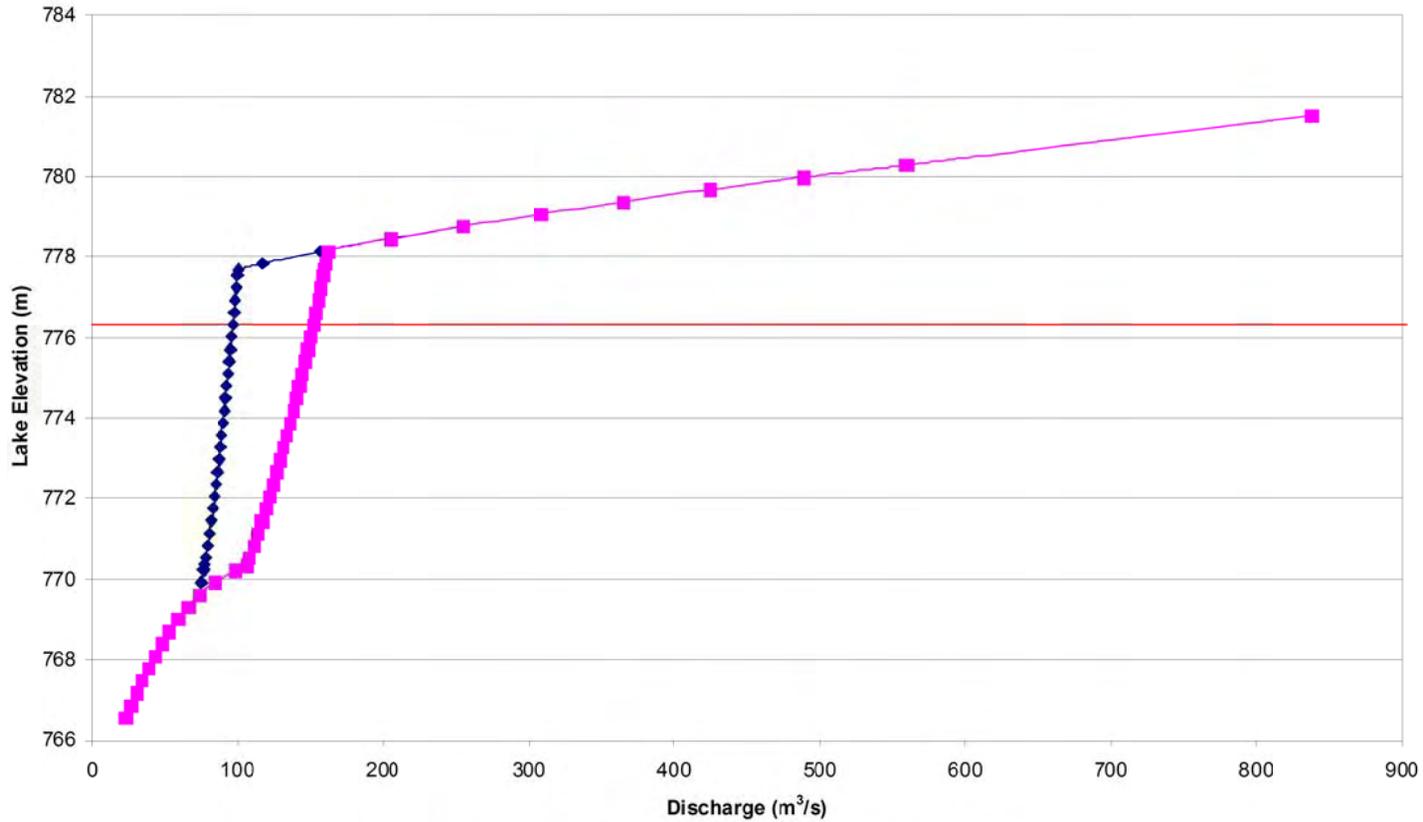
**Figure 11**

◆ Case 1 - Regulating tunnel and overflow spillway  
■ Case 2 - Regulating tunnel, overflow spillway and dam outlet works  
— Spillway Crest @ 776.33 m

CLIENT  Department of Fisheries and Oceans	<b>FULTON DAM SAFETY REVIEW 2008 HYDROTECHNICAL ASSESSMENT</b>			
	<b>CASE 1 AND CASE 2 RULE CURVES</b>			
<b>HAY &amp; COMPANY</b> CONSULTANTS A DIVISION OF EBA	PROJECT NO. V13201140	DWN ML	CKD RJW	REV 0
	OFFICE VANC	DATE March 11, 2009

these regulated flows and flood relief. Rule curves representing the capacity of the regulating tunnel and the overflow spillway (Case 1) and representing the combined capacity of the regulating tunnel, the overflow spillway and dam outlet works (Case 2) for large forecasted inflow volumes are shown on Figure 11. It should be noted that when lake levels exceed the spillway crest elevation, the regulating tunnel and outlet works were assumed to be gradually closed. As a conservative approach, it was assumed that at high tailwater levels, only the overflow spillway would be fully operational.

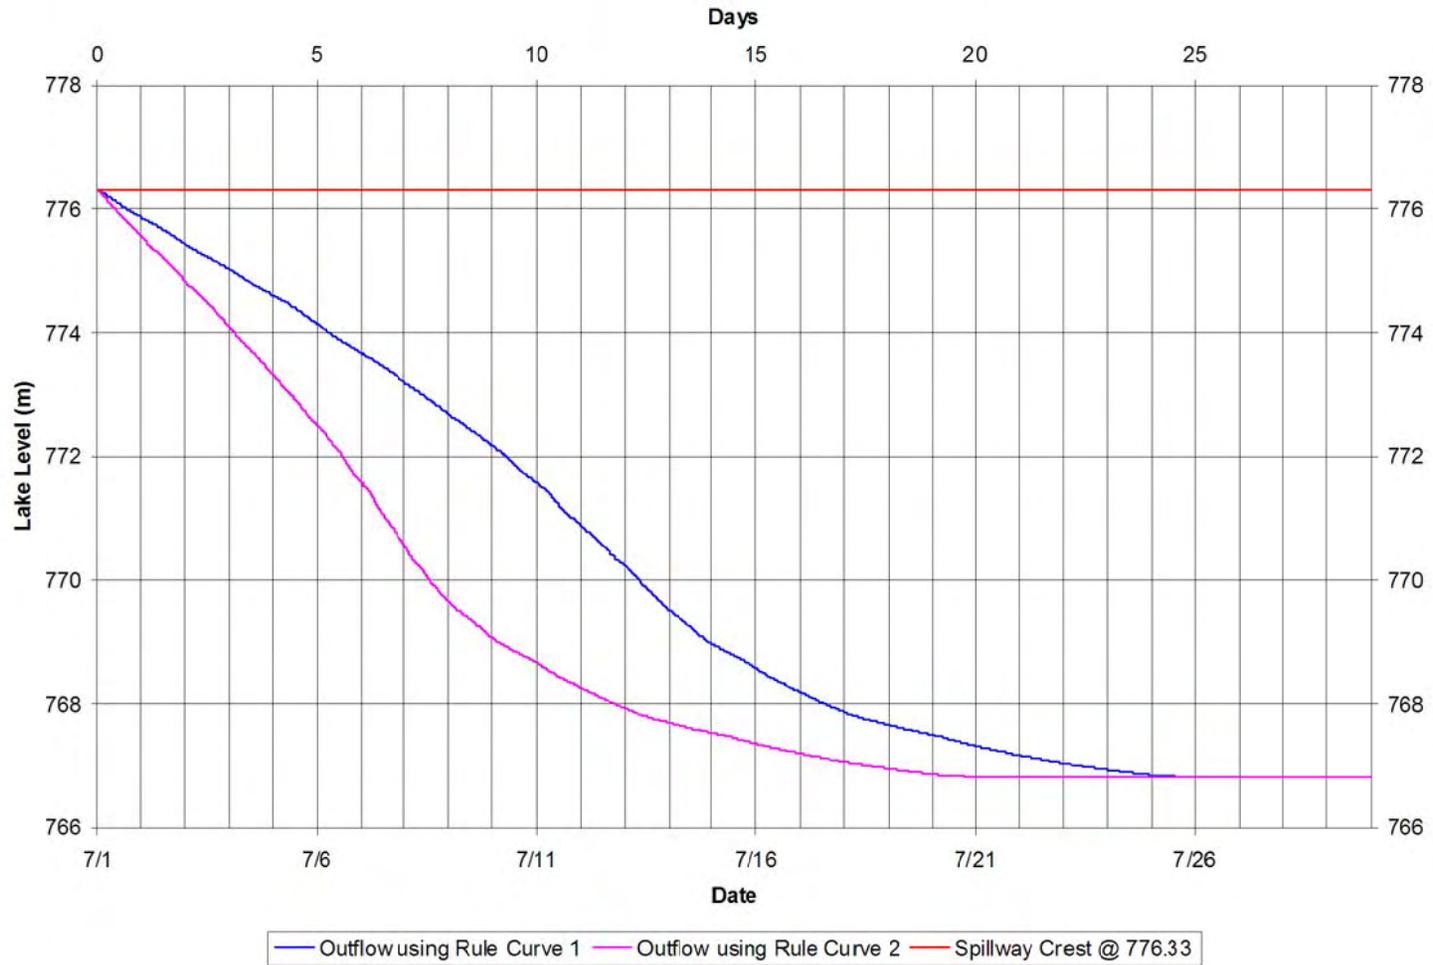
CLIENT Department of Fisheries and Oceans	<b>FULTON DAM SAFETY REVIEW 2008 HYDROTECHNICAL ASSESSMENT</b>								
<b>RESERVOIR DRAWDOWN ANALYSIS</b>									
<b>HAY &amp; COMPANY</b> CONSULTANTS A DIVISION OF EBA	<table border="1" style="width: 100%; border-collapse: collapse;"> <tr> <td style="font-size: small;">PROJECT NO. V13201140</td> <td style="font-size: small;">DWN ML</td> <td style="font-size: small;">CKD RJW</td> <td style="font-size: small;">REV 0</td> </tr> <tr> <td style="font-size: small;">OFFICE VANC</td> <td colspan="3" style="font-size: small;">DATE March 11, 2009</td> </tr> </table>	PROJECT NO. V13201140	DWN ML	CKD RJW	REV 0	OFFICE VANC	DATE March 11, 2009		
PROJECT NO. V13201140	DWN ML	CKD RJW	REV 0						
OFFICE VANC	DATE March 11, 2009								
Figure 17

TABLE 9: RESULTS OF RESERVOIR DRAWDOWN ANALYSIS				
Scenario	Condition	Peak Inflow ( $\text{m}^3/\text{s}$ )	Peak Outflow ( $\text{m}^3/\text{s}$ )	Approx. Time Required to Drain Reservoir (days)
1	Constant Inflow $20.5 \text{ m}^3/\text{s}$ Outflow Curve 1	20.5	96.8	29
2	Constant Inflow $20.5 \text{ m}^3/\text{s}$ Outflow Curve 2	20.5	151.8	24

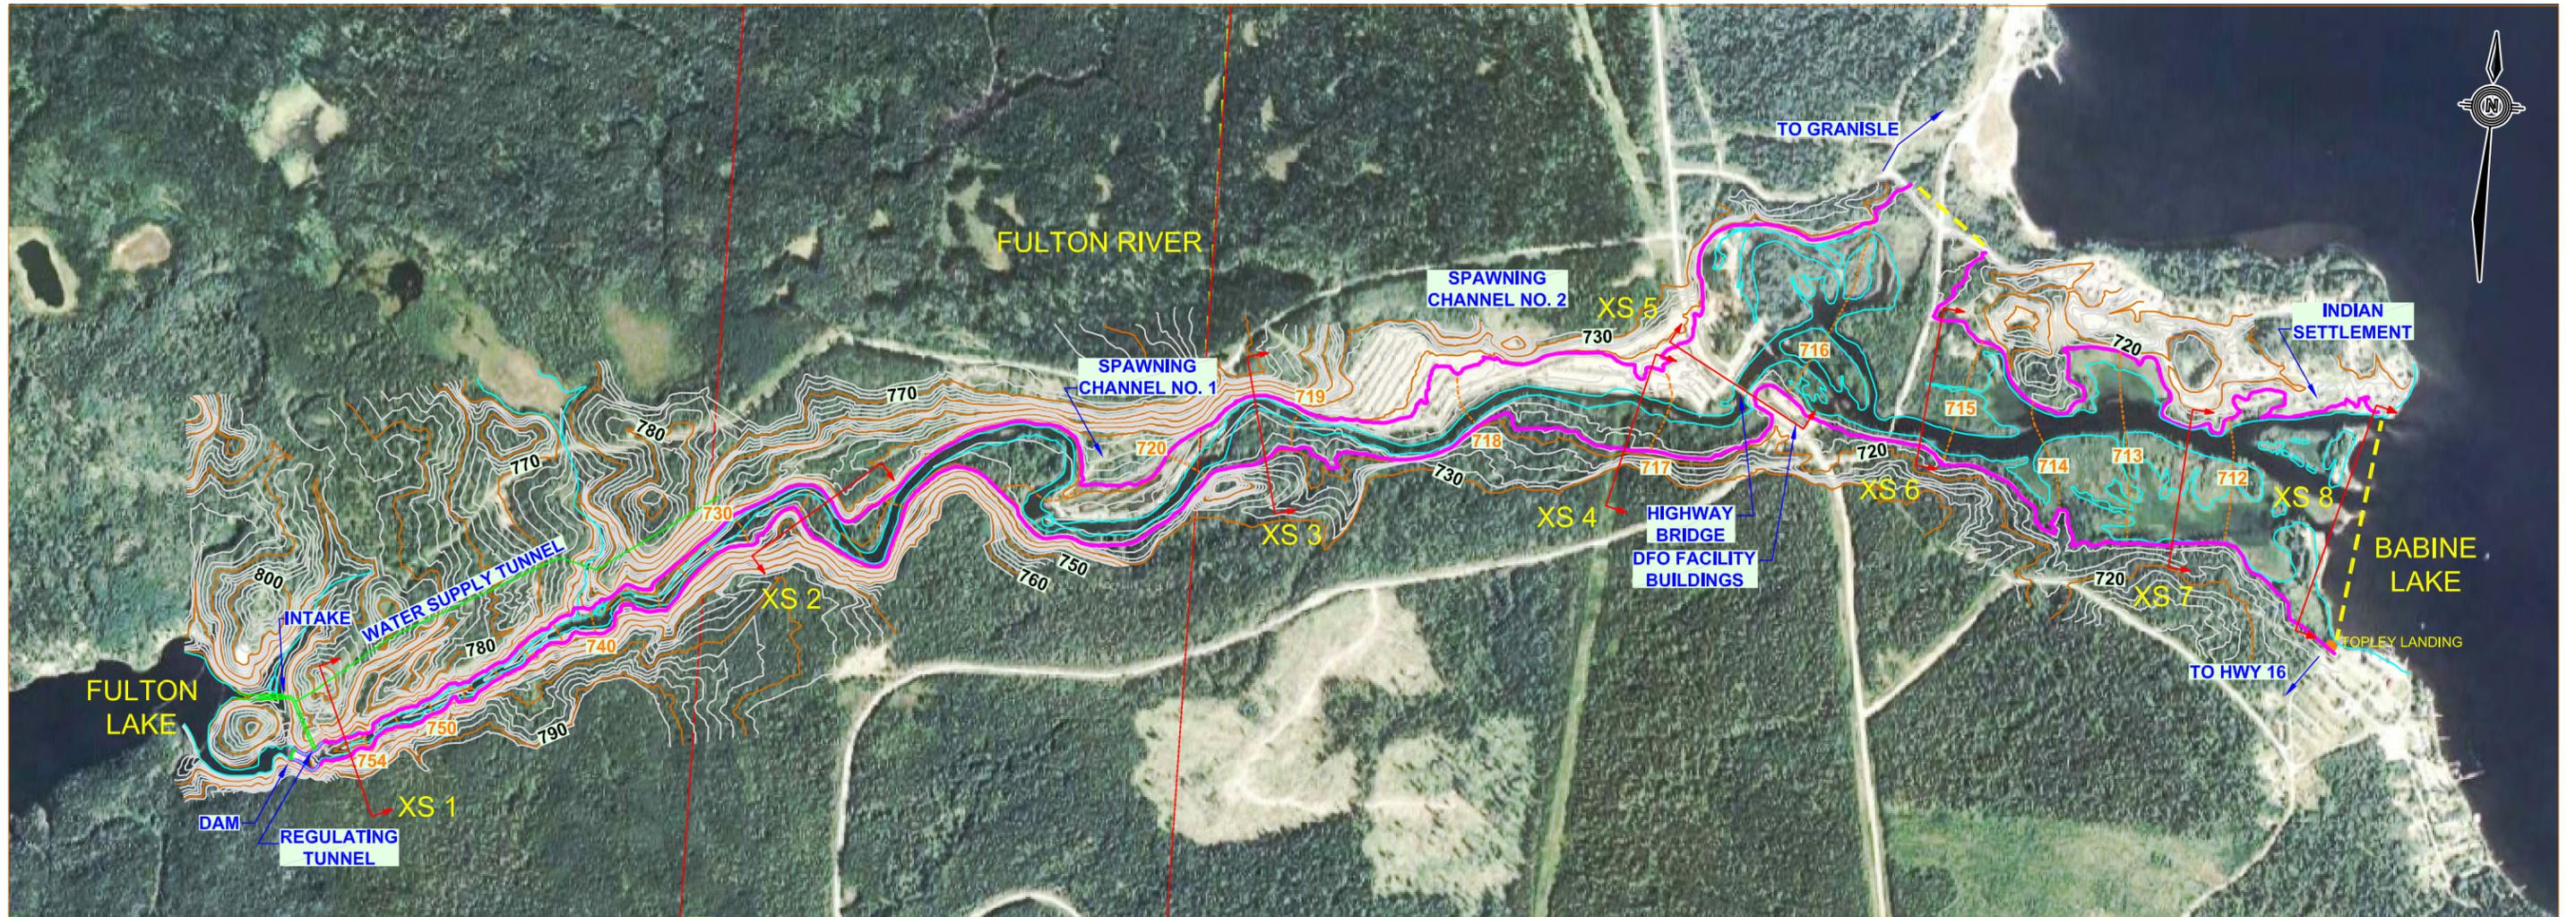
DAM BREAK ANALYSIS - SUMMARY OF RESULTS

CROSS SECTION	XS 1	XS 2	XS 3	XS 4	XS 5	XS 6	XS 7	XS 8
DISTANCE FROM DAM (km)	0.00	1.37	2.86	3.88	4.14	4.81	5.49	5.84
TIME TO PEAK ELEVATION (min)	0.0	2.4	8.4	12.6	15.6	19.8	21.6	21.6
PEAK WATER ELEVATION (m)	755.0	725.4	719.2	717.1	716.8	715.4	712.4	711.2

It should be noted that the peak flow as a result of the dam breach during the spring IDF varies from 1857 m<sup>3</sup>/s at the dam to 1645 m<sup>3</sup>/s at the lake. There is an attenuation of about 11% within this 6 km long study reach. In addition, the time to reach the peak water elevation near the outlet of the river is approximately 22 minutes. Since a different flood condition was considered compared to that in the previous inundation study, the percentages of flow attenuation as well as the time required to reach peak flow are not comparable.

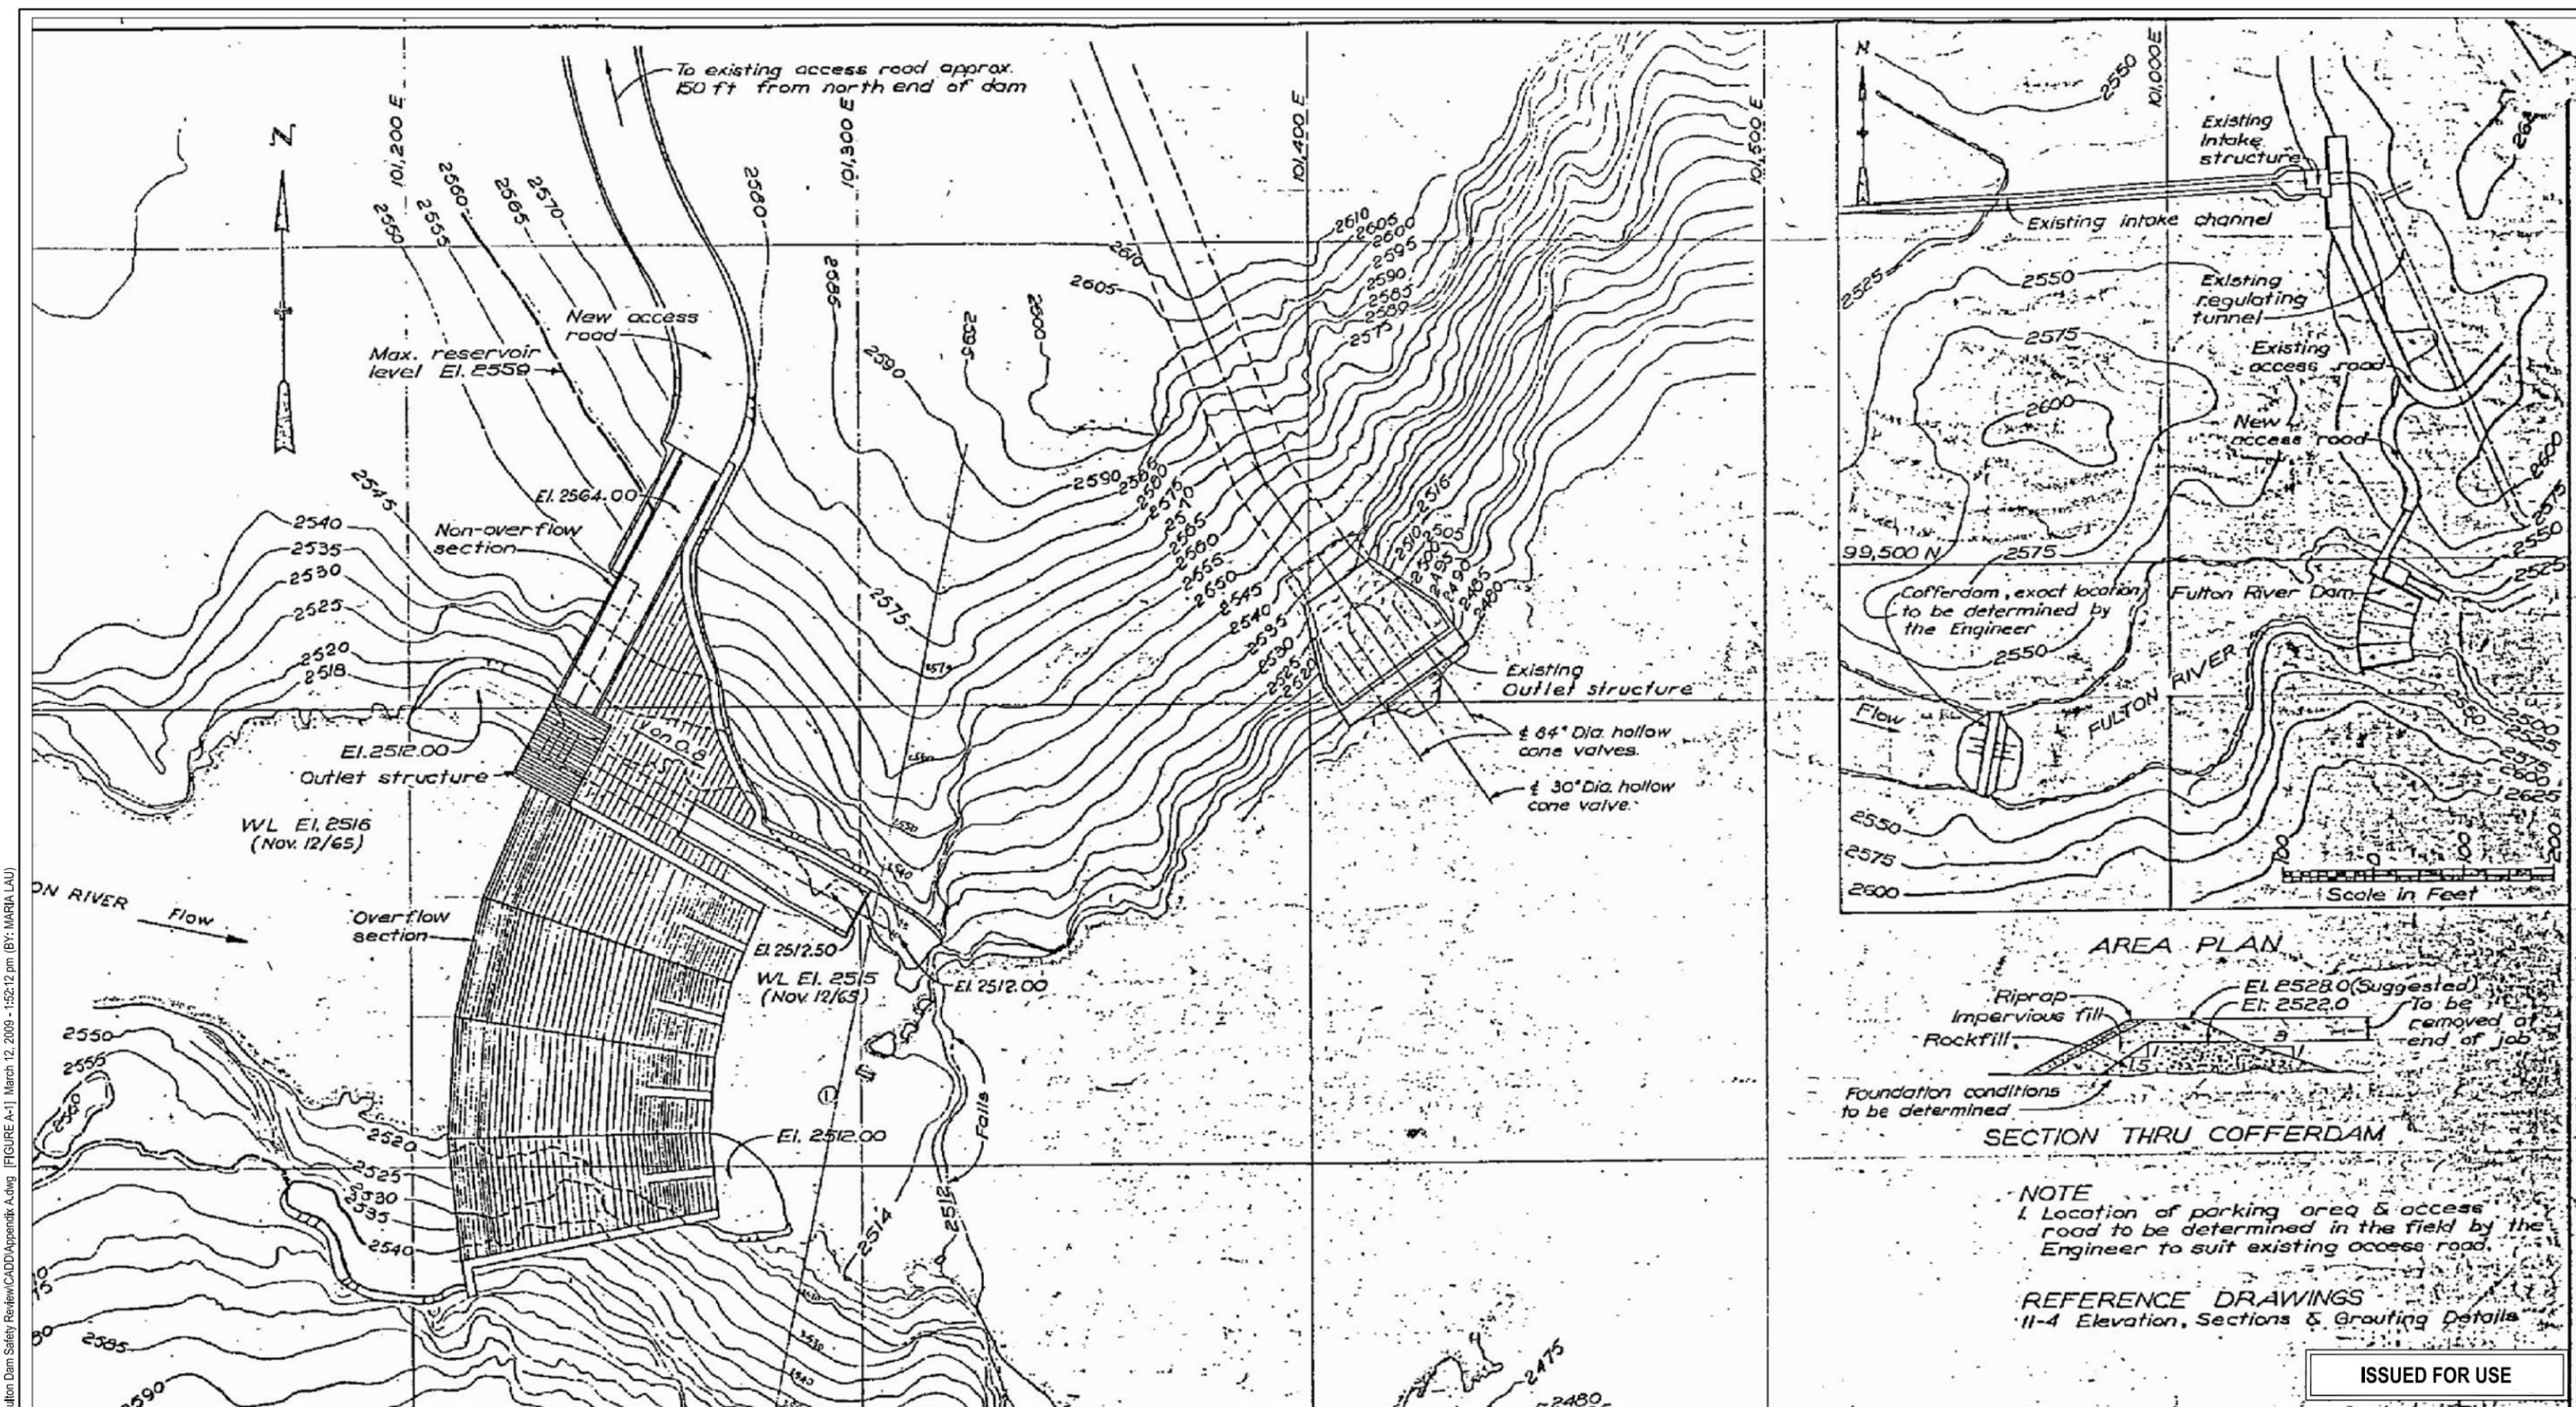
**NOTES**  
 Base drawing obtained from 1986 Fulton River Project Dam Breach Inundation Study by Patrick Fawkes & Associates - Figure 2 General Arrangement

CLIENT Department of Fisheries and Oceans		<b>FULTON DAM SAFETY REVIEW 2008 HYDROTECHNICAL ASSESSMENT</b>		
<b>HAY &amp; COMPANY</b> CONSULTANTS A DIVISION OF EBA		<b>FULTON DAM PLAN VIEW</b>		
		PROJECT NO. V13201140	DWN ML	CKD RJW
OFFICE VANC		DATE March 11, 2009		Figure A-1

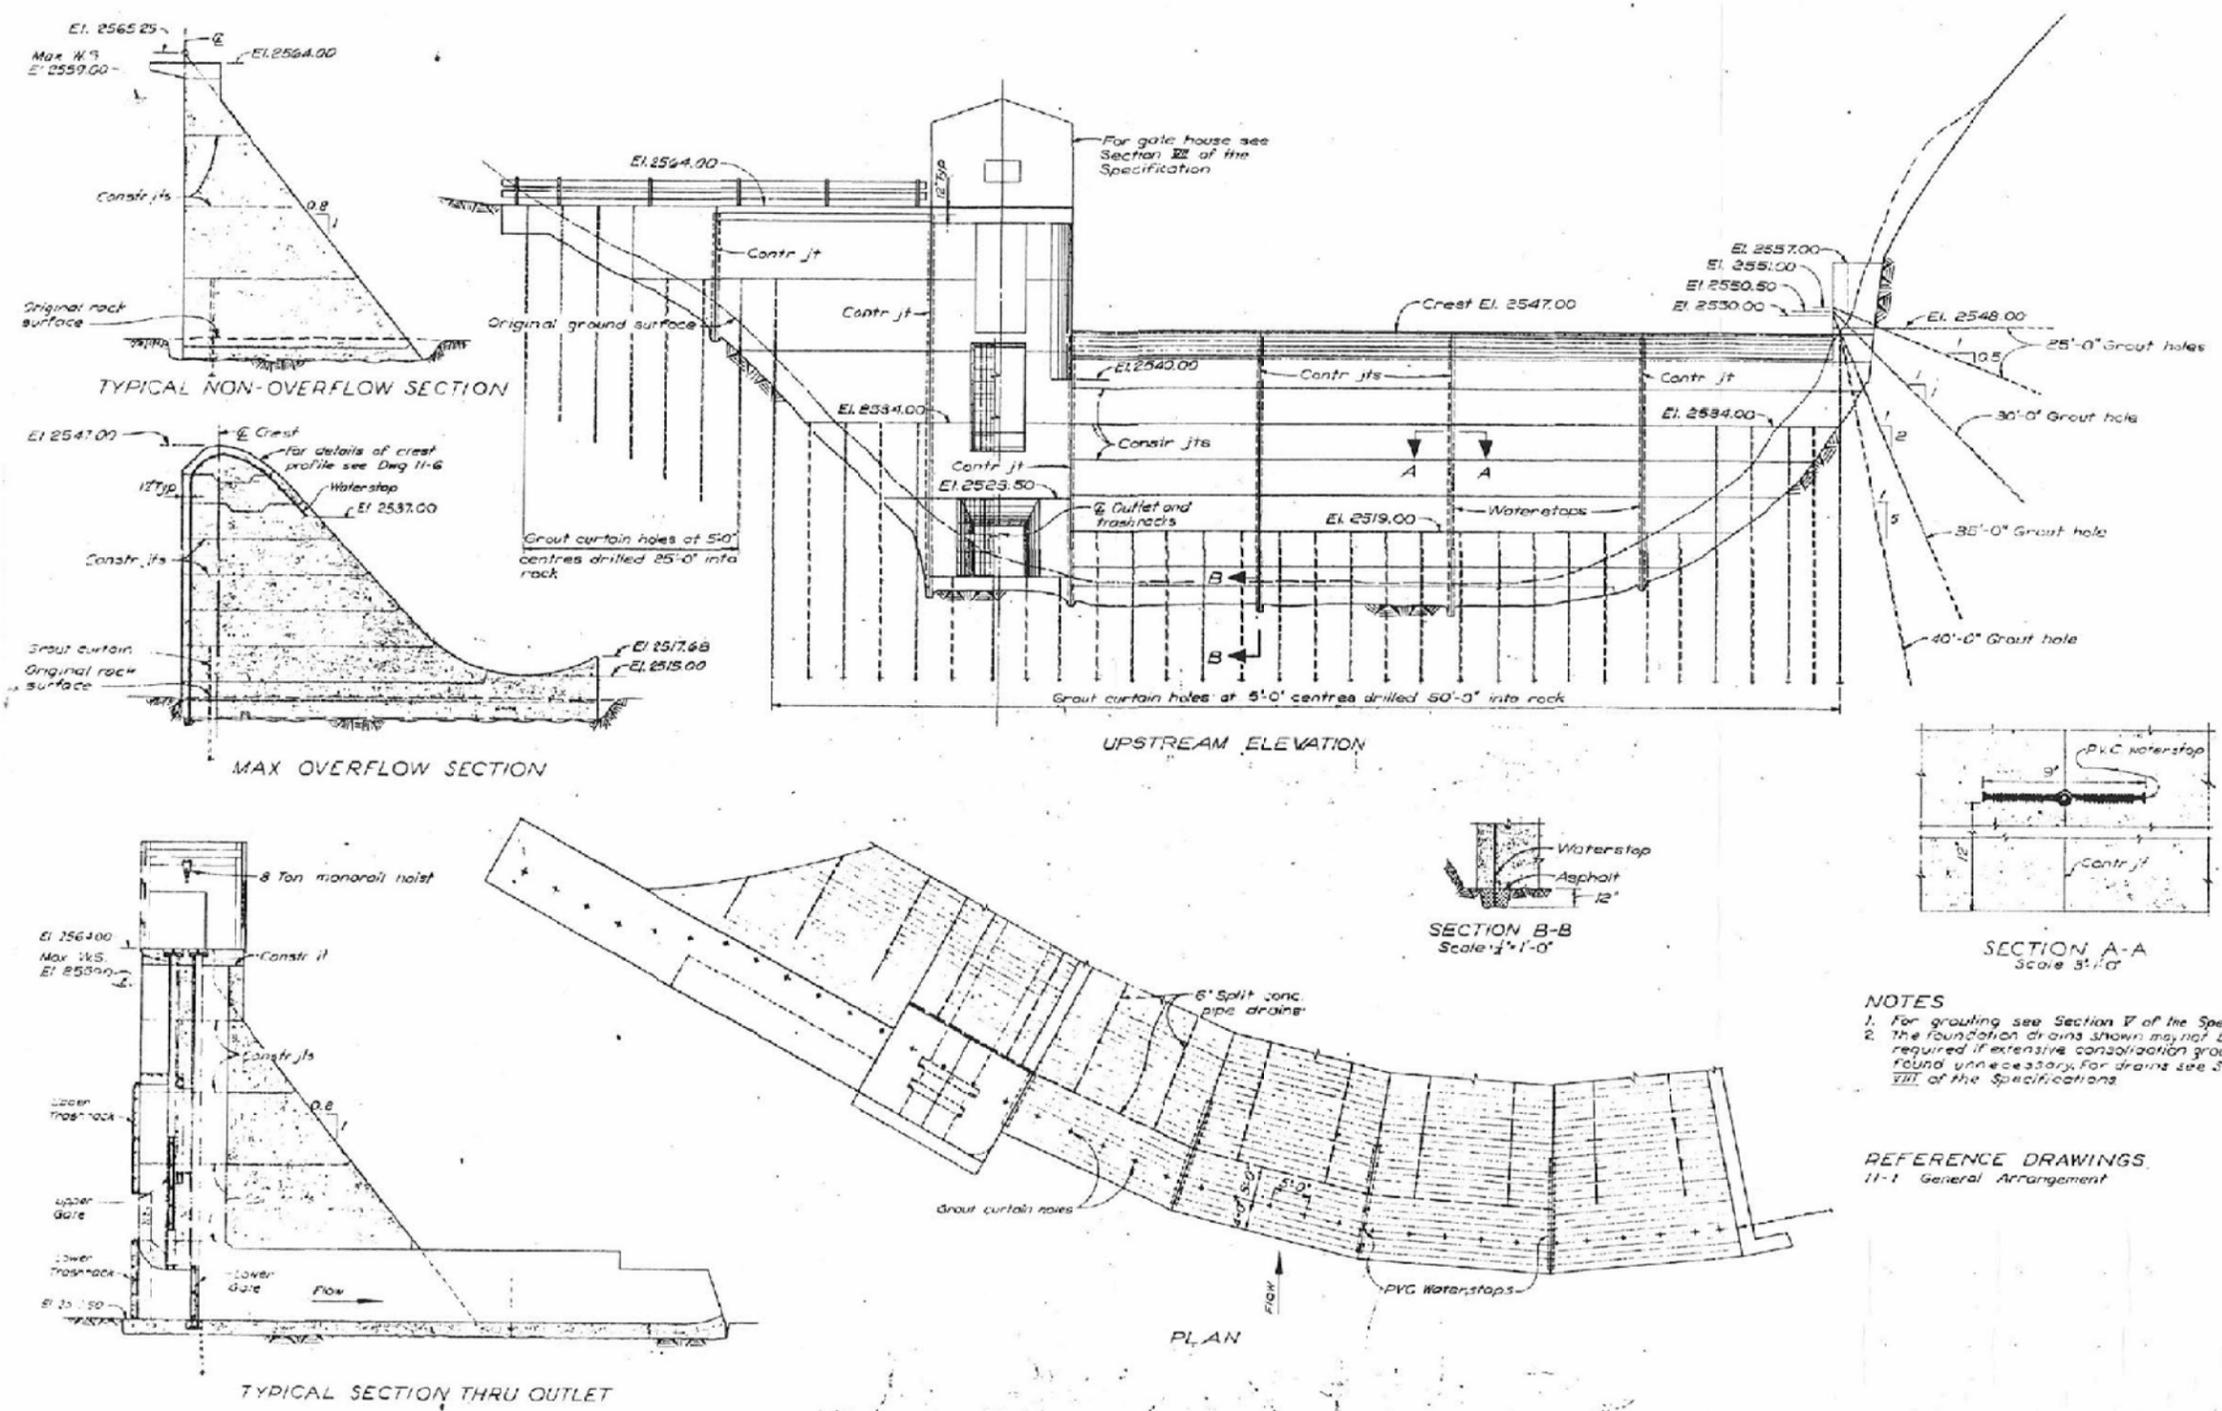
Figure A-2

**NOTES**  
 1. For grouting see Section V of the Specifications.  
 2. The foundation drains shown may not be required if extensive consolidation grouting is found unnecessary. For drains see Section VIII of the Specifications.
