Department of Fisheries and Oceans

FULTON DAM SAFETY REVIEW  
2008 HYDROTECHNICAL ASSESSMENT

V13201140

March 2009

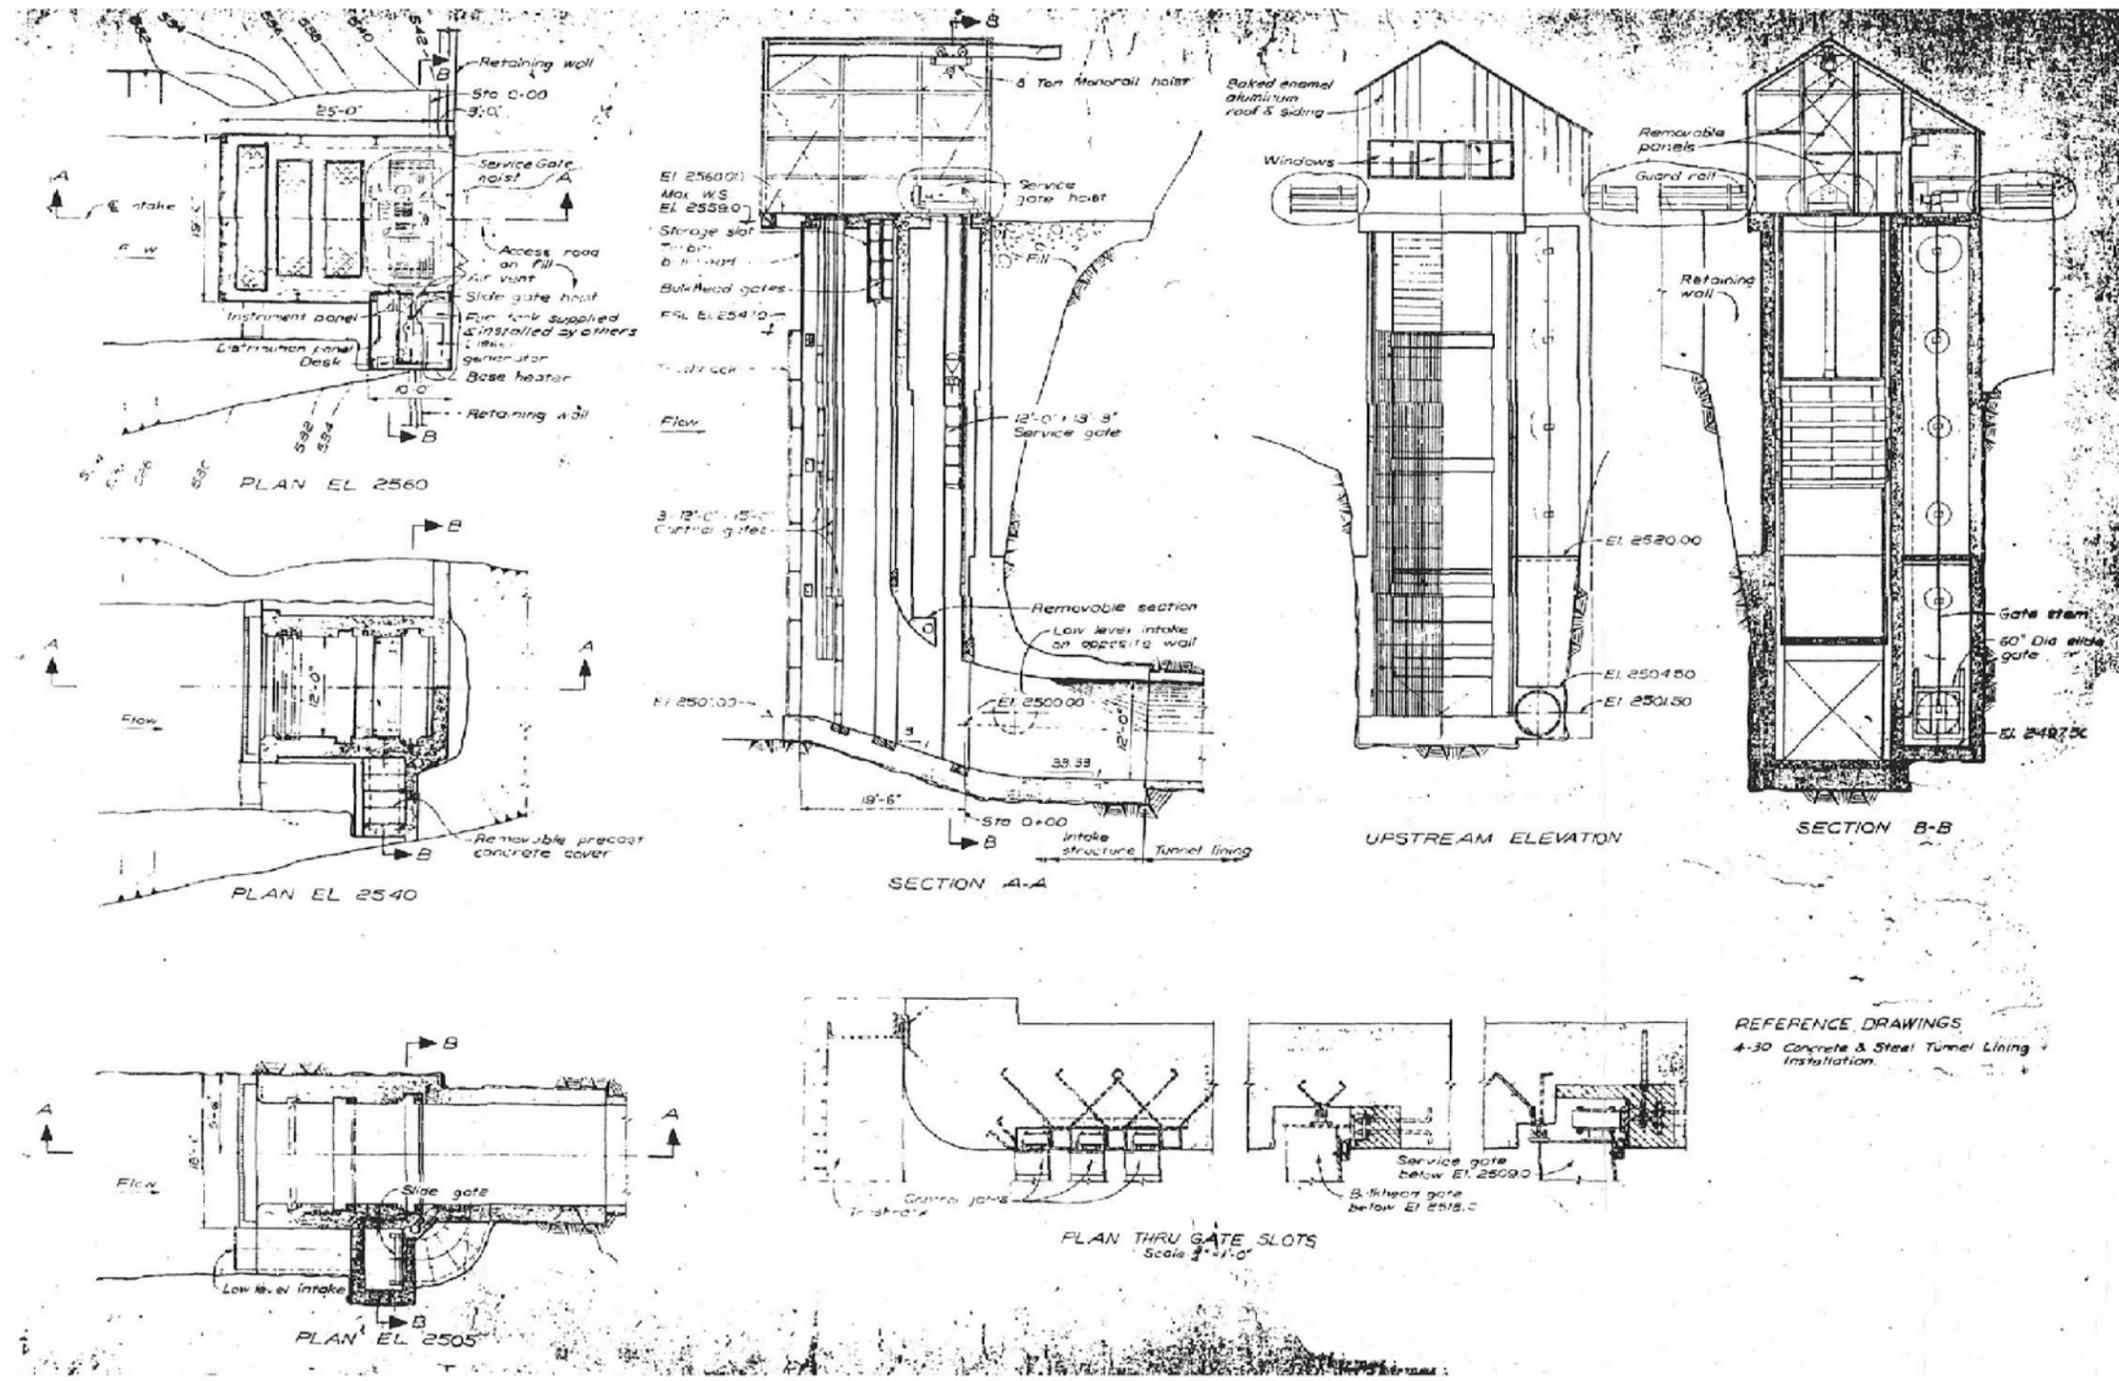
Figure A-3

**NOTES**  
Base drawing obtained from Fulton Dam Safety Review report by UMA Engineering Ltd. dated August 1997 (2507-0175-001-00-01) based on DFO Drawing No. 983-4-2R2 Babine Lake Development Project No. 4 Fulton River Regulating Works Intake General Arrangement

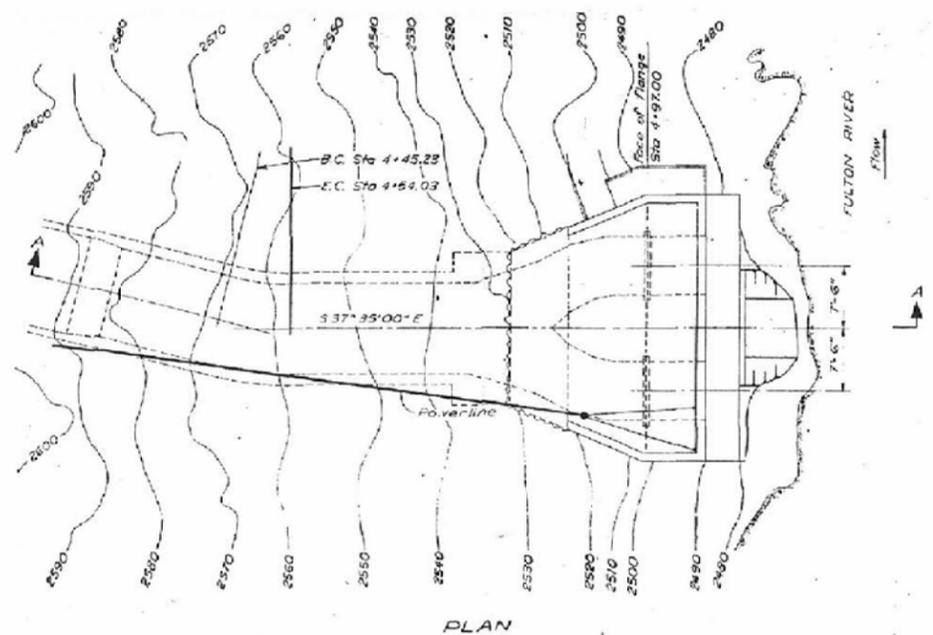
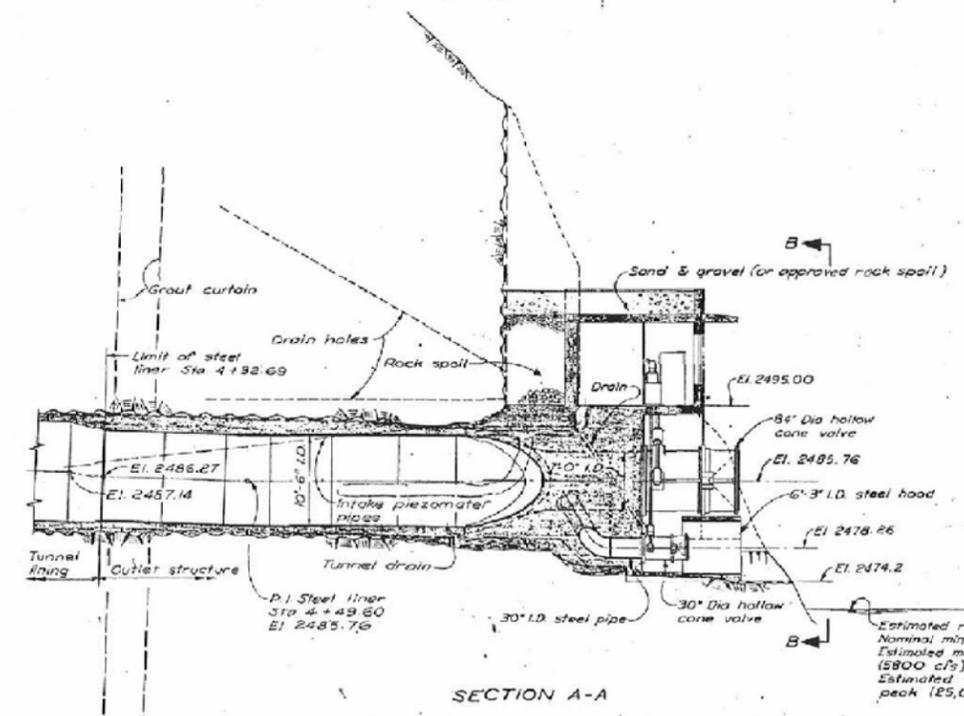
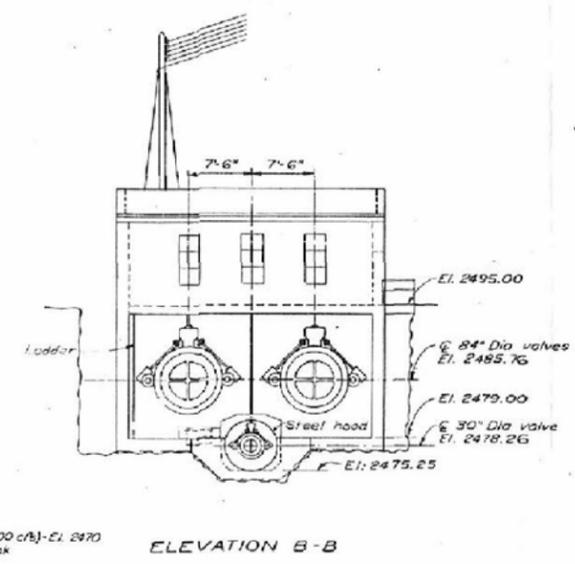
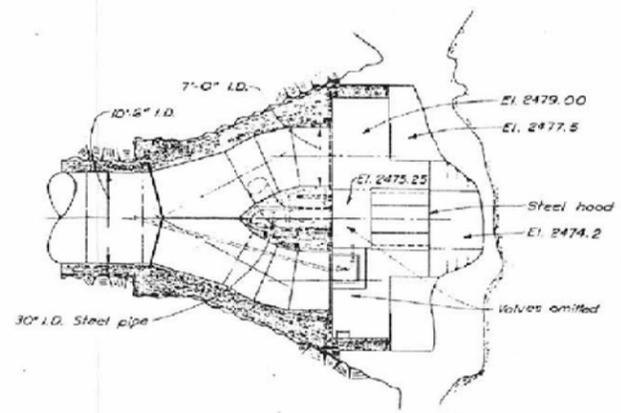
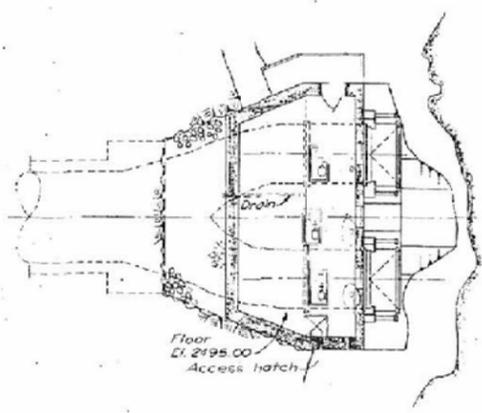
Estimated River levels:  
 Normal minimum flow (100 cfs) - El. 2470  
 Estimated mean flood peak (5800 cfs) - El. 2478  
 Estimated 10,000 year flood peak (25,000 cfs) - El. 2491

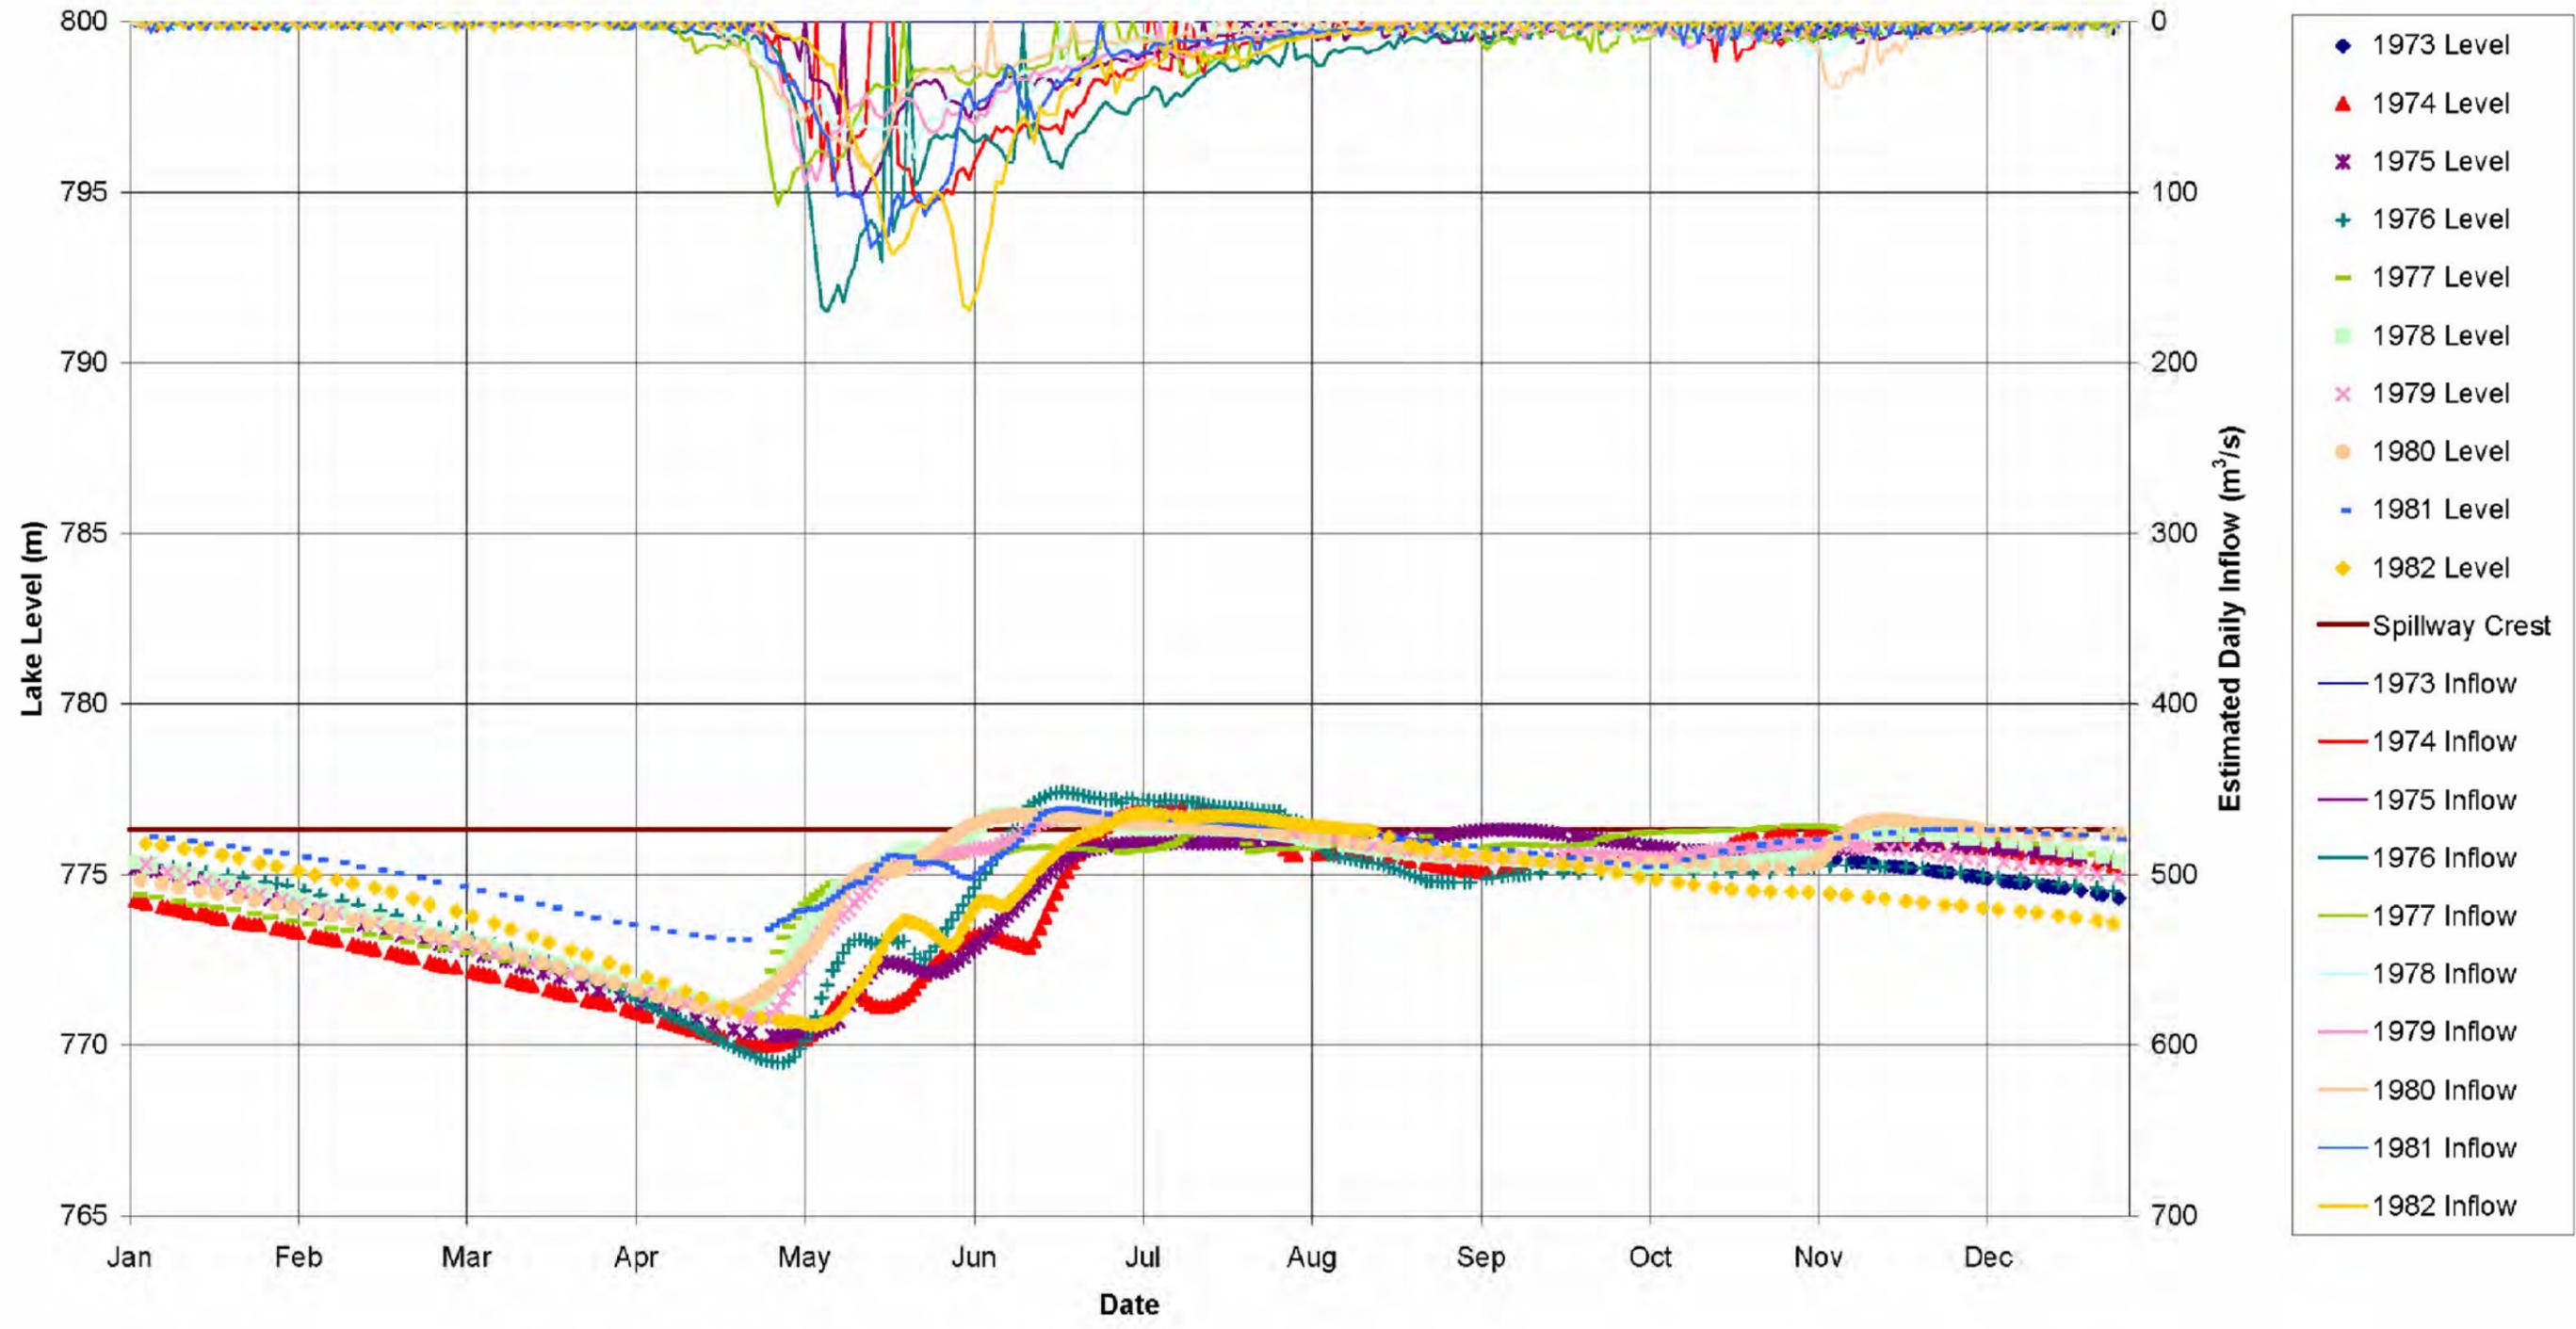
CLIENT Department of Fisheries and Oceans		<b>FULTON DAM SAFETY REVIEW 2008 HYDROTECHNICAL ASSESSMENT</b>			
		<b>HISTORICAL LAKE LEVELS AND ESTIMATED INFLOWS (1973 - 1982)</b>			
<b>HAY &amp; COMPANY</b> CONSULTANTS A DIVISION OF EBA	PROJECT NO. V13201140	DWN ML	CKD RJW	REV 0	<b>Figure B-1</b>
	OFFICE VANC	DATE March 11, 2009

Figure 6 shows the annual hydrograph and lake elevations of Fulton Lake in 2002 with the largest peak flow and snowmelt runoff volume. Graphs of the estimated daily inflow data and daily lake elevation data from 1973 to 2008 can be found in Appendix B.

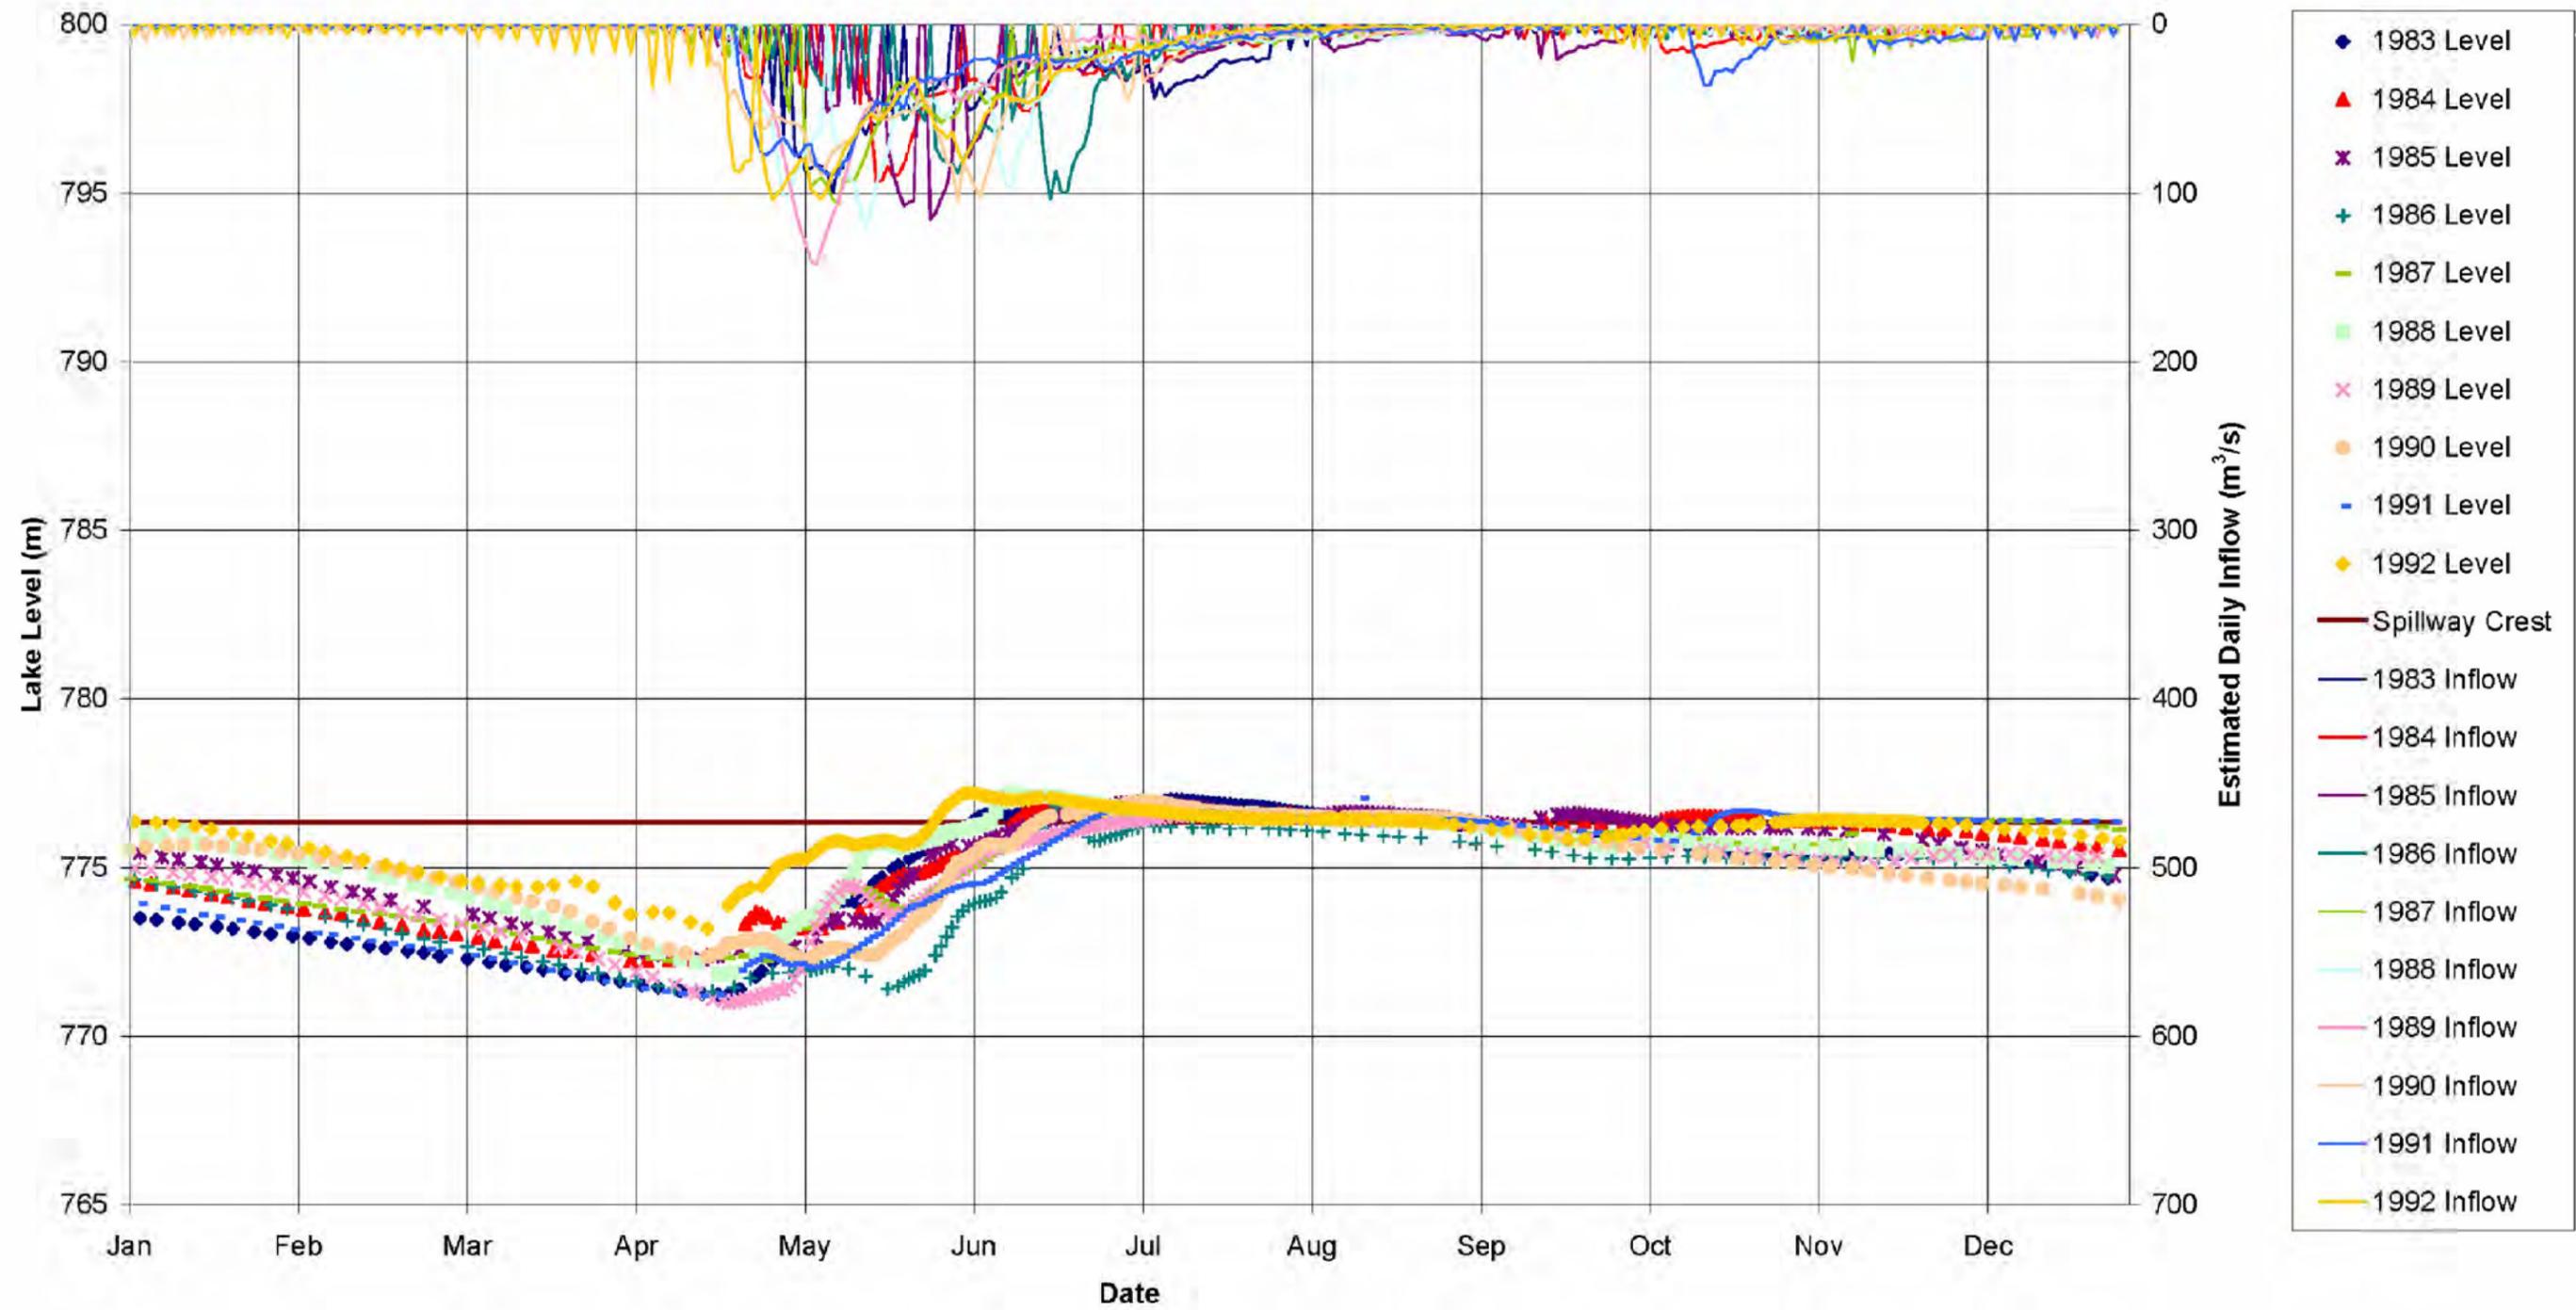
CLIENT Department of Fisheries and Oceans		<b>FULTON DAM SAFETY REVIEW</b> <b>2008 HYDROTECHNICAL ASSESSMENT</b>		
<b>HISTORICAL LAKE LEVELS AND ESTIMATED INFLOWS (1983 - 1992)</b>				
<b>HAY &amp; COMPANY</b> CONSULTANTS A DIVISION OF EBA	PROJECT NO. V13201140	DWN ML	CKD RJW	REV 0
	OFFICE VANC	DATE March 11, 2009		
				<b>Figure B-2</b>

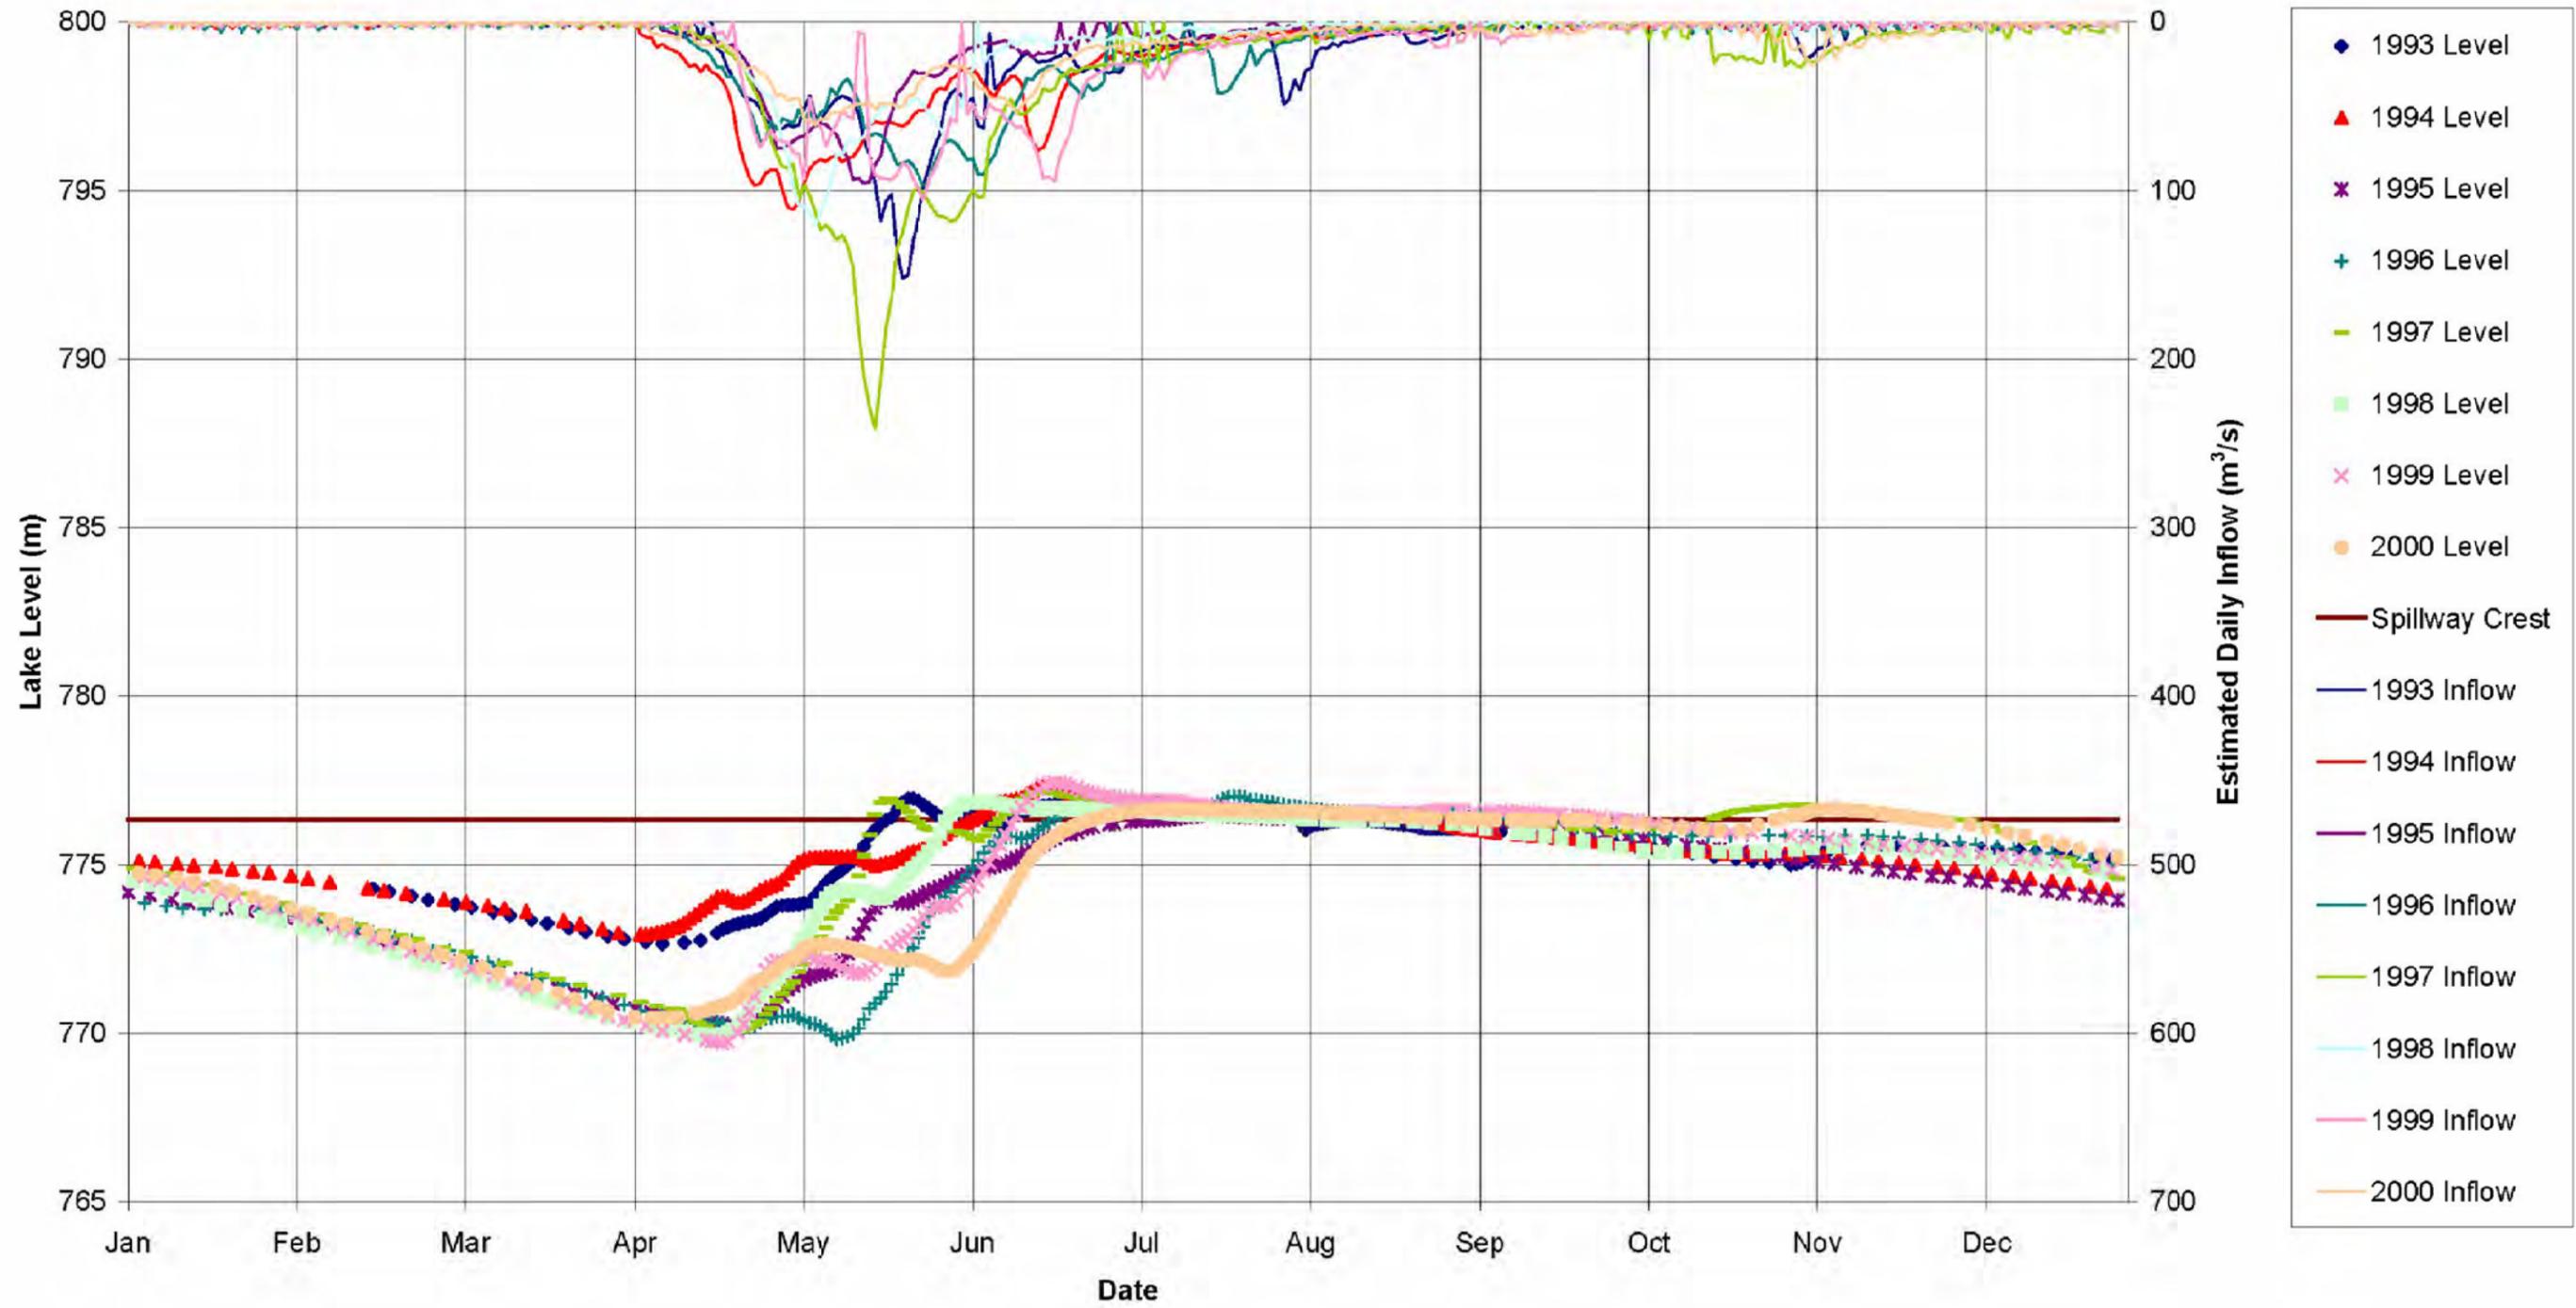
CLIENT		<b>FULTON DAM SAFETY REVIEW</b> <b>2008 HYDROTECHNICAL ASSESSMENT</b>			
Department of Fisheries and Oceans		<b>HISTORICAL LAKE LEVELS AND</b> <b>ESTIMATED INFLOWS (1993 - 2000)</b>			
<b>HAY &amp; COMPANY</b> CONSULTANTS A DIVISION OF EBA	PROJECT NO.	DWN	CKD	REV	<b>Figure B-3</b>
	V13201140	ML	RJW	0	
	OFFICE	DATE			
VANC		March 11, 2009

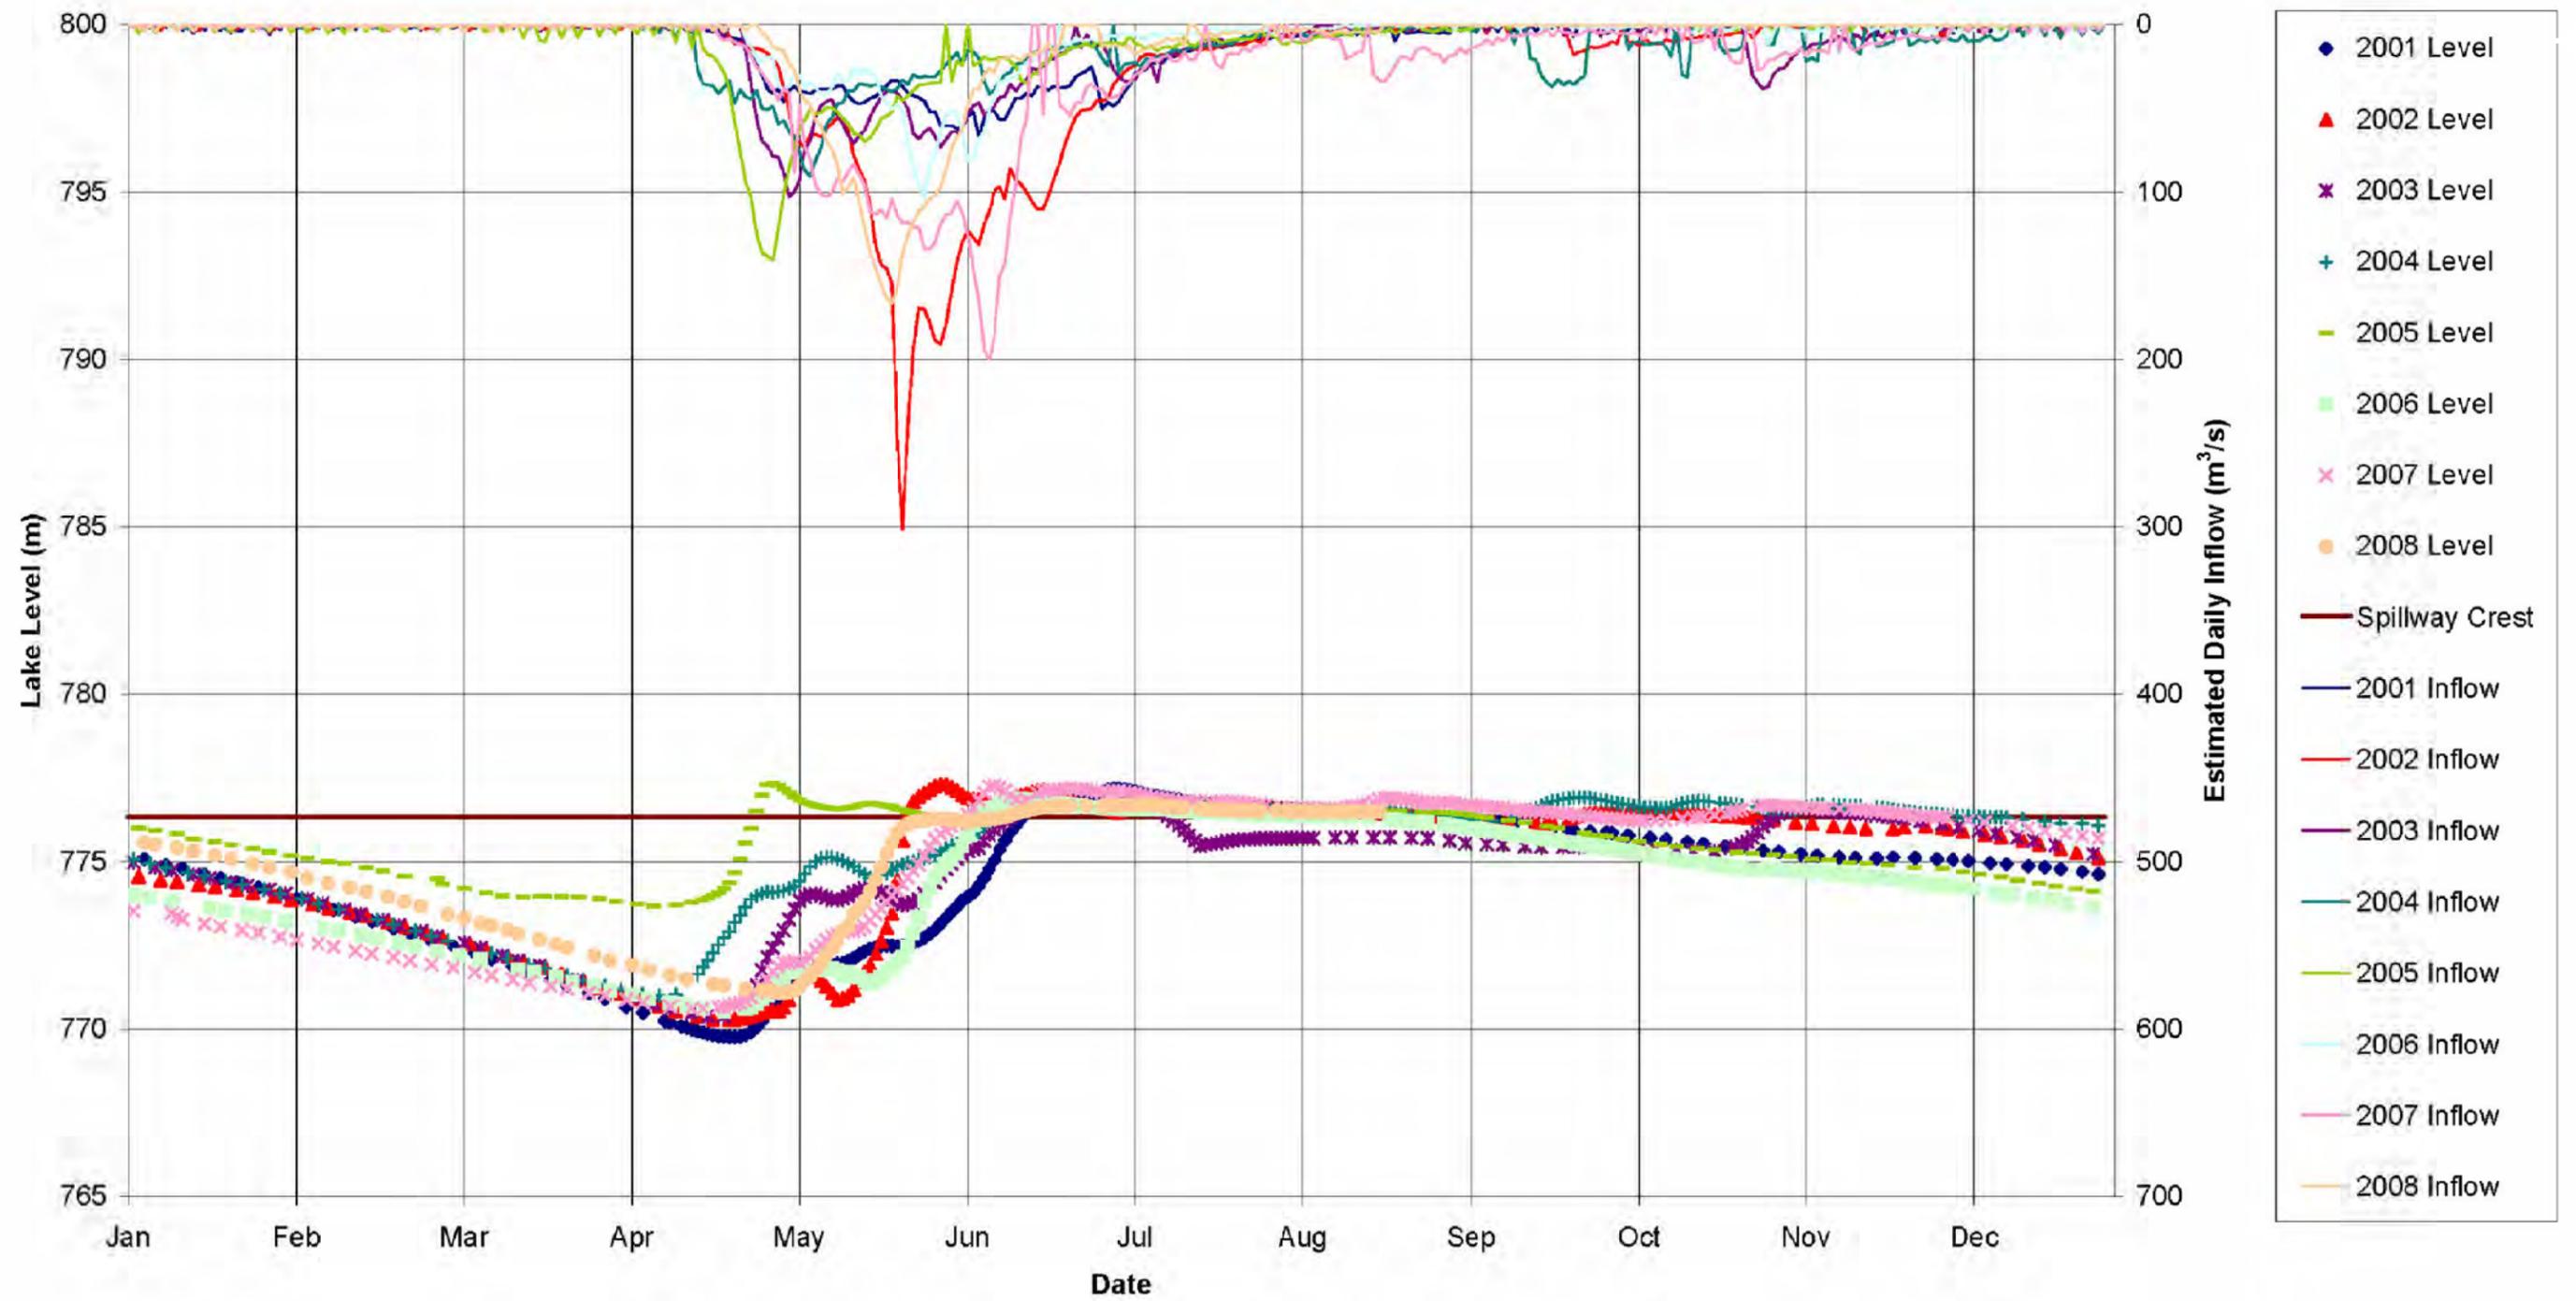
CLIENT Department of Fisheries and Oceans		<b>FULTON DAM SAFETY REVIEW 2008 HYDROTECHNICAL ASSESSMENT</b>			
		<b>HISTORICAL LAKE LEVELS AND ESTIMATED INFLOWS (2001 - 2008)</b>
