- .1 The work of the Contract comprises of the roof replacement, localized gutter replacement and localized repainting of various building at the Fort Rodd Hill National Historic Site, Victoria, BC.

Fort Rodd Hill – Roof Replacements
Project No.: R.081107.001
Issued for Tender – August 2016

**Hazardous Building
Materials Assessment**

31 Buildings/Structures at the Fort
Rodd Hill National Historic Site, BC

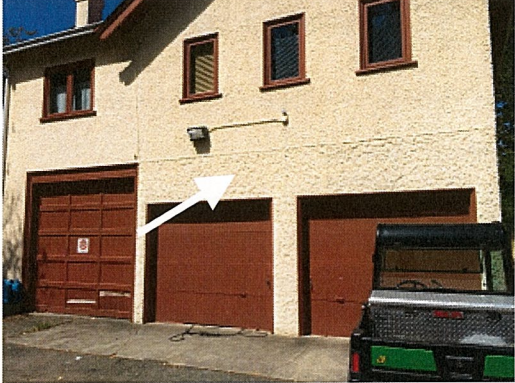
<p>Yellow colored paint on the exterior stucco.</p> <p>This paint was observed to be in good condition (not bubbling, flaking or peeling).</p>

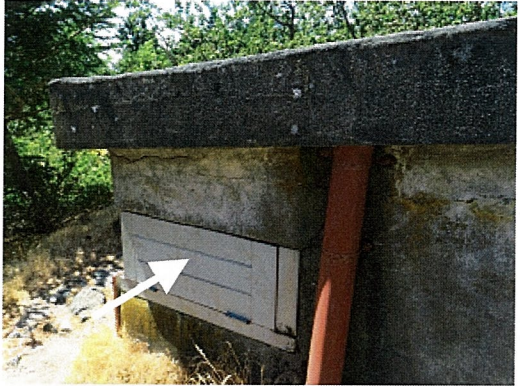
Identified LCP Description	Photo
<p>Grey colored paint on the shutters. This paint was observed to be in good condition (not bubbling, flaking or peeling).</p>

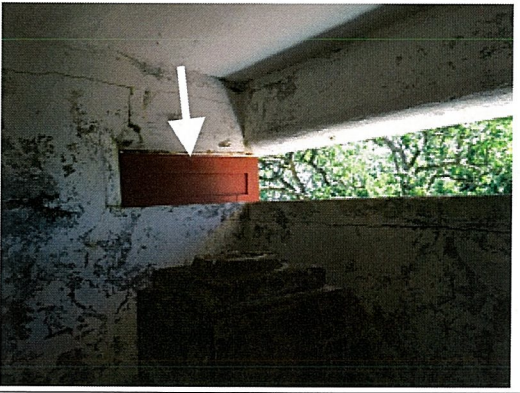
<p>Red colored paint on the window "frames". This paint was observed to be in good condition (not bubbling, flaking or peeling).</p>

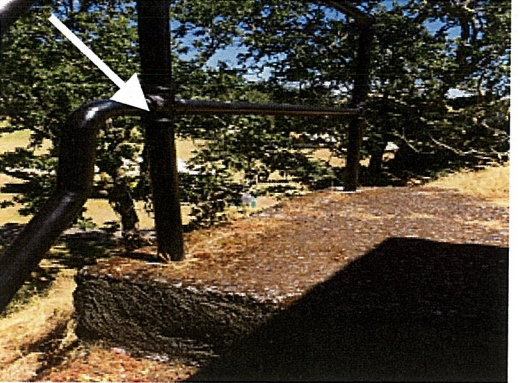
<p>Black colored paint on the railing. This paint was observed to be in good condition (not bubbling, flaking or peeling).</p>

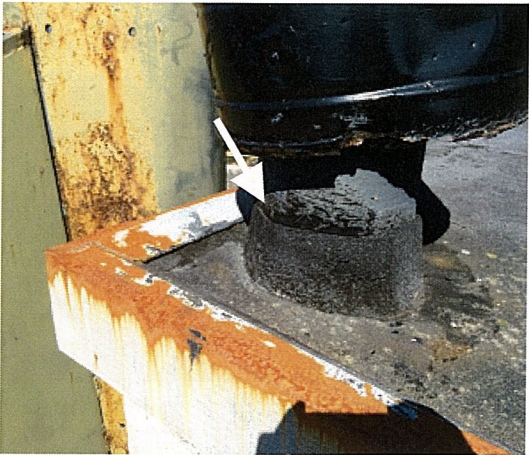
Identified ACM Description and Condition Information		Photo
Black roof mastic on vertical exhaust vents on roof

Friability	Non-friable	
Condition	Good	
Content	5% Chrysotile

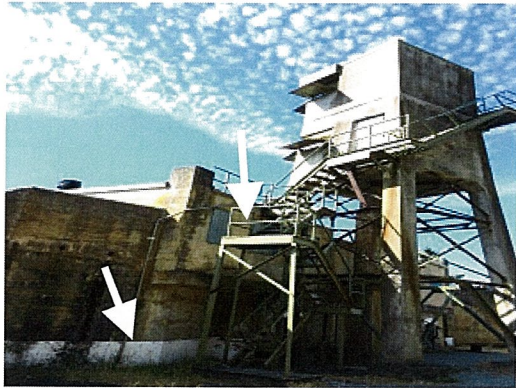
Identified LCP Description	Photo
<p>White coloured paint on the exterior trims (lower arrow).</p> <p>This paint was observed to be in good condition (not bubbling, flaking or peeling).</p> <p>Green colored paint on steel structure of the tower (upper arrow).</p> <p>This paint was observed to be in good condition (not bubbling, flaking or peeling).</p>

A photograph of a multi-level tower structure. The lower levels are painted white, and the upper levels are painted green. Two white arrows point to the white paint on the lower level and the green paint on the upper level.
<p>White coloured paint on the interior walls of the tower upper level.</p> <p>This paint was observed to be in good condition (not bubbling, flaking or peeling).</p>

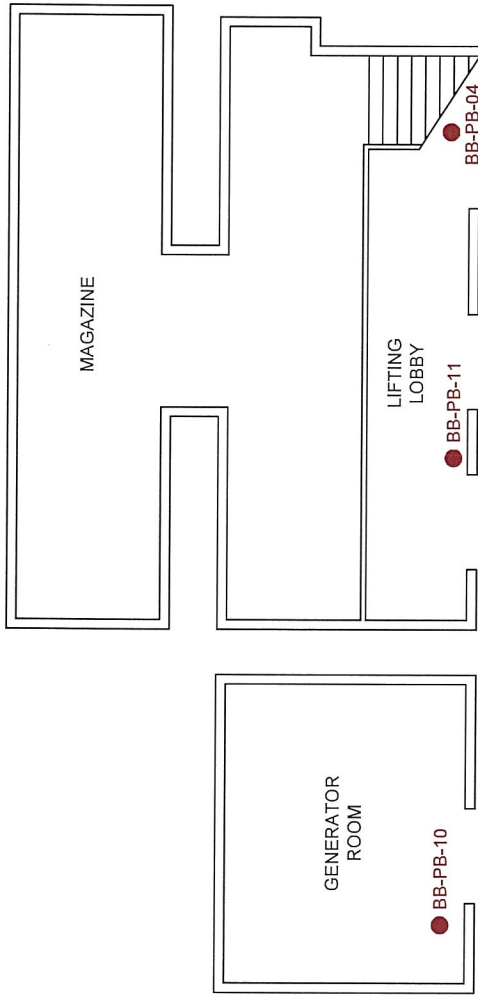
- BULK SAMPLE LOCATION
- PAINT CHIP SAMPLE LOCATION
- TEM SAMPLE LOCATION

Project No.: 123220330.400		Dwg. No.:	
Scale: N.T.S.	Date: 16/03/23	2	
FLOOR PLAN SHOWING HAZARDOUS BUILDING MATERIALS AND BULK SAMPLE LOCATIONS		Dwn. By: CD VM/DM	
FORT RODD HILL AND FISGARD LIGHTHOUSE NATIONAL HISTORIC SITES, VICTORIA		App'd By: TW	
603 FORT RODD HILL ROAD, VICTORIA, BC			
Client: PUBLIC WORKS AND GOVERNMENT SERVICES CANADA

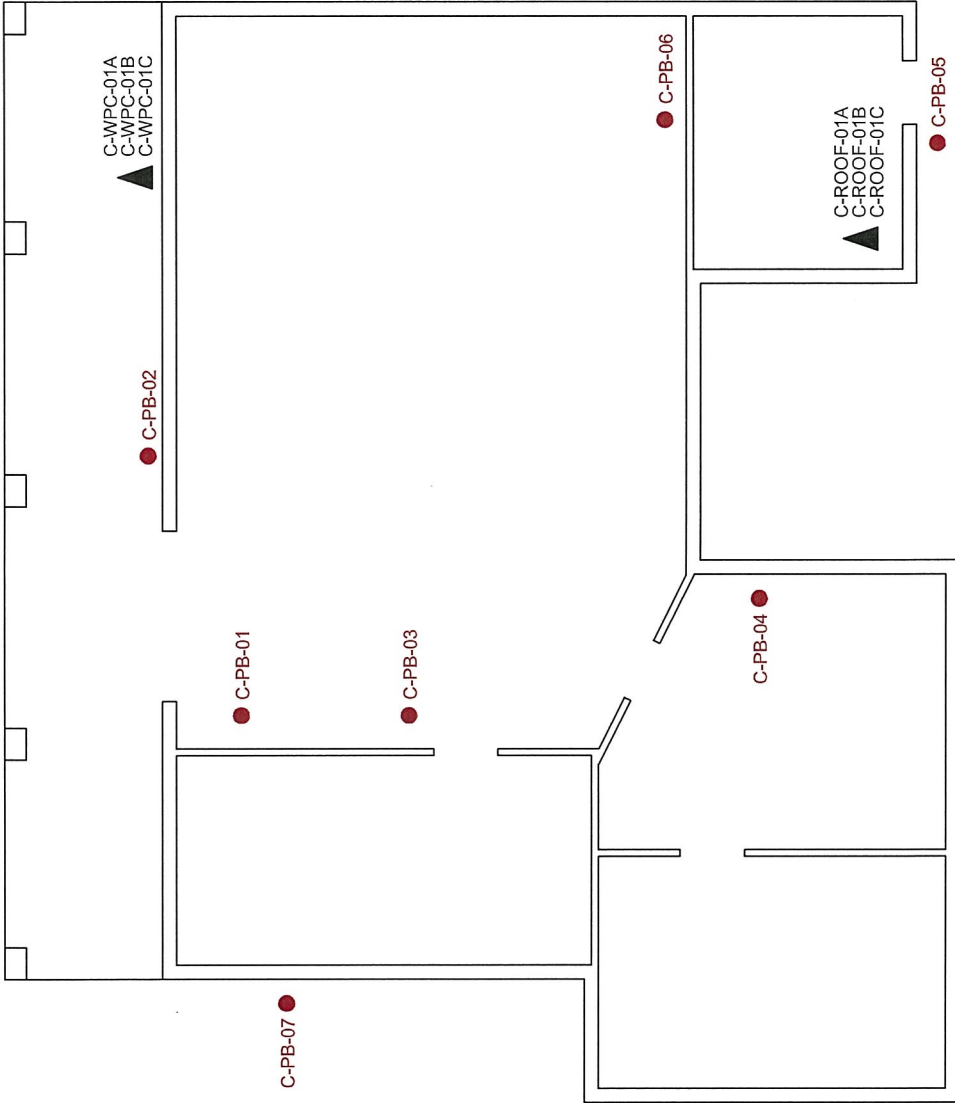
CANTEEN (C)

LEGEND
 ▲ BULK SAMPLE LOCATION
 ● PAINT CHIP SAMPLE LOCATION

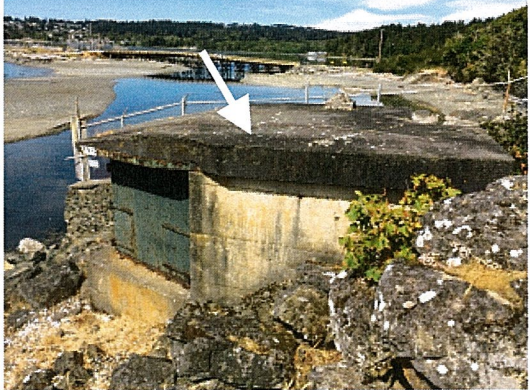
Identified ACM Description and Condition Information		Photo
Black roofing material

Friability	Non-friable	
Condition	Good	
Content	4.3% Chrysotile

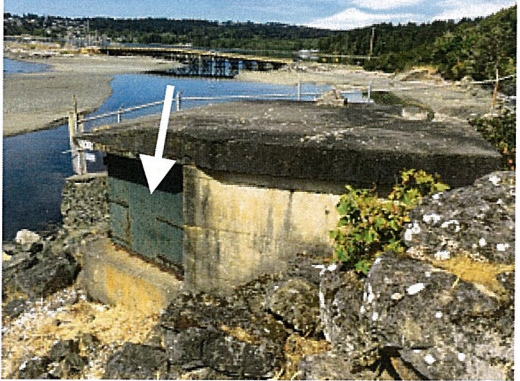
Identified LCP Description	Photo
Dark green coloured paint on the steel shutters. This paint was observed to be in good condition (not bubbling, flaking or peeling).

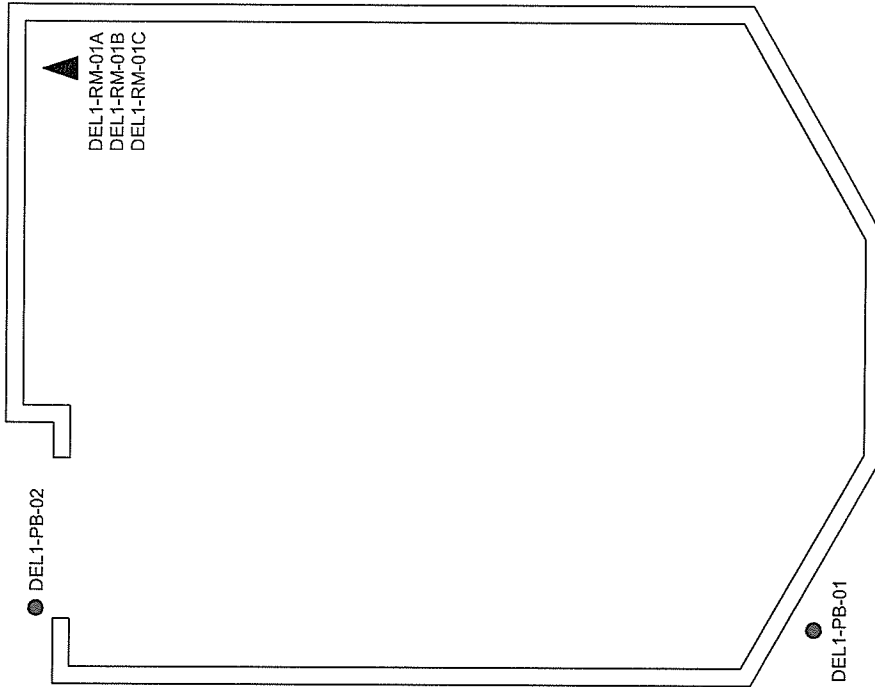
Project No.: 123220330.400		Dwg. No.:	20	Stantec
Scale:	N.T.S.			
Date:	15/10/29			
Dwn. By:	CD VM/DM			
App'd By:	TW			
FLOOR PLAN SHOWING HAZARDOUS BUILDING MATERIALS AND BULK SAMPLE LOCATIONS FORT RODD HILL AND FIGGARD LIGHTHOUSE NATIONAL HISTORIC SITES, VICTORIA 603 FORT RODD HILL ROAD, VICTORIA, BC PUBLIC WORKS AND GOVERNMENT SERVICES CANADA				
Client:

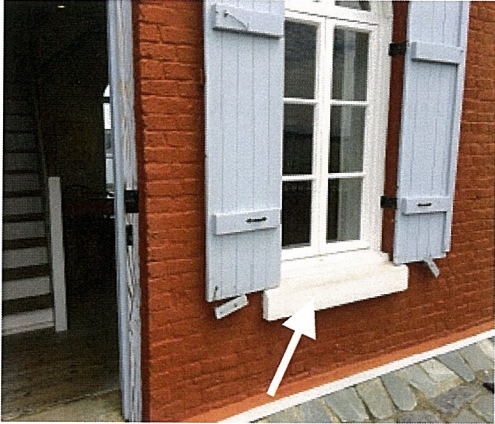
Identified LCP Description	Photo
<p>White coloured paint on the exterior window sills of the Lighthouse. This paint was observed to be in good condition (not bubbling, flaking or peeling).</p>

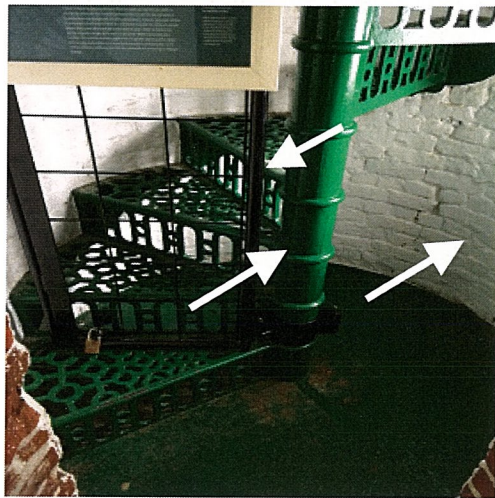
<p>Black coloured paint on the tower staircase cage (upper arrow). This paint was observed to be in good condition (not bubbling, flaking or peeling).</p> <p>Green coloured paint on the tower staircase (middle arrow). This paint was observed to be in good condition (not bubbling, flaking or peeling).</p> <p>White coloured paint on the interior walls of tower staircase (lower arrow). This paint was observed to be in good condition (not bubbling, flaking or peeling).</p>

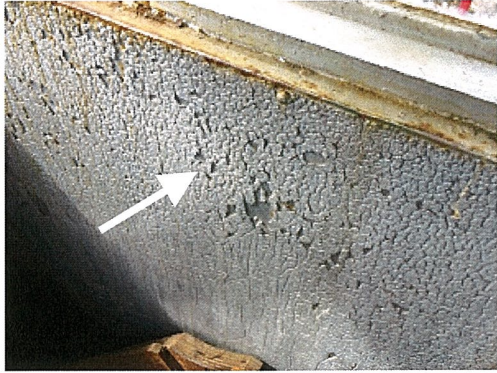
Identified LCP Description	Photo
<p>Silver coloured paint on the interior steel panel of upper tower.</p> <p>This paint was observed to be in good condition overall, with localized areas of flaking.</p>

Lead-containing paint observed in fair condition throughout the upper tower should be cleaned-up and/or addressed to mitigate potential for additional deterioration and dispersal of lead-containing paint chips/dust. Consideration should be given to re-painting surfaces to mitigate the potential for additional deterioration and hazards associated with the lead-containing paint chips/dust that may be created. If re-painting is completed, appropriate precautions to protect workers and work areas from exposure to lead will be required during painting preparation activities.

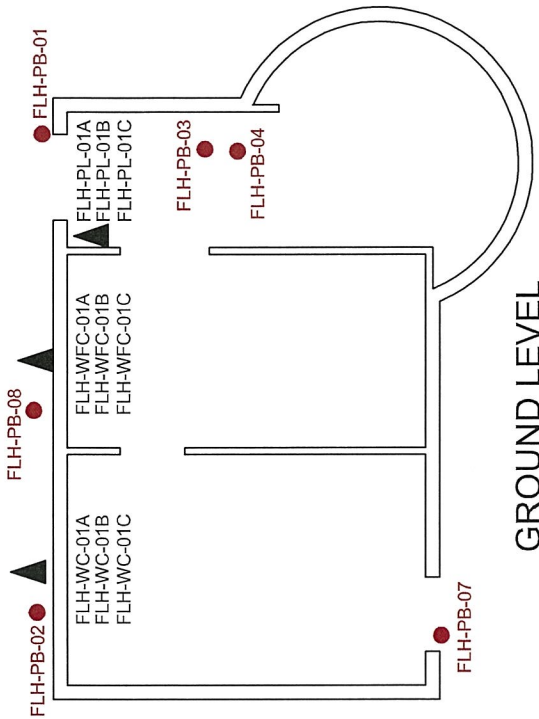
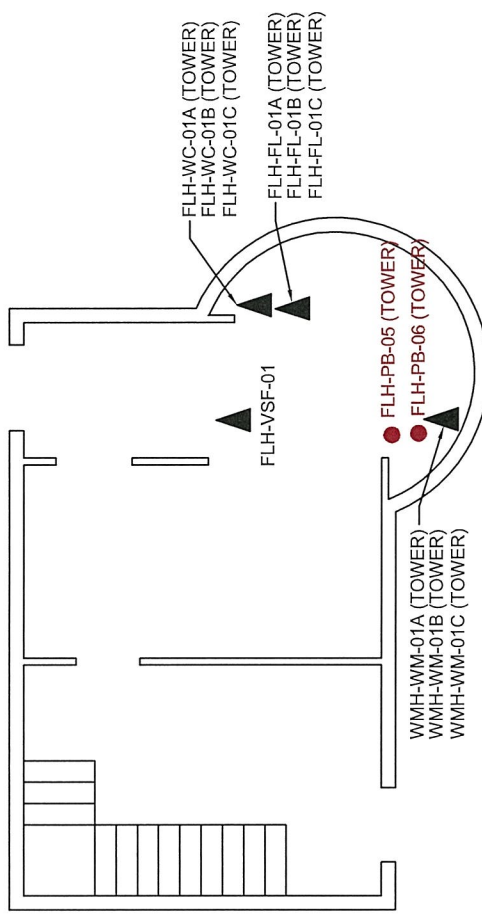
FIGGARD LIGHTHOUSE (FL)

GROUND LEVEL

UPPER TOWER

FLOOR PLAN SHOWING HAZARDOUS BUILDING MATERIALS AND BULK SAMPLE LOCATIONS FORT RODD HILL AND FIGGARD LIGHTHOUSE NATIONAL HISTORIC SITES, VICTORIA 603 FORT RODD HILL ROAD, VICTORIA, BC PUBLIC WORKS AND GOVERNMENT SERVICES CANADA	Project No.: 123220330.400	Dwg. No.: 5	
	Scale: N.T.S.	App'd By: TW	
	Date: 16/03/23	Client:	
	Dwn. By: CD VM/DM

Floor plan drawings, which include locations of the samples collected during this assessment and locations of identified hazardous building materials (where practical), are attached to this Appendix.

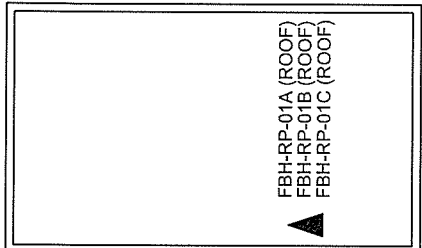
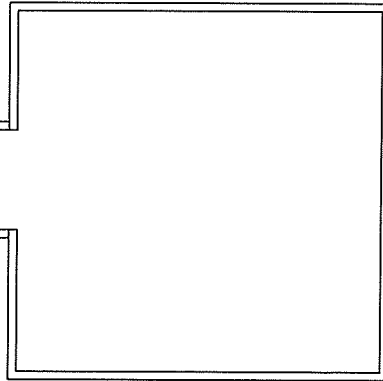
FIGGARD BOAT HOUSE

FIGGARD STORE HOUSE

Project No.: 123220330.400		Dwg. No.:	6	Stantec
Scale:	N.T.S.			
Date:	16/03/23			
Dwn. By:	CD VM/DM			
App'd By:	TW			
FLOOR PLAN SHOWING HAZARDOUS BUILDING MATERIALS AND BULK SAMPLE LOCATIONS FORT RODD HILL AND FIGGARD LIGHTHOUSE NATIONAL HISTORIC SITES, VICTORIA 603 FORT RODD HILL ROAD, VICTORIA, BC PUBLIC WORKS AND GOVERNMENT SERVICES CANADA				
Client:

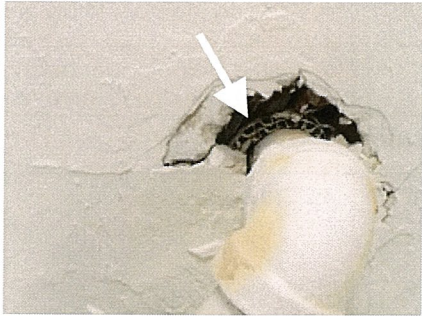
Identified ACM Description and Condition Information		Photo
Grey straight air-o-cell pipe insulation throughout the basement computer room ceiling space

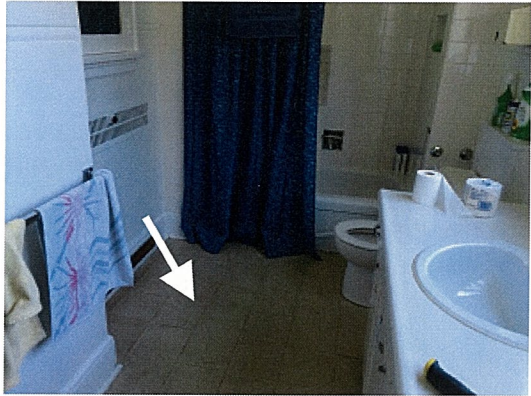
Friability	Friable	
Condition	Good	
Content	40% Chrysotile	
9"x9" vinyl floor tile (tan with brown) in the 2 nd level west and east bathrooms

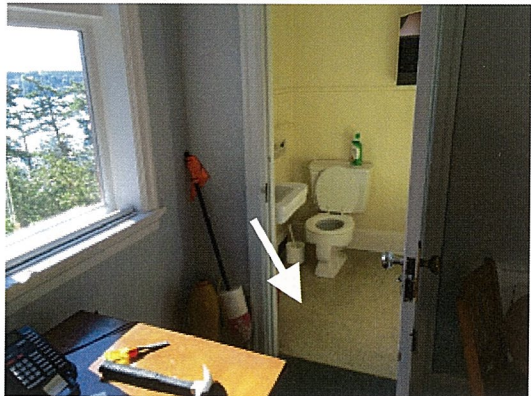
Friability	Non-friable	
Condition	Good	
Content	10% Chrysotile	
Tan vinyl sheet flooring in the 2 nd level west bathroom

Friability	Non-friable in-situ (paper backing can become friable during removal)	
Condition	Good	
Content	4.3% Chrysotile

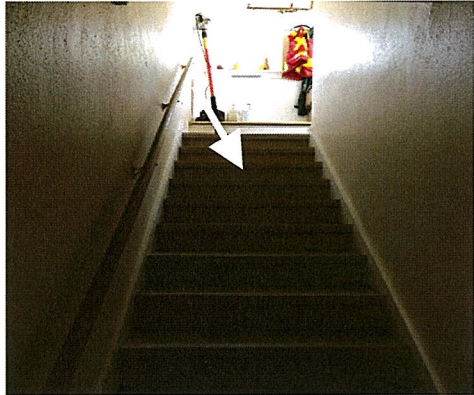
Identified ACM Description and Condition Information		Photo
Tan vinyl sheet flooring on the stairs to basement

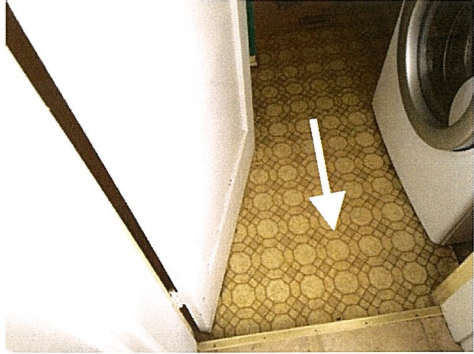
Friability	Non-friable in-situ (paper backing can become friable during removal)	
Condition	Good	
Content	1.4% Chrysotile	
Yellow vinyl sheet flooring in basement of laundry room

Friability	Non-friable in-situ (paper backing can become friable during removal)	
Condition	Good	
Content	14.5% Chrysotile

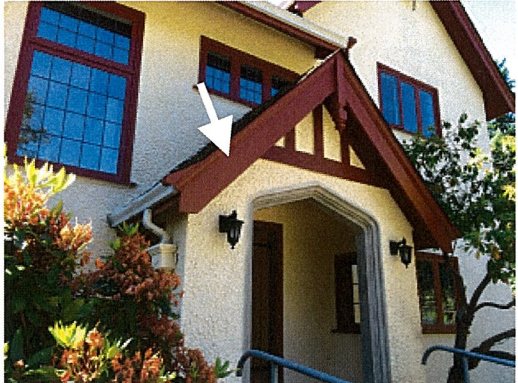
Identified LCP Description	Photo
<p>Red coloured paint on exterior trim (potential LCP – not enough paint available to achieve detection limit <600 ppm).</p> <p>This paint was observed to be in good condition (not bubbling, flaking or peeling).</p>

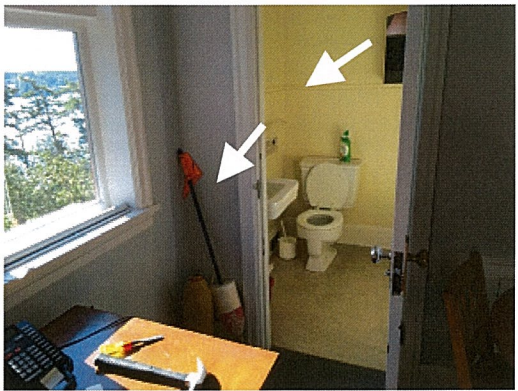
<p>White coloured paint on 2nd level west bathroom walls and trims (top arrow).</p> <p>This paint was observed to be in good condition (not bubbling, flaking or peeling).</p> <p>Grey colored paint on walls of office #2 (bottom arrow).</p> <p>This paint was observed to be in good condition (not bubbling, flaking or peeling).</p>

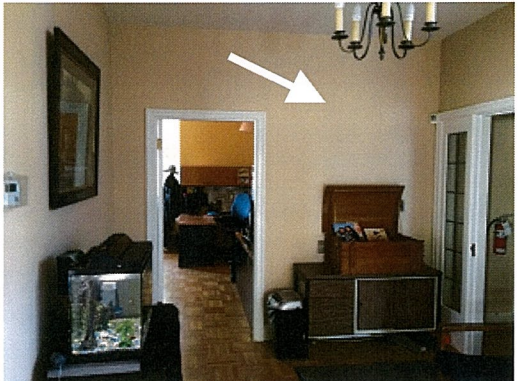
<p>Tan coloured paint on walls in main lobby.</p> <p>This paint was observed to be in good condition (not bubbling, flaking or peeling).</p>

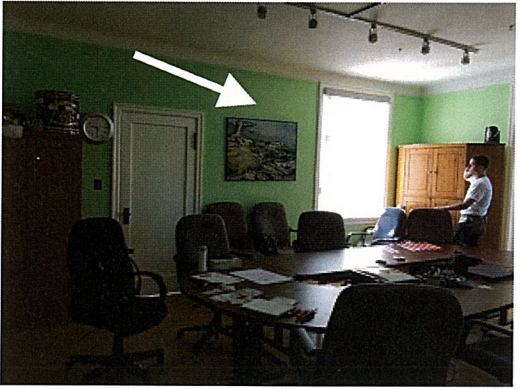
Identified LCP Description	Photo
<p>Pink colored paint on walls in room #104 . This paint was observed to be in good condition (not bubbling, flaking or peeling).</p>	 
<p>Green colored paint on walls in room #105. This paint was observed to be in good condition (not bubbling, flaking or peeling).</p>

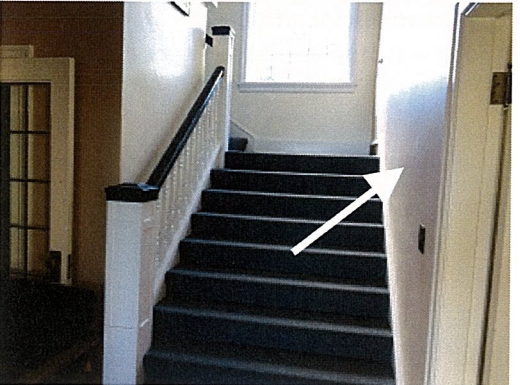
<p>White colored paint on walls by east stairs and throughout upper level corridor. This paint was observed to be in good condition (not bubbling, flaking or peeling).</p>

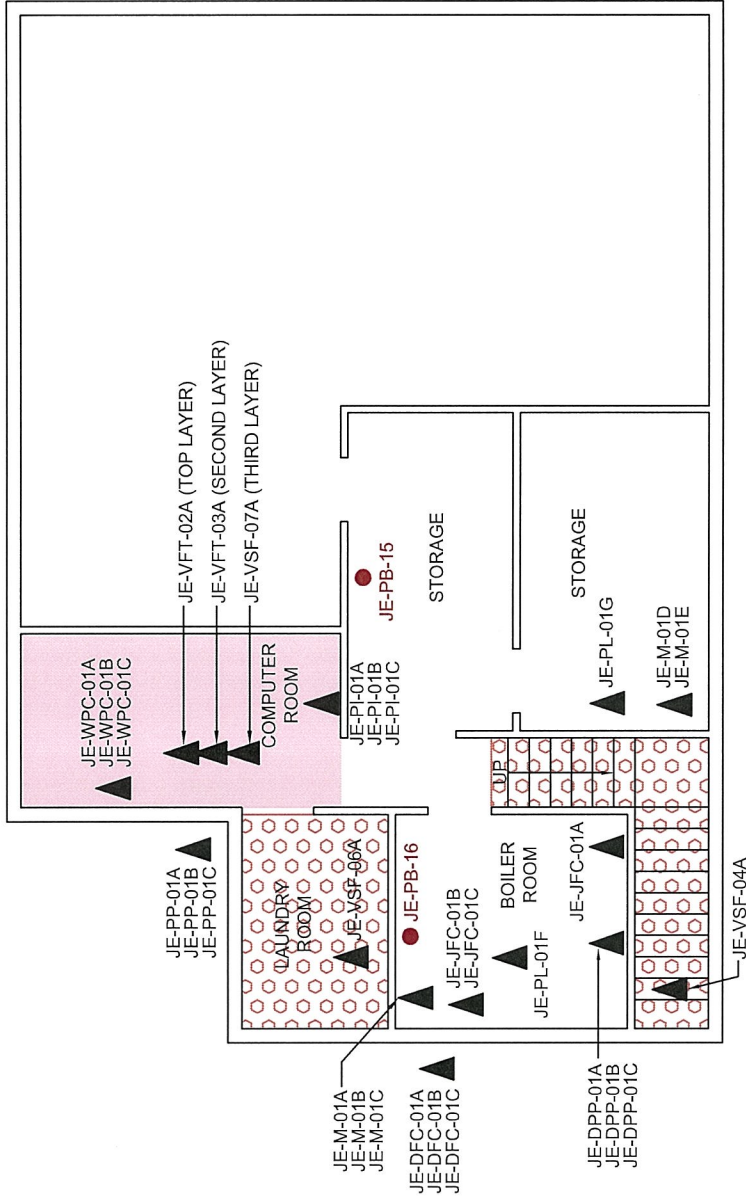
JOURNEY'S END (BASEMENT)

Project No.: 123220330.400		Dwg. No.:	7	
Scale:	N.T.S.			
Date:	16/03/19			
Dwn. By:	CD VM/DM			
App'd By:	TW			
FLOOR PLAN SHOWING HAZARDOUS BUILDING MATERIALS AND BULK SAMPLE LOCATIONS FORT RODD HILL AND FISGARD LIGHTHOUSE NATIONAL HISTORIC SITES, VICTORIA 603 FORT RODD HILL ROAD, VICTORIA, BC PUBLIC WORKS AND GOVERNMENT SERVICES CANADA				
Client:

Floor plan drawings, which include locations of the samples collected during this assessment and locations of identified hazardous building materials (where practical), are attached to this Appendix.

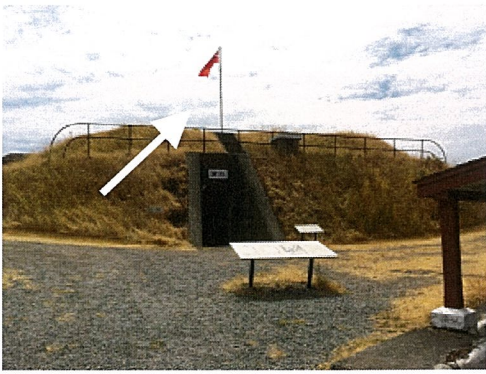
Identified LCP Description	Photo
<p>General Lower Battery - white coloured paint on the flag pole. This paint was observed to be in good condition (not bubbling, flaking or peeling).</p>

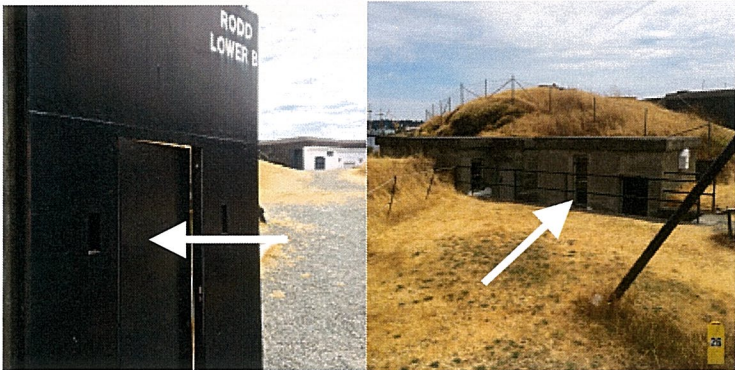
<p>General Lower Battery - black coloured paint on the main gate, railings, and gates throughout. This paint was observed to be in good condition (not bubbling, flaking or peeling).</p>

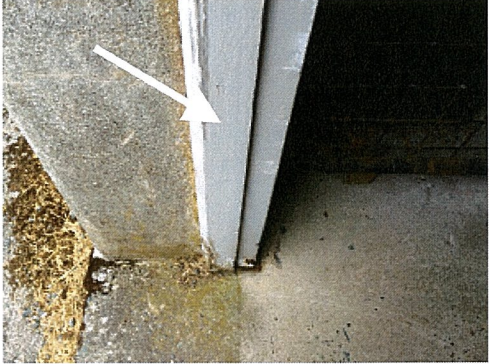
Identified LCP Description	Photo
<p>Artillery and Small Arms Ammunition Store - grey colored paint on the trims throughout.</p> <p>This paint was observed to be in good condition (not bubbling, flaking or peeling).</p>

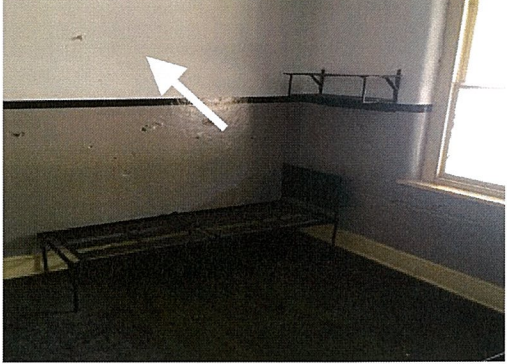
<p>Guardhouse - white colored paint on the interior walls throughout.</p> <p>This paint was observed to be in good condition (not bubbling, flaking or peeling).</p>

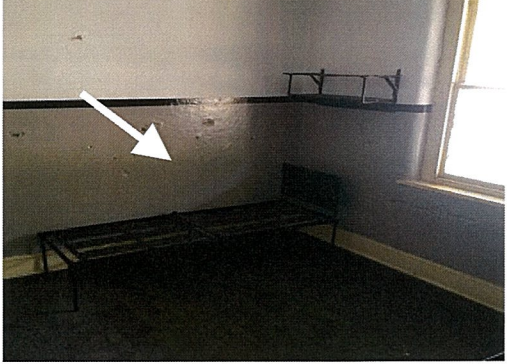
<p>Guardhouse - grey coloured paint on the lower walls throughout.</p> <p>This paint was observed to be in good condition (not bubbling, flaking or peeling).</p>

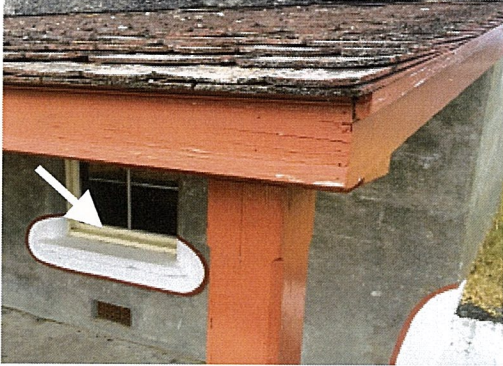
Identified LCP Description	Photo
<p>Guardhouse - yellow coloured paint on the window frames throughout.</p> <p>This paint was observed to be in good condition (not bubbling, flaking or peeling).</p>

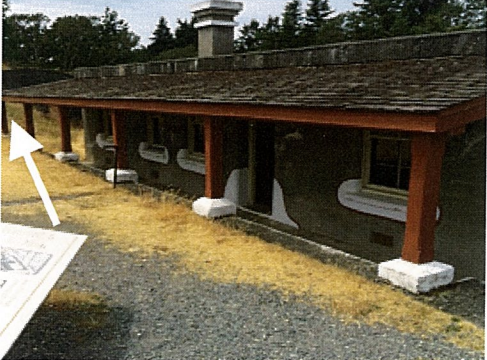
<p>Guardhouse - red coloured paint on the exterior trim throughout.</p> <p>This paint was observed to be in good condition (not bubbling, flaking or peeling).</p>

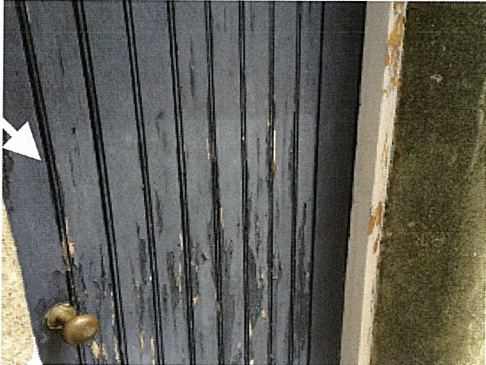
<p>Guardhouse - blue coloured paint on the doors throughout.</p> <p>This paint was observed to be in good condition (not bubbling, flaking or peeling).</p>

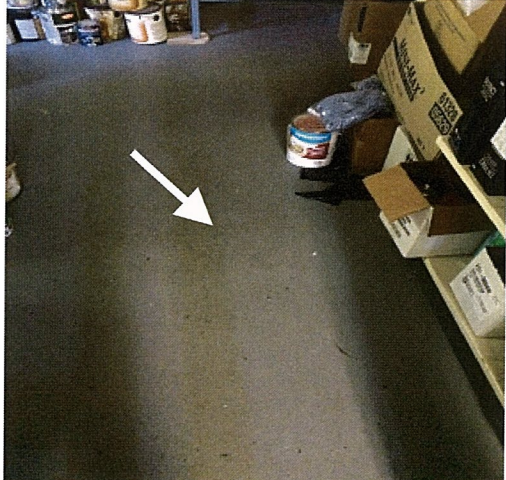
Identified LCP Description	Photo
<p>Grey colored paint on the interior floor throughout FRH2. This paint was observed to be in good condition (not bubbling, flaking or peeling).</p>

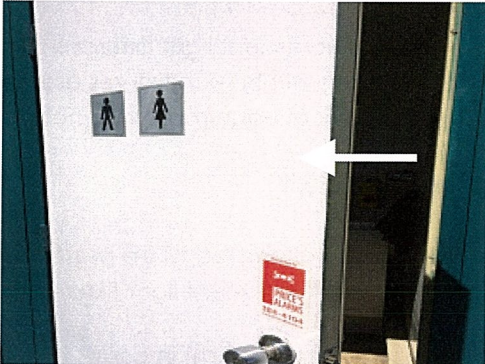
A photograph of an interior floor. The floor is a dark grey color. A white arrow points to the floor surface. In the background, there are cardboard boxes and a paint bucket.
<p>White coloured paint on the exterior doors of FRH2. This paint was observed to be in good condition (not bubbling, flaking or peeling).</p>

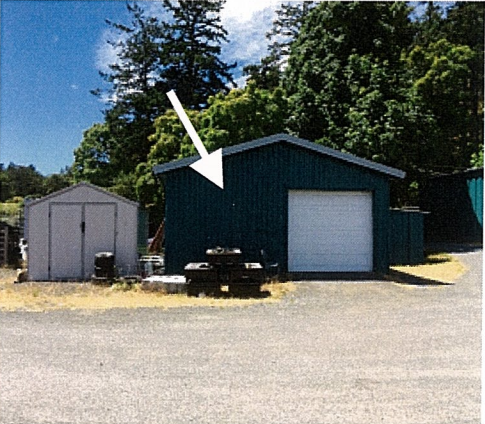
A photograph of an exterior door. The door is white. A white arrow points to the door. There are signs on the door, including a red sign that says "PRICES VARYING FROM \$1.99 TO \$2.99".
<p>Teal coloured paint on the corrugated siding throughout the exterior of FRH3. This paint was observed to be in good condition (not bubbling, flaking or peeling).</p>

A photograph of the exterior of a building. The building has teal-colored corrugated siding. A white arrow points to the siding. There is a white door on the building.

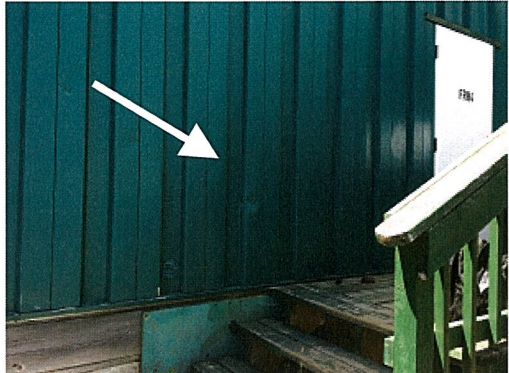
Identified LCP Description	Photo
<p>Green coloured paint on the corrugated siding throughout exterior of FRH4. This paint was observed to be in good condition (not bubbling, flaking or peeling).</p>

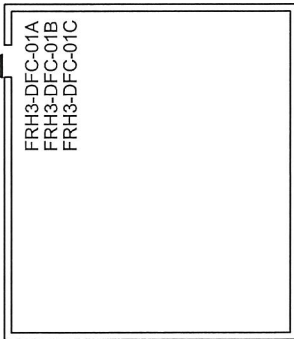
MAINTENANCE FACILITIES

Project No.: 123220330.400		Dwg. No.: 11	
Scale:	N.T.S.		
Date:	15/10/29		
Dwn. By:	CD vmi/dm		
App'd By:	TW		
FLOOR PLAN SHOWING HAZARDOUS BUILDING MATERIALS AND BULK SAMPLE LOCATIONS FORT RODD HILL AND FIGGARD LIGHTHOUSE NATIONAL HISTORIC SITES, VICTORIA 603 FORT RODD HILL ROAD, VICTORIA, BC			
Client:		PUBLIC WORKS AND GOVERNMENT SERVICES CANADA

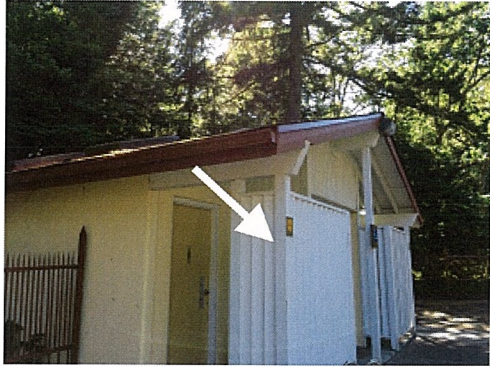
**Table N-3 Summary of Identified LCPs
Parking Lot Washroom, Fort Rodd Hill National Historic Site, BC**

Identified LCP Description	Photo
White colored paint on the exterior trims. This paint was observed to be in good condition (not bubbling, flaking or peeling).

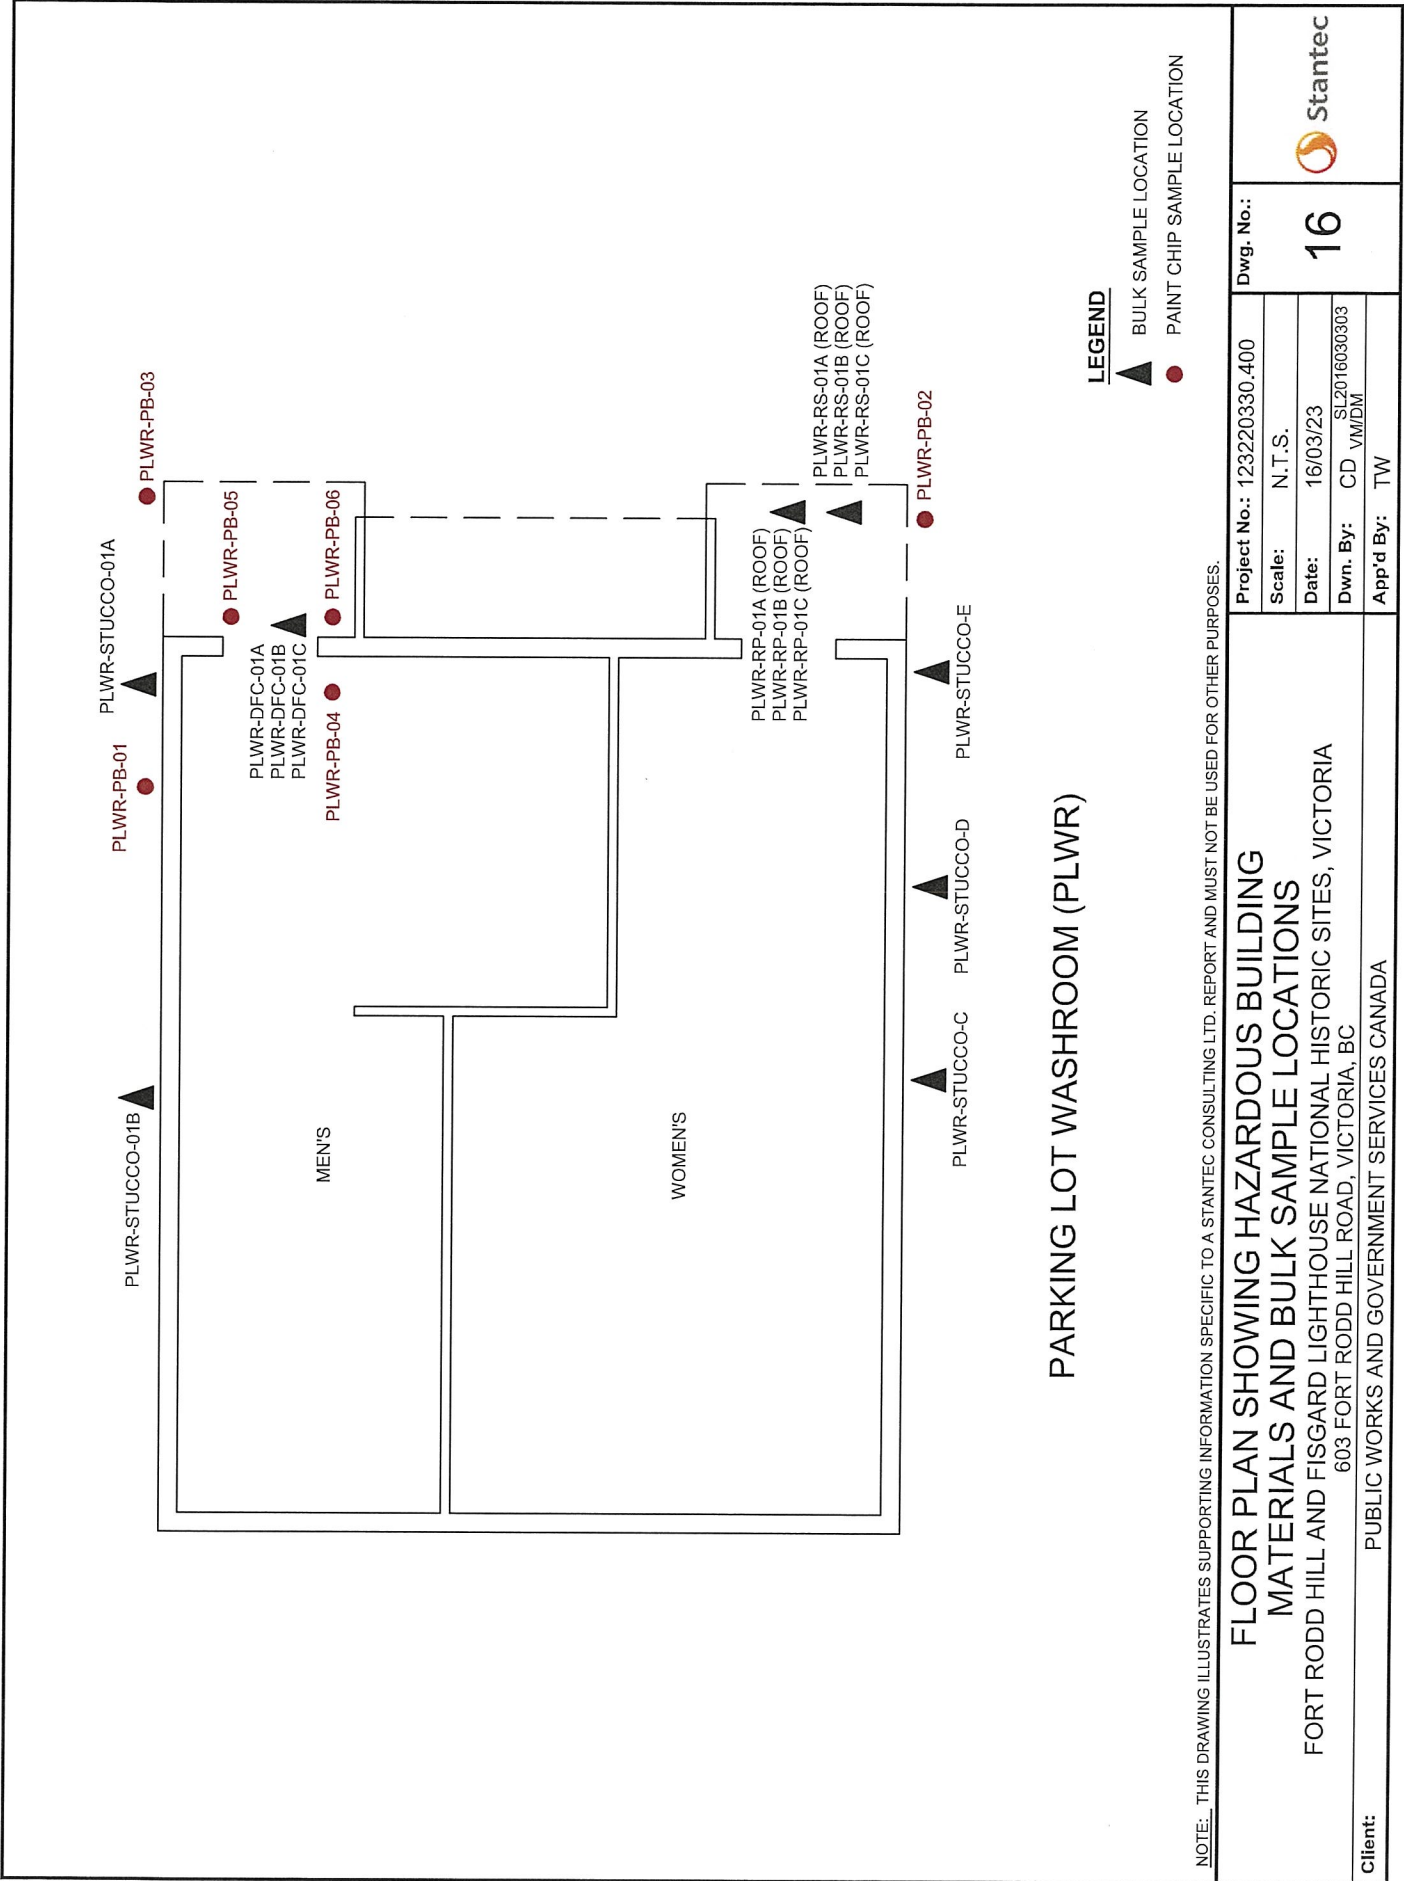
PARKING LOT WASHROOM (PLWR)

Project No.: 123220330.400		Dwg. No.:	16	Stantec
Scale:	N.T.S.			
Date:	16/03/23			
Dwn. By:	CD VM/DM			
App'd By:	TW			
FLOOR PLAN SHOWING HAZARDOUS BUILDING MATERIALS AND BULK SAMPLE LOCATIONS FORT RODD HILL AND FISGARD LIGHTHOUSE NATIONAL HISTORIC SITES, VICTORIA 603 FORT RODD HILL ROAD, VICTORIA, BC Client: PUBLIC WORKS AND GOVERNMENT SERVICES CANADA

Floor plan drawings, which include locations of the samples collected during this assessment and locations of identified hazardous building materials (where practical), are attached to this Appendix.

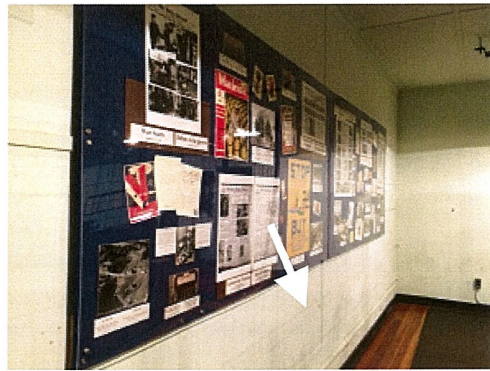
Identified LCP Description	Photo
<p>Light blue coloured paint on the east wall of the plotting room.</p> <p>This paint was observed to be in good condition (not bubbling, flaking or peeling).</p>

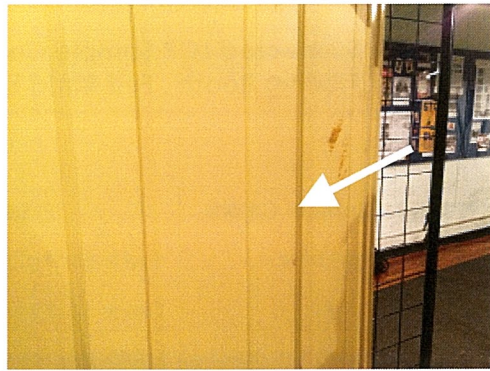
<p>Yellow coloured paint on the east wall of the north office.</p> <p>This paint was observed to be in good condition (not bubbling, flaking or peeling).</p>

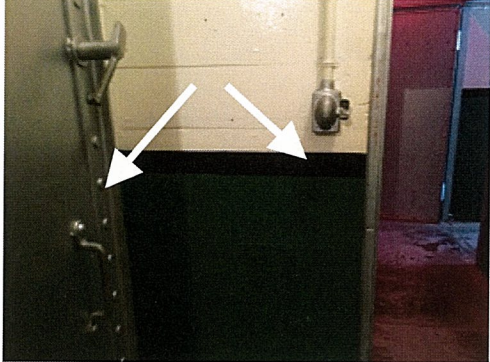
Identified LCP Description	Photo
<p>Silver coloured paint on the metal doors in corridor and on the exterior of the plotting room (left arrow). This paint was observed to be in good condition (not bubbling, flaking or peeling).</p> <p>Black coloured paint on the interior trims (right arrow). This paint was observed to be in good condition (not bubbling, flaking or peeling).</p>

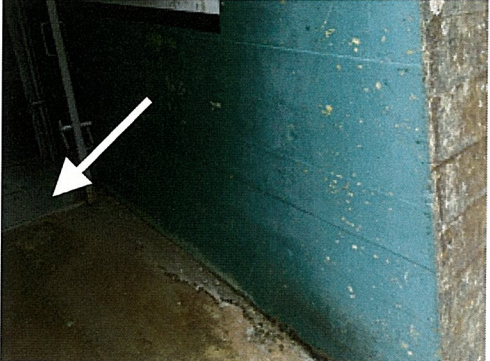
<p>Grey coloured paint on the floor at the entrance. This paint was observed to be in good condition (not bubbling, flaking or peeling).</p>

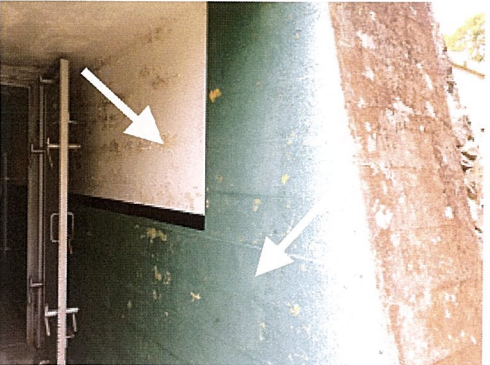
<p>Green coloured paint on the interior walls (right arrow). This paint was observed to be in good condition (not bubbling, flaking or peeling).</p> <p>White coloured paint on the exterior trim (left arrow). This paint was observed to be in good condition (not bubbling, flaking or peeling).</p>

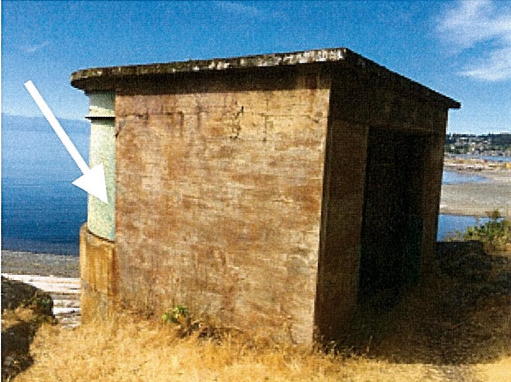
Identified LCP Description	Photo
<p>Green coloured paint on the exterior. This paint was observed to be in good condition (not bubbling, flaking or peeling).</p>

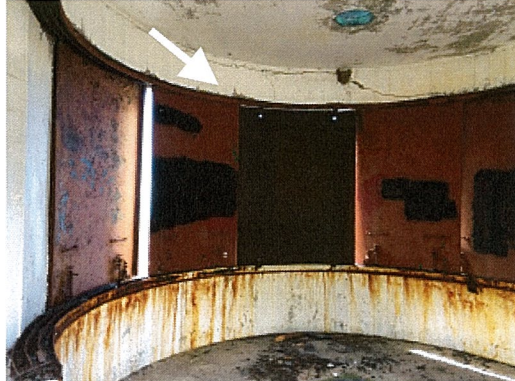
<p>White coloured paint on the interior. This paint was observed to be in good condition (not bubbling, flaking or peeling).</p>

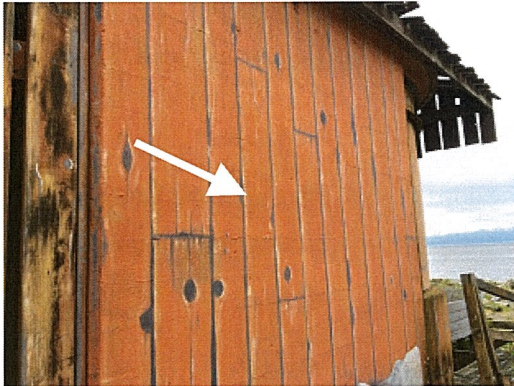
Identified LCP Description	Photo
<p>Red coloured paint on exterior walls. This paint was observed to be in good condition (not bubbling, flaking or peeling).</p>

A photograph of the exterior wall of a wooden building. The wall is covered in vertical wooden planks, many of which are painted a bright red color. A white arrow points to a specific spot on the red-painted plank.
<p>Grey coloured paint on interior walls. This paint was observed to be in good condition (not bubbling, flaking or peeling).</p>

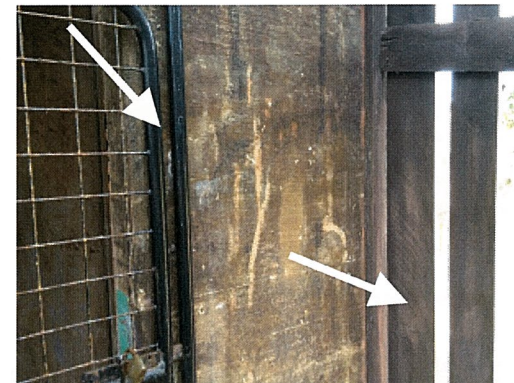
A photograph showing two different areas. On the left, a white arrow points to a black-painted steel cage. On the right, a white arrow points to a brown-painted wood canopy.

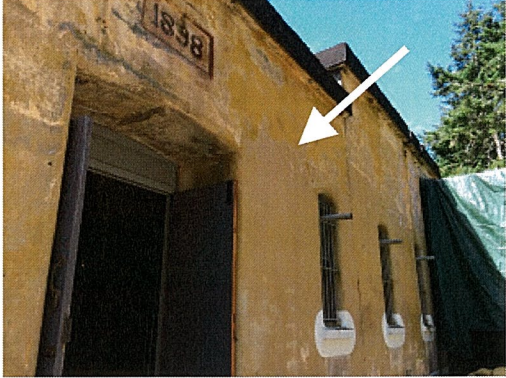
Identified LCP Description	Photo
<p>Orange colored paint on the exterior wall. This paint was observed to be in good condition (not bubbling, flaking or peeling).</p>

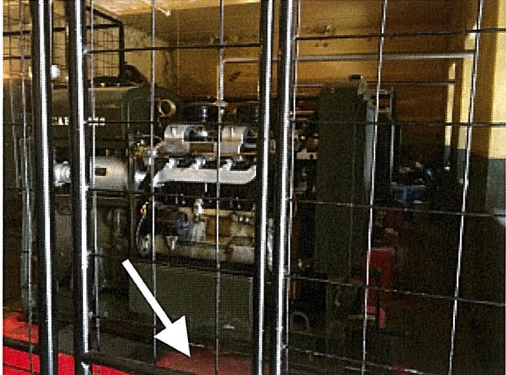
<p>Red colored paint on the floor inside caged engine room. This paint was observed to be in good condition (not bubbling, flaking or peeling).</p>

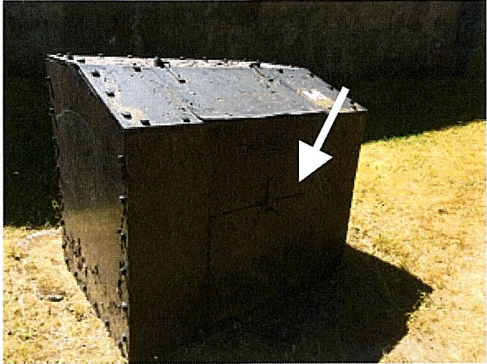
Identified LCP Description	Photo
<p>Black coloured paint on the garbage can outside main gate.</p> <p>This paint was observed to be in good condition (not bubbling, flaking or peeling).</p>

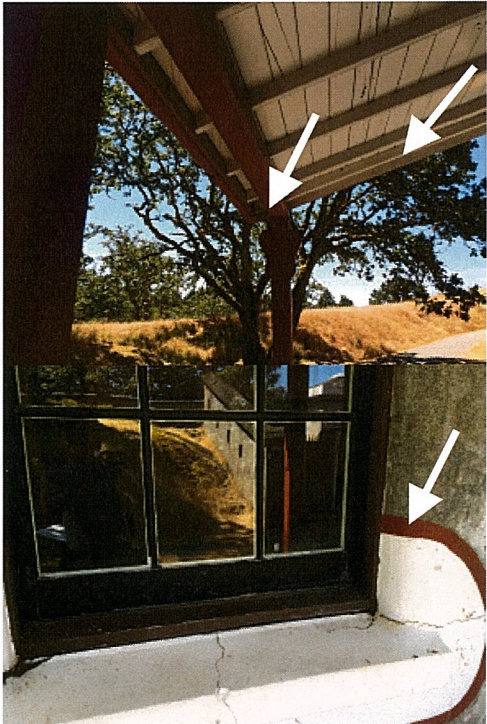
<p>Red coloured paint on the wood pillars and window sills throughout the Guardhouse.</p> <p>This paint was observed to be in good condition (not bubbling, flaking or peeling).</p>

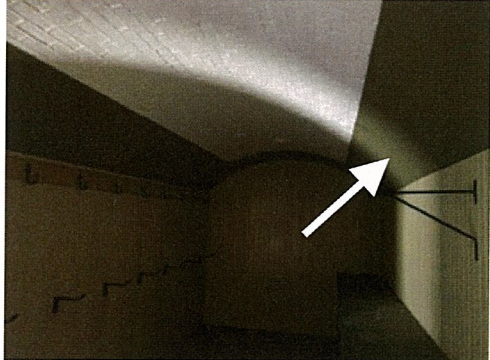
Identified LCP Description	Photo
<p>Green coloured paint on the interior ceiling trims throughout the Underground Magazine.</p> <p>This paint was observed to be in good condition (not bubbling, flaking or peeling).</p>

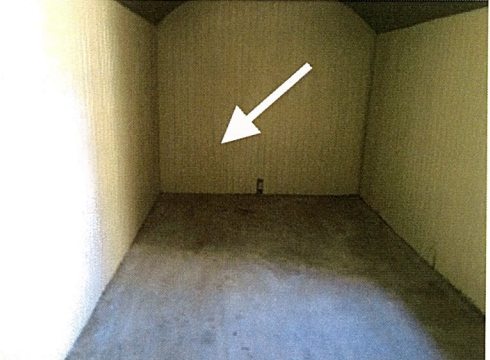
<p>Tan coloured paint on the interior walls throughout the Underground Magazine.</p> <p>This paint was observed to be in good condition (not bubbling, flaking or peeling).</p>

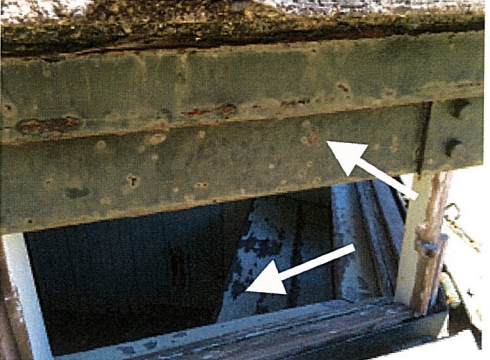
<p>Green coloured paint on the steel window frame of the Defensive Electrical Directing Station.</p> <p>This paint was observed to be in good condition (not bubbling, flaking or peeling).</p> <p>AND</p> <p>Light blue coloured paint on the interior walls of the Defensive Electrical Directing Station.</p> <p>This paint was observed to be in fair condition (flaking and peeling in some locations).</p>

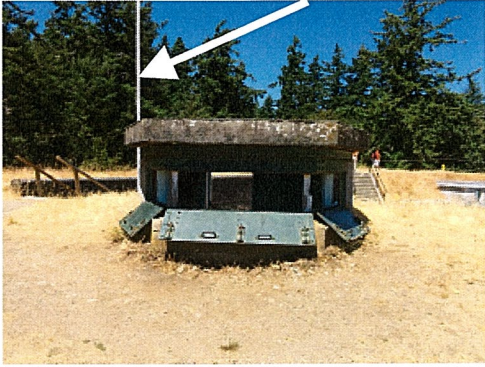
Identified LCP Description	Photo
<p>White coloured paint on the flag pole. This paint was observed to be in good condition (not bubbling, flaking or peeling).</p>

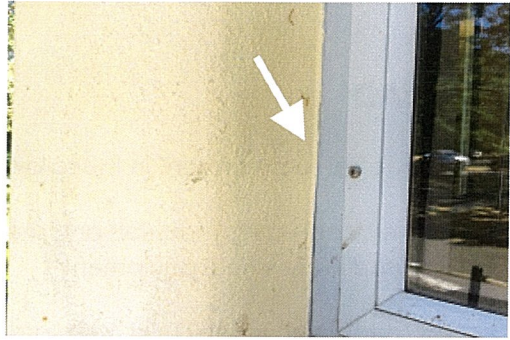
Identified ACM Description and Condition Information		Photo
Grey window frame caulking throughout

Friability	Non-friable	
Condition	Good	
Content	0.66% Chrysotile

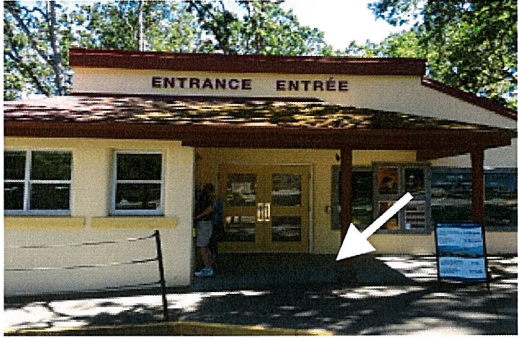
Identified ACM Description and Condition Information		Photo
Grey caulking on base of wood columns throughout

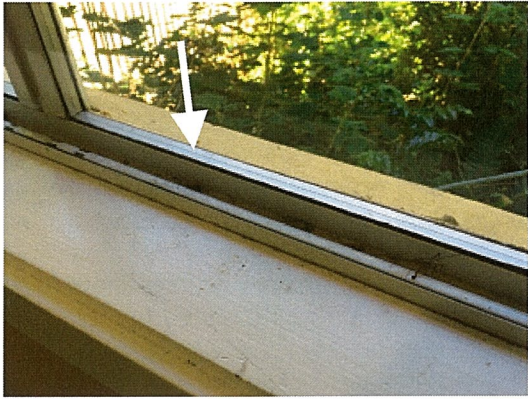
Friability	Non-friable	
Condition	Good	
Content	0.53% Chrysotile	
Black window pane caulking throughout.

Friability	Non-friable	
Condition	Good	
Content	0.81% Chrysotile

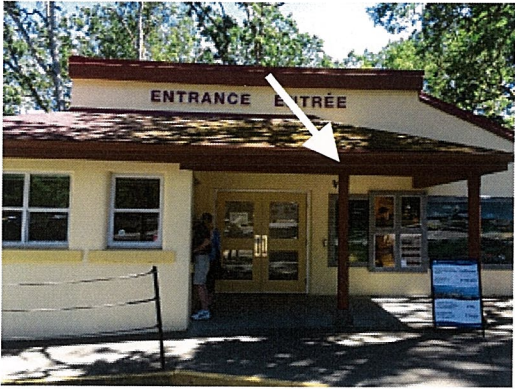
Identified LCP Description	Photo
Red coloured paint on the exterior trim and columns. This paint was observed to be in good condition (not bubbling, flaking or peeling).

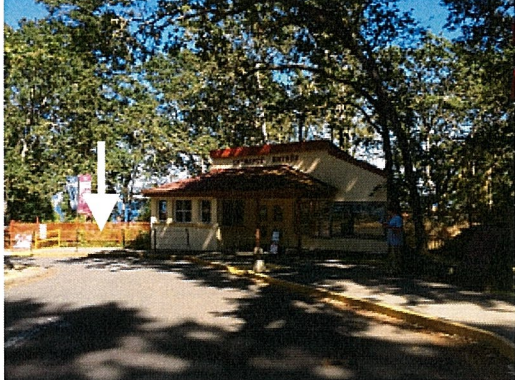
Identified LCP Description	Photo
<p>Red coloured paint on the steel fencing. This paint was observed to be in good condition (not bubbling, flaking or peeling).</p>

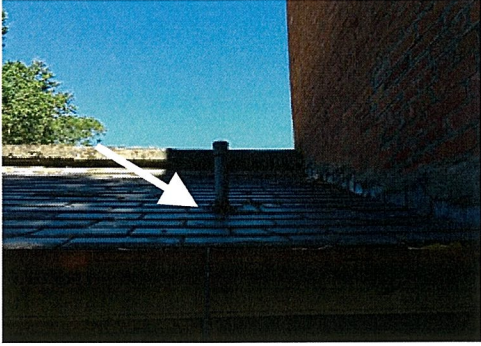
Identified ACM Description and Condition Information		Photo
Black mastic on the base of one (1) roof vent on north west side of the building

Friability	Non-friable	
Condition	Good	
Content	1.5% Chrysotile
