- .1 The work of the Contract comprises of the roof replacement, localized gutter replacement and localized repainting of various building at the Fort Rodd Hill National Historic Site, Victoria, BC.

Fort Rodd Hill – Roof Replacements
Project No.: R.081107.001
Issued for Tender – August 2016

**Hazardous Building
Materials Assessment**

31 Buildings/Structures at the Fort
Rodd Hill National Historic Site, BC

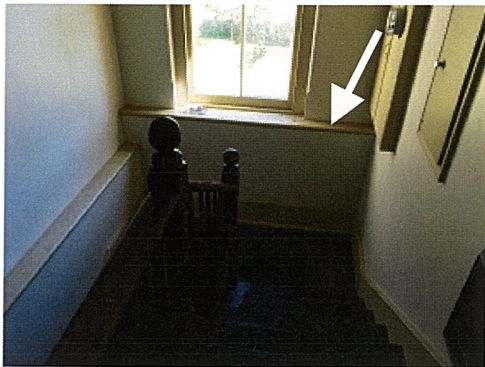
Identified LCP Description	Photo
Tan coloured paint on interior trim throughout. This paint was observed to be in good condition (not bubbling, flaking or peeling).

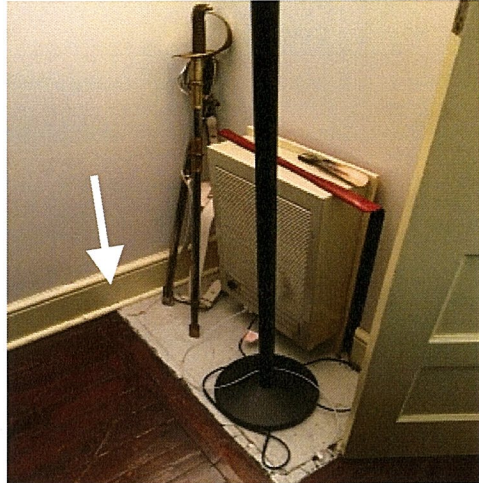
Identified LCP Description	Photo
<p>Yellow coloured paint on base boards throughout. This paint was observed to be in good condition (not bubbling, flaking or peeling).</p>

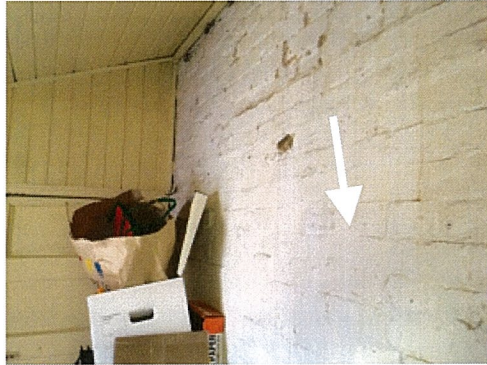
<p>White coloured paint on walls of the outhouse. This paint was observed to be in good condition (not bubbling, flaking or peeling).</p>

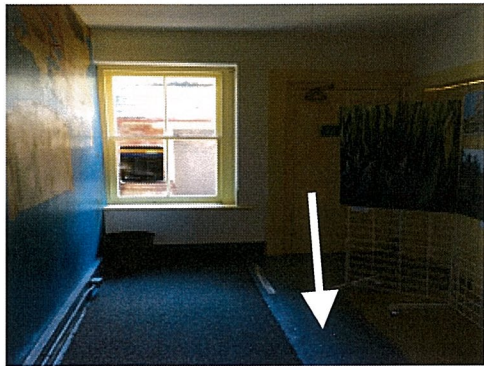
<p>Grey coloured paint on concrete floors throughout. This paint was observed to be in good condition (not bubbling, flaking or peeling).</p>

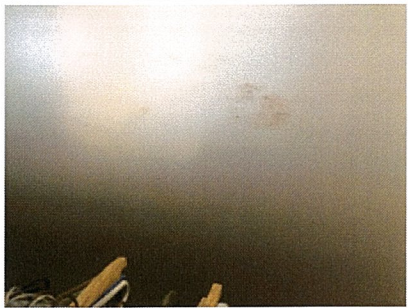
Building Area	Observation	Suspected Source of Moisture	Photo
Southeast bedroom	Localized spots of moisture staining on ceilings throughout the room – each comprising less than 1 square foot	Roof leaks

An intrusive mould assessment should be completed to assess the concealed conditions in the southwest bedroom ceiling space, and to assess for the potential source of moisture such that it can be corrected. In the interim, the ceilings in this area should be monitored for current moisture and/or mould growth. If mould growth is observed, more urgency should be placed on having the area assessed in support of abatement initiatives.

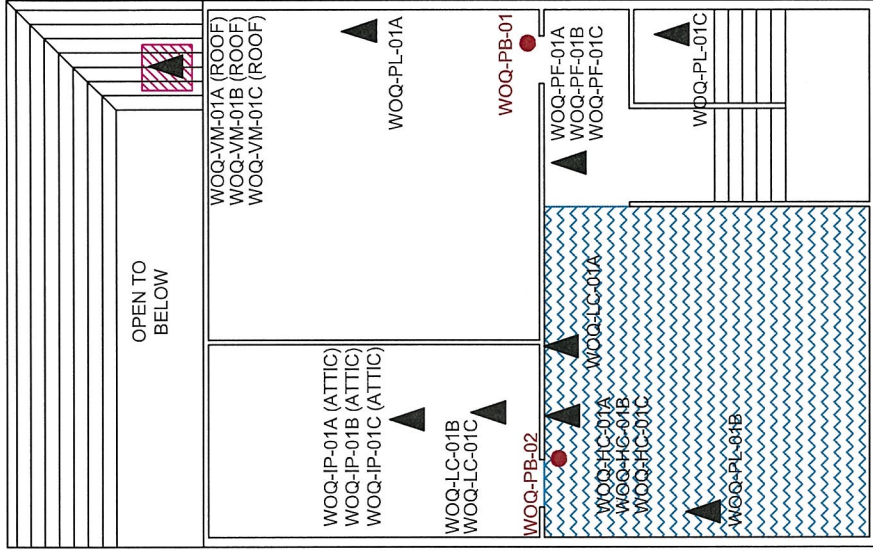
SECOND LEVEL

MAIN LEVEL

WARRANT'S OFFICER'S QUARTER (WOQ)

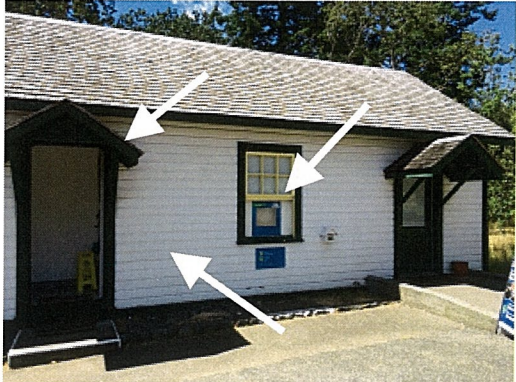
**Table V-3 Summary of Identified LCPs
WWII Hut/Visitors Orientation Centre, Fort Rodd Hill National Historic Site,
BC**

Identified LCP Description	Photo
<p>Green coloured paint on exterior trim and doors (top arrow).</p> <p>Yellow coloured paint on exterior window frame trim (middle arrow).</p> <p>White coloured paint on exterior wood paneling/siding (lower arrow).</p> <p>These paints were observed to be in good condition (not bubbling, flaking or peeling).</p>
