**Transport  
Canada**

**Mont-Joli Airport, Quebec  
Former Building H-3, Former Coal Depot and Former Landfill**

**Remediation Plan**

**Final Version**

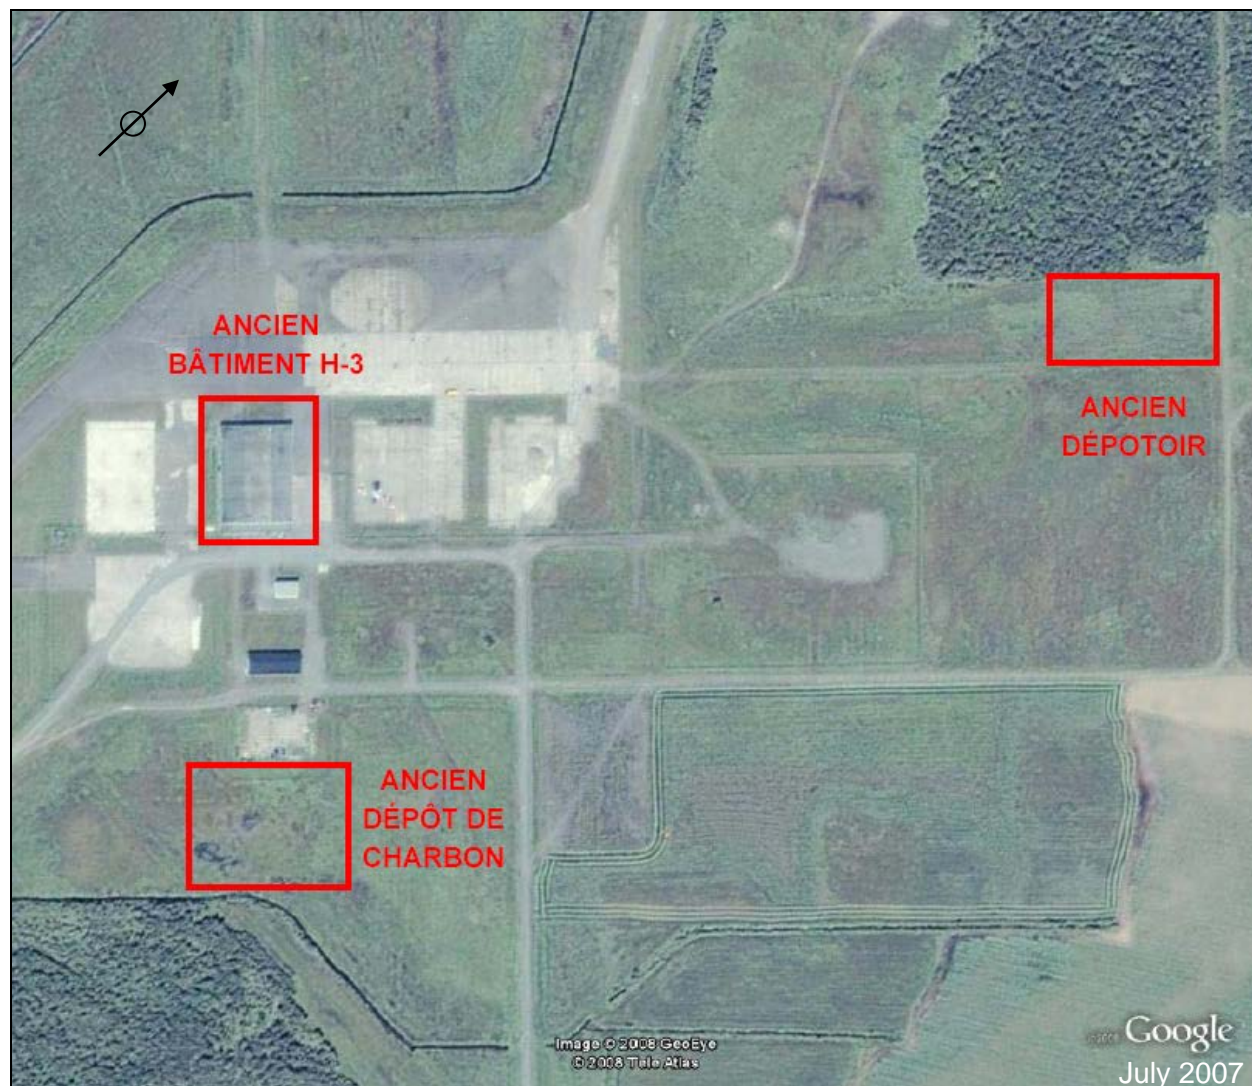
Figure 2.4 Aerial photograph of the area containing the sectors to be remediated

Note: Building H-3, visible in the photo, was demolished in 2008.

Table 2.1 provides details on the locations of the sectors to be remediated (see figures 2.1 to 2.4).

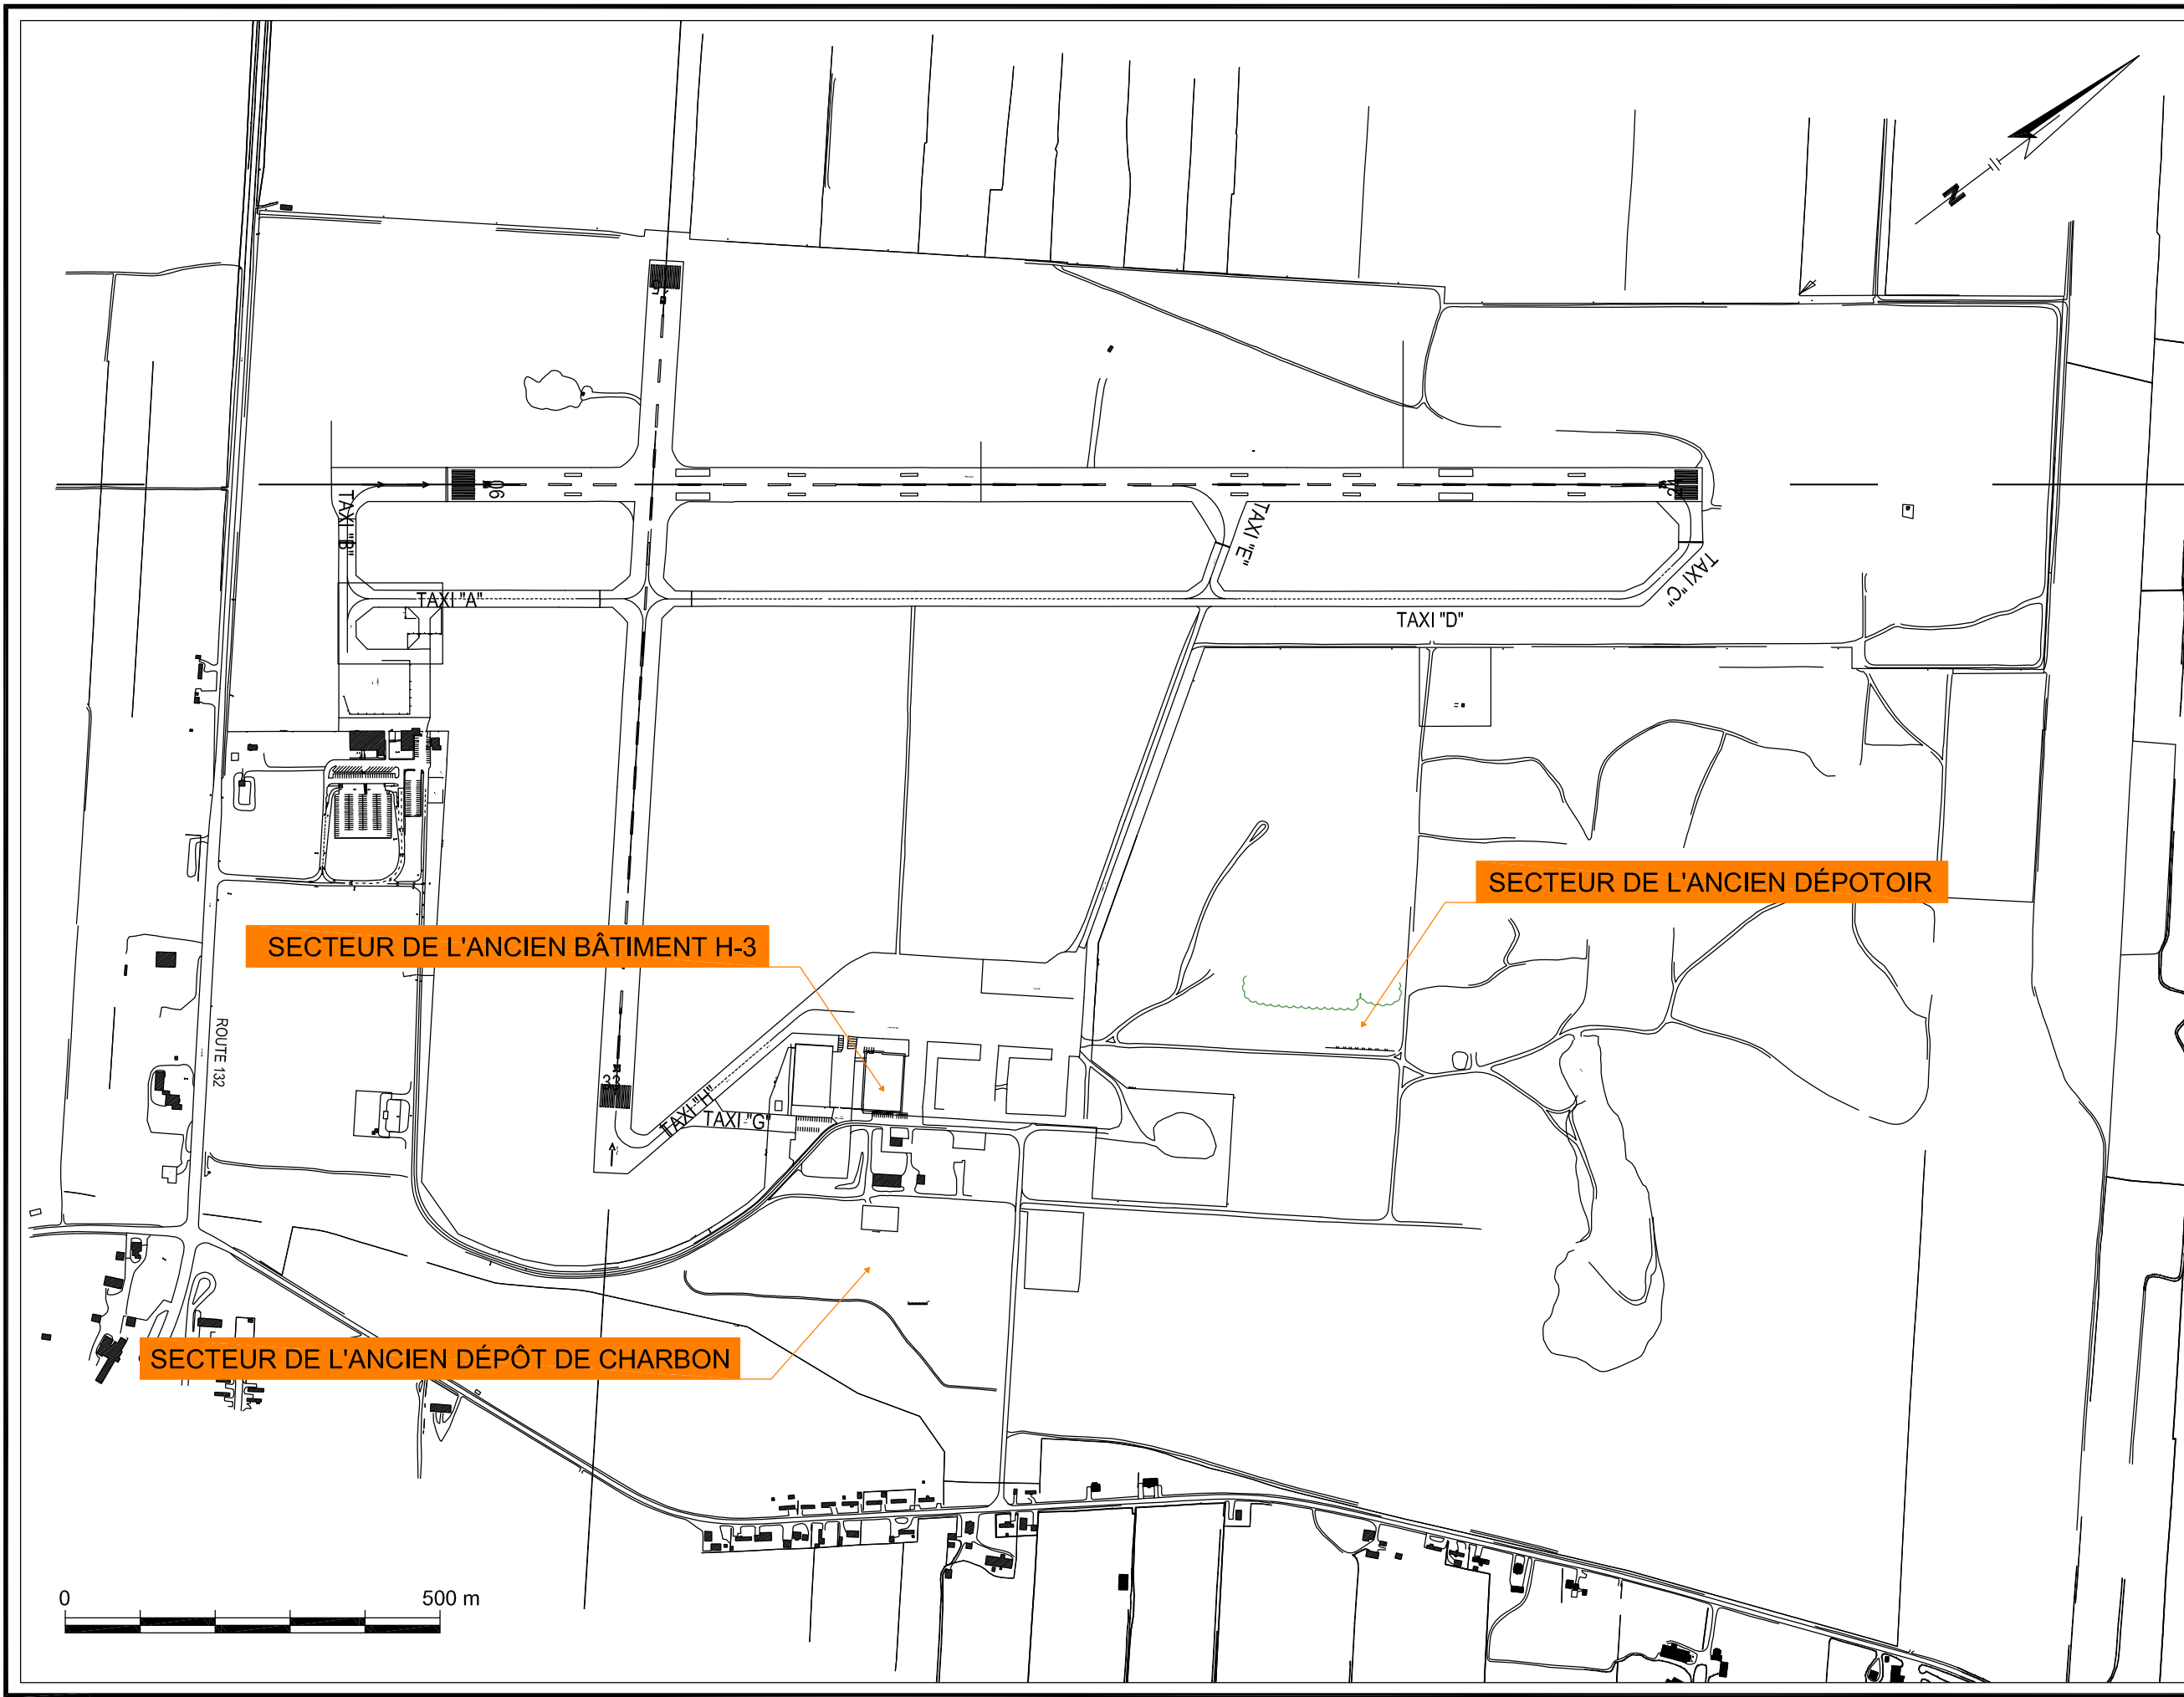
Figure 2.3 Global plan of the sectors the be remediated

Dessin / Drawing:  
**FIGURE 2.3**  
Plan d'ensemble des secteurs à réhabiliter

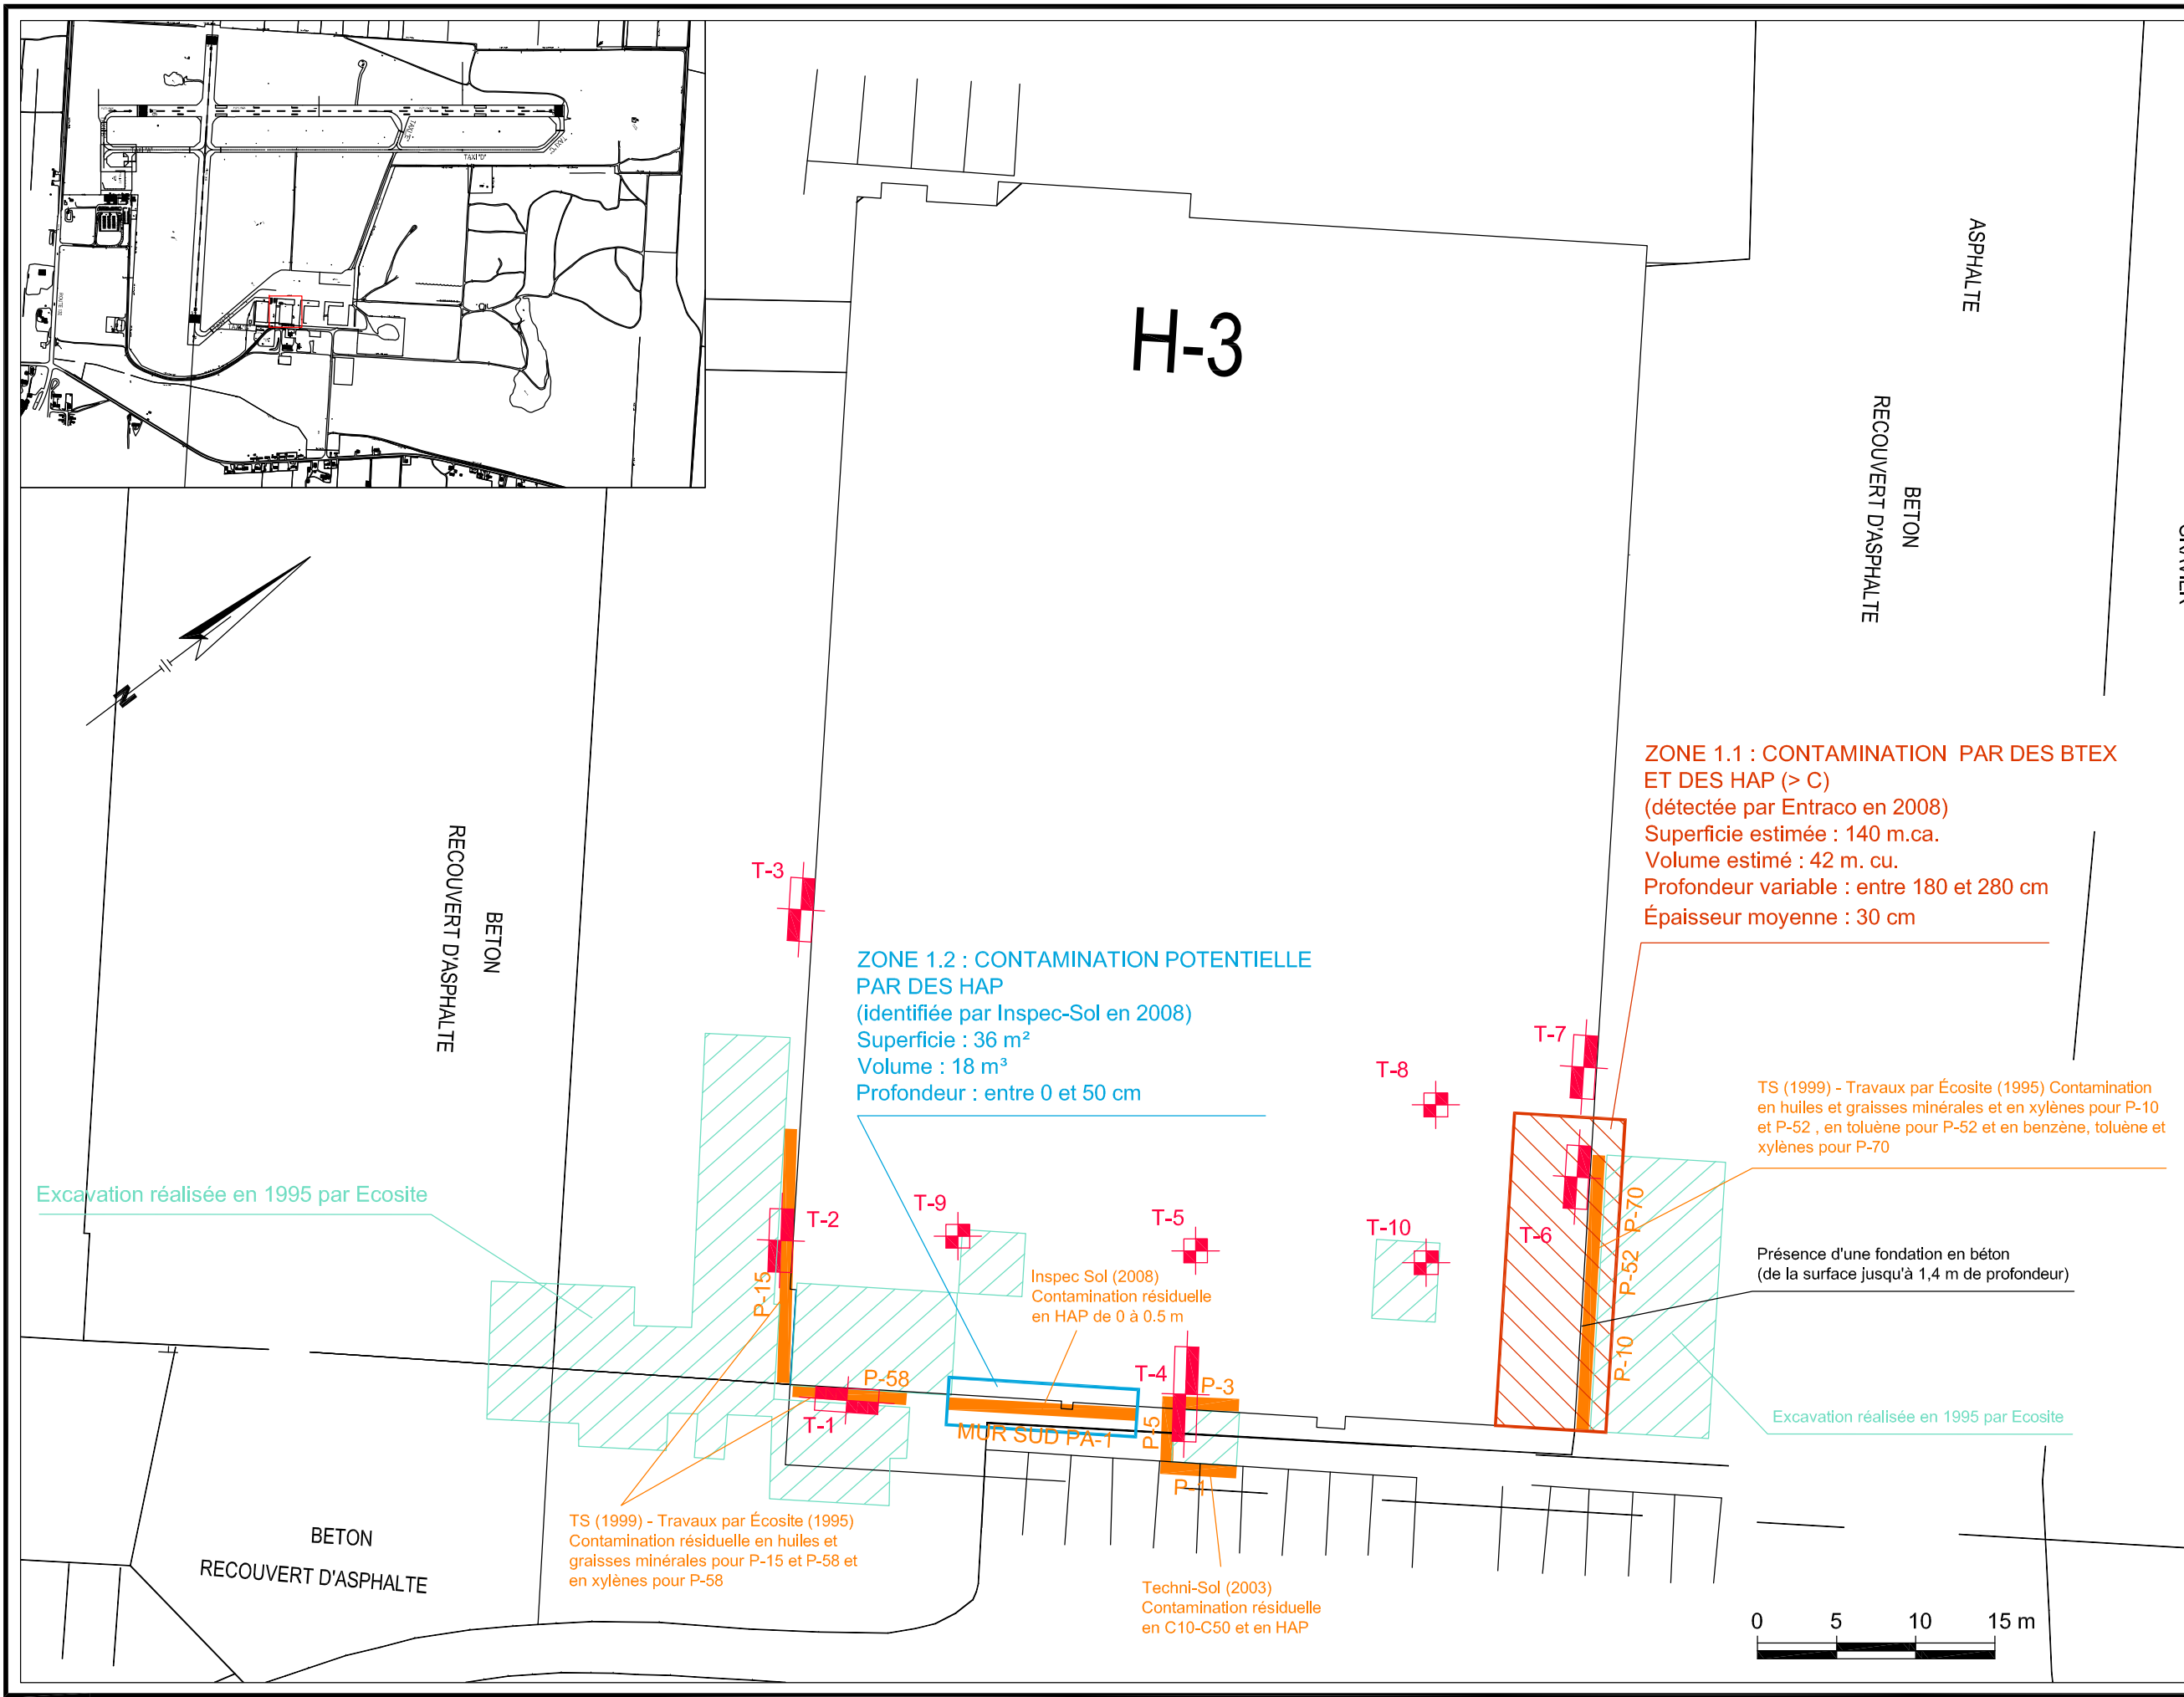
Figure 3.1 Summary of data related to the former building H-3

Dessin / Drawing:  
FIGURE 3.1  
Synthèse des données  
Secteur de l'ancien bâtiment H-3

The former building H-3 sector has been subject to a number of characterization studies and remediation initiatives for hydrocarbon-contaminated soil (see Figure 3.1). The contamination observed was primarily related to the presence of tanks near the southwest<sup>(2)</sup> and southeast corners of the building, as well as near the south wall.

Residual hydrocarbon contamination (exceeding the C criteria established by MENV, former Quebec department of the environment) was detected along the foundation walls in two areas:

This residual contamination primarily affected the sides of the walls along the building. This soil had been left in place to preserve its bearing capacity near the foundation. In addition, in 2008,

following the demolition of the building, surface (0–50 cm) PAH contamination was detected in a trench near the former south wall of the foundation (MUR SUD PA-1).

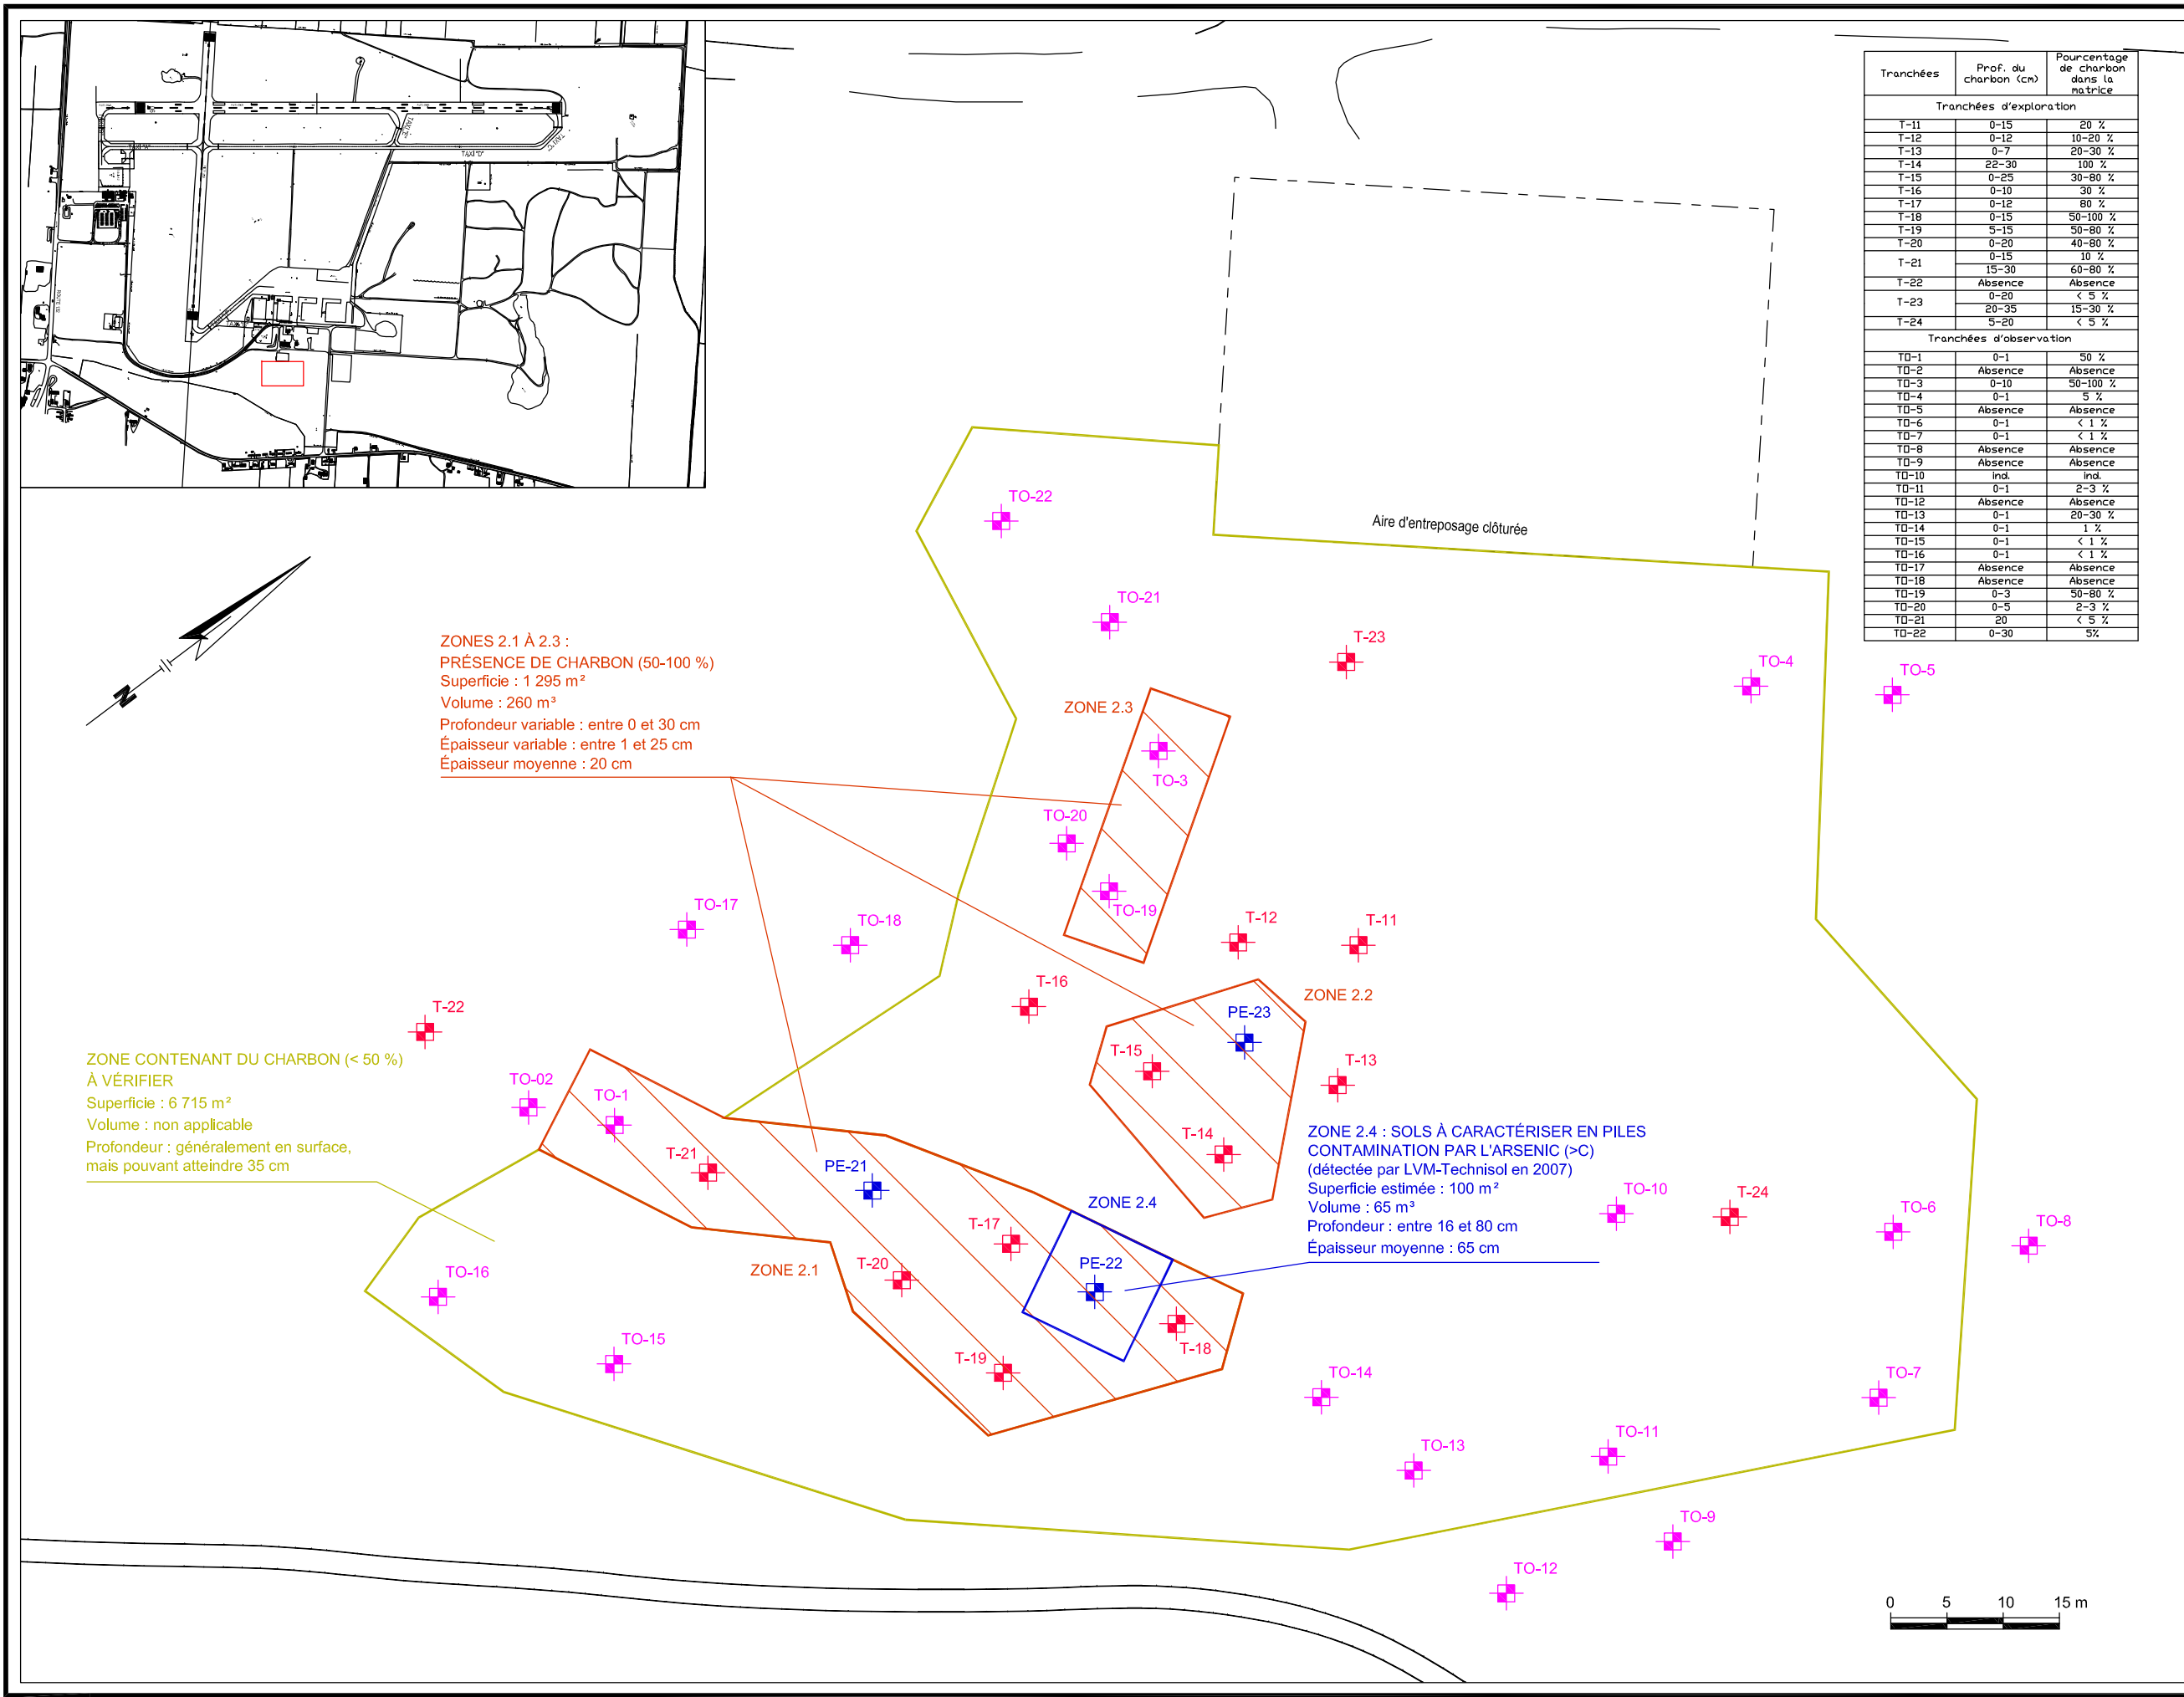
Figure 3.2 Summary of data related to the former coal depot

Tranchées	Prof. du charbon (cm)	Pourcentage de charbon dans la matrice
Tranchées d'exploration		
T-11	0-15	20 %
T-12	0-12	10-20 %
T-13	0-7	20-30 %
T-14	22-30	100 %
T-15	0-25	30-80 %
T-16	0-10	30 %
T-17	0-12	80 %
T-18	0-15	50-100 %
T-19	5-15	50-80 %
T-20	0-20	40-80 %
T-21	0-15	10 %
T-22	15-30	60-80 %
T-23	Absence	Absence
T-24	0-20	< 5 %
T-25	20-35	15-30 %
T-26	5-20	< 5 %
Tranchées d'observation		
TO-1	0-1	50 %
TO-2	Absence	Absence
TO-3	0-10	50-100 %
TO-4	0-1	5 %
TO-5	Absence	Absence
TO-6	0-1	< 1 %
TO-7	0-1	< 1 %
TO-8	Absence	Absence
TO-9	Absence	Absence
TO-10	ind.	ind.
TO-11	0-1	2-3 %
TO-12	Absence	Absence
TO-13	0-1	20-30 %
TO-14	0-1	1 %
TO-15	0-1	< 1 %
TO-16	0-1	< 1 %
TO-17	Absence	Absence
TO-18	Absence	Absence
TO-19	0-3	50-80 %
TO-20	0-5	2-3 %
TO-21	20	< 5 %
TO-22	0-30	5%

FIGURE 3.2  
Synthèse des données  
Secteur de l'ancien dépôt de charbon

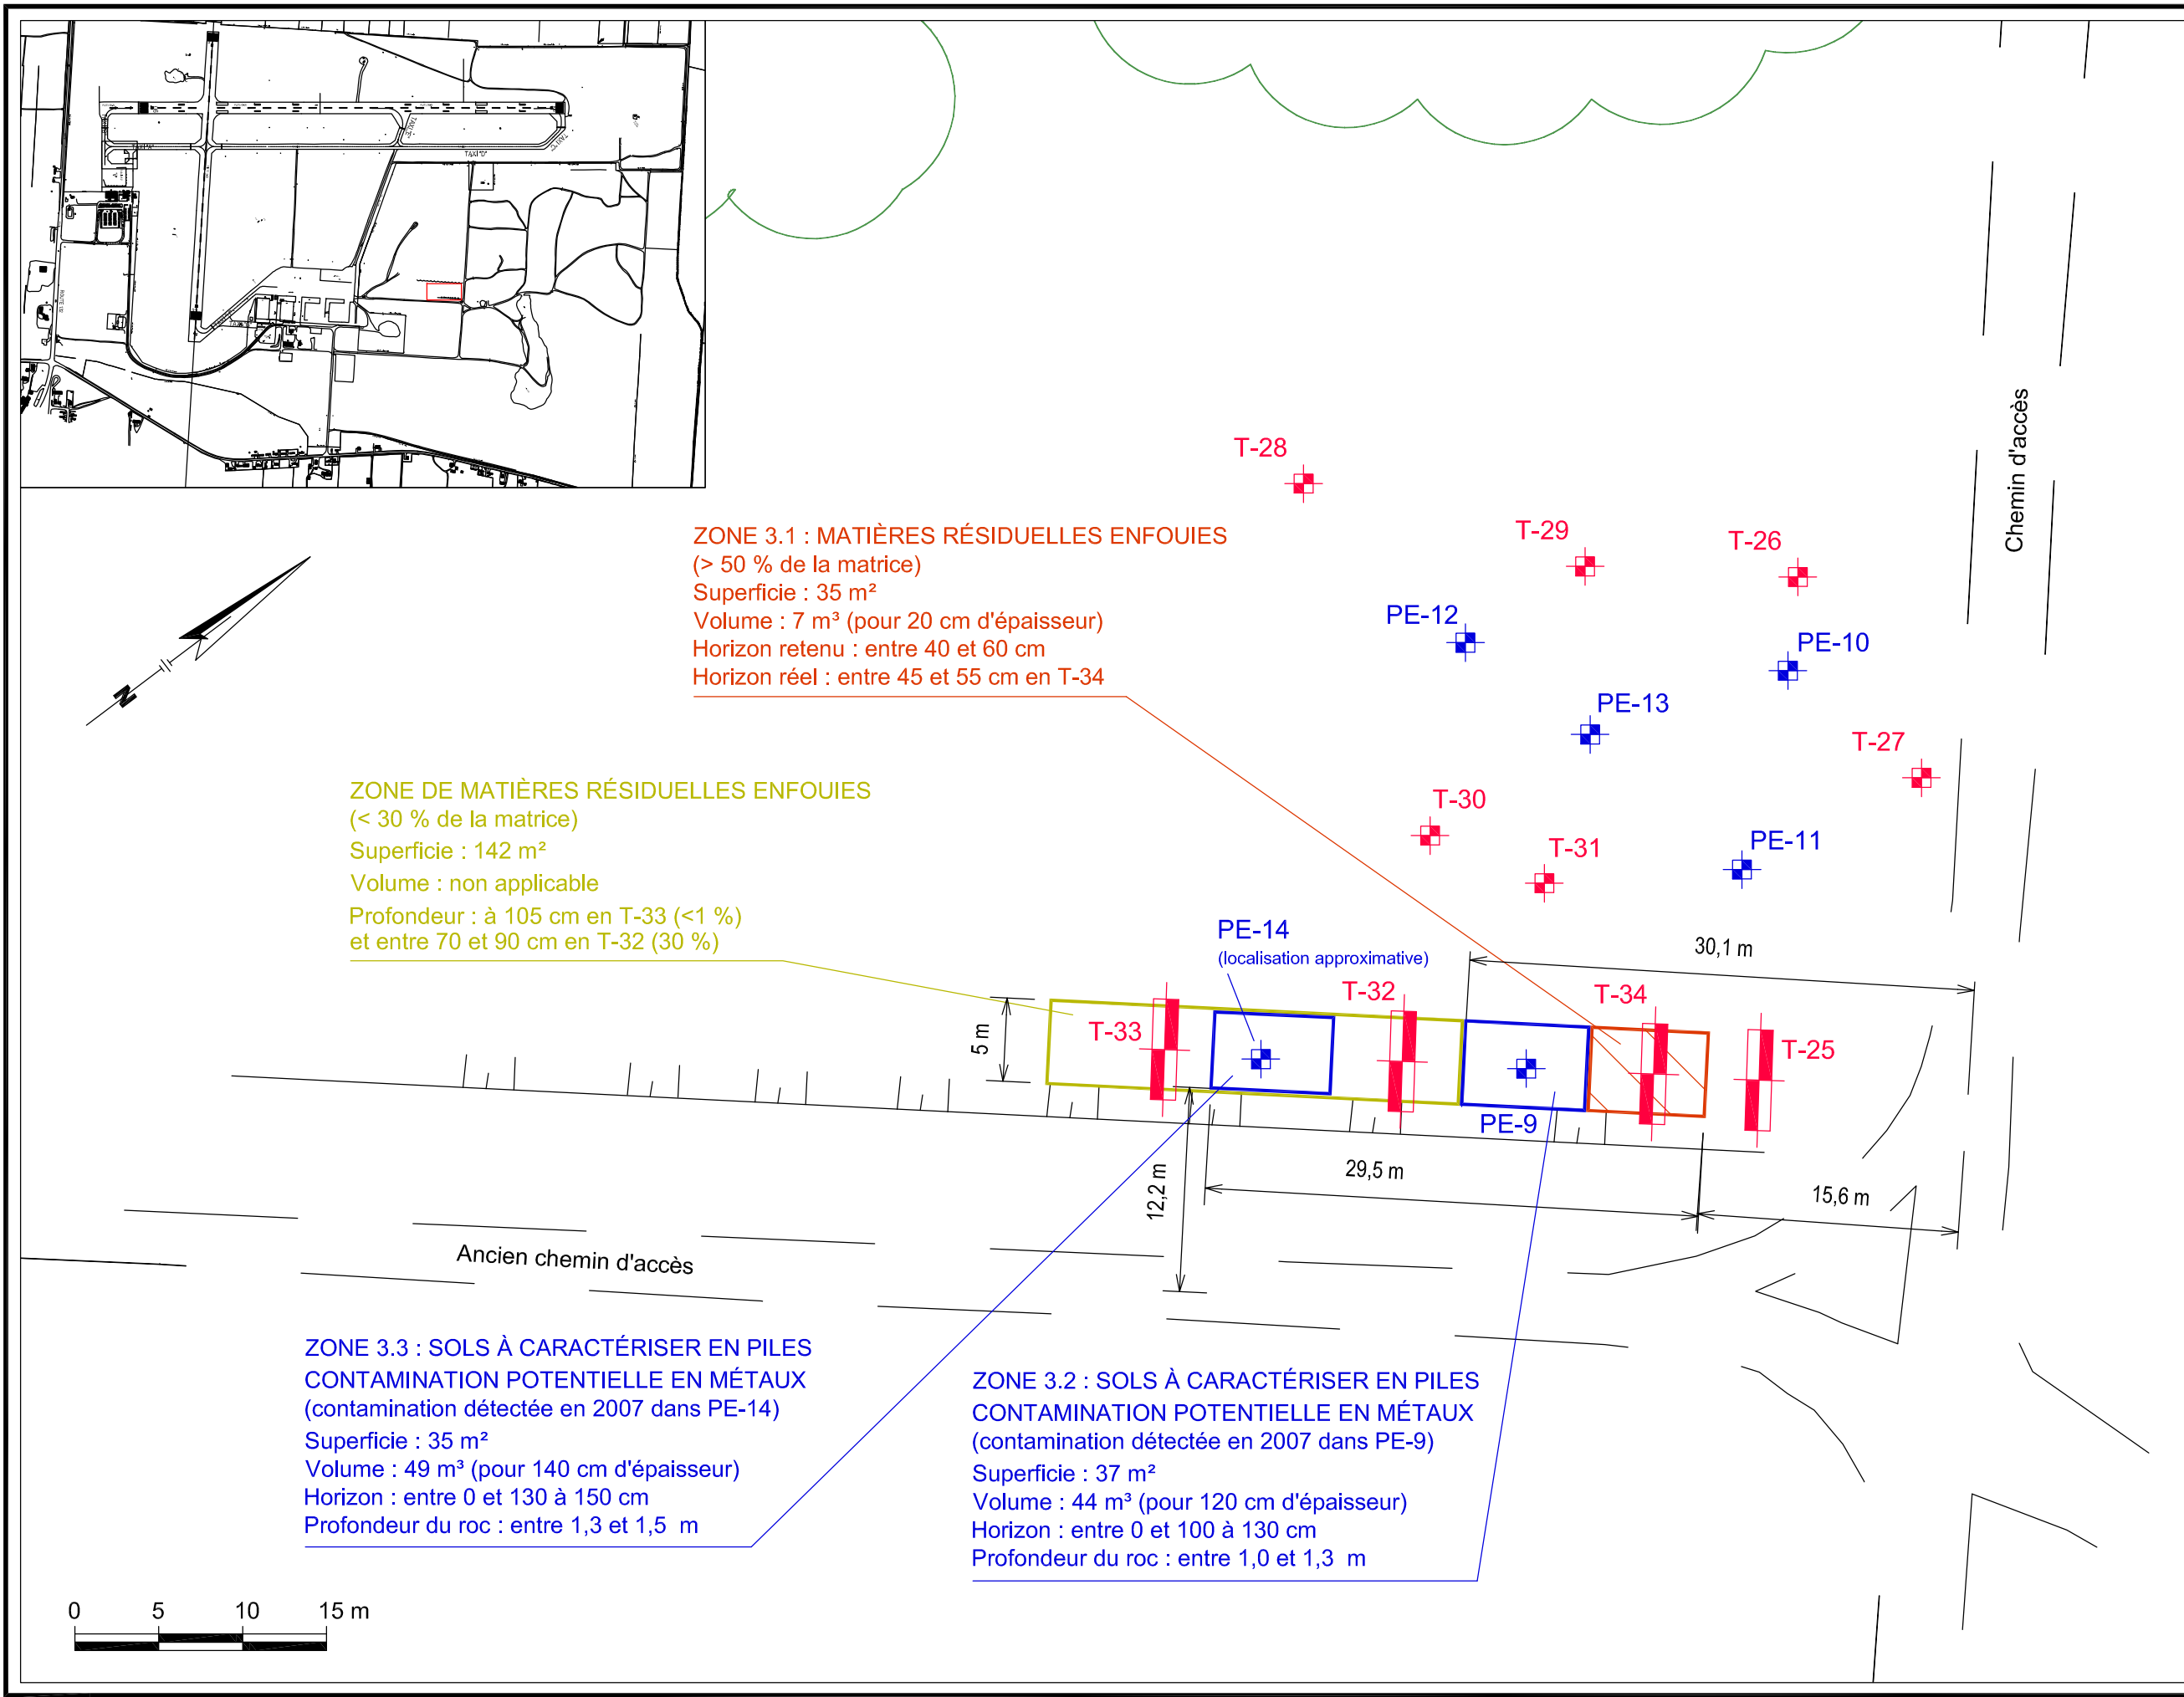
Figure 3.3 Summary of data related to the former landfill

Dessin / Drawing:  
FIGURE 3.3  
Synthèse des données  
Secteur de l'ancien dépotoir

In accordance with section 66 of the *Environment Quality Act*, a zone of residual material accumulation (more than 50% of the matrix) was delineated (see Figure 3.3, zone 3.1). This zone covers an area of 35 m<sup>2</sup> (5 m by 7 m). The estimated volume of waste is 7 m<sup>3</sup>, assuming

Taking into account the heavy metal contamination detected in 2007 in trenches PE-9 and PE-14, the following work is planned (see Figure 3.3, zones 3.2 and 3.3):

Zone	Issue	Area (m <sup>2</sup> )	Depth (cm)	Average Thickness (cm)	Volume (m <sup>3</sup> )	Selected Action
3.1	Residual material content above 50%	35	Between 40 and 60	20	7	Excavation and disposal
<b>Subtotal</b>		<b>35</b>			<b>7</b>	
3.2	Soil potentially contaminated by metals	37	Between 0 and 100 to 130	120	44	Excavation and characterization
3.3	Soil potentially contaminated by metals	35	Between 0 and 130 to 150	140	49	Excavation and characterization
<b>Subtotal</b>		<b>72</b>			<b>93</b>	
<b>Total</b>		<b>107</b>			<b>100</b>

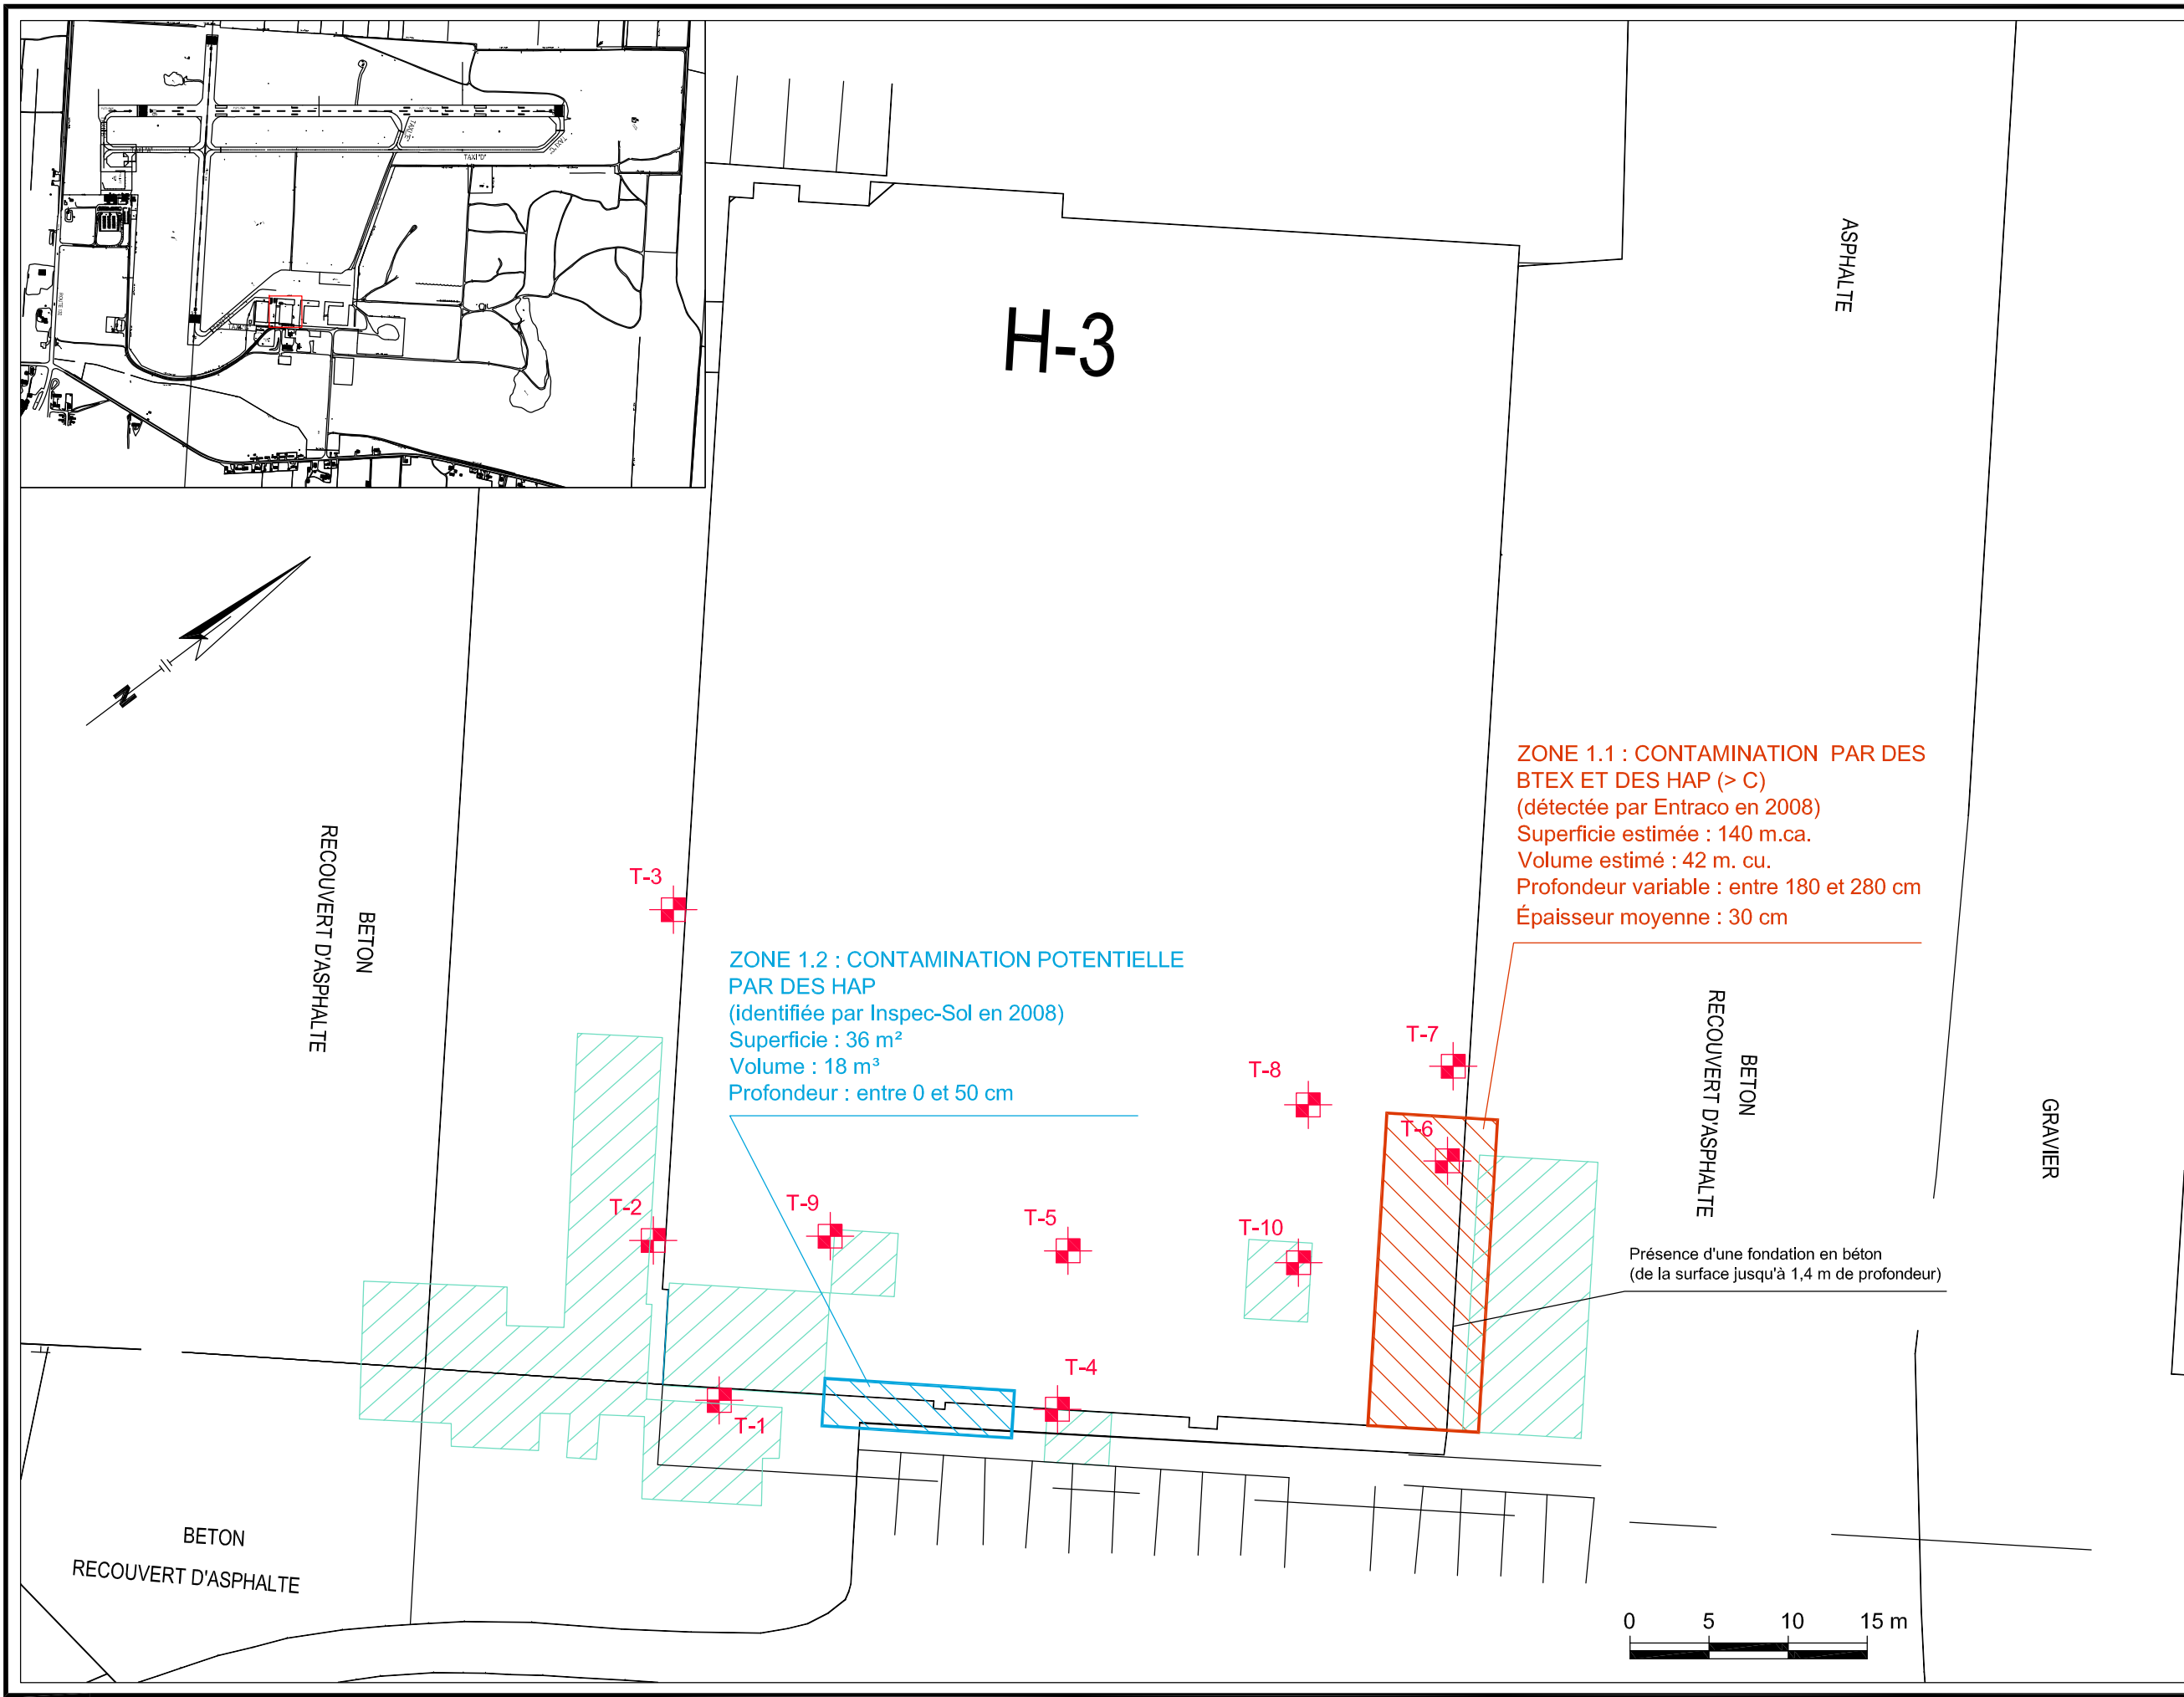
Figure 4.1      Location of zones to be remediated in the former building H-3 sector

Dessin / Drawing:  
FIGURE 4.1  
Localisation des zones d'intervention  
Secteur de l'ancien bâtiment H-3

In zone 1.1 (see Figure 4.1), i.e. at the southeast corner of the former building, it is planned to excavate the contaminated soil (above the MDDEP soil criteria level C) and dispose of it at a treatment site authorized by MDDEP. The remediation work will have to include, but not be limited to, the following activities:
