**Transport  
Canada**

**Mont-Joli Airport, Quebec  
Former Building H-3, Former Coal Depot and Former Landfill**

**Remediation Plan**

**Final Version**

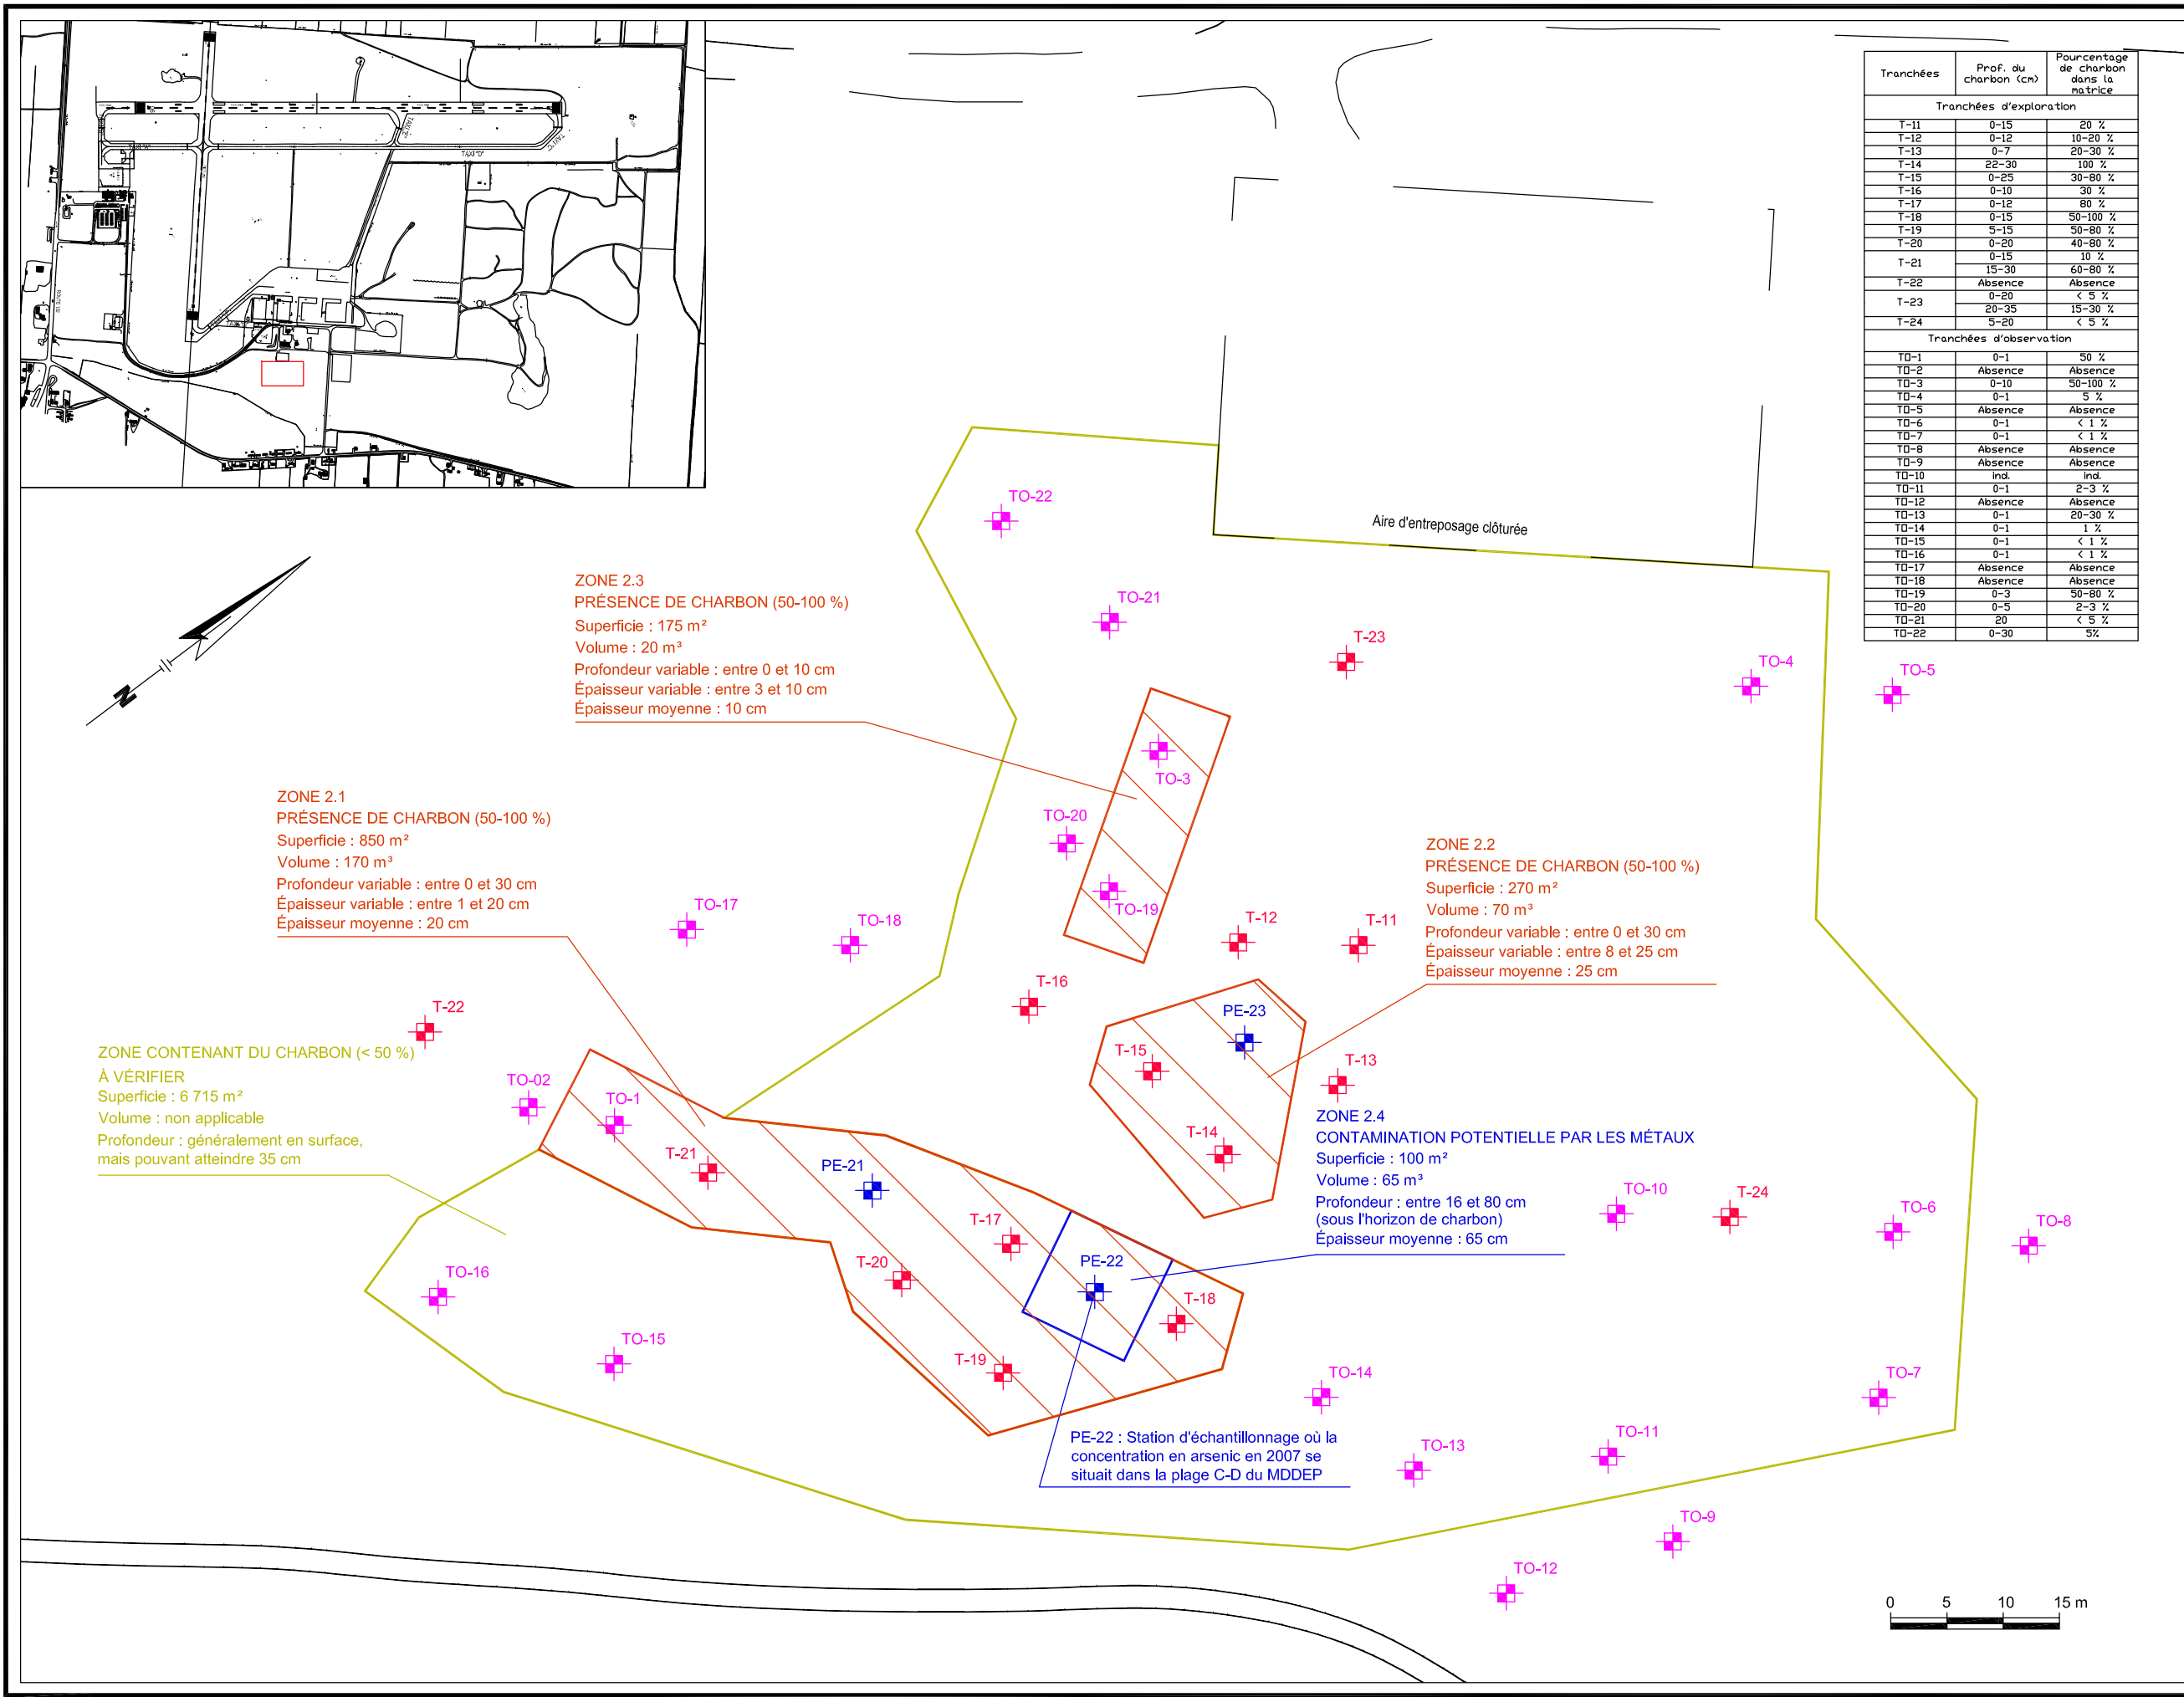
Figure 4.2 Location of zones to be remediated in the former coal depot sector

Tranchées	Prof. du charbon (cm)	Pourcentage de charbon dans la matrice
Tranchées d'exploration		
T-11	0-15	20 %
T-12	0-12	10-20 %
T-13	0-7	20-30 %
T-14	22-30	100 %
T-15	0-25	30-80 %
T-16	0-10	30 %
T-17	0-12	80 %
T-18	0-15	50-100 %
T-19	5-15	50-80 %
T-20	0-20	40-80 %
T-21	0-15	10 %
T-22	15-30	60-80 %
T-23	Absence	Absence
T-24	0-20	< 5 %
T-25	20-35	15-30 %
T-26	5-20	< 5 %
Tranchées d'observation		
TO-1	0-1	50 %
TO-2	Absence	Absence
TO-3	0-10	50-100 %
TO-4	0-1	5 %
TO-5	Absence	Absence
TO-6	0-1	< 1 %
TO-7	0-1	< 1 %
TO-8	Absence	Absence
TO-9	Absence	Absence
TO-10	ind.	ind.
TO-11	0-1	2-3 %
TO-12	Absence	Absence
TO-13	0-1	20-30 %
TO-14	0-1	1 %
TO-15	0-1	< 1 %
TO-16	0-1	< 1 %
TO-17	Absence	Absence
TO-18	Absence	Absence
TO-19	0-3	50-80 %
TO-20	0-5	2-3 %
TO-21	20	< 5 %
TO-22	0-30	5%

Dessin / Drawing:  
FIGURE 4.2  
Localisation des zones d'intervention  
Secteur de l'ancien dépôt de charbon

In areas which have accumulated residual material (coal content above 50%), that is in zones 2.1, 2.2 and 2.3 (see Figure 4.2), the remediation work will include, but not be limited to, the following activities:

- Excavate the affected materials (coal and soil with a coal content of more than 50%); the approximate depths to be excavated are indicated in Figure 4.2. As the materials are excavated, verify the percentage of residual materials in the soil from the walls and bottom to determine whether excavation should continue or cease. Note that in certain zones, the affected materials are covered by a thin layer of soil with a coal content of less than 50% that, for technical reasons, must also be excavated and managed with the underlying materials that have a coal content of more than 50%. If the horizon is more than 10 cm thick, excavate the soil, place it in temporary pile and characterize it to determine the appropriate management method. The soil must be stored on a polyethylene tarp and covered with another of the same kind.

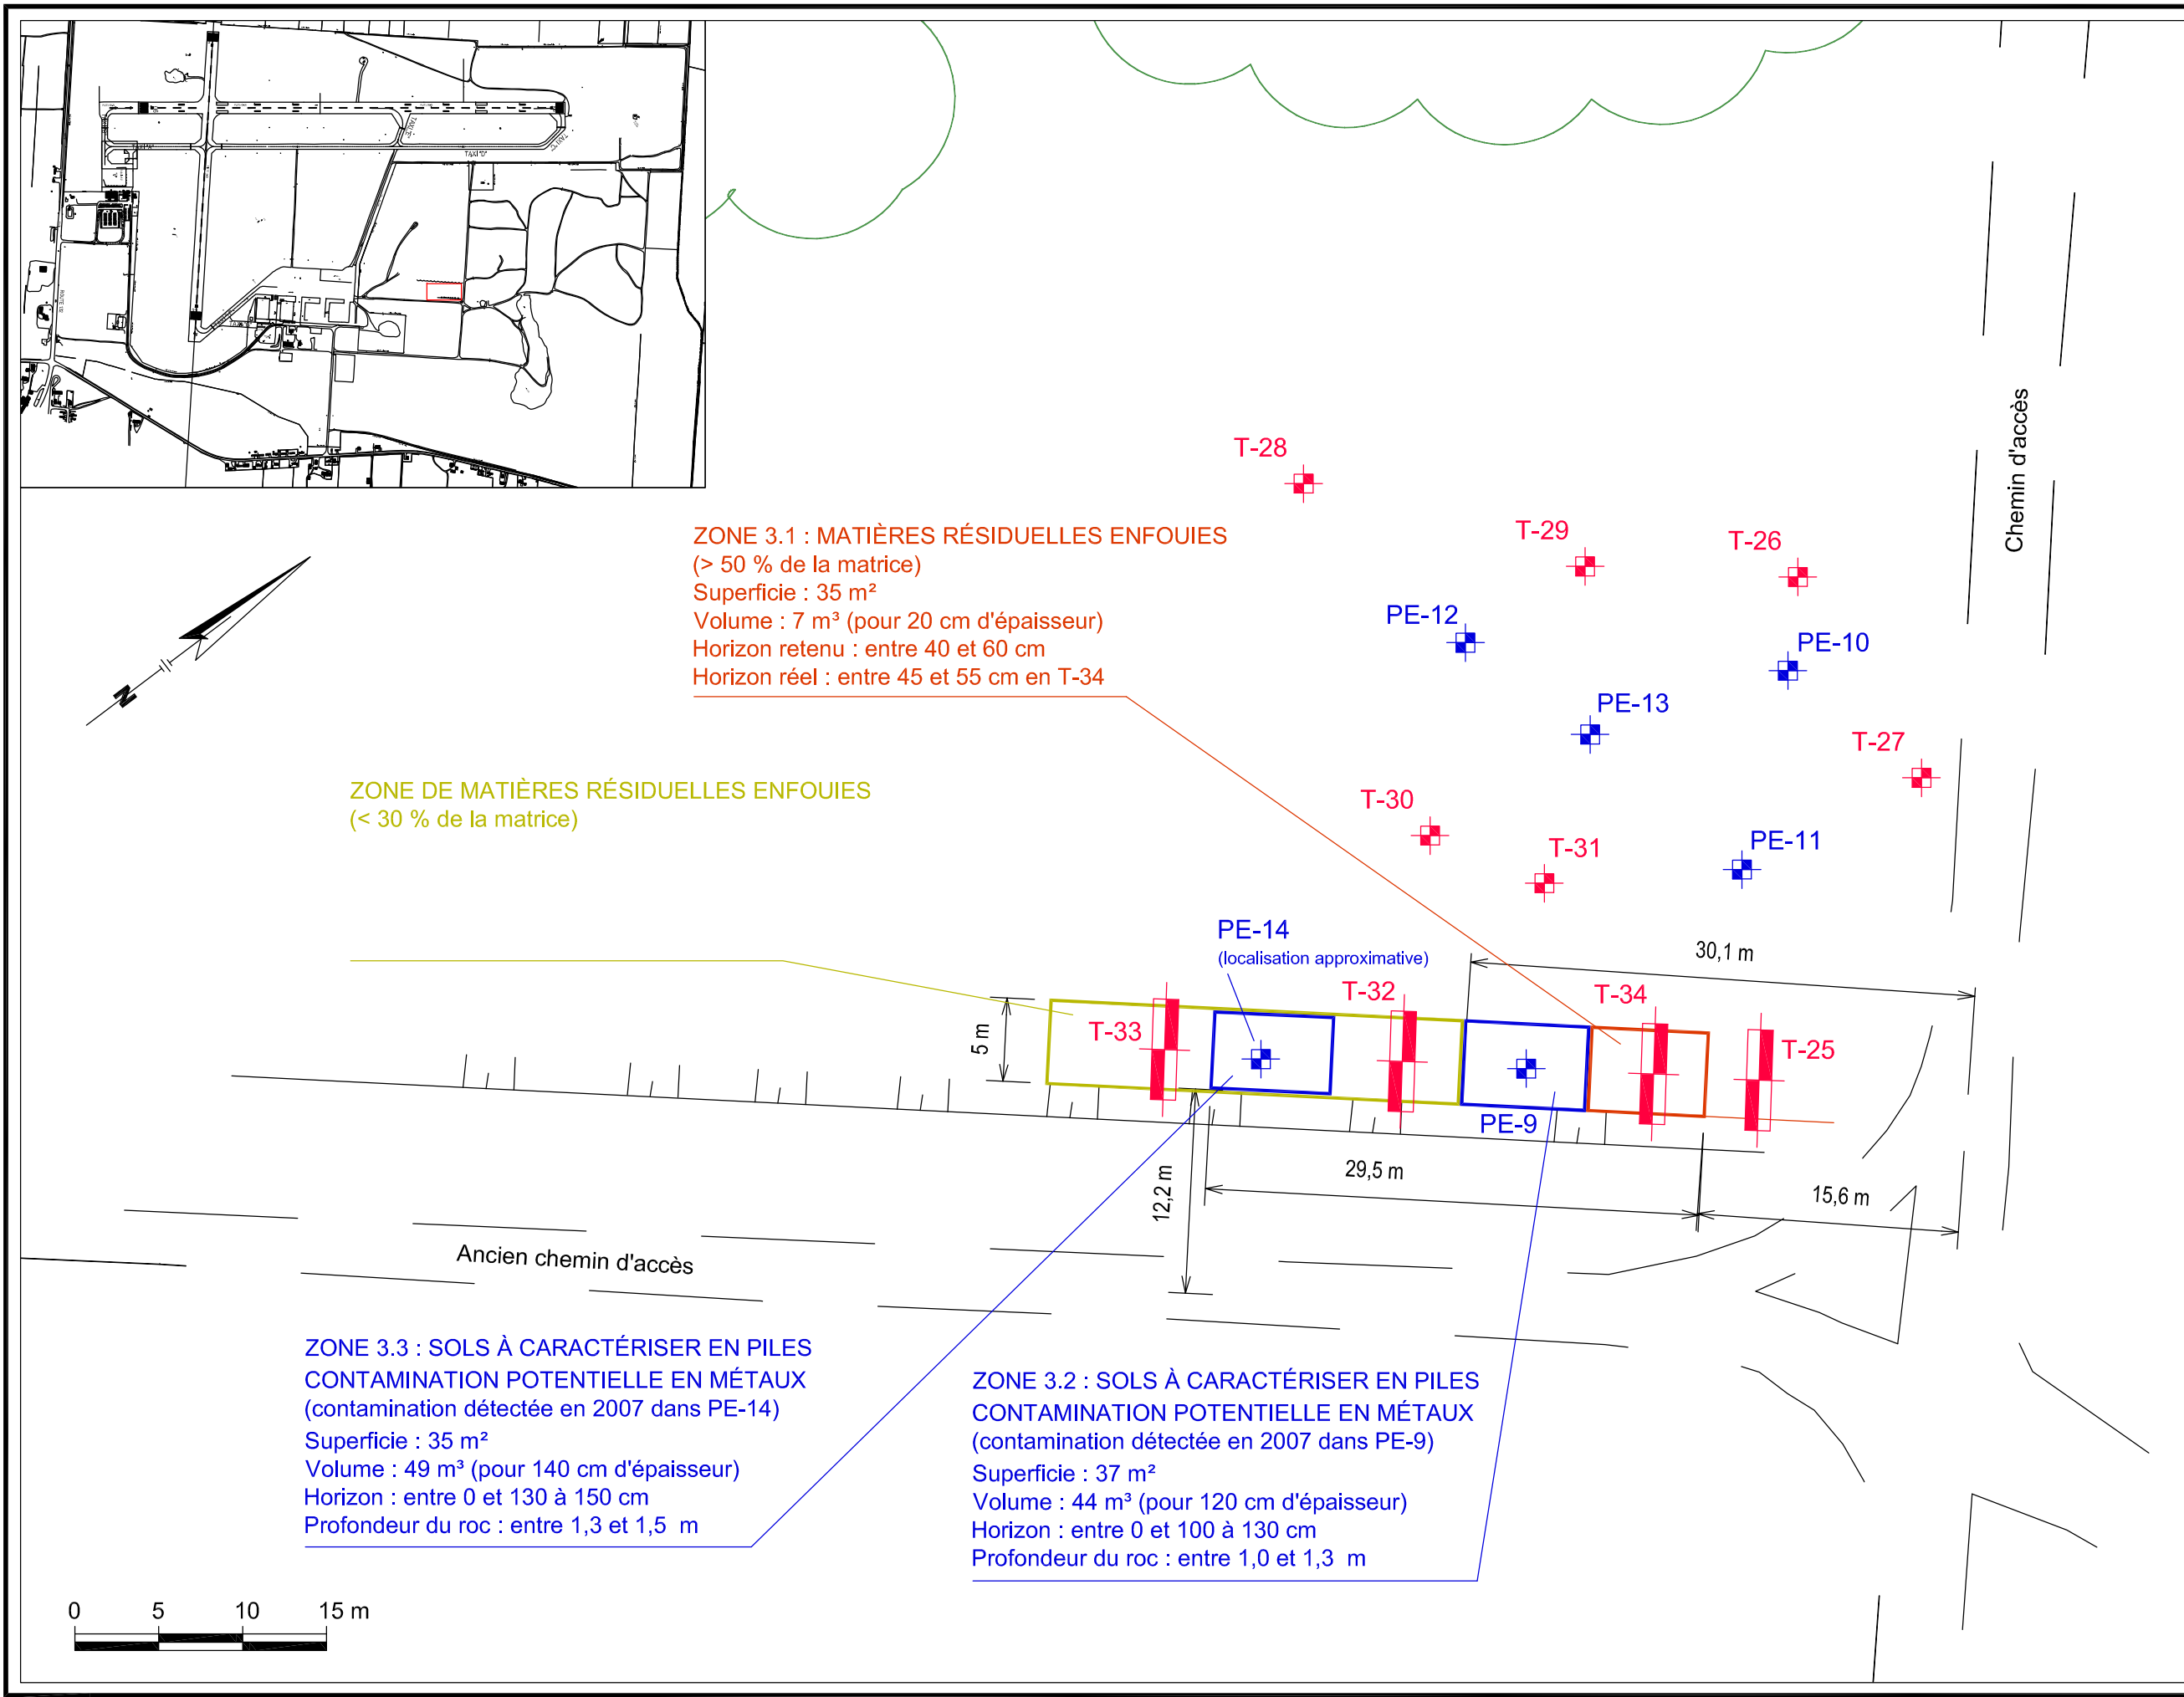
Figure 4.3 Location of zones to be remediated in the former landfill sector

Dessin / Drawing:  
**FIGURE 4.3**  
Localisation des zones d'intervention  
Secteur de l'ancien dépotoir

In zone 3.1 (see Figure 4.3), excavate the horizon of buried residual materials around station T-34 (residual material content above 50%) and dispose of the materials at an ELS. The remediation work will should include, but not be limited to, the following activities:

The following activities are planned in order to take into account the heavy metal contamination detected in 2007 in excavations PE-9 and PE-14 (see Figure 4.3):
