**Mont-Joli Airport, Quebec
Former Building H-3, Former Coal Depot and Former Landfill**

Remediation Plan

**Responses to the Supplemental Information Request from MDDEP
dated July 20, 2011,
Concerning Remediation of the Former Hangar H-3 Sector**

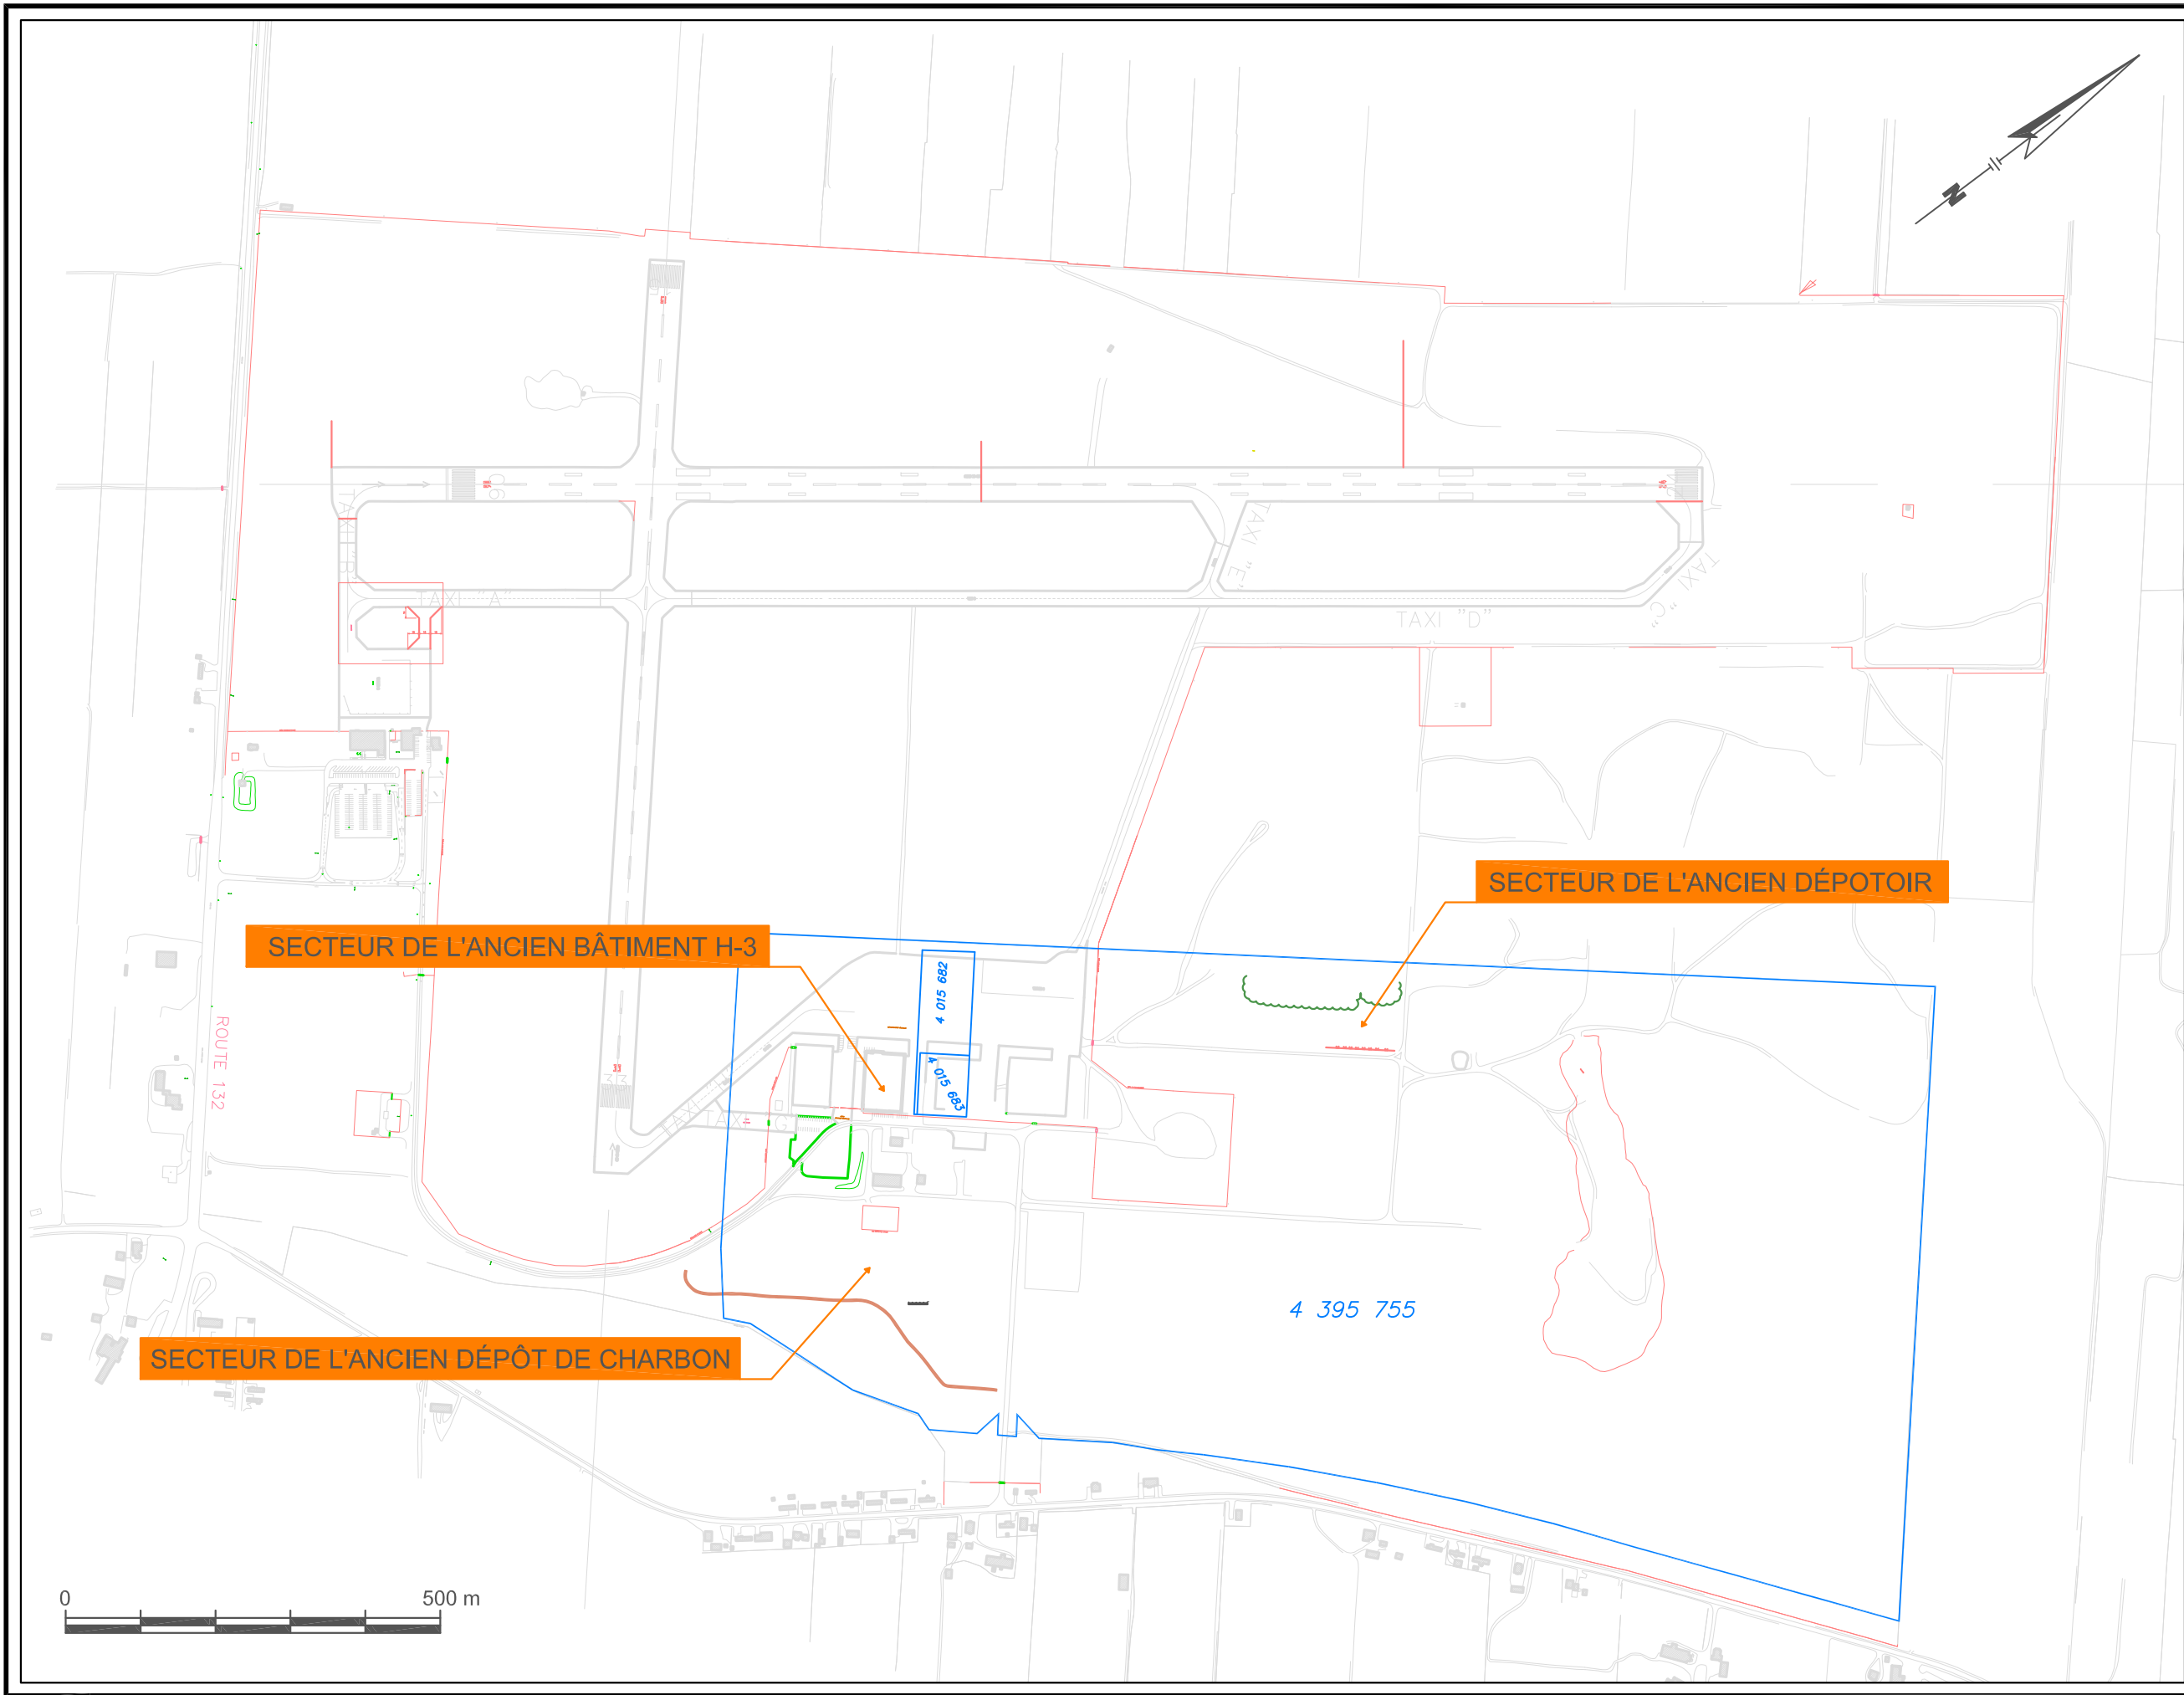
Dessin / Drawing:
FIGURE 2.3
Plan d'ensemble des secteurs à réhabiliter

SOURCE : Plan dessiné par TPSGC
(C00pg01.dwg)

- Telephone: 418-775-7285;
 - Fax: 418-775-6320;
 - Email: mont-joli@ville.mont-joli.qc.ca
2. The site is located on part of lot 4 395 755 of the Land Register of Quebec. The boundaries of this lot are illustrated in Figure 2.3 of the Plan (see Annex 2).

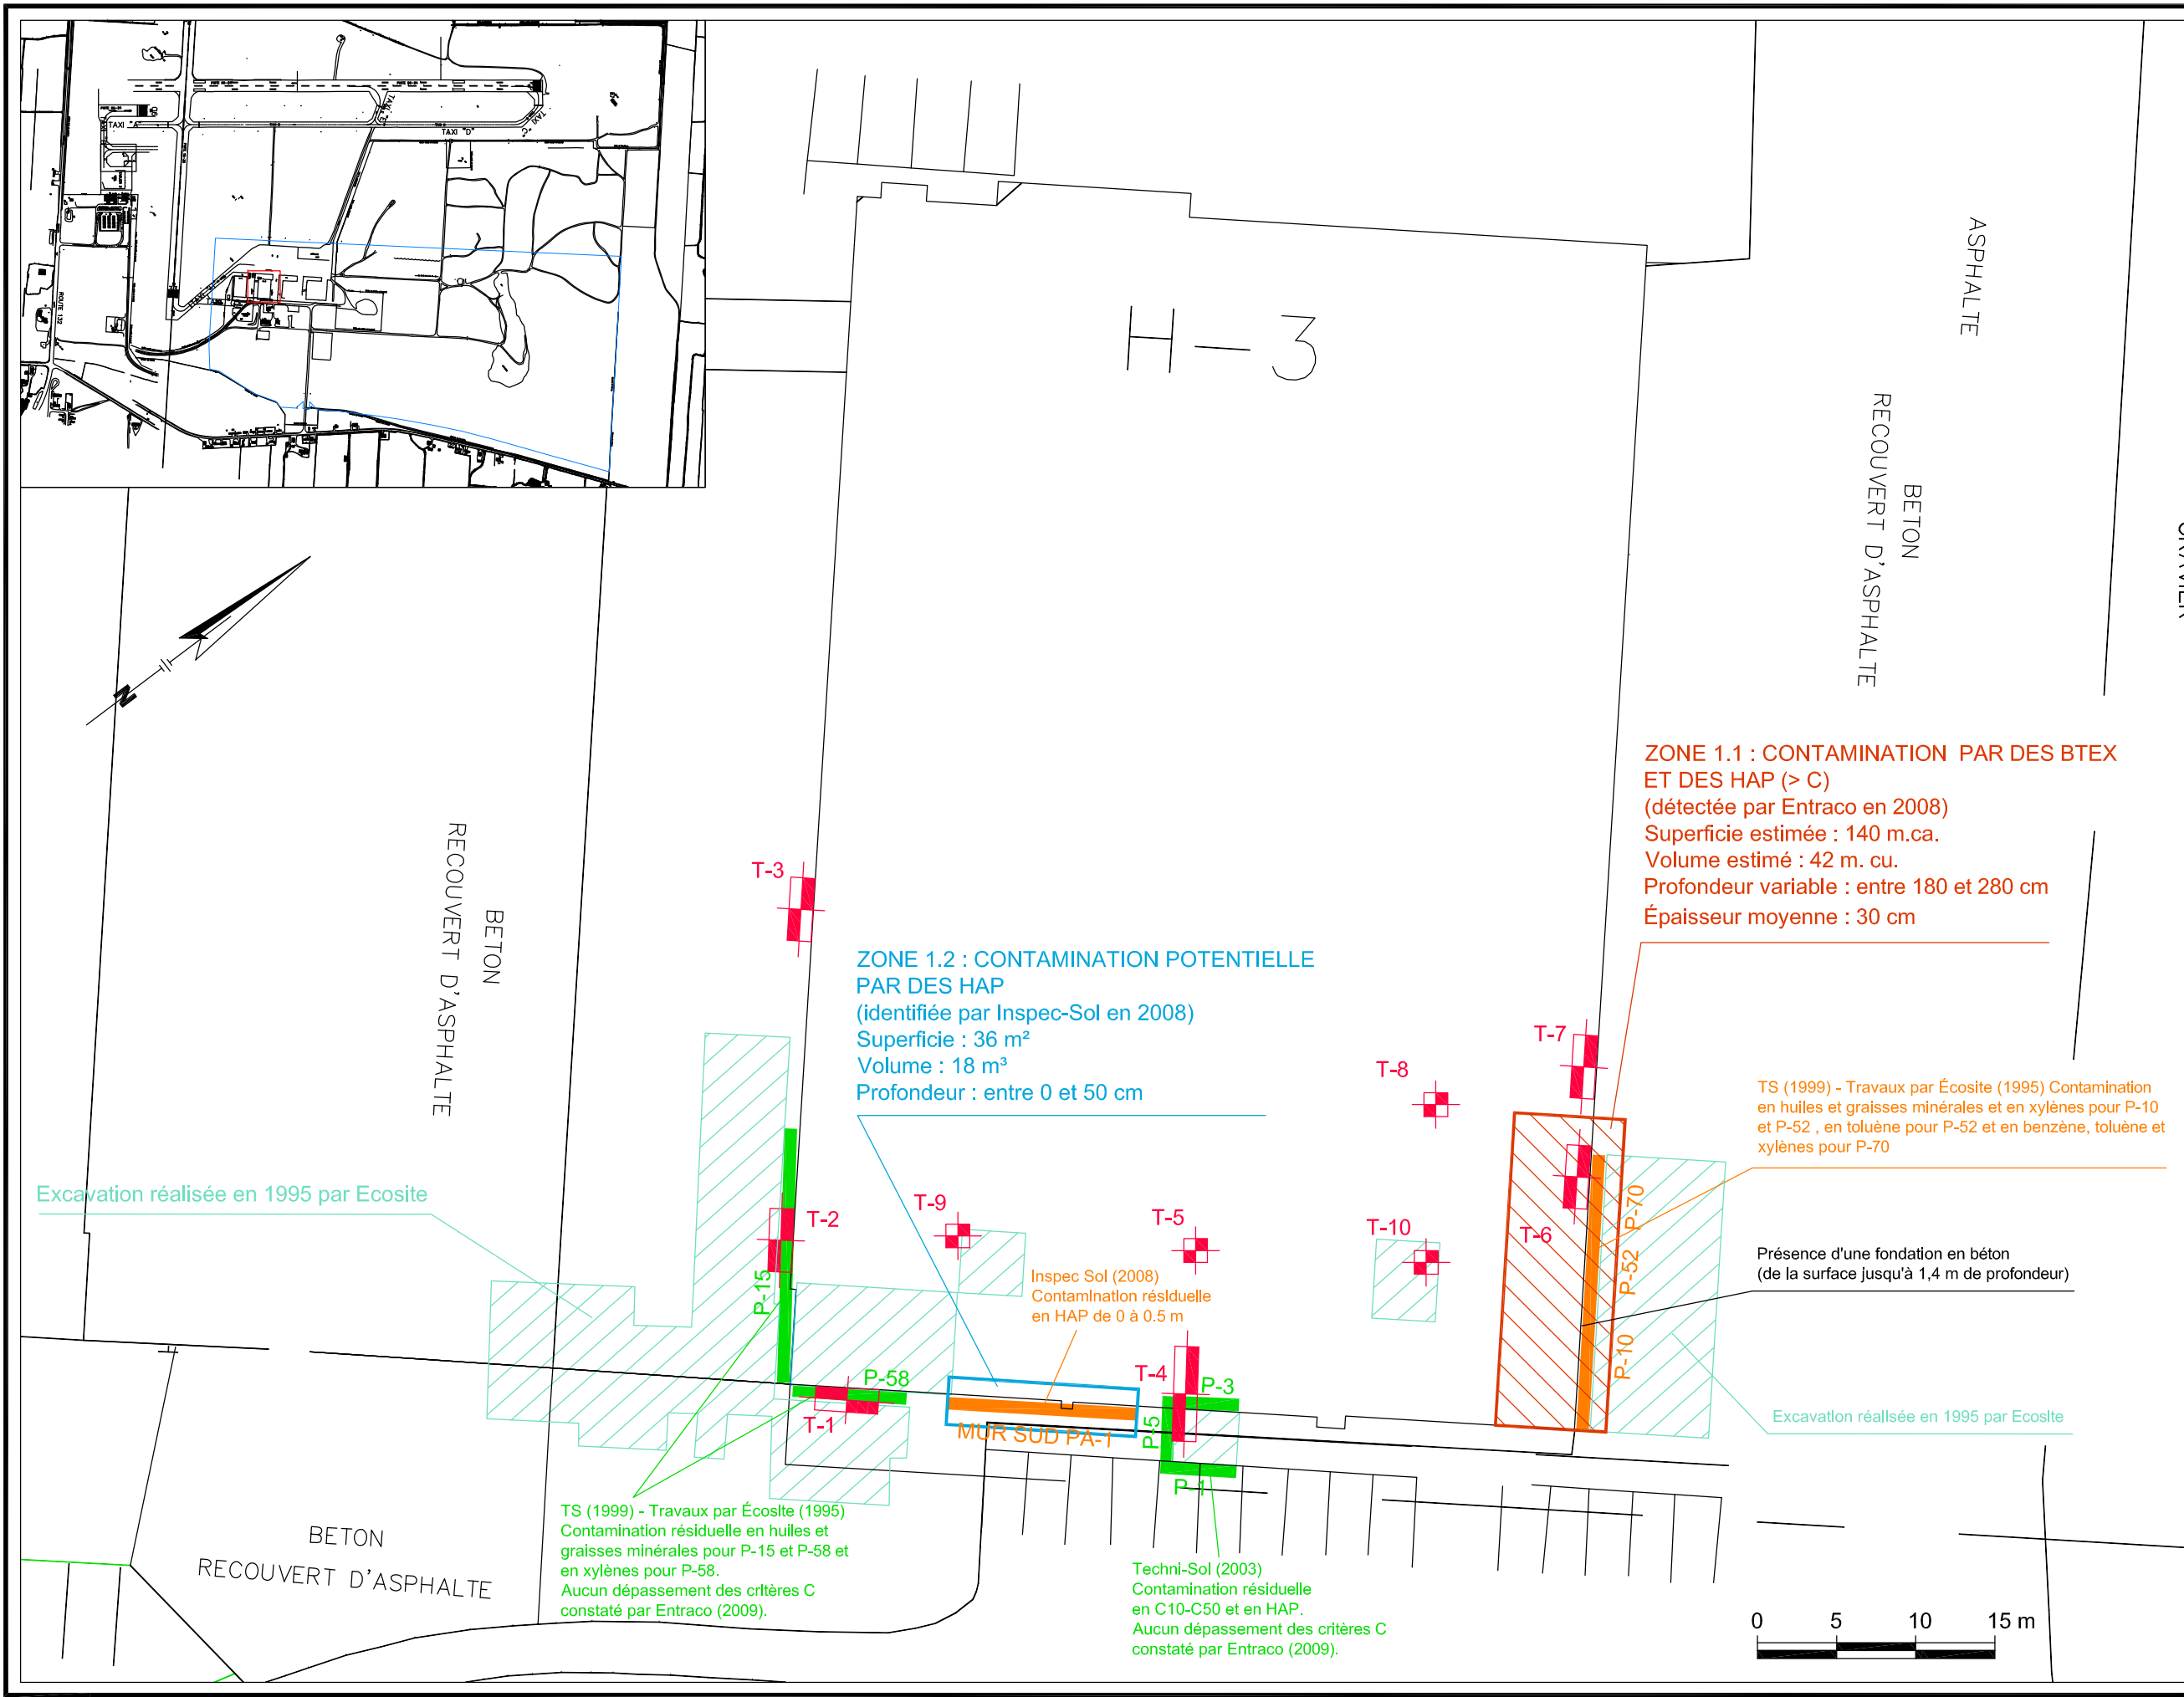
- T-11 Tranchée d'exploration_Entraco 2008
- T-25 Tranchée d'exploration allongée_Entraco 2008
- Zone contaminée à restaurer identifiée par Entraco
- Secteur potentiellement contaminé identifié par Inspec-Sol en 2008
- Zone restaurée antérieurement
- Contamination supérieure au critère C
- Contamination inférieure au critère C

5. For the two areas of residual contamination shown in Figure 3.1 in the Plan, the following information has been added (see Annex 2): "No exceedance of level C observed by Entraco (2009)." According to the Entraco study (2009), the TPH C₁₀-C₅₀ concentrations are in the B–C range in trenches T-2 and T-4, and in the A–B range in trench T-1. In 2008, during demolition of hangar H-3, no exceedances of level C were observed by Inspec-Sol in this sector.
6. The quantity of potentially contaminated soil along the southern wall of former hangar H-3 was estimated at 18 m³ within an area of 36 m². These figures, which have been used in the remediation plan, are based on the results of the Entraco study (2009).
