SPECIFICATION

DEMOLITION OF SAR BUILDING

BURIN, NL

F6879-165010

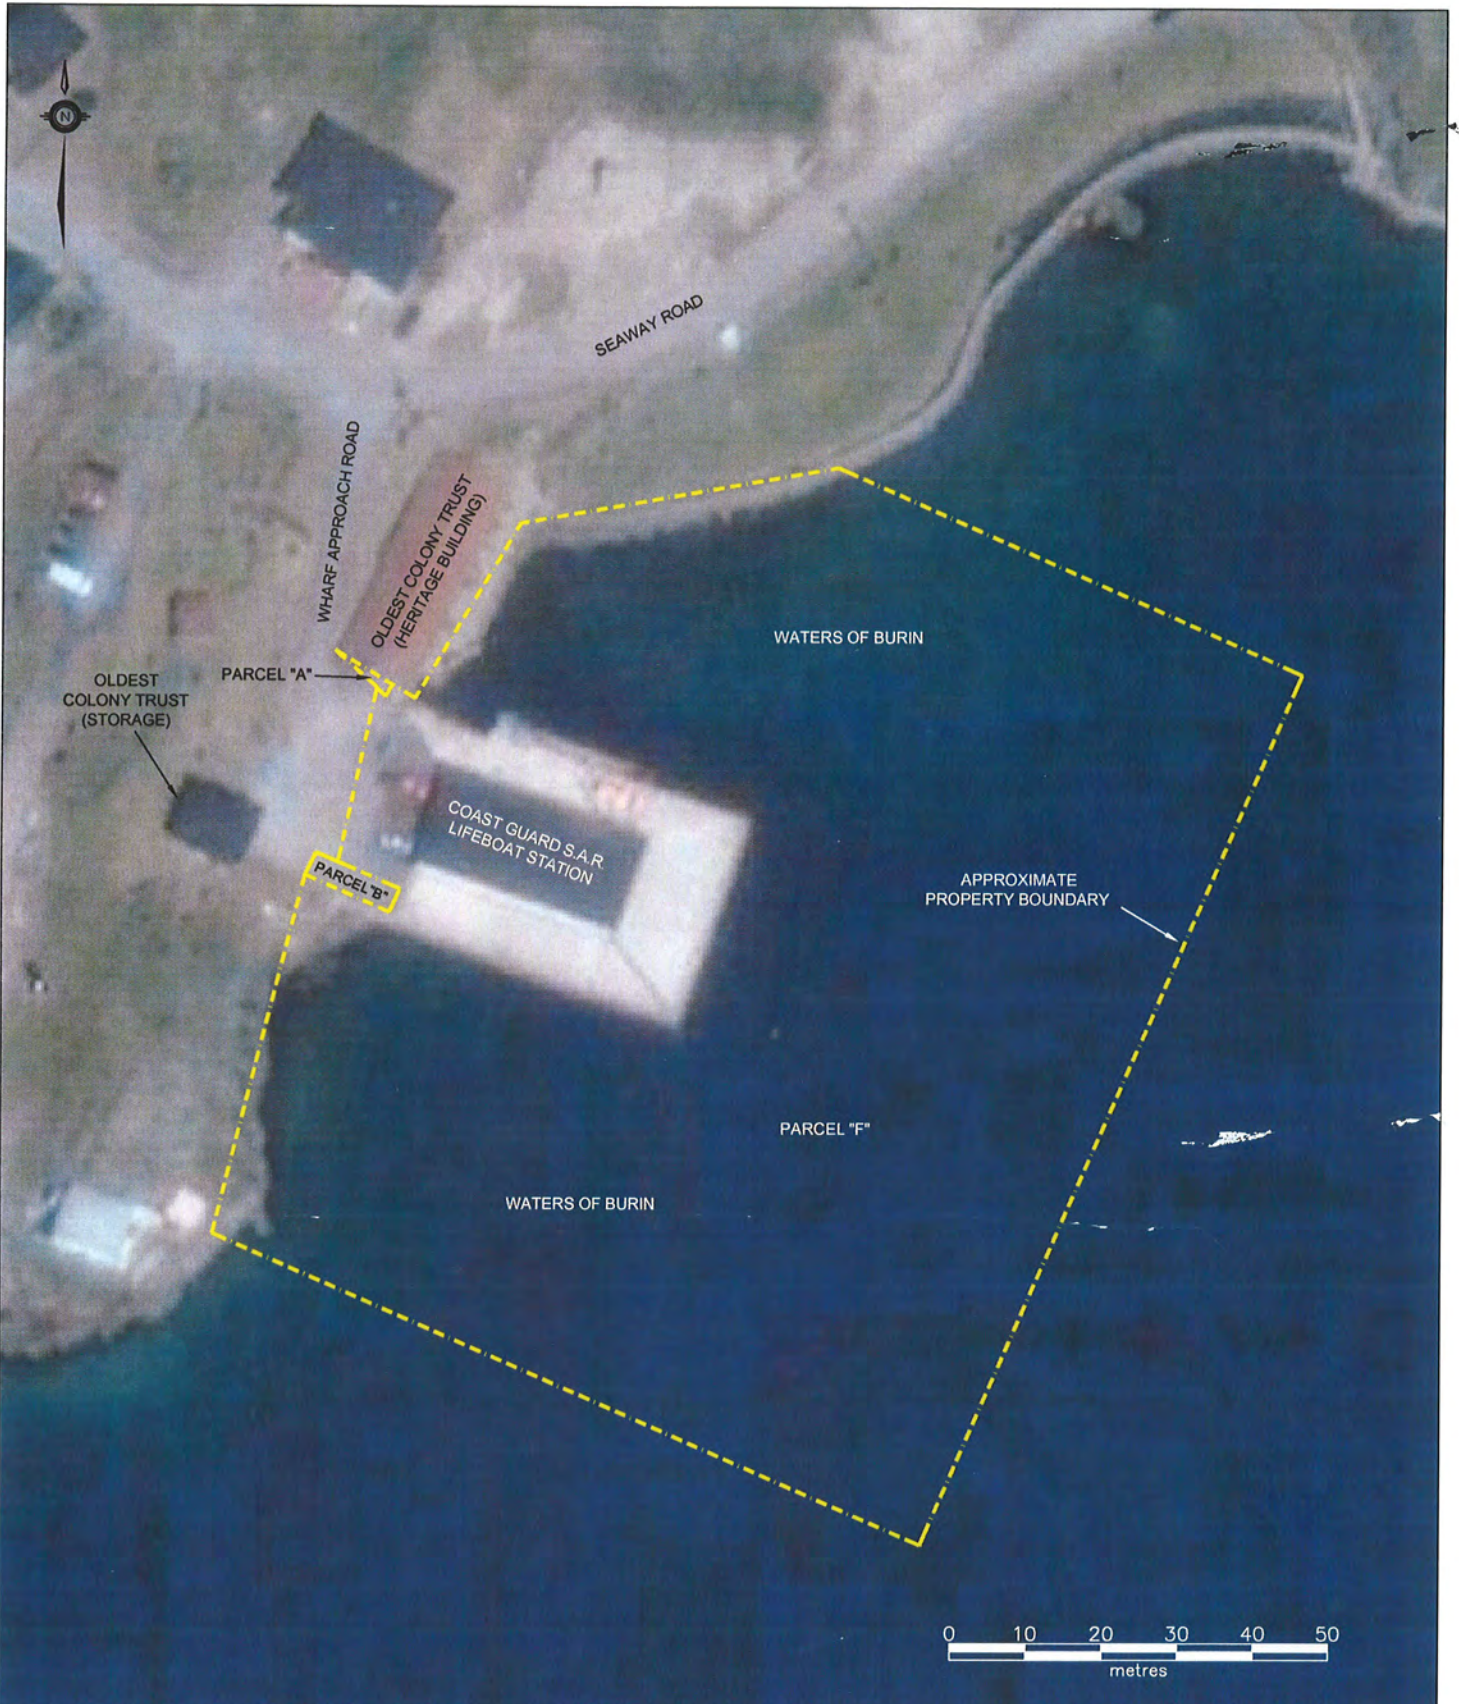
● EXTERNAL PAINT SAMPLE

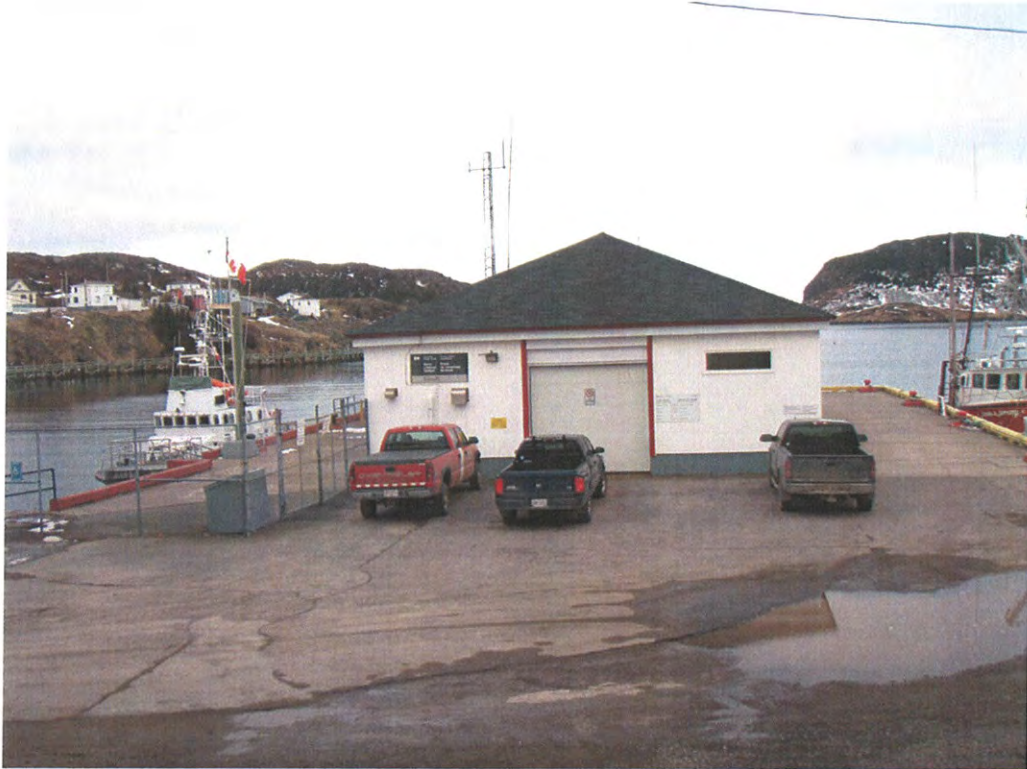
Photo 1: Canadian Coast Guard Search and Rescue Station, Burin, NL, facing southeast.

The Canadian Coast Guard Search and Rescue station is located in Burin, NL and consists of a single story, wood-frame building, as shown on Drawing No. 121410853-EE-02 in Appendix A and Photo 1 in Appendix C. The site consists of two parcels of land (Parcel A and Parcel B) and a water lot, Parcel F, as provided on the site survey plan and as shown on Drawing No. 121410853-EE-02 in Appendix A. The building, has a footprint of approximately 341 m², was constructed in 1970 and is situated on a finger pier. The finger pier is constructed of concrete cribbing and hardwood timber, with a concrete deck, wood curb stops, and metal mooring bollards.

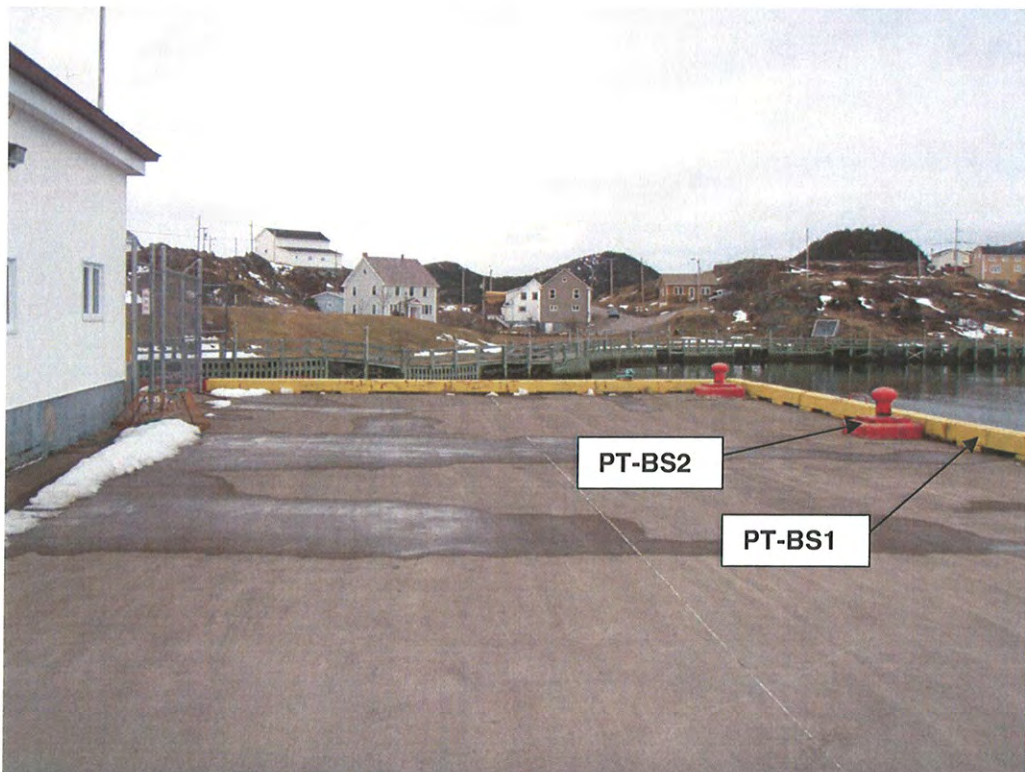
Photo 2: Concrete wharf deck showing yellow wheel guard and red bollards, facing northeast.

Sample No.	Sample Location, Color and Substrate	Paint Condition	Areas with Visually Similar Paint	Photograph of Location
PT-BS1	Grey paint on exterior concrete - Foundation Wall	Fair - good; 10% flaking	N/A	Photo 2, Appendix C
PT-BS2	Red paint on bollard - Pier	Fair - good; 5% flaking	N/A	Photo 2, Appendix C
PT-BS3	Yellow paint on traffic rail (wheelguard) - Pier (paint is on pressure treated timber)	Fair - good; 5-10% flaking	N/A	Photo 5, Appendix C
PT-BS4	Light grey paint on concrete floor - Garage/Service Area	Good; 1-2% flaking	N/A	Photo 11, Appendix C
PT-BS5	Light blue paint on drywall (wall) – Garage/Service Area	Good	<ul style="list-style-type: none"> Entrance/Storage Area Hallway 	Photo 11, Appendix C
PT-BS6	White paint on gyproc ceiling – Garage/Service Area	Good	<ul style="list-style-type: none"> Entrance/Storage Area Hallway 	Photo 11, Appendix C
PT-BS7	Dark grey floor paint - Electrical Room	Good	<ul style="list-style-type: none"> Entrance/Storage Area 	Photo 15, Appendix C

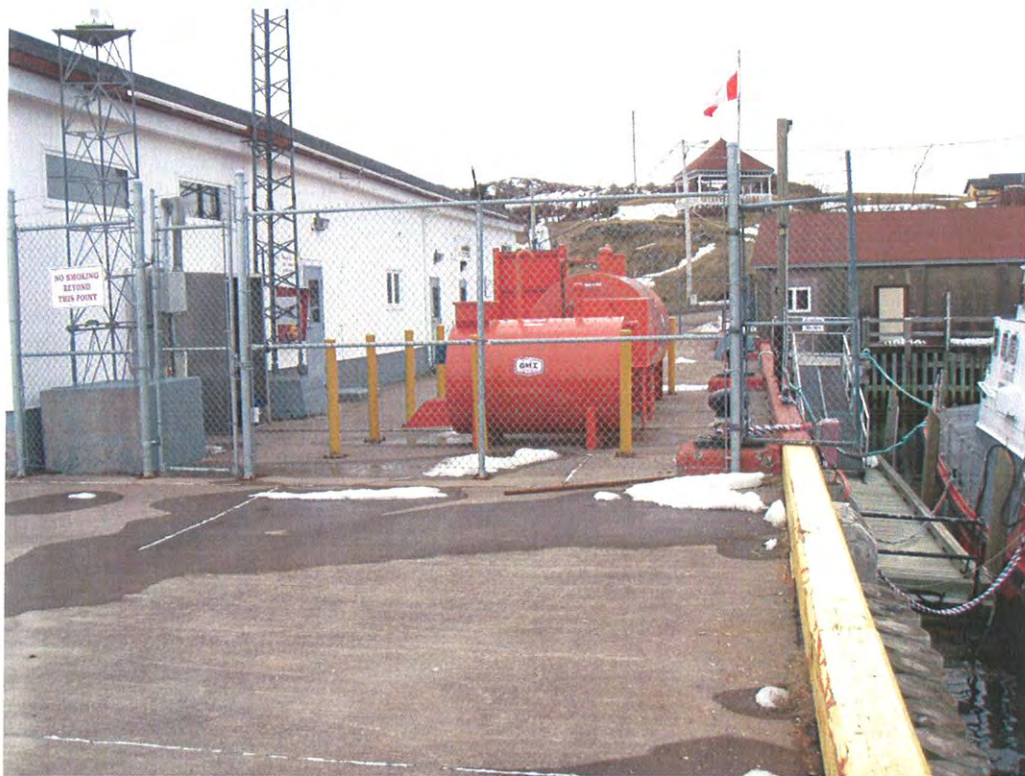
Photo 3: Waste oil AST and fuel oil AST located on the north side of the wharf, looking northwest.

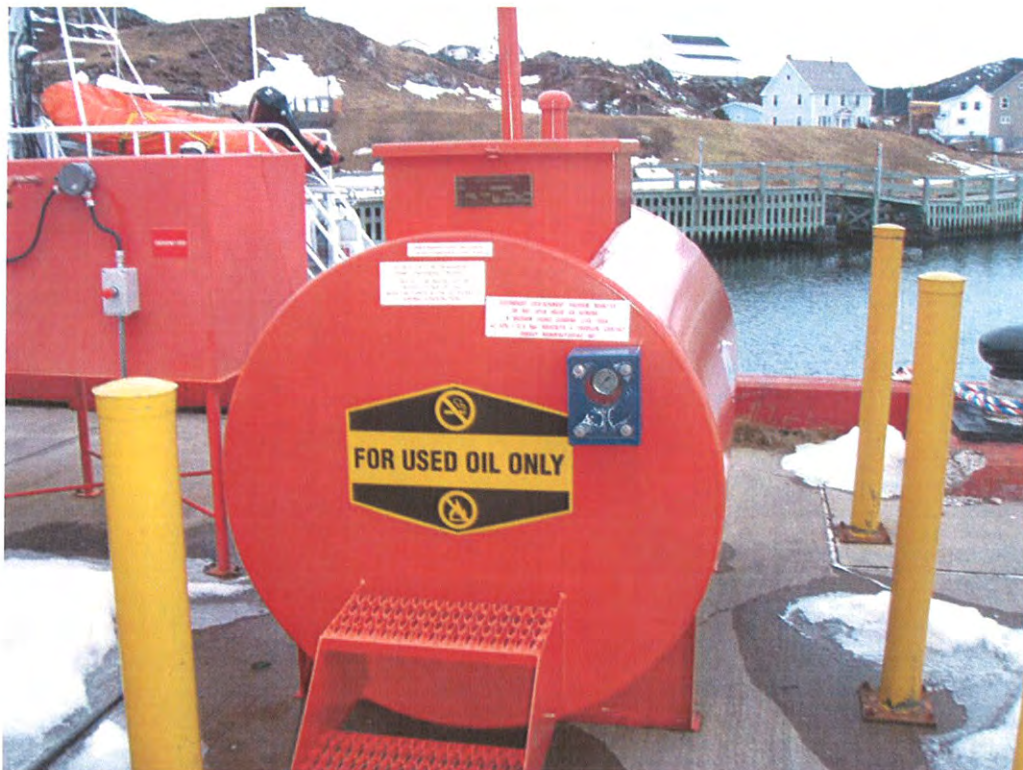
Photo 6: 2,273 L waste oil tank located on the northeastern side of the wharf. Photo taken looking northeast.

Hazardous liquid waste (i.e., waste oil) generated by the rescue boat is stored in an aboveground 2,273 L double walled steel waste oil tank, located on the finger pier on the north side of the building (refer to Photo 6 in Appendix C). No fuel pipelines are associated with the waste oil tank. The waste oil is reportedly collected by a licensed waste oil disposal company such as Pardy's Waste Management and Industrial Services on an as-needed basis.

A 6,819 L aboveground steel fuel oil storage tank (as shown in Figure 121410853-EE-03 in Appendix A and Photo 7 in Appendix C) and a 2,273 L aboveground steel waste oil tank are located in the fenced portion of the pier (as shown in as shown in Figure 121410853-EE-03 in Appendix A and Photo 6 in Appendix C). The tanks are labelled as being installed in 1999 and 2007, respectively. Both tanks appeared to be in good condition and no visible staining in the area of the tanks was noted during the site visit. No fill or vent pipes, or other indicators of potential abandoned USTs were observed on the Site. Oil spill equipment (i.e., containment boom, zodiac, absorbent booms, etc.) are stored in the garage.

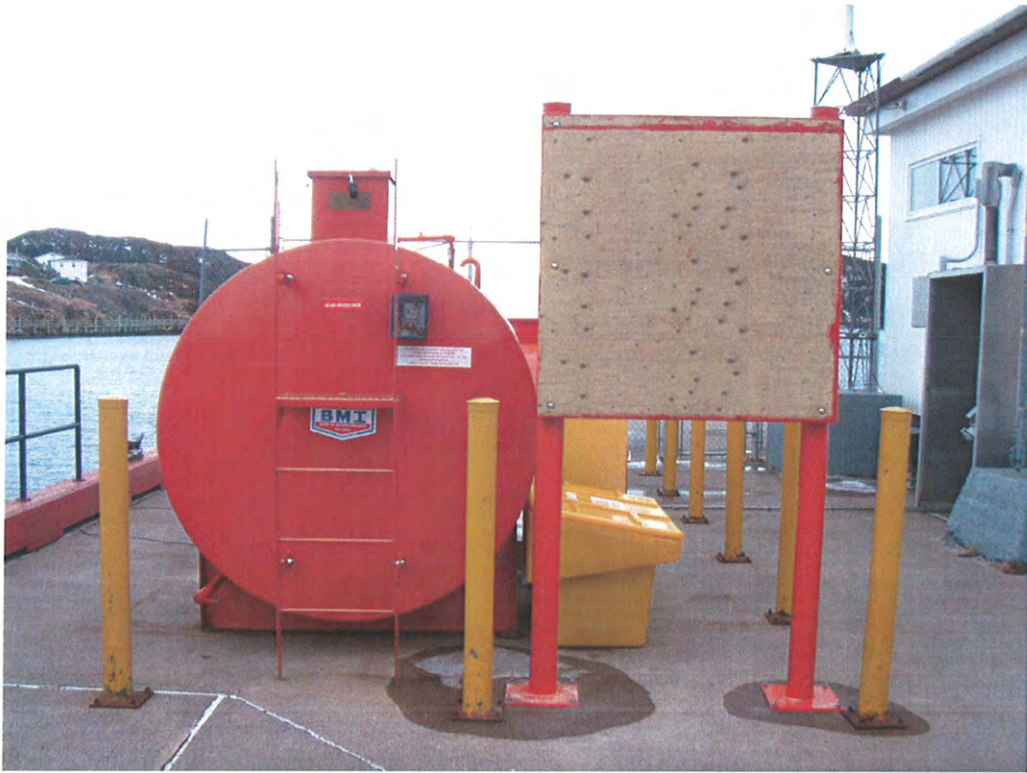
Photo 7: 6,819 L fuel oil tank located on the northeastern side of the wharf. Photo taken looking southeast.

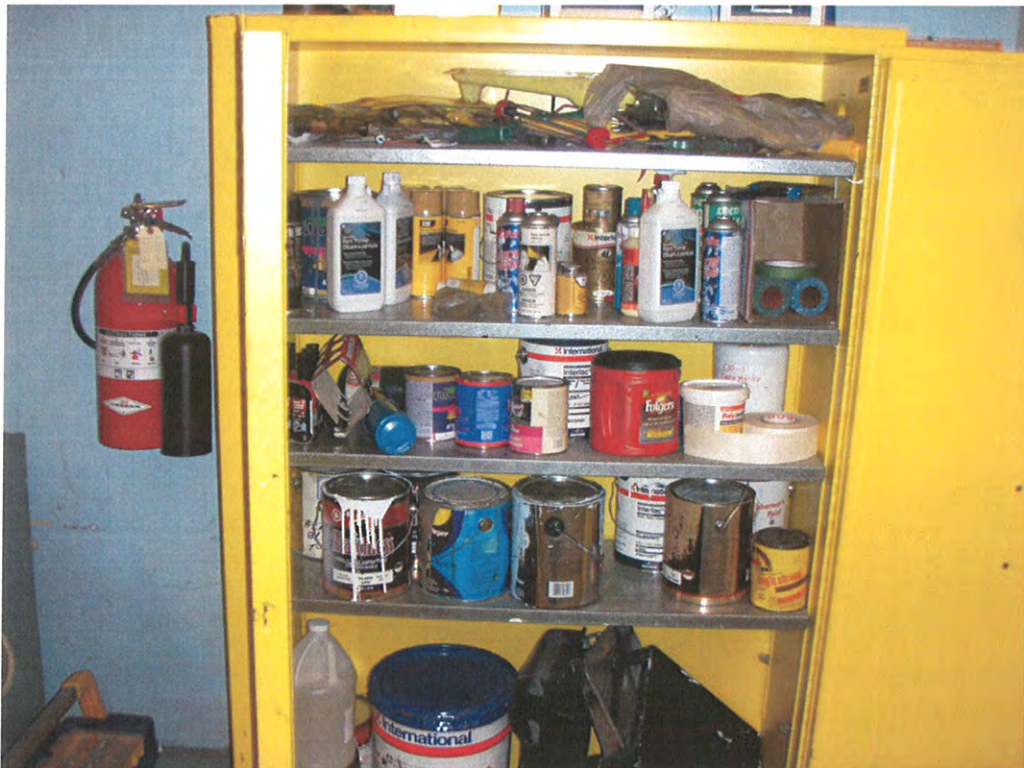
Photo 8: Chemical storage locker located inside the garage area of the Site building.

Chemicals (i.e., paints, paint thinners, glycol, lube oil, etc.) were observed in small containers (i.e., less than 4 L) in a chemical storage locker in the garage area (refer to Photo 8 in Appendix C). An additional fire proof chemical storage locker was observed on the pier inside the fenced area adjacent to the aboveground fuel oil storage tank, which contained gasoline for the Zodiac and a gasoline mix (refer to Photo 9 in Appendix C). Oxygen (O₂) and acetylene tanks were stored in the garage. Household cleaning products are stored in the small storage room. The chemicals observed were stored in original containers and packaging. No evidence of spills or stains was observed on the Site at the time of the site visit. No other chemical or petroleum hydrocarbon products were observed to be stored on the Site.

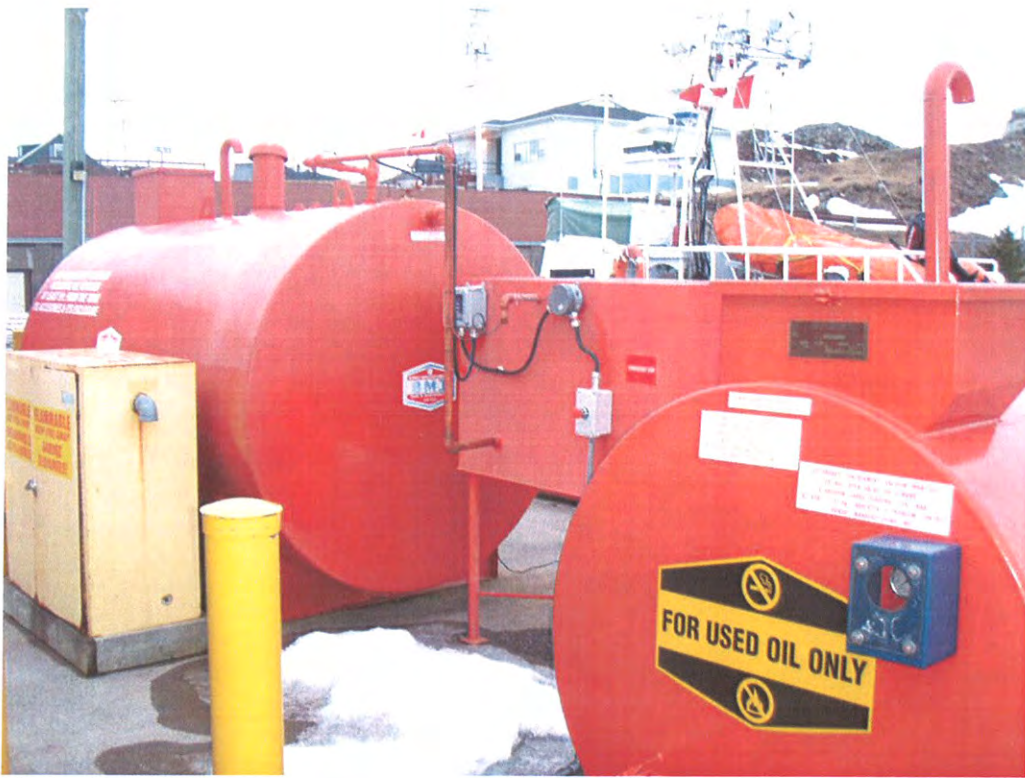
Photo 9: Location of chemical storage locker on the wharf. Photo taken looking north.

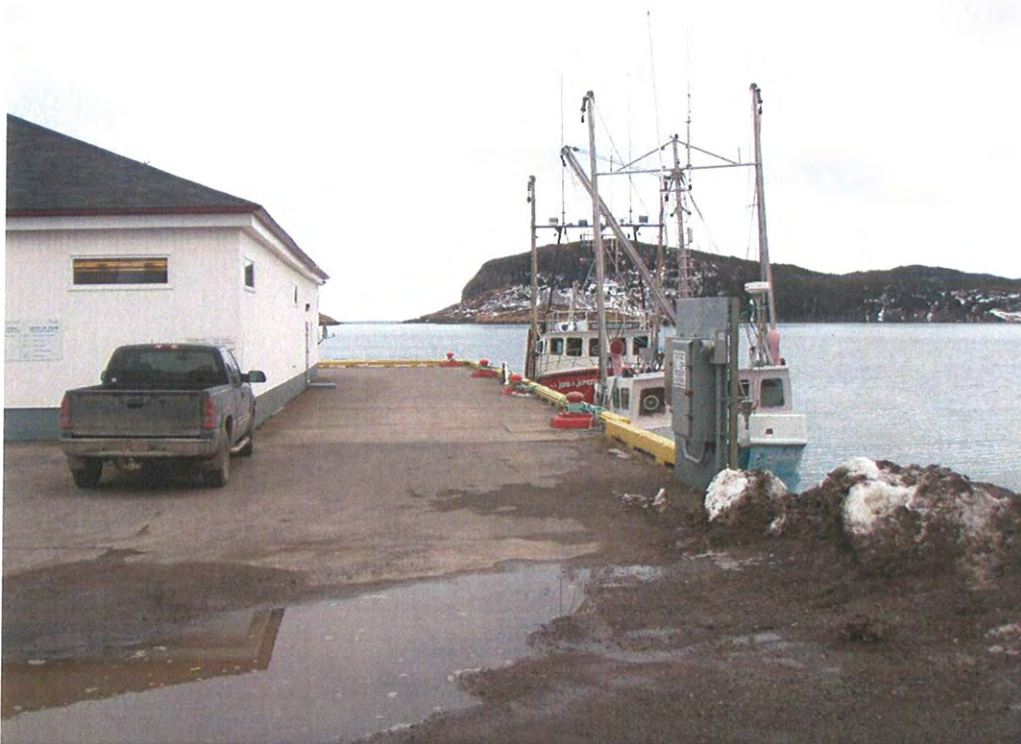
Photo 10: Standing water observed in asphalt parking area, looking southeast.

The finger pier surface is covered by concrete and the parking area at the west side of the site building/finger pier is asphalt-covered. No exposed soil exists at the site for all parcels of land. No stained surficial materials or distressed vegetation were observed on the Site at the time of the site visit. No watercourses (other than the on-site water lot), ditches, pits or lagoons were identified on the Site. Limited standing water was observed in the asphalt parking area. No sheen was observed on the standing water (refer to Photo 10 in Appendix C).

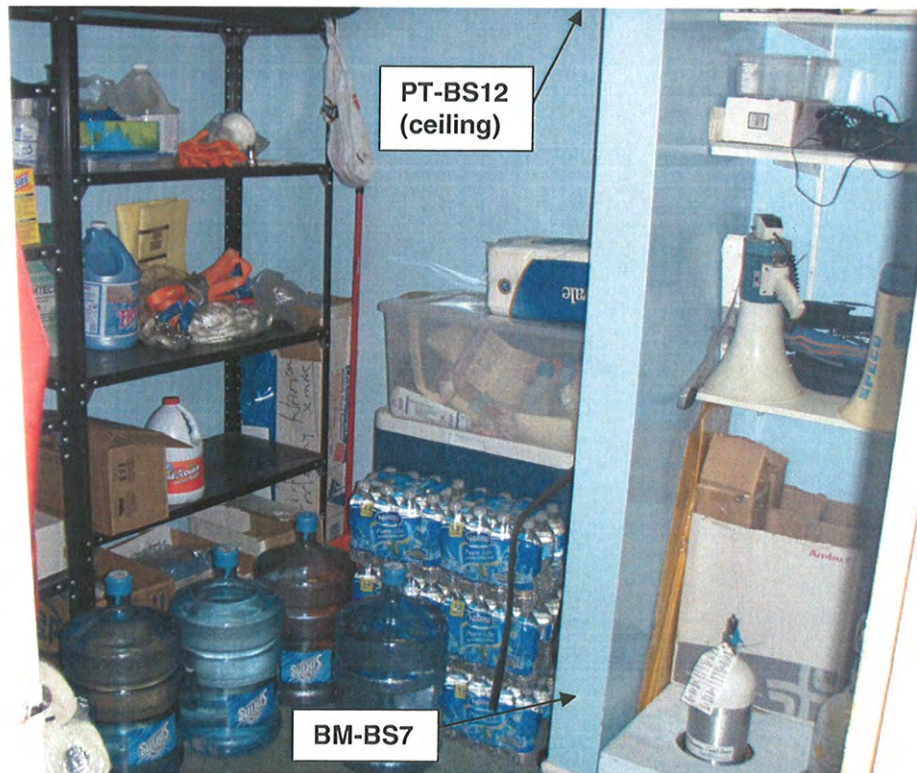
Photo 12: Beige floor tile in Storage Area.

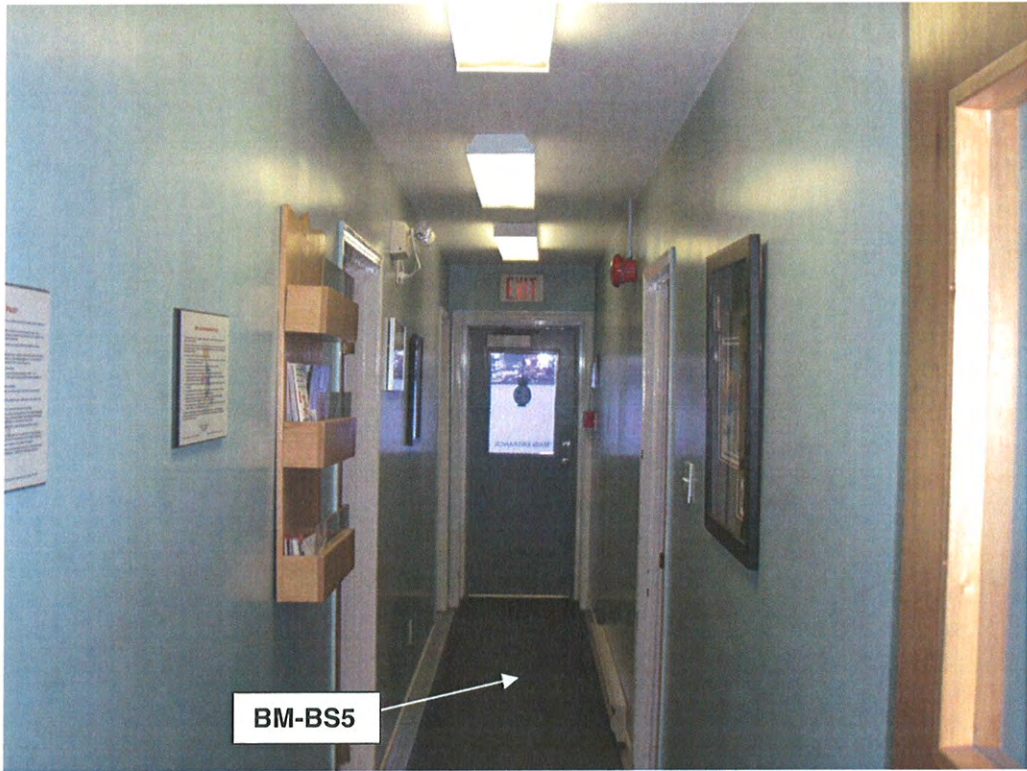
Photo 13 Hallway showing green/black floor tile
