## QUESTIONS AND ANSWERS

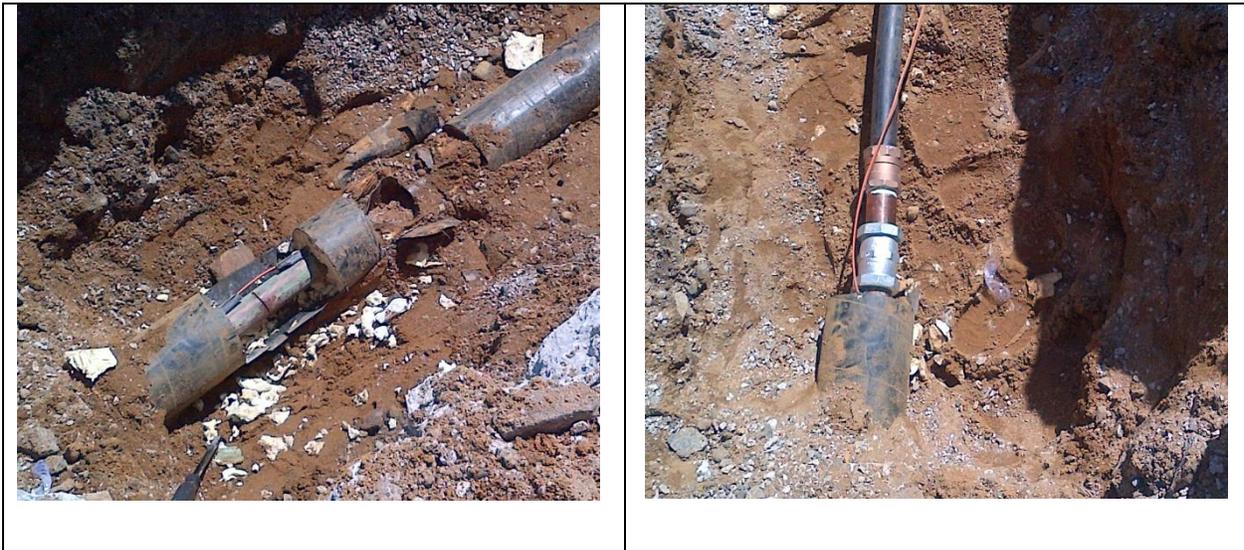
A2 There are no details available for the heat trace cable. The following photographs taken during repairs in 2013 are for visual information.

Q2 The tender package calls for the replacement of the self-regulating heat tracing cable where sections of the existing waterline are to be replaced. Does the government possess details about the type and wattage of the existing wire? The wattage of the replacement heat tracing wire will need to match the existing to maintain proper temperature regulation, and depending on the type of wire it may or may not be able to be spliced in the field as called for on the Drawings.

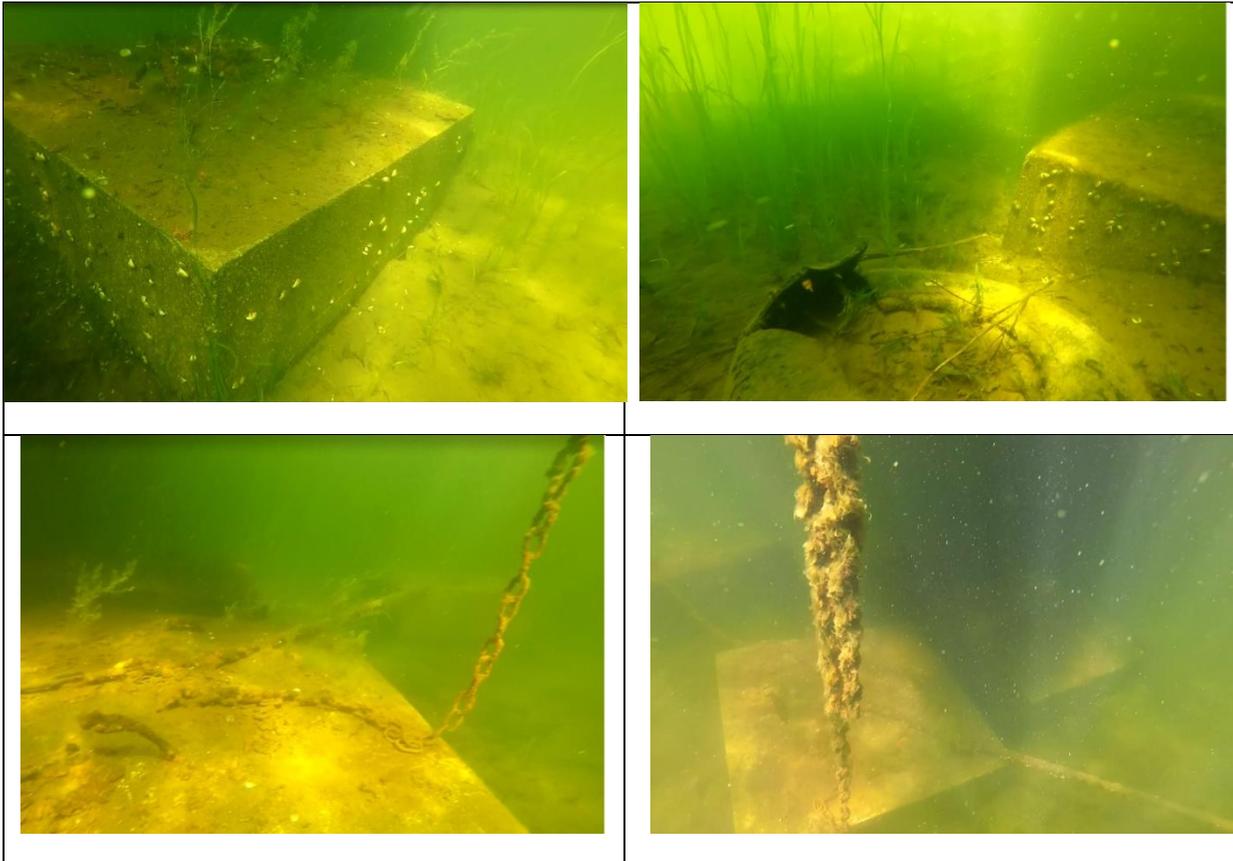
A5 The existing lake bottom is characterized as sandy silt. It is an estimated that 60 percent of the blocks are sitting on the lake bottom. The remaining have silt around them to varying degrees, with partially exposed sides. Blocks near the toe of the rip-rap shore line are partially covered with rock. There is a centre loop in each block where the chains attach. Outboard of the centre are two wire rope loops. Some wire rope loops have rusted through. Some anchor blocks in close proximity to each other are linked together with chain. Some sample photographs are below

Q5 It was made known at the meeting that there was a previous dive operation that resulted in the removal of two existing dock sections; it was also made known that the divers located the concrete anchors shown on the plan. From that operation a few items would have been documented; namely, the visibility conditions at the water bottom, the type of bottom (whether it was sand, silt, clay, etc.), how far the existing concrete blocks have sunk into the bottom (e.g. are they on top of the floor or 6" embedded), and the condition of the lifting anchors on top of the concrete blocks (e.g. did they seem to experience section loss or were they suitable for a lifting operation). Could this information please be provided along with any report from the previous dive operation?

This information is pertinent for pricing. If the concrete blocks have sunk 6" + into muck as an example, they may not be movable. Additionally, if the condition of the lifting anchors is not suitable for re-use then new anchors will need to be drilled into the concrete blocks; which is a time consuming endeavor.
