ADDENDUM NO. 2

1.1 LEAD ABATEMENT SCOPE OF WORK

**Lead Assessment
RCMP D Division
Date November 23, 2016**

Re: Summary of Lead Dust Assessment and Recommendations

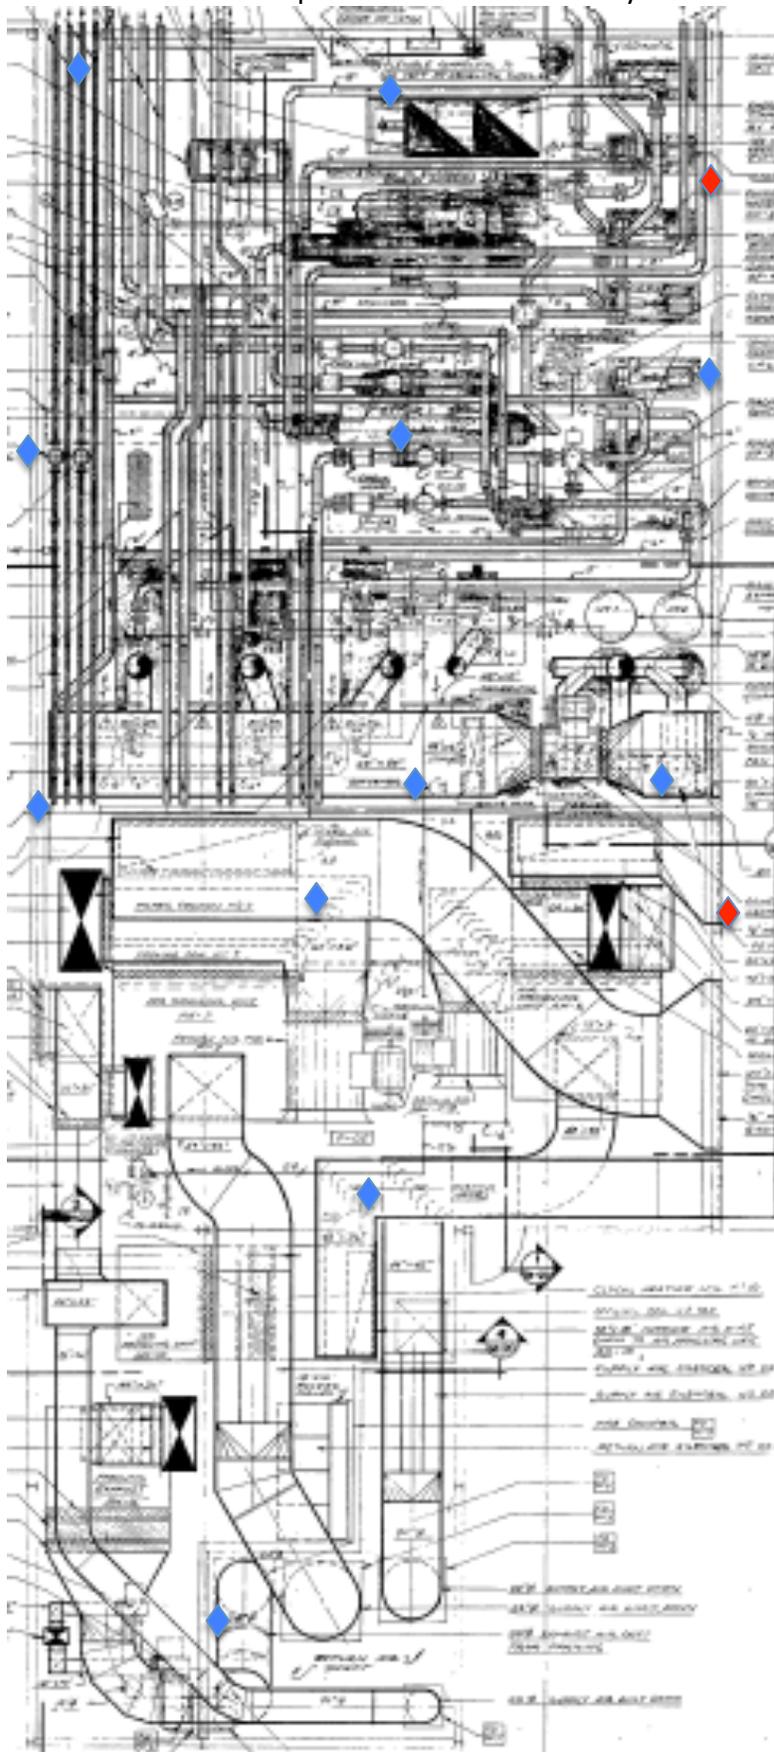
Red diamonds are samples that were analyzed

Blue diamonds are samples collected but not analyzed.
