Parks Canada Basic Impact Analysis

St. Andrew's Presbyterian Church roof and fire suppression system (sprinkler) replacement
Bennett, British Columbia

Parks Canada, Yukon Field Unit

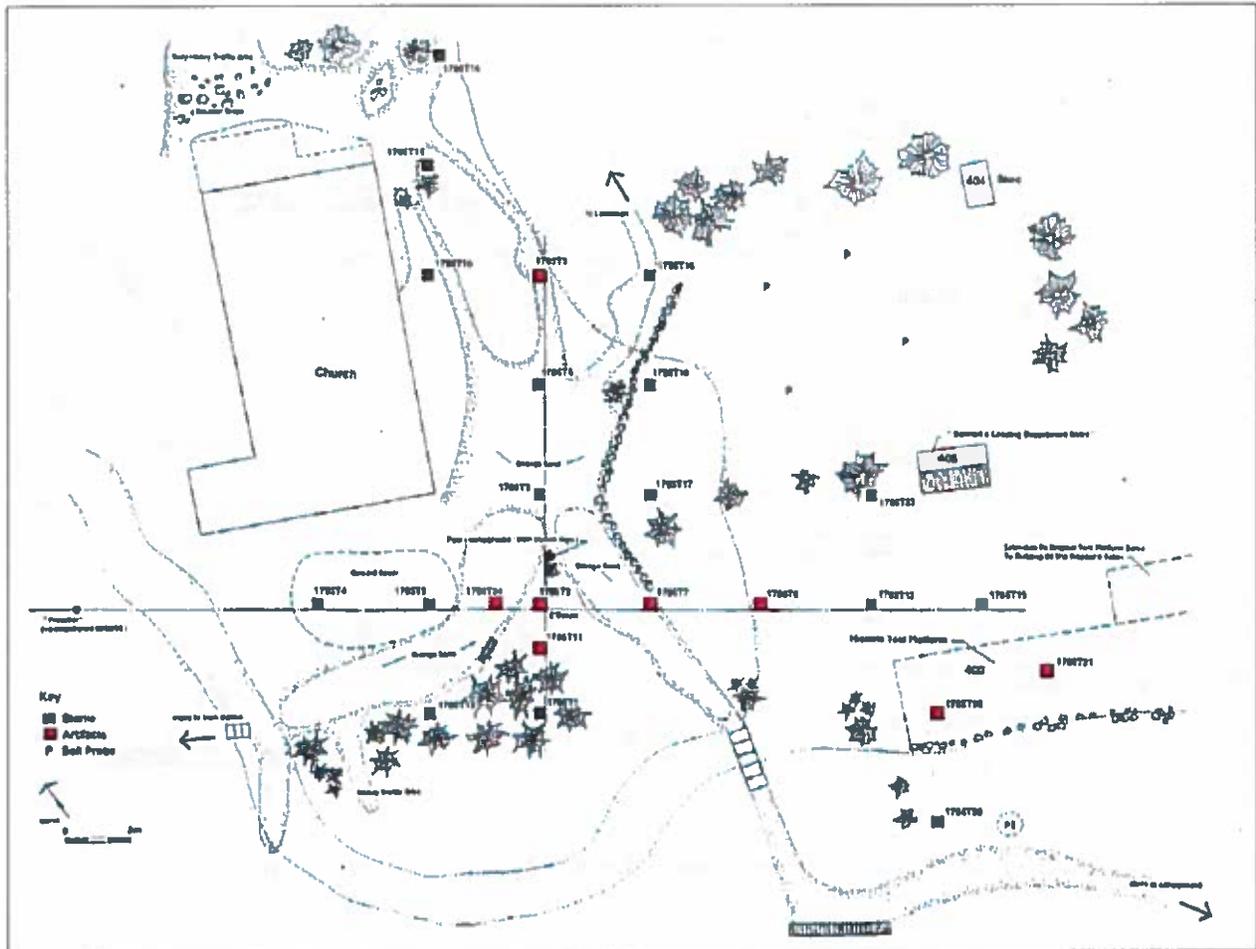
Figure 2: Map of site 1785T in relation to the St. Andrew's Church at Bennett. Boxes shaded red show where precontact artifacts were recovered in archaeological test pits. Results indicate shallowly buried artifacts may be present throughout the work area.

This pre-contact site, located immediately adjacent to St. Andrew's Church at the northern terminus of the Chilkoot Trail at Bennett Lake (Figure 2) was first recorded in 1988 and re-examined during a field survey in 1995. Artifacts were recovered both on the surface and buried at a shallow 2 cm below surface from a number of excavated test units. The following summarizes the results of the archaeological investigations:

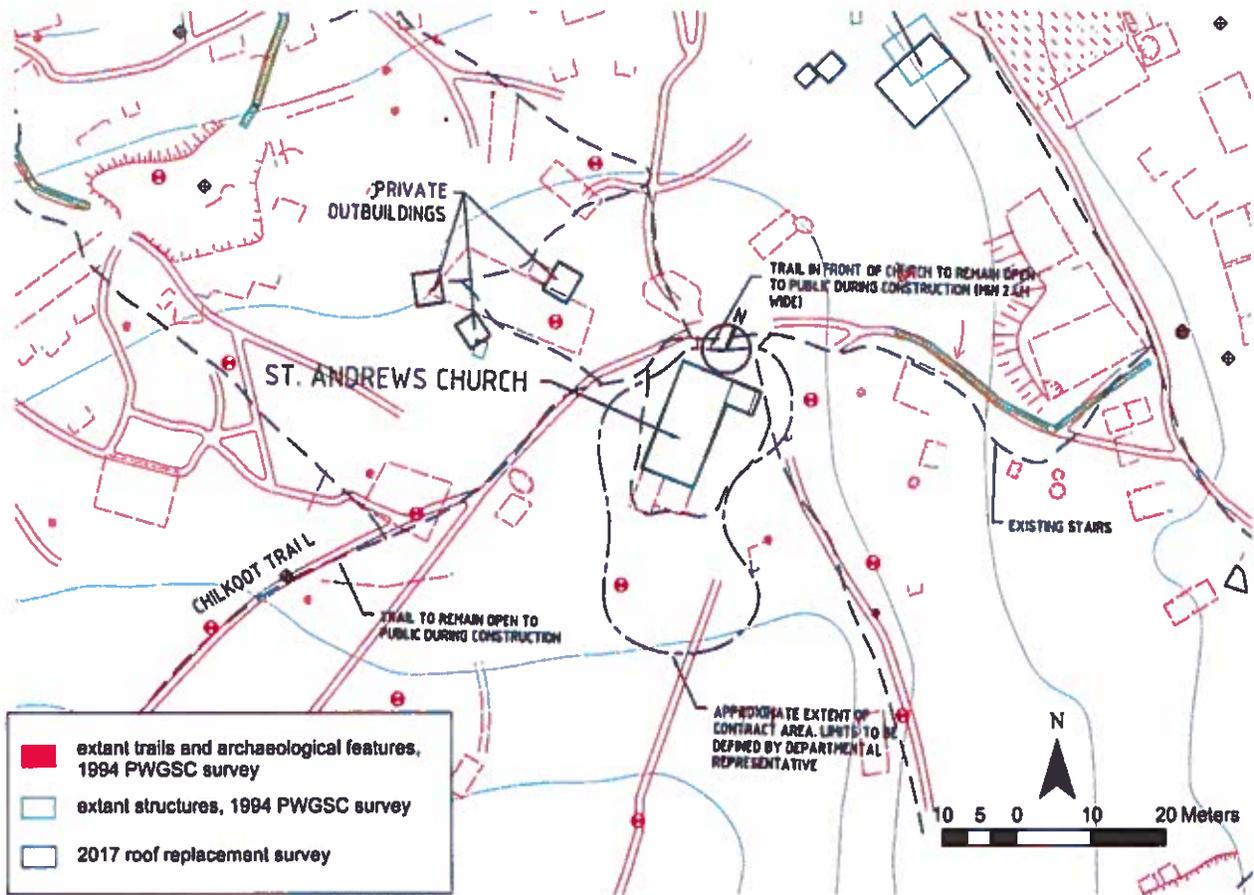
Figure 3: Extant archaeological features recorded in the vicinity of St. Andrew's Church.

There are visible archaeological resources around the church. These include stone retaining walls and raised earthen platforms that delineate the foundations of the former kitchen and woodshed at the rear of the church. Those previously recorded in close proximity to the church are depicted in Figure 3. Between the church and the Bennett Lake shoreline are a number of surface structural features as well as a number of historic period features including boat slips that become exposed as lake water levels recede throughout the summer. These features are mapped in Figure 4.

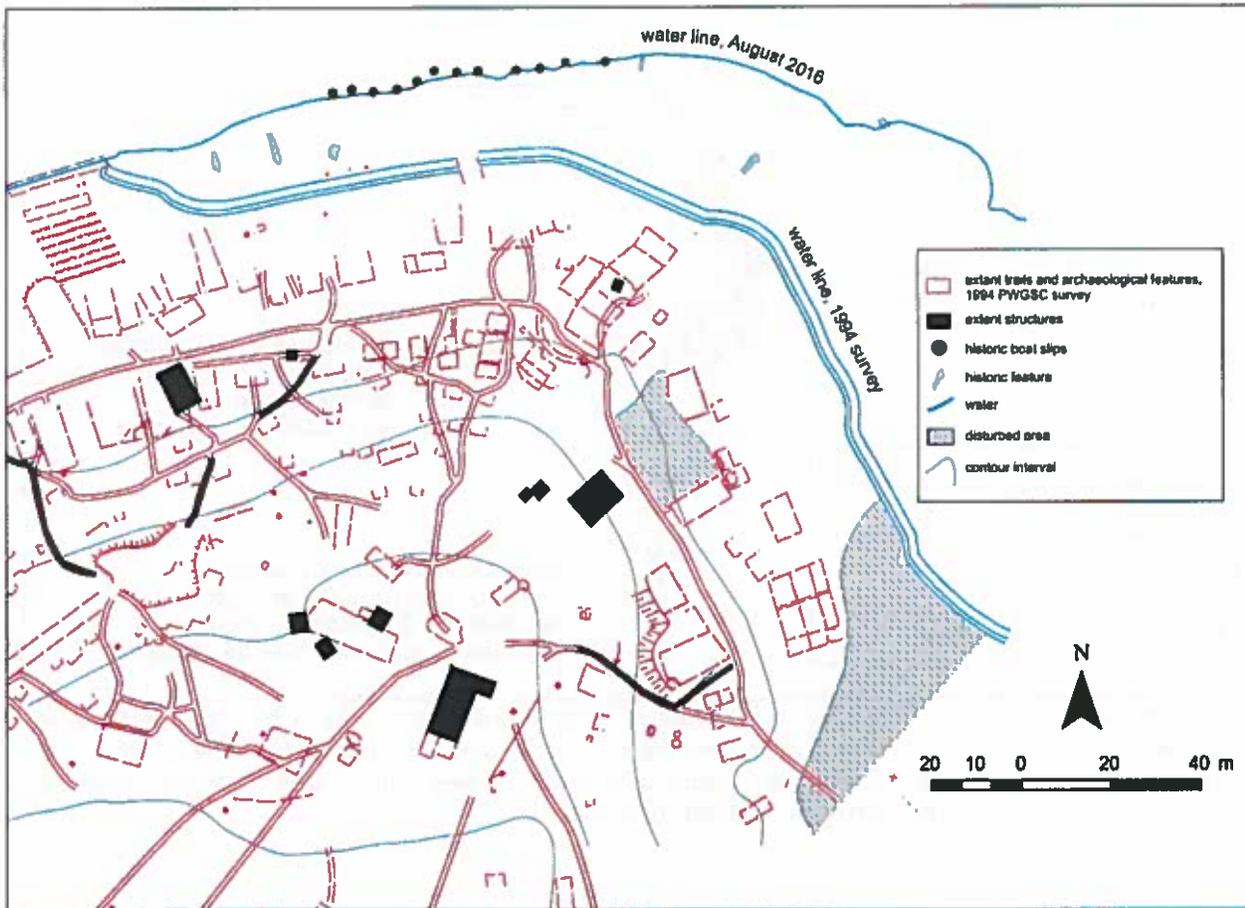
Figure 4: Extant archaeological features recorded in the vicinity of St. Andrew’s Church and Lake Bennett shoreline. Note difference in lake levels in 1994 and 2016.

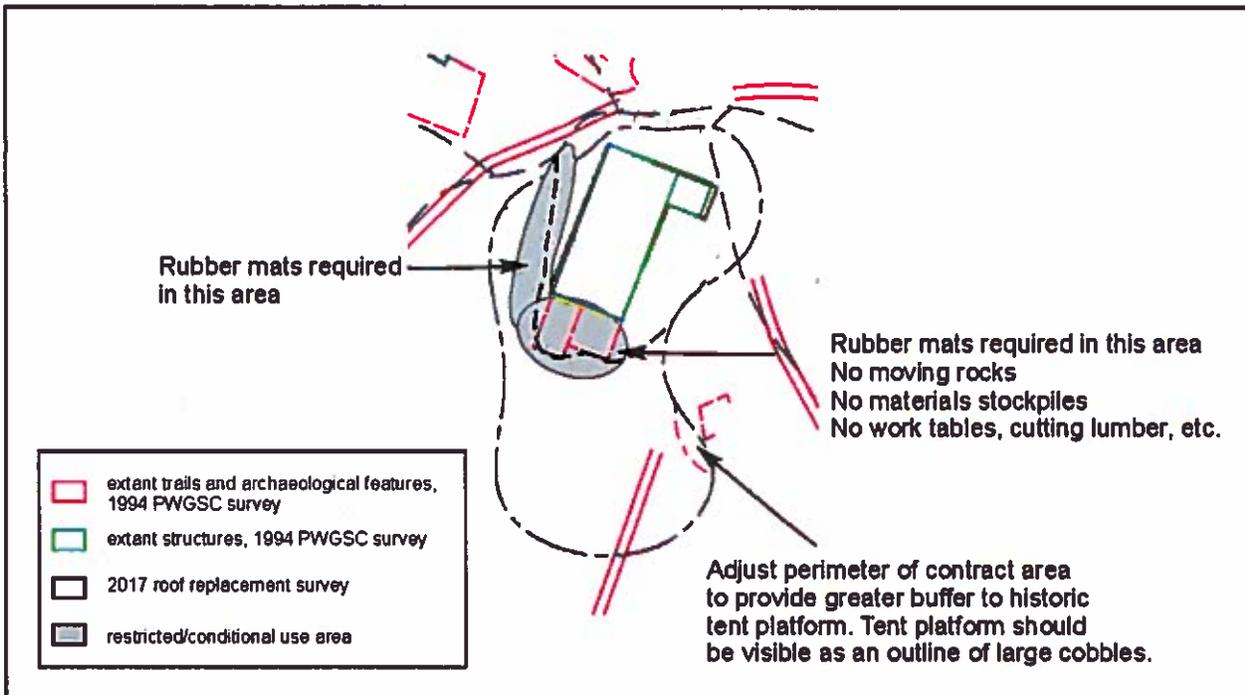
Figure 5: Immediate area surrounding Church, note former kitchen and woodshed area (to be avoided for laydown and protected from foot traffic by rubber matting –see Figure 6) on the south-southwest end of the church. A greater buffer is required for the archaeological feature to the south and east of the church. Preferred laydown or material storage area to be on hillside to the south side of church.

<p><u>Fire Suppression System Replacement</u> Low - Archaeological Resource Concerns</p>	<p>Replacement of the fire suppression system, if placed in the same location of existing system, should not impact on archaeological resources or features. A caution remains that care and attention should be made when adjusting and anchoring the intake system at the lake shoreline to avoid the recorded historic features such as the boat slips (Figure 4).</p>
<p><u>Temporary Interpretive Signage Installation</u> Low - Nil Archaeological Resource Concerns</p>	<p>Installation of signage should incorporate existing infrastructure such as fences or existing posts and walkways. No new posts or holders that impact the surface should be contemplated.</p>
<p><u>Staging and Work Areas</u> Moderate Archaeological Concerns if contract area remains as proposed Low Archaeological Resource Concerns, with modifications to the proposed contract area</p>	<p>The preferred staging area is located south of the church on the hill side. This location avoids known intact deposits of site 1785T. One historic feature to the south and east should be adequately buffered (Figure 5). The wood shed and kitchen area have both on surface boulders and shallow buried archaeological features located adjacent to the south wall of the church. This area needs to be covered with protective rubber matting (Figures 5, 6). Laydown and material storage should be restricted to designated areas only.</p>

1. Restricting use of the area abutting the south side of the church, where the foundations of a former kitchen and woodshed are present (Figs. 5, 6). These foundations are visibly marked by scattered large stone cobbles on the surface. Shallowly buried artifacts are expected to be present. Foot traffic through this area is permissible, but the ground surface must be protected by rubber matting. No work tables, cutting wood, etc. are permitted in this area. Cobbles must not be moved.
2. The contract area must be modified slightly on its east side to provide a greater buffer for a historic tent platform (Fig. 5).
3. Rubber mats must also be used in the work area on the west side of the church (Fig. 5). This will prevent erosion/exposure of shallowly buried artifacts associated with precontact use of the area around the church."

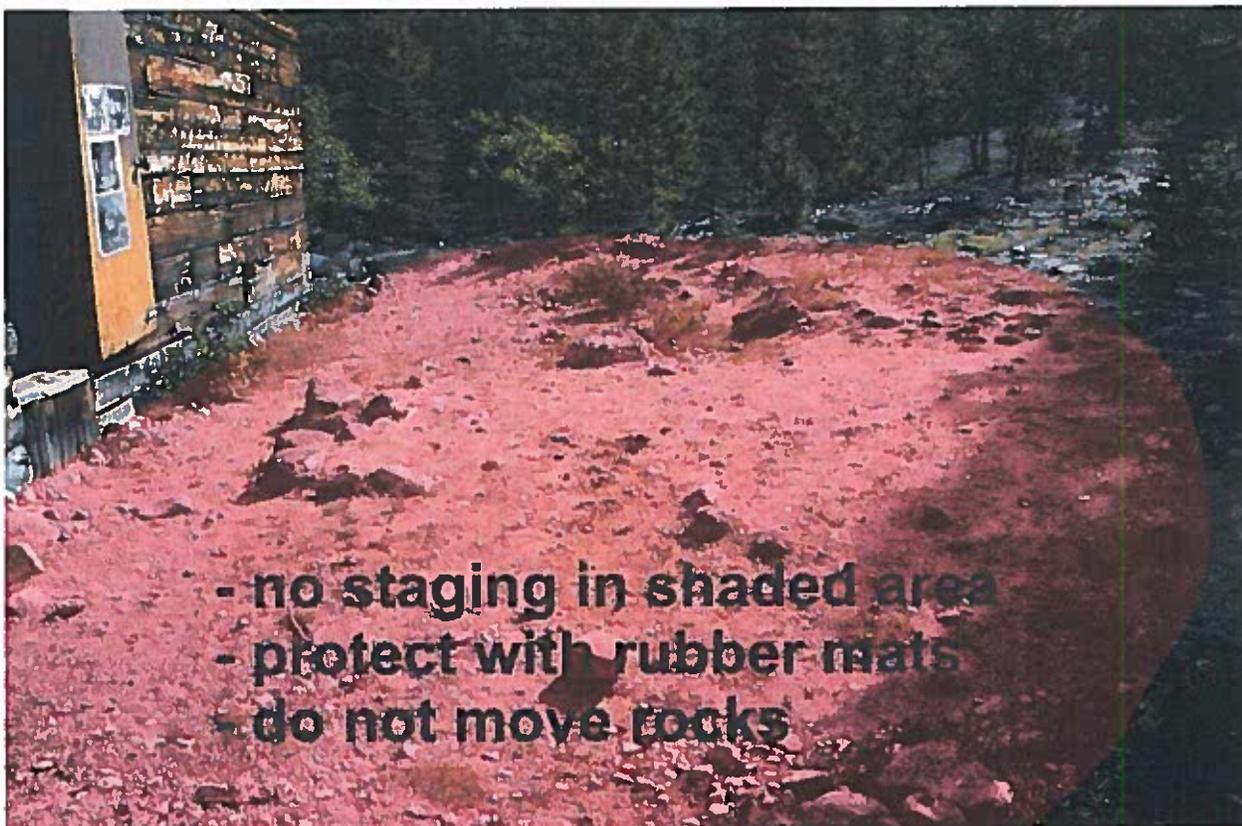
Figure 6: Kitchen and wood shed area at south end of church illustrating area to be protected during project.
