project: BOBS LAKE DAM REPLACEMENT
BOLINGBROKE - ONTARIO

title: FOUNDATION TREATMENT PLAN
SECTIONS AND DETAILS

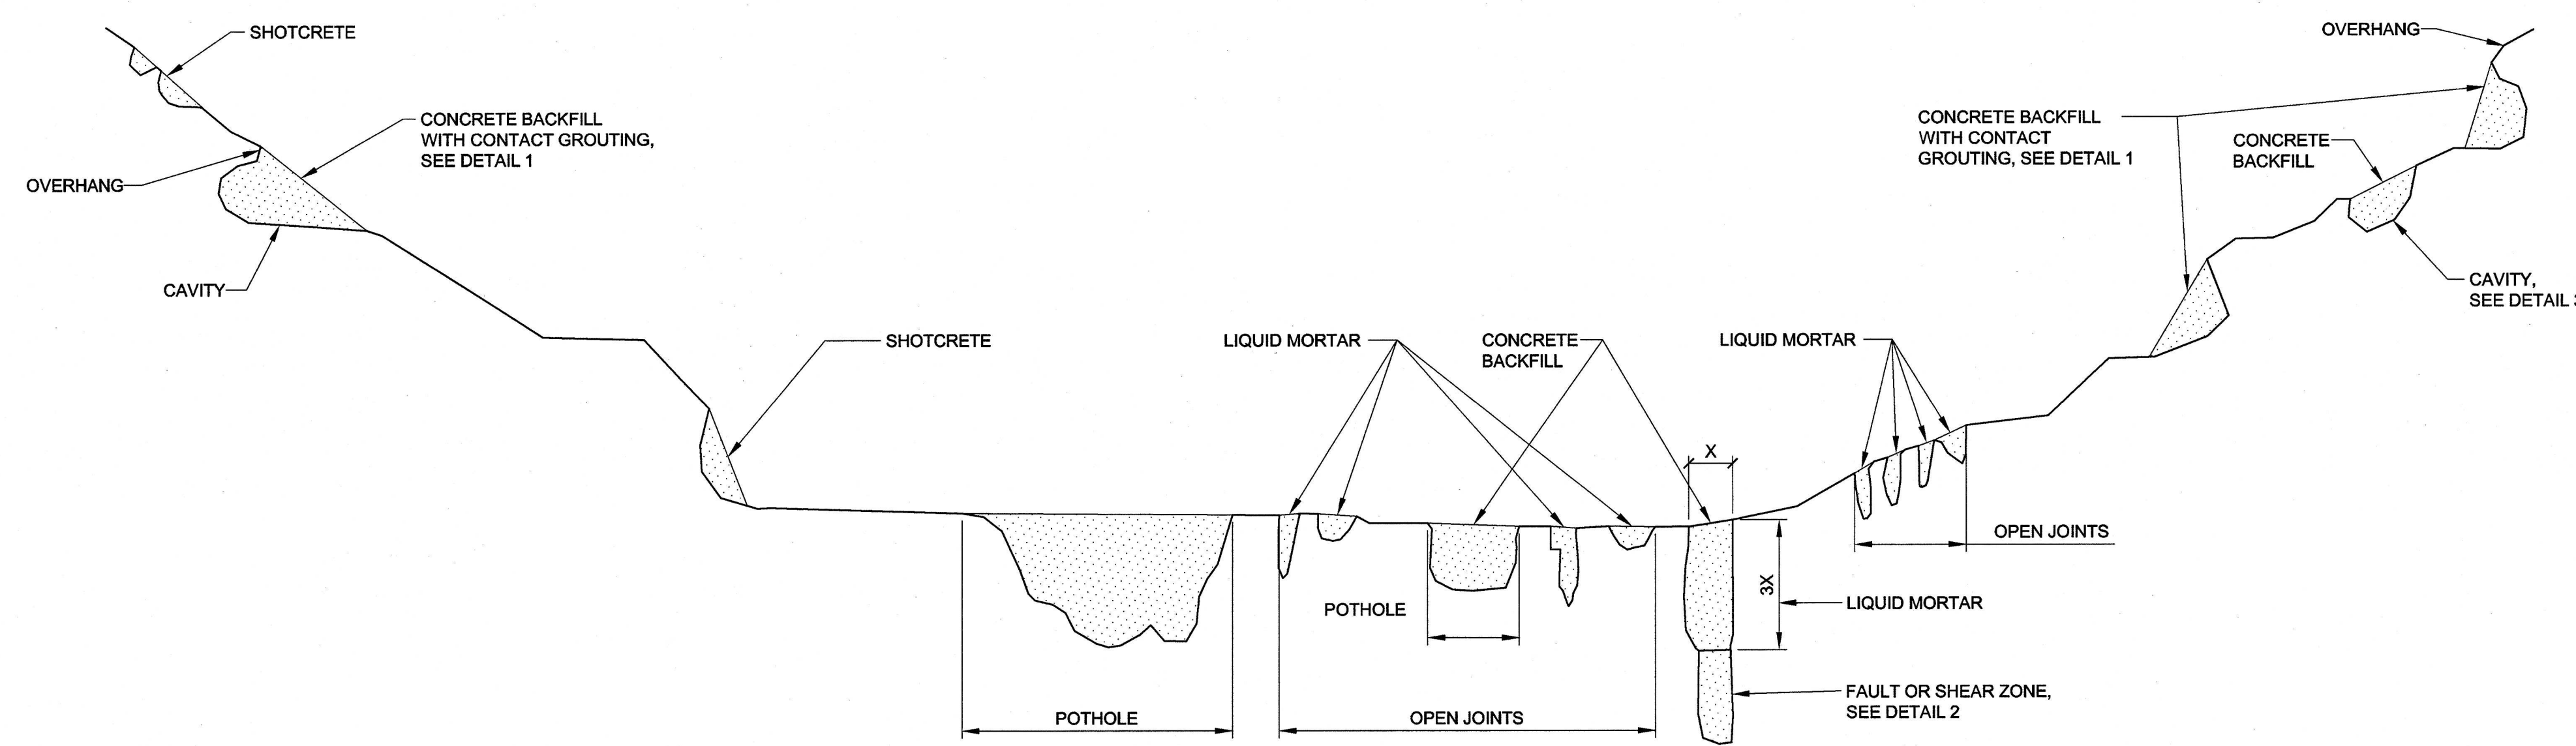
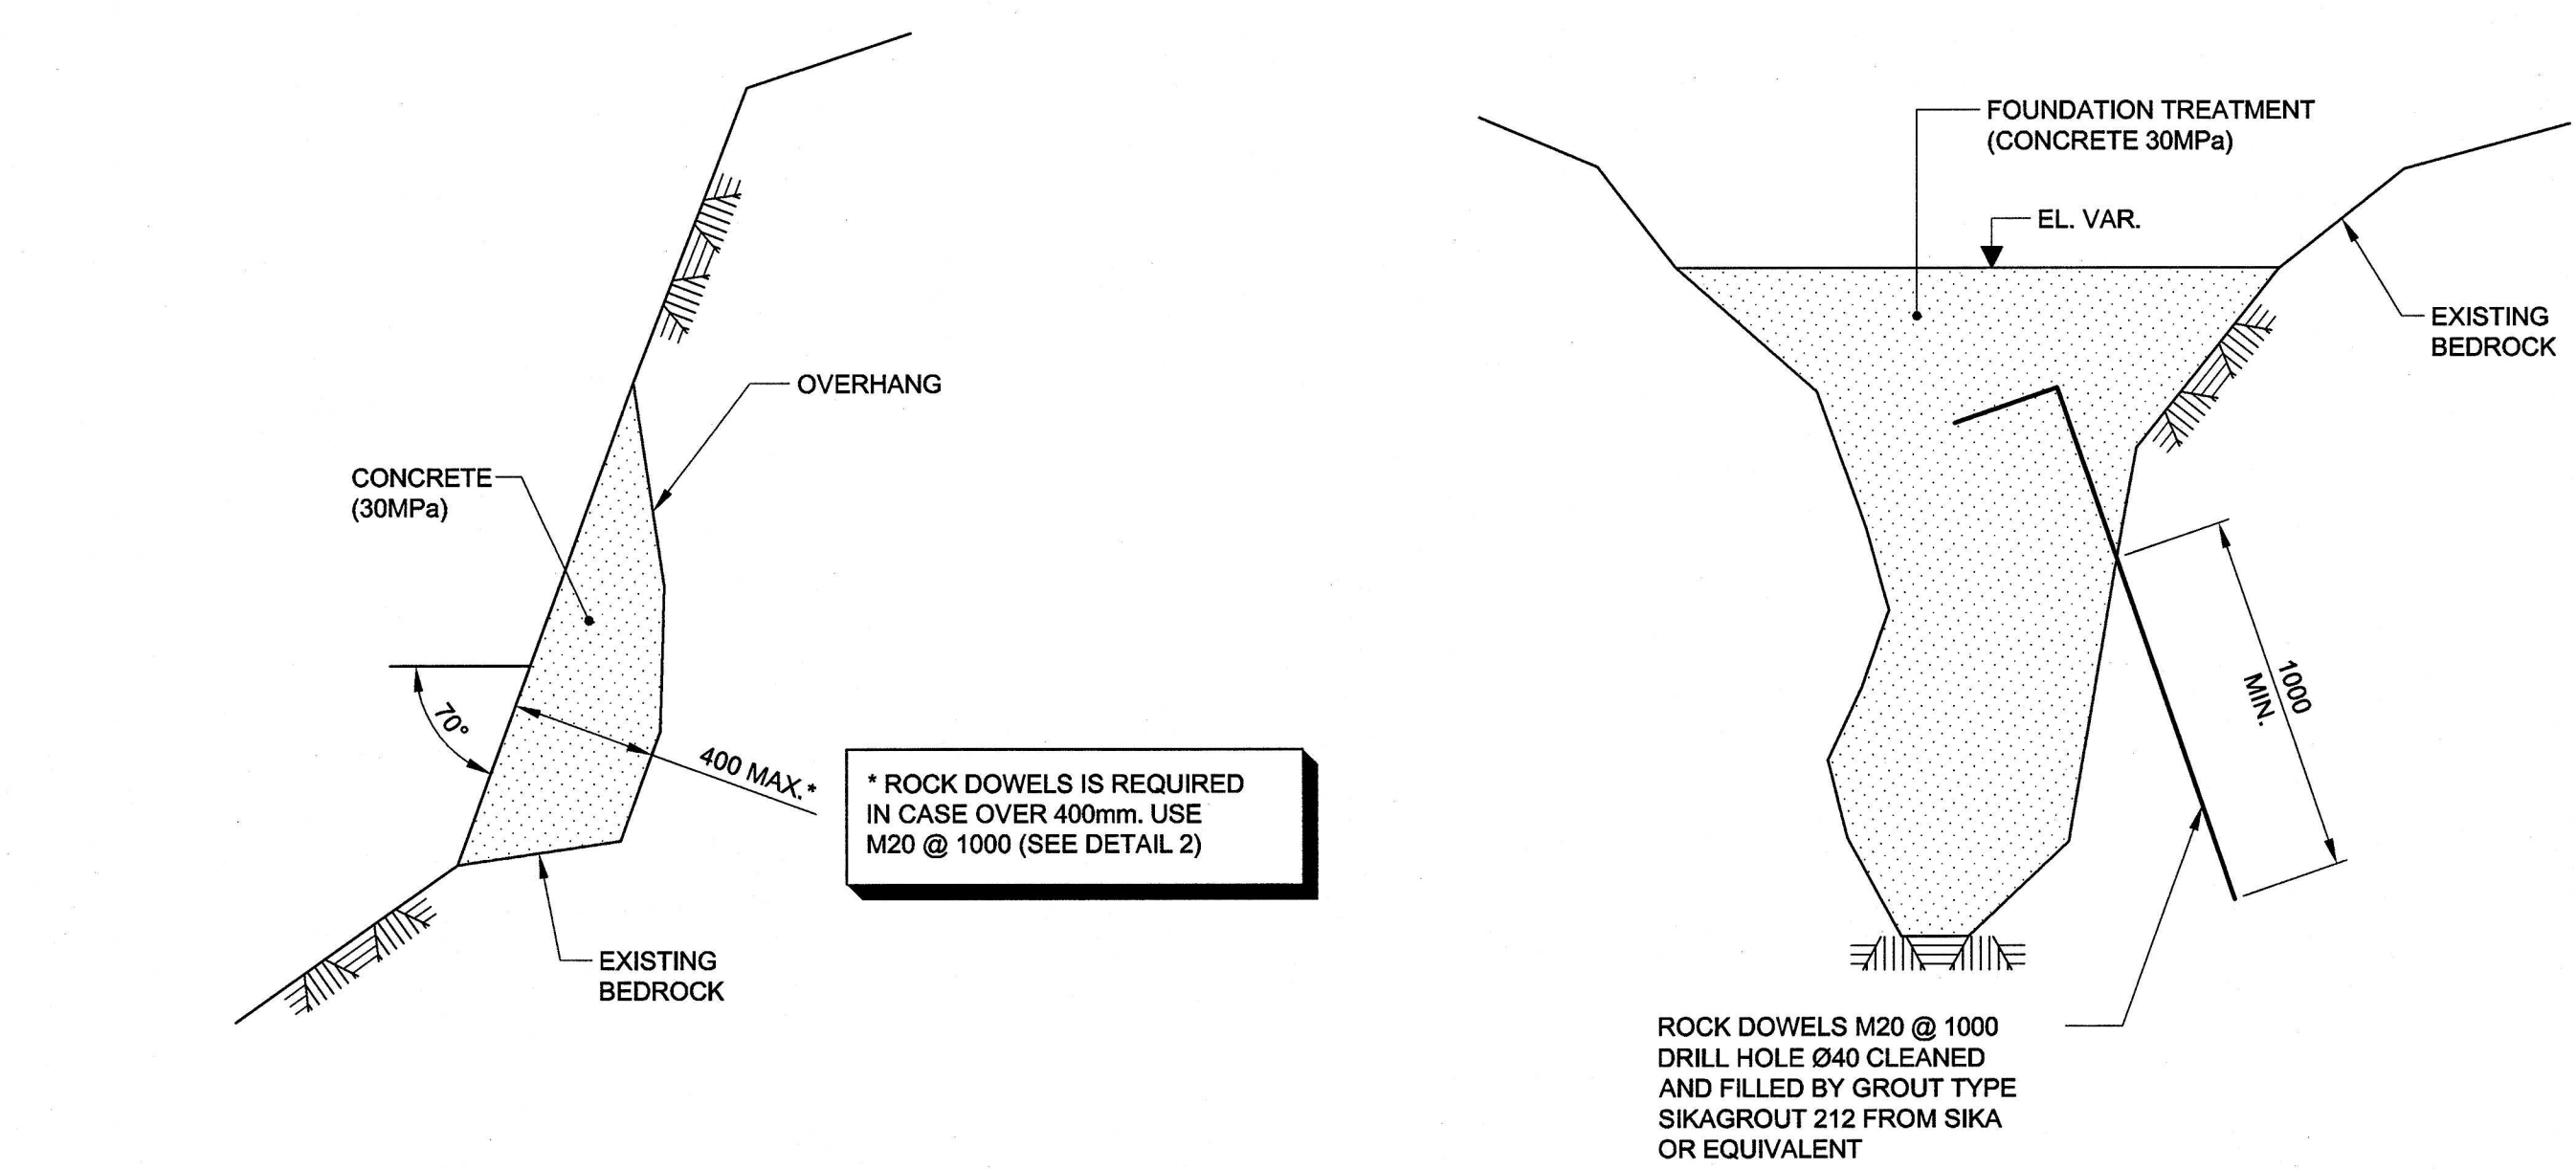
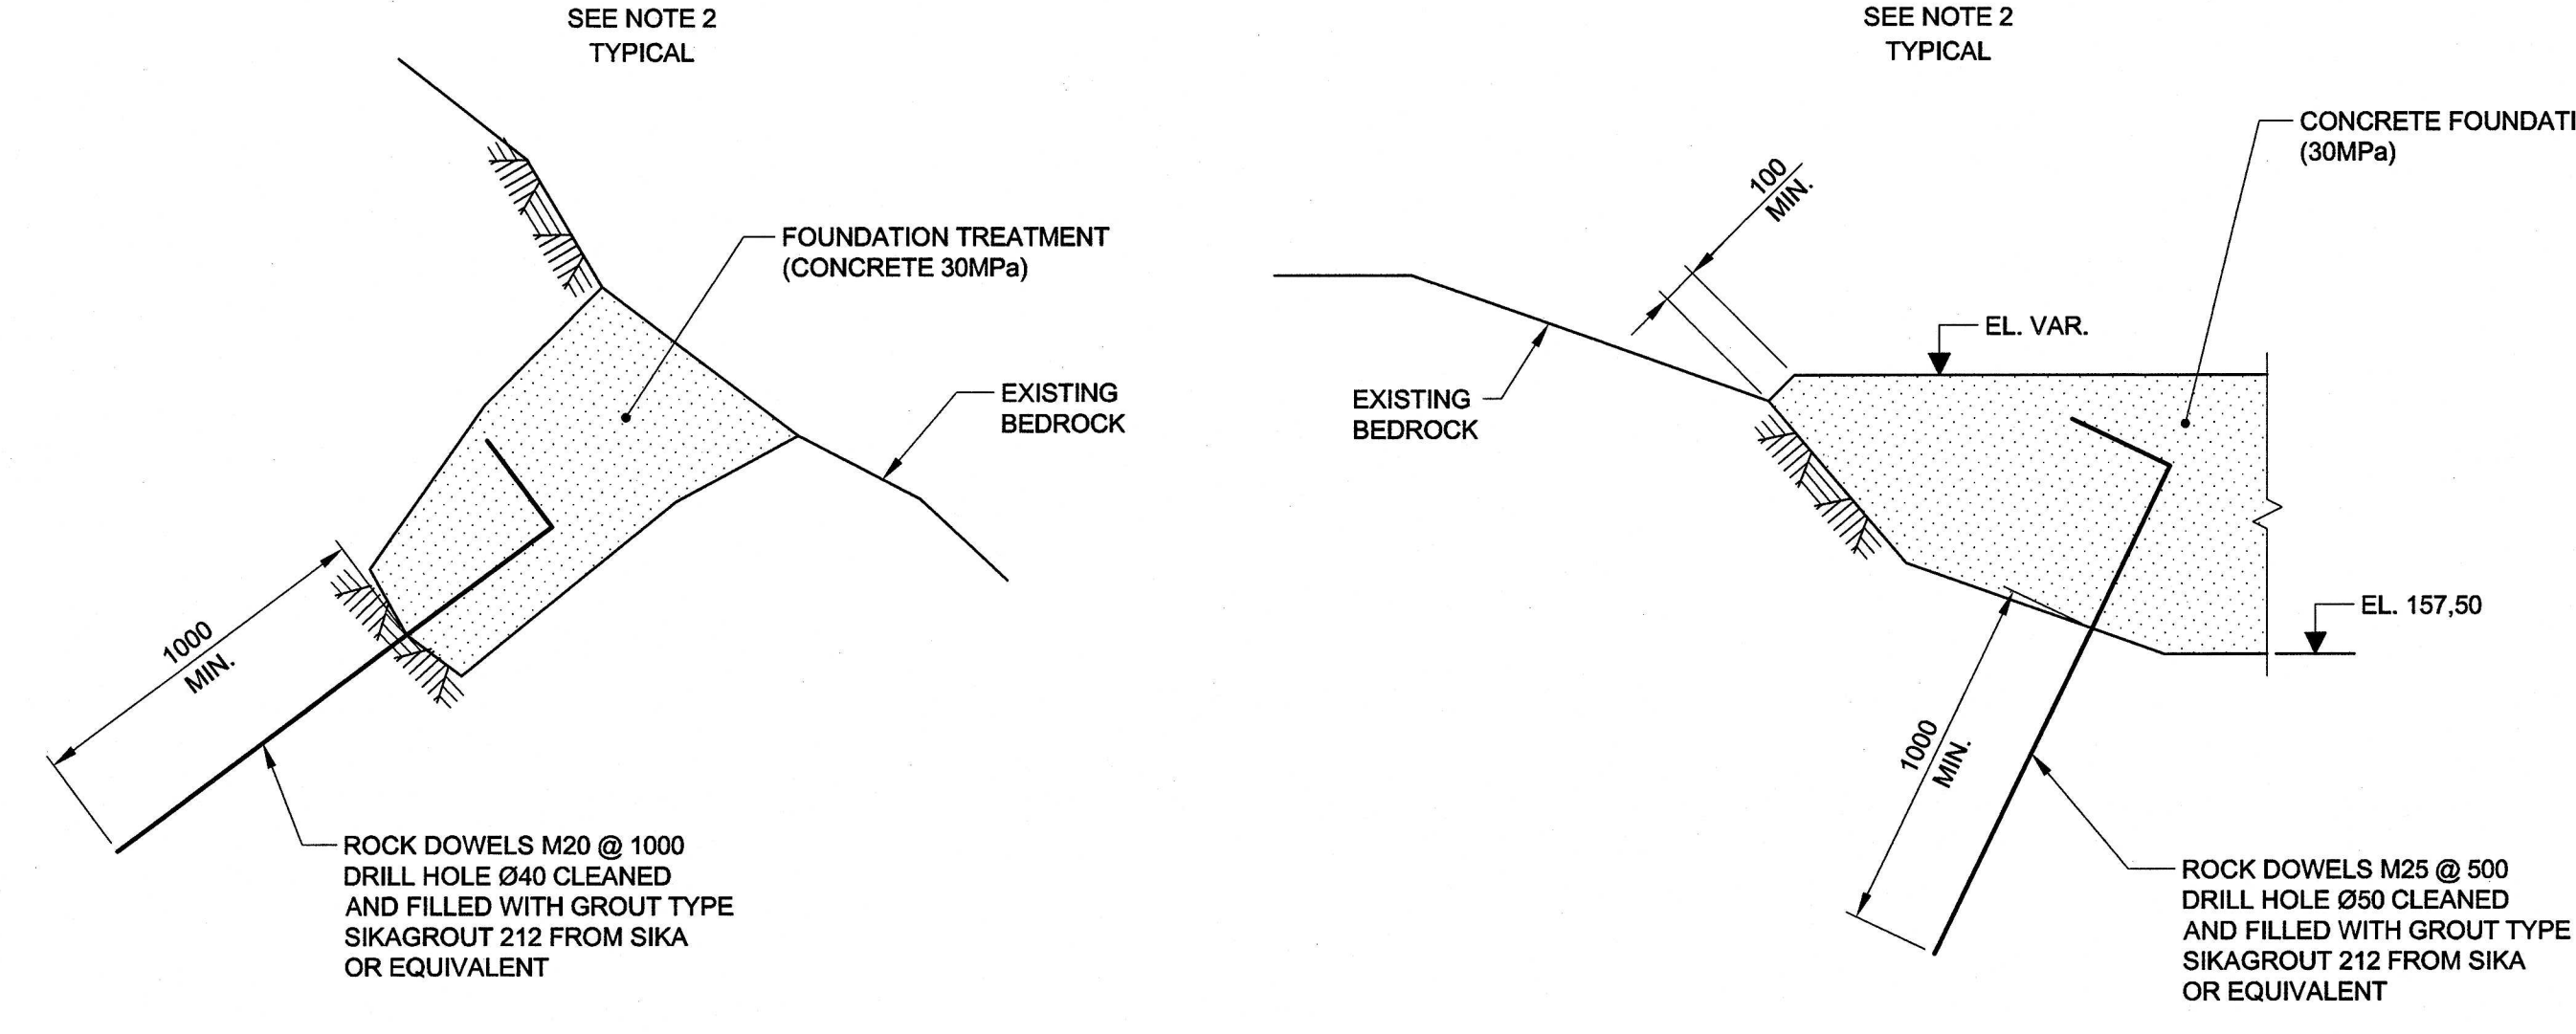
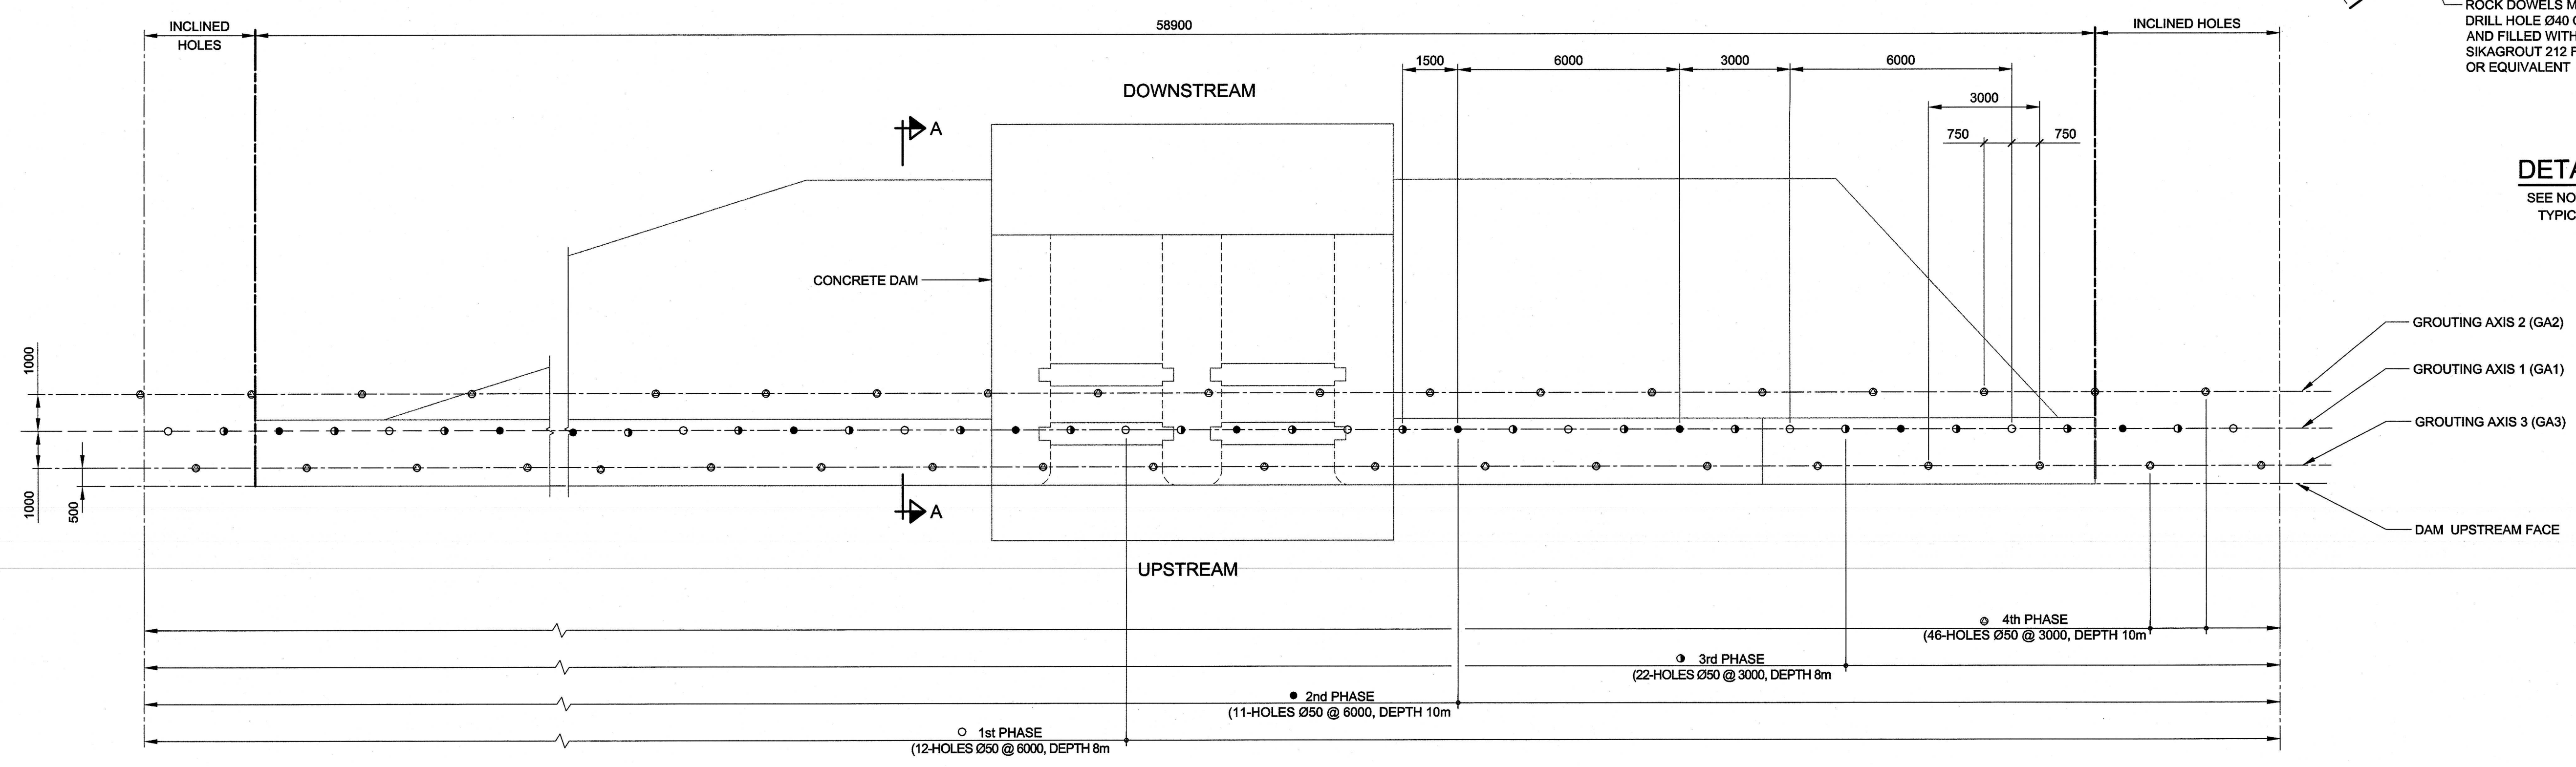
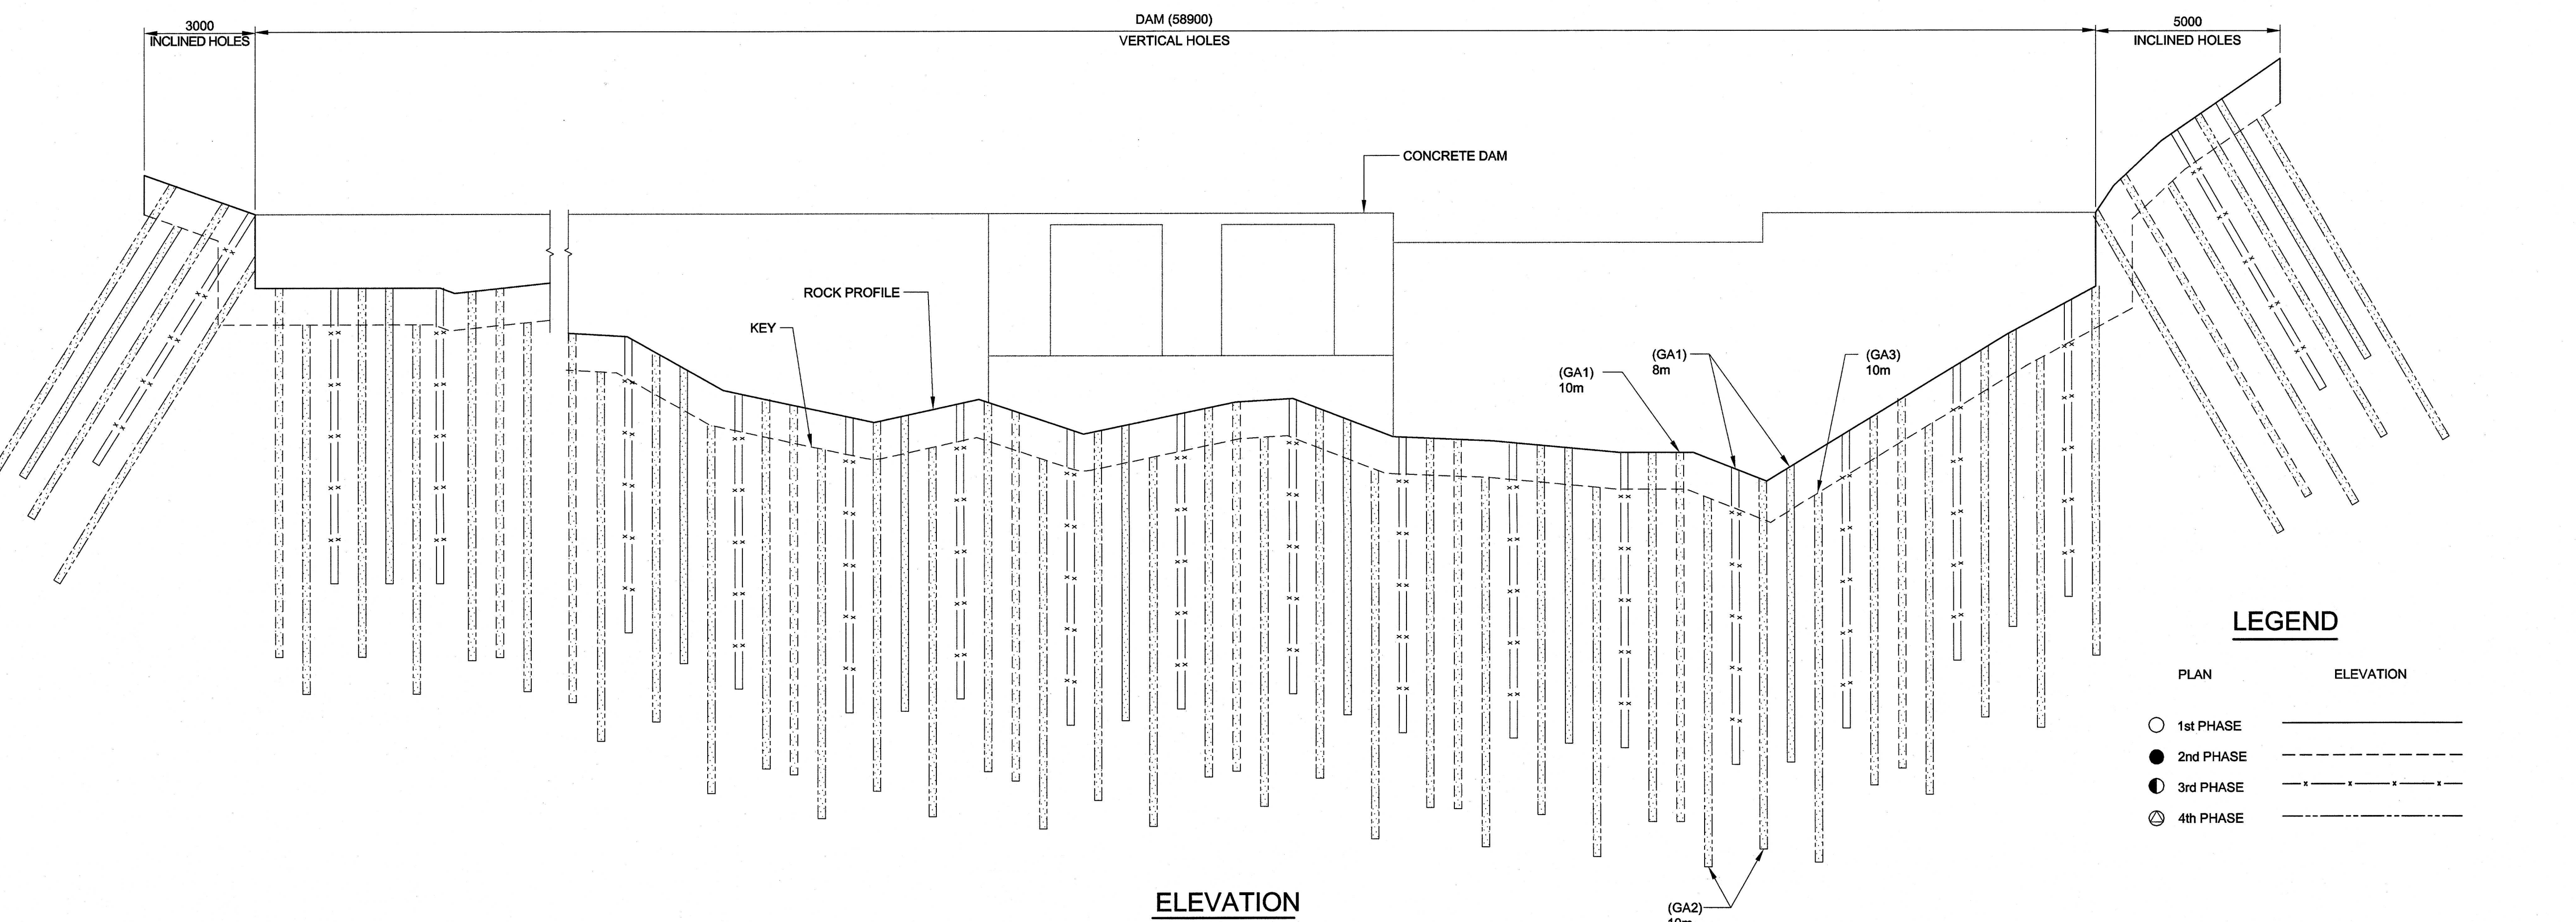
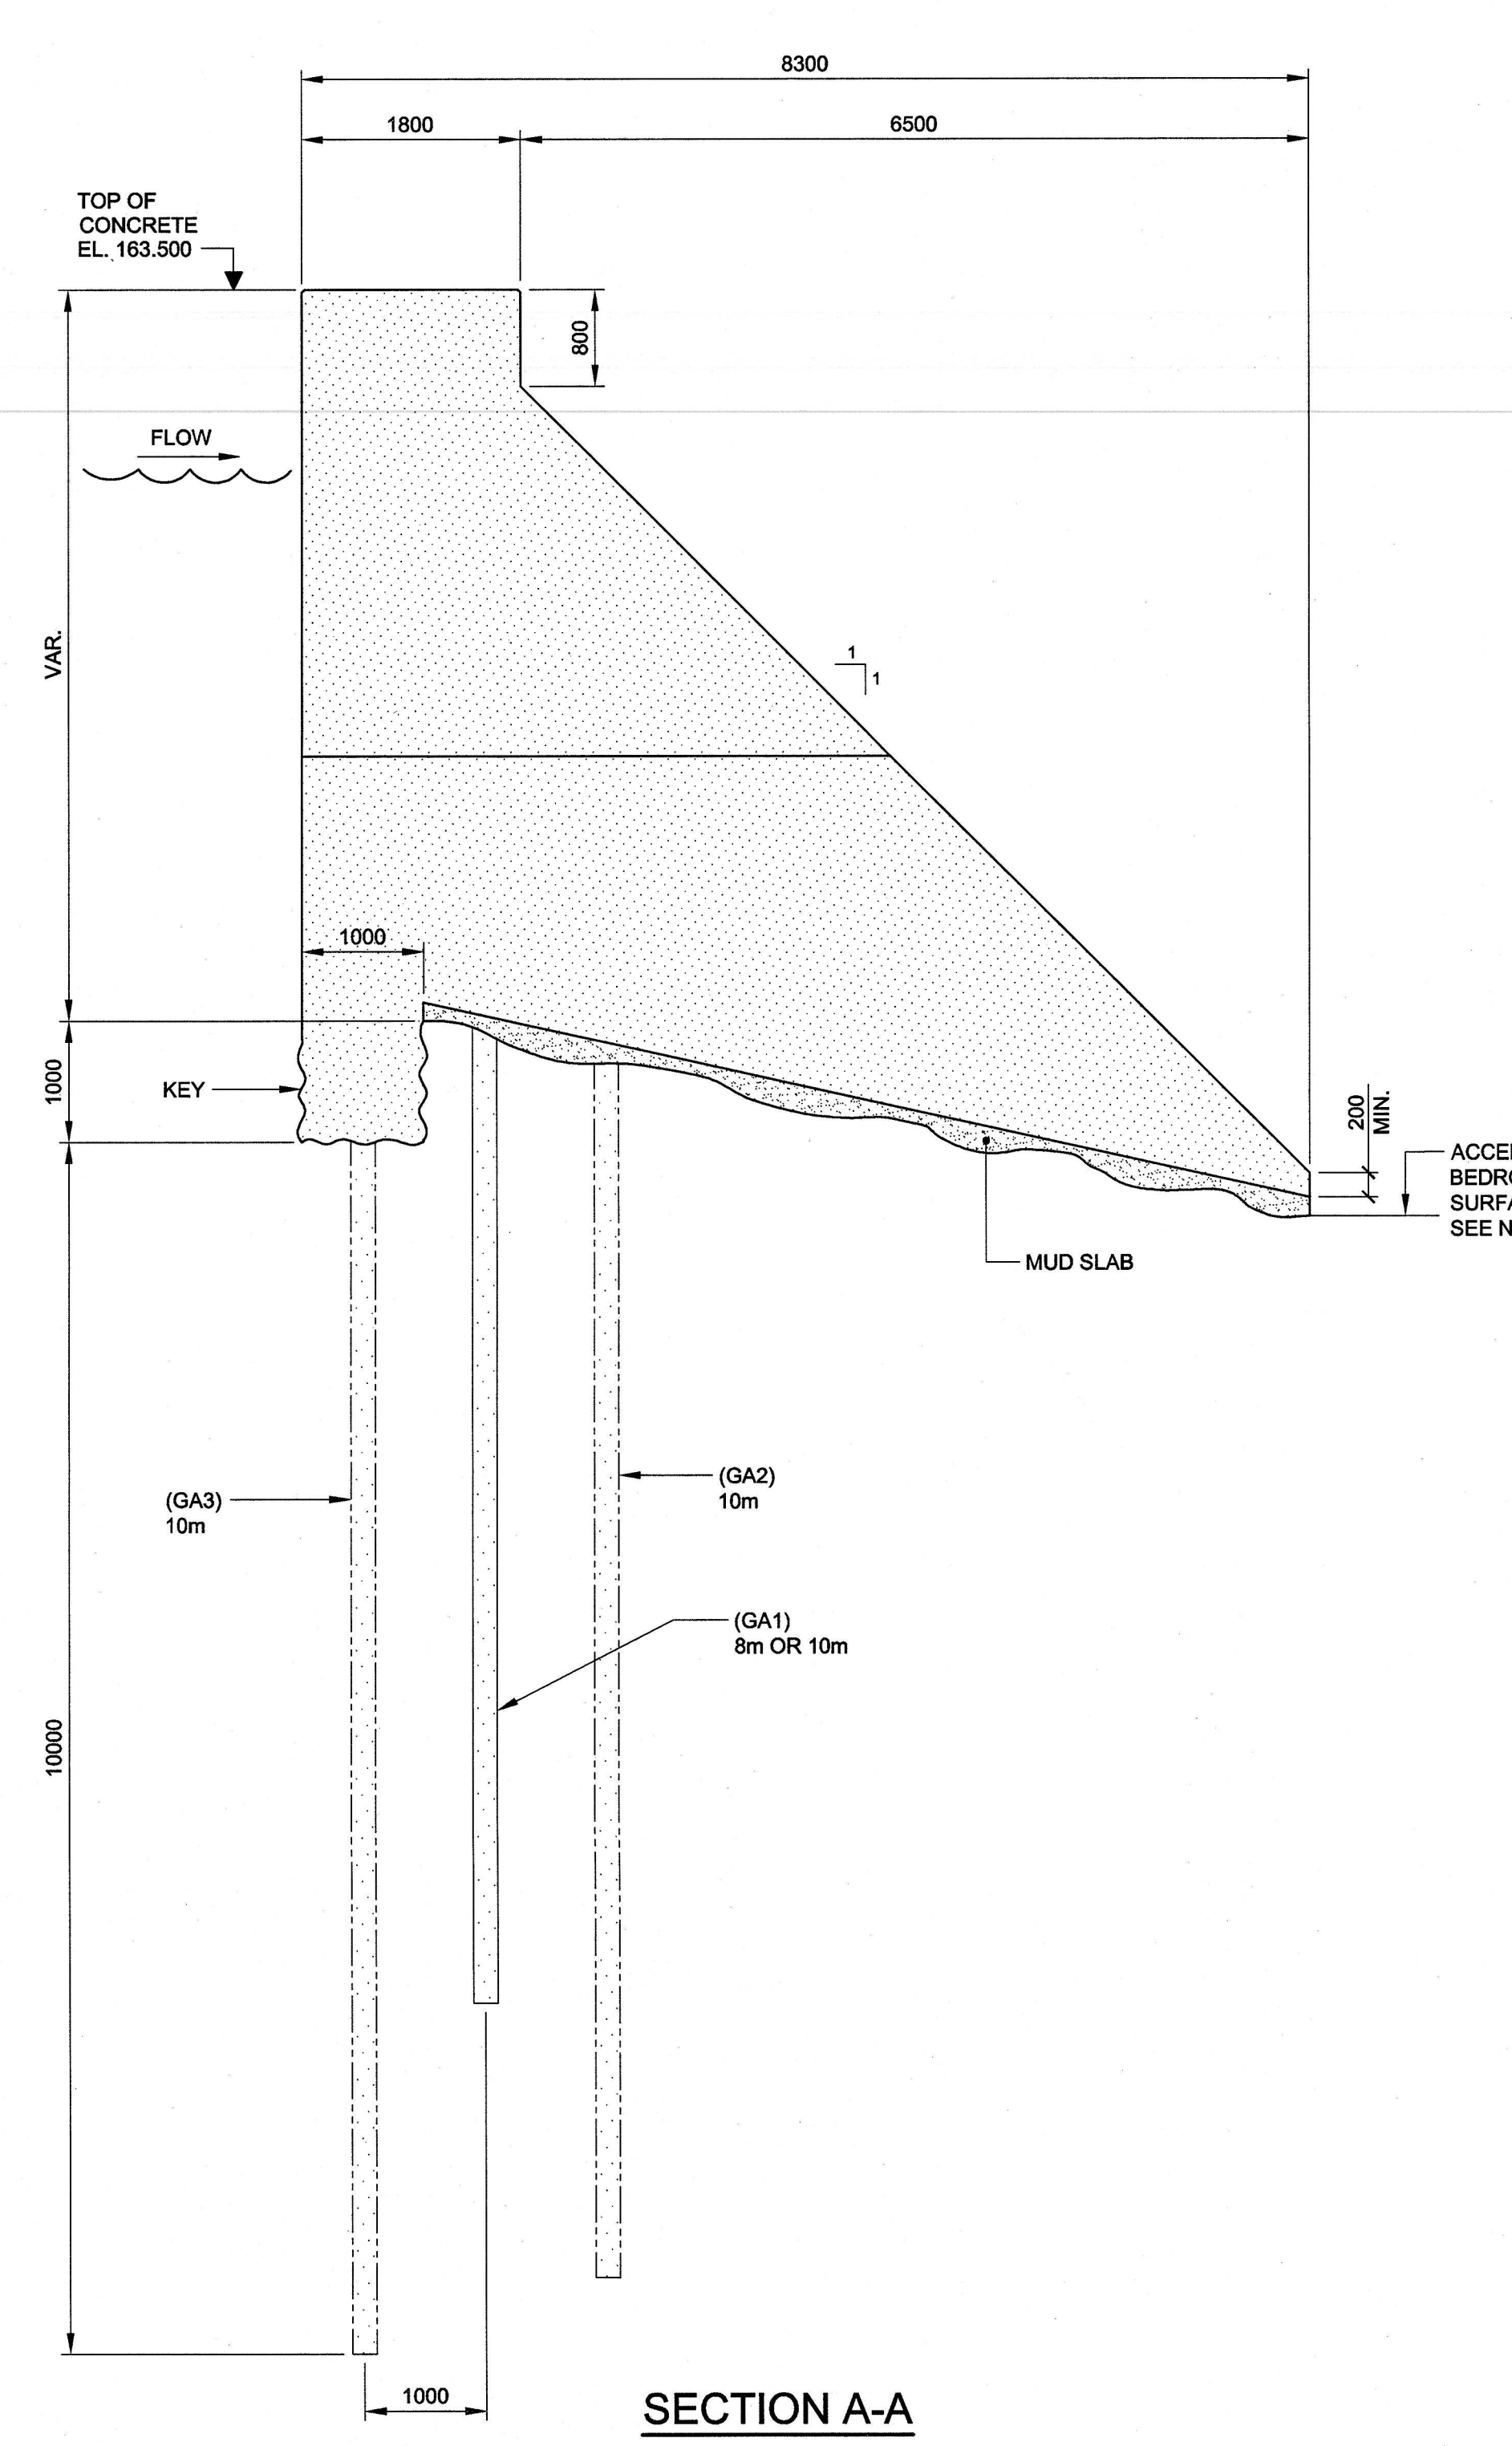
- SEE DRAWING CV-02-01 FOR GENERAL NOTES, LEGEND AND ABBREVIATIONS.
- THIS TYPICAL DETAIL APPLIES EVERYWHERE THERE IS CONCRETE FOUND.
- SURFACE TREATMENTS (SEE FOUNDATION TREATMENT DETAILS):

- MANUALLY CLEAN THE BEDROCK SURFACE ROUGHNESS.
 - EXCAVATE POTHOLES AND OTHER CAVITIES INCLUDING DETACHABLE ROCK FRAGMENTS FROM FAULT OR SHEAR ZONES.
 - CLEAR COMPLETELY THE FOUNDATION SURFACE OF ANY LOOSE ROCK USING WATER OR COMPRESSED AIR BLS.

- RESURFACE STEEP FACES AND OVERHANG WITH CONCRETE BACKFILL AND CONTACT GROUTING, SEE DETAILS.
 - FILL THE OPEN JOINTS WITH LIQUID MORTAR AND TROUGH OR CAVITIES WITH CONCRETE BACKFILL, SEE DETAILS.

- ALL FOUNDATIONS MUST BE APPROVED BY THE CONSULTANT BEFORE ANY POURING OF CONCRETE. EXCAVATE COMPLETELY THE OVERBURDEN INCLUDING ANY MATERIAL, SEDIMENT AND TOPSOIL OVER THE BEDROCK. REMOVE BEDROCK UNTIL ACCEPTABLE BEDROCK SURFACE IS REACHED. THAT IS ALL WEAK ROCK ELEMENTS OR BLOCKS THAT CAN BE EASILY DETACHED MECHANICALLY WITH AN EXCAVATOR FROM THE SUBSTRATE SURFACE. ALL FOUNDATIONS EXCAVATIONS DONE BY A MECHANICAL EXCAVATOR MUST BE DONE UNDER THE SUPERVISION OF THE CONSULTANT. SEE DETAILS FOR THE SURFACE TREATMENTS OF THE STRUCTURE'S FOUNDATIONS.
