Dessin: **Wall Sections & Details**

Canada
 Parcs Canada Parks Canada
 Gestion des biens et réalisation de projets Asset Management and Project Delivery
 Région du Terre-Neuve Est Newfoundland East Region

Dessin Drawing
FOUNDATION PLAN & VERANDA DECK FRAMING PLAN

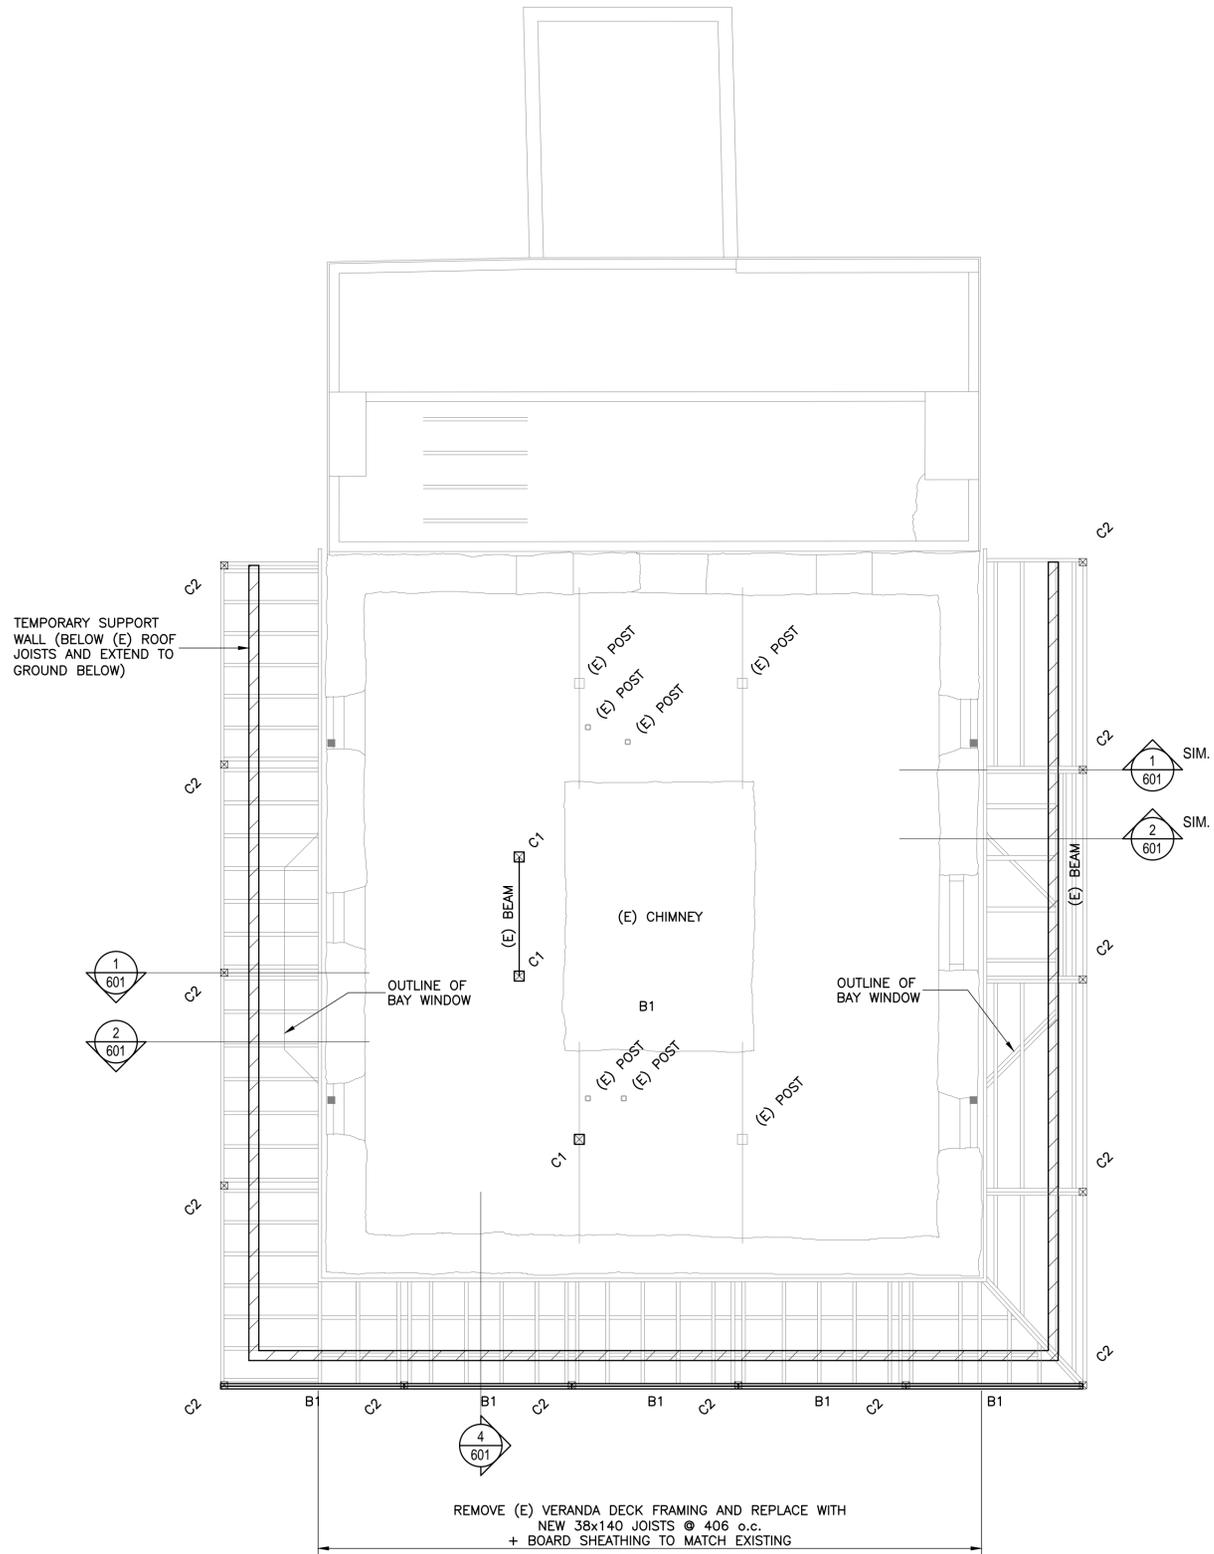
VERANDA DECK FRAMING PLAN
 SCALE - 1 : 50

- NOTES:**
- C1 - 140x140 SPF. NO. 1/2 GRADE WOOD POST
 - C2 - 102x102 DOUGLAS FIR - L NO. 1 GRADE ROUGH CUT POSTS TO REPLACE (E) POSTS
 - B1 - 2-38x140 BUILT-UP SPF. NO. 1/2 GRADE BEAM

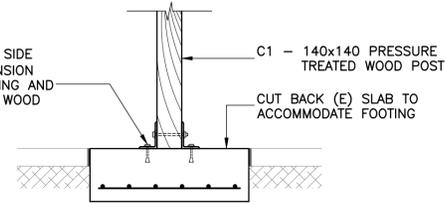
3
601

L150x100x6.0 EACH SIDE
 C/W 13mm Ø EXPANSION
 ANCHORS INTO FOOTING AND
 M13 BOLT THROUGH WOOD
 POST AS SHOWN

SECTION

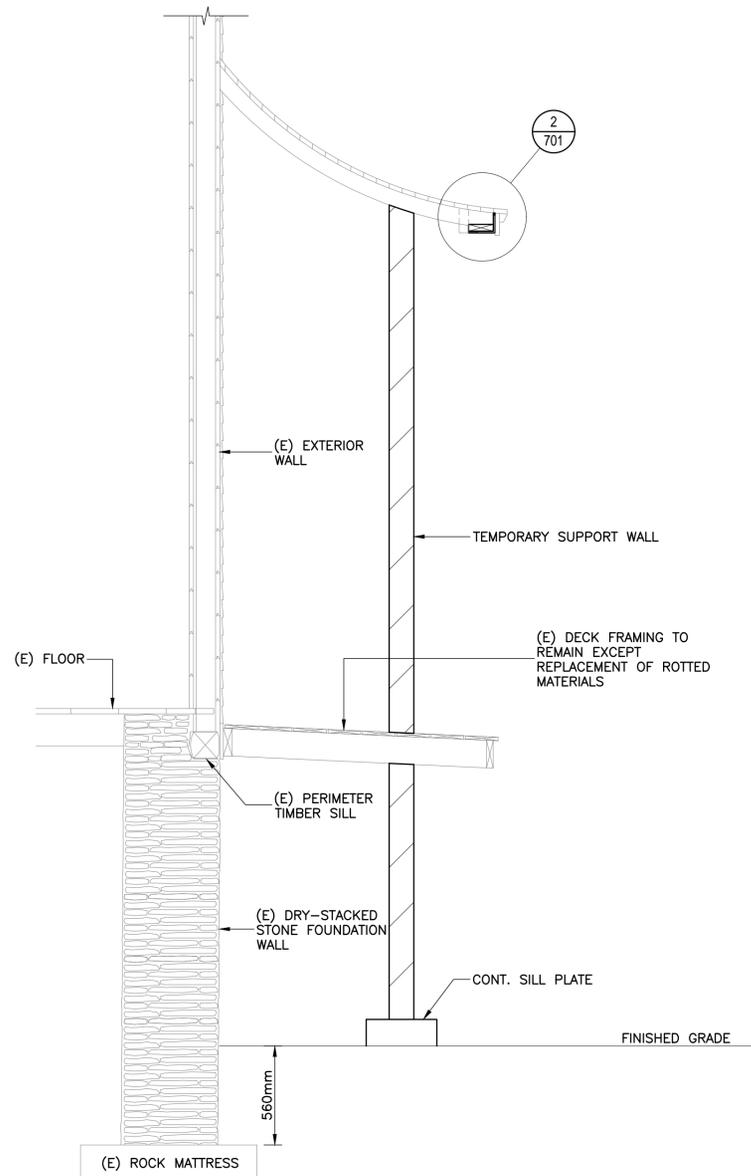
2
601

SECTION

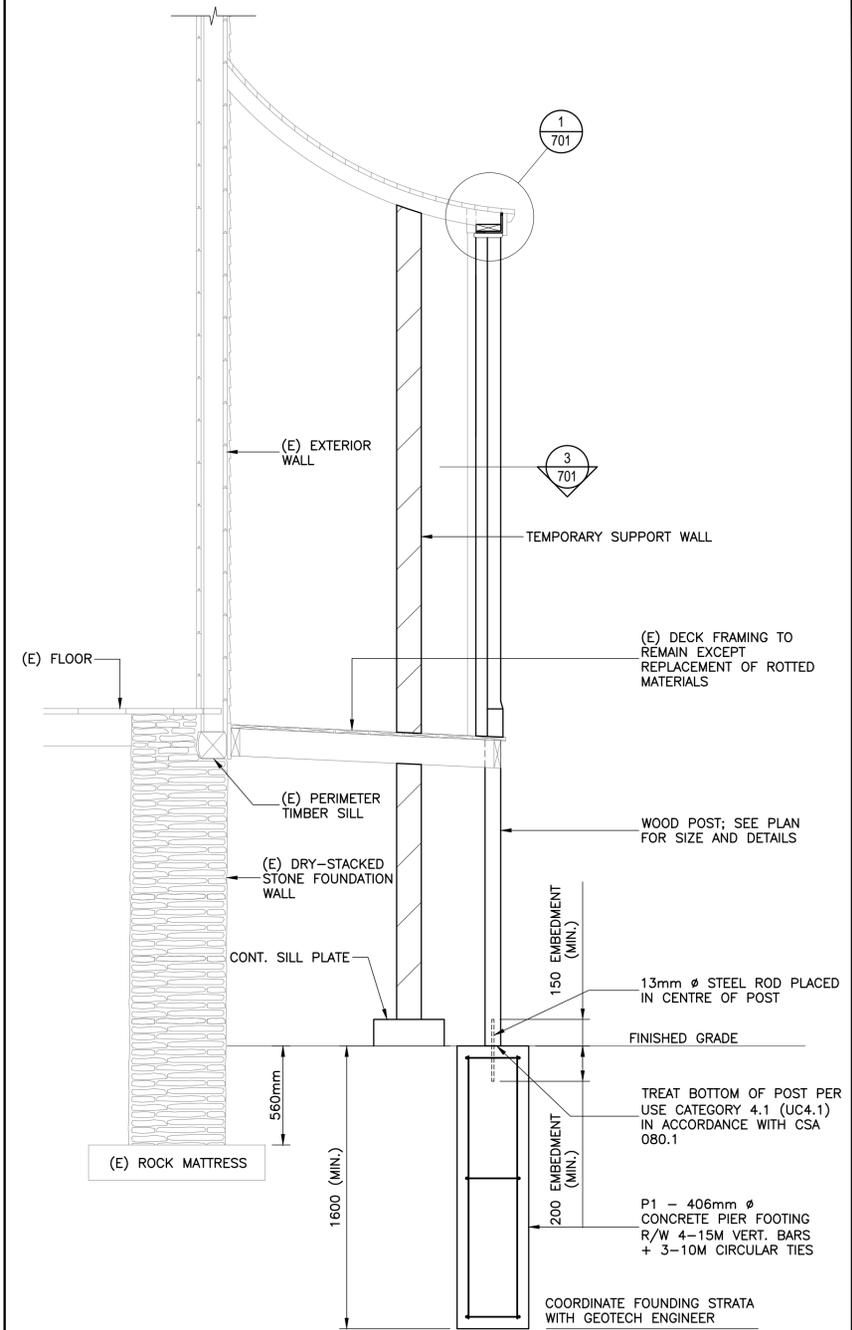
1
601

SECTION

- NOTES:**
- P1 - SEE 1/601 FOR DETAILS
