100% SUBMISSION

LEAD AND ASSOCIATED ABATEMENT AND DEBRIS REMOVAL MICHIPICOTEN ISLAND EAST END SITE LAKE SUPERIOR, ONTARIO

LIST OF SITE DRAWINGS

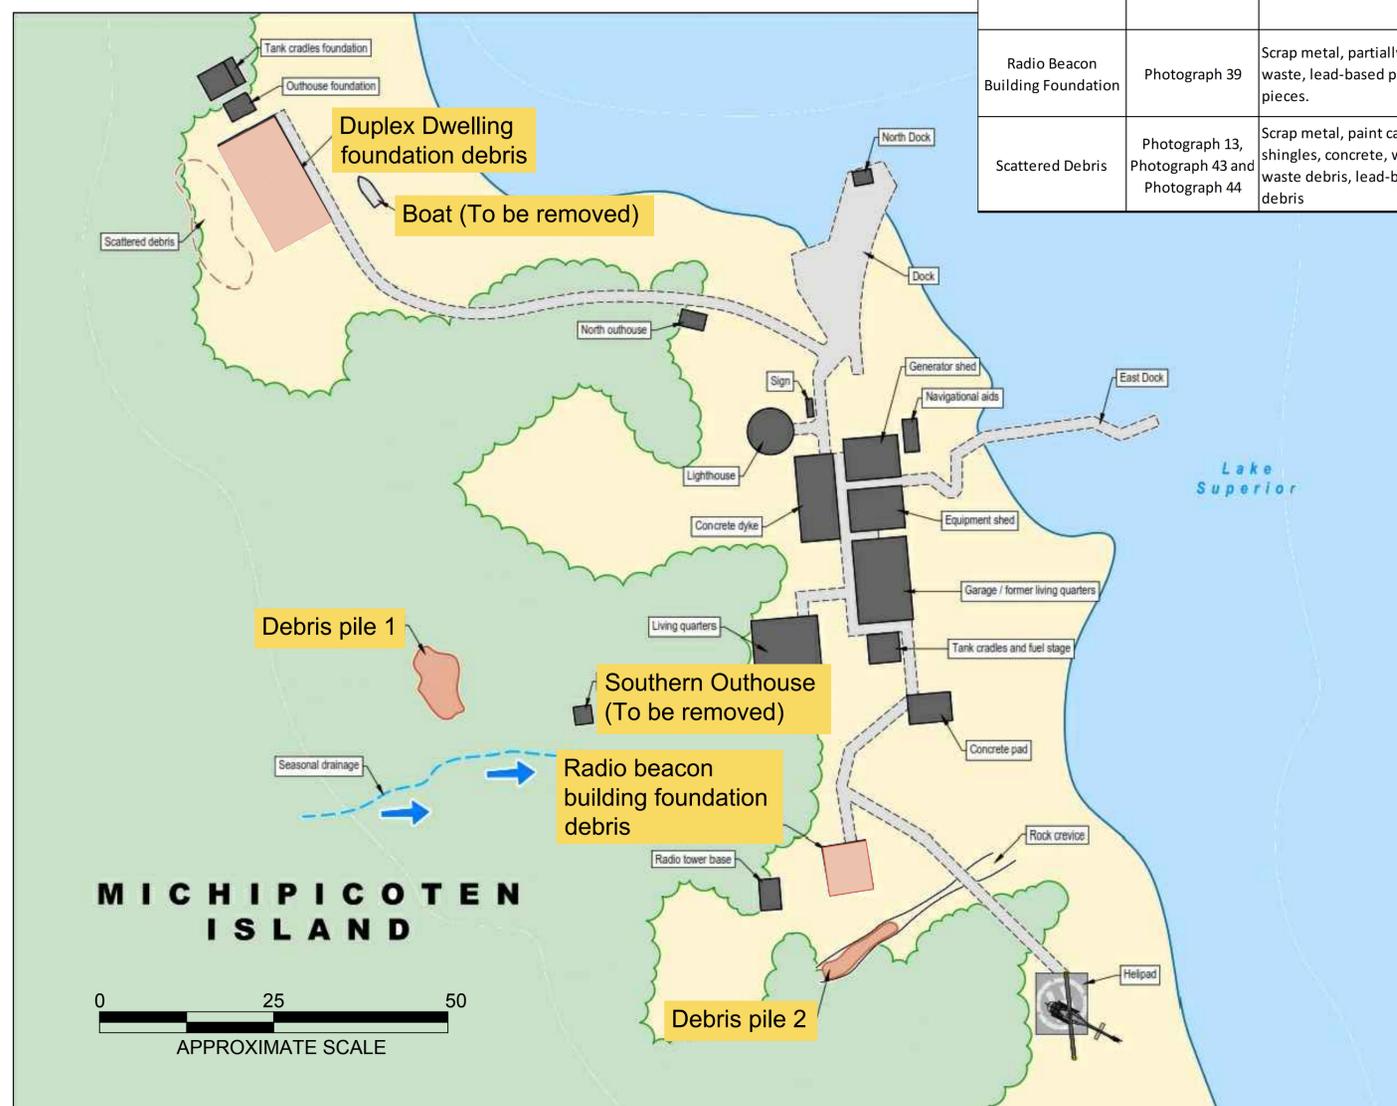
1
C-3 **CONCENTRATED DEBRIS REMOVAL AREAS**

- BASE DRAWING AND LEAD LEACHATE INFORMATION OUTLINED IN THE SUBJECT TABLE ARE PROVIDED IN THE REFERENCE REPORT, "COMPREHENSIVE DESIGNATED SUBSTANCES AND HAZARDOUS MATERIALS SURVEY, MICHIPICOTEN ISLAND, EAST END SITE, DFRP No. 67652, PWGSC No R.083149.031, FCSI No. 67652001&67652002, NEAR WAWA, ON, BLUEMETRIC ENVIRONMENTAL, JUNE 6, 2017.
- ADDITIONAL UNCONCENTRATED DEBRIS FOUND SCATTERED ACROSS THE SITE IS TO BE ABATED BY CONTRACTOR AS PART OF THE WORK.
- FOLLOWING CONCENTRATED DEBRIS PILE REMOVALS AND SUBSEQUENT INSPECTION/SAMPLING BY DEPARTMENTAL REPRESENTATIVE INSTALL GEOTEXTILE TO STABILIZE AREA AS PER SECTION 31 00 99 AND 31 25 00.

drawing / dessin
CONCENTRATED DEBRIS REMOVAL AREAS

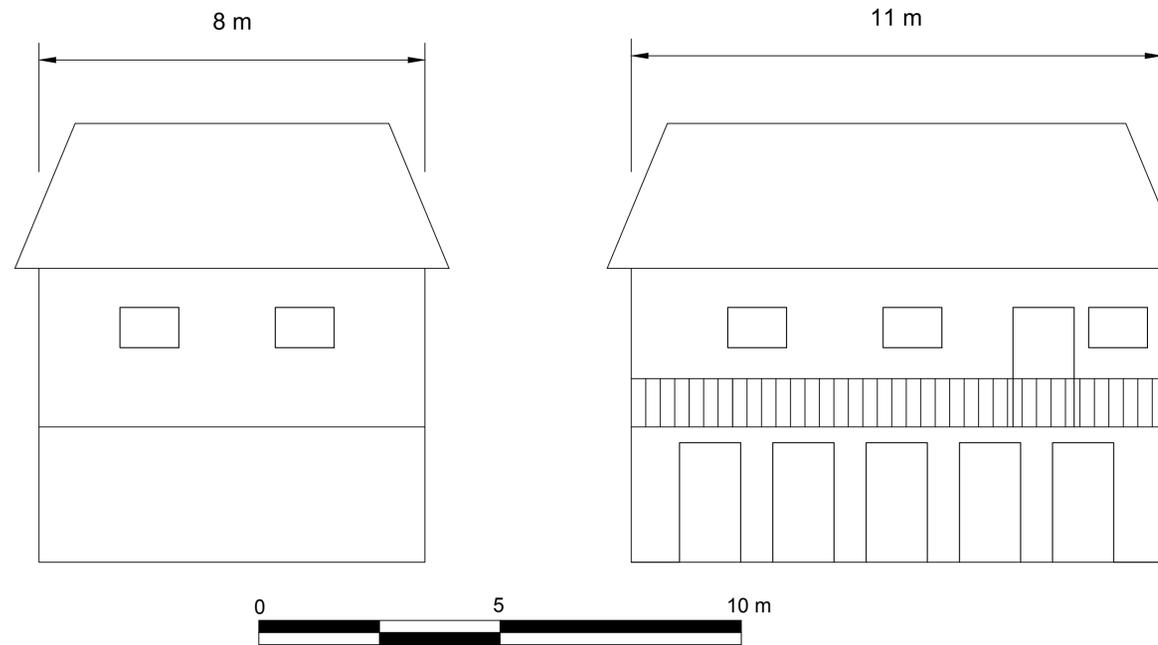
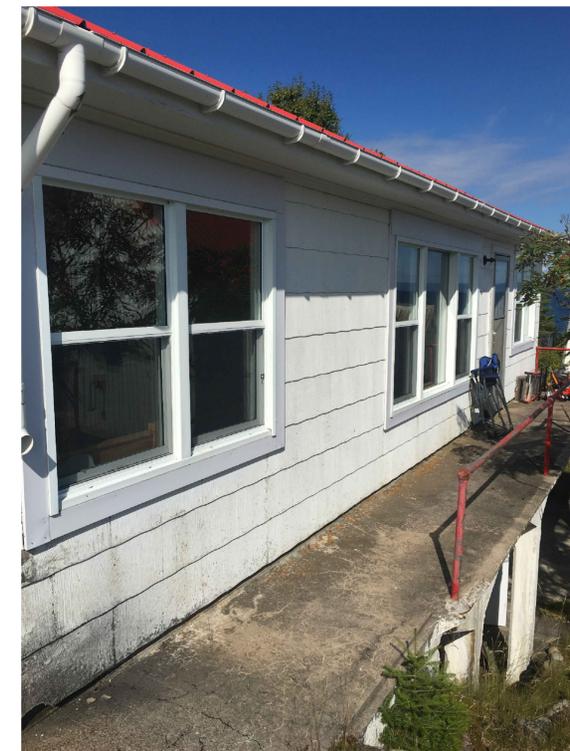
1 LIVING QUARTERS EXTERIOR ABATEMENT PLAN
C-4

LIVING QUARTERS EXTERIOR

1. BASE DRAWING AND LEAD LEACHATE INFORMATION OUTLINED IN THE SUBJECT TABLE ARE PROVIDED IN THE REFERENCE REPORT, "COMPREHENSIVE DESIGNATED SUBSTANCES AND HAZARDOUS MATERIALS SURVEY, MICHIPICOTEN ISLAND, EAST END SITE, DFRP No. 67652, PWGSC No R.083149.031, FCSI No. 67652001&67652002, NEAR WAWA, ON, BLUEMETRIC ENVIRONMENTAL, JUNE 6, 2017.
2. MATERIALS TO BE RE-INSTATED ARE TO BE MATCHED TO EXISTING CONDITION OR BETTER.
3. MATERIALS INCLUDED IN THE ABATEMENT SCHEDULE THAT ARE REMOVED MUST BE RE-INSTATED FOLLOWING SPECIFICATIONS 09 21 16, 09 91 99, 07 46 23, 07 92 00, AND 01 11 00, AS APPLICABLE.
4. ADDITIONAL UNCONCENTRATED DEBRIS FOUND SCATTERED AROUND THE STRUCTURE IS TO BE REMOVED, INCLUDING PAINT CHIPS, BY CONTRACTOR AS PART OF THE WORK

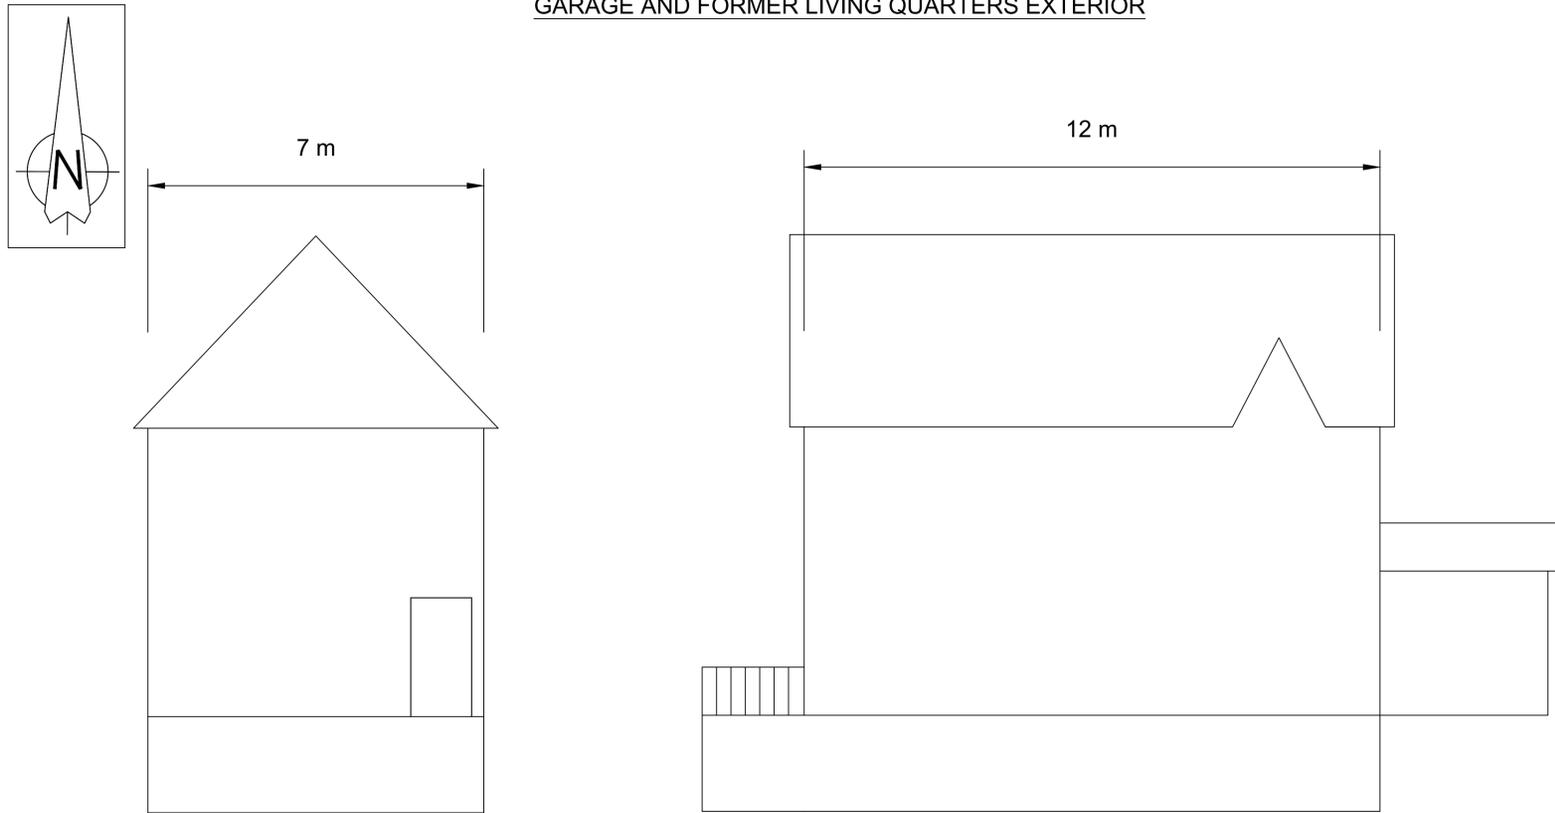
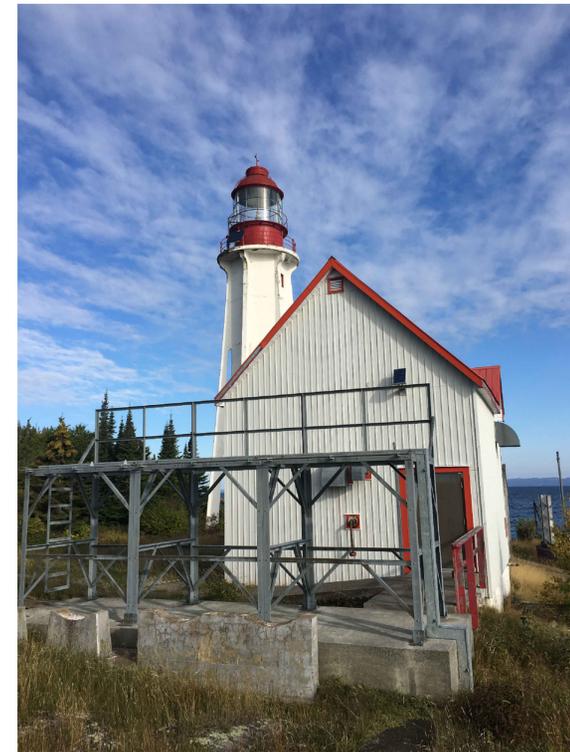
1 GARAGE AND FORMER LIVING QUARTERS EXTERIOR ABATEMENT PLAN
C-5

GARAGE AND FORMER LIVING QUARTERS EXTERIOR

1. BASE DRAWING AND LEAD LEACHATE INFORMATION OUTLINED IN THE SUBJECT TABLE ARE PROVIDED IN THE REFERENCE REPORT, "COMPREHENSIVE DESIGNATED SUBSTANCES AND HAZARDOUS MATERIALS SURVEY, MICHIPICOTEN ISLAND, EAST END SITE, DFRP No. 67652, PWGSC No R.083149.031, FCSI No. 67652001&67652002, NEAR WAWA, ON, BLUEMETRIC ENVIRONMENTAL, JUNE 6, 2017.
2. MATERIALS TO BE RE-INSTATED ARE TO BE MATCHED TO EXISTING CONDITION OR BETTER.
3. MATERIALS INCLUDED IN THE ABATEMENT SCHEDULE THAT ARE REMOVED MUST BE RE-INSTATED FOLLOWING SPECIFICATIONS 09 21 16, 09 91 99, 07 46 23, 07 92 00, AND 01 11 00, AS APPLICABLE.
4. ADDITIONAL UNCONCENTRATED DEBRIS FOUND SCATTERED AROUND THE STRUCTURE, INCLUDING PAINT CHIPS, IS TO BE REMOVED BY CONTRACTOR AS PART OF THE WORK

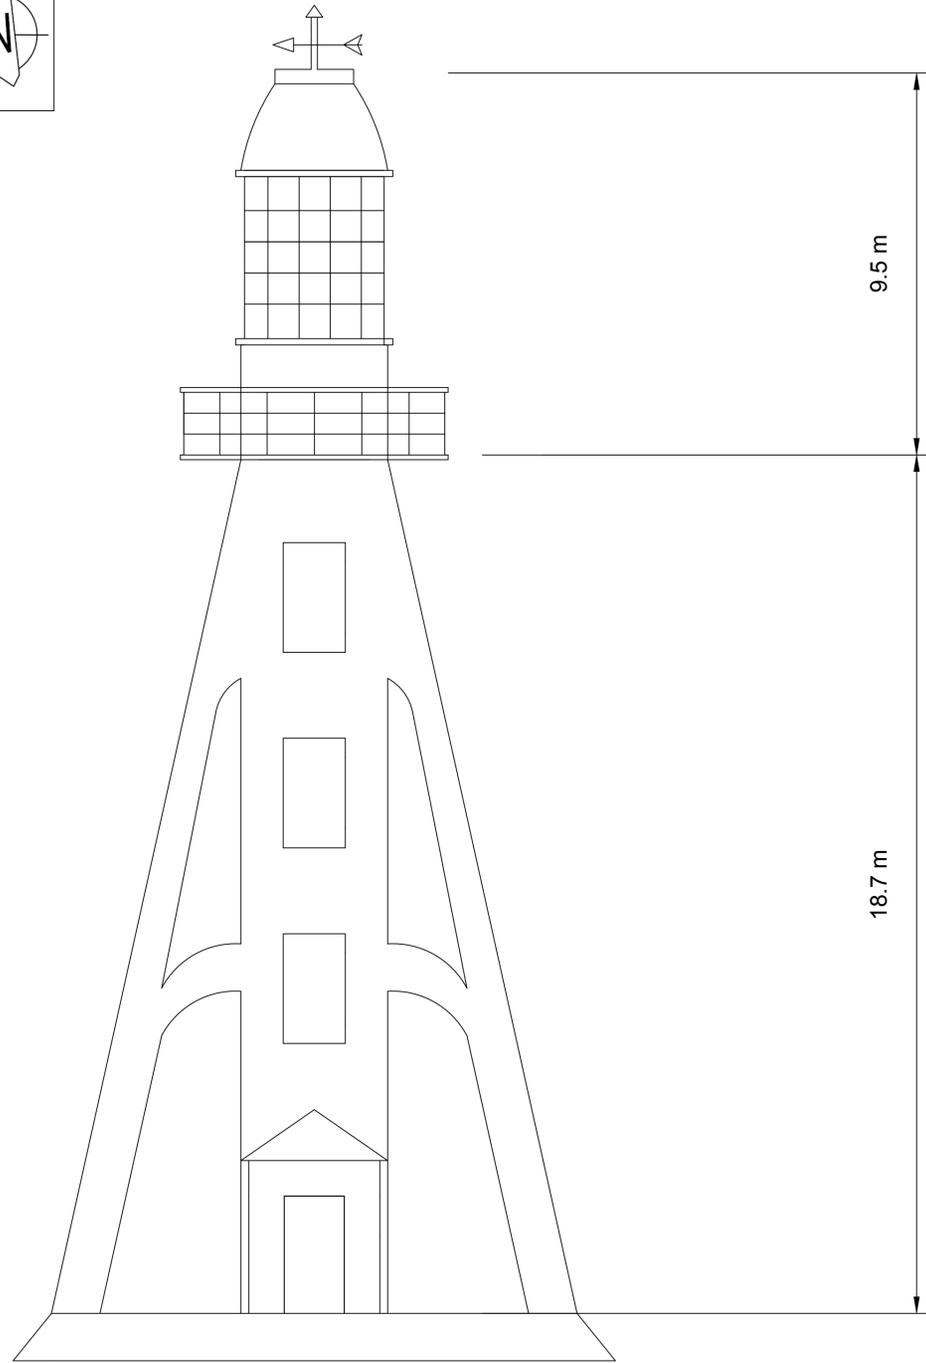
1 Lighthouse Exterior Abatement Plan
C-6

LIGHTHOUSE - EXTERIOR

- ADDITIONAL UNCONCENTRATED DEBRIS FOUND SCATTERED AROUND THE STRUCTURE, INCLUDING PAINT CHIPS, IS TO BE REMOVED BY CONTRACTOR AS PART OF THE WORK.
- CONTRACTOR TO INSTALL SCAFFOLDING IN ACCORDANCE WITH SECTION 01 54 23. UPON ERECTION OF SCAFFOLDING, CONTRACTOR TO ALLOW DEPARTMENTAL REPRESENTATIVE ACCESS TO COMPLETE AN ASSESSMENT OF THE LIGHTHOUSE PRANGING

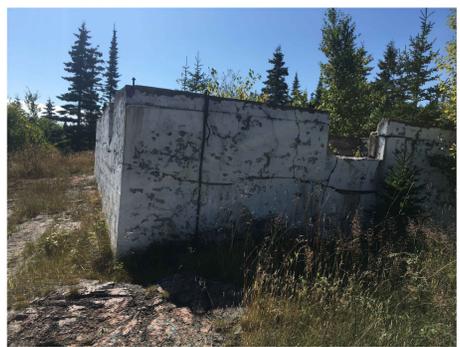
RADIO BEACON BUILDING FOUNDATION

Radio Beacon Building Foundation	Photograph 39	Scrap metal, partially burnt domestic waste, lead-based painted concrete pieces.	25	1	25	White lead-based painted surfaces on concrete debris. White paint chip debris surrounding the structure, mixed with soil and vegetation.
Scattered Debris	Photograph 13, Photograph 43 and Photograph 44	Scrap metal, paint cans, asphalt shingles, concrete, wood, domestic waste debris, lead-based paint chip debris	NA	NA	NA	Throughout Site. Includes scattered paint chip debris and other materials.

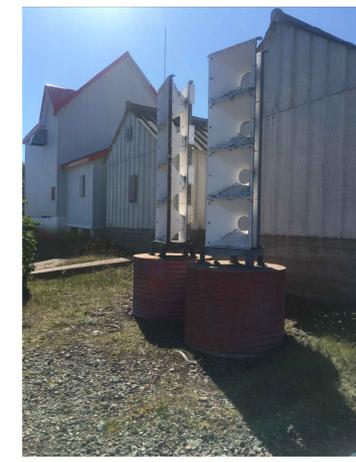
NAVIGATIONAL AIDS

Outhouse Foundation near Duplex Dwelling Foundation	Photograph 37								None	
Multiple Structures: Navigational Aids	Photograph 30	Red	86 m ²	Debris	Soil and Bedrock	Poor	Yes	Minimum Precaution Lead or Intermediate Precaution Lead	None	Red paint chip debris surrounds the corrugated metal base of the navigation aid. Painted wood debris surrounds northern outhouse and southern outhouse.
Northern Outhouse and Southern Outhouse	Photograph 31 and photograph 37									
Radio Beacon Building Foundation	Photograph 19	White	30 m ²	Exterior surfaces, debris	Concrete, Soil and Bedrock	Poor	No	Minimum Precaution Lead or Intermediate Precaution Lead	None	White painted surfaces on remaining foundation structure. White paint chip debris surrounding the structure, mixed with soil and vegetation.
Rock Pillars	Photograph 32	White	10 m ²	Debris	Soil and Bedrock	Poor	No	Minimum Precaution Lead or Intermediate Precaution Lead	None	Two rock pillars located north of lighthouse. Paint chip debris surrounding structure.
