DRAWINGS & SPECIFICATIONS
For
Project No.: R.097979.001
Mission Medium Institution
Building A-K - Flooring Replacement
Room 102, 103, 104, 121

Title: **HAZARDOUS MATERIALS ASSESSMENT - MISSION MEDIUM INSTITUTION - ADMINISTRATION BUILDING KITCHEN**

Appendix 5.1 Findings and Recommendations—Building A—Administration (849-14-RP)
May 2017

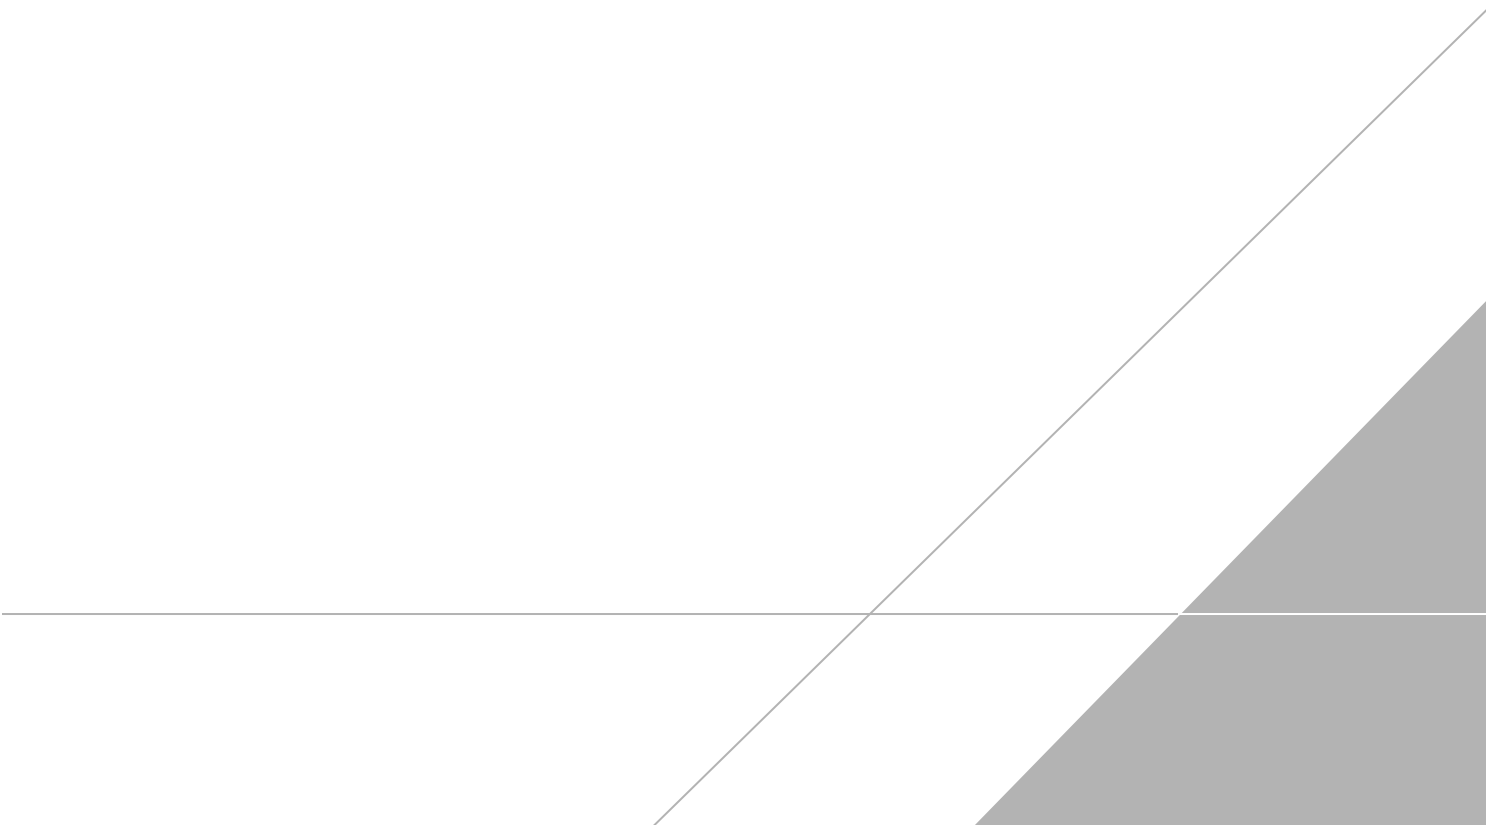
FIGURE 1

Floor Plan

- L1 Paint Chip Sample Location
- A1 Bulk Sample Location

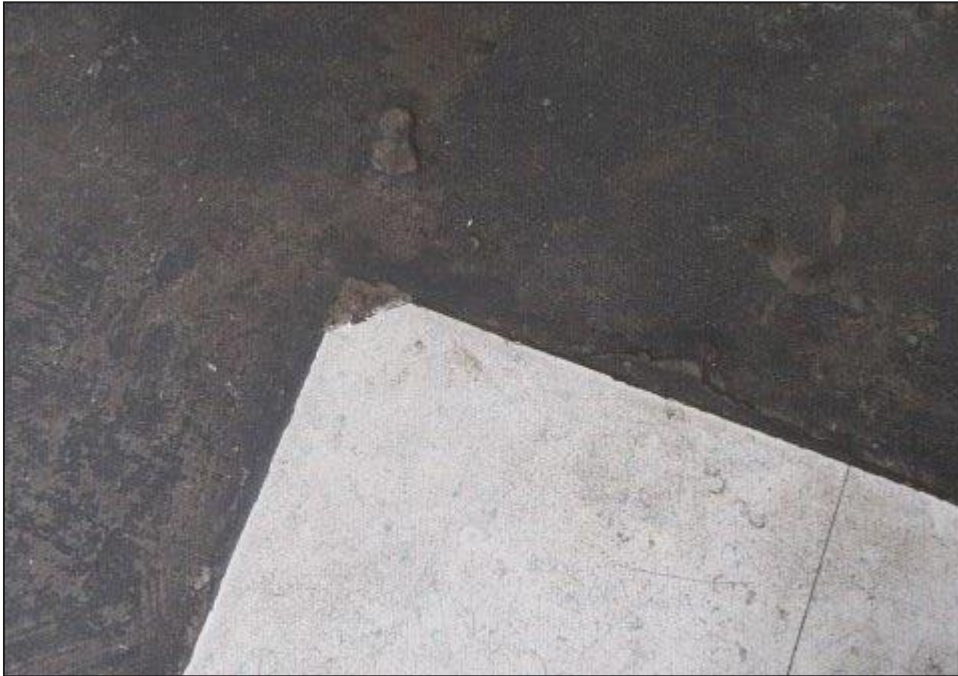
Photo: 1

Sample A1C – Floor tile and mastic around the area has already been damaged and removed. Traces of mastic and leveling compound remaining.

Room 121.

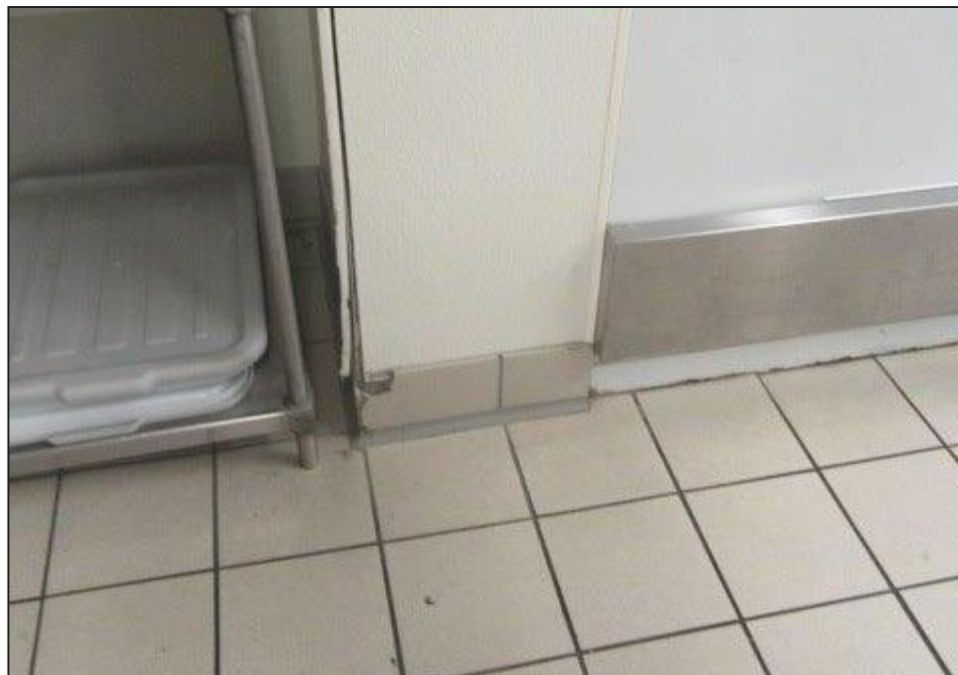
Photo: 2

Samples A3C & A4C – Ceramic tile seam grout, and ceramic tile base grout, previously damaged. Fibreglass panels on walls

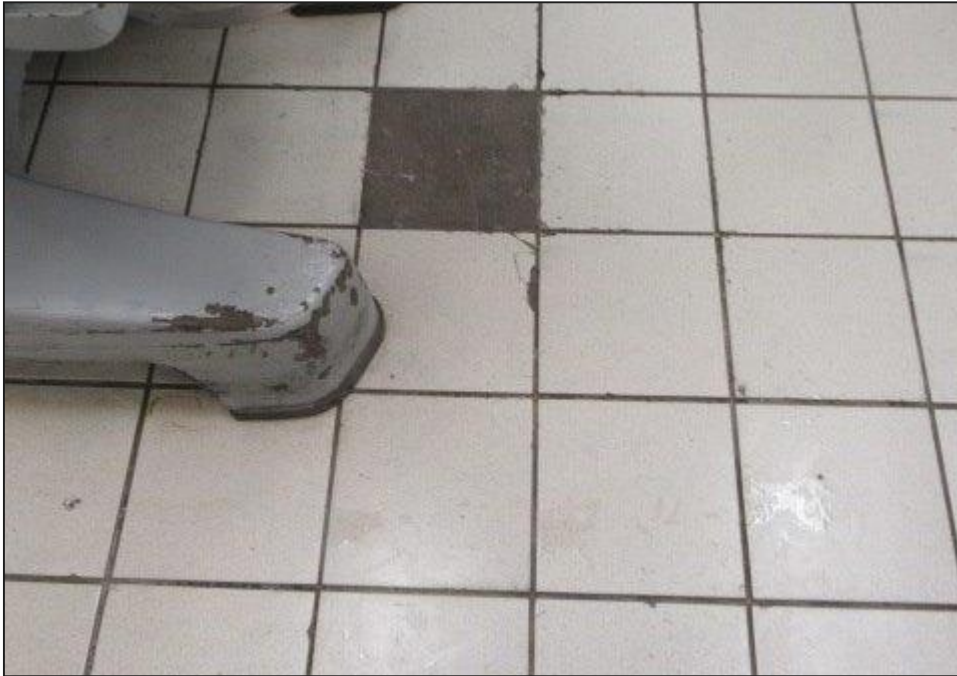
Photo: 3

Sample A3B – Ceramic tile seam grout, previously damaged and removed.

Room 104.

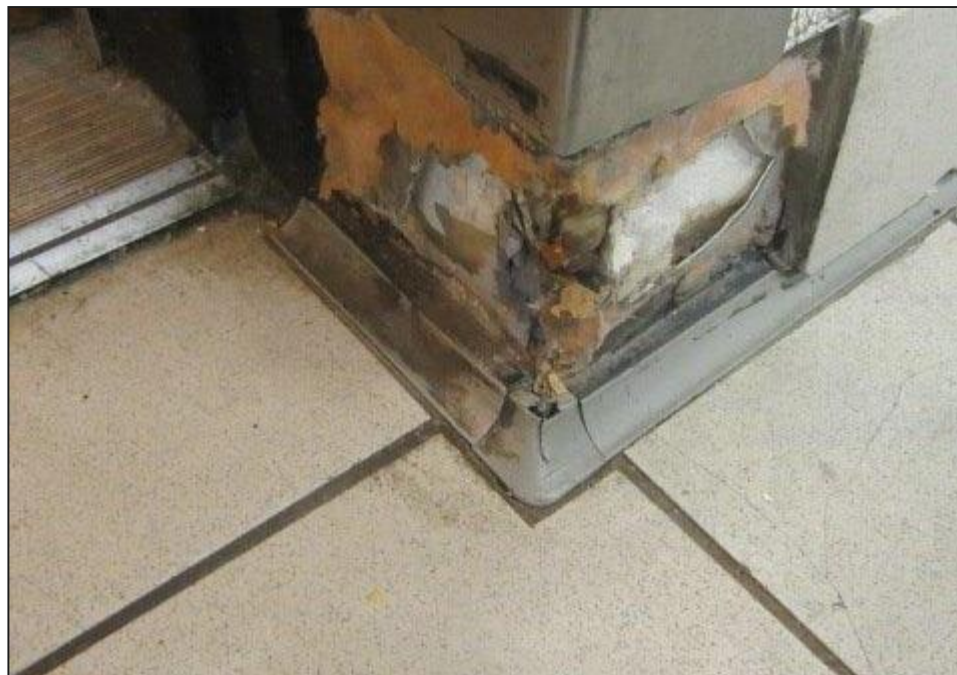
Photo: 4

Sample A5A/B/C – Wall fibre panel, previously damaged, exposing wall panel. Grey lower trim is rubber.

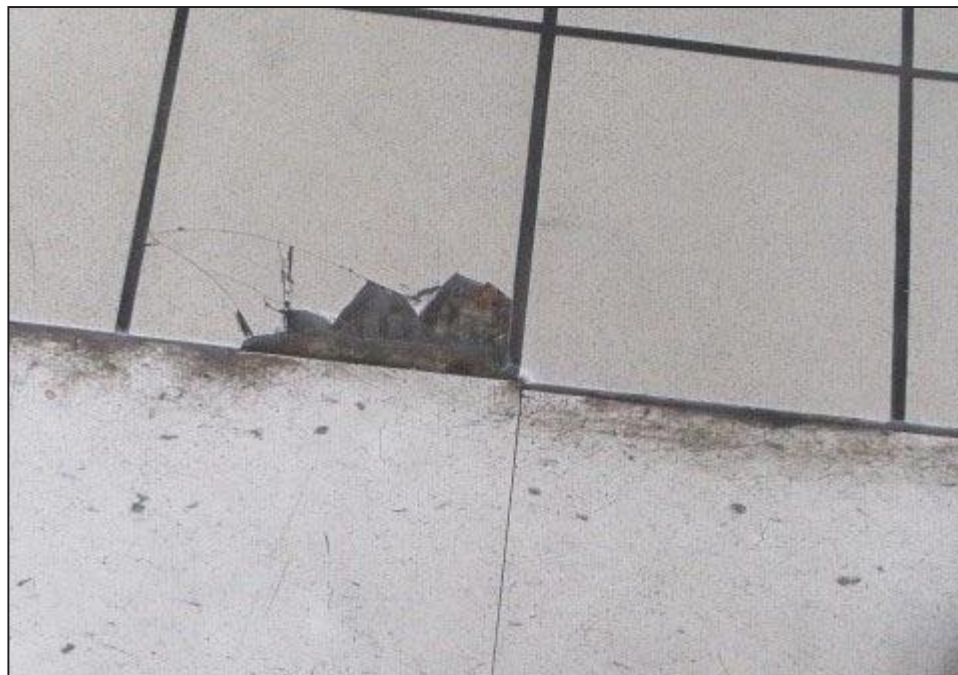
Photo: 6

Sample A4A – ceramic tile
base grout, previously
damaged.

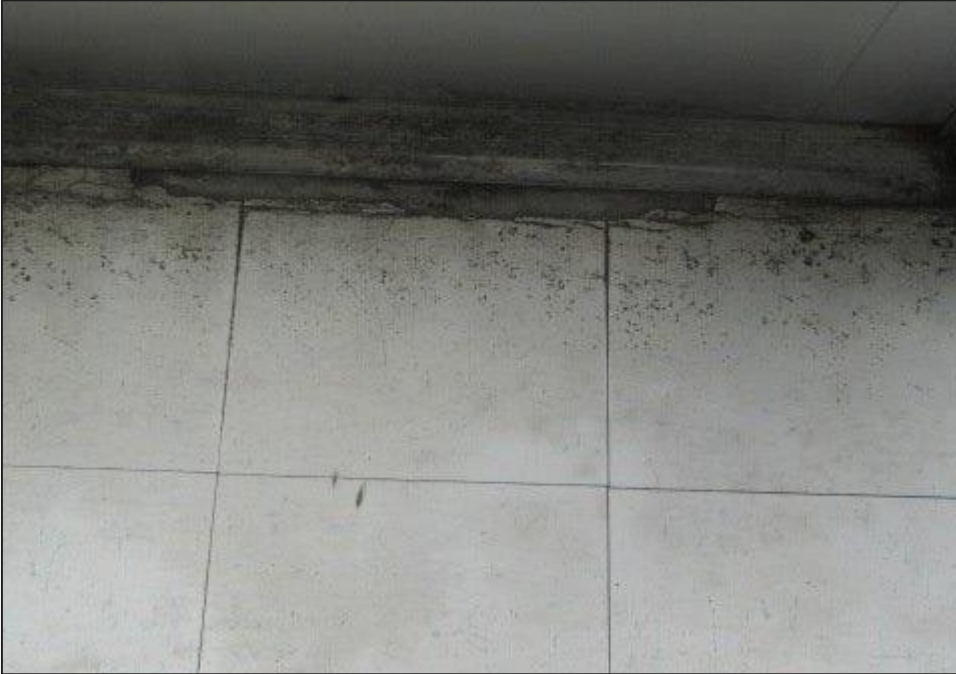
Photo: 9

Sample A2A – grey leveling compound, existing damage.

Room 121.

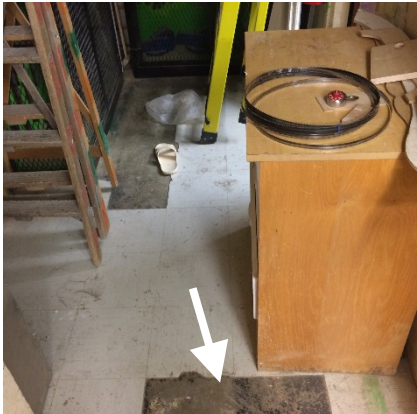
Identified ACM Description and Condition Information		Photo
Mastic associated with floor tiles throughout (see 5.1-1.1)

Friability	Non-friable	
Condition	Good (concealed beneath floor tiles)	
Content	0.5 – 1.25% (varies per report)	
12"x12" off-white vinyl floor tile with light grey streaks within the following areas of Unit A-P <ul style="list-style-type: none"> • The storage rooms of Rooms 247A, 247B and 247C • Under lockers and tables within room 248 hobby shop (Arcadis Hobby Shop report).

5.1-1.1 Vinyl Floor Tile Mastic

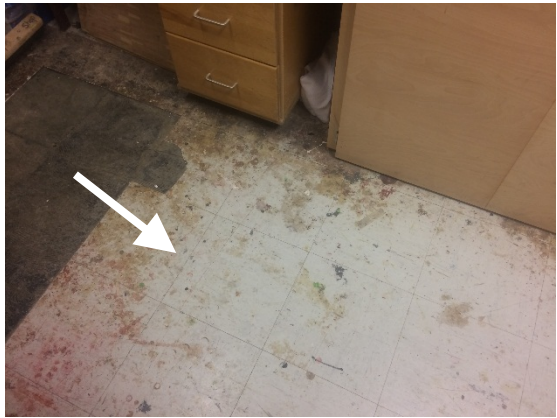
Friability	Non-friable	
Condition	Good	
Content	Tile: 0.33% Chrysotile (see 5.1-1.2); 1% Chrysotile (Arcadis Hobby Shop report)

It should be noted that less than 0.5% chrysotile asbestos was detected in the samples of vinyl floor tile (off-white with light grey streaks and beige with grey streaks) collected from the storage rooms of Room 247 and Room 272 (A-VFT-07: 0.33% chrysotile and A-VFT-08: 0.27% chrysotile). Although the asbestos content in these tile samples is less than 0.5%, these floor tiles should be considered ACM, based on the following:

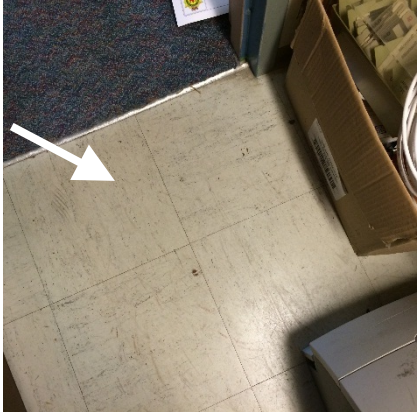
Identified ACM Description and Condition Information		Photo
12"x12" beige vinyl floor tile with grey streaks within Unit A-M, room 272, storage. (see 5.1-1.2)

Friability	Non-friable	
Condition	Good	
Content	Tile: 0.27% Chrysotile	
12"x12" dark beige vinyl floor tile with brown smears within Unit A-W, room 226, administration and discharge.

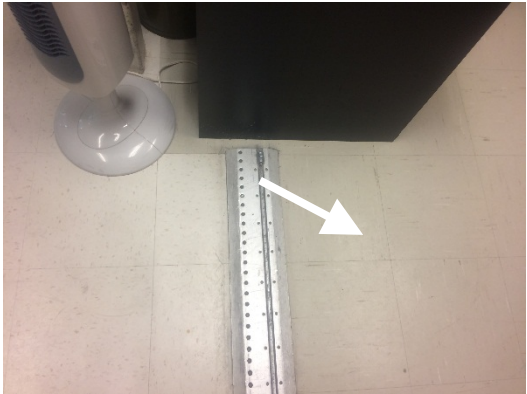
Friability	Non-friable	
Condition	Good	
Content	0.98% Chrysotile	
12"x12" vinyl floor tile with light and dark beige lines within Unit A-W, room 209, electronics.

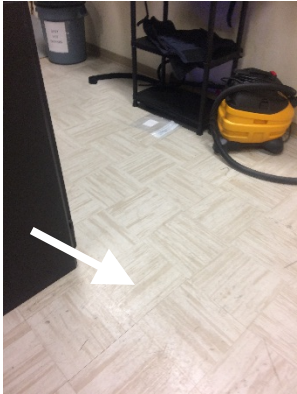
Friability	Non-friable	
Condition	Good	
Content	0.57% Chrysotile

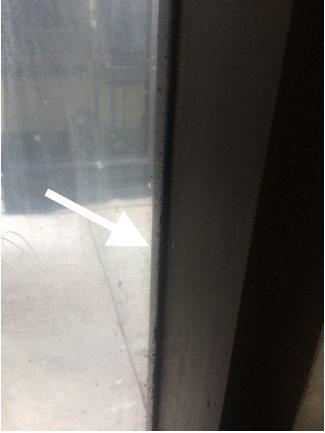
Identified ACM Description and Condition Information		Photo
Black window pane caulking applied to single pane windows and windows within doors throughout.

Friability	Non-friable	
Condition	Good	
Content	3.2% Chrysotile	
Silver (painted white in most locations) mastic applied to the seams of HVAC ducting throughout.

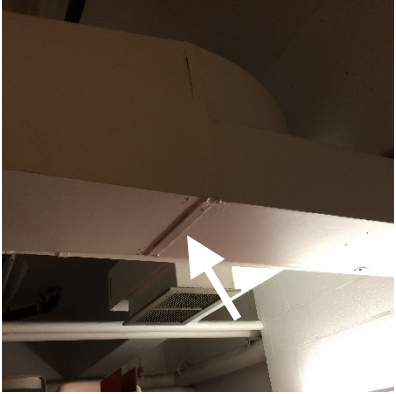
Friability	Non-friable	
Condition	Good	
Content	2.0% Chrysotile	
White cementitious insulation applied to horizontal 8" tank within Unit A-K, room 117, mechanical room.

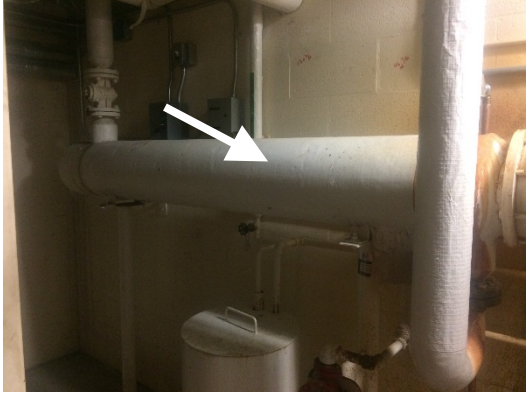
Friability	Friable	
Condition	Good	
Content	2.0% Chrysotile

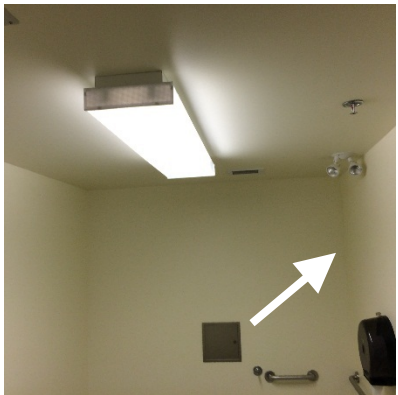
Identified ACM Description and Condition Information		Photo
<p>Drywall joint compound applied to drywall walls and ceilings throughout.</p> <ul style="list-style-type: none"> This material has been removed from the interior partition walls of rooms 207, 209, 210, 213, 214, 214c (Unit A-R, now identified as rooms R01 – R12).

Friability	Non-friable in situ, can be made friable during removal or if damaged	
Condition	Good	
Content	0.5 - 5% Chrysotile (PGL report) 1 - 2% Chrysotile (Arcadis reports)

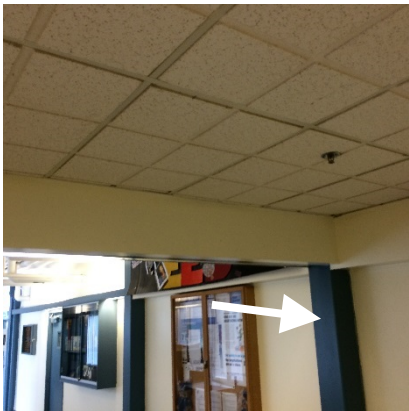
Identified LCP Description		Photo
Paint colour	Blue

Substrate	Steel columns	
Location/approx. extent	Throughout	
Lead content	6,100 ppm	
Condition	Good

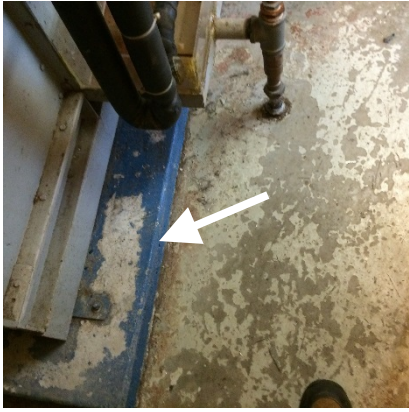
Identified LCP Description		Photo
Paint colour	Blue

Substrate	Concrete pad	
Location/approx. extent	Unit A-M, Room 246, mechanical room	
Lead content	1,800 ppm	
Condition	Poor (Flaking and peeling)	
Paint colour	Grey

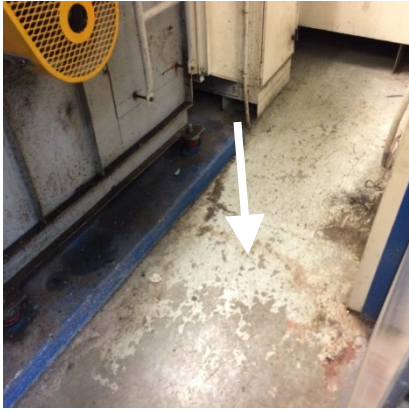
Substrate	Concrete floor	
Location/approx. extent	Unit A-M, Room 246, mechanical room	
Lead content	3,100 ppm	
Condition	Poor (Flaking and peeling)	
Paint colour	Blue

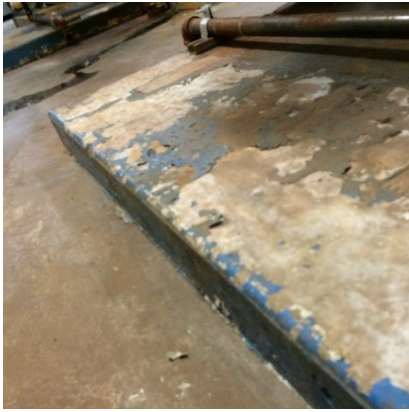
Substrate	Concrete pad	
Location/approx. extent	Unit A-K, Room 118, mechanical room	
Lead content	4,400 ppm	
Condition	Poor (Flaking and peeling)

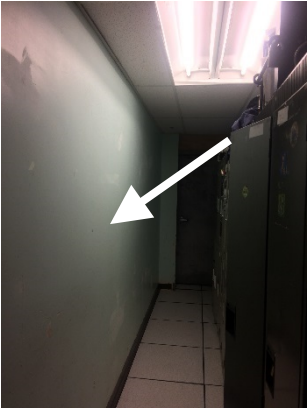
Identified LCP Description		Photo
Paint colour	Light green

Substrate	Drywall	
Location/approx. extent	Unit A-W, Room 204, corridor wall	
Lead content	780 ppm	
Condition	Good	
Paint colour	Cream (Red underneath)

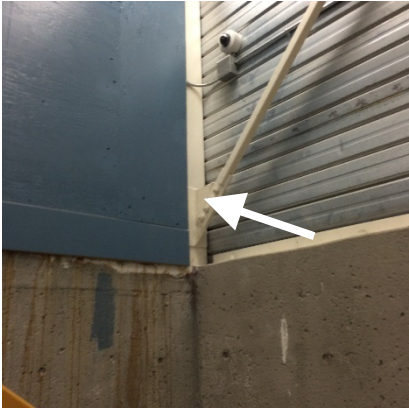
Substrate	Structural Steel	
Location/approx. extent	Throughout	
Lead content	2,300 ppm	
Condition	Good	
Paint colour	Blue

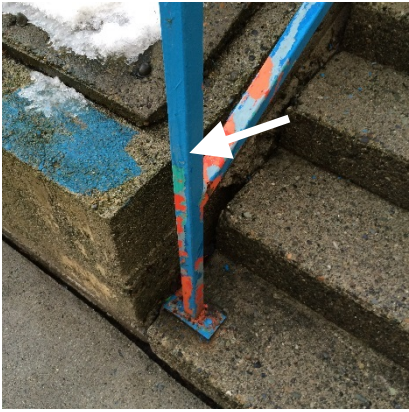
Substrate	Metal handrail	
Location/approx. extent	Around the exterior	
Lead content	1,500 ppm	
Condition	Poor (Flaking and peeling)

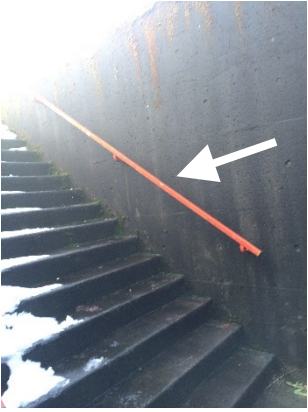
Identified LCP Description		Photo
Paint colour	Orange

Substrate	Metal handrail	
Location/approx. extent	Exterior handrail on south side of gym	
Lead content	62,000 ppm	
Condition	Good	
Paint colour	Blue

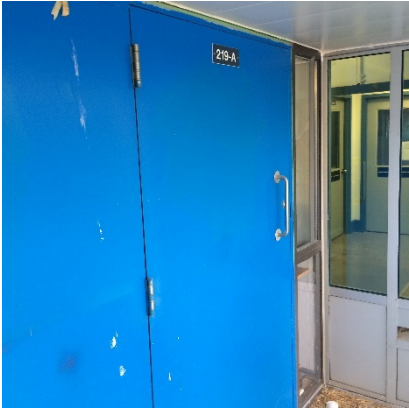
Substrate	Metal door	
Location/approx. extent	Exterior door outside south side of room 219	
Lead content	3,600 ppm	
Condition	Good	
Paint colour	Grey/blue	<p style="text-align: center;">No Photo Available</p>
Substrate	Metal	
Location/approx. extent	Window bars	
Lead content	5,500 ppm (Arcadis Cladding report)	
Condition	Good	
Paint colour	Blue/red/white	<p style="text-align: center;">No Photo Available</p>
Substrate	Various	
Location/approx. extent	Unit A-P, room 247C, storage, wall trim paint	
Lead content	670 ppm (Arcadis Hobby Shop report)	
Condition	Fair

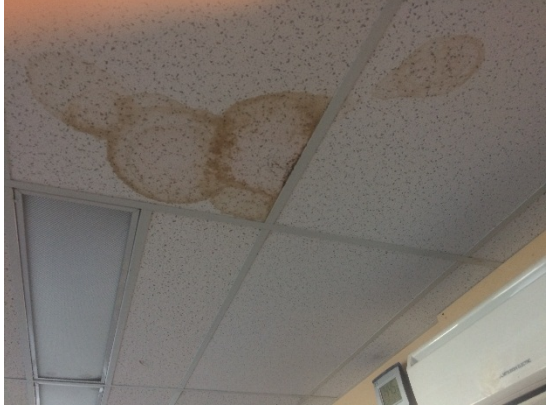
Building Area	Observation	Suspected Source of Moisture	Photo
Various locations throughout	Moisture stained suspended ceiling tiles	Pipe leaks

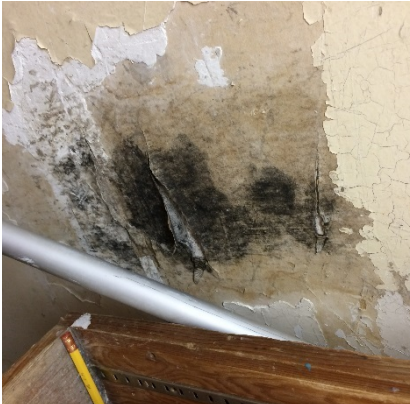
Unit A-P, Janitor room 232	Suspect mould on drywall	Cleaning activities related to the slop sink
