**PEC Site Road Routing and  
Health & Safety Features**

Site Control Zones

Site Layout

**Contaminated Soil Storage Areas**

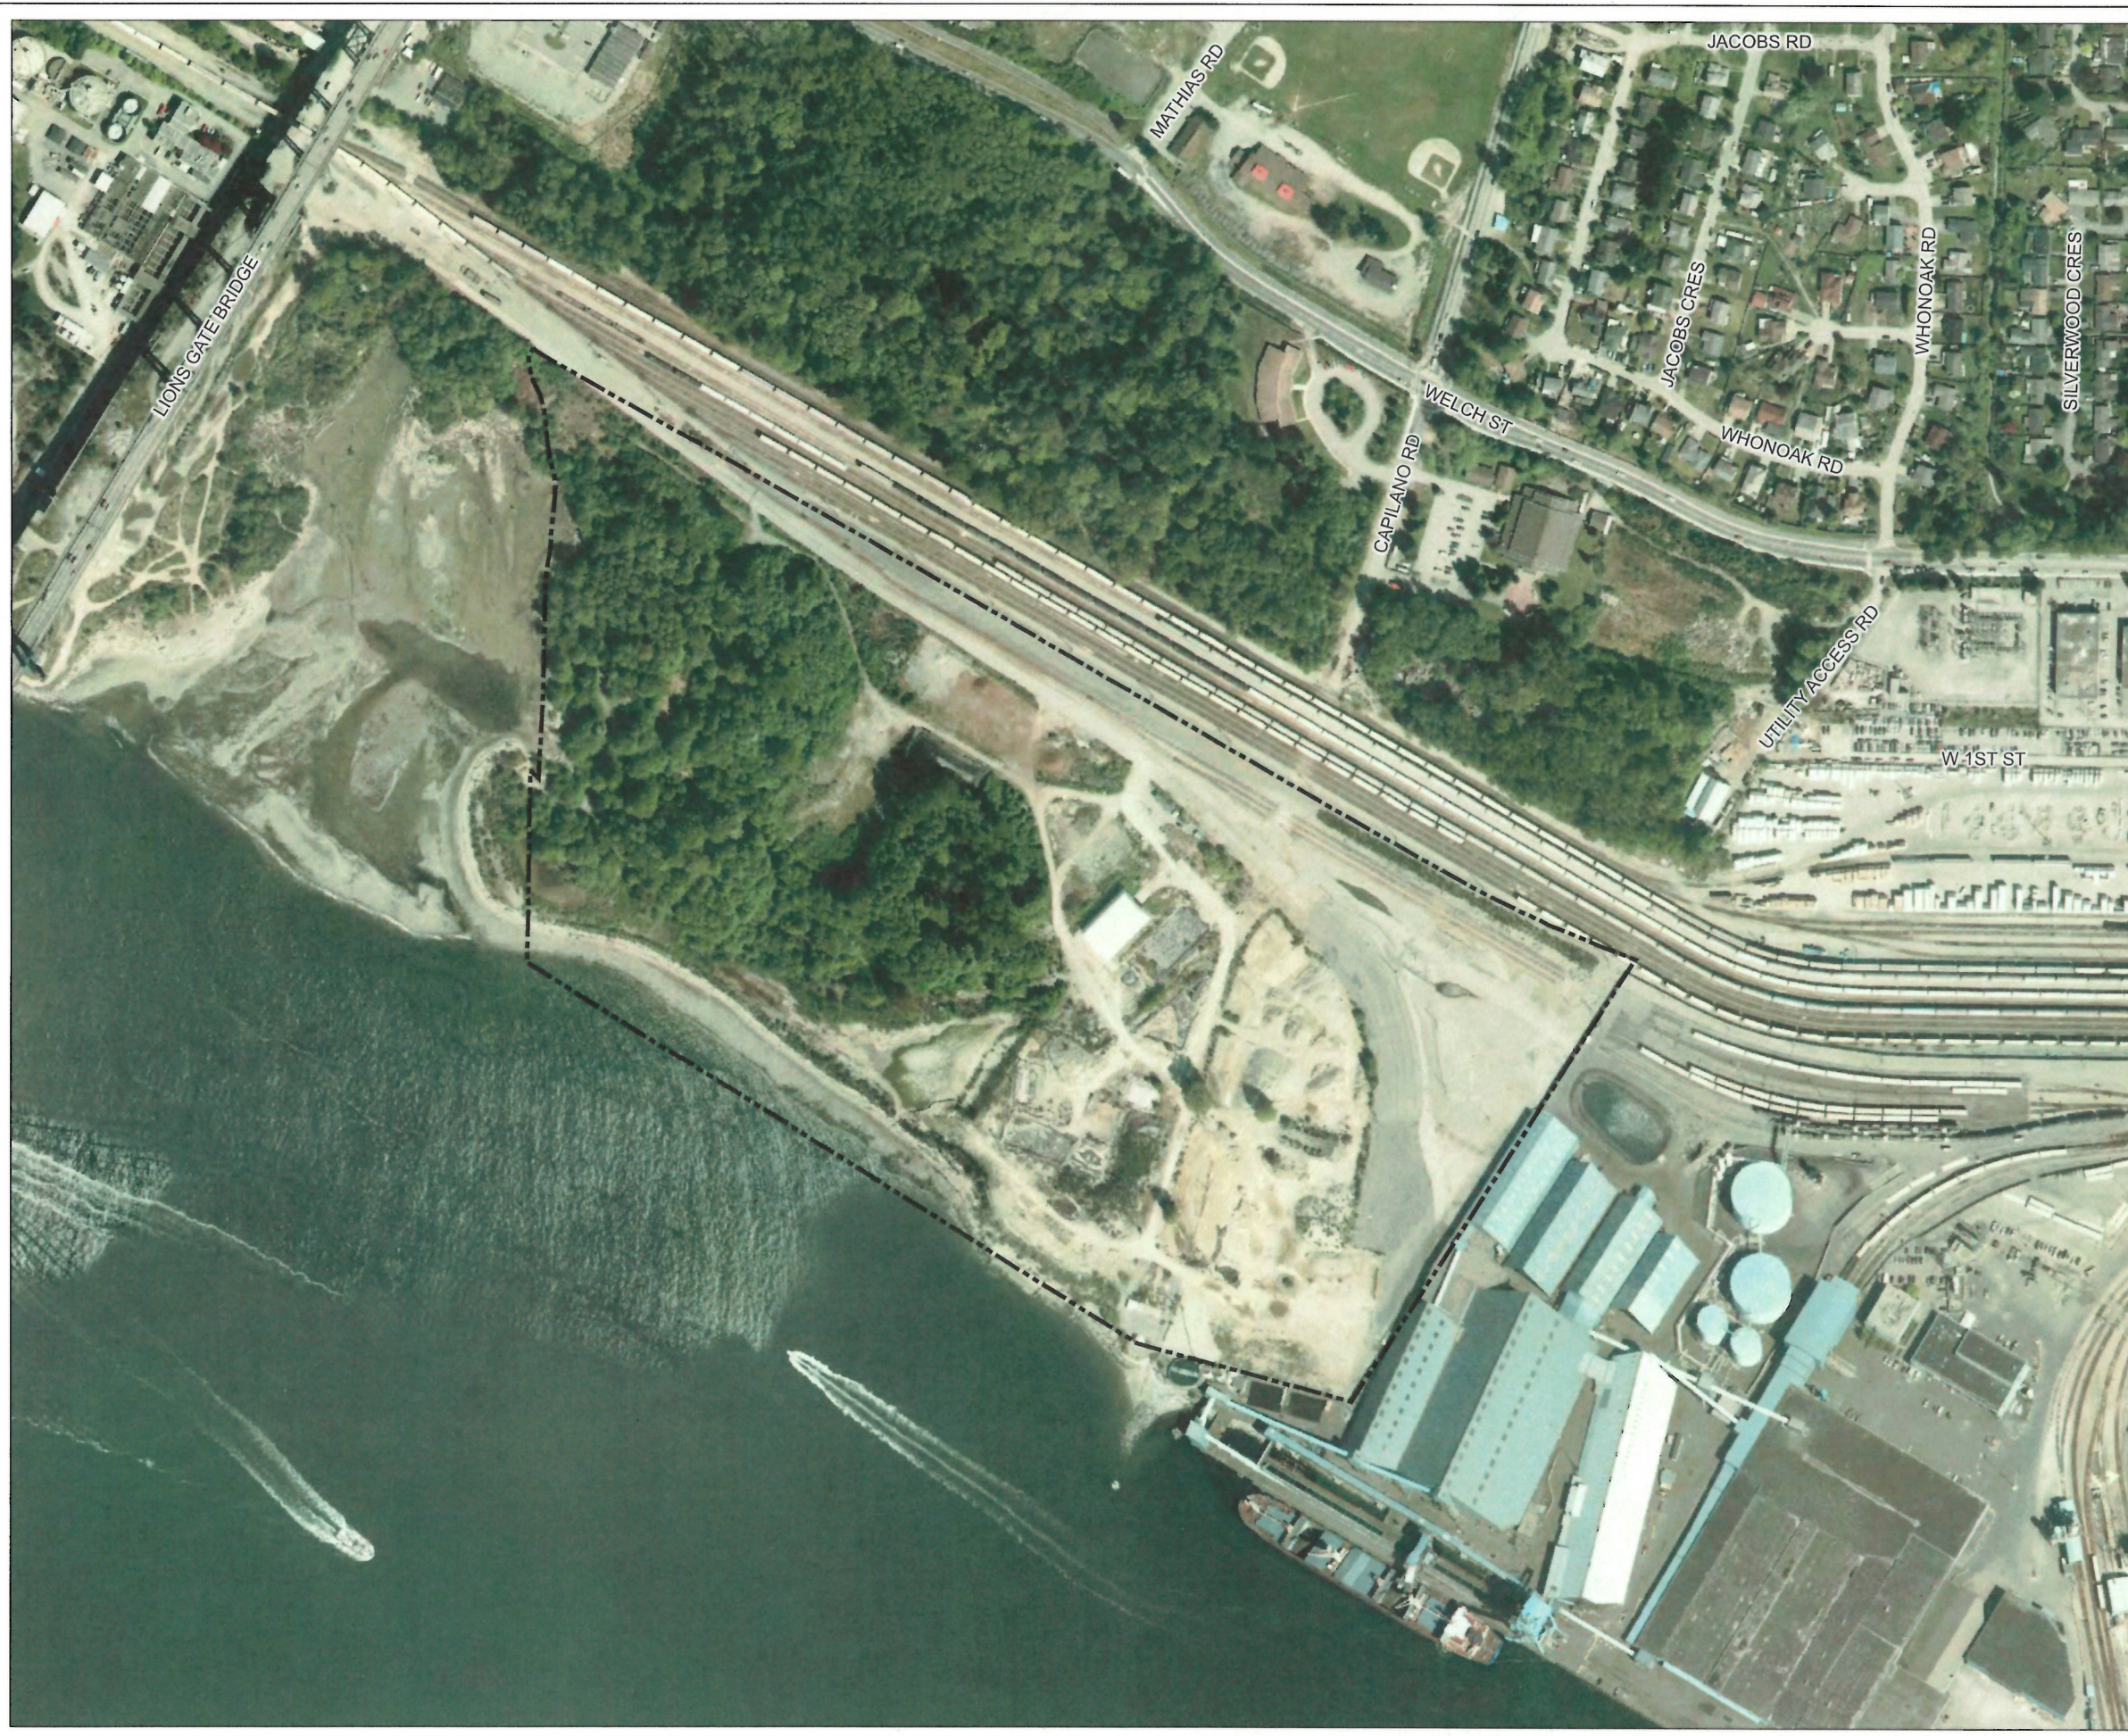
- Fence
- [ ] Site Location
- [ ] Proposed Contractor Support Zone
- [ ] Site Support Zone
- [ ] New Pavement
- [ ] Wheel Wash
- [ ] Access Roads

1. The Contractor may use the east room of the PEC Site office for general meetings and project co-ordination.
2. If the Contractor requires additional office facilities, including meeting/project management space, phone and fax facilities, the Contractor shall supply and maintain temporary site facilities as noted on the figure.

3. The Contractor may use the existing personnel decontamination facility. If the Contractor requires additional decontamination facilities the Contractor shall supply and maintain it at a location adjacent to the Site Support Zone.

4. The Contractor may use the existing portable toilet facilities. If the Contractor requires additional toilet facilities the Contractor shall supply and maintain temporary toilet facilities adjacent to the Contractors support facilities.

5. Electrical power is available to the PEC Site via primary overhead electrical transmission lines that are located along the MV right of way. There is a 30 amp service at the proposed contractor support zone available for Contractor to use. Contractor is responsible for modification to the existing services to meet their needs. Alternatively, Contractor may supply their own generators.

6. Location of proposed site facilities mentioned above shall be discussed with the Departmental Representative before commencing. The Departmental Representative may restrict the location for Contractor work areas (e.g. location of field offices).

7. The existing gravel/cobble stockpiles on-site are not available for Contractor use.
8. The Contractor shall supply and operate a water truck/mobile street washer (or equivalent) for the purposes of dust suppression and control.

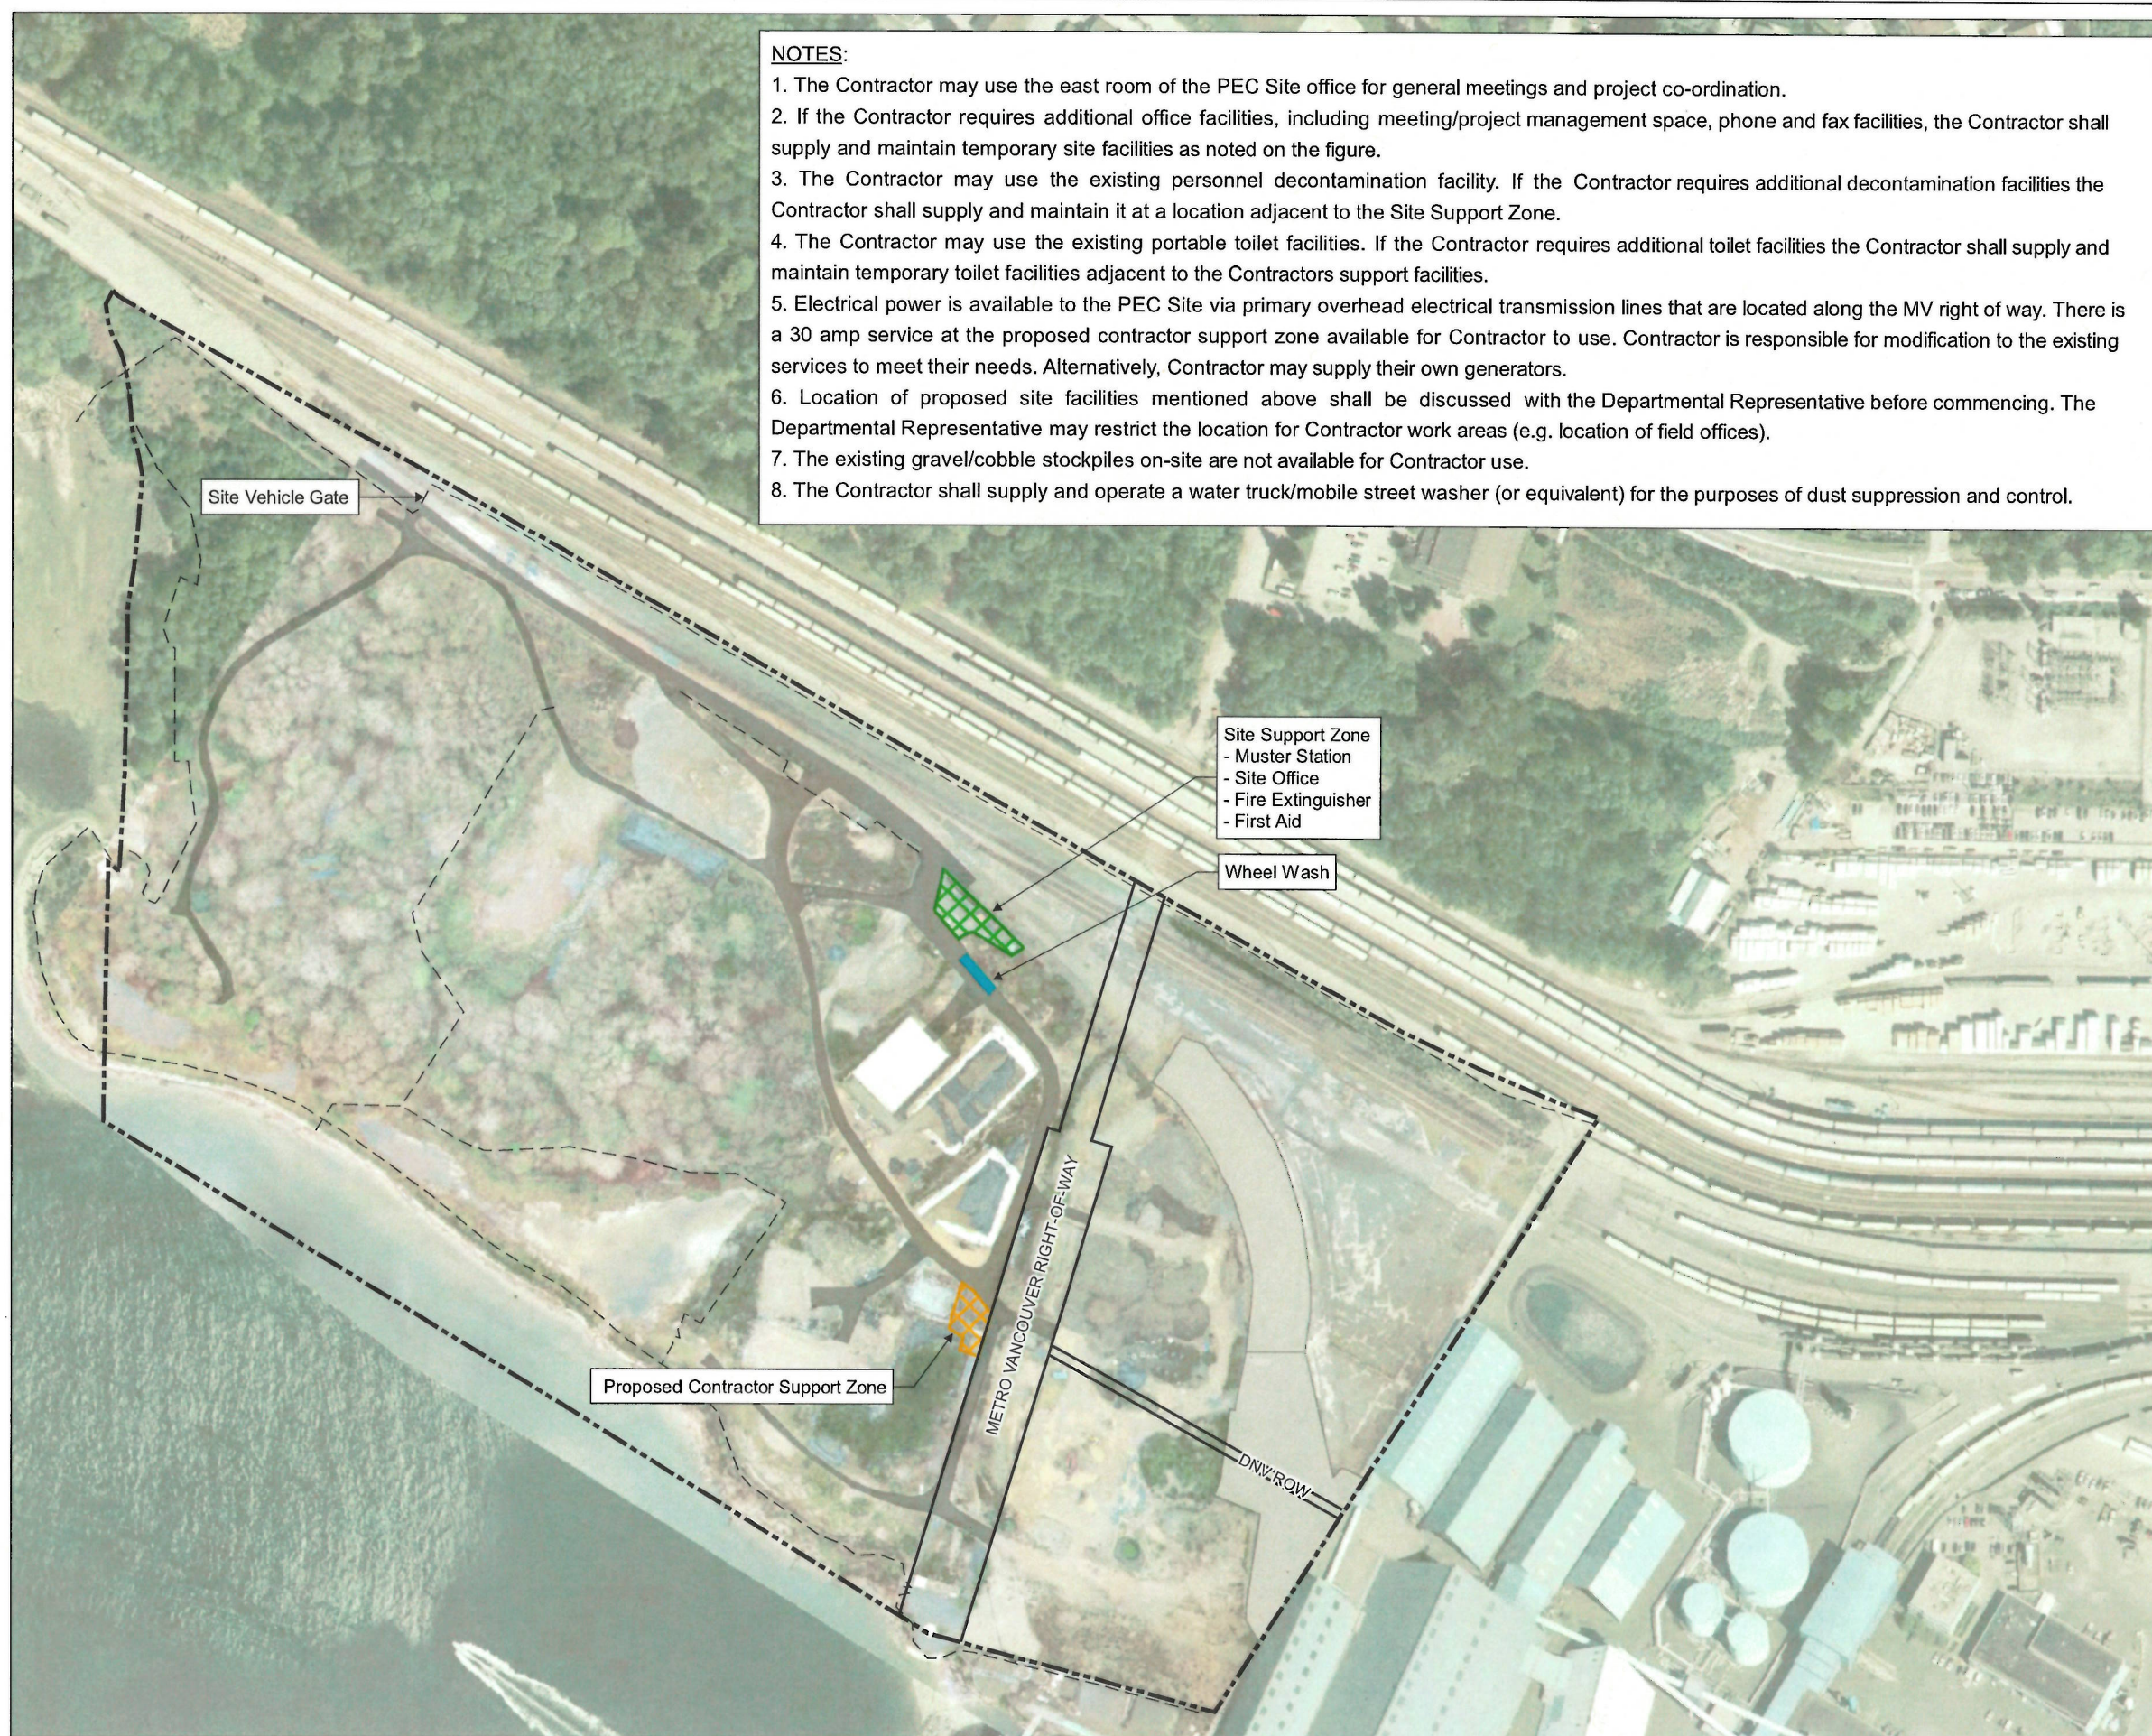
- Fence
- Site Location
- Work Exclusion Zone
- Work Zone
- Contractor Support Zone
- Site Support Zone
- New Pavement Area
- Wheel Wash
- Access Roads

1. The Contractor shall not enter or conduct any type of work in the Work Exclusion Zone without the written consent of Departmental Representative.
2. The Contractor shall review the most recent PEC Site Master Health and Safety Plan.

4. There are two right-of-ways crossing the PEC Site. A Metro Vancouver Right-of-Way (ROW) containing two water mains is present from the northern property boundary to the southern shoreline along Burrard Inlet. A District of North Vancouver (DNV) ROW, containing one water main runs from the Metro Vancouver water main to the eastern property boundary. To mitigate potential damage to the water main pipes, heavy equipment movement is limited across the ROWs, parking or storage of materials over top of the ROWs is prohibited, and excavations anywhere within or across the ROWs are prohibited. The Contractor shall also maintain 24 hour access to the Metro Vancouver ROW. The Contractor is to ascertain and abide by all DNV and Metro Vancouver requirements for work in and around the ROWs. This project shall not include any excavation within the Metro Vancouver or DNV right of ways, with the exception of the work described on Figure 5.

5. More than 100 groundwater-monitoring wells (MWs) have been installed on-site, including within and near the work areas. The Contractor must make all reasonable efforts to maintain the integrity of the MWs located within the excavation footprint (53 MWs located within the excavation footprint) and outside of the excavation footprint. If necessary, the Contractor may cut and cap the MWs polyvinyl chloride (PVC) well pipes as the excavation progresses. The Contractor is responsible for the cost of repairs and/or replacement necessary to the MWs in the event they are damaged or destroyed during their activities. An effort has been made to identify and mark the MWs on-site; however, extreme caution must be exercised during the moving of equipment, placing of materials, foot traffic, etc.

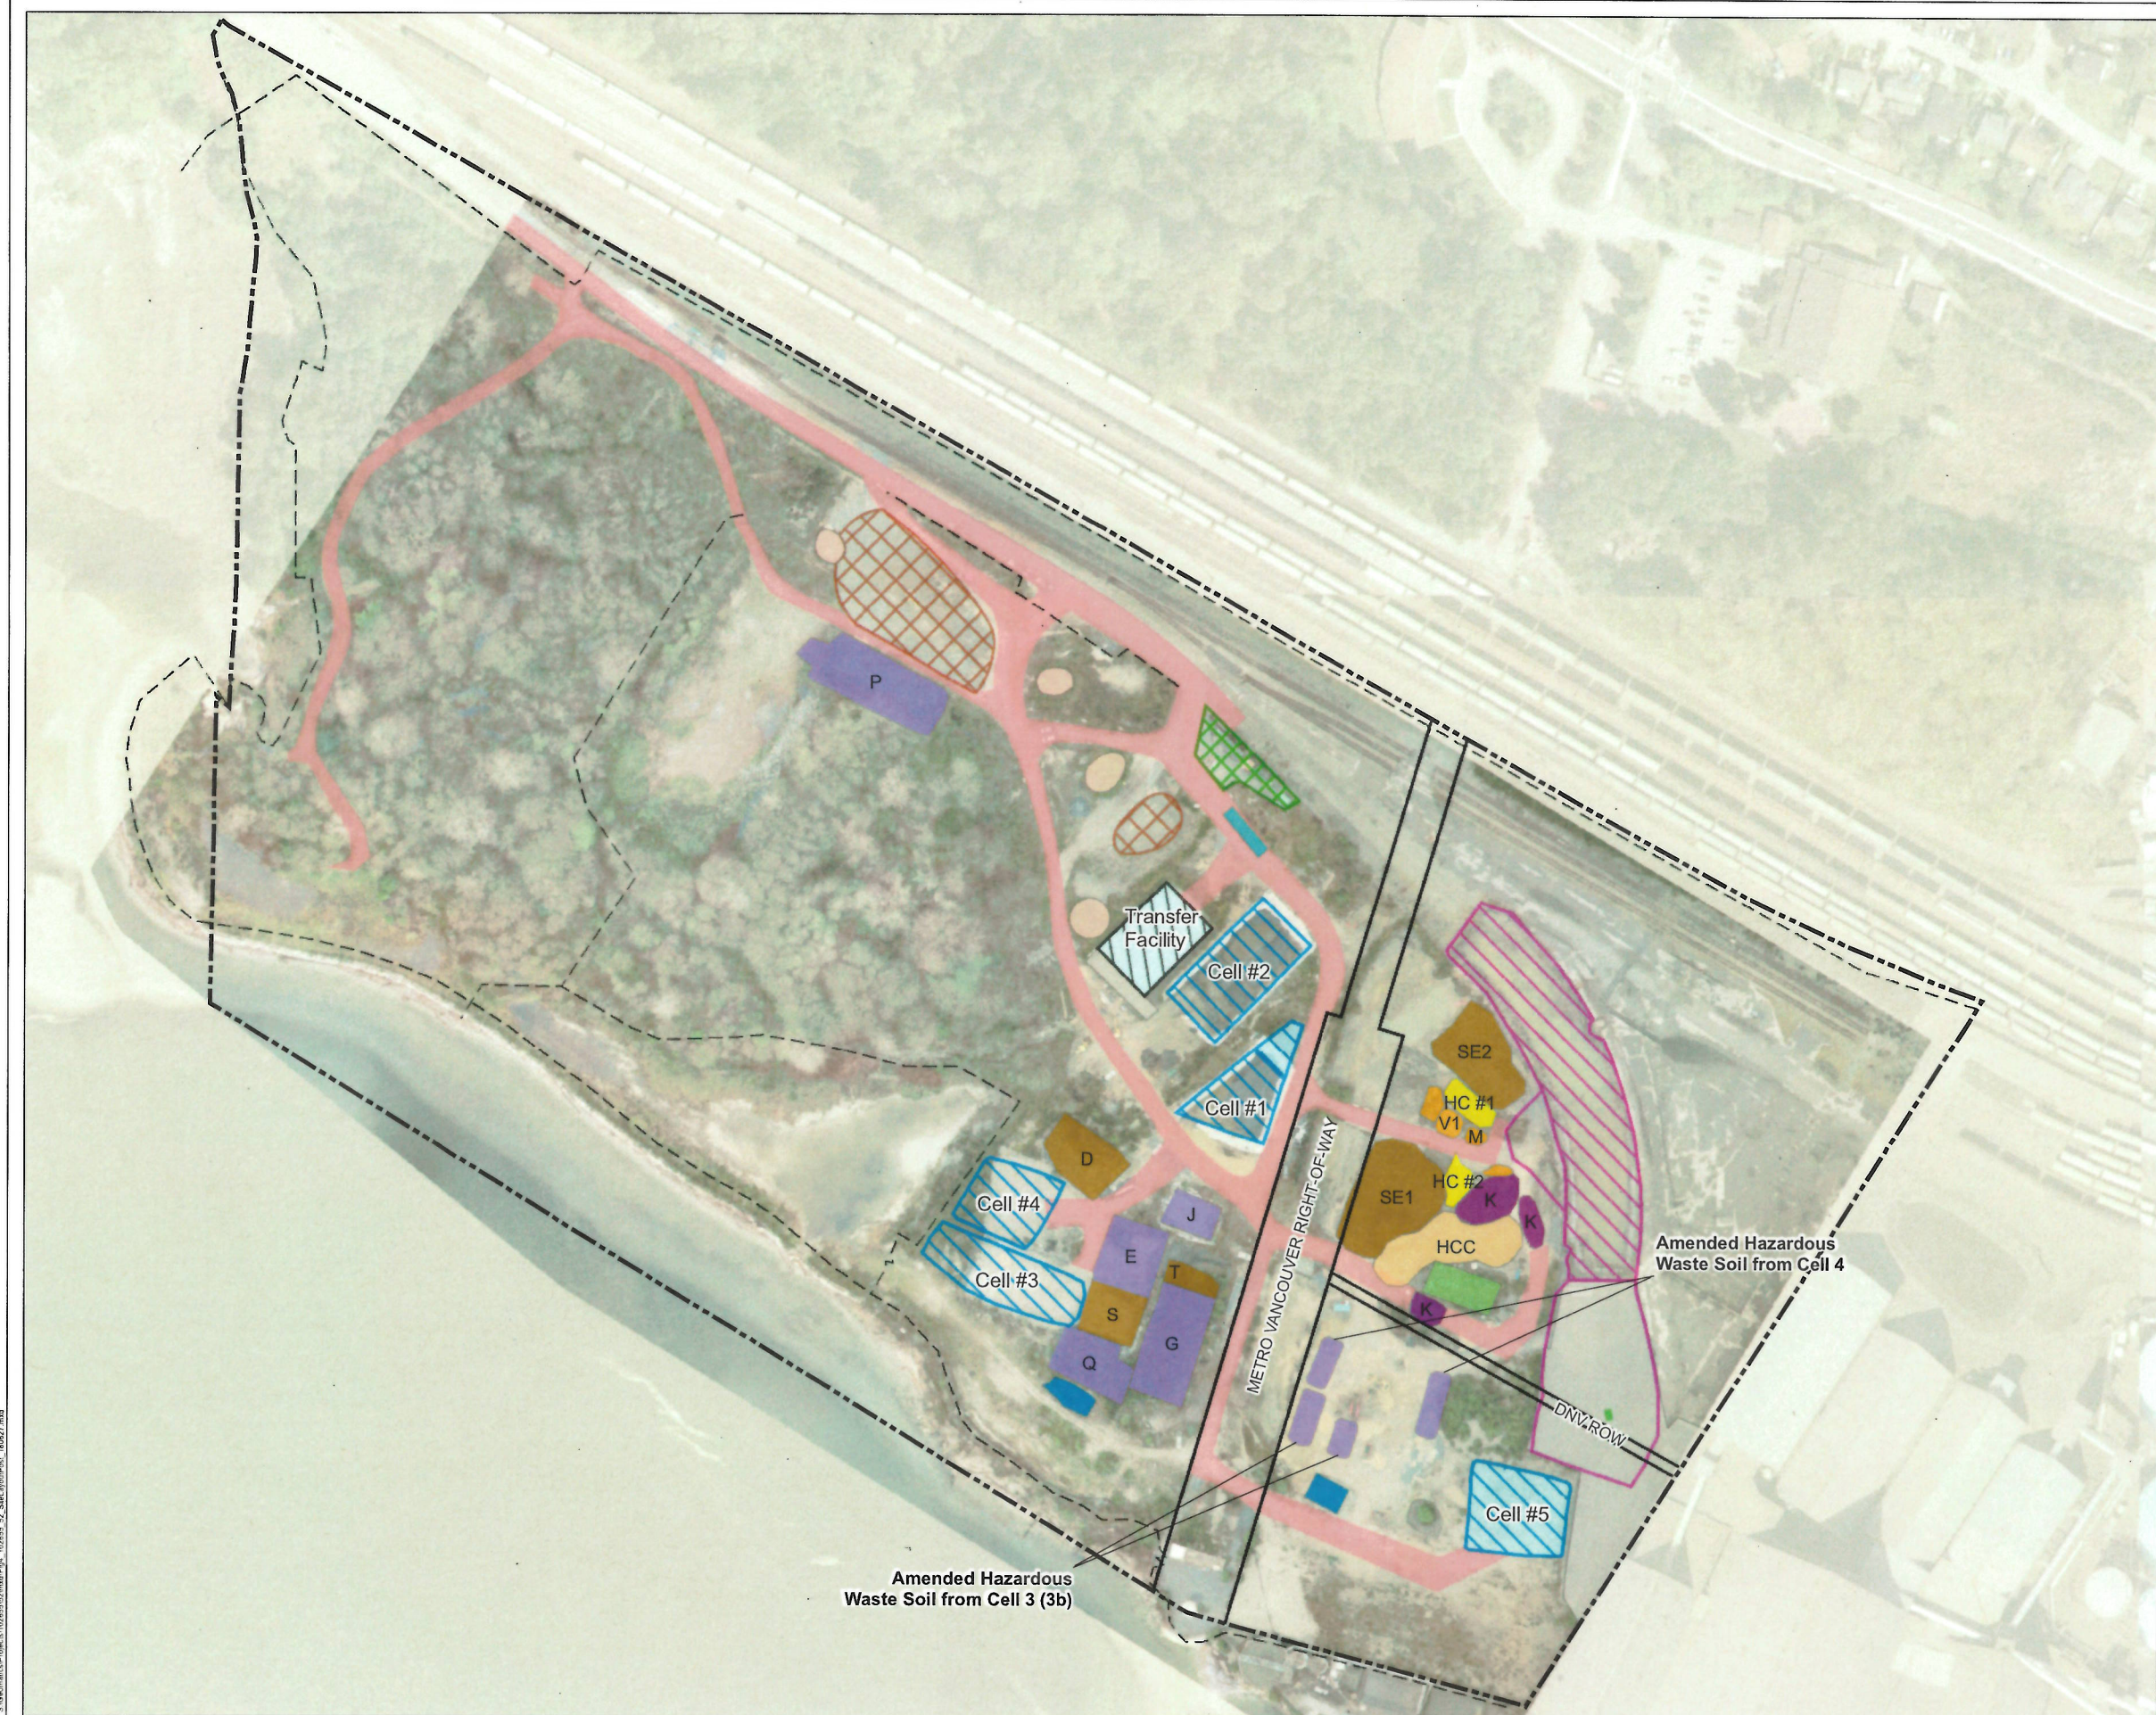
Site Facility Maintenance

- Fence
- Water Service Repair
- Road Relocation
- Road Repair Area
- Fence Section to be Replaced
- Site Location
- Access Road
- Wheel Wash

1. The Contractor shall repair fence section A to close the opening to the satisfaction of the Department Representative.
2. The ground below fence section B has eroded leaving a gap between the bottom of the fence and the ground surface. The Contractor shall repair or replace this section of the fence to eliminate the gap to the satisfaction of the Department Representative.

3. The Contractor shall clean out the existing wheel wash and maintain it during the project in a condition (by controlling water level, water quality and sediment accumulation) to the satisfaction of the Department Representative such that it performs adequately and prevents contamination outside of the containment area. The Contractor must completely clean the wheel wash at the project completion. Wheel wash sediments and wastewater must be managed by the Contractor. Sediments may be disposed of on site within one of the waste cells.

4. A four inch diameter water supply line has previously been installed within the District of North Vancouver water Right or Way (DNV ROW) directly east of the 60 inch diameter Metro Vancouver ROW. The Contractor shall complete the following two items:
  - a. A damaged gate valve installed on the four inch water supply line shall be repaired or replaced to the satisfaction of the Department Representative; and
  - b. The 12 inch diameter DNV ROW shall be exposed, cut and capped directly east (as close as possible) of the four inch water supply line. This pipe is 12 inch steel with 3/8 inch wall thickness throughout.

6. The road shall be regraded and compacted in the areas indicated, and left in this condition at the end of the project. Onsite stockpiles are not available for road surface repair, additional material may need to be imported and must meet backfill environmental quality requirements.

7. The road shall be relocated to the west of the existing road as identified below, such that it is no longer above the Metro Vancouver right-of-way.

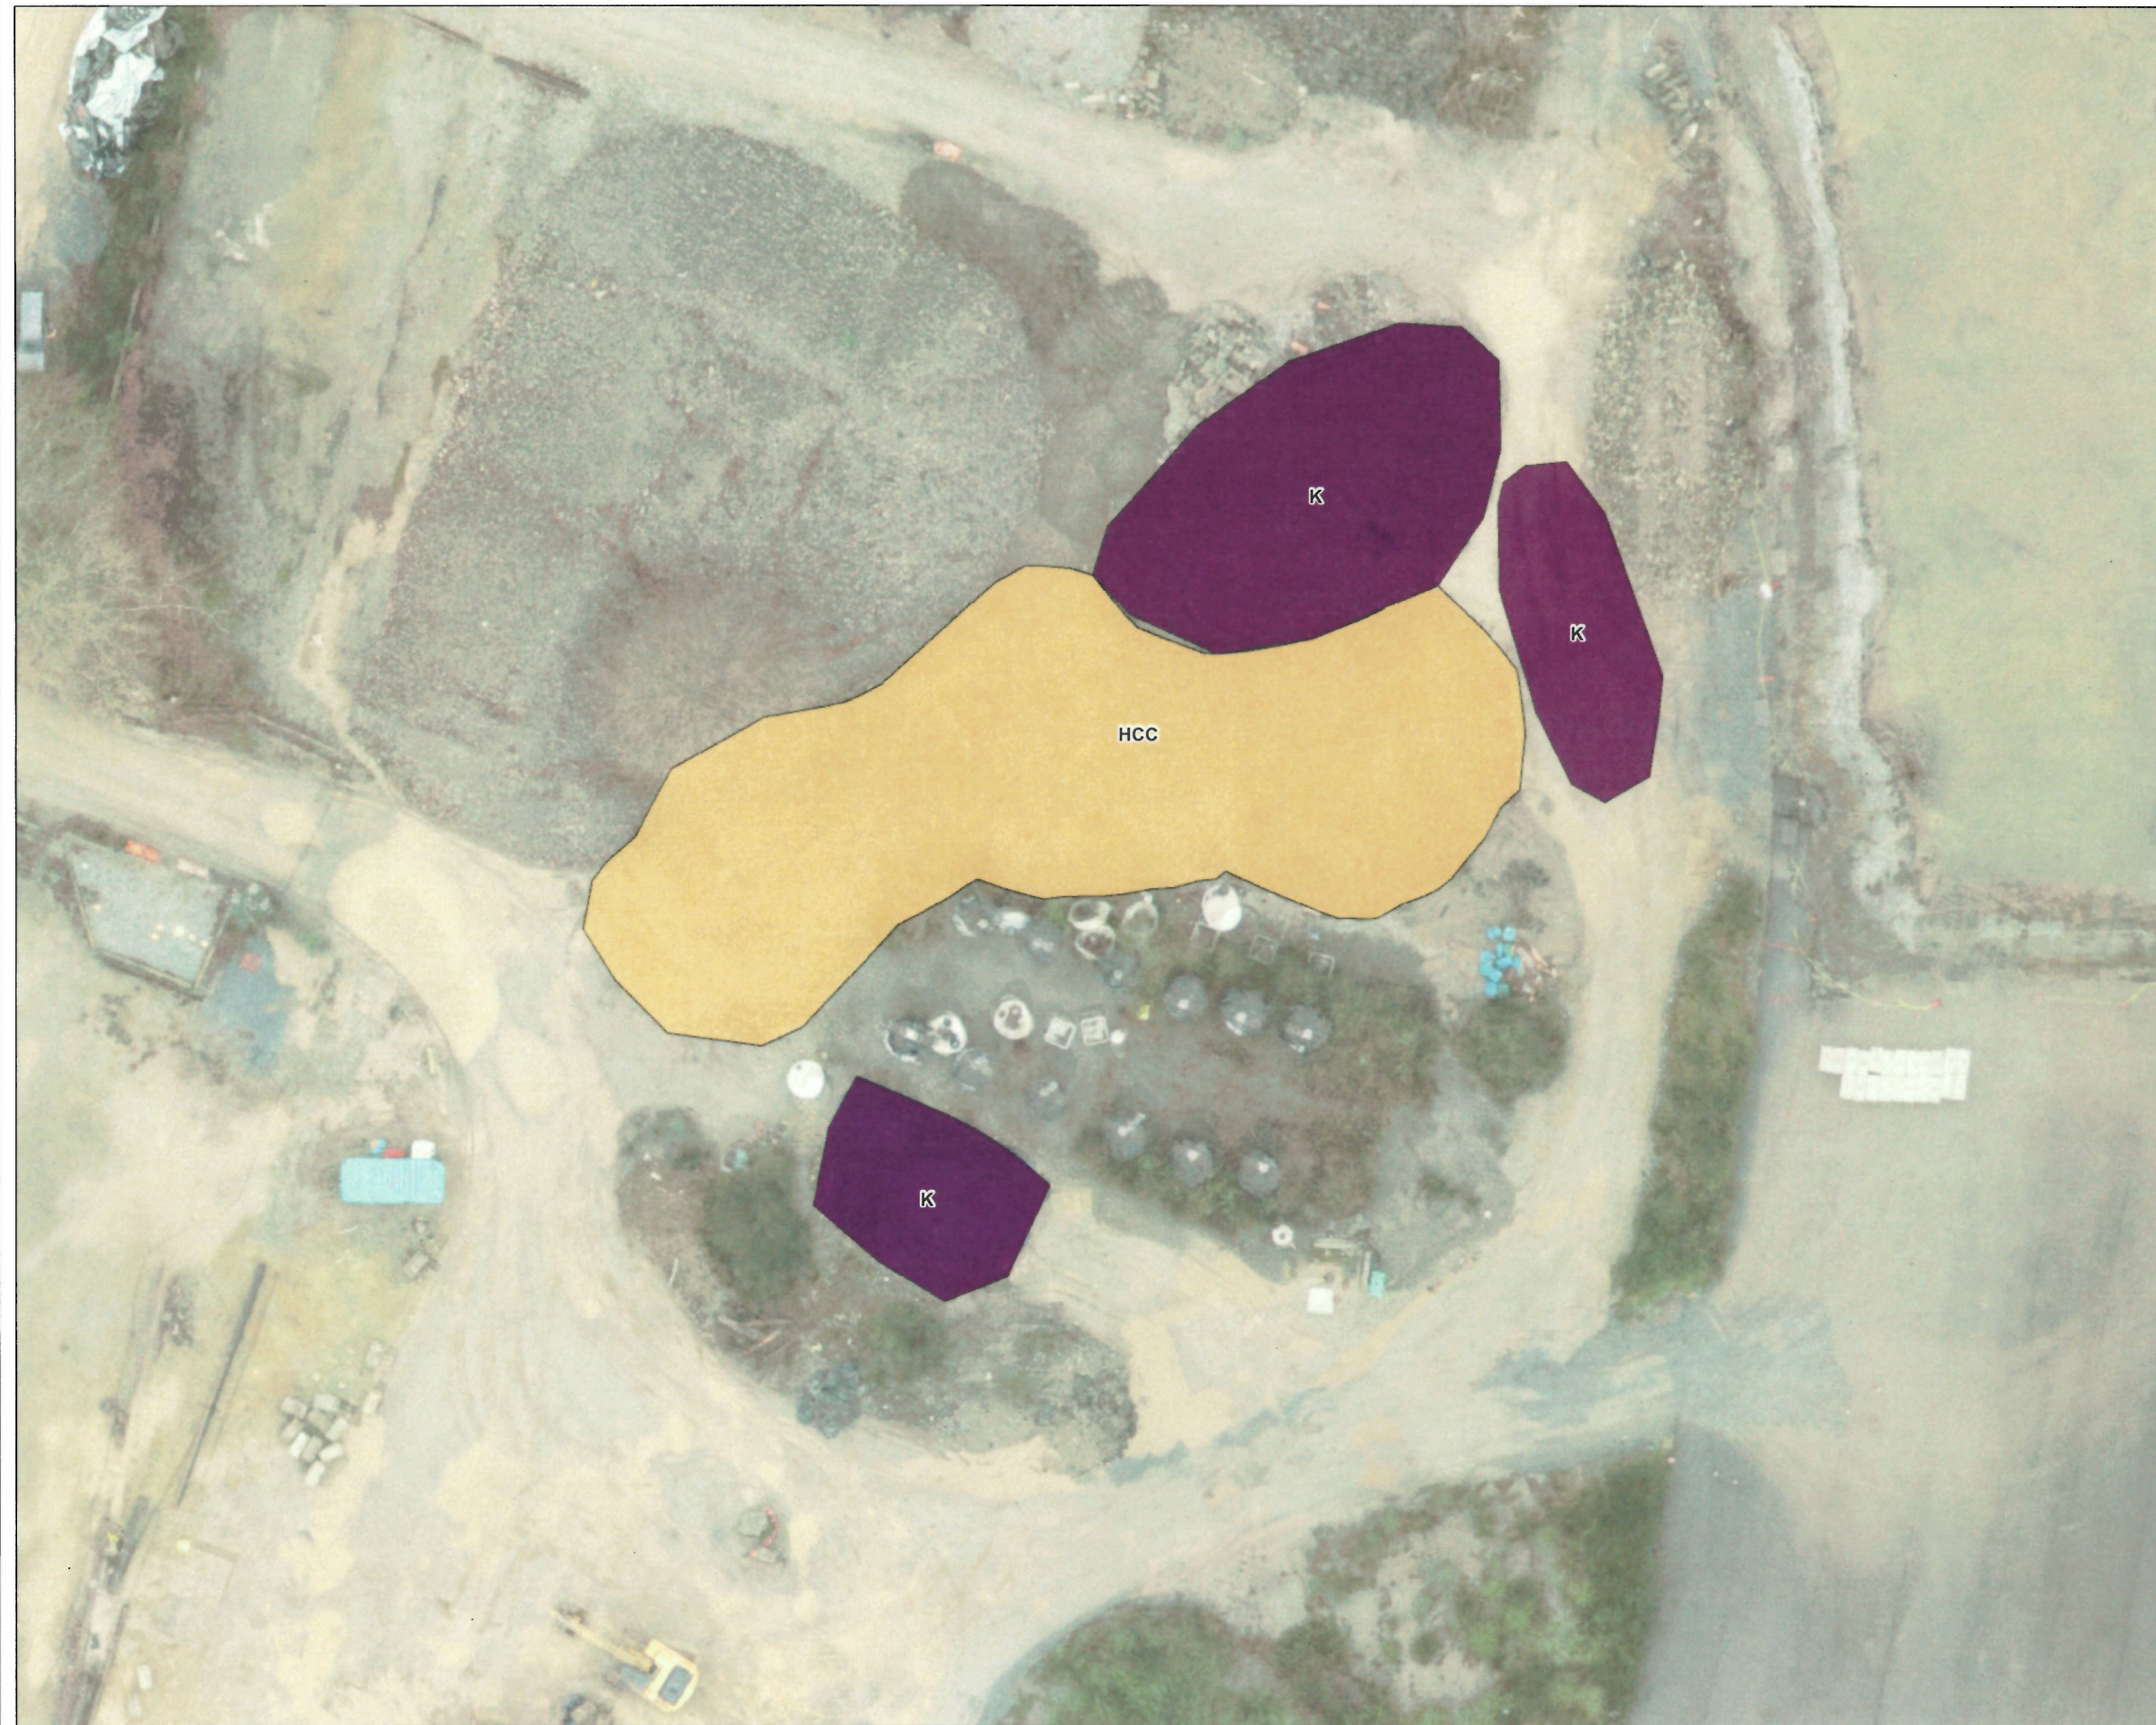
**Stockpile - HCC and K**

Gravel and cobble screened from hazardous waste and waste quality soil
-

Gravel and cobble screened from hazardous waste soil

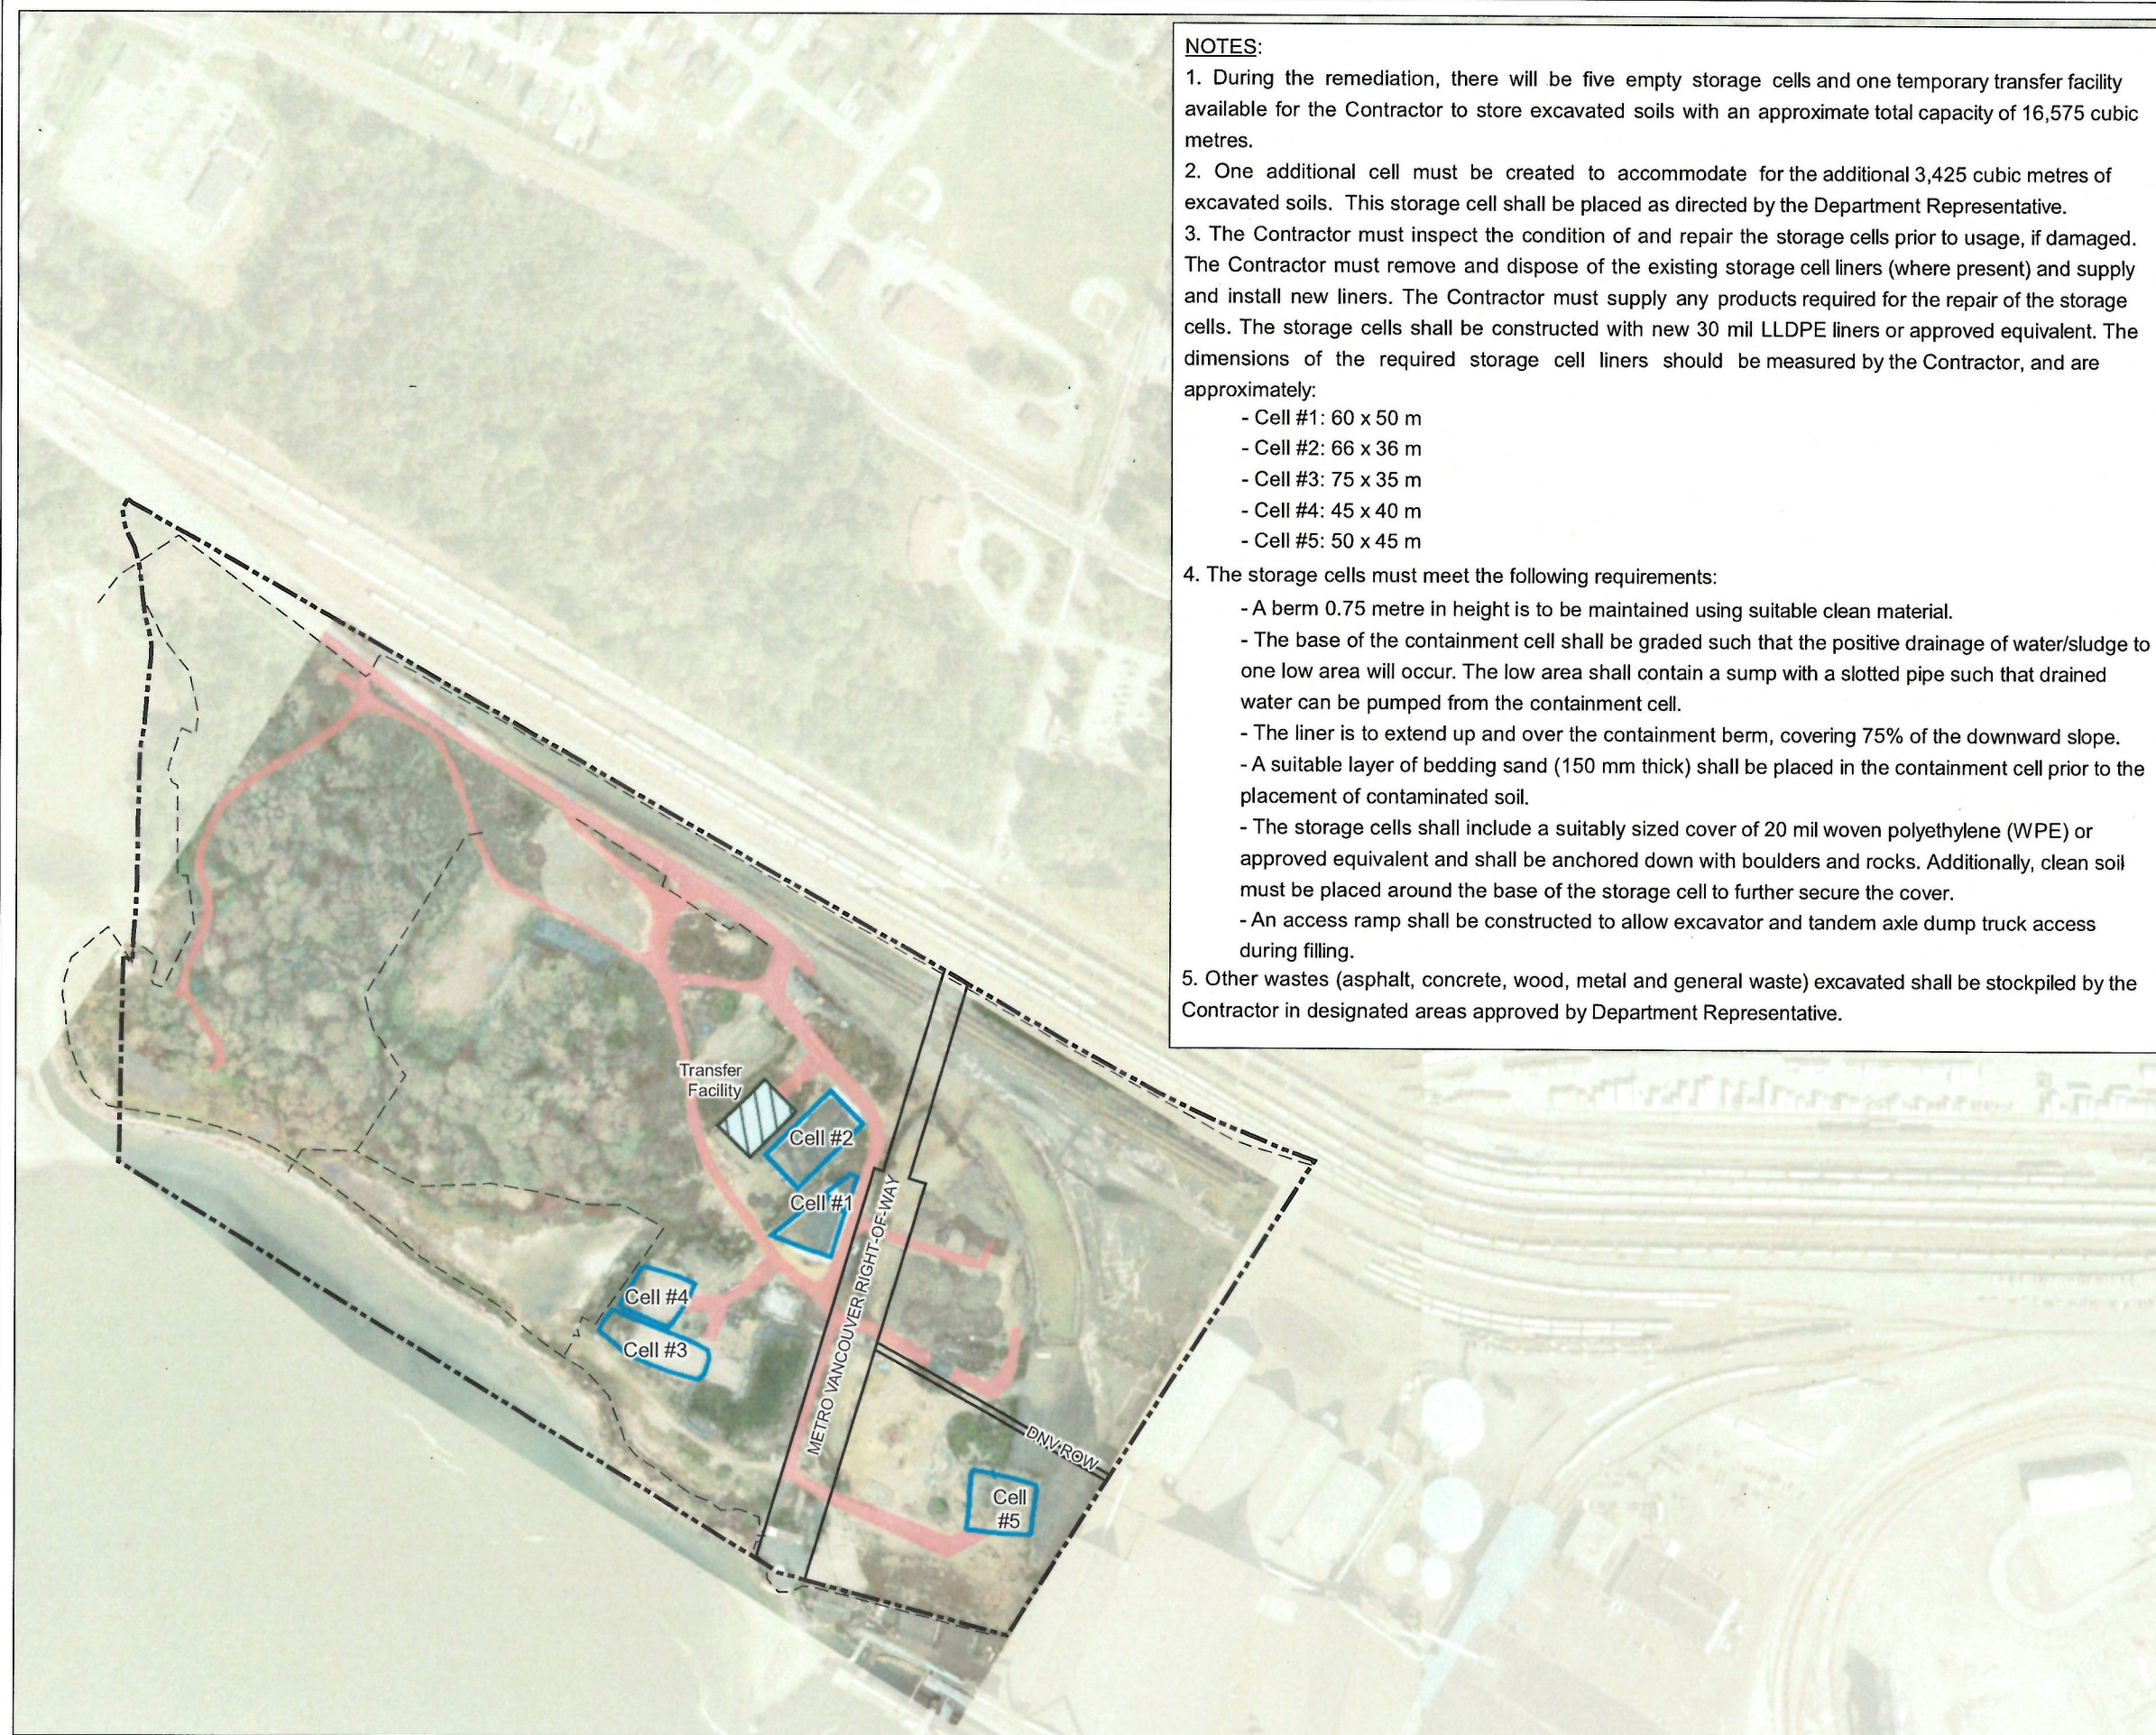
1. During the remediation, there will be five empty storage cells and one temporary transfer facility available for the Contractor to store excavated soils with an approximate total capacity of 16,575 cubic metres.

2. One additional cell must be created to accommodate for the additional 3,425 cubic metres of excavated soils. This storage cell shall be placed as directed by the Department Representative.

3. The Contractor must inspect the condition of and repair the storage cells prior to usage, if damaged. The Contractor must remove and dispose of the existing storage cell liners (where present) and supply and install new liners. The Contractor must supply any products required for the repair of the storage cells. The storage cells shall be constructed with new 30 mil LLDPE liners or approved equivalent. The dimensions of the required storage cell liners should be measured by the Contractor, and are approximately:

- Cell #1: 60 x 50 m
  - Cell #2: 66 x 36 m
  - Cell #3: 75 x 35 m
  - Cell #4: 45 x 40 m
  - Cell #5: 50 x 45 m
4. The storage cells must meet the following requirements:

- The storage cells shall include a suitably sized cover of 20 mil woven polyethylene (WPE) or approved equivalent and shall be anchored down with boulders and rocks. Additionally, clean soil must be placed around the base of the storage cell to further secure the cover.

- An access ramp shall be constructed to allow excavator and tandem axle dump truck access during filling.
5. Other wastes (asphalt, concrete, wood, metal and general waste) excavated shall be stockpiled by the Contractor in designated areas approved by Department Representative.
