**PEC Site Road Routing and  
Health & Safety Features**

Site Control Zones

Site Layout

**Contaminated Soil Storage Areas**

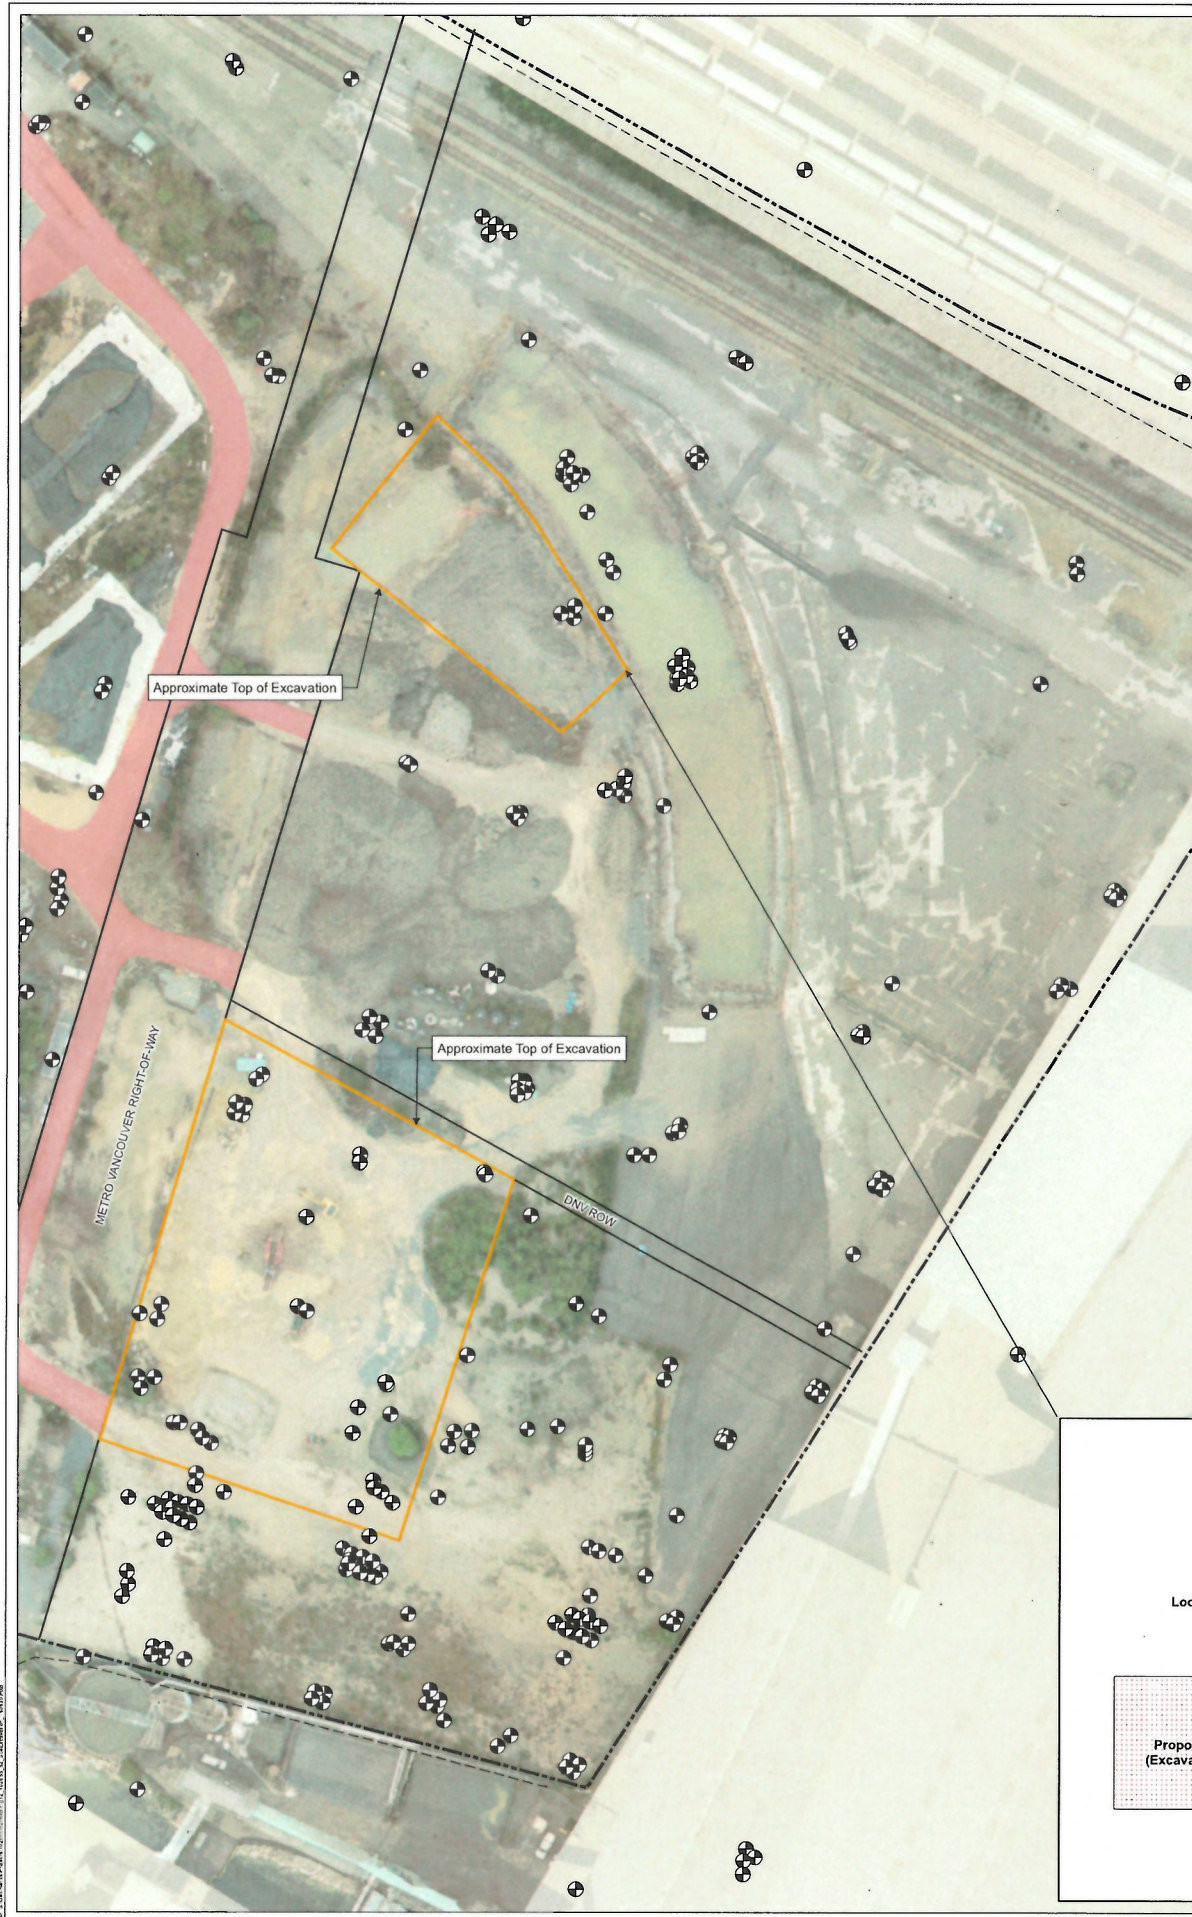
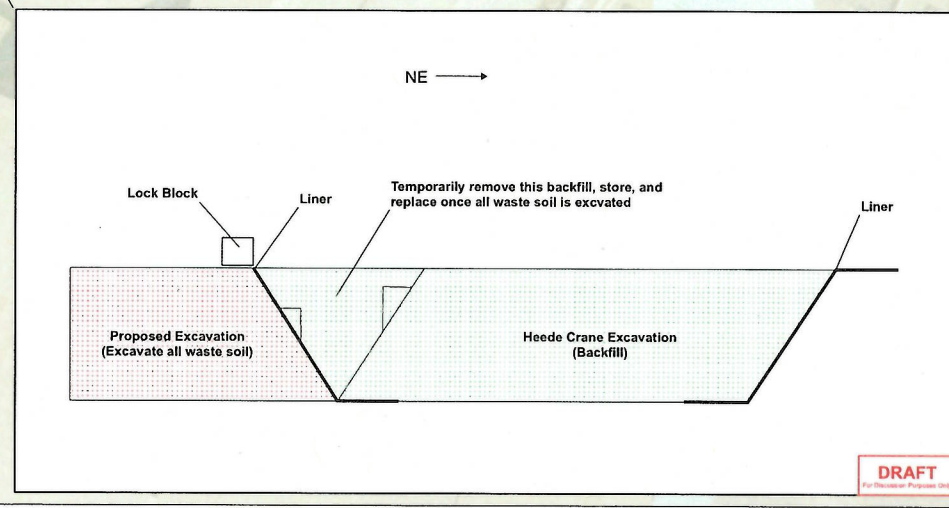
Proposed Soil Excavations

- The depth of excavation from the existing grade to the groundwater table is approximately 3.5 m below grade, and is expected to fluctuate with the tide.

- Utility lines which are abandoned and not in use may be removed during excavation activities.
- More than 100 groundwater-monitoring wells (MWs) have been installed on-site, including within and near the work areas. The Contractor must make all reasonable efforts to maintain the integrity of the MWs at the site, including those within the excavation footprint (approximately 53 MWs located within the excavation footprint). If necessary, the Contractor may cut and cap the MWs polyvinyl chloride (PVC) well pipes as the excavation progresses. The Contractor is responsible for the cost of repairs and/or replacement necessary to the MWs in the event they are damaged or destroyed during their activities. An effort has been made to identify and mark the MWs on-site; however, extreme caution must be exercised during the moving of equipment, placing of materials, foot traffic, etc.

- The excavation of material shall continue until the limits of the excavation are reached based on visual observation of groundwater table by the Department Representative. A limited quantity of hazardous waste and suspect hazardous waste soils will be removed as part of the excavation program. The suspect hazardous waste soils must be segregated from the waste soils during excavation and stockpiled in a designated soil storage cell determined by the Department Representative. Borehole logs from select monitoring wells within the excavation area are attached for soil stratigraphy reference purposes only (see Appendix B).

- The approximate sizes of each excavation are as follows (L x W x D):  
North: 62 x 36 x 3.5m  
South: 92 x 70 x 3.5m

- The backfill materials shall be placed to a minimum of 95 percent of their Modified Proctor Maximum Dry Density (ASTM D1557) while at a moisture content within 2 percent of optimum for compaction.
