Reconstruction of Dam at Lock 38 (EQ754-190606/B)

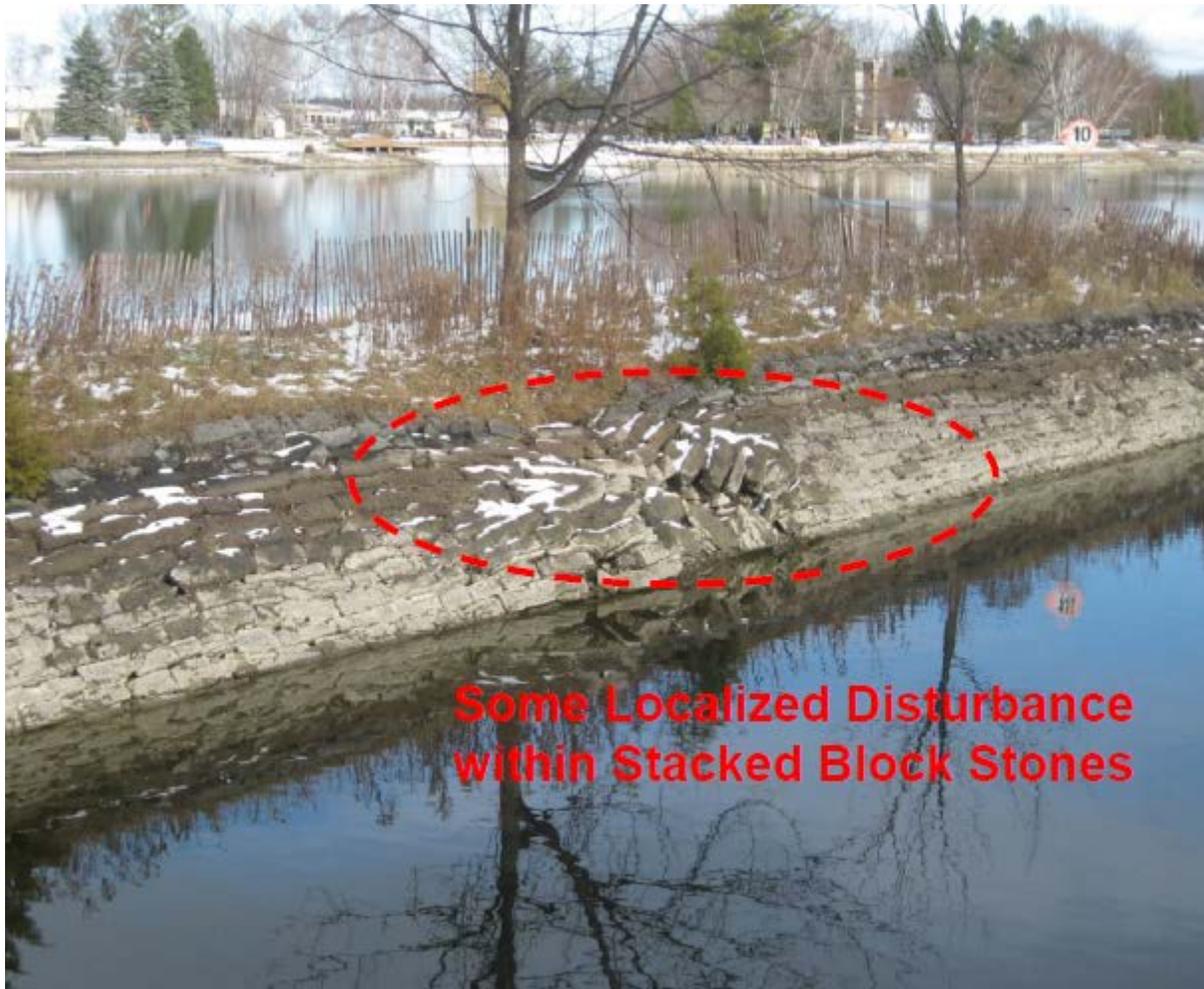
Answer 1) A drawing will not be generated. The photograph of the slumped area is shown in attached Figure 1. It has been anticipated that the stacked stone wall would be removed and replaced by divers from the upstream face of the dam to the upstream edge of the slumped area. Stones to be managed in accordance with the technical specifications.

Figure 1. Slumped area of stacked stone.

Answer 7) Slumped stacked stone repair to remain in the Lump Sum Amount as the exact dimensions of the repair are highly dependent on the means and methods of contractors. Please refer to Figure 1 for further reference.
