**SOLICITATION AMENDMENT**  
**MODIFICATION DE L'INVITATION**

<b>Title - Sujet</b> Maint. Facility Construction-Fundy	
<b>Solicitation No. - N° de l'invitation</b> EC015-193152/A	<b>Amendment No. - N° modif.</b> 004
<b>Client Reference No. - N° de référence du client</b> EC015-193152	<b>Date</b> 2019-04-03
<b>GETS Reference No. - N° de référence de SEAG</b> PW-\$PWB-013-4426	
<b>File No. - N° de dossier</b> PWB-8-41126 (013)	<b>CCC No./N° CCC - FMS No./N° VME</b>
<b>Solicitation Closes - L'invitation prend fin</b> <b>at - à 02:00 PM</b> <b>on - le 2019-04-10</b>	
<b>Time Zone</b> Fuseau horaire Atlantic Daylight Saving Time ADT	
<b>F.O.B. - F.A.B.</b> <b>Plant-Usine:</b> <input type="checkbox"/> <b>Destination:</b> <input checked="" type="checkbox"/> <b>Other-Autre:</b> <input type="checkbox"/>	
<b>Address Enquiries to: - Adresser toutes questions à:</b> Johnston, Edward PWB	<b>Buyer Id - Id de l'acheteur</b> pwb013
<b>Telephone No. - N° de téléphone</b> (506) 343-6382 ( )	<b>FAX No. - N° de FAX</b> (506) 636-4376

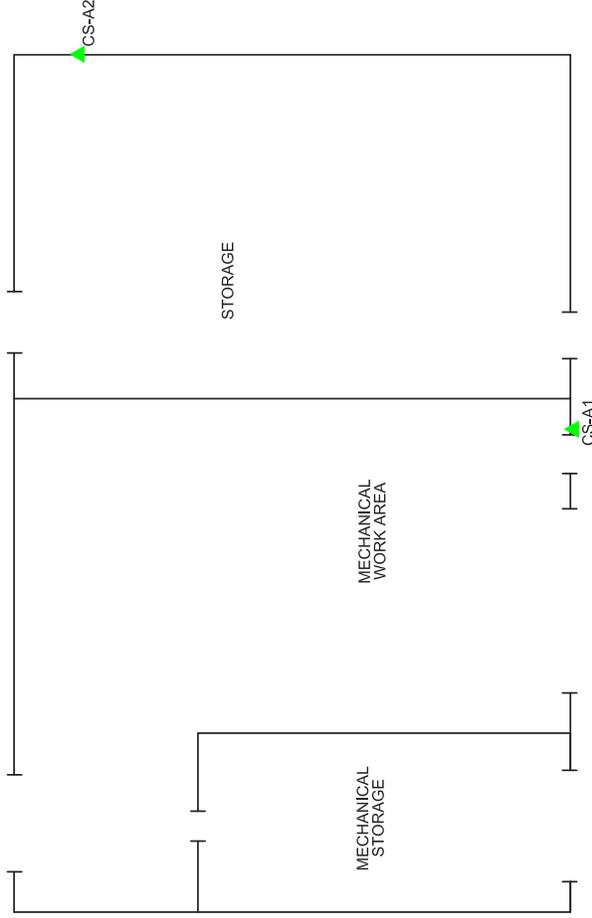
<p><b>Public Works and Government Works Canada</b></p> <p><b>Englobe Corp.</b> 118 - 1067 Champlain Street Dieppe New Brunswick E1A 1P9</p>	<p><b>Hazardous Building Materials Assessment</b> Maintenance Compound, Cold Storage Building (#21) Fundy National Park, Alma, New Brunswick</p> <p style="text-align: center;"><b>Asbestos Sample Location Plan</b></p>	<p>1 2 3 4m</p> <p><small>CONFIDENTIALITY STATEMENT: This document, protected by law, is the property of Englobe and is for the sole use of the intended purpose. Any distribution or modification, partial or total, is strictly prohibited without prior written approval from Englobe Corp.</small></p>																																										
<p><b>SF P-0010928 08 200</b></p>
