Project title/Titre du projet
ESQUIMALT GRAVING DOCK
825 ADMIRALS ROAD, VICTORIA, BC

WATER INGRESS AT SECTION 1 STAIRWELL NORTH SIDE

KEY PLAN AND SITE PLAN

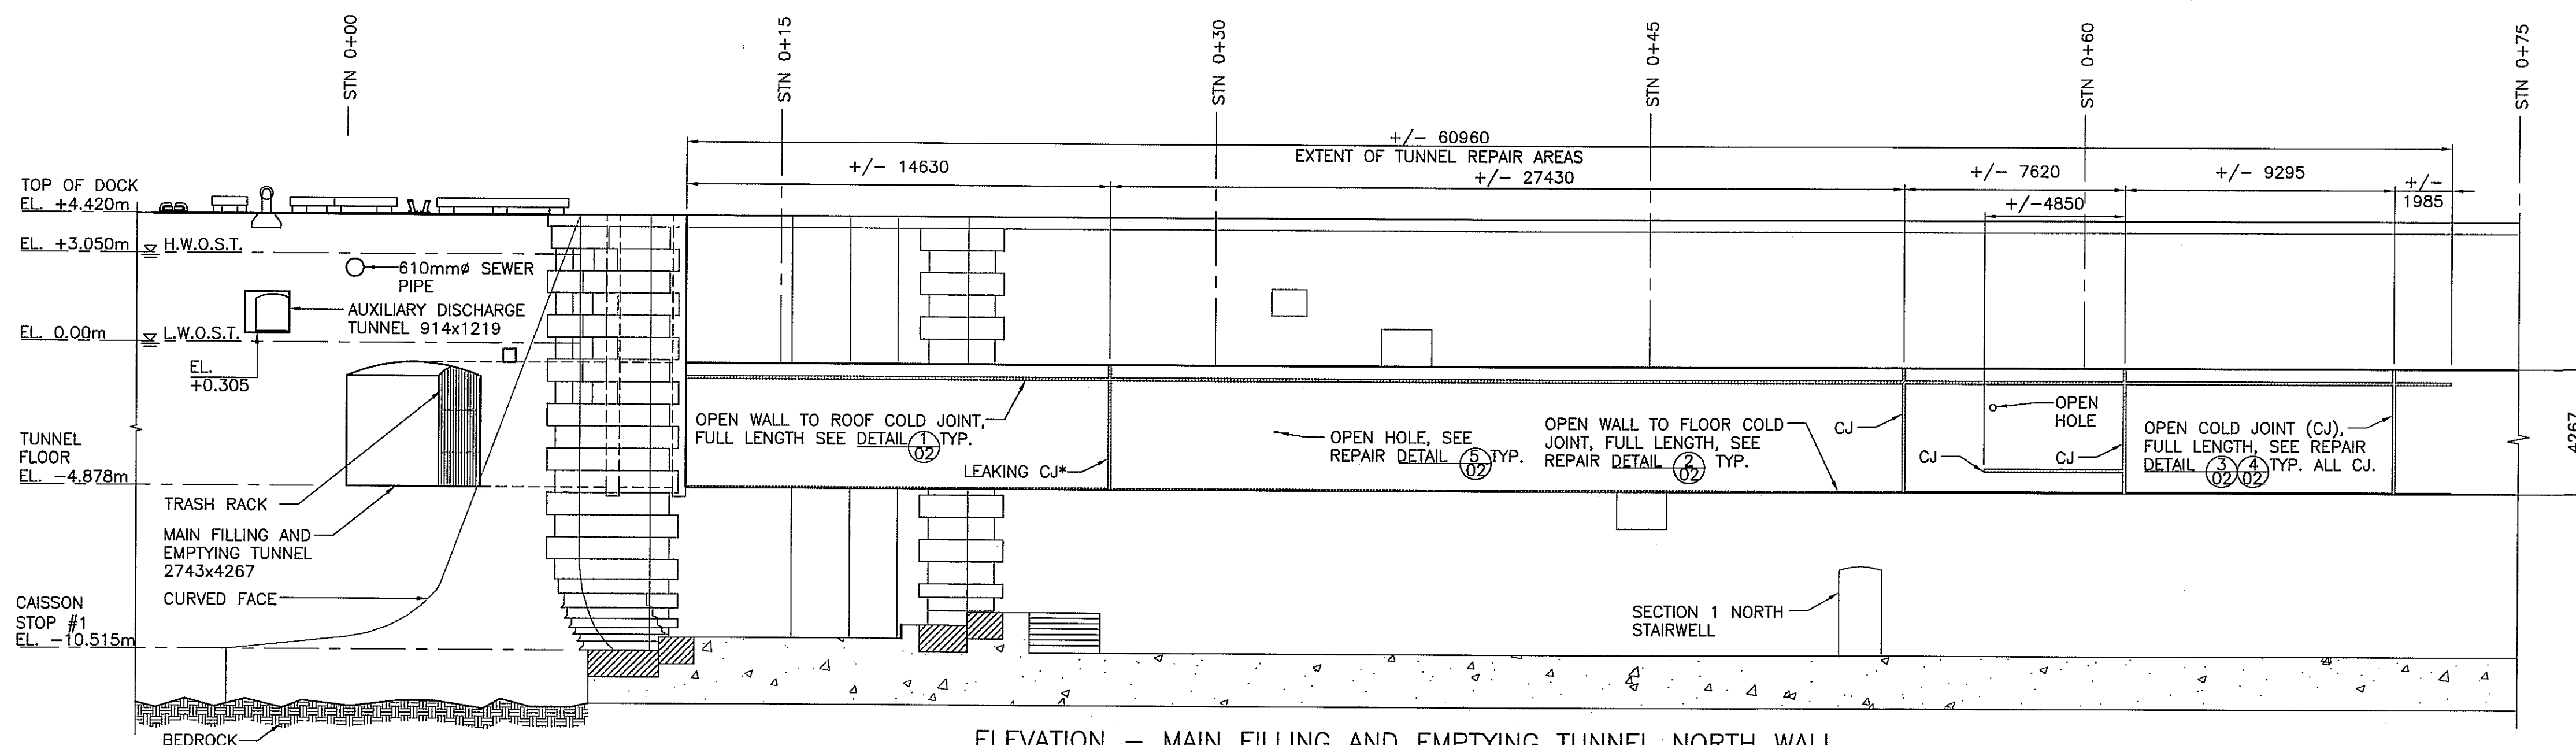
ELEVATION - MAIN FILLING AND EMPTYING TUNNEL NORTH WALL

*NOTE: COLD JOINTS MARKED AS LEAKING ARE BASED ON OBSERVED LEAKAGE ON 2017.11.16. LEAKAGE AT TIME OF REPAIRS ARE SUBJECT TO TIDAL AND GROUNDWATER FLUCTUATIONS. SELECT DETAIL 3 OR 4 TO SUIT CONDITIONS AT TIME OF REPAIR.

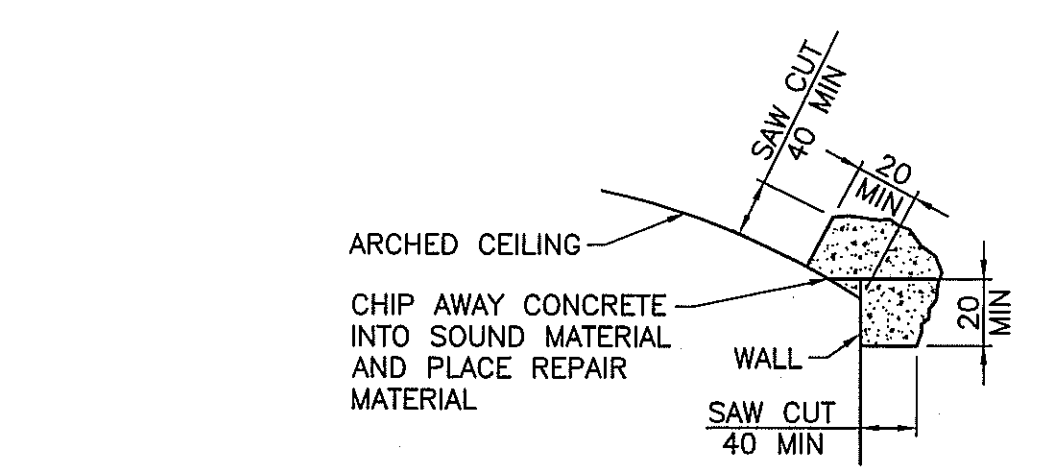
1
01
DETAIL - WALL TO ROOF COLD JOINT REPAIR
1:5

NOTE: PLACE REPAIR MATERIAL AS PER SPECIFICATION FOR NON-LEAKING JOINTS, OR LEAKING JOINTS AS APPLICABLE, TO MATCH ORIGINAL PROFILE
NOTE: CONCRETE DEMO DEPTHS SHOWN ARE MINIMUM REQUIRED TO FACILITATE REPAIRS AND INCLUDE REMOVAL OF SOUND CONCRETE

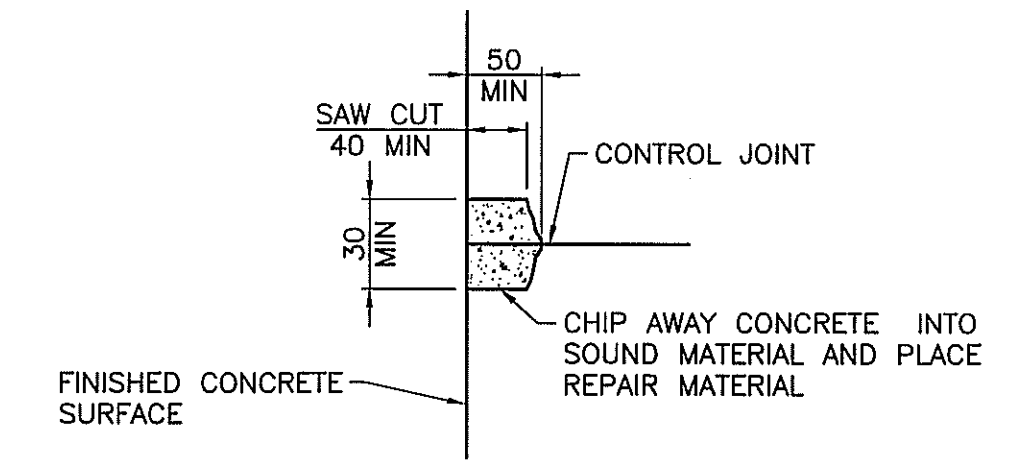
3
01
DETAIL - COLD JOINT REPAIR
1:5
NOTE: INCREASE WIDTH OF REPAIR TO SUIT DAMAGE AT COLD JOINT INTERSECTION
