PWGSC Moosonee Buildings Demolition

SPECIFICATIONS

DESIGNATED SUBSTANCES & HAZARDOUS MATERIALS SURVEY

**Designated Substances and Hazardous Material Survey
Four Buildings at the Moosonee DND Radar Base
Moosonee, Ontario**

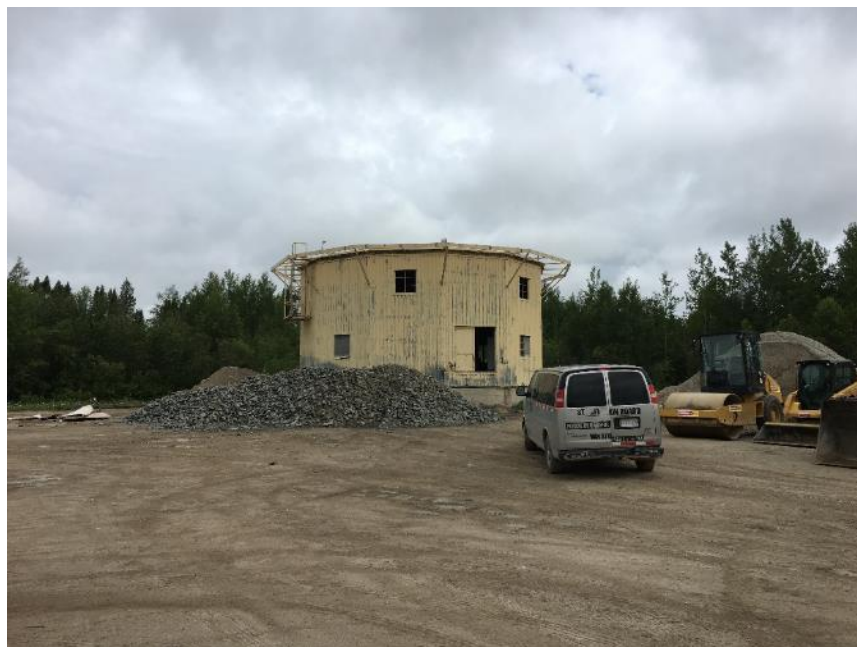
Photo 4: View of Building 1A with lead-containing yellow paint on metal cladding (DST 2006, 353-1A-LP-01). This paint has been identified as leachate hazardous with respect to lead.

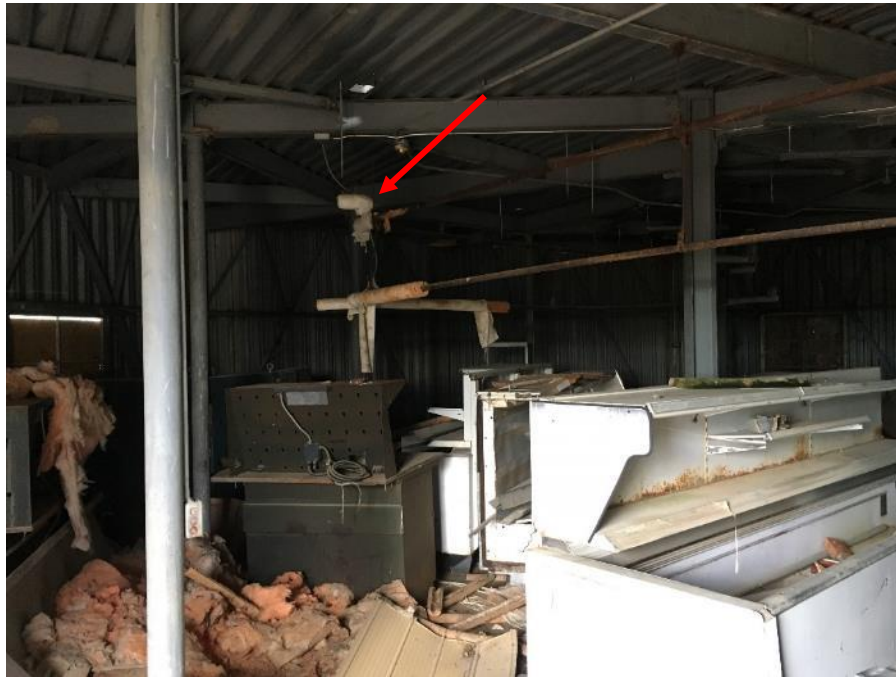
Photo 5: View of asbestos-containing grey cement compound on pipe fittings (DST Sample 29911-1A-01A) and old grocery display refrigeration units, located in Building 1A.

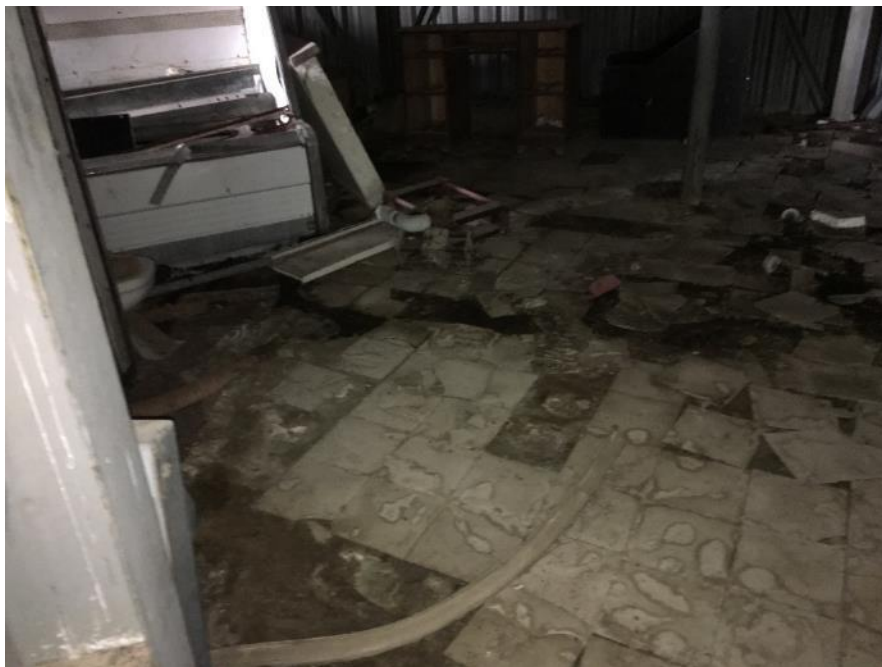
Photo 6: Asbestos-containing beige 9"x9" vinyl floor tiles (DST Sample 29911-1A-02A), observed on the main floor of Building 1A). The associated mastic was found to not contain asbestos.

not analyzed	
1728584-10	10-Jul-17	sample homogenized	Grey	Parging	Yes	Client ID: 29911-1A-01A	
						Chrysotile	65
						Non-Fibers	35
1728584-11	10-Jul-17					Client ID: 29911-1A-01B	
						not analyzed	
1728584-12	10-Jul-17					Client ID: 29911-1A-01C	
						not analyzed	
1728584-13	10-Jul-17	sample homogenized	Tan	Floor Tile	Yes	Client ID: 29911-1A-02A (VFT)	
						Chrysotile	1
						Non-Fibers	99
1728584-14	10-Jul-17					Client ID: 29911-1A-02B (VFT)	
						not analyzed	
1728584-15	10-Jul-17					Client ID: 29911-1A-02C (VFT)	
						not analyzed

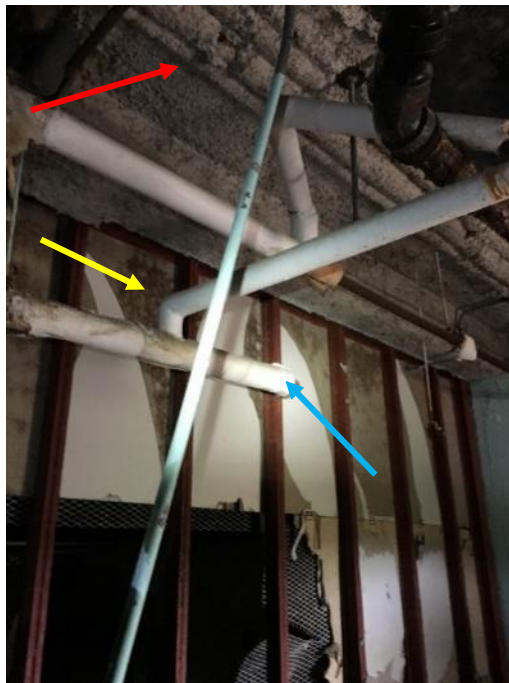
Photo 11: View of asbestos-containing fireproofing (red arrow, DST Sample 29911-3-02A), pipe fittings (blue arrow, DST Sample 29911-3-03A), and mould-impacted drywall (yellow arrow) on the main floor at Building 3.

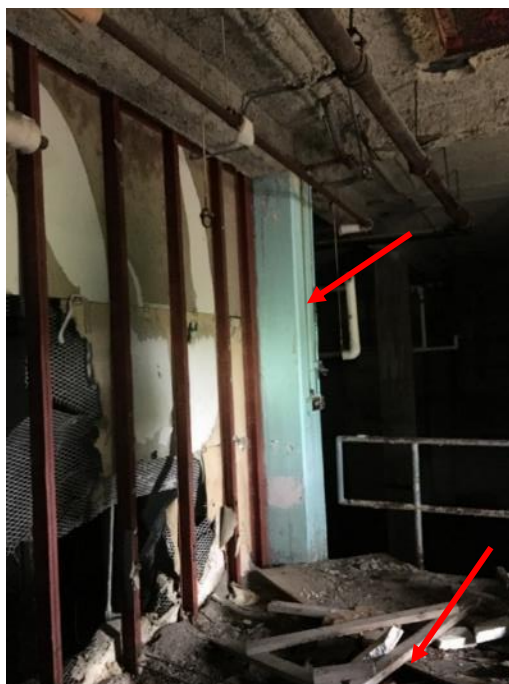
Photo 12: View of lead-containing blue paint (DST Sample 29911-3-LP-01, non-hazardous for disposal) and asbestos-containing fireproofing debris, observed on the Ground Floor of Building 3.

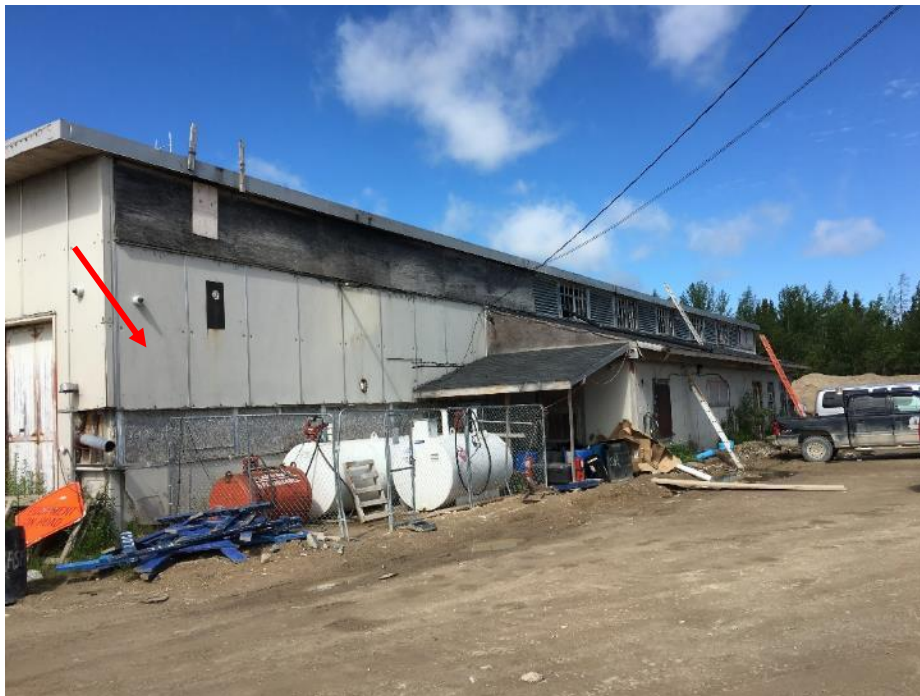
Photo 14: View of Building 4 with asbestos-containing Transite exterior wall paneling (DST Sample 29911-4-01A). One (1) 1,000-gallon diesel, one (1) 500-gallon gasoline and one (1) 250-gallon red re-fueling tank are present at the building's exterior.

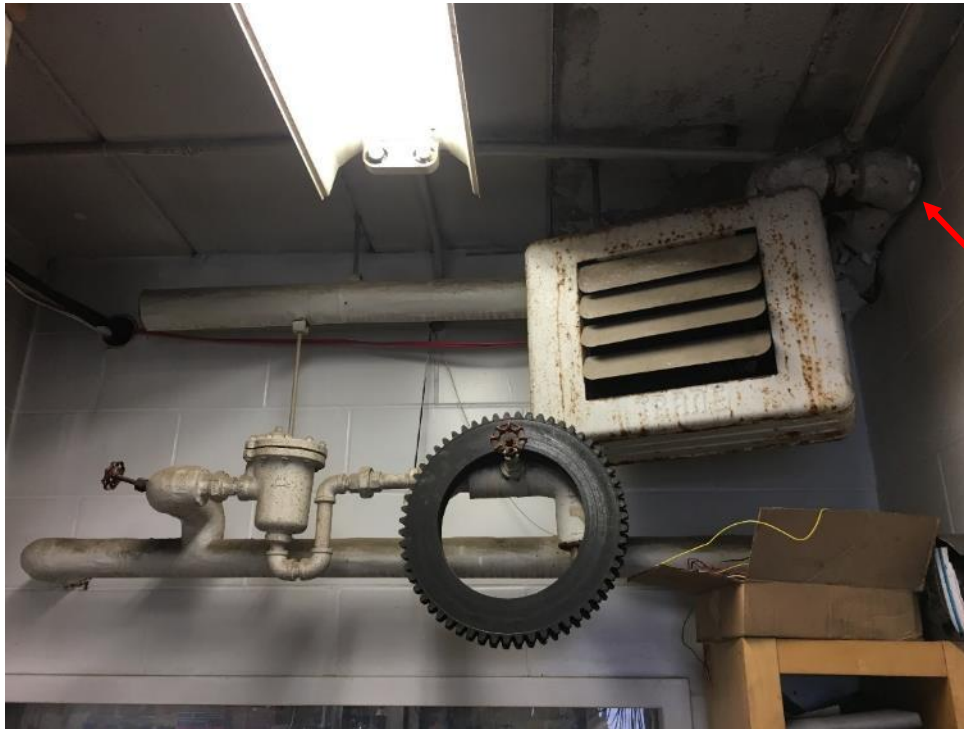
Photo 15: View of asbestos-containing grey cement compound on pipe fittings (DST 2006 Sample 353-04-MI-01) in a small workshop, observed throughout Building 4.

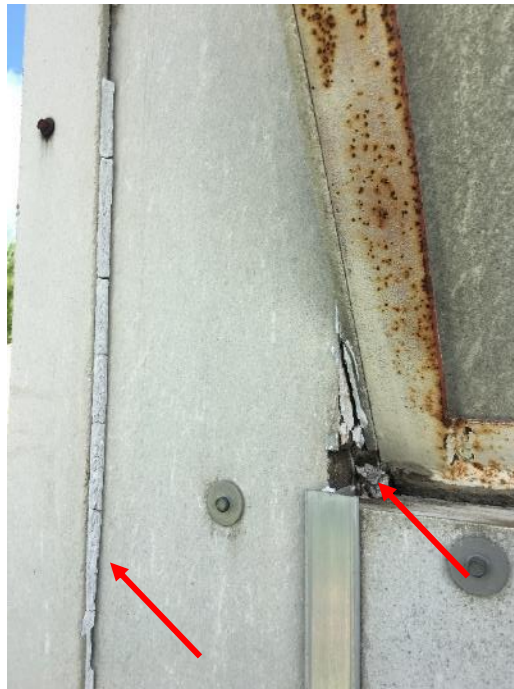
Photo 16: Asbestos-containing caulking (DST Sample 29911-4-04A) observed throughout the exterior of Building 4, between Transite paneling.

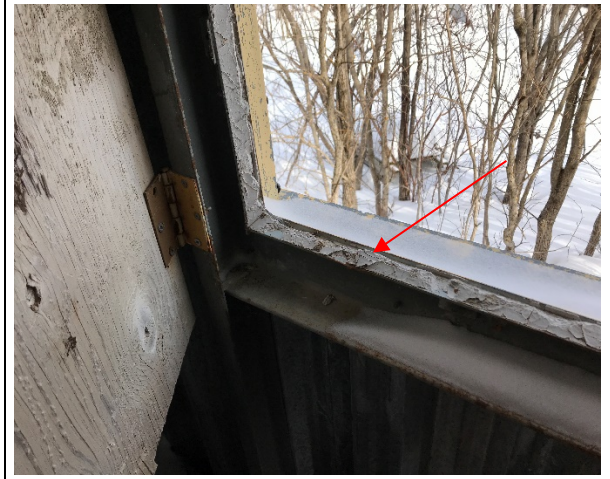
Photo 2: Building 1 – Asbestos-containing (2% chrysotile) interior window glaze compound – grey observed to be in poor condition (cracking).

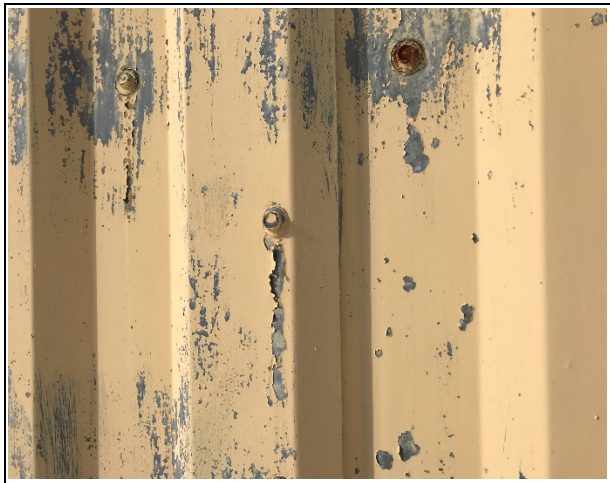
Photo 4: Building 1 – lead-containing (350 ppm) yellow/grey coloured paint on the exterior metal cladding.

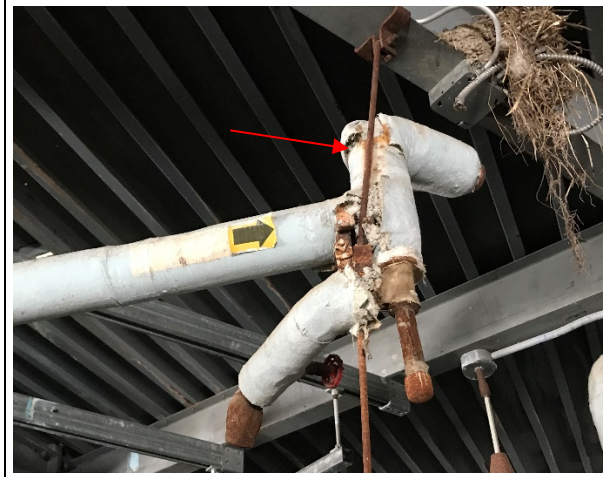
Photo 6: Building 1A – Asbestos-containing (65% chrysotile) insulating cement on pipe fittings.

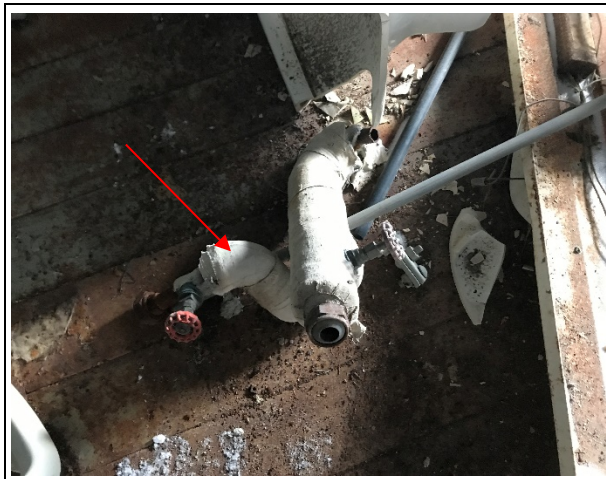
Photo 7: Building 1A – Asbestos-containing (65% chrysotile) insulating cement on pipe fittings observed debris on floor.

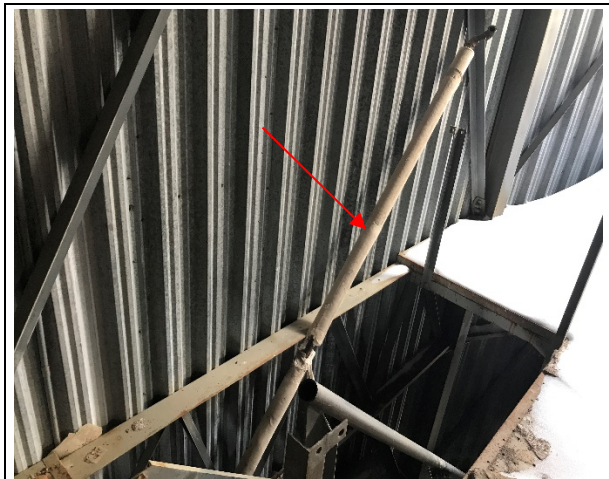
Photo 8: Building 1A – Asbestos-containing (30% chrysotile) pre-formed pipe straight insulation.

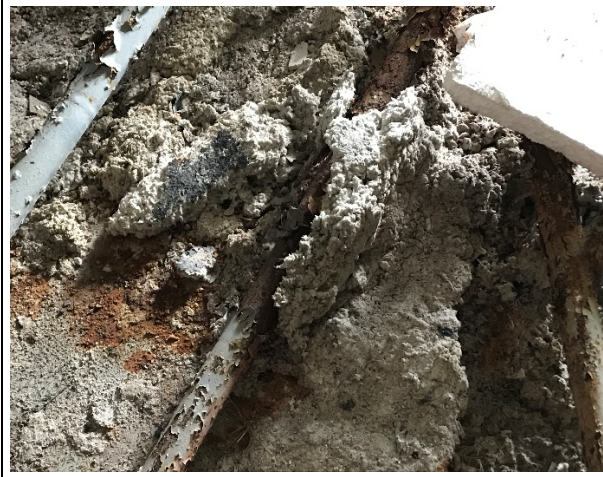
Photo 25: Building 3 – Asbestos-containing (10% chrysotile) sprayed fireproofing debris located on the floor in the entrance.

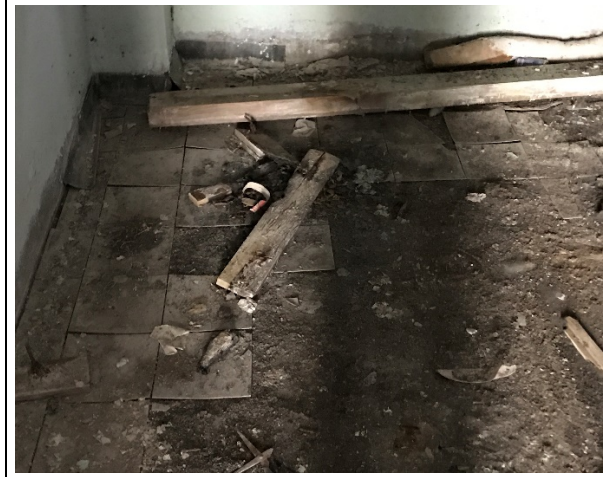
Photo 26: Building 3 – Asbestos-containing (2% chrysotile) 9"x9" vinyl floor tile – grey located in the entrance.

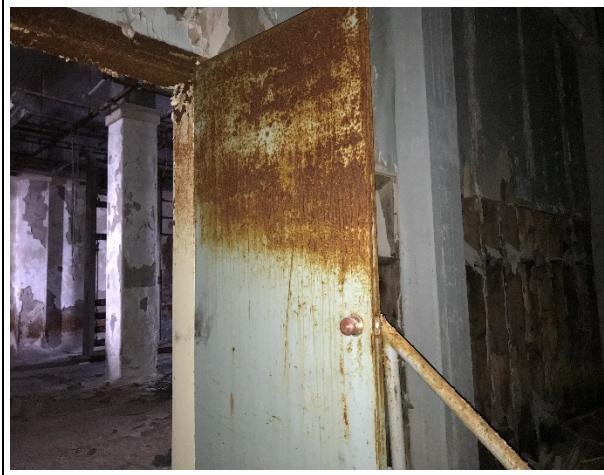
Photo 29: Building 3 – Presumed asbestos-containing fire rated door located between communications and the storage room.

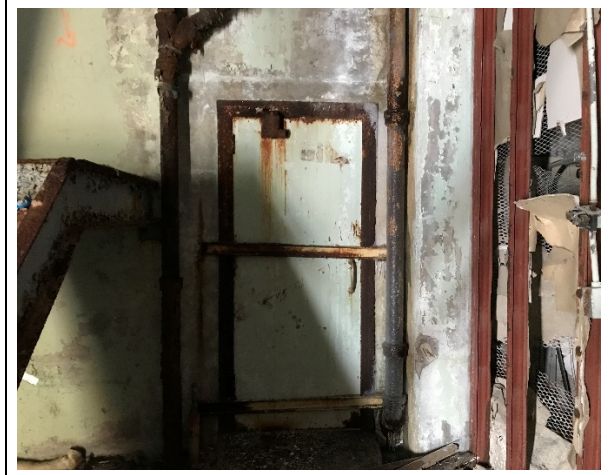
Photo 30: Building 3 – Presumed asbestos-containing fire rated door located in the entrance.

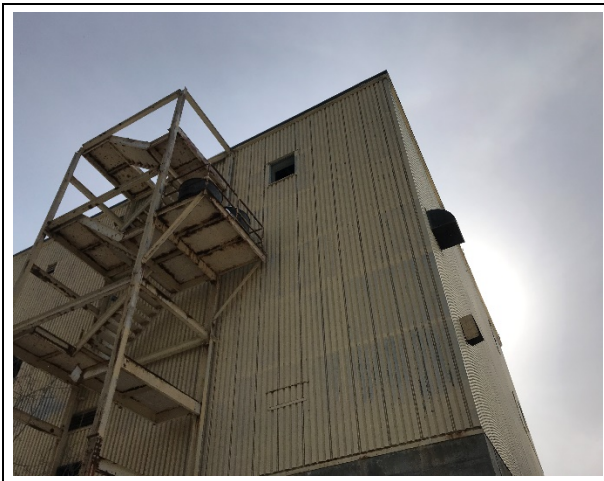
Photo 31: Building 3 – Lead-containing (200 ppm) yellow/off-white coloured paint located on the exterior metal cladding.

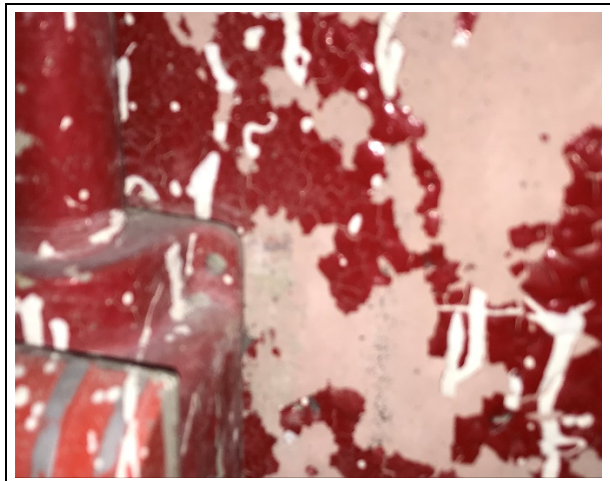
Photo 32: Building 3 – Lead-containing (4,800 ppm) red coloured paint located on the interior walls of the storage room.

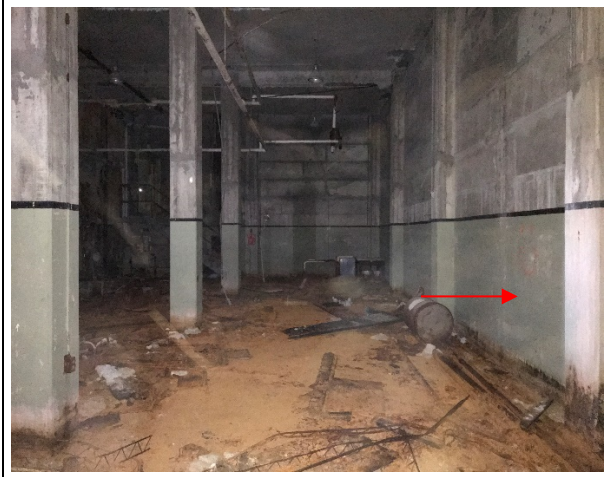
Photo 33: Building 3 – Lead-containing (2,100 ppm) green coloured paint on the interior walls of the storage room.

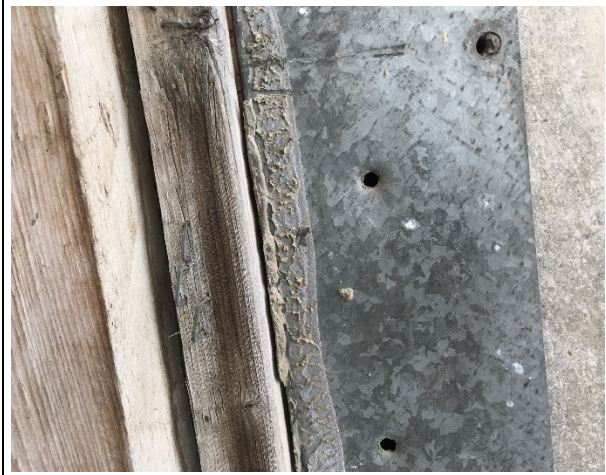
Photo 41: Building 4 – Asbestos-containing (2% chrysotile) exterior window caulking – grey located on the storage room window.

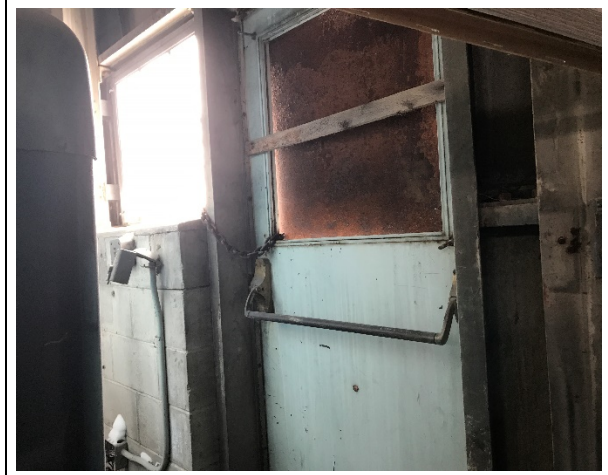
Photo 42: Building 4 – Presumed asbestos-containing fire rated door located in bay 2 (west wall).

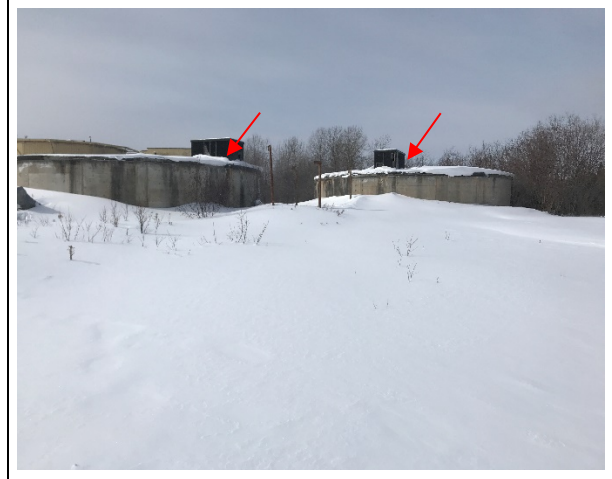
Photo 46: Building 5&5A – Presumed asbestos-containing roofing materials and roof caulking.

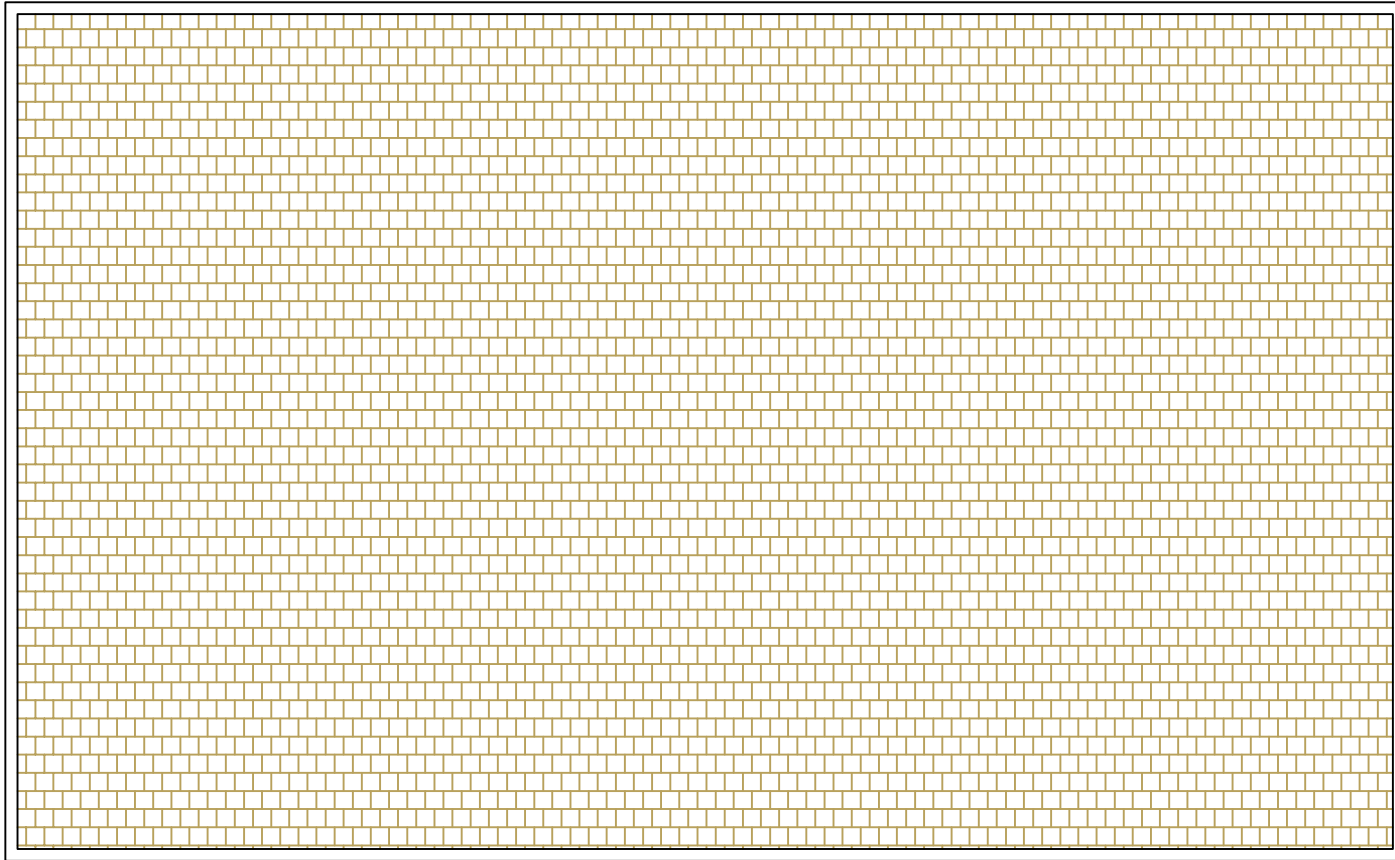
7

BUILDING 2 - ROOF

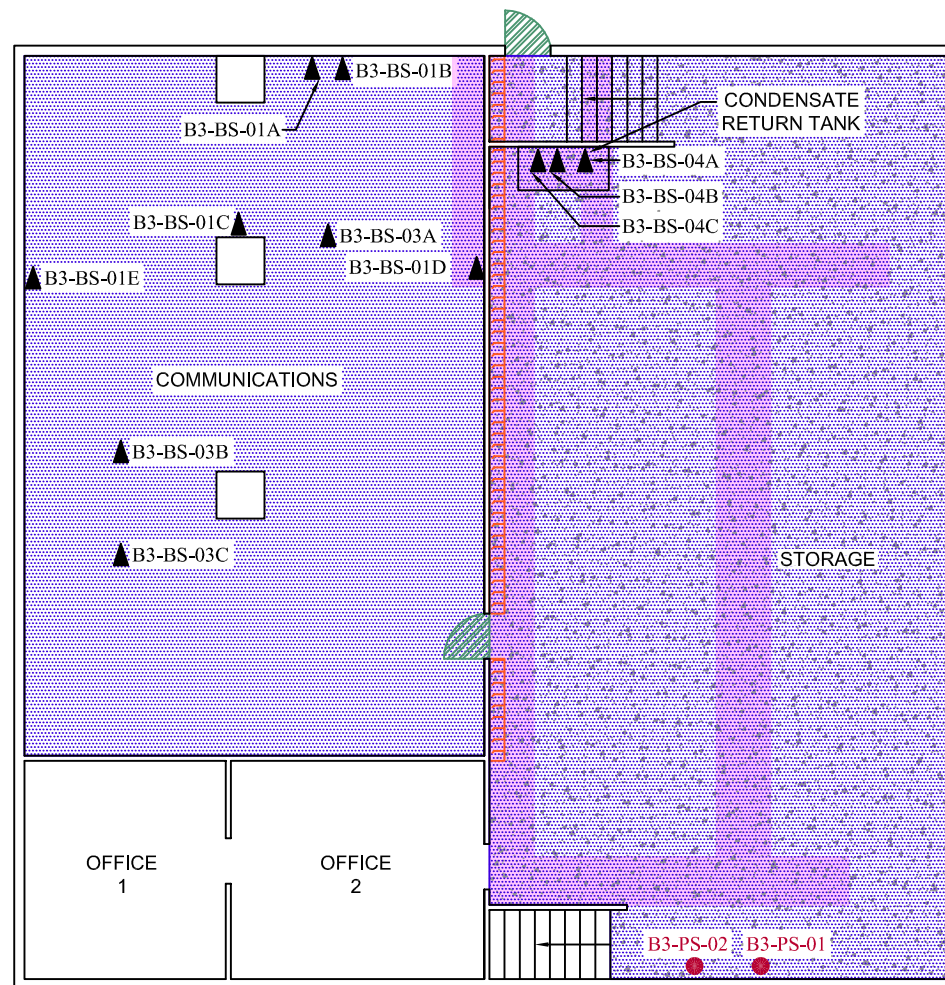
8

BUILDING 3 - FIRST FLOOR

NOTES: 1. CAULKING MATERIALS ON CAST IRON DRAIN PIPES ARE PRESUMED TO BE ASBESTOS-CONTAINING.
 2. GASKET MATERIALS ON MECHANICAL PIPING IS PRESUMED TO BE ASBESTOS-CONTAINING.
 3. THIS DRAWING ILLUSTRATES SUPPORTING INFORMATION SPECIFIC TO A STANTEC CONSULTING LTD. REPORT AND MUST NOT BE USED FOR OTHER PURPOSES.

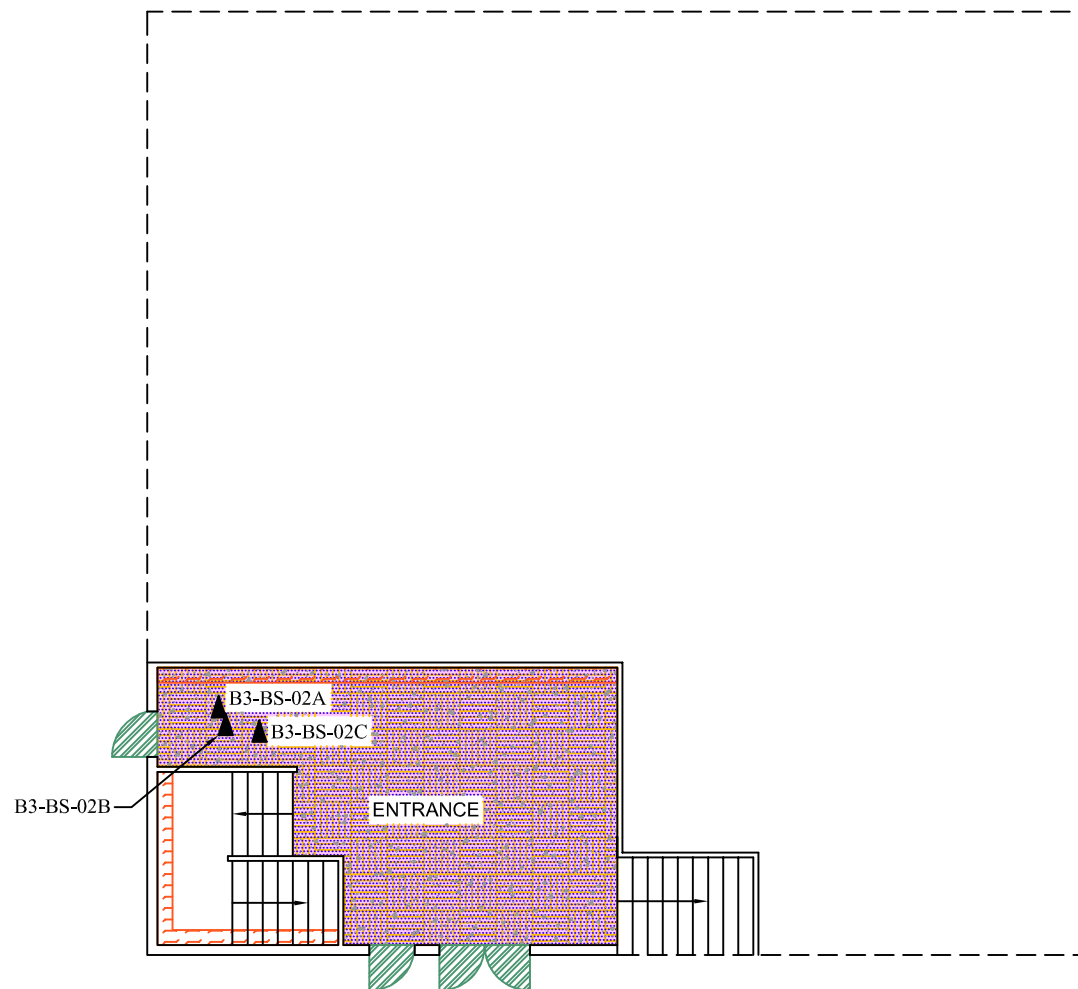
9

BUILDING 3 - FIRST FLOOR MEZZANINE

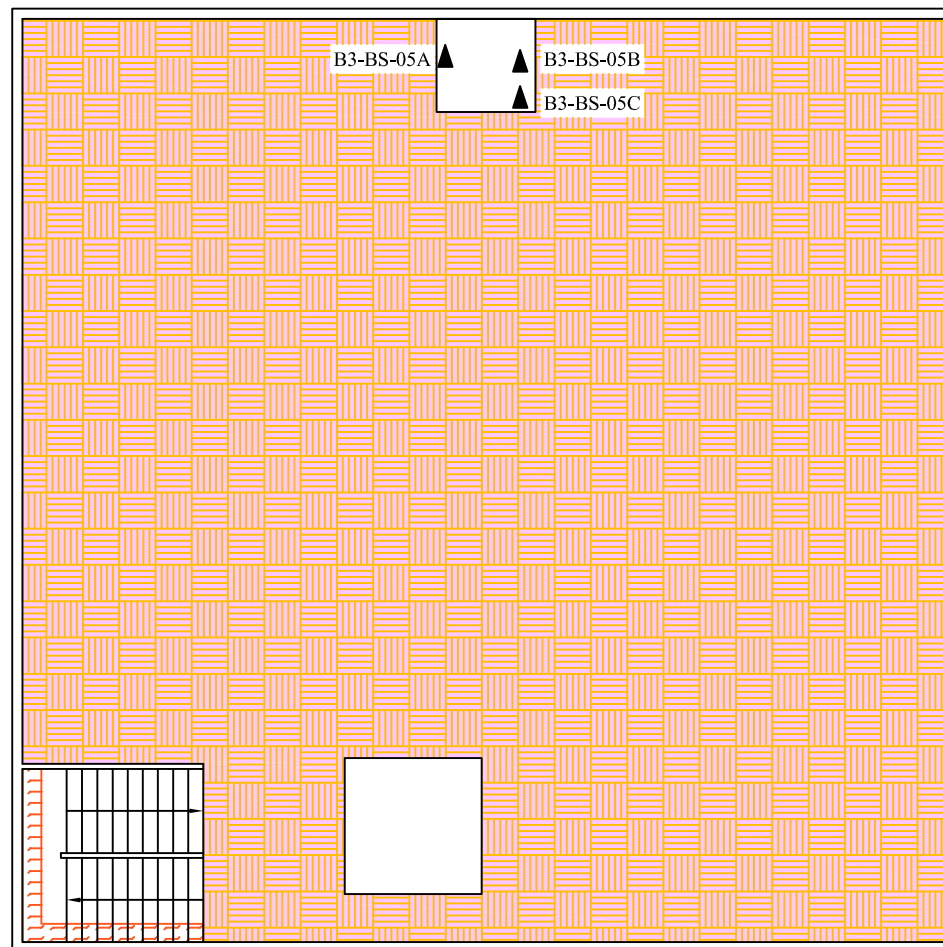
10

BUILDING 3 - SECOND FLOOR

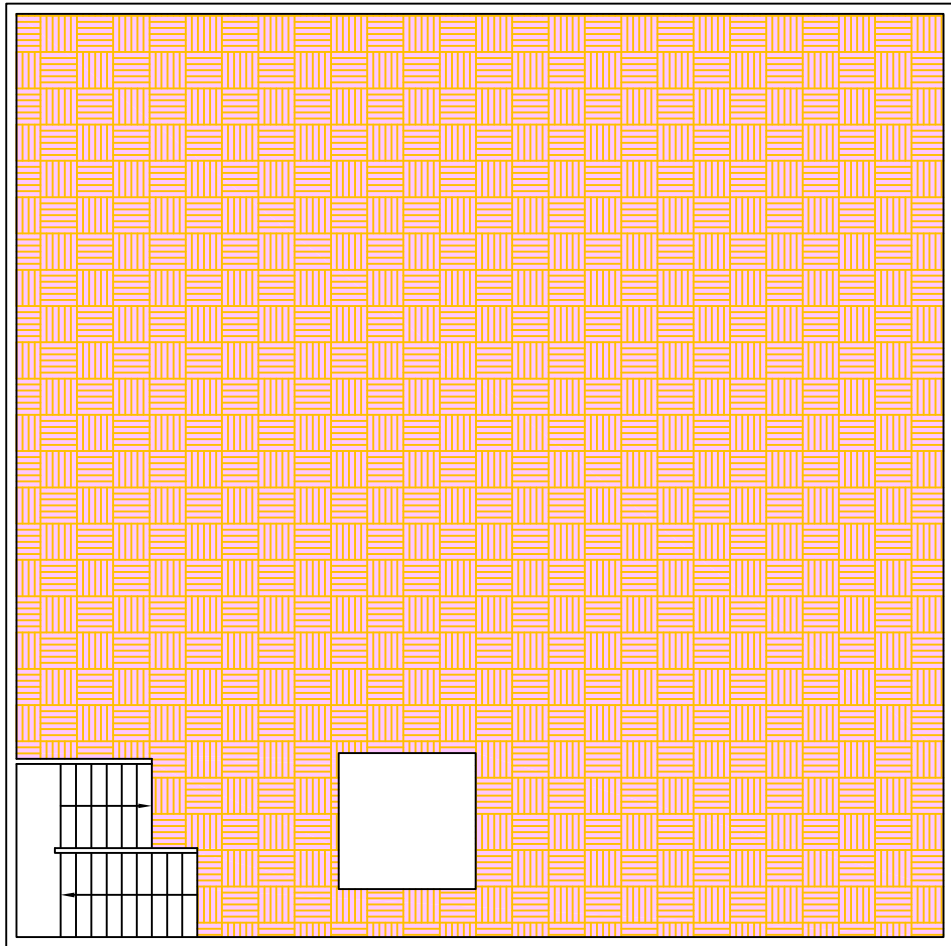
11

BUILDING 3 - THIRD FLOOR

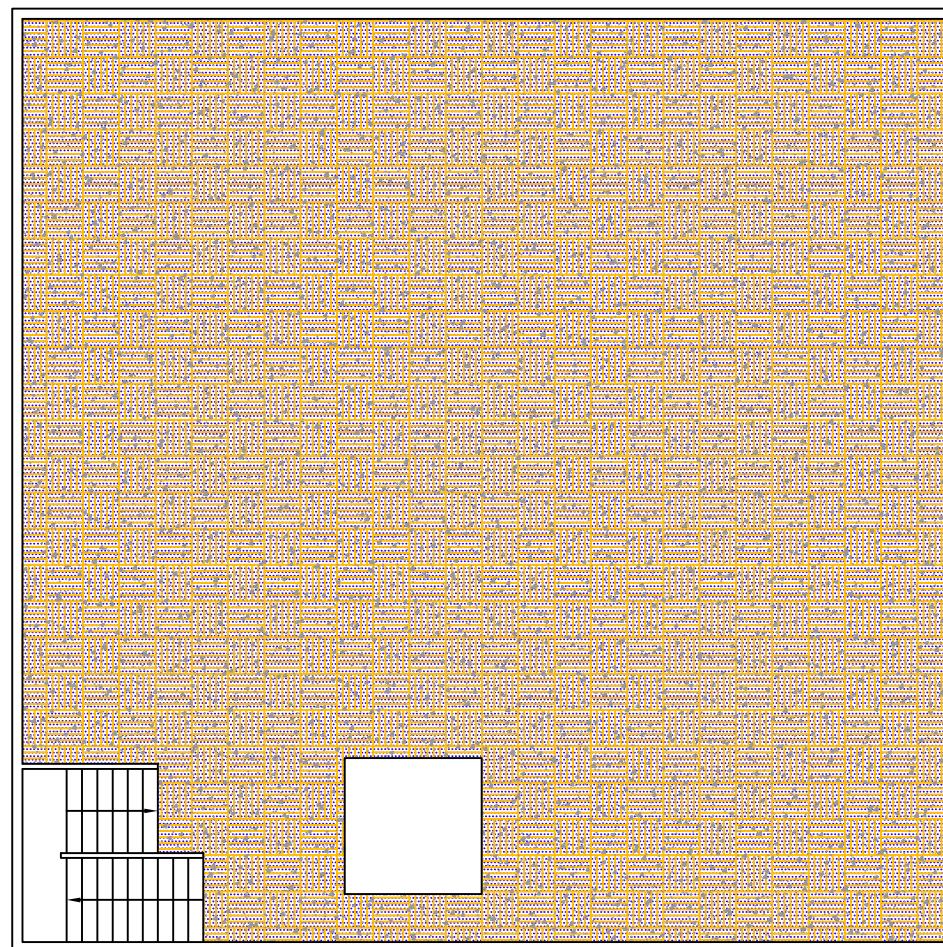
12

BUILDING 3 - FOURTH FLOOR

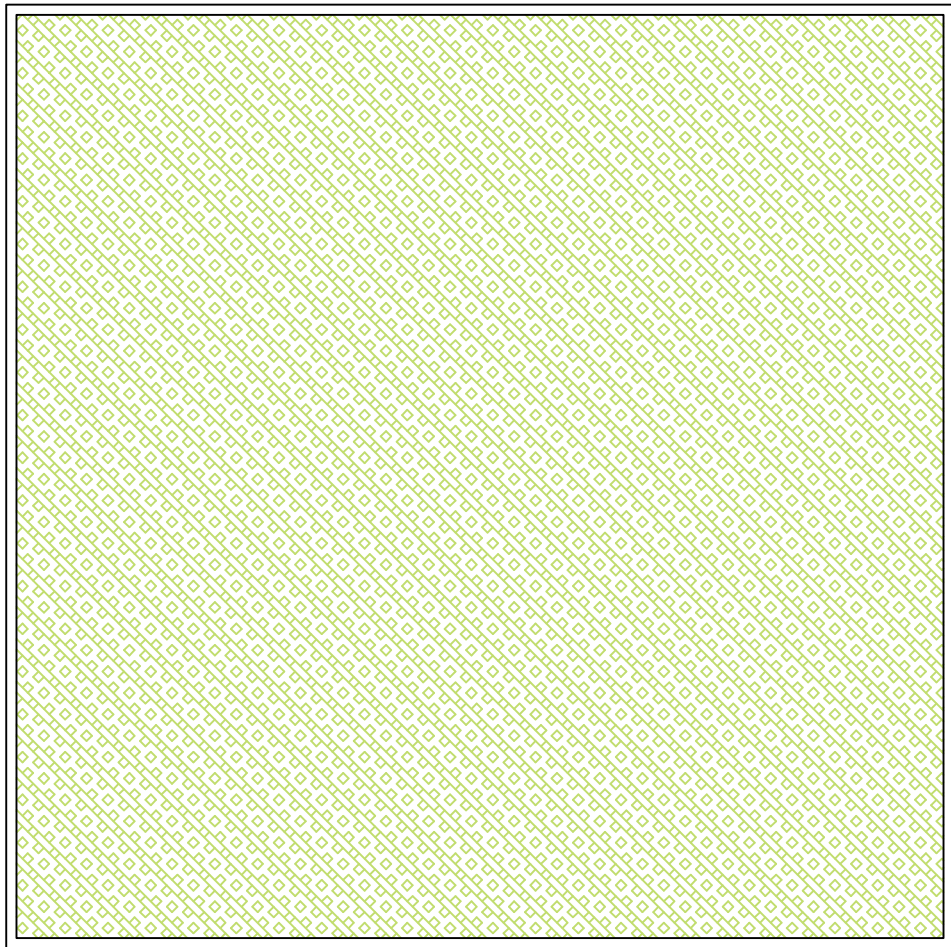
13

BUILDING 3 - ROOF

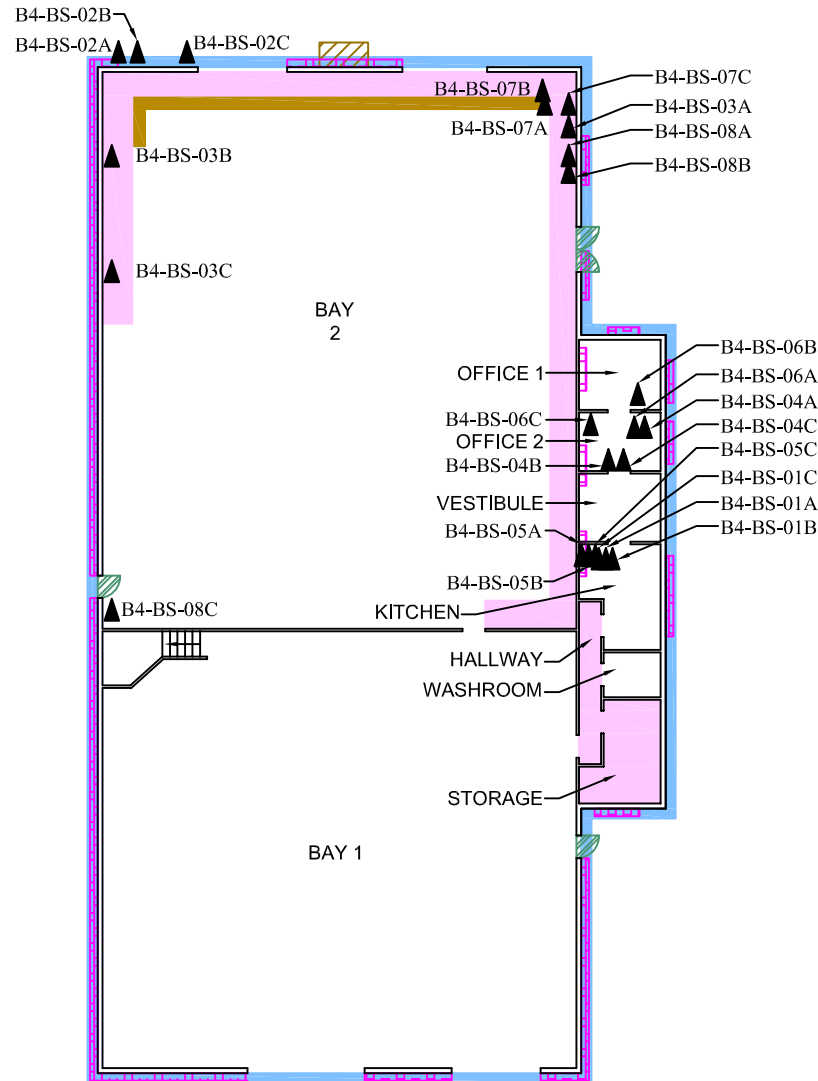
14

BUILDING 4 - MAIN FLOOR

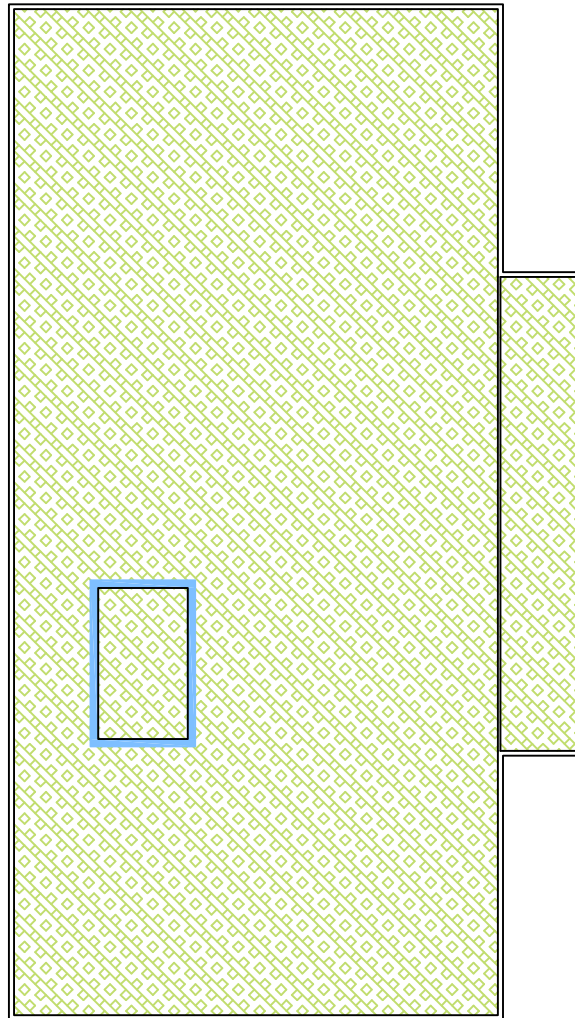
15

BUILDING 4 - ROOF

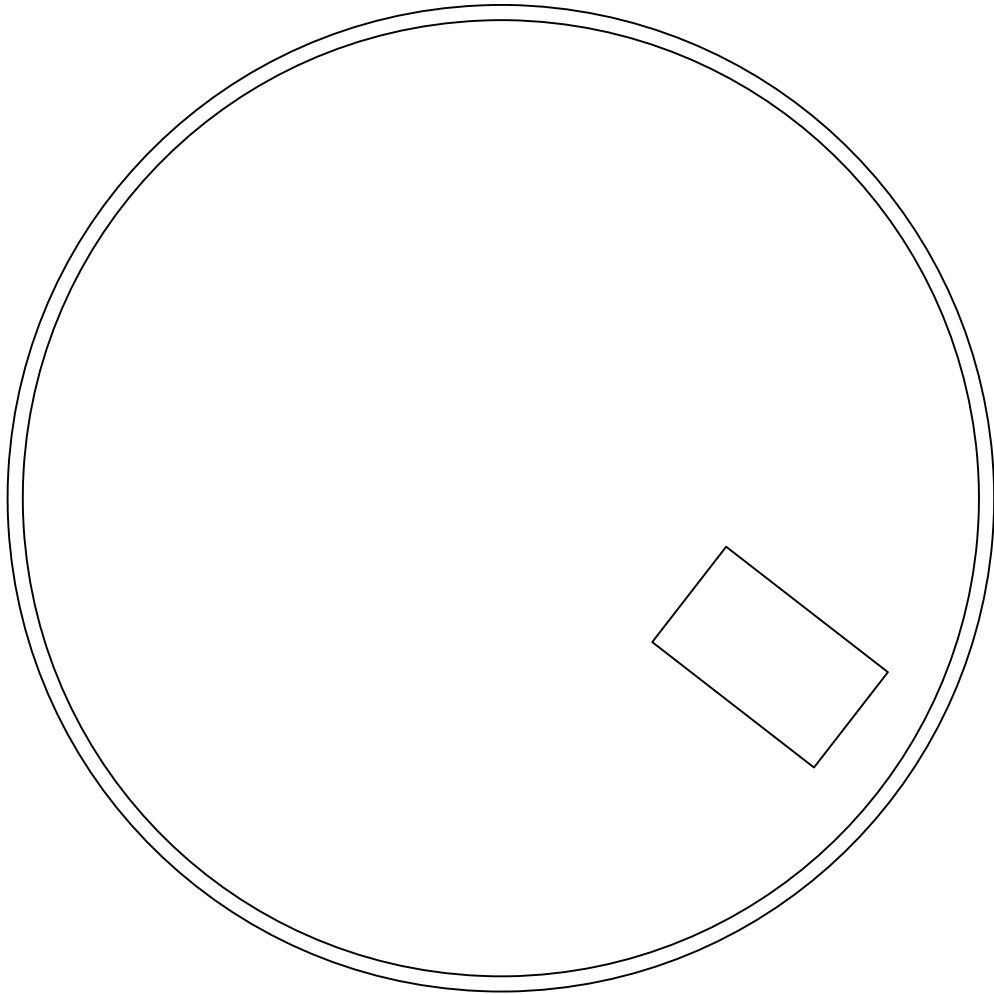
16

BUILDING 5 - CLARIFIER 1

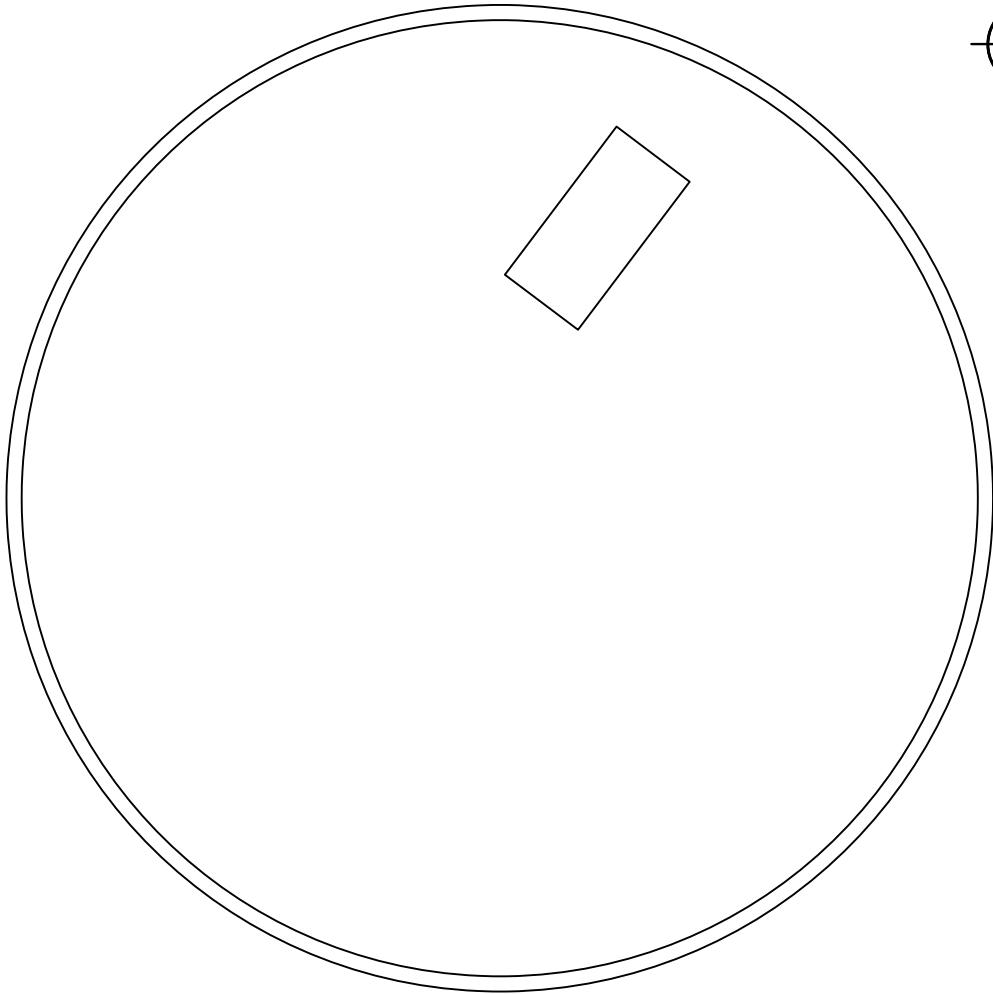
BUILDING 5A - CLARIFIER 2

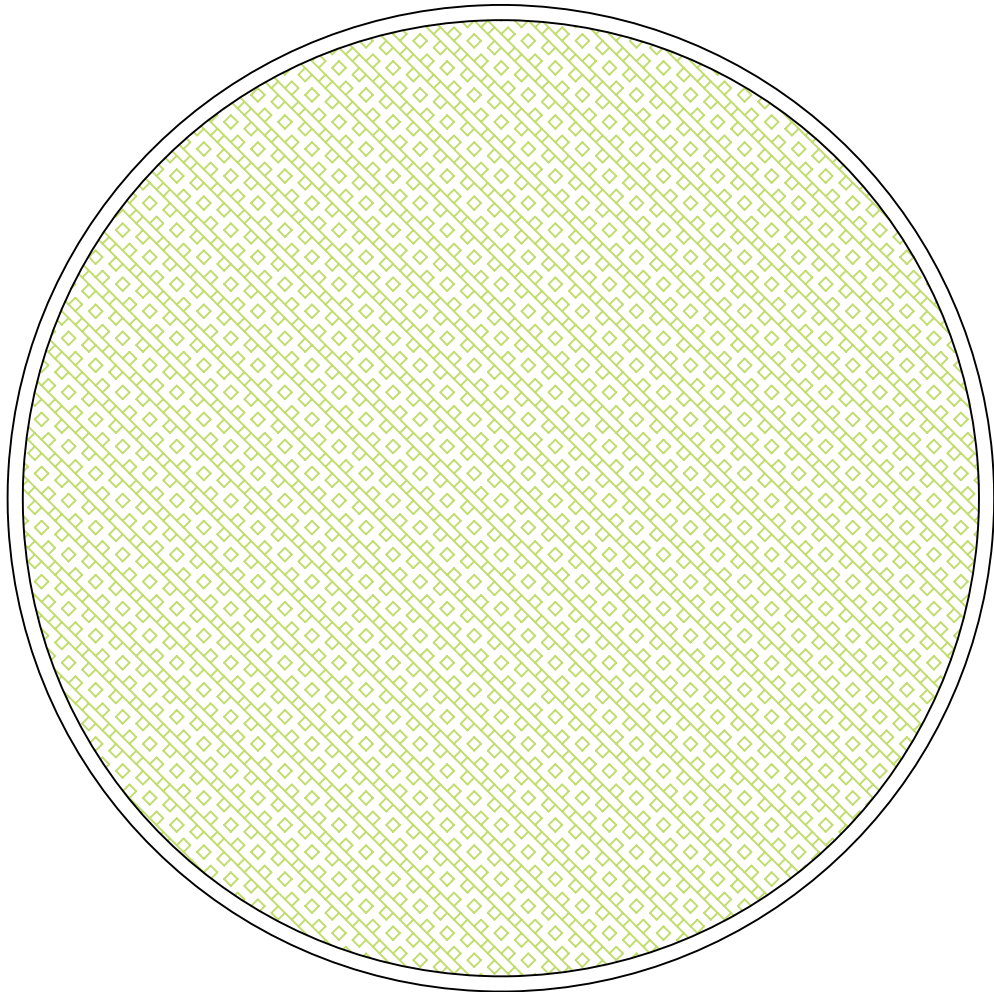
BUILDING 5 - CLARIFIER 1 ROOF

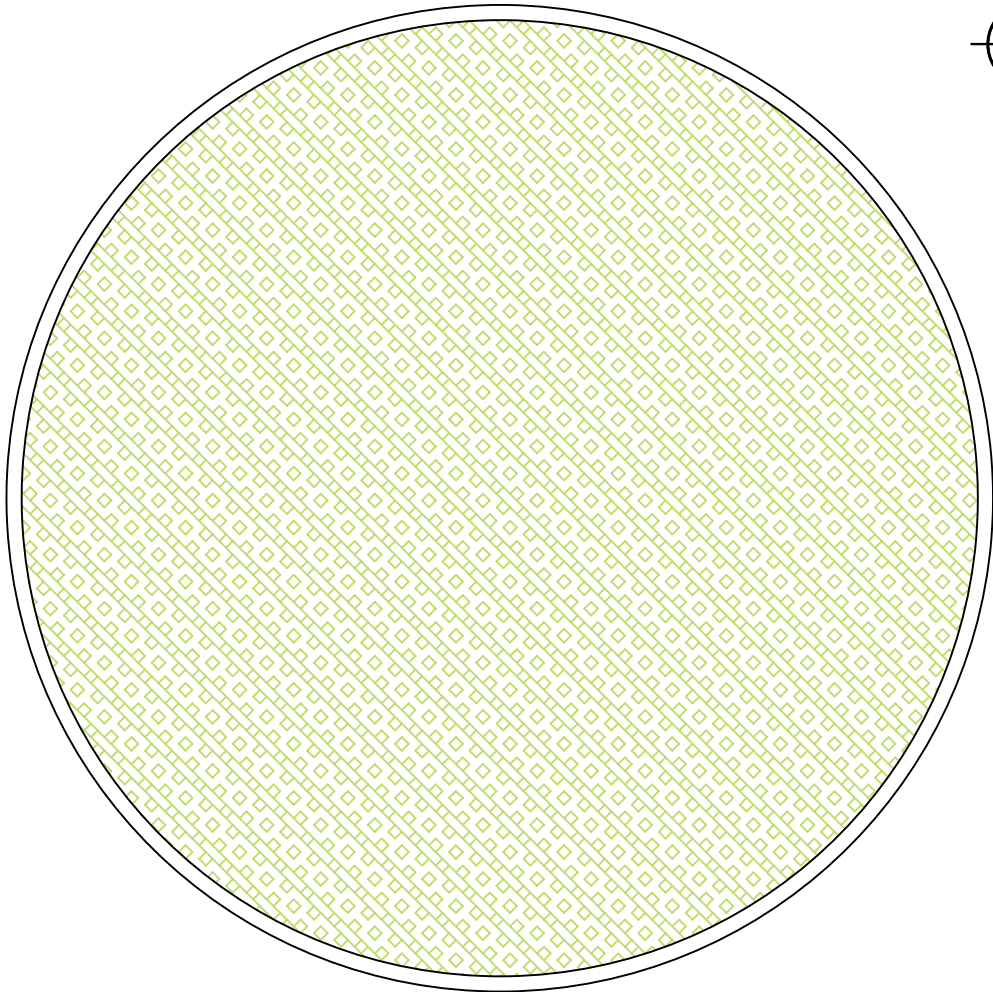
BUILDING 5A - CLARIFIER 2 ROOF
