Drawing title / Titre du dessin
REPOINTING, STONE REPAIR & ROOF DEMOLITION DRAWINGS

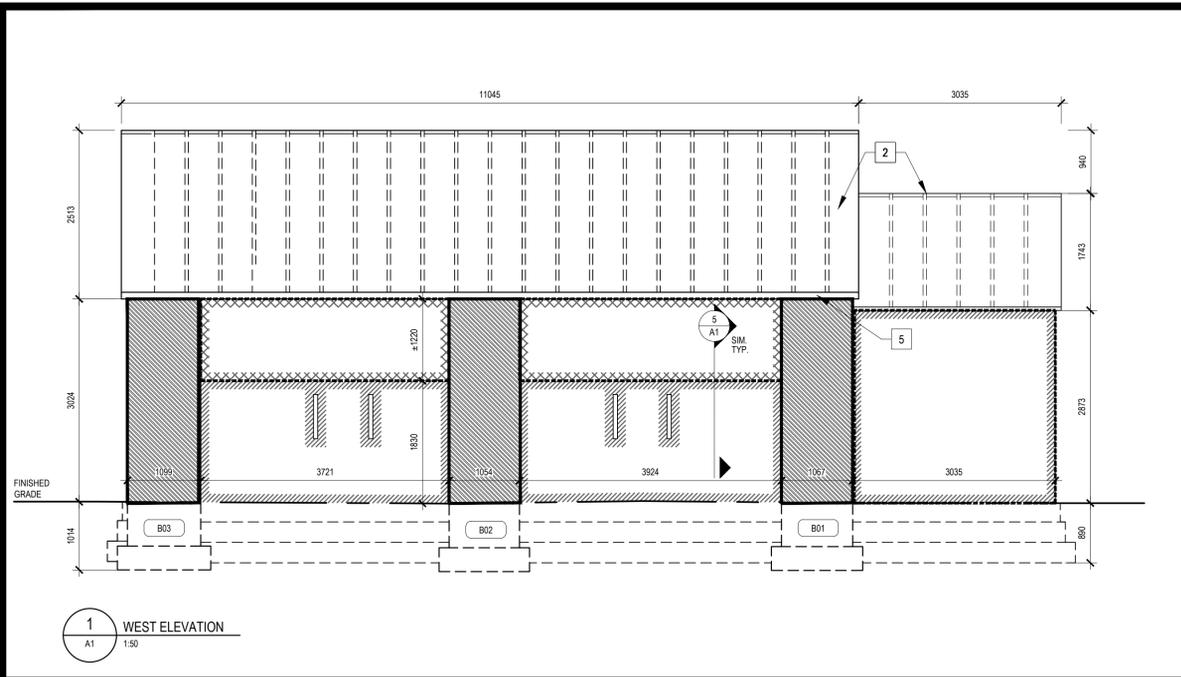
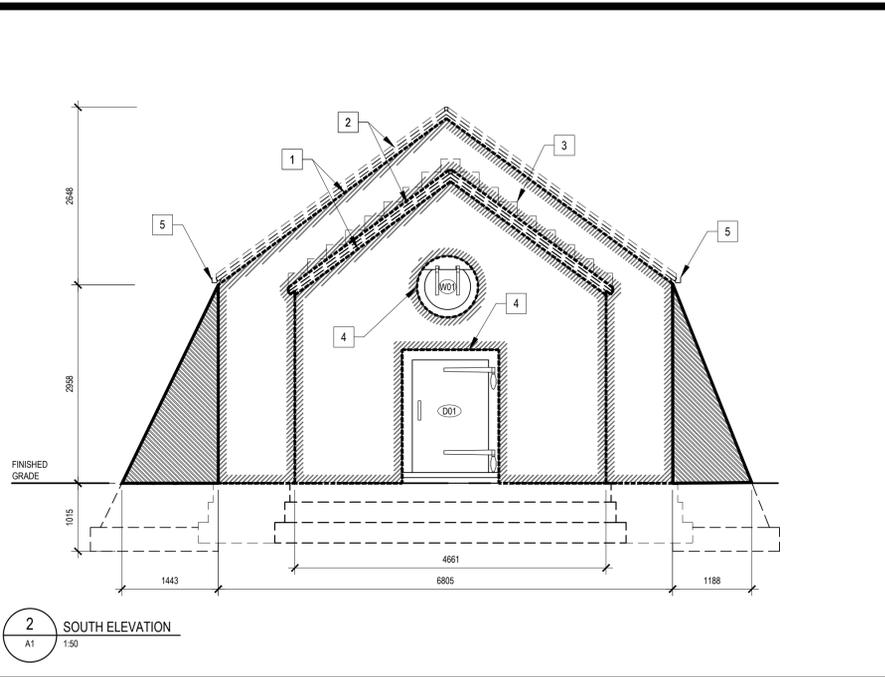
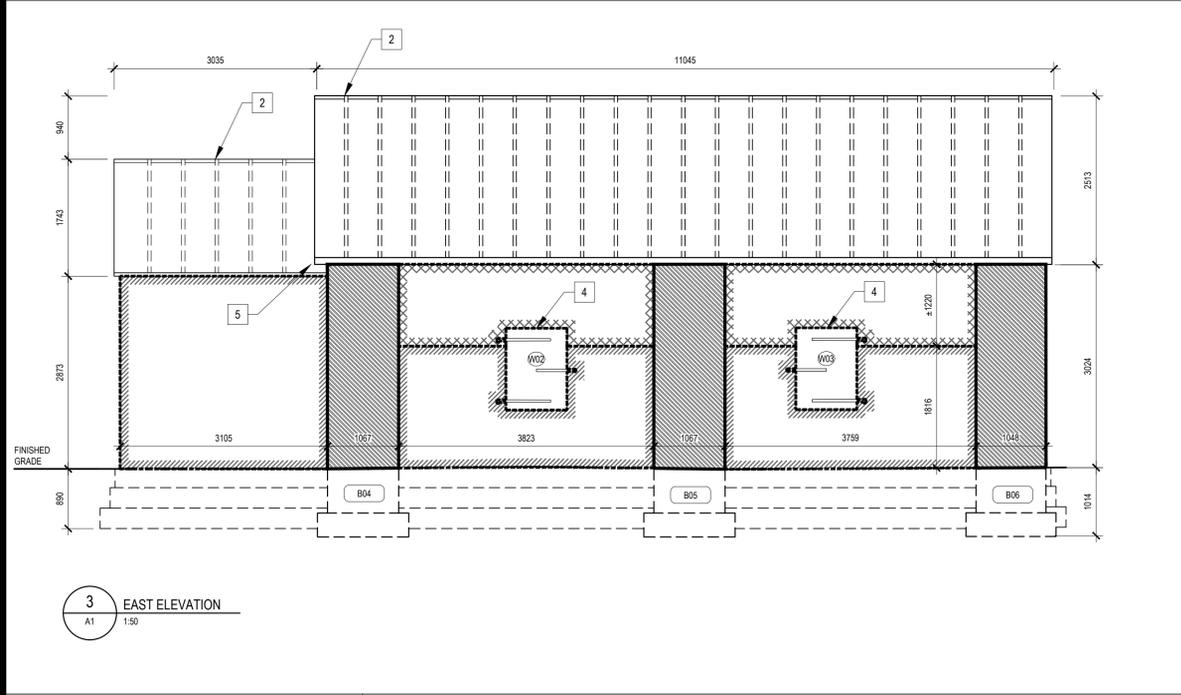
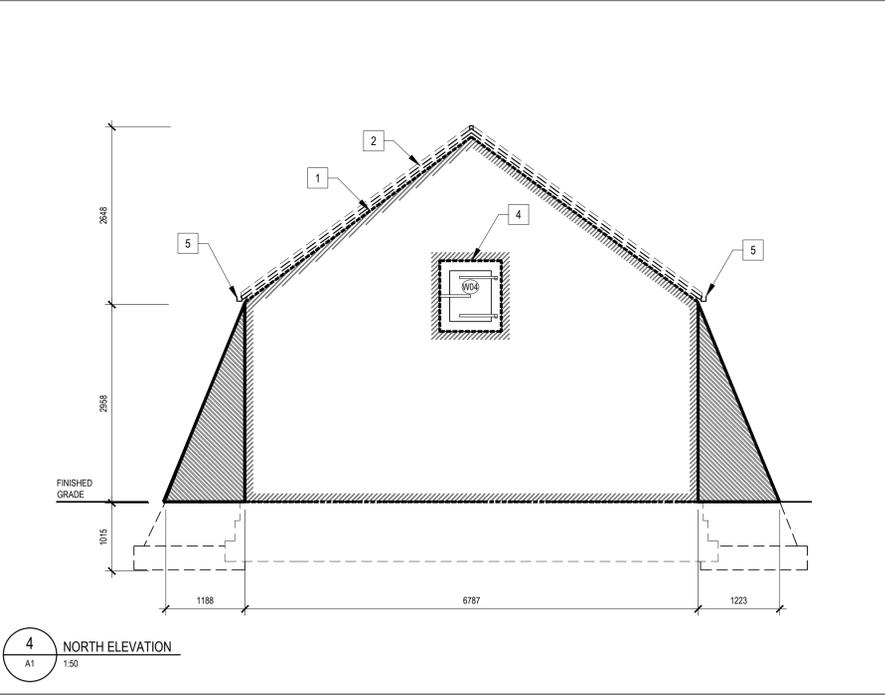
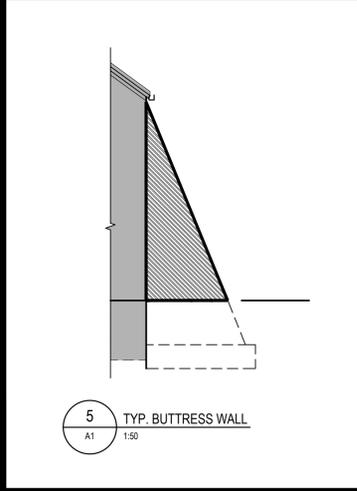
STONE REPAIRS	
ALLOW FOR THE FOLLOWING NUMBER OF STONE REPAIRS/REPLACEMENTS. SEE SPECIFICATION SECTIONS 04.03.42, 04.03.43, & 04.03.45.	
FILLING OF STONE CRACKS IN SITU	15
MECHANICAL CONSOLIDATION OF CRACKS IN SITU	15
REPAIR OF REMOVED FRACTURED STONE	50
REPLACEMENT OF IRREGULAR SIZED STONES RANGING FROM 100 TO 300mm IN HEIGHT, 125 TO 375mm IN LENGTH & 50 TO 250mm IN DEPTH.	50

- RAKE OUT JOINTS FROM EXTERIOR FACE OF WALL REMOVING ALL HARD CEMENTITIOUS MORTAR TO A MINIMUM DEPTH OF 40MM. ADD GALLETS INTO MORTAR WHERE GAPS BETWEEN STONES ARE LARGER THAN 40MM. CONFIRM WALL CORE CONDITION. REMOVE ANY LOOSE STONES AND/OR CORE MATERIAL. CONSOLIDATE RUBBLE CORE AND REINSTALL REMOVED STONE.

- RAKE OUT JOINTS FROM EXTERIOR FACE OF WALL REMOVING ALL HARD CEMENTITIOUS MORTAR TO A MINIMUM DEPTH OF 150MM. ADD GALLETS INTO MORTAR WHERE GAPS BETWEEN STONES ARE LARGER THAN 40MM. CONFIRM WALL CORE CONDITION. REMOVE ANY LOOSE STONES AND/OR CORE MATERIAL. CONSOLIDATE RUBBLE CORE AND REINSTALL REMOVED STONE.

- BUTTRESS SCOPE IS INCREMENTAL. CONTRACTOR TO PRICE FULL DISMANTLE.
 - CUT OUT ALL JOINTS AND REMOVE OVERPOINTING
 - ALLOW FOR CONSULTANT ASSESSMENT OF STONES AND IDENTIFICATION OF EXTENT OF DISMANTLING & STONE REPLACEMENT
