Appendix A
Archaeological Report

Re: HCA 2019-0132 – Summary Letter Report: AIA Surveys of Fisheries and Oceans Canada (DFO) PID 008-170-762 (Lot 22, Section 31, Township 6, Rupert District, Plan 45348), PID 008-179-771 (Lot 23, Section 31, Township 6, Rupert District, Plan 45348), PID 016-857-674 (Lot 1, District Lot 2263, Rupert District, Plan VIP51510 (the “Water Lot”), Water Lot Lease No. 104843), at Jensen Cove Road, Port Hardy, B.C.

DESIGNATED SUBSTANCES SURVEY
6270 JENSEN COVE ROAD, PORT HARDY, BC

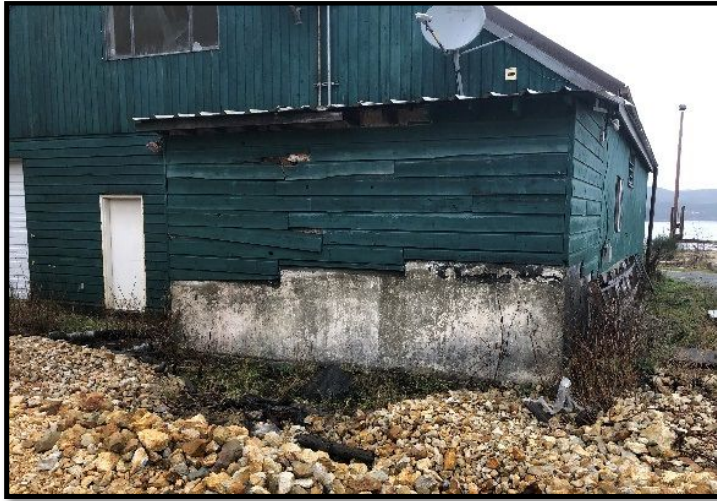
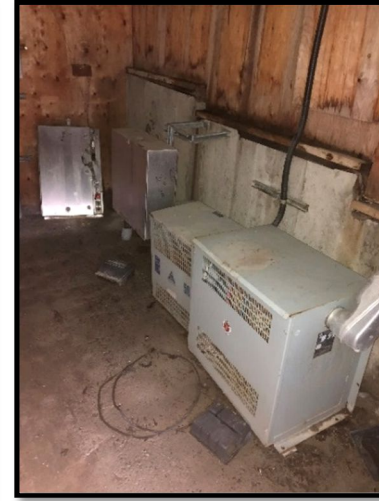
Electrical Shed/Room attached to the east extent of the southeast elevation of the building (top left) and interior with transformers (top centre & right).

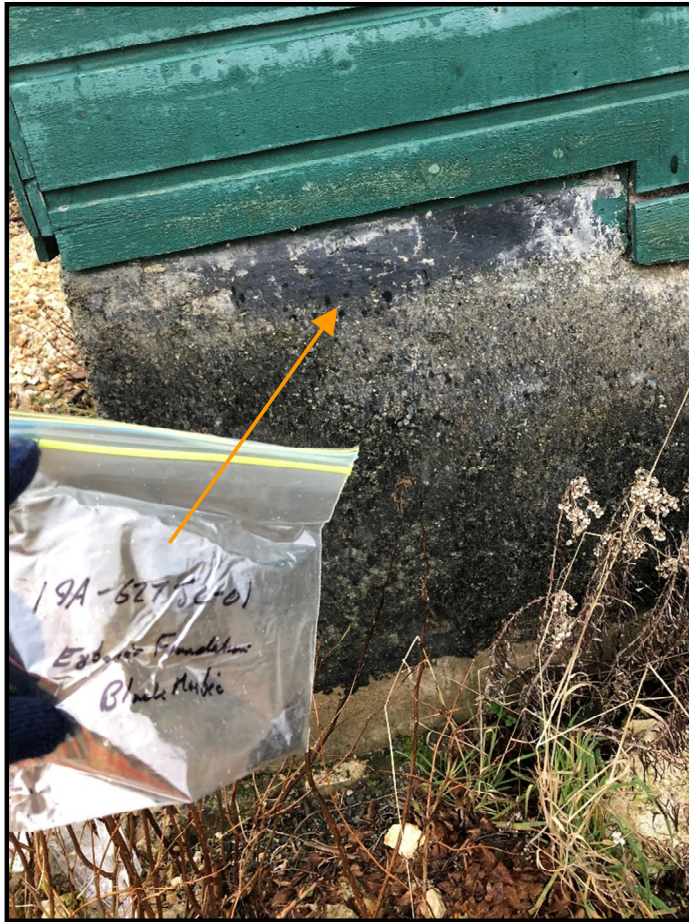
Sample 19A-6270JC-01 black mastic on exterior perimeter foundation (PC 0.25% Chrysotile) (left).

MATERIAL LOCATION/ DESCRIPTION	ASSESSMENT ¹	ACTION ²	PHOTO ³
<p>Black Mastic</p> <p>On exterior perimeter foundation</p> <p>(refer to Site Sample Location Plan - Lower Level- Figure 2 in the attached Appendix A).</p>	<p>Sample ID: 19A-6270JC-01 (Lab Sample ID 6942051)</p> <p>Concentration: 0.25% Chrysotile</p> <p>Condition: Poor Material: Friable Accessibility: A (Areas of the exterior foundation of the building within reach of all building users although not common. The remaining mastic is adhered to the exterior concrete foundation and is patchy in appearance having apparently degraded over time. Disturbance is possible during planned demolition activities such as cutting, breakage or other destructive activities.)</p>	<p>Action 5 – Proactive Removal – Removal of black mastic from the exterior perimeter foundation walls may be considered, where ACM is easily accessible, limited in quantity, and removal would be cost-effective.</p> <p>Consideration should be given towards its removal based on commonly implemented safety principles for maintaining As Low As Reasonably Achievable (ALARA) risk of exposure.</p> <p>Trained workers or service provider must use appropriate asbestos precautions (low, intermediate or high) during disturbance of the remaining ACM (i.e., drilling, coring or cutting).</p>	<p>Refer to photograph on Page v in Appendix B</p>

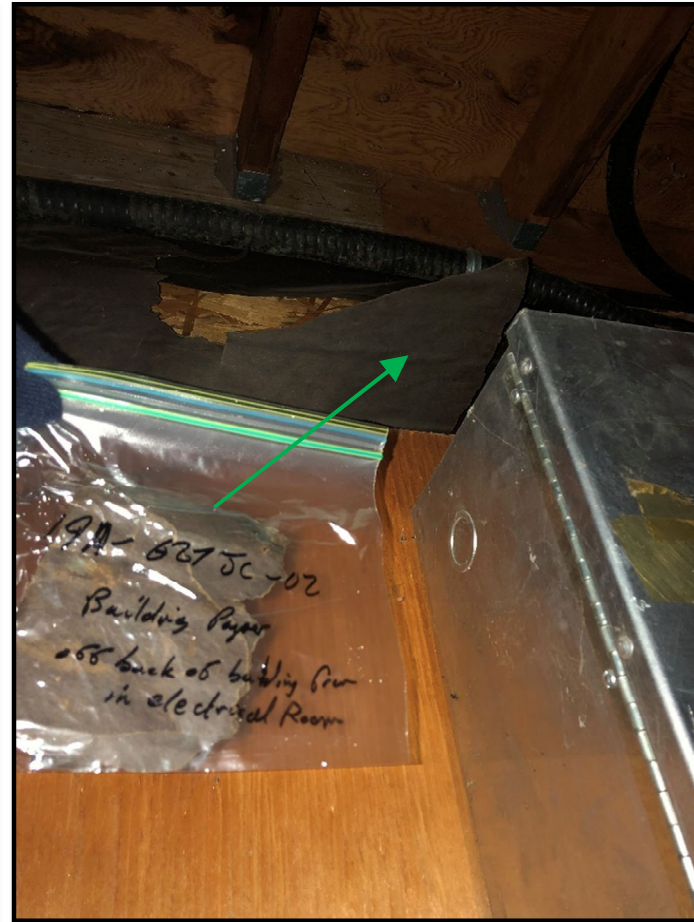
Sample 19A-6270-JC-02 building paper off back of building from within east electrical room was 'None Detected' for asbestos (right).

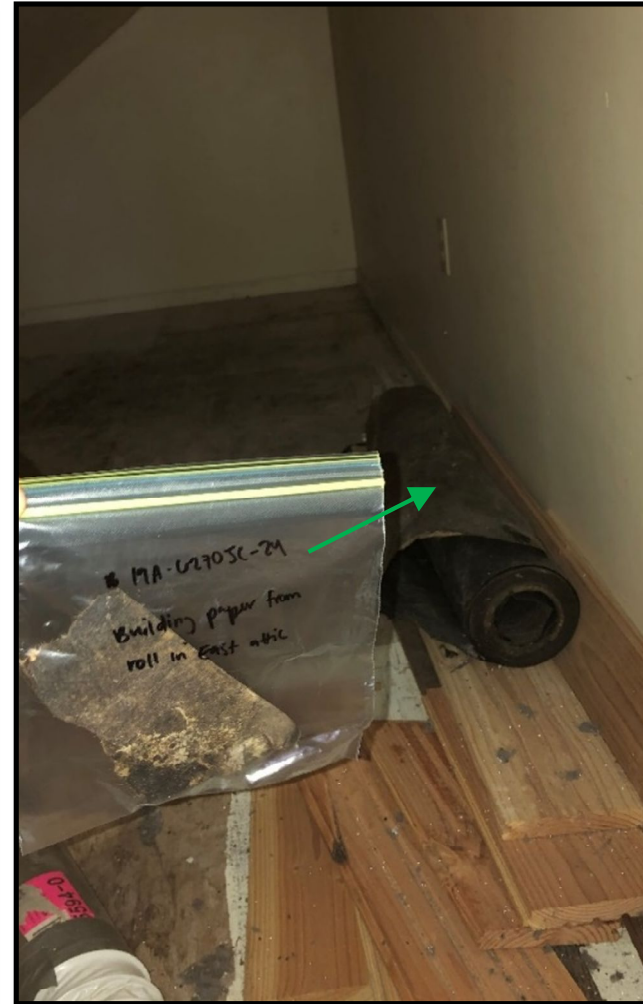
Sample 19A-6270JC-23 of building paper from the upper level top of staircase behind wood siding was 'None Detected' for asbestos (left).
Sample 19A-6270-JC-24 stored roll of building paper within the side attic was 'None Detected' for asbestos (right).

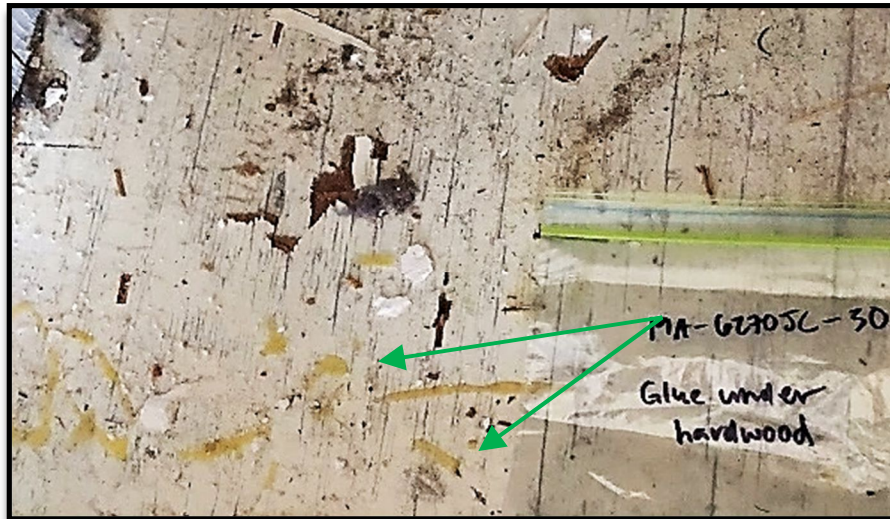
Sample 19A-6270-JC-30 glue on the subfloor under plank flooring at the entrance to the side attic was 'None Detected' for asbestos (left).
Sample 19A-6270-JC-31 building paper under plank flooring at the entrance to the side attic was 'None Detected' for asbestos (right).

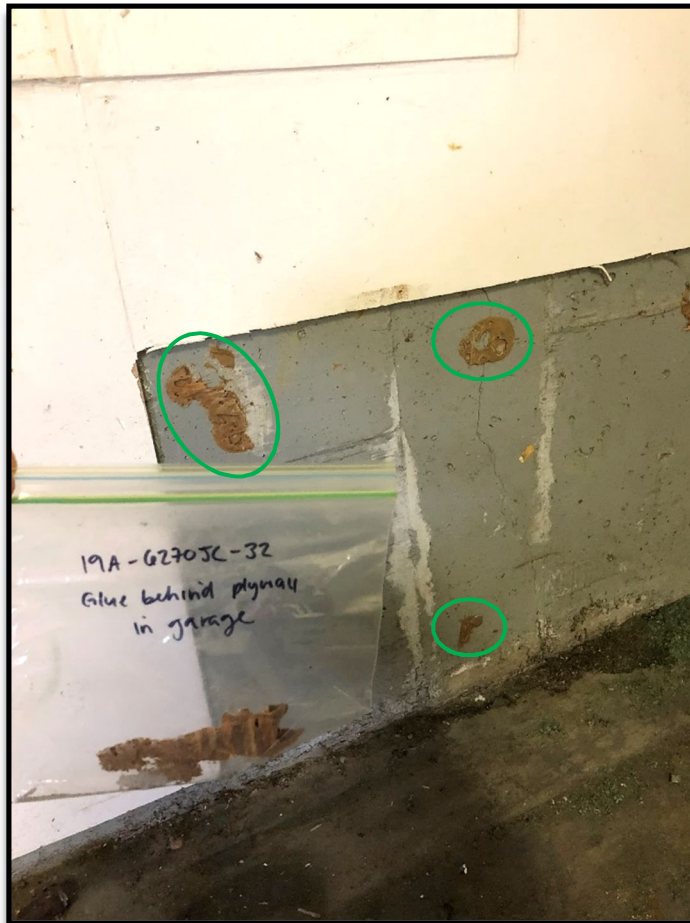
Sample 19A-6270-JC-32 glue between plywood panelling and concrete perimeter foundation on the northeast wall of the warehouse was 'None Detected' for asbestos (left).

Sample 19A-6270-JC-33 glue behind white hard surface panel sheet and base mount plywood panelling on the southwest wall of the warehouse was 'None Detected' for asbestos (right).

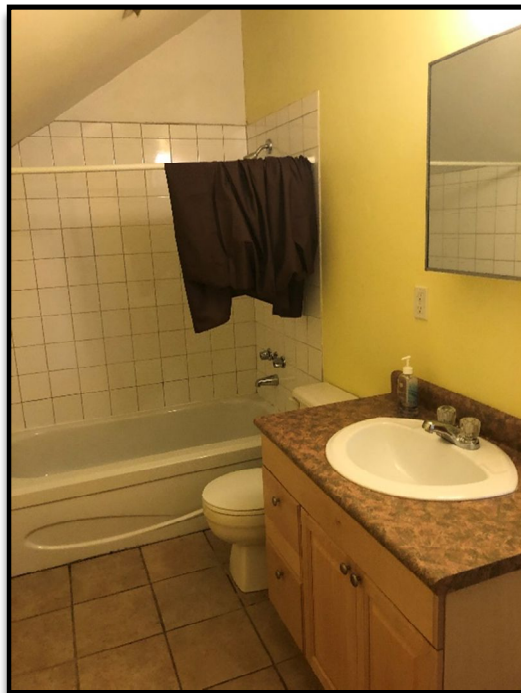
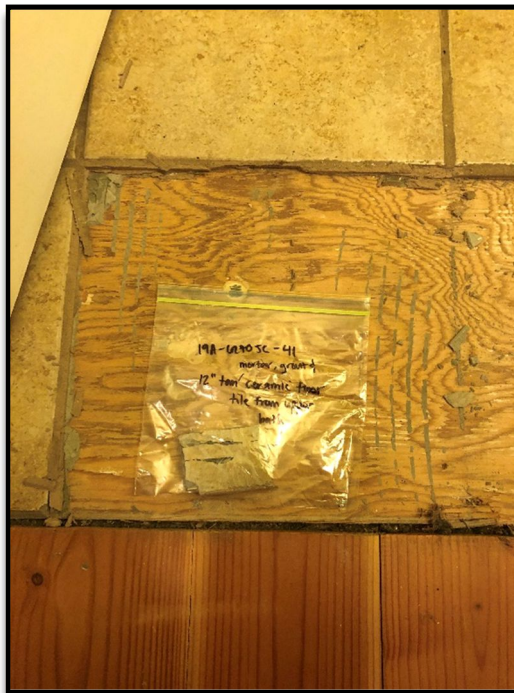
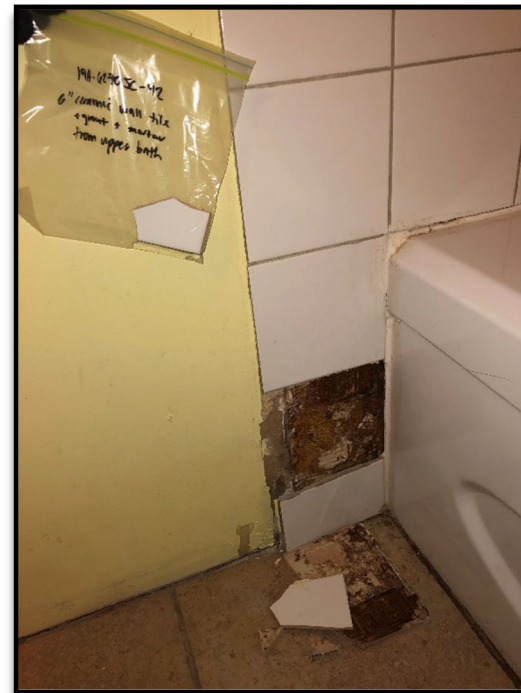
Upper residence bathroom showing 12" tan ceramic floor tile and 6" white ceramic wall tile (left).
Sample 19A-6270-JC-41 of 12" tan ceramic floor tile with grout and mortar was 'None Detected' for asbestos (centre).
Sample 19A-6270-JC-42 of 6" white ceramic wall tile with grout and mortar was 'None Detected' for asbestos (right).

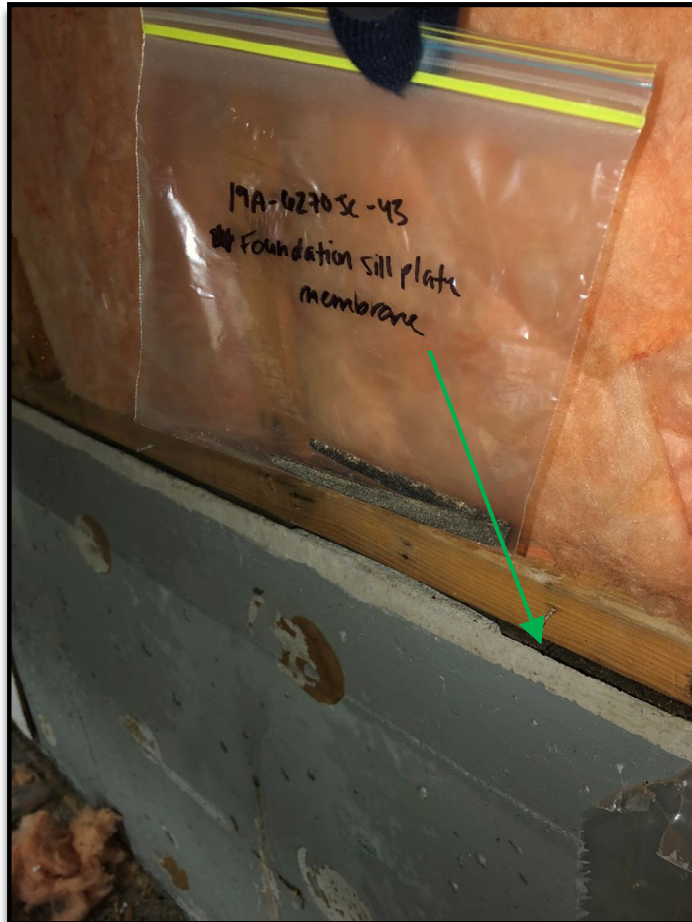
Sample 19A-6270-JC-43 membrane between sill plate and perimeter foundation in the warehouse was 'None Detected' for asbestos (left).
Sample 19A-6270-JC-44 building paper between outer layer of OSB and exterior wood siding (coring) was 'None Detected' for asbestos (right).

Lab No.: 6942093 Client No.: 19A-6270JC-43	Analyst Observation: Black Backing Material Client Description: Foundation Sill Plate Membrane	Location: Facility:
<u>Percent Asbestos:</u> <i>None Detected</i>	<u>Percent Non-Asbestos Fibrous Material:</u> 75 Cellulose	<u>Percent Non-Fibrous Material:</u> 25

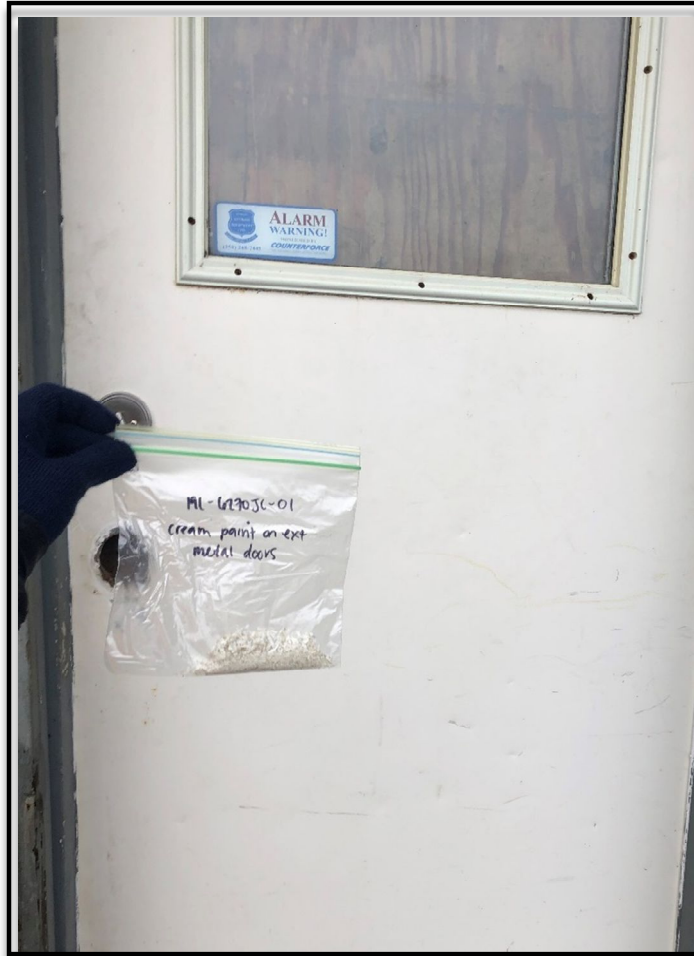
Cream paint sample 19L-6270JC-01 applied to the exterior metal doors with lead concentration: 0.041 wt% (410 ppm).

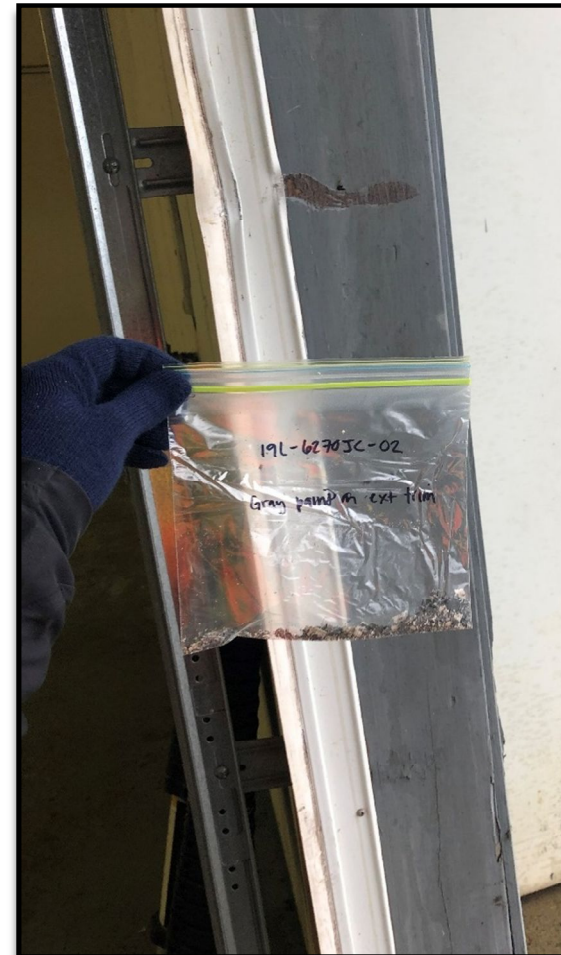
Grey paint sample 19L-6270JC-02 applied to the exterior wood trim with lead concentration: <0.0058 wt% (<58 ppm).

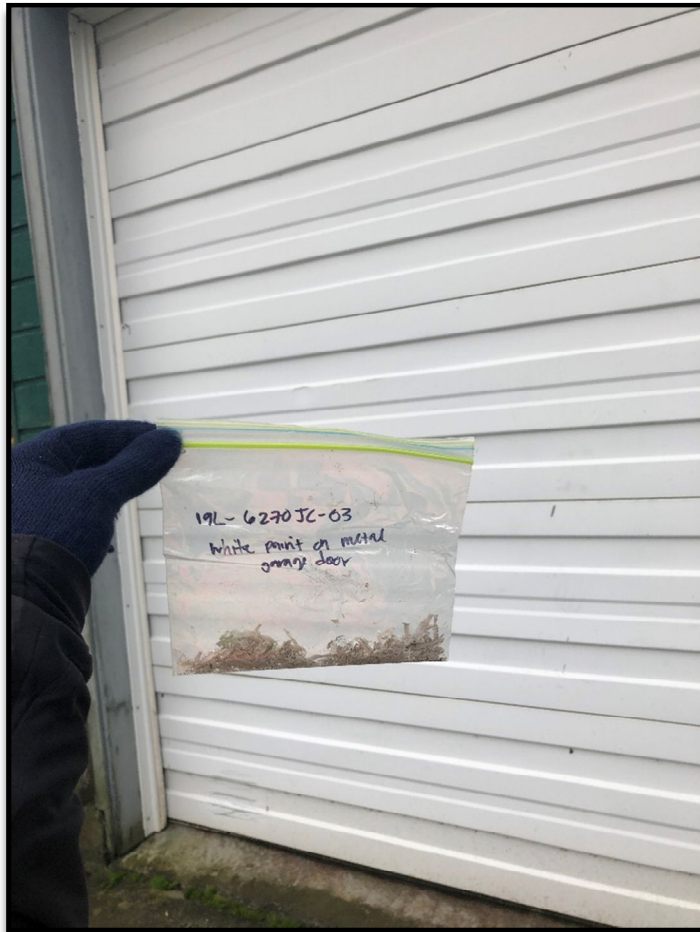
White paint sample 19L-6270JC-03 applied to the exterior of the roll-up metal door with lead concentration: <math><0.0083\text{ wt\%}</math> (<math><83\text{ ppm}</math>).

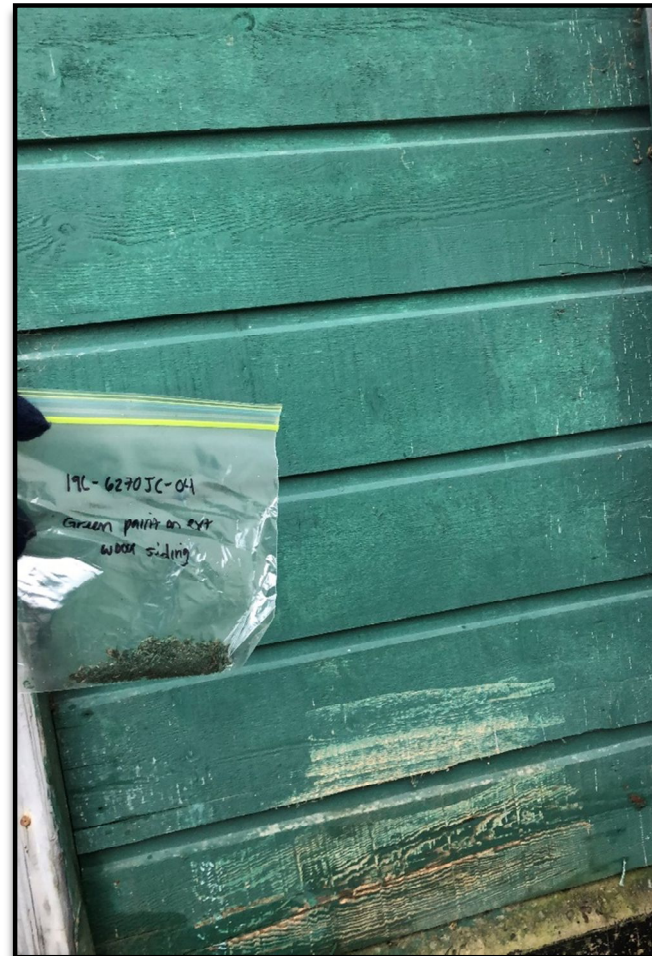
Green paint sample 19L-6270JC-04 applied to the exterior wood siding with lead concentration: 0.022 wt\% (220 ppm).

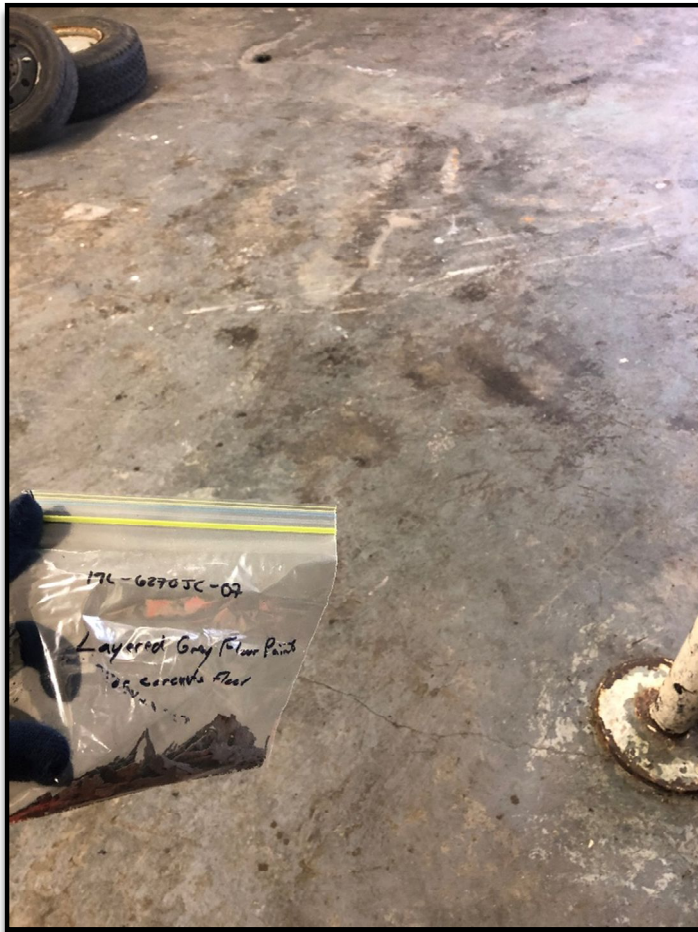
Layered grey paint sample 19L-6270JC-07 applied to the warehouse concrete floor with lead concentration: 0.011 wt% (110 ppm).

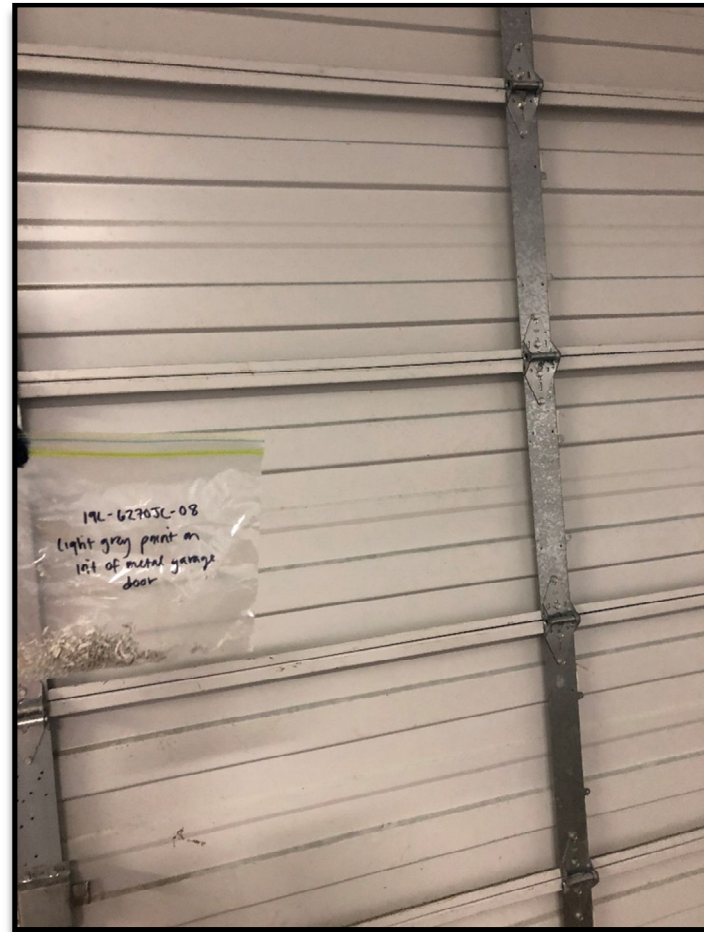
Light grey paint sample 19L-6270JC-08 applied to the interior of the roll-up metal door with lead concentration: <0.0084 wt% (<84 ppm).

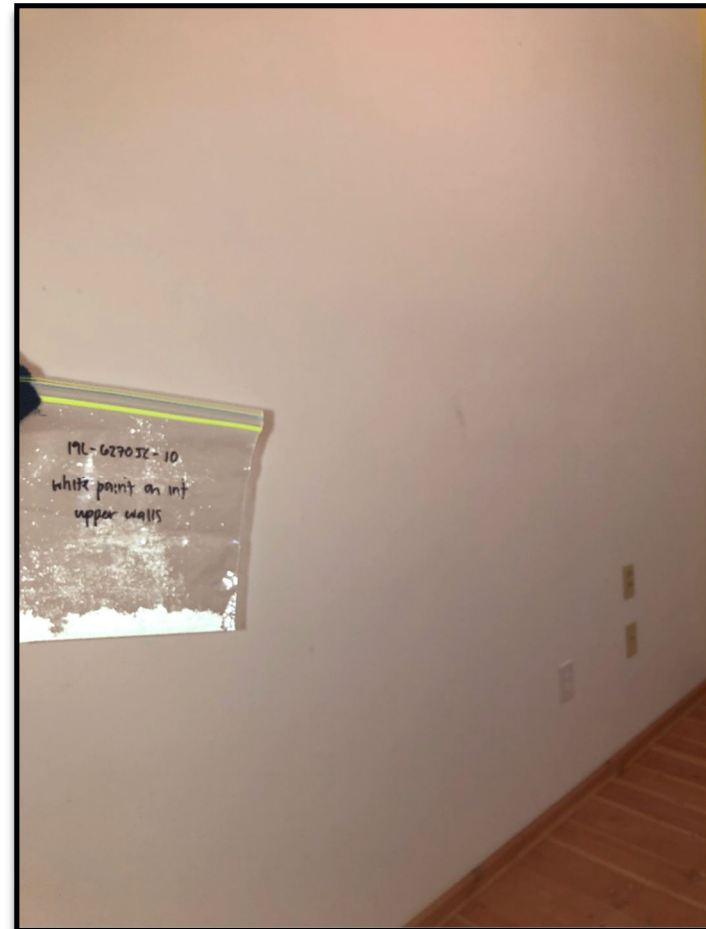
White paint sample 19L-6270JC-10 applied to the upper residence interior drywall walls with lead concentration: 0.0086 wt\% (86 ppm).

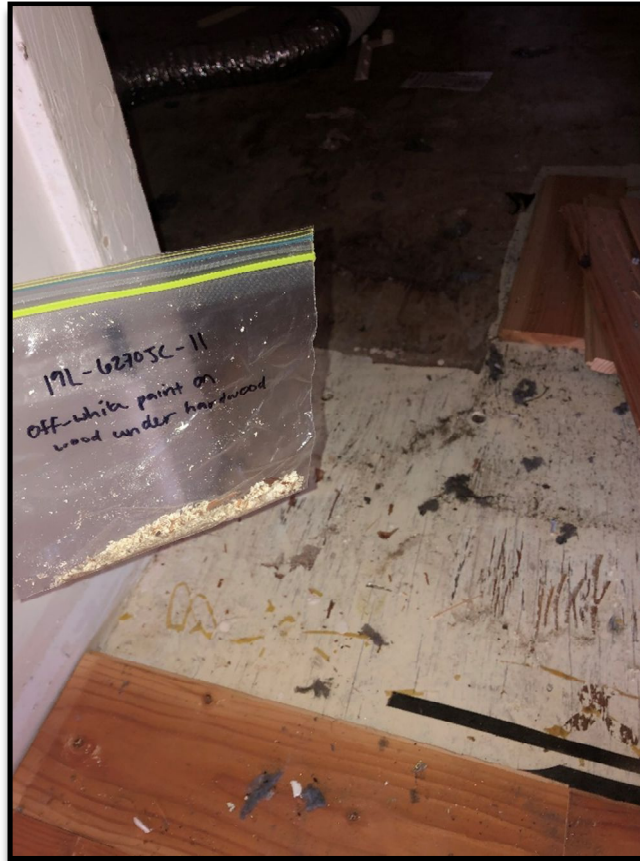
Off-white paint sample 19L-6270JC-11 applied to the upper residence sub-floor at the entrance to the side attic with lead concentration: <math><0.0080\text{ wt\%}</math> (<math><80\text{ ppm}</math>).

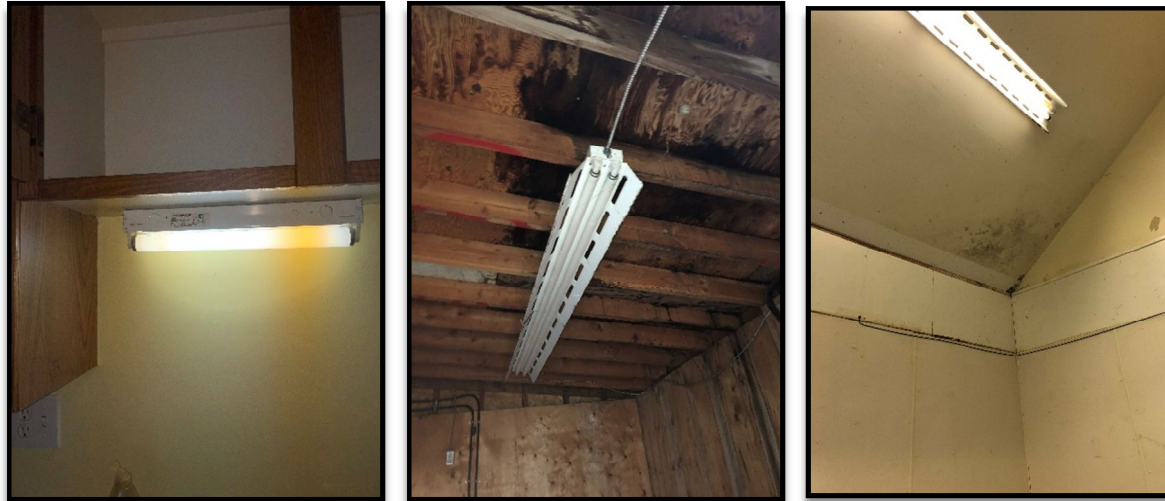
Fluorescent light fixtures within the upper residence kitchen (left), the east electrical room (centre) and the warehouse (right).

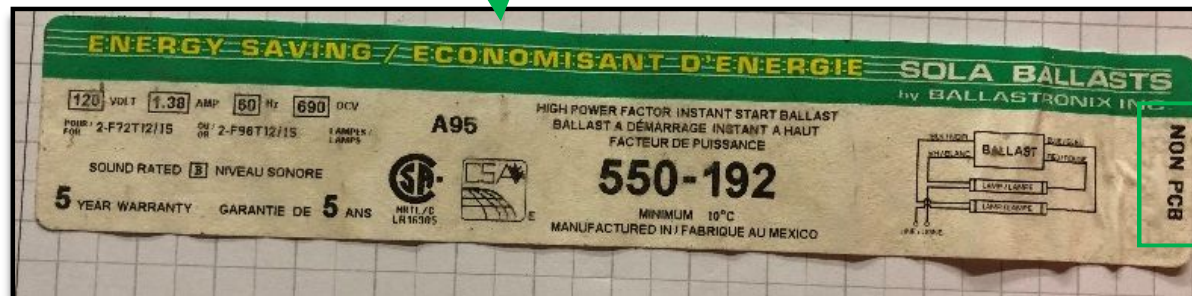
Fluorescent fixture lamp ballasts as inspected within the warehouse were found to be labeled “NON PCB”.

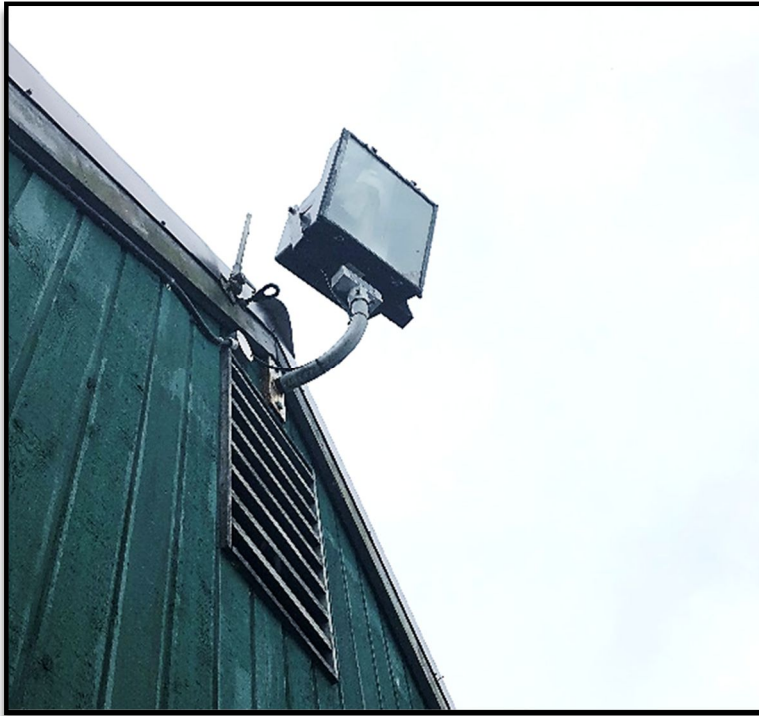
Exterior area flood lamp fixtures as observed to be mounted on the upper portion of the northwest elevation wall. The lamps are assumed to contain bulb(s) that are anticipated to be either metal halide or high pressure sodium bulbs. Metal halide and high pressure sodium bulbs typically contain mercury and/or other heavy metals.

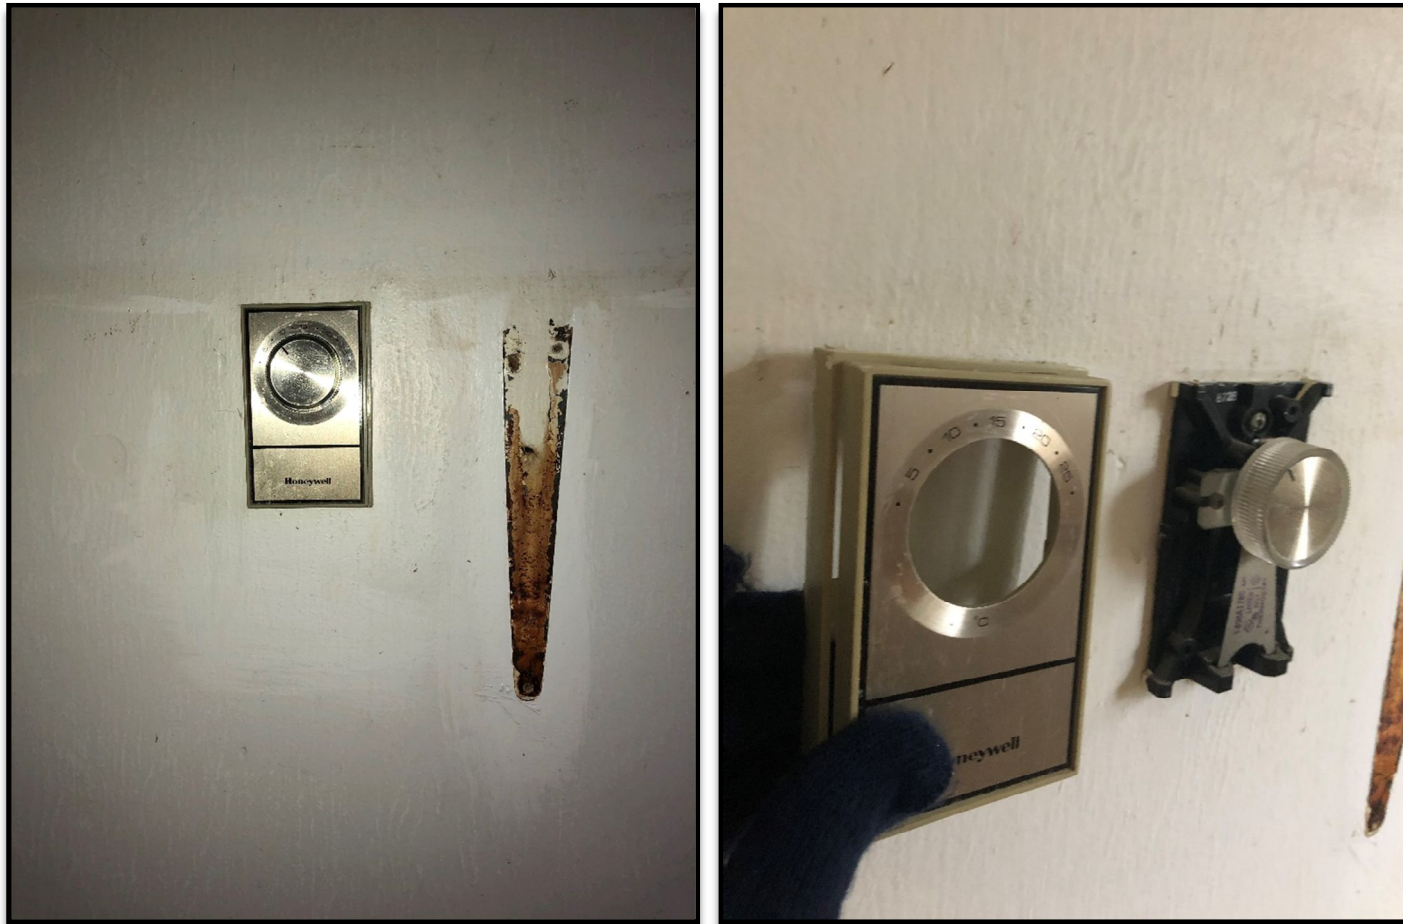
Thermostats within the Subject Site were inspected and did not contain mercury filled glass activator switch bulbs.

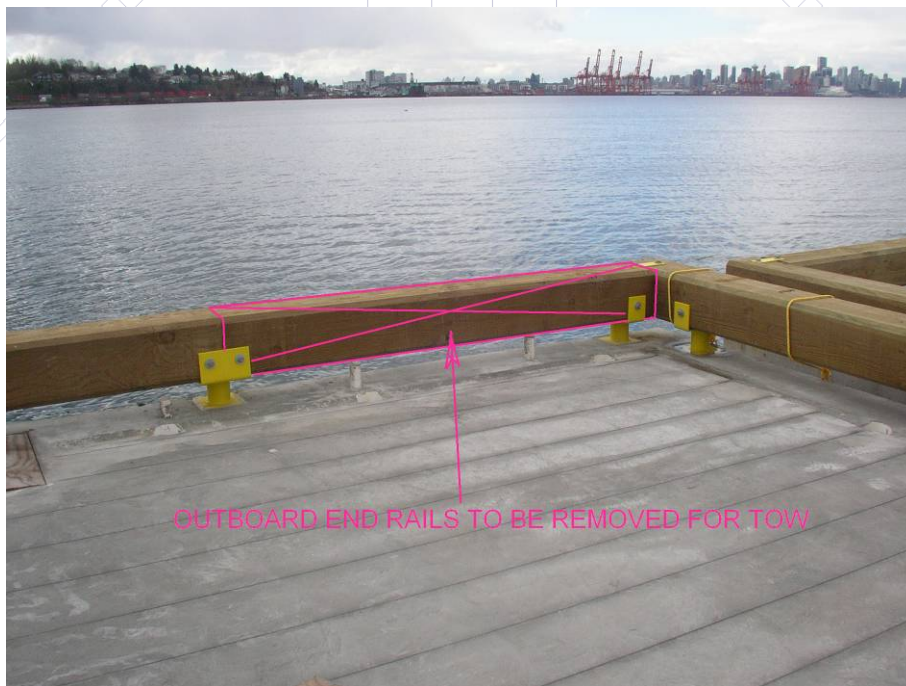
View showing 1 of 2 outboard bull rails to be removed for tow

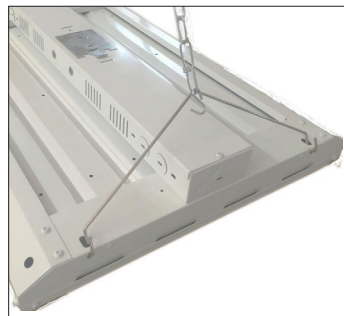
PENDANT MOUNT WITH HOOKS (V-HOOKS STANDARD)

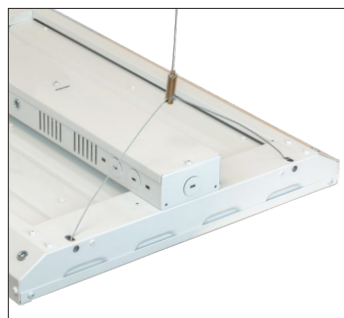
AVIATION CABLE MOUNT

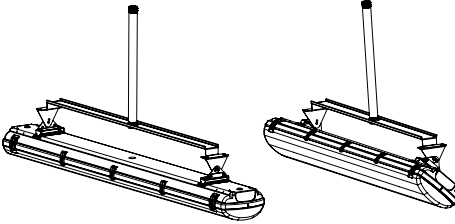
<p>PVPM-05 Pivot mount bracket with 3/4" (1/2npt) drilled on bracket</p> <p>PVPM-075 Pivot mount bracket with 1" (3/4npt) drilled on bracket</p>	<ul style="list-style-type: none"> - Two pivot mount brackets installed on rigid mount bracket support. Bracket can be predrilled for 1/2" or 3/4" NPT, select appropriate compatible size. Should additional hole on top of luminaire be required, select desired CH option. (Stem provided by others)

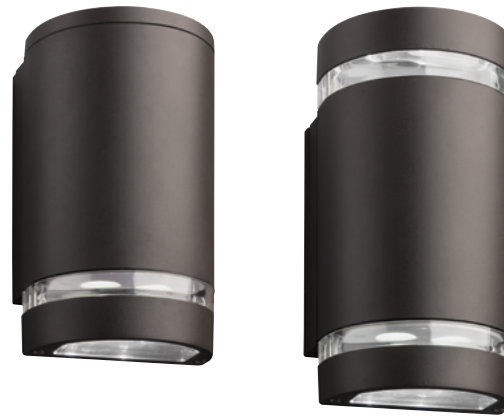
LED WALL CYLINDER LIGHT

OLLWD & OLLWU

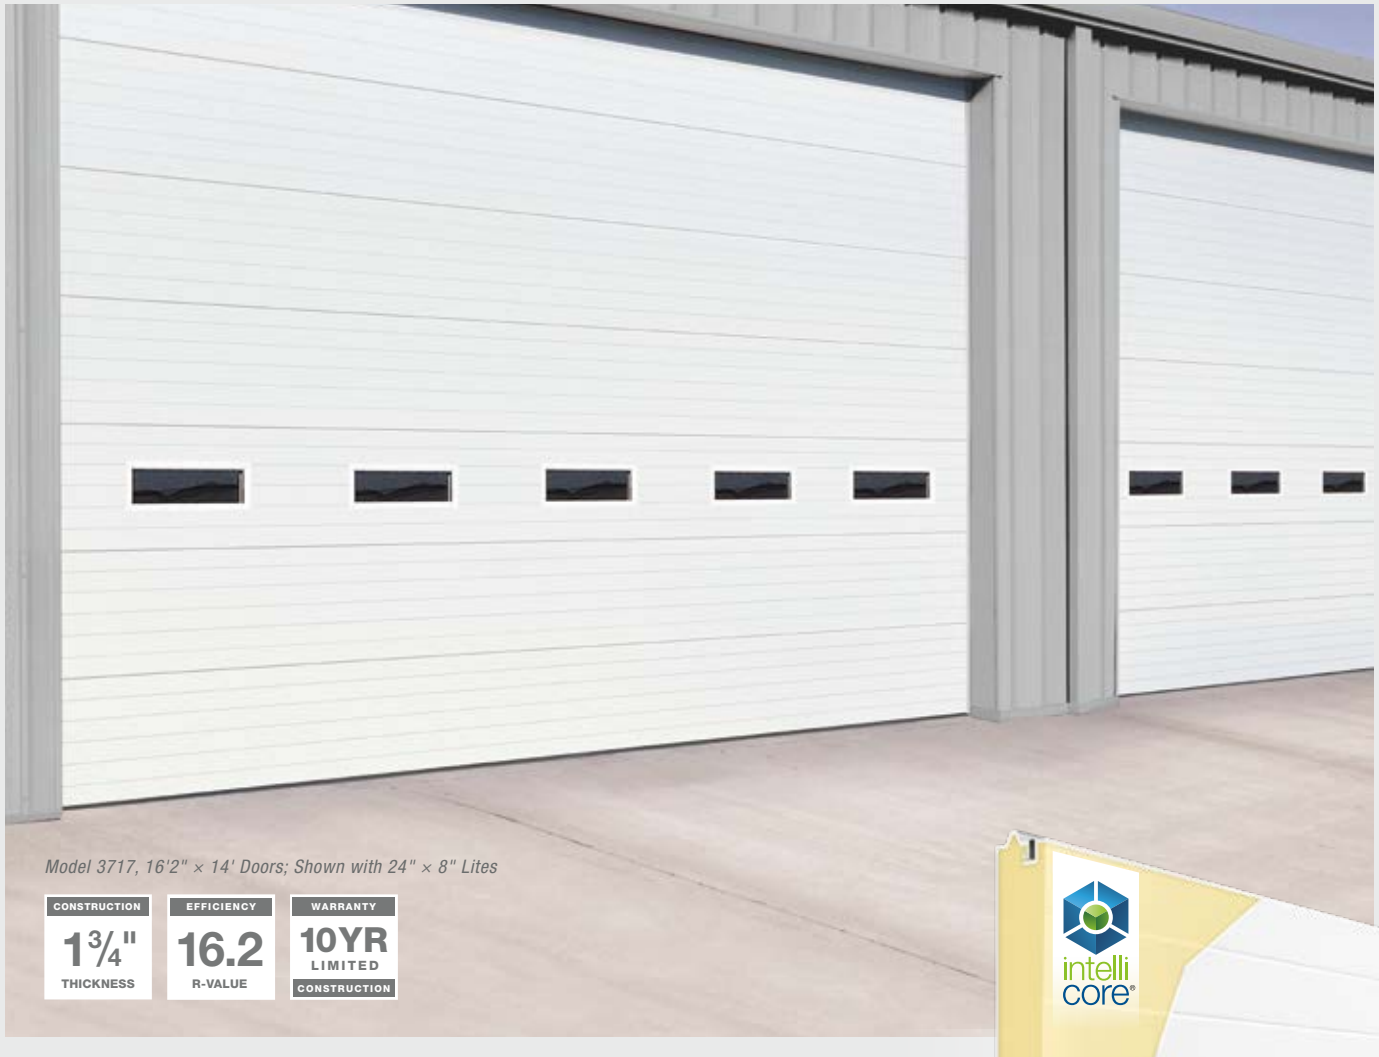
Model 3717, 16'2" x 14' Doors; Shown with 24" x 8" Lites

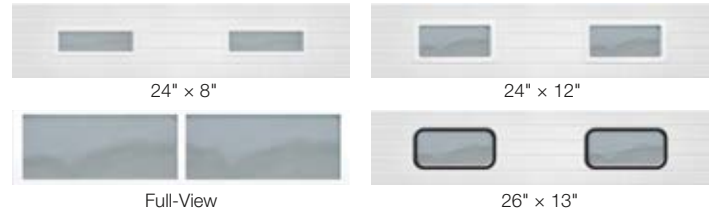
WINDOW OPTIONS

Available with insulated, insulated tempered or tempered glass. Full-view section, preprinted Standard White or Chocolate; glazing options include DSB, tempered, plexiglass, insulated, insulated tempered and polycarbonate. 26" x 13" (66.04 cm x 33.02 cm) windows are available with Lexan® or plexiglass.

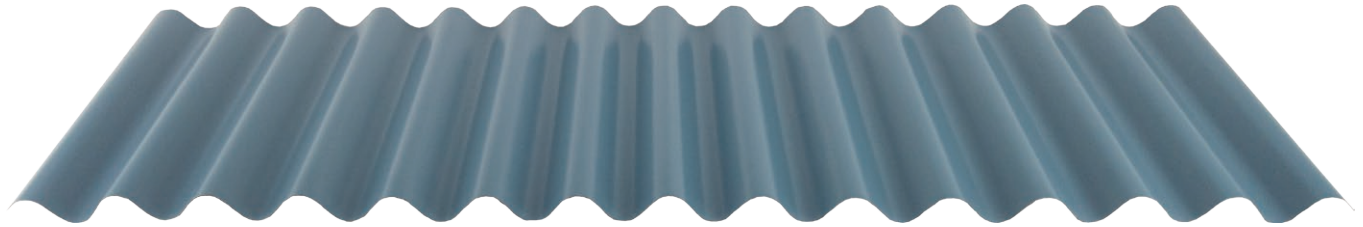
WF-7/8" CORRUGATED

Uniformly Distributed Loads (pounds/square foot) for 3 span condition

GA	PURLIN SPACING	3'	3'6"	4'	4'6"	5'
26	LBS. PER SQ FT	101	74	57	45	36

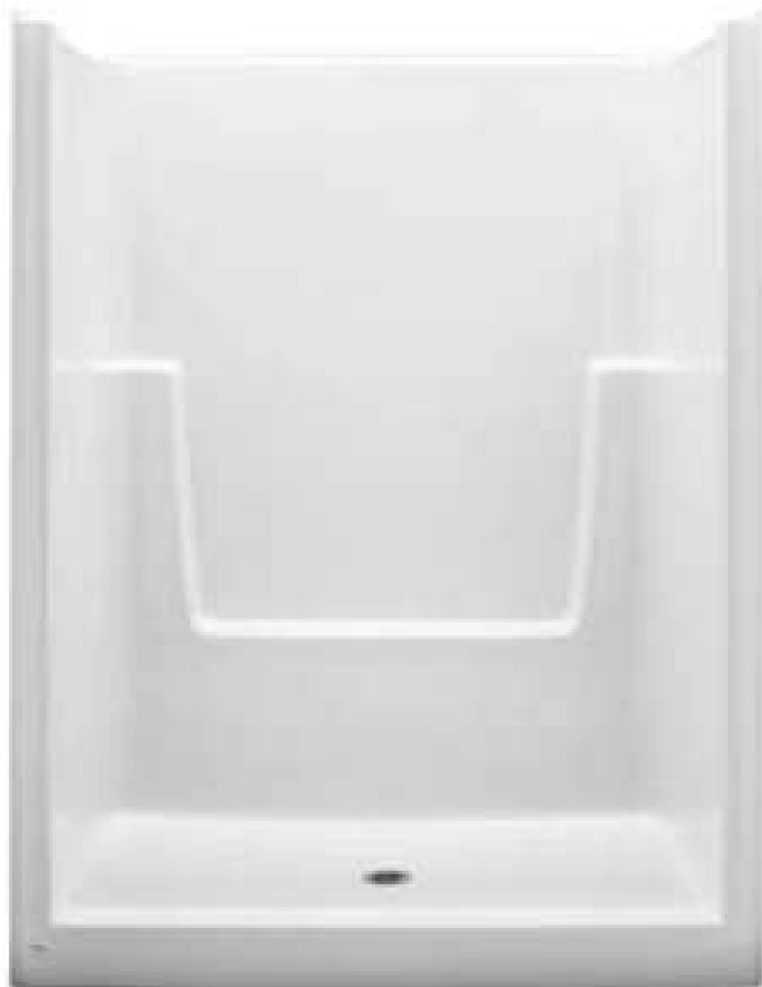
Model S601

Model S601**Length:** 60" (1524 mm)**Width:** 36" (914 mm)**Height:** 76 5/8" (1946 mm)**Shipping Weight:** 120 lbs. (54.5 Kg)**Materials:** Gelcoat finish reinforced with fibreglass.

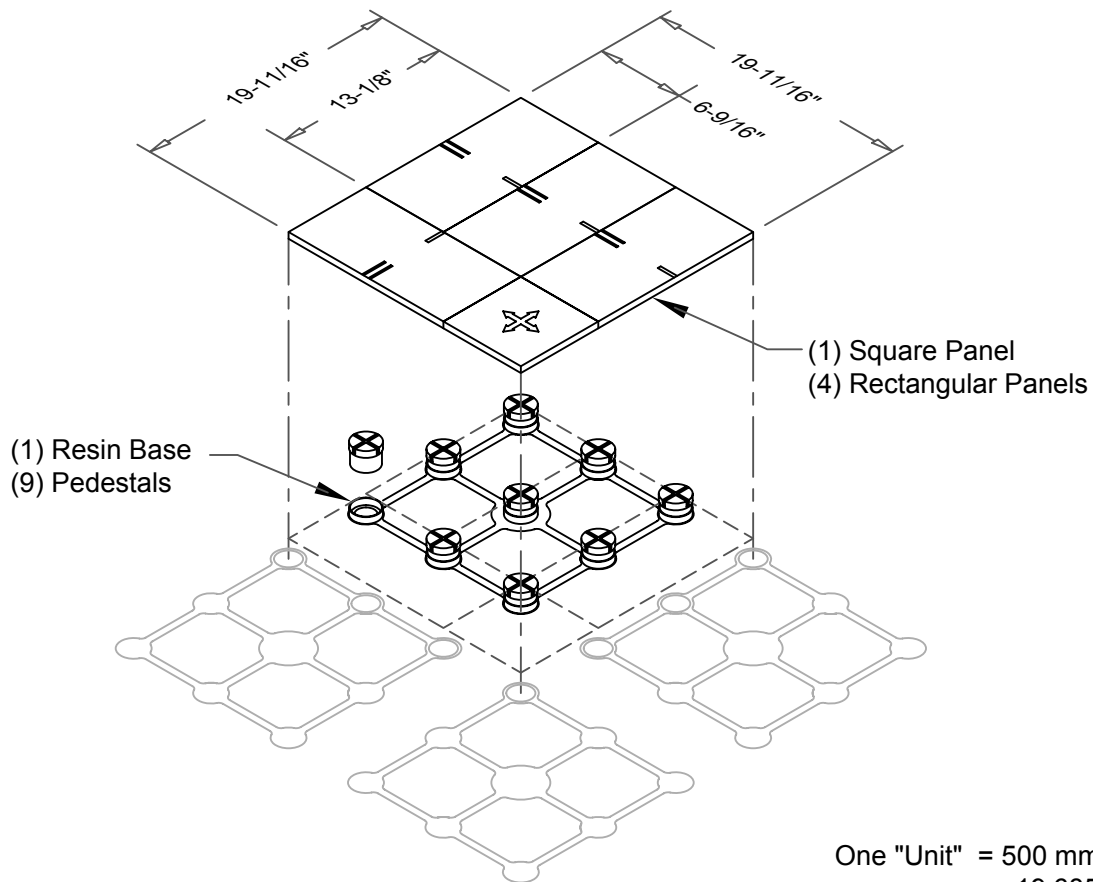
One "Unit" = 500 mm Sq.
 = 19.685" Sq.
 = 2.69 Sq. Ft.
 100 Sq. Ft. = 37.2 "Units"
