**Site F – Burleigh Falls Dam
Underwater Inspection Footage
May 30th and 31st 2018**

The purpose of this report is to convey the data collected during the underwater inspection of the Site F – Burleigh Falls Dam on the Trent Severn waterway undertaken on May 30th and May 31st, 2018. This document is meant to be read in conjunction with the included video footage and to be used as a guide for those using the footage to assess the state of the dam.

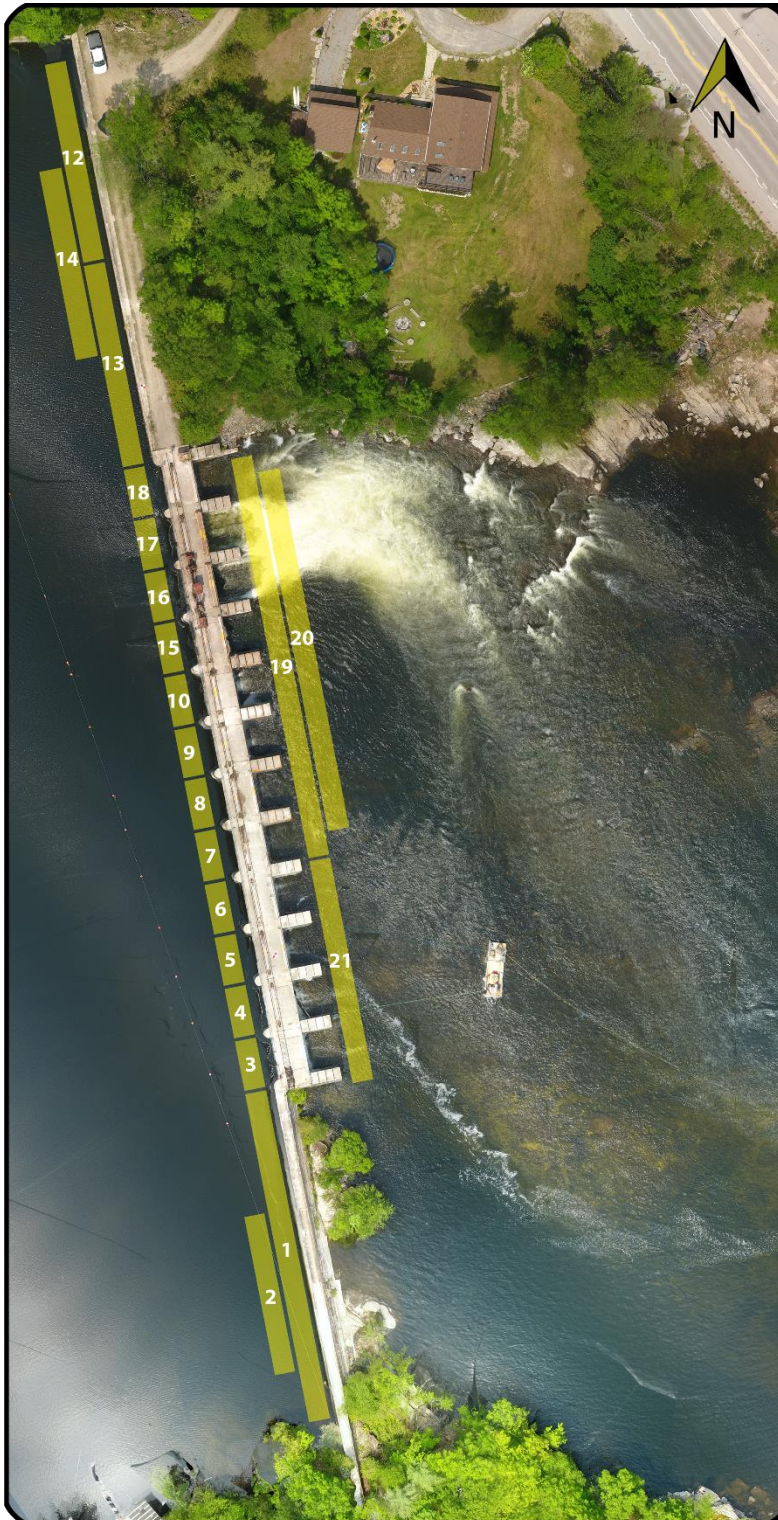
3.0 Footage Location Map

A map of the dam showing the approximate location of each video clip included with this report can be found in section 3.0 below. The aerial imagery used on the map was taken on May 30th, 2018. In addition, a table describing each video clip can be found below in section 4.0 of this report.

Locations shown on this map are approximate.

Numbers shown represent the clip number where relevant video footage can be found.
