## Statement of Cultural Resource Impact Analysis

For: Rehabilitation of Burleigh Falls Dam at Lock 28,  
TSW, ON (RPA 1224)

#### Project overview

The project scope entails the rehabilitation of Burleigh Falls Dam, improvements to public and operator safety, and reliability at the site. The existing dam is composed of the following main structures: South Gravity Dam Section; Spillway Section composed of 12 Sluices; North Retaining wall; and North Closure wall.

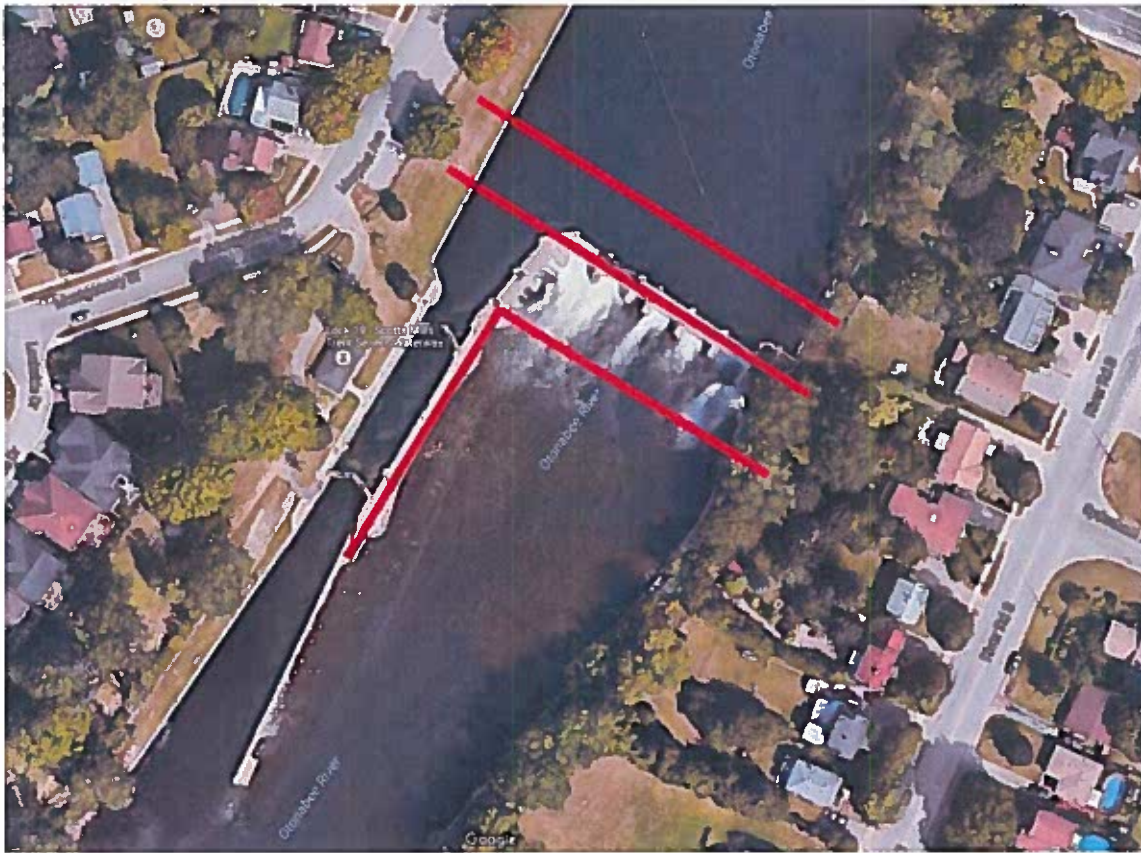
Figure 2. Proposed lines of Geotechnical Investigations at dam at Lock 19 (Scott's Mills), Kawartha Sector (PCA files).

Many of the concrete structures along the Trent-Severn Waterway are in poor condition and require extensive repairs and replacements (PCA 2015a). Parks Canada Agency (PCA) has proposed to rehabilitate the dams along the Kawartha Sector, including dams at Lock 19 (Scott's Mills), Lock 22 (Nassau Mills), Lock 23 (Otonabee), Lock 24 (Douro), Lock 25 (Sawer Creek near Primrose Lake), Burleigh Falls Dam and Perry's Creek Dam 1 at Lock 28 (Burleigh Falls) (Figure 1). Geotechnical investigations are required to target the areas of dams or embankments, where rehabilitation measures are currently proposed to address new areas of concern that were detected during the initial site visit and obtain sufficient information to evaluate rehabilitation options and complete final design. The geotechnical information will also assess the state of the dam structures, the soil composition of the embankments, and in-water conditions (Figures 2 to 8).

The preliminary geotechnical plans note the following: the actual final depth of boreholes may vary depending on site condition; the drilling will be laid out every ten meters upstream and downstream of the dams, drilling through overburden will include SPT every 5ft, if applicable; HQ (2.5") cores will be advanced vertically through concrete into bedrock and a 4" diameter masonry bit will be utilized for the horizontal short cores; the piezometer will consist of a slotted pipe with sand filter, bentonite seal and protective casing with caps; water depths are approximately 20 ft. upstream and downstream of the dam; the lock and dam shall be in operation during the investigations; the drilling contractor is responsible for access to all borehole locations; and the drilling contractor will supply trailer(s) on site and any additional equipment as required for the work and the health and safety of workers.

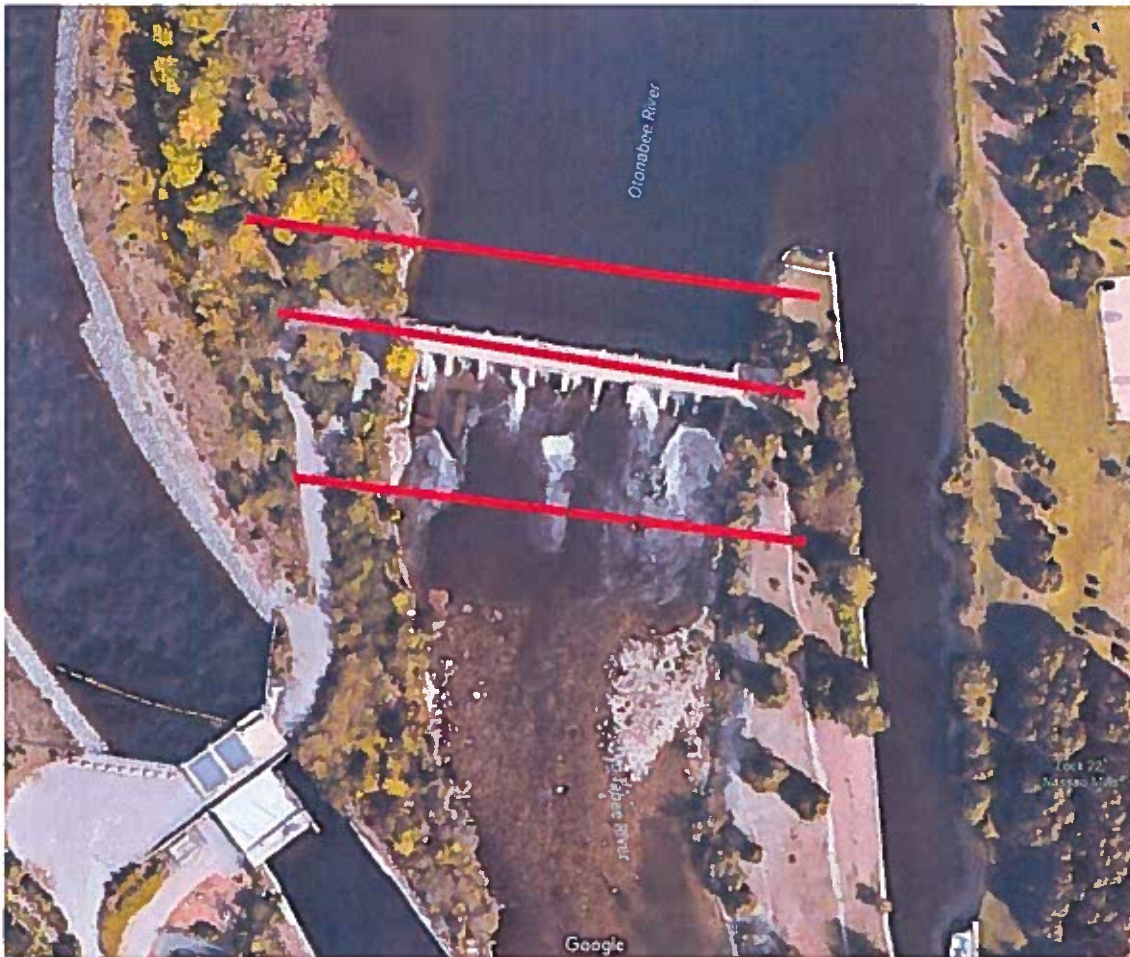
Figure 3. Proposed lines of Geotechnical Investigations at dam at Lock 22 (Nassau Mills), Kawartha Sector (PCA files).

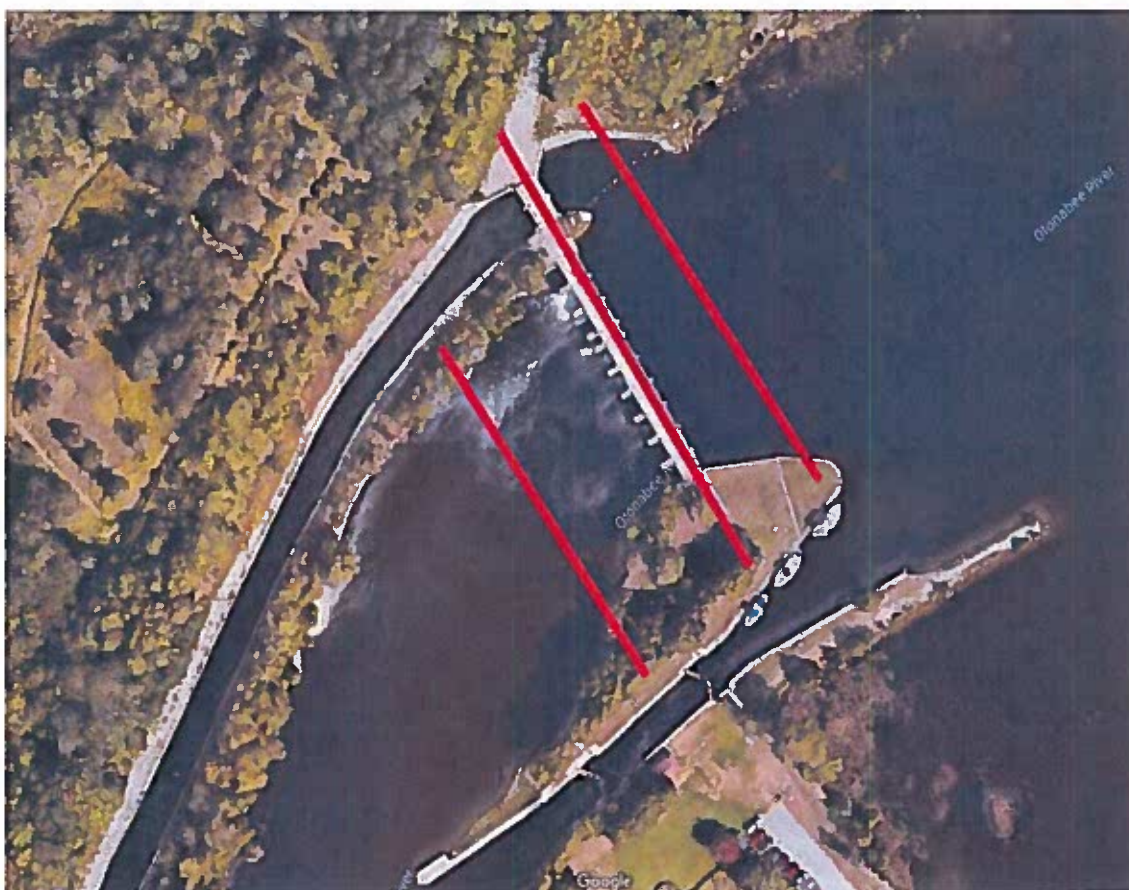
Figure 4. Proposed lines of Geotechnical Investigations at dam at Lock 23 (Otonabee), Kawartha Sector (PCA files).

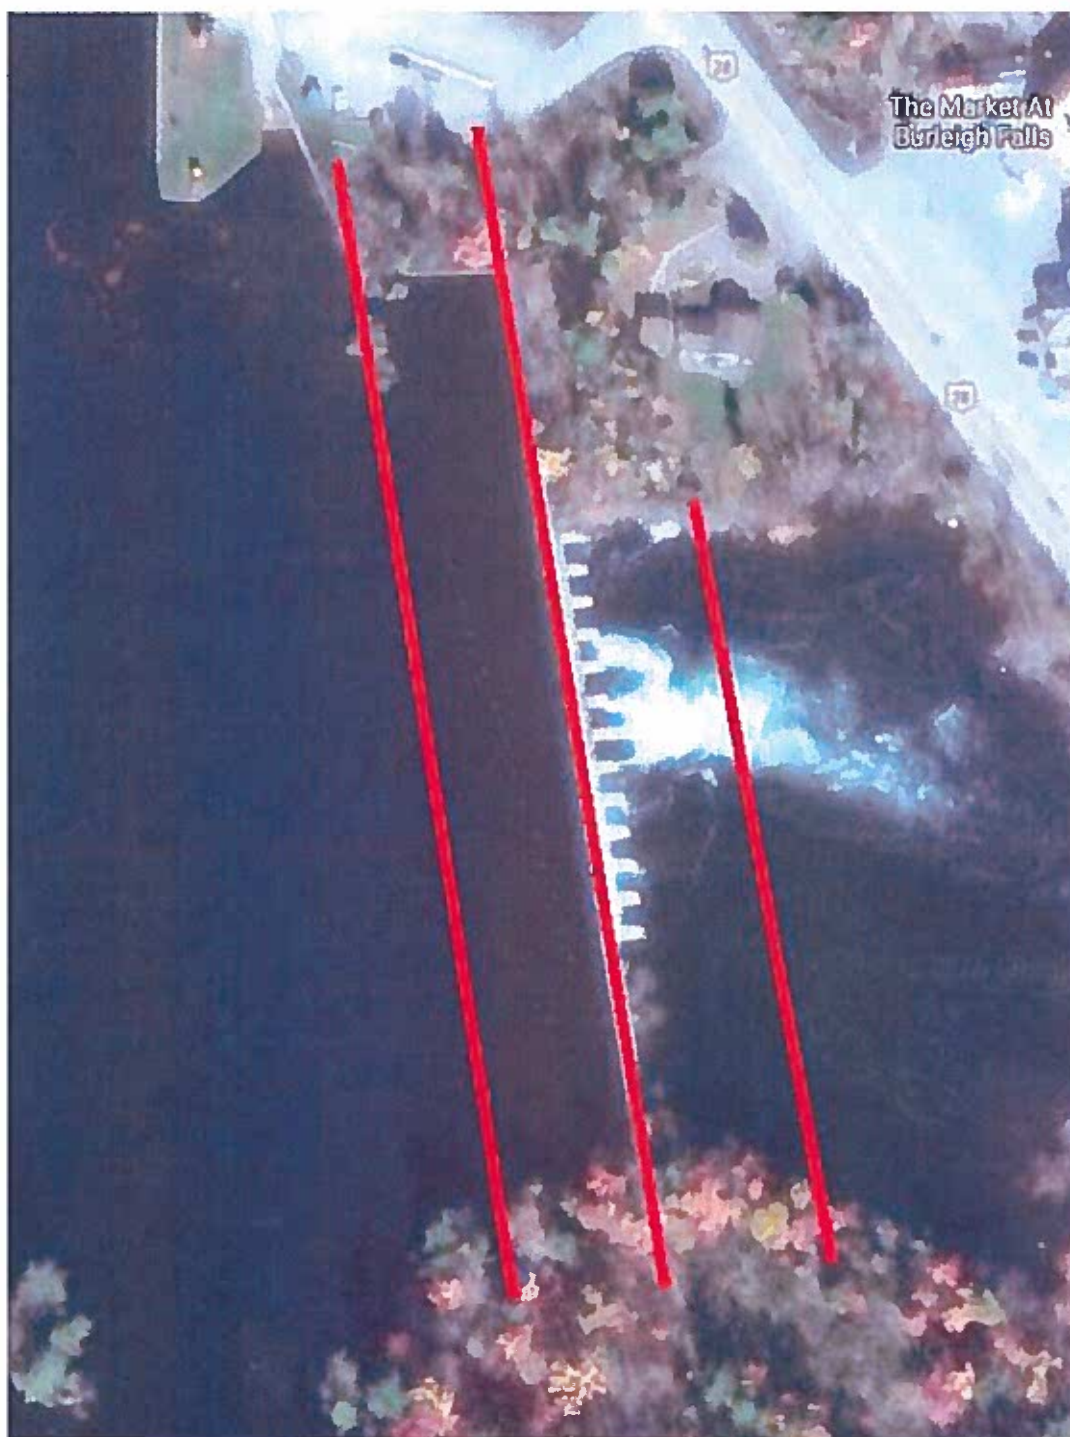
Figure 7. Proposed lines of Geotechnical Investigations at Burleigh Falls Dam at Lock 28 (Burleigh Falls), Kawartha Sector (PCA files).

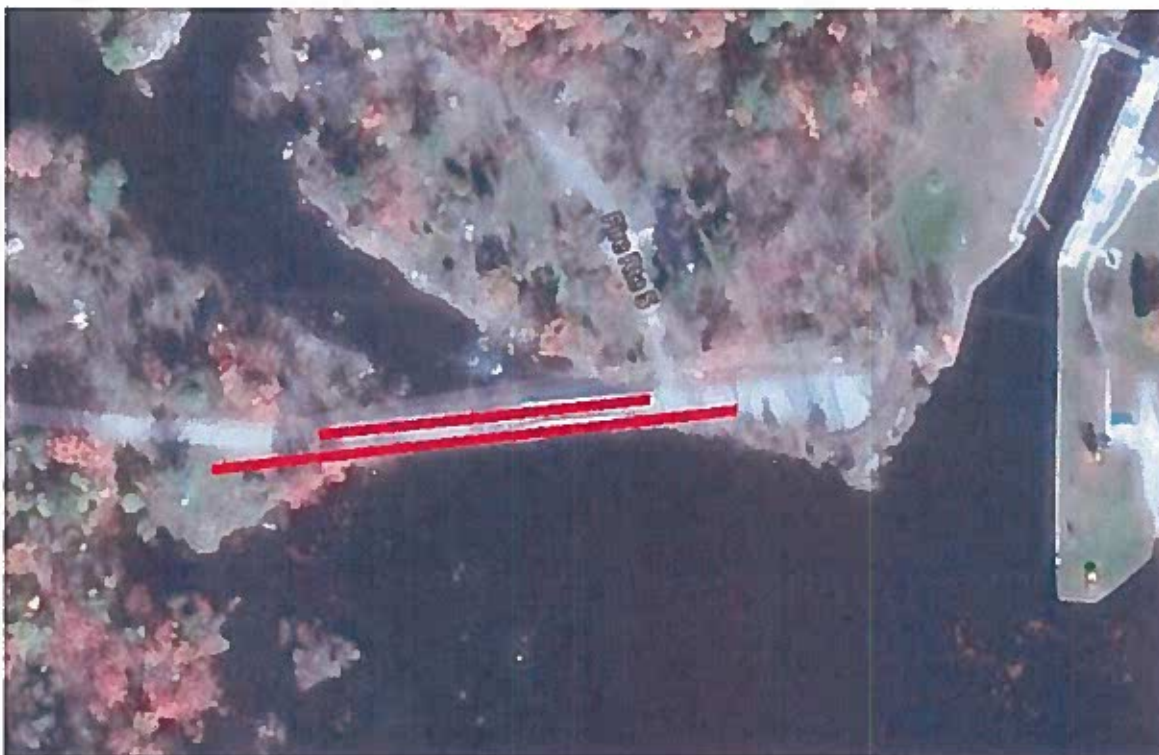
Figure 8. Proposed lines of Geotechnical Investigations Perry's Creek Dam 1 at Lock 28 (Burleigh Falls), Kawartha Sector (PCA files).

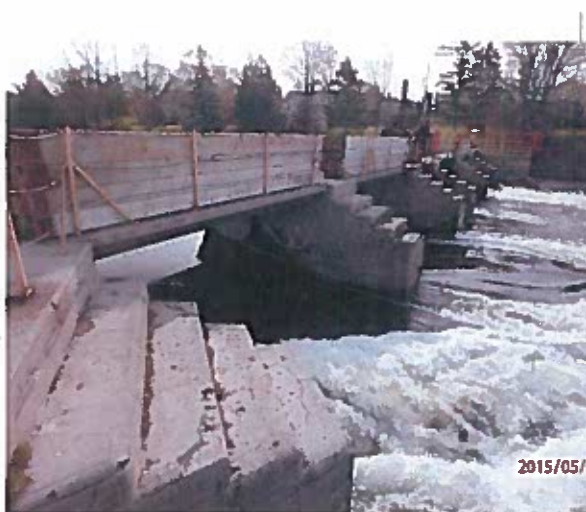
Figure 9. Scotts Mills Dam, Main Dam (PCA 2015b).

Scotts Mills Dam at Lock 19 is located in the city of Peterborough, just South of Lansdowne Street Bridge, on the Otonabee River section of the Waterway. Scotts Mills Dam is a concrete structure with seven spillways and one log chute (Figures 9 and 10). Built in 1904 replacing an earlier dam, the Scotts Mills Dam is largely unchanged except for minor surface repairs (Figure 18; PCA 2015b). As one of the four earliest locks on the Trent-Severn Waterway, the Scotts Mills Dam was classified as a PCA Level 2 Cultural Resource.

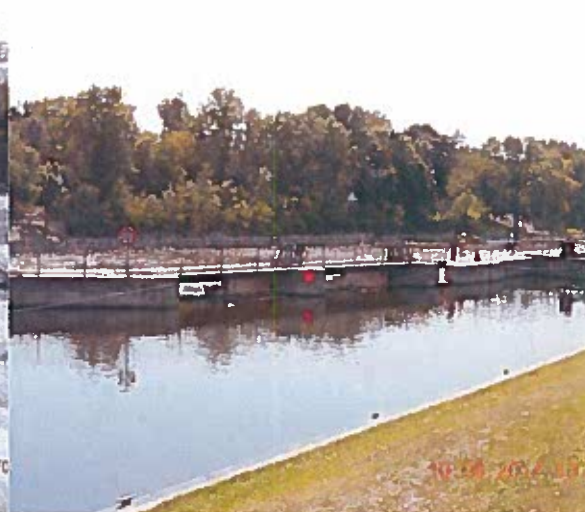
Figure 10. Scotts Mills Dam, Side Dam and Approach Wall to Lock 19 (PCA 2015b).

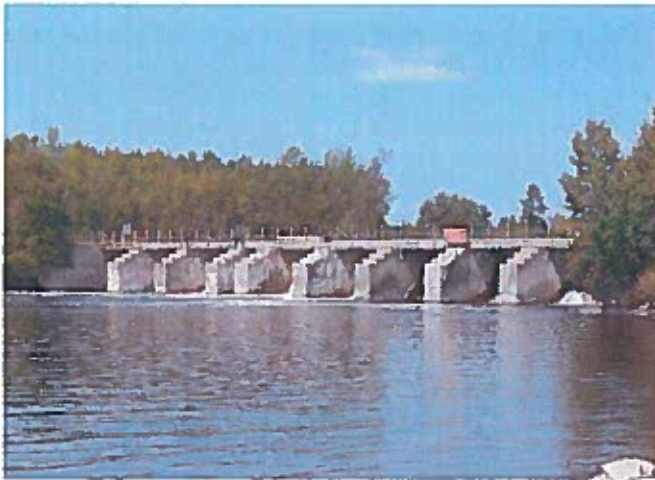
Figure 13. Otonabee Dam, Downstream View (PCA 2015d).

6.1 m in width, and one log chute, 2.4 m in width (Figure 13; PCA 2015e). The stoplog weirs are operated by a hydraulic log lifter mounted on rails (Figure 14).

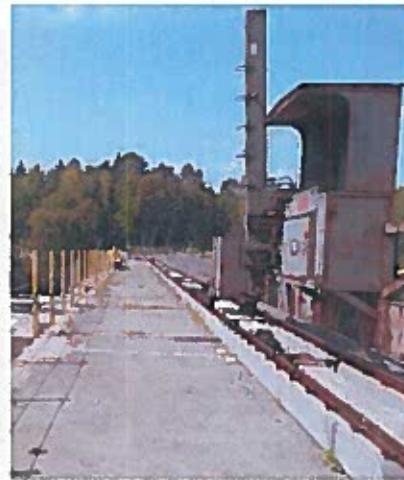
Figure 14. Otonabee Dam with a hydraulic log lifter mounted on rails to right (PCA 2015d).

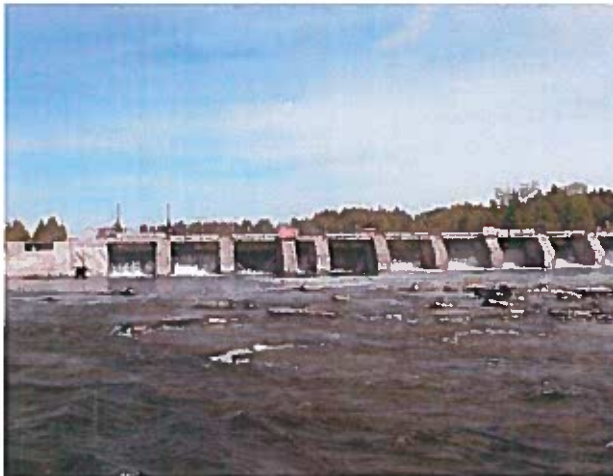
Figure 15. Douro Dam, Downstream View (PCA 2015c).

As with the dams at Nassau Mills, Otonabee and Sawyer Creek, Douro Dam is a manually-operated concrete gravity dam structure featuring nine sluices with wooden stop logs and a wooden deck (Figure 15; PCA 2015c). The concrete dam was constructed in 1928 replacing an earlier dam situated immediately upstream (Figure 21). The earlier waste weir dam was a composite structure comprising a timber crib faced with concrete (HSMBC 1988). Douro Dam was classified as a PCA Level 2 Cultural Resource.

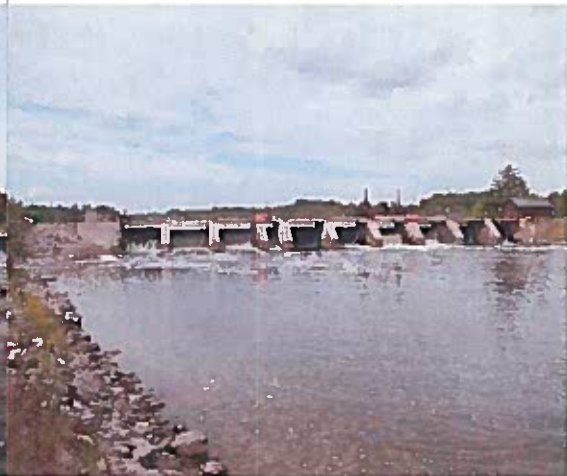
Figure 16. Sawyer Creek Dam, Downstream View (PCA 2015c)

Sawyer Creek is a manually-operated concrete gravity dam structure featuring nine sluices with wooden stop logs and a wooden deck (Figure 16; PCA 2015c). The concrete dam was constructed in 1932 replacing an earlier dam situated immediately upstream (Figure 22). Sawyer Creek Dam was classified as a PCA Level 2 Cultural Resource.
