SPECIFICATIONS
for

Waterton Remediation and Abatement – 11 Sites

Waterton Lakes National Park, Alberta

Project No. _____ February 2020

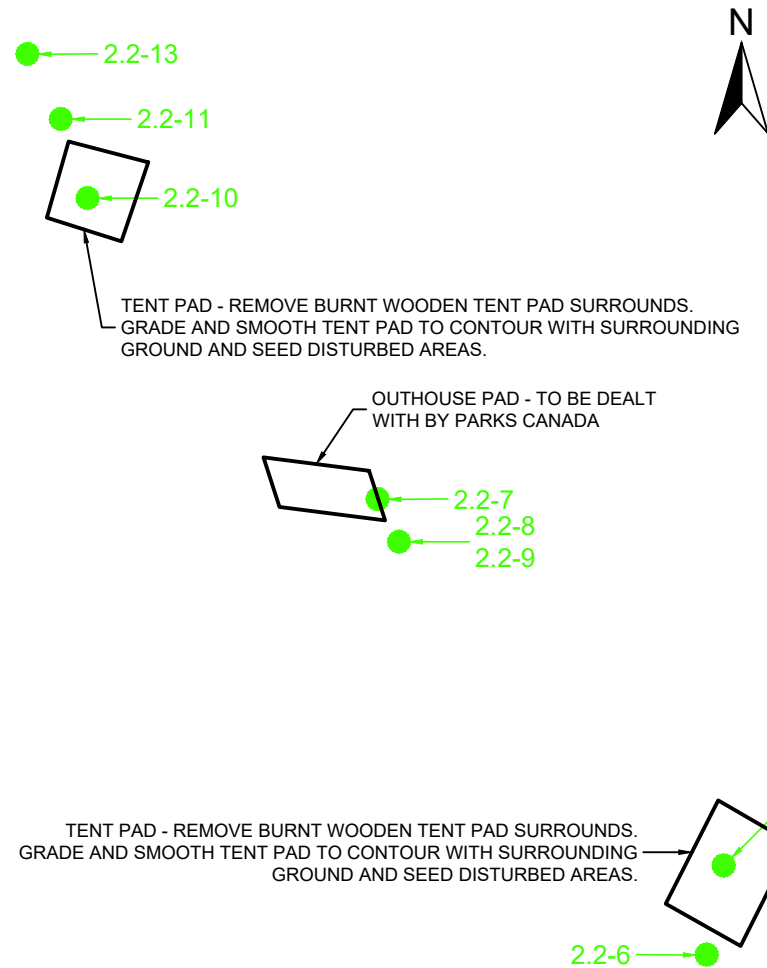
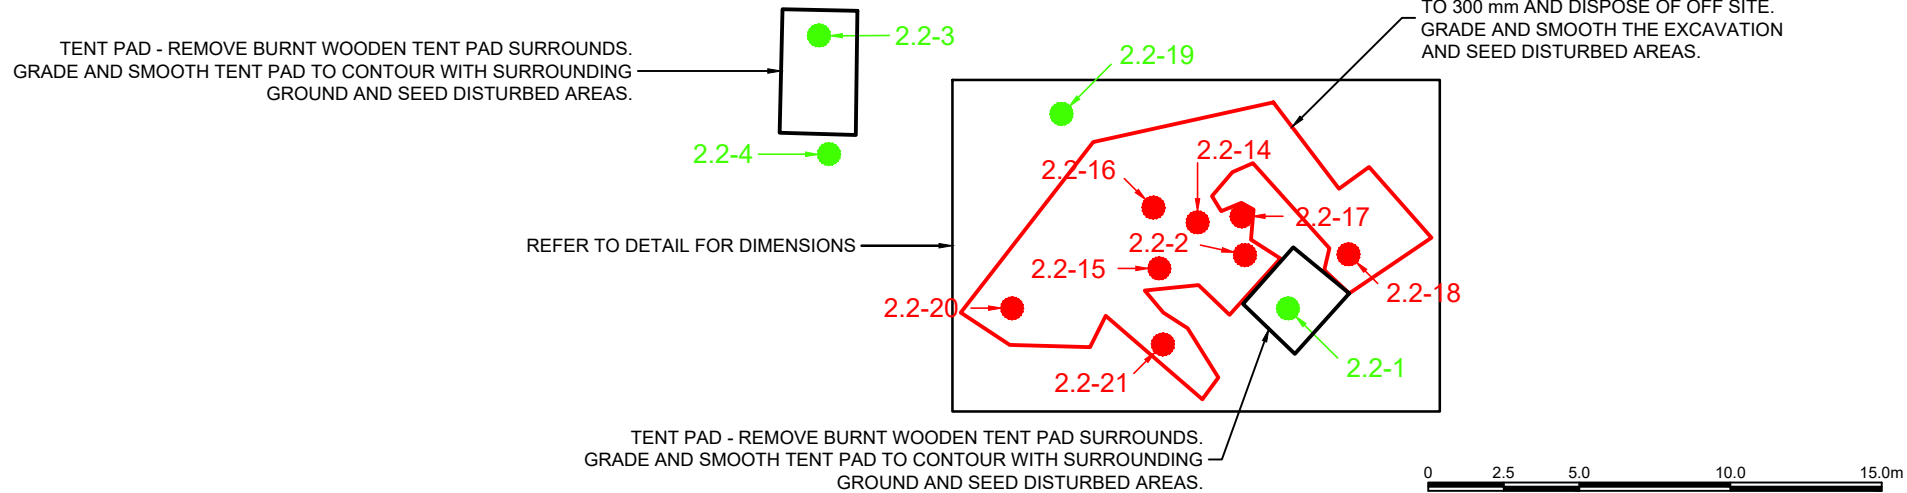
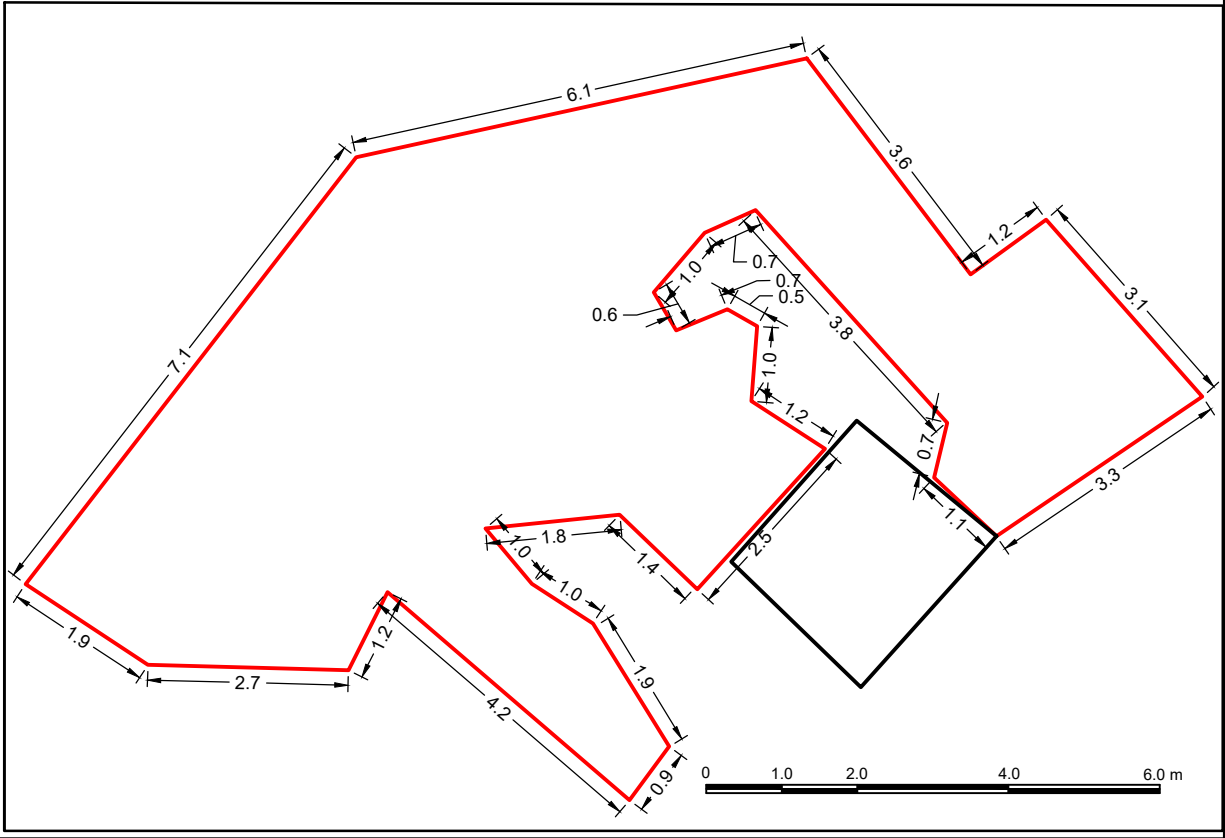
- APPROXIMATE VOLUME OF ASH AND NON-HAZARDOUS DEBRIS TO BE REMOVED AND DISPOSED OF OFF SITE. DEBRIS INCLUDES BUT IS NOT LIMITED TO ASH, WOODEN TENT PAD BORDERS AND METAL TIE DOWN BOLTS = 2 m³
- APPROXIMATE VOLUME OF IMPACTED SOIL TO BE REMOVED AND DISPOSED OF OFF SITE (EXCAVATION DEPTH OF 300 mm) = 20 m³

NAPHTHALENE	BARIUM (NON-BARITE)
		mg/kg	mg/kg
CCME SOILQG TIER 1 AL		0.013	750
CCME SOILQG TIER 1 RL/PL		0.013	500
REFERENCE VALUE		0.086	720
2.2-2	30-NOV-2018	0.03	1,000
2.2-3	30-NOV-2018	0.021	460
2.2-10	30-NOV-2018	<0.005	520
2.2-11	30-NOV-2018	<0.005	510
2.2-13	15-MAY-2019	<0.005	530
2.2-14	15-MAY-2019	0.039	1,400
2.2-15	07-AUG-2019	-	1,200
2.2-16	07-AUG-2019	-	810
2.2-17	07-AUG-2019	-	900
2.2-18	07-AUG-2019	-	2,400
2.2-19	07-AUG-2019	-	700
2.2-20	07-AUG-2019	-	1,200
2.2-21	07-AUG-2019	-	2,500

SAMPLE EXCEEDS MOST STRINGENT OF CCME AL AND RL/PL SQG (COARSE GRAINED SOIL), AND THE REFERENCE VALUE

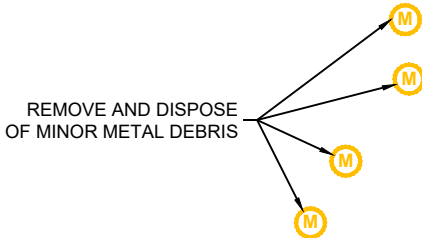
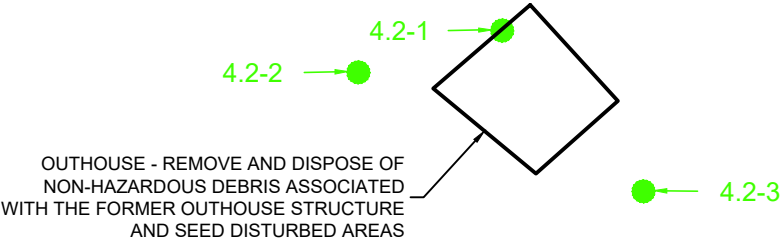
- APPROXIMATE VOLUME OF ASH AND NON-HAZARDOUS DEBRIS TO BE REMOVED AND DISPOSED OF OFF SITE. DEBRIS INCLUDES BUT IS NOT LIMITED TO ASH, BURNT WOOD, GLASS AND METAL = 0.5 m³

4.2	Goat Lake Backcountry Campground Outhouse	Not Sampled ¹	None	0	0	0.5	0	-Hand-pick minor non-hazardous debris (metal and glass) and broken food hang pole and removal off-site by helicopter.

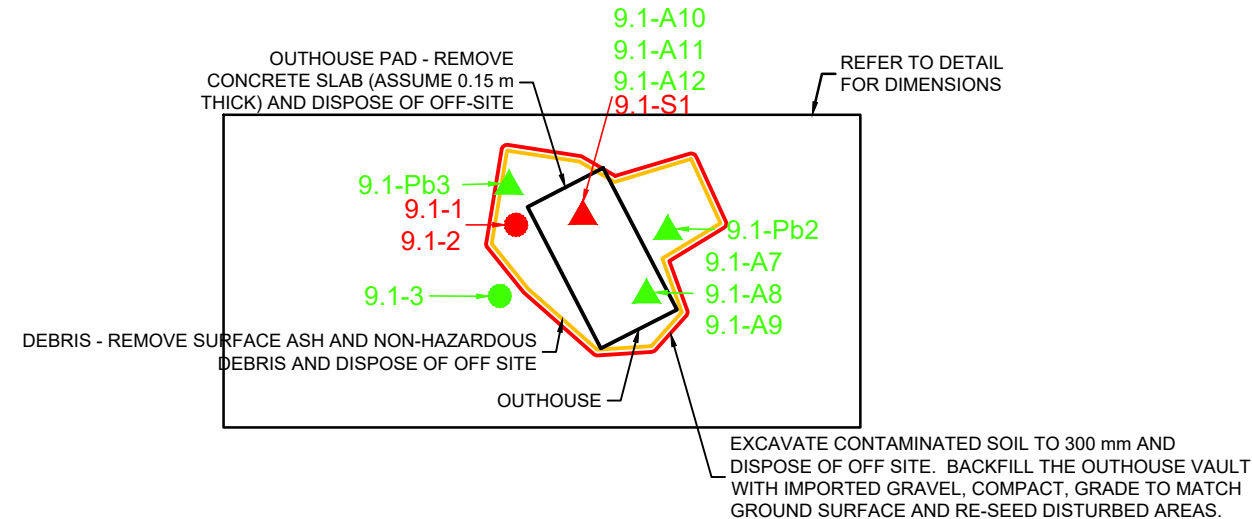
- APPROXIMATE VOLUME OF ASH AND NON-HAZARDOUS DEBRIS TO BE REMOVED AND DISPOSED OF OFF SITE. DEBRIS INCLUDES BUT IS NOT LIMITED TO ASH, A METAL STOVE, CONCRETE BLOCKS, METAL FRAMES OF TWO PICNIC TABLES, TWO UPRIGHT, BUT BURNT, TIMBER COLUMNS, BURNT WOODEN BEAMS, METAL, ONE METAL DOOR, CERAMIC TILES AND DRY WALL = 17 m³

- APPROXIMATE VOLUME OF IMPACTED SOIL TO BE REMOVED AND DISPOSED OF OFF SITE (EXCAVATION DEPTH OF 300 mm) = 4 m³
- APPROXIMATE VOLUME OF CONCRETE/FOUNDATION MATERIAL TO BE REMOVED AND DISPOSED OF OFF SITE = 7 m³
CONCRETE CONTAINS SILICA. CONTROL WORKER EXPOSURE TO SILICA DUST.

- APPROXIMATE VOLUME OF HAZARDOUS MATERIALS TO BE REMOVED AND DISPOSED OF OFF-SITE (INCLUDES BROWN PAINT IN POOR CONDITION ON THE PICNIC SHELTER BEAMS WHICH COVERS AN AREA OF APPROXIMATELY 1 m² IN TOTAL) = < 0.1 m³

- APPROXIMATE VOLUME OF CLEAN IMPORTED BACKFILL TO BE COMPACTED AND GRADED TO MATCH EXISTING GRADE = 5 m³

CONCRETE PAD - REMOVE CONCRETE SLAB AND DISPOSE OF OFF-SITE

NAPHTHALENE	PHENANTHRENE	CHROMIUM (III + VI)	TIN
		mg/kg	mg/kg	mg/kg	mg/kg
CCME SOILQG TIER 1 AL		0.013	0.046	64	5
CCME SOILQG TIER 1 RL/PL		0.013	0.046	64	50
REFERENCE VALUE		0.086	-	-	-
9.1-1	30-NOV-2018	0.038	0.052	65	2.5
9.1-2	30-NOV-2018	0.13	0.042	40	6.5

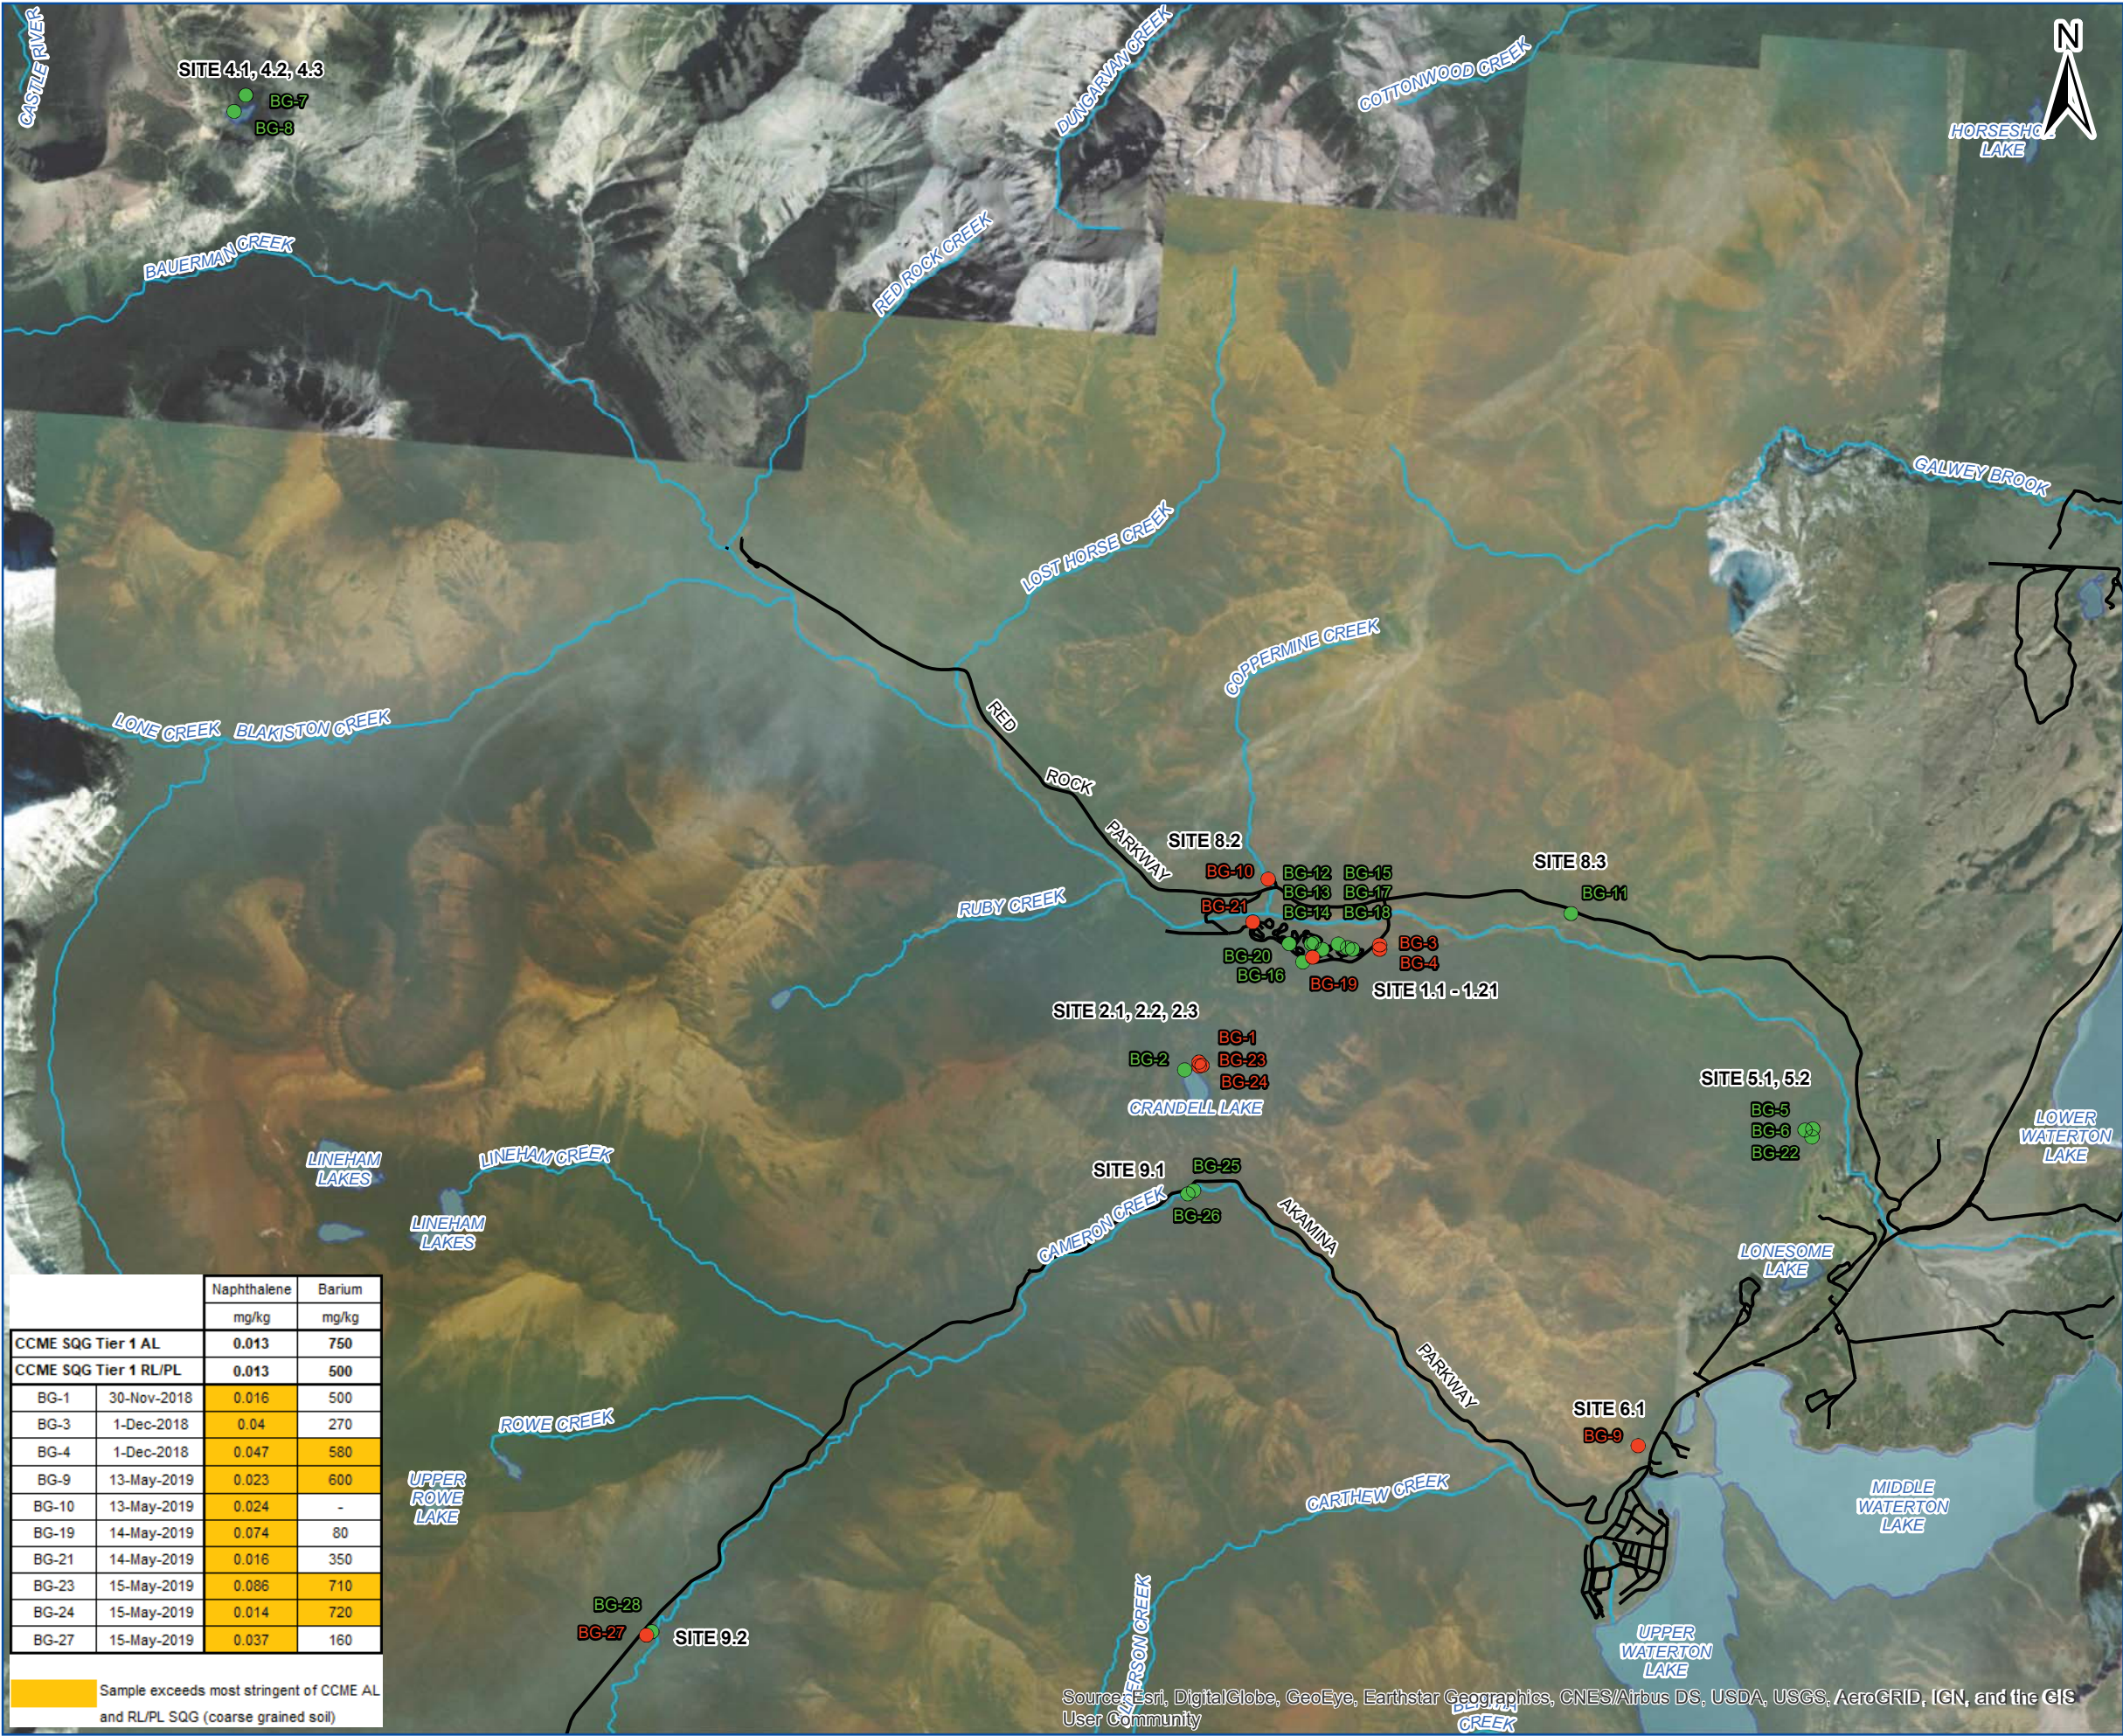
Naphthalene	Barium
		mg/kg	mg/kg
CCME SQG Tier 1 AL		0.013	750
CCME SQG Tier 1 RL/PL		0.013	500
BG-1	30-Nov-2018	0.016	500
BG-3	1-Dec-2018	0.04	270
BG-4	1-Dec-2018	0.047	580
BG-9	13-May-2019	0.023	600
BG-10	13-May-2019	0.024	-
BG-19	14-May-2019	0.074	80
BG-21	14-May-2019	0.016	350
BG-23	15-May-2019	0.086	710
BG-24	15-May-2019	0.014	720
BG-27	15-May-2019	0.037	160

Sample exceeds most stringent of CCME AL and RL/PL SQG (coarse grained soil)

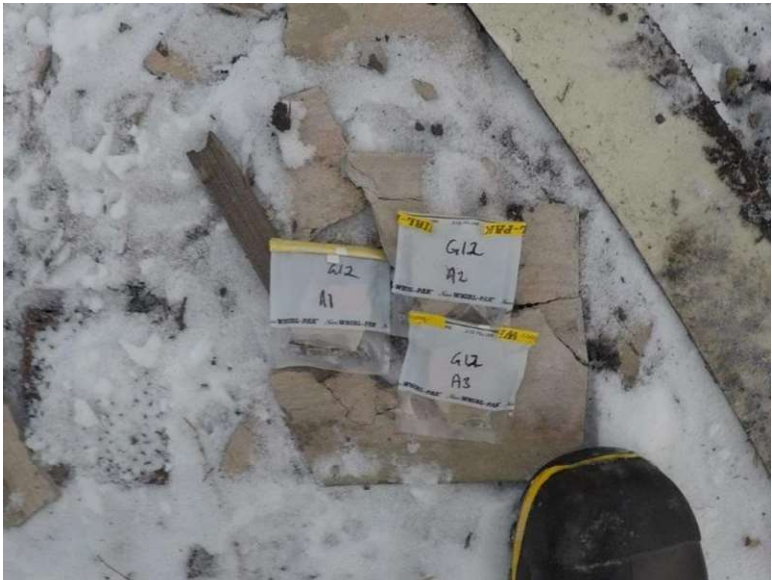
Photograph 1.1-2: Site 1.1 Crandell Campground Generator House Asbestos Samples A1-A3, None Detected.

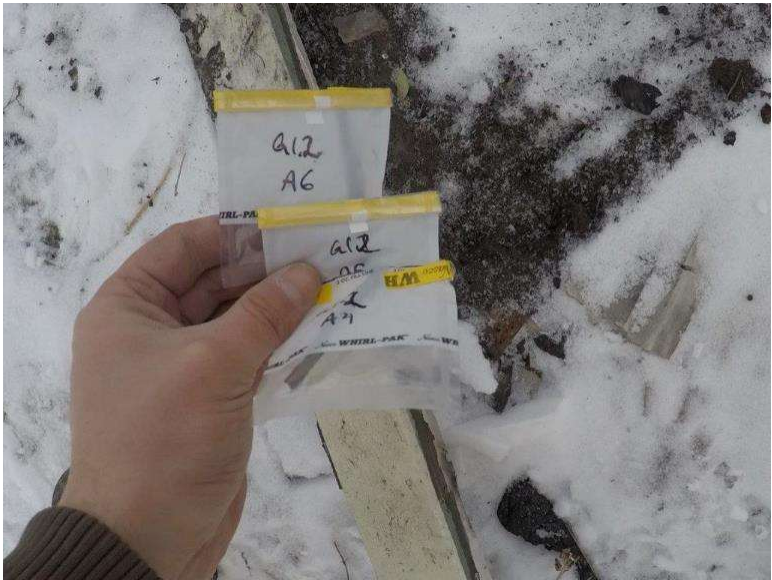
Photograph 1.1-3: Site 1.1 Crandell Campground Generator House Asbestos Samples A4-A6, None Detected.

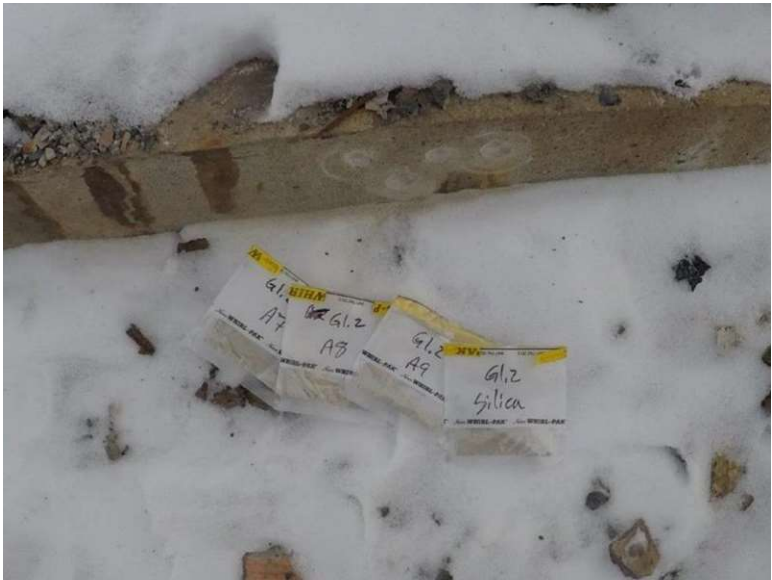
Photograph 1.1-4: Site 1.1 Crandell Campground Generator House Asbestos Samples A7-A9, None Detected.
Silica Sample S1, 52.07% SiO₂.

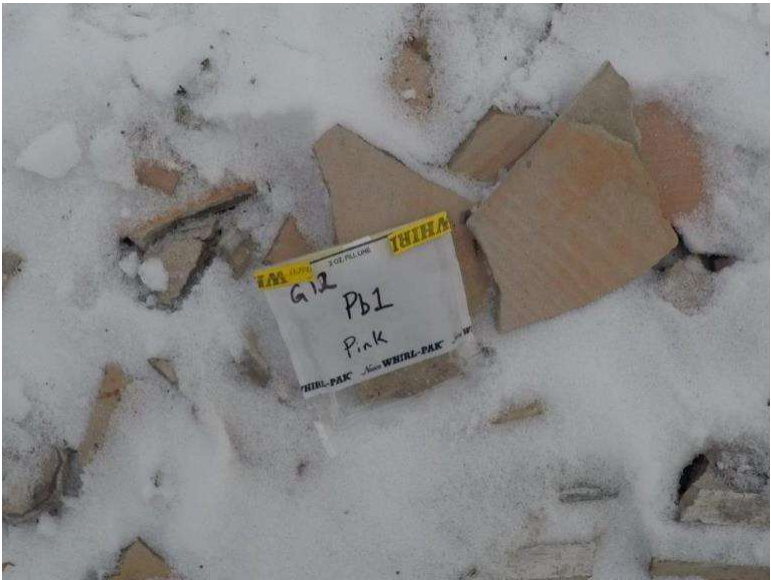
Photograph 1.1-5: Site 1.1 Crandell Campground Generator House Lead Sample Pb1, 11mg/kg.

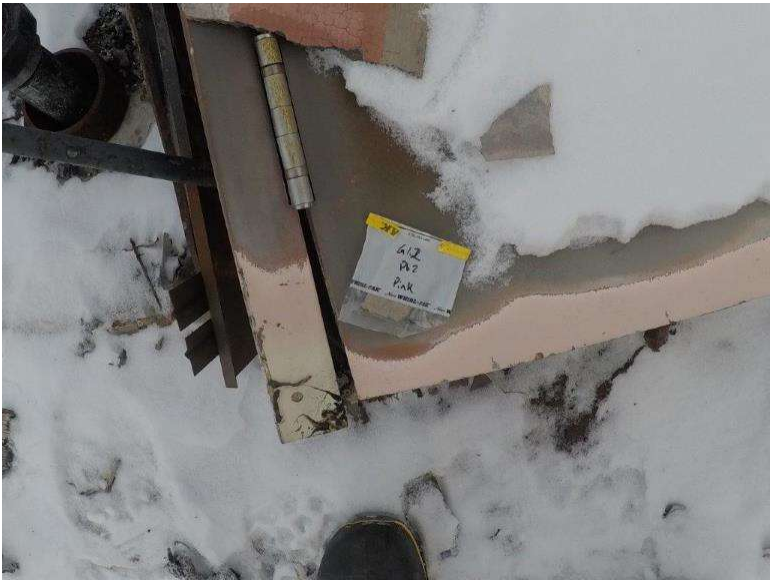
Photograph 1.1-6: Site 1.1 Crandell Campground Generator House Lead Sample Pb2, 300mg/kg.

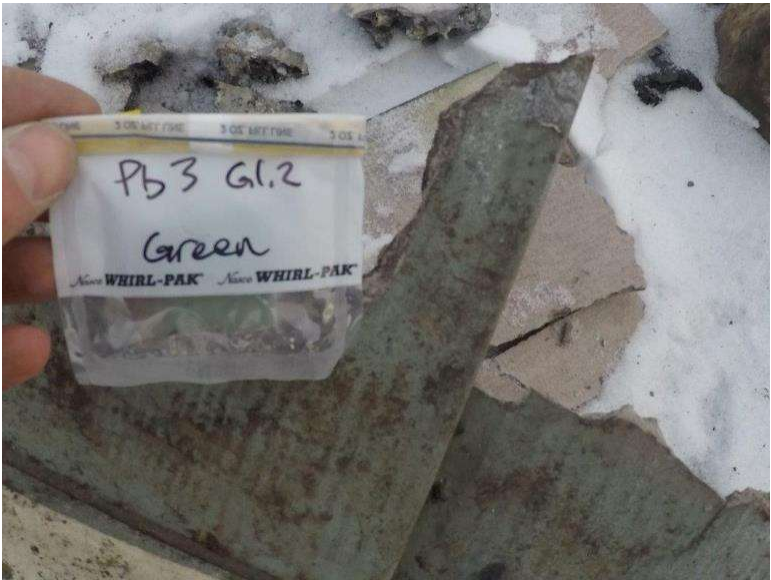
Photograph 1.1-7: Site 1.1 Crandell Campground Generator House Lead Sample Pb3, 14mg/kg.

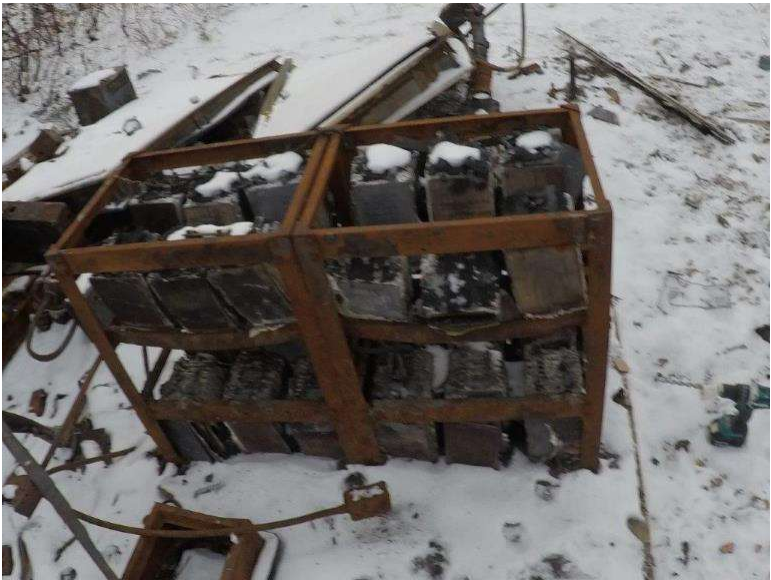
Photograph 1.1-8: Site 1.1 Crandell Campground Generator House, Example of Melted Battery Bank.

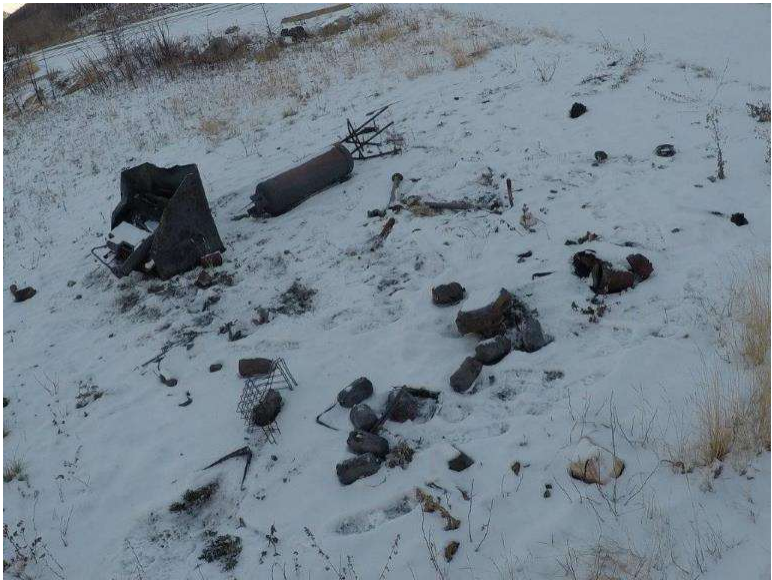
Photograph 1.2.-1: Site 1.2 Crandell Campground Wood Storage Shed, Heater and Propane Cylinders.

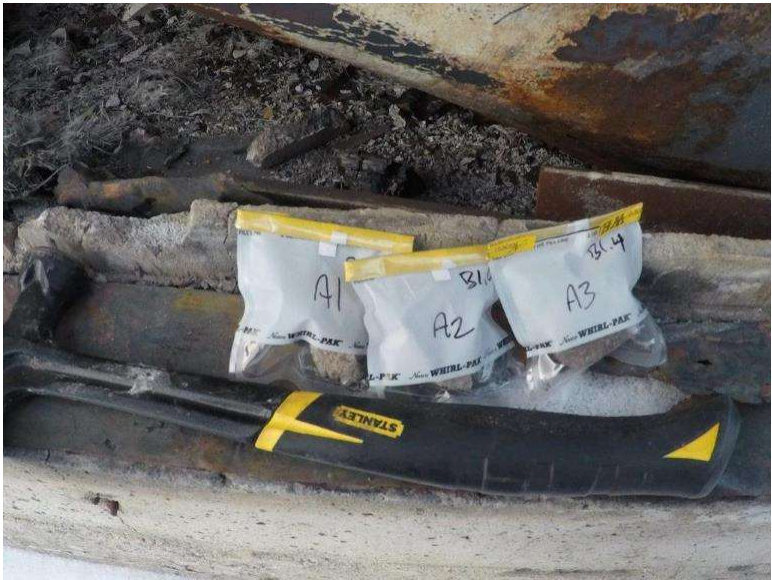
Photograph 1.3-2: Site 1.3 Crandell Campground Washroom 1 Asbestos Samples 1.4-A1 to 1.4-A3, None Detected.

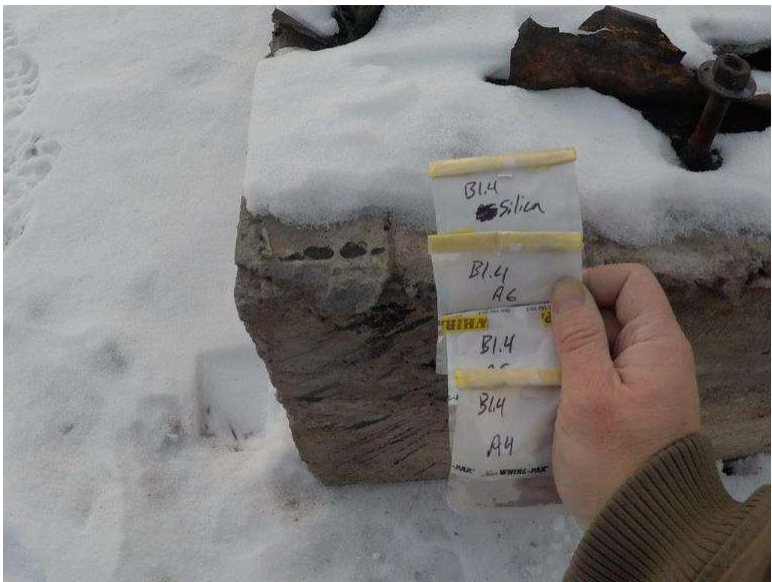
Photograph 1.3-3: Site 1.3 Crandell Campground Washroom 1 Asbestos Samples 1.4-A4 to 1.4-A6, None Detected. Silica Sample 1.4-S1, 50.14% SiO₂.

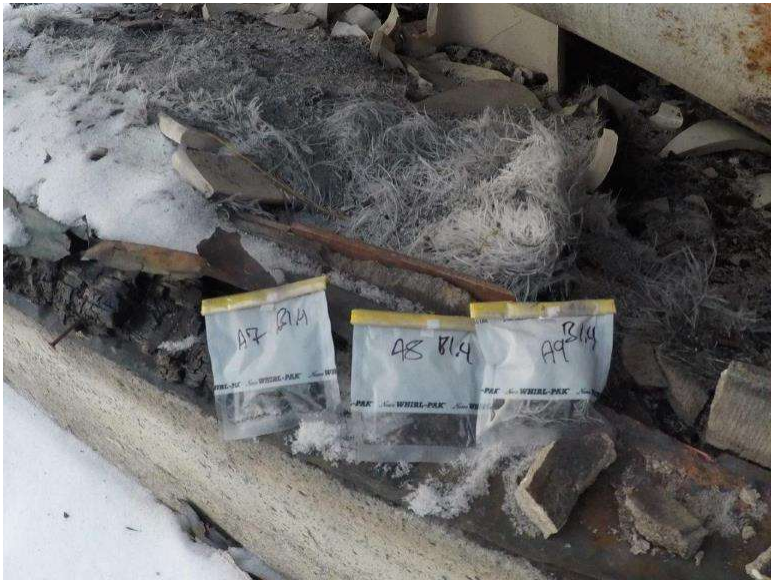
Photograph 1.3-4: Site 1.3 Crandell Campground Washroom 1 Asbestos Samples 1.4-A7 to 1.4-A9, None Detected.

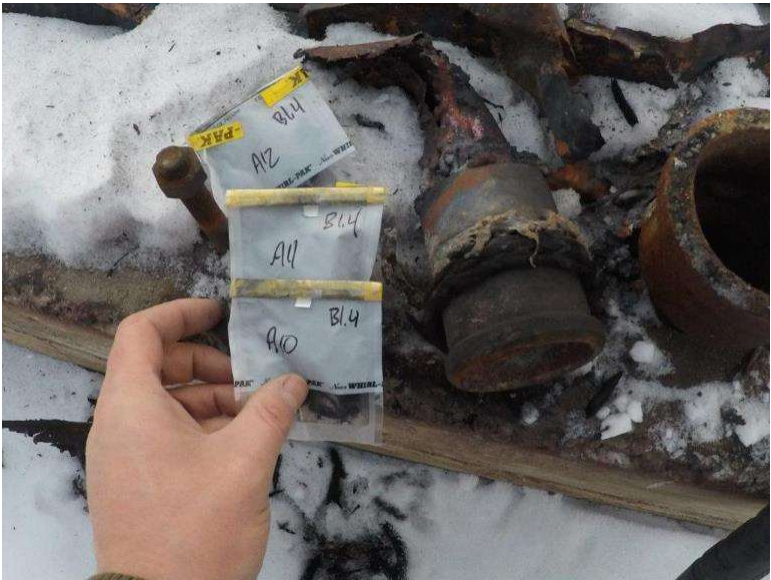
Photograph 1.3-5: Site 1.3 Crandell Campground Washroom 1 Asbestos Samples 1.4-A10 to 1.4-A12, None Detected.

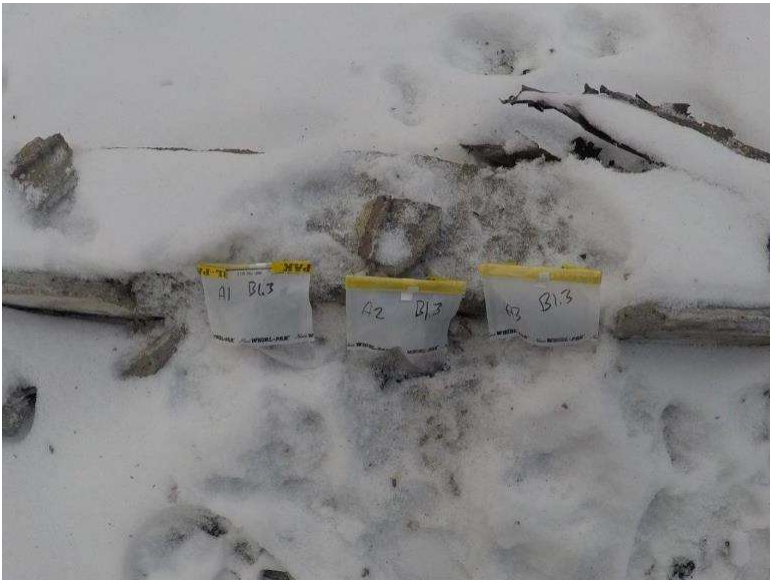
Photograph 1.4-2: Site 1.4 Crandell Campground Washroom 2 Asbestos Samples 1.3-A1 to 1.3-A3, None Detected.

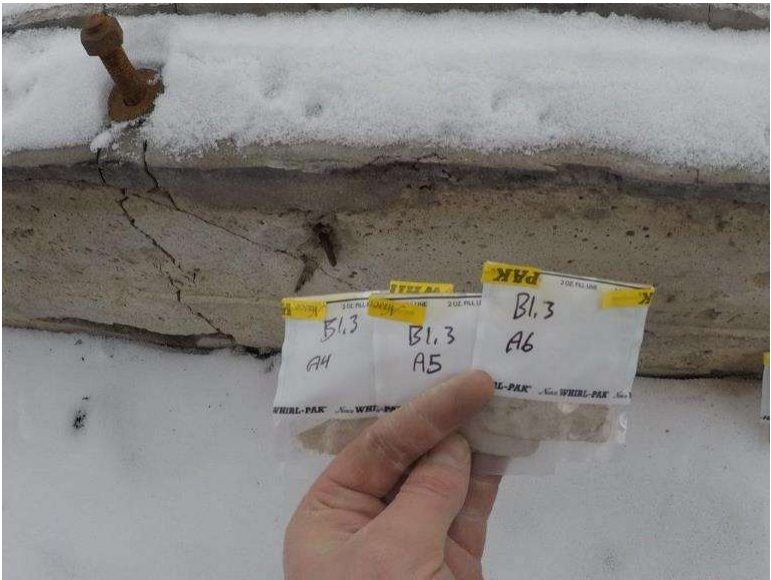
Photograph 1.4-3: Site 1.4 Crandell Campground Washroom 2 Asbestos Samples 1.3-A4 to 1.3-A6, None Detected.

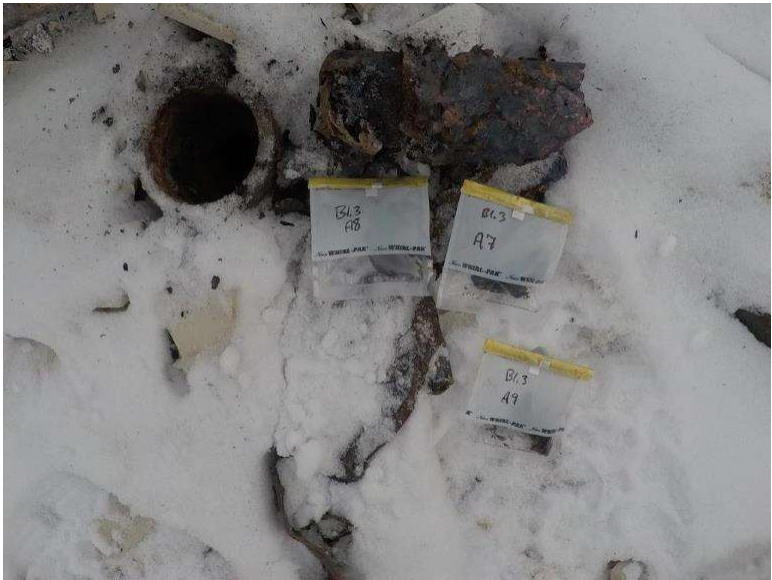
Photograph 1.3-4: Site 1.3 Crandell Campground Washroom 2 Asbestos Samples 1.3-A7 to 1.3-A9, None Detected.

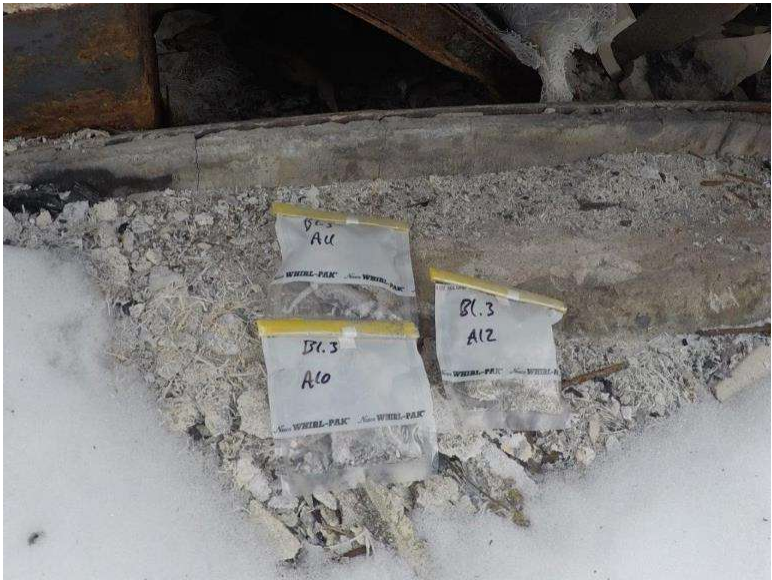
Photograph 1.4-4: Site 1.4 Crandell Campground Washroom 2 Asbestos Samples 1.3-A10 to 1.3-A12, None Detected.

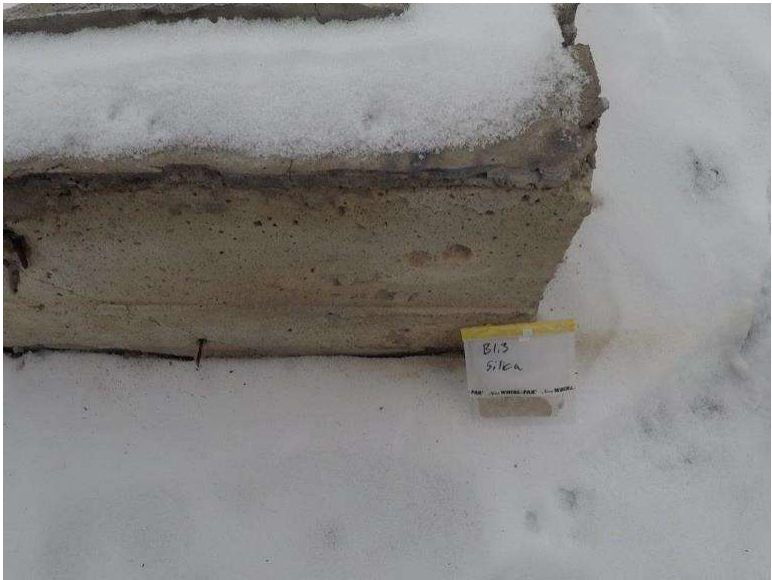
Photograph 1.4-5: Site 1.4 Crandell Campground Washroom 2 Silica Sample 1.3-S1, 48.70% SiO₂.

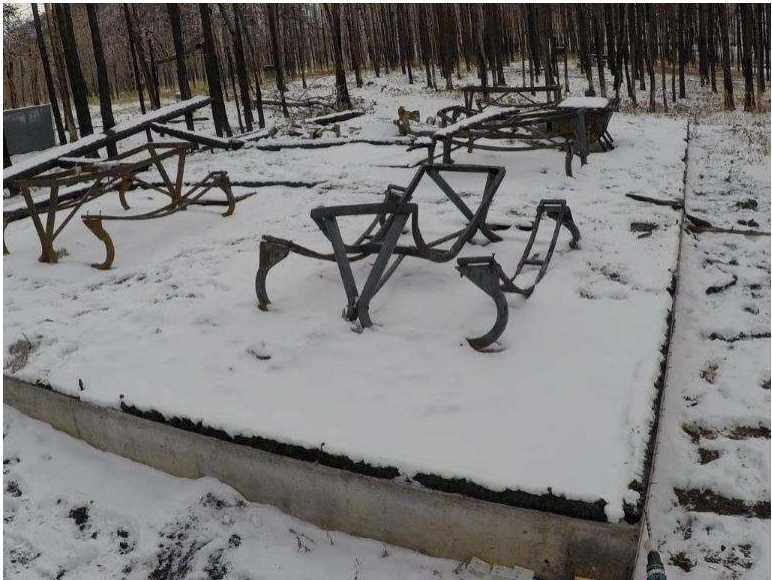
Photograph 1.5-5: Site 1.5 Crandell Campground Kitchen Shelter 1 Lead Sample Pb1, <10mg/kg, and Pb2, 60mg/kg..

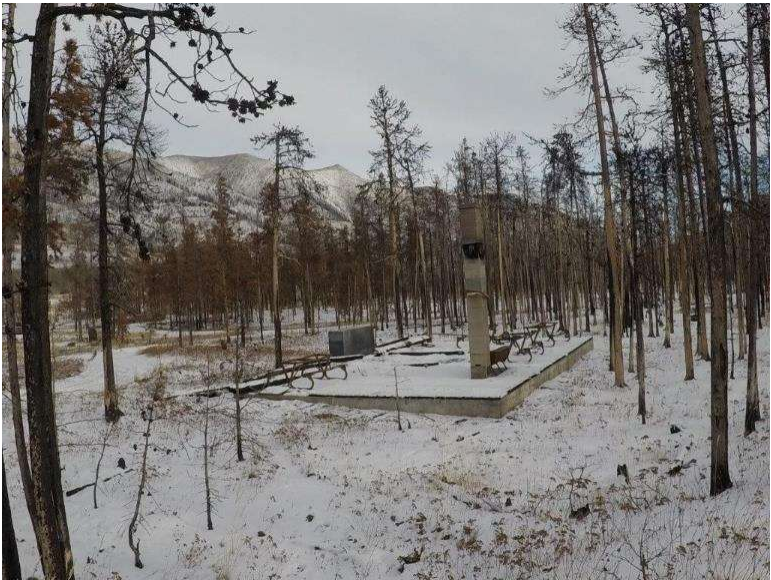
Photograph 1.6-7: Site 1.6 Crandell Campground Kitchen Shelter 2 Lead Sample Pb1, 10mg/kg. PCB sample PCB1, <0.2mg/kg.

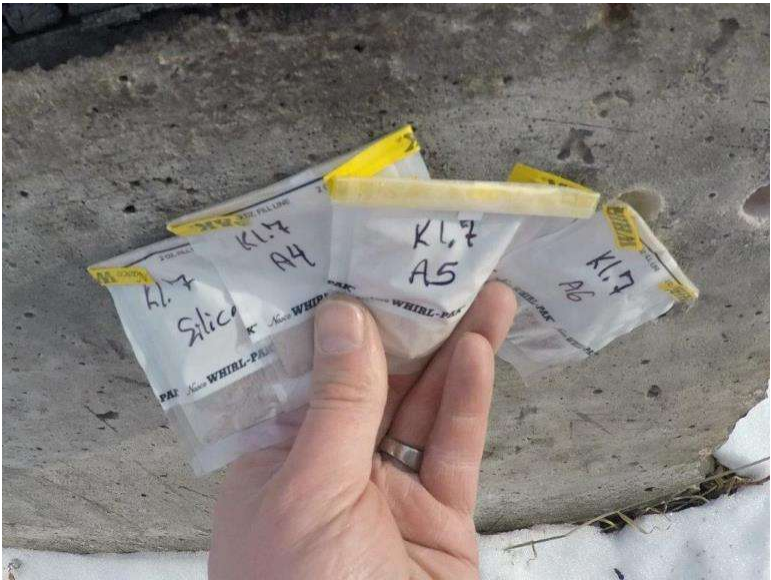
Photograph 1.7-2: Site 1.7 Crandell Campground Kitchen Shelter 3 Asbestos Samples A1-A3, None Detected.

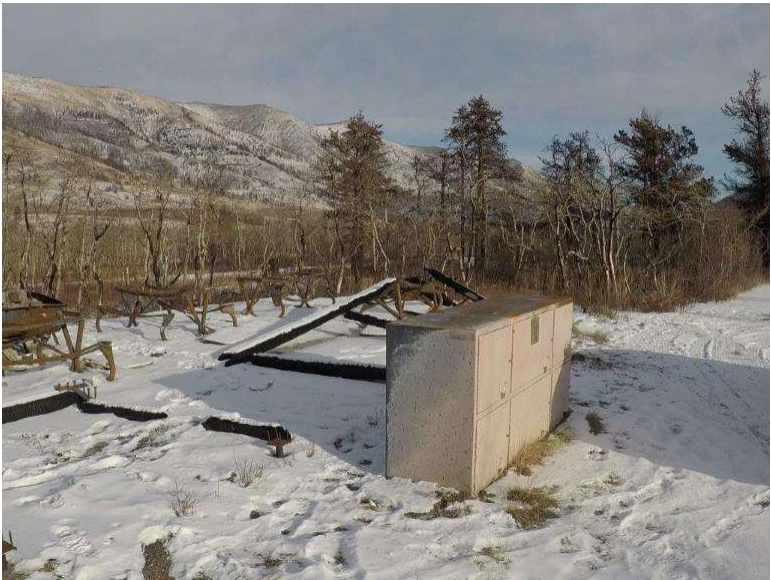
Photograph 1.7-5: Site 1.7 Crandell Campground Kitchen Shelter 3 Lead Sample Pb1, 76mg/kg. PCB Sample PCB1, <0.02mg/kg.

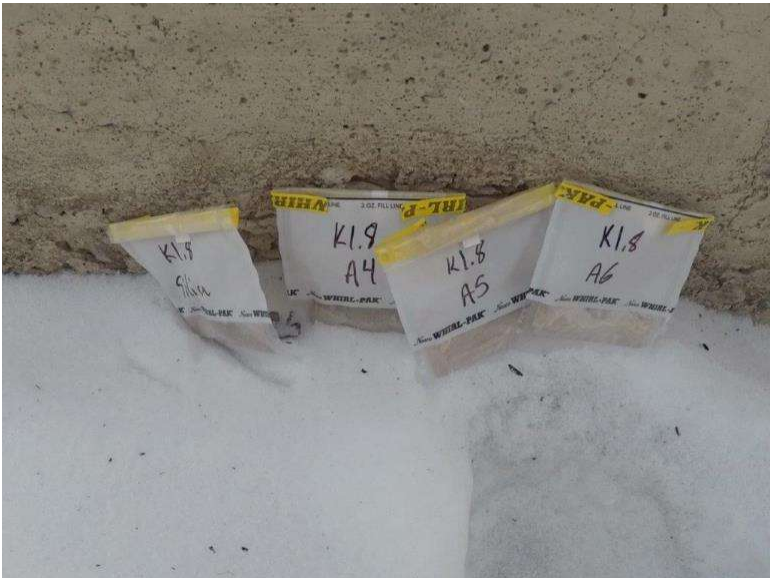
Photograph 1.8-2: Site 1.8 Crandell Campground Kitchen Shelter 4 Asbestos Samples A1-A3, None Detected.

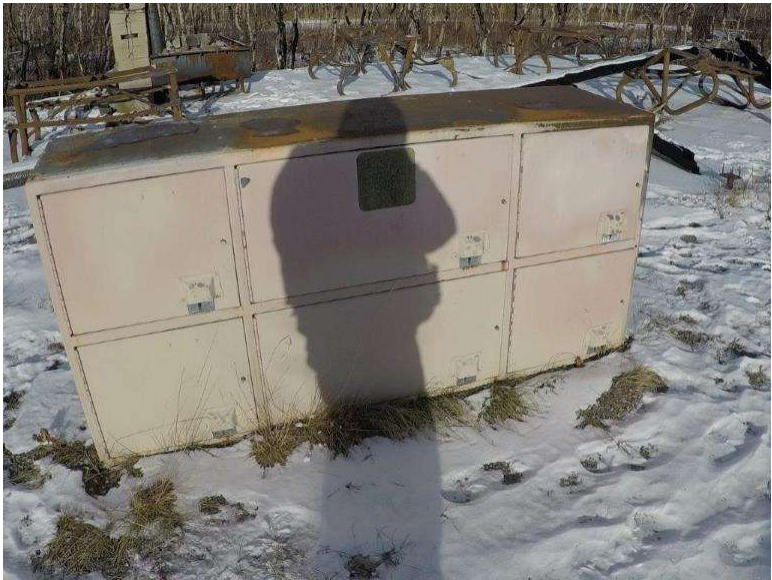
Photograph 1.8-6: Site 1.8 Crandell Campground Kitchen Shelter 4 Lead Sample Pb2, 56mg/kg. PCB Sample PCB1, <0.02mg/kg.

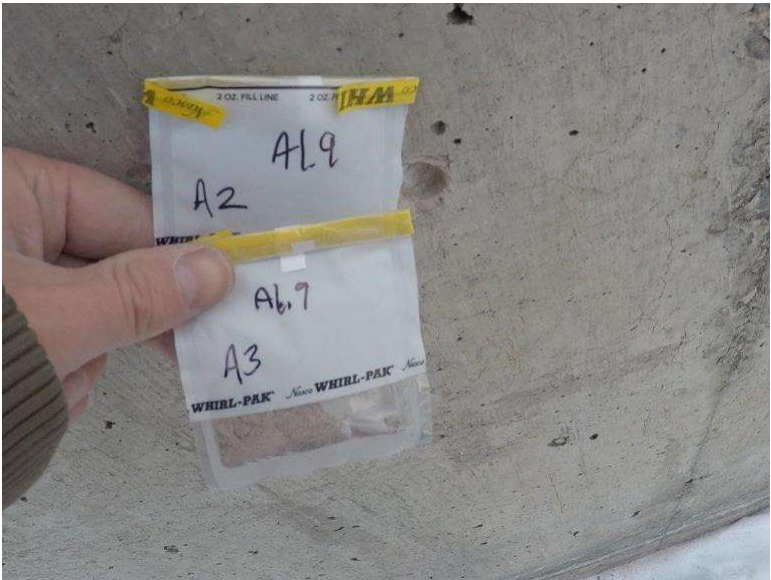
Photograph 1.9-2: Site 1.9 Crandell Campground Interpretive Theatre Asbestos Sample A1, None Detected.

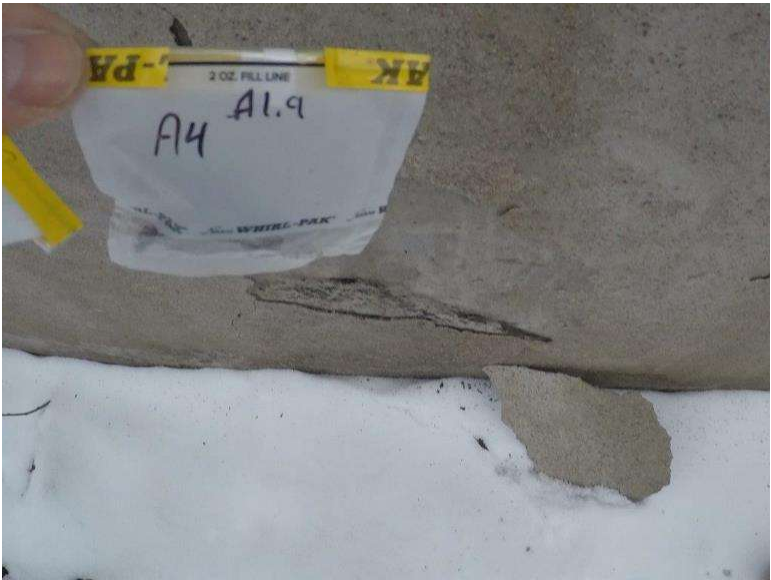
Photograph 1.9-3: Site 1.9 Crandell Campground Interpretive Theatre Asbestos Samples A2-A3, None Detected.

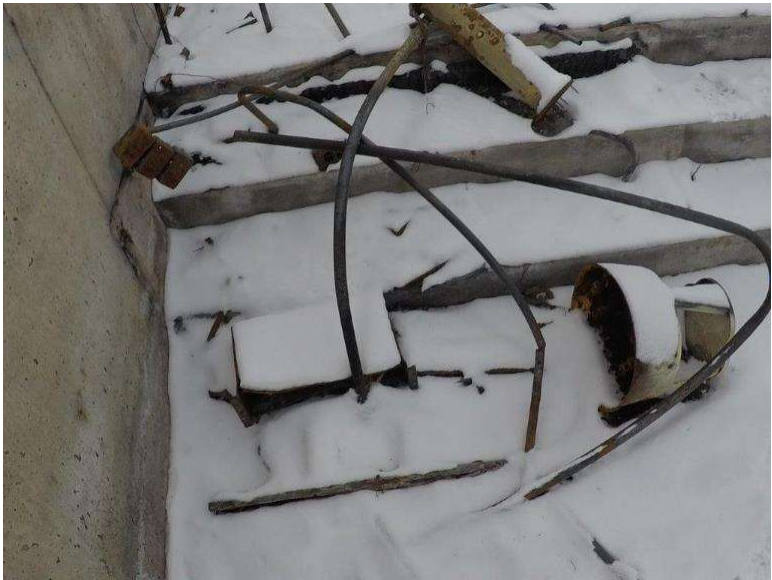
Photograph 1.9-10: - Site 1.9 Crandell Campground Interpretive Theatre Silica Sample S1 49.72% SiO₂.

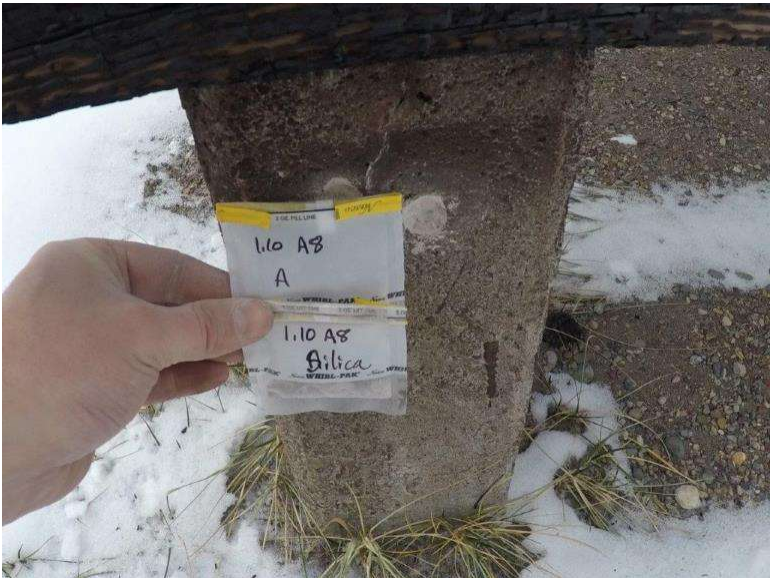
Photograph 1.10-6: Site 1.10 Crandell Campground 129 Campsites (Loop A Campsite 8) Asbestos Sample A1, None Detected.
Silica Sample S1 45.85% SiO₂.

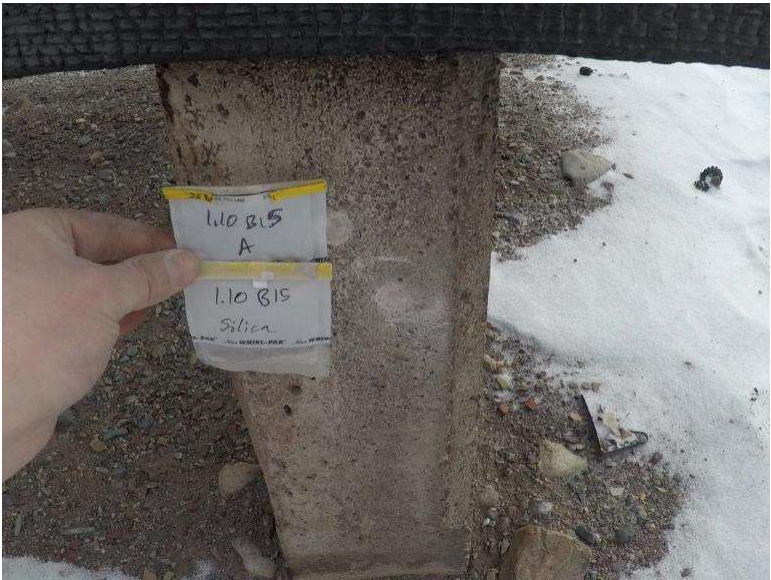
Photograph 1.10-7: Site 1.10 Crandell Campground 129 Campsites (Loop B Campsite 13) Asbestos Sample A2, None Detected.
Silica Sample S2 49.94% SiO₂.

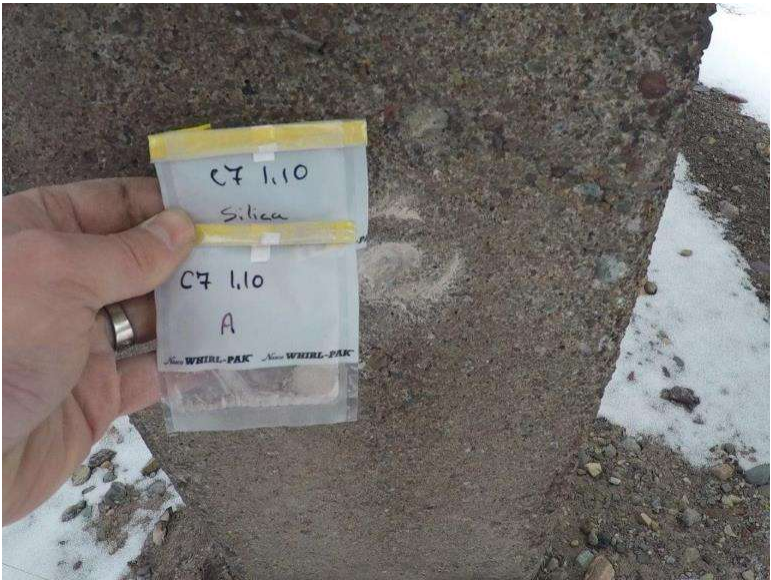
Photograph 1.10-8: Site 1.10 Crandell Campground 129 Campsites (Loop C Campsite 7) Asbestos Sample A3, None Detected.
Silica Sample S3 49.52% SiO₂.

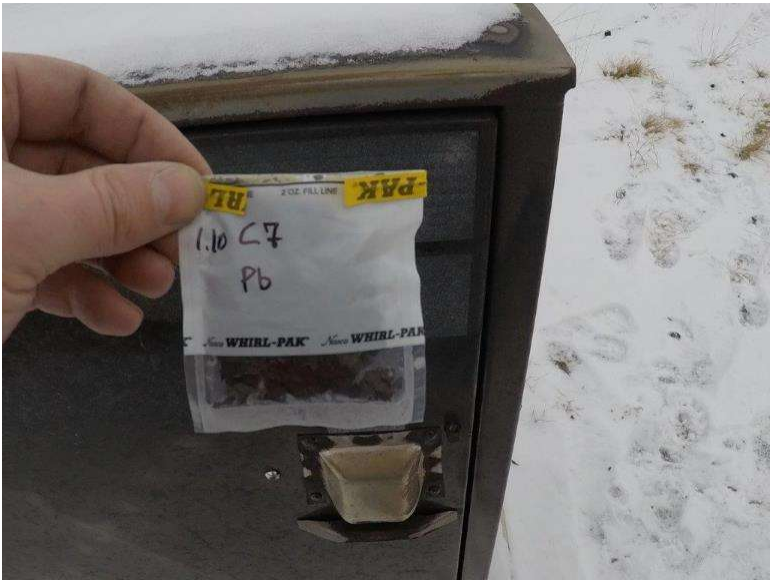
Photograph 1.10-9: Site 1.10 Crandell Campground 129 Campsites (Loop C Campsite 7) Lead Sample Pb1, <10mg/kg.

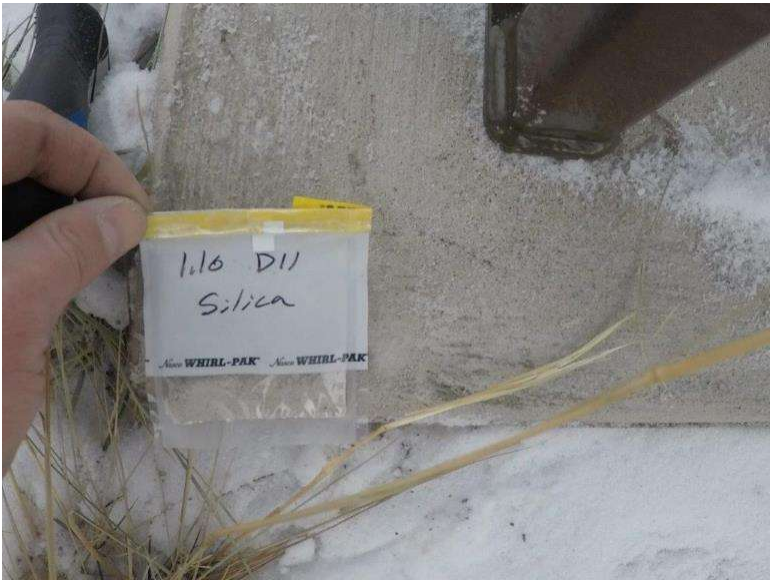
Photograph 1.10-12: Site 1.10 Crandell Campground 129 Campsites (Loop D Campsite 11) Silica Sample S4, 52.26% SiO₂.
