SPECIFICATIONS
for

Waterton Remediation and Abatement – 11 Sites

Waterton Lakes National Park, Alberta

Project No. _____ February 2020

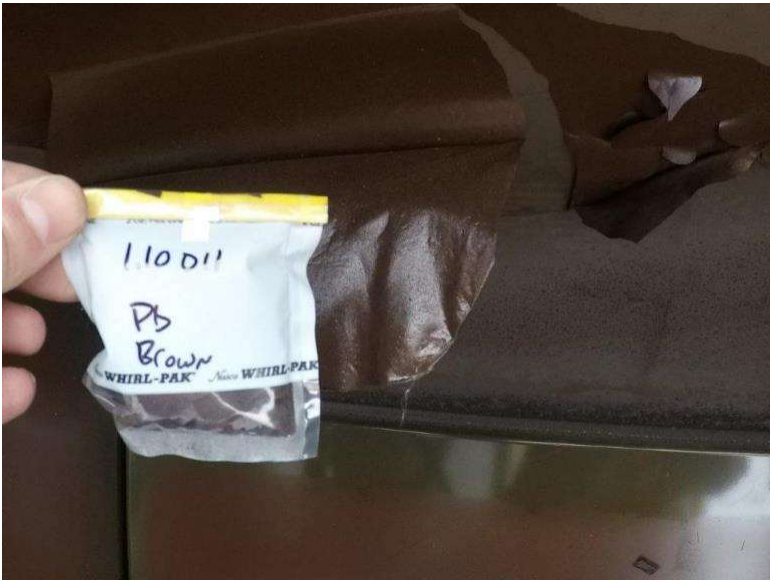
Photograph 1.10-13: Site 1.10 Crandell Campground 129 Campsites (Loop D Campsite 11) Lead Sample Pb2, <10mg/kg.

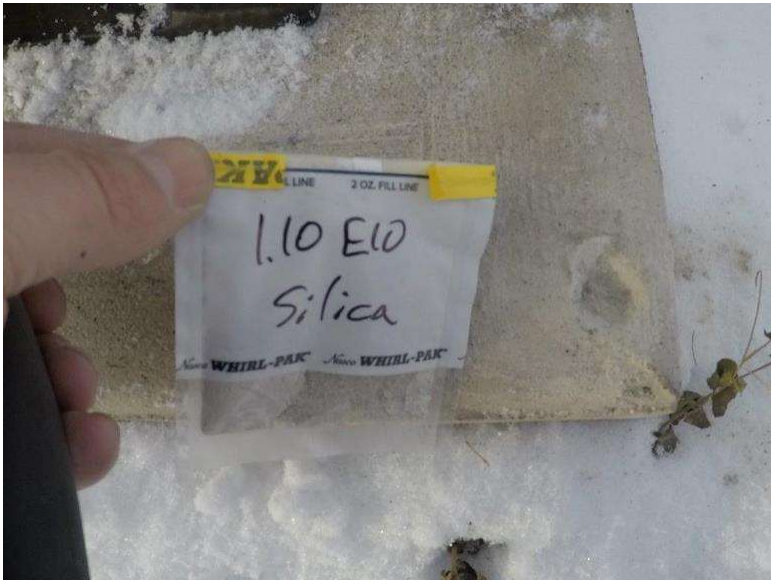
Photograph 1.10-15: Site 1.10 Crandell Campground 129 Campsites (Loop E Campsite 10) Silica Sample S5, 55.93% SiO₂.

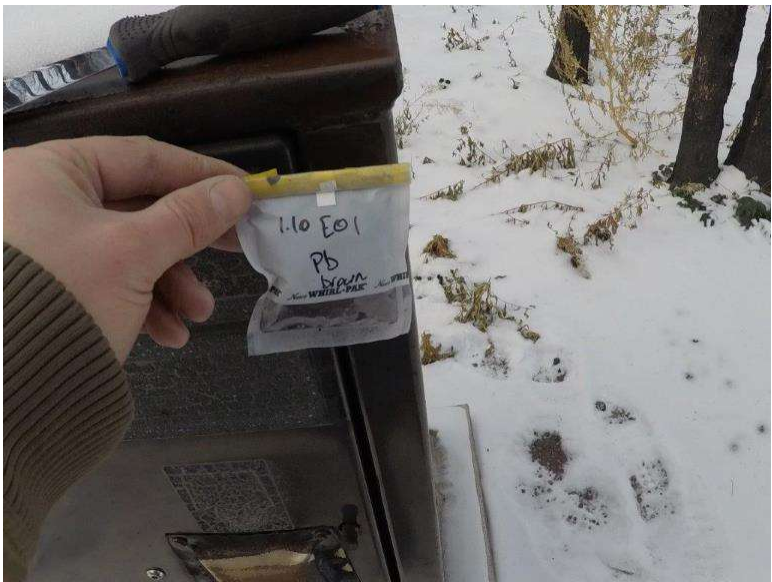
Photograph 1.10-16: Site 1.10 Crandell Campground 129 Campsites (Loop E Campsite 1) Lead Sample Pb3, <10mg/kg.

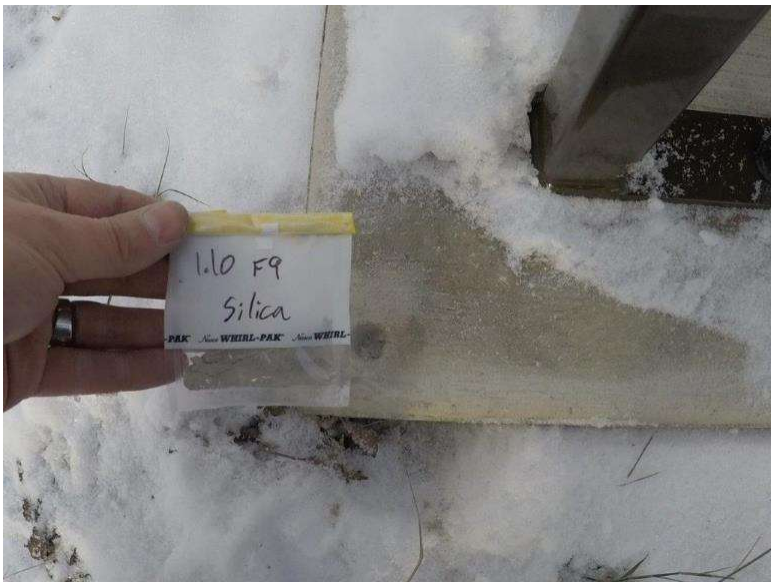
Photograph 1.10-18: Site 1.10 Crandell Campground 129 Campsites (Loop F Campsite 9) Silica Sample S6, 55.06% SiO₂.

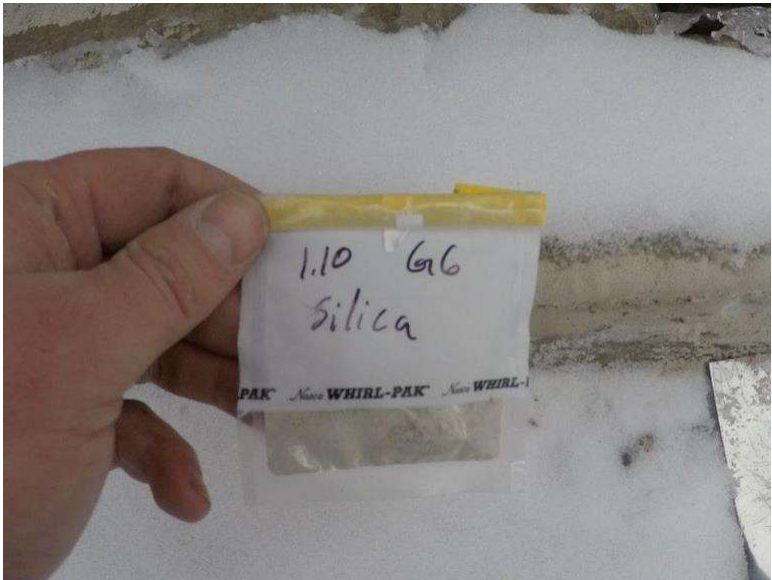
Photograph 1.10-20: Site 1.10 Crandell Campground 129 Campsites (Loop G Campsite 6) Silica Sample S7, 55.60% SiO₂.

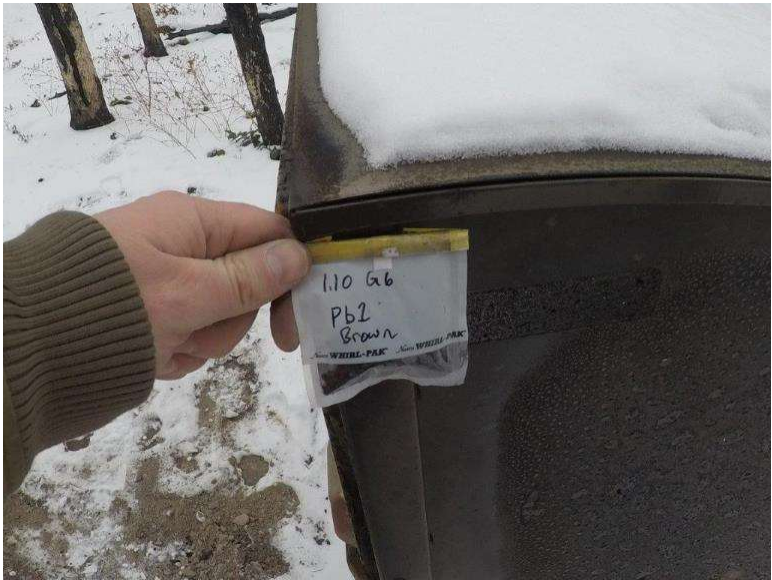
Photograph 1.10-21: Site 1.10 Crandell Campground 129 Campsites (Loop G Campsite 6) Lead Sample Pb4, 510mg/kg.

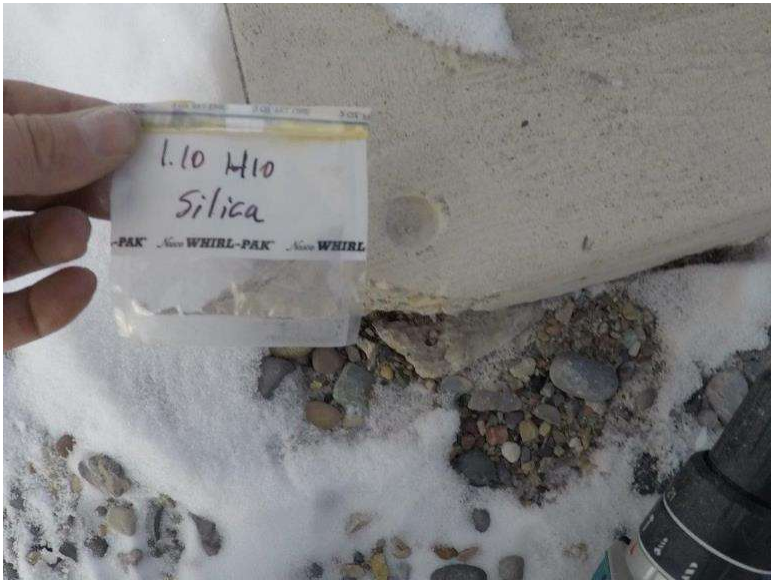
Photograph 1.10-23: Site 1.10 Crandell Campground 129 Campsites (Loop H Campsite 10) Silica Sample S8, 55.66% SiO₂.

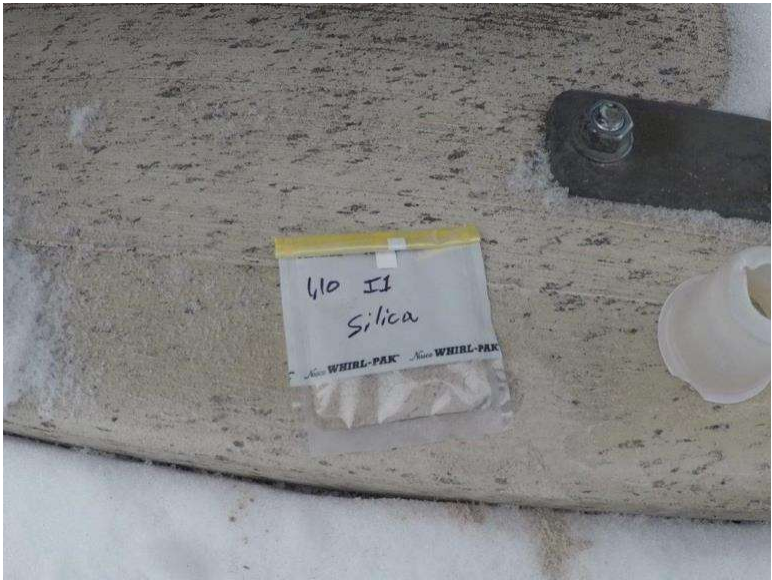
Photograph 1.10-29: Site 1.10 Crandell Campground 129 Campsites (Loop I Campsite 1) Silica Sample S9, 58.21% SiO₂.

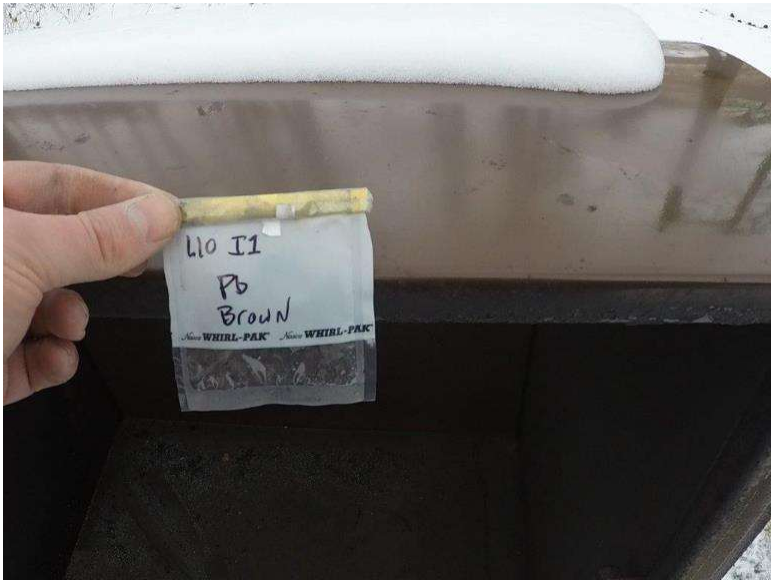
Photograph 1.10-30: Site 1.10 Crandell Campground 129 Campsites (Loop I Campsite 1) Lead Sample Pb5, <10mg/kg.

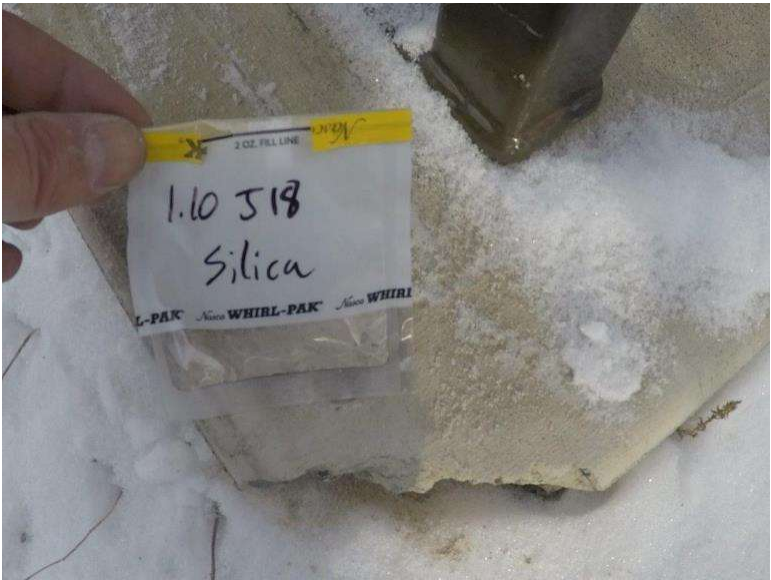
Photograph 1.10-31: Site 1.10 Crandell Campground 129 Campsites (Loop J Campsite 18) Silica Sample S10, 57.78% SiO₂.

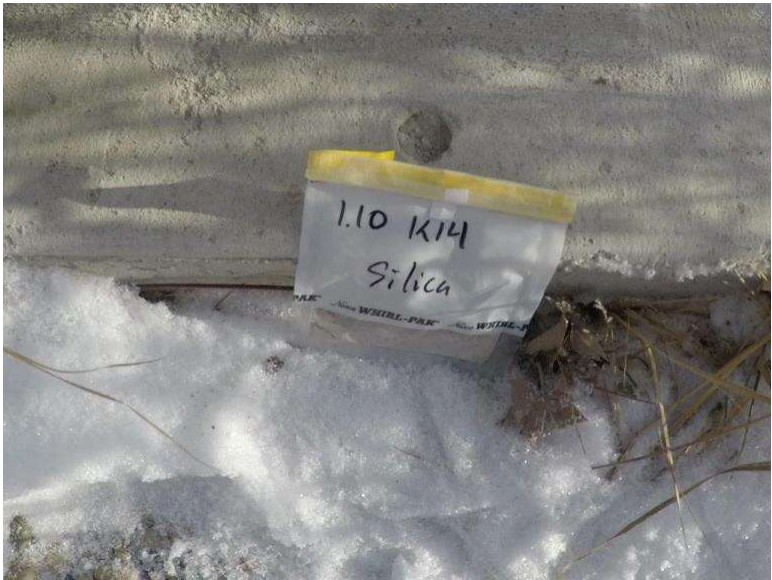
Photograph 1.10-35: Site 1.10 Crandell Campground 129 Campsites (Loop K Campsite 14) Silica Sample S11, 57.01% SiO₂.

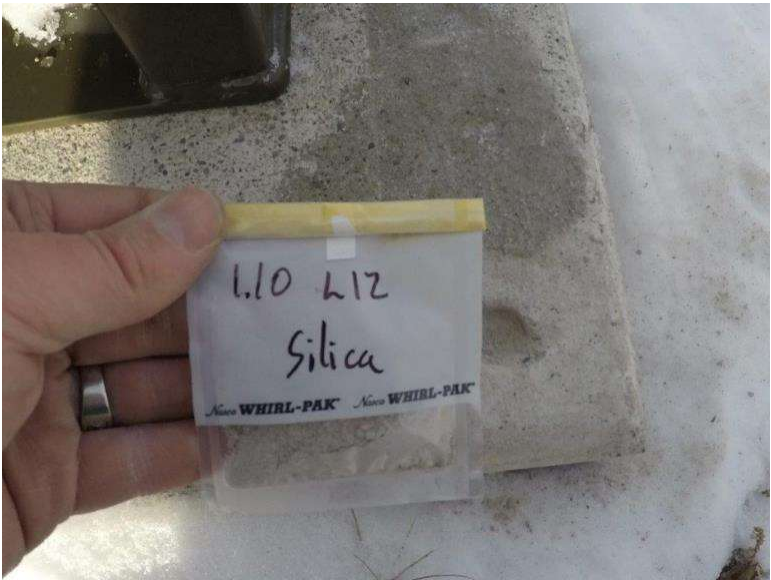
Photograph 1.10-38: Site 1.10 Crandell Campground 129 Campsites (Loop L Campsite 12) Silica Sample S12, 57.01% SiO₂.

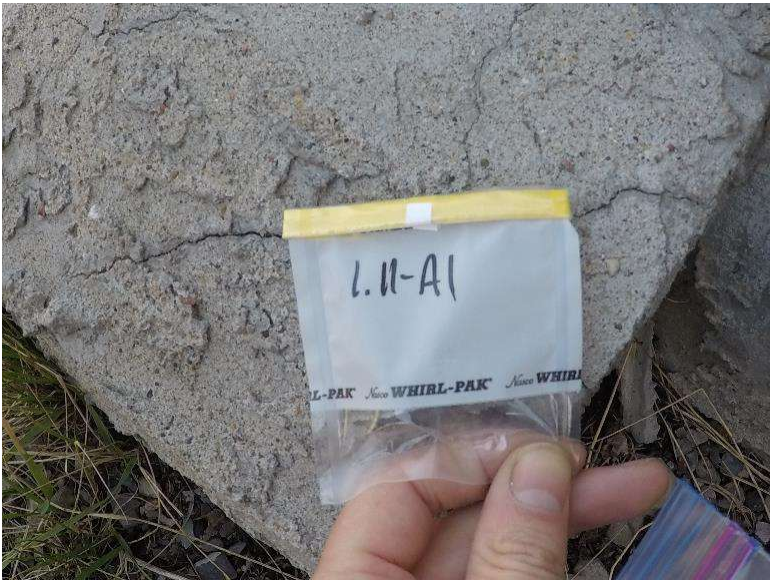
Photograph 1.11-2: Site 1.11 Entrance Kiosk Asbestos Sample A1, None Detected.

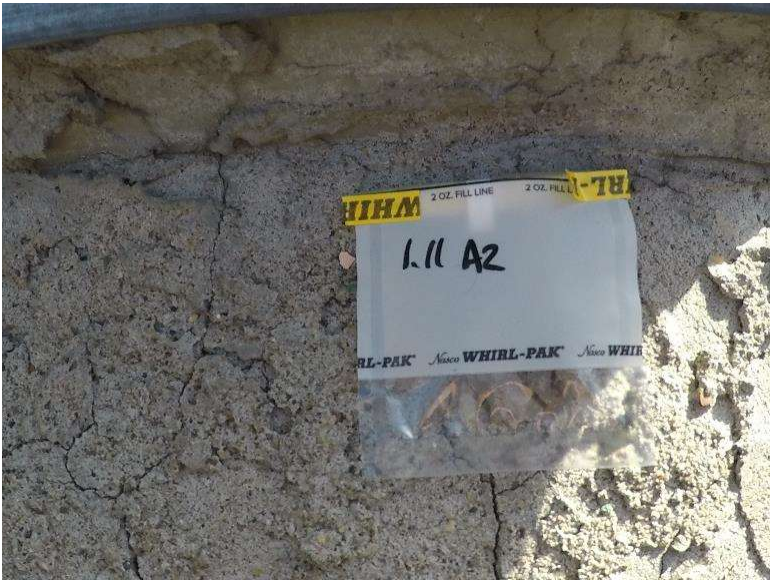
Photograph 1.11-3: Site 1.11 Entrance Kiosk Asbestos Sample A2, None Detected.

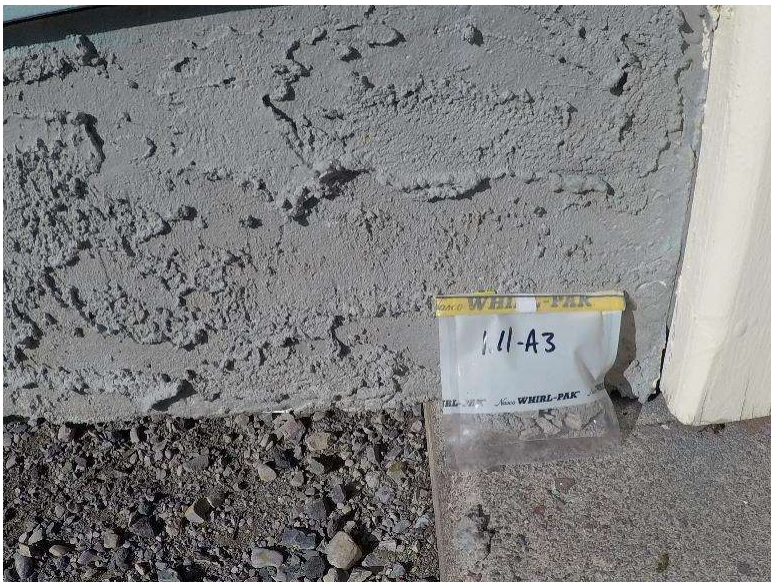
Photograph 1.11-4: Site 1.11 Entrance Kiosk Asbestos Sample A3, None Detected.

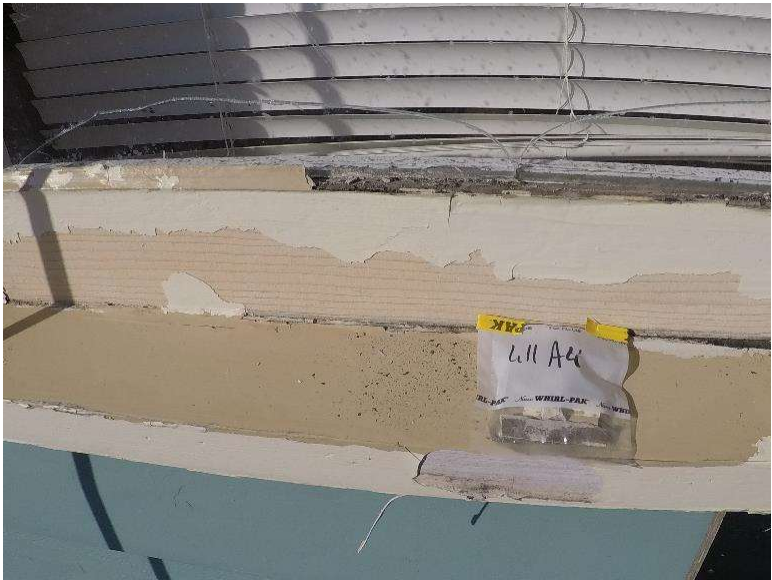
Photograph 1.11-5: Site 1.11 Entrance Kiosk Asbestos Sample A4, None Detected.

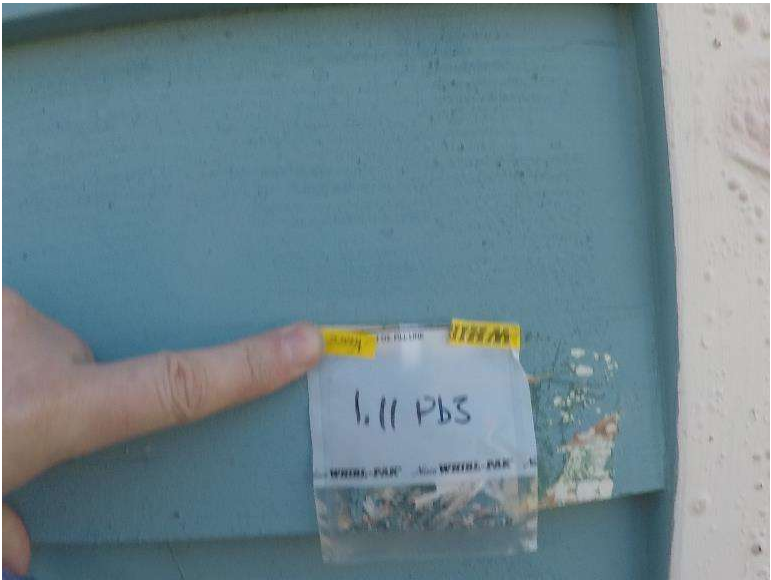
Photograph 1.11-9: Site 1.11 Entrance Kiosk Lead Sample Pb2, 4,7010mg/kg.

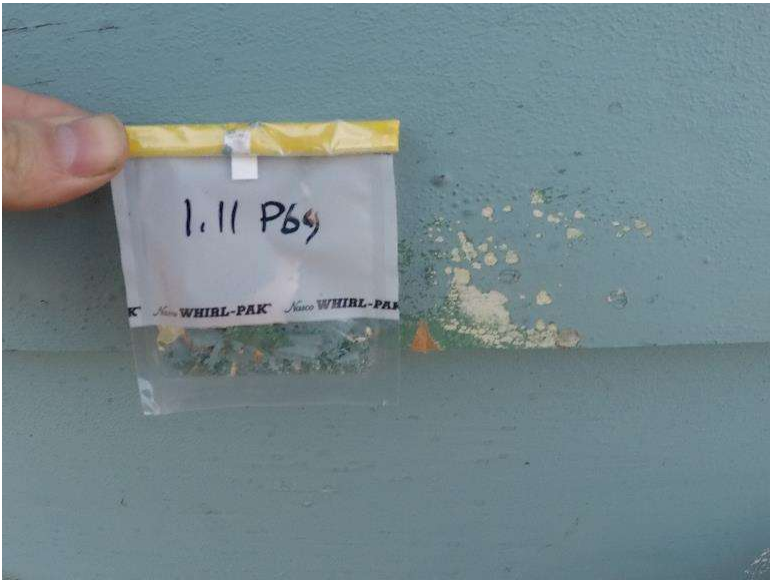
Photograph 1.11-10: Site 1.11 Entrance Kiosk Lead Sample Pb3, <20mg/kg.

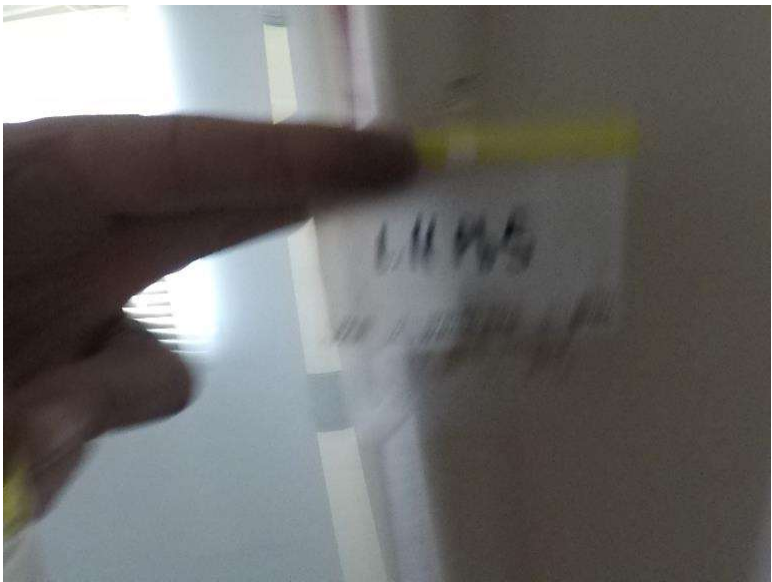
Photograph 1.11-11: Site 1.11 Entrance Kiosk Lead Sample Pb4, <20mg/kg.

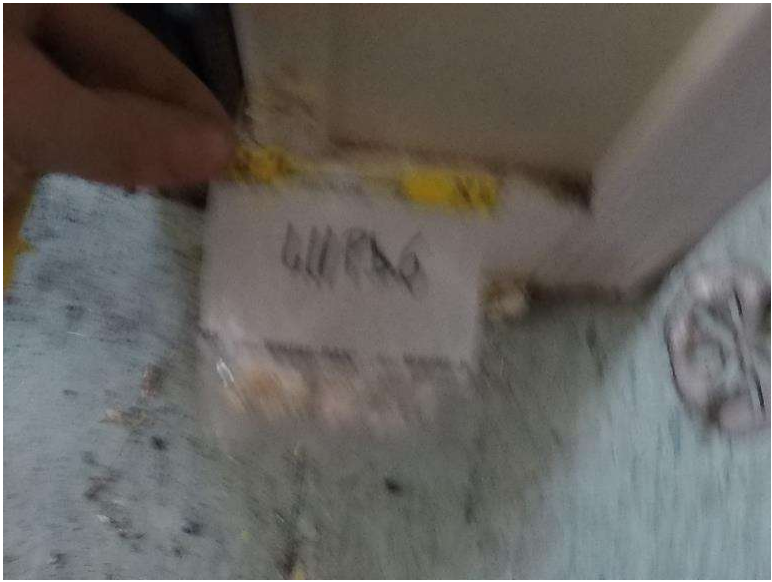
Photograph 1.11-12: Site 1.11 Entrance Kiosk Lead Sample Pb5, <20mg/kg.

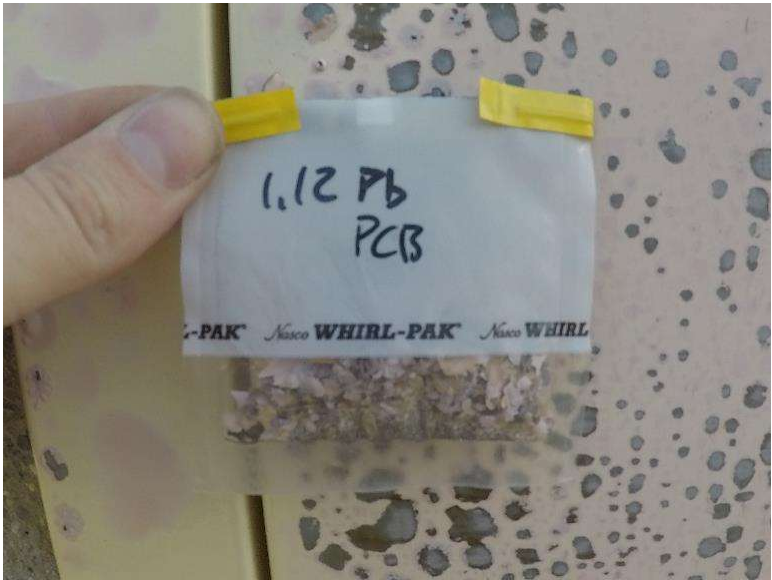
Photograph 1.12-4: Site 1.18 Solar Building # 1 Lead Sample Pb1, <13mg/kg.

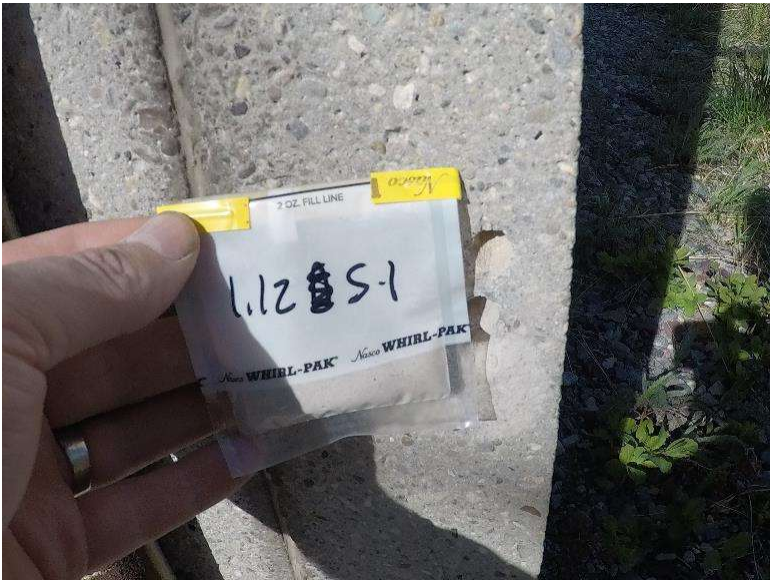
Photograph 1.12-5: Site 1.12 Solar Building # 1 PCB Sample PCB1, <0.02mg/kg.

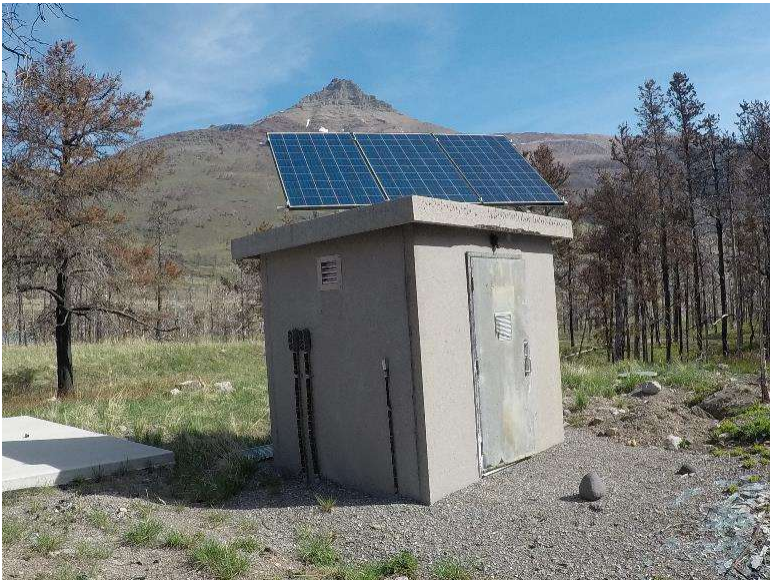
Photograph 1.12-6: Site 1.12 Solar Building # 1 Silica Sample S1, 58.6%.

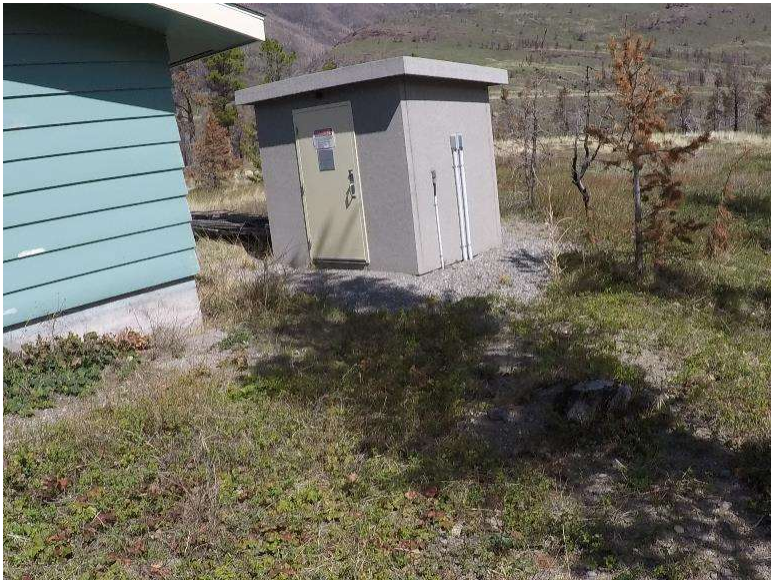
Photograph 1.13-4: Site 1.13 Solar Building #2 Silica Sample S1, 56.7% SiO₂.

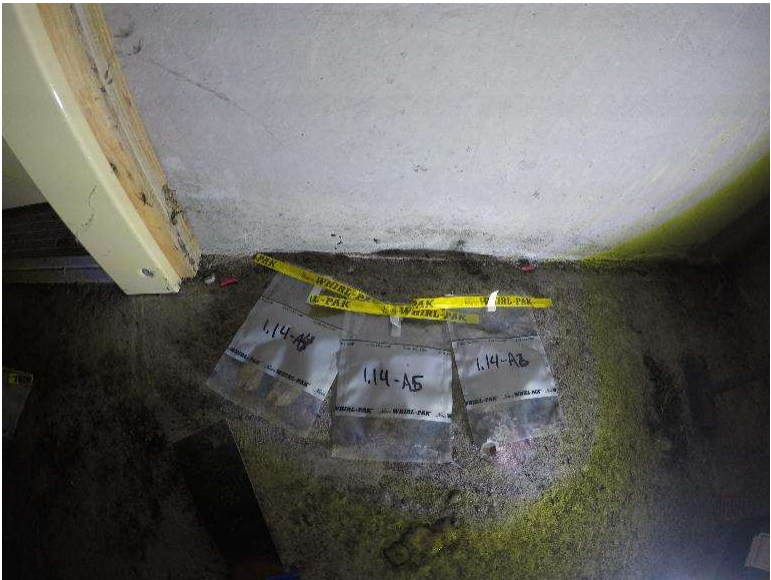
Photograph 1.14-2: Site 1.14 Solar Building #3 Asbestos Sample A1, A2, A3, None Detected.

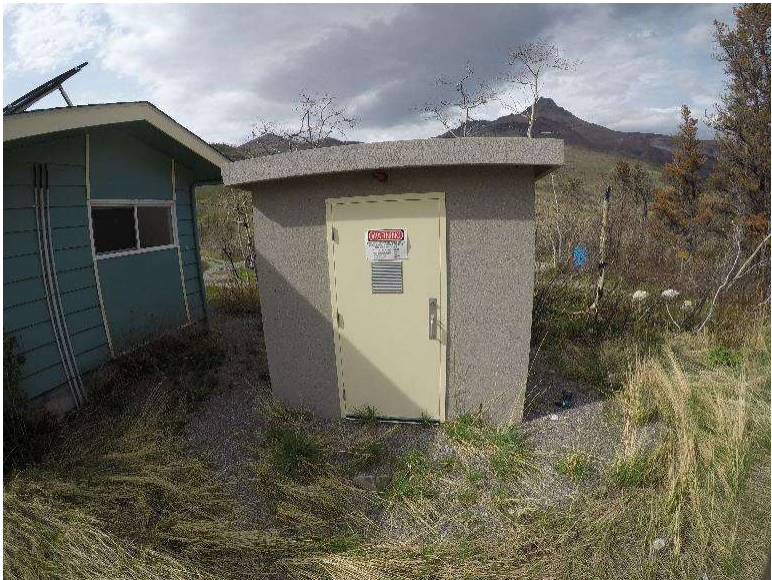
Photograph 1.14-4: Site 1.14 Solar Building #3 Silica Sample S1, 52.2% SiO₂.

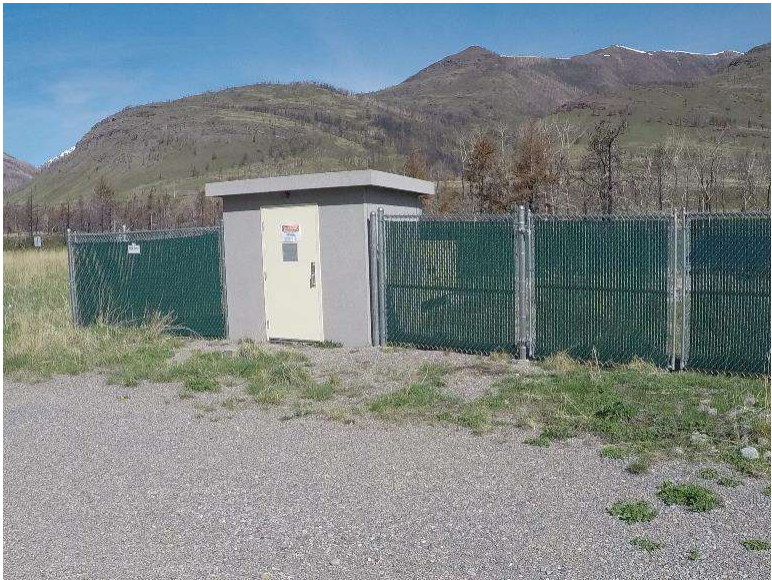
Photograph 1.15-5: Site 1.15 Solar Building #4 Silica Sample S1, 55.4% SiO₂.

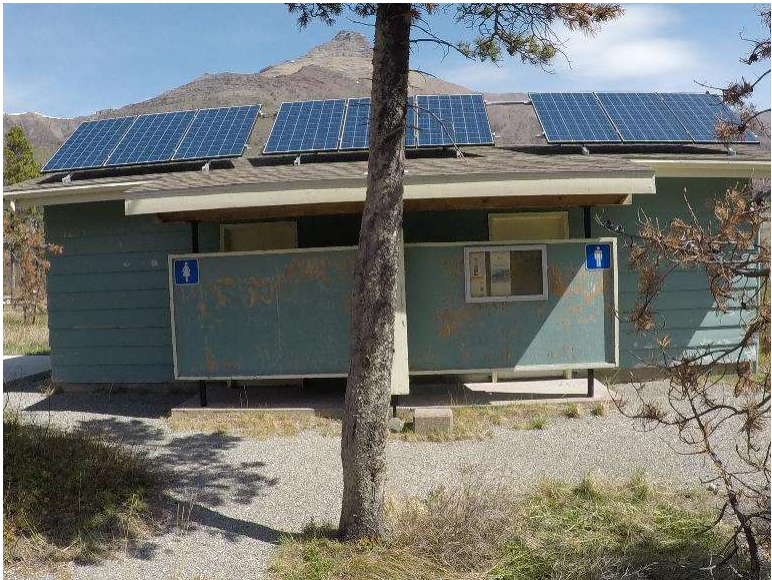
Photograph 1.18-1: Site 1.18 Crandell Campground Washroom 3.

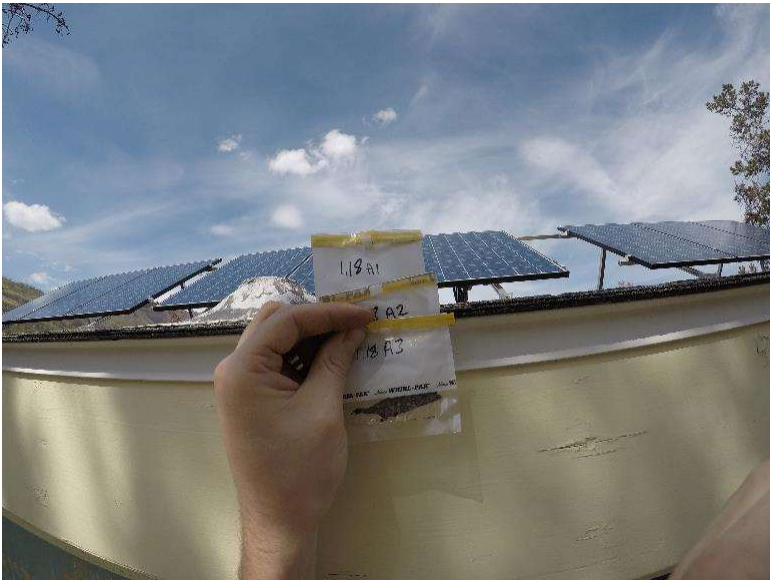
Photograph 1.18-2: Site 1.18 Washroom 4 Asbestos Sample A1, A2, A3, None Detected.

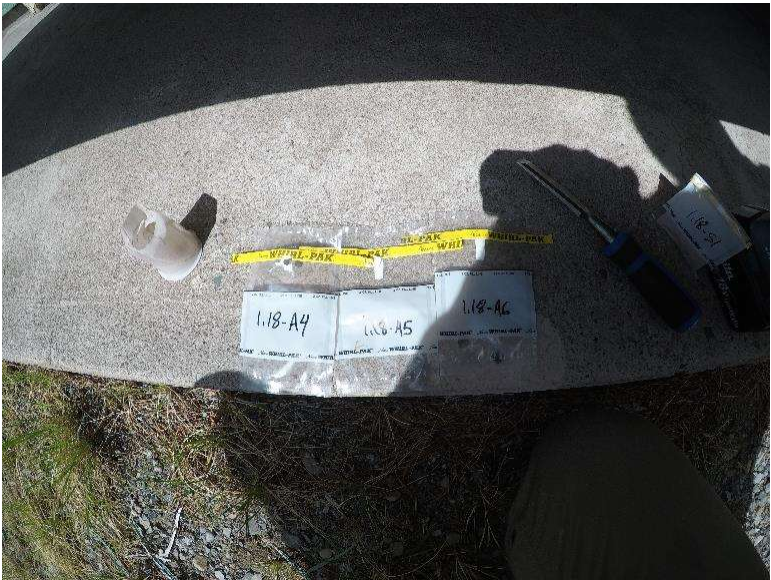
Photograph 1.18-3: Site 1.18 Washroom 4 Asbestos Sample A4, A5, A6, None Detected.

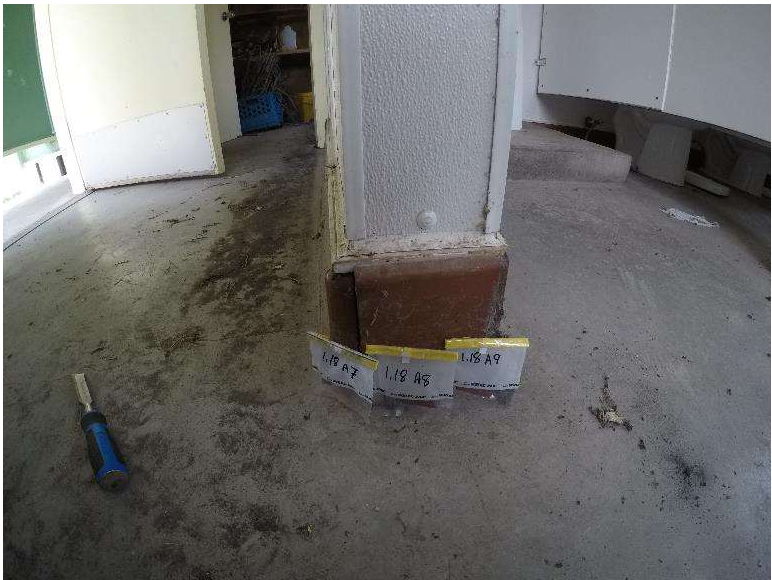
Photograph 1.18-4: Site 1.18 Washroom 4 Asbestos Sample A7, Chrysotile, <1%, A8, A9, None Detected.

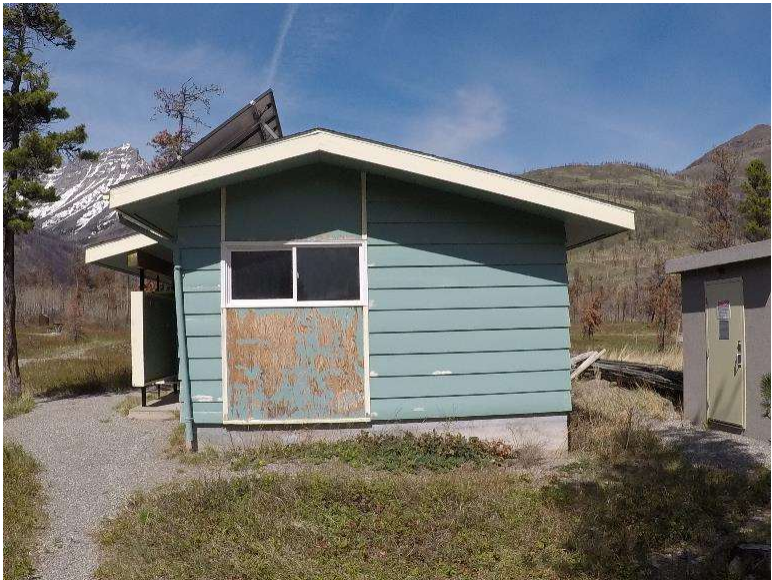
Photograph 1.18-5: Site 1.18 Washroom 4 Lead Sample Pb1, 23,700mg/kg.

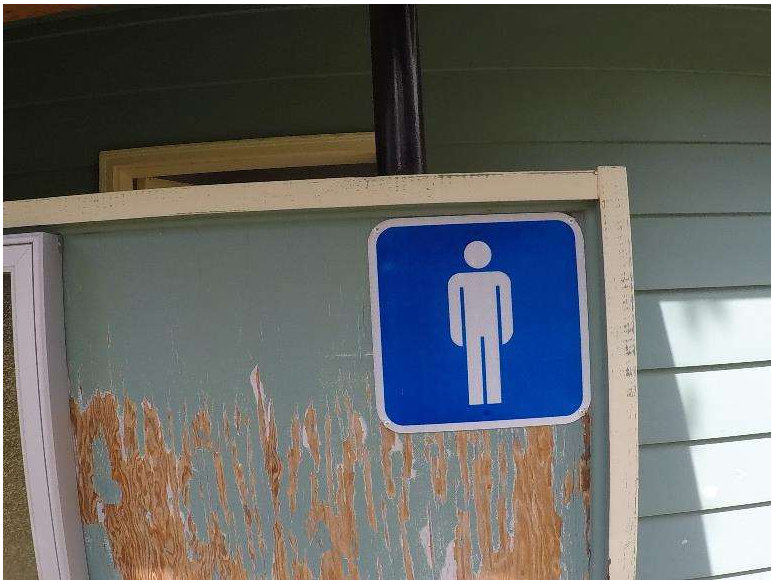
Photograph 1.18-6: Site 1.18 Washroom 4 Lead Sample Pb2, 28,400mg/kg.

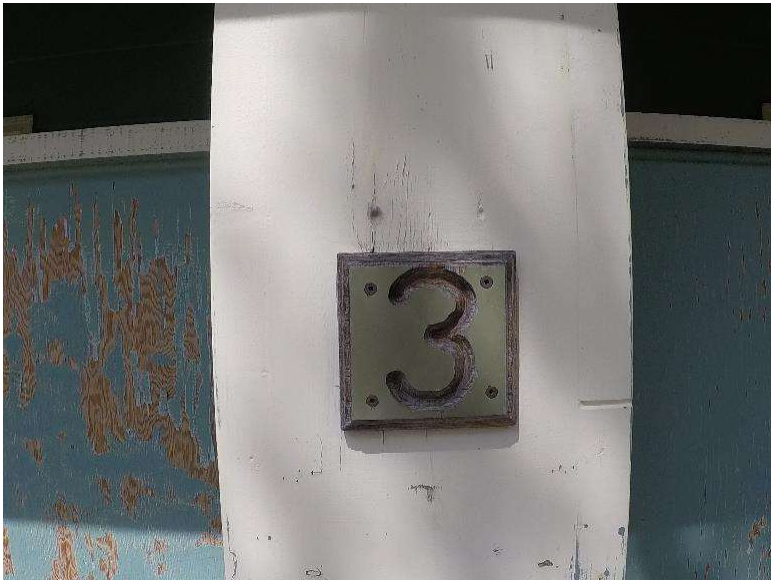
Photograph 1.18-7: Site 1.18 Washroom 4 Lead Sample Pb3, 620mg/kg.

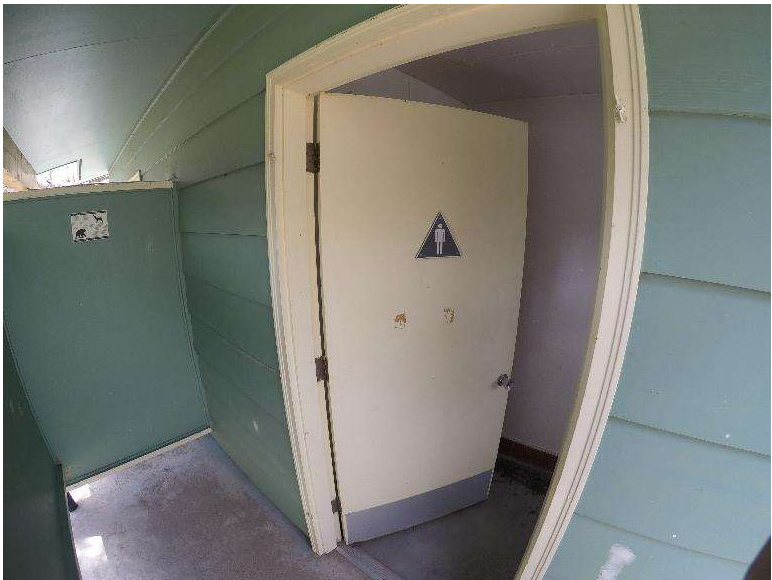
Photograph 1.18-8: Site 1.18 Washroom 4 Lead Sample Pb4, 3,980mg/kg.

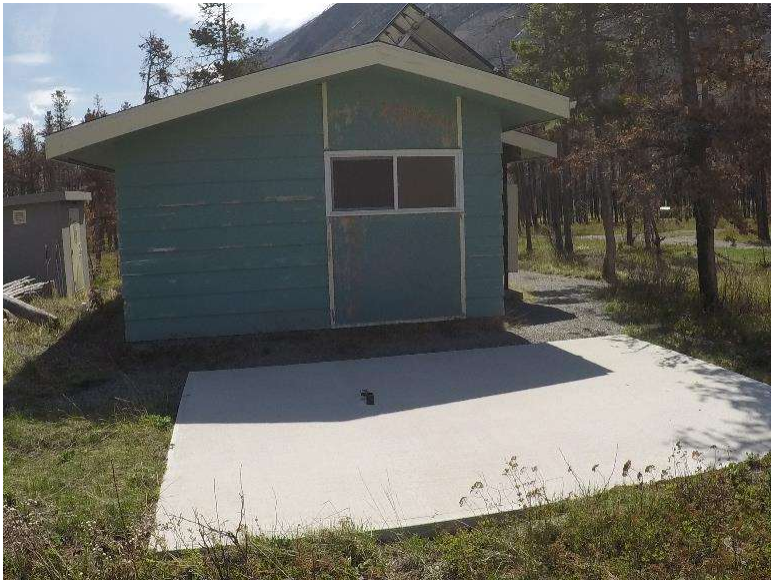
Photograph 1.18-9: Site 1.18 Washroom 4 Lead Sample PCB1, <0.02mg/kg.

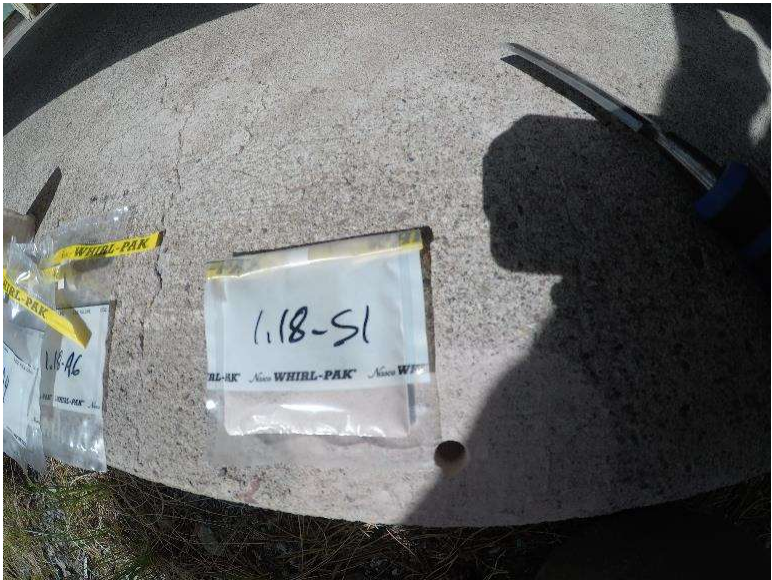
Photograph 1.18-10: Site 1.18 Washroom 3 Silica Sample S1, 52.8% SiO₂.

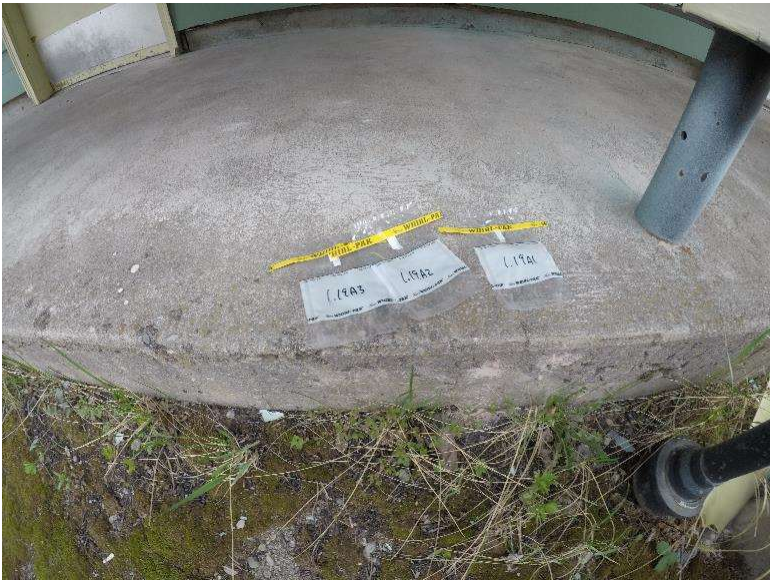
Photograph 1.19-2: Site 1.19 Washroom 4 Asbestos Sample A1, A2, A3, None Detected.

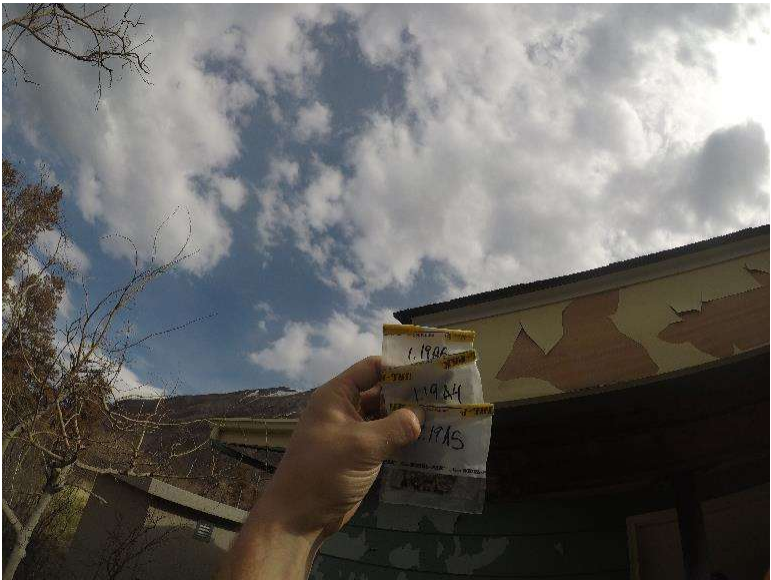
Photograph 1.19-3: Site 1.19 Washroom 4 Asbestos Sample A4, A5, A6, None Detected.

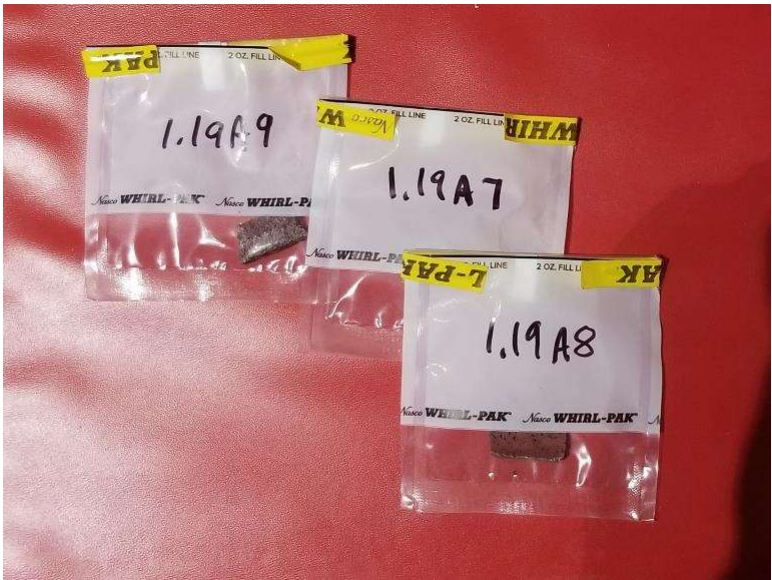
Photograph 1.19-4: Site 1.19 Washroom 4 Asbestos Sample A7, A8, A9, None Detected.

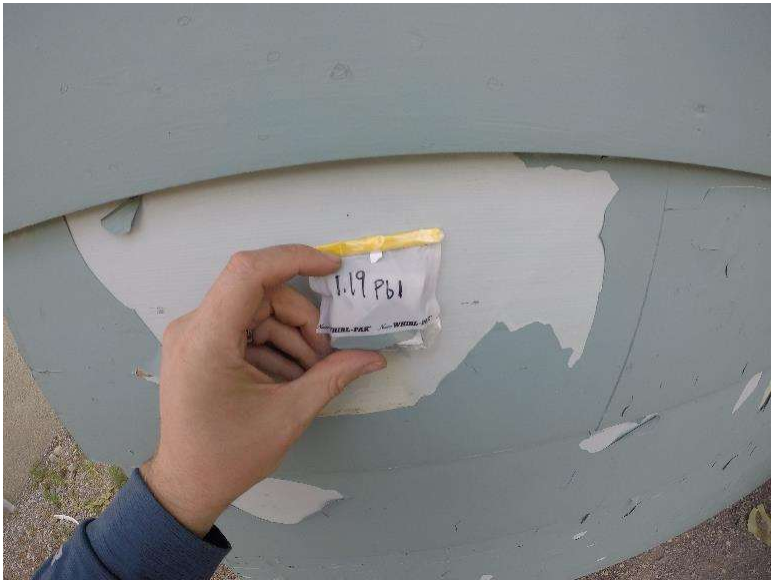
Photograph 1.19-5: Site 1.19 Washroom 4 Lead Sample Pb1, 11,100mg/kg.

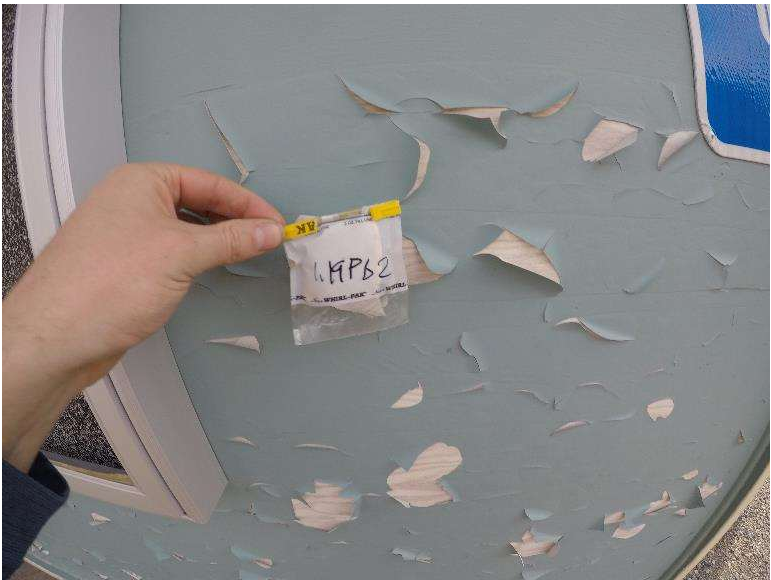
Photograph 1.19-6: Site 1.19 Washroom 4 Lead Sample Pb2, 9,140mg/kg.

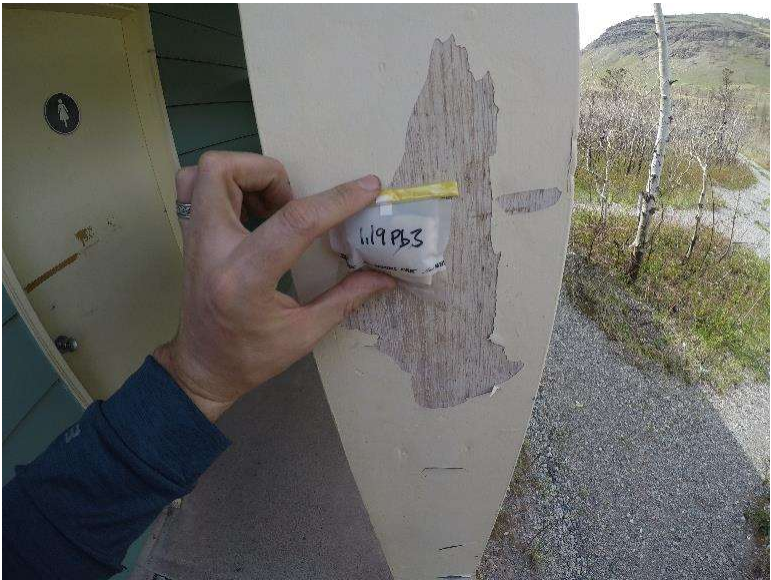
Photograph 1.19-7: Site 1.19 Washroom 4 Lead Sample Pb3, 9,360mg/kg.

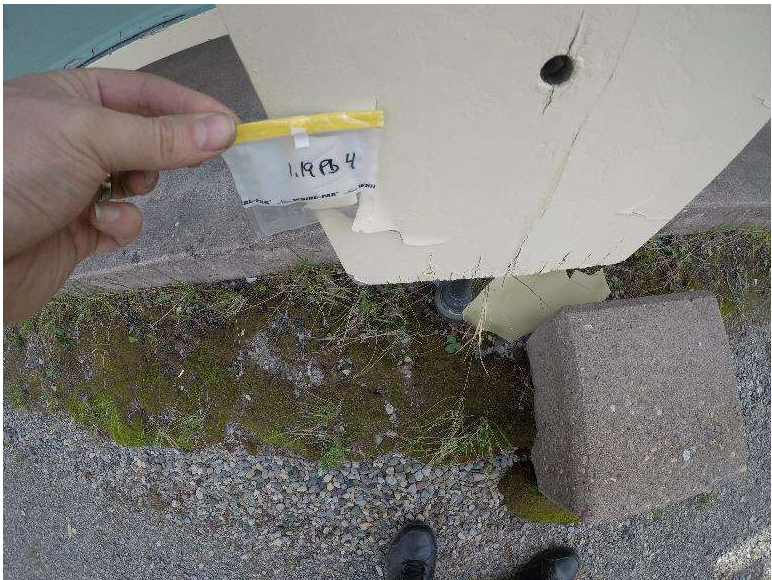
Photograph 1.19-8: Site 1.19 Washroom 4 Lead Sample Pb4, 8,280mg/kg.

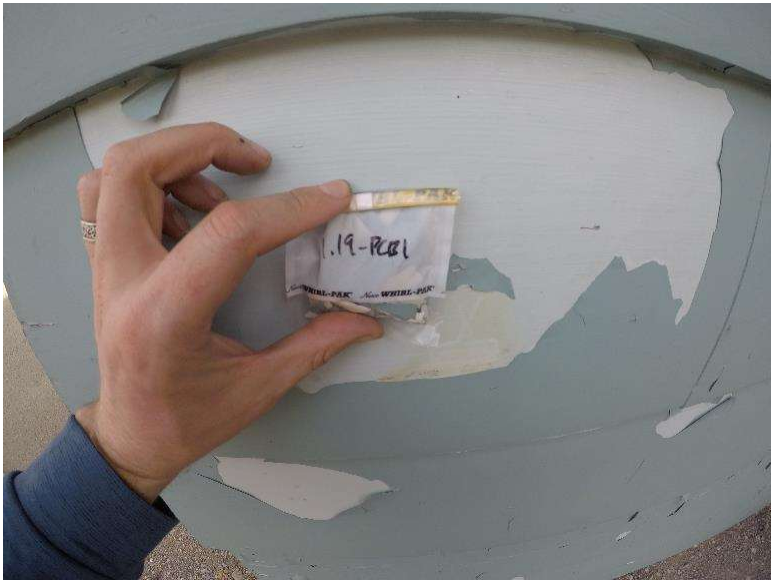
Photograph 1.19-9: Site 1.19 Washroom 4 Lead Sample PCB1, <0.02mg/kg.

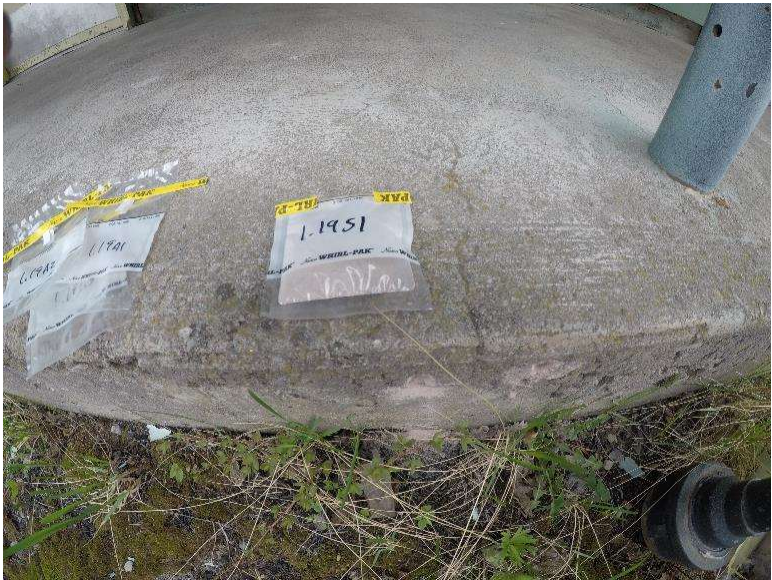
Photograph 1.19-10: Site 1.19 Washroom 4 Silica Sample S1, 52.8% SiO₂.

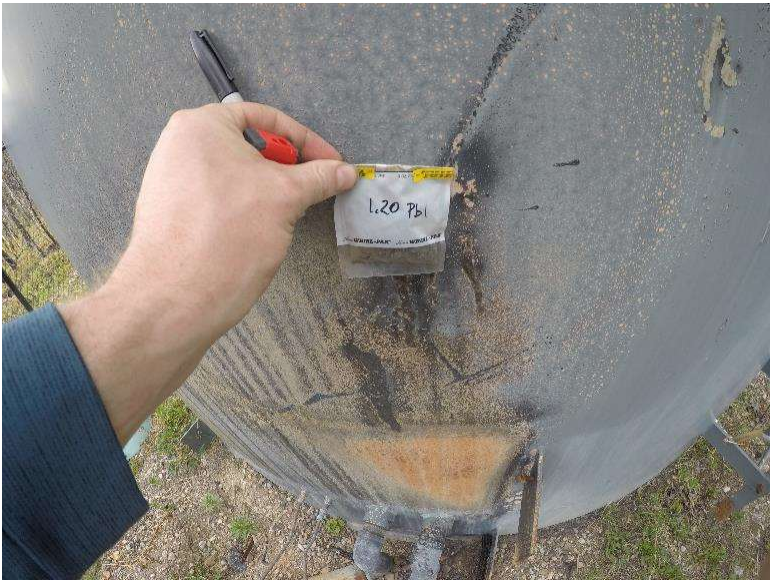
Photograph 1.20-1: Site 1.20 Water Tower Lead Sample Pb1, 6,890mg/kg.

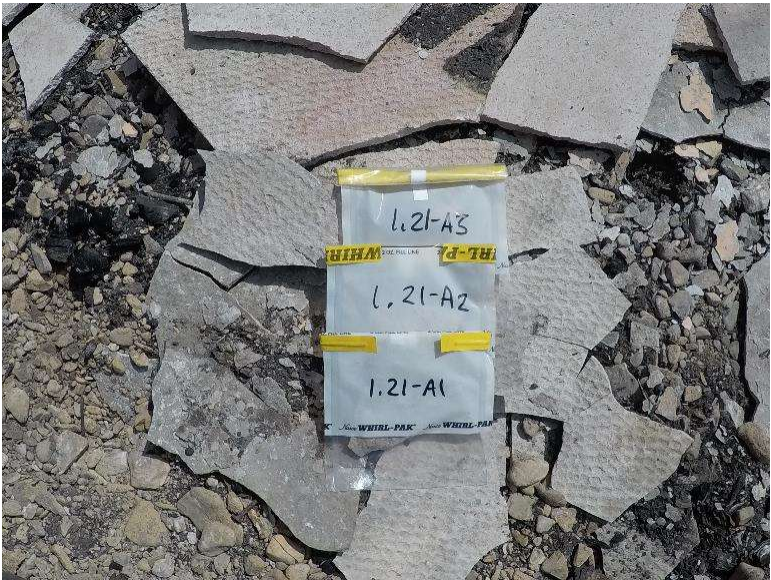
Photograph 1.21-2: Site 1.17 Host Campground Asbestos Sample A1, A2, A3, None Detected.

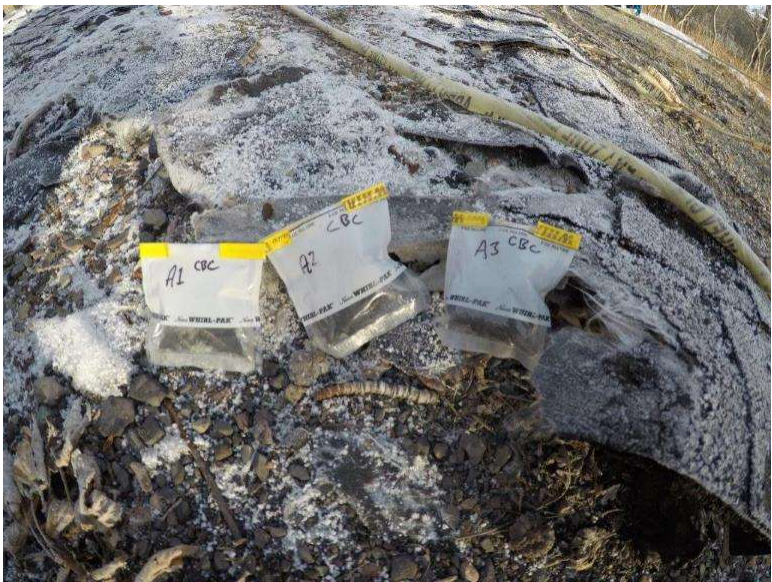
Photograph 2.1-2: Site 2.1 Kitchen Shelter - Crandell Backcountry Asbestos Samples A1-A3, None Detected.
