SPECIFICATIONS
for

Waterton Remediation and Abatement – 11 Sites

Waterton Lakes National Park, Alberta

Project No. _____ February 2020

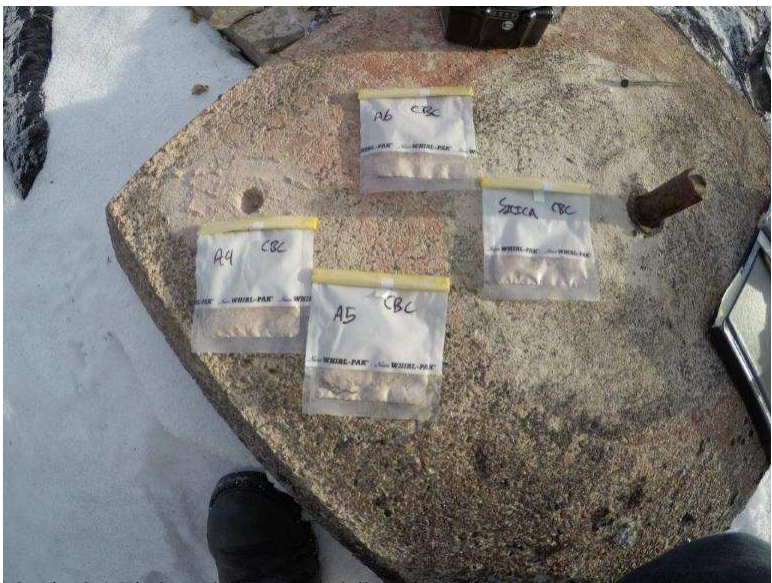
Photograph 2.1-3: Site 2.1 Kitchen Shelter - Crandell Backcountry Asbestos Samples A4-A6, None Detected.
Silica Sample S1, 51.49% SiO₂.

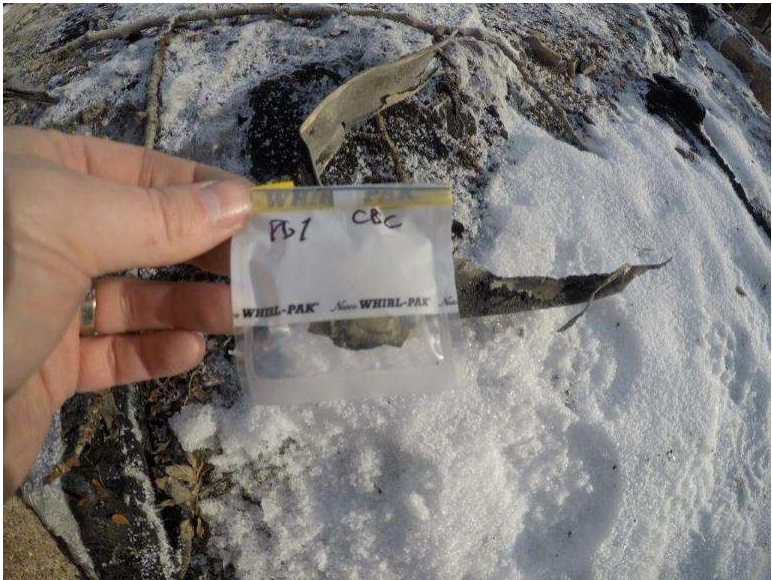
Photograph 2.1-4: Site 2.1 Kitchen Shelter - Crandell Backcountry Lead Sample Pb1, 86mg/kg.

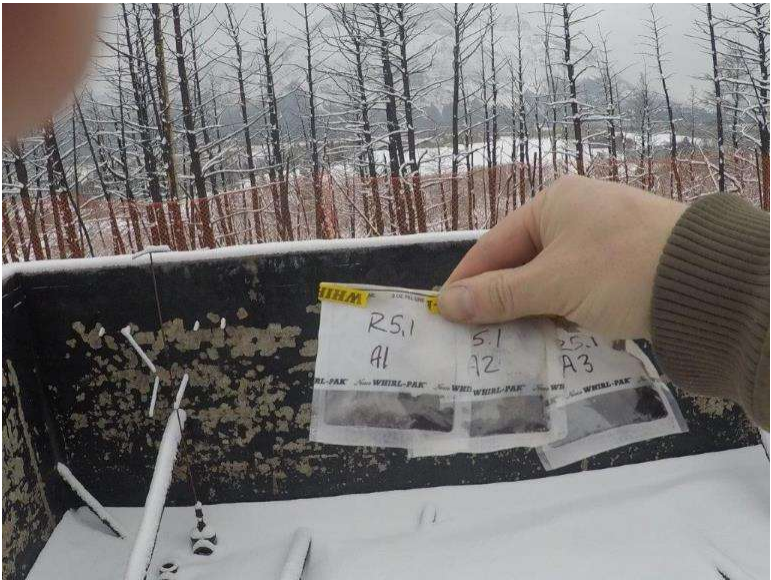
Photograph 5.1-2: Site 5.1 Waterton Golf Course Reservoir Asbestos Samples A1-A3, None Detected.

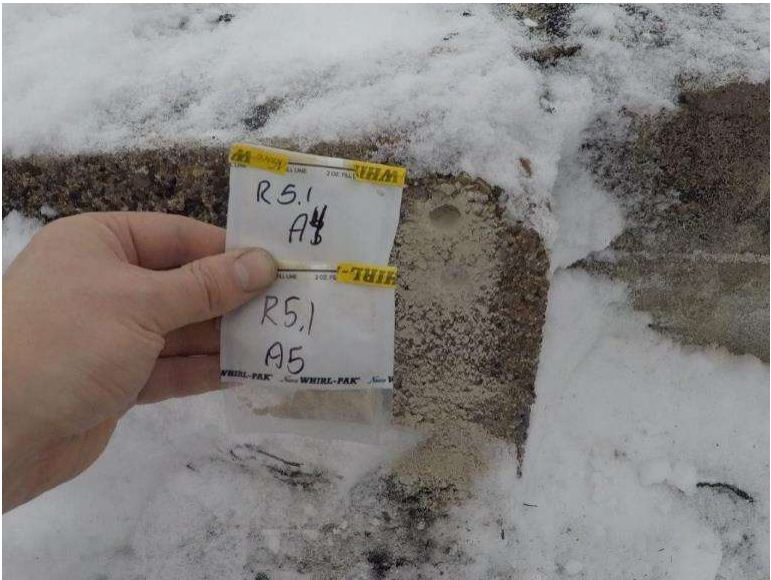
Photograph 5.1-3: Site 5.1 Waterton Golf Course Reservoir Asbestos Samples A4-A5, None Detected.

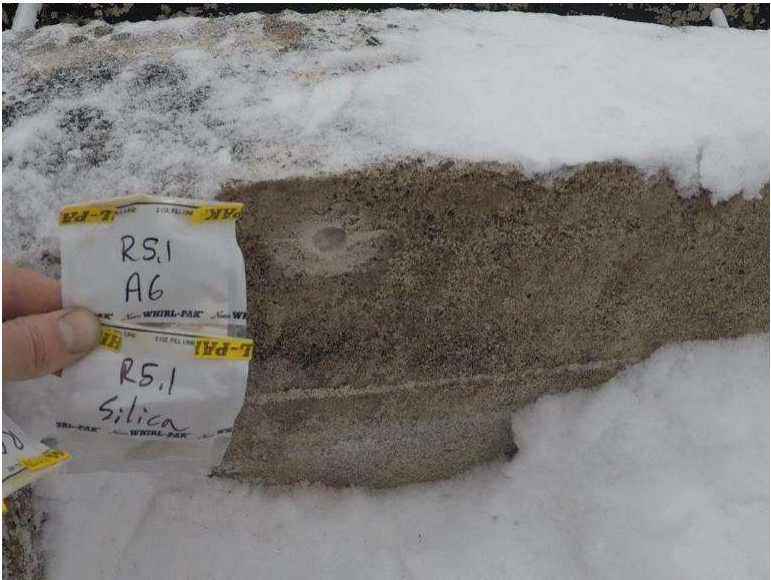
Photograph 5.1-4: Site 5.1 Waterton Golf Course Reservoir Asbestos Sample A6, None Detected.
Silica Sample S1, 46.08% SiO₂.

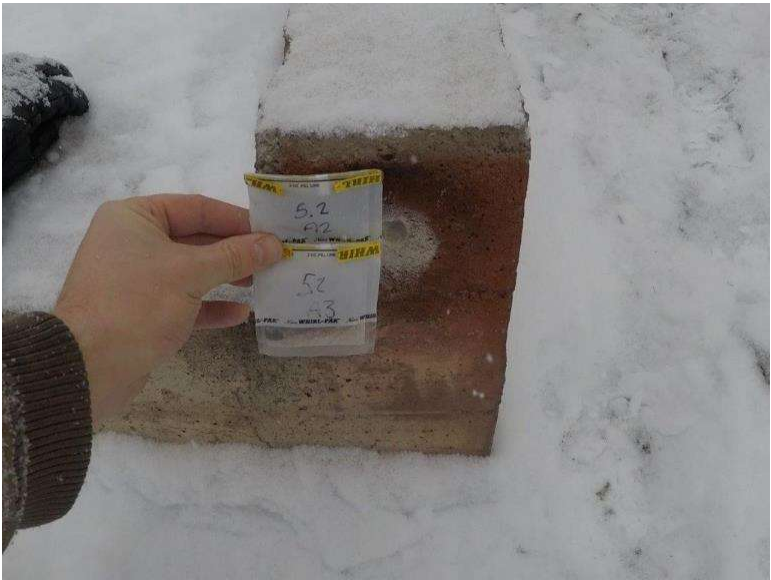
Photograph 5.2-1: Site 5.2 Waterton Golf Course Lightning Shelter Shed Asbestos Sample A1, None Detected.
Silica Sample S1, 46.92% SiO₂.

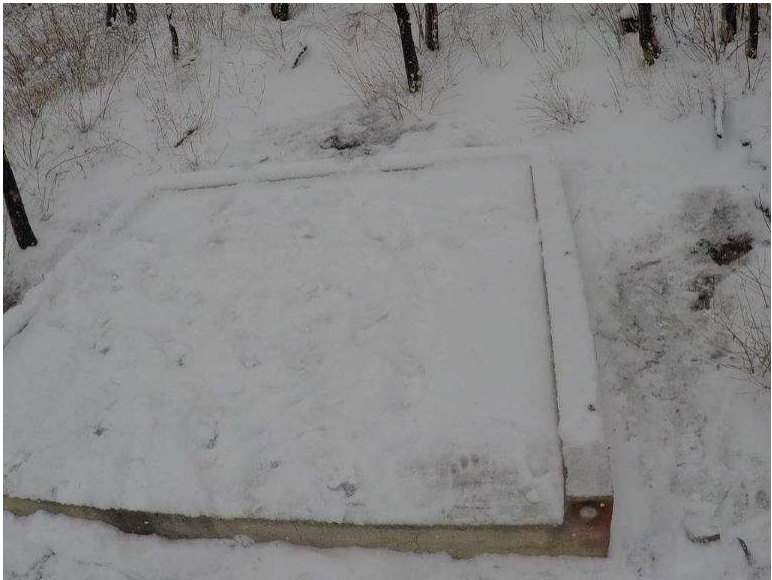
Photograph 5.2-2: Site 5.2 Waterton Golf Course Lightning Shelter Shed Asbestos Samples A2-A3, None Detected.

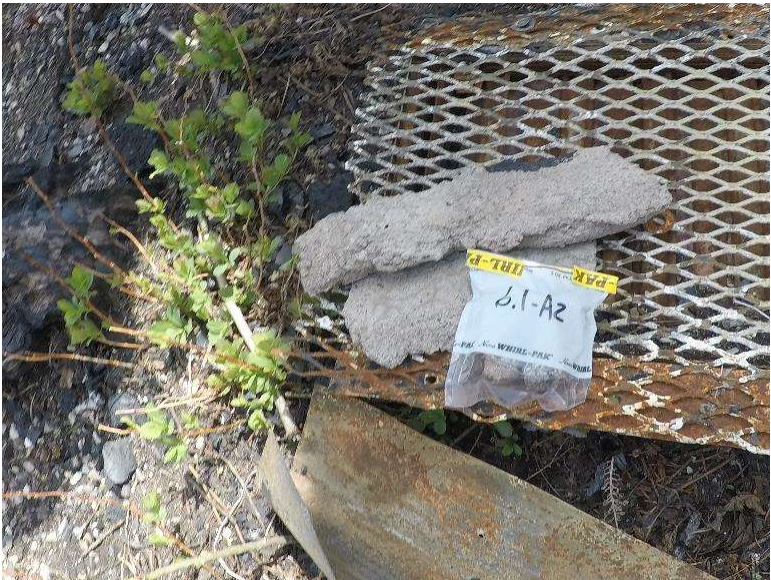
Photograph 6.1-2: Site 6.1 Bear's Hump Seismic Station Asbestos Sample A1, None Detected.

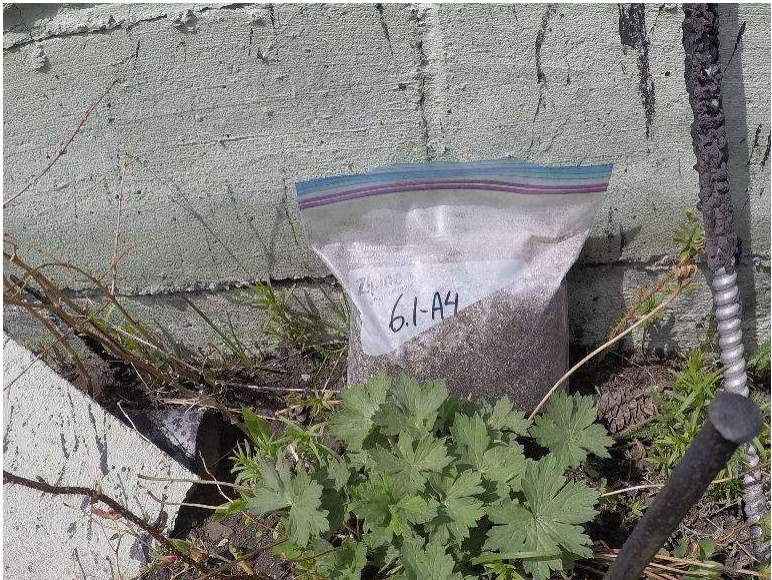
Photograph 6.1-4: Site 6.1 Bear's Hump Seismic Station Asbestos Sample A3, None Detected.

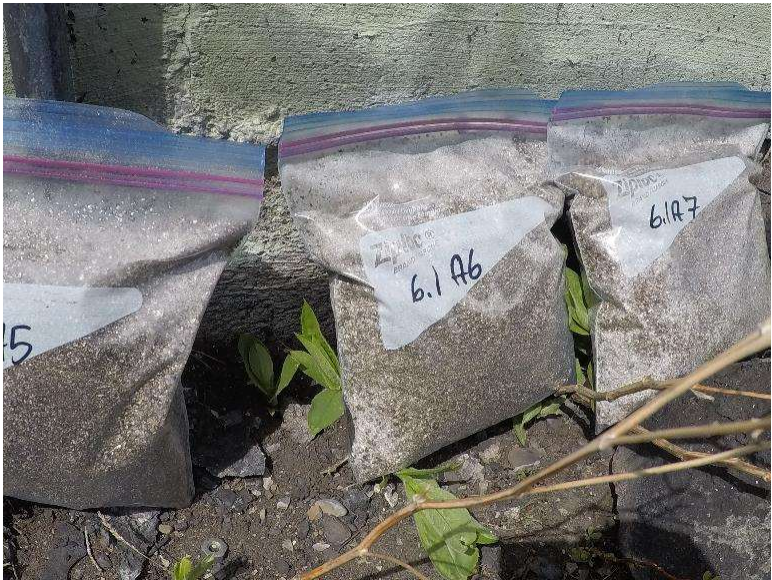
Photograph 6.1-5: Site 6.1 Bear's Hump Seismic Station Asbestos Sample A4, Actinolite, 3%.

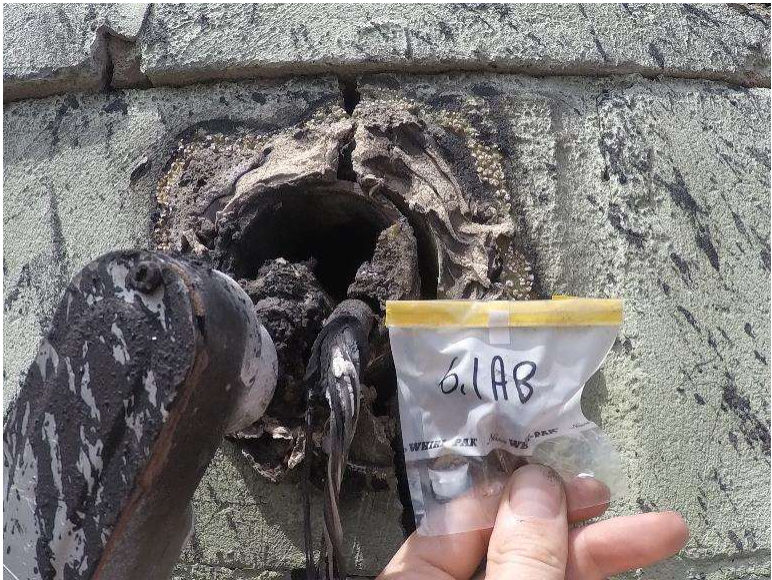
Photograph 6.1-6: Site 6.1 Bear’s Hump Seismic Station Asbestos Sample A5, A6, A7, Actinolite, 3%.

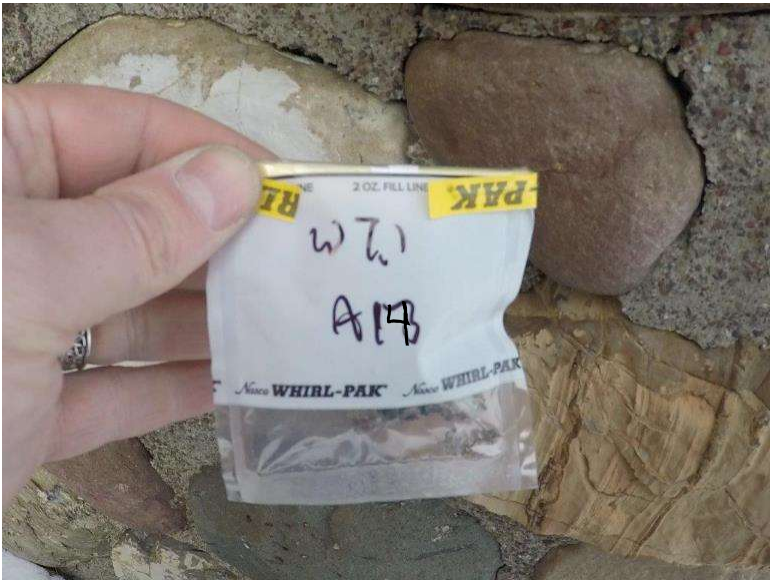
Photograph 7.1-13 Site 7.1 Waterton Townsite Campground Washroom #2 Asbestos Sample A13, None Detected.

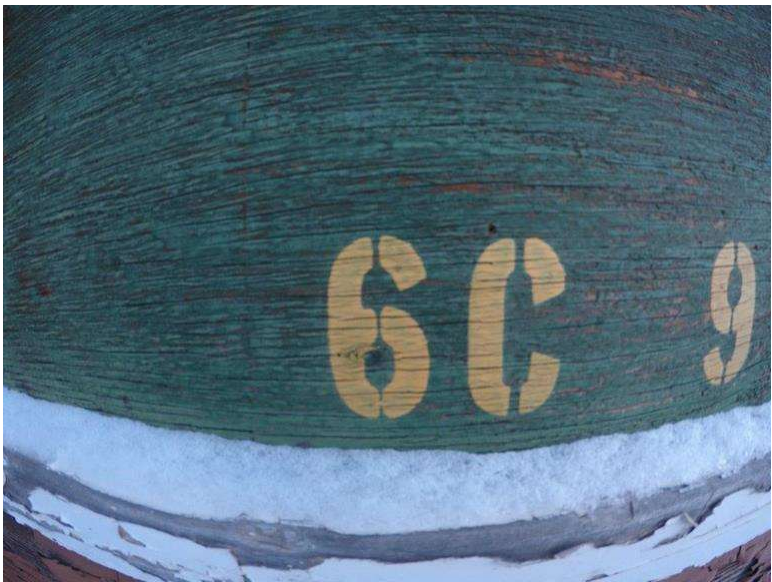
Photograph 7.2-16: Site 7.2 Waterton Townsite Campground Washroom #6 Lead Sample Pb7, 130,000mg/kg.

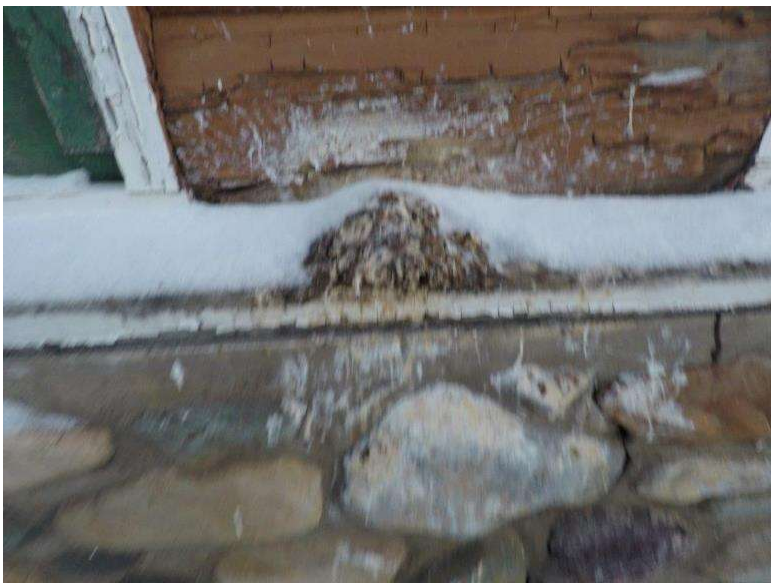
Photograph 7.2-17 Site 7.2 Waterton Townsite Campground Washroom #6 Lead Sample Pb8, 12,000mg/kg.

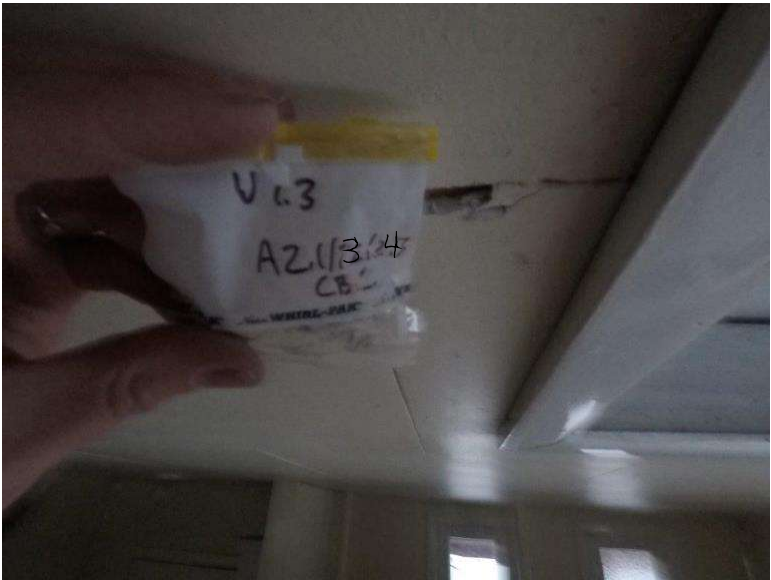
Photograph 7.3-3: Site 7.3 Waterton Townsite Campground Washroom #8 Asbestos Sample A1, Chrysotile, 15%.

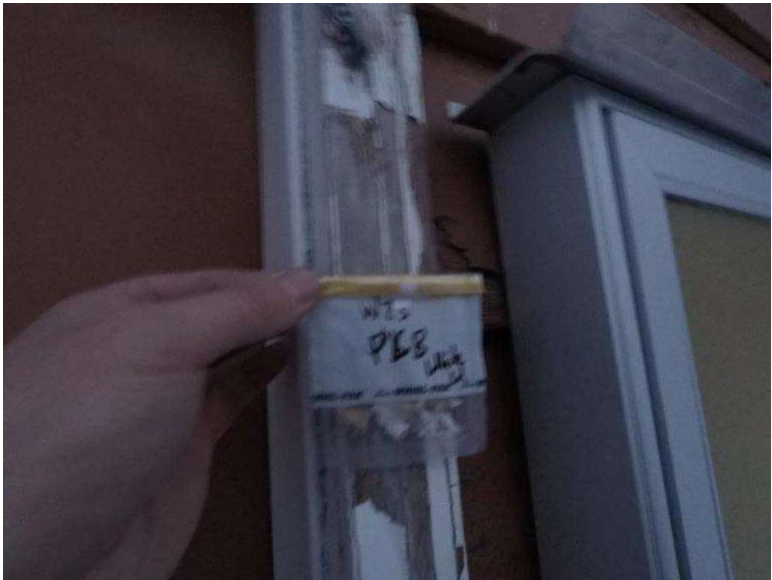
Photograph 7.3-11: Site 7.3 Waterton Townsite Campground Washroom #8 Lead Sample Pb6, 1,200mg/kg.

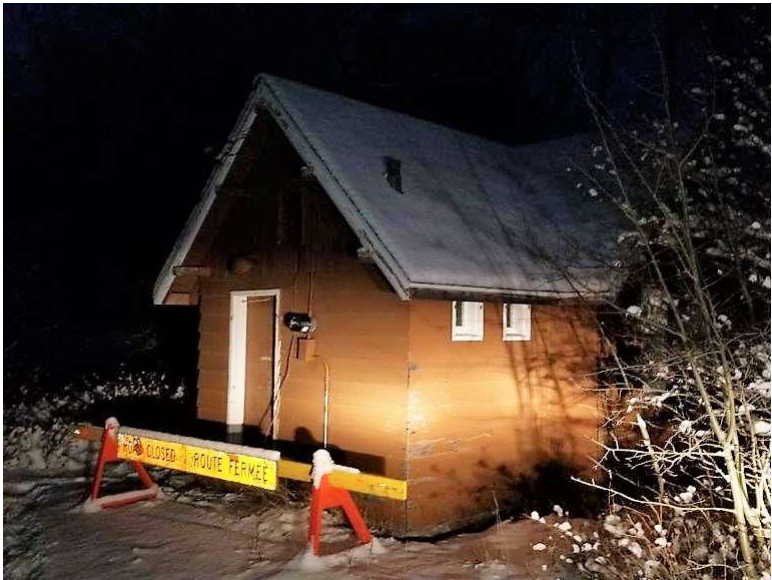
Photograph 7.3-12: Site 7.3 Waterton Townsite Campground Washroom #8 PCB Sample PCB1, <0.20mg/kg.

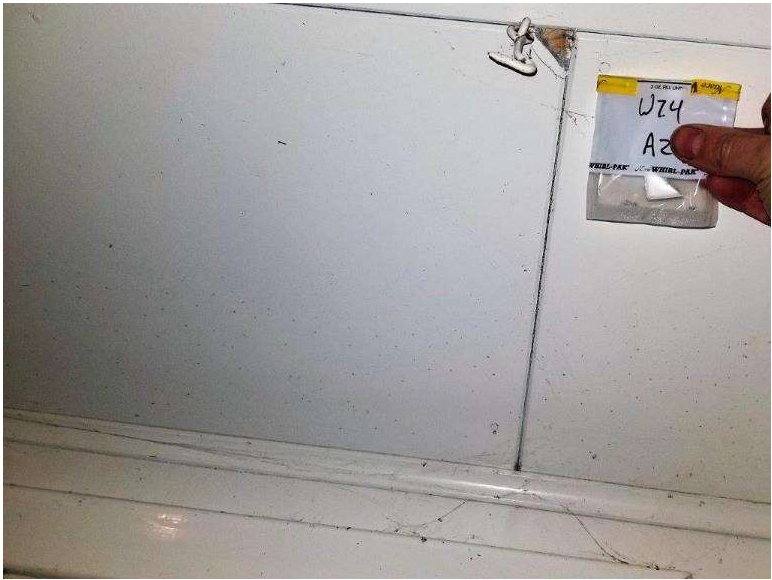
Photograph 7.4-3 Site 7.4 Waterton Townsite Campground Washroom #9 Asbestos Sample A1, Chrysotile, 15%.

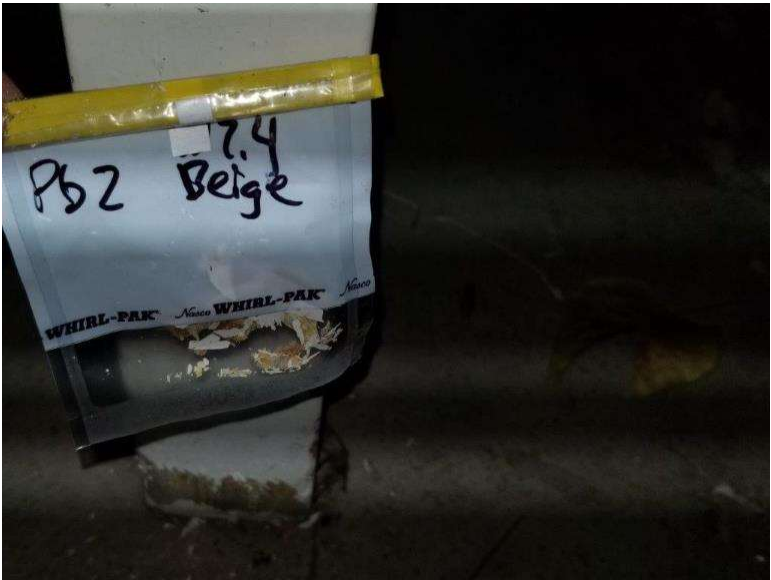
Photograph 7.4-7: Site 7.4 Waterton Townsite Campground Washroom #9 Lead Sample Pb1, 26,000mg/kg.

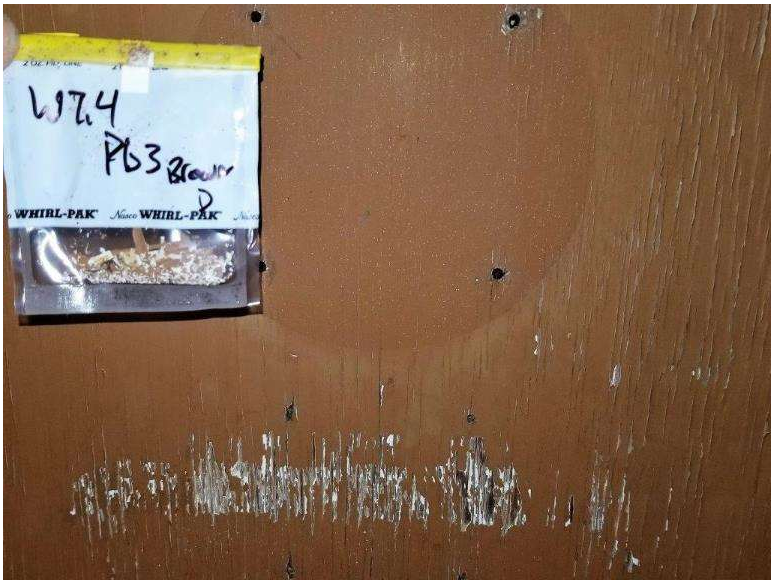
Photograph 7.4-8: Site 7.4 Waterton Townsite Campground Washroom #9 Lead Sample Pb2, 32,000mg/kg.

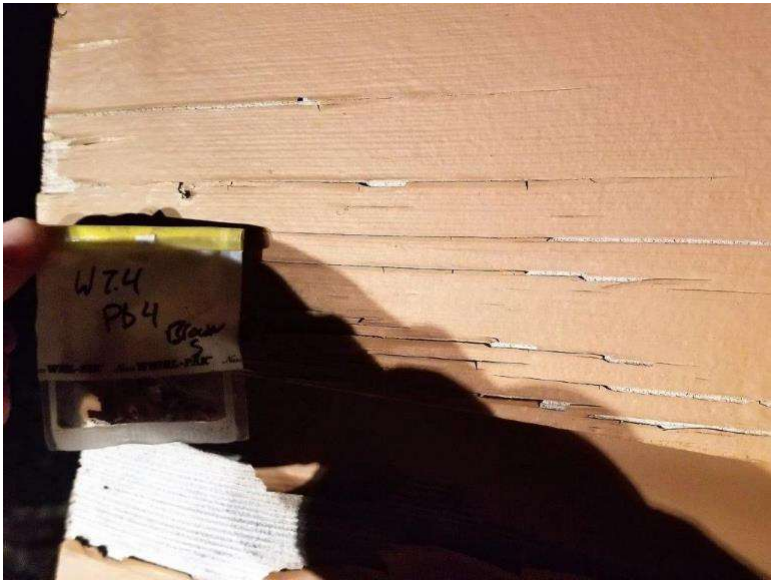
Photograph 7.4-9: Site 7.4 Waterton Townsite Campground Washroom #9 Lead Sample Pb3, 110,000mg/kg.

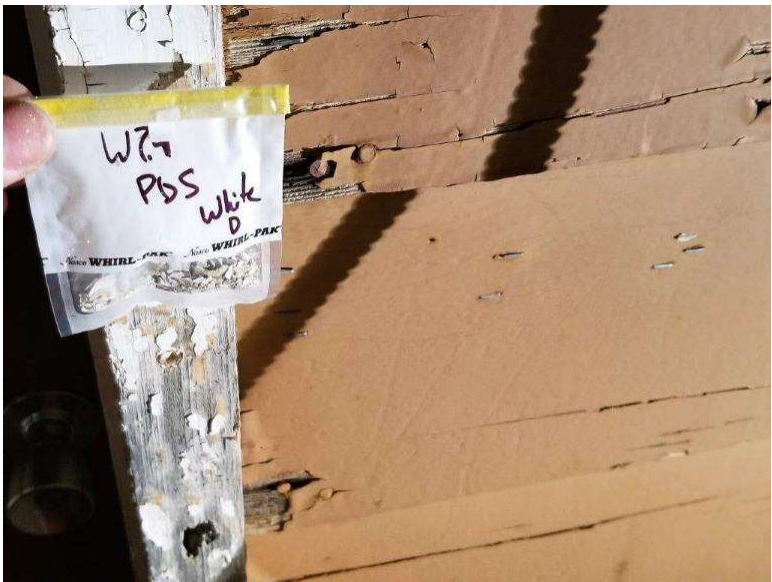
Photograph 7.4-10: Site 7.4 Waterton Townsite Campground Washroom #9 Lead Sample Pb4, 110,000mg/kg.

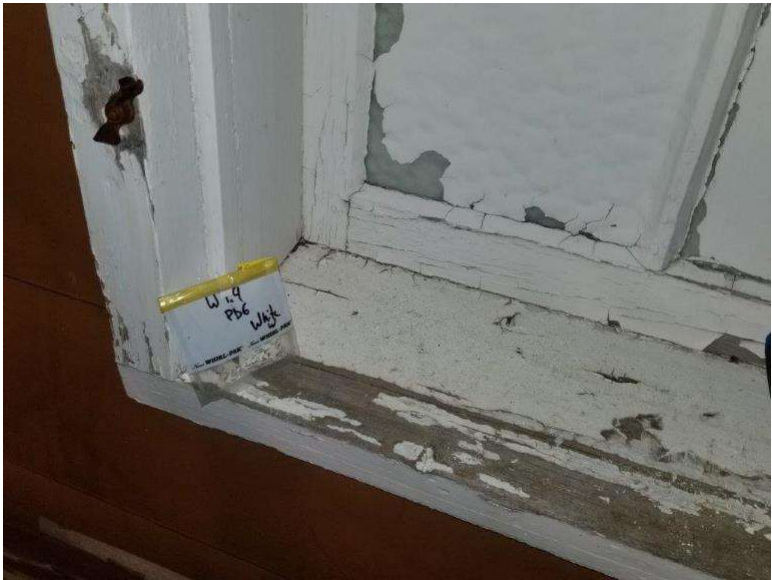
Photograph 7.4-11: Site 7.4 Waterton Townsite Campground Washroom #9 Lead Sample Pb5, 35,000mg/kg.

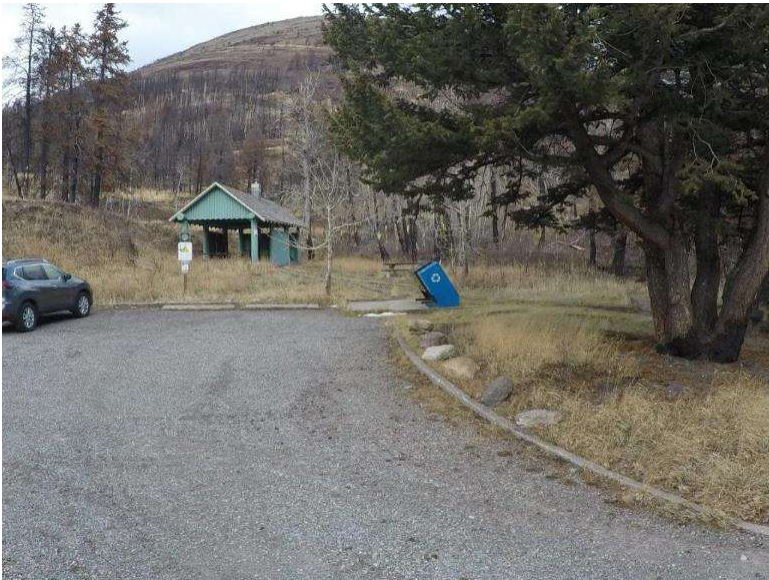
Photograph 8.1-2: Site 8.1 Lost Horse Day Use Area - Red Rock Parkway Outhouse.

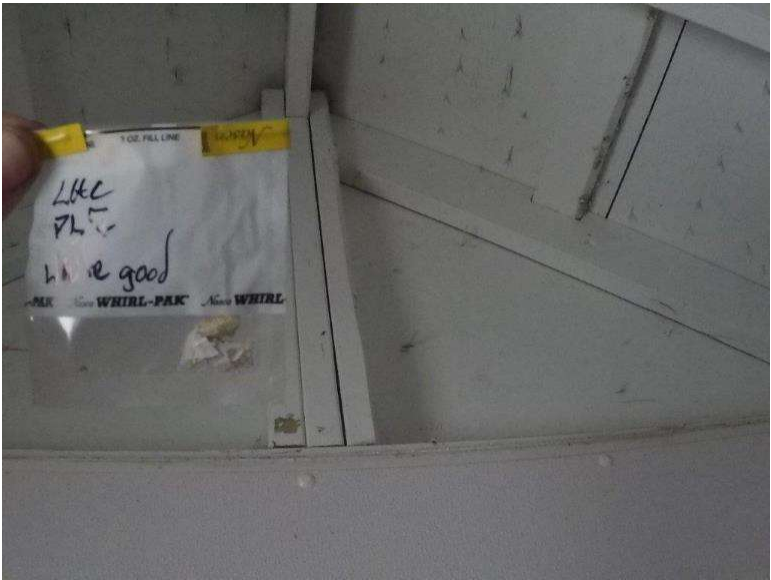
Photograph 8.1-16: Site 8.1 Lost Horse Day Use Area - Red Rock Parkway Lead Sample Pb6, <18mg/kg.

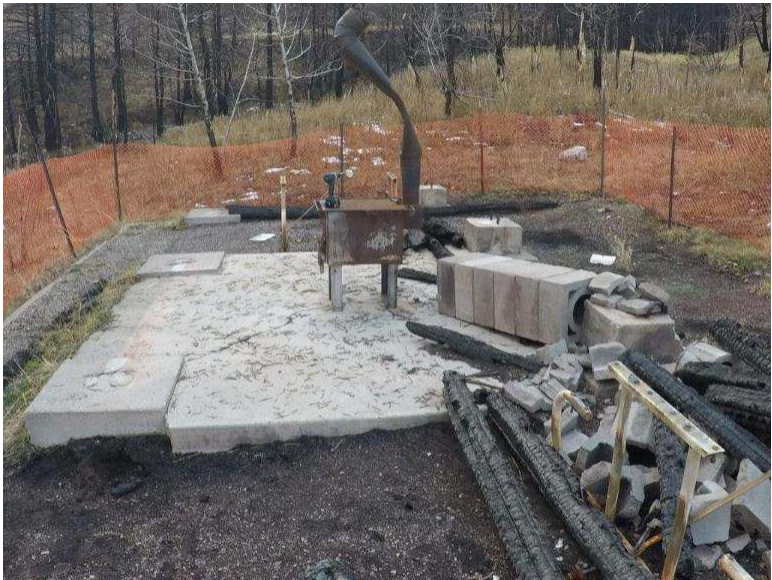
Photograph 8.2-1: Site 8.2 Coppermine Day Use Area - Red Rock Parkway Outhouse.

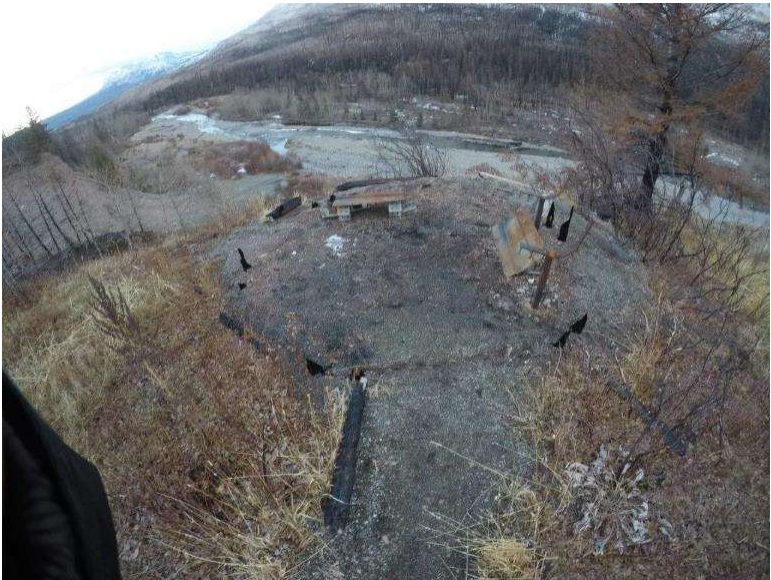
Photograph 8.2-10: Site 8.2 Coppermine Day Use Area - Red Rock Parkway PCB Sample PCB1, <0.2mg/kg.

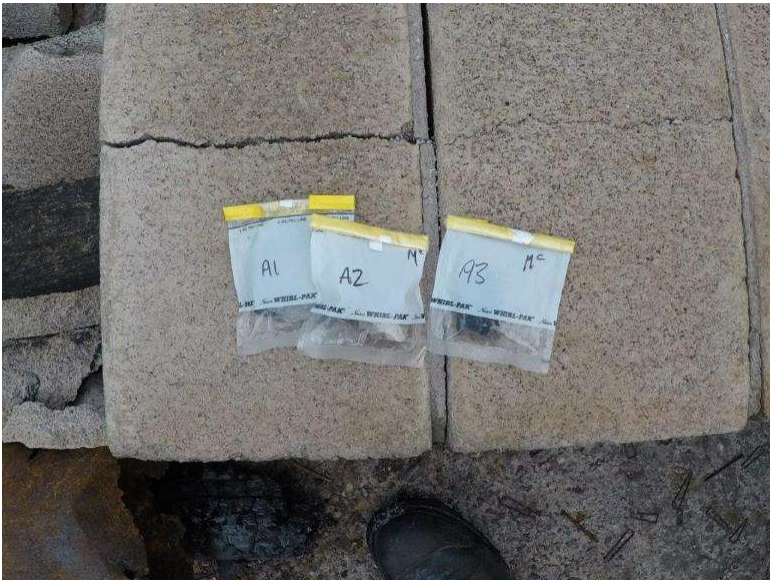
Photograph 8.3-2 Site 8.3 Indigenous History Viewpoint - Red Rock Parkway Asbestos Sample A1, None Detected.
Silica Sample S1, 76.21% SiO₂.

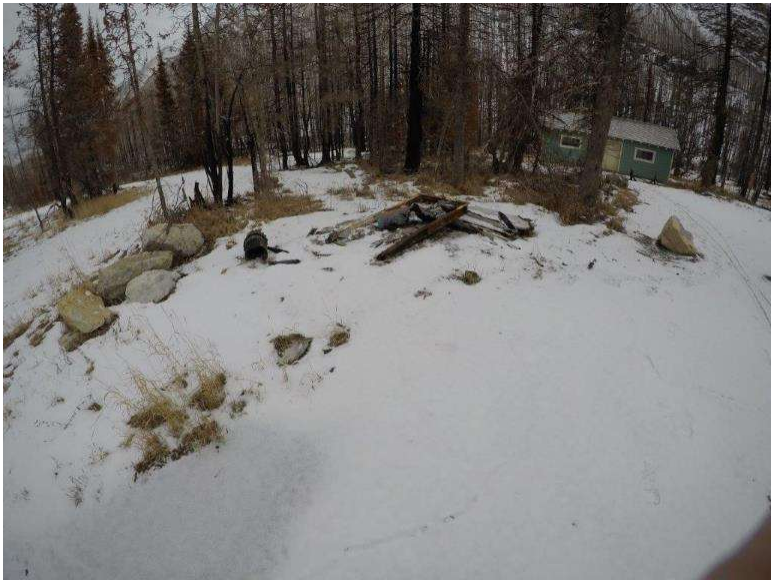
Photograph 9.1-7: Site 9.1 McNealy's Day Use Area - Akamina Parkway Lead Sample Pb3, <80mg/kg.

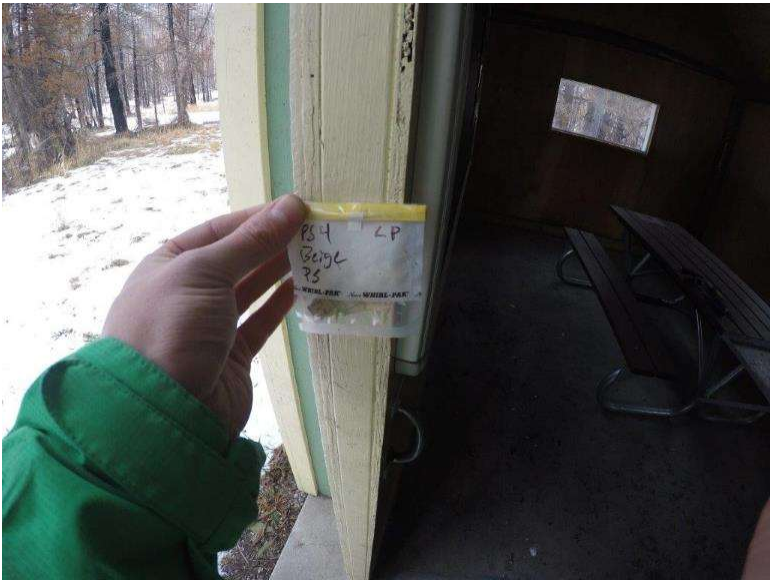
Photograph 9.2-11: Site 9.2 Little Prairie Day Use Area - Akamina Parkway Lead Sample Pb3, <10mg/kg.

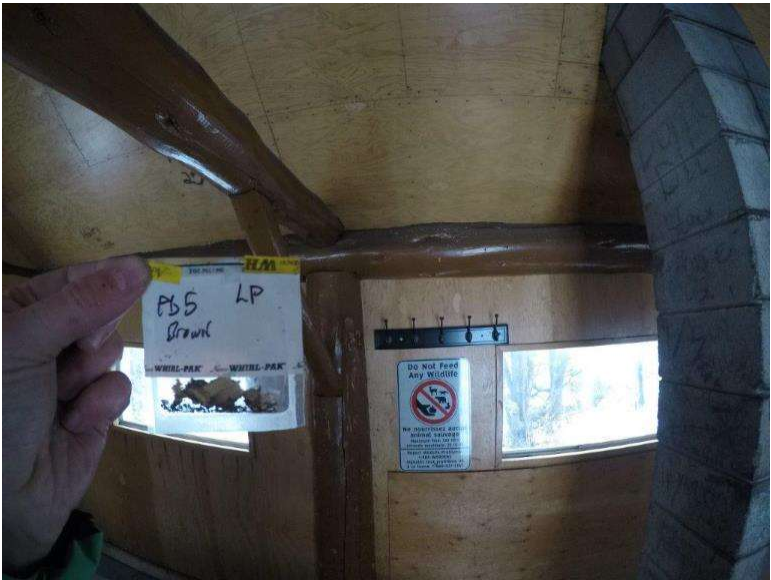
Photograph 9.2-12: Site 9.2 Little Prairie Day Use Area - Akamina Parkway Lead Sample Pb4, <10mg/kg.

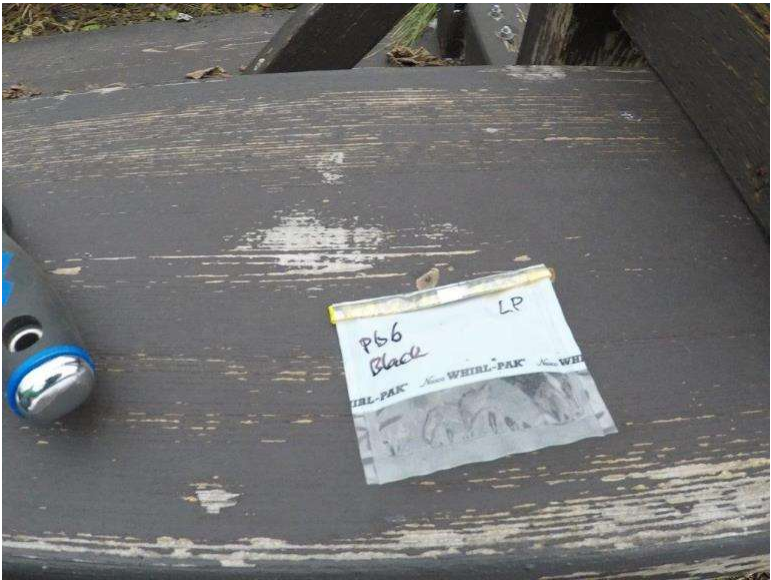
Photograph 9.2-13: Site 9.2 Little Prairie Day Use Area - Akamina Parkway Lead Sample Pb5, 1,500mg/kg.

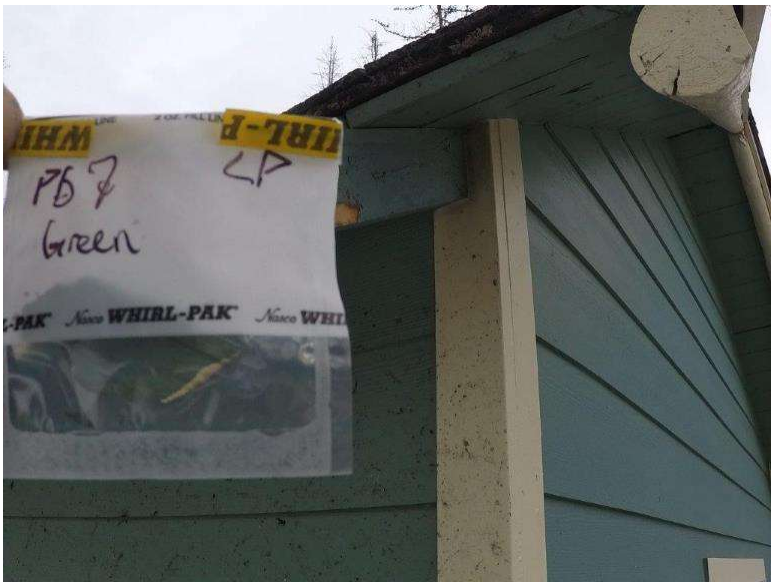
Photograph 9.2-14: Site 9.2 Little Prairie Day Use Area - Akamina Parkway Lead Sample Pb6, <28mg/kg.

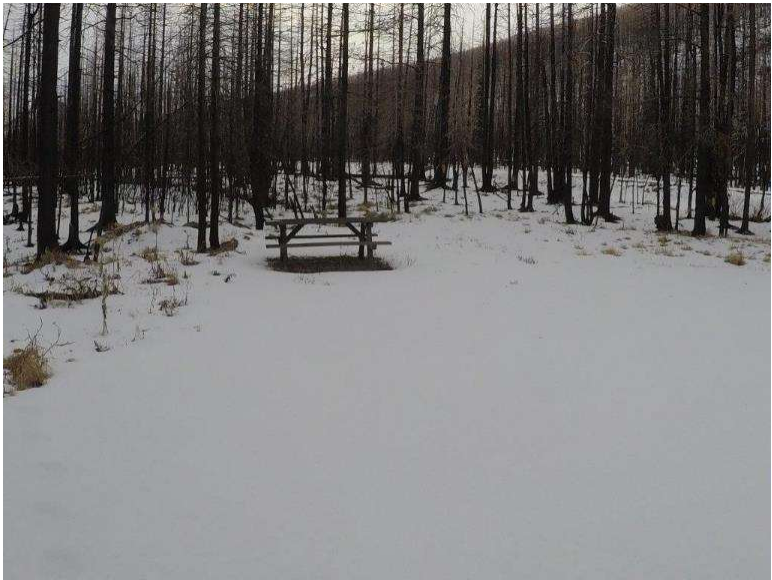
Photograph 9.2-15: Site 9.2 Little Prairie Day Use Area - Akamina Parkway Lead Sample Pb7, 660mg/kg.

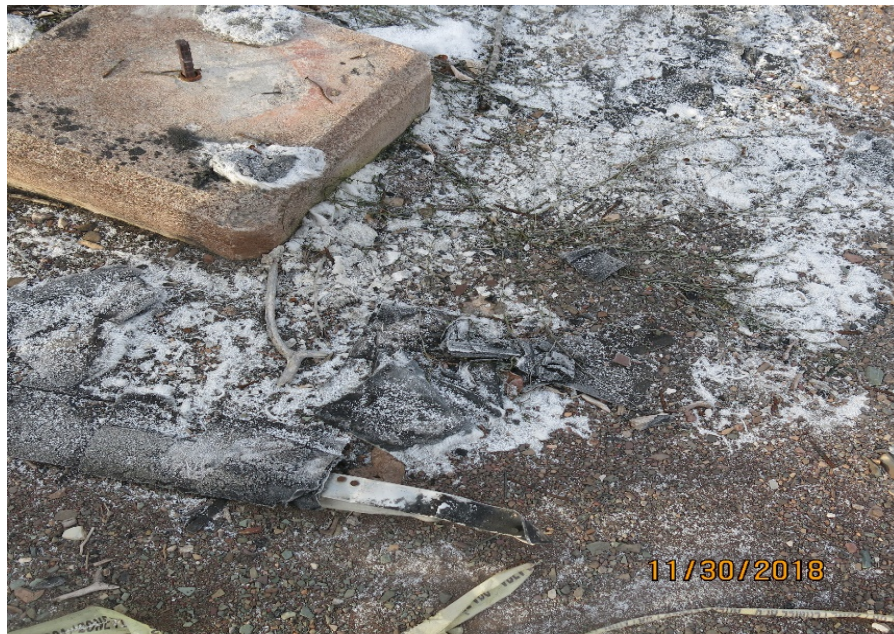
Photo 2.1 B: General overview of metal and melted shingle debris of the Crandell backcountry kitchen shelter facing north from the south site boundary.

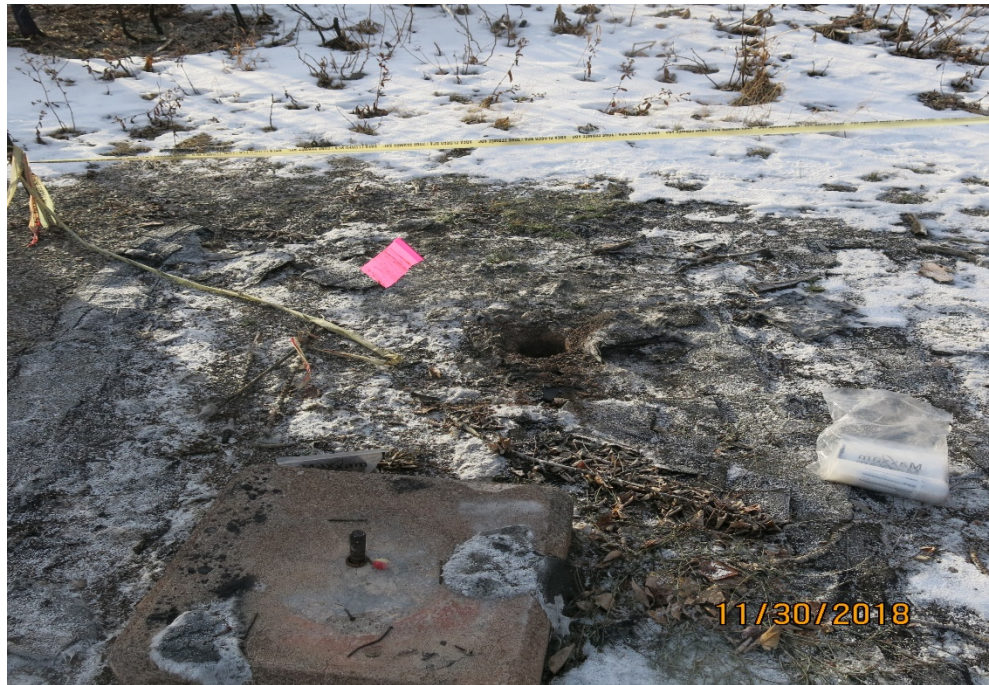
Photo 2.1 C: Sample location 2.1-1 under largest observed melted asphalt shingle debris pile on the southwest side of the kitchen shelter.

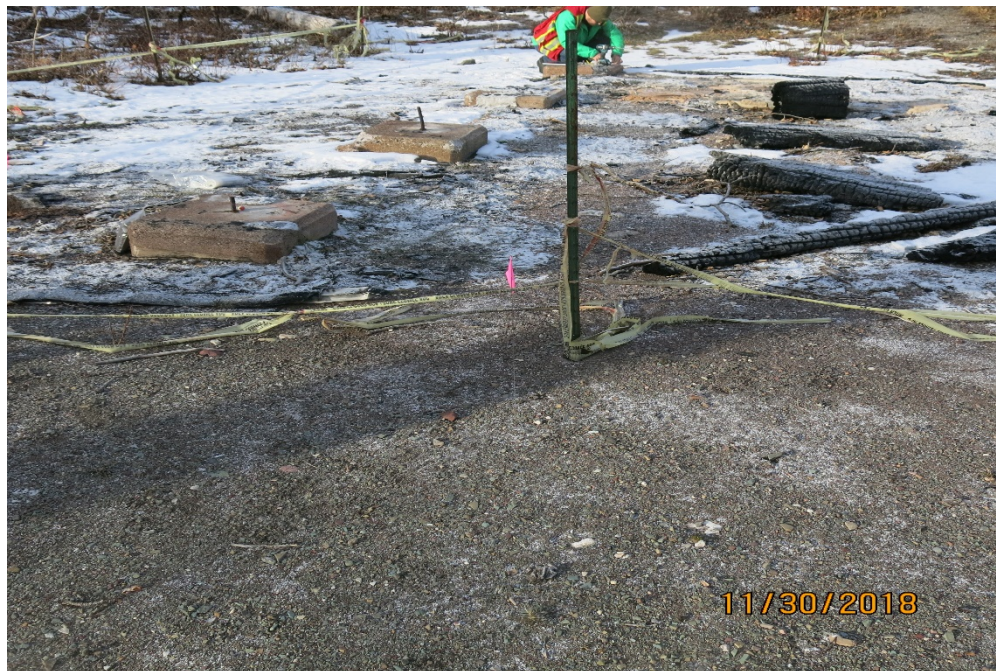
Photo 2.1 D: Location 2.2-2 depicting the south side delineation sample of the kitchen shelter.

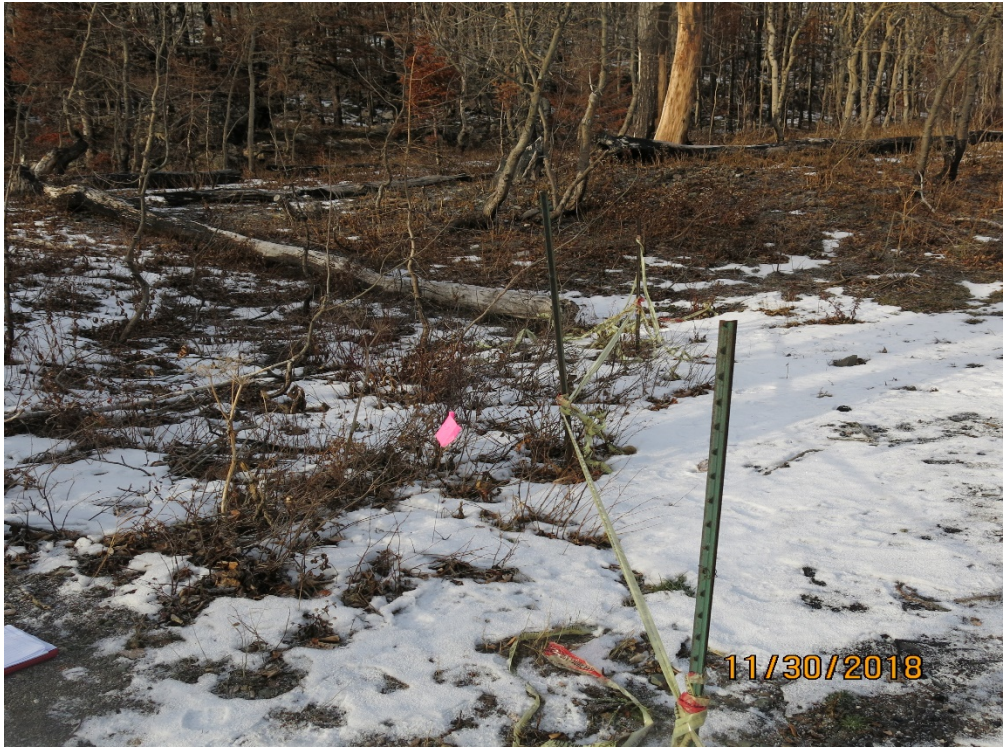
Photo 2.1 E: Location 2.1-3 depicting the west side delineation sample of the kitchen shelter.

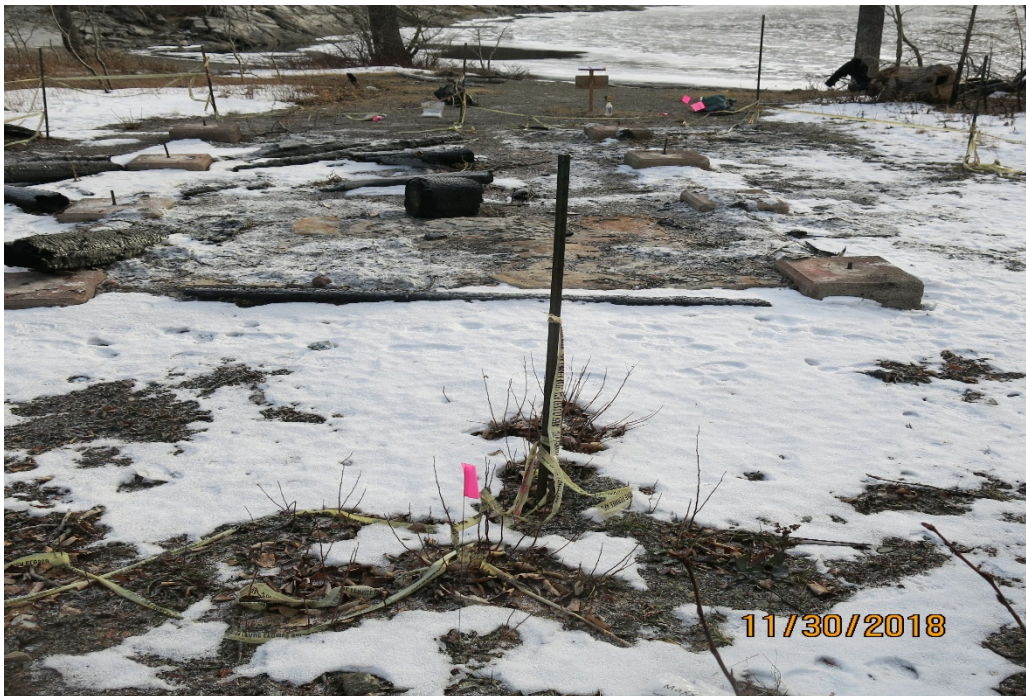
Photo 2.1 F: Location 2.1-4 depicting the north side delineation sample of the kitchen shelter.

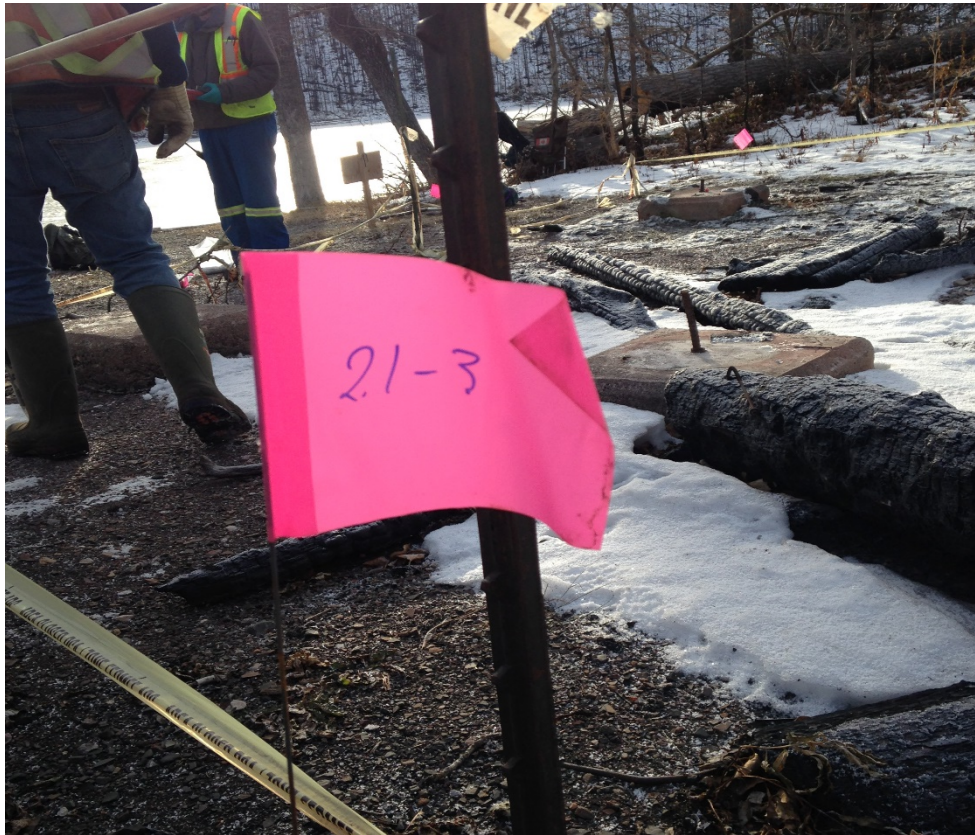
Photo 2.1 G: Location 2.1-3 depicting the east side delineation sample of the kitchen shelter.

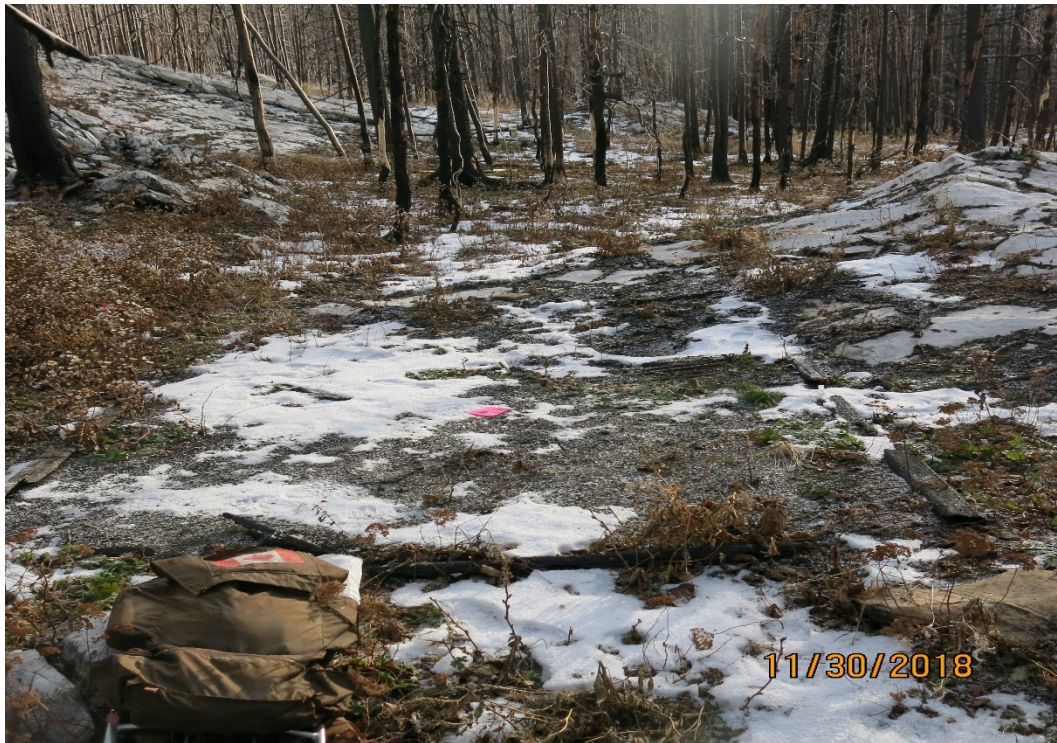
Photo 2.2 A: Location # 1 on the center of the camping pad located furthest to the east of the campground.

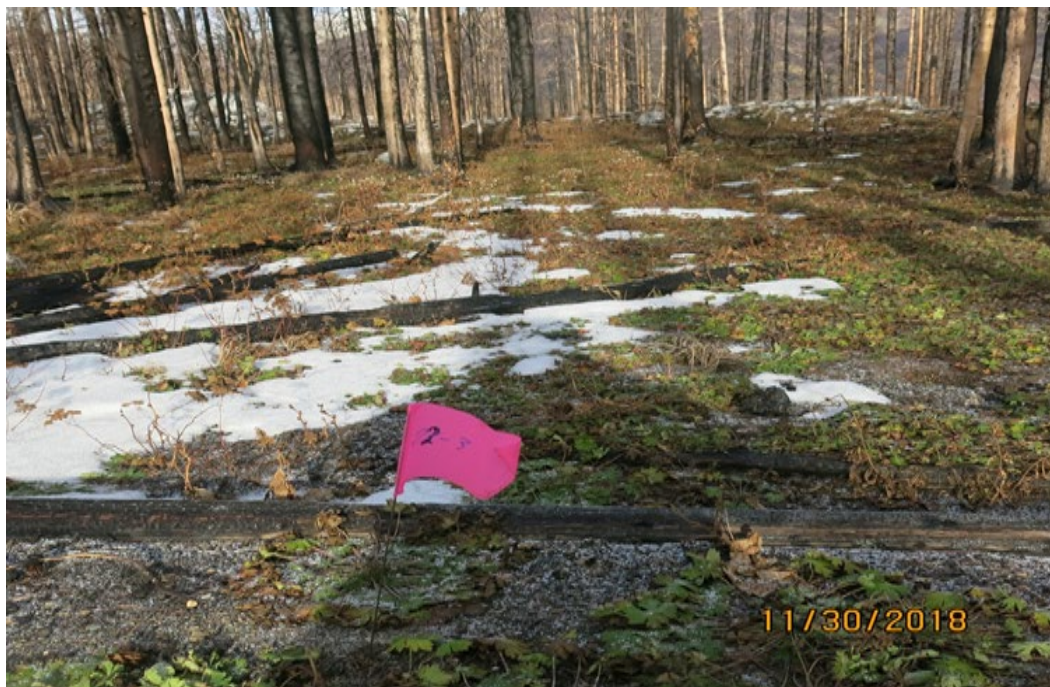
Photo 2.2 B: Location # 2 on the center of the camping pad located furthest to the north of the campground.

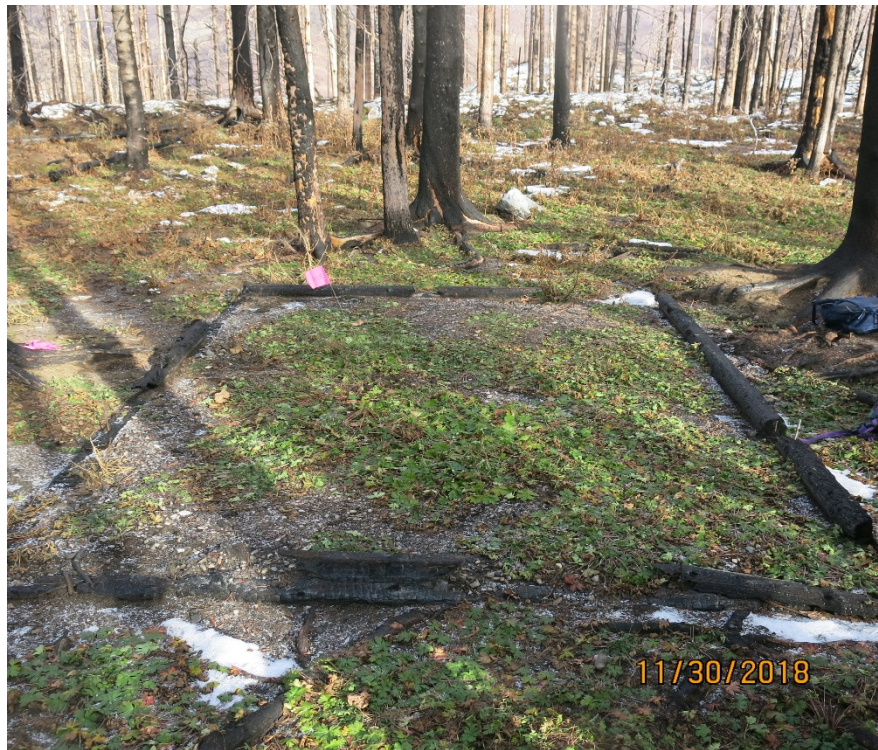
Photo 2.2 C: Location # 3 on the center of the camping pad located directly north of the lake.
