SPECIFICATIONS
for

Waterton Remediation and Abatement – 11 Sites

Waterton Lakes National Park, Alberta

Project No. _____ February 2020

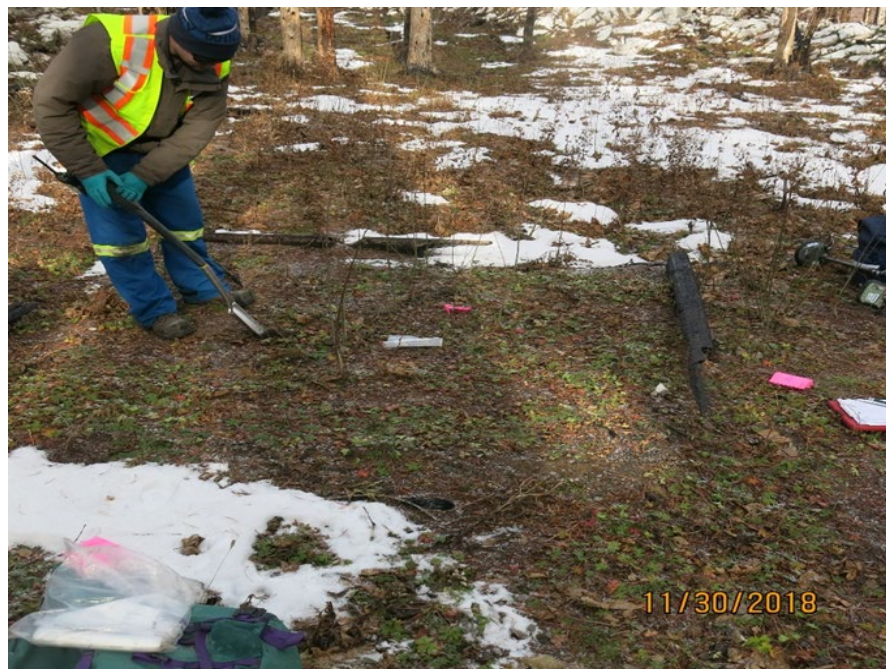
Photo 2.2 D: Location # 4 on the center of the camping pad located furthest to the east of the campground.

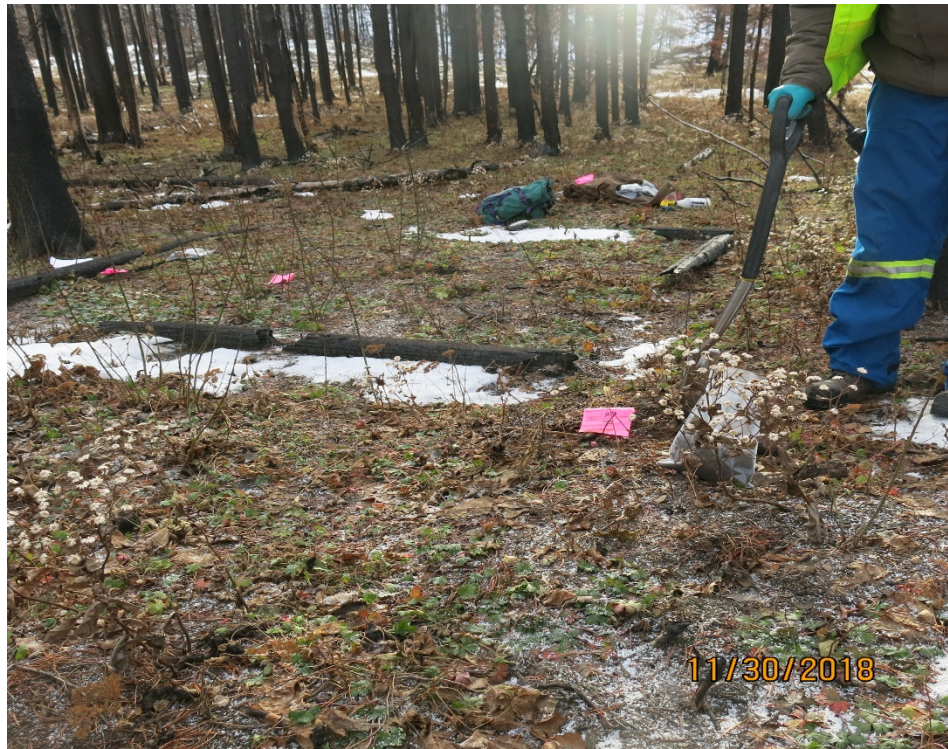
Photo 2.2 E: Location # 5 on a camping pad furthest south of the campground.

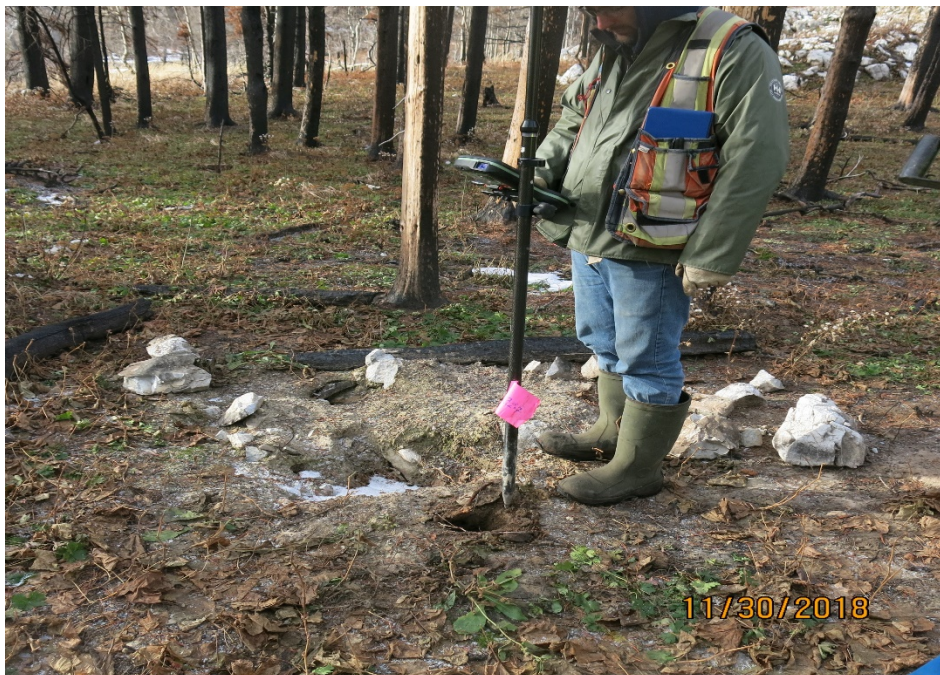
Photo 2.2 F: Sample location # 6 on the west side of all the campsites under the largest pile of debris observed at the site of the previous outhouse.

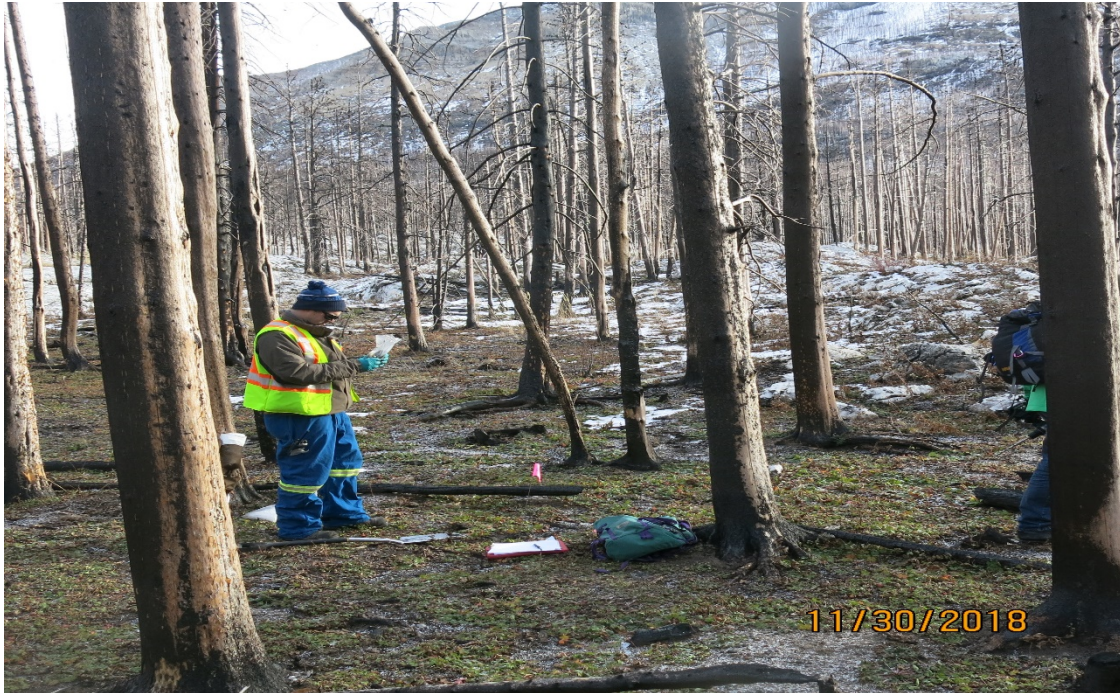
Photo BG-1: Back-ground (1) sample taken upslope at the northeast corner of all the campsites.

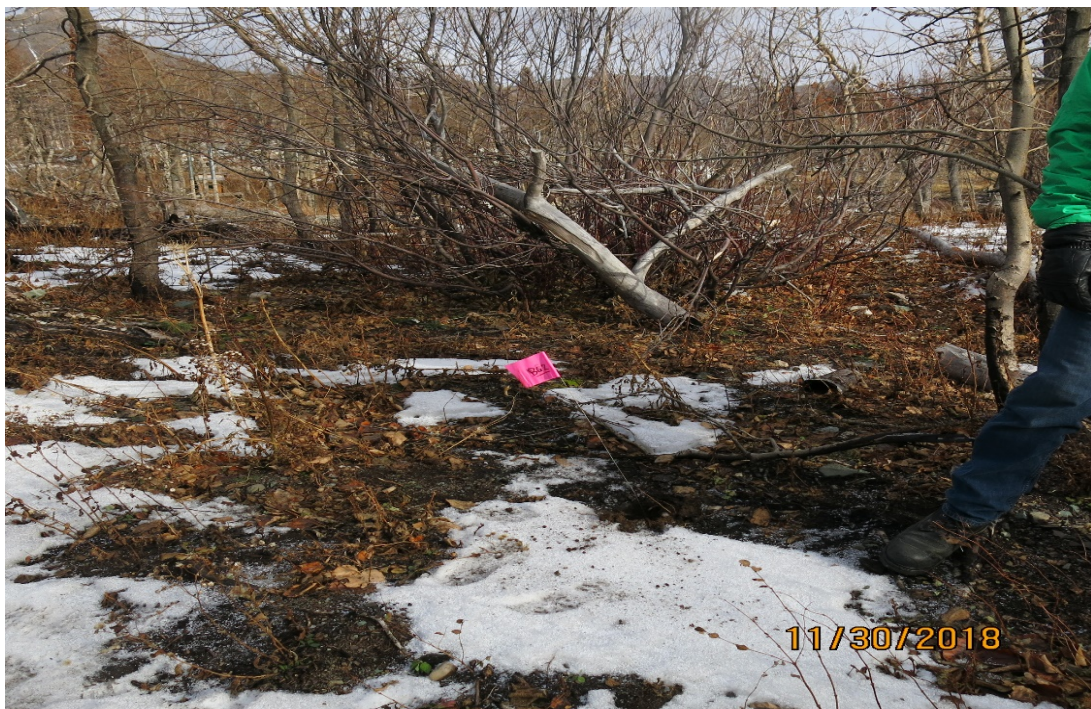
Photo BG-2: Back-ground (2) sample taken downslope at the southwest corner of the campground.

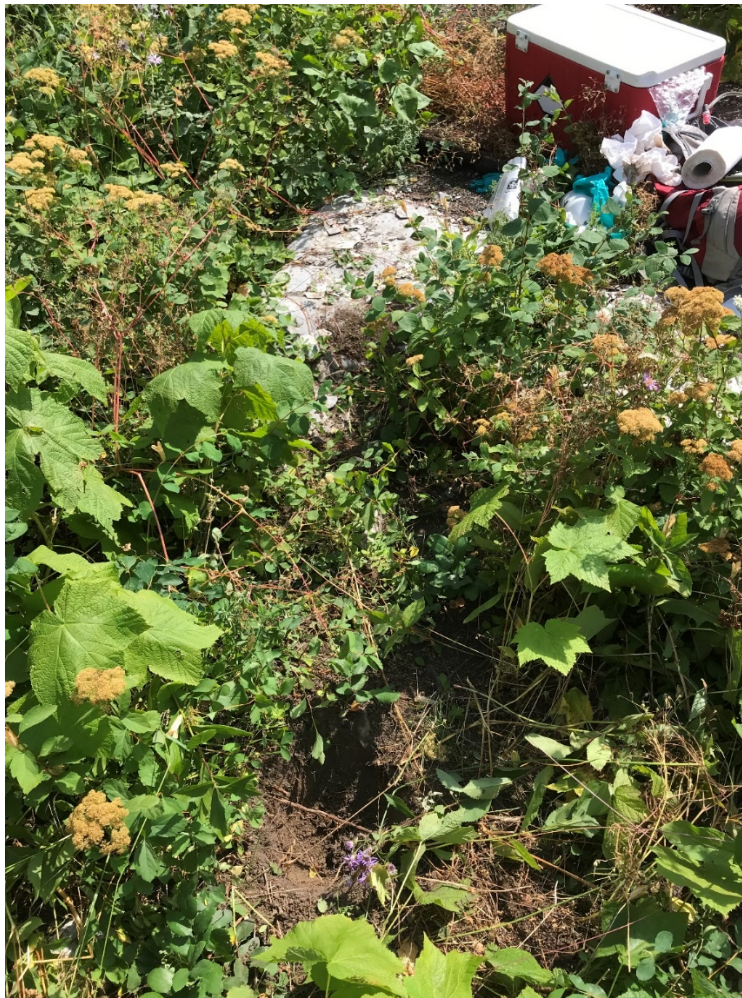
Photo 2.2 A: 2.2-A: Delineation sample location 2.2-17.

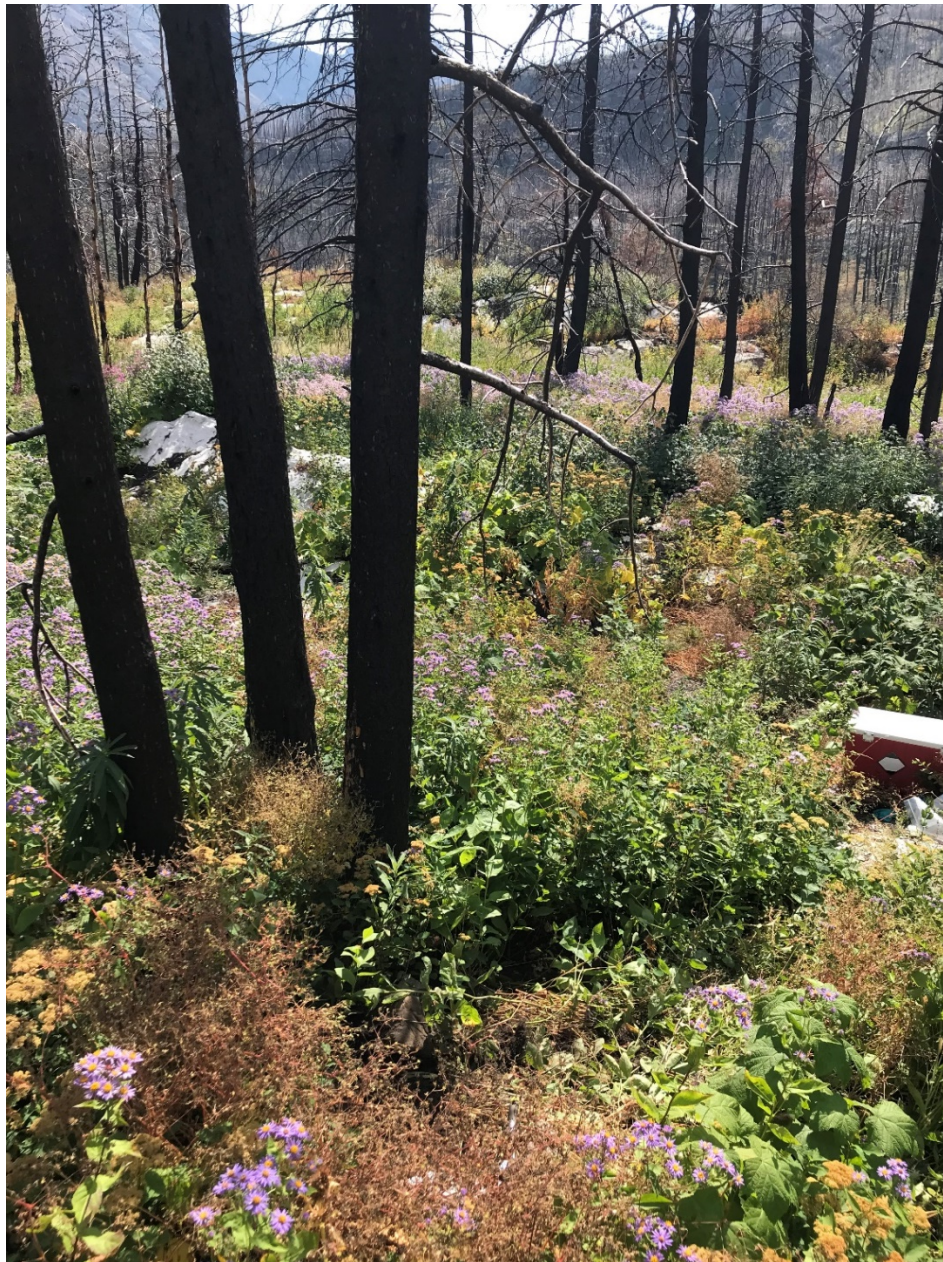
Photo 2.2 B: General location of delineation sample 2.2-16.

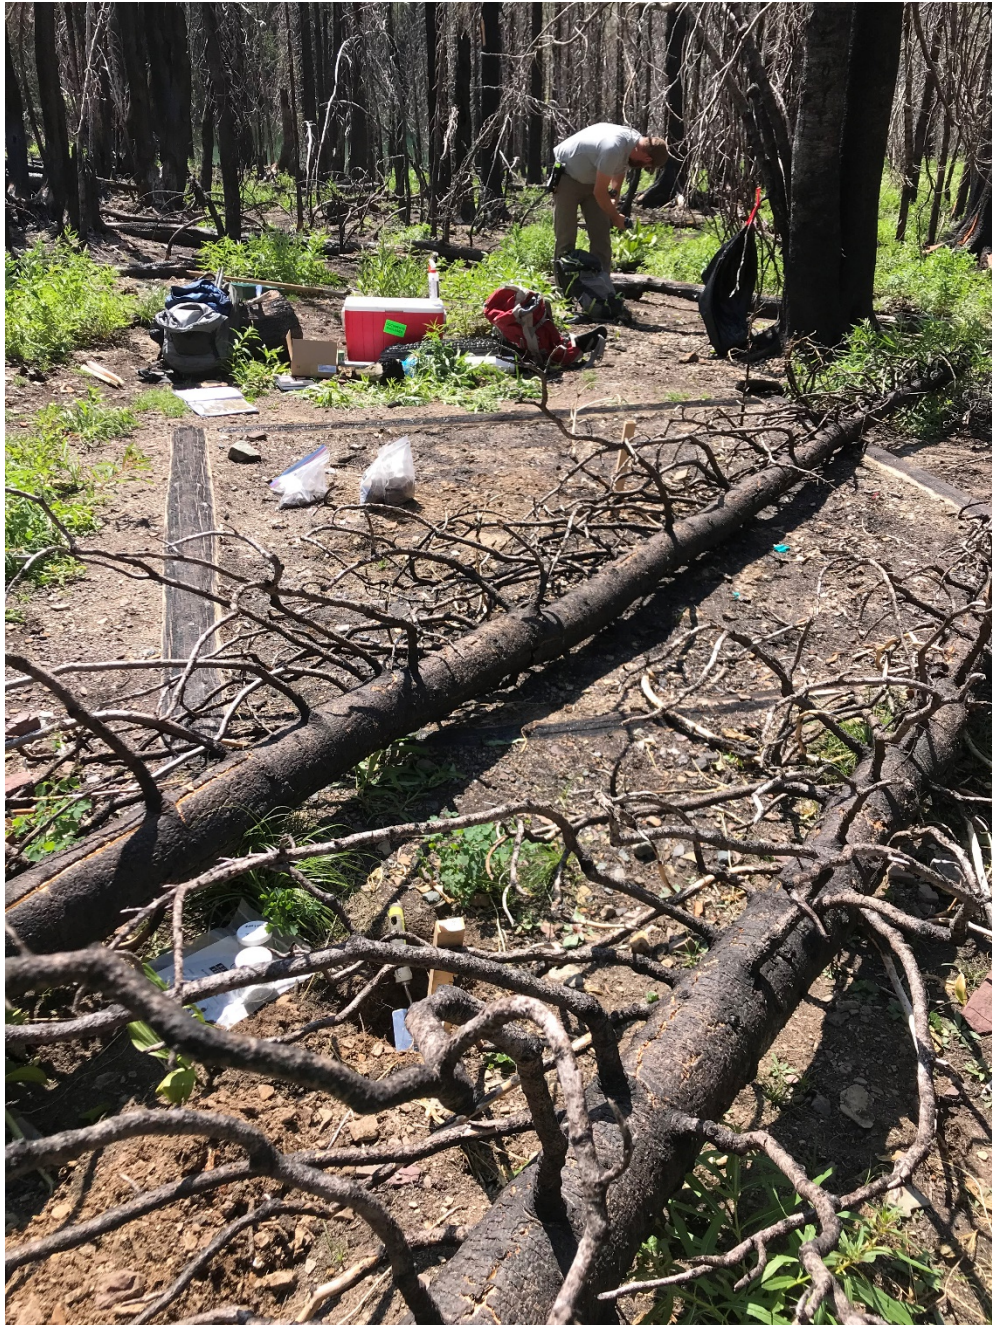
Photo 4.1A Location of sample 4.1-1 in the centre of a tent pad.

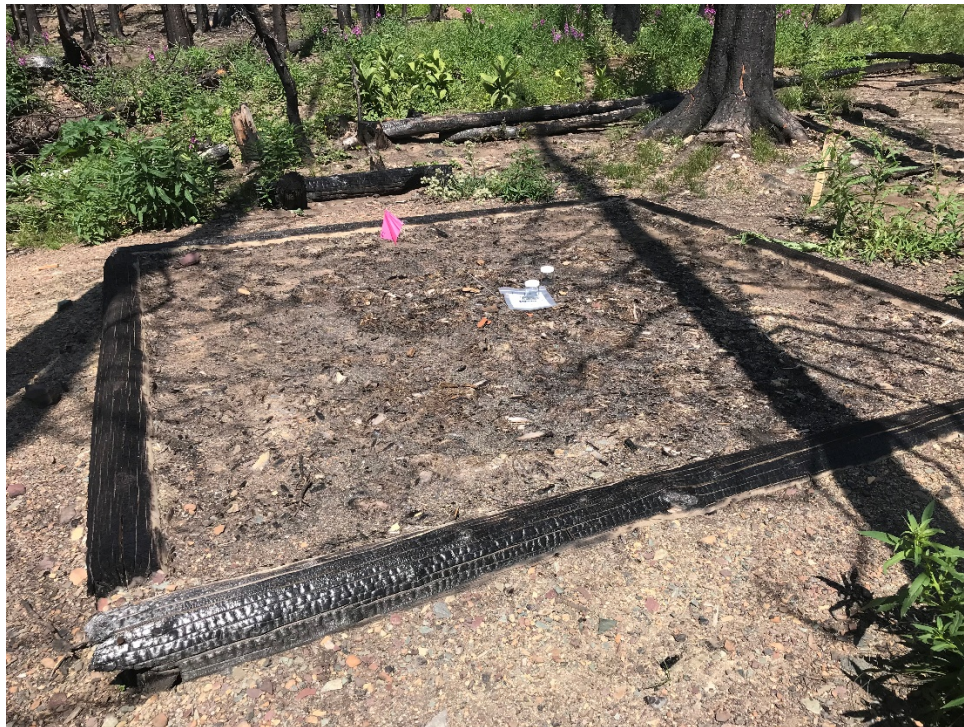
Photo 4.1 B: Location of sample 4.1-3 in the centre of a tent pad.

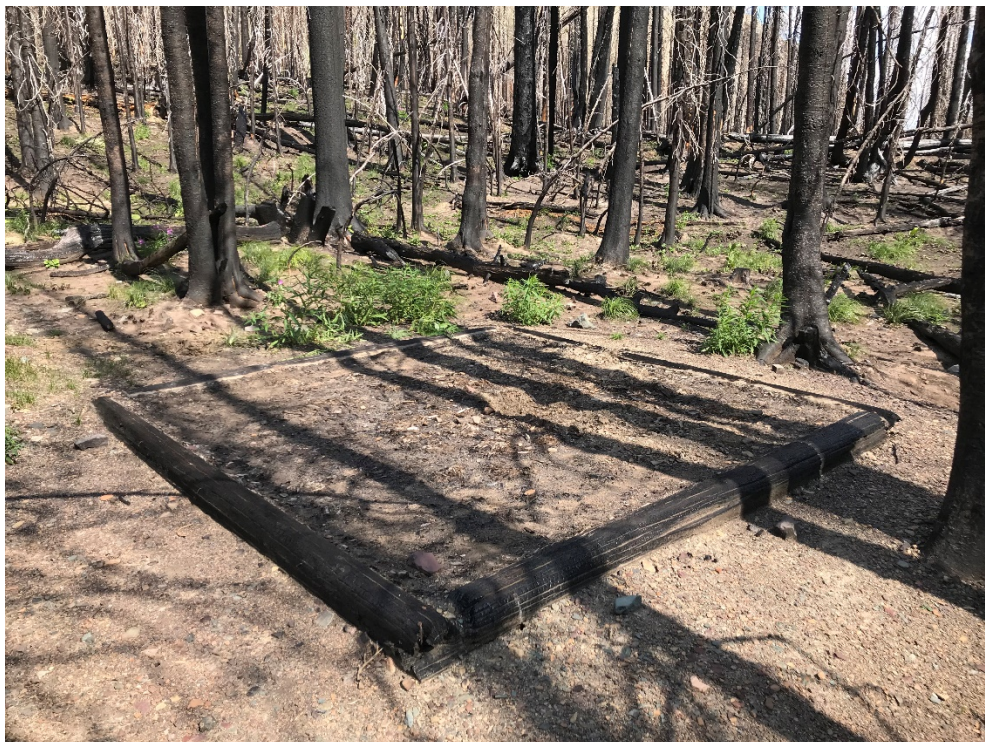
Photo 4.1 C: Location of sample 4.1-5 in the centre of a tent pad.

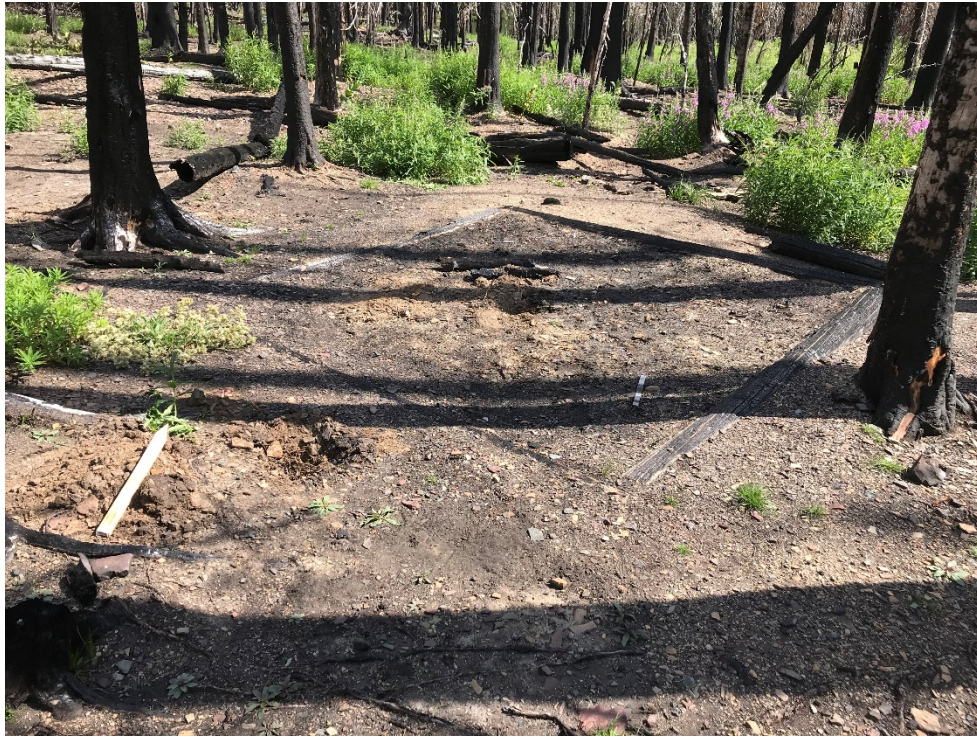
Photo 4.1 D: Location of sample 4.1-7 in the centre of a tent pad.

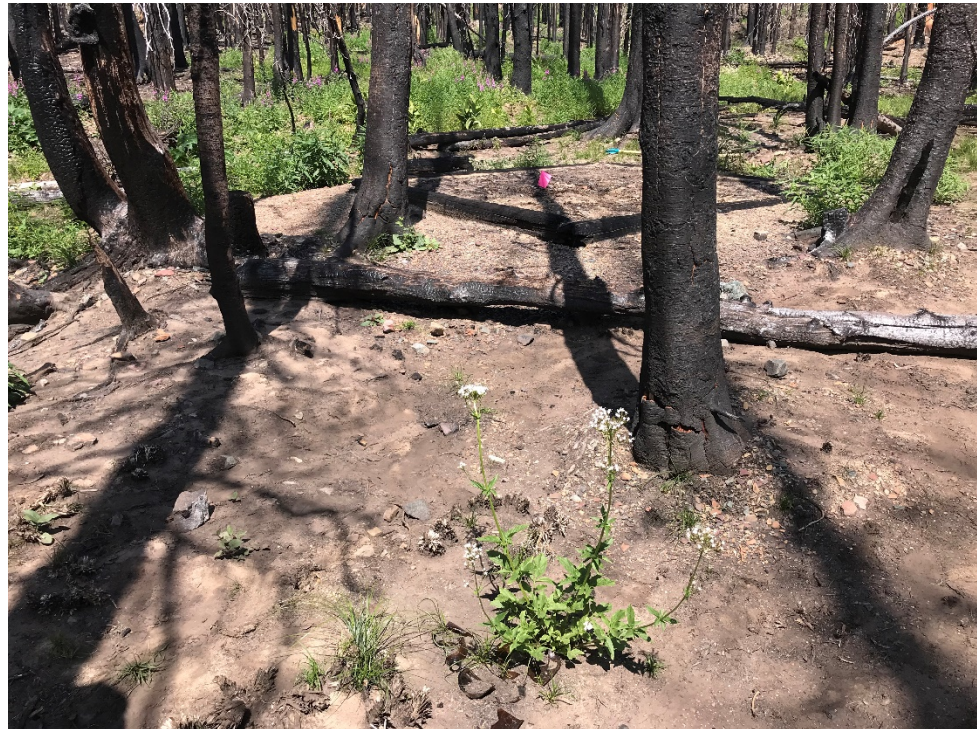
Photo 4.1 E: Glass debris around one of the tent pads.

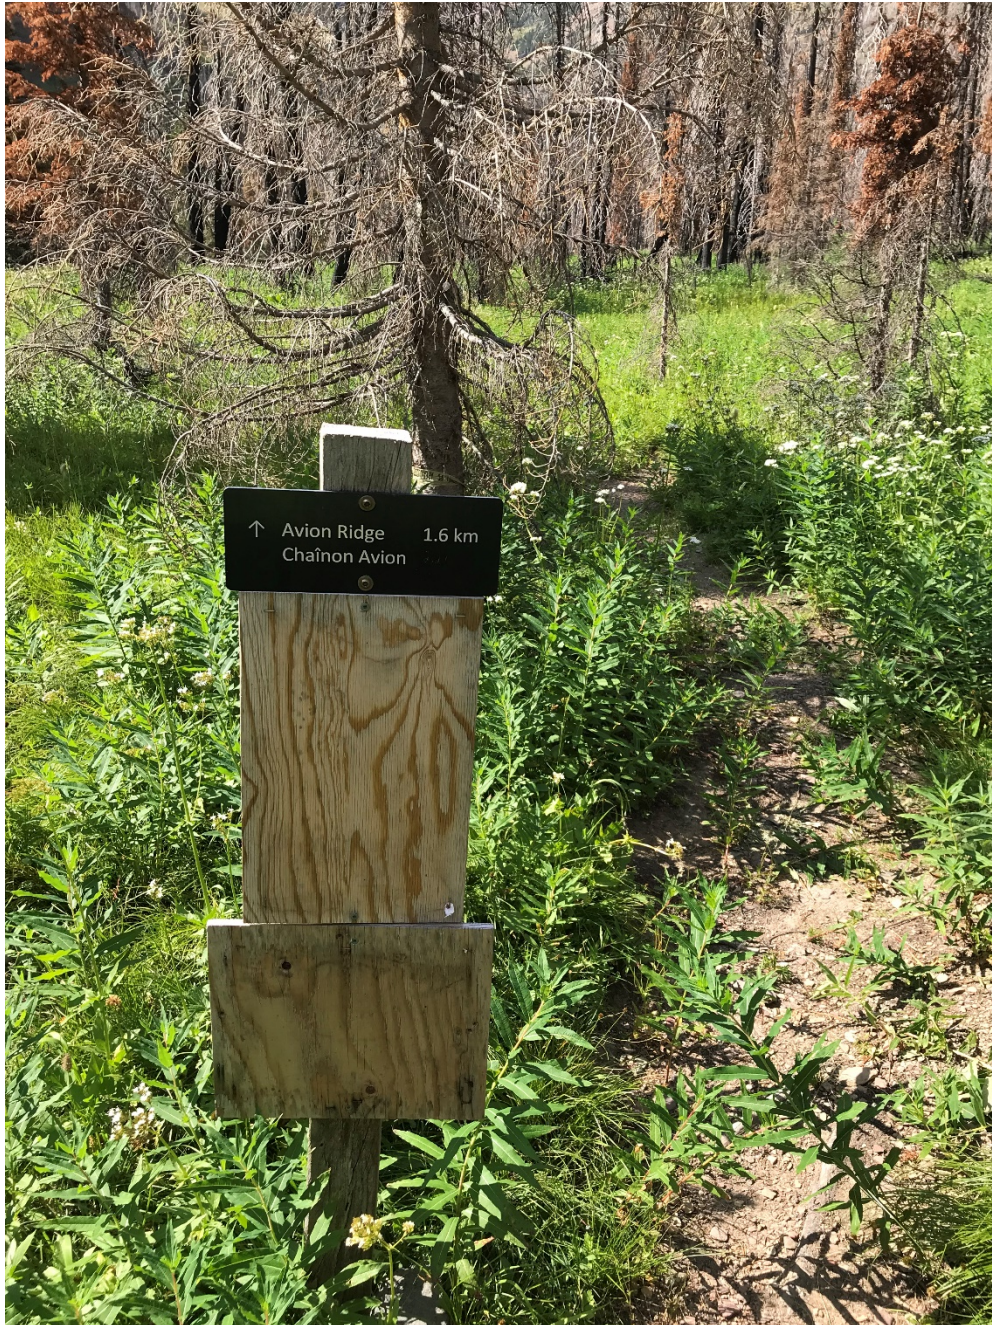
Photo 4.1 G: Campground location sign.

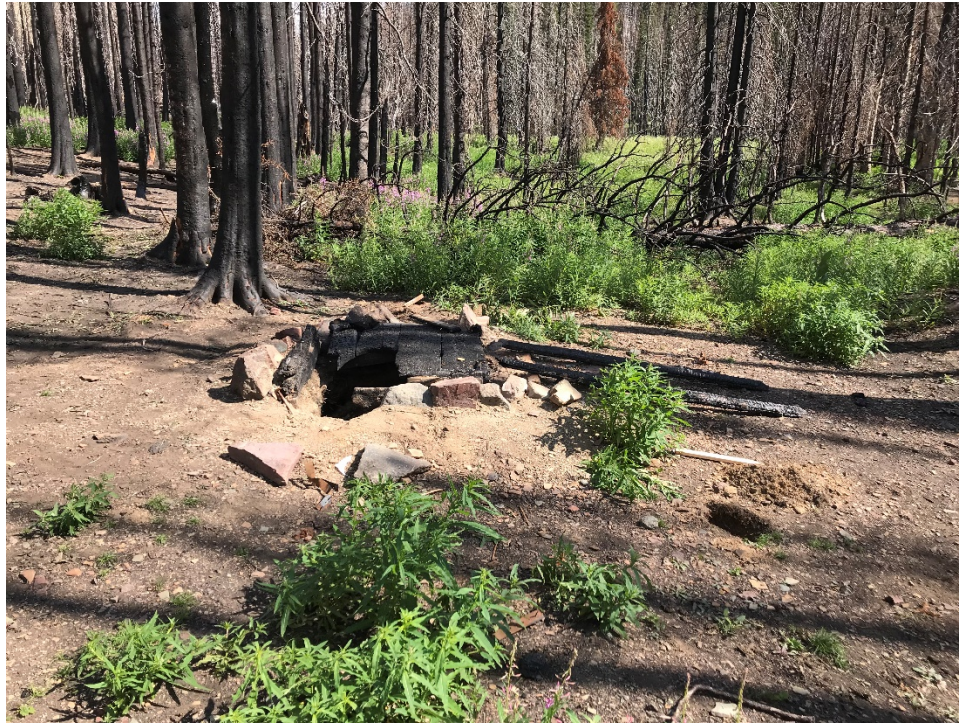
Photo 4.2 A: The former outhouse structure and vicinity.

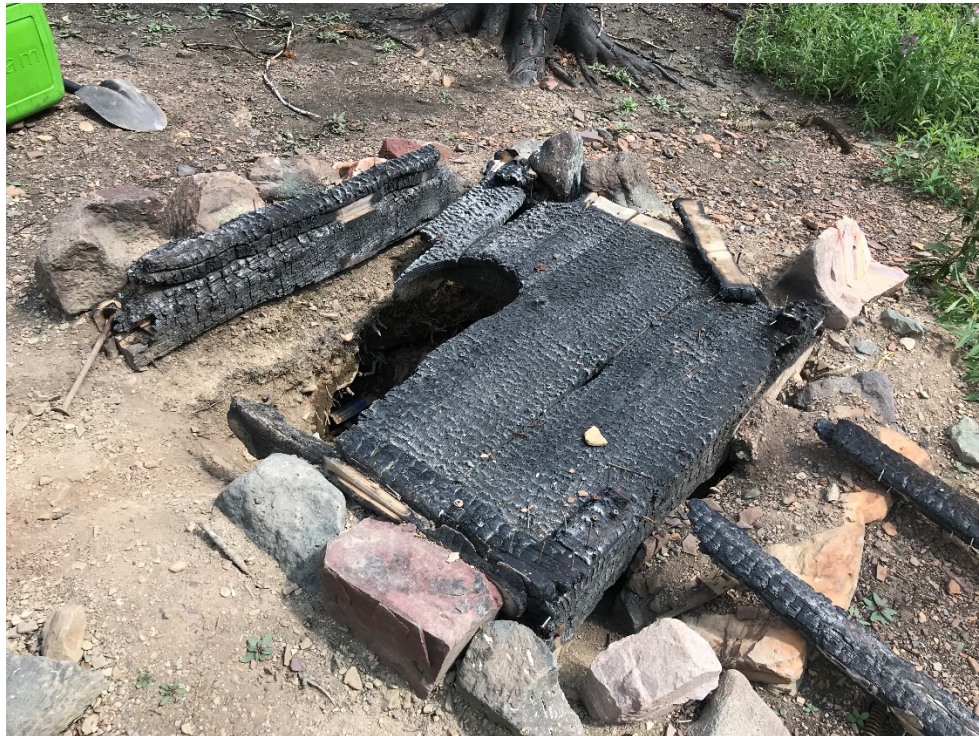
Photo 4.2 B: Debris associated with the outhouse structure.

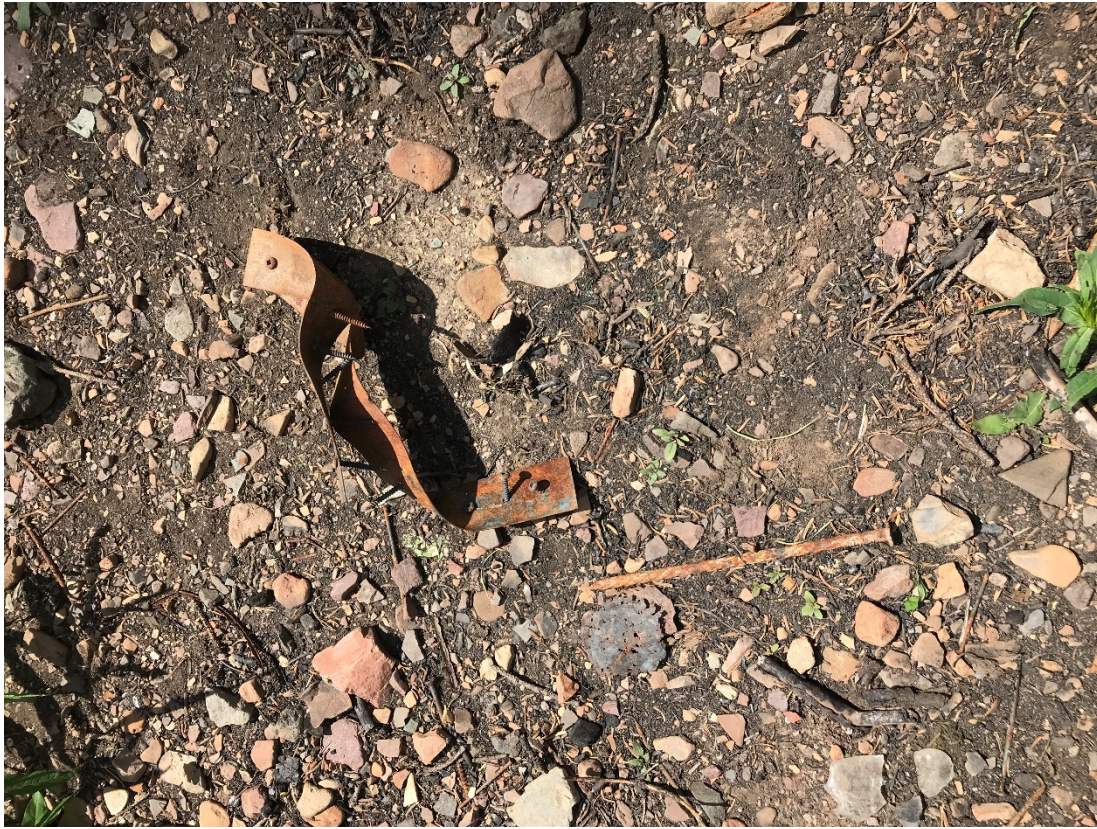
Photo 4.2 C: Minor metal debris associated with the outhouse structure.

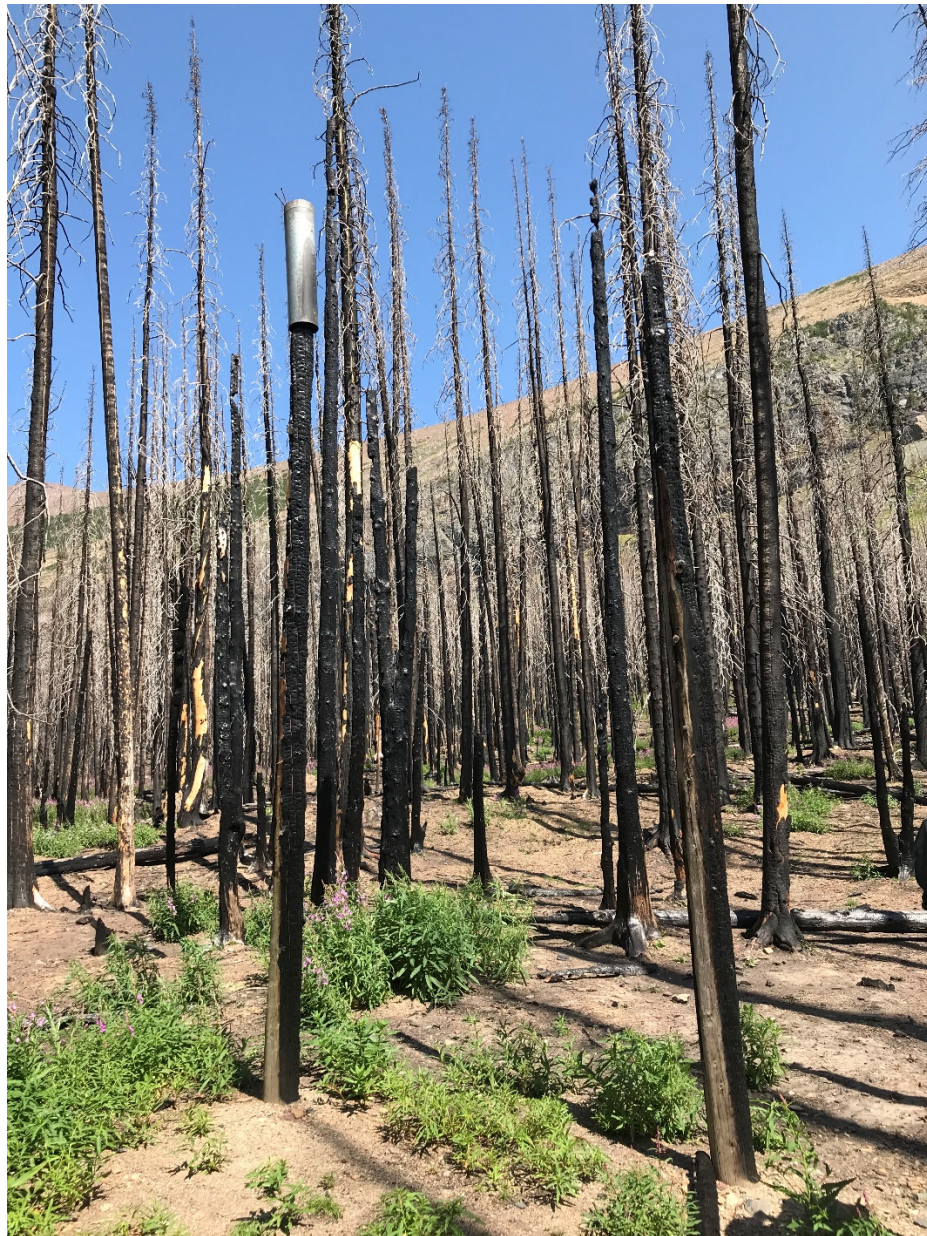
Photo 4.2 D: Remains of the food hang pole.

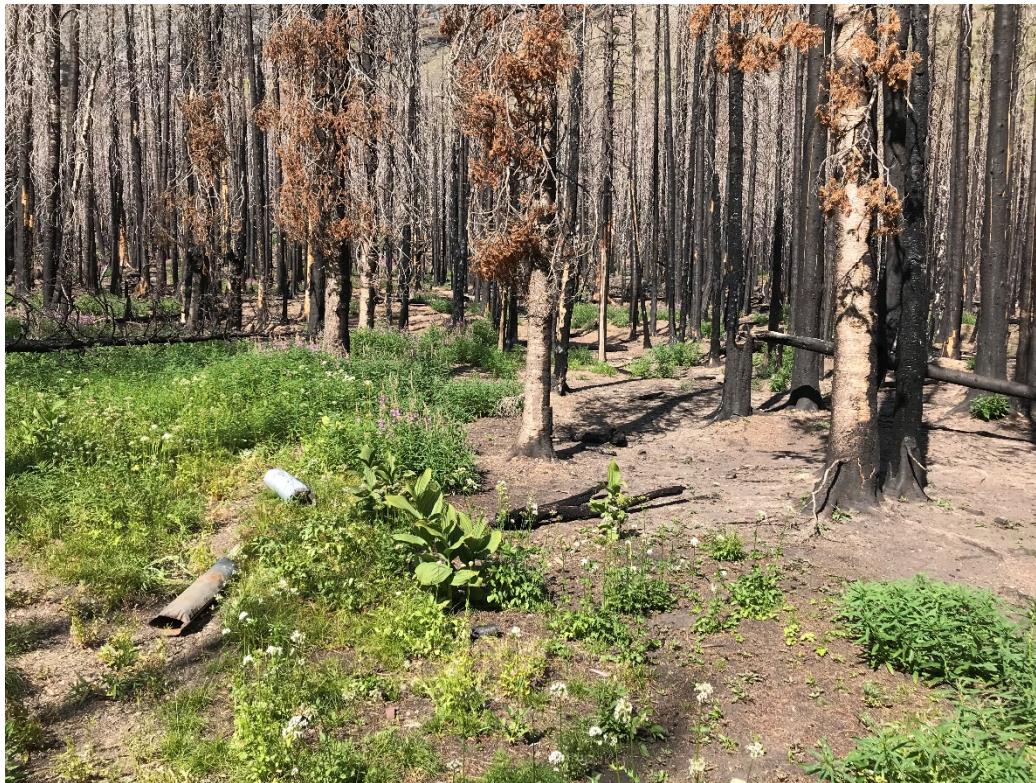
Photo 4.2 E: Remains of the food hang pole.

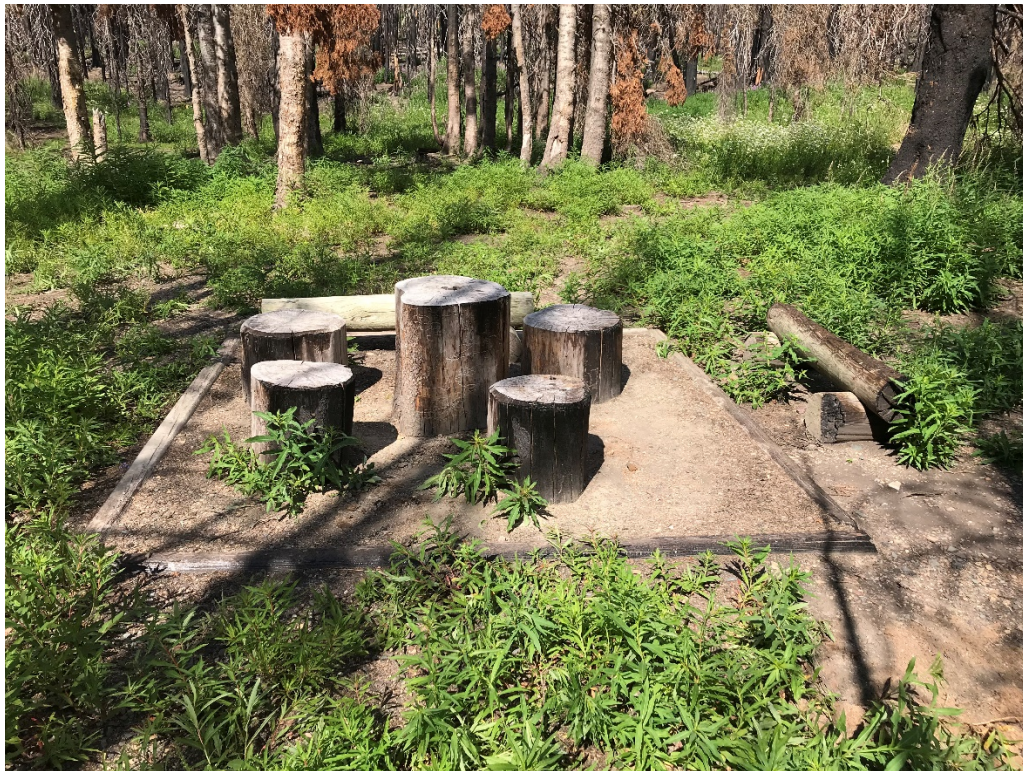
Photo 4.3 A: View of the picnic table and gravel pad. Note the minor superficial burning on the logs.

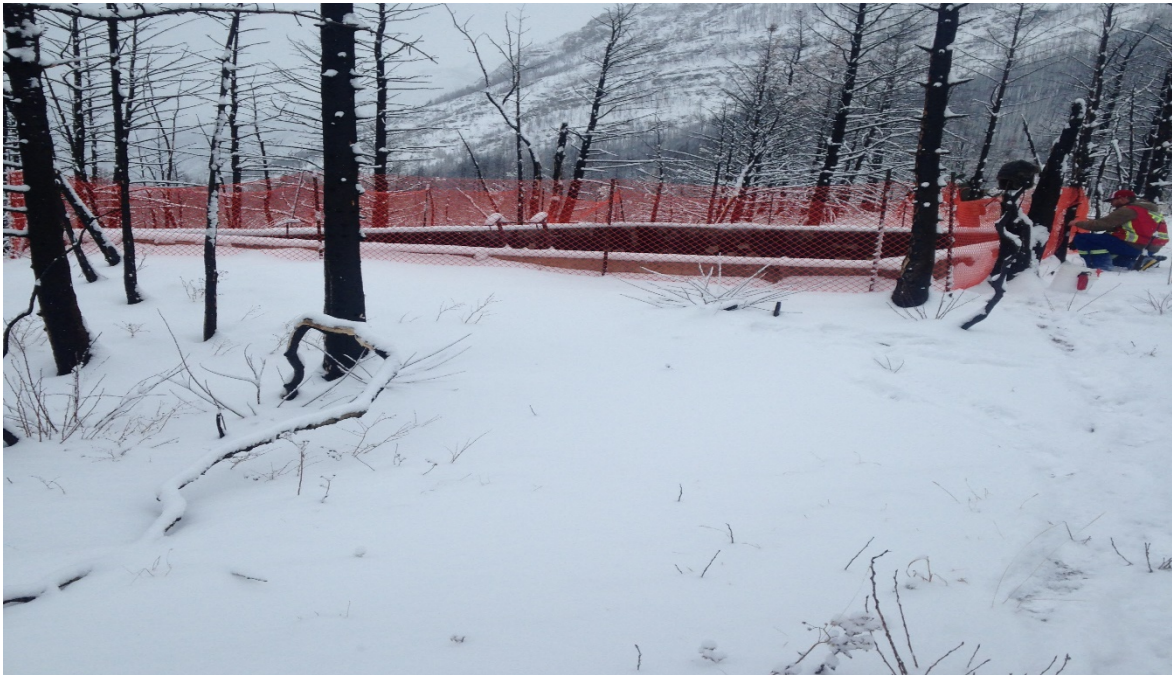
Photo 5.1 A: General overview of the Waterton Lakes Golf Course water reservoir site facing south at the north site boundary.

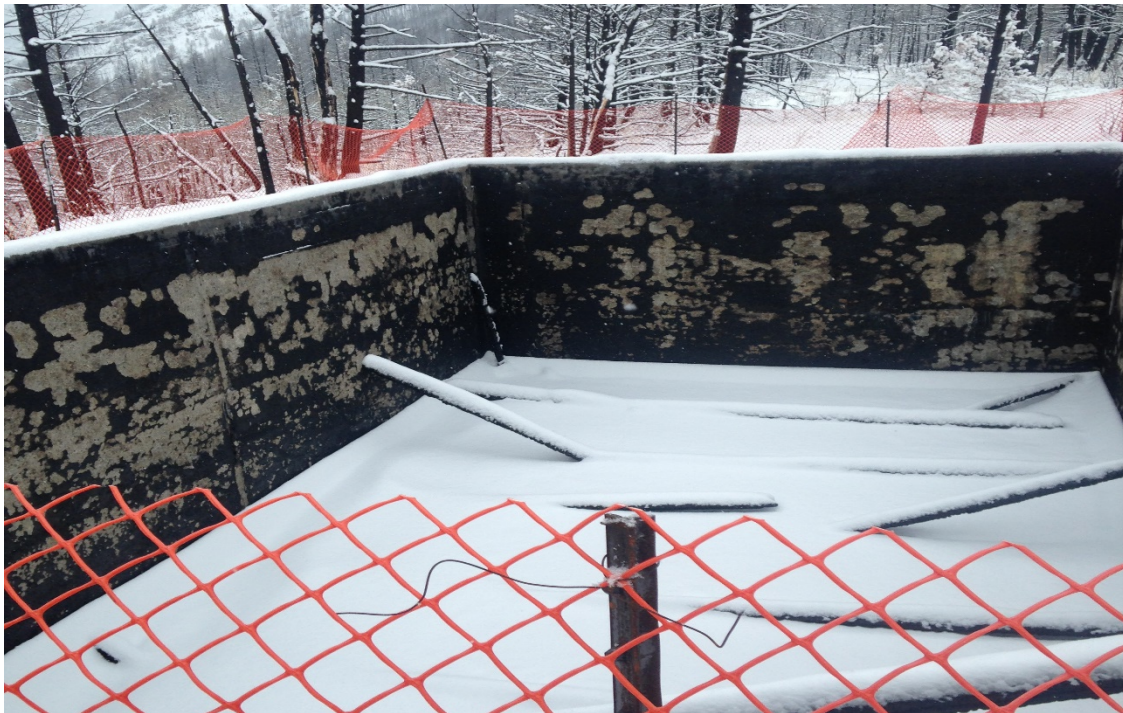
Photo 5.1 B: General overview of metal and wood debris inside the of the Waterton Lakes Golf Course water reservoir facing south from the north site boundary.

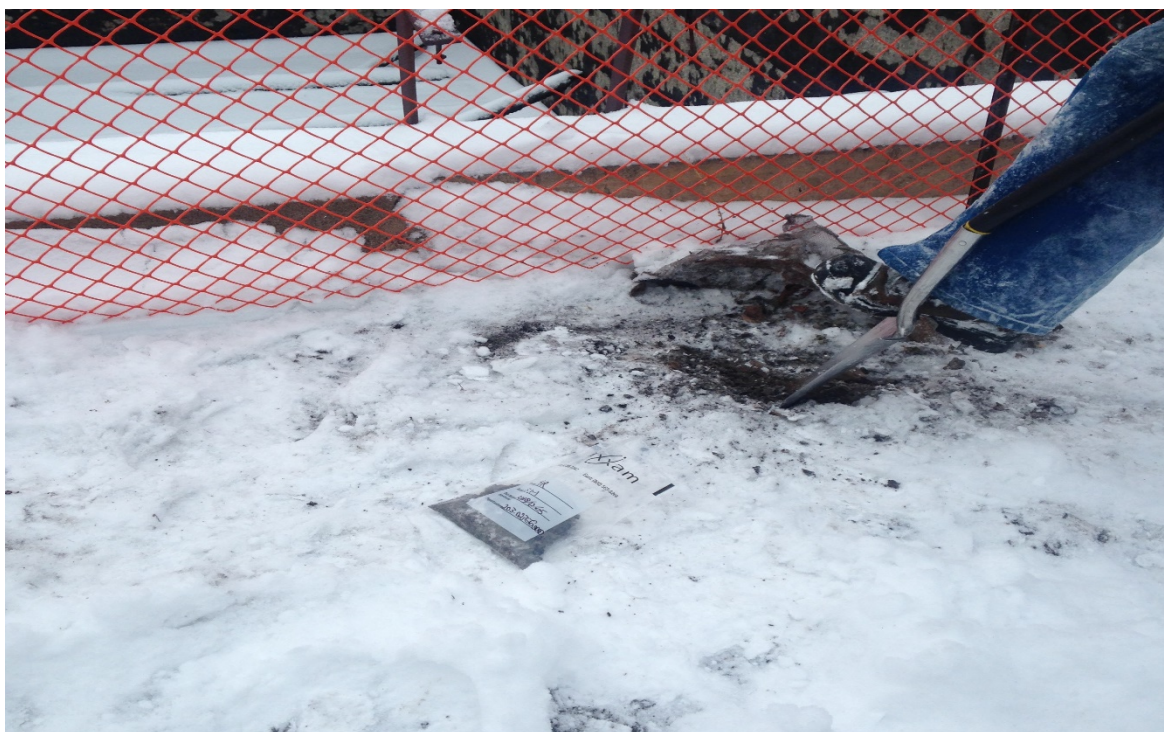
Photo 5.1-1: Sample location # 1 under plastic material debris pile on the north side of the water reservoir.

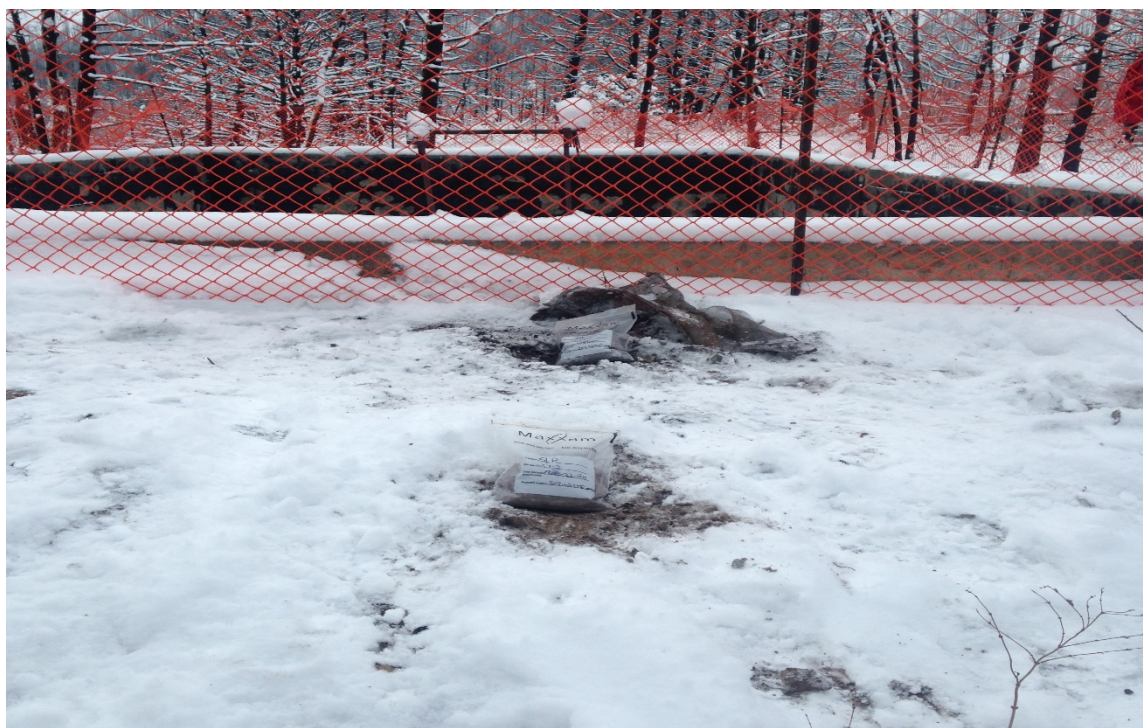
Photo 5.1-2: Location # 2 depicting the north side delineation sample of the water reservoir.

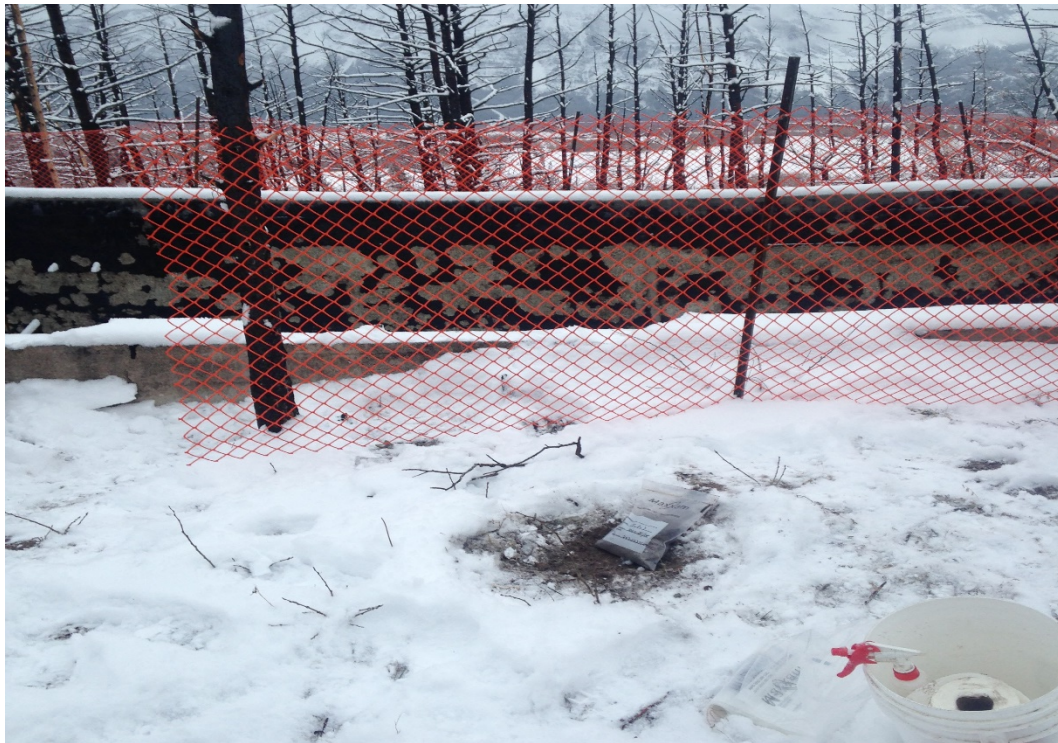
Photo 5.1-3: Location # 3 depicting the west side delineation sample of the water reservoir.

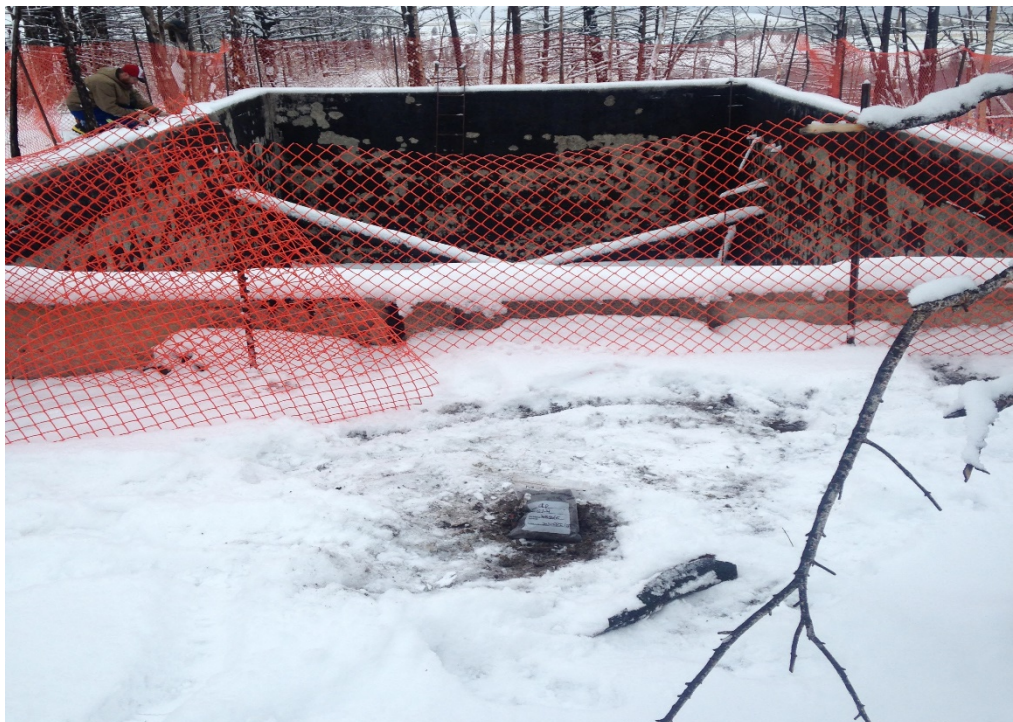
Photo 5.1-4: Location # 4 depicting the south side delineation sample of the water reservoir.

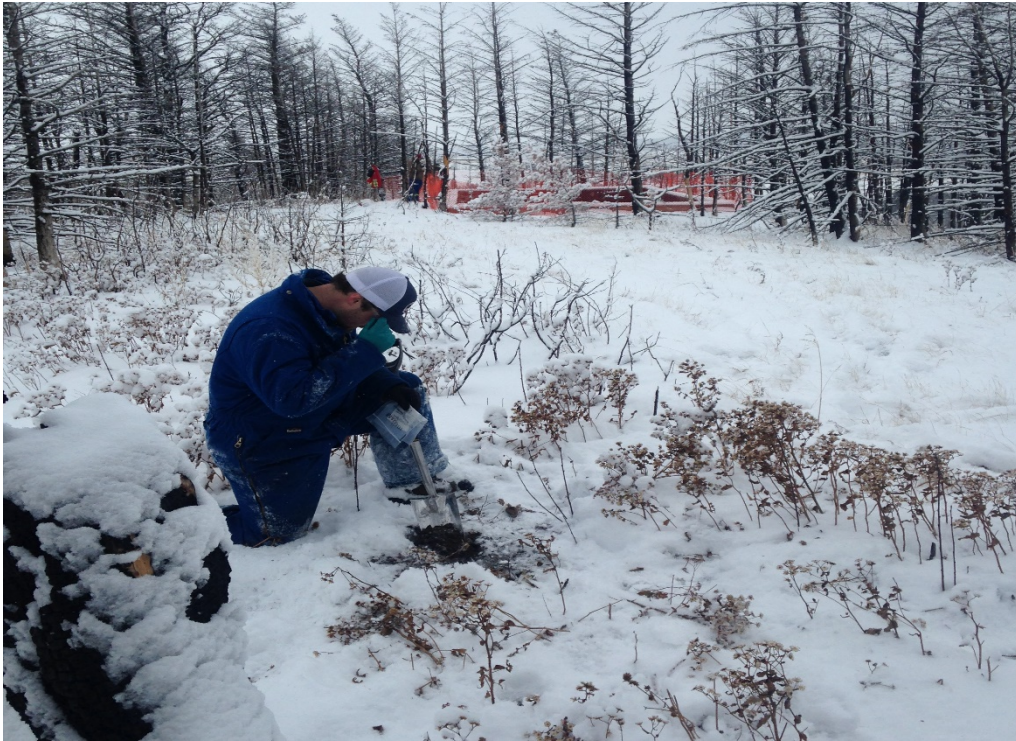
Photo BG-5: Location # 5 depicting the background sample taken on the southeastern side of the water reservoir.

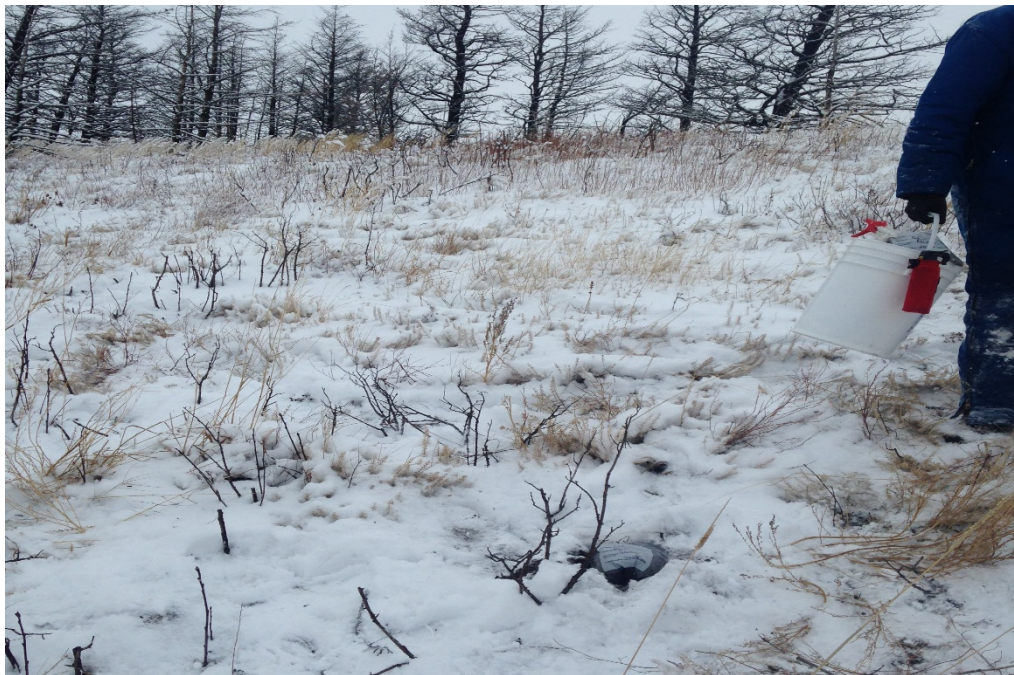
Photo BG-6: Location # 6 depicting the background sample taken on the northeastern side of the water reservoir.
