SPECIFICATIONS
for

Waterton Remediation and Abatement – 11 Sites

Waterton Lakes National Park, Alberta

Project No. _____ February 2020

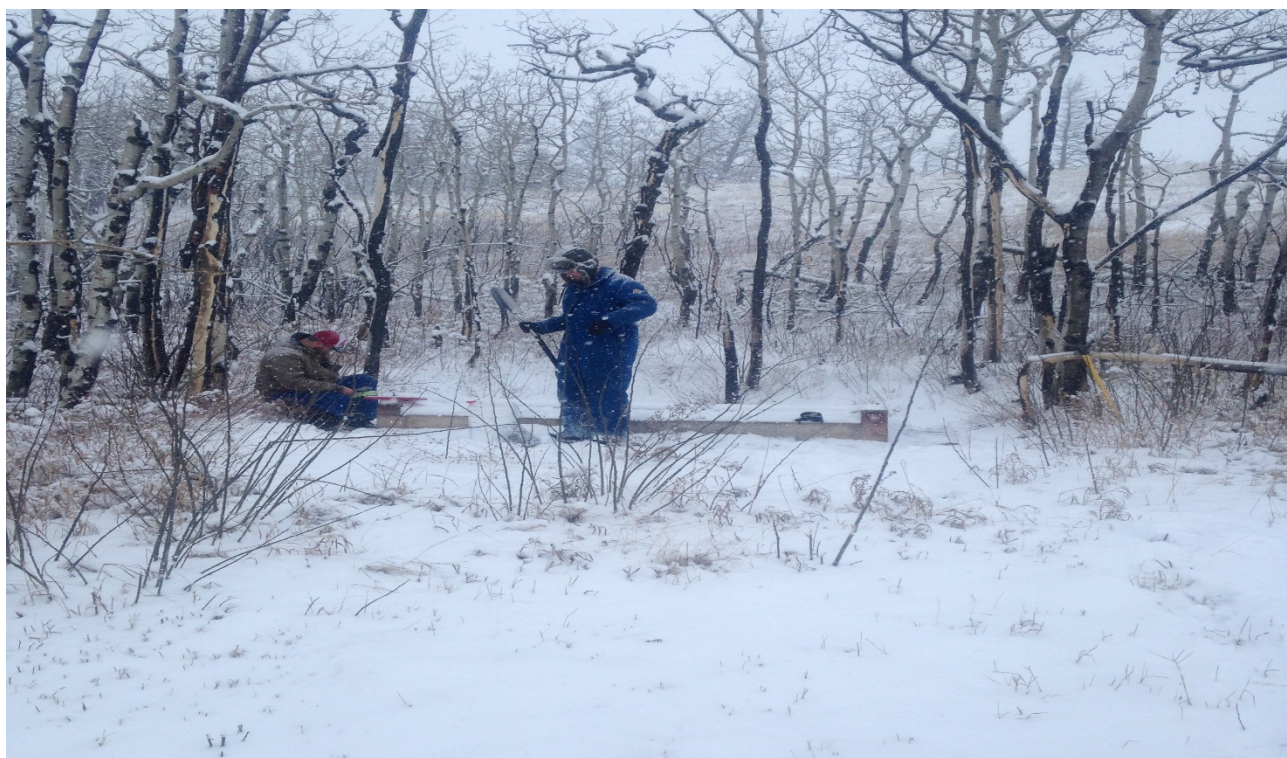
Photo 5.2 A: General overview of the Waterton Lakes Golf Course lightning shelter shed facing west at the east site boundary.

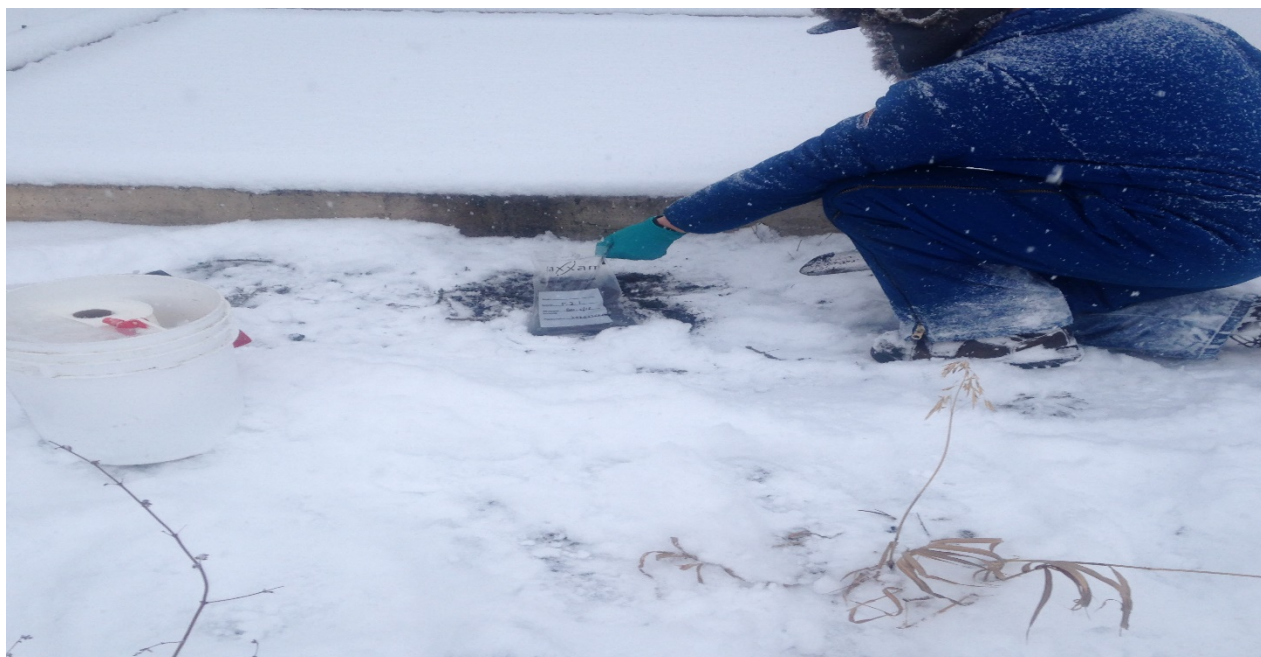
Photo 5.2-1: Sample location # 1 under melted shingle debris pile on the east side of the lightning shelter shed.

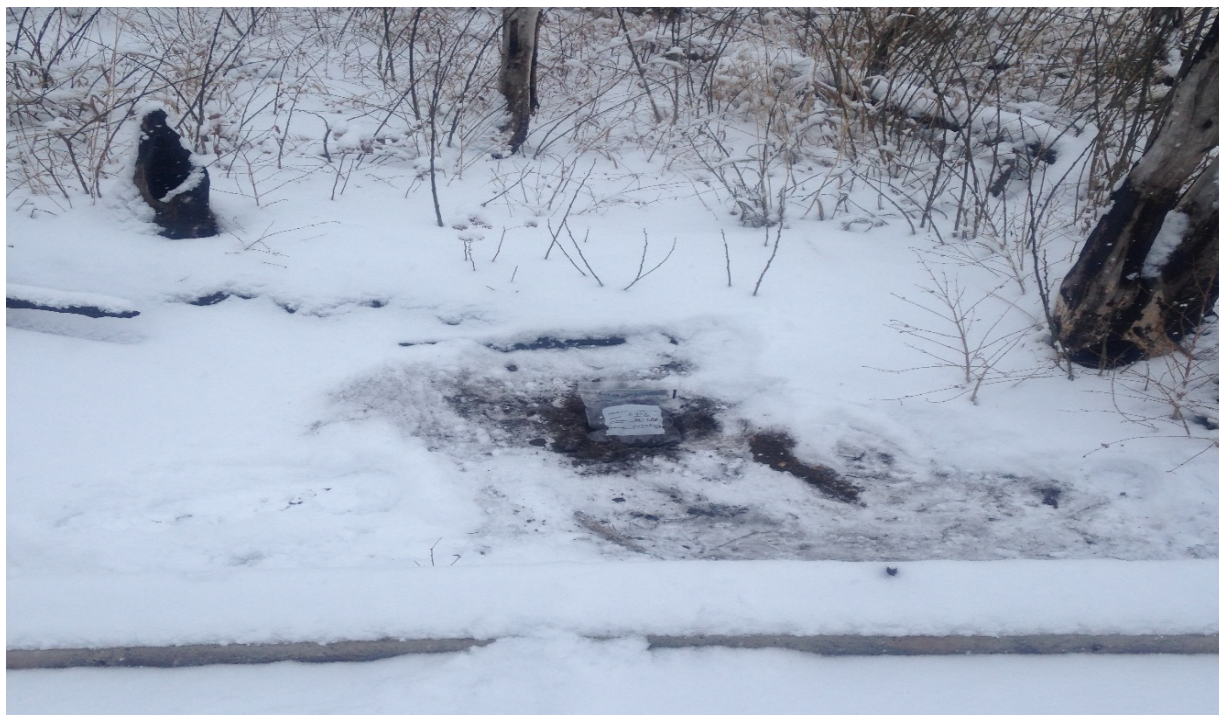
Photo 5.2-2: Location # 2 depicting the west side delineation sample of the lightning shelter shed.

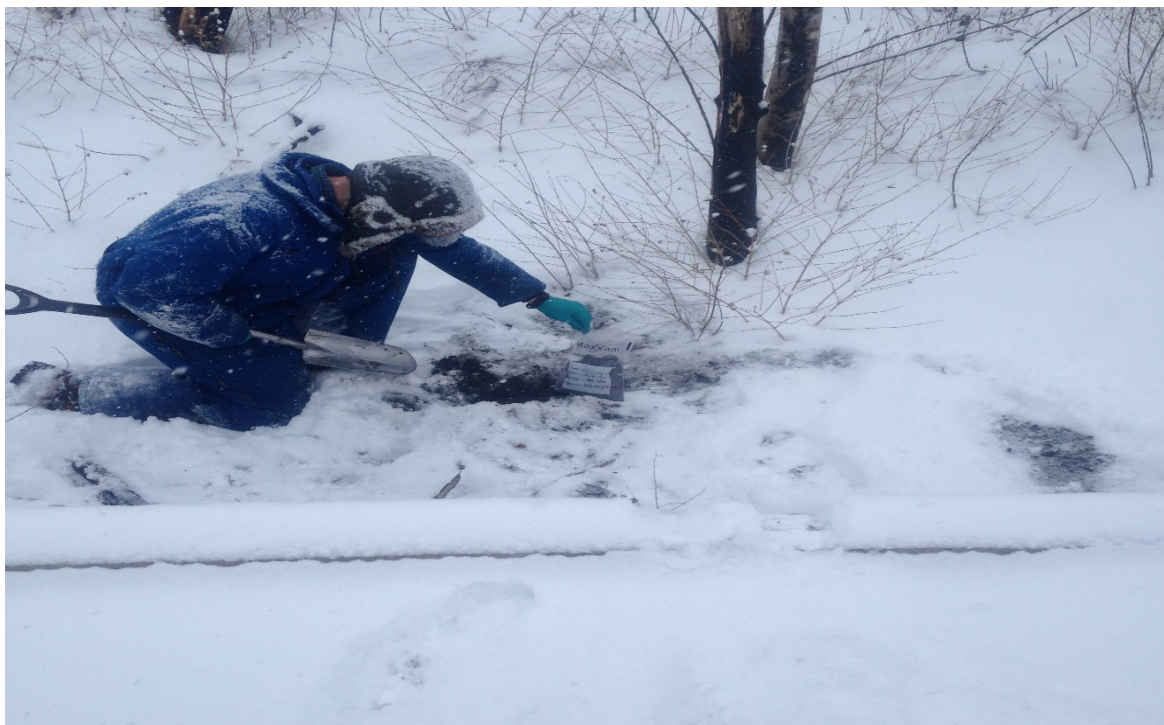
Photo 5.2-3: Location # 3 depicting the north side delineation sample of the lightning shelter shed.

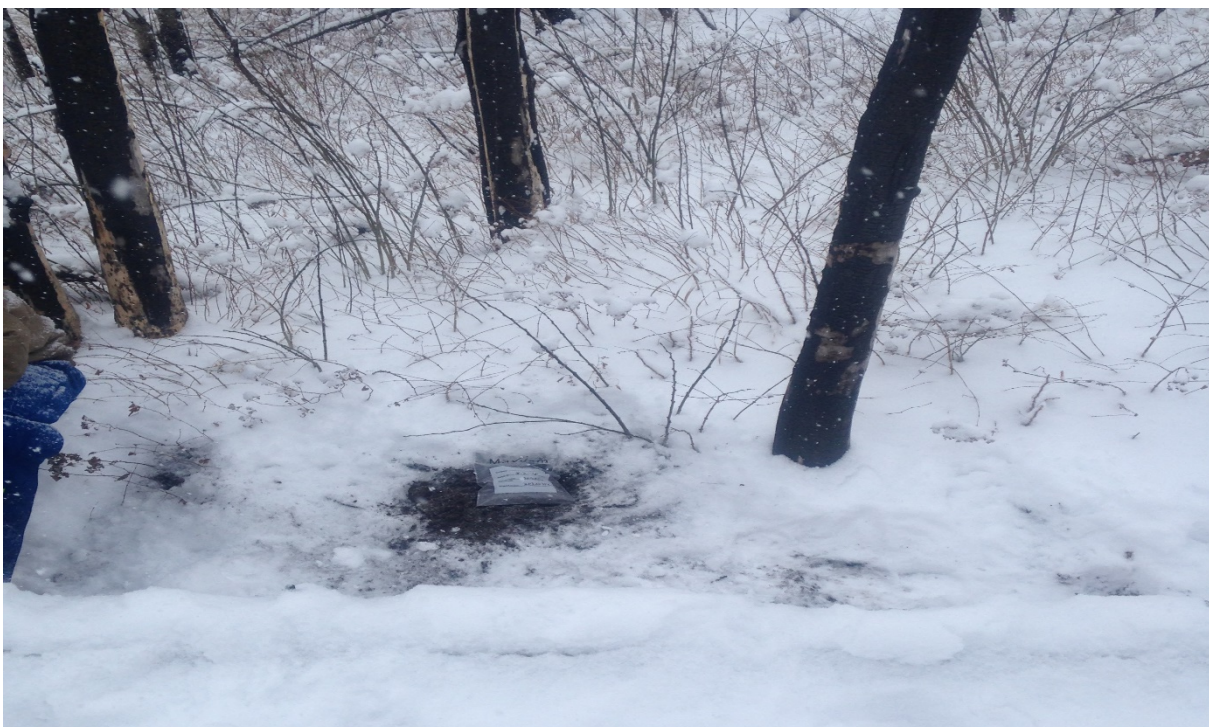
Photo 5.2-4: Location # 4 depicting the south side delineation sample of the lightning shelter shed.

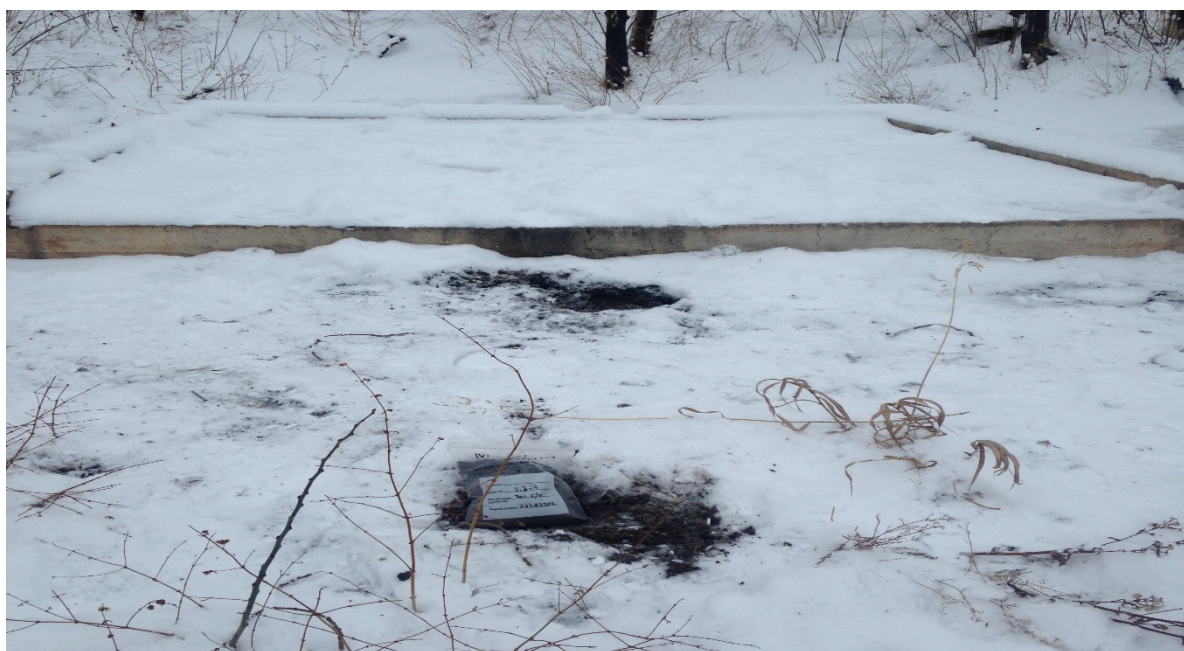
Photo 5.2-5: Location # 5 depicting the east side delineation sample of the lightning shelter shed.

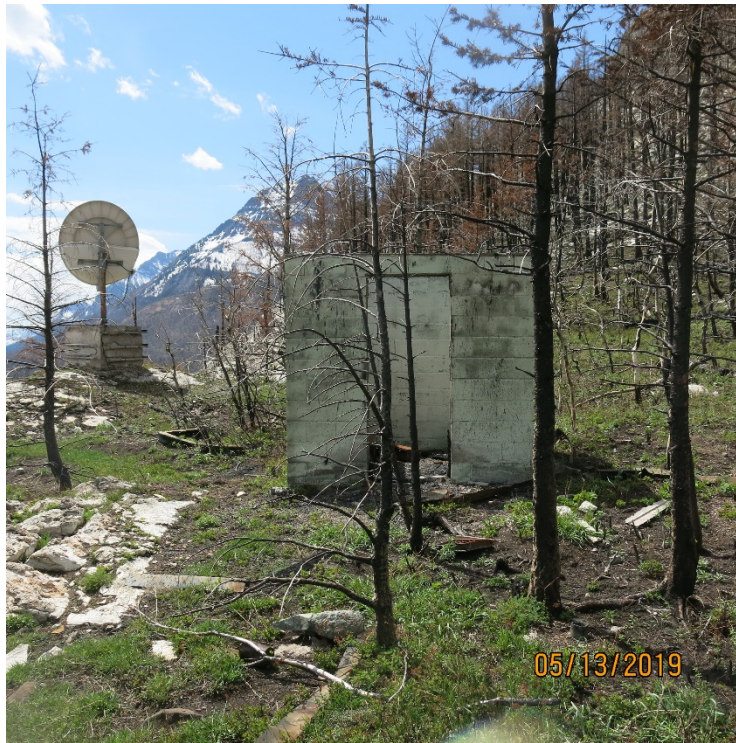
Photo 6.1 A: General overview of seismic station facing south at the north site boundary.

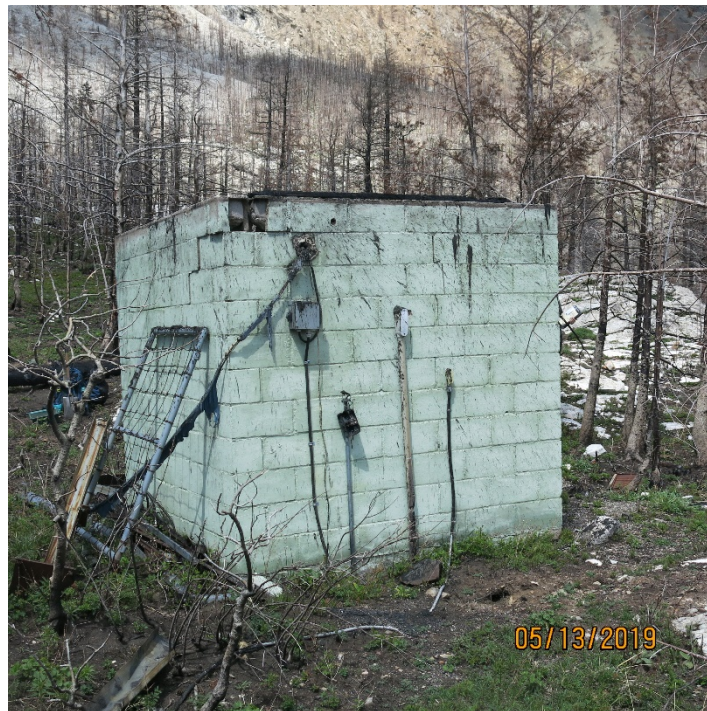
Photo 6.1 B: View of building facing northwest from the southeast site boundary.

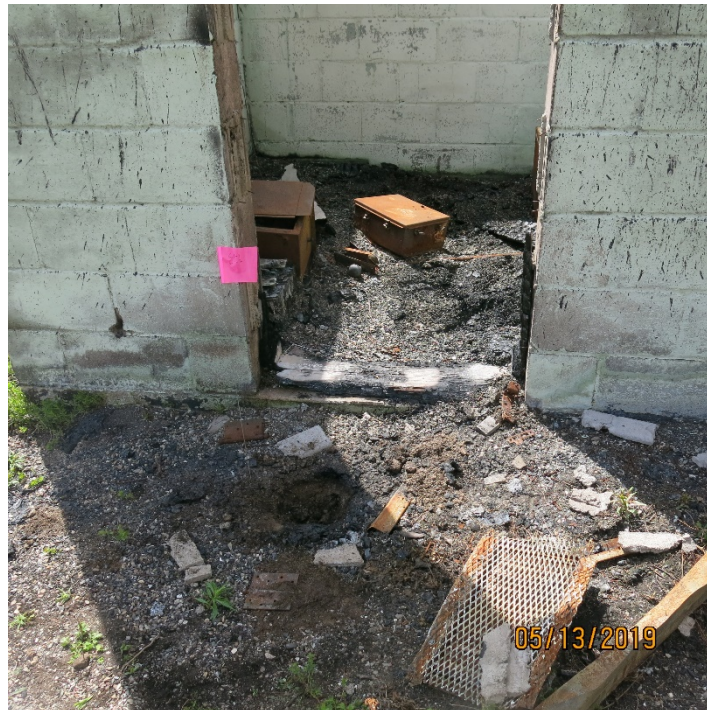
Photo 6.1 C: General overview of ash and debris pile observed in and around the building and view of sample location 6.1-1 (pink flag) facing south.

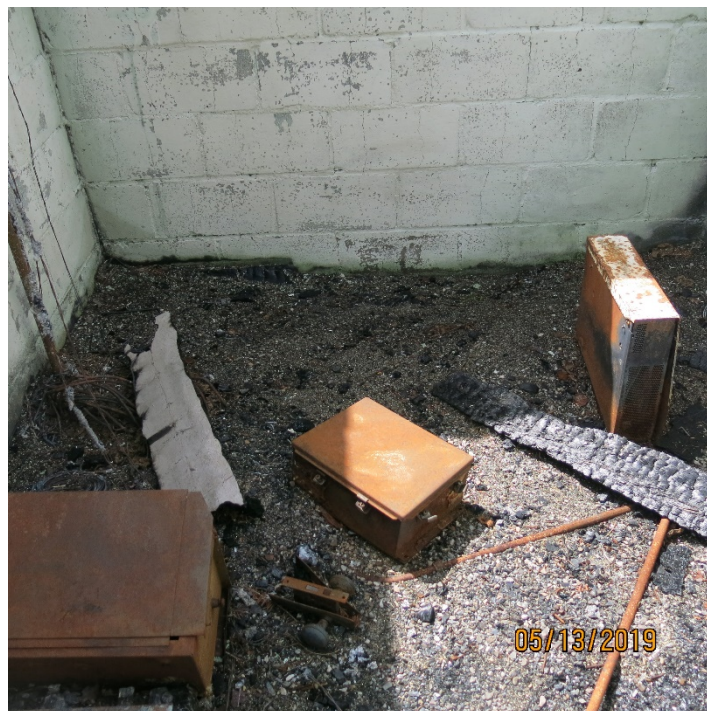
Photo 6.1 D: View of ash and debris observed over foundation of building.

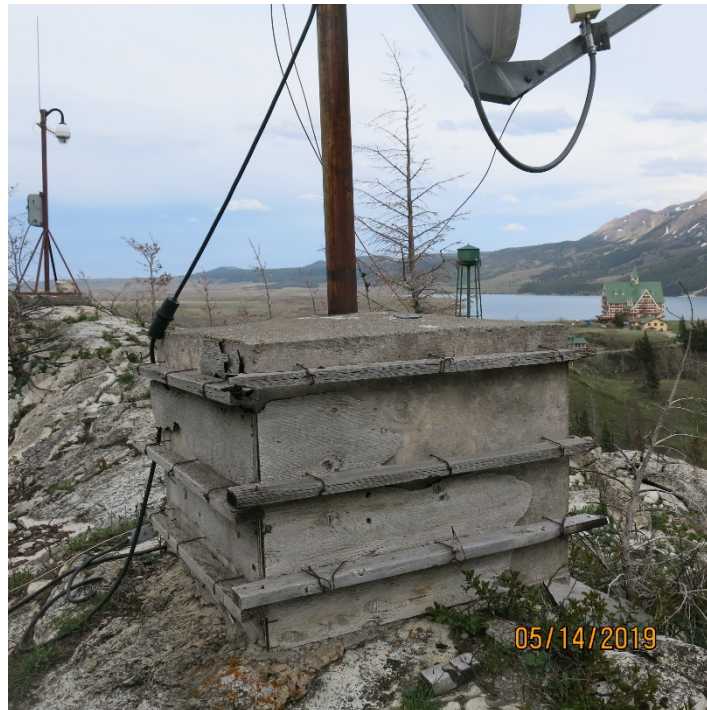
Photo 6.1 E: View of satellite dish support base and antenna (background beyond the satellite dish) facing northeast from the southeast corner of the site.

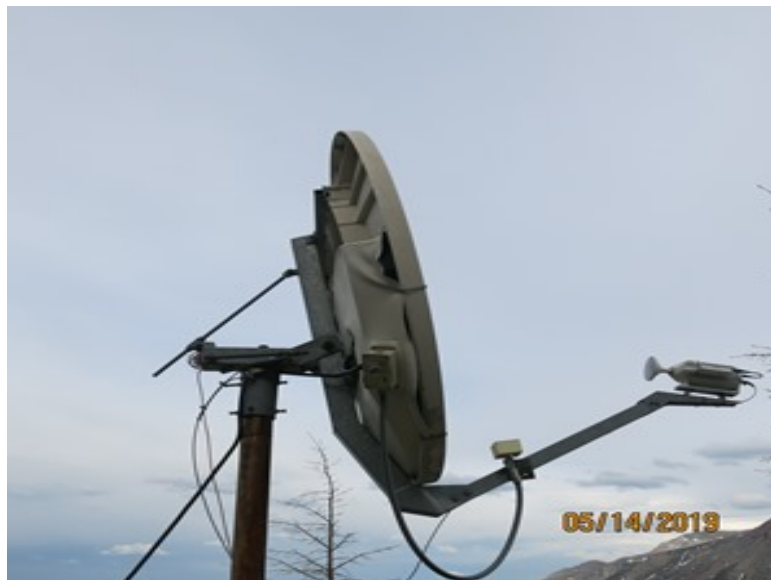
Photo 6.1 F: View of heat damage to satellite dish.

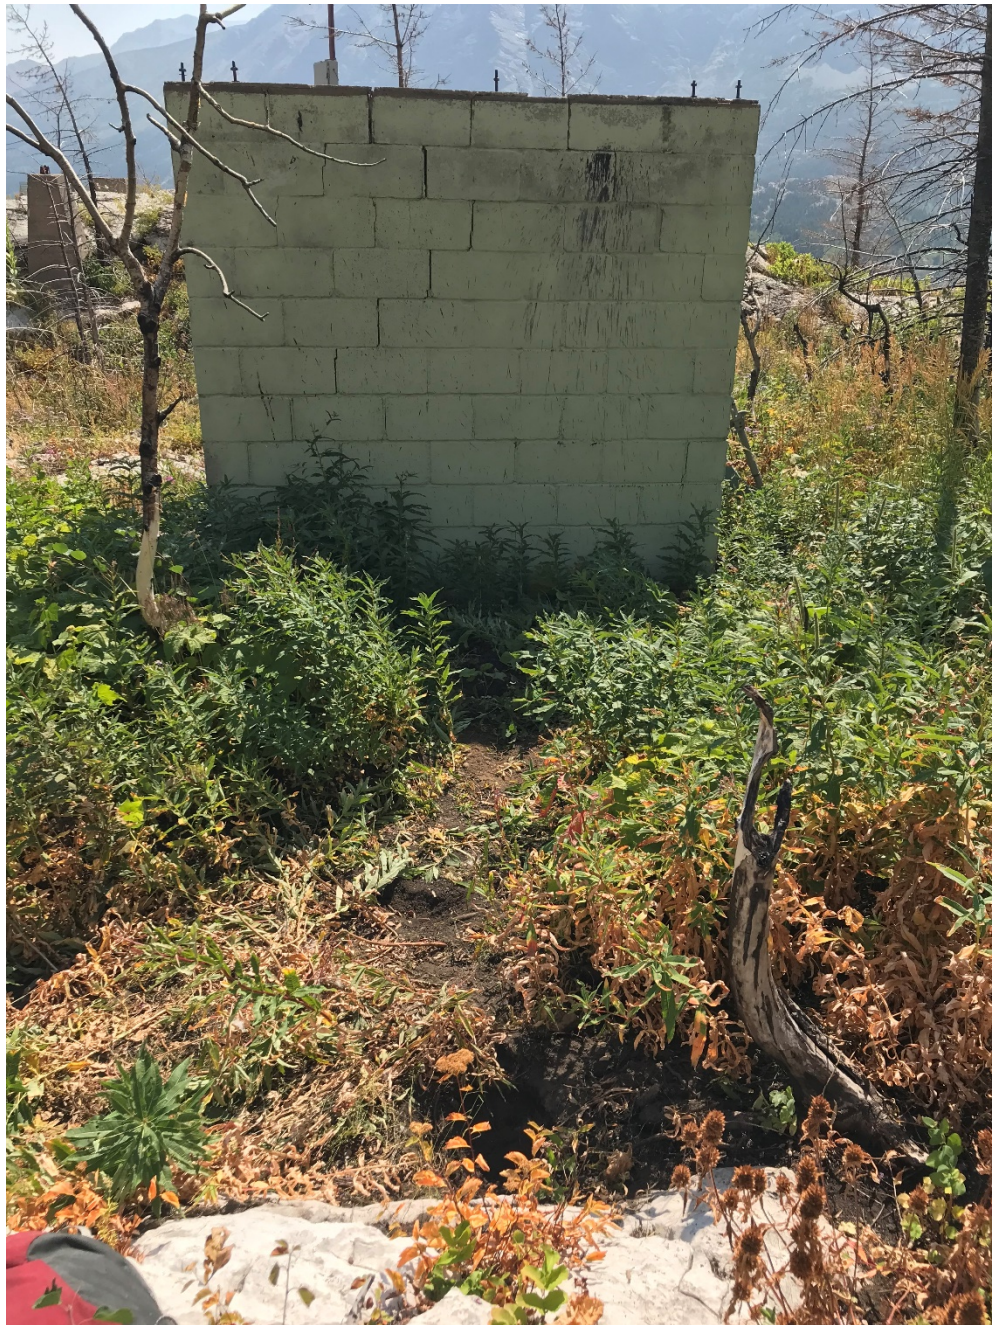
Photo 6.1 A: Location of delineation sample 6.1-15 with the seismic station in the background.

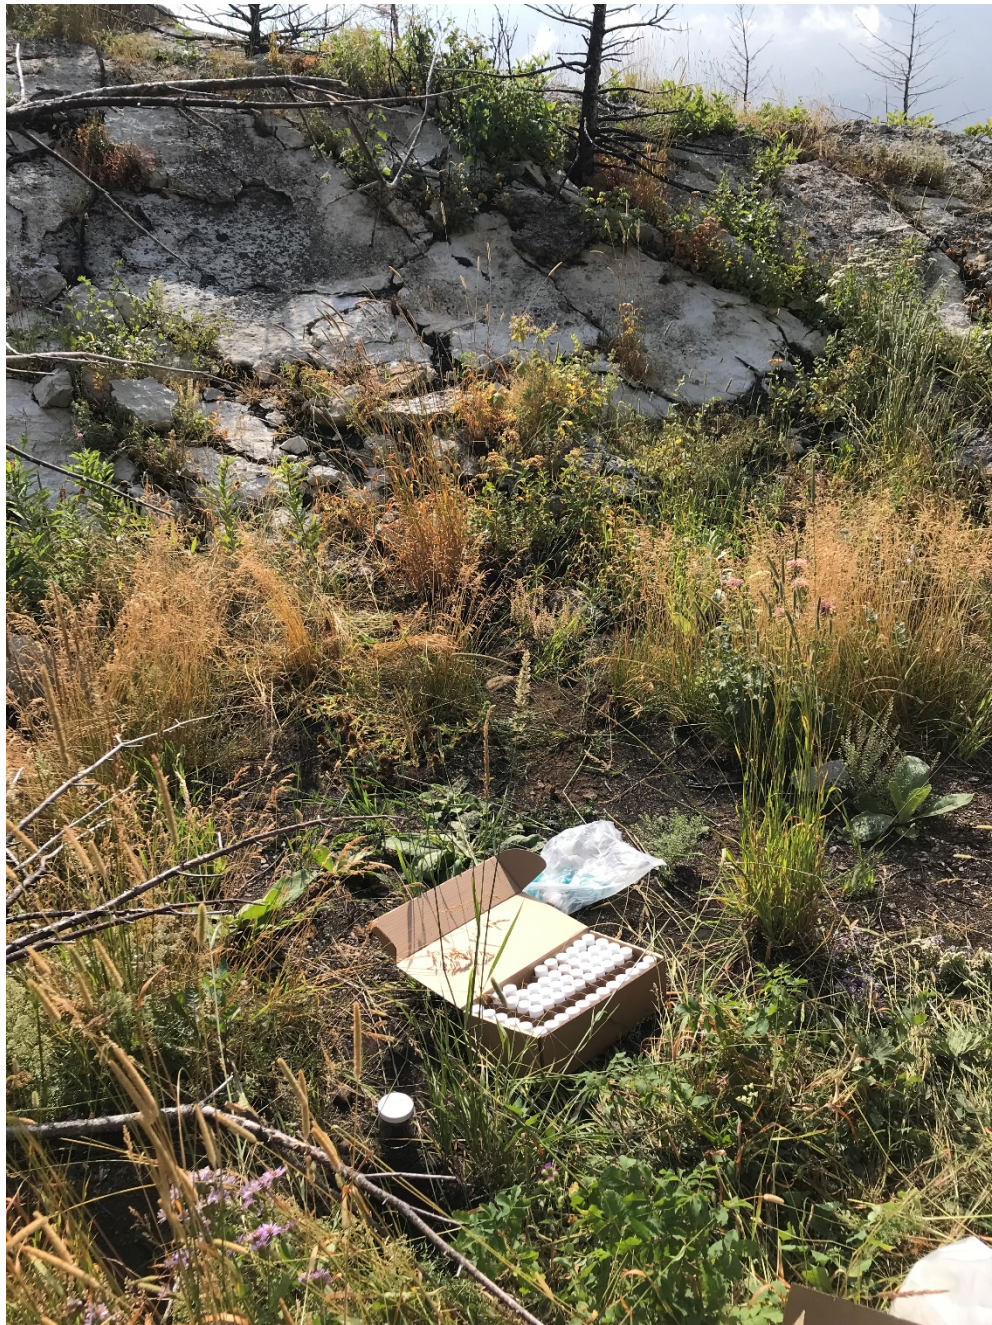
Photo 6.1 B: Location of delineation sample 6.16 located adjacent to one of the bedrock outcrops in the area.

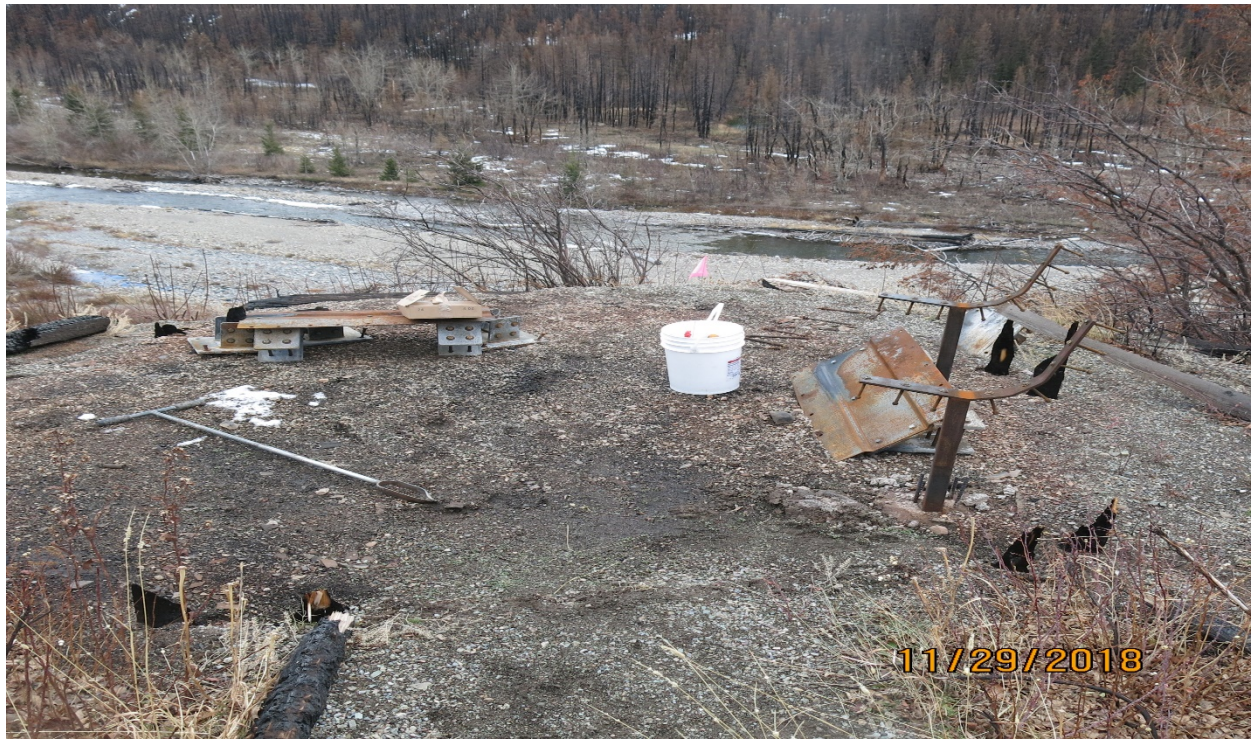
Photo 8.3 A: General overview of the indigenous lookout site debris facing south at the north site boundary.

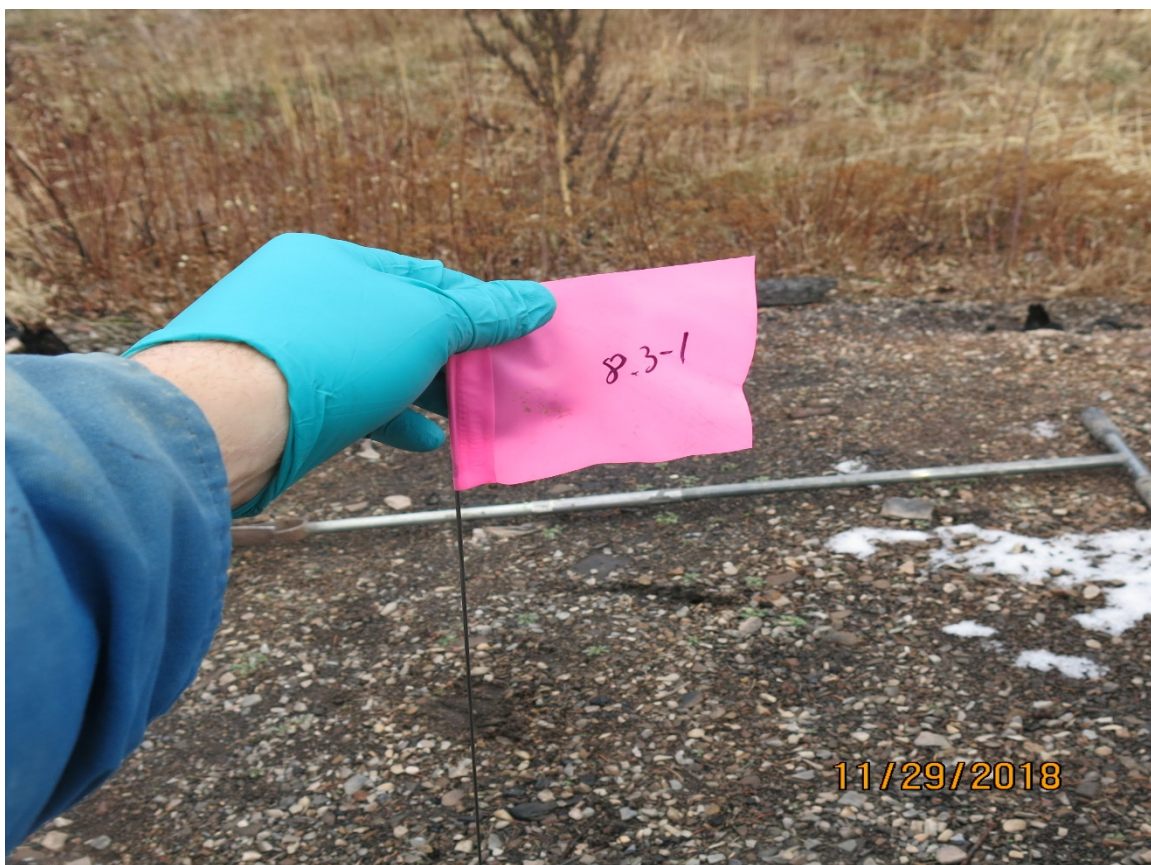
Photo 8.3-1: Sample location # 1 under metal debris pile on the north side of the indigenous lookout.

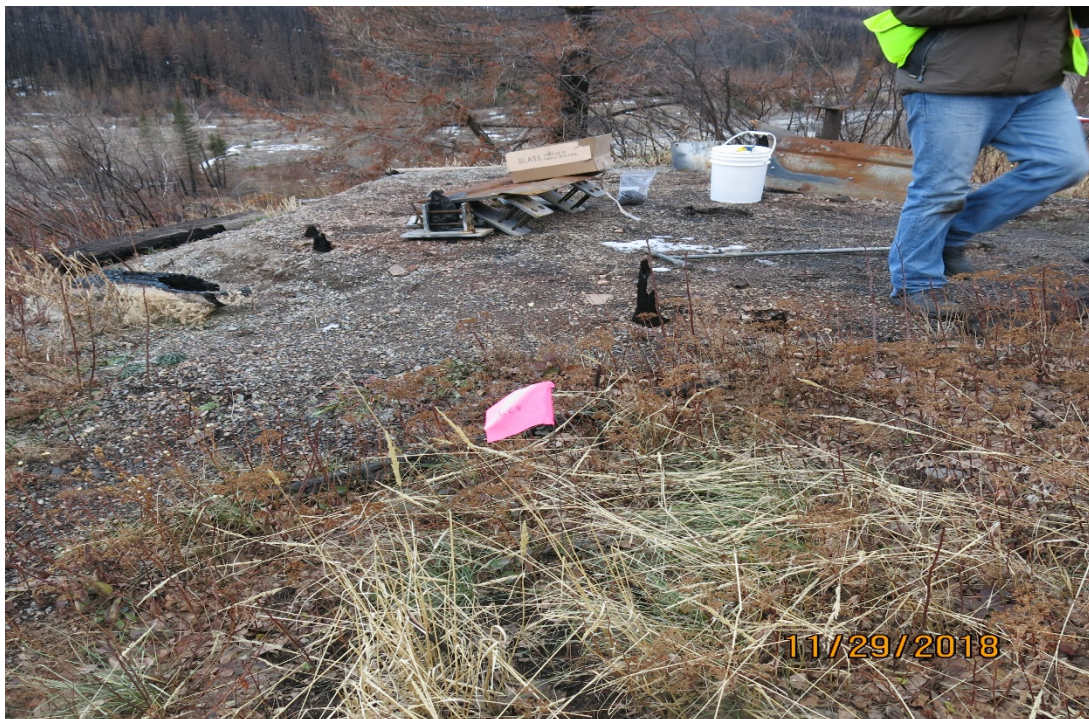
Photo 8.3-2: Location # 2 depicting the east side delineation sample of the indigenous lookout.

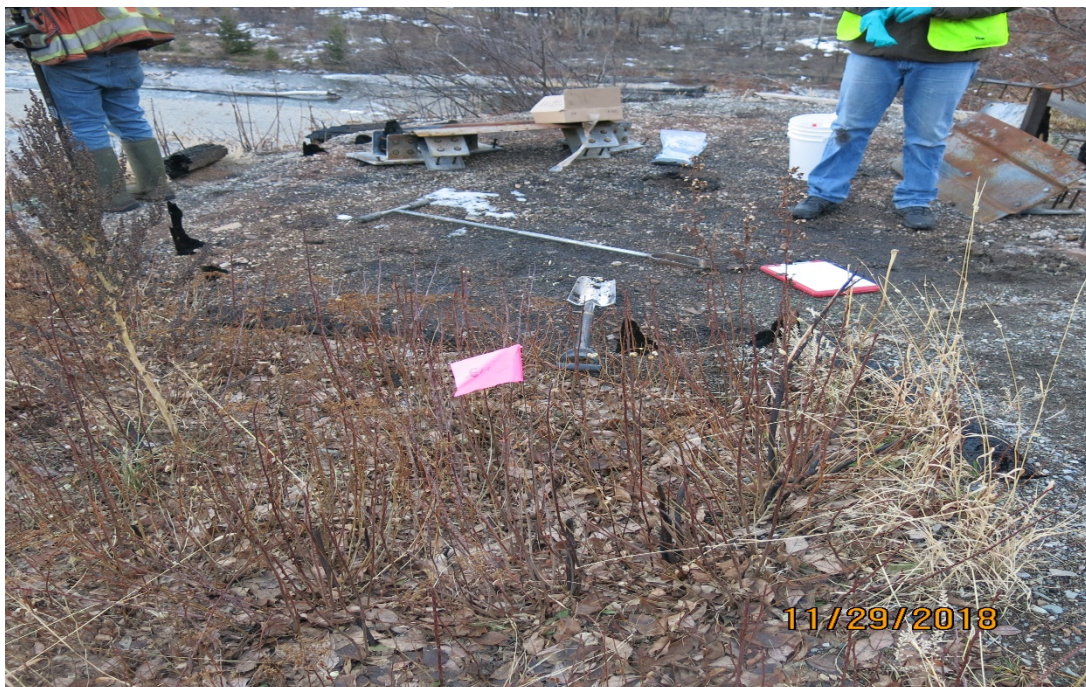
Photo 8.3-3: Location # 3 depicting the north side delineation sample of the indigenous lookout.

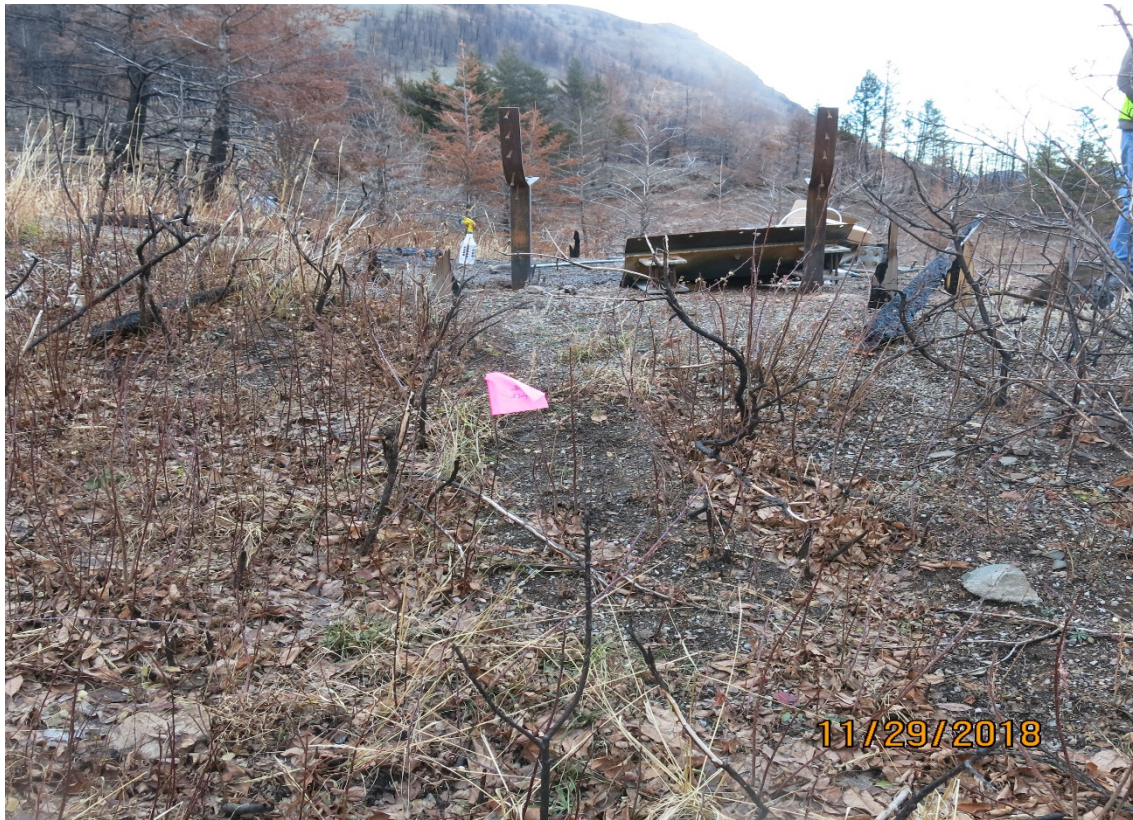
Photo 8.3-4: Location # 4 depicting the west side delineation sample of the indigenous lookout area.

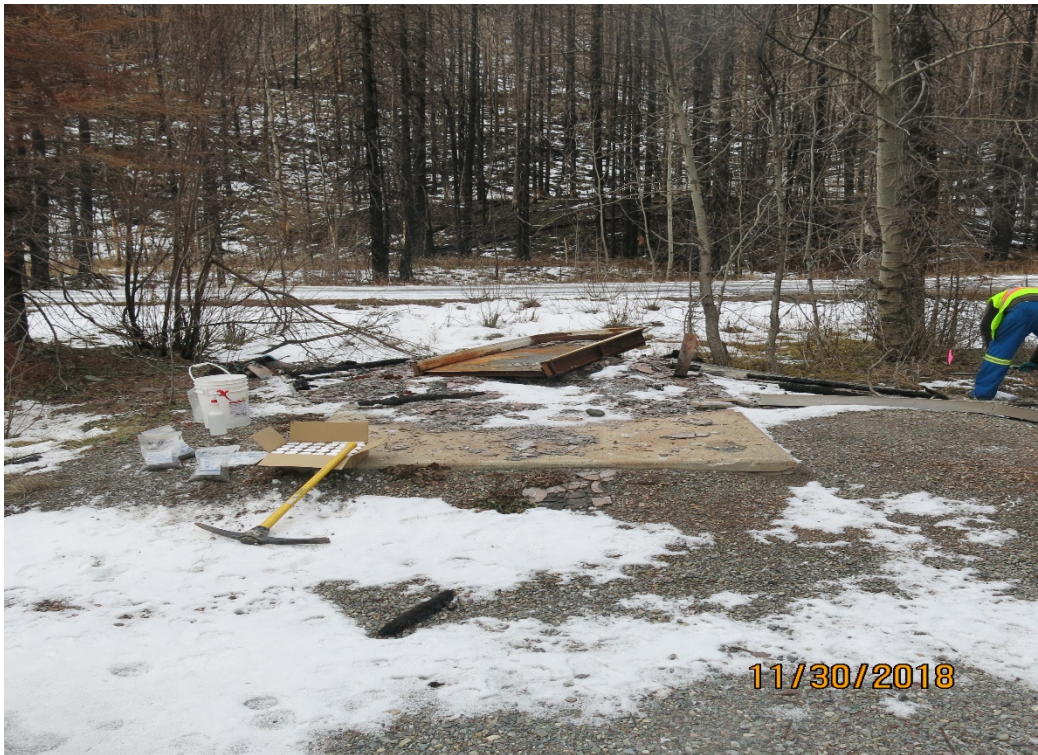
Photo 9.1 A: General overview of the McNealy's day use area washroom facing north at the east site boundary.

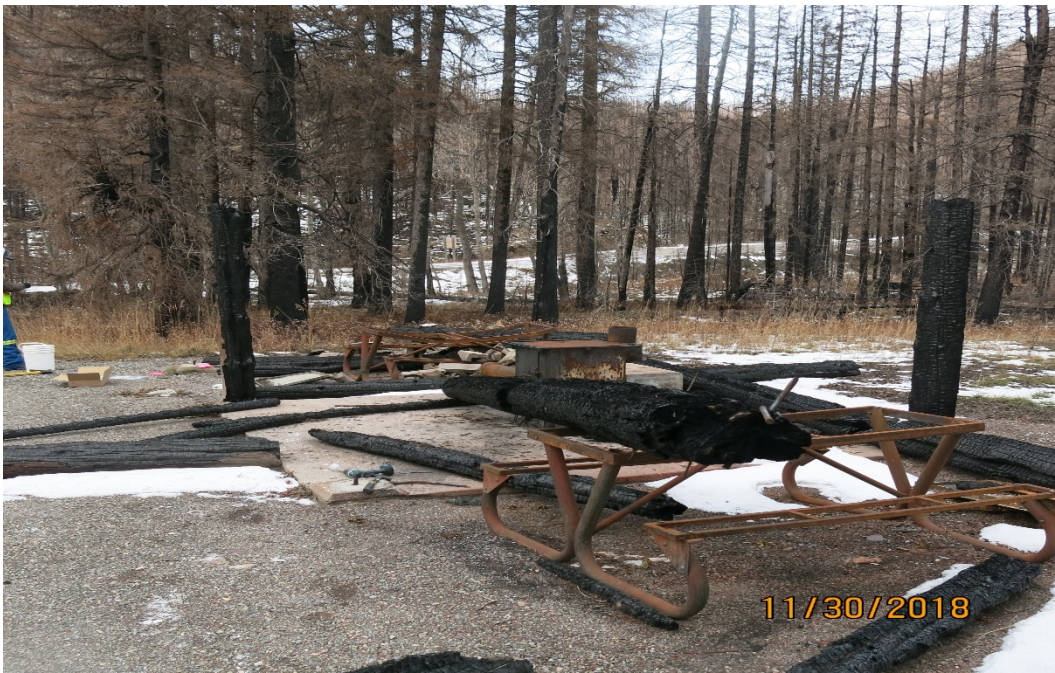
Photo 9.1 B: General overview of the McNealy's day use area kitchen shelter facing north from the south site boundary.

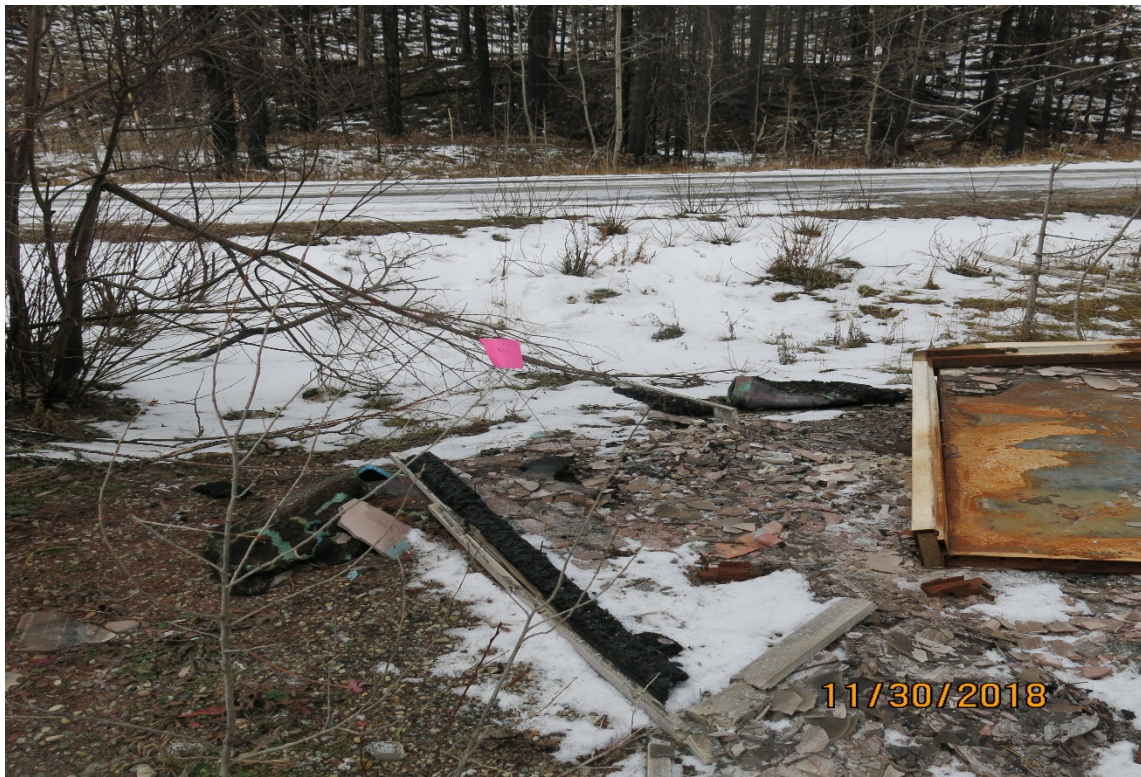
Photo 9.1-1: Sample location # 1 taken under largest observed brick and wood debris pile on the west side of the washroom debris area.

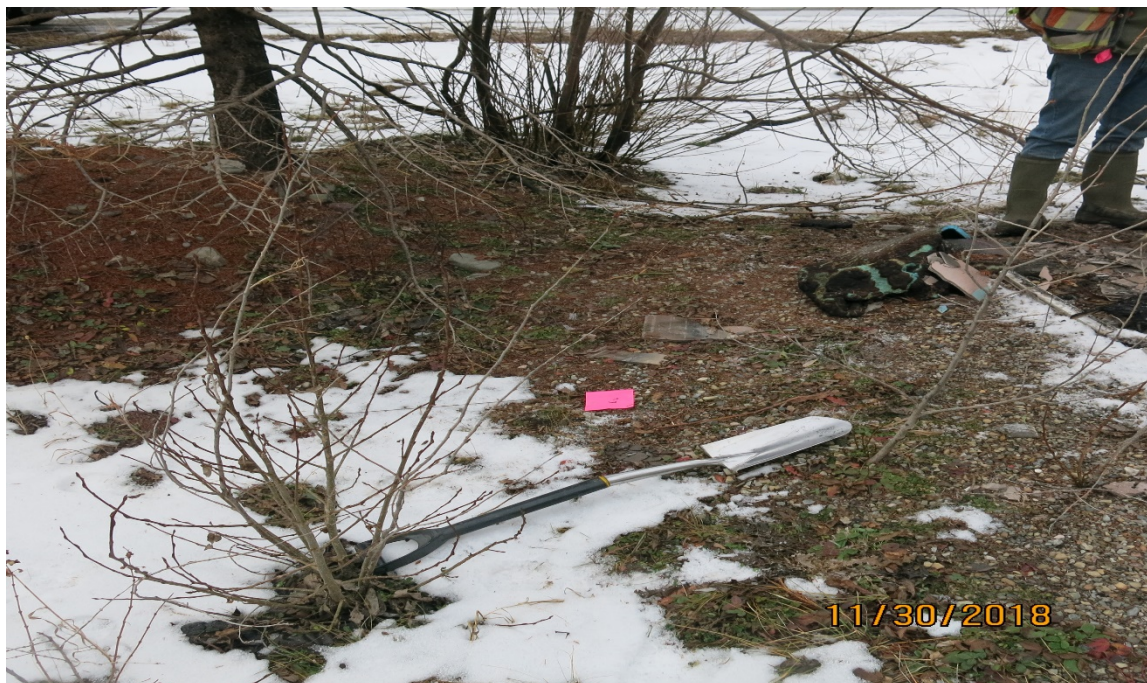
Photo 9.1-2: Location # 2 depicting the west side delineation sample of the McNealy's day use area washroom.

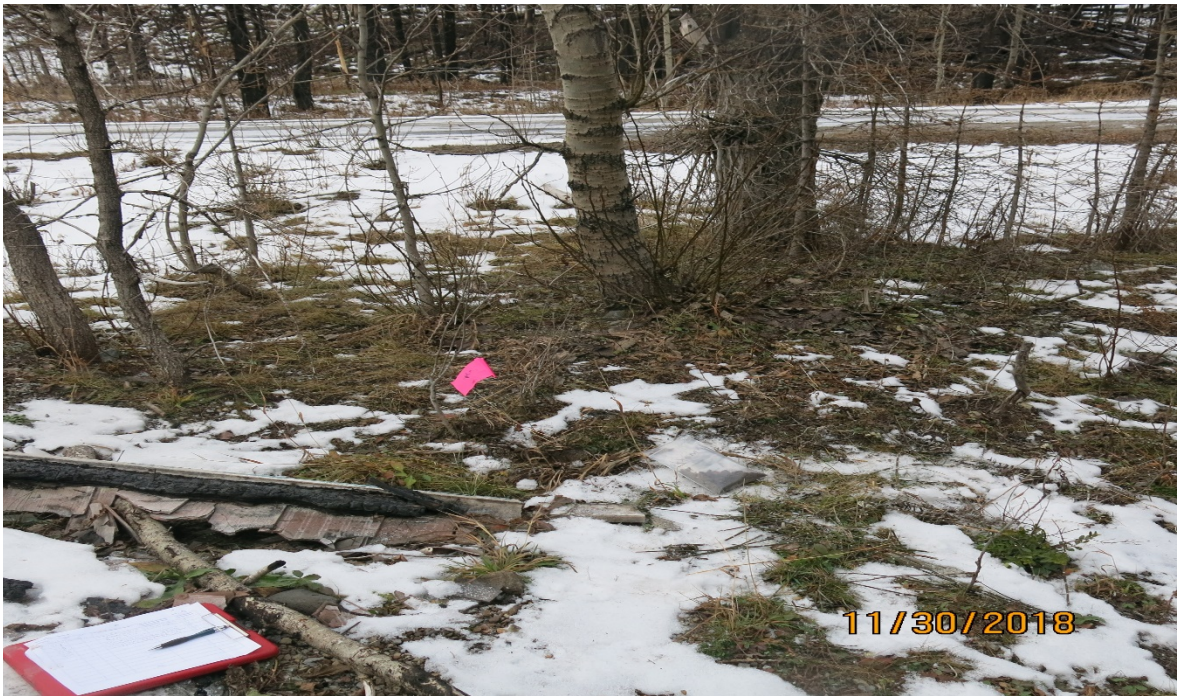
Photo 9.1-3: Location # 3 depicting the east side delineation sample of the McNealy's day use area washroom.

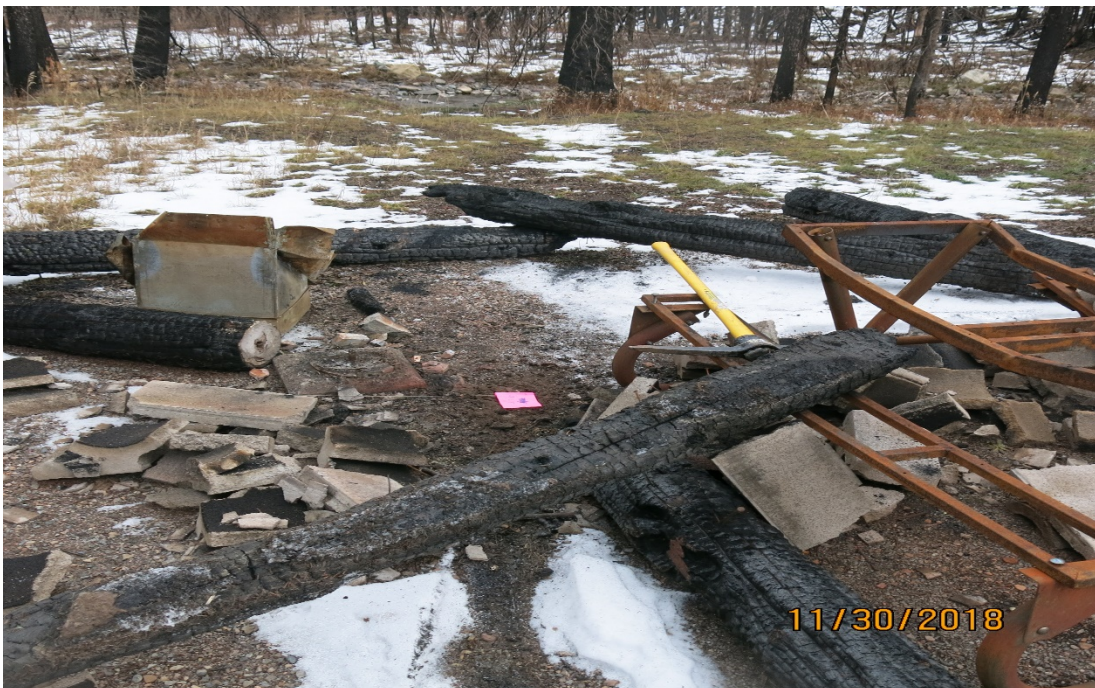
Photo 9.1-4: Sample Location # 4 was taken under largest metal and wood debris pile observed on the north east side of the McNealy's kitchen shelter.

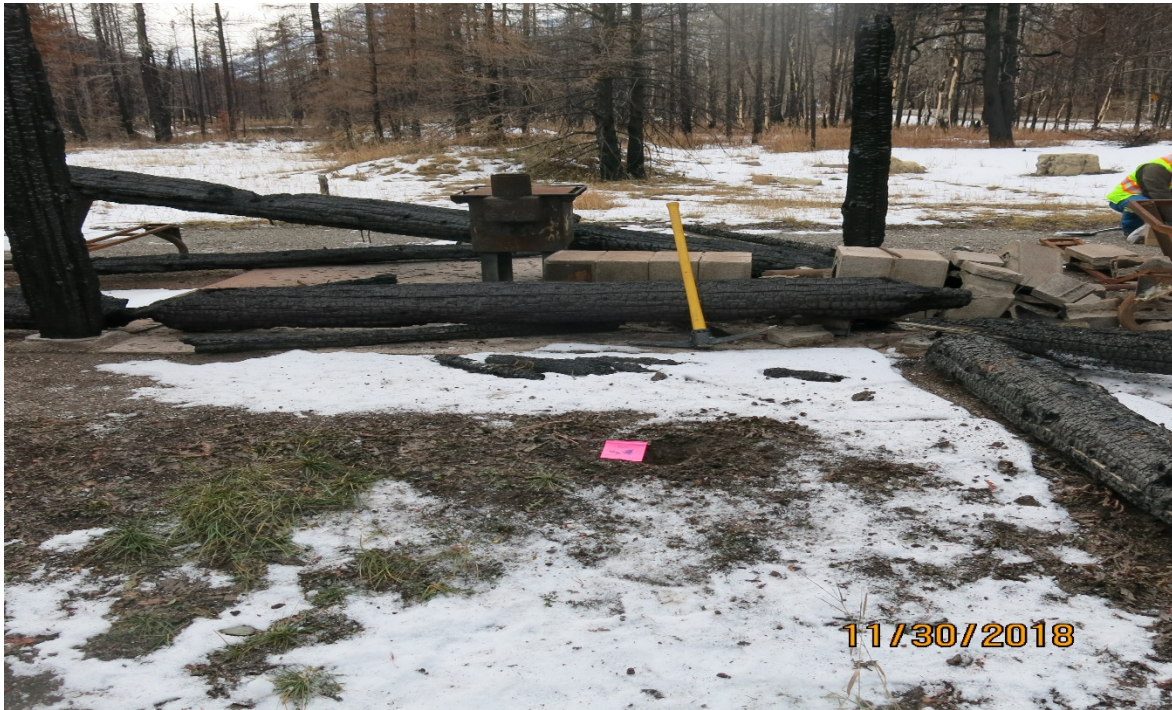
Photo 9.1-5: Location # 5 depicting the east side delineation sample of the McNealy's day use area kitchen shelter.

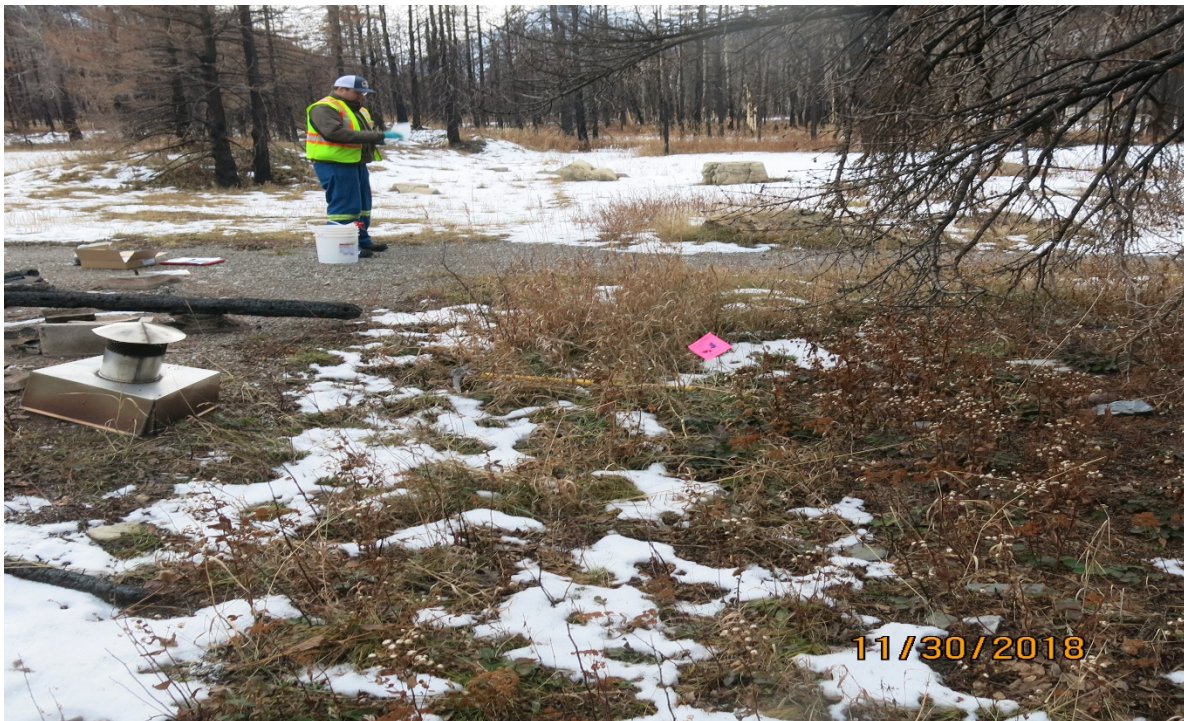
Photo 9.1-6: Location # 6 depicting the north side delineation sample of the McNealy's day use area kitchen shelter.

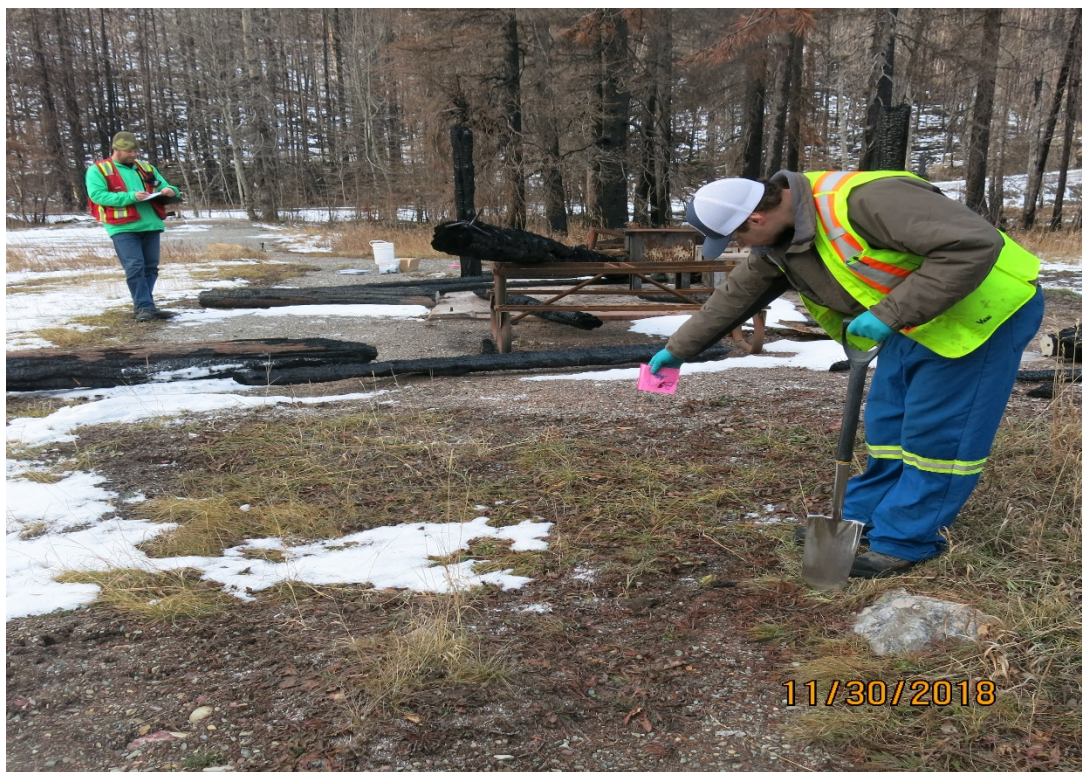
Photo 9.1-7: Location # 7 depicting the south side delineation sample of the McNealy's day use area kitchen shelter.
