SPECIFICATIONS
for

Waterton Remediation and Abatement – 11 Sites

Waterton Lakes National Park, Alberta

Project No. _____ February 2020

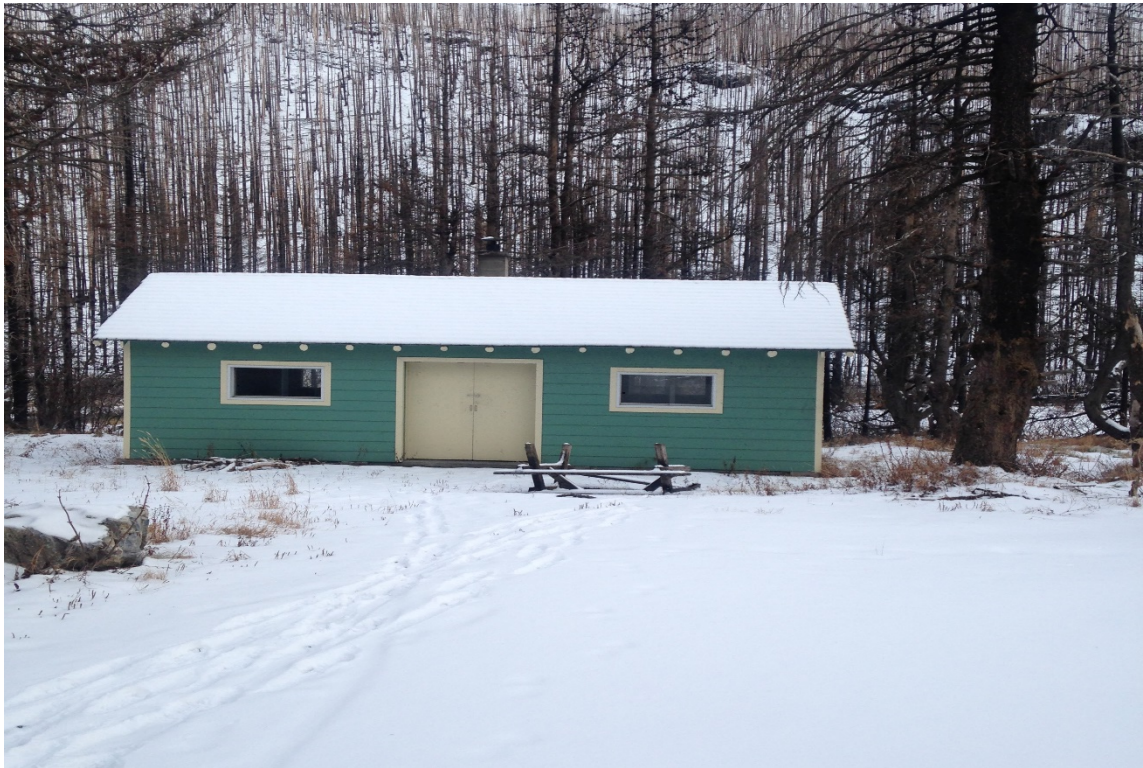
Photo 9.2 A: General overview of the Little Prairie day use area kitchen shelter facing south at the north site boundary.

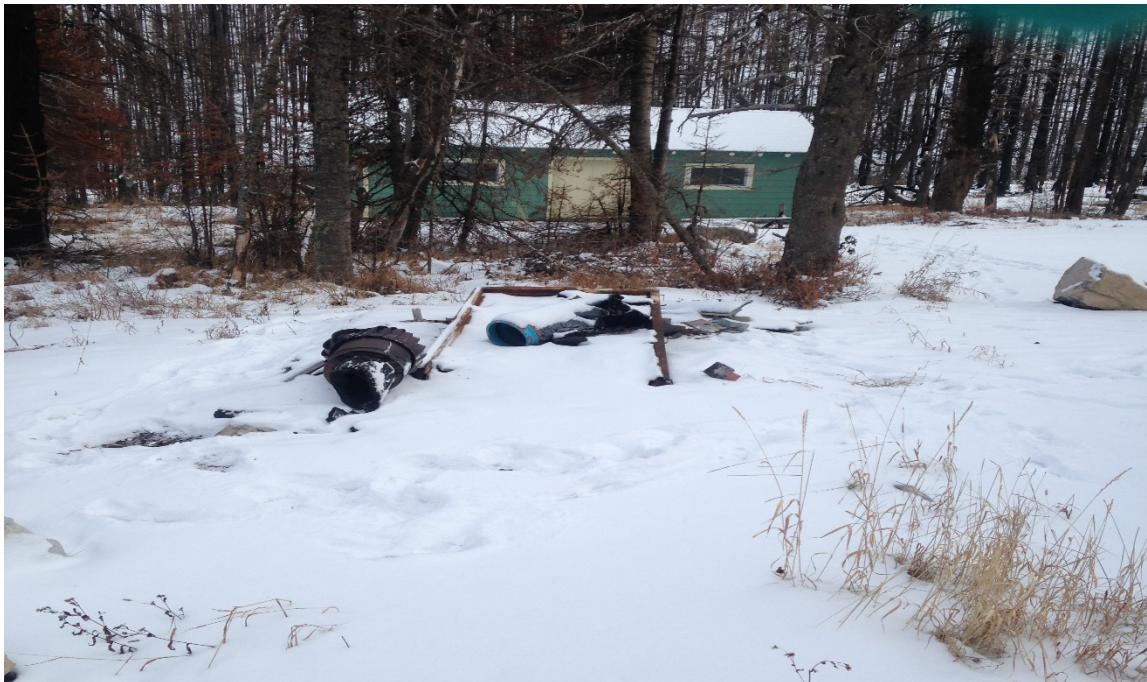
Photo 9.2 B: General overview of the Little Prairie day use area washroom shelter facing south from the north site boundary.

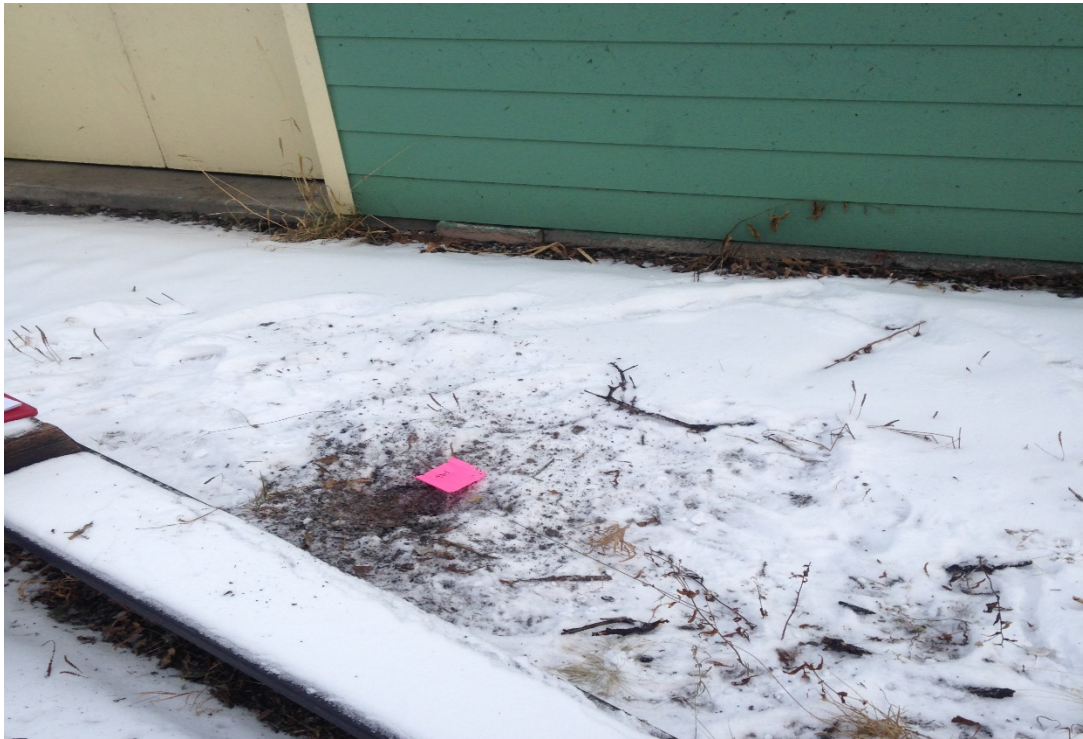
Photo 9.2-1: Sample location # 1 depicting the north side delineation sample of the Little Prairie day use area kitchen shelter.

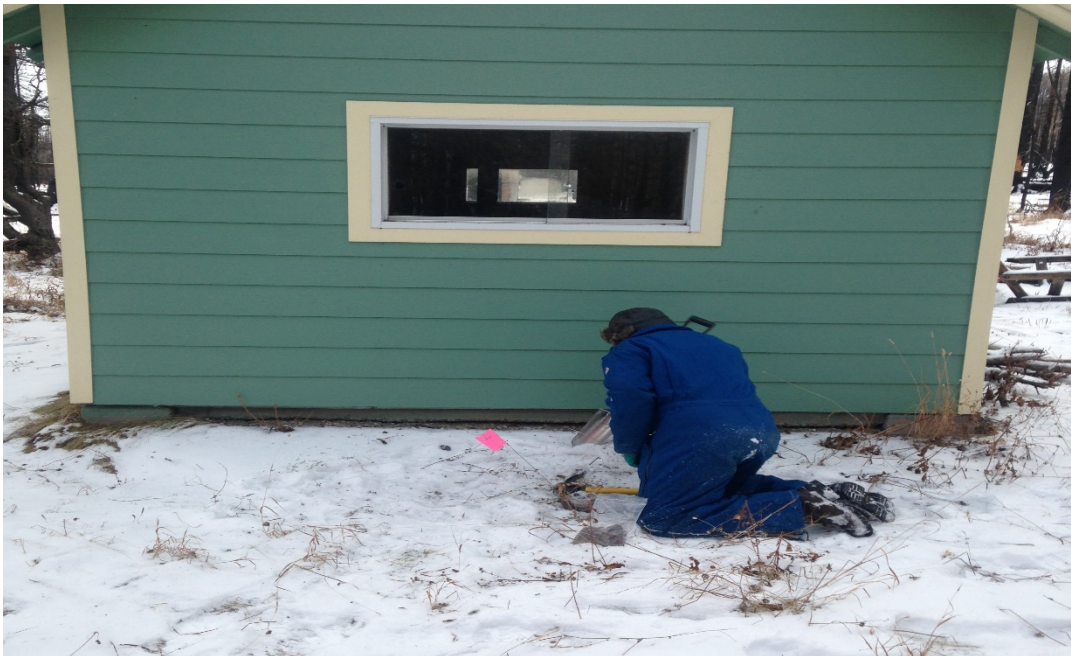
Photo 9.2-2: Location # 2 depicting the east side delineation sample of the Little Prairie day use area kitchen shelter.

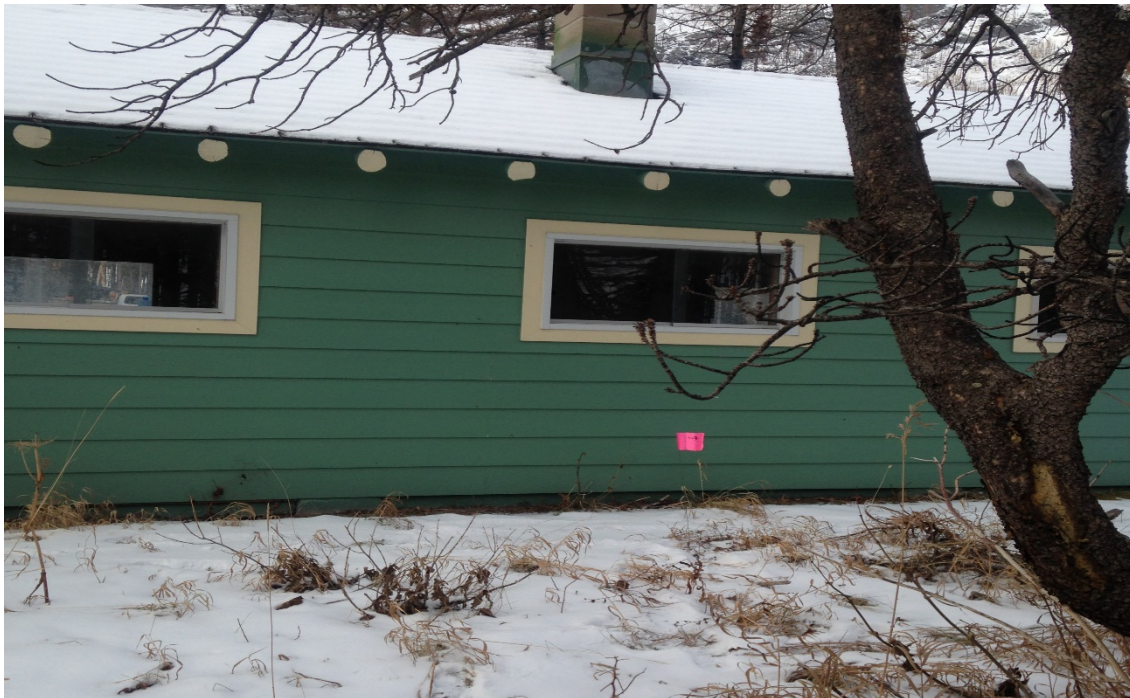
Photo 9.2-3: Location # 3 depicting the south side delineation sample of the Little Prairie day use area kitchen shelter.

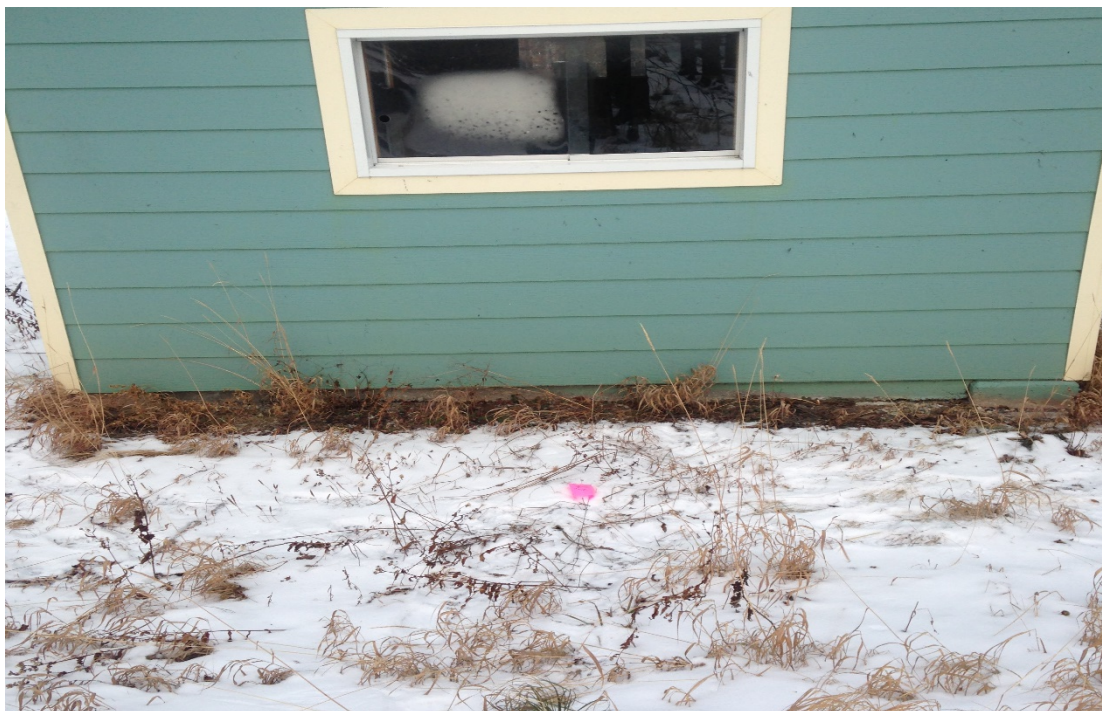
Photo 9.2-4: Location # 4 depicting the west side delineation sample of the Little Prairie day use area kitchen shelter.

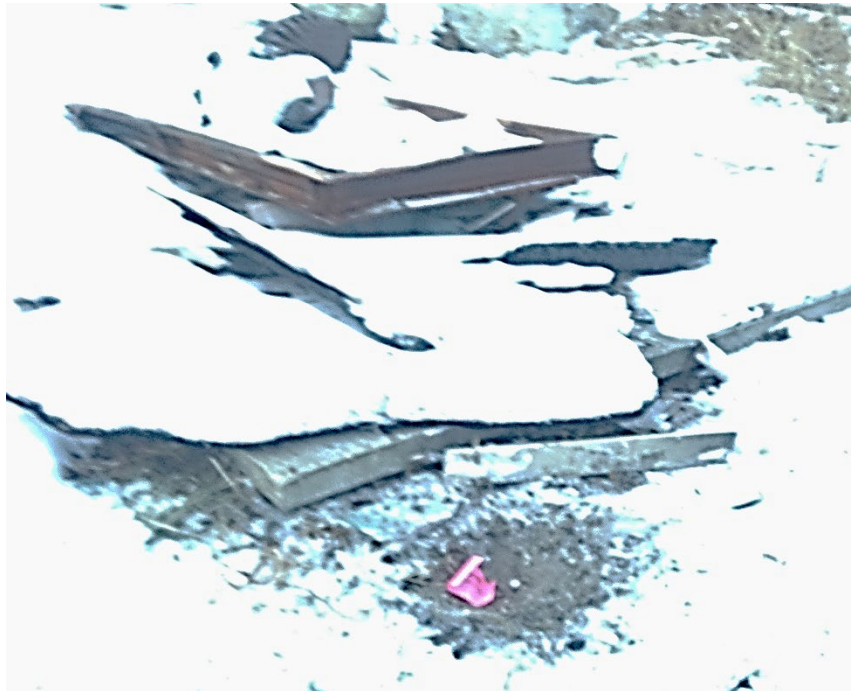
Photo 9.2-5: Sample Location # 5 taken under largest observed metal debris pile of the Little Prairie day use area washroom.

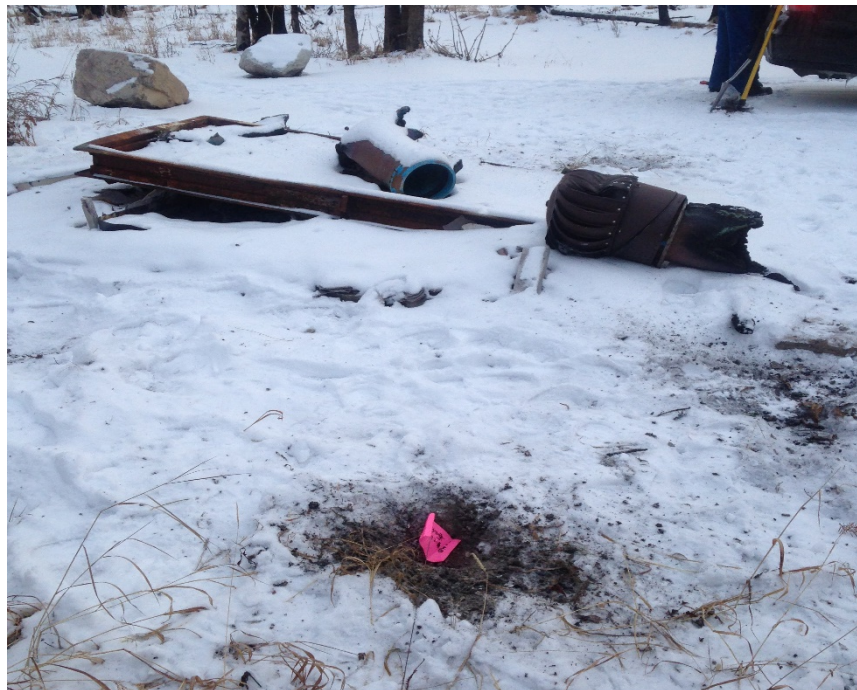
Photo 9.2-6: Location # 6 depicting the east side delineation sample of the Little Prairie day use area washroom.

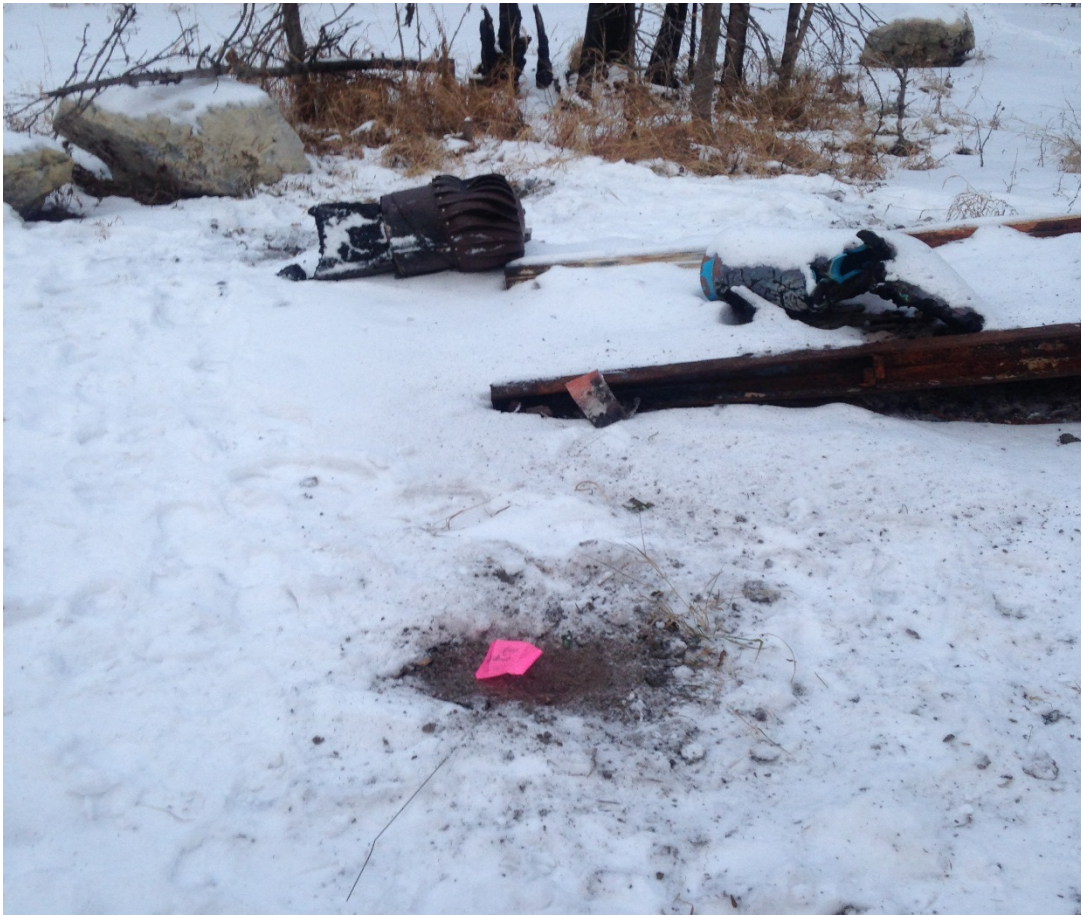
Photo 9.2-7: Location # 7 depicting the south side delineation sample of the Little Prairie day use area washroom.
