# **LaSalle Causeway Bascule Bridge**

**Steel Deck Grating Replacement Study –  
Phase 1 Feasibility Assessment (Rev.1)**

**PSPC Project Numbers: R.09736.004 and  
R.089507.003**

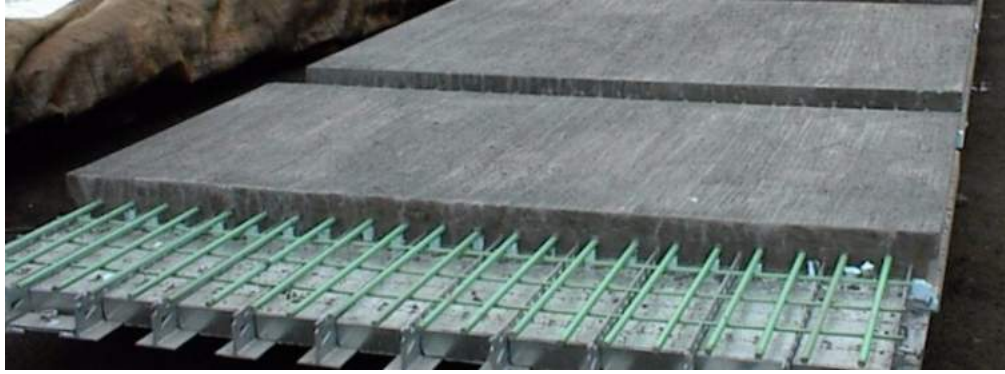
Figure 4: Exodermic deck cross section (photo credit <http://www.faddis.com/product/bridge-decks/>)

This deck type consists of a hybrid system constituted from a reinforced concrete slab on top of an open steel deck grating. It is in fact an optimized half concrete filled steel grating. The cast-in-place or pre-cast concrete slab on top is made composite with the steel bottom half to maximize concrete compressive strength and steel tensile properties. The system provides the advantages of a closed deck surface (riding quality, noise reduction, waterproofness), while being significantly lighter than traditional full-depth concrete decks. A standard wearing surface can be installed on the concrete slab to increase the riding quality, water tightness and durability of the deck. This type of deck has been used in North America for bridge deck replacements for more than 35 years. A deck mass of 280 kg/m<sup>2</sup> to 360 kg/m<sup>2</sup> has been achieved according to the 1998 "Exodermic Decks and Steel Bridges" article by Robert A. Bettigole<sup>7</sup>. Optimized design with modern codes could probably achieve an even lighter deck system. Deck thickness ranges from 165 mm to 240 mm without the wearing surface, which is compatible with the existing deck thickness, thus limiting impacts to the approaches and joints to the transition from the road profile to the exodermic deck crown.

For the exodermic deck option, existing grating, sills and stringers would be replaced by new stringers and an exodermic deck. This type of deck would increase the wind loading by 18% when compared with the existing deck (CHBDC S6-19 section 13.6.4.6). Deck mass, even for a modern design, would be at least 25% heavier than the existing deck, ranging between 250 kg/m<sup>2</sup> and 400 kg/m<sup>2</sup>.

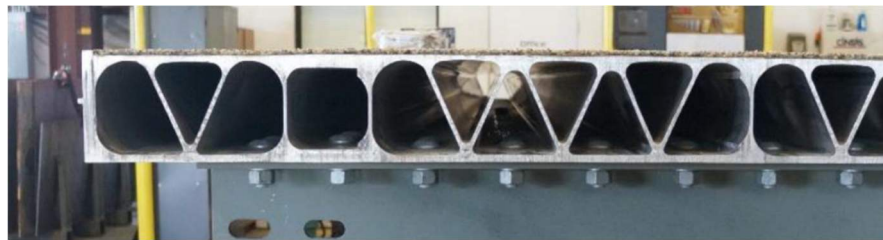
Figure 6: Florida DOT Aluminum Orthotropic Deck Test Panel, with wearing surface, bolted on steel stringer<sup>10</sup>

Orthotropic aluminum decks consist of extruded hollow aluminum profiles of various shapes, friction-stir welded together to create panels. Once assembled on-site by bolting, those panels create a lightweight closed deck stiffer than open steel grating. However, their use is currently mostly limited to proprietary products. Some Department of Transportation (DoT) in the US such as the Florida DoT have investigated this type of deck in depth, because of the significant weight reduction they yield compared to typical closed deck such as cast-in-place concrete, or because they provide a weight neutral closed deck solution to replace existing open deck grating. Challenges of using aluminum in bridge construction such as galvanic corrosion and differential thermic movements have been successfully addressed in some prototype projects<sup>9</sup>.

Similar to all closed deck systems, crowning would be required for drainage. Furthermore, the installation of a wearing surface (epoxy aggregate or other similar lightweight product) is required to provide sufficient skid resistance and protect the top aluminum plate. A deck thickness similar to the existing is achievable with the use 125 mm (5") deep extrusion panels with shims on floor beams and stringers, as demonstrated in Delcan's 2013, "LaSalle Causeway Bascule Bridge Deck and Sidewalk Concepts Report." The use of 125 mm deep panels requires the use of a minimum of three to four stringers, the latter configuration being better for constructability (phasing). With the use of 125 mm deep orthotropic aluminum panels with shims on the stringers and floor beams, modifications to the roadways, abutments, curbs, railings and joints are limited to adjustments to match the approaches to match the deck crowning.
