Archaeological Overview Assessment
RPA 1716: Terra Nova National Park Utility Systems Recapitalization
Terra Nova National Park (Newfoundland and Labrador)
Funding: To Be Determined

Prepared By: J. Higdon, Archaeologist, IACH Directorate
Date: May 15, 2019

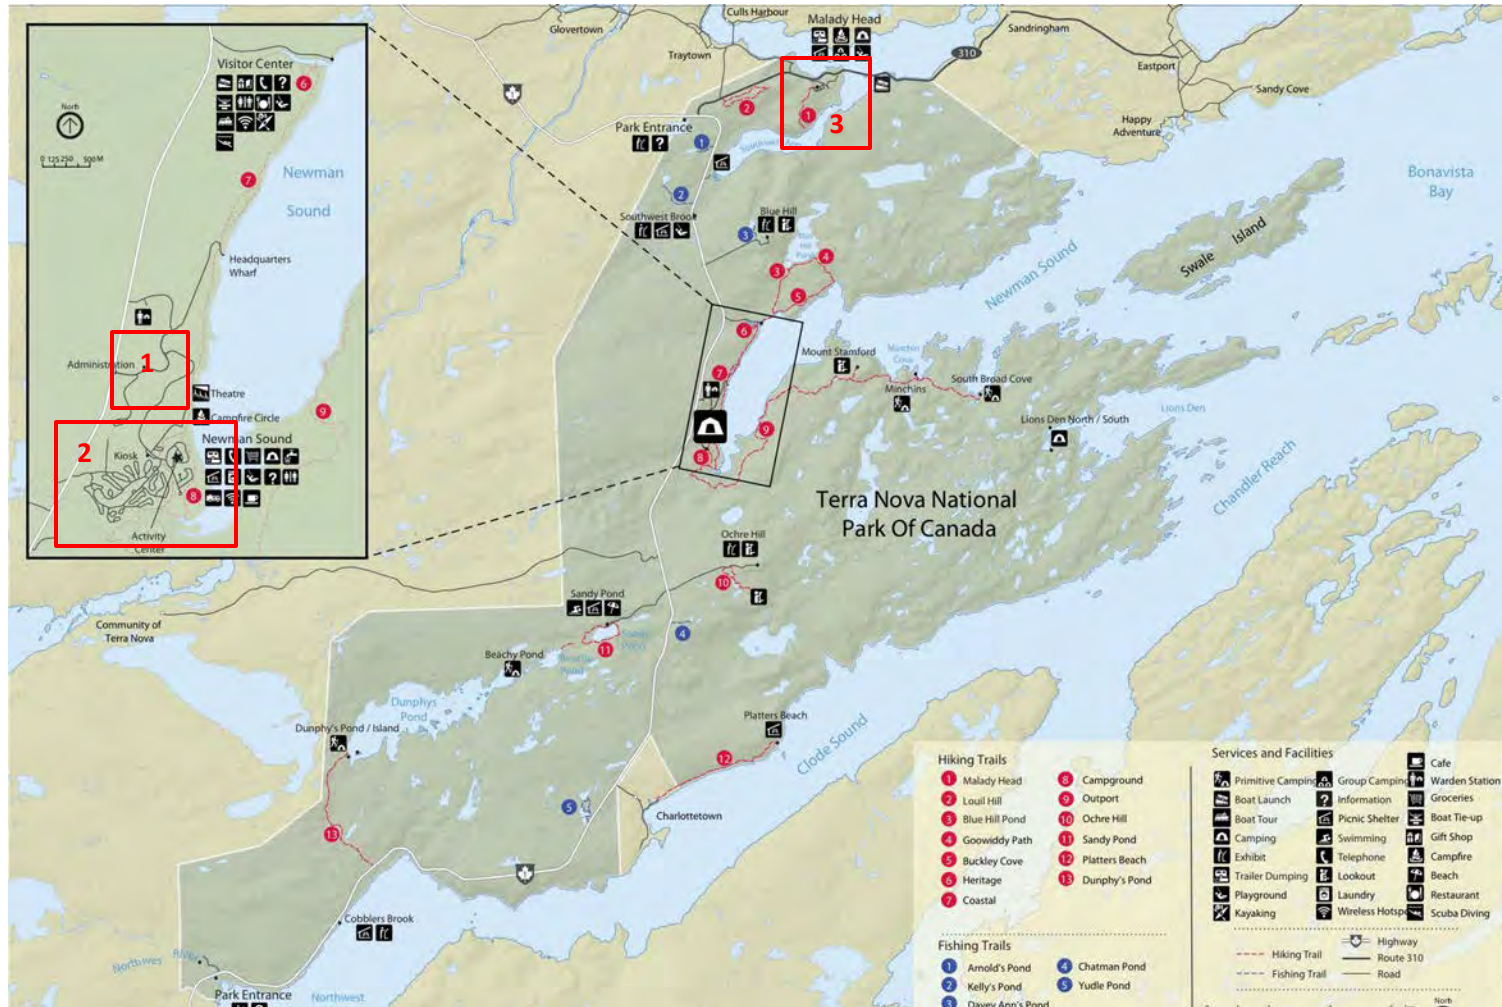
Figure 1: Map of Terra Nova National Park showing locations of projects. 1) Newman Sound Administration 2) Newman Sound Campgrounds, 3) Malady Head Campground (Heritage Foundation of Terra Nova National Park n.d.).

Located at the northern extent of the park, Malady Head Campground is situated 4.0km northeast of where Highway 30 intersects the Trans-Canada Highway and 2km southeast of Traytown (Figures 1 & 19). The Malady Head Campground Wastewater Recapitalization project can be broken down into three main areas. They will involve excavations associated with the installation of:

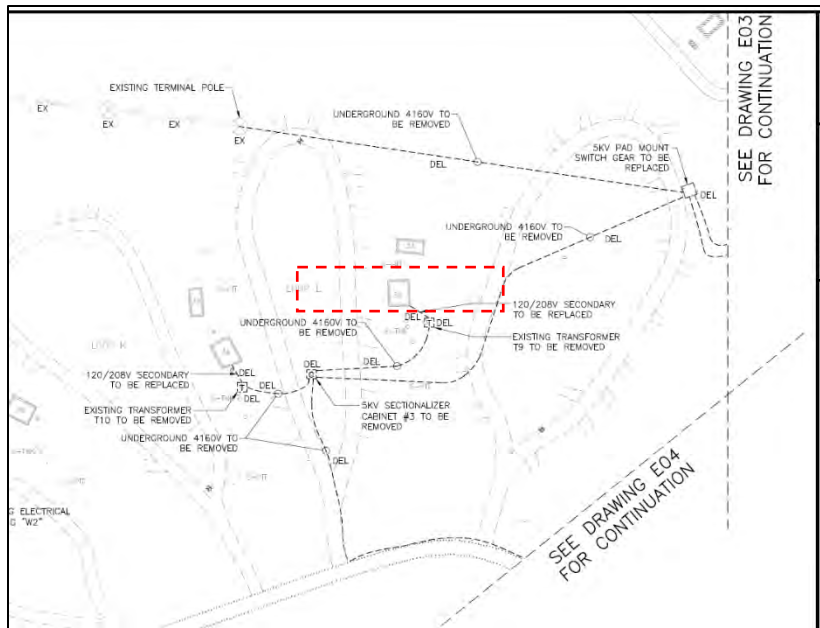
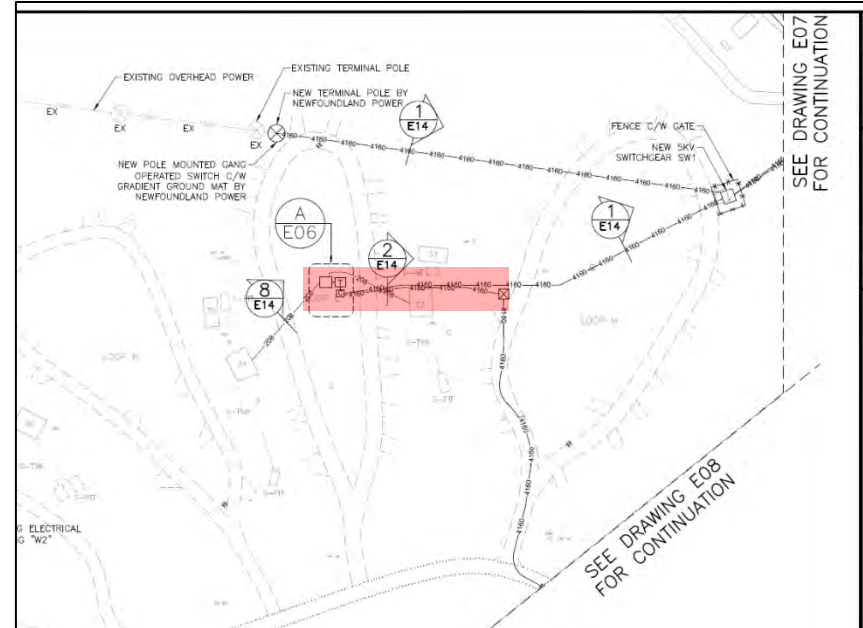
Figure 3: Newman Sound Campground Underground Electrical Primary Recapitalization. Left: Location of existing underground cables (Sheet E02) with dashed box showing area void of existing underground cables. Right: Proposed location of new underground cable and transformer pad installation (Sheet E06) with red rectangle shows proposed excavations in previously undisturbed area (Crandall 2019c).

- E06 - Installation of new underground cable (Table 2, Figure 3).
- E07 - Installation of new underground cable (Table 2, Figure 4).

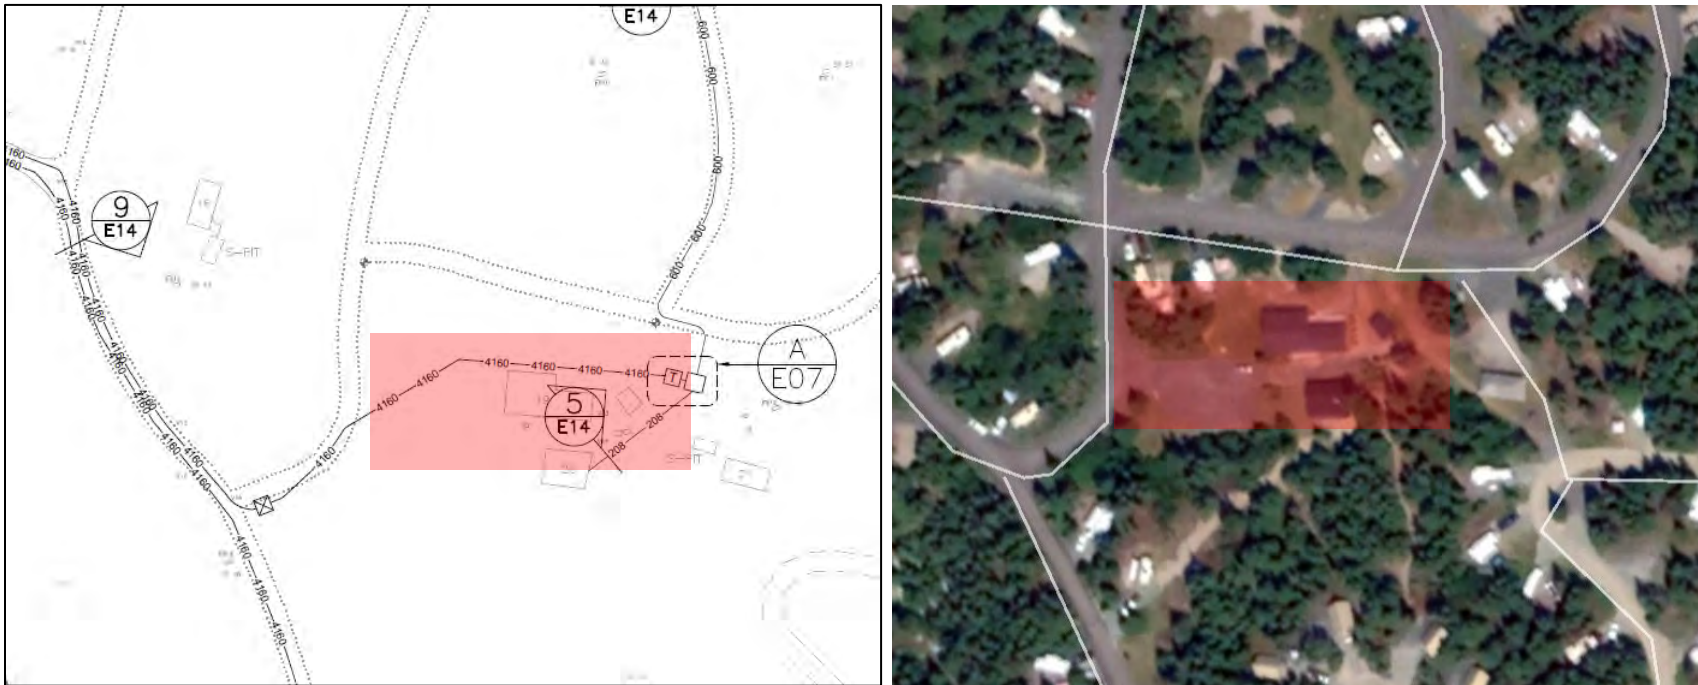
Figure 4: Newman Sound Campground Underground Electrical Primary Recapitalization. Left: Area in Sheet E07 showing the installation of new underground cable outside existing roadway. Right: Google Earth image of same area showing the approximate location of project activity area (Crandall 2019c).

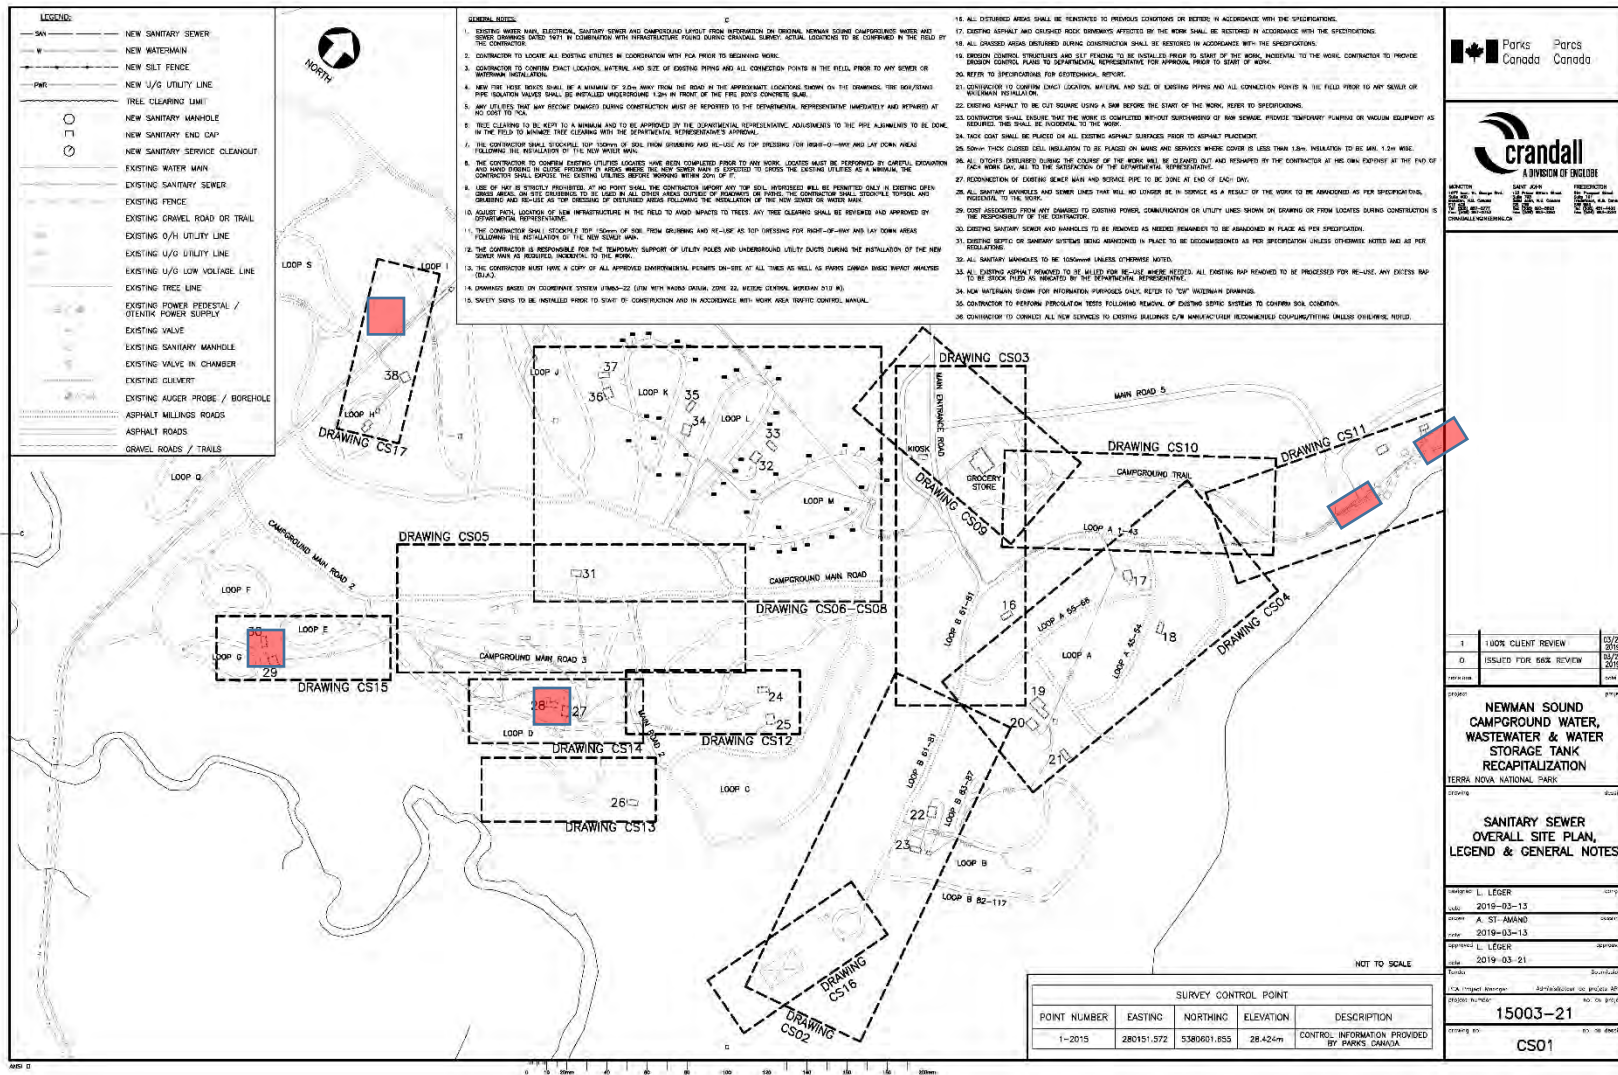
Figure 6: Newman Sound Campground Water, Wastewater & Water Storage Tank Recapitalization – Sanitary Sewer Overall Site Plan, Legend and General Notes. Red rectangles highlight approximate areas of interest. (Crandall 2019d:CS01)

Table 3: Summary of Newman Sound Campground Sanitary Sewer Infrastructure Recap Activities, comments and AIA Recommendations (Crandall 2019d) (Figure 6)

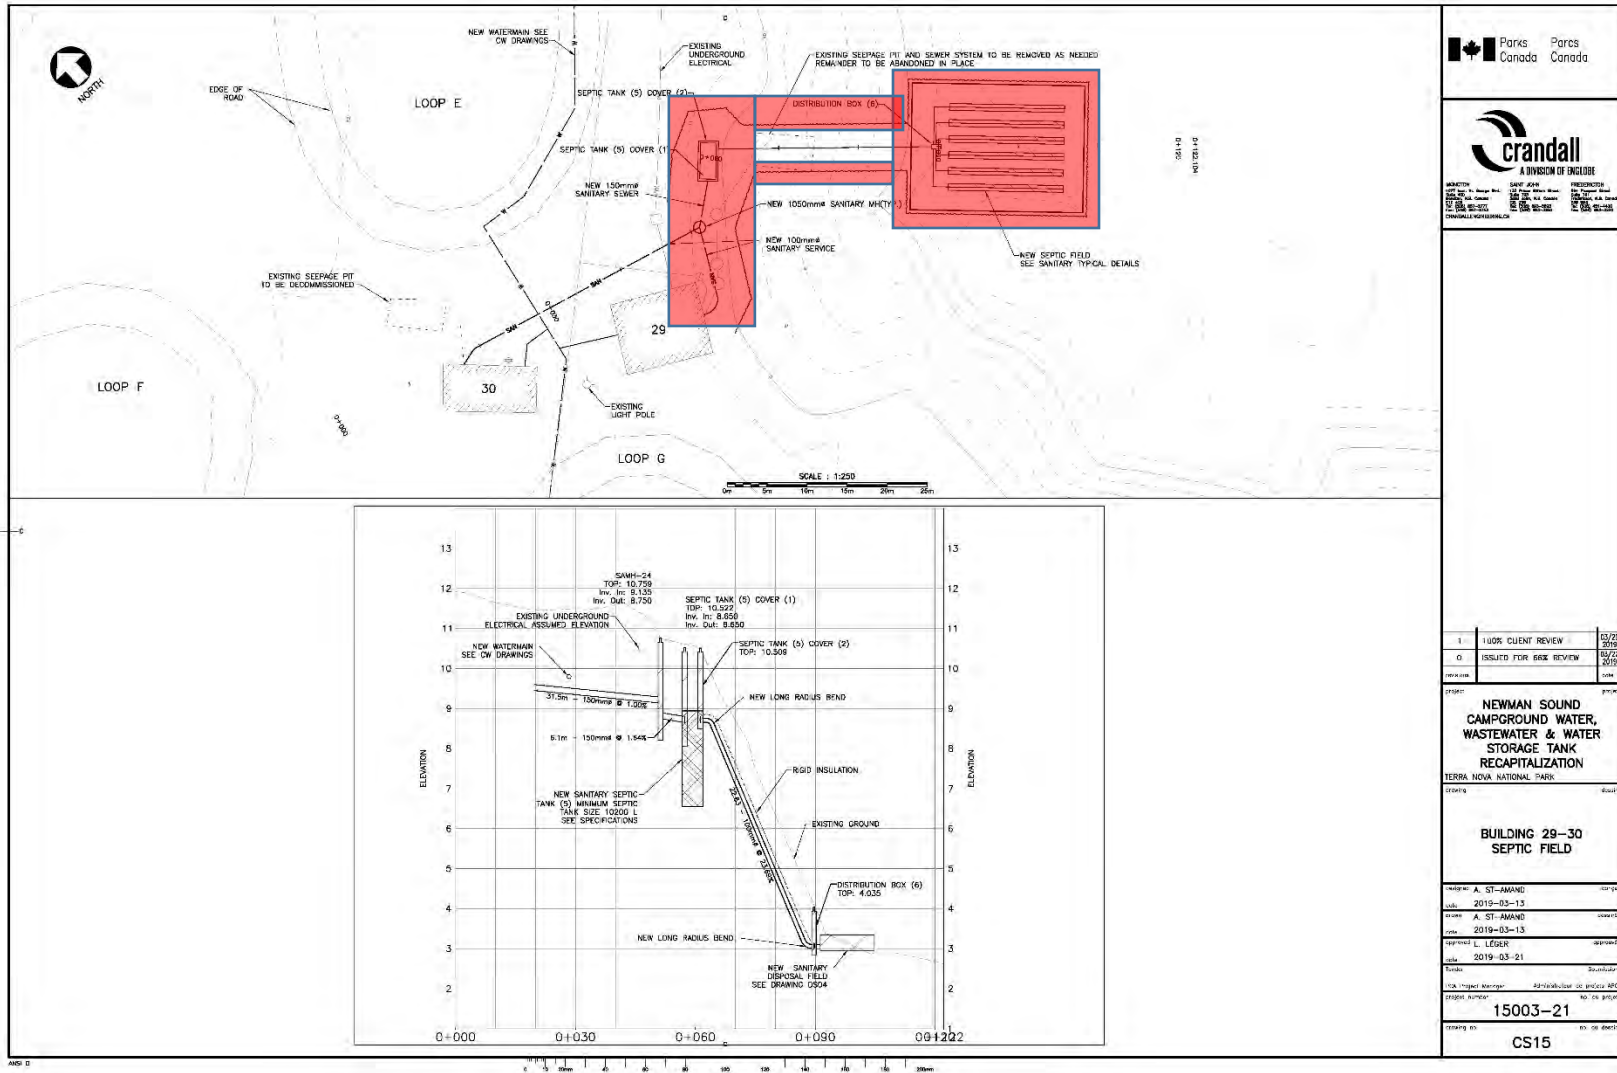
Figure 9: New septic field and related lines. Red rectangles highlight project areas outside disturbed roadway and other previously disturbed areas (Crandall 2019d: CS15).

CS15	New Septic Field (~ 20 x 25m) & new lines (~30m) (Figure 9)	Located in seemingly undisturbed area.	Yes. Site Visit to see if judgemental test pitting is required.
CS16	New Septic Field (~25x40m) & new lines (~40m)	New Septic Field atop existing septic field. Area disturbed. While one new line appears to be in an undisturbed area, the slope suggests that this area is of lower archaeological potential. The remaining sections of the line intersect previously disturbed areas.	No
CS17	New Septic Field (~15x25) (Figure 10)	South half overlaps with existing septic field.	Yes. Site Visit to see if judgemental test pitting is required.

- CS14 - New Septic Field & Waterline (Table 3, Figure 8).
- CS15 - New Septic Field & Waterline shown in CS15 (Table 3, Figure 9).
- CS17 - New Septic Field (north half) shown in CS17 (Table 3, Figure 10).

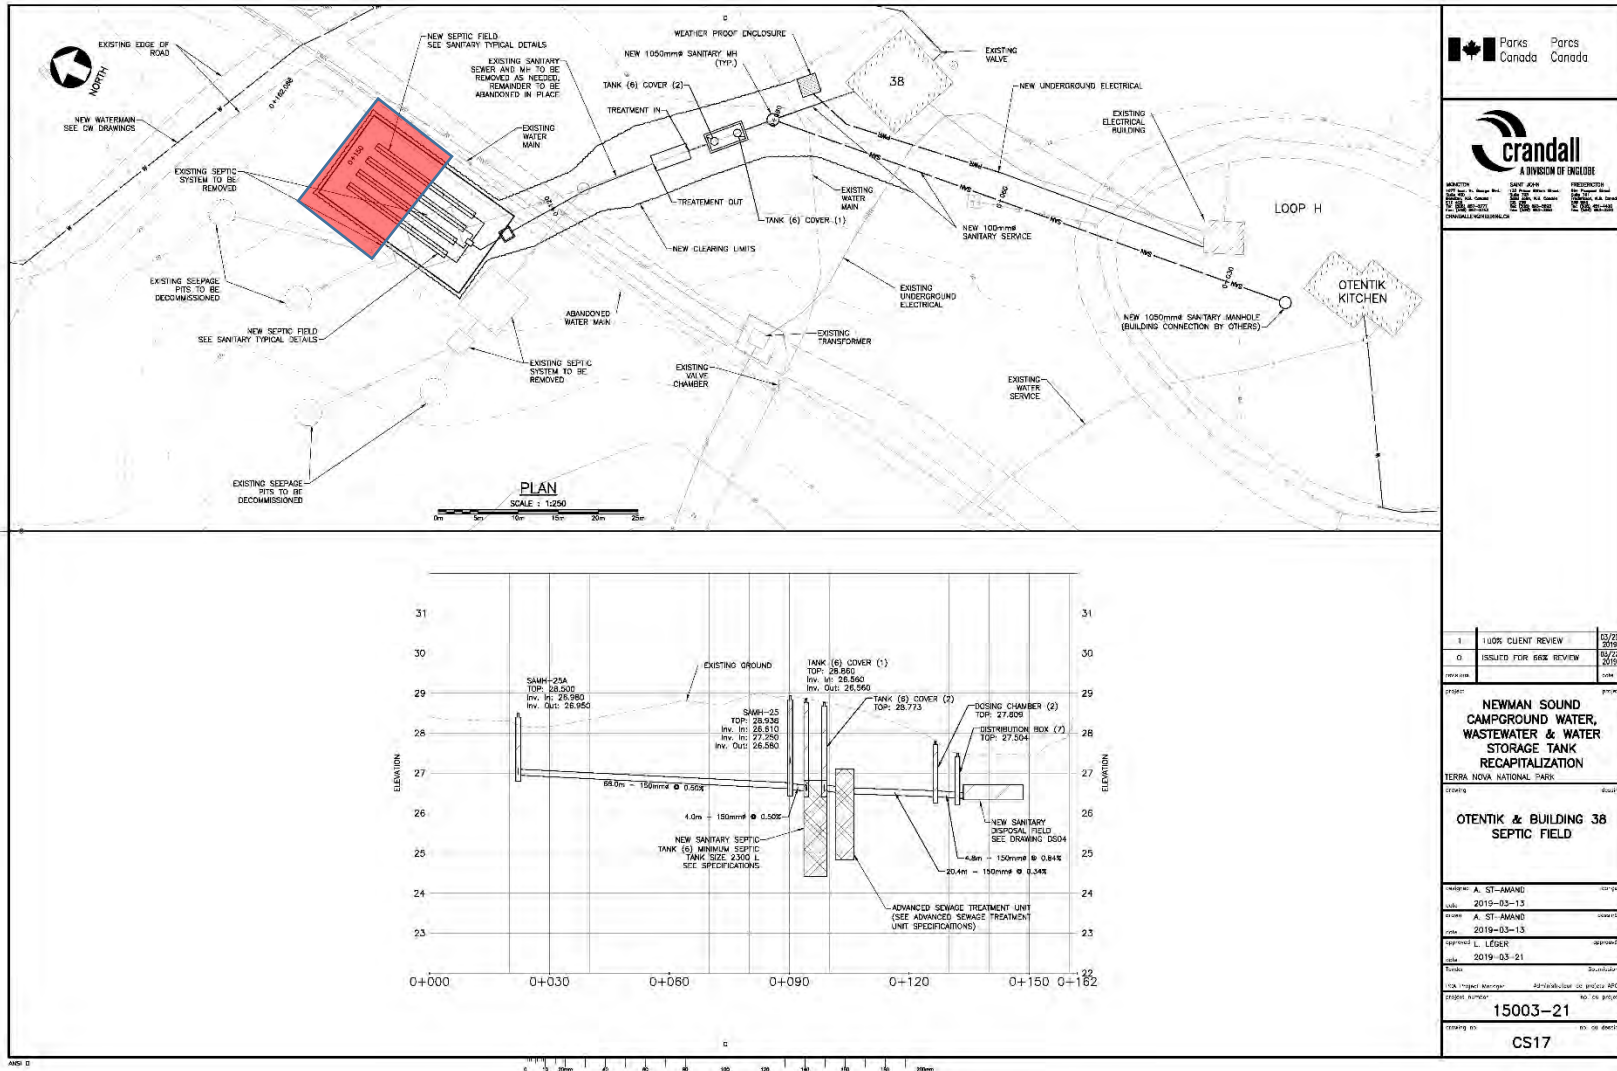
Figure 10: New septic field and related lines. Red rectangles highlight project areas outside disturbed roadway and other previously disturbed areas (Crandall 2019d: CS17).

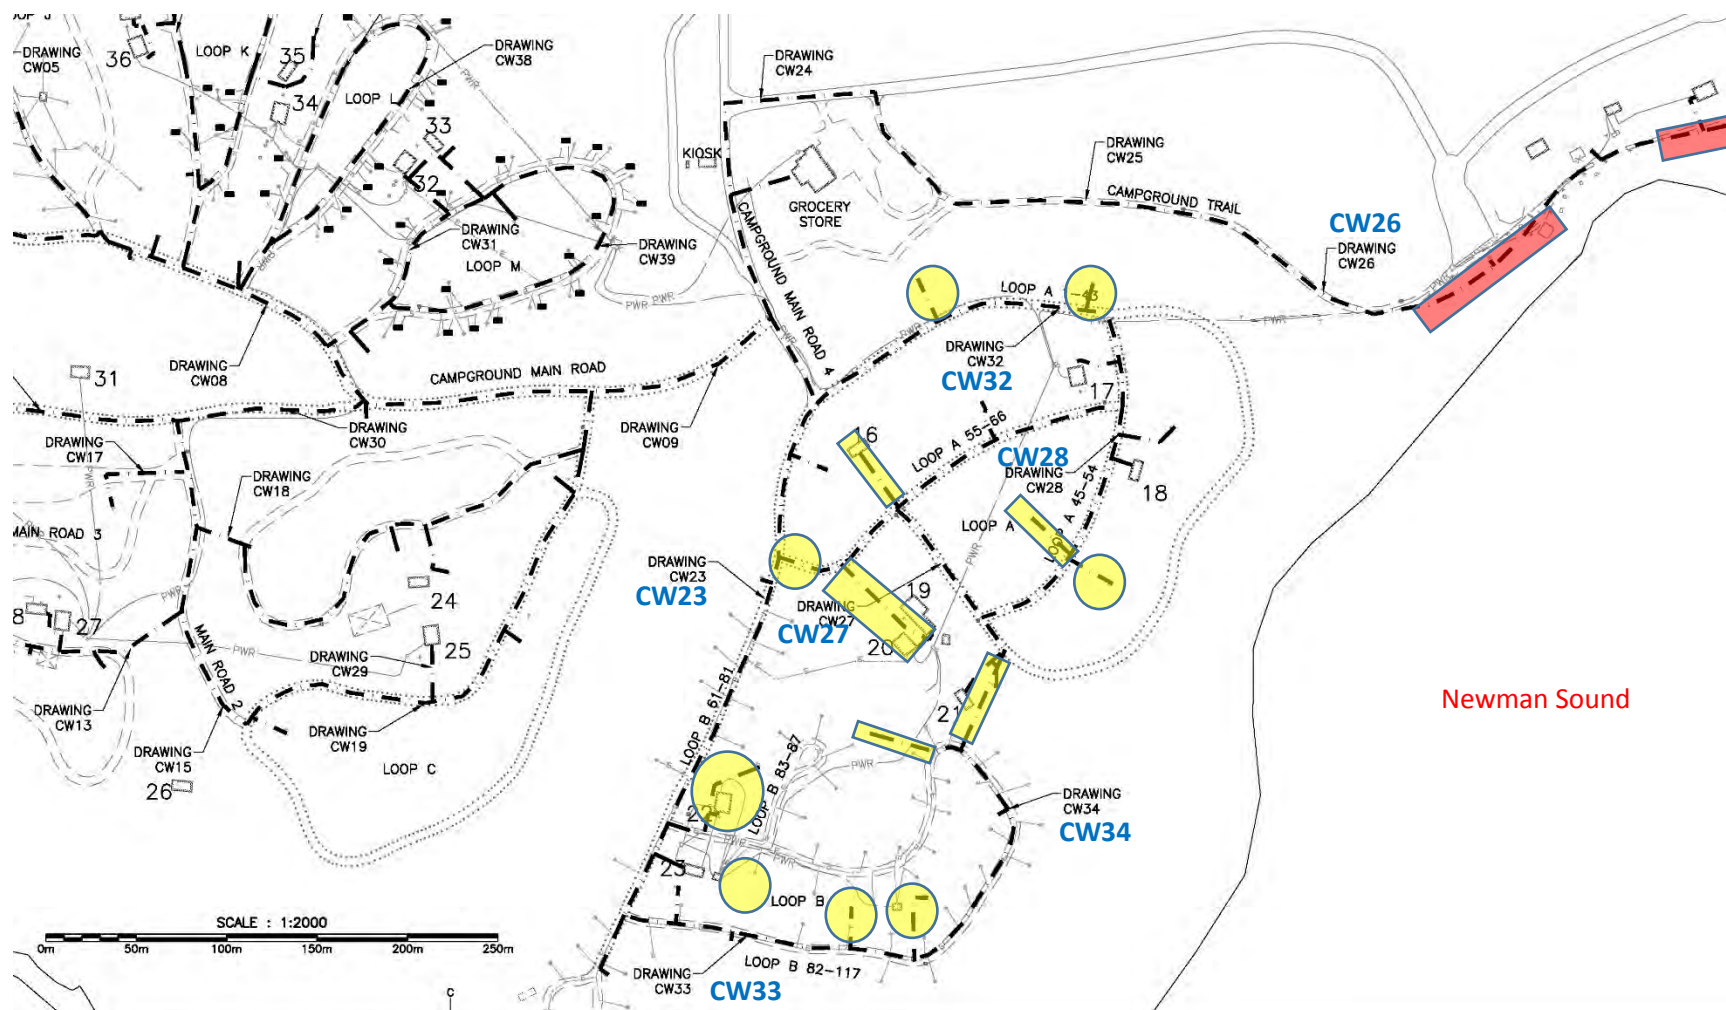
Figure 12: Watermain Overall Site Plan (Newman Sound Campground Water, Waterwater & Water Storage Tank Recapitalization) (Crandall 2019d: CW01). Close up of areas of archaeological potential areas. Red = High, Yellow = Moderate.

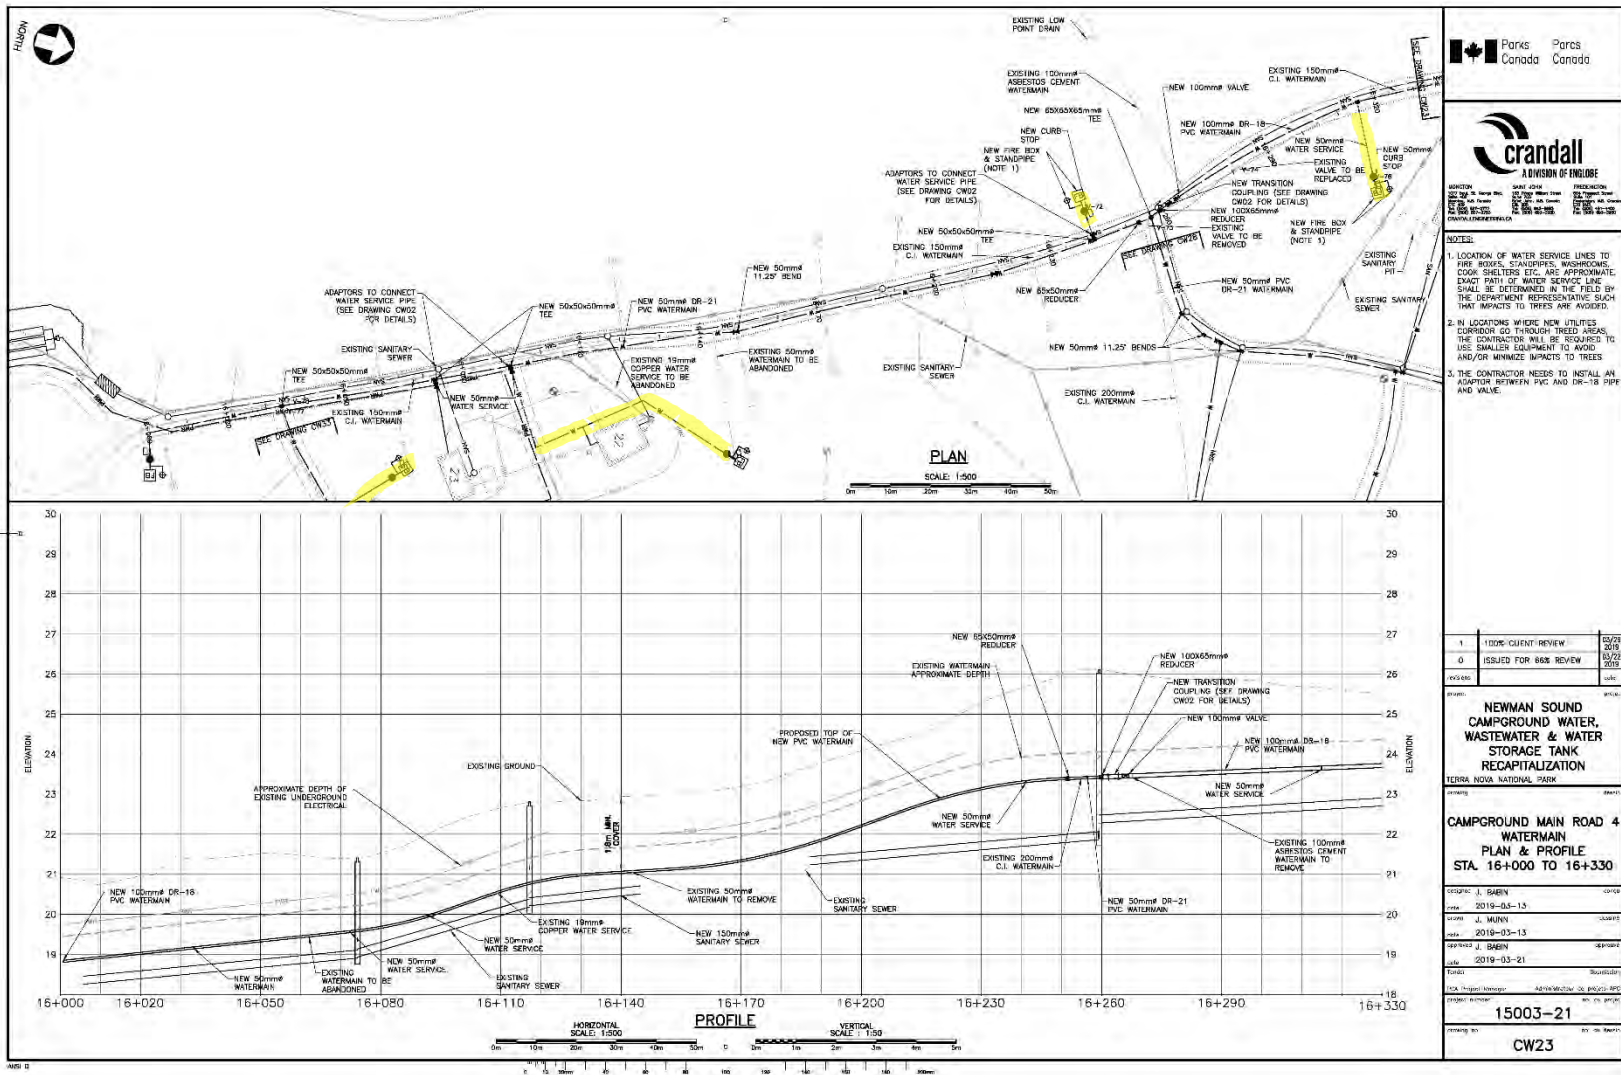
Figure 13: Campground Main Road 4 Watermain Plan and Profile. Yellow lines highlight proposed excavations in undisturbed locations of moderate archaeological potential. (Crandall 2019d: CW23)

Sheet	Activity Impacting Ground Surface / Sub-Surface (approx. length)	Comments	AIA Required?
CW23	Watermain (60m) and Firebox (Figure 13).	Moderate archaeological potential. <250m west of Newman Sound.	Yes. Site Visit to see if judgemental test pitting is required.
CW26	Watermain & Forcemain (75m, 20m, 20m, 40m), and 2 Fireboxes (Figure 14).	High archaeological potential. Located at the Day Use Area, southeast of the trail and parking lot and 20-40m east of Newman Sound. Portions of proposed work lie outside of existing watermain footprint. That being said, this area could have been grubbed during the levelling of the area for use as a day use area. <i>The areas of concern in this area overlap with the areas of concern listed in Table 3, Sheet CS10 / CS11.</i>	Yes. Site Visit to see if judgemental test pitting is required.
CW27	Watermain (2 x 50m, 2 x 20m, 10m) and 4 Fireboxes (Figure 15).	Moderate archaeological potential. ~250m west of Newman Sound	Yes. Site Visit to see if judgemental test pitting is required.

- CW23 - Watermain and Firebox installation (Table 4, Figure 13).
- CW27 - Watermain and firebox installation (Table 4, Figure 15).
- CW28 - Watermain / water service & Fire Box (Table 4, Figure 16).
- CW33 - Watermain / water service, sanitation line, power line and fireboxes (Table 4, Figure 17).
- CW34 - Watermain / water service, sanitation line and fireboxes (Table 4, Figure 18).

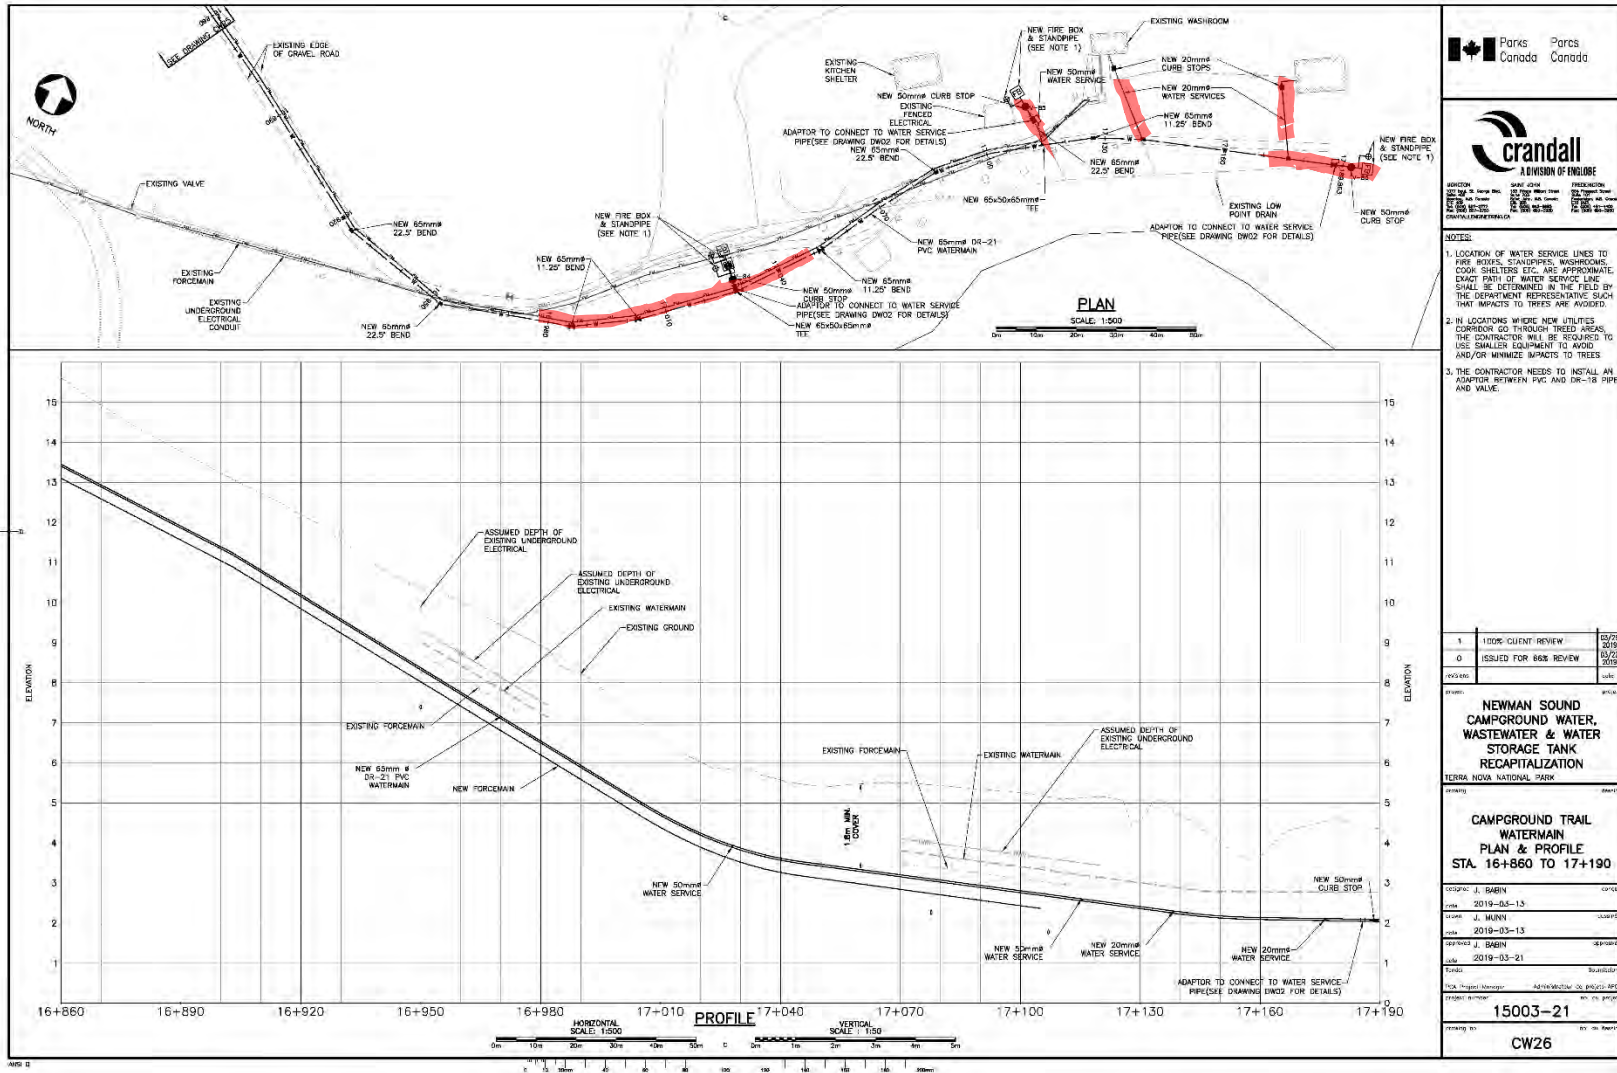
Figure 14: Campground Trail Watermain. Red lines highlight proposed excavations in undisturbed locations of low archaeological potential. (Crandall 2019d: CW26)

- **Project:** Newman Sound Campground Water, Wastewater & Water Storage Tank Recap (Crandall 2019c)
- **Summary:** Watermain, sanitary force main and fire boxes to be installed in previously undisturbed area.
- Project activities are outlined in section 3.3; Crandall 2019c: CS10/11 (Table 3, Figure 7) and Crandall 2019c:CW26 (Table 4, Figure 14).

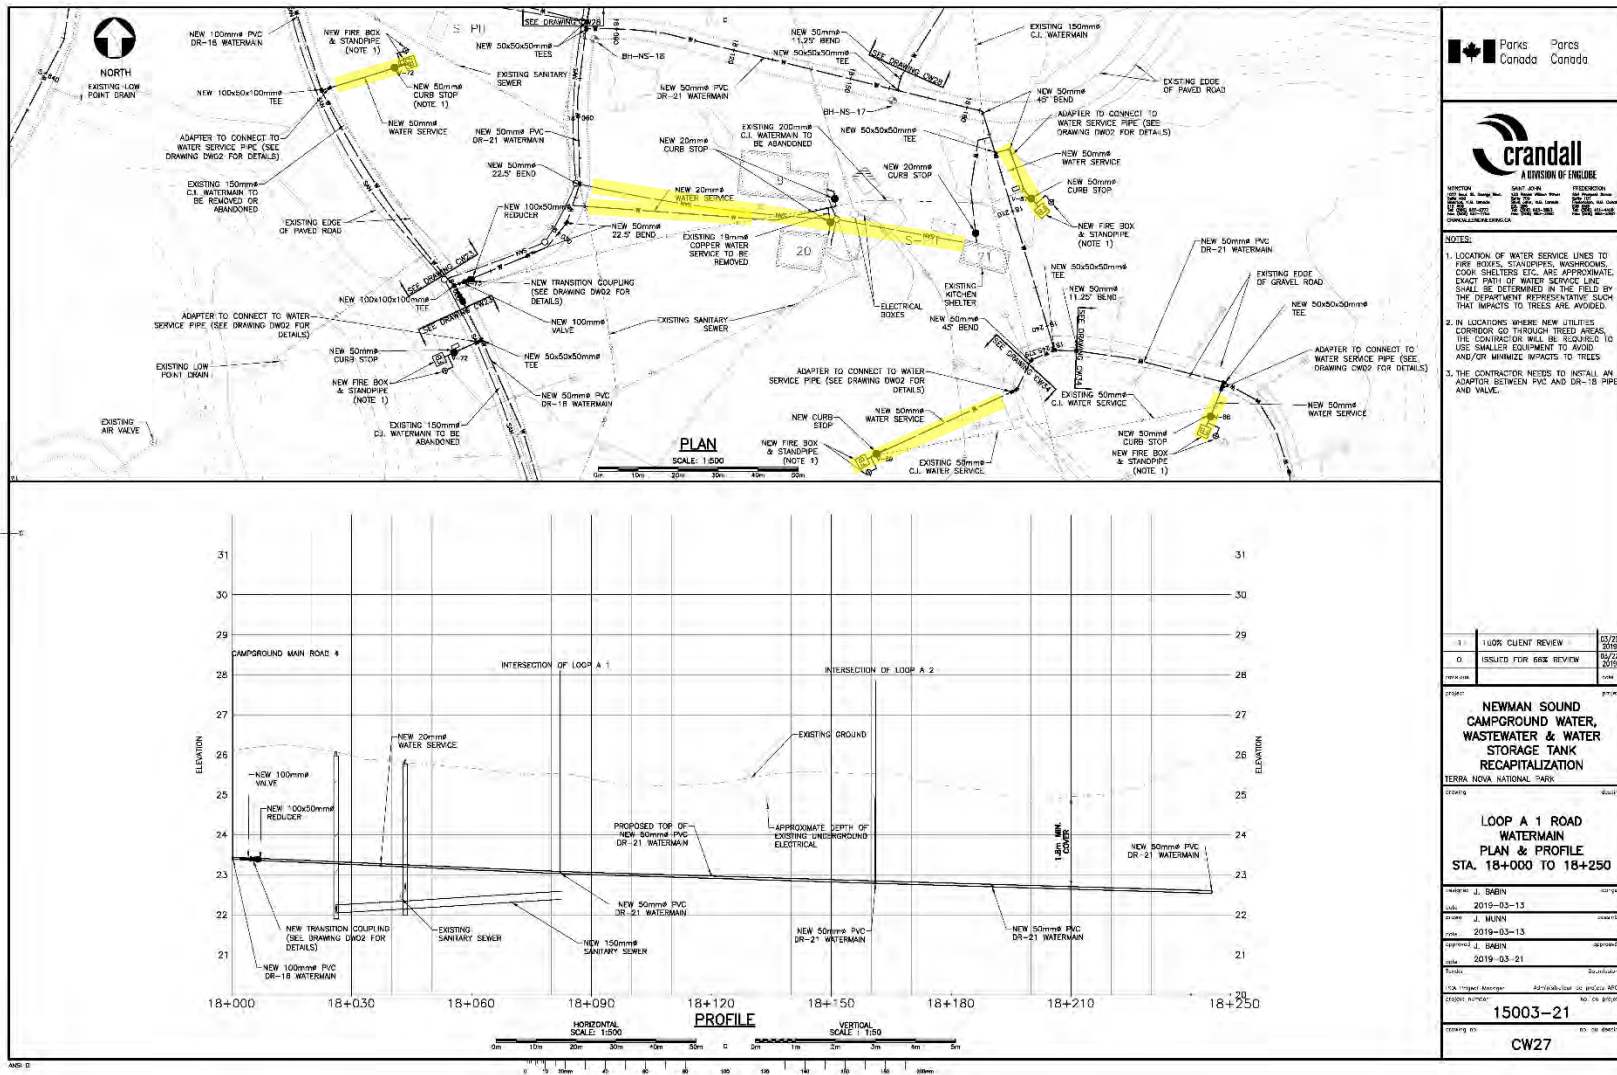
Figure 15: Loop A 1 Road Watermain. Yellow lines highlight proposed excavations in undisturbed locations of moderate archaeological potential. (Crandall 2019d: CW27).

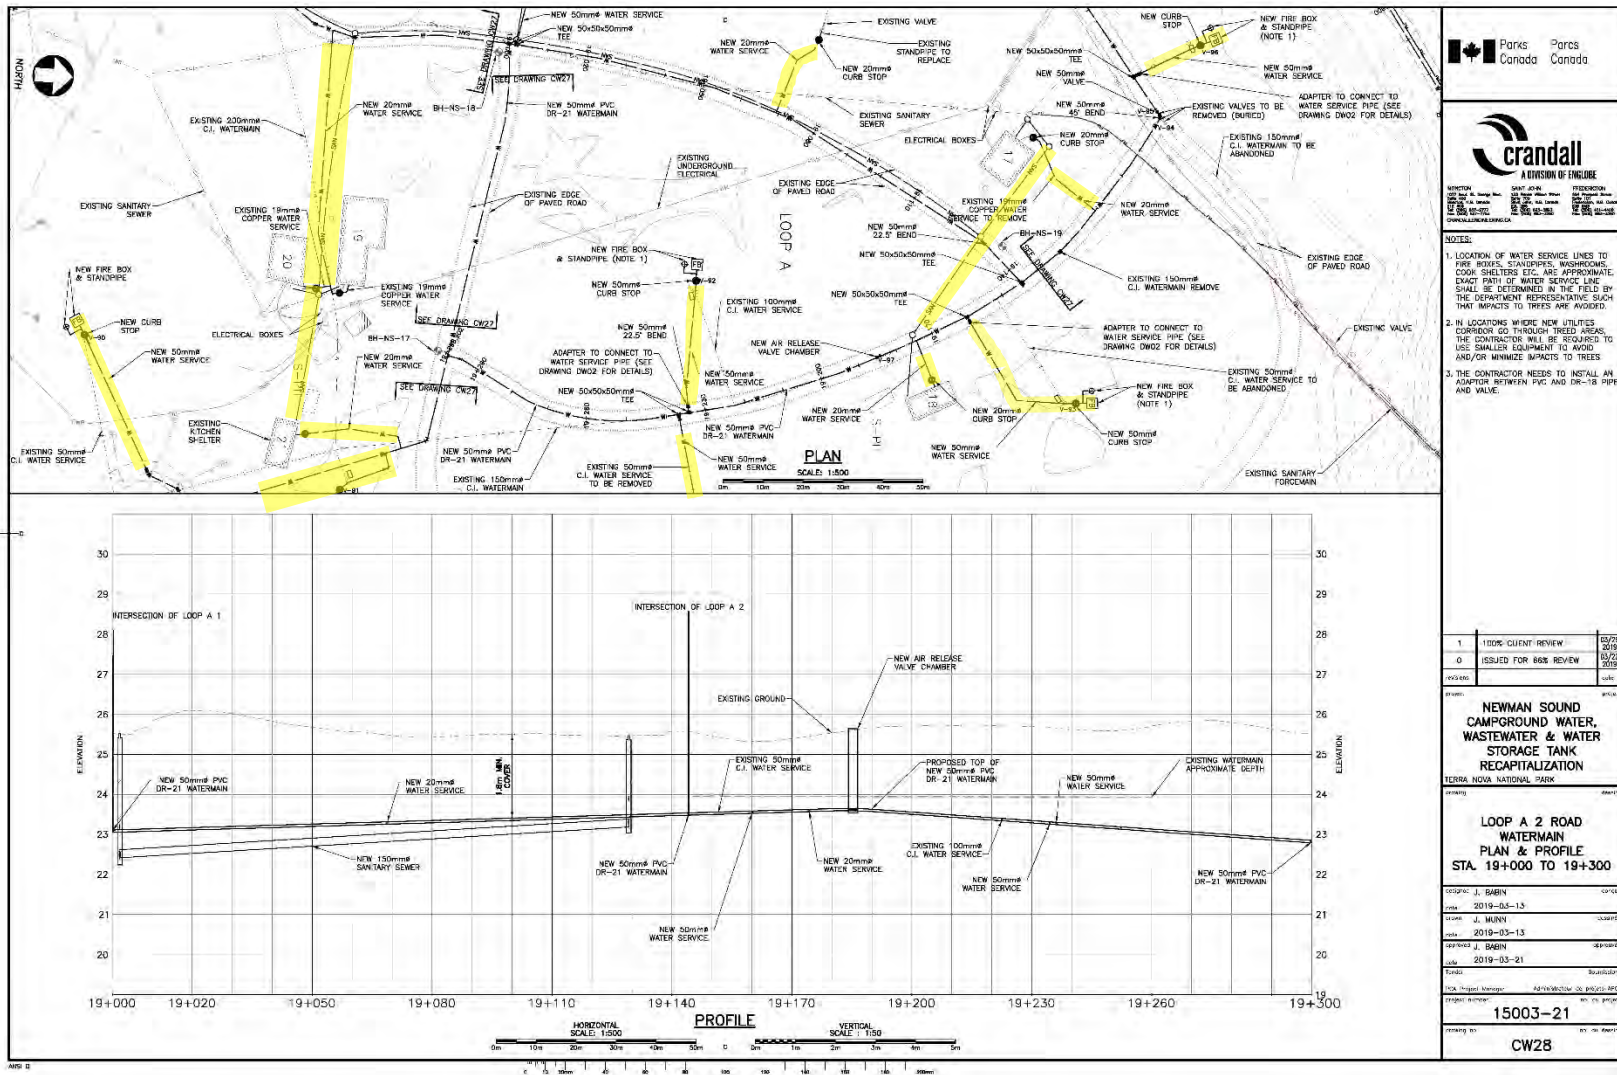
Figure 16: Loop A 2 Road Watermain. Yellow lines highlight proposed excavations in undisturbed locations of moderate archaeological potential. (Crandall 2019d: CW28).

CW28	Watermain/water service (3 x 30m, 3 x 40m, 50m, 100m) & Fire Box; 4 Fireboxes (Figure 16).	Moderate archaeological potential. ~250m west of Newman Sound	Yes. Site Visit to see if judgemental test pitting is required.
CW33	Watermain/water service (2x 10m, 20m, 30m, 40m, 60m), Sanitation line (30m), Power line (20m) & 6 Fire boxes (Figure 17).	Moderate archaeological potential. ~250m west of Newman Sound	Yes. Site Visit to see if judgemental test pitting is required.
CW34	Watermain/water service (20m, 2 x 30m, 3 x 50m, 60m), Sanitation line (90m) & 4 fire boxes (Figure 18).	Moderate archaeological potential. Less than 250m west of Newman Sound.	Yes. Site Visit to see if judgemental test pitting is required.

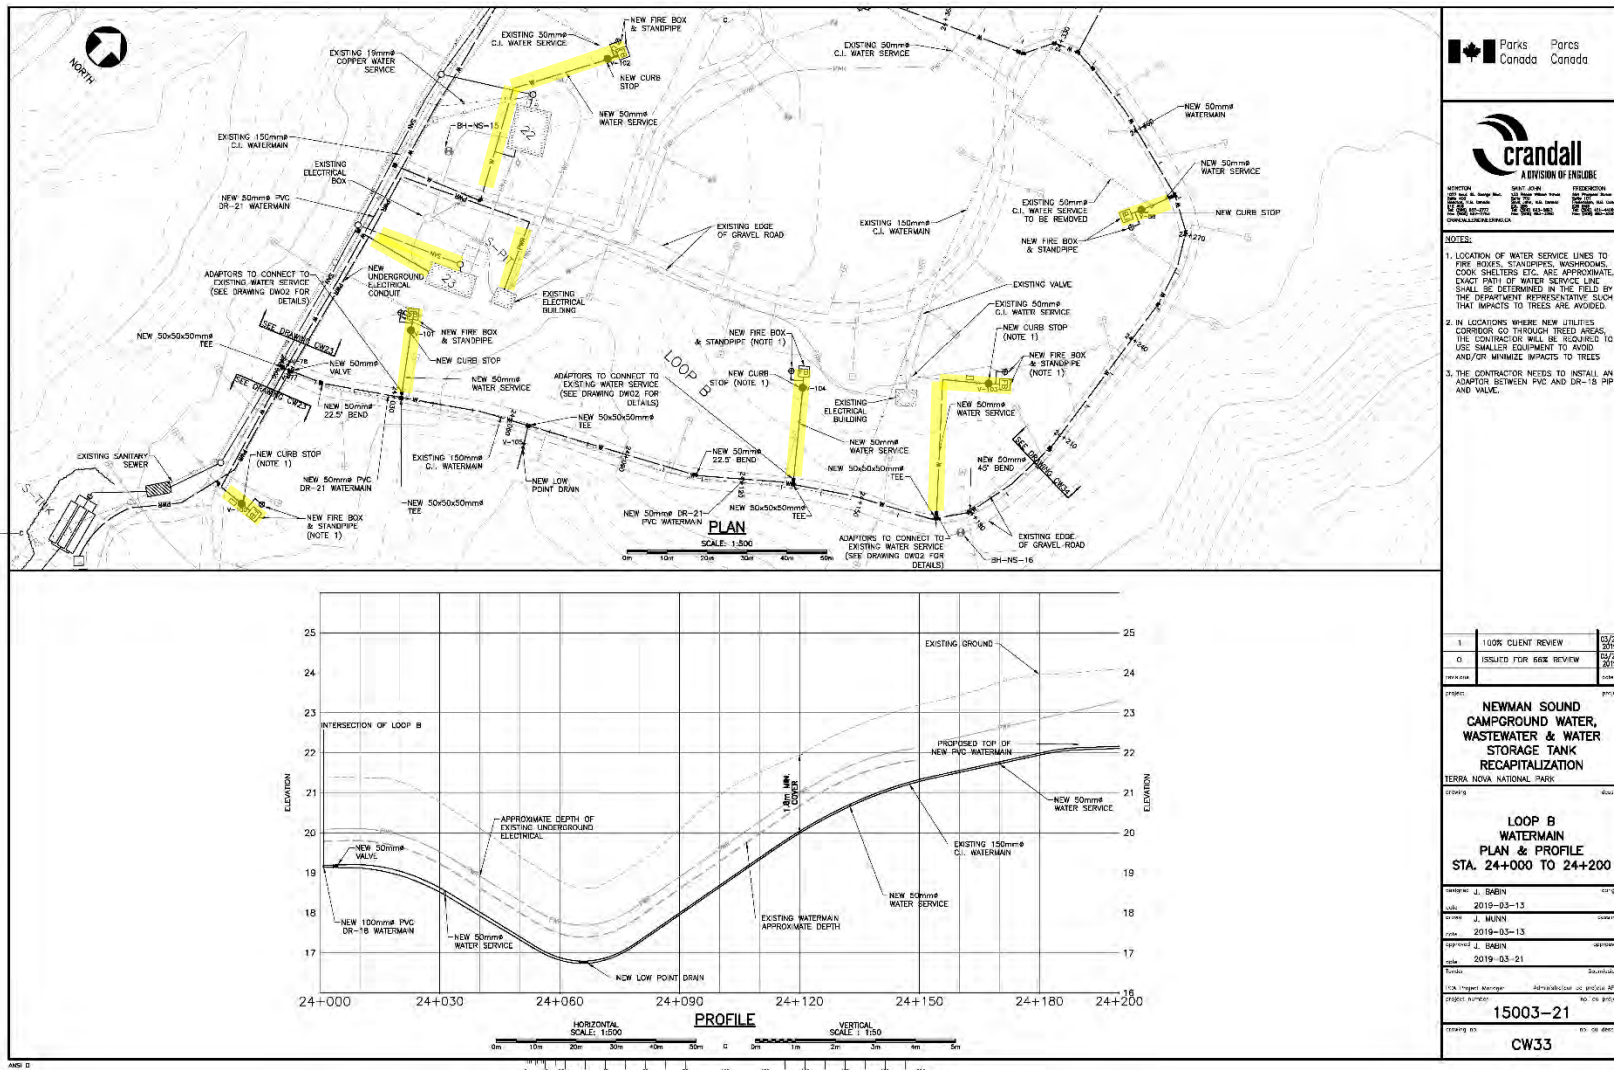
Figure 17: Loop B Watermain. Yellow lines highlight proposed excavations in undisturbed locations of moderate archaeological potential. (Crandall 2019d: CW33).

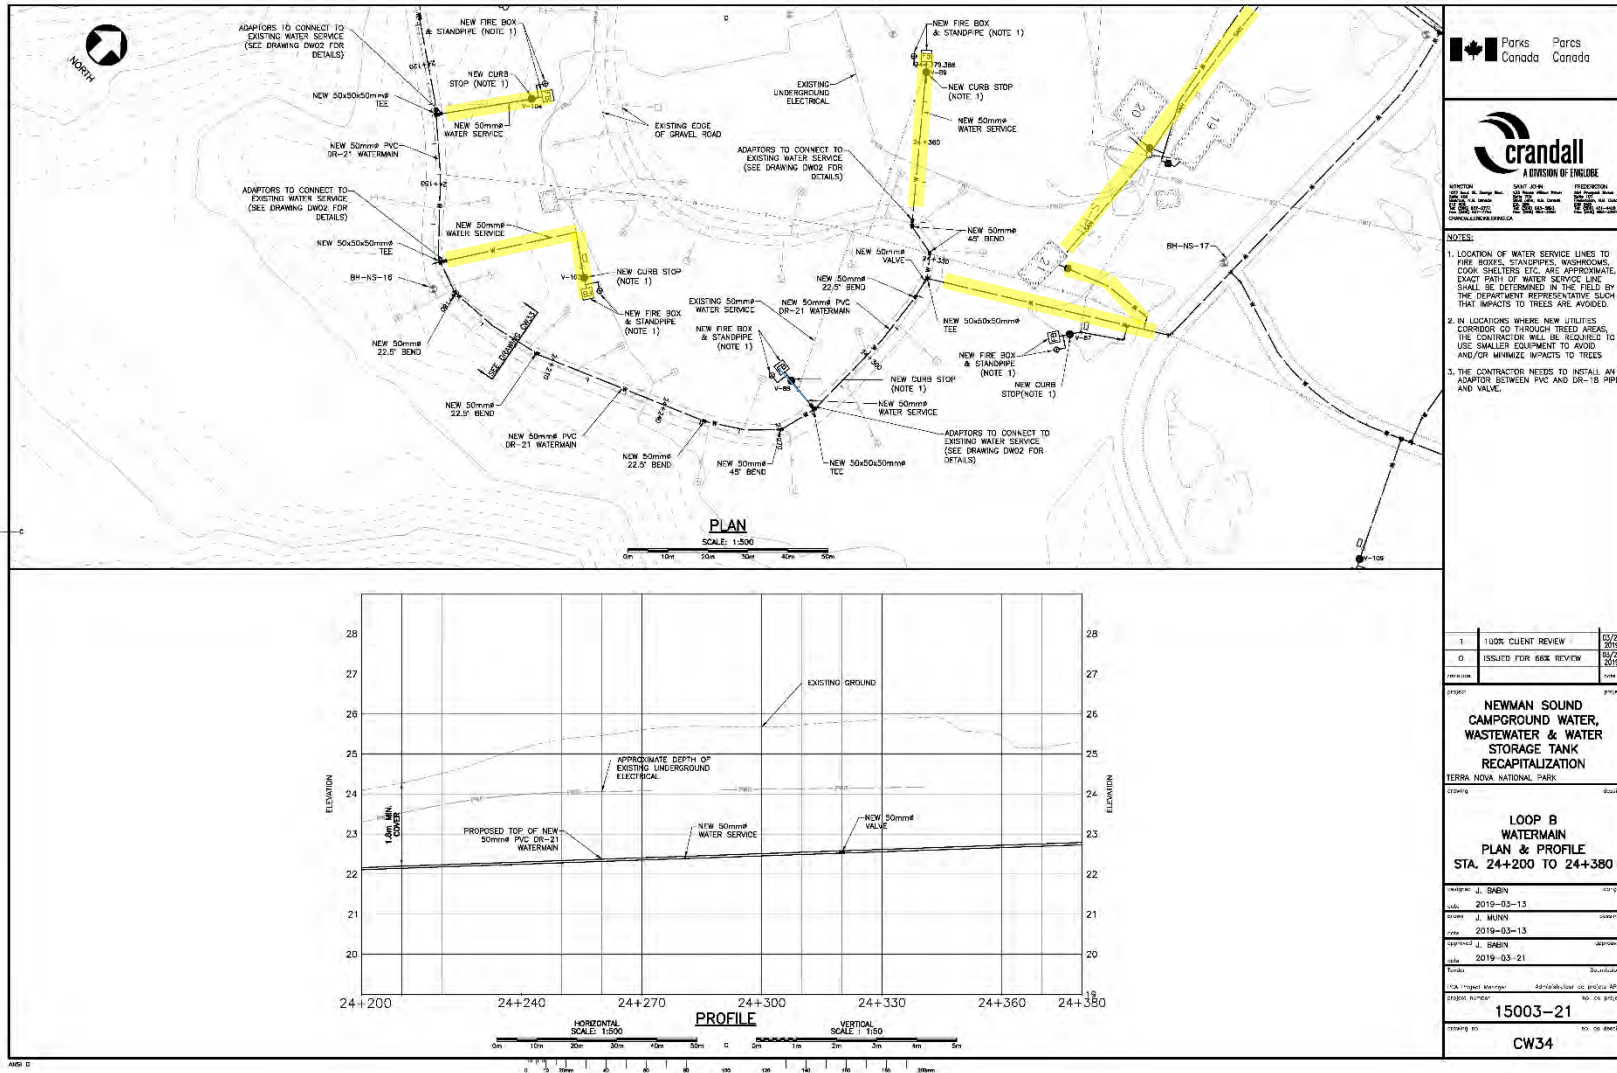
Figure 18: Loop B Watermain. Yellow lines highlight proposed excavations in undisturbed locations of moderate archaeological potential. (Crandall 2019d: CW34).
