Archaeological Overview Assessment
RPA 1716: Terra Nova National Park Utility Systems Recapitalization
Terra Nova National Park (Newfoundland and Labrador)
Funding: To Be Determined

Prepared By: J. Higdon, Archaeologist, IACH Directorate
Date: May 15, 2019

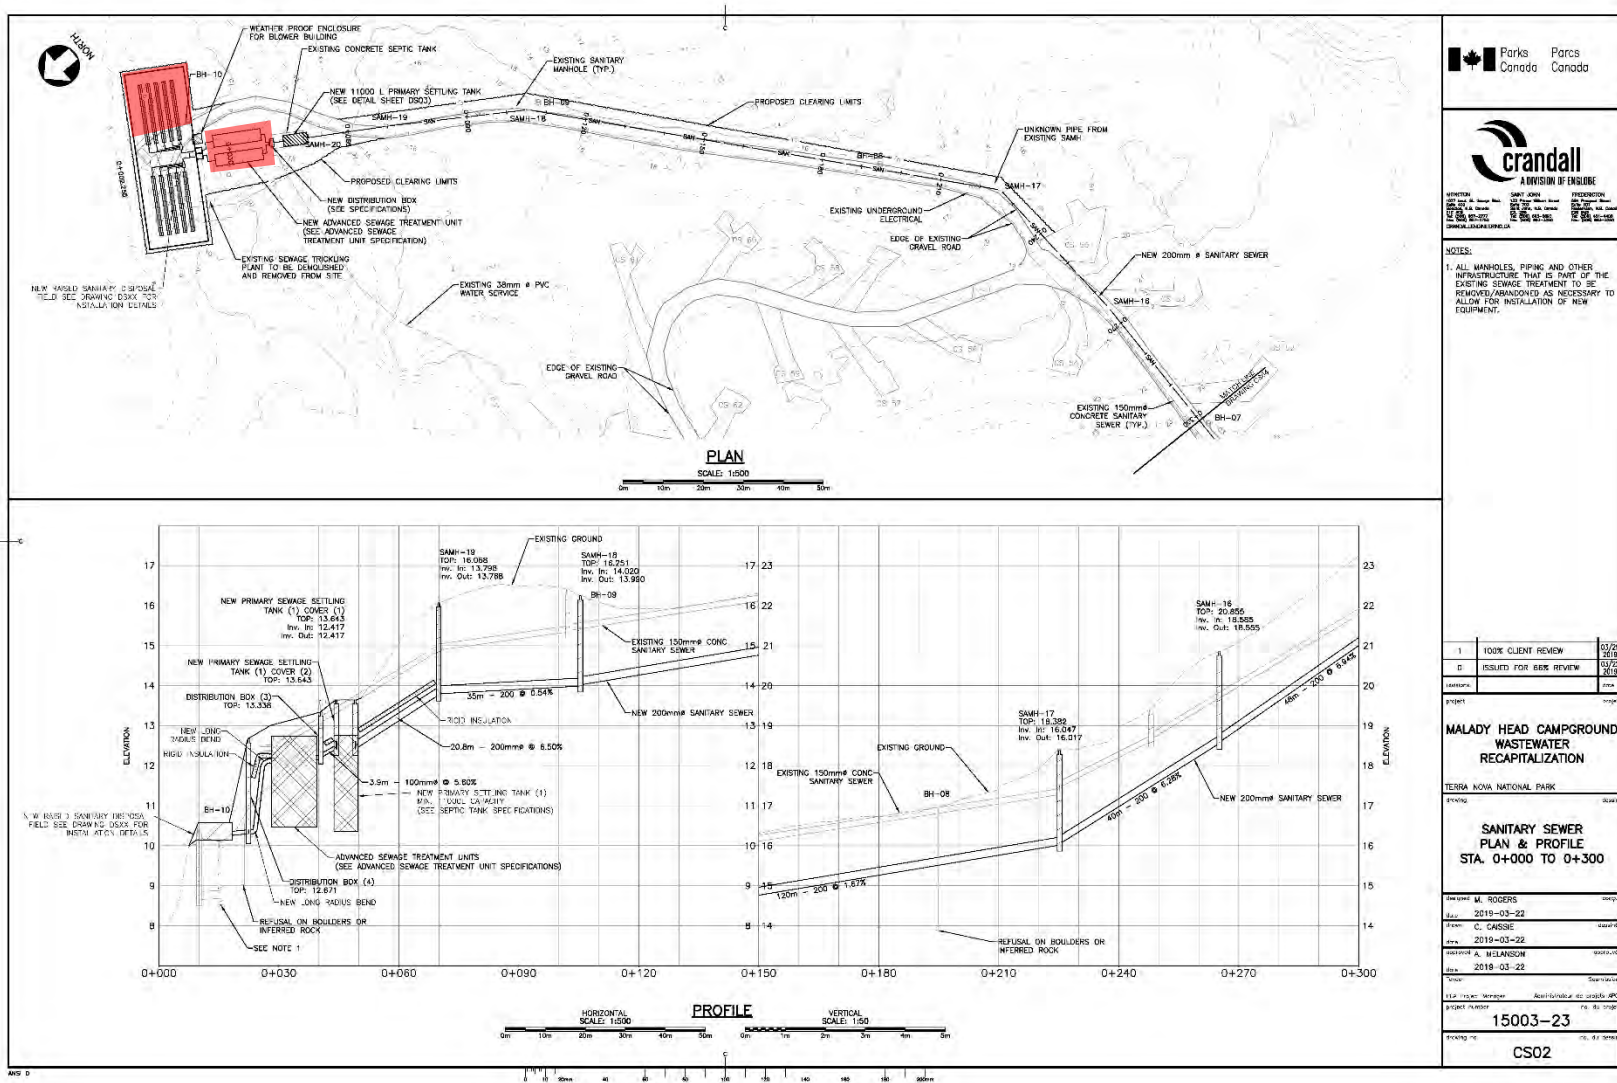
Figure 20: Sanitary Sewer Plan and Profile STA.0+000 to 0+300 with red rectangles showing project areas that may be located within previously undisturbed areas of the park (Crandall 2019a).

- CS02 - New raised sanitary disposal field at northern eastern extent of campground area (Section 3.4.2, Figure 20).
- CS06 - New septic field associated with existing kitchen shelter (Section 3.4.3, Figure 21).

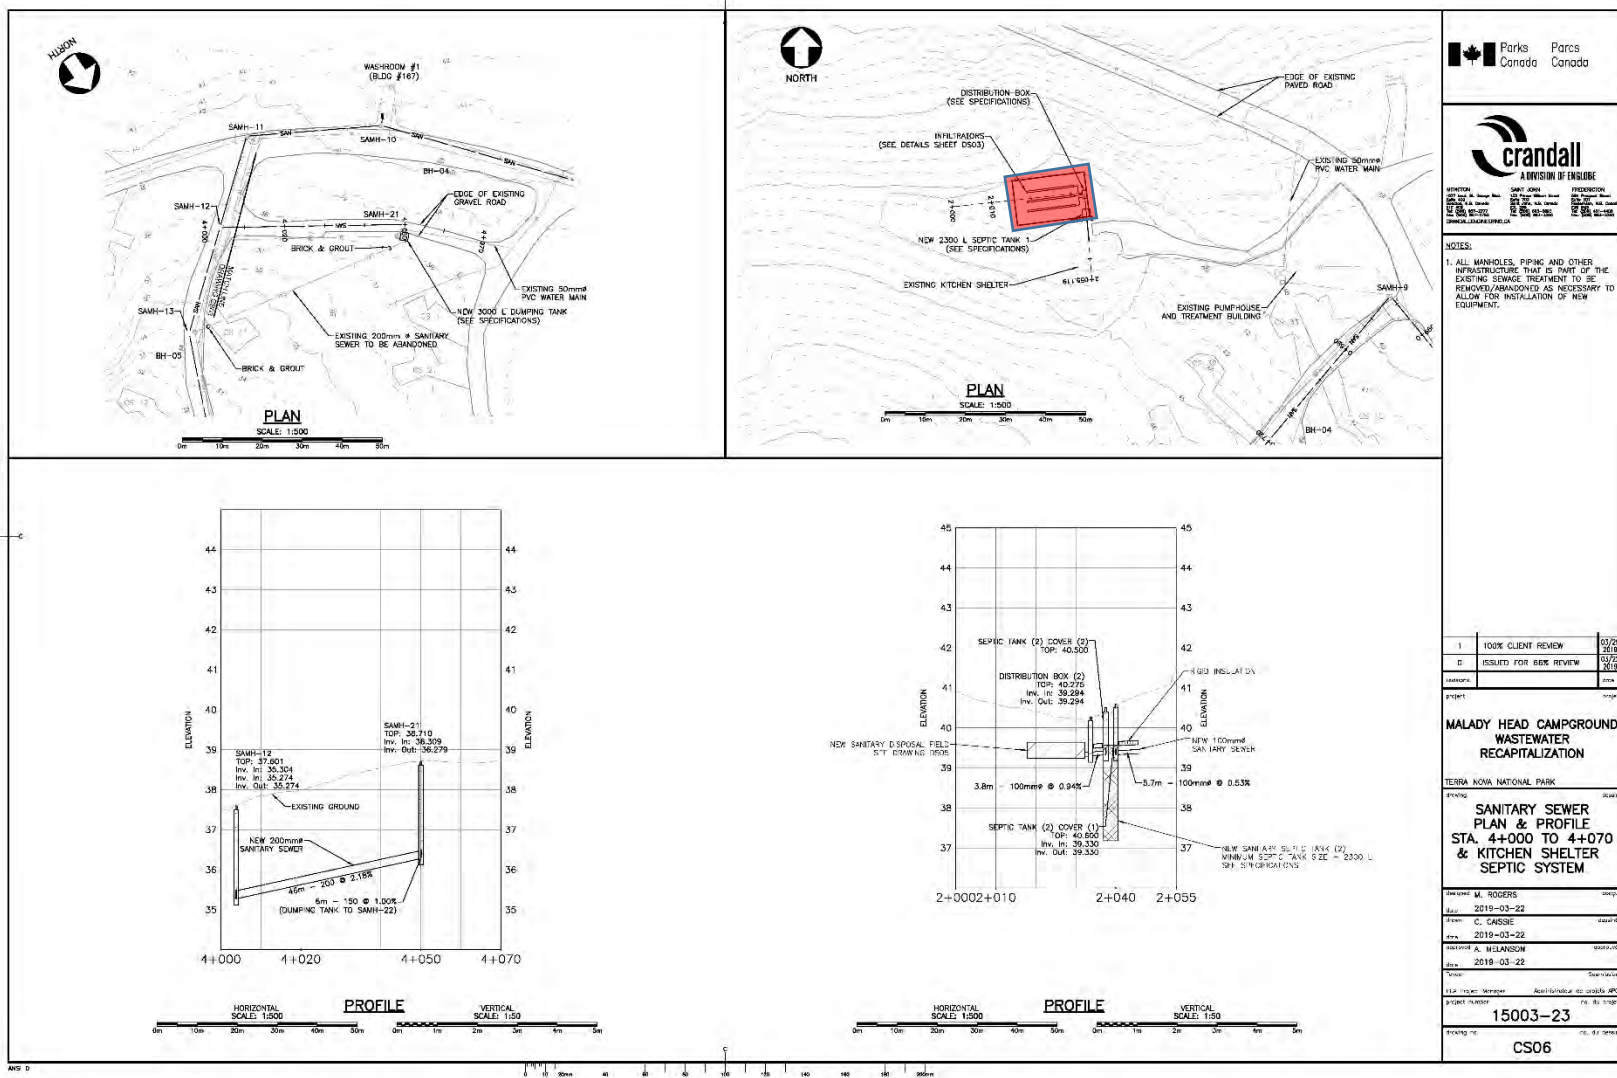
Figure 21: Sanitary Sewer Plan and Profile STA.4+000 to 4+070 & Kitchen Shelter Septic System. Red rectangles showing project areas that may be located within previously undisturbed areas of the park (Crandall 2019a).

Drawing CS06 shows the proposed location of a new 2300L septic tank and related system to the north of the existing kitchen shelter (Figure 21). Excavation associated with the septic tank and associated infiltrators and distribution box will impact an area approximately 10m x 20m and 2-3m deep. While this area is of low archaeological potential, it will involve excavation in previously undisturbed areas. **An Archaeological Impact Assessment in the form of a site visit to determine if judgmental test pitting is required.**

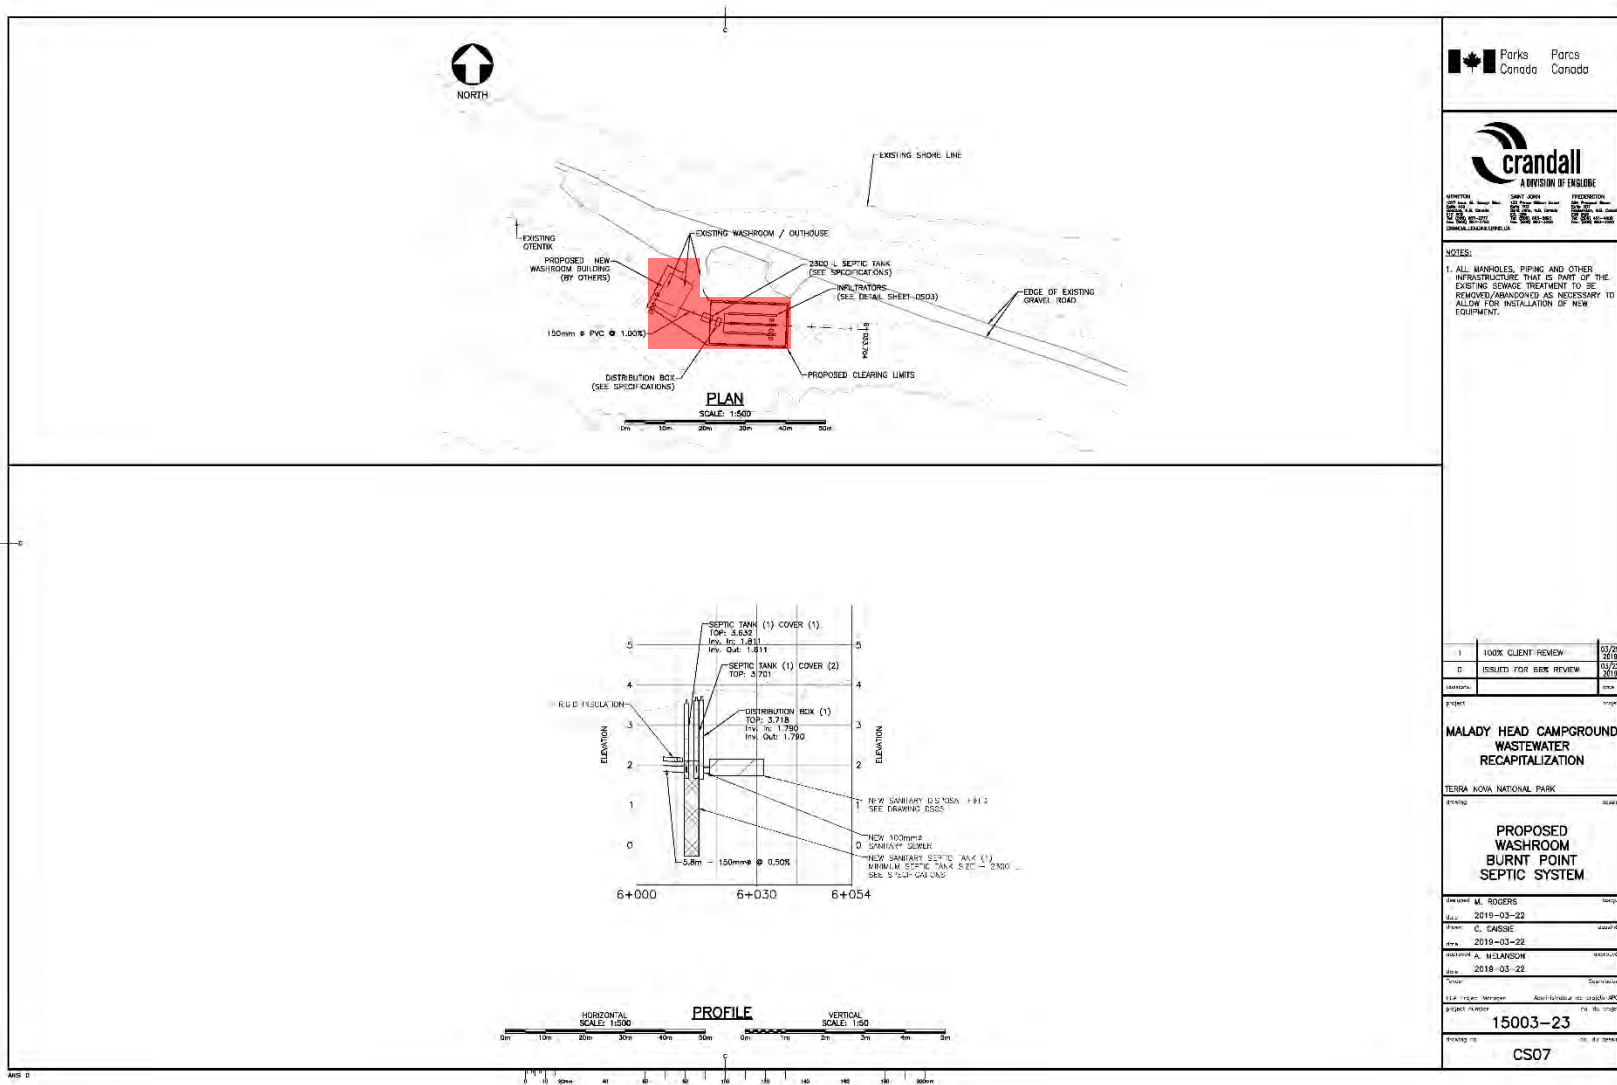
Figure 22: Proposed Washroom Burnt Point Septic System (Crandall 2019a)..

Located within 40m of the current beach, this portion of the project includes the removal of existing washroom / outhouse buildings and the installation of a new washroom building and associated septic tank system (Figure 22). While the specific dimensions of the washroom facility have not been given, the drawings show an area approximately 10m x 10m. A sewage pipe connects the facility to a 2300L septic tank and associated 10m x 20m septic field containing infiltrators and a distribution box. Excavations for the septic tank and infiltrators involve excavations at depths of 2-3m.

- **Project:** Malady Head Campground Wastewater Recap Newman Sound ([Crandall2019a](#))
- **Summary:** Installation of new washroom building and septic day at Burnt/Point / Beach Cove Day Use area (Figure 22).
- Project Activities are outlined in Section 3.4.3 and Crandall 2019, Sheet CS07 (Figure 22).
- **More information about the nature and extent of washroom building is needed to complete this portion of the AOA.**
