Building 1007 Demolition  
Esquimalt Graving Dock  
Project No.: R.118910.001  
2021-12-22

**Public Works Government Services Canada**  
**Esquimalt Graving Dock**  
**Building 1007 Demolition**  
**Project No. R.118910.001**

1. Stantec Consulting Ltd. Report for Project No. 123221957 entitled “Supplemental Pre-Demolition Hazardous Building Materials Assessment Report” for “Project Name: Demolition of Esquimalt Graving Dock Building 1007 – Kiln Building”, issued December 3, 2021, prepared for Public Services and Procurement Canada.
2. Stantec Consulting Ltd. Report for Project No. 123221425 entitled “Pre-Demolition Hazardous Building Materials Assessment, Building 1007 – Kiln Building, Esquimalt Graving Dock, 825 Admirals Road, Victoria” dated March 31, 2020, prepared for Public Services and Procurement Canada.
3. North West Environmental Group Ltd. Report No. 15609 entitled “Hazardous Building Material Assessment; Esquimalt Graving Dock—DND Buildings” dated December, 2011, prepared for Public Works and Government Services Canada.

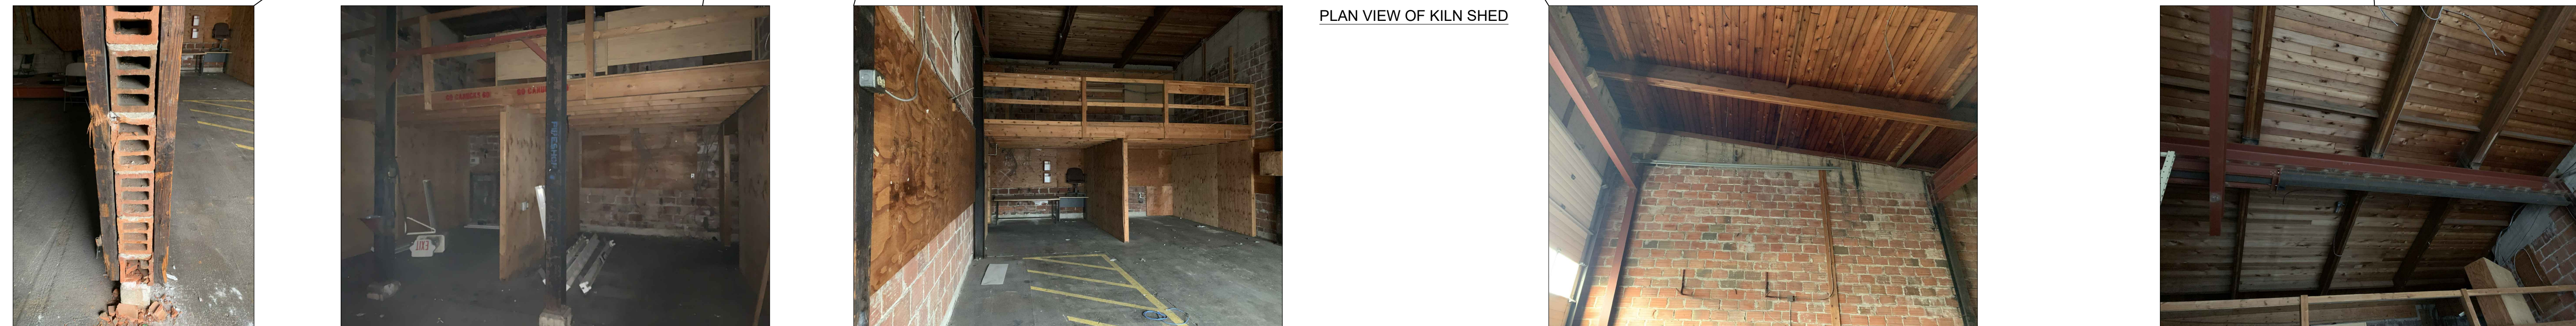
PLAN VIEW OF KILN SHED

Note: All equipment within the project work site shown in the photos will be removed by PSPC prior to contract award.

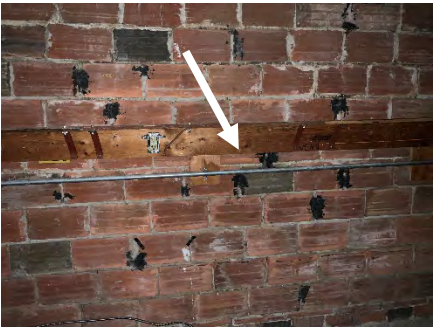
<p><u>ACM black/grey wall mastic applied to red masonry block walls (interior).</u></p>

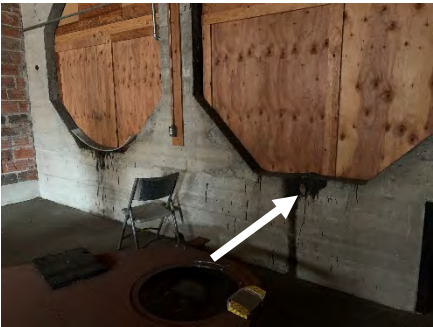
<p><u>ACM black wall mastic applied to concrete wall surfaces.</u></p>

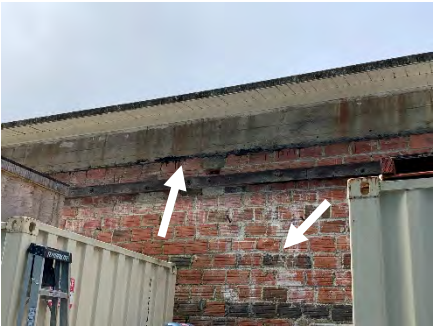
<p><u>ACM black/grey wall mastic applied to red masonry block walls (exterior) and upper wall seams between concrete walls and red masonry block walls.</u></p>

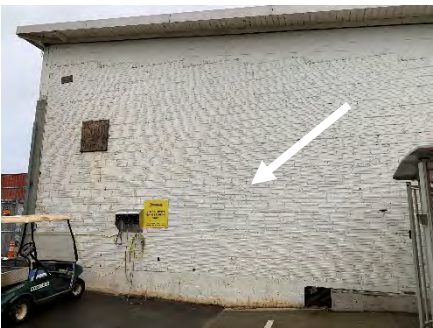
<p><u>Potential ACM black/grey wall mastic applied to red masonry block walls (exterior) painted over white on two exterior sides of the building</u></p>

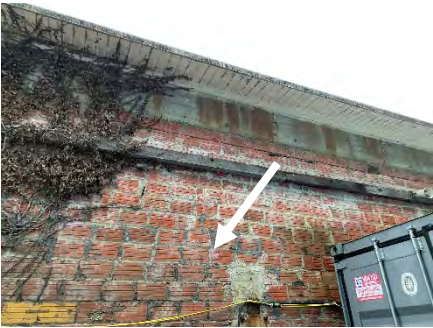
<p><u>ACM black/grey wall mastic applied to red masonry block walls</u></p>	N/A	<p>Previously confirmed ACM:</p> <p>9.2% Chrysotile (2020 Stantec Report)</p> <p>10% Chrysotile (2011 North West Report)</p>

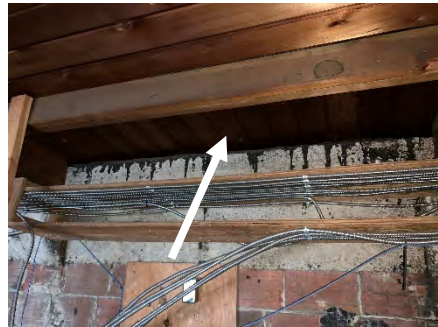
<p>Asphalt sheet layer: KR-01 KR-02 KR-03</p>	<p>No Asbestos Detected</p>

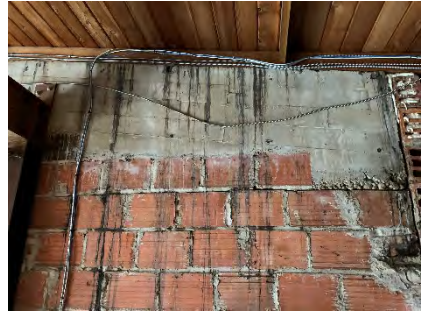
<p><u>Excess roof tar applied ('dripping down') between upper concrete wall and roof.</u></p>	<p>Tar felt layer KR-01 KR-02 KR-03</p>	<p>0.26% Chrysotile detected in first sample (KR-01-Tar Felt)</p> <p>NOTE: anticipated to be residue from underlying tar layer</p>

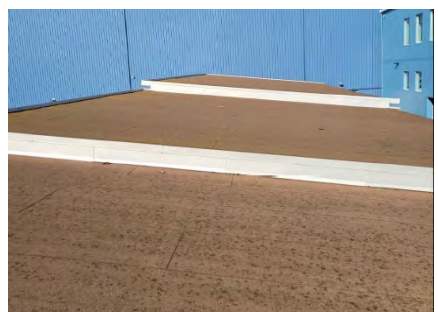
<p><u>Top View of Roof Assembly</u> (Photo Provided by Flynn)</p>	<p>Tar layer KR-01 KR-02 KR-03</p>	<p>2.8% Chrysotile detected in first sample (KR-01-Tar)</p> <p>10% Chrysotile (2011 North West Report)</p>
Throughout interior ceiling	<p>Additional suspected ACM:</p> <ul style="list-style-type: none"> <li>- Black building paper applied between wood beam and walls/ceiling</li> </ul>

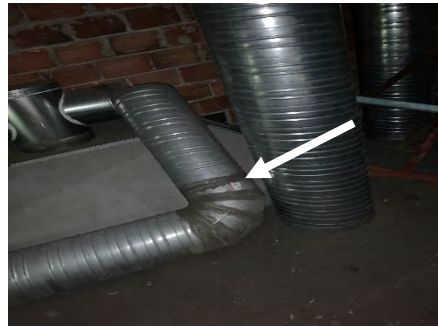
<p>1007-DM-01A 1007-DM-01B 1007-DM-01C</p>	<p>No Asbestos Detected</p>

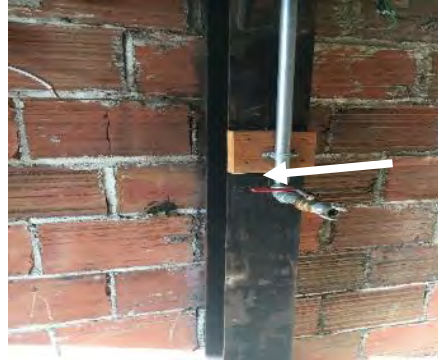
<p><u>Black LCP on Strucural Steel</u></p>	<p>N/A</p>	<p>1,500 ppm Lead (2020 Stantec Report)</p>

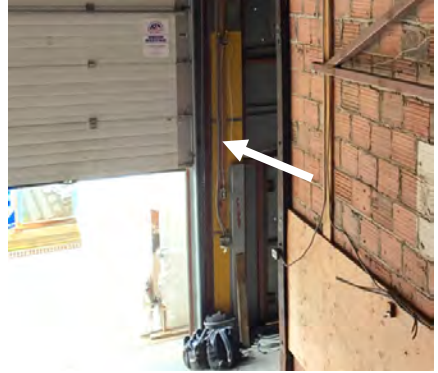
<p><u>Yellow LCP on Concrete Walls</u></p>	N/A	96,000 ppm Lead (2020 Stantec Report)
Throughout Interior	Previously confirmed LCP: - Yellow on concrete floor lines (typical throughout)

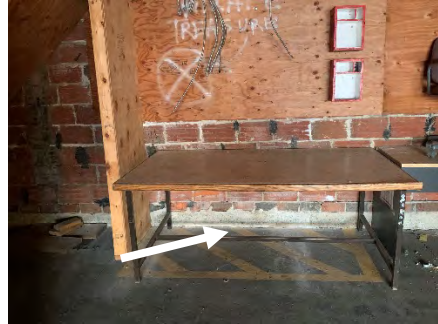
<p><u>Yellow LCP on Concrete Floor Lines</u></p>	N/A	68,000 ppm Lead (2020 Stantec Report)
Exterior	Previously confirmed LCP: - White on exterior masonry block walls and underside of roof decking (on wood soffits)

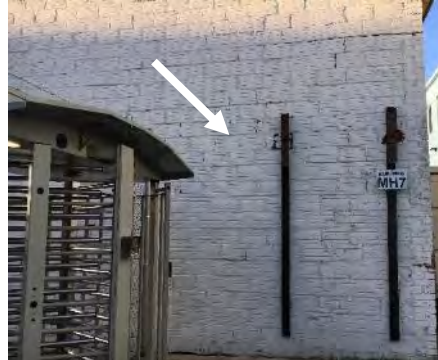
<p><u>White LCP on Masonry Block Walls</u></p>

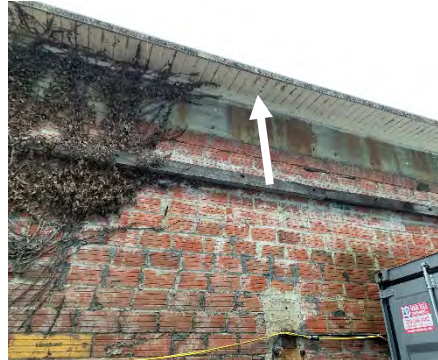
<p><u>White LCP on Underside of Roof Decking (soffits)</u></p>	N/A	690 ppm Lead (2020 Stantec Report)
Exterior	Red on metal corrugated walls (typical front exterior)

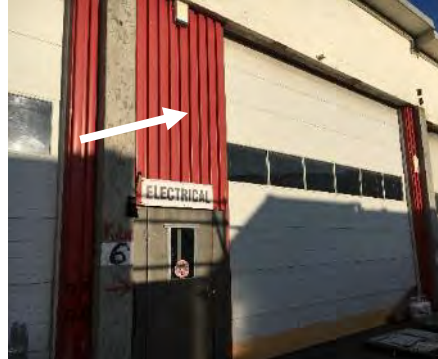
<p><u>Red LCP on Metal Corrugated Walls</u></p>	N/A	22,000 ppm Lead (2020 Stantec Report)

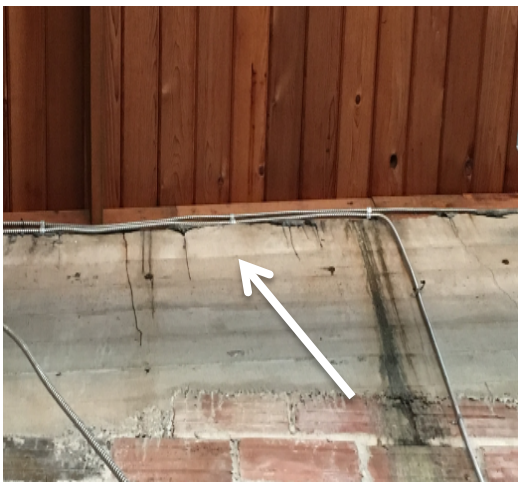
Identified ACM Description and Condition Information	
<p><b>Roof tar</b></p> <ul style="list-style-type: none"> <li>• Roof not accessed during the current assessment</li> <li>• Previous Report indicates “roof tar” as ACM. Observations indicate that this may be a “base” layer. As such, overlying roofing materials are unlikely to be reasonably separable from the base layer, and roofing materials in general should be considered ACM unless additional assessment and testing proves otherwise.</li> </ul>

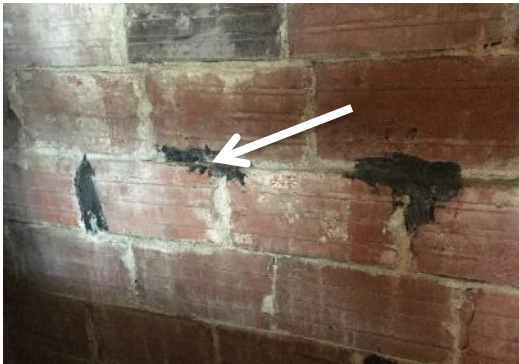
<p>% Type</p>	<p>10% Chrysotile (Previous Report)</p>
<p>Friability</p>	<p>Non-friable</p>
<p>Condition</p>	<p>Good</p>
<p><b>Black firestop/wall mastic applied to red masonry block walls throughout various interior/exterior penetrations</b></p>	
<p>% Type</p>	<p>10% Chrysotile (Previous Report)                  9.3% Chrysotile (current assessment)</p>
<p>Friability</p>	<p>Non-friable</p>
<p>Condition</p>	<p>Good</p>

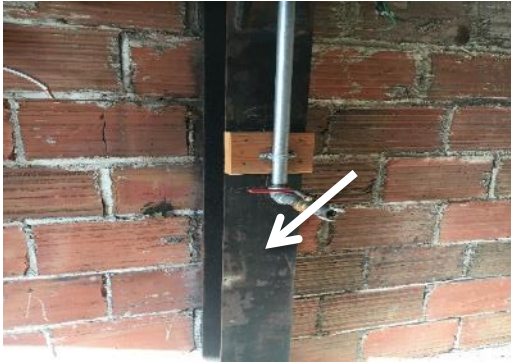
LCP Description		Photo
Paint colour	Black

Substrate	Steel	
Location/approx. extent	Structural steel (typical interior throughout)	
Lead content	1,500 ppm	
Condition	Good	
Paint colour	Yellow	<p>No photo available.</p>
Substrate	Concrete	
Location/approx. extent	Interior wall between Bay 5 and Bay 6	
Lead content	96,000 ppm	
Condition	Good	
Paint colour	Yellow

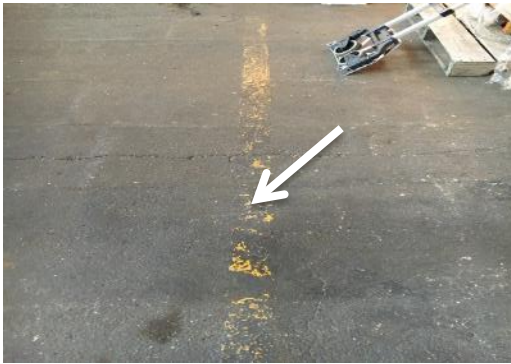
Substrate	Concrete	
Location/approx. extent	Floor lines (typical throughout)	
Lead content	68,000 ppm	
Condition	Good

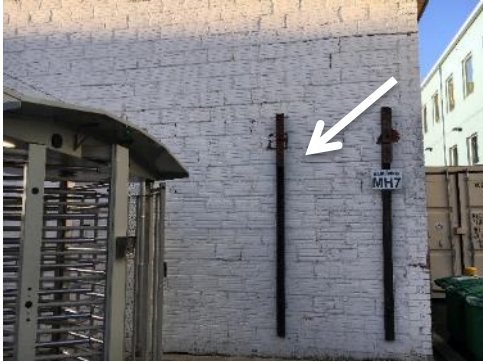
LCP Description		Photo
Paint colour	White

Substrate	Brick	
Location/approx. extent	Walls (typical exterior throughout)	
Lead content	1,100 ppm (converted from Previous Report) 690 ppm (current assessment)	
Condition	Good	
Paint colour	Red

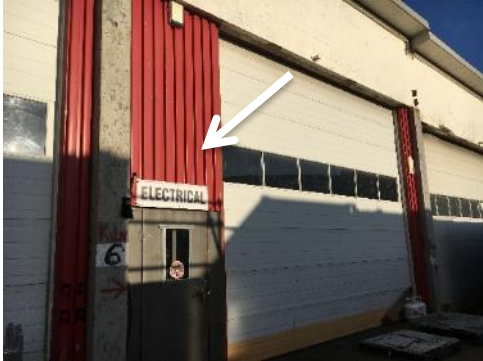
Substrate	Metal	
Location/approx. extent	Corrugated walls (typical front exterior)	
Lead content	22,000 ppm	
Condition	Good

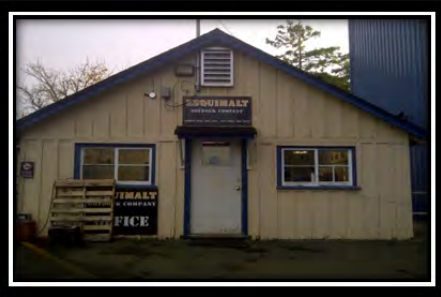
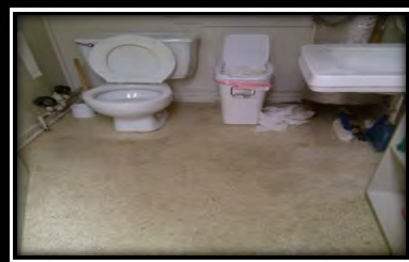
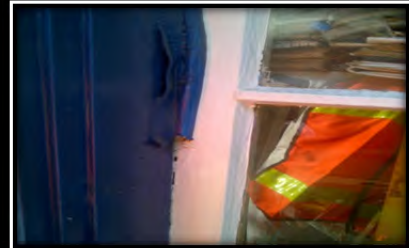
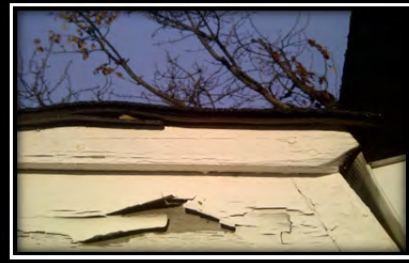
Building: 4 DND Property – EDC Office	
<b>Area: EDC Office</b>

<b>Details:</b> <ul style="list-style-type: none"><li>• Construction Date: 1970</li><li>• Ceiling: Drywall and wood panels</li><li>• Walls: Drywall and wood panels</li><li>• Flooring: Floor tiles and sheet flooring on wood substrate</li><li>• Roof: Asphalt shingles</li></ul>	
<b>Area: Office and Bathroom</b>	
<b>Hazardous Materials Observed:</b> <ul style="list-style-type: none"><li>• Lead: Lead based paint on walls and trim</li><li>• Mercury containing equipment:</li><li>• Fluorescent light fixtures present</li><li>• Mercury containing Thermostat present</li><li>• Ozone depleting substances: Fridge present</li><li>• PCB's: [potential] Fluorescent light ballasts present</li><li>• Mould: None observed</li></ul>

<b>Samples:</b> <p>15609-01: Sheet Flooring (Lt. Grey Mosaic) Bathroom 20% Chrysotile Asbestos Content</p> <p>15609-02: Insulation (Window Frame) Exterior No Asbestos Detected</p> <p>15609-03: Roofing Material (3 Layers) Roof No Asbestos Detected</p> <p>15609-04 : Floor Tile (White 12"x12") Office Area &lt;1% Chrysotile Asbestos Content</p> <p>No access to attic space.</p>

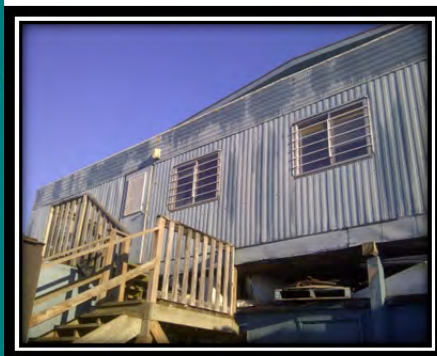
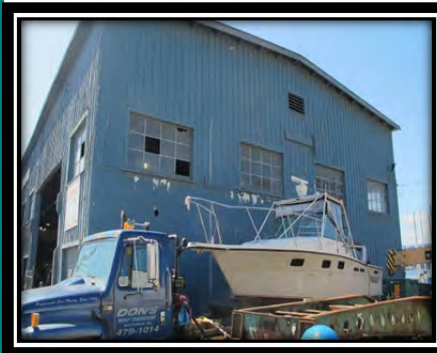
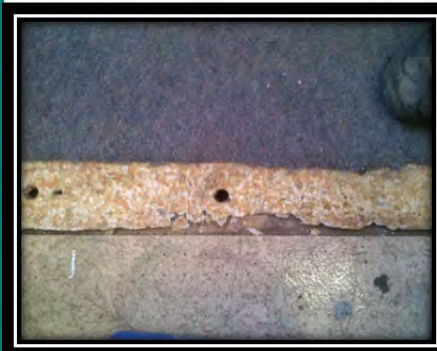
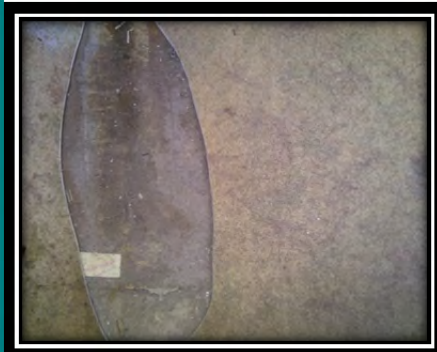
- Construction Date: 1940
- Ceiling: Wood Structure
- Walls: Wood Paneling
- Flooring: Concrete
- Roof: Not Accessible

15609-13: Sheet Flooring (Beige – Top Layer)  
Office Area  
No Asbestos Detected

15609-14: Sheet Flooring (Bottom Layer)  
Office Area  
25% Chrysotile Asbestos Content

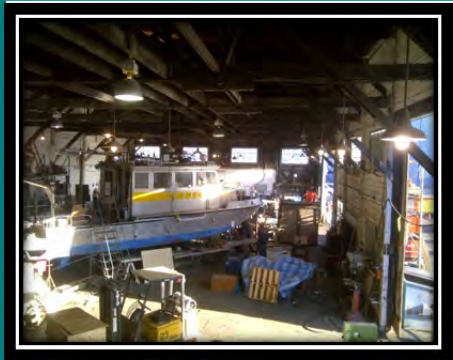
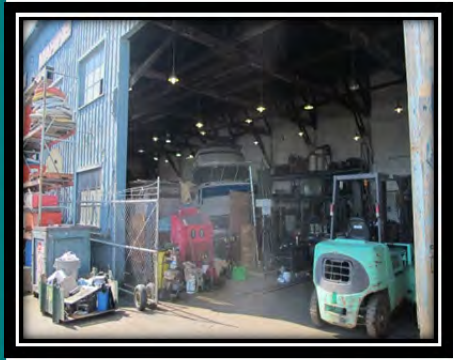
Building: 5 DND Property – Jenkins Marine

15609-15: Blue Paint  
Exterior of Jenkins Marine Warehouse  
Lead Concentration 5.3% w.t.

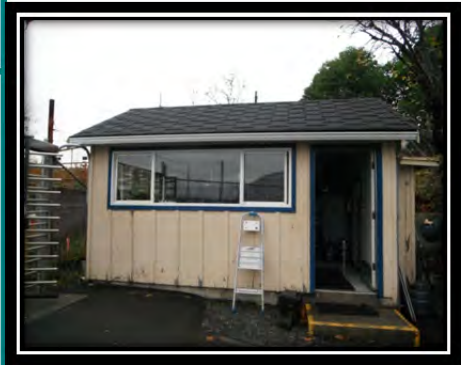
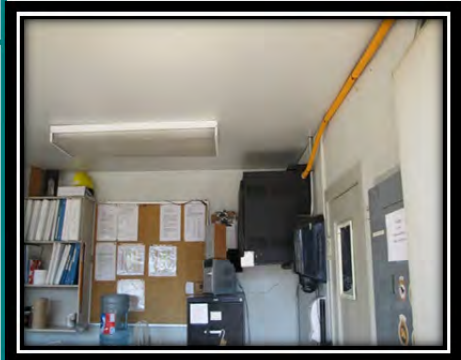
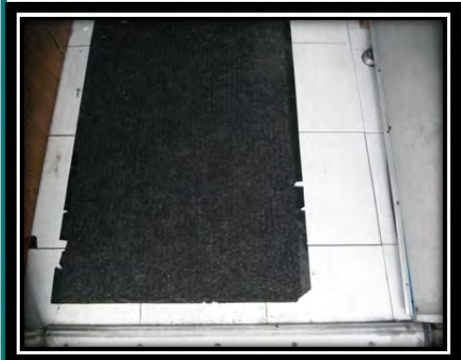
- Construction Date: 1940
- Ceiling: Drywall
- Walls: Drywall & Wood Panel
- Flooring: Floor Tiles on Concrete Substrate
- Roof: Roofing Materials

15609-18: Floor Mastic  
Mastic beneath Floor Tile on Concrete Substrate  
No Asbestos Detected

Window and door trim paint (blue) and exterior wall paint (cream)  
visually similar as Building 4 DND Property – EDC Office.

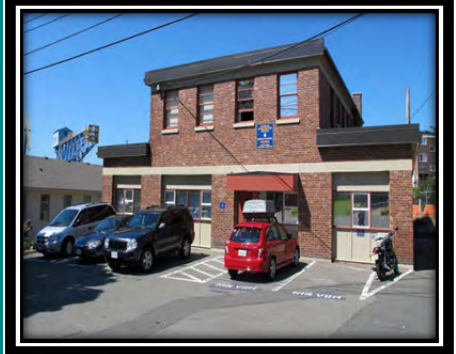
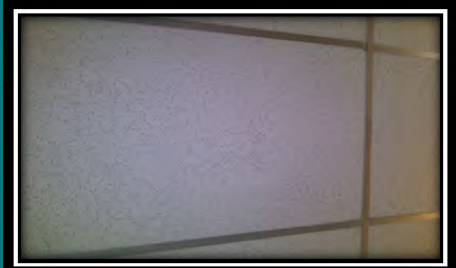
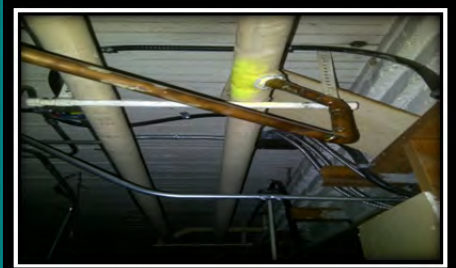
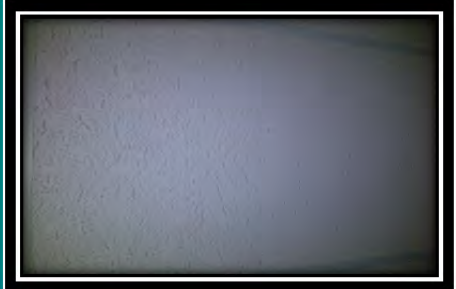
Construction Date: 1943  
Ceiling: Wood Planks  
Walls: Brick, Mortar & Drywall  
Flooring: Floor Tiles, Sheet Flooring on Concrete Substrate  
Roof: Roof Membrane (Not Accessible)

15609-21: Drywall Joint Compound  
Commissionaire Front Security Desk  
No Asbestos Detected

15609-22: Acoustic Ceiling Tile  
Long Horizontal Fissure & Random Pinhole (2'x4')  
Room 101  
No Asbestos Detected

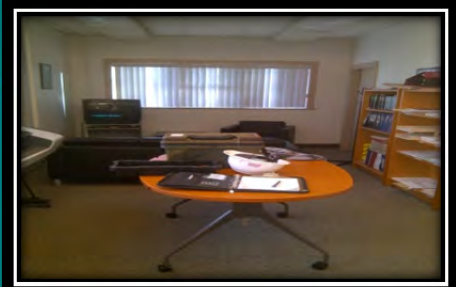
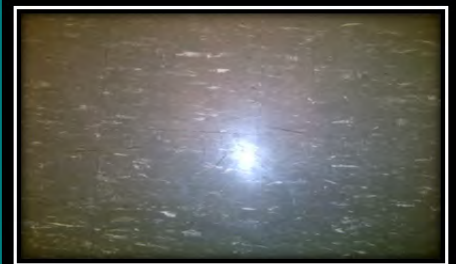
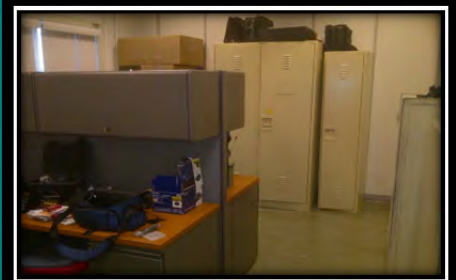
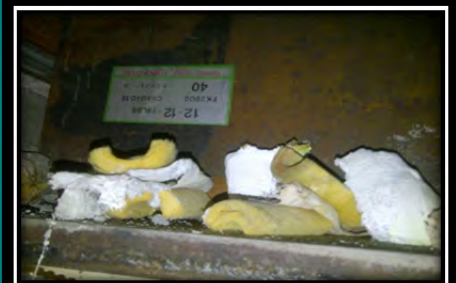
15609-27: Drywall Joint Compound  
Room 110  
No Asbestos Detected

Sample 15609-26 was observed to be damaged in very poor condition. A moderate risk clean-up of this damaged asbestos material by a qualified contractor is required.

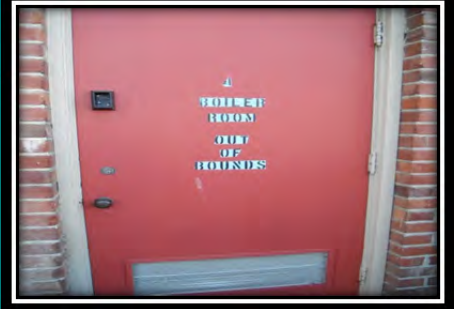
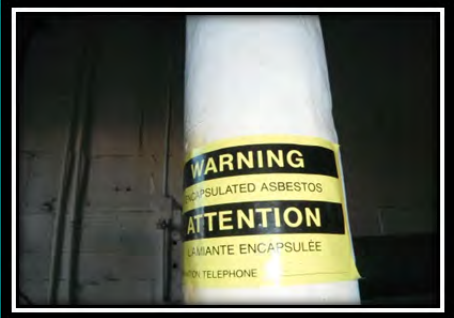
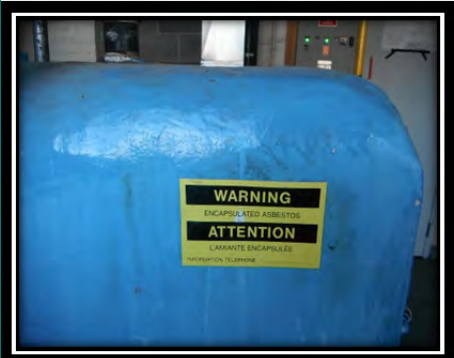
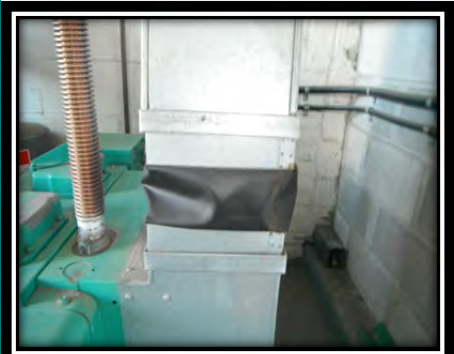
Area: **Boiler Room**

- Boiler Room mechanical piping insulation identified as asbestos containing by warning sign and was not sampled.
- Boiler mechanical insulation identified as asbestos-containing by warning sign and was not sampled.
- Black duct expansion material was not sampled and suspected of containing asbestos.

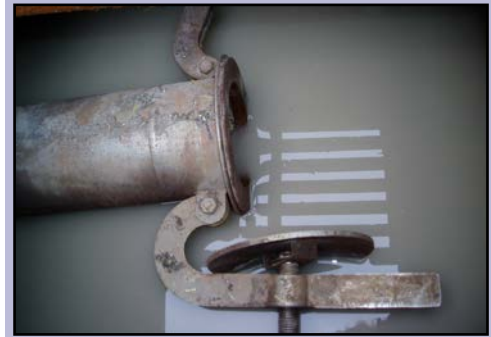
Sump well valves in the drydock floor can be opened to manage rainwater under the following conditions ONLY:

- Dock floor has been pre-cleaned, prior to the completion of the work period.
- A filter cloth has been installed to reduce the migration of debris.

**All wastewater containing paint contaminants must be directed to the collection trench drains and sump wells on the drydock floor, collected, and sent for proper treatment.**

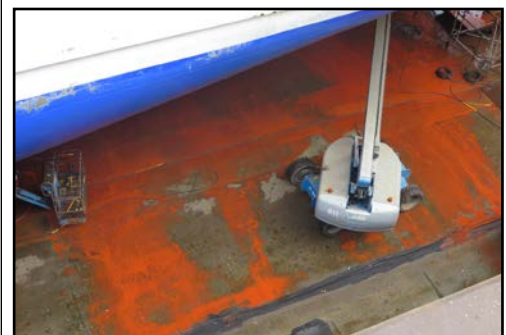
*Antifoulant contaminated washwater entering the collection system (trench drains and sump wells) on the drydock floor.*

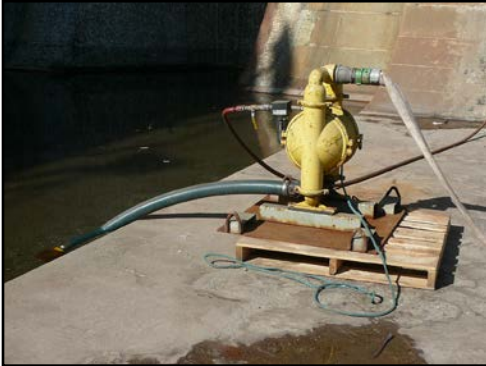
The sill diversion pump removes clean seawater from the pool at the front of Section 1 (moon pool) and discharges into the tunnel drains through a hard pipe on the graving dock wall.

- Divert caisson leakage water away from pressure washing areas.
- Water leakage from the caisson can be diverted by using a sump pump connected to the PVC diversion pipe installed on the north wall of the drydock Section 1.
- Divert water leakage from the graving dock walls, during high tide, directly into the drainage tunnel.

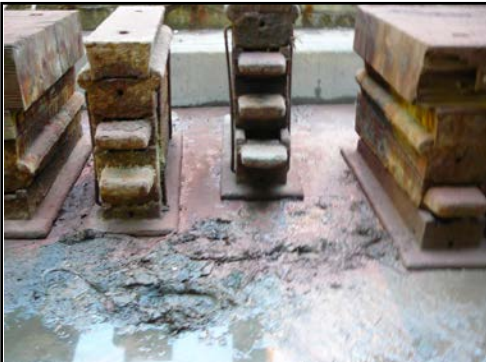
Sediment from the harbour often settles on dock bottom after dewatering. If this becomes contaminated with paint, etc., it must be disposed of.

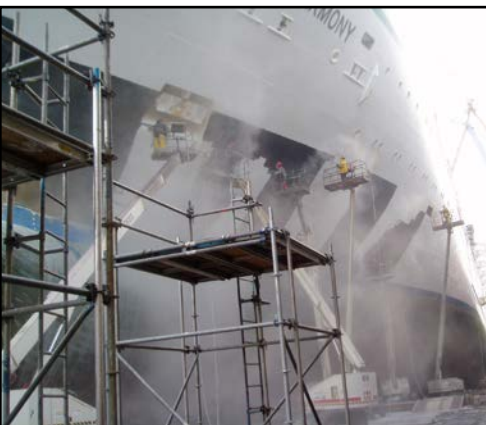
The hull of a cruise ship being ultra high pressure washed.

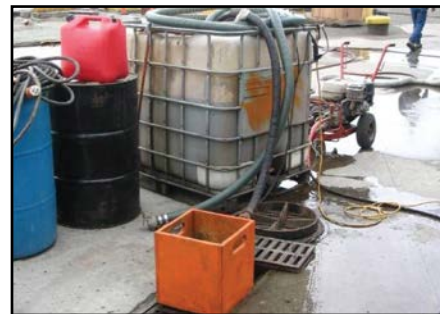
*The trench drain is blocked and a sump pump is installed to collect wash water into a tote.*

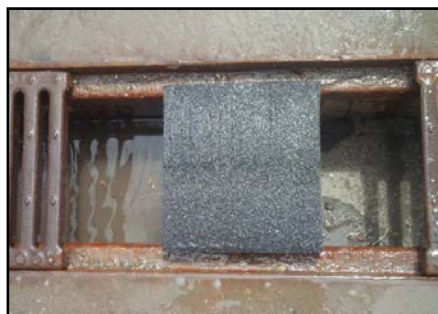
*Example of high density styrofoam blocks used as a drain blocker on the NLW.*

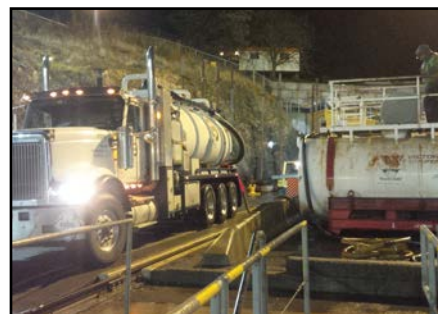
*Large tank dockside with an attendant.*

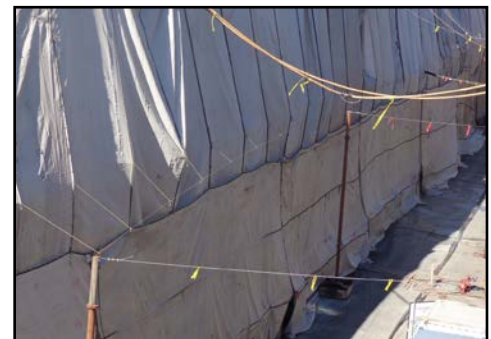
ADEQUATE containment.

- Use containment such as tarps, shrouds or portable structures to prevent airborne particles from entering the atmosphere and surface waters.
- Containment should be large enough to adequately enclose or segregate the working area and reach the dock floor or walls.
- Ensure containment is properly installed (*connected and overlapped*) so there are no gaps.
- Used tarps with tears and holes should be replaced, repaired or doubled with additional layers.

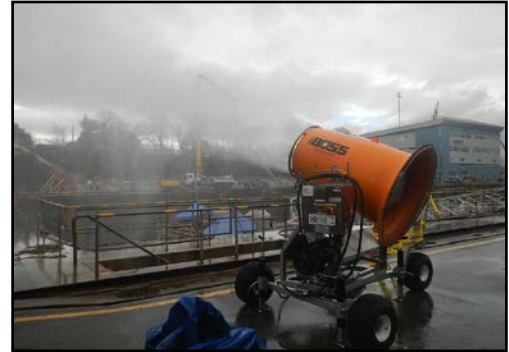
*Dust suppression unit in operation.*

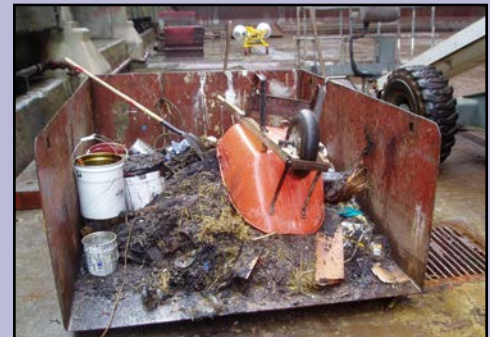
*INADEQUATE waste grit storage.*

- Cover trench drains and tunnel grates in work areas with filter cloth. Replace the cloth as required.
- Manage waste grit by sweeping it into central areas, away from trenches, tunnel grates and dock floor traffic.
- Remove waste grit from work areas as soon as possible.
- Store all waste grit in appropriate containers to prevent leakage.
- Cover all skips, storage bins, tanks, and hoppers to prevent dust emissions and spills.
- Characterize and dispose of waste grit in accordance with applicable provincial regulations.

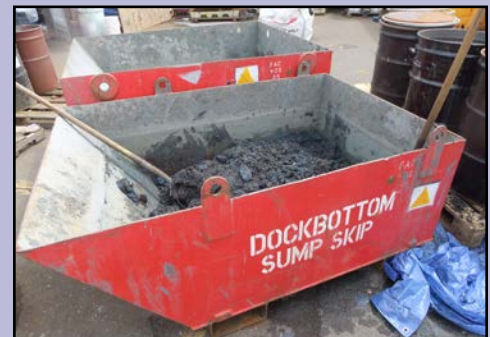
*ADEQUATE waste grit storage.*

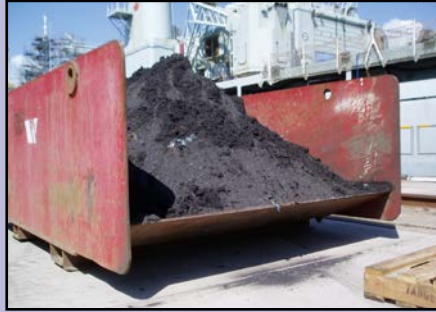
*Store waste grit in appropriate containers.*

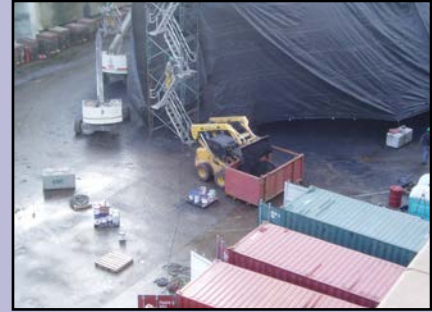
*Remove waste grit from work areas as soon as possible to prevent migration of contaminants throughout the drydock floor.*

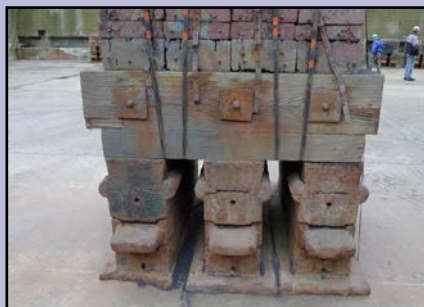
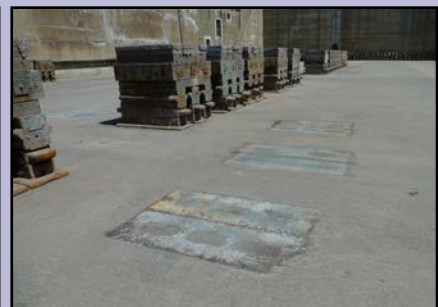
Waste grit must be removed from areas around excess blocks stored in the dock bottom. To prevent grit from collecting between the blocks, they can be relocated or covered prior to sandblasting.

Power washing at the base of the blocks can be effective in removing contaminants.

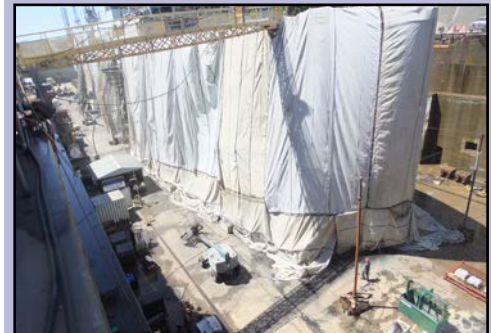
*ADEQUATE containment.*

- Do not spray paint during conditions that render containment ineffective (e.g. windy).
- Place containment beneath and around structures being painted on dock floor and in work areas to ensure overspray does not reach the surrounding area (e.g. during painting of anchor chains, or grates).

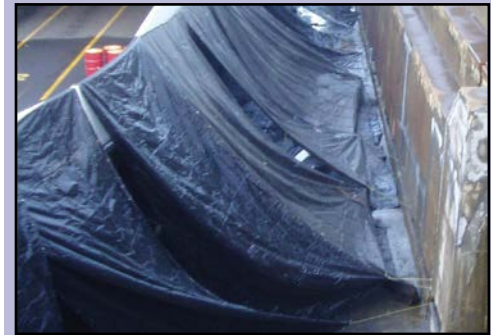
*INADEQUATE containment.*

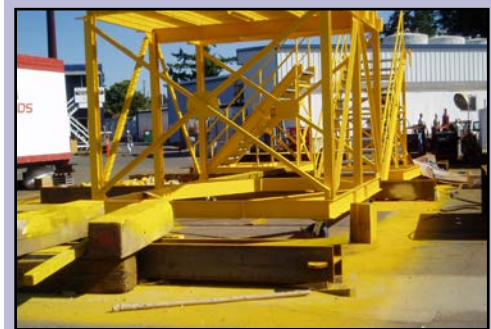
*INADEQUATE containment.*

*Ensure tarps are in place to prevent overspray impacting the surrounding work area.*

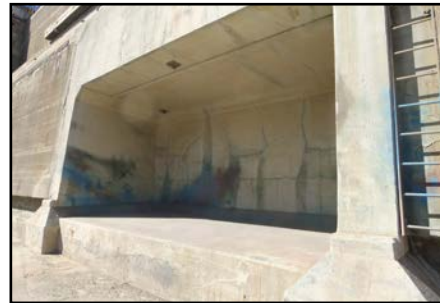
*Paint overspray due to INADEQUATE containment stabilizer pocket doors.*

- Manage overspray on the drydock floor to prevent safety hazards (e.g. slippage).
- When spray painting materials inside the stabilizer pockets, ensure the area is sealed and that the walls and floors are covered.

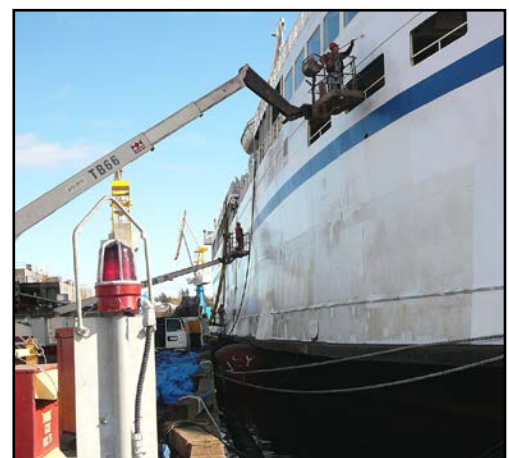
*While painting vessels docked alongside the wharves or jetties, do not spray paint. Take sufficient measures to prevent paint from entering the marine environment.*

- Do not spray paint vessels docked alongside the wharves or jetties (*e.g. North Landing Wharf*).
- Use rollers and brushes to paint vessels dockside.
- Ensure tarps are in place below work areas, as well as in between the vessel and the dock, to prevent spills and drips from entering the water.
- Ensure paint cans are stored securely when working alongside vessel edges.
- Ensure floor grates of manlifts are covered to prevent spills from going into the marine environment.
- Waste generated from painting and other activities such as grinding, hand tooling and welding, must be prevented from entering the marine environment.

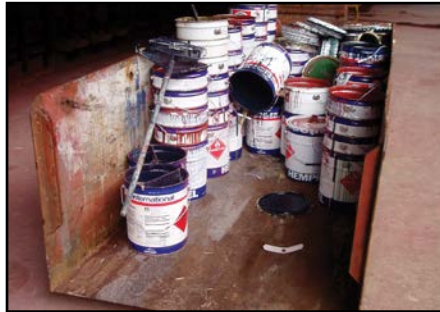
*Residual paint in the cans may drip out of the skip and enter the marine environment through the drain systems.*

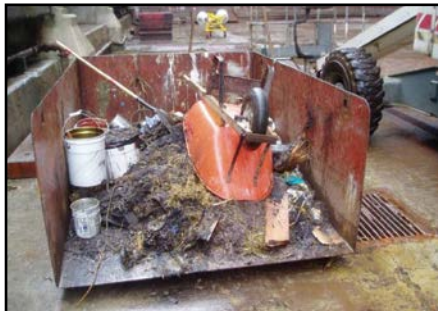
*When cleaning dock bottom, skips of waste sandblast grit may leak contaminated water and should be removed as soon as possible.*

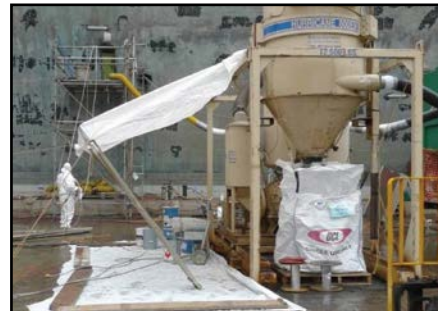
*All hazardous materials must be stored in appropriate containment and away from tunnel drain system.*

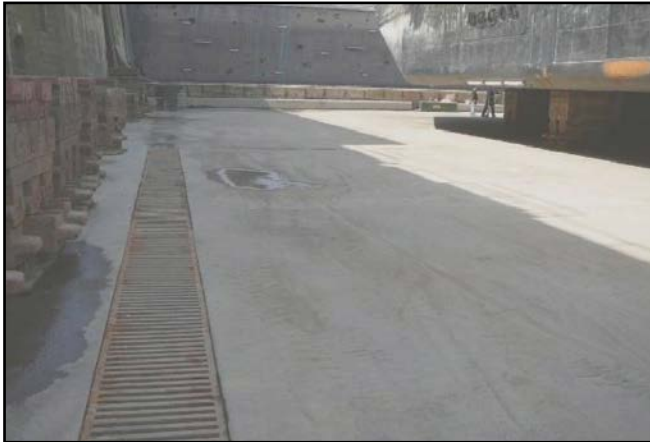
*ADEQUATE:*  
Example of a dock floor that would pass inspection.

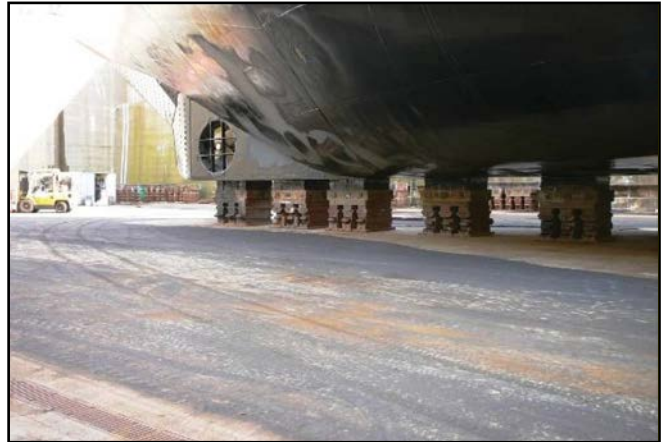
*INADEQUATE:*  
Example of a dock floor that would not pass inspection.

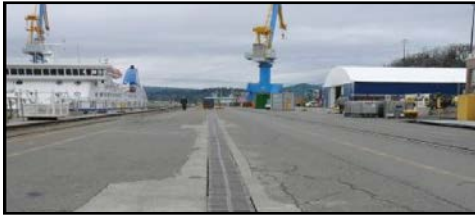
### Trench Storm Drains

Any containers placed directly over top or beside a trench drain have the potential to spill to the drain leading directly to the ocean.

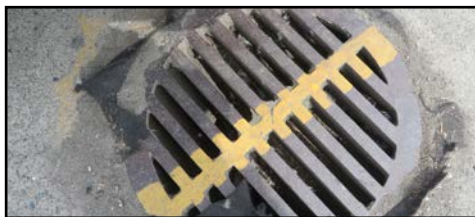
### Storm Drains

Any containers placed directly over top or beside a storm drain have the potential to spill to the drain leading directly to the ocean.

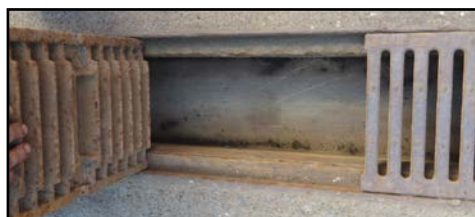
### Dock Floor Trench Drains

If a tote or drum is placed directly over or beside a trench drain, hazardous materials have the potential to flow down the drain and into the marine environment. Although the drains are designed for rapid containment and recovery, there is no guarantee that workers will be present to close drain valves during an incident.

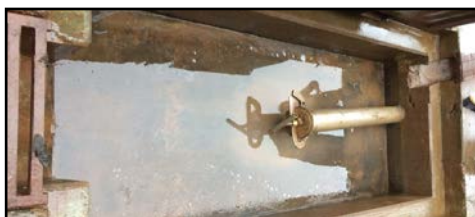
### Dock Floor Sump Wells

When the sump well valve is open the sump drains directly into the marine environment. Any containers placed on top of or adjacent to the sump well have the potential to enter the ocean if a spill were to occur.

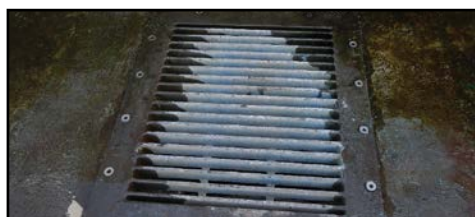
### Dock Floor Tunnel Grate Drains

Tunnel grate drains lead directly to the marine environment. Any containers placed directly over top of or beside a tunnel grate have the potential to impact the marine environment, should a spill occur.

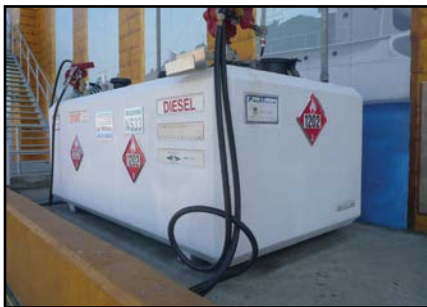
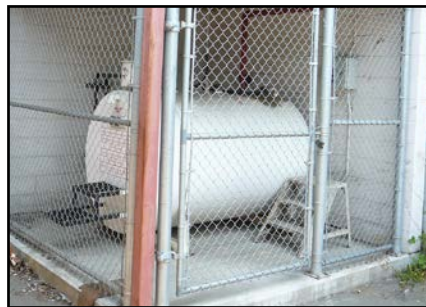
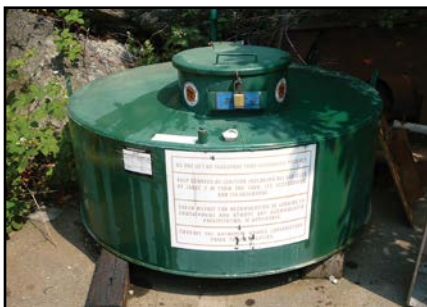
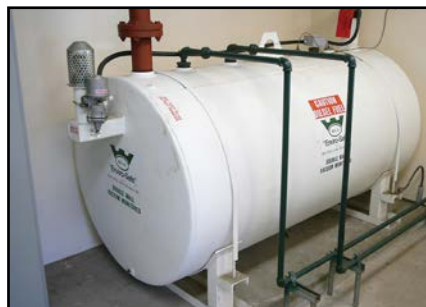
*There are four different fuel tanks at the Esquimalt Graving Dock.*

The EGD is a Federal facility; therefore, storage tanks onsite need to comply with the Storage Tank Systems for Petroleum Products and Allied Petroleum Products Regulations. Users may be required to register their tanks with Environment Canada. **Contact EGD Environmental Services for information.**

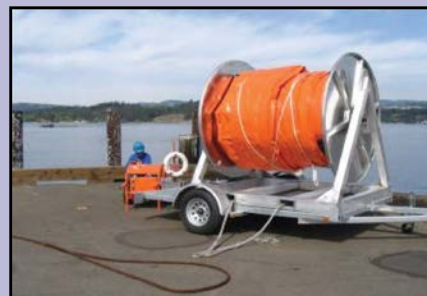
*The hydraulic powered deployment reel with inshore containment boom available for requisition.*

The Esquimalt Graving Dock has containment boom and deployment equipment available for requisition. To arrange for booking or rental, contact the EGD Operations Manager.

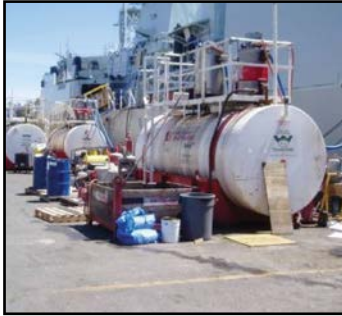
### Scenario 2: BULK OIL TRANSFER FROM A BERTHED VESSEL

- Completed and signed **EGD Oil Transfer Checklist** submitted to EGD Pumphouse.
- Containment boom deployed and adequately secured at both ends.
- Receiving containers located away from pathways to the harbour (*e.g. storm drains, edge of dock*).
- Receiving containers in secondary containment and in good condition.
- Emergency response plan in place.
- Adequate spill response equipment and qualified personnel available.

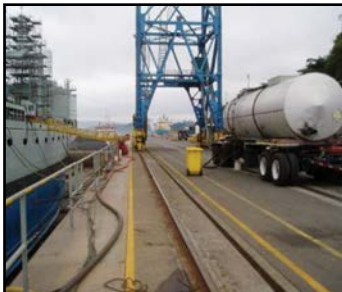
### Scenario 3: FUELLING A VESSEL OR BULK OIL TRANSFER IN THE DRYDOCK

- Pumphouse operation on site prepared to shut down auxiliary pumps in case of an emergency.
- Receiving containers located away from pathways to the harbour (*e.g. trench drains, sump wells, tunnel grate drains*).
- Receiving containers in secondary containment and in good condition.
- Emergency response plan in place.
- Adequate spill response equipment and qualified personnel available.

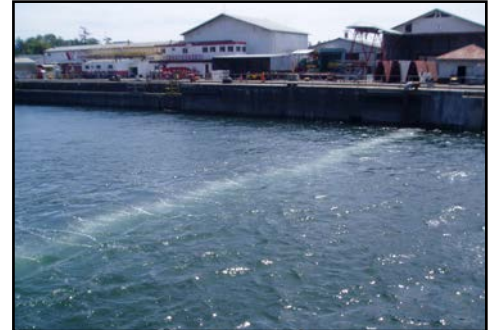
*Bubble curtain employed during vessel transfer.*

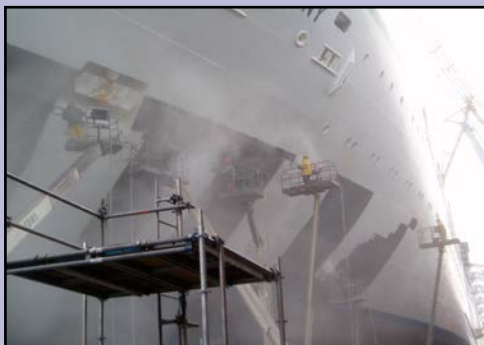
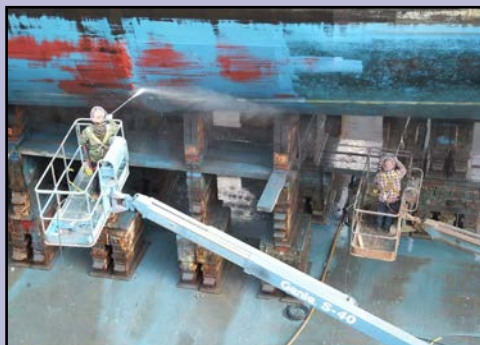
*Conventional pressure washing and ultra high pressure (UHP) washing use large amounts of water at high pressure to scour paint and biological material from the hulls of ships.*

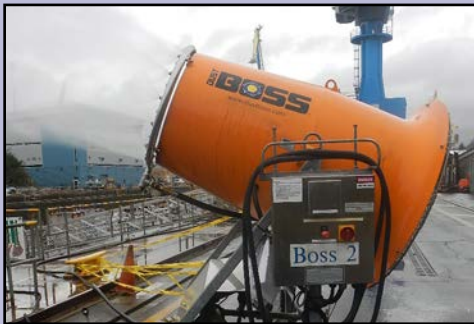
*Dust Suppression Units are used to mitigate the escape of dust from sandblasting operations in the drydock.*

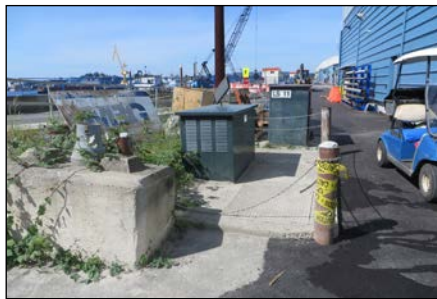
AUTHORIZED Sanitary Sewer Discharge point, Lift Station #11.

**Discharge to the sanitary sewer at any location other than at LS#15, LS#11 or at vessel connections located in the services tunnels of the drydock is prohibited.**

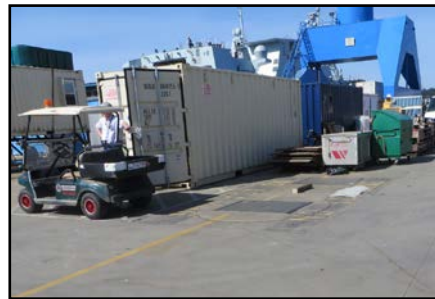
AUTHORIZED Sanitary Sewer Discharge point, Lift Station #15.

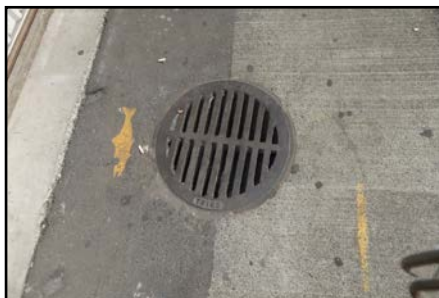
UNAUTHORIZED Sanitary Sewer Discharge point (i.e. storm drain).

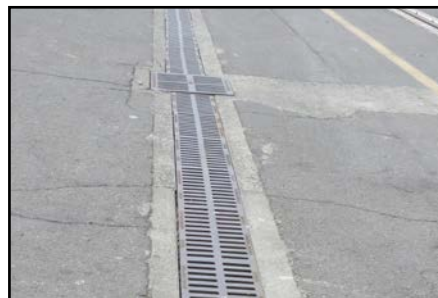
UNAUTHORIZED Sanitary Sewer Discharge point (i.e. trench drains).

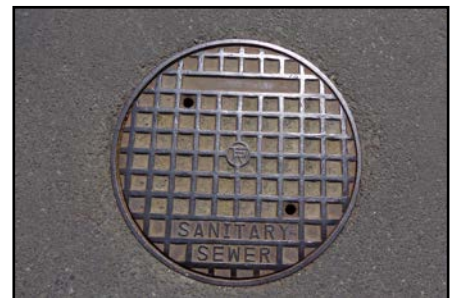
UNAUTHORIZED Sanitary Sewer Discharge point (i.e. sewer manhole).

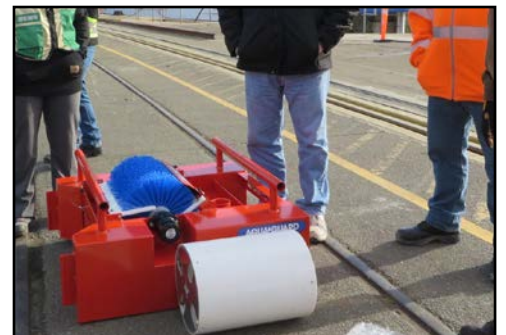
*Spill response equipment: Skimmer.*

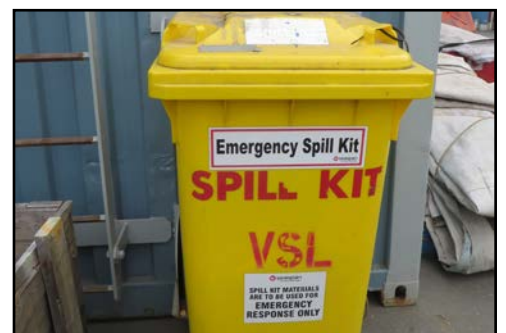
*Spill response equipment: Spill Kit.*

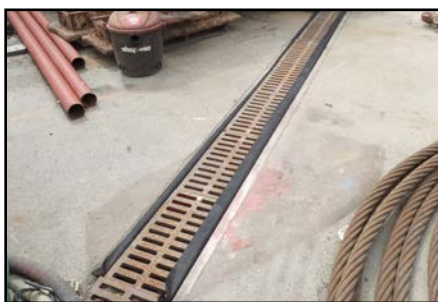
*Prevent deleterious substances entering marine environment by placing filter cloth in the trench drains.*

- Place filter cloth over storm and trench drains when working with deleterious substances that are in close proximity to, and that could pose a hazard to the marine environment.

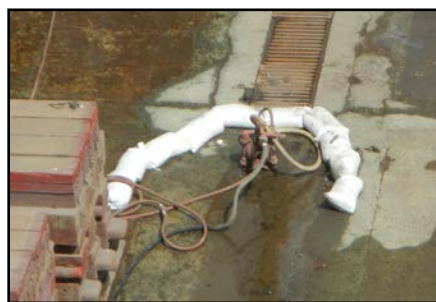
*Sand bags used on dock bottom to divert and filter excess water.*

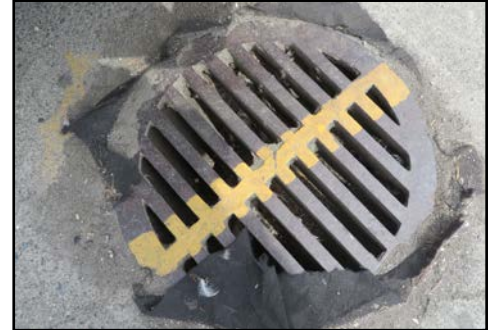
*Uplands storm drain with filter cloth. Avoid storing hazardous materials near storm drains, which are directly linked to the marine environment.*

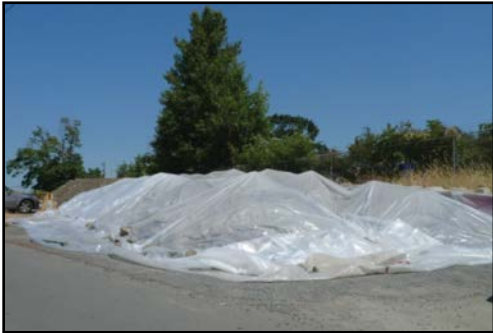
*ADEQUATE soil stockpile management. Soils placed on poly and covered.*

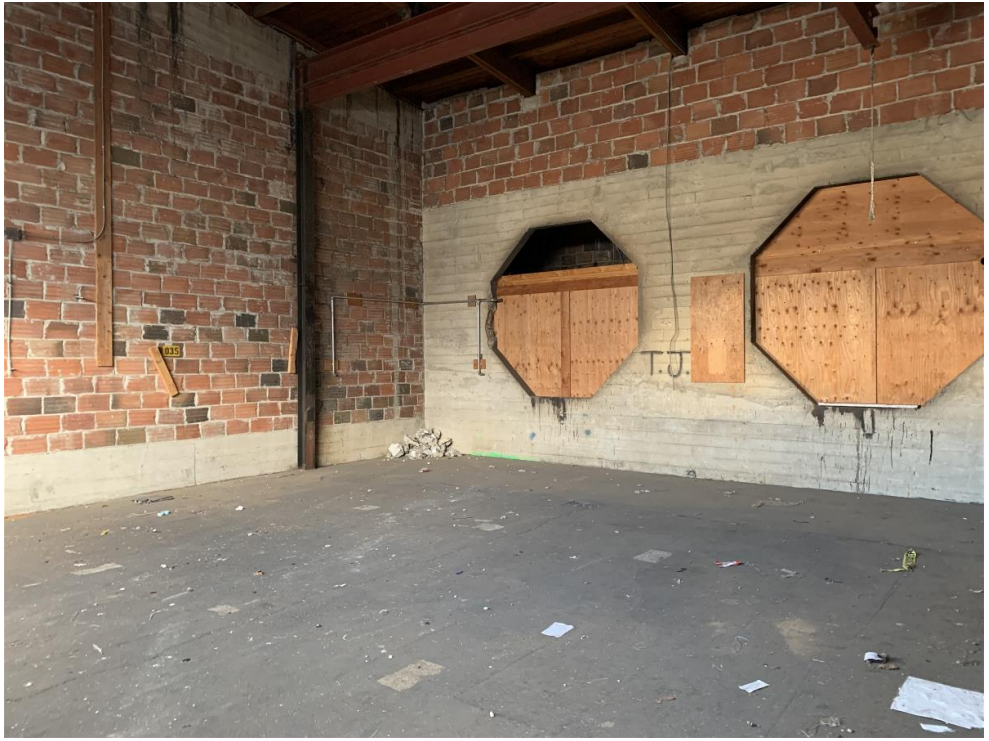
<p><b>Photograph ID: 1</b></p> <p><b>Photo Location:</b> Interior bay</p> <p><b>Direction:</b> Looking northeast</p> <p><b>Survey Date:</b> 10/18/2021</p> <p><b>Comments:</b> Typical brick and concrete walls with plywood inserts</p>

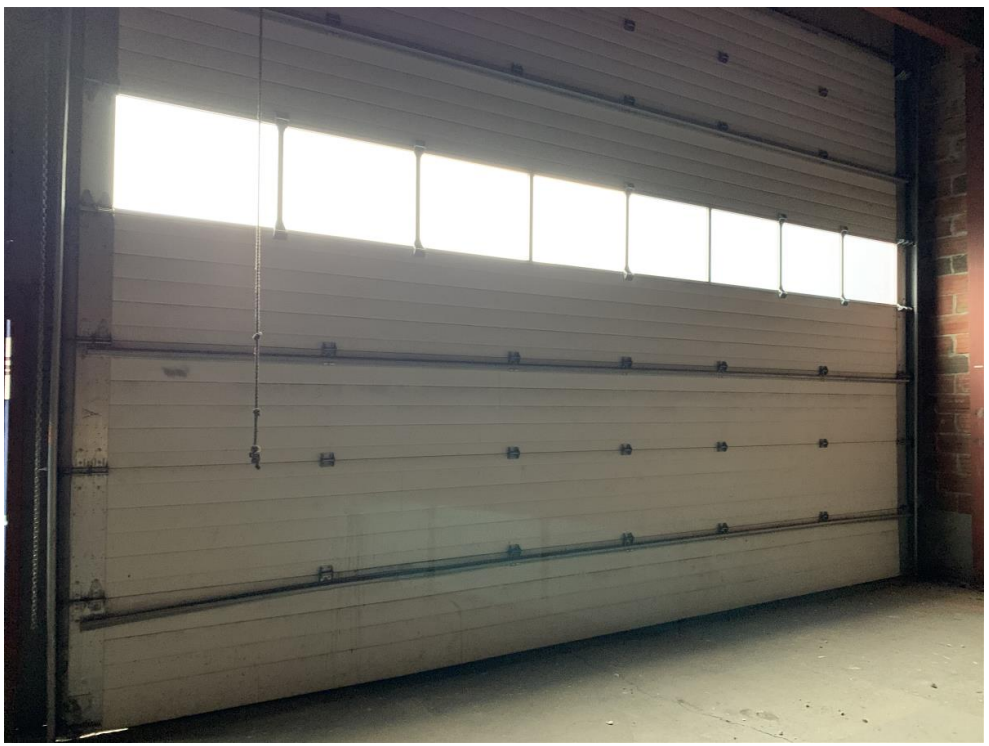
<p><b>Photograph ID:</b> 4</p> <p><b>Photo Location:</b> Interior bay</p> <p><b>Direction:</b> Looking northwest</p> <p><b>Survey Date:</b> 10/22/2021</p> <p><b>Comments:</b> Interior side of typical bay door</p>

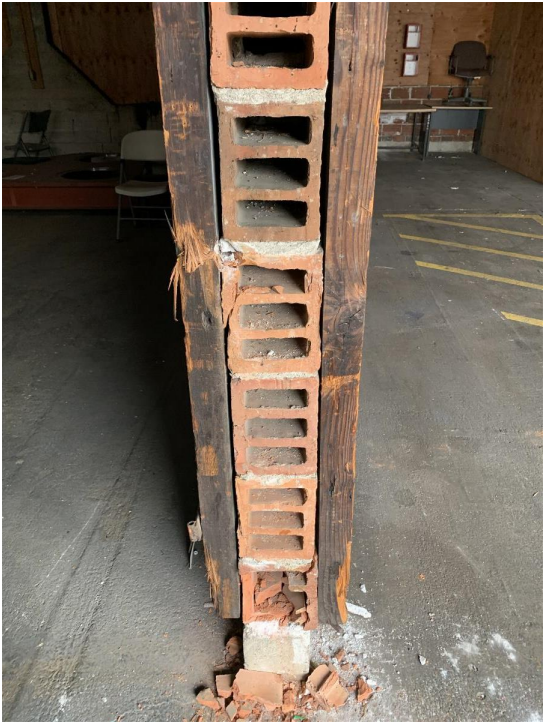
<b>Photograph ID: 5</b>

<b>Photo Location:</b> Interior between bays	
<b>Direction:</b> Looking northeast	
<b>Survey Date:</b> 10/18/2021	
<b>Comments:</b> Typical brick interior partition wall
