Building 1007 Demolition  
Esquimalt Graving Dock  
Project No.: R.118910.001  
2021-12-22

**Public Works Government Services Canada**  
**Esquimalt Graving Dock**  
**Building 1007 Demolition**  
**Project No. R.118910.001**

1. Stantec Consulting Ltd. Report for Project No. 123221957 entitled “Supplemental Pre-Demolition Hazardous Building Materials Assessment Report” for “Project Name: Demolition of Esquimalt Graving Dock Building 1007 – Kiln Building”, issued December 3, 2021, prepared for Public Services and Procurement Canada.
2. Stantec Consulting Ltd. Report for Project No. 123221425 entitled “Pre-Demolition Hazardous Building Materials Assessment, Building 1007 – Kiln Building, Esquimalt Graving Dock, 825 Admirals Road, Victoria” dated March 31, 2020, prepared for Public Services and Procurement Canada.
3. North West Environmental Group Ltd. Report No. 15609 entitled “Hazardous Building Material Assessment; Esquimalt Graving Dock—DND Buildings” dated December, 2011, prepared for Public Works and Government Services Canada.

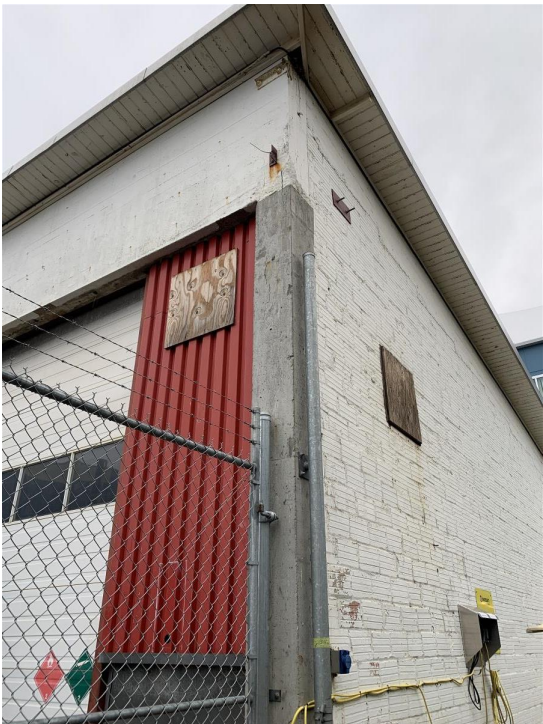
<b>Photograph ID: 6</b>

<b>Photo Location:</b> Southwest exterior	
<b>Direction:</b> Looking north	
<b>Survey Date:</b> 10/22/2021	
<b>Comments:</b> Typical concrete column, spandrel beam, brick wall and corrugated metal panel at bay door - southwest corner

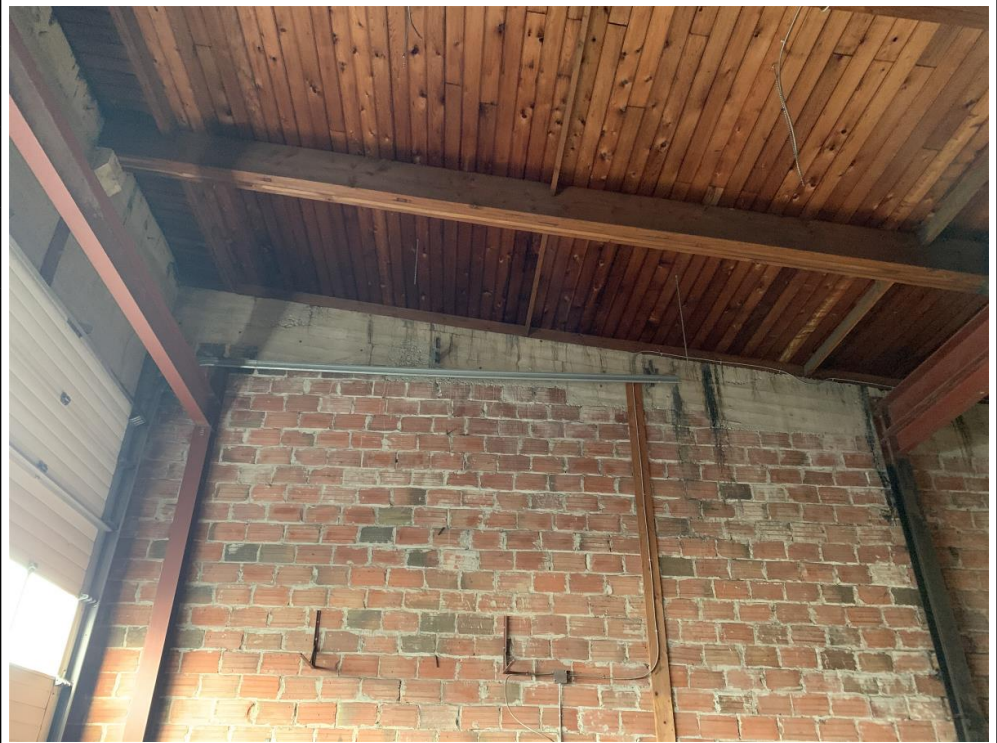
<b>Photograph ID:</b> 9
<b>Photo Location:</b> Interior bay
<b>Direction:</b> Looking northwest
<b>Survey Date:</b> 10/18/2021
<b>Comments:</b> Typical brick walls with concrete cap and wood beams/ceiling. Steel hoist support also shown.

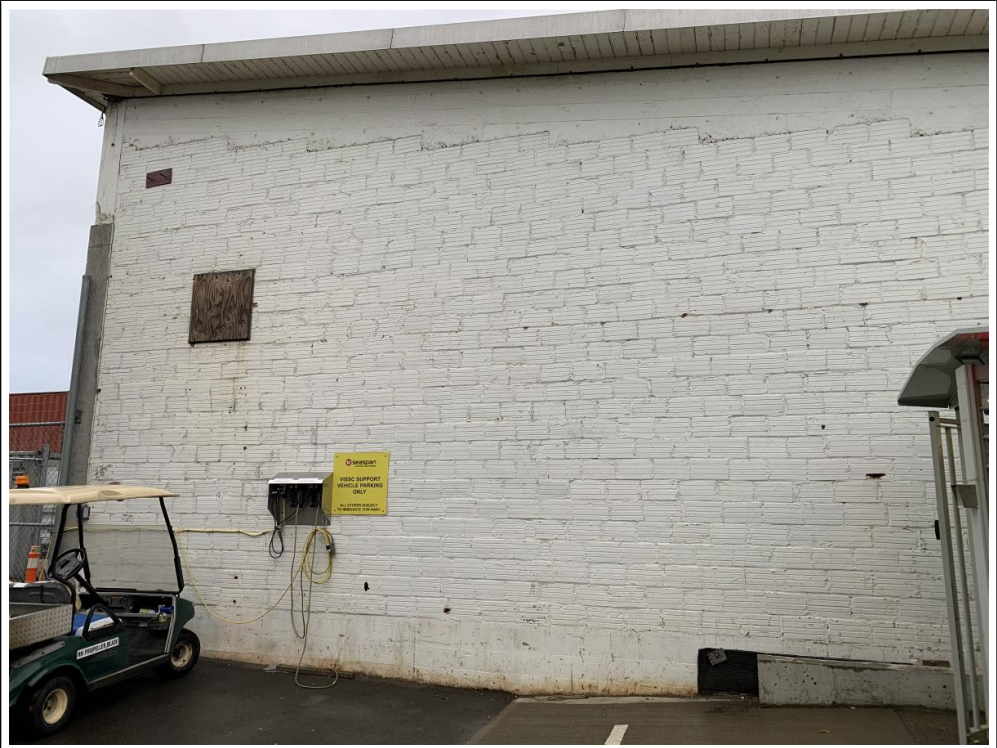
<b>Photograph ID:</b> 10
<b>Photo Location:</b> Exterior south side
<b>Direction:</b> Looking northwest
<b>Survey Date:</b> 10/22/2021
<b>Comments:</b> Brick wall

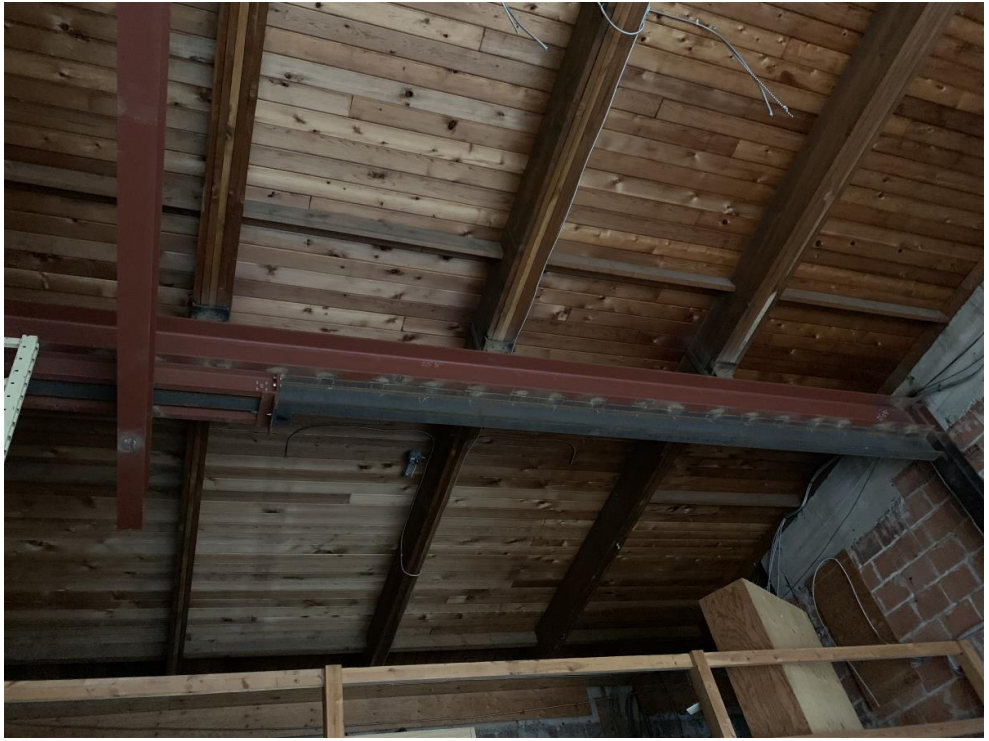
<b>Photograph ID:</b> 11

<b>Photo Location:</b> Interior bay	
<b>Direction:</b> Looking east	
<b>Survey Date:</b> 10/22/2021	
<b>Comments:</b> Steel hoist and wood beams at ceiling level

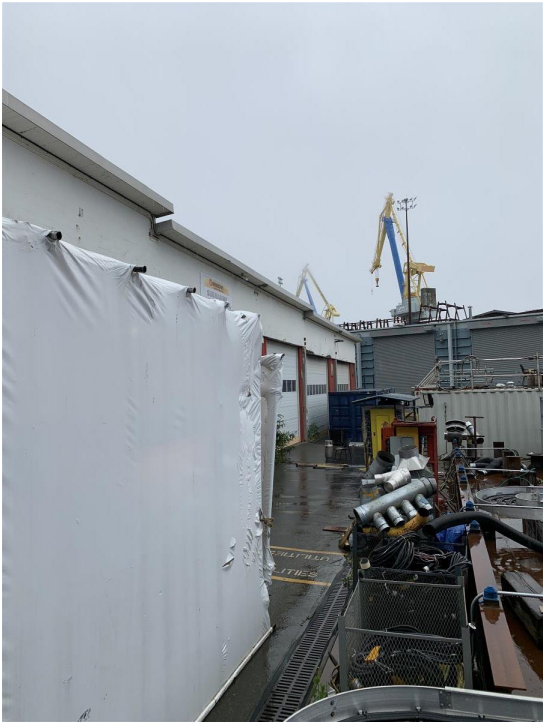
<b>Photograph ID:</b> 13

<b>Photo Location:</b> Exterior - west side, north area	
<b>Direction:</b> Looking south	
<b>Survey Date:</b> 10/22/2021	
<b>Comments:</b> Typical exterior wall components of west elevation. Shrink-wrapped shelter at north end of building has been removed.

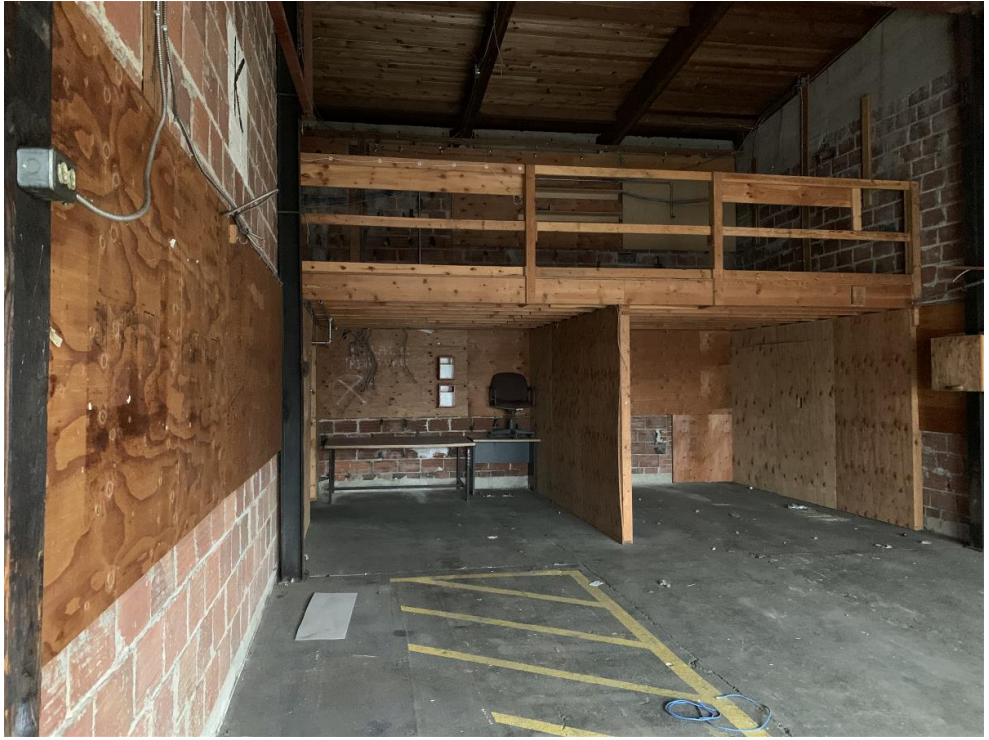
<p><b>Photograph ID:</b> 15</p> <p><b>Photo Location:</b> Interior bay</p> <p><b>Direction:</b> Looking northeast</p> <p><b>Survey Date:</b> 10/22/2021</p> <p><b>Comments:</b> Typical wood-framed mezzanine</p>

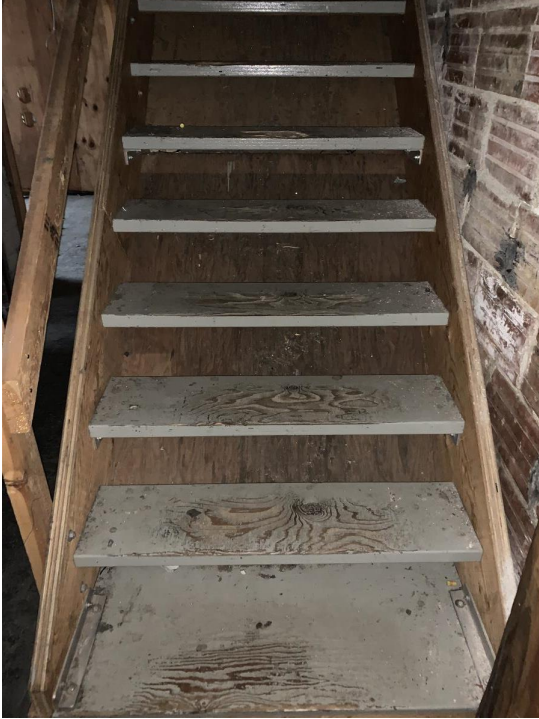
<p><b>Photograph ID:</b> 16</p> <p><b>Photo Location:</b> Interior bay</p> <p><b>Direction:</b> Looking northwest</p> <p><b>Survey Date:</b> 10/22/2021</p> <p><b>Comments:</b> Typical wood-framed stairs to mezzanine</p>

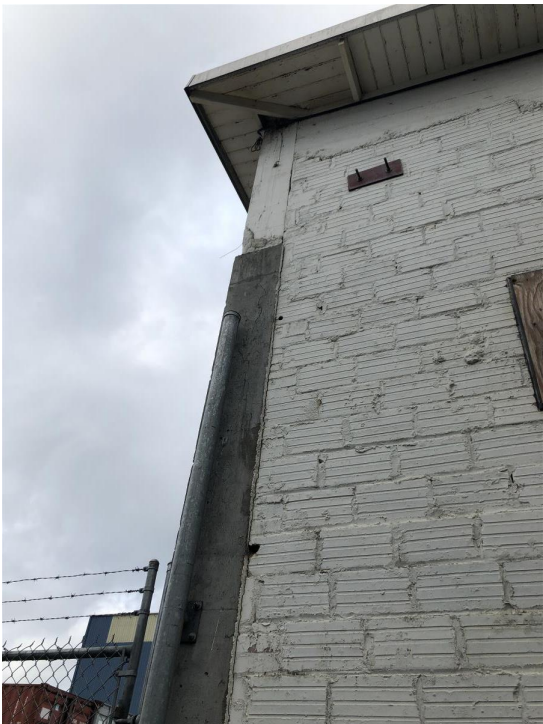
<b>Photograph ID:</b> 18

<b>Photo Location:</b> Exterior - southwest corner	
<b>Direction:</b> Looking north	
<b>Survey Date:</b> 10/29/2021	
<b>Comments:</b> Typical exterior brick wall and concrete column of south elevation

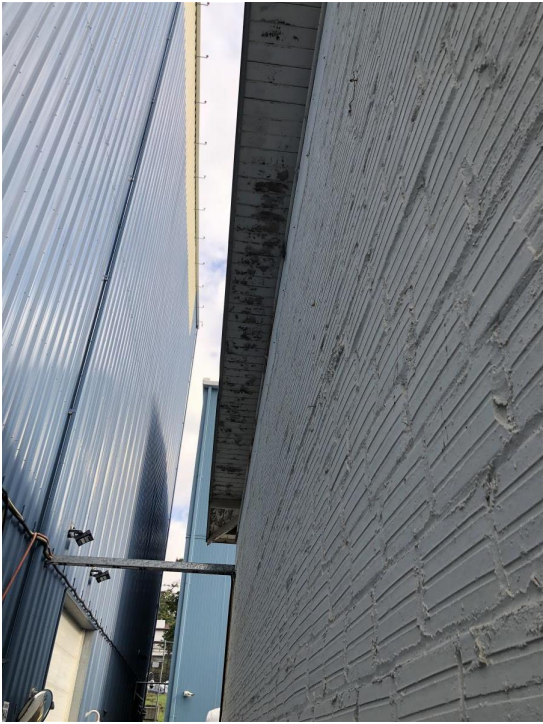
<b>Photograph ID:</b> 19

<b>Photo Location:</b> Exterior north end of building	
<b>Direction:</b> Looking northeast	
<b>Survey Date:</b> 10/29/2021	
<b>Comments:</b> North exterior wall and roof soffit. Spacing between Building 1007 and adjacent (north) building is also shown

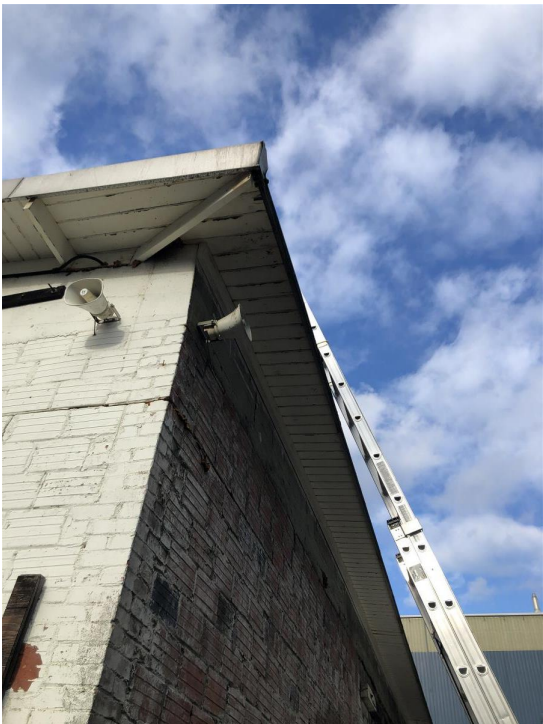
<b>Photograph ID:</b> 20

<b>Photo Location:</b> Exterior southeast corner	
<b>Direction:</b> Looking northeast	
<b>Survey Date:</b> 10/29/2021	
<b>Comments:</b> Typical brick walls and wood soffit

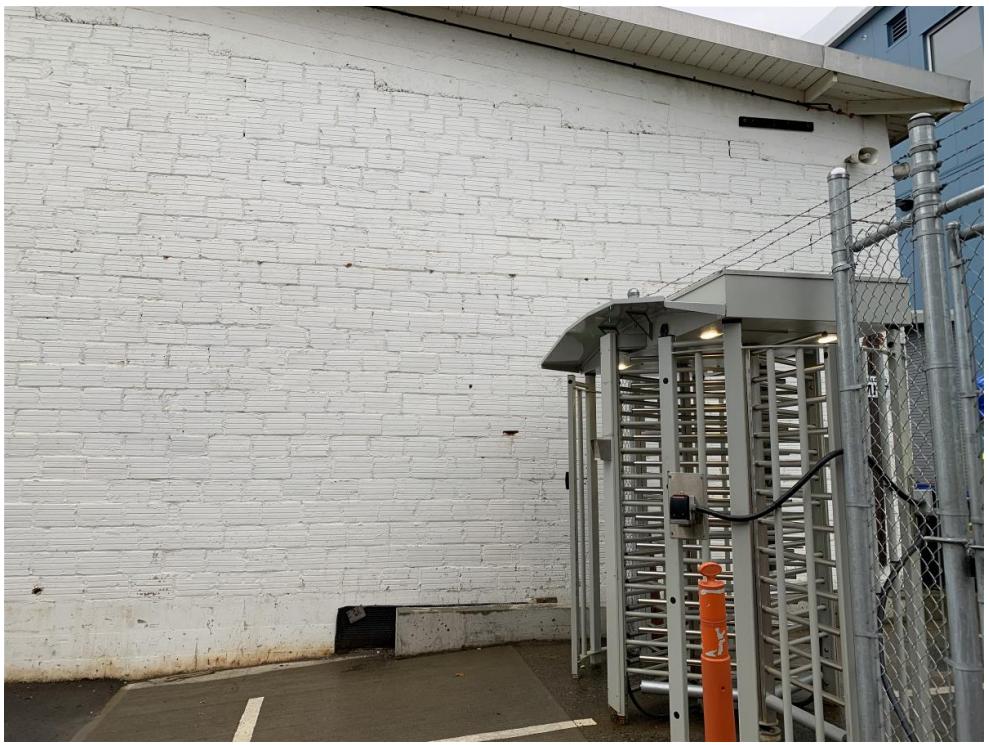
<b>Photograph ID:</b> 21

<b>Photo Location:</b> South end of building - exterior	
<b>Direction:</b> Looking northwest	
<b>Survey Date:</b> 10/22/2021	
<b>Comments:</b> Typical brick and concrete comprising wall of south elevation

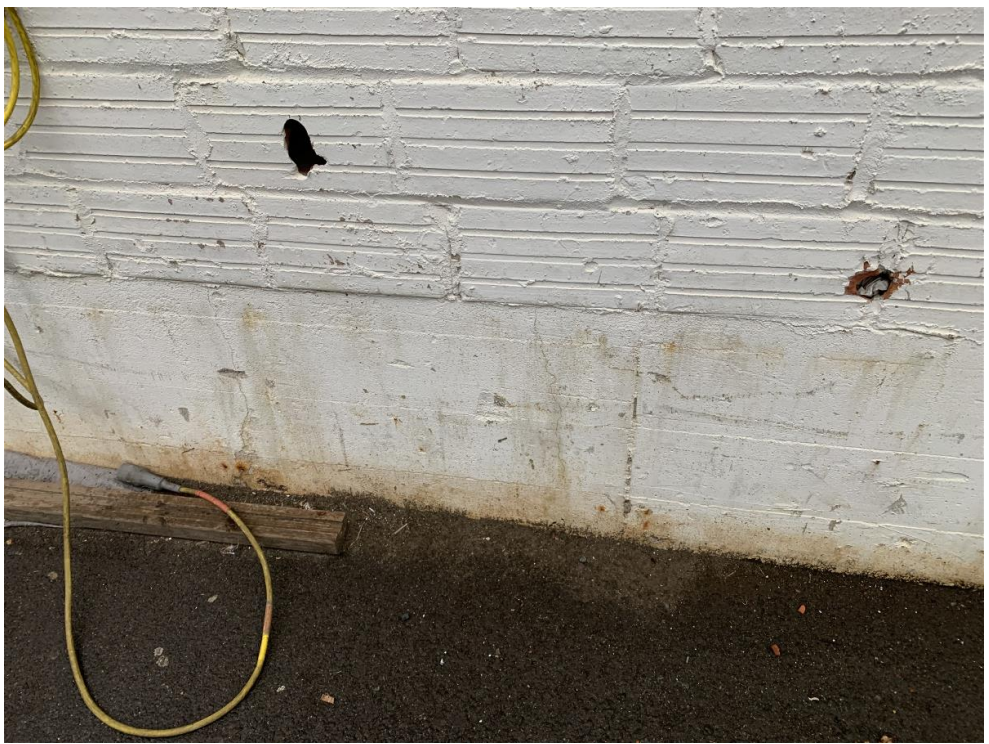
<b>Photograph ID:</b> 22

<b>Photo Location:</b> South end of building	
<b>Direction:</b> Looking southeast	
<b>Survey Date:</b> 10/22/2021	
<b>Comments:</b> Typical foundation wall of south elevation

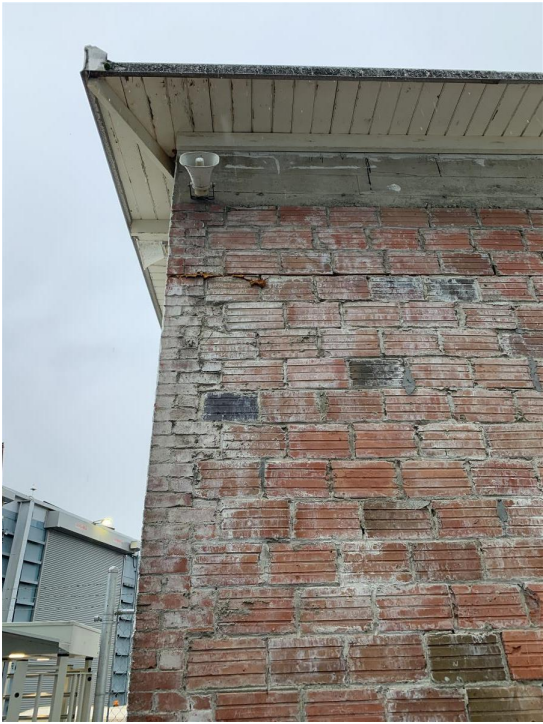
<b>Photograph ID:</b> 23

<b>Photo Location:</b> North end of building - exterior	
<b>Direction:</b> Looking southeast	
<b>Survey Date:</b> 10/22/2021	
<b>Comments:</b> Brick walls and wood soffit

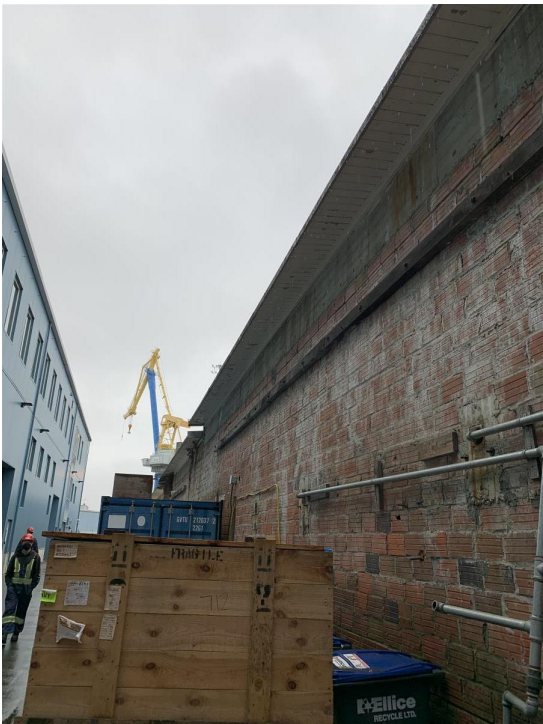
<b>Photograph ID:</b> 24

<b>Photo Location:</b> Northeast corner of building - exterior	
<b>Direction:</b> Looking south	
<b>Survey Date:</b> 10/22/2021	
<b>Comments:</b> Typical components of exterior walls and roof overhang on east elevation

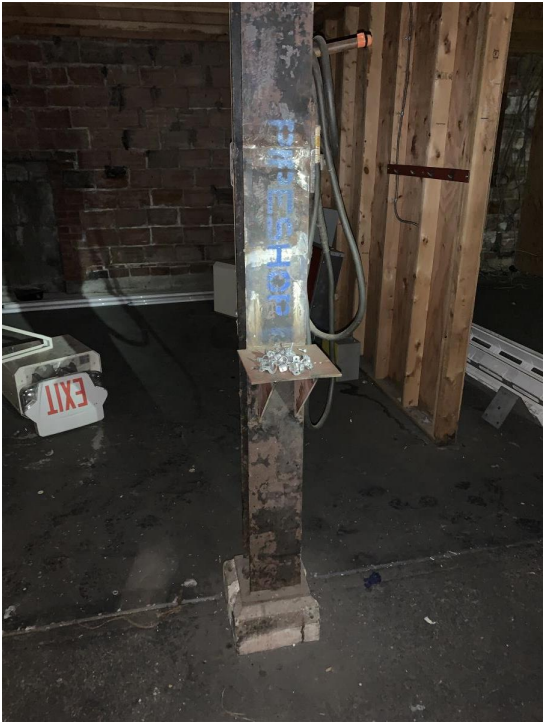
<b>Photograph ID:</b> 25

<b>Photo Location:</b> Interior bay	
<b>Direction:</b> Looking south	
<b>Survey Date:</b> 10/22/2021	
<b>Comments:</b> Steel column for support

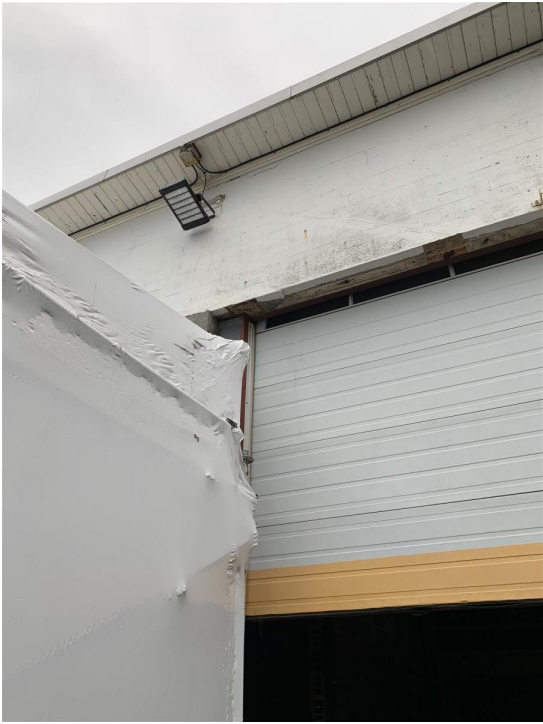
<b>Photograph ID:</b> 27

<b>Photo Location:</b> West exterior	
<b>Direction:</b> Looking east	
<b>Survey Date:</b> 10/22/2021	
<b>Comments:</b> Roof overhang and concrete spandrel beam of west elevation. Shrink-wrapped shelter at north end of building has been removed.

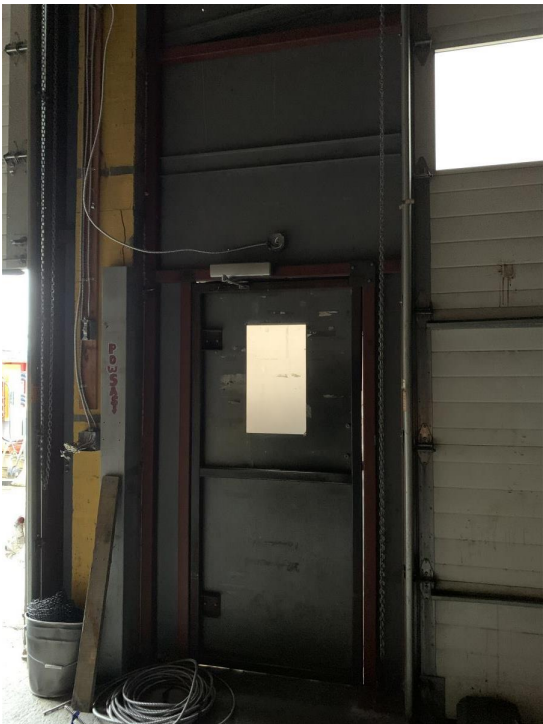
<b>Photograph ID:</b> 28

<b>Photo Location:</b> Interior	
<b>Direction:</b> Looking southwest	
<b>Survey Date:</b> 10/22/2021	
<b>Comments:</b> Typical man door and frame

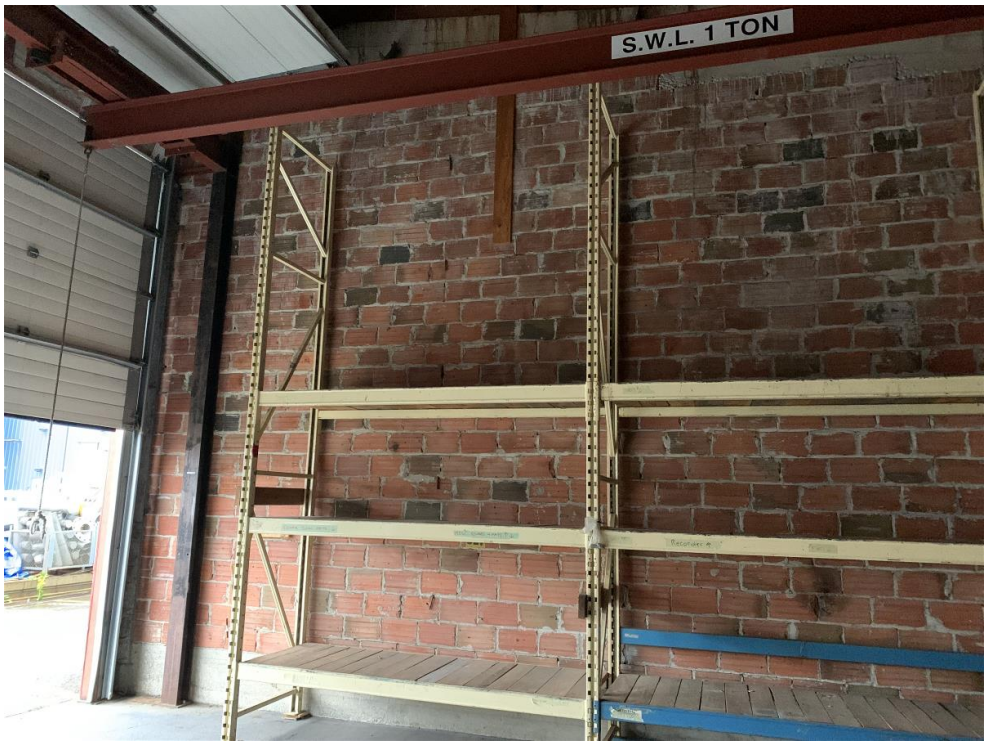
<p><b>Photograph ID:</b> 30</p> <p><b>Photo Location:</b> Interior bay</p> <p><b>Direction:</b> Looking northwest</p> <p><b>Survey Date:</b> 10/22/2021</p> <p><b>Comments:</b> Typical brick walls and metal shelving</p>

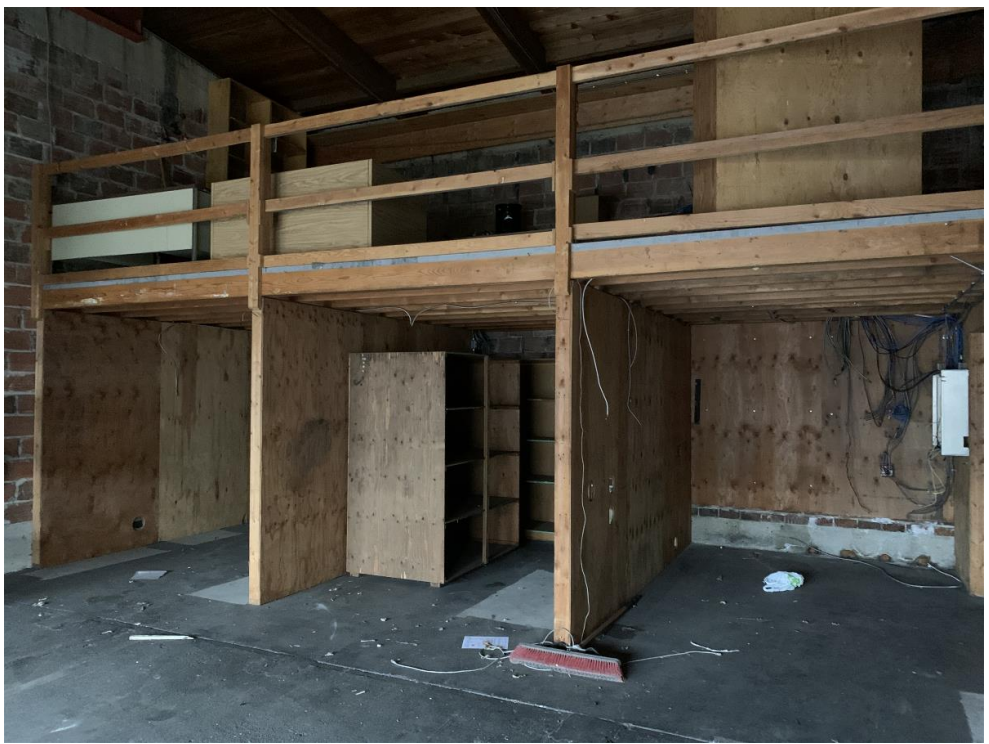
<p><b>Photograph ID:</b> 32</p> <p><b>Photo Location:</b> Interior bay</p> <p><b>Direction:</b> Looking east</p> <p><b>Survey Date:</b> 10/22/2021</p> <p><b>Comments:</b> Typical wood mezzanine construction</p>

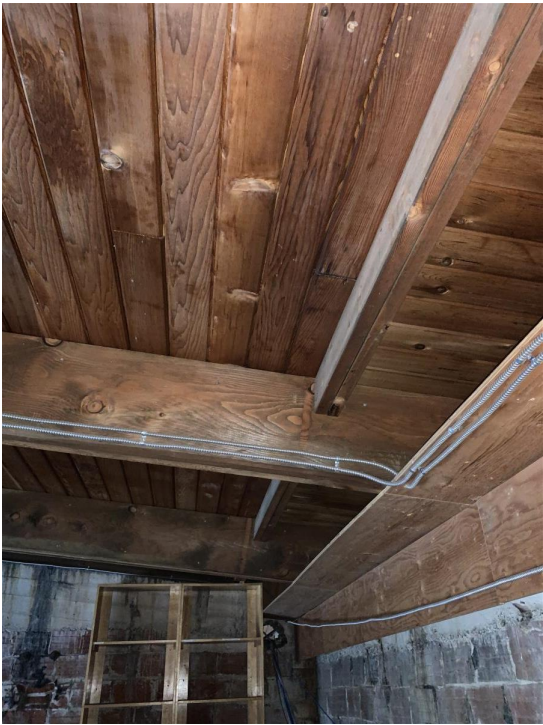
<b>Photograph ID:</b> 34

<b>Photo Location:</b> Interior bay	
<b>Direction:</b> Looking north	
<b>Survey Date:</b> 10/22/2021	
<b>Comments:</b> Typical wood roof structural support and roof underside (ceiling) components

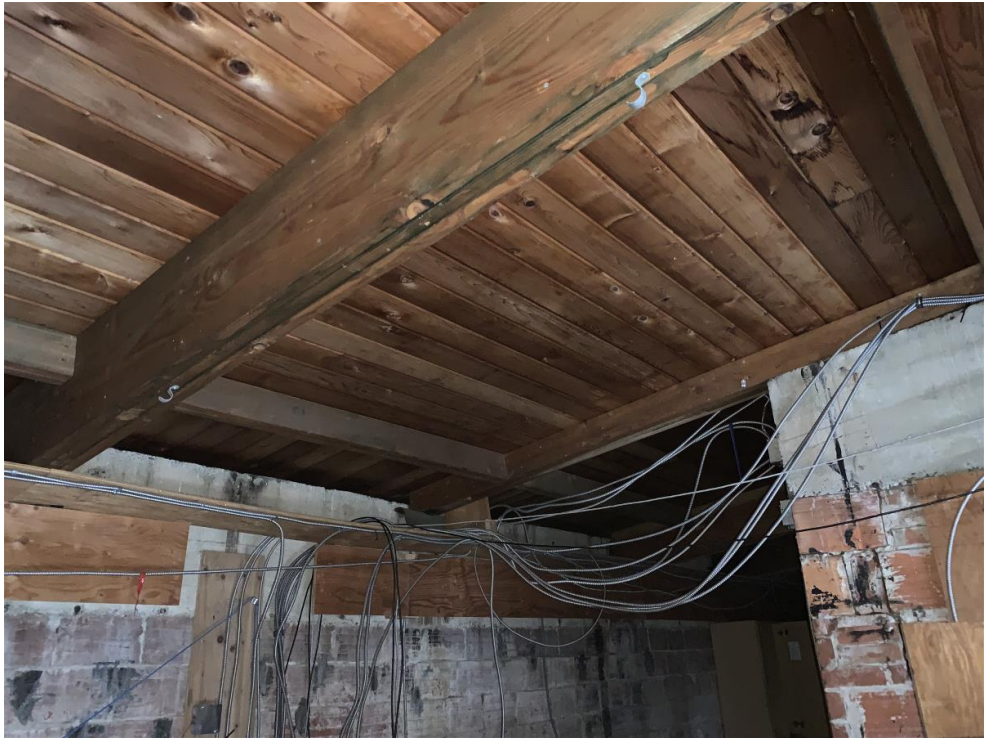
<b>Photograph ID:</b> 35

<b>Photo Location:</b> Interior bay	
<b>Direction:</b> Looking north	
<b>Survey Date:</b> 10/22/2021	
<b>Comments:</b> Typical wood roof structural support and roof underside (ceiling) components

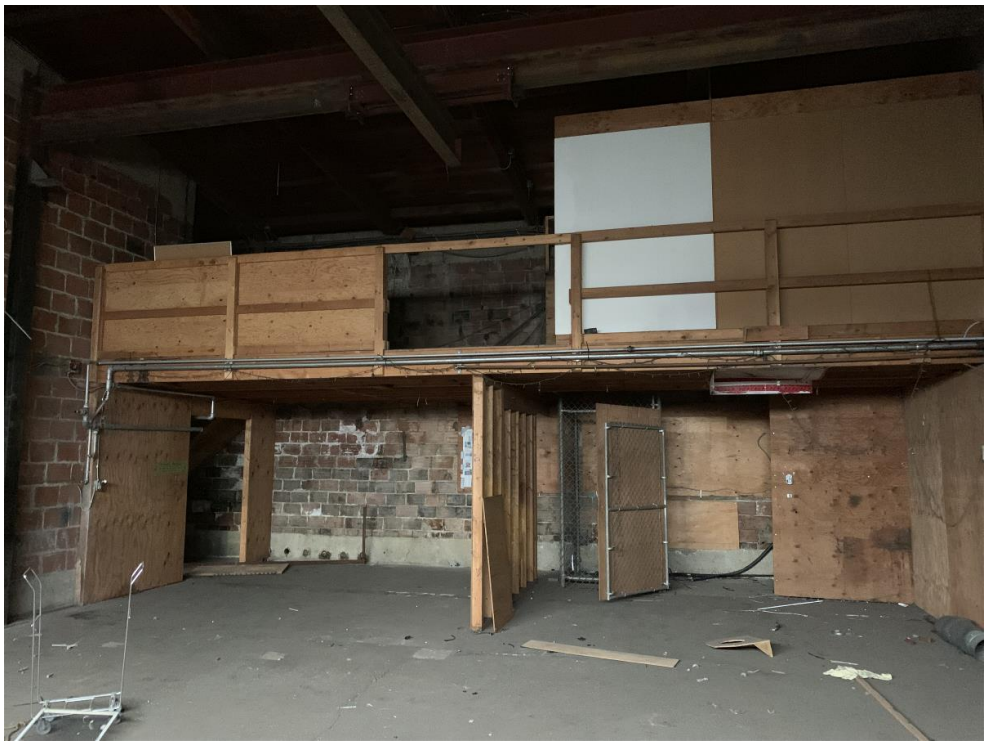
<b>Photograph ID:</b> 36

<b>Photo Location:</b> Interior bay	
<b>Direction:</b> Looking east	
<b>Survey Date:</b> 10/22/2021	
<b>Comments:</b> Typical wood mezzanine construction

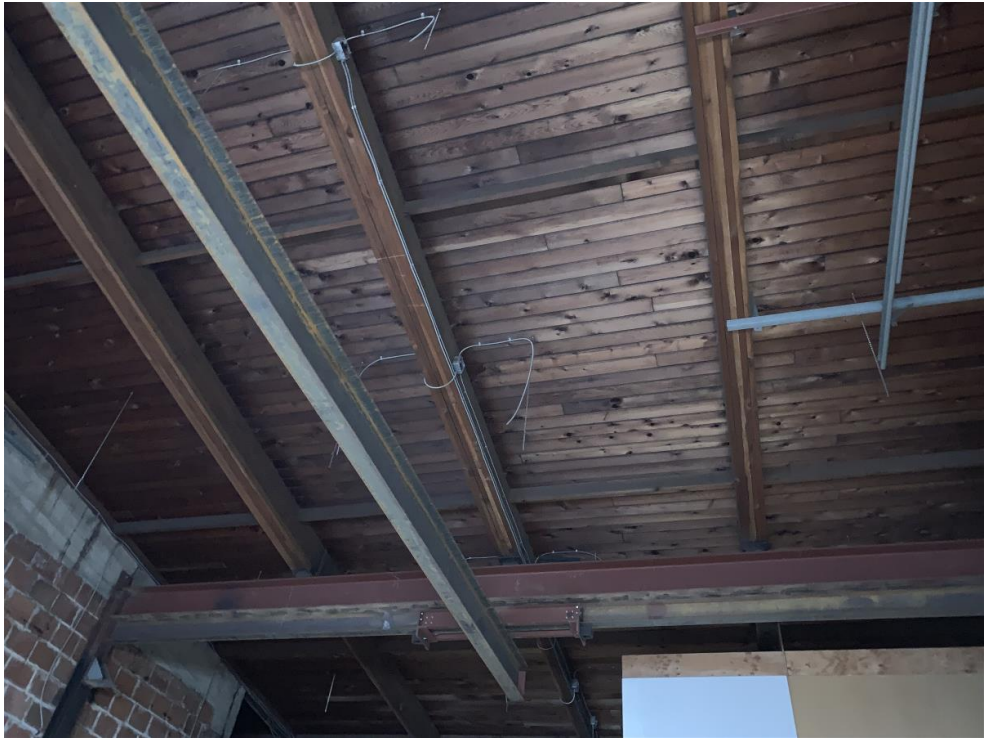
<b>Photograph ID:</b> 37

<b>Photo Location:</b> Interior bay	
<b>Direction:</b> Looking east	
<b>Survey Date:</b> 10/22/2021	
<b>Comments:</b> Typical roof support including steel i-beam
