Asset Overview Report

Hay River CCG Base

Region: Central and Arctic

Site: Hay River CCG Base

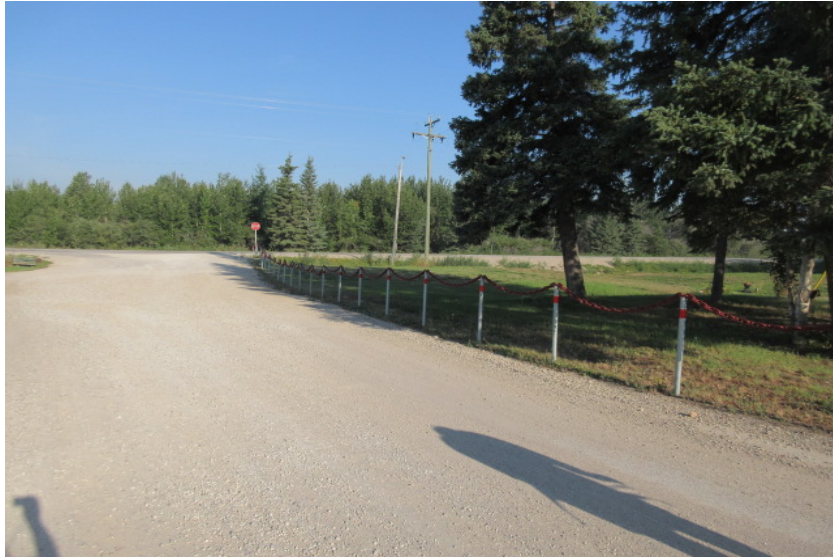
Signature - Exterior Elevation Access Road

The Hay River Canadian Coast Guard Base can be found at 42037 Mackenzie Highway, Hay River, Northwest Territories, X0E 0R9. The site infrastructure includes a paved, asphalt Access Road, Asset Code: C L 00002 17660, which leads onto the site from the Mackenzie Highway. The Access Road is approximately 8.5 meters wide by 250 lineal meters long.

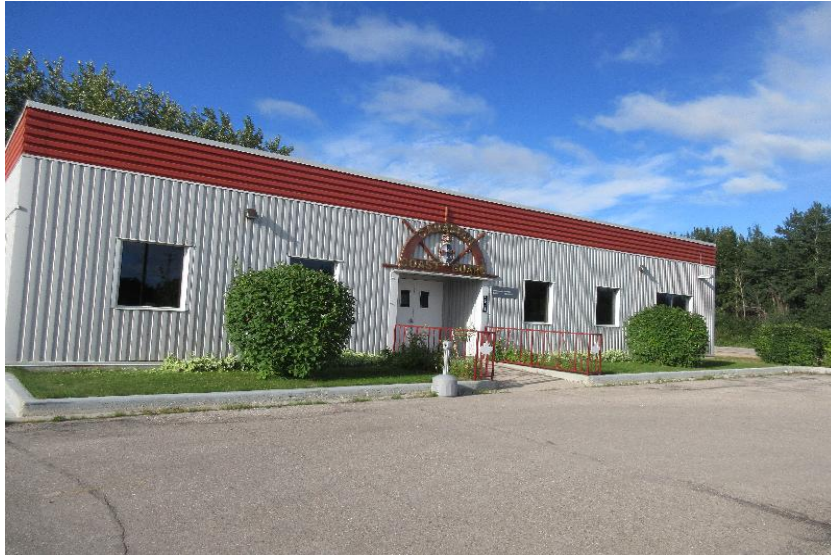
Signature - Front Elevation Administration Building

The Administration building, Asset Code C L 00002 16580, can be found on the Hay River Canadian Coast Guard Base at 42037 Mackenzie Highway, Hay River, Northwest Territories, X0E 0R9. The facility is a single level building with crawlspace foundation built in 1984. The Administration building contains 462 square meters of floor space.

The substructure construction found beneath the Administration building facility consists of an elevated wood floor, supported on wood floor trusses and sitting on an exterior perimeter cast concrete foundation walls founded on strip concrete footings. The entire foundation substructure is supported by steel piles driven into the highly compressible discontinuous permafrost soils to prevent subsidence and settlement issues. Exterior walls are clad with prefinished metal panel siding on an insulated wood framed backup wall, finished with vapour retarder and painted gypsum wallboard. Roof framing consists of pre-engineered wood roof trusses and is waterproofed with a protected membrane roof assembly. Fenestration consists of insulated aluminum window

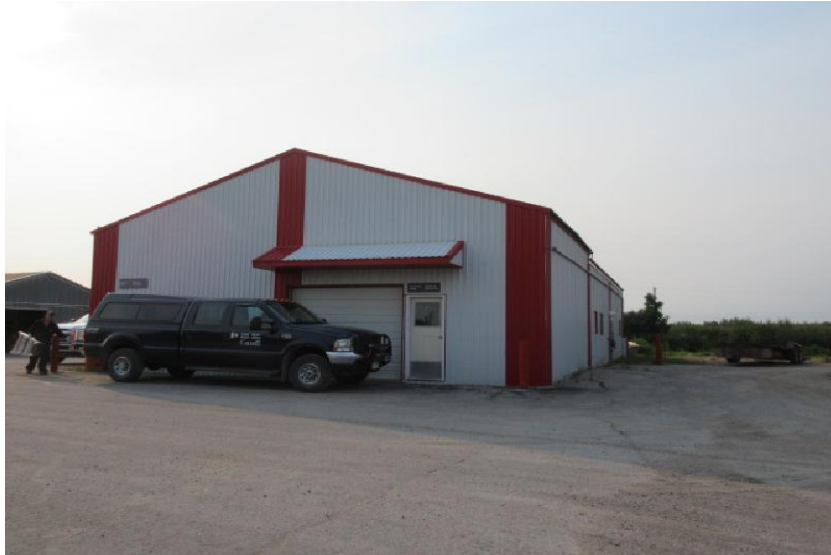
Signature - Exterior Elevation Carpenter Shop

The Carpenter Shop building, Asset Code C L 00002 17465, can be found on the Hay River Canadian Coast Guard Base at 42037 Mackenzie Highway, Hay River, Northwest Territories, X0E 0R9. The facility is a single level building with a slab on grade foundation built in 1968. The Carpenter Shop building contains 318 square meters of floor space.

The substructure construction found beneath the Carpenter Shop building facility consists of a concrete floor slab on grade with exterior perimeter cast concrete foundation walls founded on strip concrete footings. Exterior walls are clad with prefinished metal panel siding on an insulated steel framed backup wall, finished with vapour retarder and either painted gypsum wallboard or prefinished metal wall panels. Roof framing consists of a metal roof deck supported on structural steel members and waterproofed with a standing seam metal roof panel assembly. Fenestration consists of wood framed window assemblies and entry doors are finished, wood panel doors and frames, some with glazing.

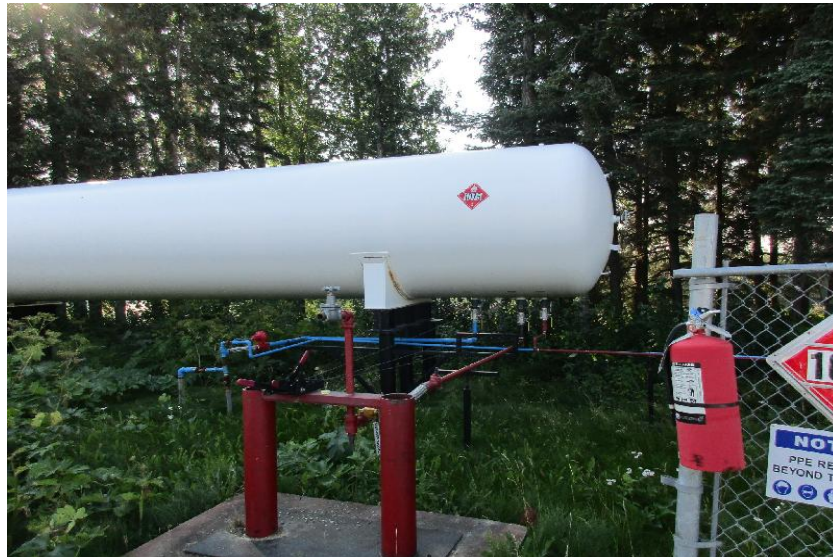
D3012 - Propane Tank

Uniformat	System Name	Lifetime (Years)	% Renew	Year Installed	Next Renewal Year	Renewal Cost	Replacement Cost
D3012 - Gas Supply System	Propane Vaporizer System	30	100	1991	2021	39,631	39,631
D3012 - Gas Supply System	Propane Tank - 45.4 Cubic Meters	30	100	1991	2021	33,263	33,263
D3012 - Gas Supply System	Propane Gas Service to Buildings - Underground	40	125	1991	2032	107,274	85,820
Subtotal							158,714
Overhead:							0
Subtotal							0
Total Replacement Value Based on System Costs with Overheads							158,714

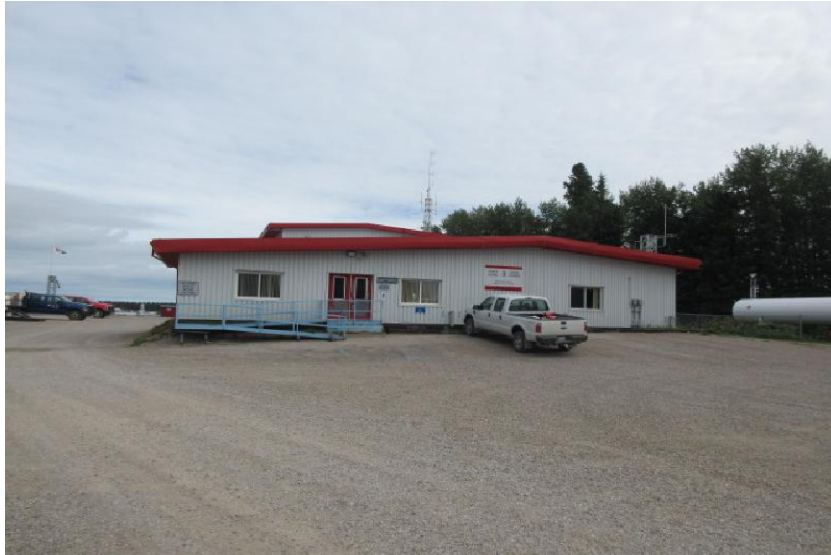
Signature - Front Elevation Stores / Maintenance Shop

The Stores / Maintenance Shop, Asset Code C L 00002 17009, can be found on the Hay River Canadian Coast Guard Base at 42037 Mackenzie Highway, Hay River, Northwest Territories, X0E 0R9. The facility is a single level building with crawlspace foundation built in 1968 and renovated in 1991. The Stores / Maintenance Shop contains 804 square meters of floor space.

The substructure construction found beneath the Stores / Maintenance Shop facility consists of an elevated concrete floor, supported on concrete grade beams and resting on an exterior perimeter cast concrete foundation walls founded on strip concrete footings. The entire foundation substructure is supported by steel piles driven into the highly compressible discontinuous permafrost soils to prevent subsidence and settlement issues. Exterior walls are clad with prefinished metal panel siding on an insulated wood framed backup wall, finished with vapour retarder and either painted gypsum or prefinished metal wall panels. Roof framing consists of pre-engineered structural steel support members and is waterproofed with a standing seam metal roofing assembly. Fenestration

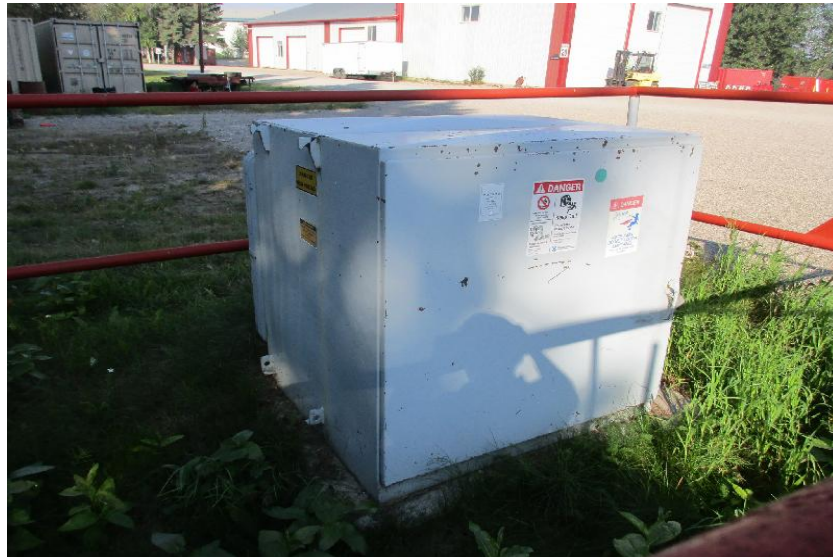
G4013 - Underground Electrical System - Service Transformer

Uniformat	System Name	Lifetime (Years)	% Renew	Year Installed	Next Renewal Year	Renewal Cost	Replacement Cost
D5039 - Local Area Networks	Fiber Optics System	15	100	2010	2025	96,536	96,536
G4013 - Underground Power Distribution	Underground Electrical System	30	100	1982	2023	551,649	551,649
Subtotal							648,185
Overhead:							0
Subtotal							0
Total Replacement Value Based on System Costs with Overheads							648,185

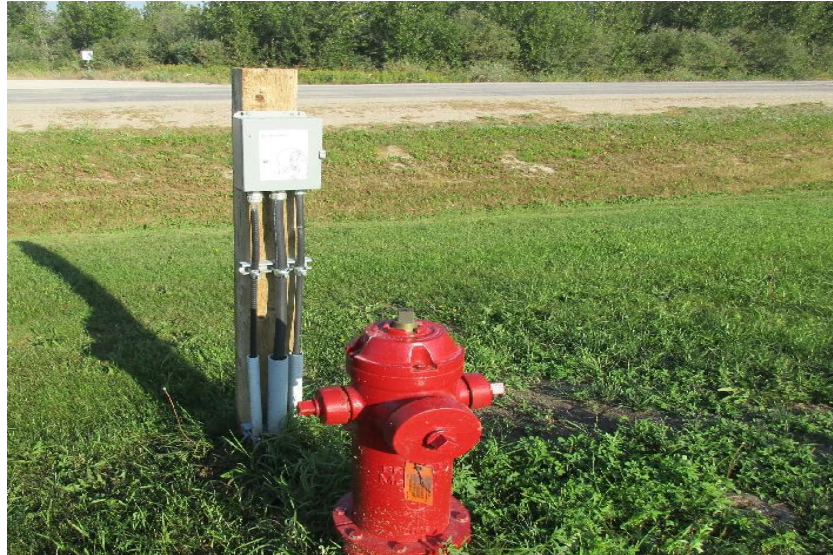
G3011 - Underground Water System - Hydrant

Uniformat	System Name	Lifetime (Years)	% Renew	Year Installed	Next Renewal Year	Renewal Cost	Replacement Cost
G3011 - Potable Water Distribution and Storage	Underground Water System	25	100	1995	2020	621,497	621,497
					Subtotal		621,497
					Overhead:		0
					Subtotal		0
							Total Replacement Value Based on System Costs with Overheads
							621,497

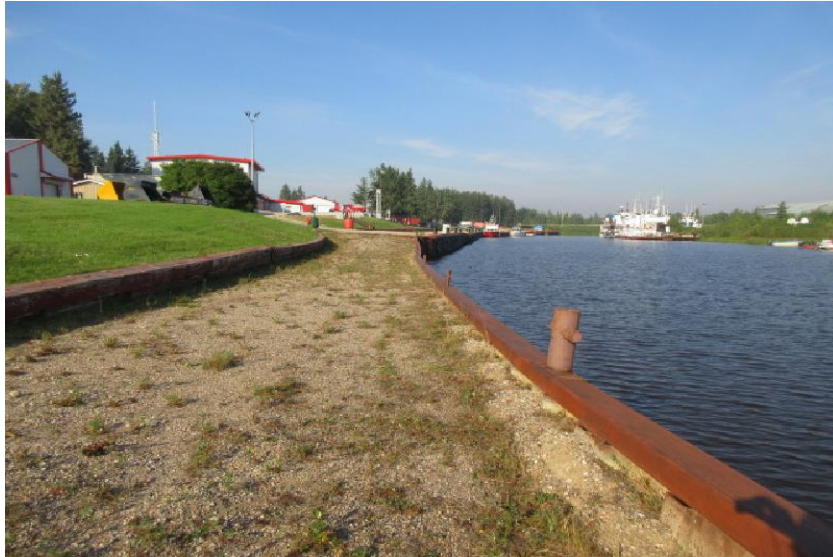
Signature - Exterior View Wharf

G2049 - Miscellaneous Structures	Sheet Steel Seawall Two	60	125	1970	2030	420,326	336,261
G2049 - Miscellaneous Structures	Mooring Accessories Two	30	125	2000	2030	2,586	2,068
G2049 - Miscellaneous Structures	Mooring Accessories One	30	125	2000	2021	2,586	2,068
G4013 - Underground Power Distribution	Underground Electrical Power Distribution	30	100	2000	2030	91,603	91,603
Subtotal							1,724,263
Overhead:							0
Subtotal							0
Total Replacement Value Based on System Costs with Overheads							1,724,263
