Project Description / Description de projet	
S77 4th floor Process Steam Boiler/ Chaudière à vapeur de procédé au 4e étage	
Project No./No de projet	Departmental Representative / représentant ministériel
6092	Eric Poirier
Solicitation No./N° de sollicitation	
22-58138	
Notice: This addendum shall form part of the tender documents and all conditions shall apply and be read in conjunction with the original plans and specifications.	
Nota: Cet addenda fait partie intégrale des dossiers d'appel; toutes les conditions énoncées doivent être lues et appliquées en conjonction avec les plans et les devis originaux.

PROJECT NAME	100 SUSSEX DR. - NRC BUILDING S77 - 4TH FLOOR STEAM BOILER - CNRC BÂTIMENT S77 - CHAUDIÈRE À VAPEUR DU 4ÈME ÉTAGE PROJECT/PROJET NO. 6092
PROJECT NO.	GWAL 2022-471
DATE	MARCH 6, 2023
ADDENDUM NO.	ME1
<p>The following additions, deletions & revisions form part of the drawings and specifications for the above referenced project: Les ajouts, suppressions et révisions suivants font partie des dessins et des spécifications pour le projet susmentionné:</p>

**DESIGNATED SUBSTANCES SURVEY
BUILDING S-77
OTTAWA, ONTARIO**

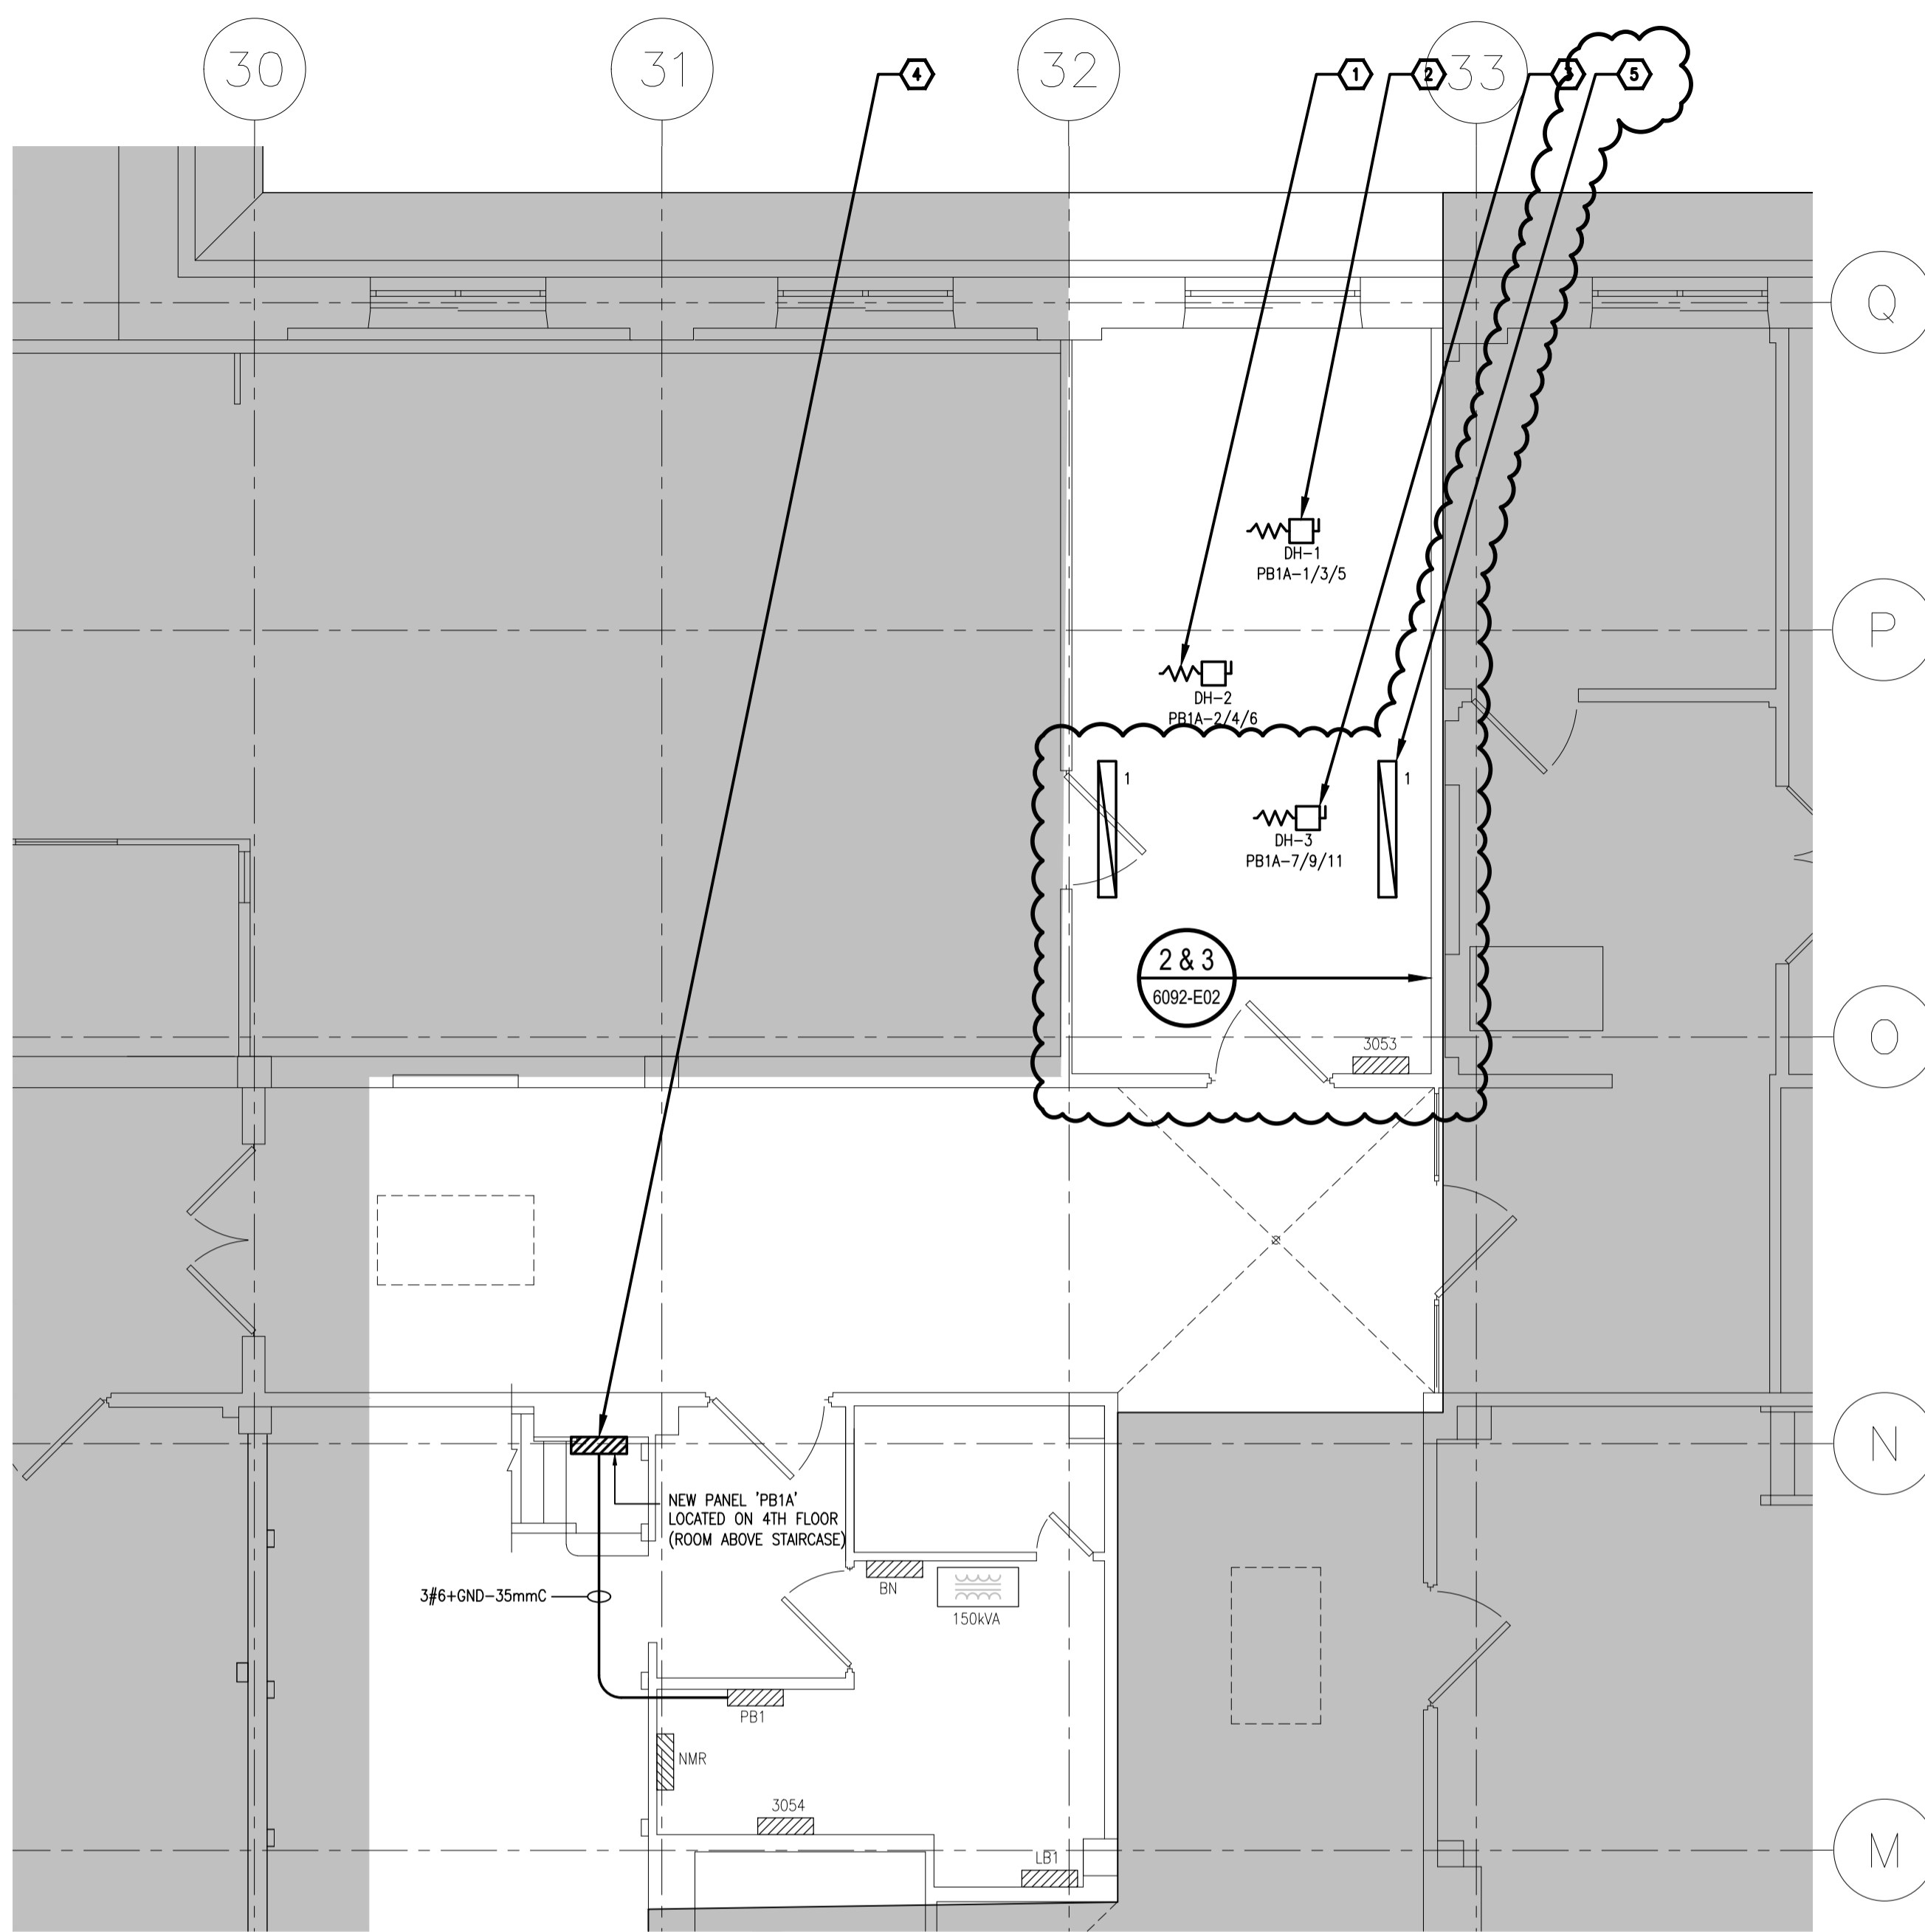
PROJECT S77 6092 PROCESS STEAM BOILER	1688 Woodward Dr. Ottawa Ontario Canada K2C 3R8 613 727-5111 Voice 613 727-5115 Fax www.gwal.com Web		
TITLE MECHANICAL RM 3053 - STEAM HUMIDIFIER REMOVAL	DATE 2023-03-06	DRAWN KN	SCALE AS NOTED
	PROJECT No. 2022-471	CHECKED RL	No. ADD-M1-SK1

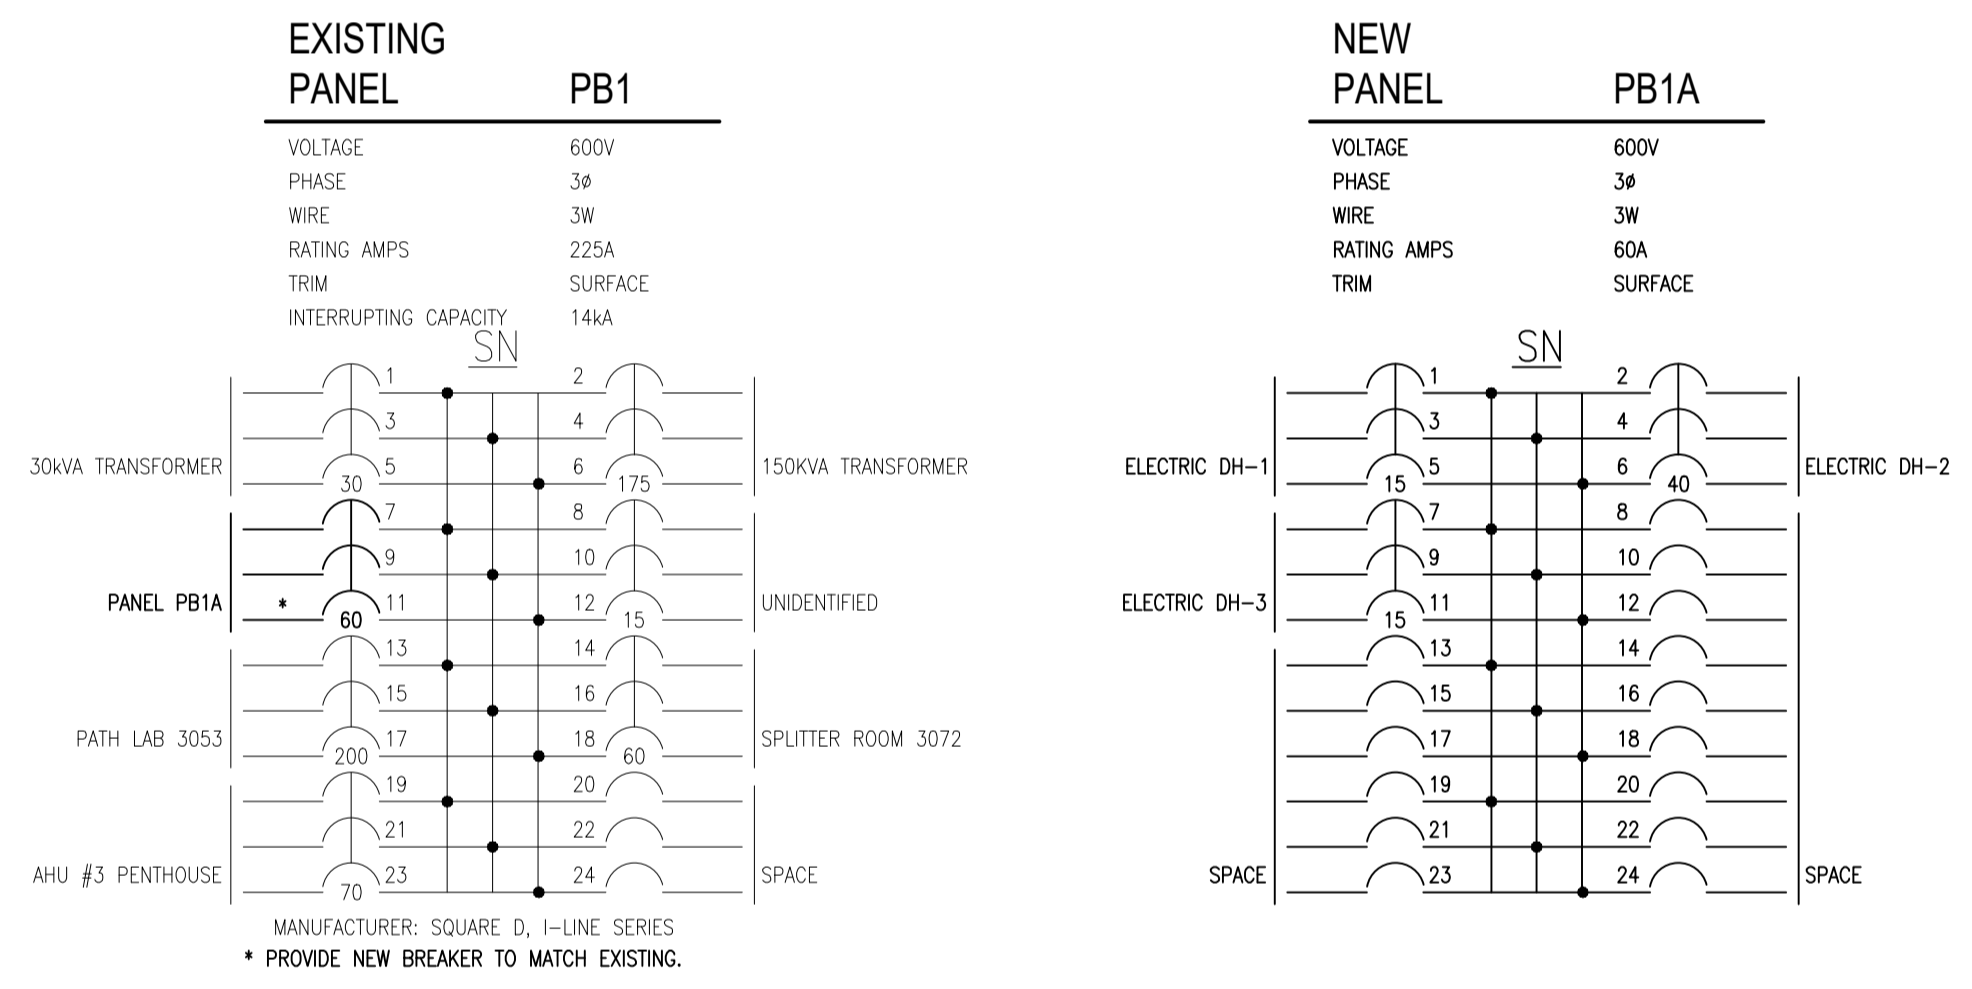
1 E02 1:50

- PROVIDE NEW 600V, 3-PHASE, 60A, 24 CIRCUIT SURFACE MOUNT ELECTRICAL PANEL ON 4TH FLOOR ABOVE STAIRWELL AS SHOWN. REPLACE EXISTING 40A, 3-POLE BREAKER IN PANEL 'PB1' LOCATED IN ROOM 3054 WITH NEW 60A, 3-POLE BREAKER. PROVIDE NEW 3#6+GND-35mmC FEEDER AS SHOWN. PROVIDE CORING AND FIRESTOP ALL PENETRATIONS.

ROOM 3053 ELECTRICAL NEW WORK

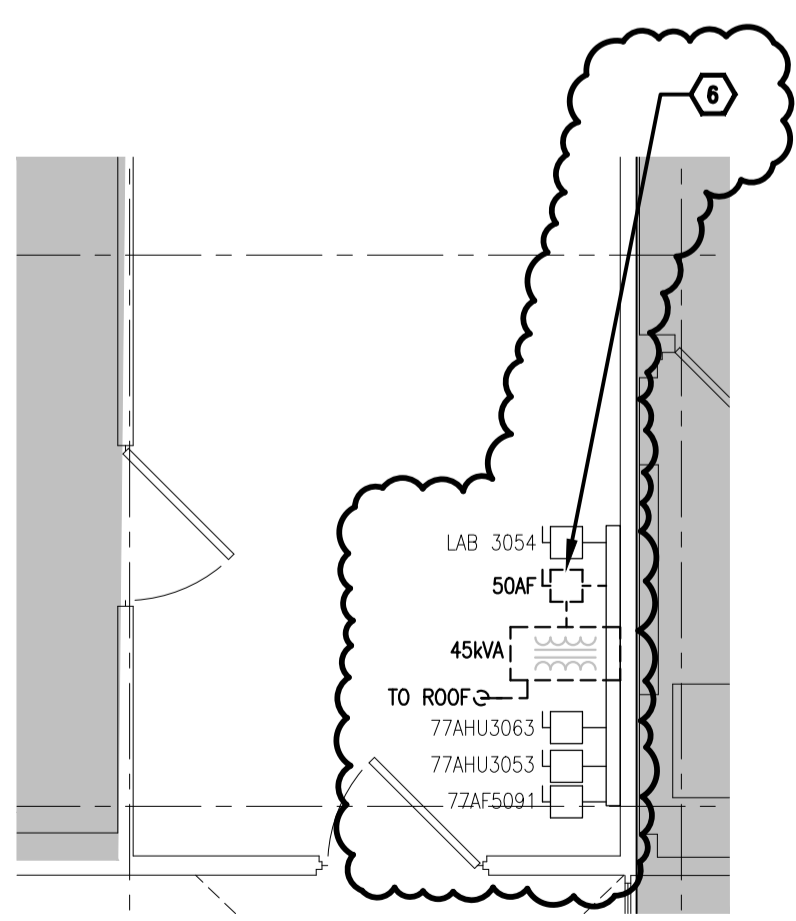
2 E02 1:50

- TEMPORARILY DISCONNECT AND REMOVE (2) EXISTING 1,220mm SUSPENDED FLUORESCENT STRIP LIGHT FIXTURES TO ACCOMMODATE MECHANICAL WORK. RE-INSTATE UPON COMPLETION OF WORK. EXTEND CONDUIT AND WIRING AS REQUIRED. COORDINATE EXACT LOCATION ON SITE.

- DISCONNECT AND REMOVE EXISTING WALL MOUNTED 600V, 50AF DISCONNECT SWITCH AND EXISTING 600-120/208V, 3-PHASE, 45kVA TRANSFORMER FEEDING REDUNDANT CONDENSER UNIT ON THE ROOF. DISCONNECT AND REMOVE ALL ASSOCIATED WIRING AND CONDUIT UP TO ROOF SLAB AND MAKE SAFE. COORDINATE EXACT LOCATION ON SITE.

ROOM 3053 ELECTRICAL DEMOLITION WORK

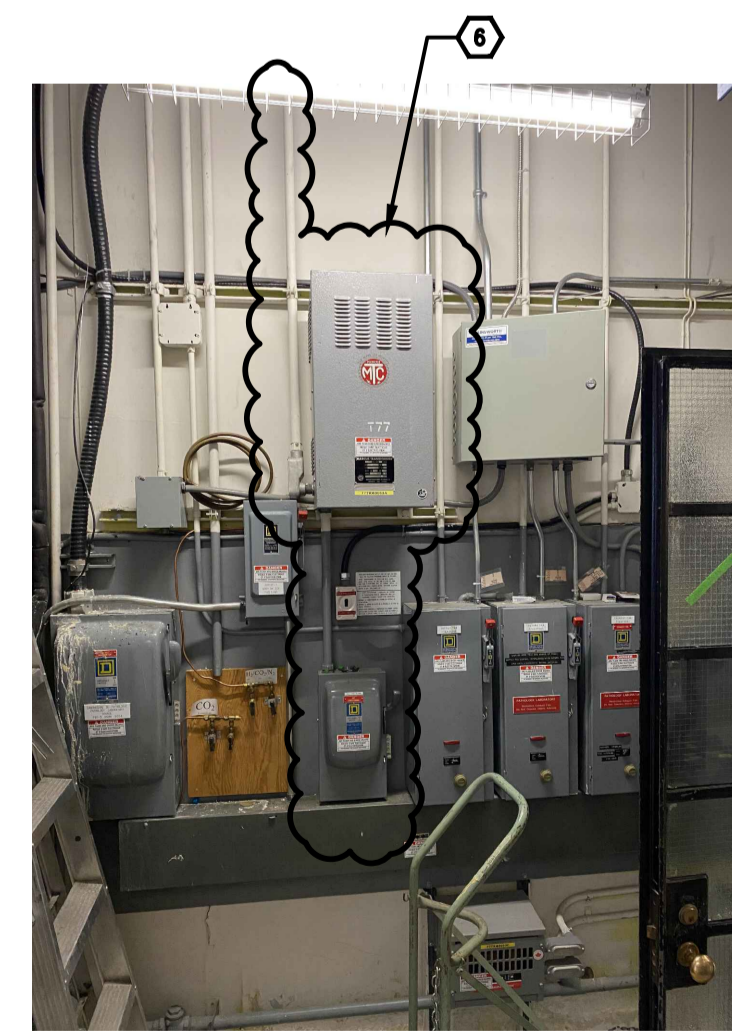
3 E02 N.T.S.

ROOM 3053 ELECTRICAL DEMOLITION WORK

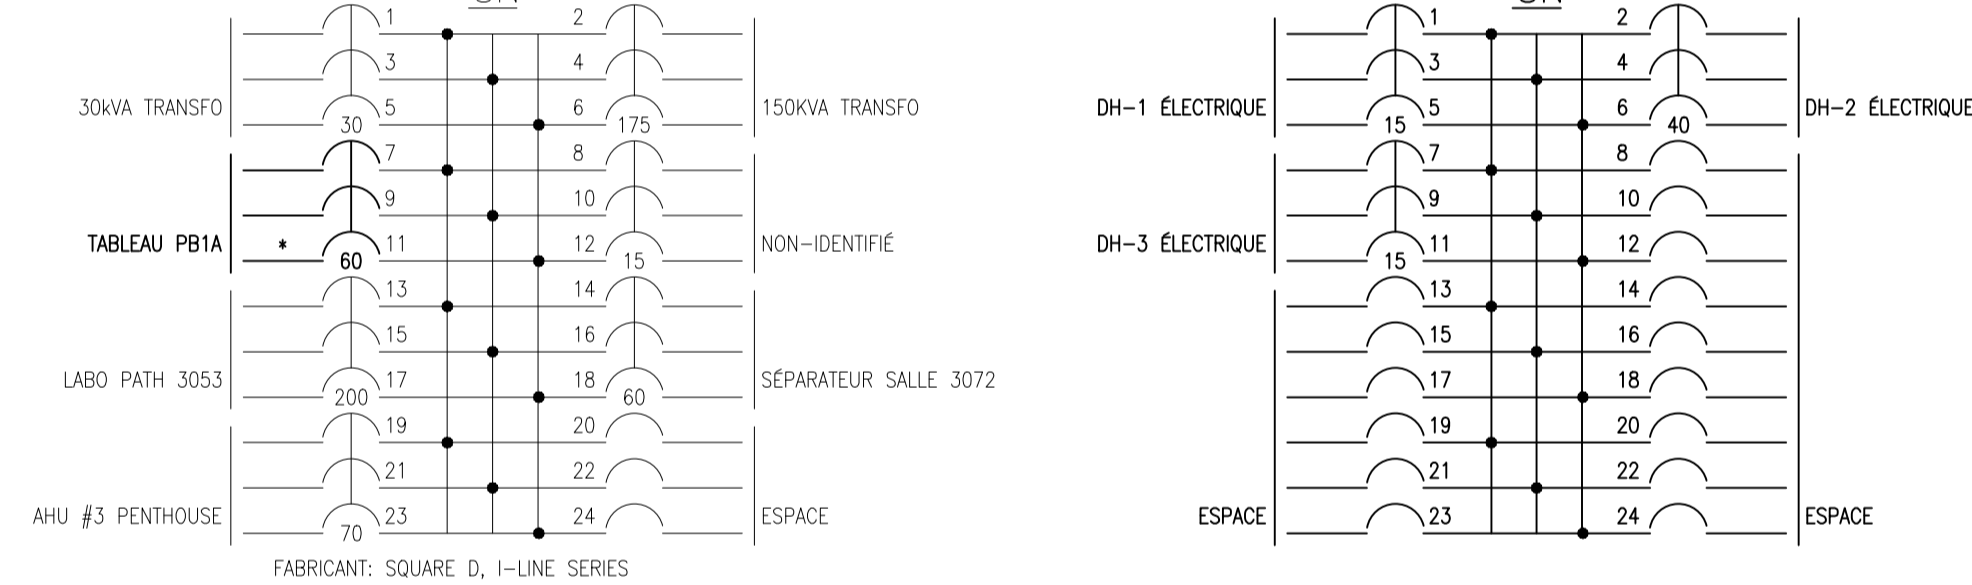
1 E02 1:50

LOCAL 3053 NOUVEAUX TRAVAUX ÉLECTRIQUES

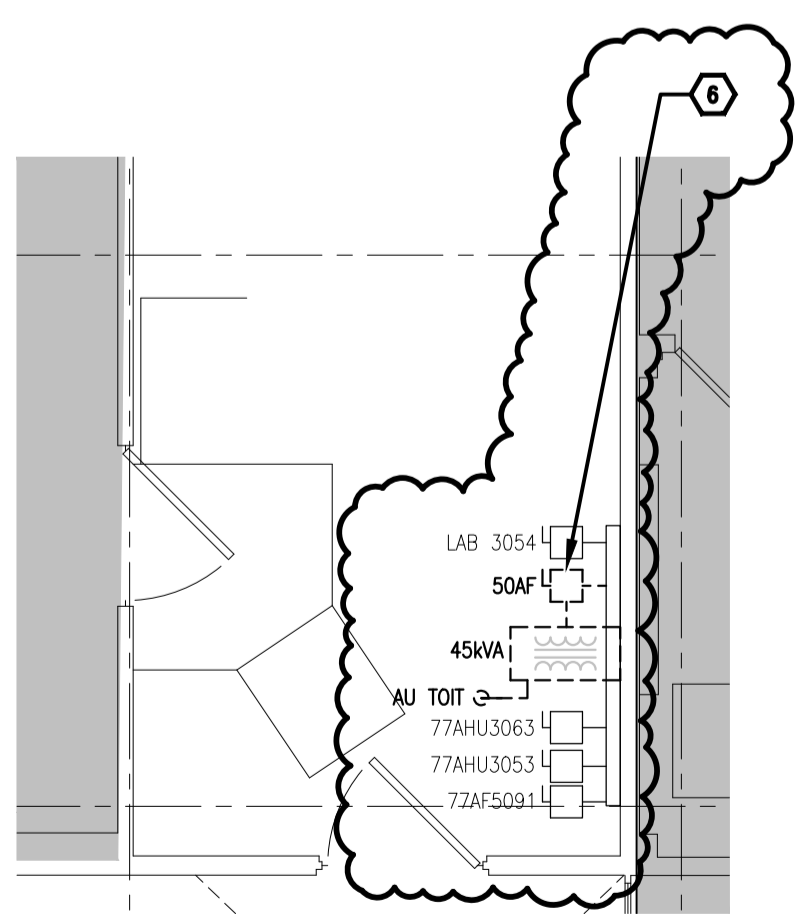
2 E02 1:50

- DÉBRANCHER ET ENLEVER TEMPORAIREMENT DEUX (2) LUMINAIRES À BANDE FLUORESCENTE SUSPENDUS DE 1 220 mm POUR PERMETTRE DES TRAVAUX MÉCANIQUES. PROLONGER LE CONDUIT ET LE CÂBLAGE SELON LES BESOINS. COORDONNER L'EMPLACEMENT EXACT SUR PLACE.

- DÉBRANCHER ET ENLEVER LE DISJONCTEUR MURAL EXISTANT DE 600V, 50 AMPÈRE AVEC FUSIBLE AINSI QUE LE TRANSFORMATEUR EXISTANT DE 600-120/208V, 3-PHASES, 45KVA QUI ALIMENTE L'UNITÉ DE CONDENSATION EXISTANTE SUR LE TOIT. DÉBRANCHER ET ENLEVER TOUTS LES CÂBLES ET CONDUITS ASSOCIÉS JUSQU'À LA DALLE DU TOIT PUIS RENDRE LE TOIT PARFAITEMENT SÉCURITAIRE. COORDONNER L'EMPLACEMENT EXACT SUR PLACE.

LOCAL 3053 TRAVAUX DE DÉMOLITION ÉLECTRIQUE

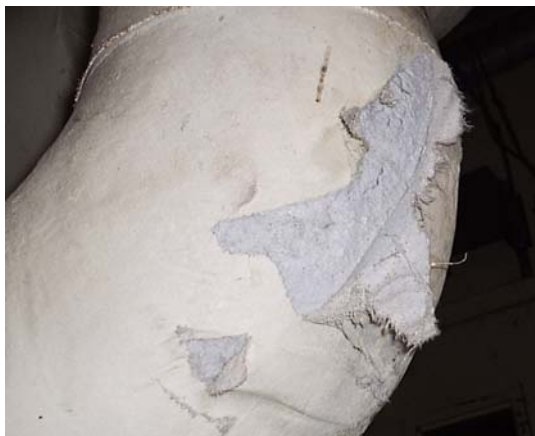
Mud Joint Compound

A representative photograph of mud joint compound fitting insulation. This material is a malleable grey insulation that has the appearance of granular mud. It appears smooth, round and hard when it is intact with appropriate exterior jacketing.

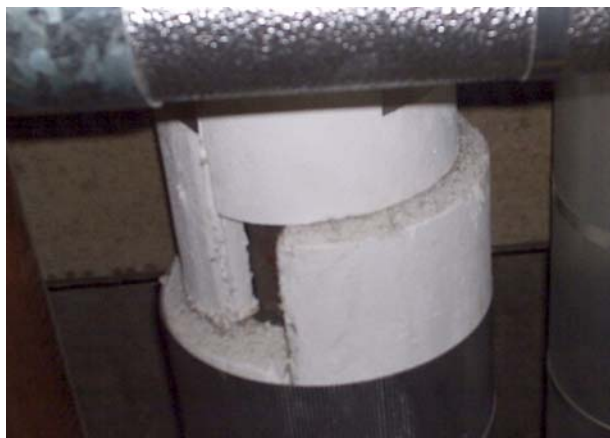
A representative photograph of MagBlock pipe insulation. This material is normally white or off-white in colour. MagBlock pipe insulation typically consists of a chalky, fibrous collection of blocks that is friable when found as seen in this photograph (without jacketing).

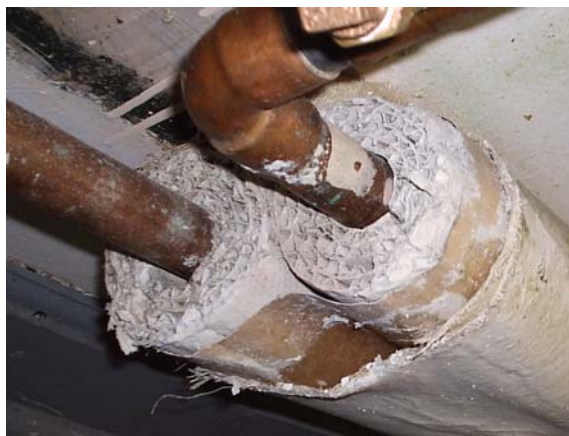
A representative photograph of aircell pipe insulation. This material is grey and white in colour. Aircell is layers of corrugated paper, which gives it the appearance of a honeycomb pattern when the profile is observed.

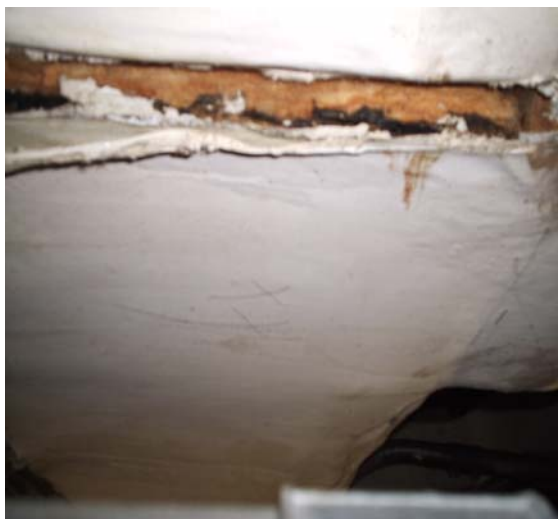
Duct Insulation

A representative photograph of asbestos duct insulation. The ACM duct insulation in this building was found to contain fibreglass with a tar paper layer and ACM parging. The parging material is a malleable grey insulation that has the appearance of granular mud.

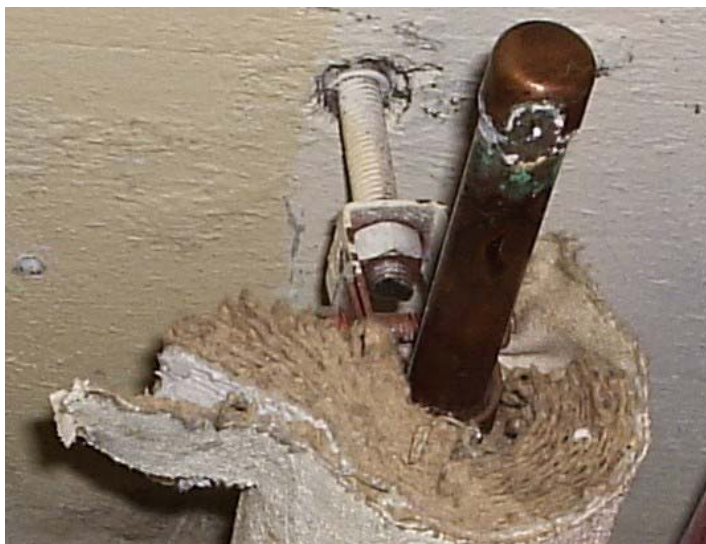
Sweat Wrap (with white paper layer)

A representative photograph of sweat wrap with white paper layer pipe insulation. This material has several layers of brown or grey waffle pattern paper layers with the outer layer consisting of a white paper layer that contains asbestos. This type of pipe insulation was used for low temperature applications only.

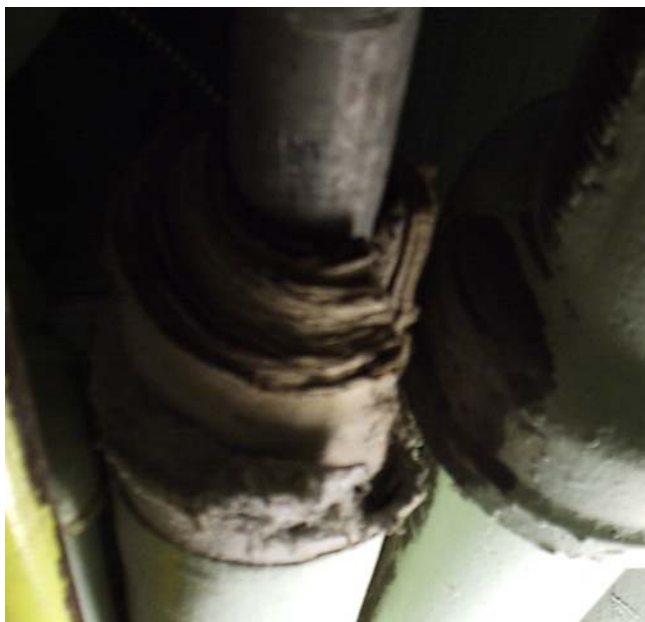
Sweat Wrap (with tar paper layer and parging)

A representative photograph of sweat wrap with tar paper layers and parging. This material has several layers of brown waffle pattern paper layers and tar paper layers with the outer layer consisting of parging and jacketing. This type of pipe insulation is typically used for low temperature applications.

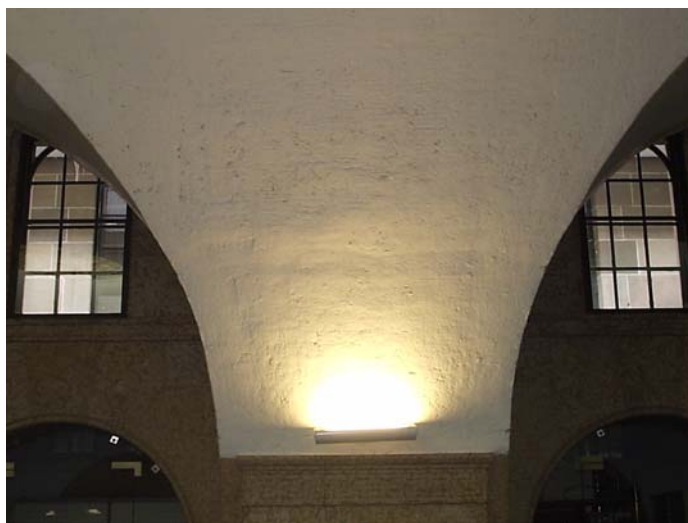
Fireproofing

This material is painted in this facility and appears as a type of plaster finishing coat. It is however, readily friable if disturbed.

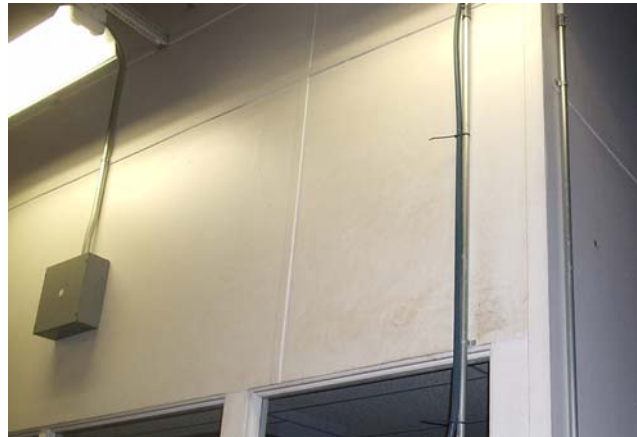
Transite Panel

A representative photograph of transite panel. Transite is a composite material made up of asbestos and cement that was a manufactured product at the time of installation. It was generally used in areas as a fire retardant. It is a rigid material that fractures when broken and may appear as other types of non-acm panel.

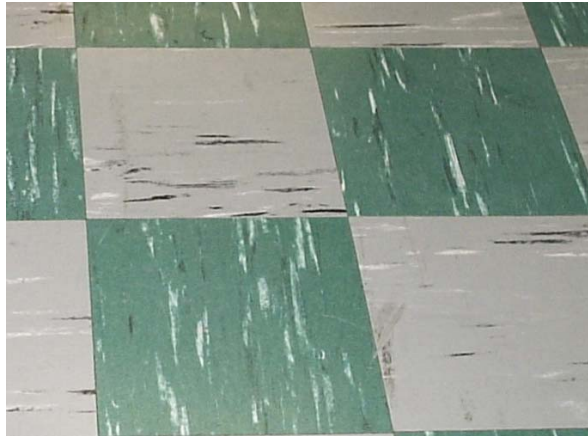
9" x 9" Floor Tile

A representative photograph of 9" x 9" vinyl asbestos floor tile (VAT). This material may be found in any number of different colours and patterns. VAT's are normally quite rigid and non-friable. VAT's are sometimes found under carpeting or they may be present as the only flooring.

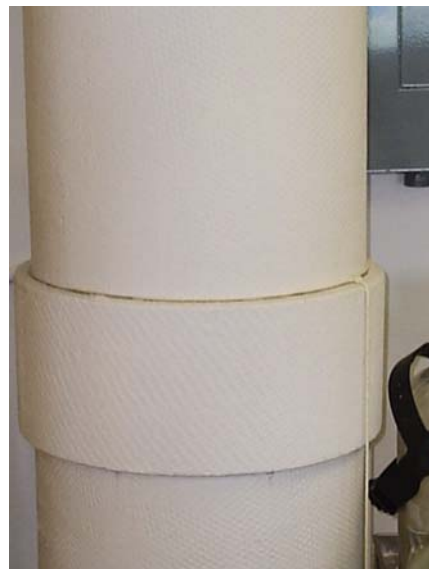
Transite Pipe

A representative photograph of transite pipe. Transite is a composite material made up of asbestos and cement that was a manufactured product at the time of installation. It is a rigid material that fractures when broken.

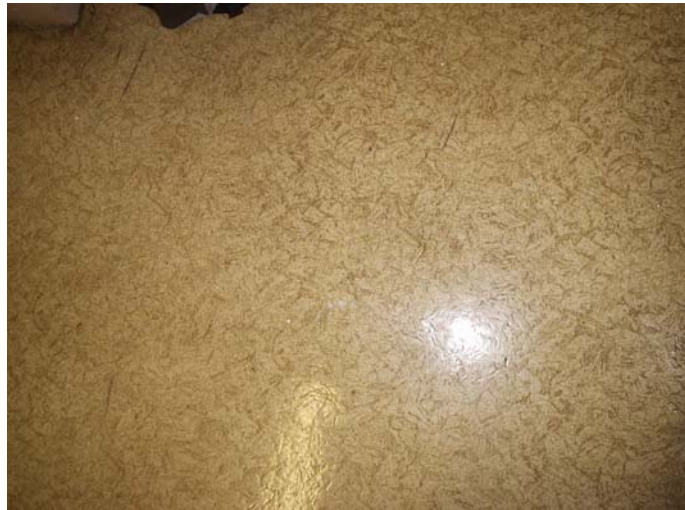
Linoleum (Gold)

A representative photograph of Linoleum asbestos flooring. This material may be found in any number of different colours and patterns. They are normally semi-rigid and non-friable. They are sometimes found under carpeting or they may be present as the only flooring.

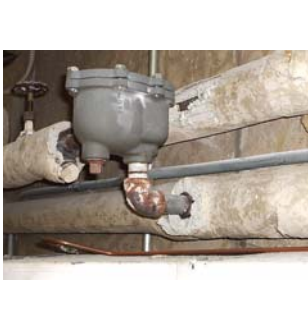
SB44	One removal is required on the damaged aircell pipe insulation on the condensate system. (0.3 LM)
34

SB44	One encapsulation is required on the damaged aircell pipe insulation on the steam system. (0.3 LM) Two encapsulations are required on the damaged mud joint compound fitting insulation on the condensate system.

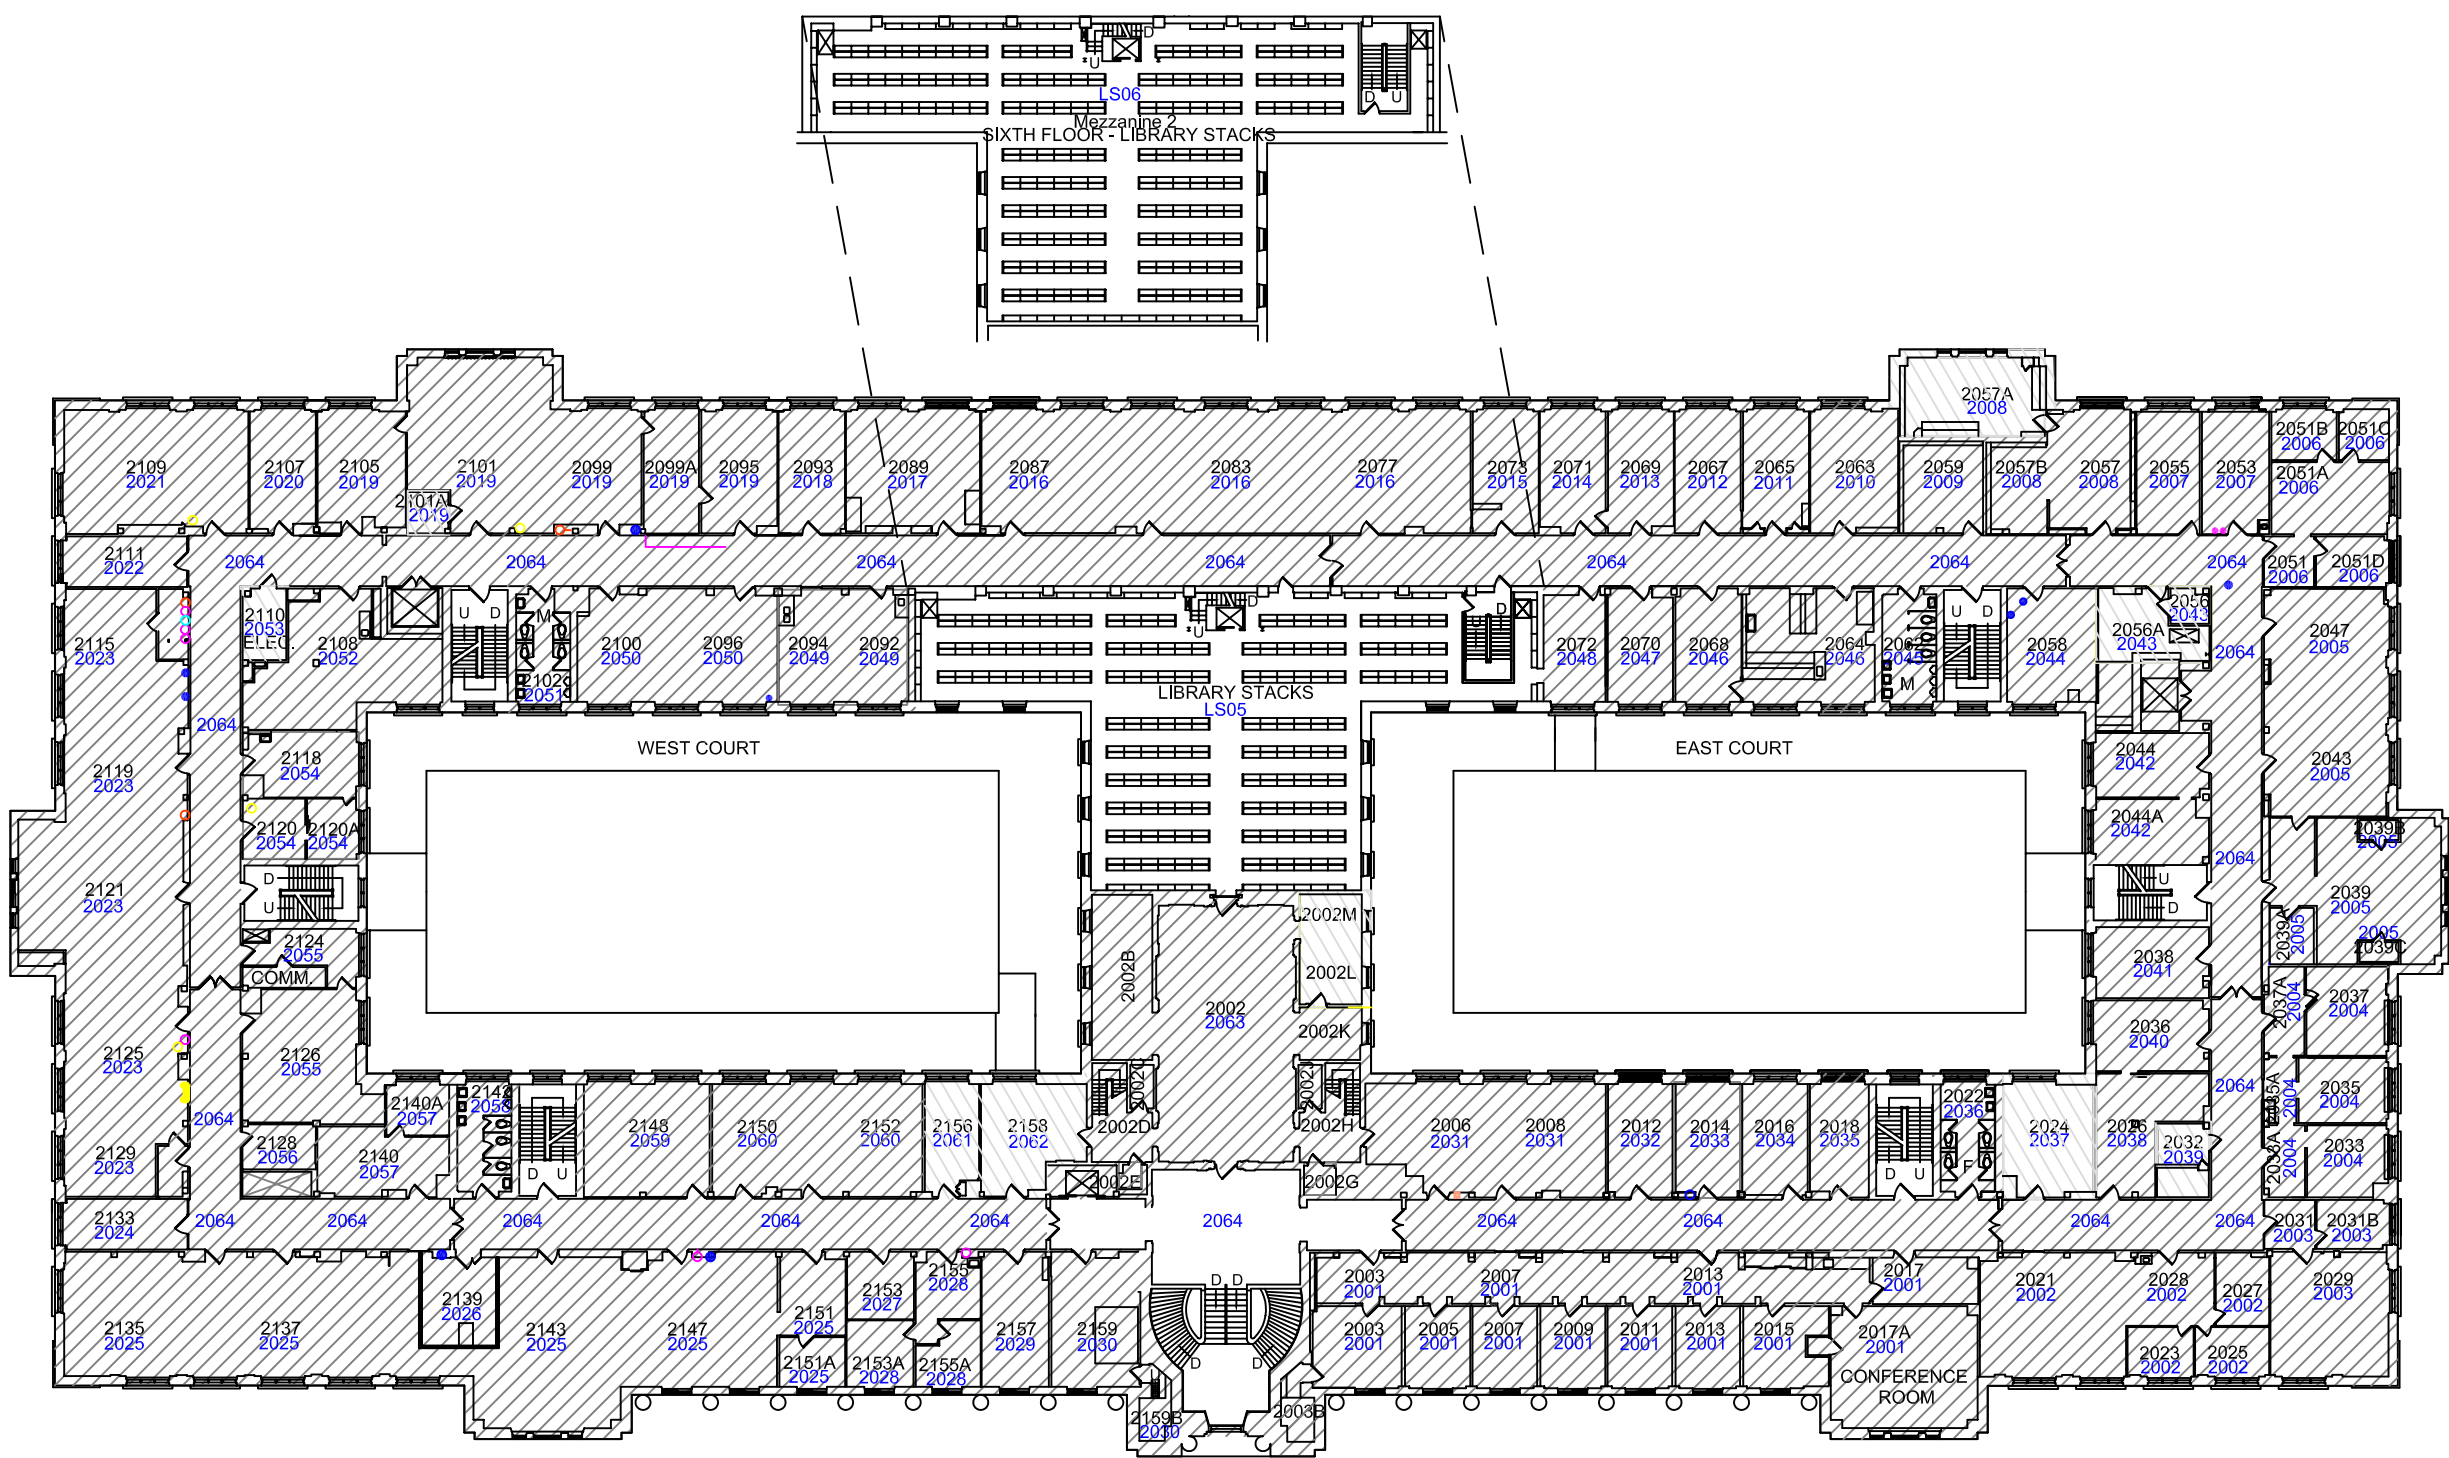
SHEET
2-1

TITLE
SECOND FLOOR ASBESTOS LOCATIONS
