Title - Sujet 50 Bed Living Unit, Westmorland Ins	
Solicitation No. - N° de l'invitation EC016-130878/A	Amendment No. - N° modif. 002
Client Reference No. - N° de référence du client R.043929.001	Date 2012-08-14
GETS Reference No. - N° de référence de SEAG PW-\$PWB-020-3101	
File No. - N° de dossier PWB-2-35024 (020)	CCC No./N° CCC - FMS No./N° VME
Solicitation Closes - L'invitation prend fin at - à 02:00 PM on - le 2012-09-13	
Time Zone Fuseau horaire Atlantic Daylight Saving Time ADT	
F.O.B. - F.A.B. Plant-Usine: <input type="checkbox"/> Destination: <input type="checkbox"/> Other-Autre: <input type="checkbox"/>	
Address Enquiries to: - Adresser toutes questions à: Donovan, Janine PWB	Buyer Id - Id de l'acheteur pwb020
Telephone No. - N° de téléphone (506) 636-5347 ()	FAX No. - N° de FAX (506) 636-4376
Destination - of Goods, Services, and Construction: Destination - des biens, services et construction:

This Tender Amendment Number 2 is raised to include the following **Addendum No. 2**.

Addendum No. 2

**GEOTECHNICAL INVESTIGATION
WESTMORLAND INSTITUTION
DORCHESTER,
NEW BRUNSWICK**

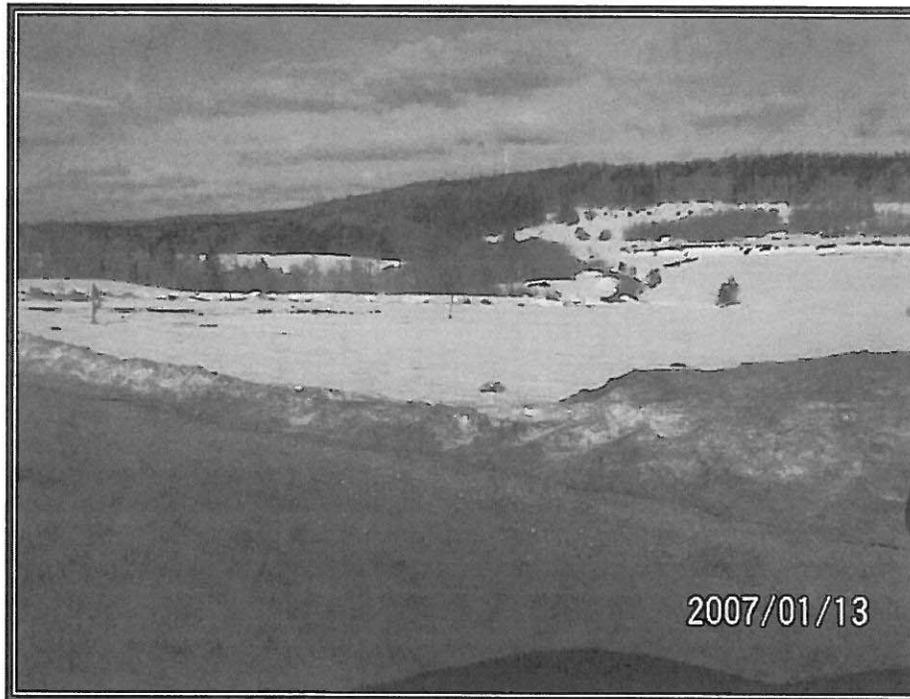
Figure 1 – Cleared vegetative area to the east of the existing facilities (photo taken by Darren Oulton on March 14, 2011).

The existing area is a cleared vegetated field, which is located to the east of the existing facilities that make up Westmorland Institution. There is a gravel road that runs west to east along the northern side of this cleared area, with an existing baseball field beyond this road to the north. In addition, there is a small watercourse that exists to the east of the area of interest. The focus of this geotechnical investigation was primarily to the north-west of this cleared area.

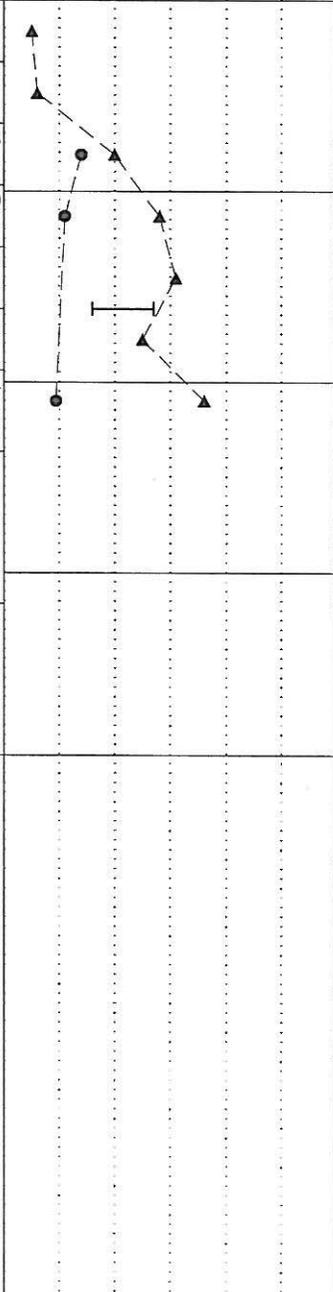
**BOREHOLE LOG
No. BH4**

4.96	16.53	Fair Reddish Brown Mudstone RQD=53%								10-13-23-25 (36)	50.4	-	-		
														61	
6.2	20.67														
7.44

Plastic Limit — Liquid Limit
Water Content - ●
SPT N-Value - ▲

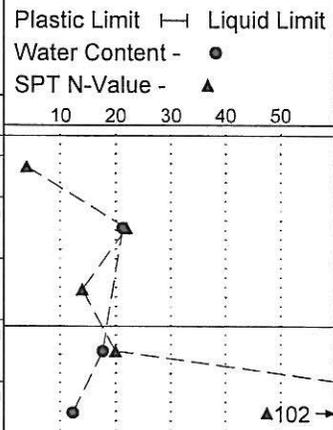
Depth (meters)	Depth (feet)	Description	Elevation (m)	Groundwater	Graphic	Sample Type	Sample No.	Lab Tests	Sample Rec (cm)	Blow Counts (N Value)	% < #200	TEST RESULTS	
												Plastic Limit	Liquid Limit
0	0	Topsoil with Roots	45.78						45	1-1-3-5 (4)			
		Loose Brown Sand with Trace Gravel							46	6-12-10-6 (22)	26.5		
1.24	4.13	Compact Brown Silty Sand with Trace Gravel							15	6-6-8-10 (14)			
		Very Stiff to Hard Brown Clay and Sand Till with Some Gravel							61	7-10-10-10 (20)	44.9		
2.48	8.27								61		42.9		
		Poor to Fair Reddish Brown Mudstone RQD=33%											
3.72	12.4												
		RQD=69%											
4.96	16.53

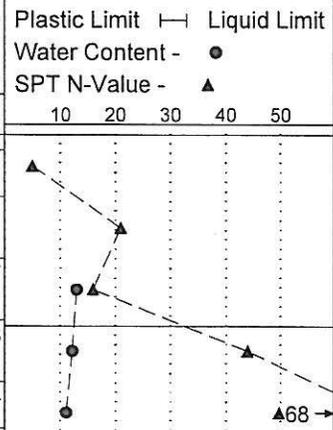
**BOREHOLE LOG
No. BH5**

Depth (meters)	Depth (feet)	Description	Elevation (m)	Groundwater	Graphic	Sample Type	Sample No.	Lab Tests	Sample Rec (cm)	Blow Counts (N Value)	% < #200	TEST RESULTS				
												Plastic Limit	Liquid Limit	SPT N-Value		
0	0	Topsoil with Roots	44.26						41	1-2-3-7 (5)						
		Loose Brown Sand with Gravel								52	5-11-10-8 (21)					
1.24	4.13	Compact Brown Silt and Sand with Trace Gravel								48	7-8-8-8 (16)	37.7				
2.48	8.27	Hard Reddish Brown Sandy Clay Till with Some Gravel								43	15-16-28-34 (44)	47.8				
		Poor Reddish Brown Mudstone RQD=39%								40		47.4				
3.72	12.4															
4.96	16.53	Fair Reddish Brown and White Sandstone RQD=53% Compressive Strength= 29 MPa

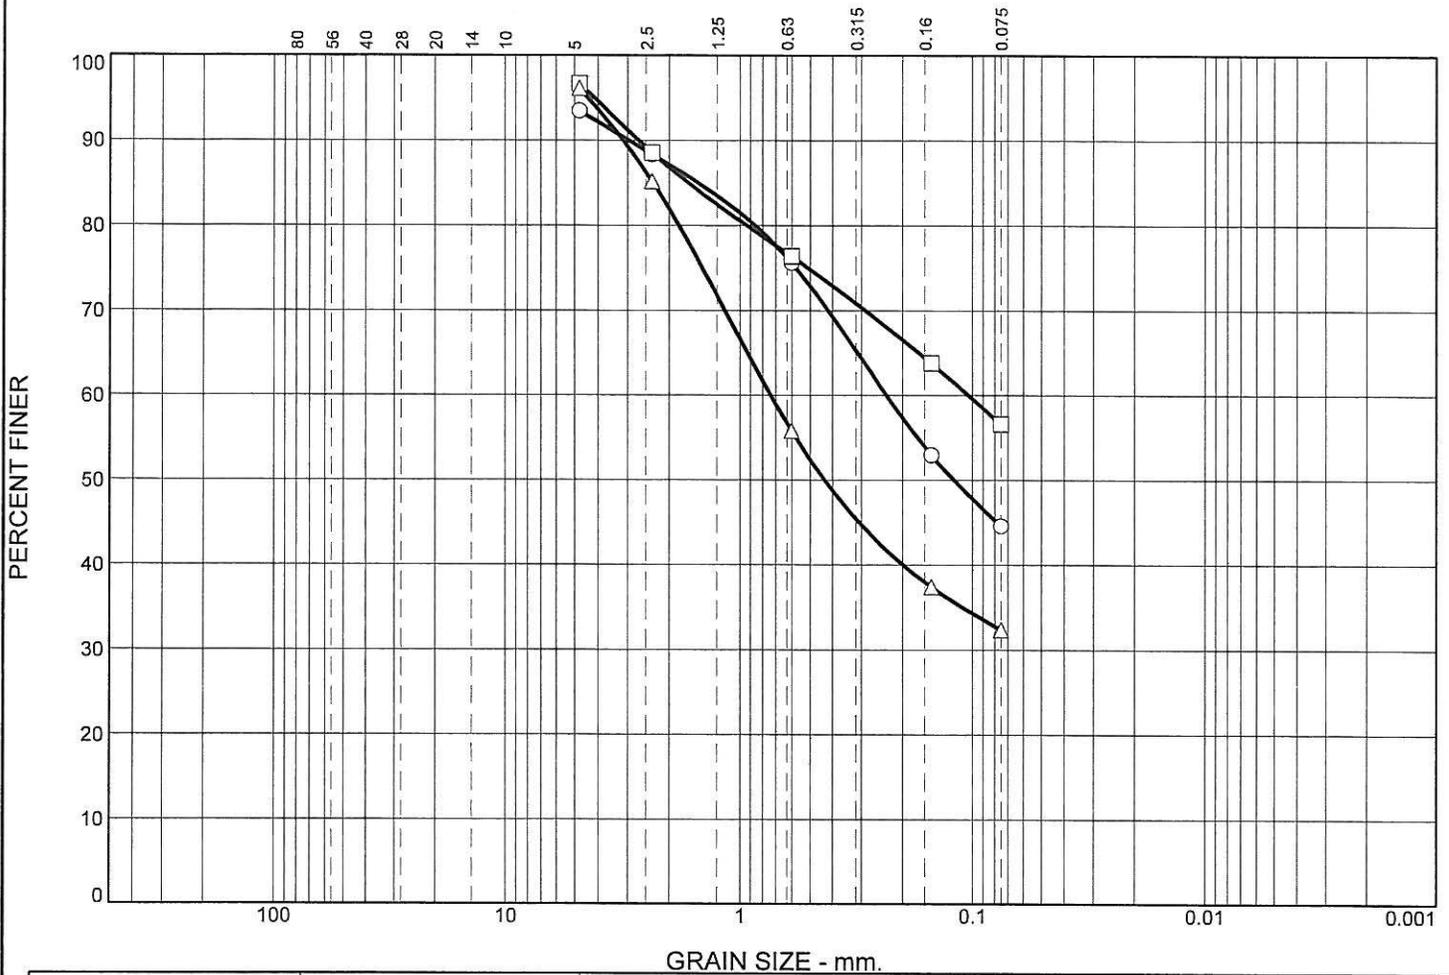
Particle Size Distribution Report

% +3"		% Gravel		% Sand			% Fines		
		Coarse	Fine	Coarse	Medium	Fine	Silt	Clay	
○				6.4	16.8	25.7	44.6		
□				9.9	13.3	16.9	56.6		
△				14.2	32.2	17.3	32.4		
LL	PL	D ₈₅	D ₆₀	D ₅₀	D ₃₀	D ₁₅	D ₁₀	C _c	C _u
○		1.5049	0.2332	0.1201					
□		1.6561	0.1036						
△		2.3416	0.7381	0.4320

Material Description	USCS	AASHTO
○ BH1 8-10 ft	CL/SC CL	
□ BH1 12-14 ft		
△ BH1 10-12 ft

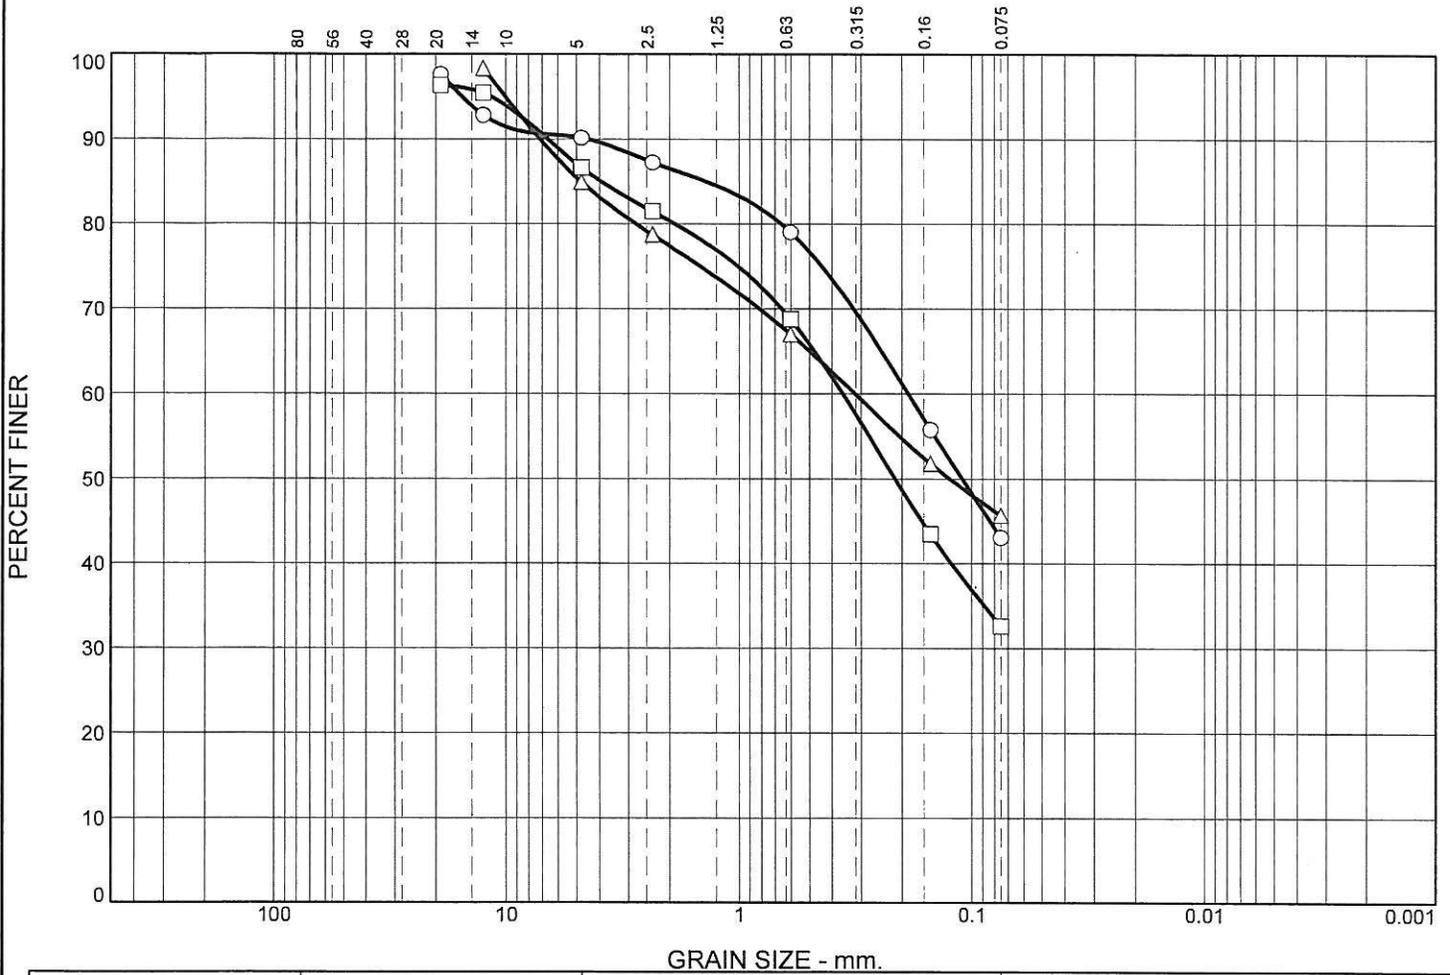
Particle Size Distribution Report

% +3"	% Gravel		% Sand			% Fines			
		Coarse	Fine	Coarse	Medium	Fine	Silt	Clay		
○				3.6	12.1	31.4	43.0			
□				6.2	17.3	30.5	32.6			
△				7.5	14.1	17.6	45.7			
⊗	LL	PL	D ₈₅	D ₆₀	D ₅₀	D ₃₀	D ₁₅	D ₁₀	C _c	C _u
○			1.3917	0.1873	0.1099					
□			3.9476	0.3586	0.2137					
△			4.8012	0.3177	0.1239

Material Description	USCS	AASHTO
○ BH2 2-4 ft		
□ BH2 6-8 ft		
△ BH2 10-12 ft	VS

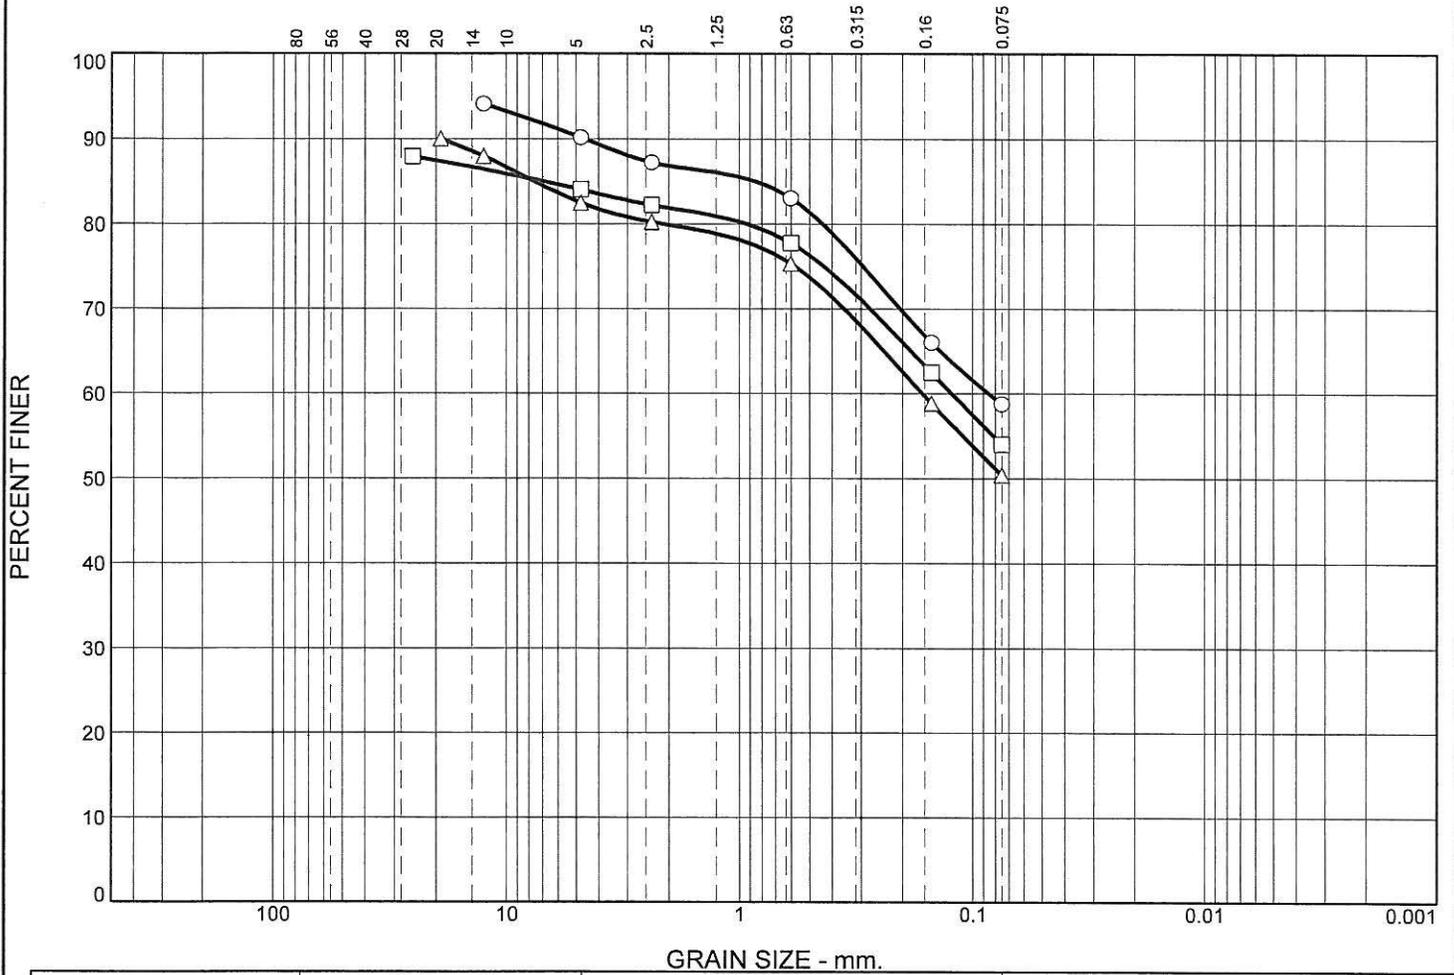
Particle Size Distribution Report

% +3"	% Gravel		% Sand			% Fines			
		Coarse	Fine	Coarse	Medium	Fine	Silt	Clay		
○				3.3	7.1	20.9	58.8			
□			3.3	2.2	7.0	20.8	54.0			
△				2.6	7.8	21.7	50.4			
⊗	LL	PL	D ₈₅	D ₆₀	D ₅₀	D ₃₀	D ₁₅	D ₁₀	C _c	C _u
○			0.8482	0.0851						
□			6.8920	0.1228						
△			7.5437	0.1639

Material Description	USCS	AASHTO
○ BH3 4-6 ft		
□ BH3 6-8 ft		
△ BH3 12-14 ft

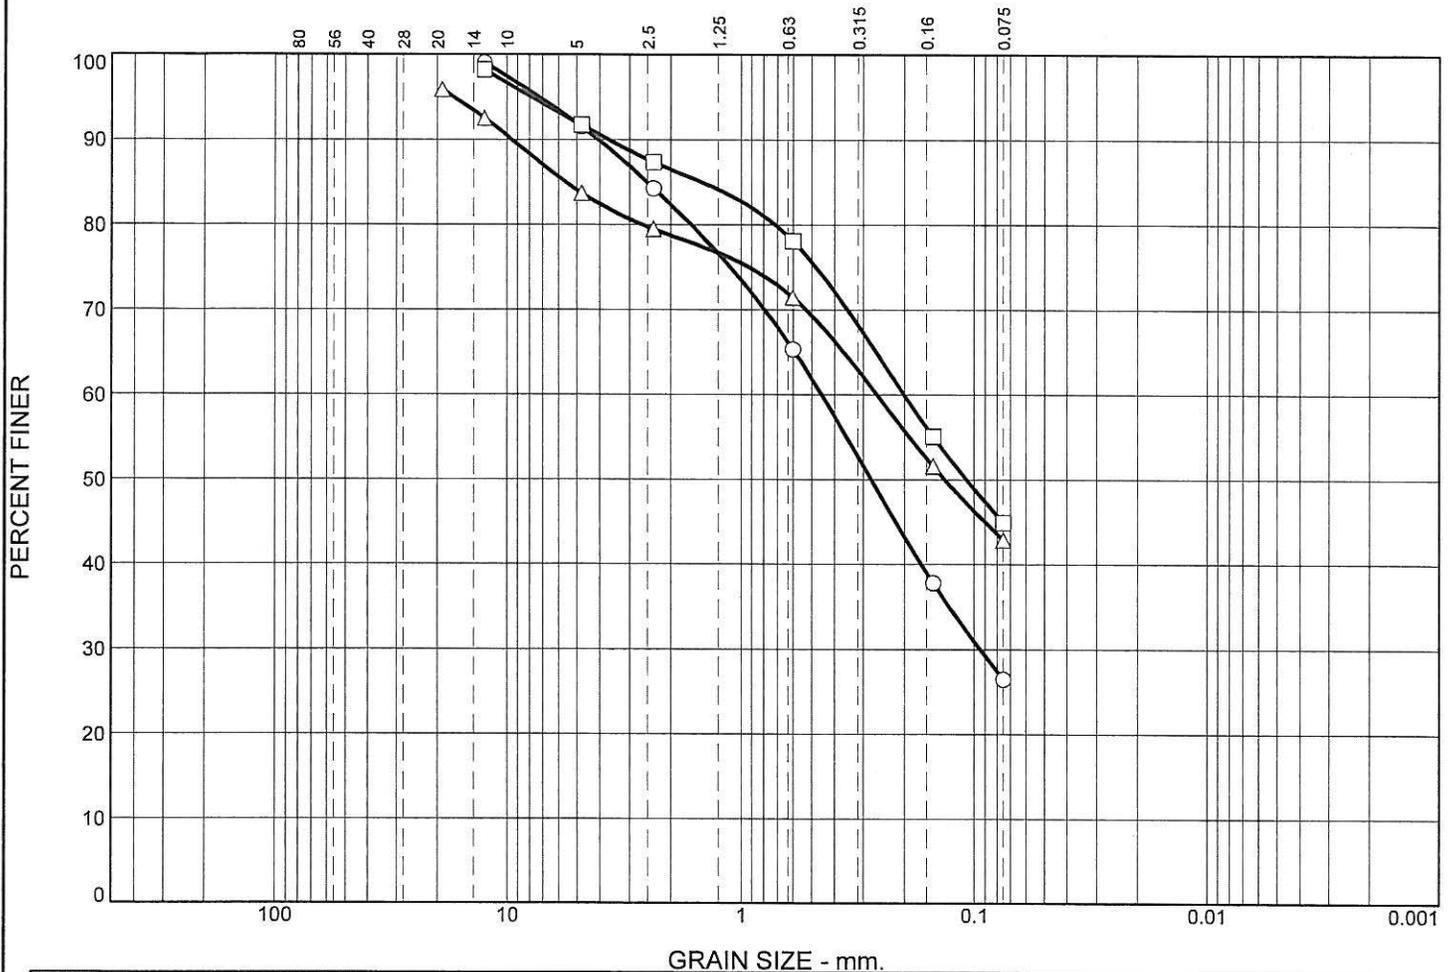
Particle Size Distribution Report

% +3"		% Gravel		% Sand			% Fines		
			Coarse	Fine	Coarse	Medium	Fine	Silt	Clay	
○					9.1	23.6	32.3	26.5		
□					5.2	13.3	28.3	44.9		
△					5.0	11.4	24.4	42.9		
×	LL	PL	D ₈₅	D ₆₀	D ₅₀	D ₃₀	D ₁₅	D ₁₀	C _c	C _u
○			2.5286	0.4520	0.2776	0.0942				
□			1.4793	0.1998	0.1078					
△			5.5733	0.2612	0.1336

Material Description	USCS	AASHTO
○ BH4 2-4 ft	VG	
□ BH4 6-8 ft		
△ BH4 8-10 ft

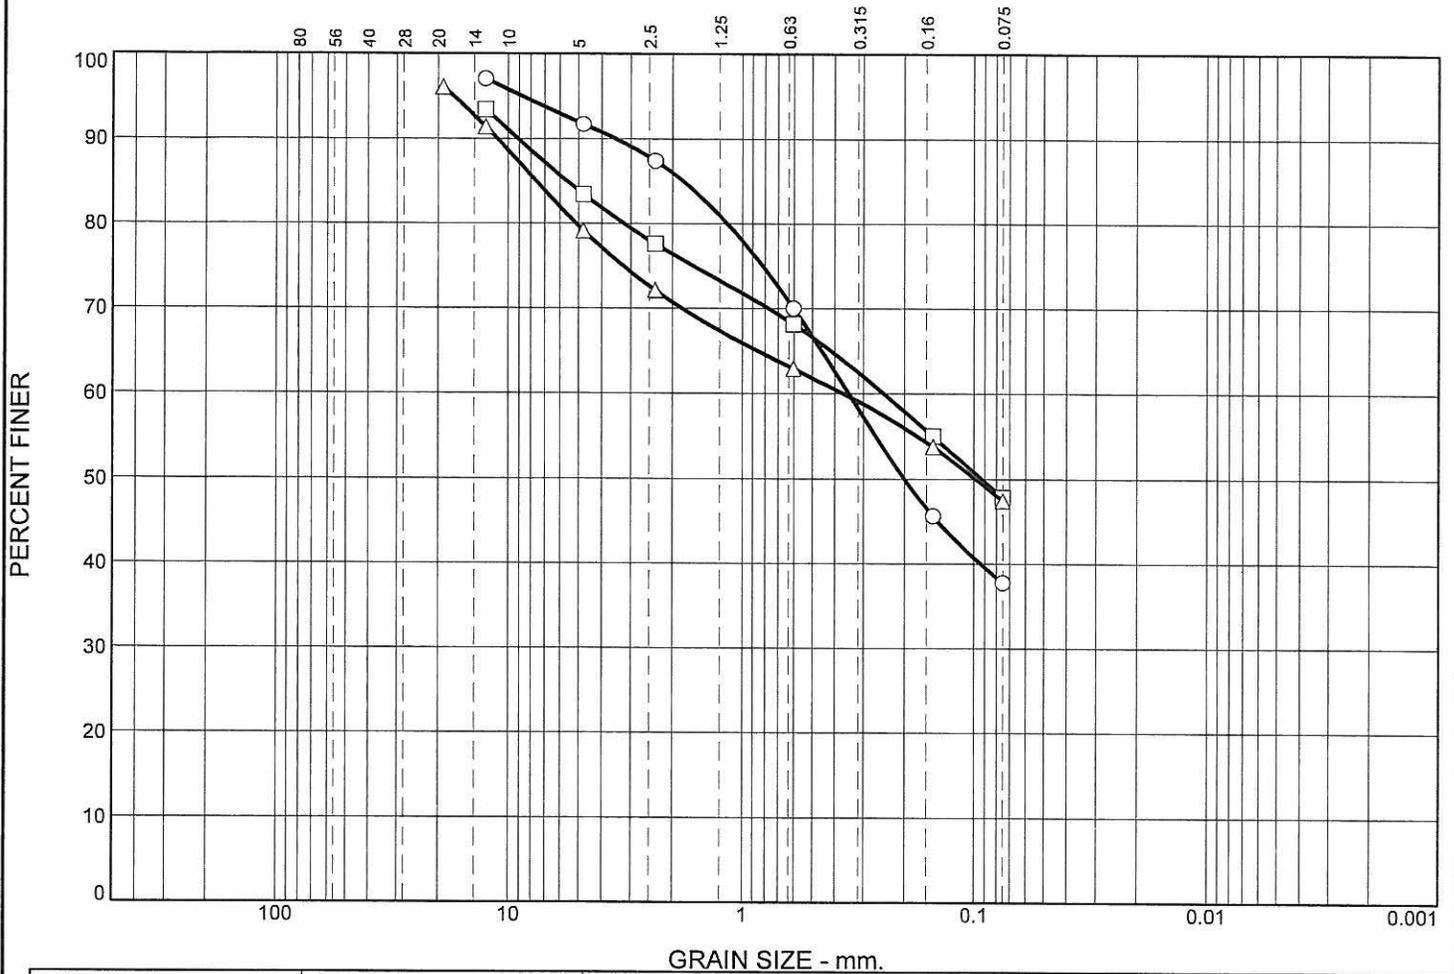
Particle Size Distribution Report

% +3"		% Gravel		% Sand			% Fines		
			Coarse	Fine	Coarse	Medium	Fine	Silt	Clay	
○					5.7	22.2	26.1	37.7		
□					7.0	11.2	17.4	47.8		
△					8.4	9.8	13.5	47.4		
	LL	PL	D ₈₅	D ₆₀	D ₅₀	D ₃₀	D ₁₅	D ₁₀	C _c	C _u
○			1.8002	0.3474	0.1992					
□			5.6041	0.2446	0.0925					
△			7.5826	0.3647	0.0981

Material Description							USCS	AASHTO
○ BH5 4-6 ft								
□ BH5 6-8 ft								
△ BH5 8-10 ft

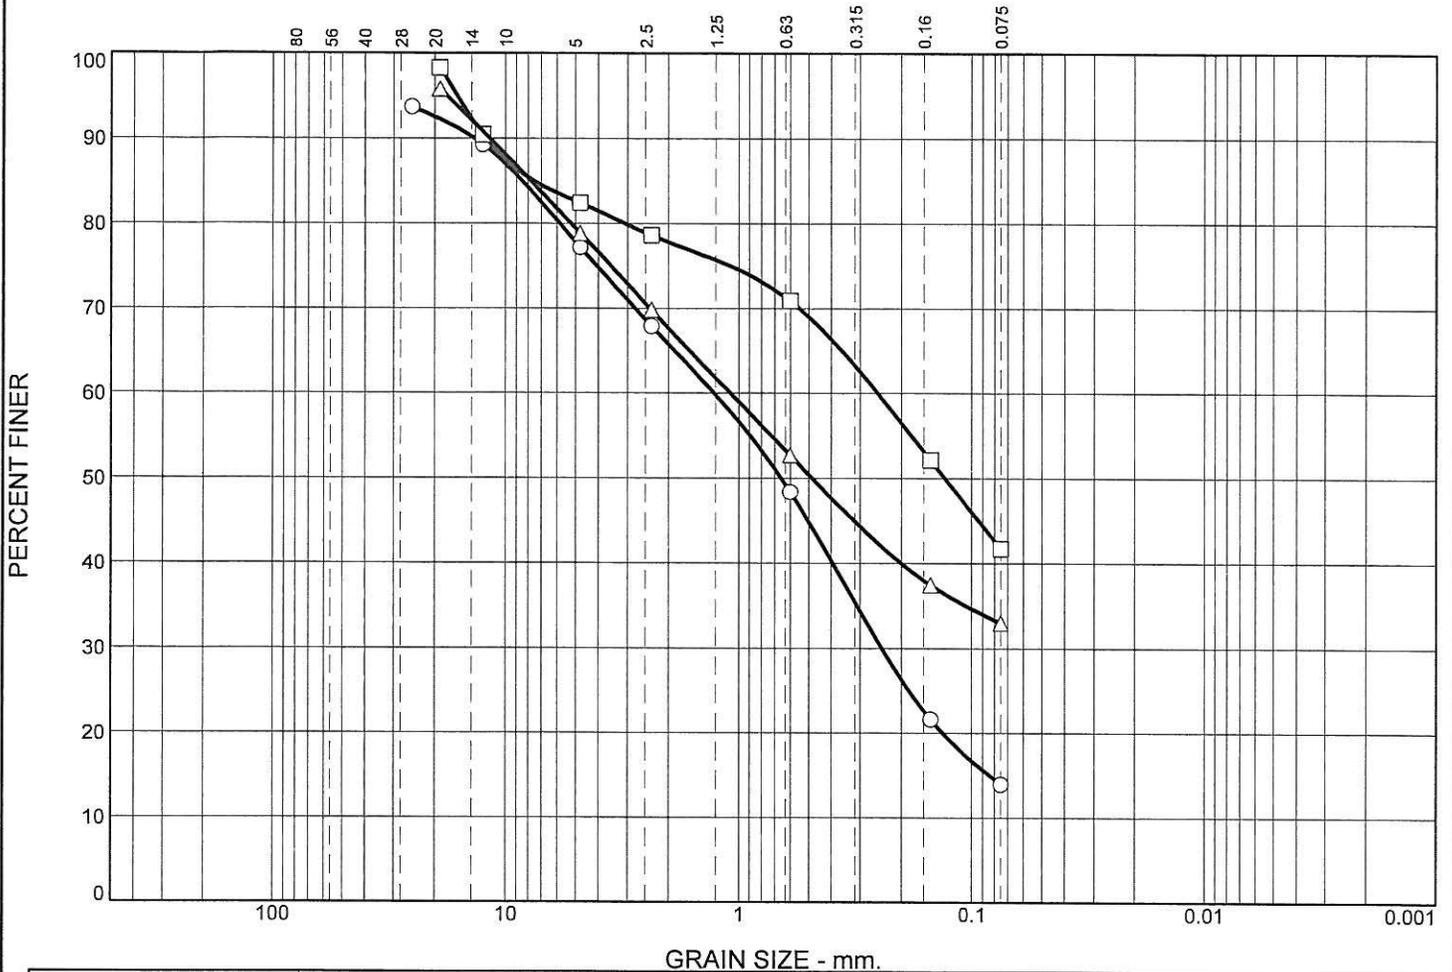
Particle Size Distribution Report

% +3"	% Gravel		% Sand			% Fines			
		Coarse	Fine	Coarse	Medium	Fine	Silt	Clay		
○			15.1	11.4	24.2	27.7	13.9			
□				4.6	10.6	25.5	41.7			
△				11.1	19.3	15.4	33.0			
×	LL	PL	D ₈₅	D ₆₀	D ₅₀	D ₃₀	D ₁₅	D ₁₀	C _c	C _u
○			8.4753	1.2712	0.6570	0.2422	0.0842			
□			7.5373	0.2515	0.1303					
△			7.7791	1.0833	0.4829

Material Description	USCS	AASHTO
○ BH6 2-4 ft	GM-SM	
□ BH6 6-8 ft		
△ BH6 14-16 ft

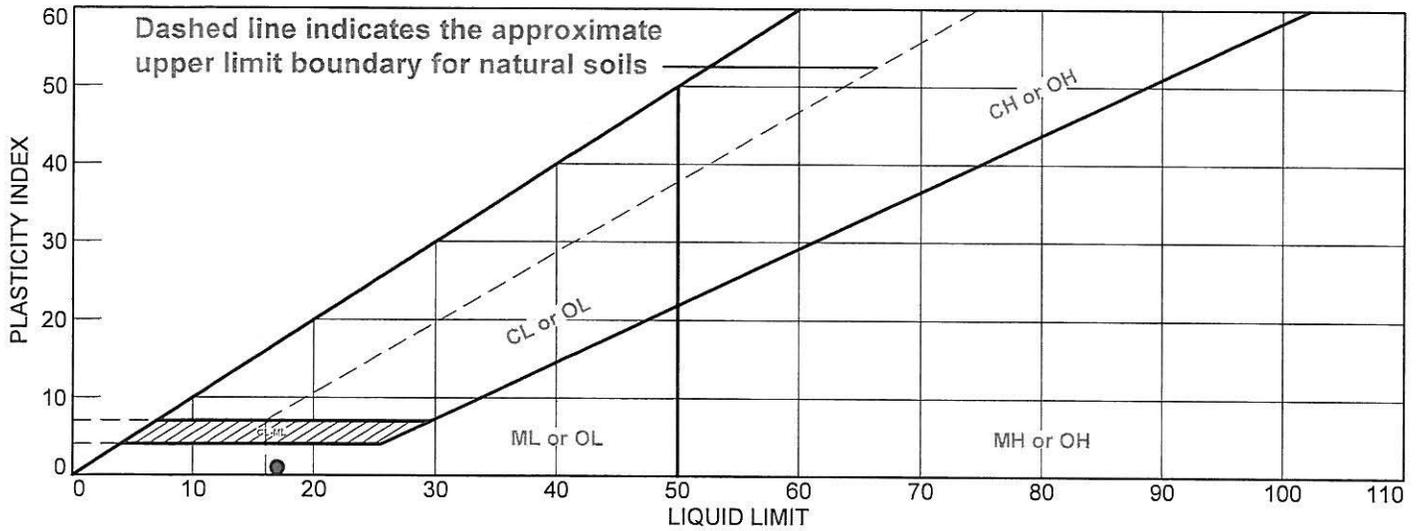
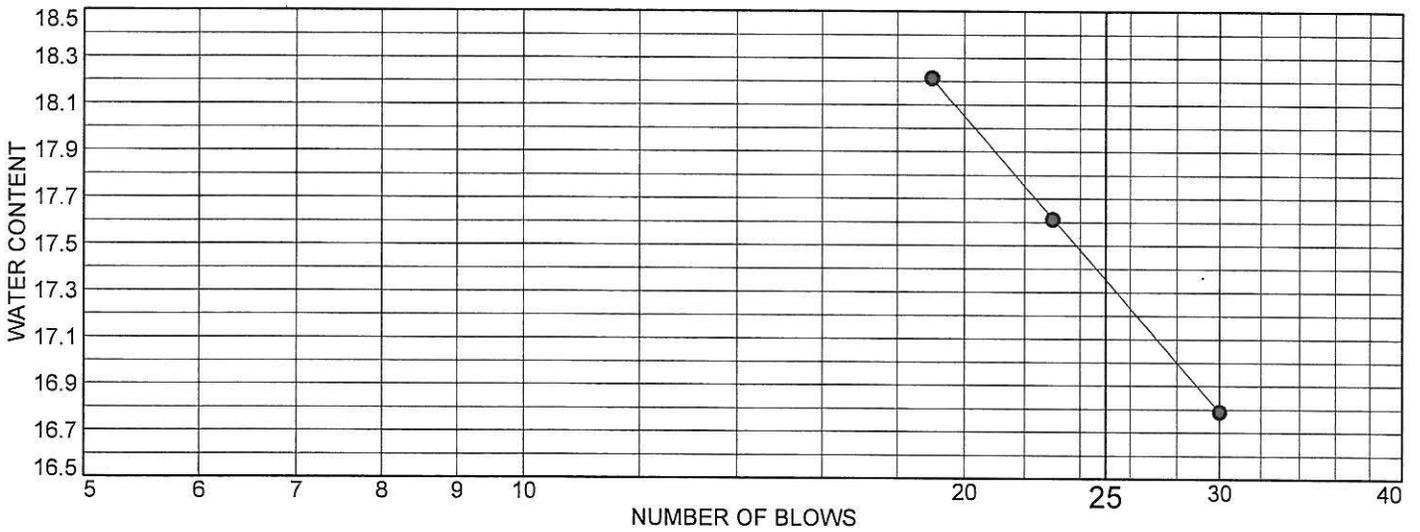
LIQUID AND PLASTIC LIMITS TEST REPORT

MATERIAL DESCRIPTION	LL	PL	PI	%<#40	%<#200	USCS
● Dense Brown Silty Sand with Some Gravel	17	16	1

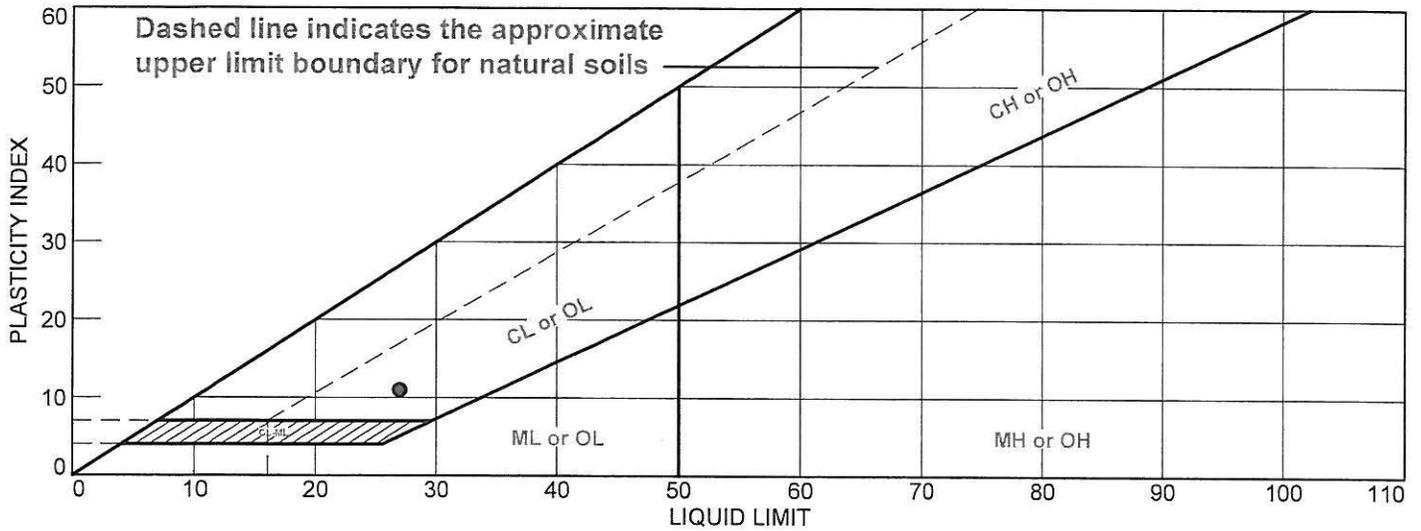
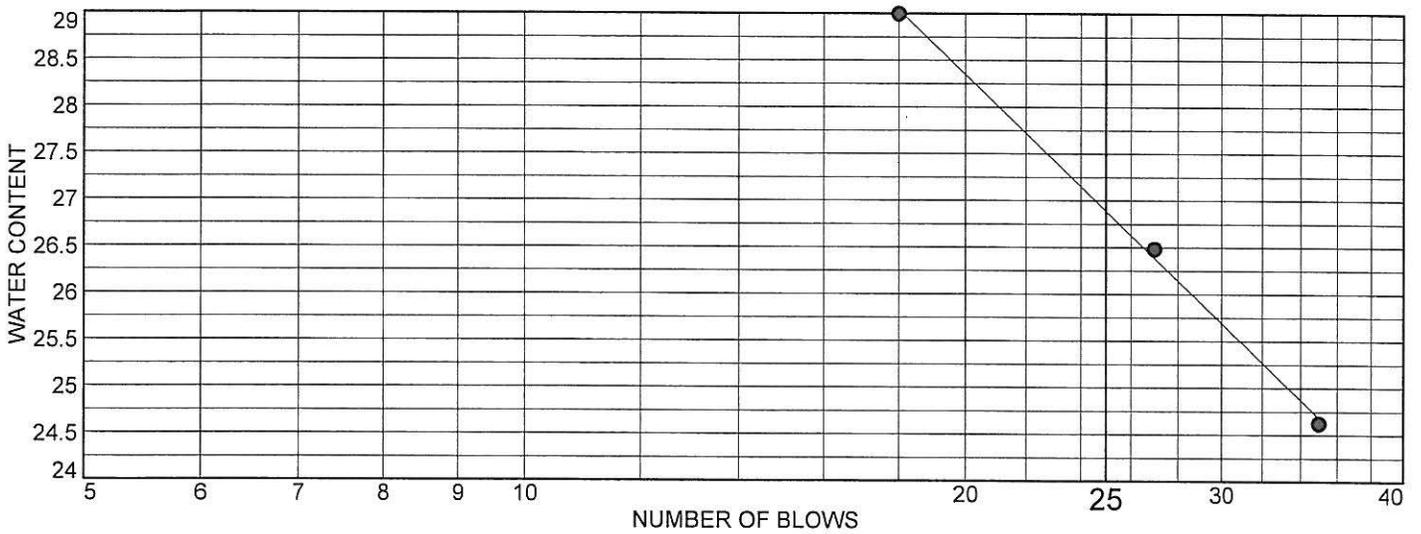
LIQUID AND PLASTIC LIMITS TEST REPORT

MATERIAL DESCRIPTION	LL	PL	PI	%<#40	%<#200	USCS
●	Very Stiff Brown Sandy Silt with Some Gravel	27	16	11

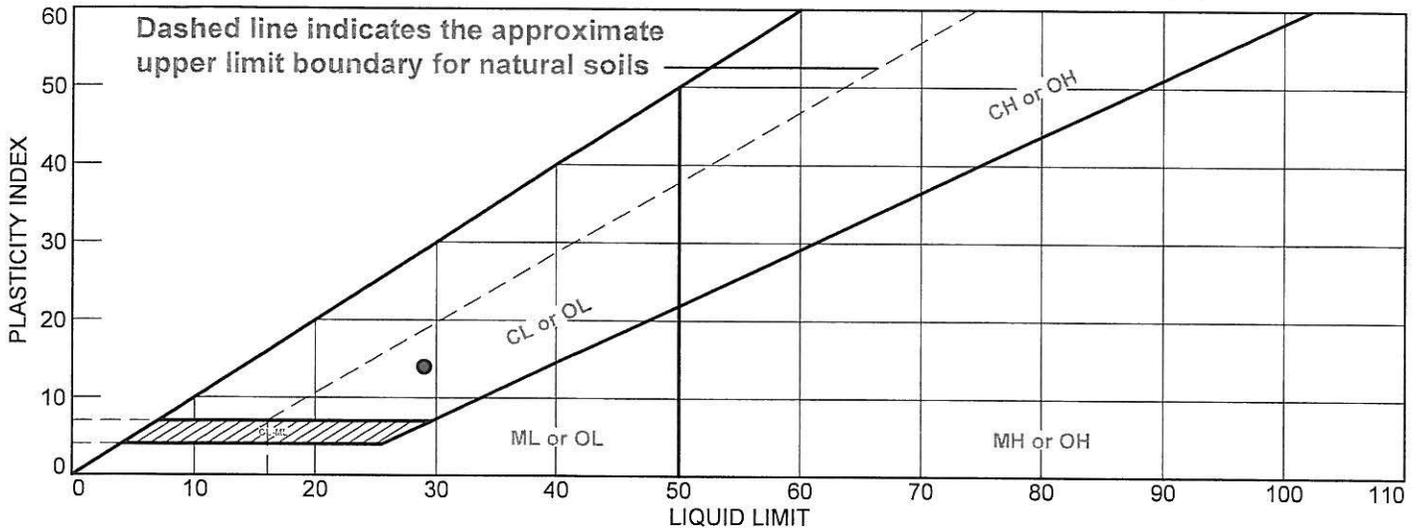
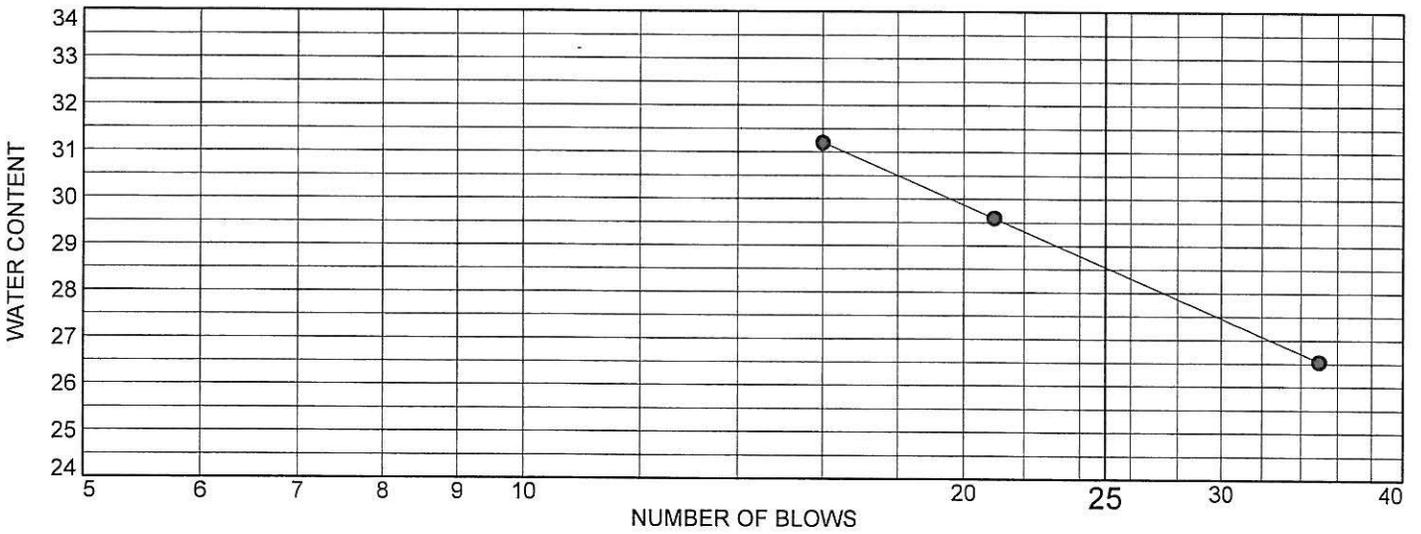
LIQUID AND PLASTIC LIMITS TEST REPORT

MATERIAL DESCRIPTION	LL	PL	PI	%<#40	%<#200	USCS
• Very Dense Reddish Brown Silty Sand with Some Gravel	29	15	14
