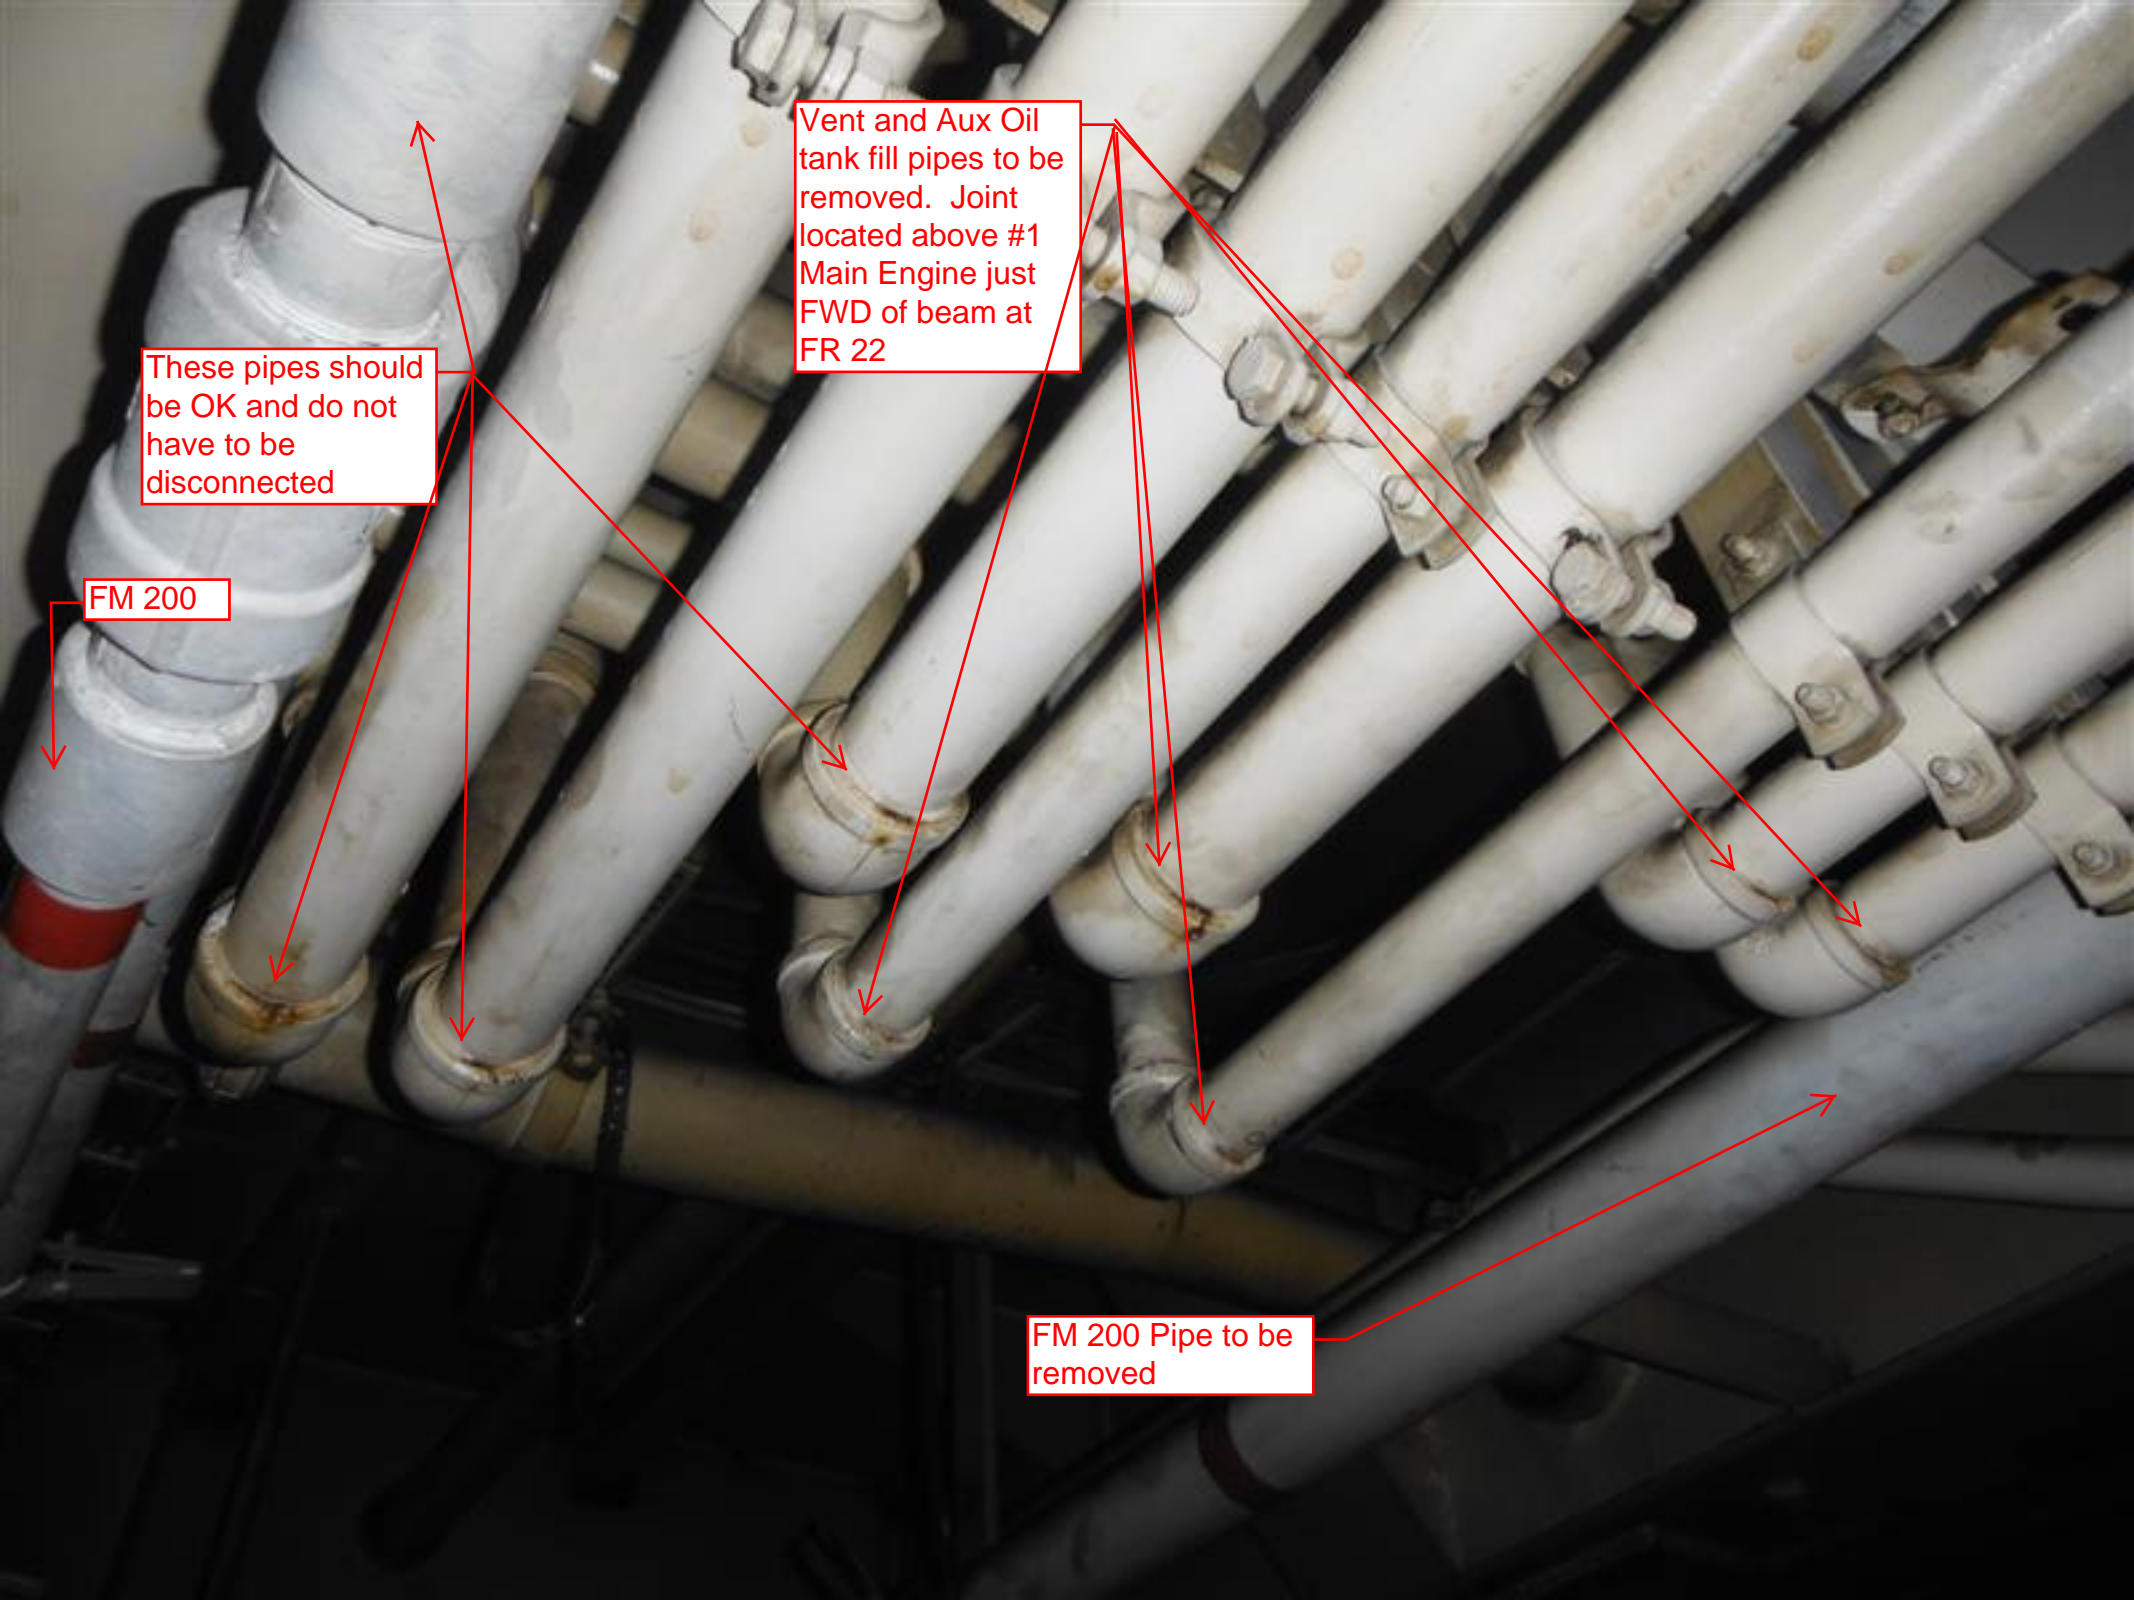
These pipes should be OK and do not have to be disconnected

FM 200

Vent and Aux Oil tank fill pipes to be removed. Joint located above #1 Main Engine just FWD of beam at FR 22

FM 200 Pipe to be removed
