<p>Project title/Titre du projet Protection Mountain Campground Road Reconstruction Banff National Park</p>		<p>Partis Canada Parcs Canada Asset Management Gestion des biens Western and Région de l'Ouest et du Nord</p>	
<p>Drawing title/Titre du dessin East Loop Ring Road Layout and Typical Section</p>		<p>Consultant's Name Infirmières Eng. Stomp Secu de l'ingénieur</p>	
<p>Surveys by/Agrants par Designed by/Conseil par Client Acceptance/Acception du client/ Approved by/ Approuvé par</p>		<p>Drawn by/Dessiné par Reviewed by/Revisé par Scale/Echelle 1:1000</p>	
<p>Project No./No du projet Drawing Set No./No de série du dessin</p>		<p>Sheet No./Feuille No de la feuille</p>

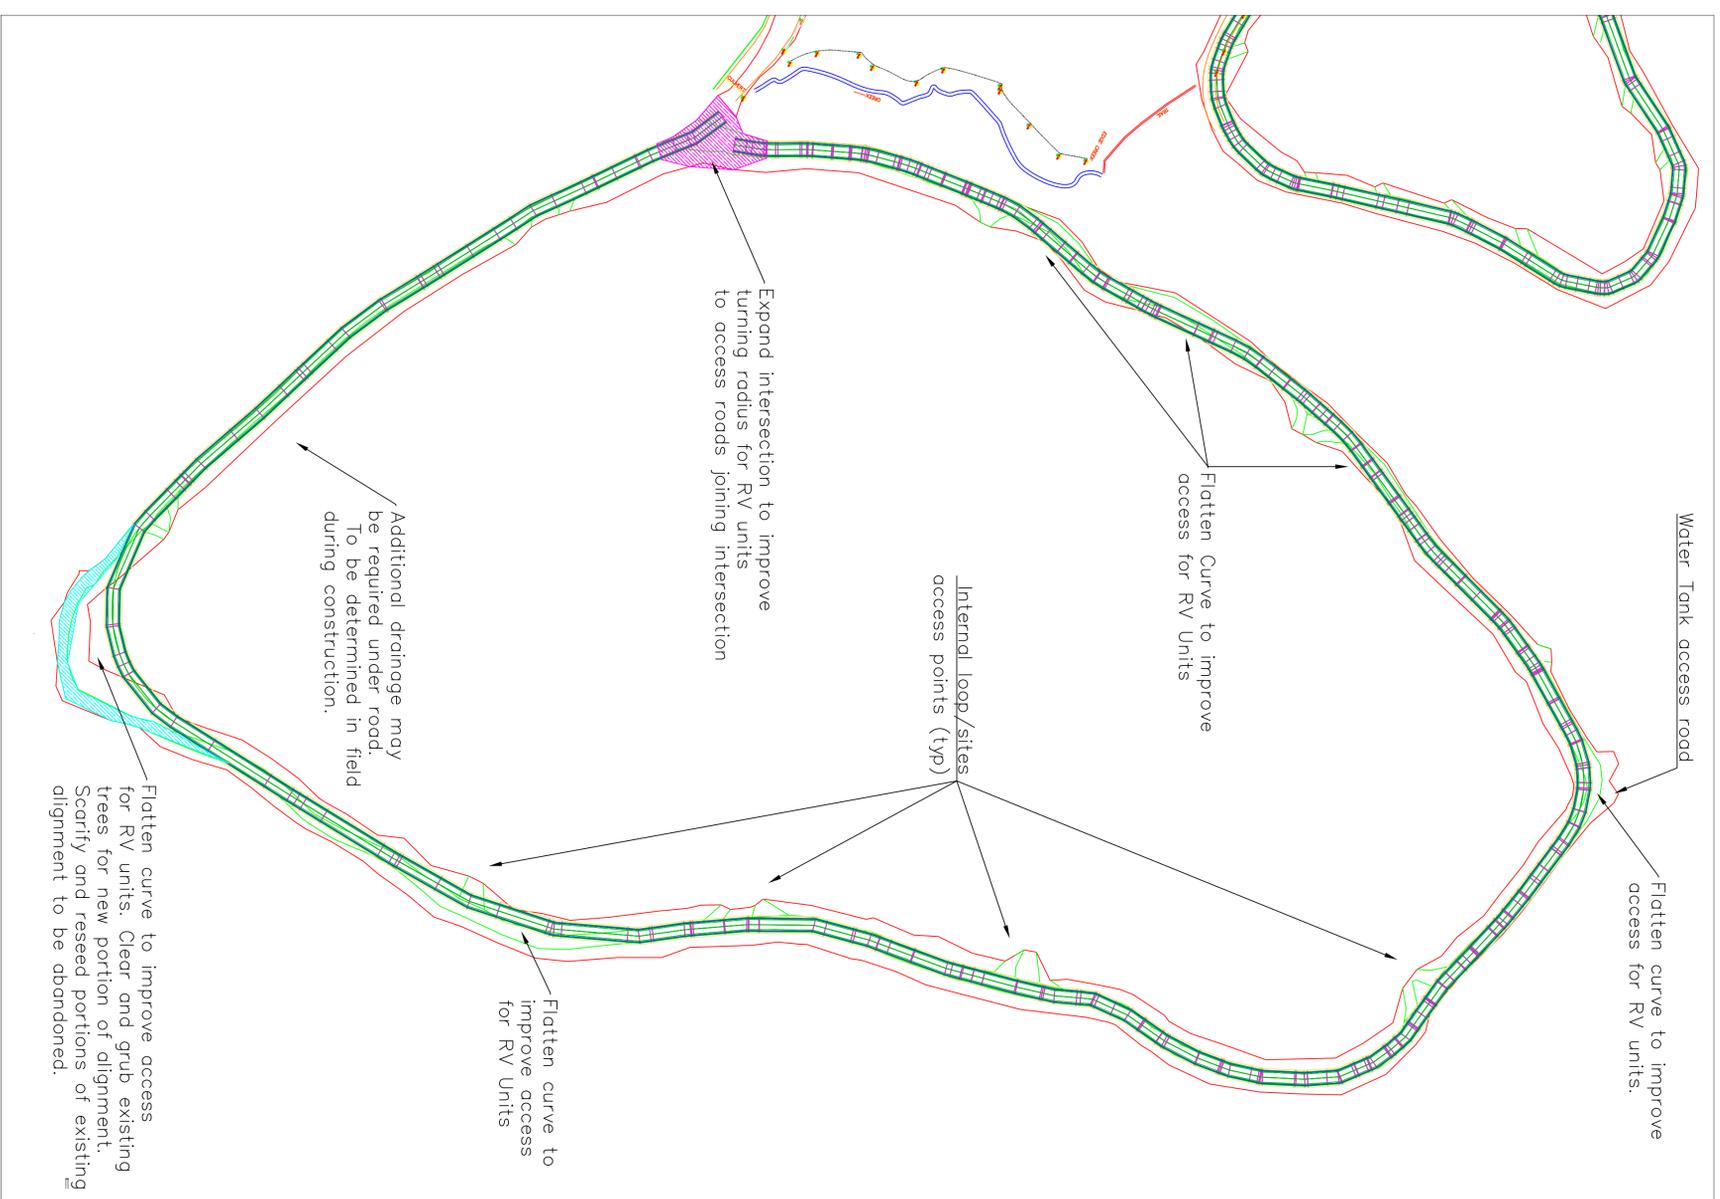
- Notes**
- Road to be reconstructed to grades and profile as specified
 - Remove existing road and subcut 300 mm to begin reconstruction. Line excavation with geotextile (Nilix 2016) and construct subbase using imported pitrun gravel. Top subbase with 150 mm of 20 mm road crush.

- Clear and grub stumps, brush and trees as required to facilitate new alignment where required and to prepare existing ground for reconstruction of new road. Dispose of materials as directed by the Departmental Representative.

- Straighten (flatten) the alignment of the existing road in locations indicated to improve access for RV units in campground.
 - Feather road embankment into the connecting internal loops/sites to provide relatively flat access into these sites. Feather the embankment 1 to 2 m in length into these locations as required.

- Recover and reinstall gate to the water tank access road. Repair portions of the Water Tank Access Road as directed by the Departmental Representative by spreading a lift of 20 mm road crush in the locations as directed by the Departmental Representative
