PROJECT  
FTA AT THUNDER BAY INTERNATIONAL AIRPORT  
THUNDER BAY, ONTARIO

CROSS SECTION A-A' & B-B'

FIGURE C-3

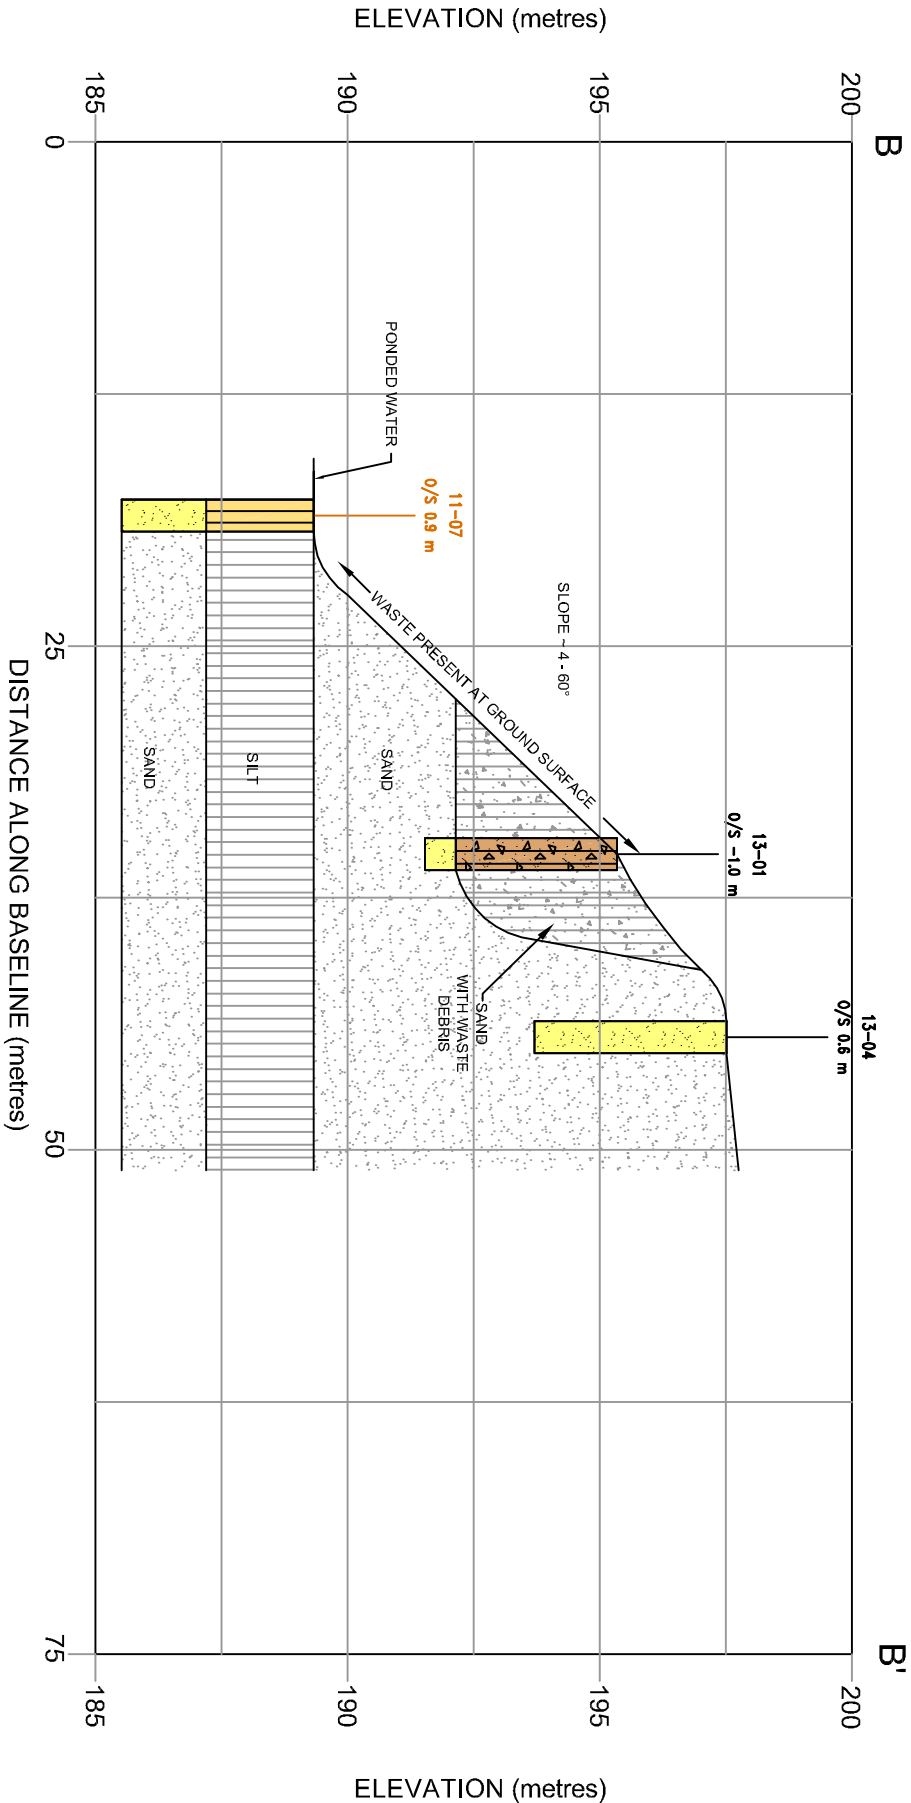
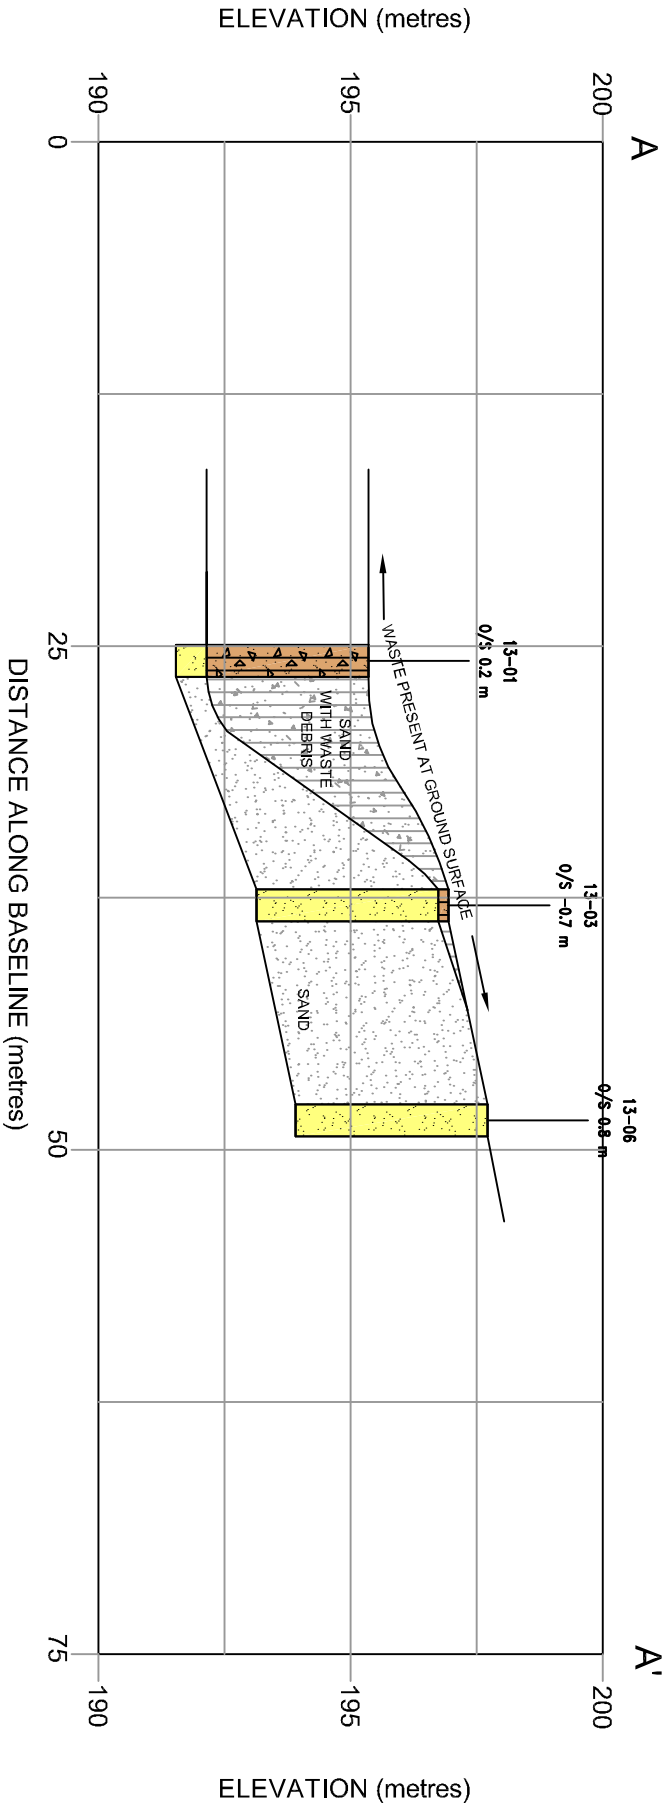
1. TYPICAL CROSS-SECTION THROUGH WASTE BASED ON BOREHOLES ADVANCED TO 3.8 m BELOW GROUND SURFACE IN AUGUST 2013. CONDITIONS MAY VARY
2. REFER TO FIGURE C-2 FOR APPROXIMATE LATERAL EXTENT OF WASTE AT GROUND SURFACE, OBSERVED IN AUGUST 2013.
3. GROUNDWATER PREVIOUSLY ENCOUNTERED BETWEEN 188.1 AND 193.5 m IN THE WORK AREA (LOCAL DATUM, BASED ON THIS PLAN)
4. THIS FIGURE IS TO BE READ IN CONJUNCTION WITH THE ACCOMPANYING TENDER SPECIFICATIONS
